Rio Grande Boulevard and Candelaria Road Intersection Evaluation

A/E Job No. 7380-01, NTP #2
PB Project 33612

City of Albuquerque

October 2008

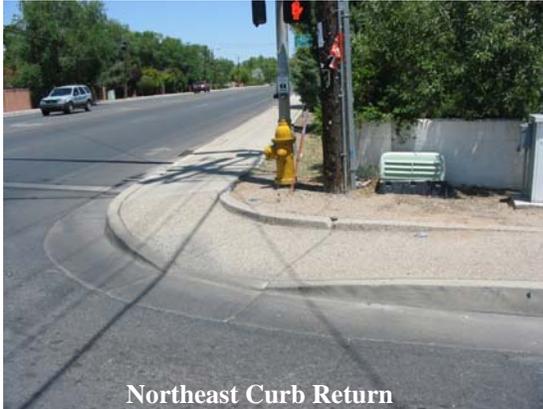
There do not appear to be any significant intersection grading issues. There is no visual evidence of water ponding within the intersection. The crown section of the roadway conveys flows to the curb and gutter located along the edge of the roadway. Drop inlets are located on either side of Rio Grande Boulevard, north of the intersection.

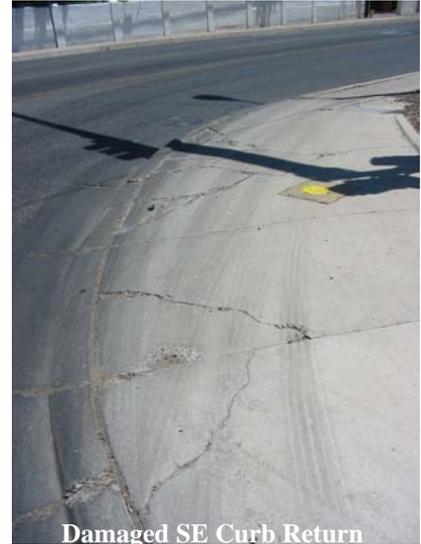
Based on visual observations, the overall pavement condition at the intersection appears good. There is minor rutting within the travel lanes at several of the approaches. There is minor longitudinal cracking along the north leg of Rio Grande Boulevard and along the east leg of Candelaria Road. The curb and gutter within the project area is also generally in good shape. There is evidence of vehicle off-tracking in all for quadrants. The off-tracking in the southeast quadrant appears to have damaged the curb and gutter in this area.

Damaged SE Curb Return

The southeast curb return shows evidence of significant vehicle off-tracking which is a danger to pedestrians in this quadrant of the intersection. Reconstructing this curb return to accommodate a 30-ft radius will allow larger vehicles to navigate the curve without driving through the pedestrian ramp and on the sidewalk.

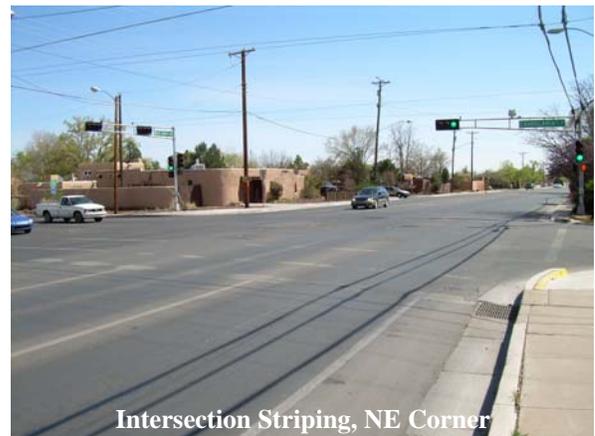
Intersection Striping, NE Corner

The overall striping condition at the intersection appears fair. Lane and centerline striping at each of the intersection approaches is clearly visible, yet crosswalk and stop bar striping is badly worn where vehicles track through it. Pavement markings (arrows, symbols, and words) are in fair condition throughout the intersection.

The pedestrian crossings are poorly marked at the intersection as a result of deteriorated pavement striping. A combination of restriping each crosswalk and pedestrian activated in-pavement flashing lights should be implemented to better mark the crosswalks for pedestrians. The in-pavement markings would be manually actuated through the pedestrian push buttons at each mastarm and would better define the crosswalk when in use. Stop bars at the intersection should also be refreshed.

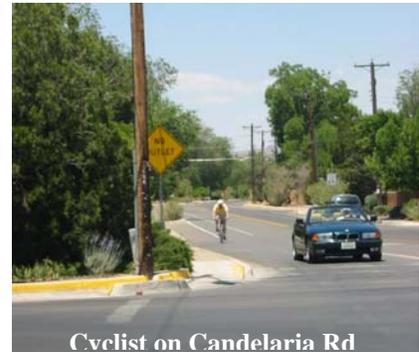
Cyclist on Candelaria Rd

Rio Grande Boulevard has 4-ft bike lanes on either side of the roadway through the intersection which is consistent with the current MRCOG Long Range Bikeway System map. The lanes are labeled with thermoplastic pavement markings which are supplemented by panel signs. Candelaria Road is designated as a bicycle route. There are no on-street facilities but there are panel signing designated the facility as a bicycle route which is consistent with the designation.

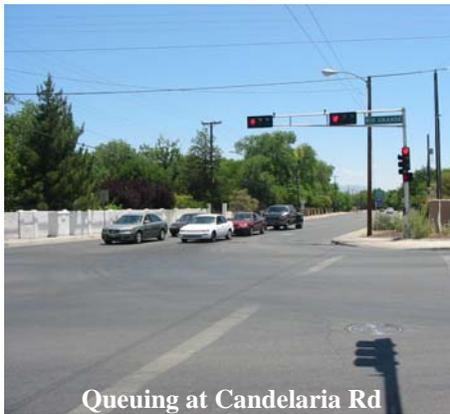
The existing queue storage at both approaches to Candelaria Road for the left-turn movement is not adequate based upon existing volumes. A site investigation confirms that vehicular queuing exceeds the available storage, particularly at the east approach (westbound traffic). The analysis indicates that there are no queue storage issues along Rio Grande Boulevard.

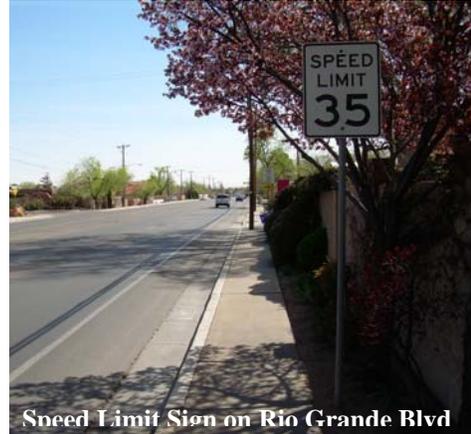
Panel signs through the project area are in good condition. All signs are mounted in accordance with the MUTCD and are visible. One item of note is that the speed limit sign in the southbound direction, north of the intersection, is over one mile away from the Rio Grande Boulevard and Candelaria Road intersection. Because of this, many vehicles entering the roadway have no speed limit indication prior to reaching the intersection.

Speed Limit Sign on Rio Grande Blvd

Speed limit signing is sporadic throughout the Rio Grande Boulevard and Candelaria Road corridors. Additional signing should be installed to reinforce the speed limits to motorists.
