# PARCEL 8 ADDITIONAL CHARACTERIZATION REPORT

## CITY OF ALBUQUERQUE RAIL YARDS

Albuquerque, Bernalillo County, New Mexico

**April 27, 2017**

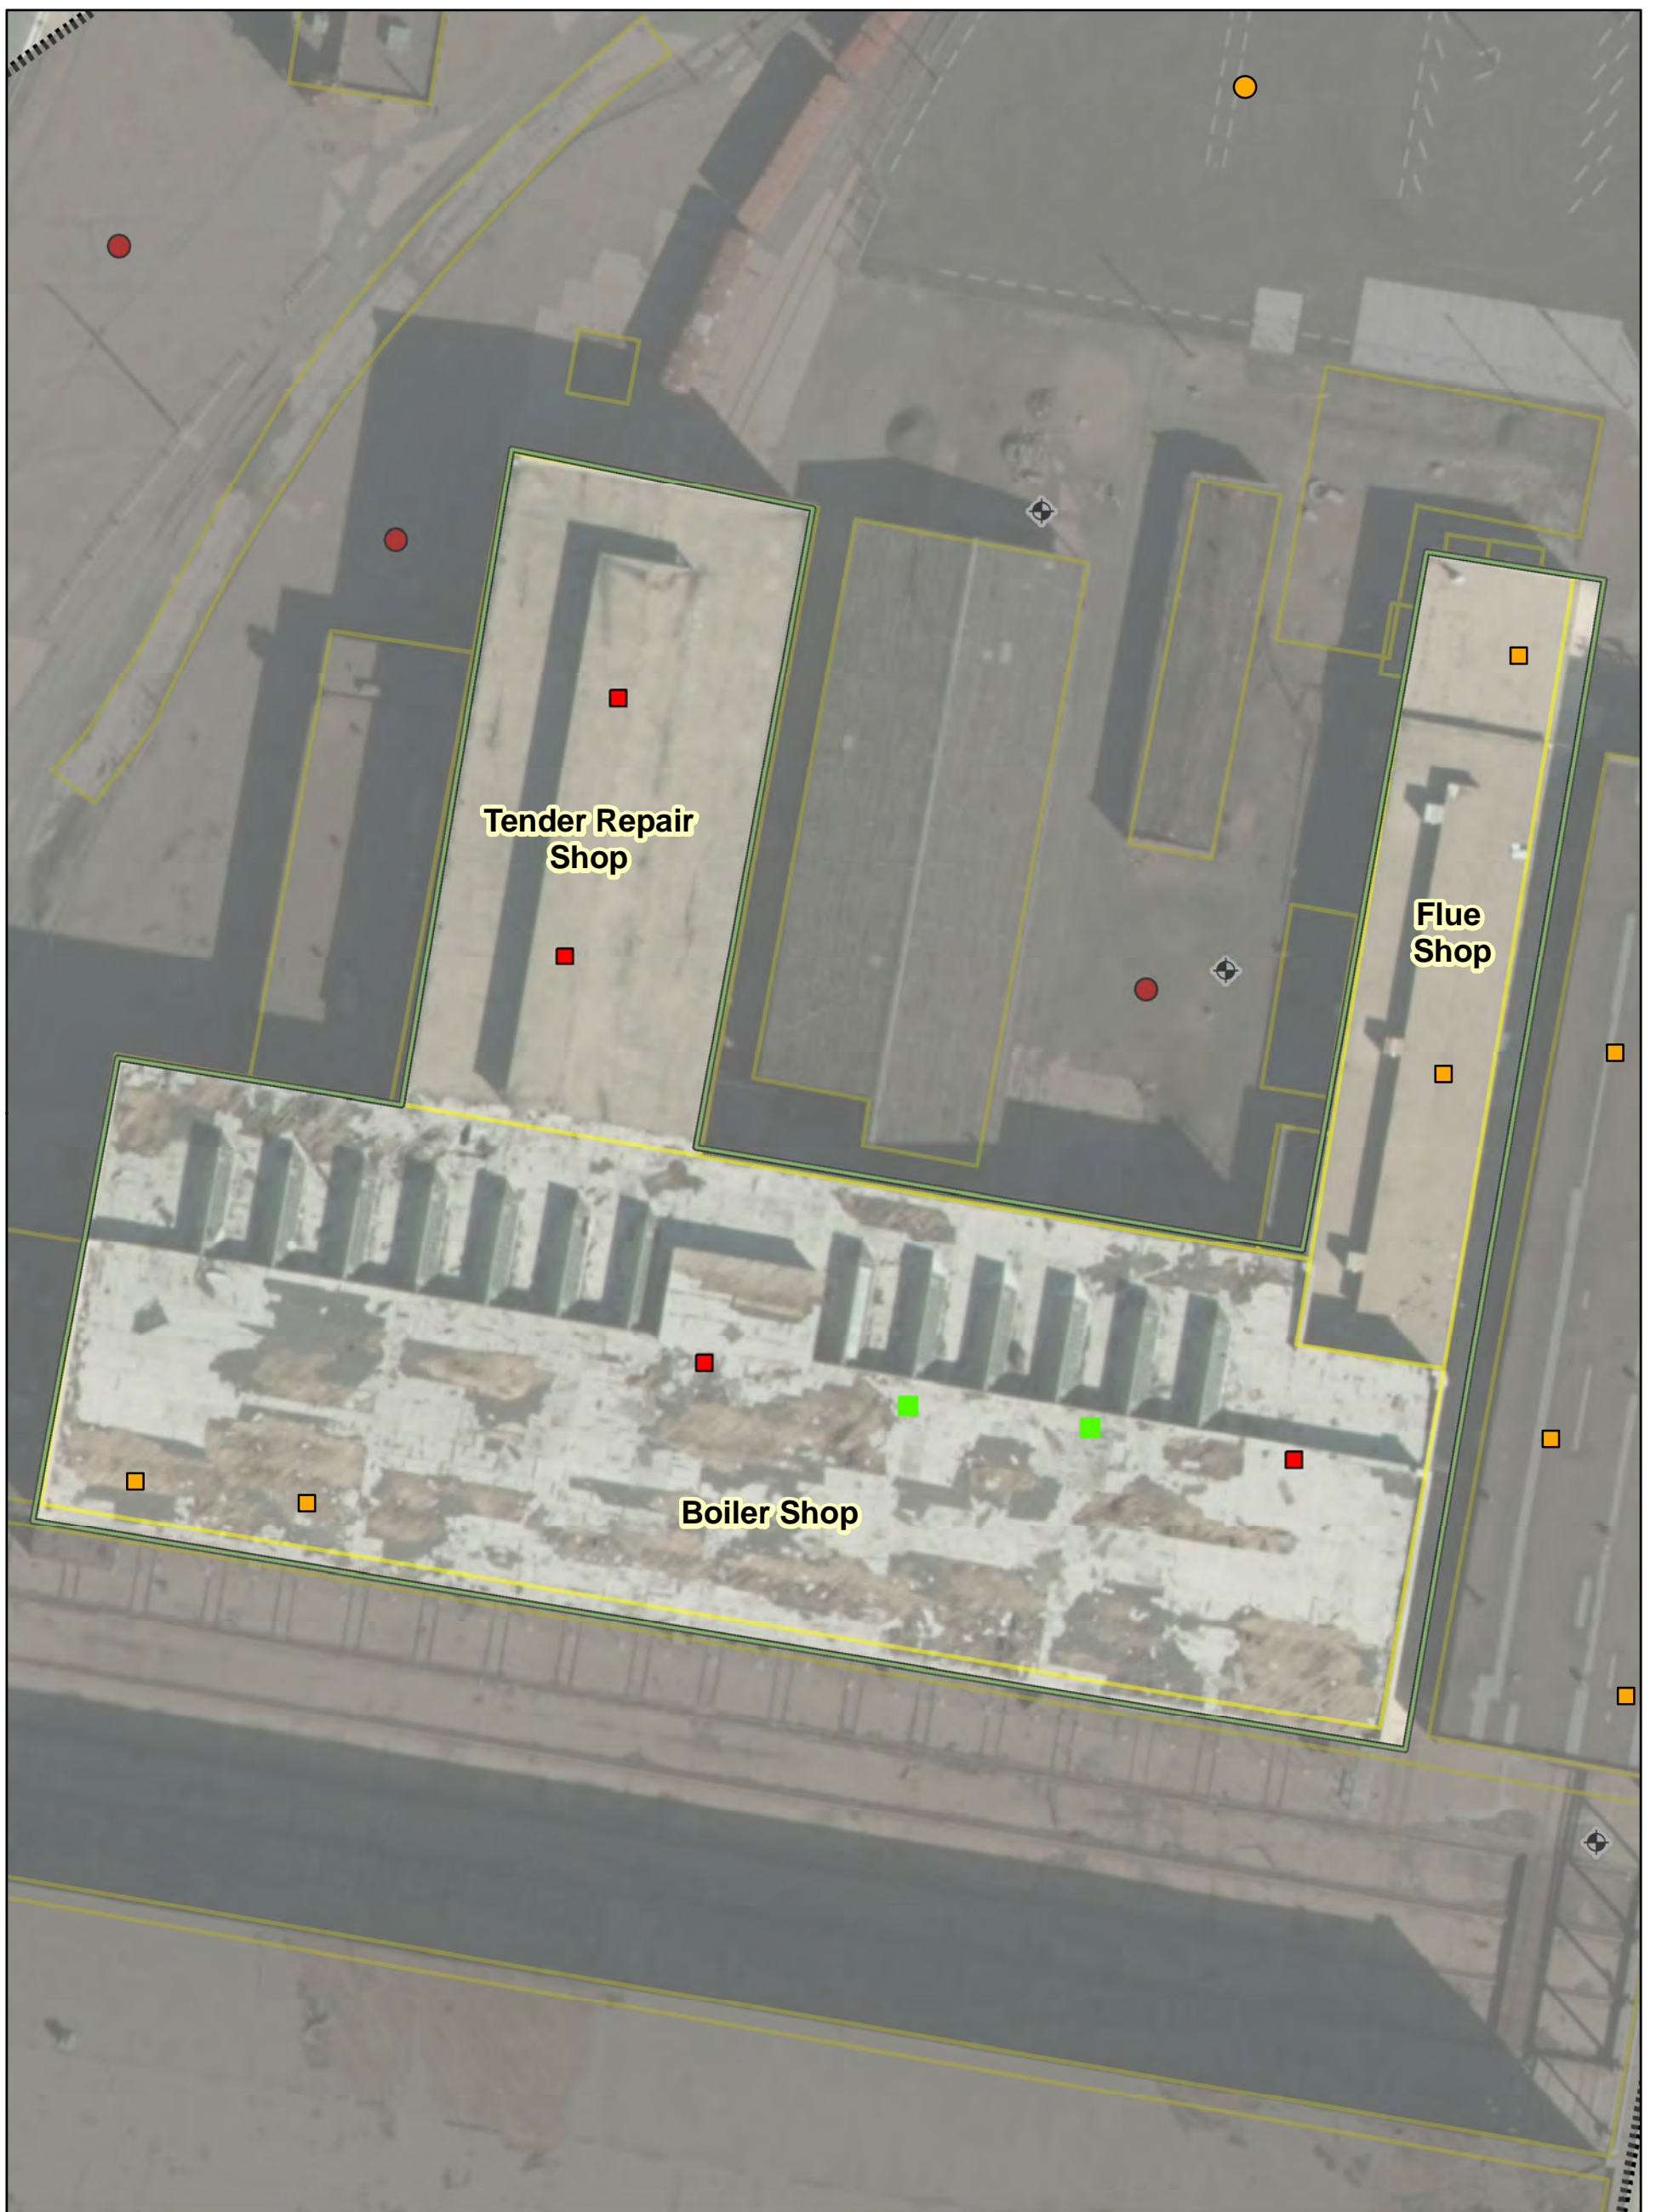
- Naphthalene concentrations in soil gas exceeded the NMED VISL of 8.26  $\mu\text{g}/\text{m}^3$  at four of the 10 sub-slab soil vapor sampling locations, two within the Tender Repair Shop and two within the Boiler Shop, indicating a potential for vapor intrusion (**Table 1** and **Figure 3**).
- The laboratory RL for EDB in soil gas exceeded the corresponding NMED VISL (**Table 1**).
- Asbestos and LBP were detected in the Boiler Shop, Flue Shop, and Tender Repair Shop.

- Soil Gas Engineering Controls: Soil gas samples collected within Parcel 8 revealed potential vapor intrusion issues within the Boiler Shop and Tender Repair Shop (naphthalene concentrations in soil gas). Even though the laboratory RL for EDB in soil gas exceeded the corresponding NMED VISL, EDB is not considered a contaminant of concern of the Site because it has not been identified above RL in either Site soil or ground water or was associated with historical Site uses. Engineering controls to prevent vapor intrusion should be evaluated and selected to eliminate this exposure pathway. These engineering controls could include a vapor intrusion membrane, passive depressurization system, active depressurization system, or some combination. INTERA recommends installing a vapor intrusion membrane in all new buildings. If the Boiler Shop, Tender Repair Shop, and/or Flue Shop are retrofitted for occupancy, a vapor intrusion membrane should be installed or a depressurization system should be evaluated to minimize the potential exposure to vapor. INTERA recommends documenting any engineering controls implemented via institutional controls.

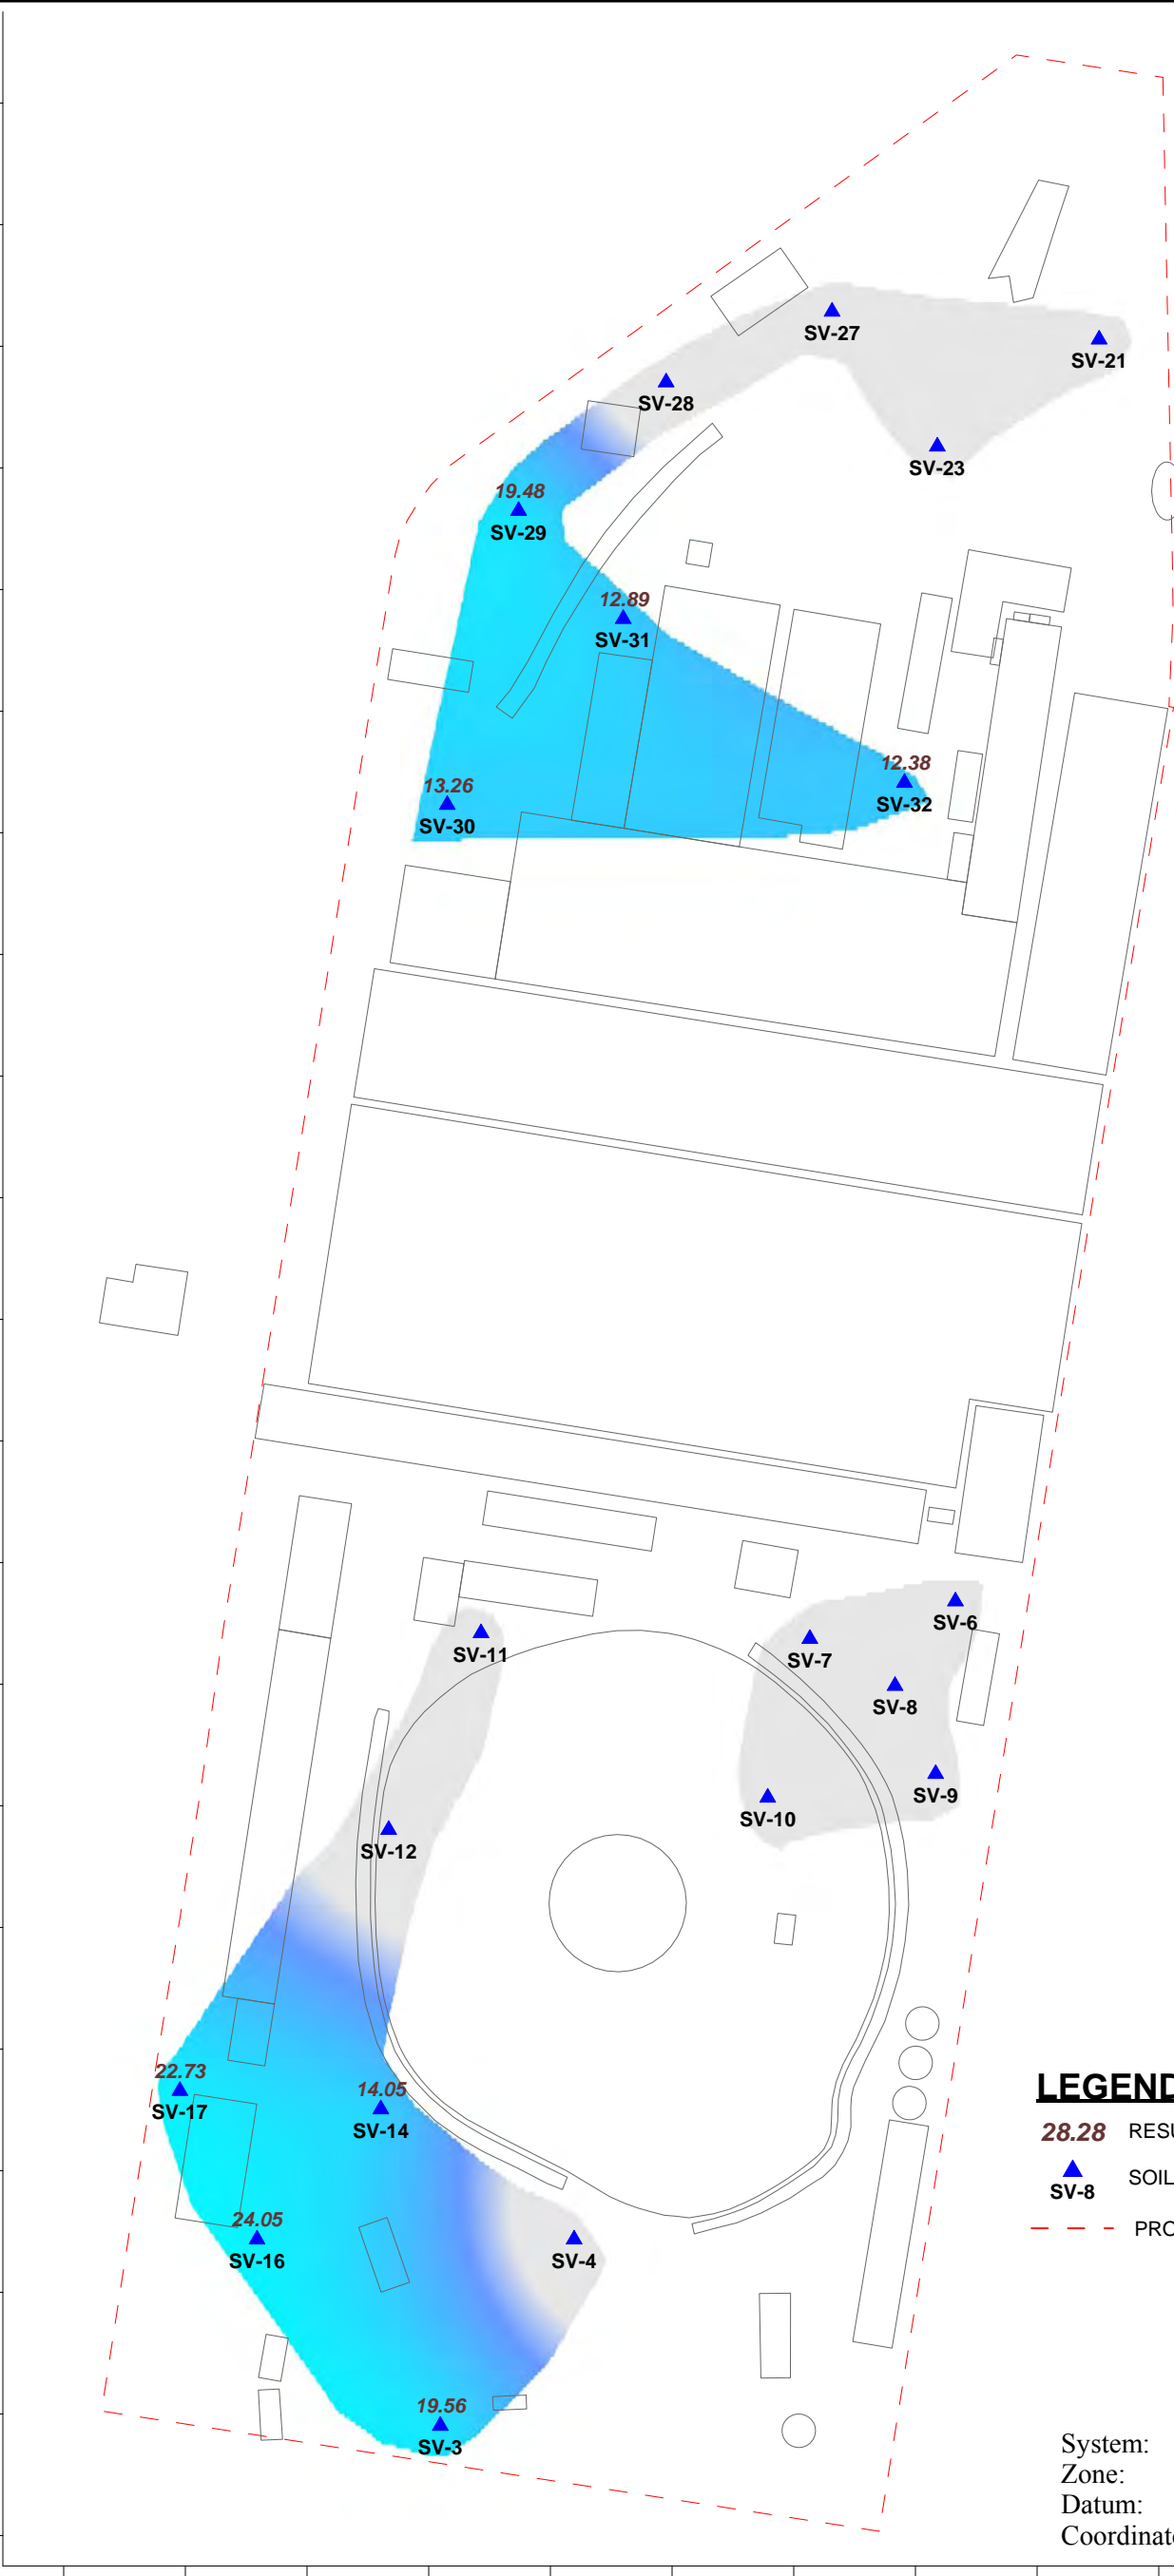
**Figure 3**  
**Soil-Gas Survey**  
**Naphthalene**  
**Albuquerque Railyards**  
**Albuquerque, NM**

Numerous VOC constituents were detected in the sub-slab soil vapor samples collected at the Tender Repair Shop including: 1,1,1-trichloroethane, 2-methylnaphthalene, ethylbenzene, naphthalene, p&m-xylene, and toluene; however, the detected concentrations did not exceed their respective NMED or EPA VISLs with the exception of naphthalene (**Table 1**). The concentration of total naphthalenes detected at sub-slab soil vapor samples SV-08-05 (56.69  $\mu\text{g}/\text{m}^3$ ) and SV-08-06 (12.95  $\mu\text{g}/\text{m}^3$ ) exceeded the NMED VISL of 8.26  $\mu\text{g}/\text{m}^3$  (**Table 1**).
