507 FOURTH STREET SW
STRUCTURAL ASSESSMENT
FOR THE CITY OF ALBUQUERQUE

APRIL 29, 2010
SMPC ARCHITECTS

STRUCTURAL EVALUATION
UNOCCUPIED HOUSE AT 507 FOURTH STREET SW
ALBUQUERQUE, NEW MEXICO

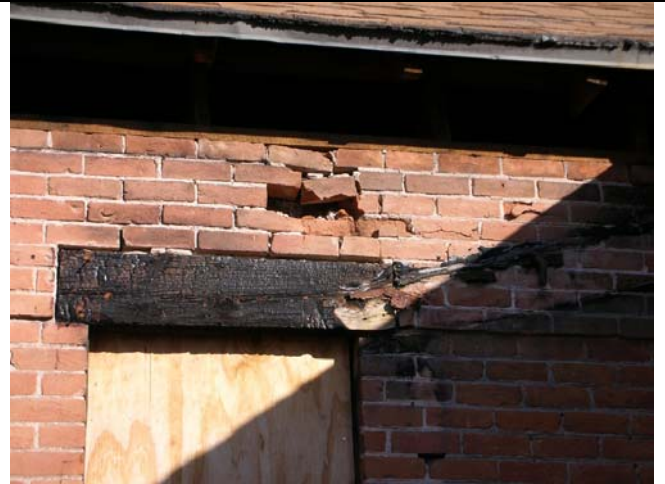
Fire damage at northwest porch

The porch in the northwest corner measures approximately 9' 0" (east-west) x 5' 6" (north-south) and has steps on the west side. The superstructure of this porch was at some time destroyed by fire.

11. The most visibly damaged west wall and northwest porch area should be partially removed, with corners to receive 12" columns, new foundation and wood stud wall. A future addition could be added to the west. Salvaged brick could be used for replacement. **\$13,115**

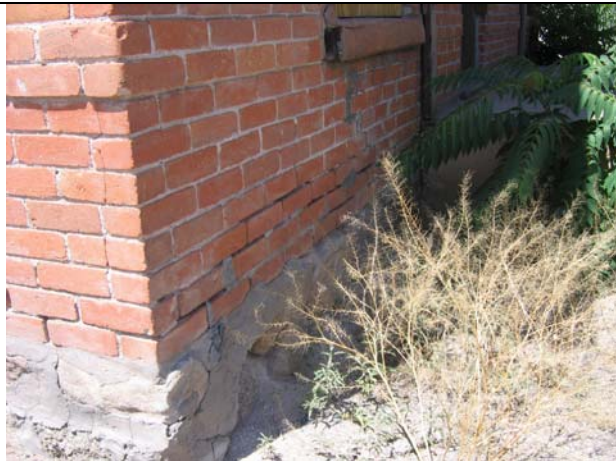
Typical stone foundation comprised of various stones with eroding mortar

Foundations. The original foundation for the house consists of natural boulders in mortar beds. The depth of embedment is not known. With this system, there is no possibility of reinforcement. There has been some cracking of the mortar joints at various places indicating possible differential settlement or possibly wracking loads such as those which might be caused by wind.

3. Remove loose stem wall mortar and replace **\$3,660**
4. Add a wall constructed of 4" 16 gauge studs @ 16" O.C. with steel reinforced sheathing on the interior side of the exterior walls to support the roof structure. Tie into the existing brick wall. **\$18,300**

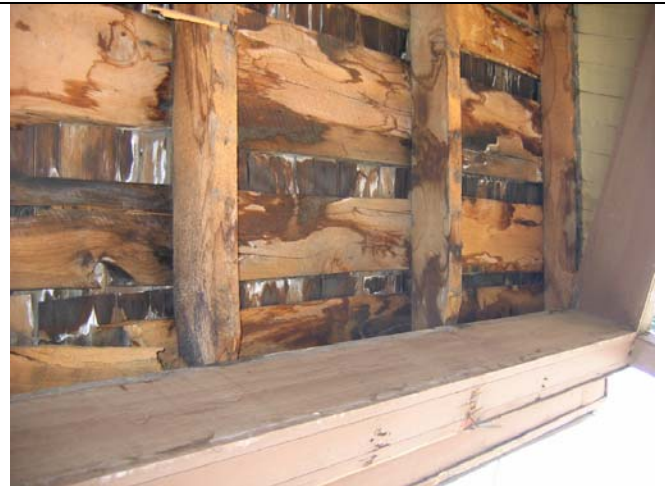
Front porch roof deck

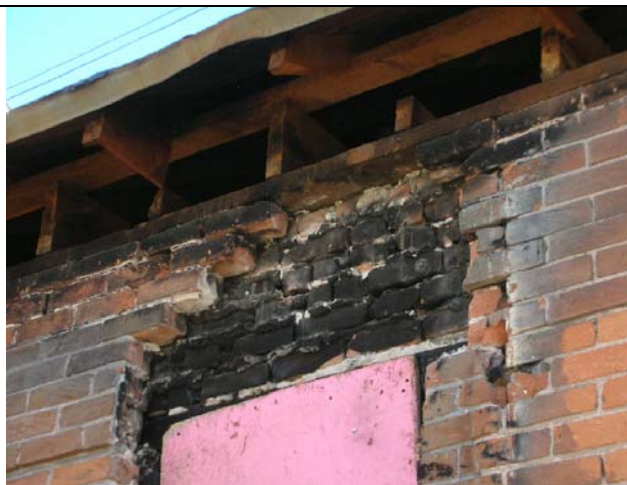
Window header fire damage at northwest facade

7. Replace headers and window sills with two 4 x 6. **\$8,296**
8. Reinforce rafters with one 2 x 6 sandwiched to each chord. Provide diagonal bracing. **\$9,150**

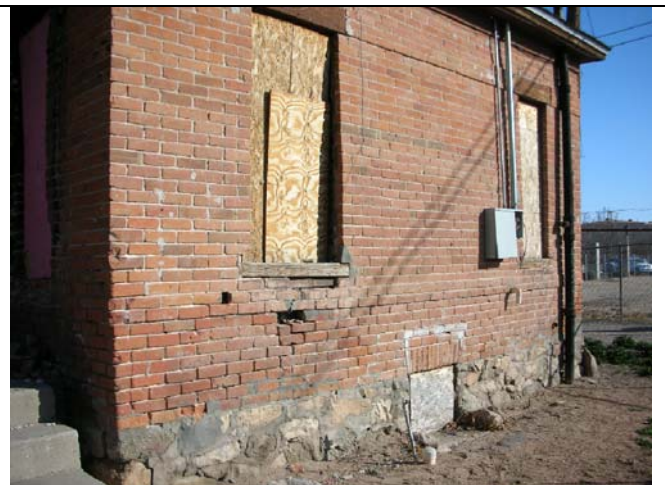
West façade, bowed horizontally and vertically

As discussed above, all of the walls exhibit some bowing but the west wall is the worst. It has been suggested that an addition could be constructed on the west side could be constructed to brace the wall as well as to provide additional floor space. The extra floor space would no doubt be welcome but the wall would now be an interior wall which could be demolished and replaced by a stud wall.

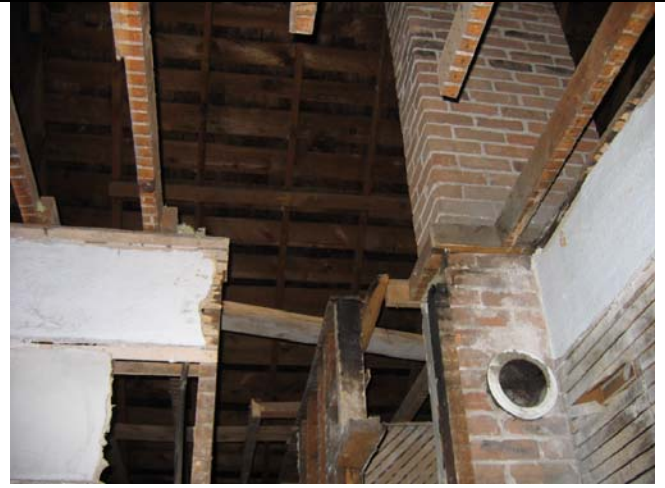
Interior brick flue, fire damaged bottom chords removed

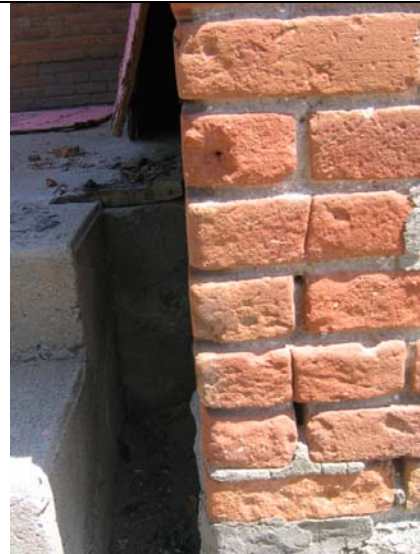
Brick and mortar erosion

There has been cracking in many areas of the wall, some of it structurally significant. Some of the cracking has been caused by loads, primarily wind loads. Some has been caused by differential settlement. All of the cracks should be filled with lime mortar; in more serious cases it may be necessary to remove and replace the brick adjacent to and crossing the crack, again using lime mortar.

5. Remove loose mortar and repoint brick walls and chimney. Replace 20% of brick. Chimneys should be capped. **\$75,142**
6. Provide mechanical ties to connect the double wythe brick. This can be accomplished by drilling through interior brick wall at no less than every 288 sq. in. to epoxy anchor a threaded rod to exterior brick, epoxy anchor and attach washer and nut to interior brick to new C-stud. **\$32,940**
