EL VADO MOTEL

Structural Evaluation

Final Report August 2006

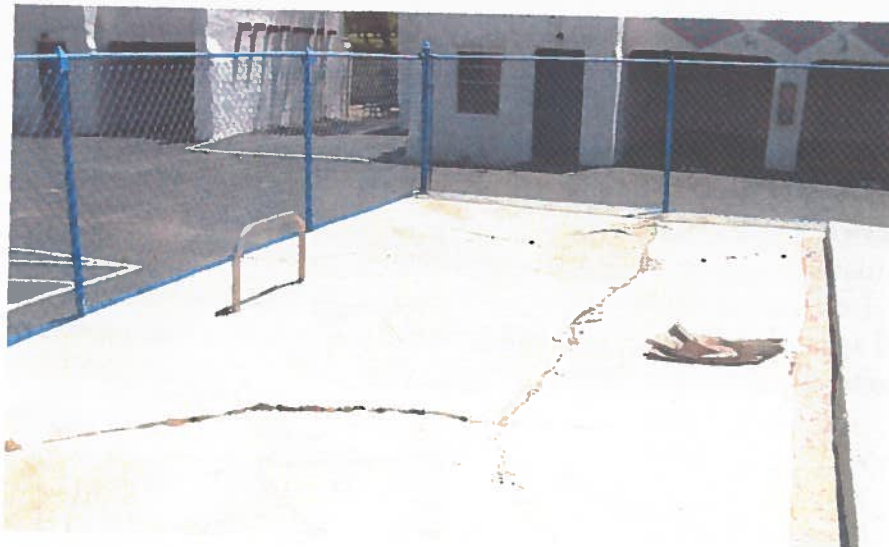
The swimming pool of the El Vado has been closed for a few years due to structural cracks in the concrete walls and decking (Figure 13). Currently the perimeter is enclosed with a chain link fence. The pool surface is covered with plywood panels and asphalt roofing. The mechanical room for the pool is also dilapidated and is out of compliance with plumbing and electrical codes.

Figure 13 Cracked Concrete at Swimming Pool deck

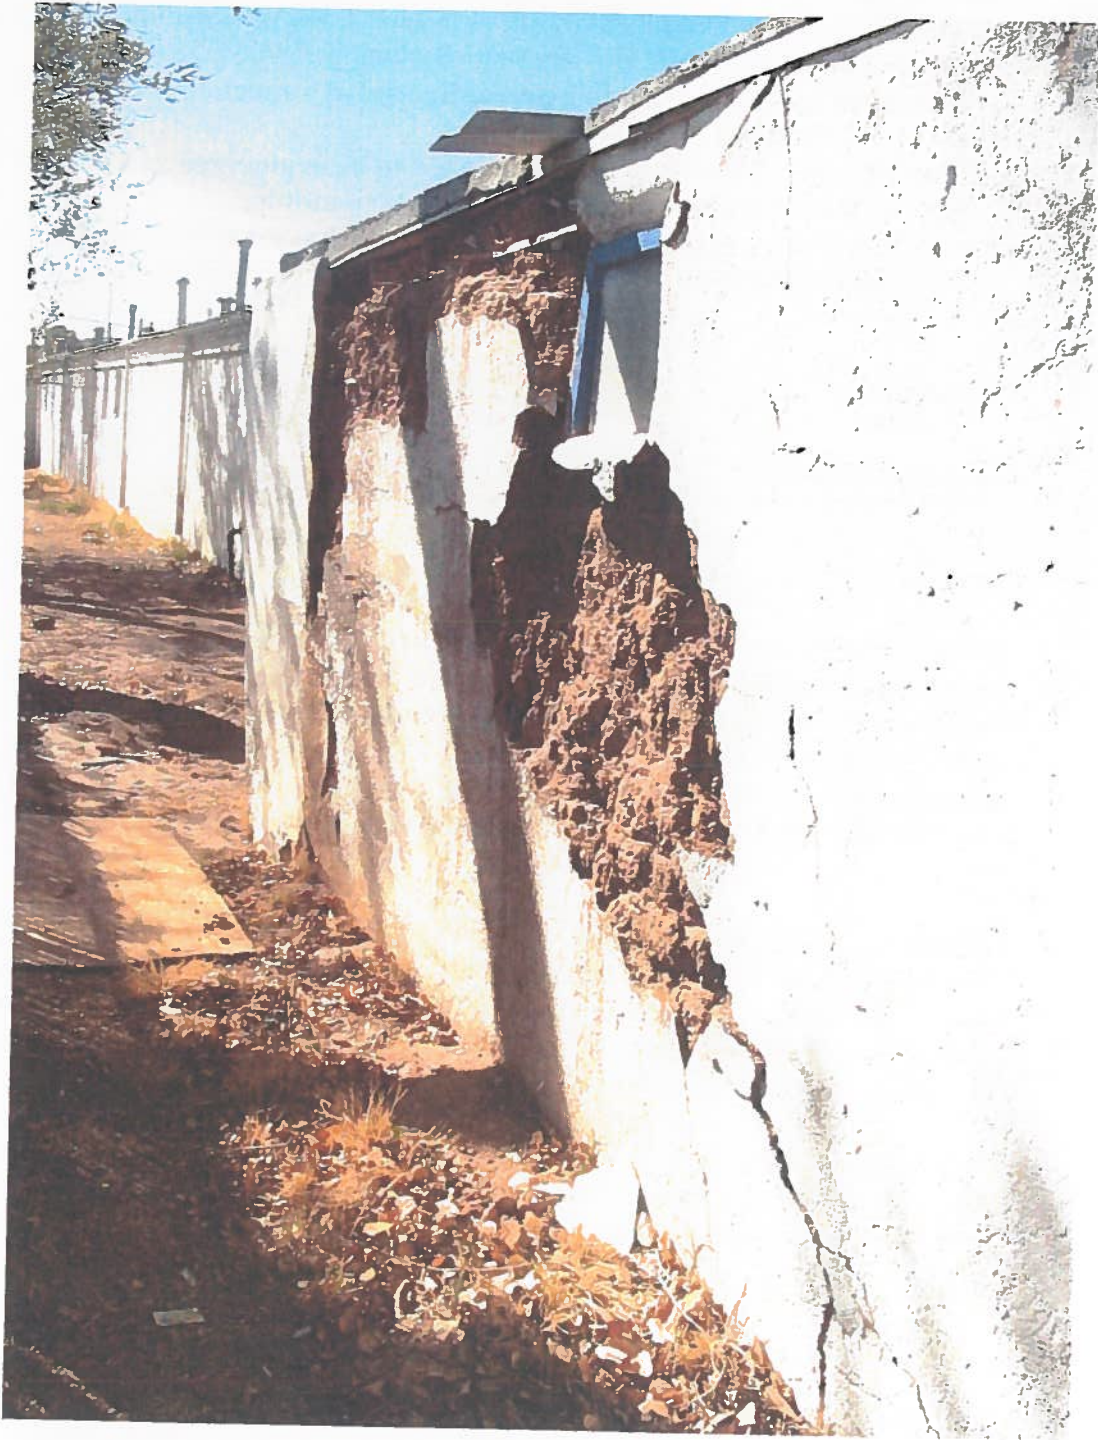
Figure 15 Wall Failure at Southeast Building Cluster

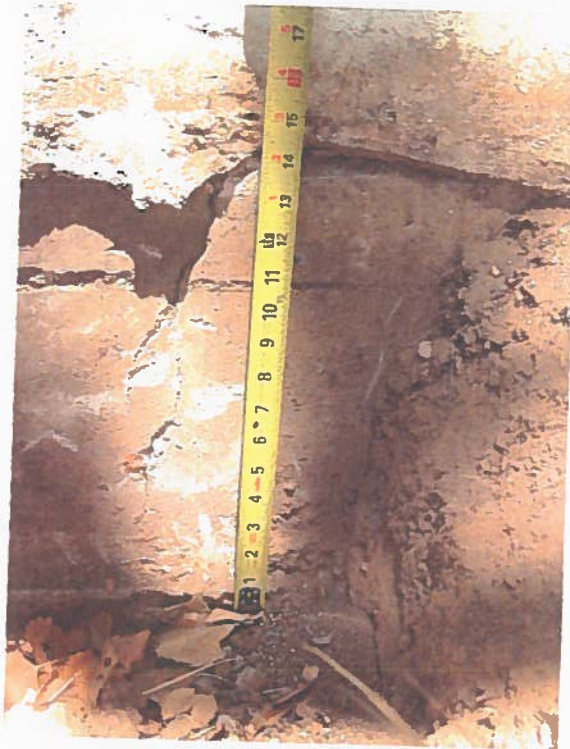
Figure 16 Foundation Wall

1. The soils adjacent to the footing need to be lowered so that all adobes are above finish grade. Offsite drainage to the south needs to be mitigated.
2. The footing wall needs to be waterproofed and insulated by an approved method. A foundation drain should be installed adjacent to the footing. An approved design should include a drain pipe, with an appropriate geotextile to prevent clogging, and appropriate placed gravel to direct moisture into the drain. The drain should run down at an appropriate slope out to daylight.
3. Downspouts and gutters need to be cleaned, prepared and sealed.
4. Leaders should be installed to divert water away from the building foundation.
5. The roof needs to be reconstructed to provide appropriate overhangs, parapets and flashing.

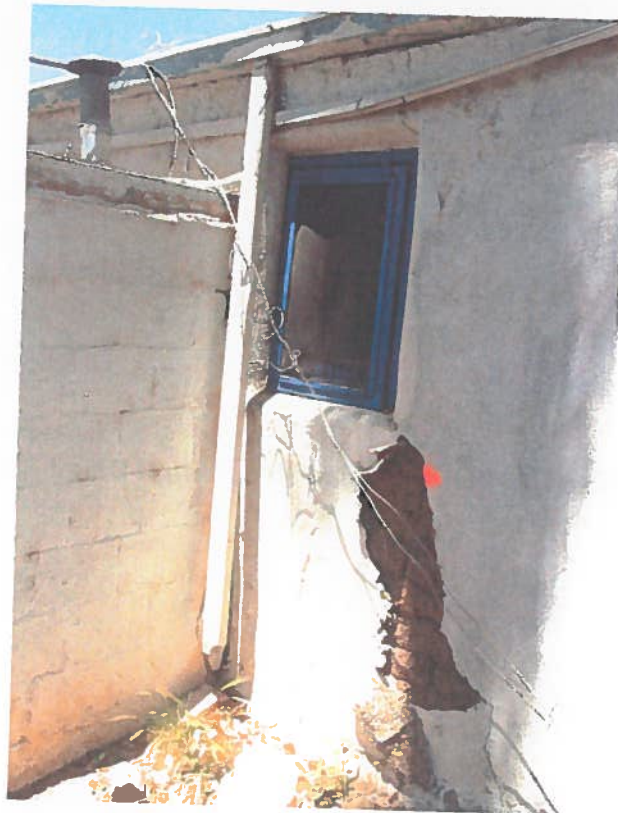
Figure 17 Roof Gutters/Downspout

The southwest building (Building 3, Figure 9) has several low spots where storm water has been pooling near the foundation perimeter. This is especially critical at the adobe storage shed addition where there has been intensive moisture damage from the leaking gutters and damp ground leading upwards to the base of the adobe walls. As a result of the moisture saturation, the adobe walls at the storage sheds have collapsed.

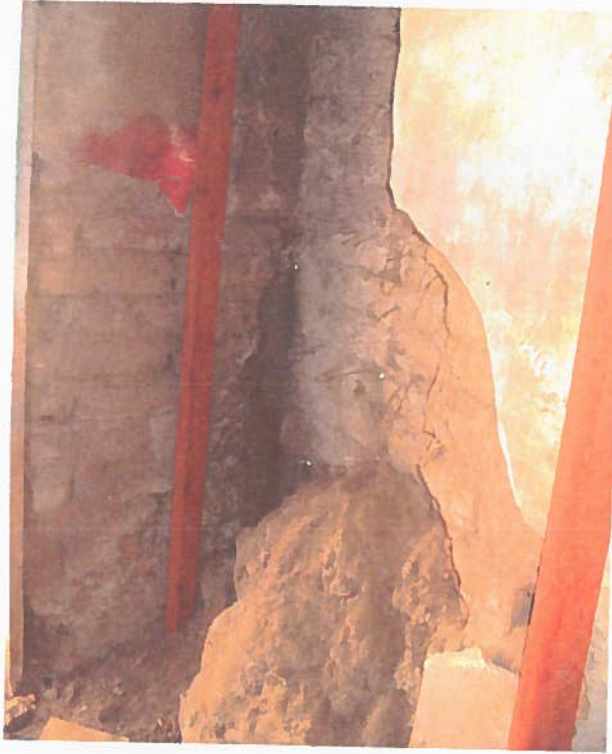
Figure 19 Collapsed Storage Shed Adobe Walls

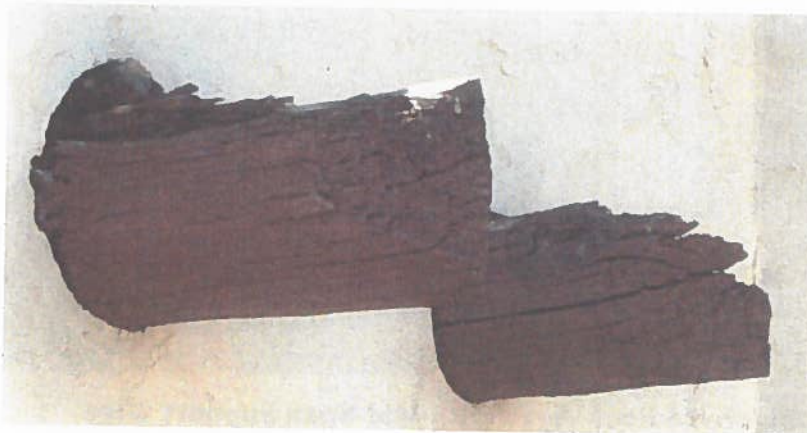
The main structural framing members for all the roofs of the El Vado are the structural wood vigas. The vigas have diameters ranging from 6-inches to 8-inches at their ends. *Some vigas have serious problems with dry rot at the exposed ends where they are supported on load bearing walls.* The structure of the motel's roofs is composed of a roof ceiling assembly (vigas spanned by 3/4 of an inch thick tongue and groove wood decked ceiling with no insulation above) then layers of roofing material.

Figure 22 Dry Rot Viga Ends

- 1. Inspect and evaluate each viga end throughout the buildings to check for rot and repair as necessary.**
- 2. Inspect and evaluate each viga for stress cracks, excessive deflection and repair as necessary.**
- 3. Inspect and evaluate roof sheathing. Replace with 3/4 inch sheathing as necessary.**
- 4. Insulate roofs to code standards and replace entire roof surfaces.**
- 5. Overhangs, gutters etc.**

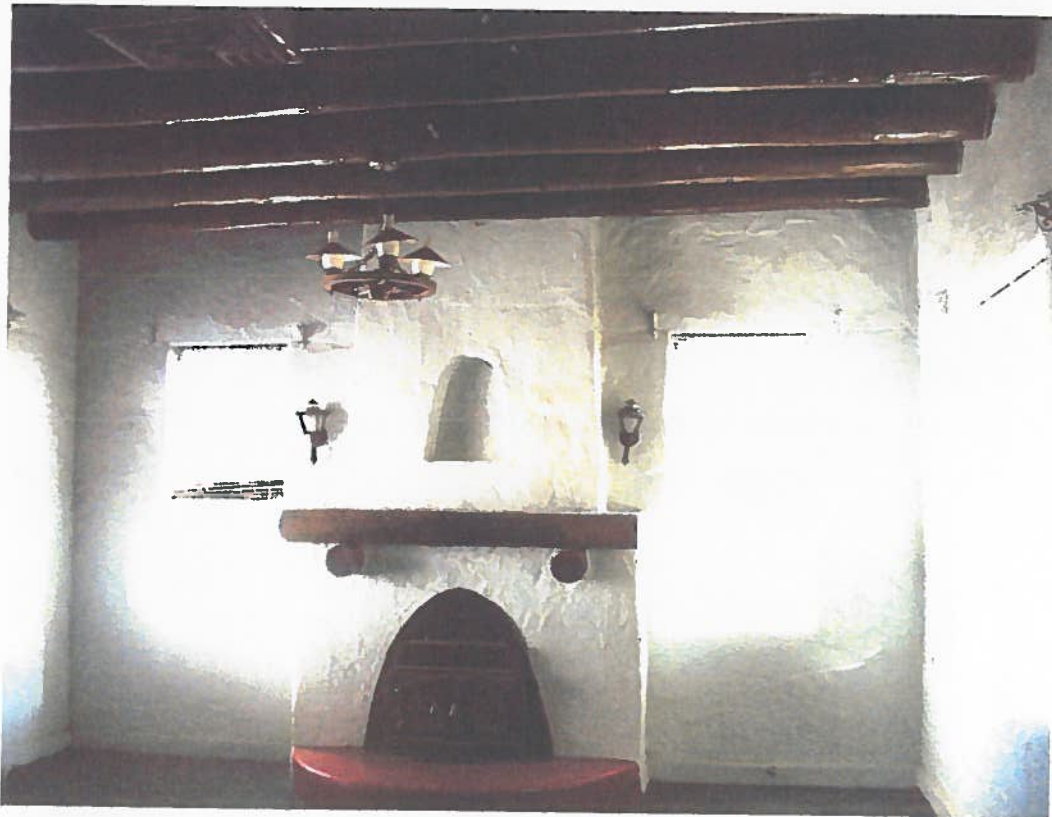
The lobby/office building of the El Vado's roof structure is composed of wood beams spaced at approximately 24 inches from centers. The low pitched roof is covered with lapped asphalt membrane roofing. This roof appears to be in poor condition. This roof contains numerous vent stacks, swamp cooler and ventilating equipment. The exposed viga ends that extend beyond the walls are in a deteriorating condition due to dry rot.

Figure 25 Roof Vigas at Office/Lobby

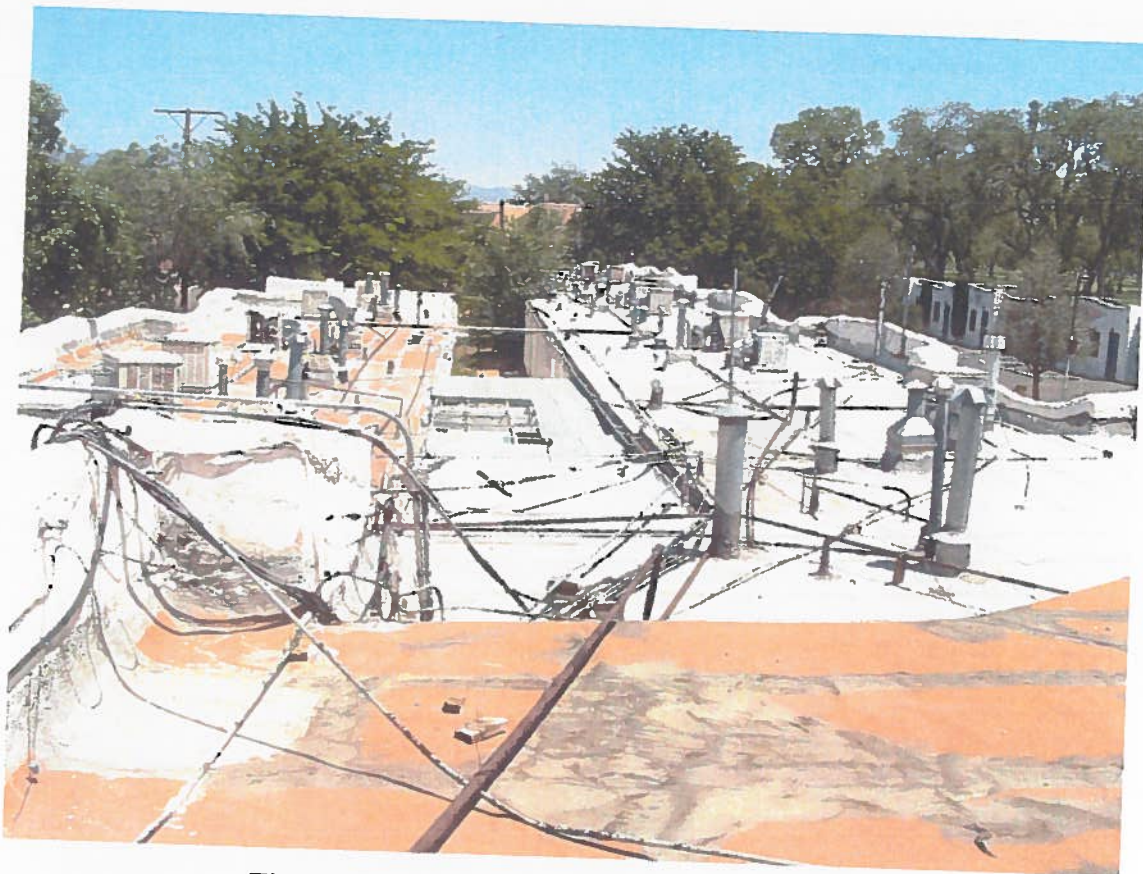
Generally, such penetrations to roofing membranes at the El Vado facility have created roof and ceiling leaks.

Figure 28 Roof Penetrations at North Room Block

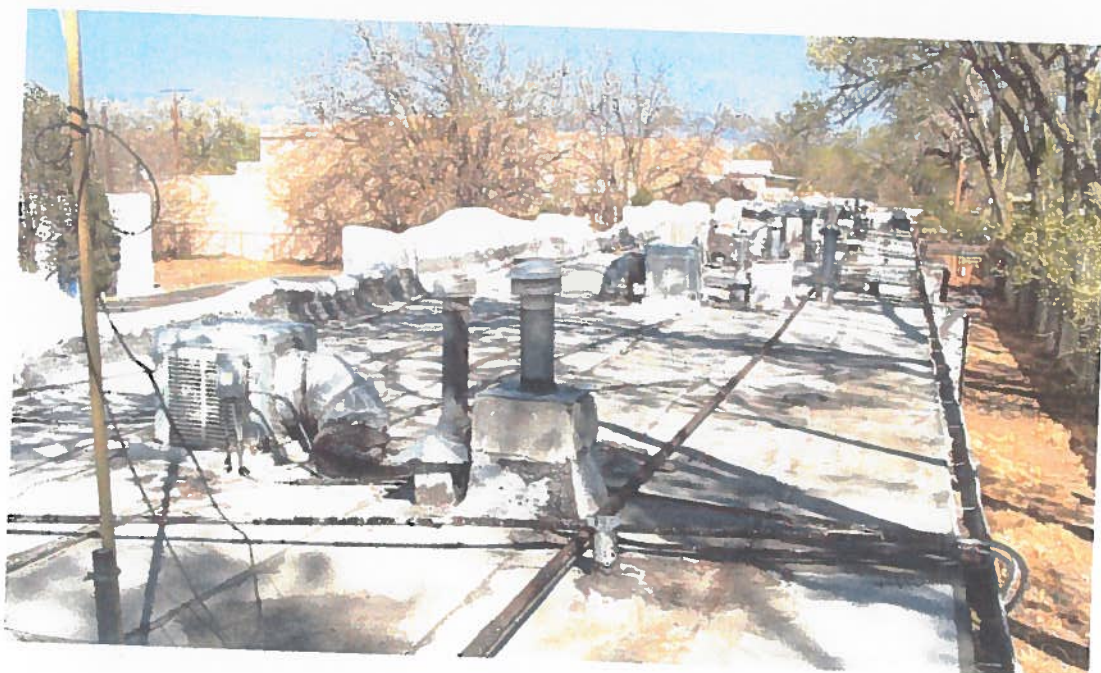
Figure 29 Roof Penetrations at South Room Block

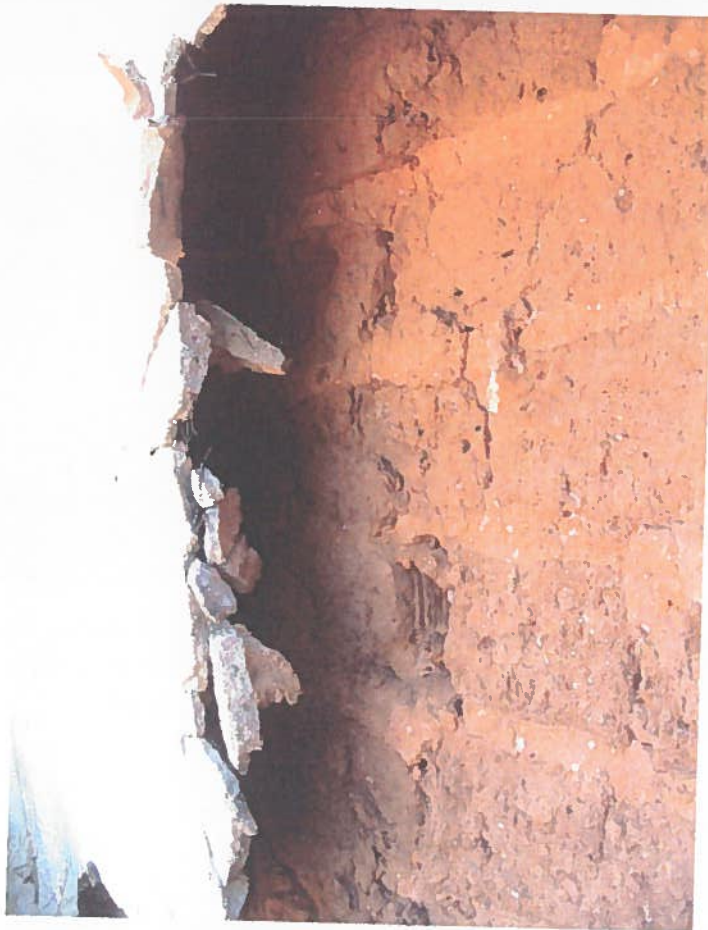
A severe condition that requires immediate attention occurs adjacent to the parapet wall on the north side of the building. The damage occurring is due to moisture infiltration because of cracked stucco which allows moisture in between the adobe walls and cement plaster. The moisture becomes trapped and cannot get out. The adobe blocks become saturated with the moisture and begin to deteriorate. As the blocks deteriorate, chunks of adobe mud and mortar separate from the rest of the block. This creates a larger void between the cement stucco and the adobe, giving access for snow melt and rain to enter the cavity. The adobe chunks become wedged between the intact wall and the cement plaster causing a further cycle of deterioration. As trapped moisture freezes and expands it creates even more damage as the cement stucco is forced away from the building dragging pieces of adhered adobe with it.

The north wall is now at the point where large sections of cement plaster are falling off the building. **This constitutes a dangerous, severe existing condition.** Exposed adobe walls, cracked stucco and wall damage at the northeast as evident by the bulging stucco and separated concrete apron.

Figure 39 - Cement Stucco Separation from Adobe Wall

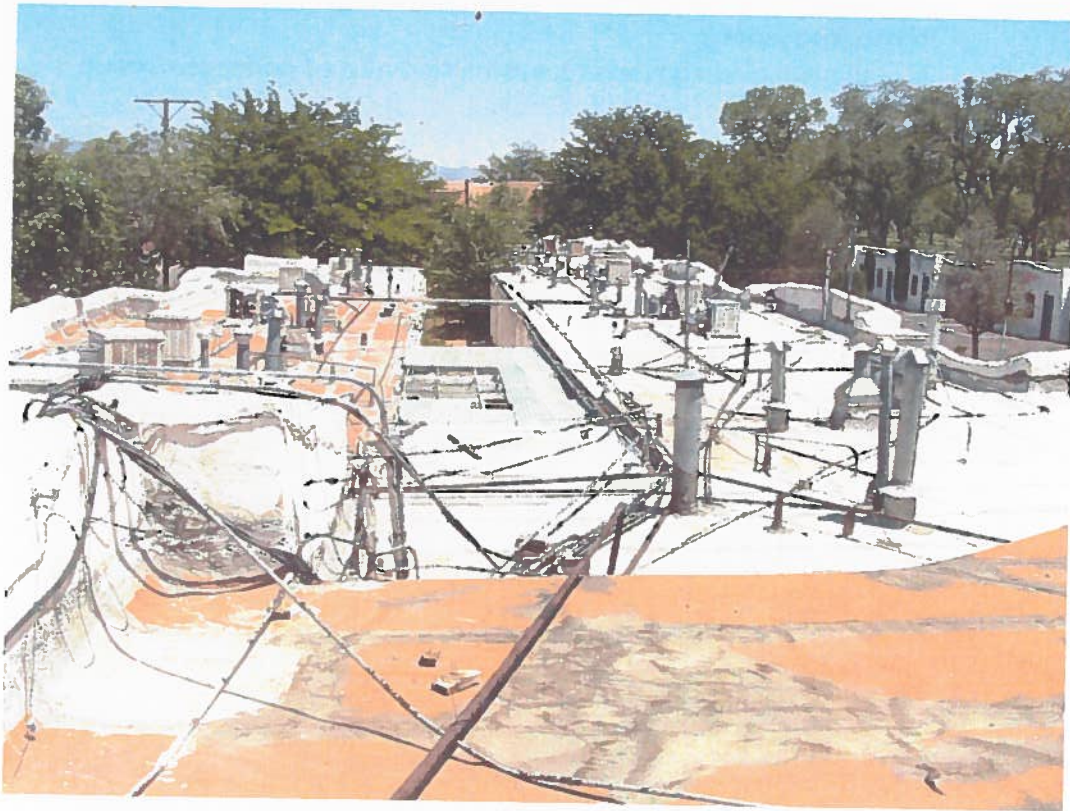
The El Vado buildings have asphalt based roofing. *The roof surfaces are in fair to poor condition.* Maintenance is required periodically to inspect fasteners, joints and the ridge/parapet connections. The parapet flashing has separated from the walls creating gaps and cracks in the walls. *Areas of particular concern exist at the parapets and perimeter of all building walls. The roof vigas which protruding from the walls are in poor shape due to dry rot conditions*

Figure 41– Roofing Materials at Building 1.

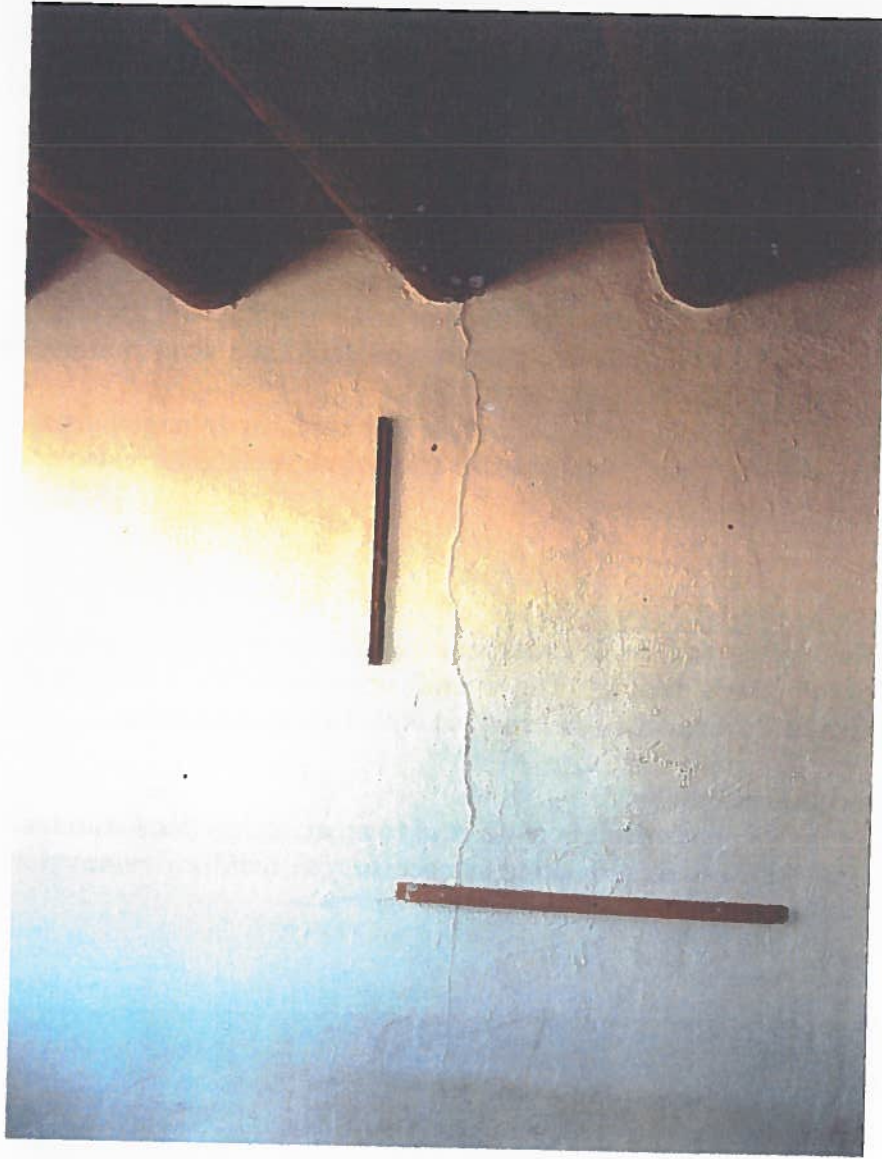
Figure 43 Typical Interior Wall Plaster

In all buildings, the interior wall surfaces are coated with cementitious plaster. The thickness of the plastered surface varies from 1/4 inch to 1/2 inches. Several layers of paint in different colors have been applied over the original whitewash. At several locations, the interior plaster is flaking, cracking and crumbling. *The main cause of this problem is moisture infiltration and wear and tear due to use.*

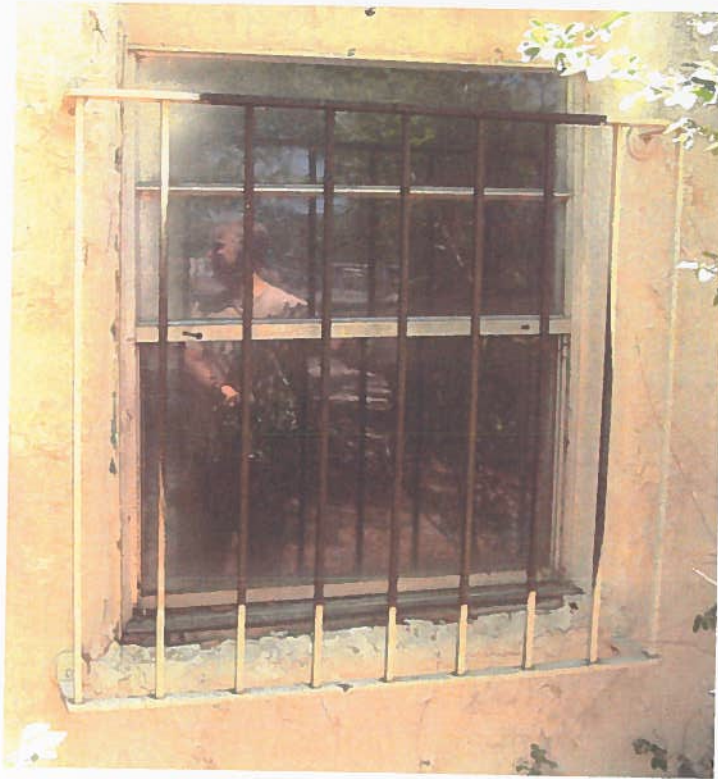
Figure 45 - Single Hung Window With Security Bars

The overall condition of the windows are poor. Numerous repairs and replacement is required. The paint is peeling and is in poor condition. Entry doors and interior doors need refinishing.

1. Inspect, repair and or replace exterior doors.
2. Inspect, repair and or replace windows.
3. Door hardware should comply with accessibility standards.
4. Door trim needs to be refinished or replaced to original finish.
5. New energy efficient windows and doors are recommended.
6. Inspect, repair or replace single hung windows to original integrity. Frames and trim are included in this procedure.
7. Replace bathroom window with new window comparable to original opening and style to include energy efficient glass.
8. Repair or replace concrete sills and paint.
9. Restore original window openings, install new frames windows comparable to existing windows.
10. Patch and repair around all window frames.
11. Incorporate new door hardware, include security locks.
12. Handicap requirements.
