# 2015 AS BUILT REPORT FOR INFRASTRUCTURE REPAIRS AND MAINTENANCE

## FORMER LOS ANGELES LANDFILL

**May 5, 2016**

# 2015 AS BUILT PLANS FOR REPAIRS TO LANDFILL GAS EXTRACTION AND VAPOR EXTRACTION SYSTEMS

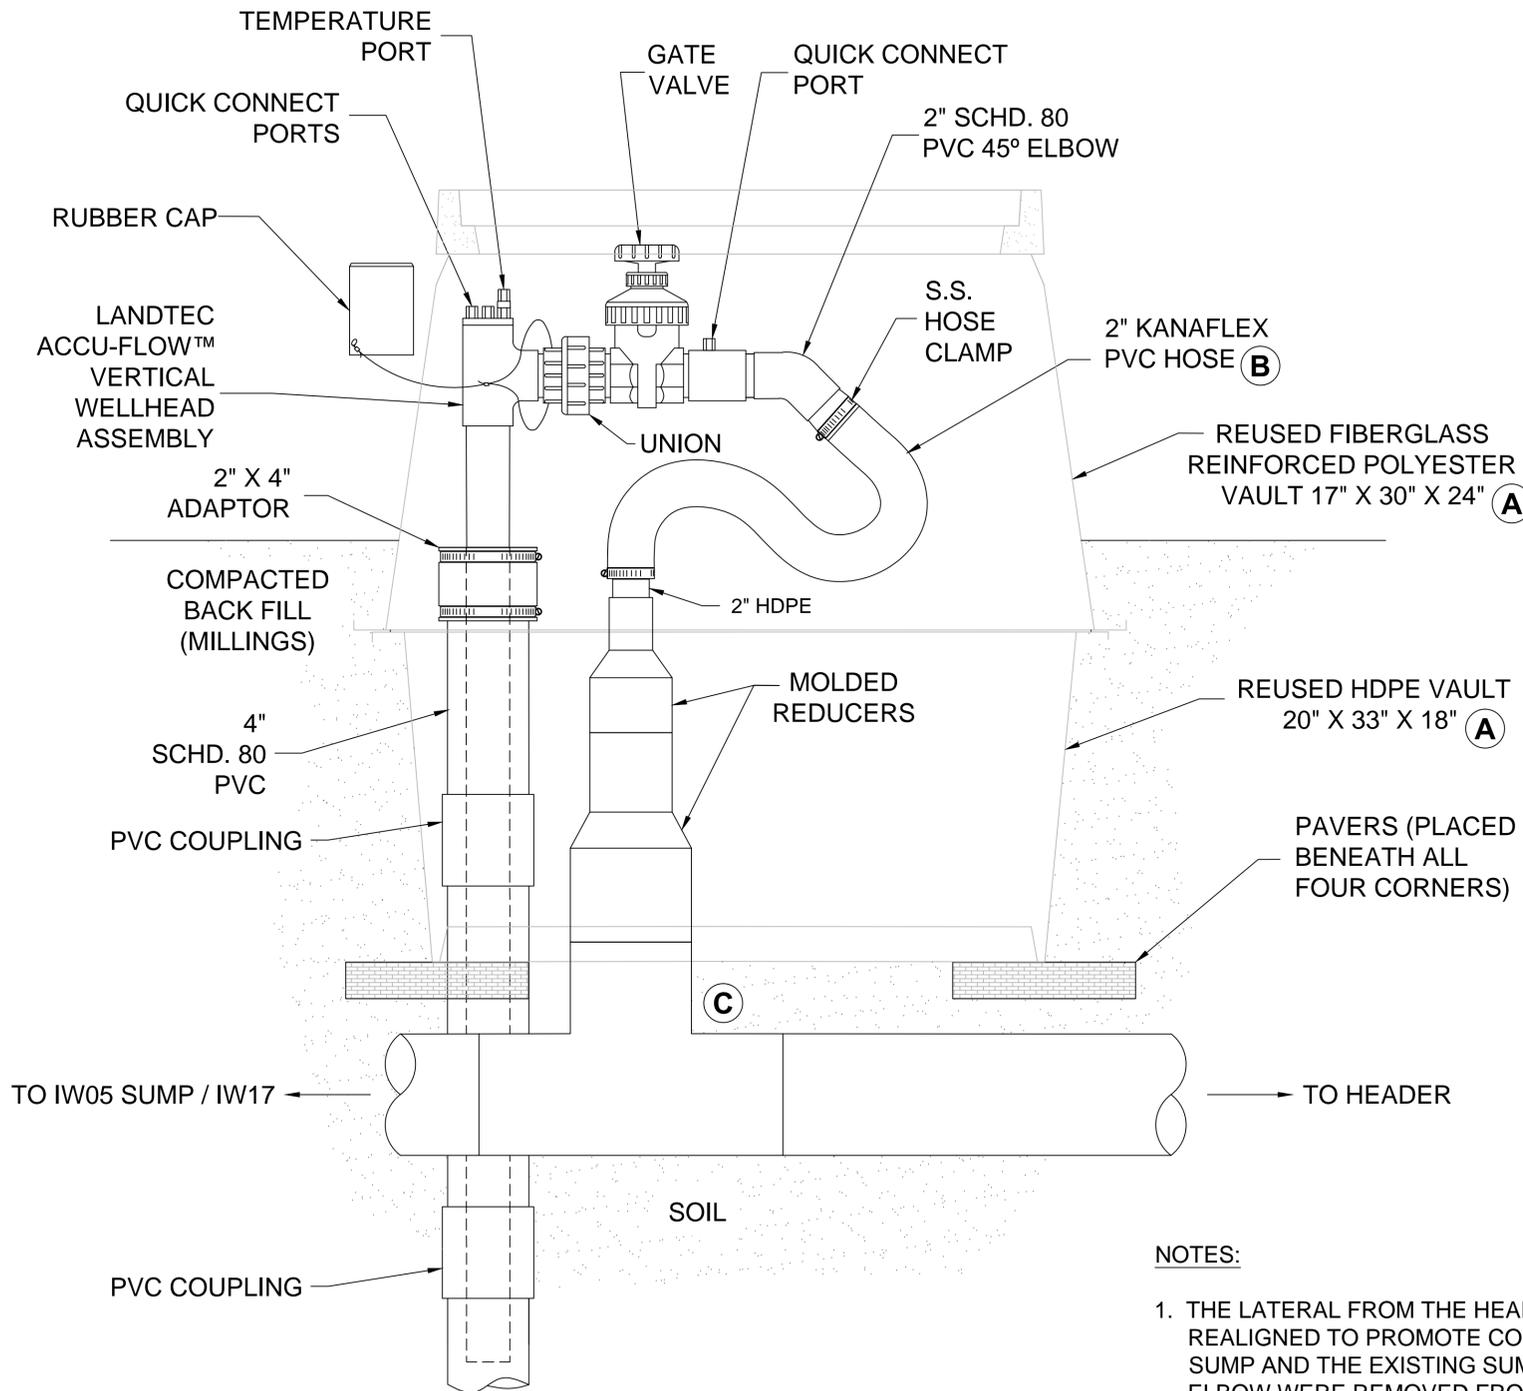
AS BUILT FOR IW05  
2015 SYSTEM REPAIRS

1. THE LATERAL FROM THE HEADER TO IW17 WAS EXCAVATED AND REALIGNED TO PROMOTE CONDENSATE DRAINAGE TO THE NEW IW05 SUMP AND THE EXISTING SUMP AT IW17. THE T-CONNECTION AND 90° ELBOW WERE REMOVED FROM THE LATERAL AND THE PIPE WAS REALIGNED TO PASS DIRECTLY ADJACENT TO IW05.
2. FOR WELL CONSTRUCTION DETAILS, SEE: *AS-BUILT FOR THE LANDFILL GAS EXTRACTION SYSTEM LOCATED AT THE FORMER LOS ANGELES LANDFILL*, IT CORPORATION, JULY 1998.
3. HDPE FITTING SIZES MAY VARY. DIMENSIONS ARE APPROXIMATE.

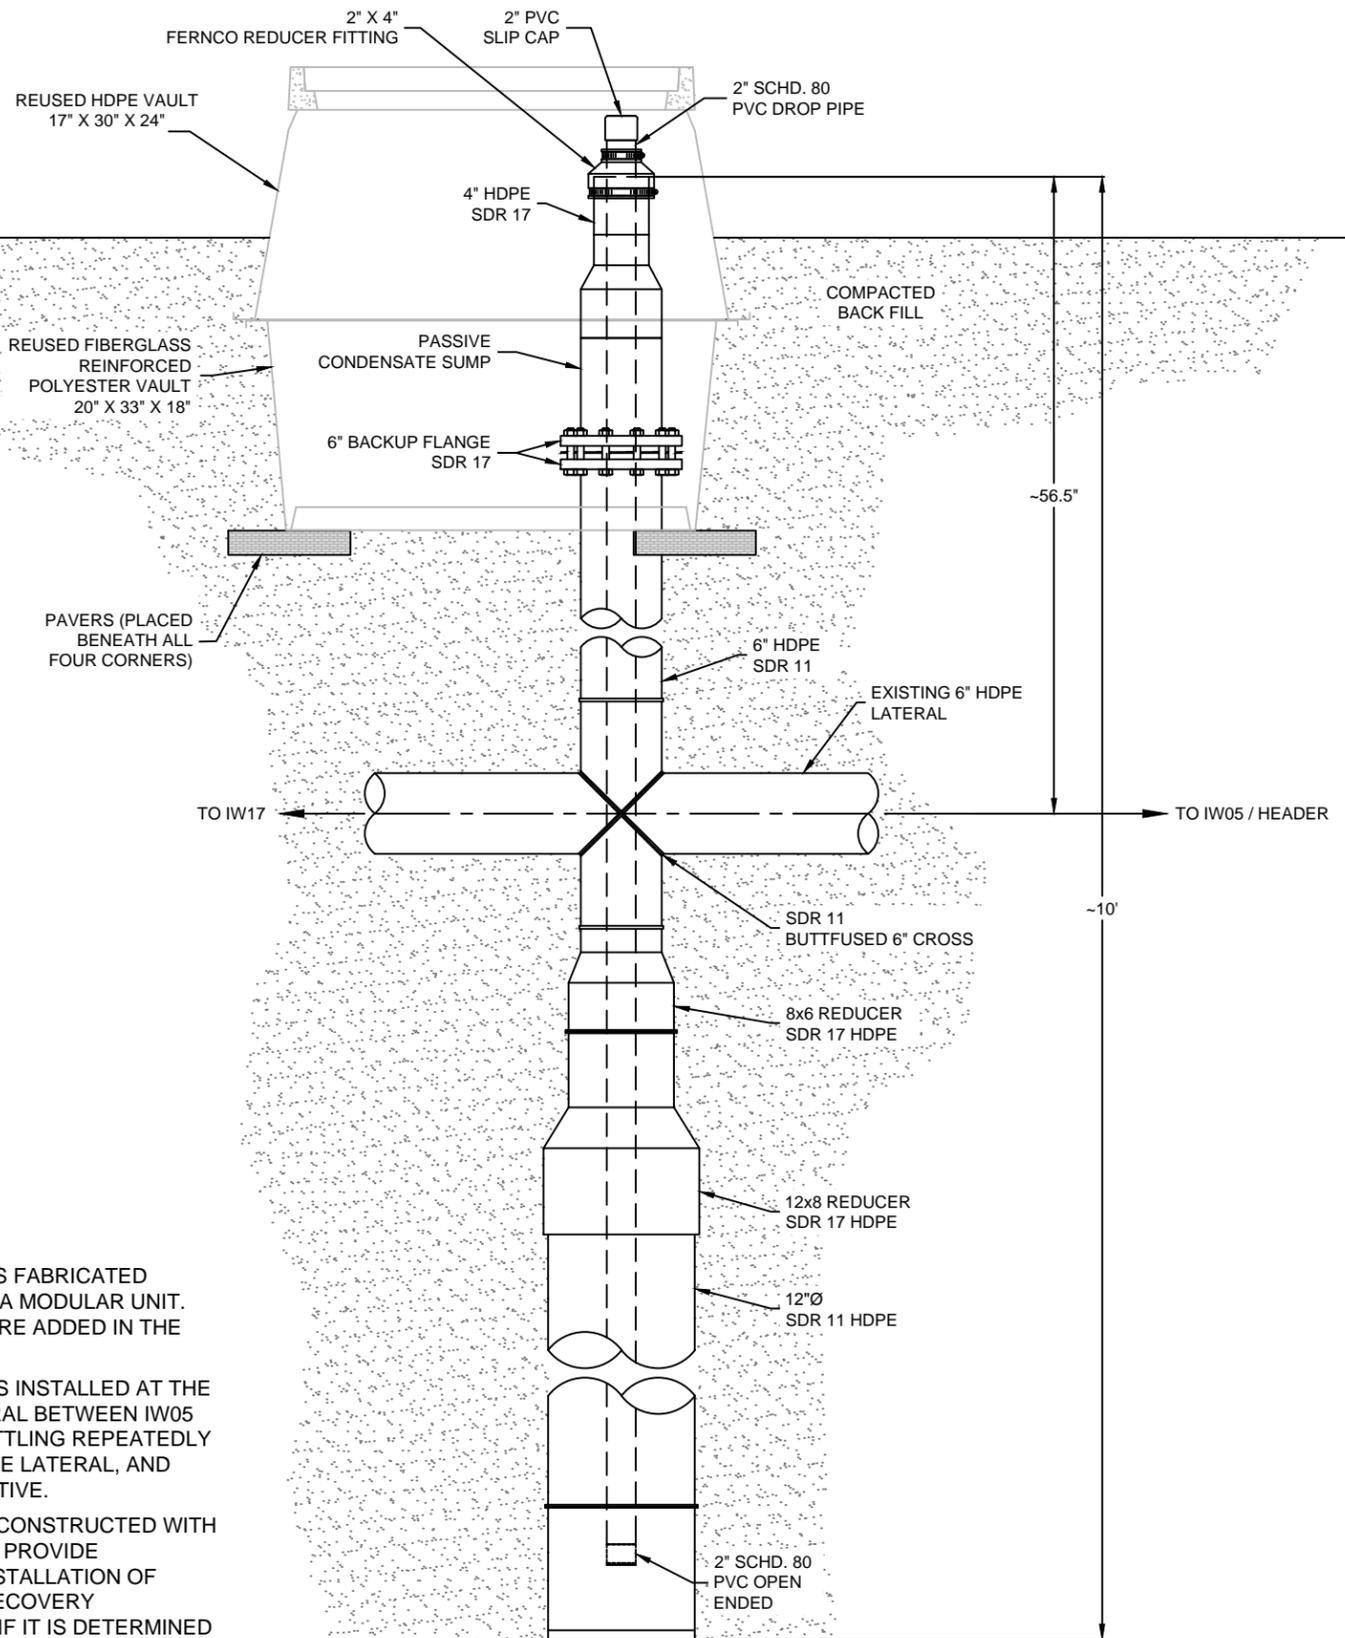
**AS BUILT FOR IW05 SUMP  
 2015 SYSTEM REPAIRS**

1. THE CONDENSATE SUMP WAS FABRICATED OFFSITE AND DELIVERED AS A MODULAR UNIT. THE DROP PIPE AND CAP WERE ADDED IN THE FIELD.
2. THE CONDENSATE SUMP WAS INSTALLED AT THE LOWEST POINT IN THE LATERAL BETWEEN IW05 AND IW17. DIFFERENTIAL SETTLING REPEATEDLY CREATED A LOW POINT IN THE LATERAL, AND REALIGNMENT WAS INEFFECTIVE.
3. THE TOP OF THE SUMP WAS CONSTRUCTED WITH A FLANGED CONNECTION TO PROVIDE OPPORTUNITIES FOR THE INSTALLATION OF PNEUMATIC CONDENSATE RECOVERY EQUIPMENT IN THE FUTURE, IF IT IS DETERMINED THAT A MORE AGGRESSIVE CONDENSATE REMOVAL PROCESS IS WARRANTED.
4. SECTIONS OF 6-INCH HDPE LATERAL PIPE WERE BUTT-FUSED TO BOTH SIDES OF THE SUMP.
5. HDPE FITTING SIZES MAY VARY. DIMENSIONS ARE APPROXIMATE.

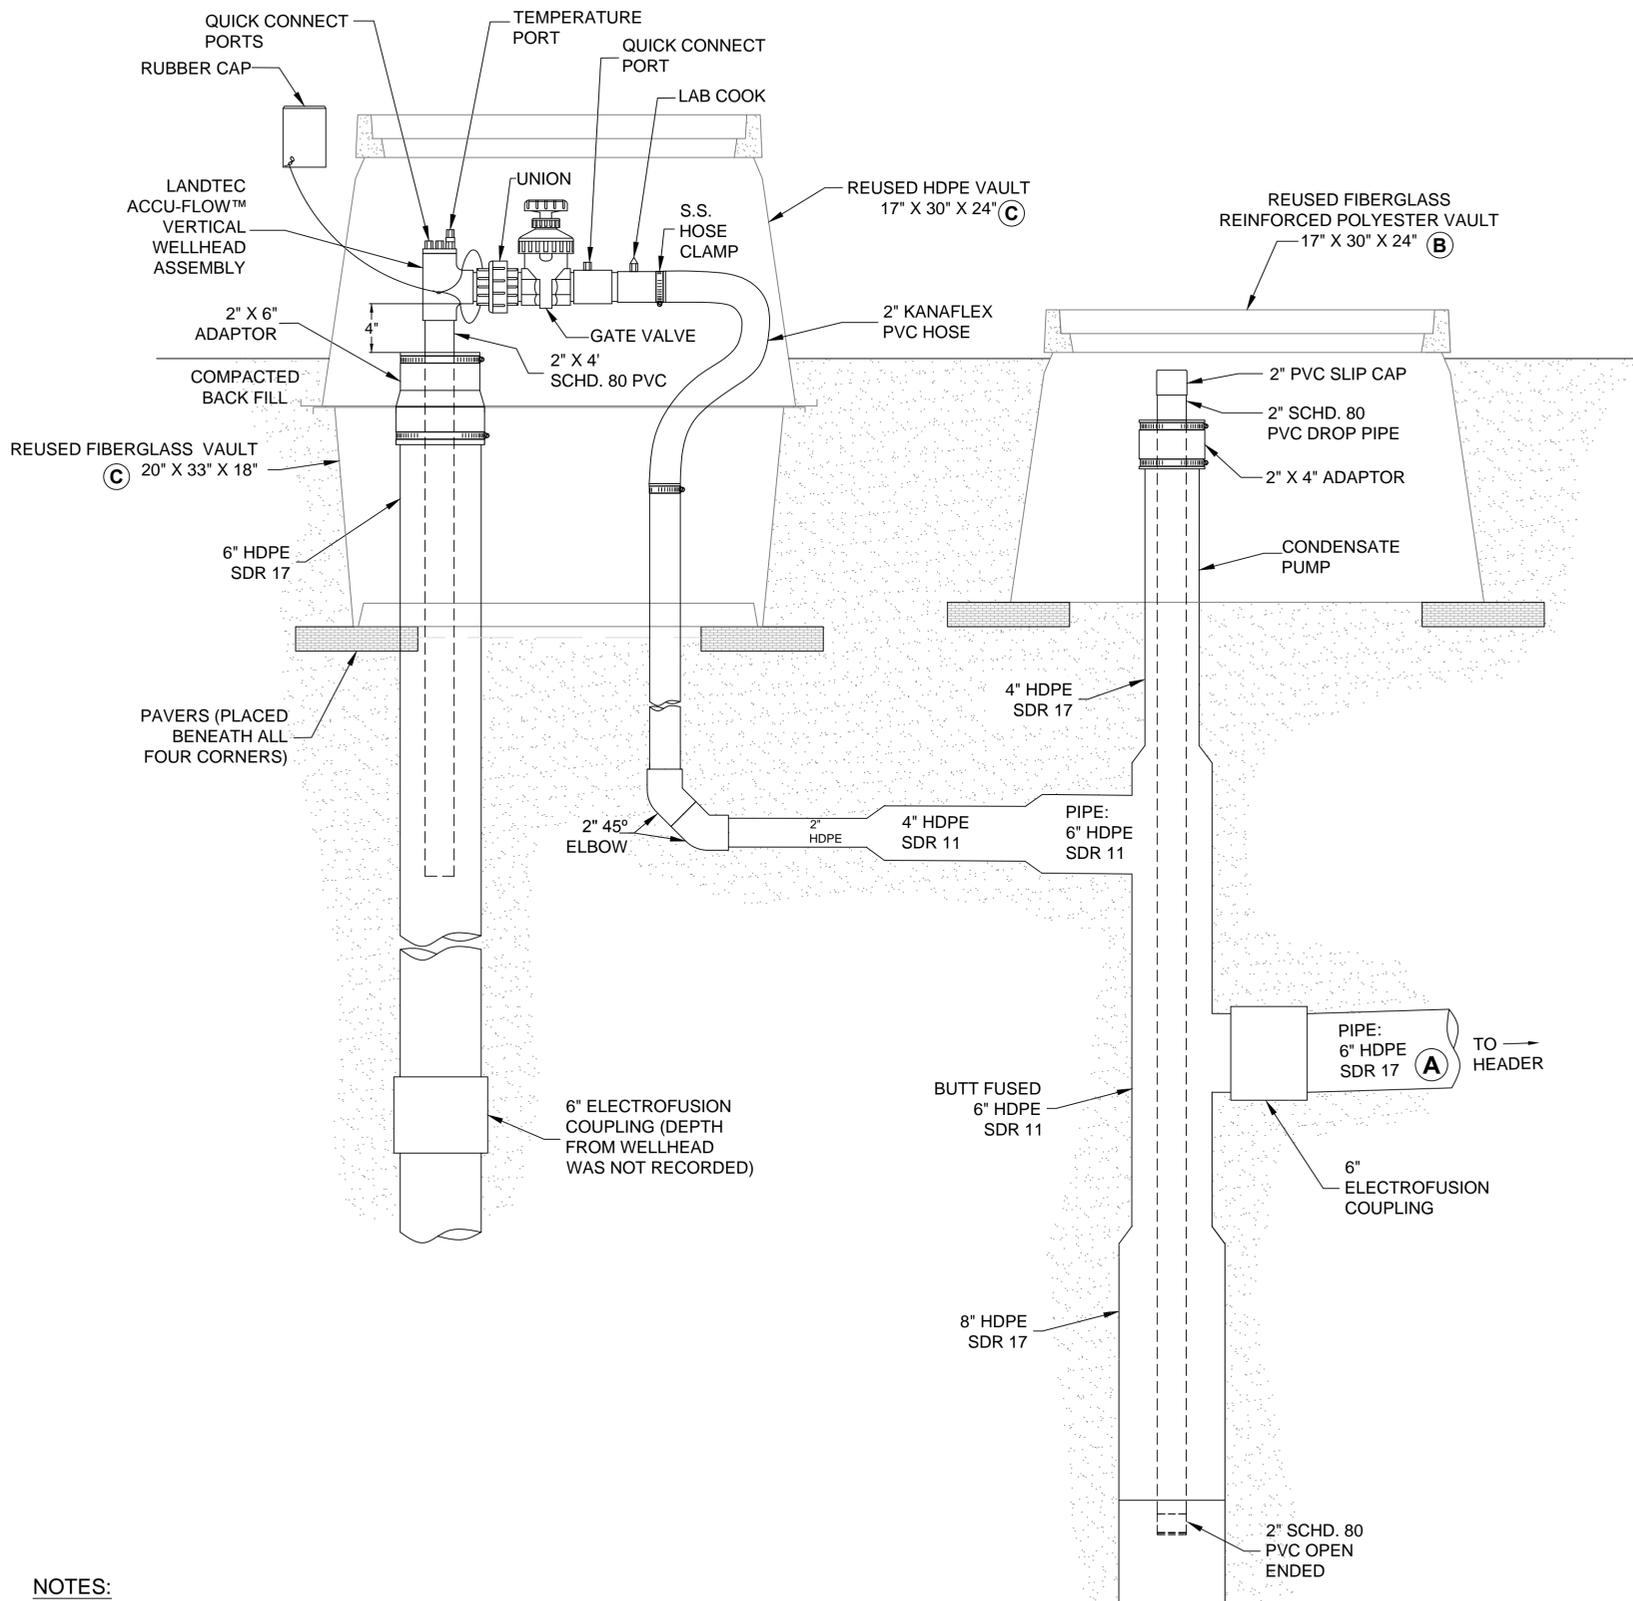
**AS BUILT FOR IW09/SUMP  
2015 SYSTEM REPAIRS**

1. THE EXISTING PASSIVE CONDENSATE SUMP WAS NOT REMOVED AND WAS RETAINED AT THE SAME ELEVATION DURING THE REALIGNMENT OF THE CONNECTING LATERAL.
2. FOR WELL CONSTRUCTION DETAILS, SEE: *AS-BUILTS FOR THE PHASE II EXPANSION OF THE LANDFILL GAS EXTRACTION SYSTEM LOCATED AT THE FORMER LOS ANGELES LANDFILL, IT CORPORATION, APRIL 2000.*
3. LENGTH OF KANAFLEX HOSE AND CONNECTING NIPPLE ARE NOT SHOWN TO SCALE.

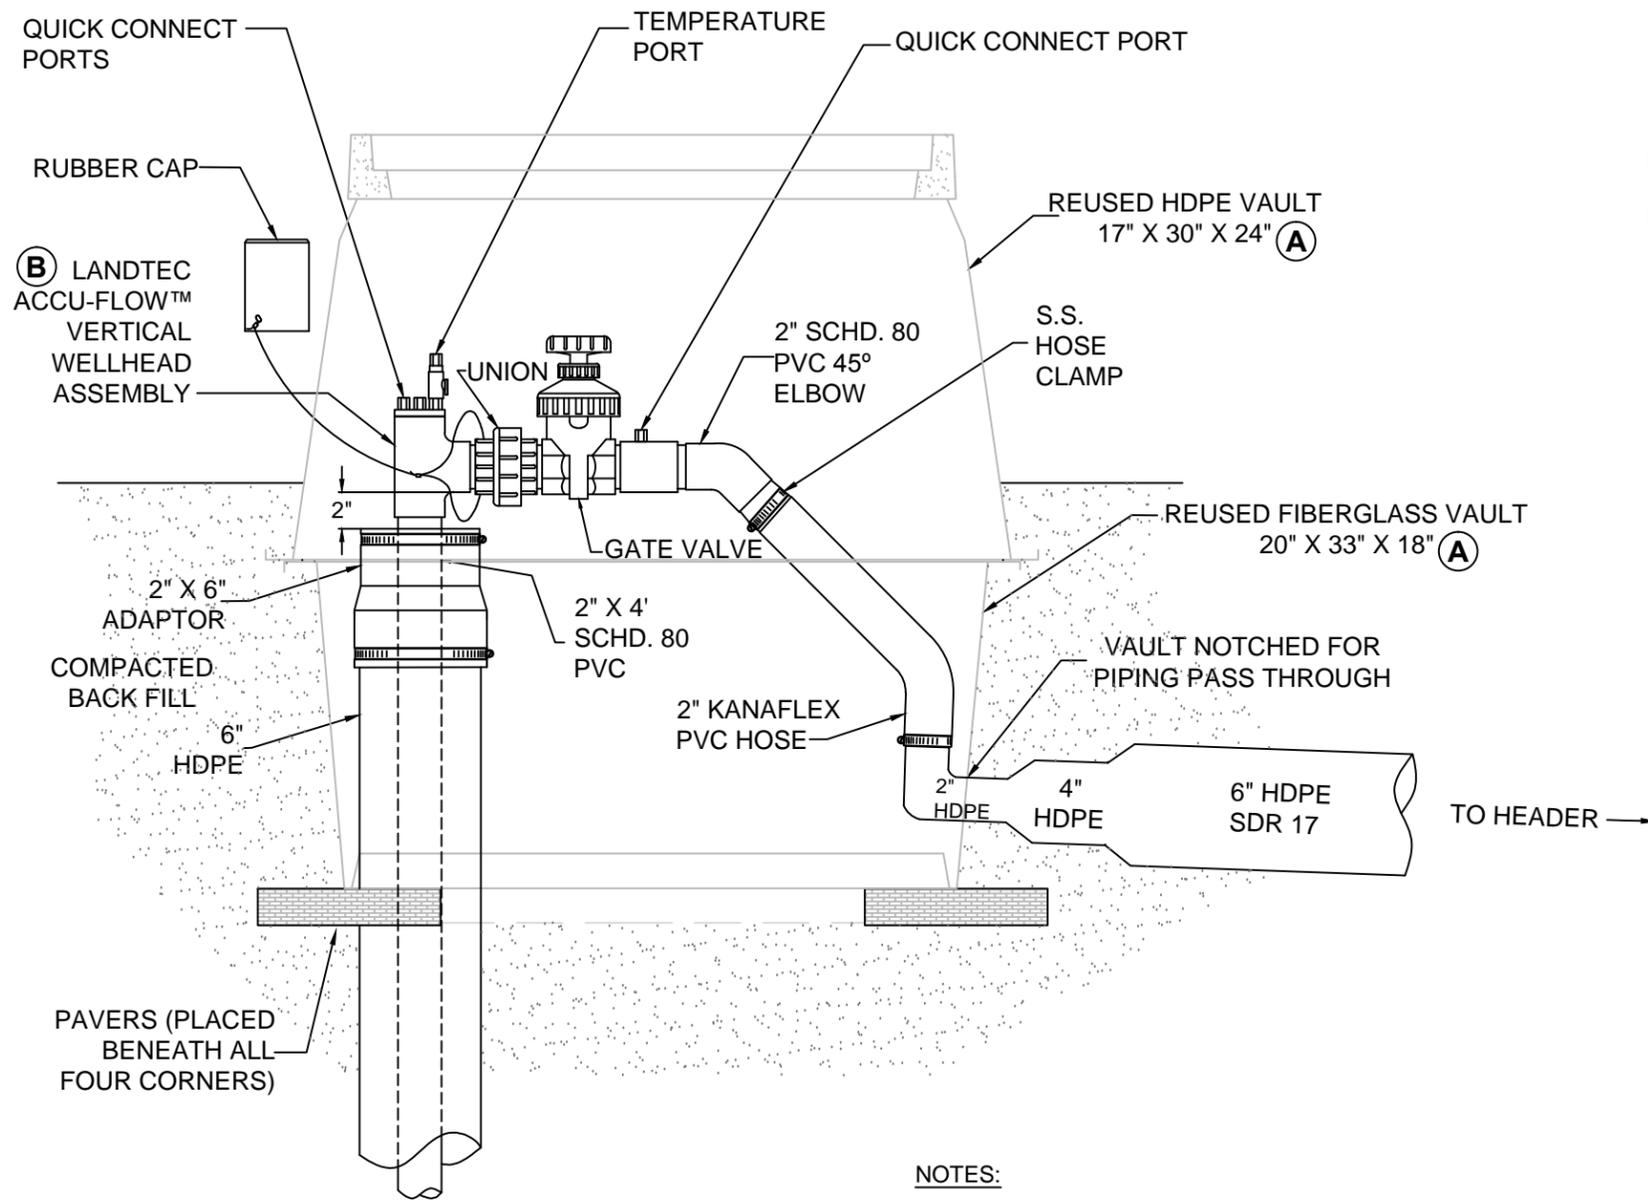
AS BUILT FOR PW-20  
2015 SYSTEM REPAIRS

- (A) RAISED AND LEVELED VAULTS.
- (B) ADJUST LANDTEC ACCU-FLOW™ VERTICLE WELLHEAD ASSEMBLY USING 2" X 6" FLEXIBLE ADAPTOR.

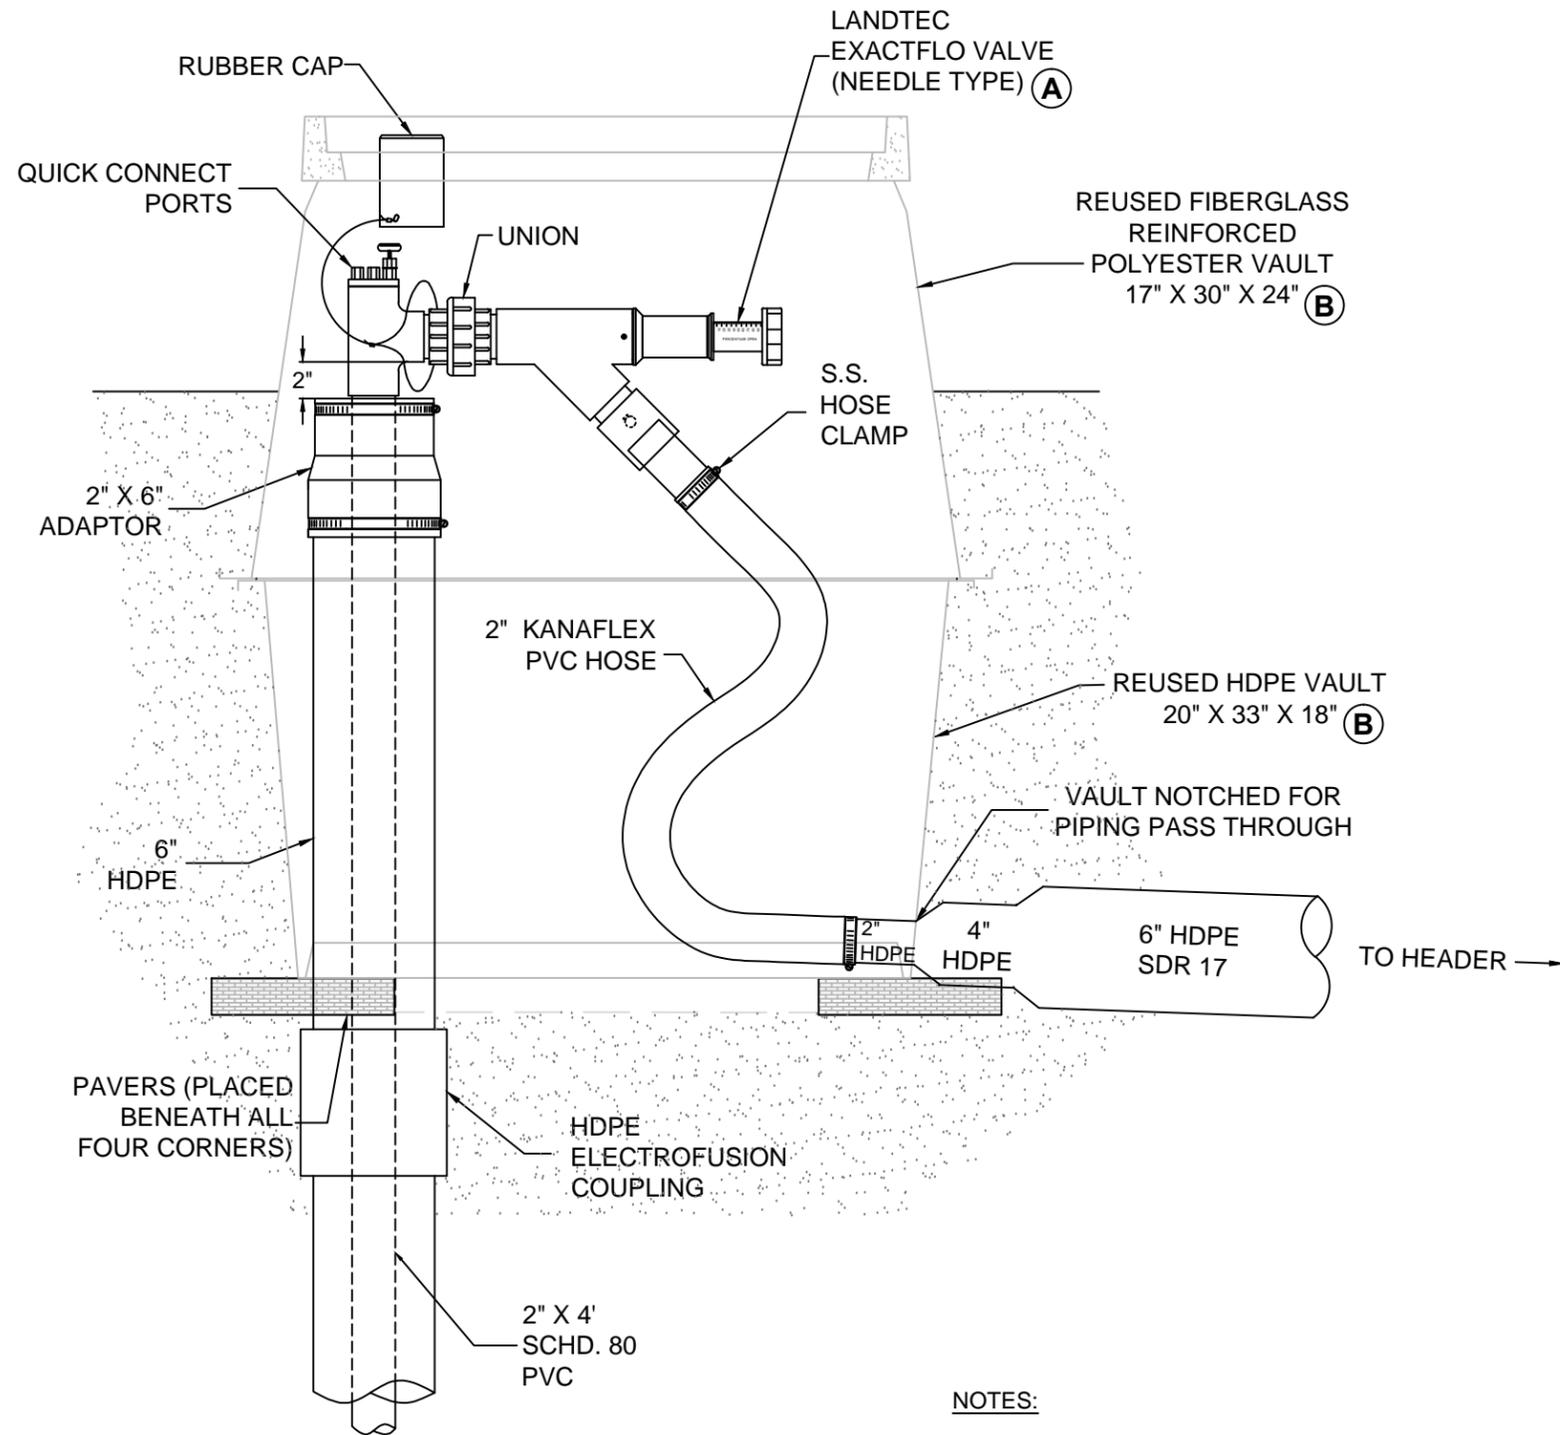
AS BUILT FOR PW-32  
2015 SYSTEM REPAIRS

- (A) THE EXISTING LANDTEC ACCU-FLOW™ VERTICAL WELLHEAD ASSEMBLY WAS REPLACED WITH A LANDTEC EXACTFLO VALVE WELLHEAD ASSEMBLY. THE VALVES WERE SWITCHED AT THE EXISTING UNION AND THE PITOT TUBE AND QUICK CONNECT PORTS FROM THE ORIGINAL WELLHEAD WERE RETAINED.
- (B) THE VAULTS WERE RMOVED AND RESET TO ACCOMMODATE THE NEW WELLHEAD CONFIGURATION.

1. THE ONLY MODIFICATION TO THE WELL WAS THE REPLACEMENT OF THE GATE VALVE WITH THE NEEDLE VALVE. THIS WILL ALLOW FOR GREATER CONTROL OF FLOW AND VACUUM APPLIED TO THE WELL. THE VAULTS WERE ADJUSTED TO ACCOMMODATE THE NEW WELLHEAD ASSEMBLY.
2. FOR WELL CONSTRUCTION DETAILS, SEE: *AS-BUILTS FOR THE PHASE II EXPANSION OF THE LANDFILL GAS EXTRACTION SYSTEM LOCATED AT THE FORMER LOS ANGELES LANDFILL, IT CORPORATION, APRIL 2000.*

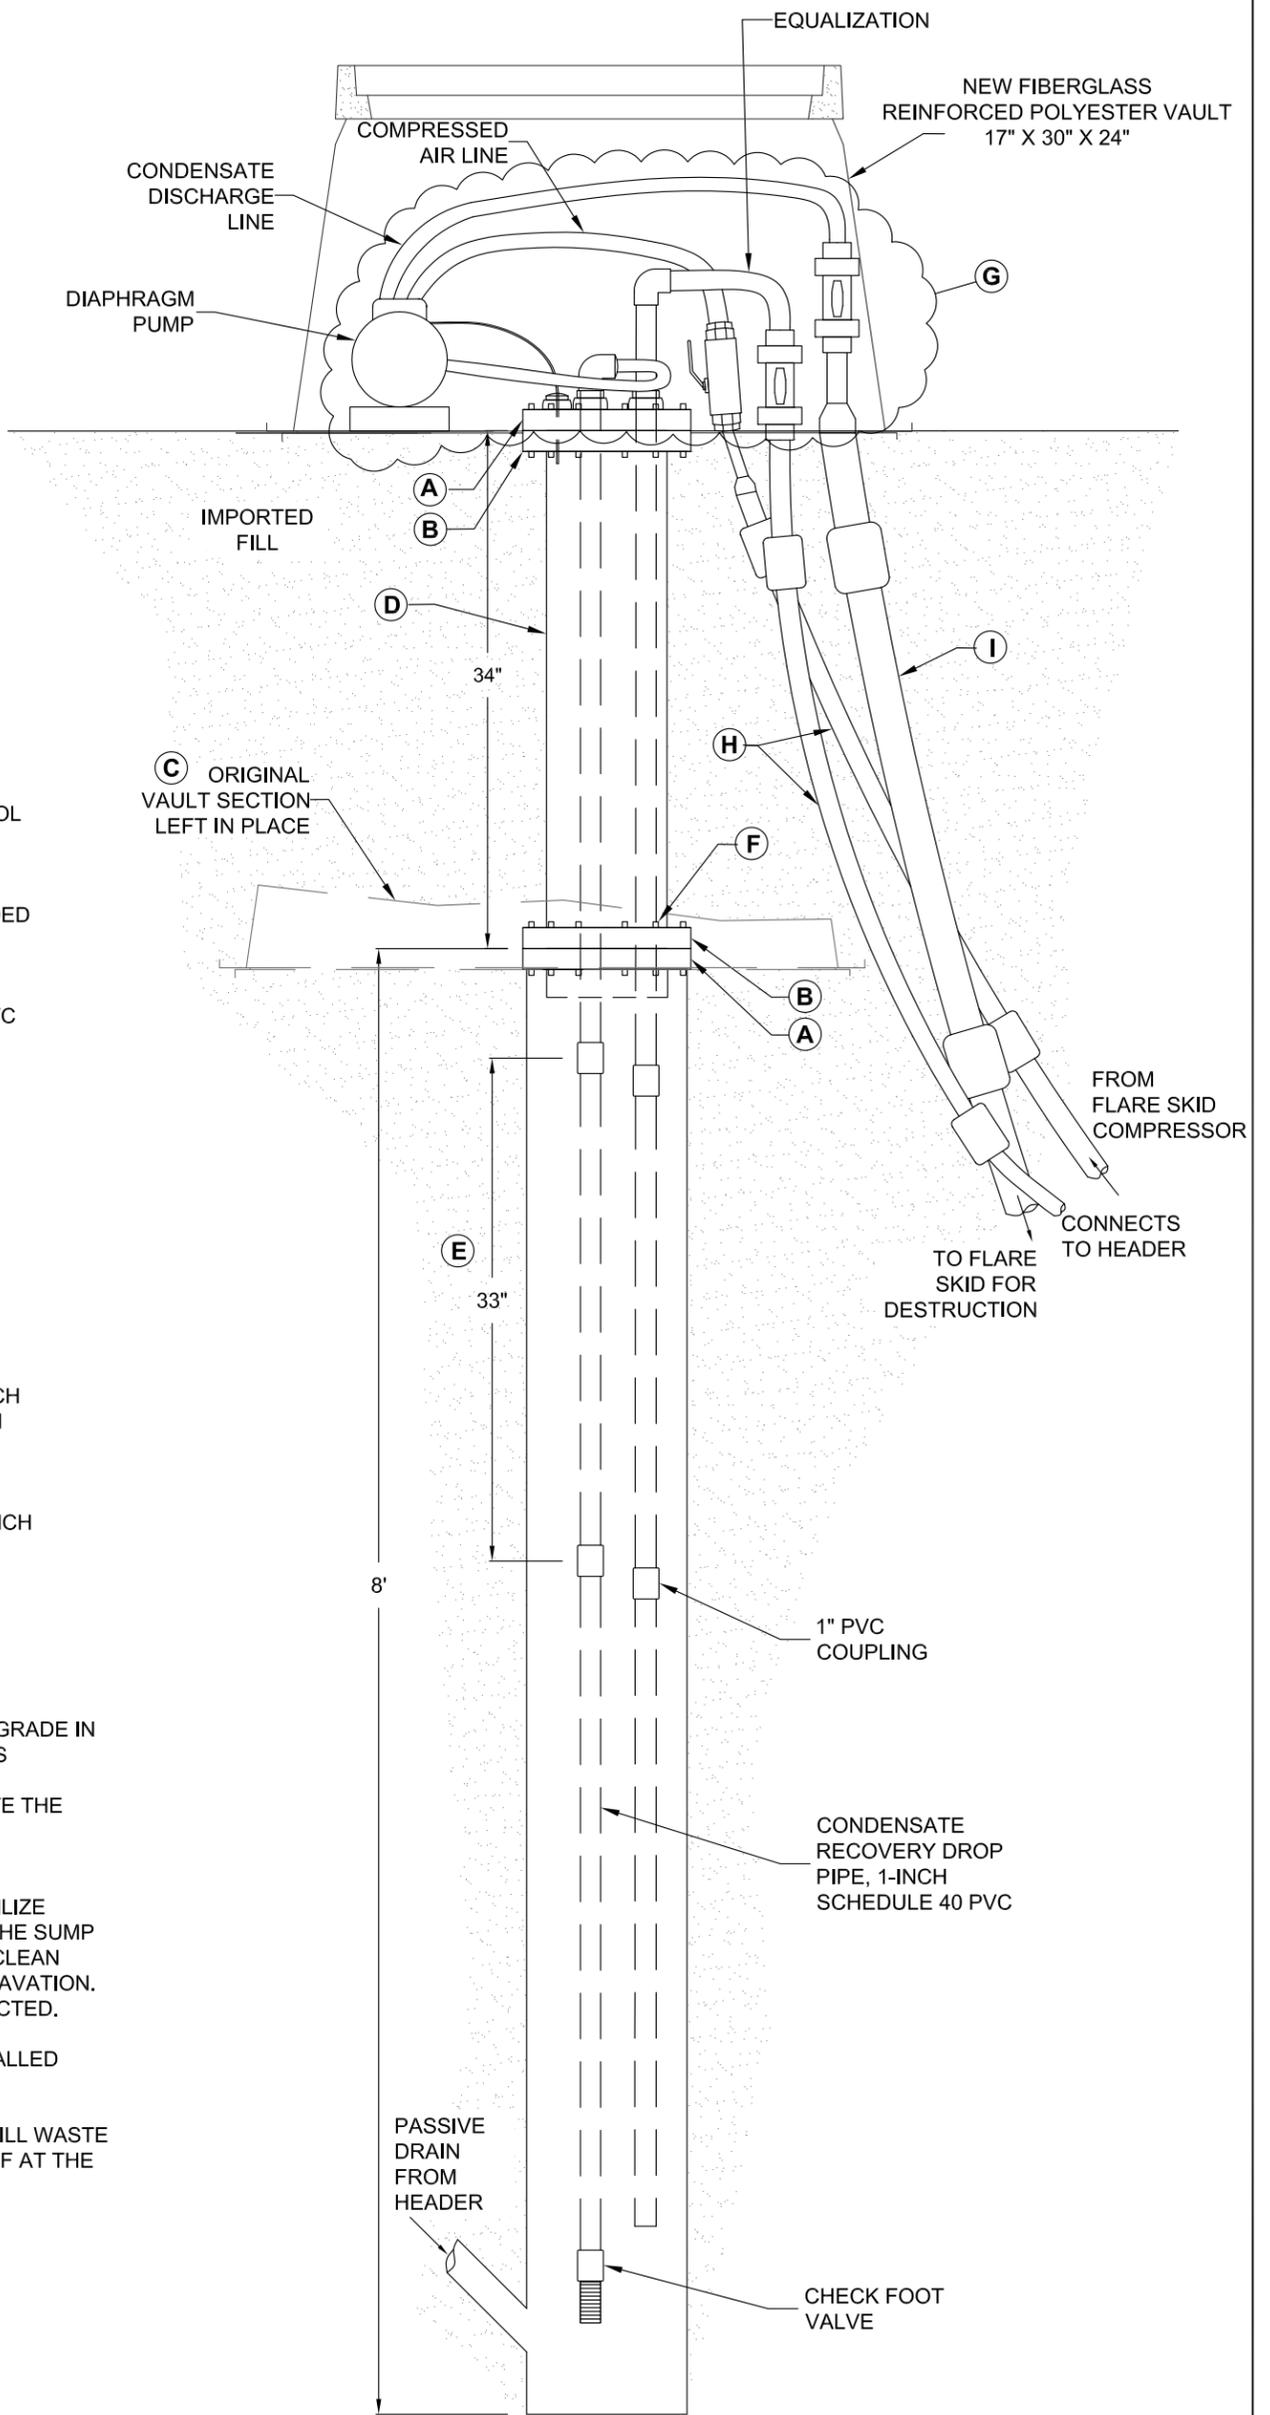
- (A)** 6" HDPE FLANGE (ORIGINAL INFRASTRUCTURE)
- (B)** 6" PVC FLANGE (NEW INFRASTRUCTURE)
- (C)** TOP OF ORIGINAL VAULT CUT OFF AT BASE AND BURIED IN PLACE. THE REMOVED SECTION WAS DISPOSED OF OFFSITE.

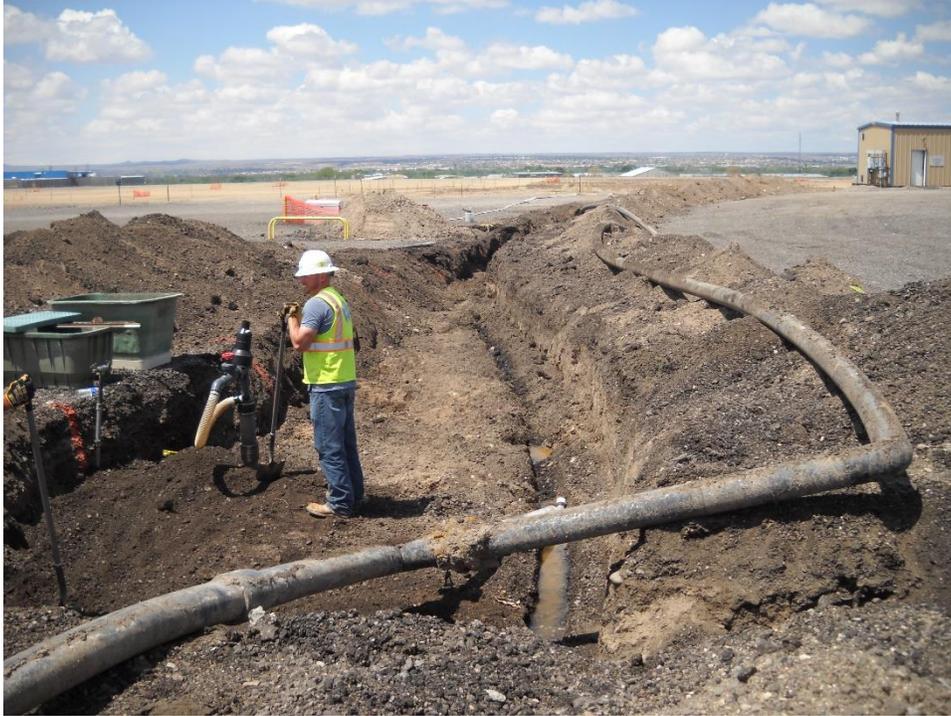
**IW05/IW17:** LFG extraction wells IW05 and IW17 are located on the south end of the landfill in an area where subsidence is occurring at a greater rate than other areas. Both wells are connected to the header by the same lateral. This section of lateral was occluded by condensate, and its entire length was excavated and exposed. Several low points in the pipeline were observed, and it was determined that it would be infeasible to obtain and maintain a constant slope from the header to the most distal well, IW17. To address these issues, a passive condensate sump was fabricated and installed between IW05 and IW17. The lateral from the header was realigned to the new sump (identified as IW05 Sump). A high point in the lateral was maintained between IW05 and IW17, with the intent of splitting condensate recovery between the new IW05 sump and the existing passive sump adjacent to IW17. A drawing of the new IW05 sump is provided in **Appendix A**, and photographs of the sump are provided in Appendix B.

*No. 1 – Former lateral pipe showing the configuration of the tee and elbow in the lateral between IW05 (left of worker) and IW17 (located out of site at top of photo). Photo looking west.*

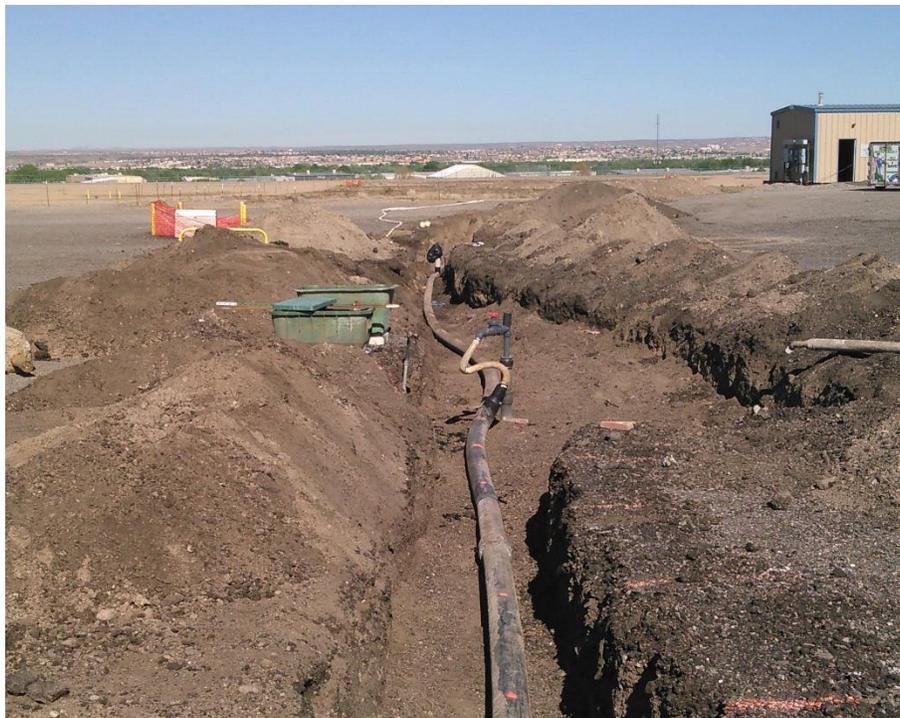
*No. 2 – Modified IW05/IW17 lateral alignment from April 2015. The lateral now passes directly south of IW05 (center of photo). Photo looking west.*

Concurrent with realignment of the lateral to IW05/IW17, the lateral was relocated from north of IW05 to south of the well. The original design had the lateral running from the header directly to IW05. The continuing lateral to IW17 teed off of the lateral to IW05 with a 90-degree elbow after the tee (see Photograph No. 1 in **Appendix B**). This configuration made it difficult to realign the lateral and ensure that condensate drained to the new sump. The tee and elbow were removed and the lateral was placed directly south of IW05 with a new tee connecting the wellhead directly to the lateral (see the record drawing for IW05 in **Appendix A** and Photograph No. 2 in **Appendix B**).

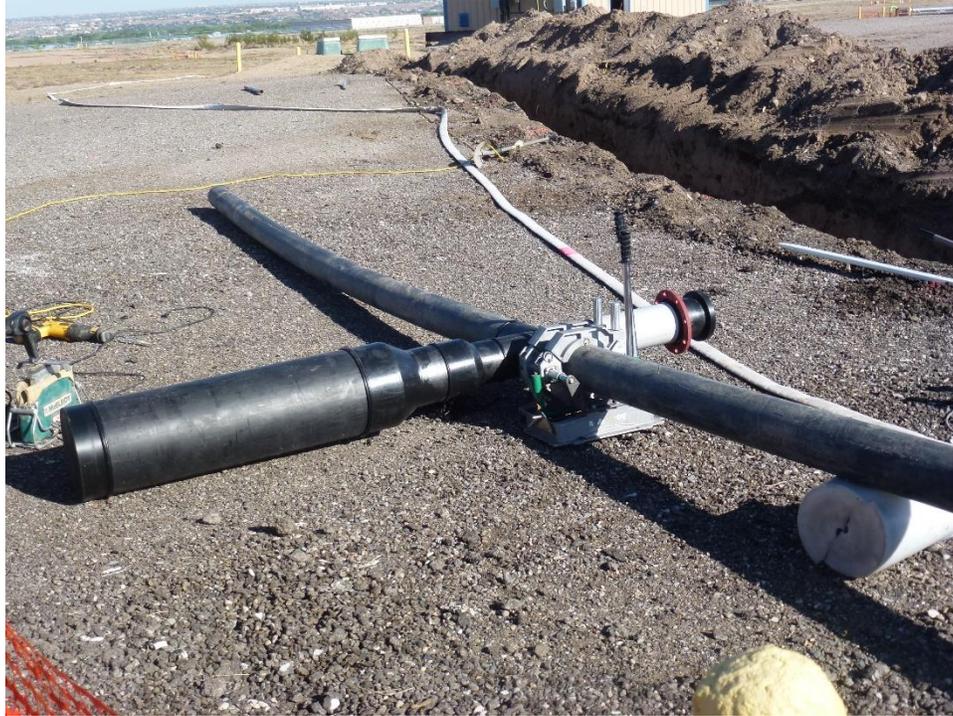
*No. 3 – IW05 Sump being butt-fused to lateral pipe. Photo looking northwest.*

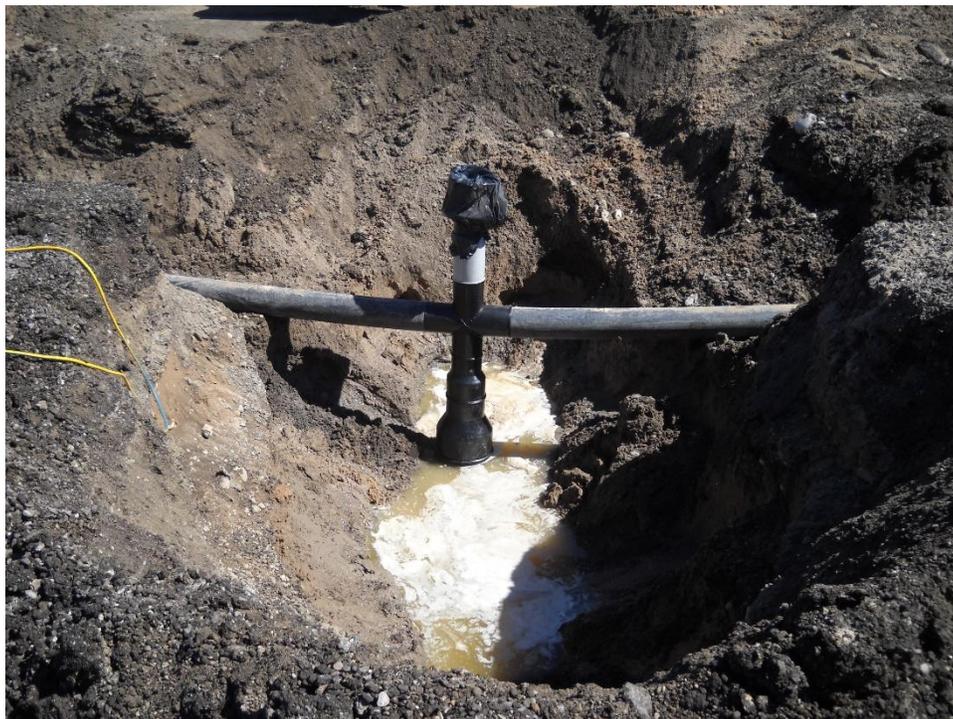
*No. 4 – IW05 Sump installed at lowest point in the lateral. The water in the excavation was draining from the surrounding soil into the trench. Photo looking north.*

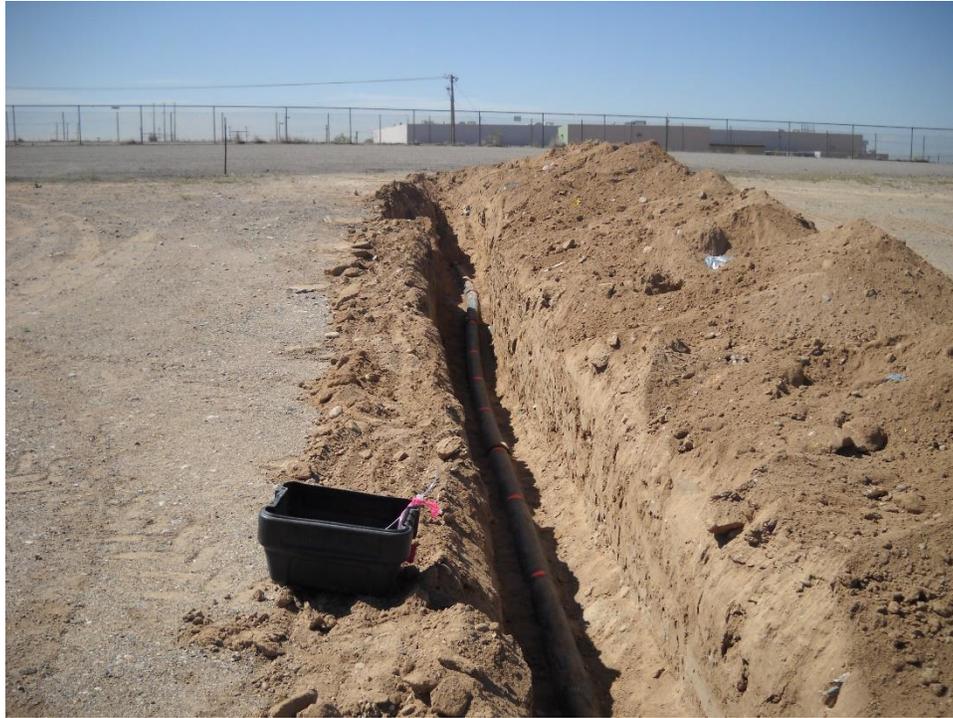
*No. 5 – Excavation of the lateral from the header to IW09. Photo looking south.*

**IW09:** The lateral to extraction well IW09 was excavated and realigned to return a constant grade toward the existing condensate sump south of the well and address the occlusion of the pipe by condensate (see Photograph No. 5 in **Appendix B**). To complete the realignment, the vaults were removed from the passive sump and wellhead. The as built condition after the vaults were reinstalled is shown on the record drawings provided in **Appendix A**.

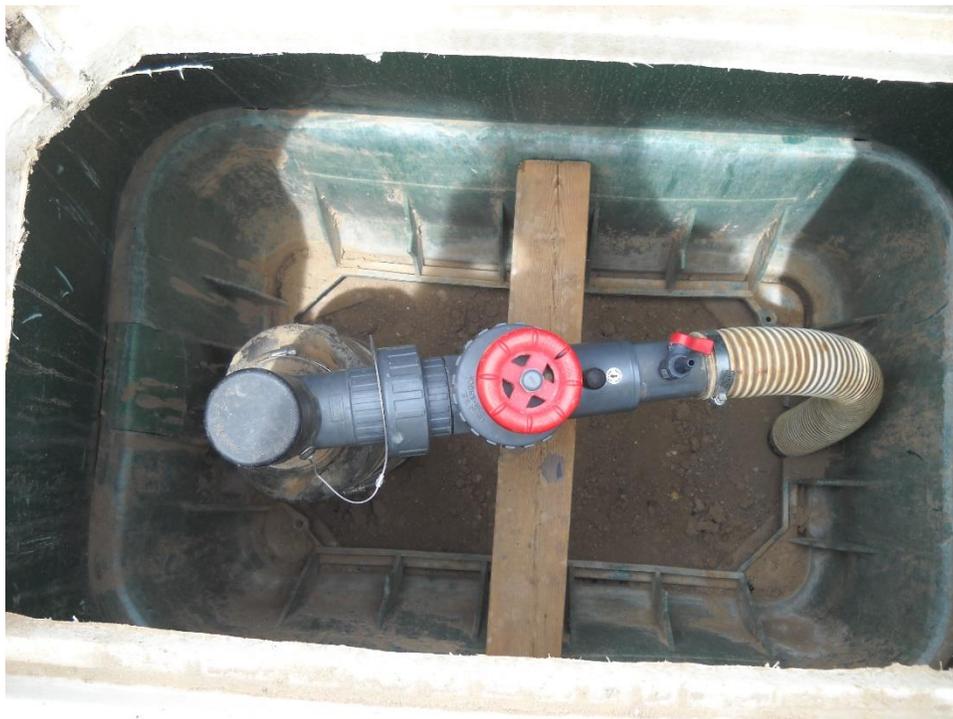
*No. 6 – Wellhead at extraction well PW20 after repairs to the well.*

**PW20:** Extraction well PW20 is connected to the same lateral that extends from the header to IW09. The adjustments made to the lateral (described above) required that the vaults at PW20 be removed and corrections made to the plumbing to the well. The resulting minor changes in the wellhead configuration in the vault are shown in the drawings in **Appendix A** and a photograph of the final wellhead configuration is shown on Photograph No. 6 in **Appendix B**.

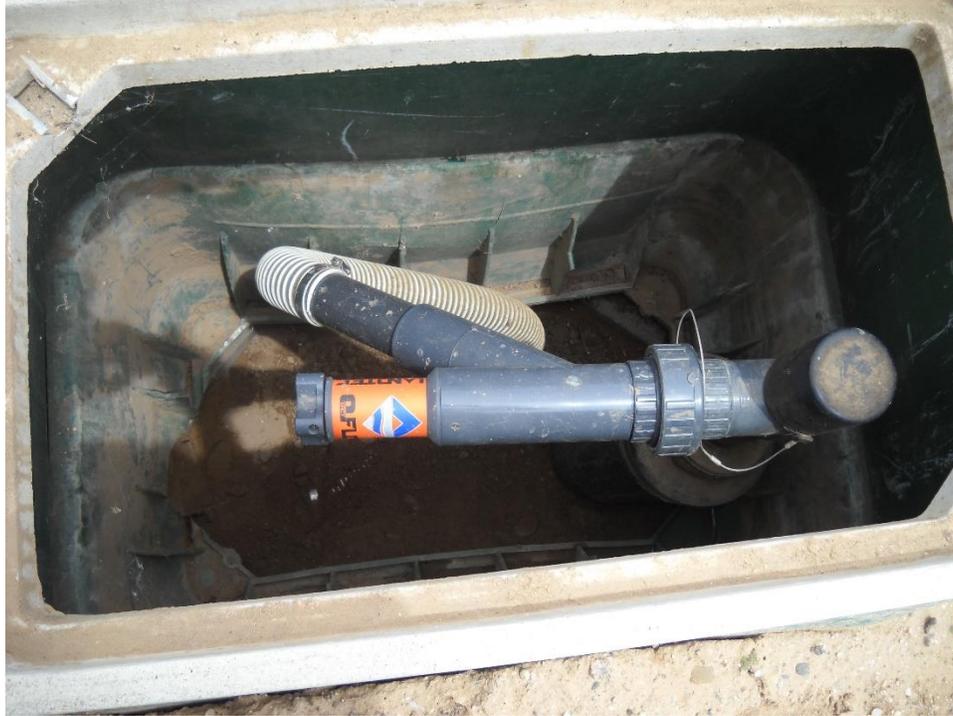
*No. 7 – New Landtec e-flo needle valve installed at PW32.*

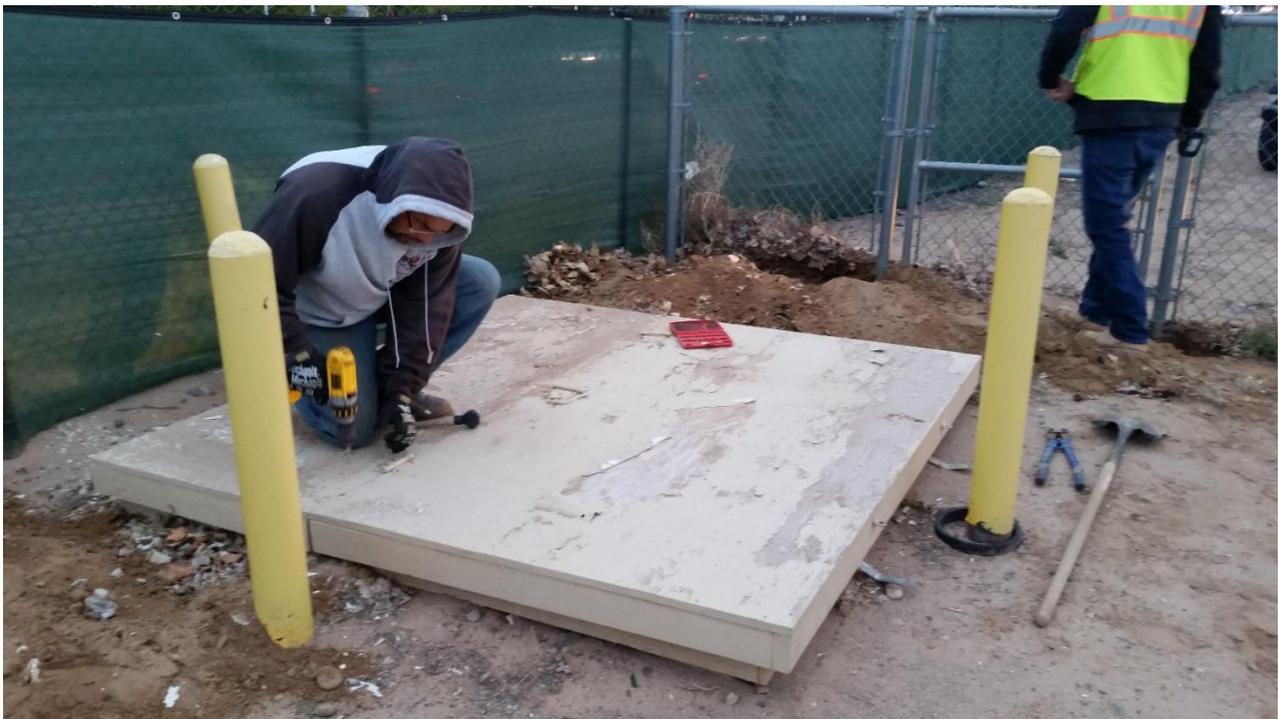
**CS09:** Condensate sump CS09 is located at the north end of the landfill. Improvements to the landfill prior to 2006 had resulted in the pump vault for the sump being several feet below grade. To account for this condition, a large timber and plywood vault with a hinged wooden lid had been constructed around the sump. This vault was designated as a permit confined space, meaning entry could only be conducted with special planning and only by personnel with confined space training. The AEHD had requested that measures be taken to eliminate the confined space issues. In October, the timber vault was removed, an extension to the sump body was installed at the existing flange, the plumbing and pump were relocated to near ground surface, and a new vault was installed at grade. Photograph Nos. 8 through 12 in **Appendix B** show the progression of the repairs, and an as built drawing is provided in **Appendix A**. Approximately 0.75 tons of waste material from excavate trash and debris from the former timber vault were removed from the LALF.

*No. 8 – CS09 condensate sump – Timber vault over the subgrade pump system prior to demolition. Photo looking northeast.*

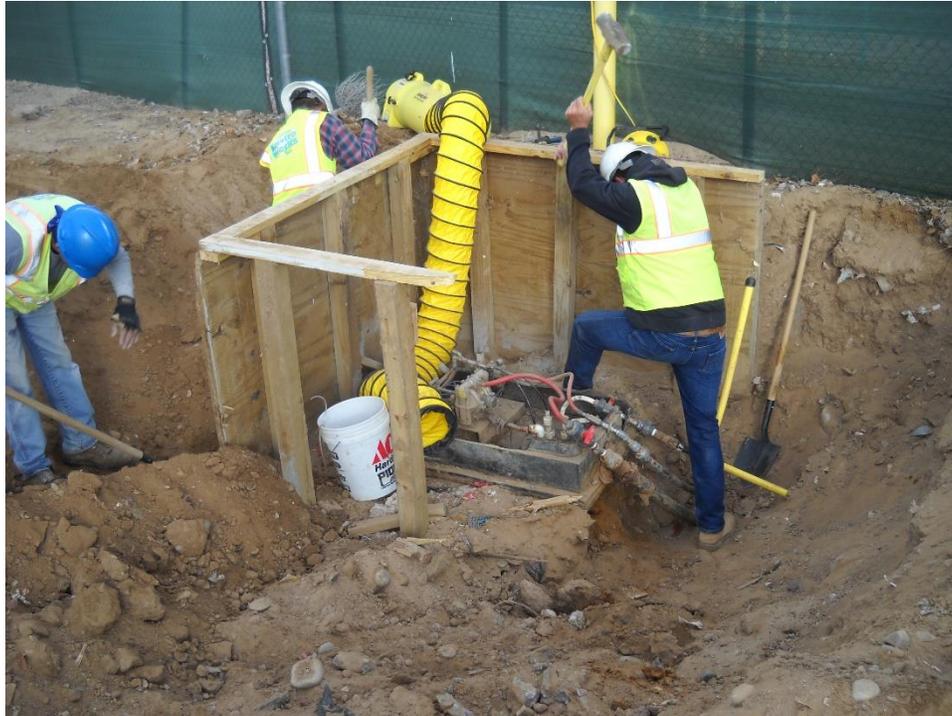
*No. 9 – CS09 condensate sump – demolition of timber vault over the condensate pump skid.*
