# 2015 AS BUILT REPORT FOR INFRASTRUCTURE REPAIRS AND MAINTENANCE

## FORMER LOS ANGELES LANDFILL

**May 5, 2016**

# 2015 AS BUILT PLANS FOR REPAIRS TO LANDFILL GAS EXTRACTION AND VAPOR EXTRACTION SYSTEMS

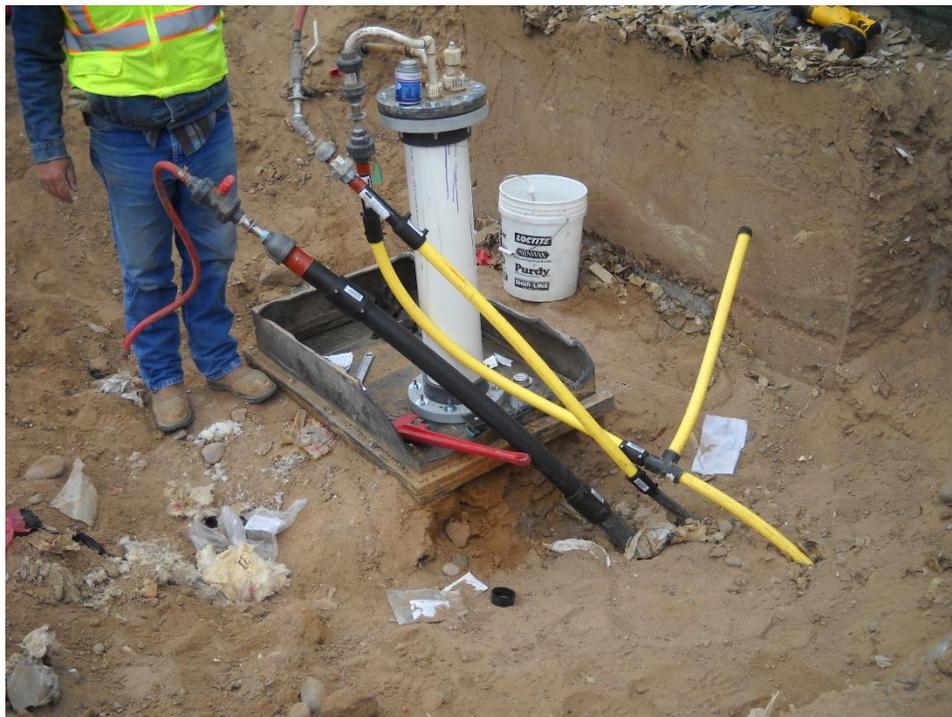
*No. 10 – CS09 condensate sump – extension of the sump body and connecting pipes were required to eliminate subgrade infrastructure.*

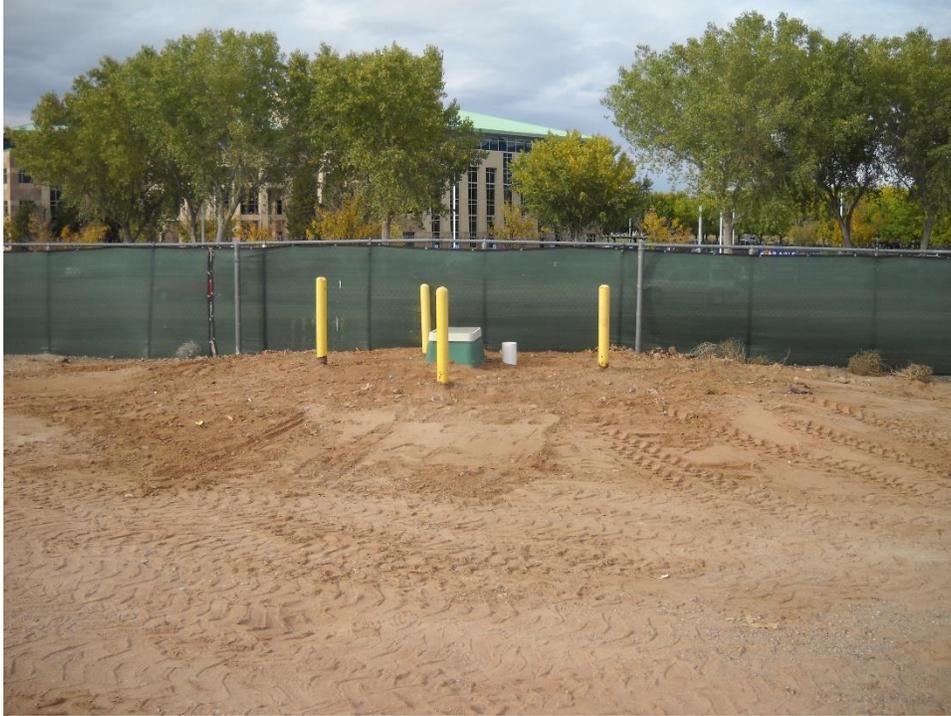
*No. 11 – CS09 condensate sump – as built condition after raising infrastructure and installing surface vault over the pump.*

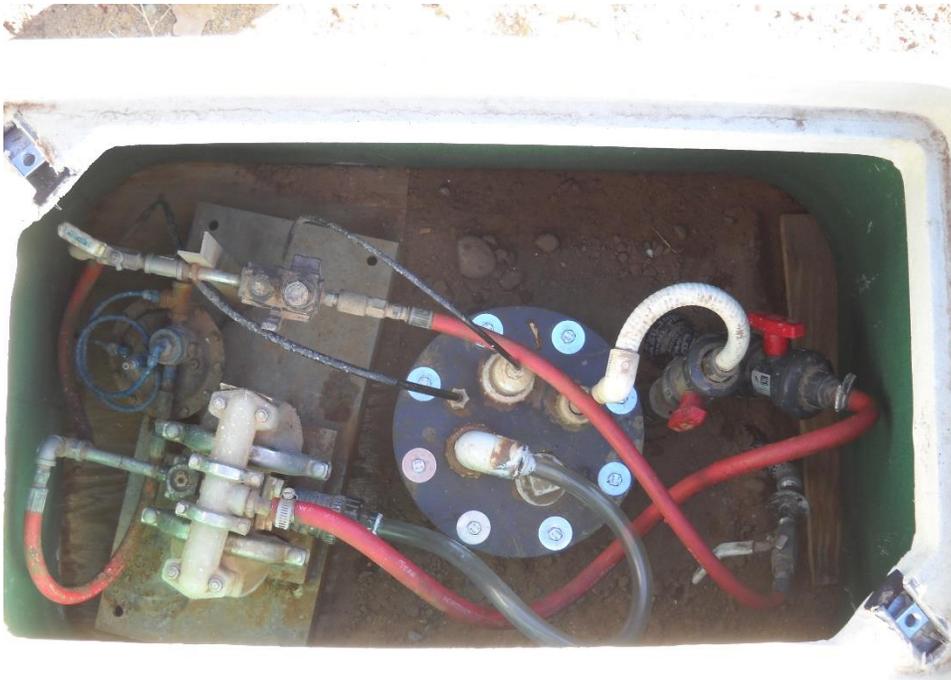
*No. 12 – CS09 condensate sump – interior of the new condensate sump vault that houses the plumbing and the double diaphragm pump.*

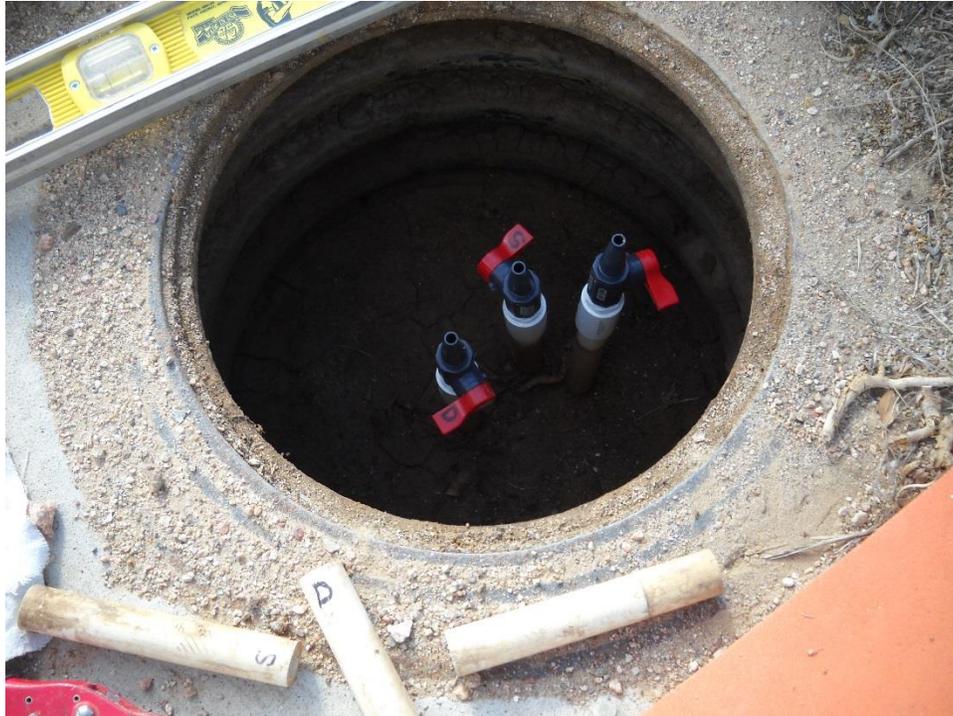
*No. 13 – Typical landfill gas probe in the Alameda Business Park where ¼-inch labcock valves were installed on the probe casings. Note the section of casing that was cut off of the probe to facilitate fitting the valves in the vault.*

In 2014, the AEHD directed that improvements be made to LFG probes associated with the routine (every other week) off-site gas readings. These improvements were extended in 2015 to probes measured quarterly in the Alameda Business Park. Improvements included digging out loose soil in vaults, cutting the casing of the probes down to facilitate modification, installation of schedule 80 polyvinyl chloride ¼-inch labcock sample ports, and labeling of the valves. To avoid the introduction of volatiles into the vapors in the probes, the slip fittings were “dry fit,” meaning that the fittings were not solvent-welded to the probe casing. The probes that were modified included the shallow, medium, and deep probes at locations AM12, AM14, AM16, AM18, AM19, AM28, AM30, AM33, AM34, AM35, AM57, AM58, and AM59. A photo from the 2014 improvements is provided in **Appendix B** (Photograph No. 13) to show typical wellhead conditions after the work.

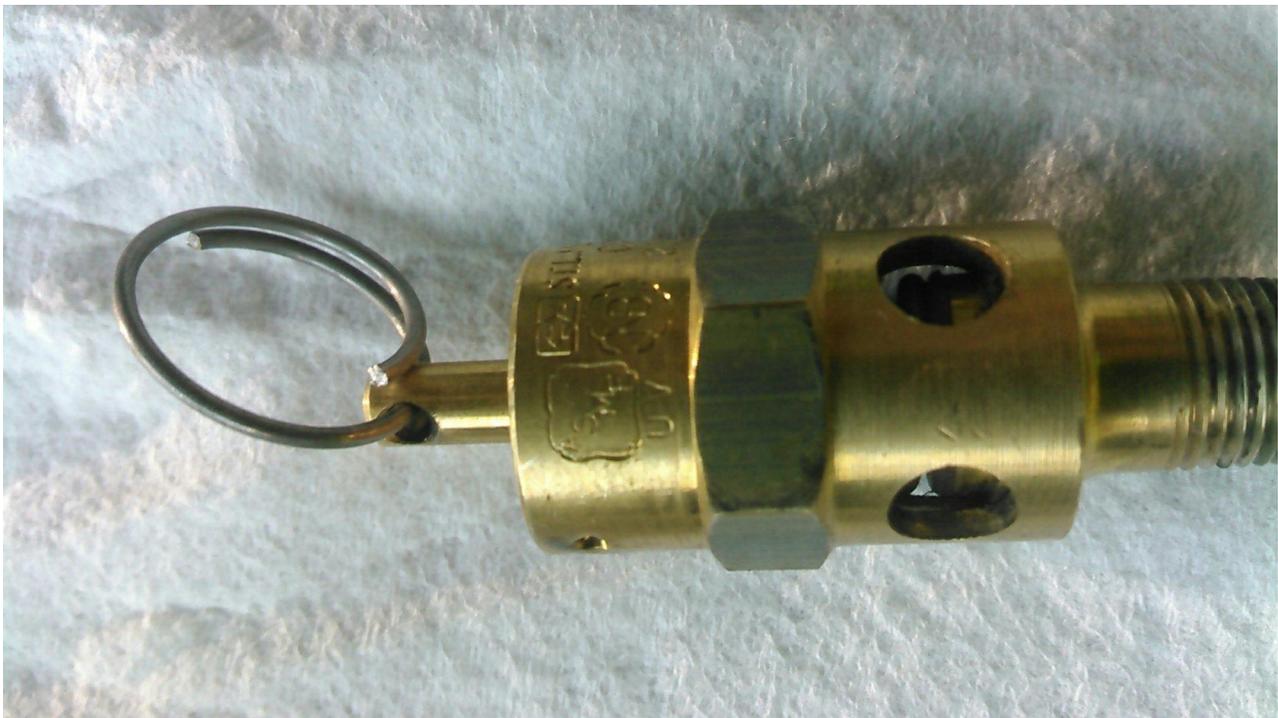
In December, the pressure relief valve on the air compressor at the enclosed ground flare malfunctioned. It was replaced with a part from the compressor’s manufacturer (Quincy). The specifications for the safety valve were:

*No. 14 – Pressure relief valve replaced on the compressor at the enclosed flare station.*

- Part No. QUI 111089-215.
- ½-inch male National Pipe Thread connector.
- Set pressure 215 pounds per square inch.
- Rated flow = 190 standard cubic feet per minute.

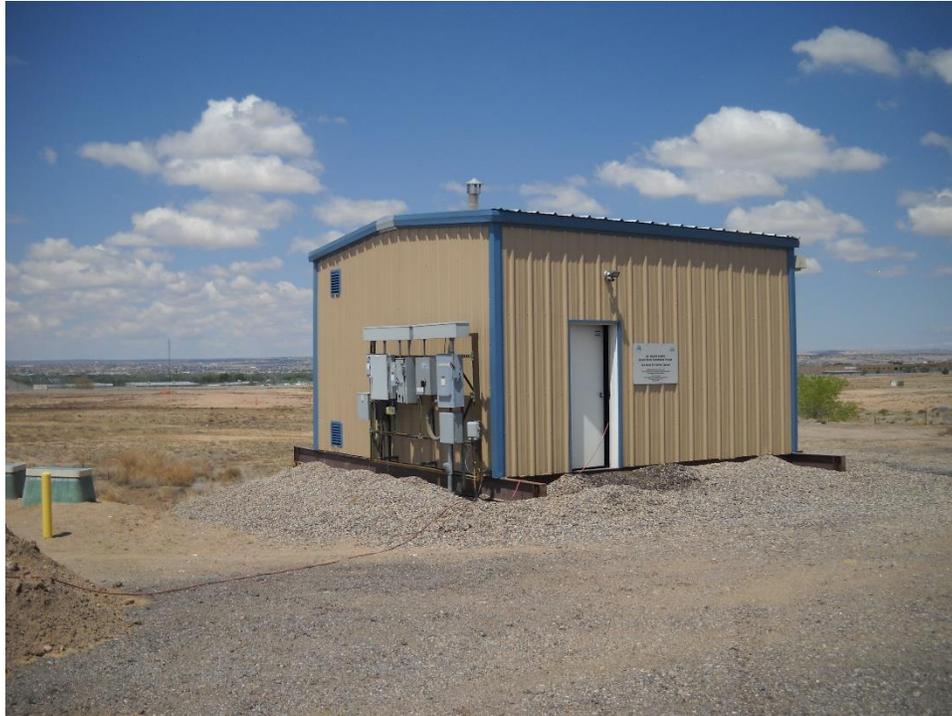
*No. 15 – Prior to leveling the SVE building, the existing gravel was excavated from around the piers and supporting beams. Additional gravel was imported to raise the level of the gravel in and around the building after leveling. Photo looking northwest.*

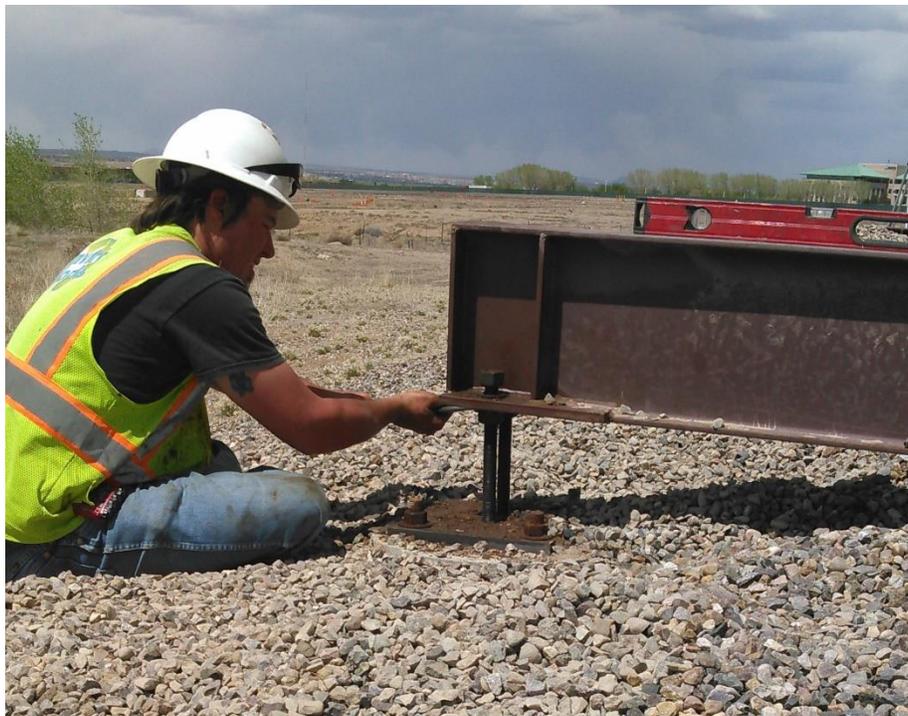
*No. 16 – Leveling of the SVE building was accomplished by raising the beam on the jacking lug. Photo taken of the southwest corner, looking northwest.*

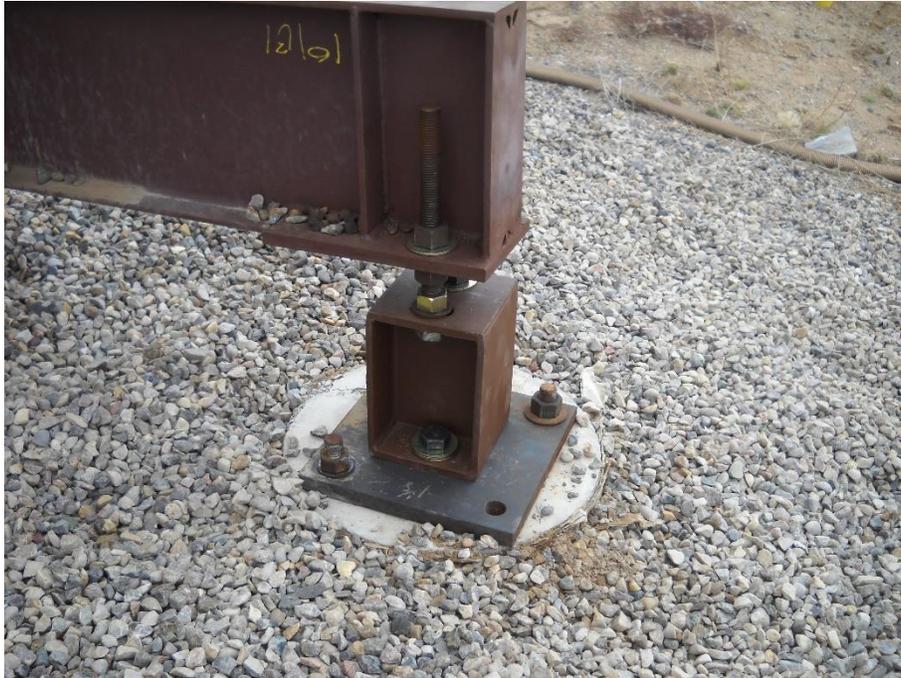
*No. 17 – The settlement on the southwest corner of the SVE building was so great that a steel extension spacer and new jacking studs (shown) were needed to achieve level. Photo taken looking southeast.*

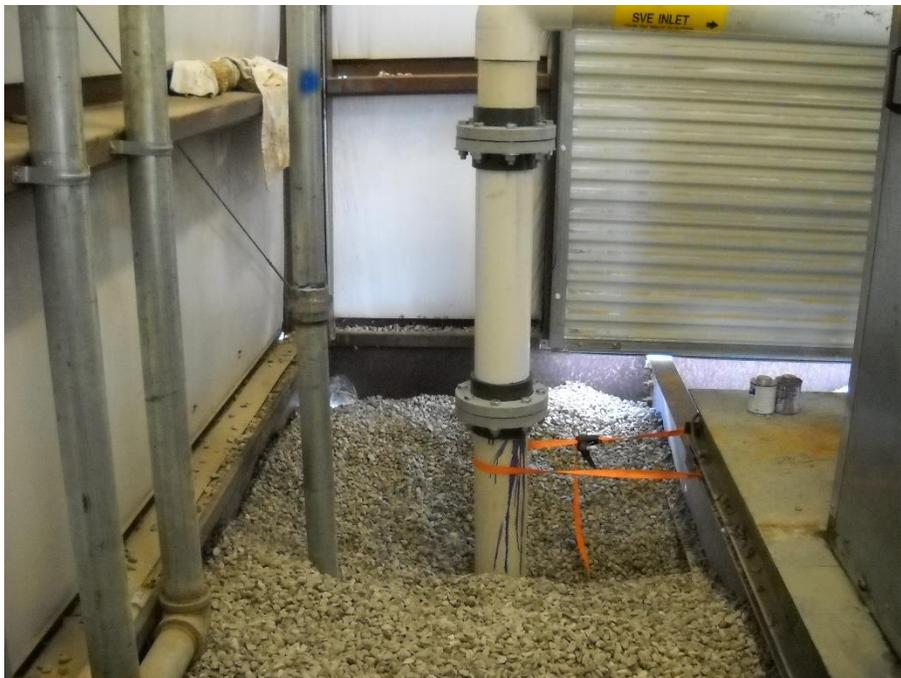
*No. 18 – Interior of the SVE building showing the section of vertical polyvinyl chloride pipe added between the equipment skid (right) and the pipe leaving the building through the floor. The section of galvanized pipe with the blue mark was also added to make up the difference in the air injection pipe. Photo taken looking north.*

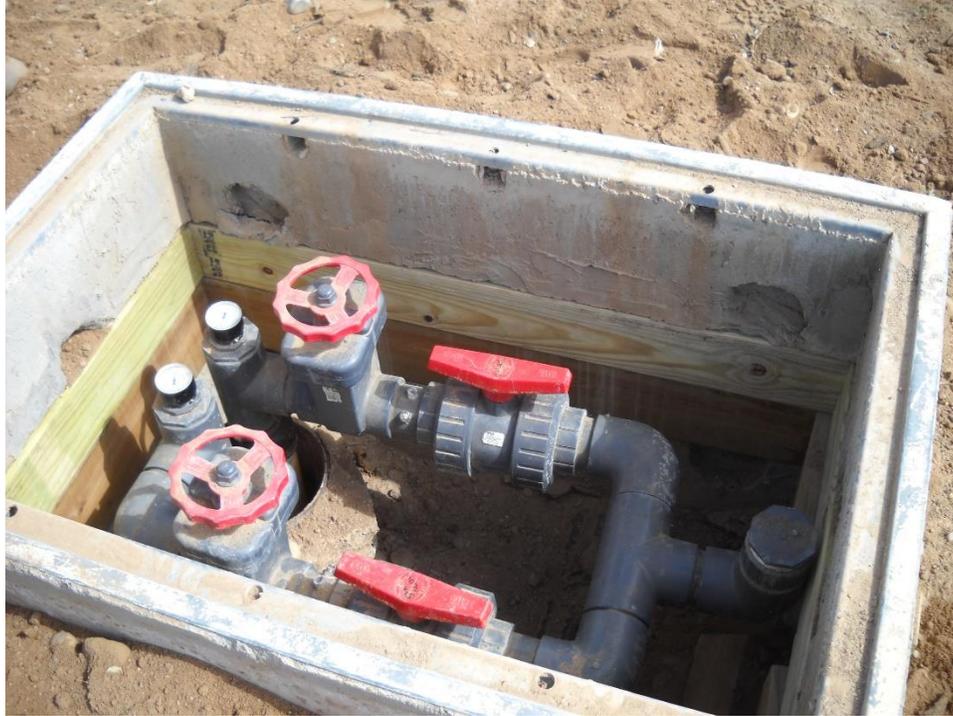
**SVE01:** This well was significantly impacted by the effect of landfill settlement. The concrete vault rings were not level and were in contact with the plumbing, which was placing stress on the pipes. The wellhead infrastructure was excavated and the top concrete vault ring was raised by fabricating and installing a spacer made of 2-inch by 6-inch (nominal) pressure-treated timbers. This timber spacer was installed on top of a timber spacer that had been installed during previous repairs to this well (see Photograph No. 19 in **Appendix B**).

No. 19 – SVE well vault at SVE01. Note the timber spacer installed below the top concrete vault ring. Photo taken looking north.

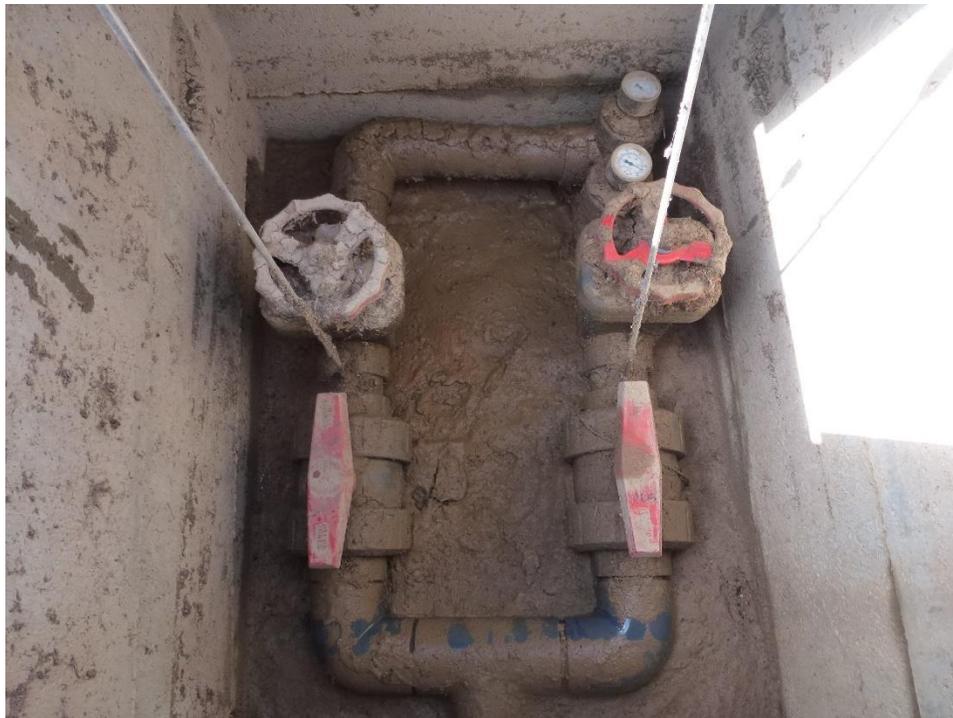
No. 20 – SVE09 before improvements. The wellhead manifold was several feet below grade and inconvenient to reach. Photo taken looking south.

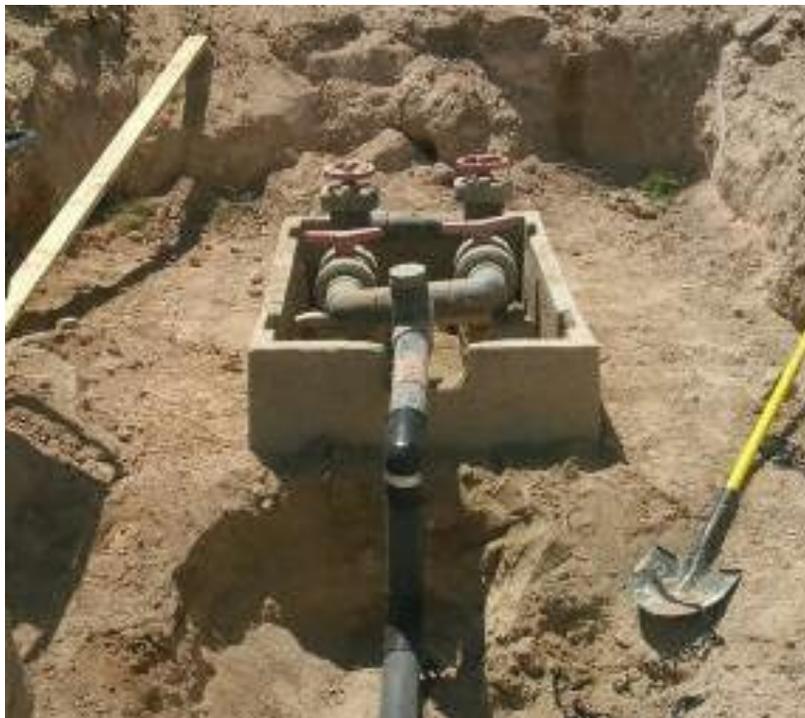
*No. 21 – SVE09 during repairs. Note that two butt-fusion elbows were installed on the extraction pipe to raise the wellhead plumbing in the vault. Photo taken looking south.*

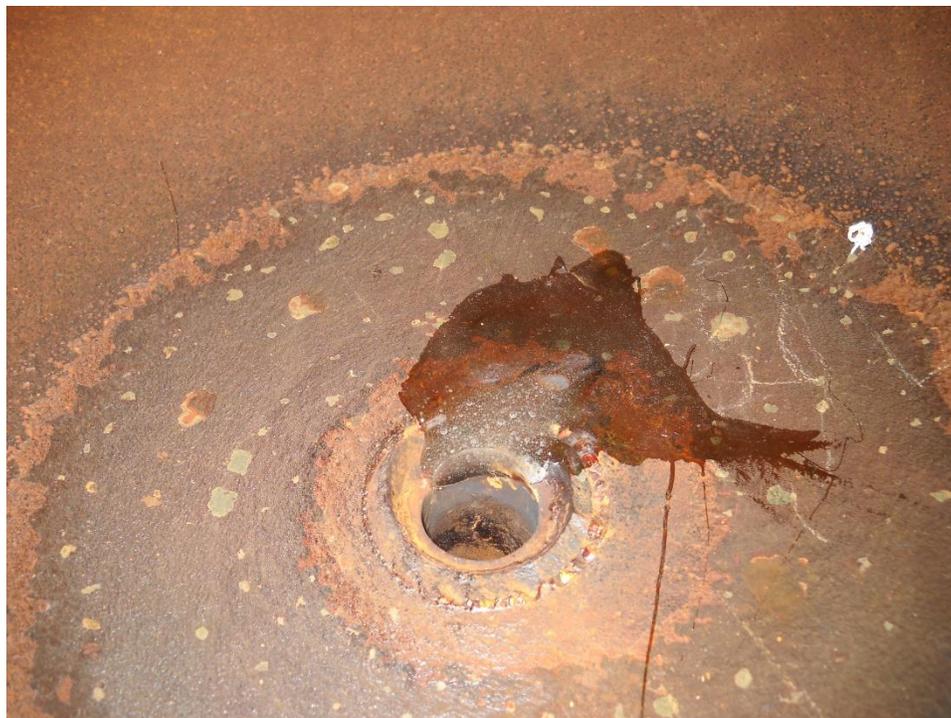
In February, a leak was observed in the condensate knock-out vessel on the blower skid. The vessel was opened and it was determined that debris had circulated in the bottom of the vessel, and with time had worn a hole in the metal. The vessel was cleaned and dried, and an epoxy seal was applied to the hole. A photograph of the epoxy repair is included as Photograph 22 in **Appendix B**.

*No. 22 – Epoxy patch to inside of the moisture knock-out vessel on the SVE blower skid.*
