LIMITED ASBESTOS SURVEY

**GIBSON MEDICAL CENTER
5400 GIBSON BOULEVARD SE
ALBUQUERQUE, NEW MEXICO 87108**

Project No.: 20-48

October 5, 2020

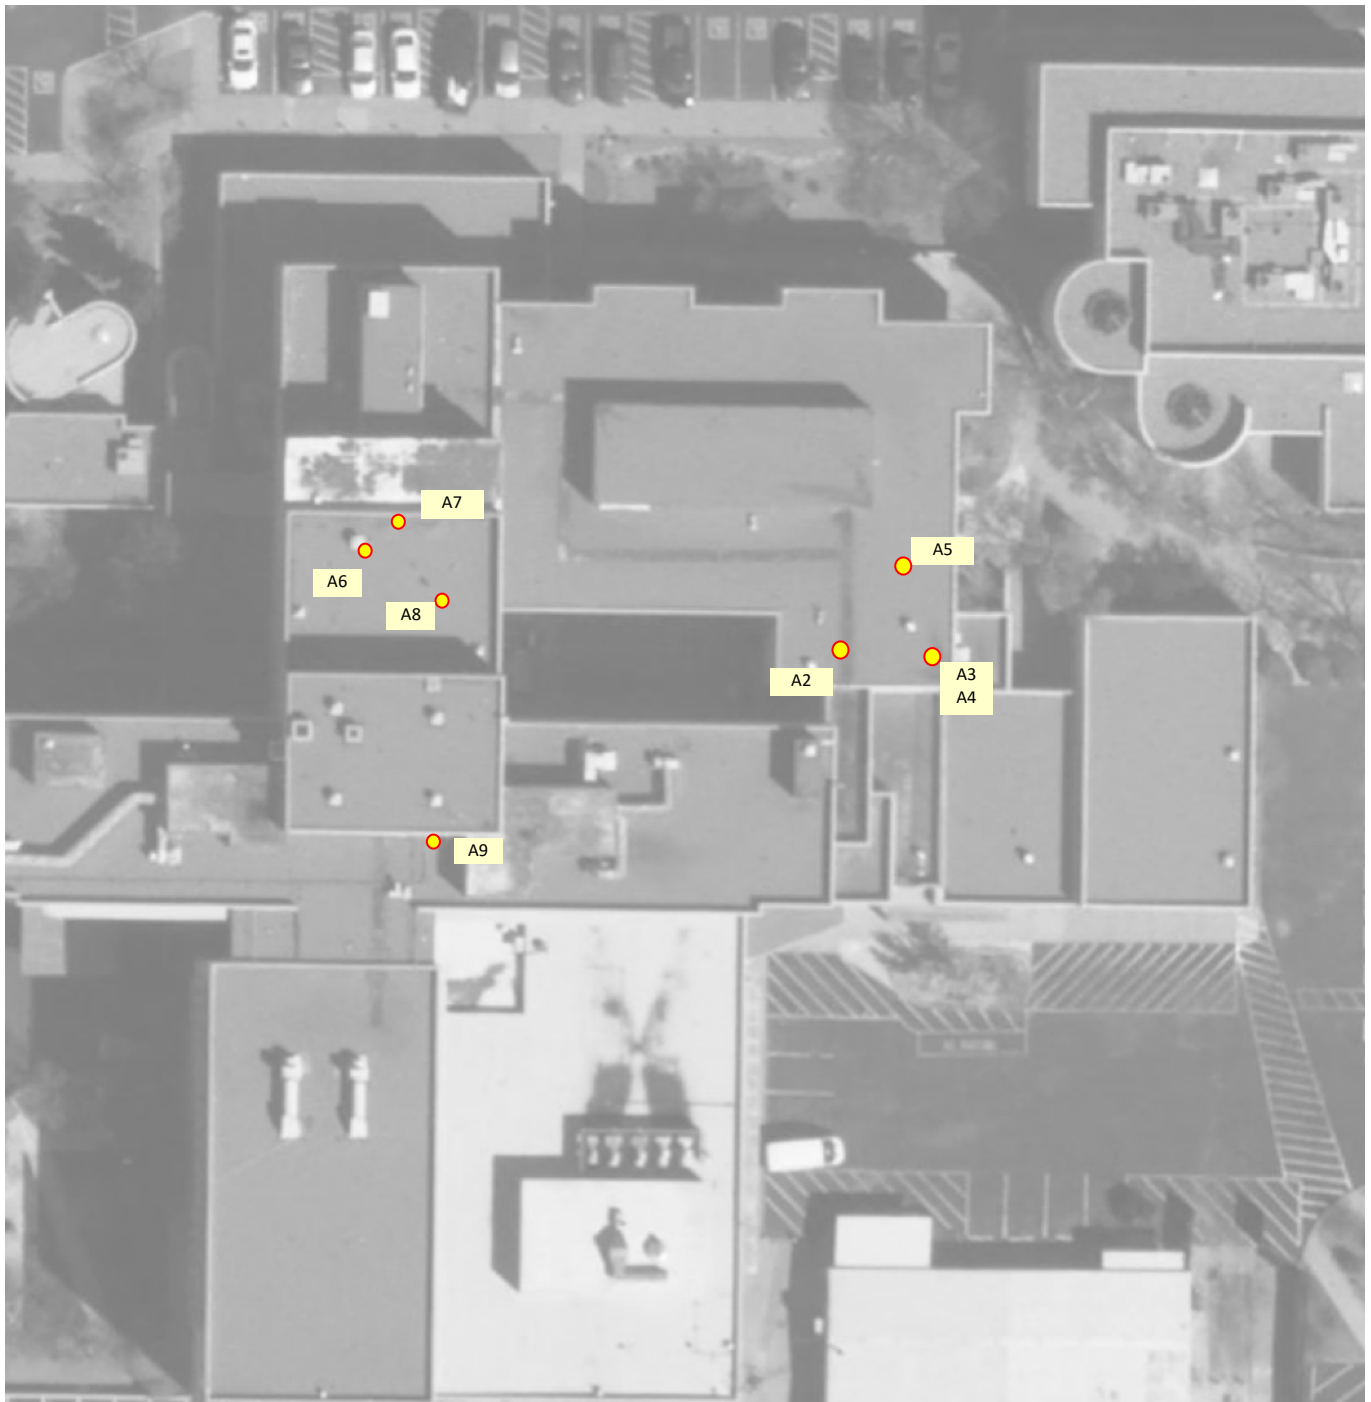
Figure A-1

Asbestos Sample Locations (Main Hospital Building Roof – East Portion)

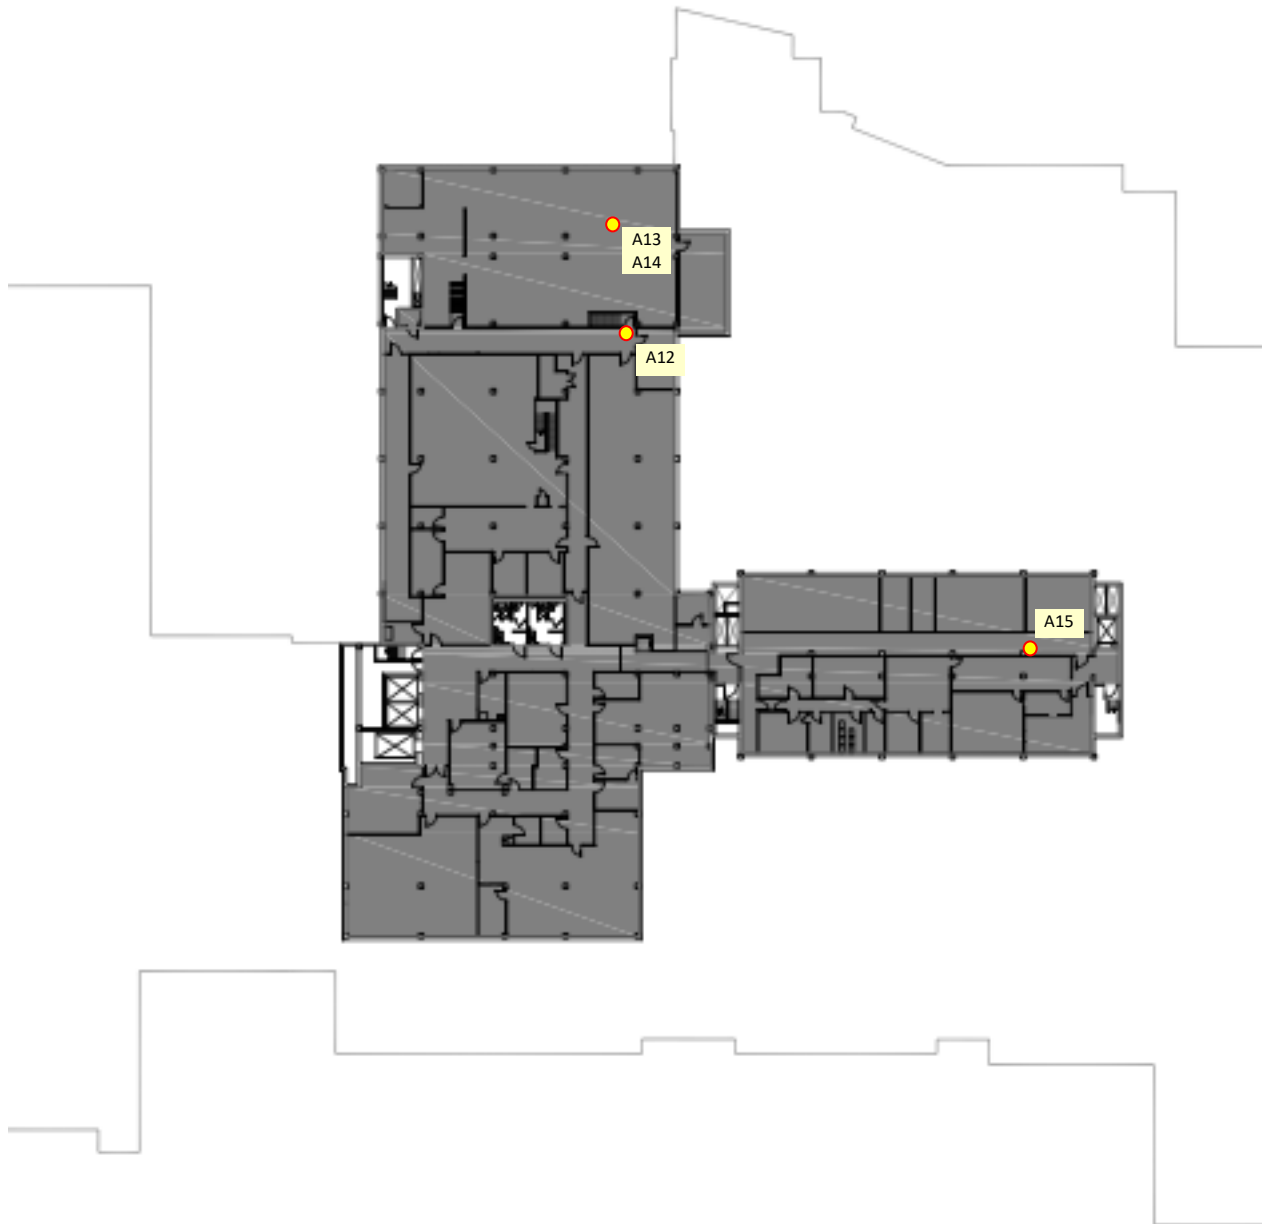
Client: City of Albuquerque
Sendero Environmental Project No. 20-48
No Scale
Figure A-3

Asbestos Sample Locations (Main Hospital Building – Basement)

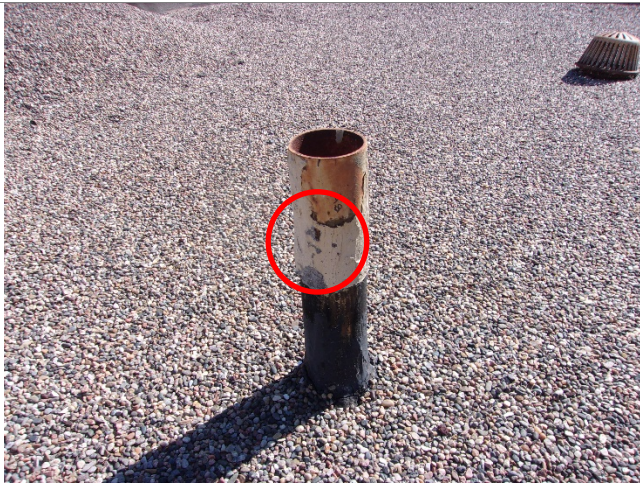
- Sample No. 48-A8 of black, non-friable roof vent penetration sealant tar at the main hospital building contained 3% chrysotile asbestos. There are approximately 250 roof penetrations at the main hospital building. A portion of this roof is covered with a membrane. Three samples of parapet sealant tar, one sample of main roofing tar, one sample of an exhaust fan base sealant tar, and one other sample of roofing vent penetration sealant tar were non-detect for asbestos. Sendero Environmental recommends that all vent penetration sealant tar at the main hospital building should be assumed to contain asbestos. However, additional sampling may delineate some areas of non-asbestos bent penetration sealant tar, based on dates of construction, etc. The asbestos-containing roofing vent penetration sealant tar is a non-friable exterior material. It is locally damaged and has a rare potential for exposure.

- One sample of black, non-friable roof vent penetration sealant tar at the main hospital building contained 3% chrysotile asbestos. There are approximately 250 roof penetrations at the main hospital building. A portion of this roof is covered with a membrane. Three samples of parapet sealant tar, one sample of main roofing tar, one sample of an exhaust fan base sealant tar, and one other sample of roofing vent penetration sealant tar were non-detect for asbestos. Sendero Environmental recommends that all vent penetration sealant tar at the main hospital building should be assumed to contain asbestos. However, additional sampling may delineate some areas of non-asbestos bent penetration sealant tar, based on dates of construction, etc. The asbestos-containing roofing vent penetration sealant tar is a non-friable exterior material. It is locally damaged and has a rare potential for exposure.

Photo 9: Sample No. 48-A8 of roofing vent penetration tar contained 3% chrysotile asbestos.

No additional sampling for asbestos is recommended in the Gibson Medical Center buildings at this time. Although mitigation priorities are the responsibility of an Asbestos Management Planner, Sendero Environmental recommends that the TSI “hard” joints in the main hospital building should receive priority consideration for abatement. The asbestos-containing floor tile and mastic should receive secondary consideration. The asbestos-containing roofing tars are exterior materials and have a very low potential for exposure to asbestos fibers – they may be assigned the lowest priority for abatement.

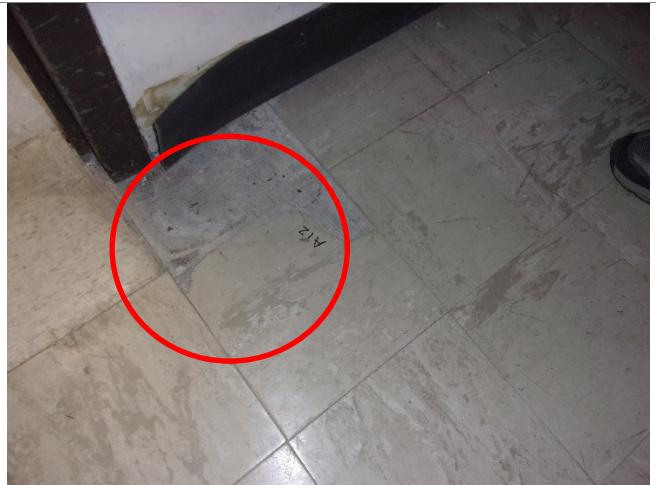
- Sample No. 48-A12 of 9-inch by 9-inch vinyl floor tile in the basement at the main hospital contained 2% chrysotile asbestos. There are approximately 1,500 square feet of this grayish speckled basement floor tile. This floor tile is non-friable; however, it is significantly damaged at several locations. It has a potential for daily exposure. Most of the hospital has newer 12-inch by 12-inch vinyl floor tile. It is not known at this time whether the older 9-inch by 9-inch asbestos-containing floor tile is present underneath the newer floor tile or carpeted areas.

- One sample of 9-inch by 9-inch vinyl floor tile in the basement at the main hospital contained 2% chrysotile asbestos. There are approximately 1,500 square feet of this grayish speckled basement floor tile. This floor tile is non-friable; however, it is significantly damaged at several locations. It has a potential for daily exposure. Most of the hospital has newer 12-inch by 12-inch vinyl floor tile. It is not known at this time whether the older 9-inch by 9-inch asbestos-containing floor tile is present underneath the newer floor tile or carpeted areas.

Photo 10: Sample No. 48-A12 of 9"x9" floor tile with black mastic in the basement contained 2% and 4% chrysotile asbestos, respectively.

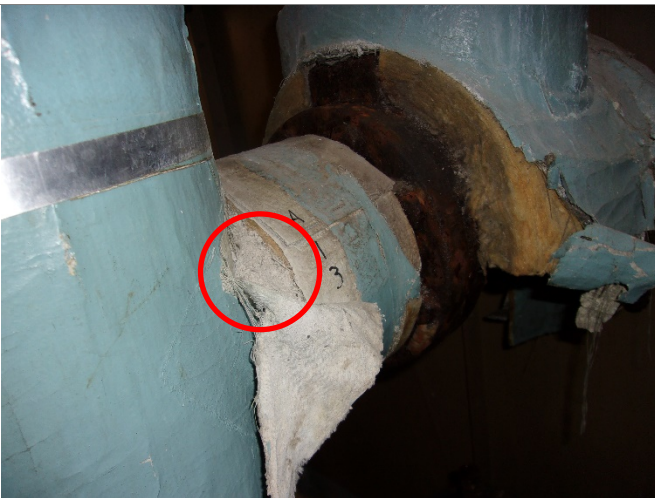
- Sample No. 48-A13 of “hard” (wrapped white powder) thermal system insulation (TSI) in the basement of the main hospital building contained 3% chrysotile asbestos. Perhaps 50 of the wrapped TSI joints are present in the basement; however, there may be many more wrapped TSI joints hidden in the walls. Many of the asbestos-containing “hard” TSI joints are significantly damaged and are therefore considered friable. There is a significant potential for damage and a significant potential for exposure. It appears that many of the “hard” joints have already been replaced with non-asbestos material.

significantly damaged and are therefore considered friable. There is a significant potential for damage and a significant potential for exposure. It appears that many of the "hard" joints have already been replaced with non-asbestos material.

Photo 11: Sample No. 48-A13 of "hard" white powder TSI elbow contained 3% chrysotile asbestos.
