## Limited Asbestos-Containing Building Materials for Gibson Medical Center Third Floor, Albuquerque, New Mexico

May 2, 2023  
Project No. 23-109

Subject: Limited Asbestos-Containing Building Materials Survey for Gibson Medical Center Third Floor  
5400 Gibson Boulevard SE, Albuquerque, New Mexico

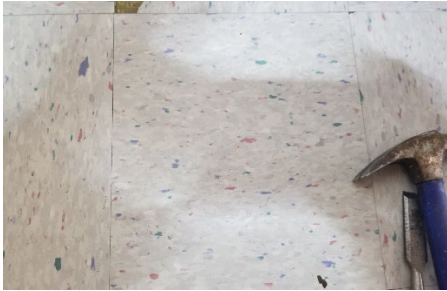
| 23-109-09 | 12 x 12 blue-gray mottled floor tile | None Detected |
| 23-109-10 | 12 x 12 blue-gray mottled floor tile | None Detected |

**Photo 1: Blue-Grey Floor Tile.**

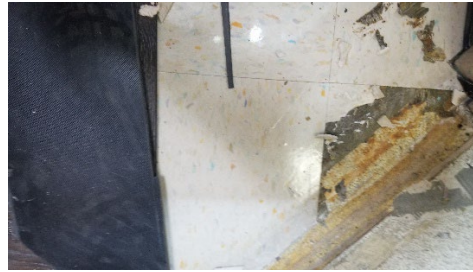
| 23-109-07 | 12 x 12 white candy spotted floor tile | None Detected |
| 23-109-08 | 12 x 12 white candy spotted floor tile | None Detected |

**Photo 2: Candy-spotted Floor Tile.**

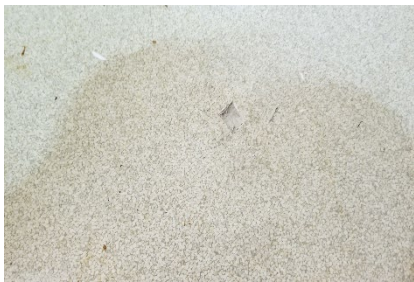
| Sample Identification # | Description | Asbestos Type/Percent |
|---|---|---|
| 23-109-05 | Gray-whited spotted linoleum | None Detected |
| 23-109-06 | Gray-whited spotted linoleum | None Detected |

**Photo 3: Sampled Linoleum.**
