1703

A R T

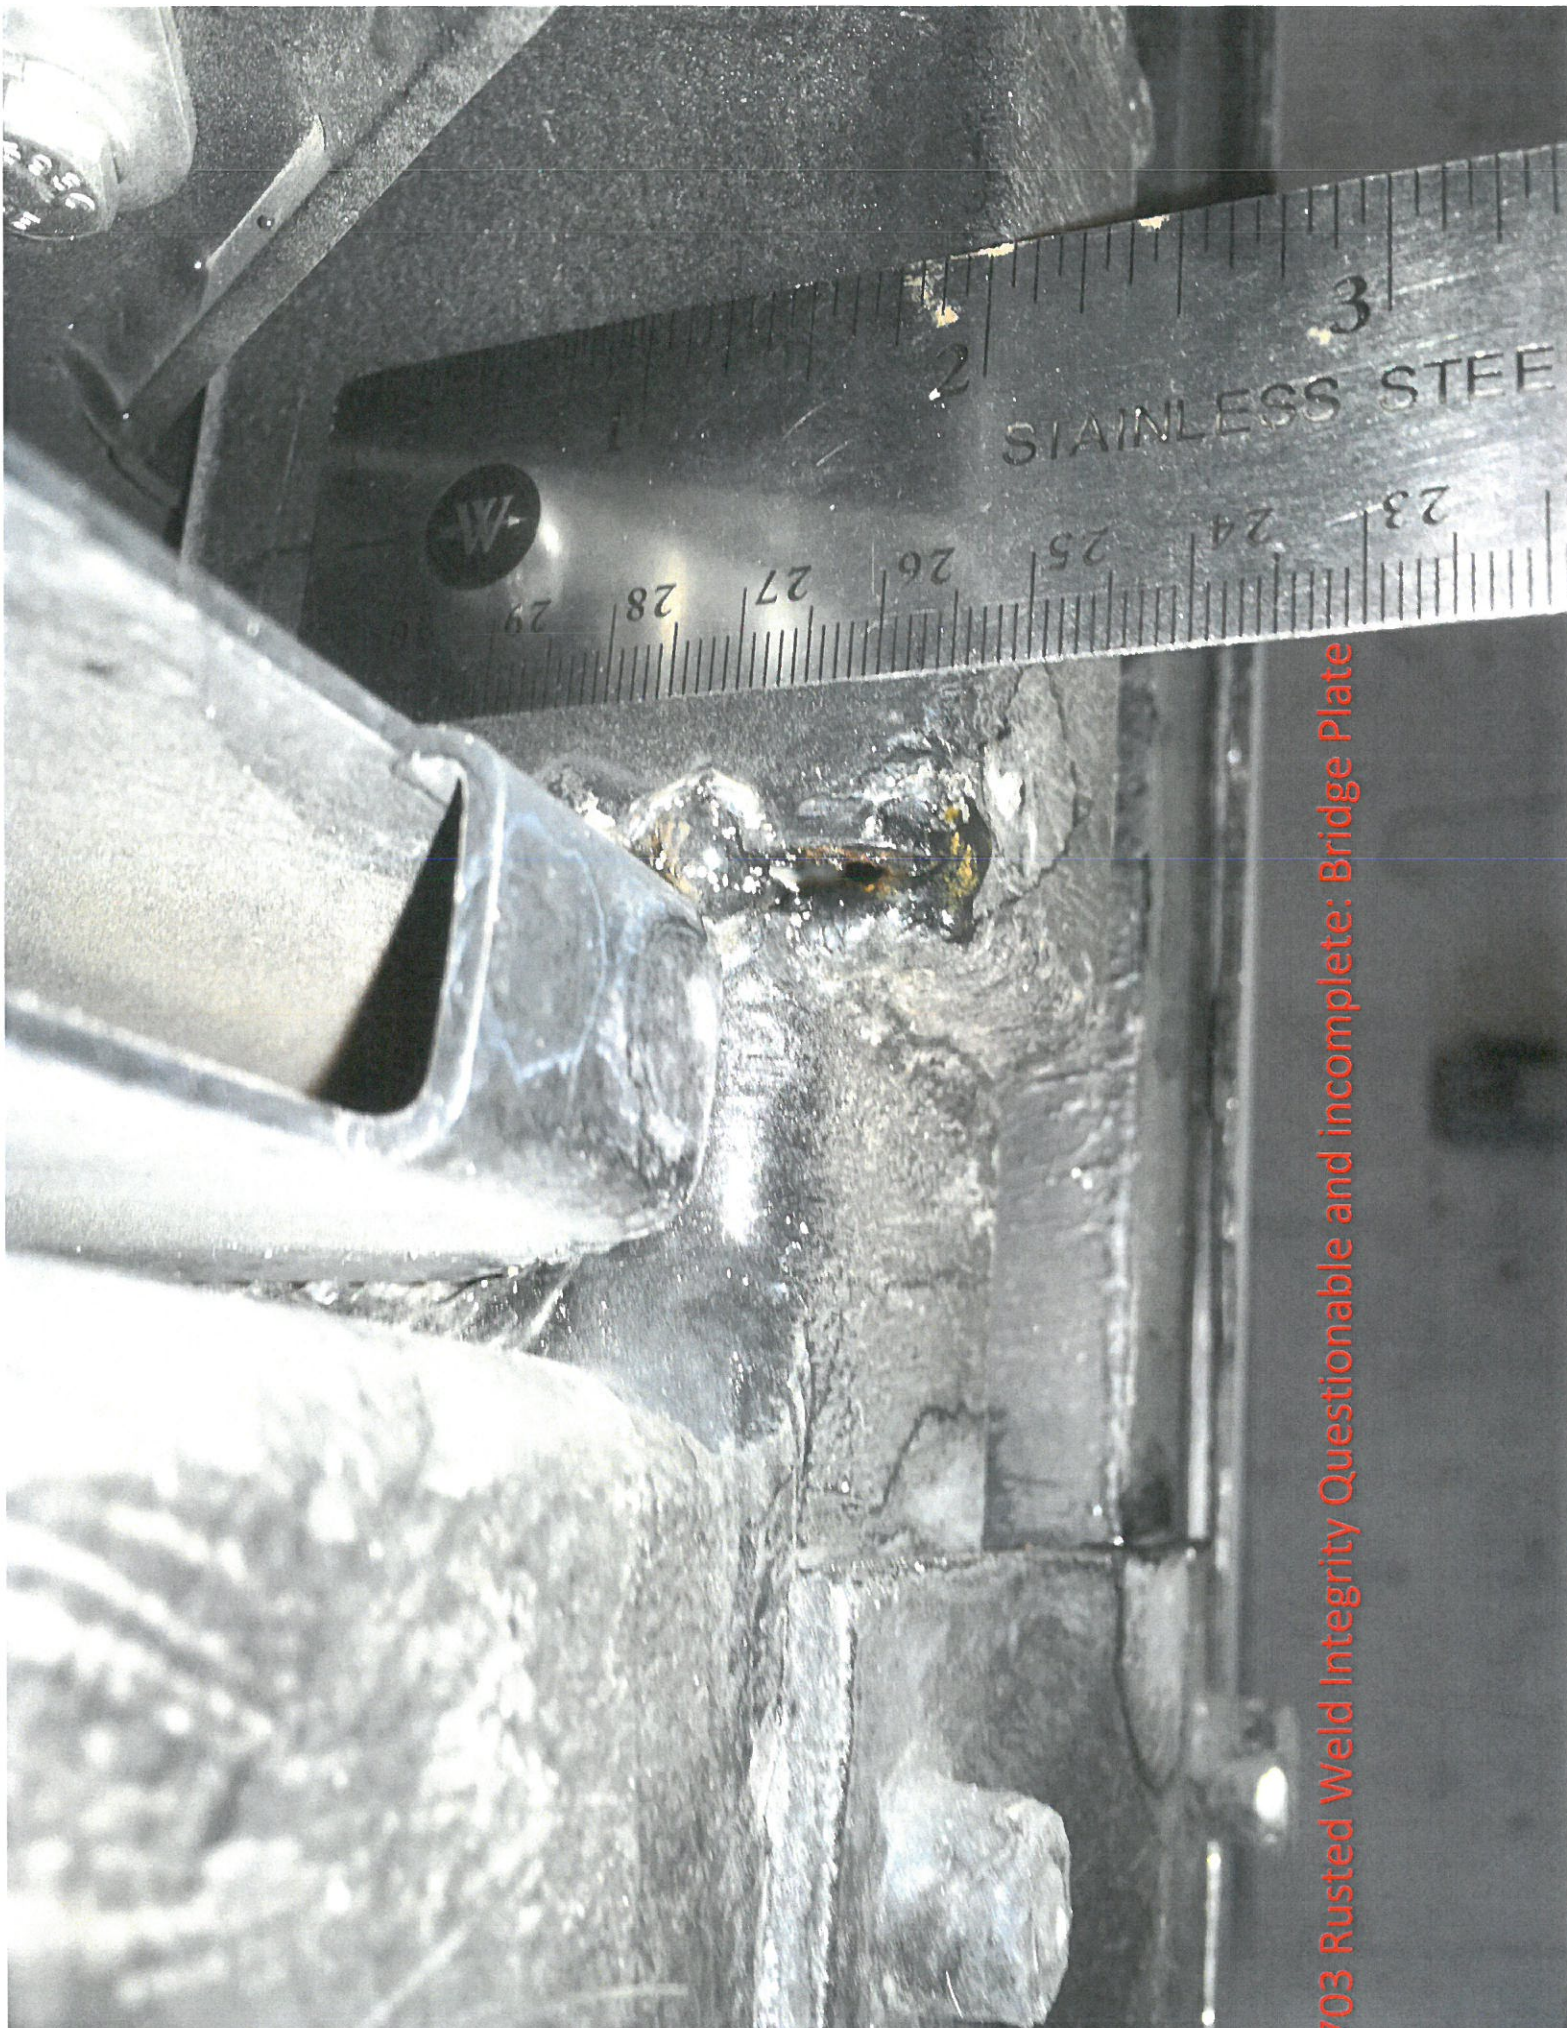
703 Rusted Weld Integrity Questionable and incomplete: Bridge Plate

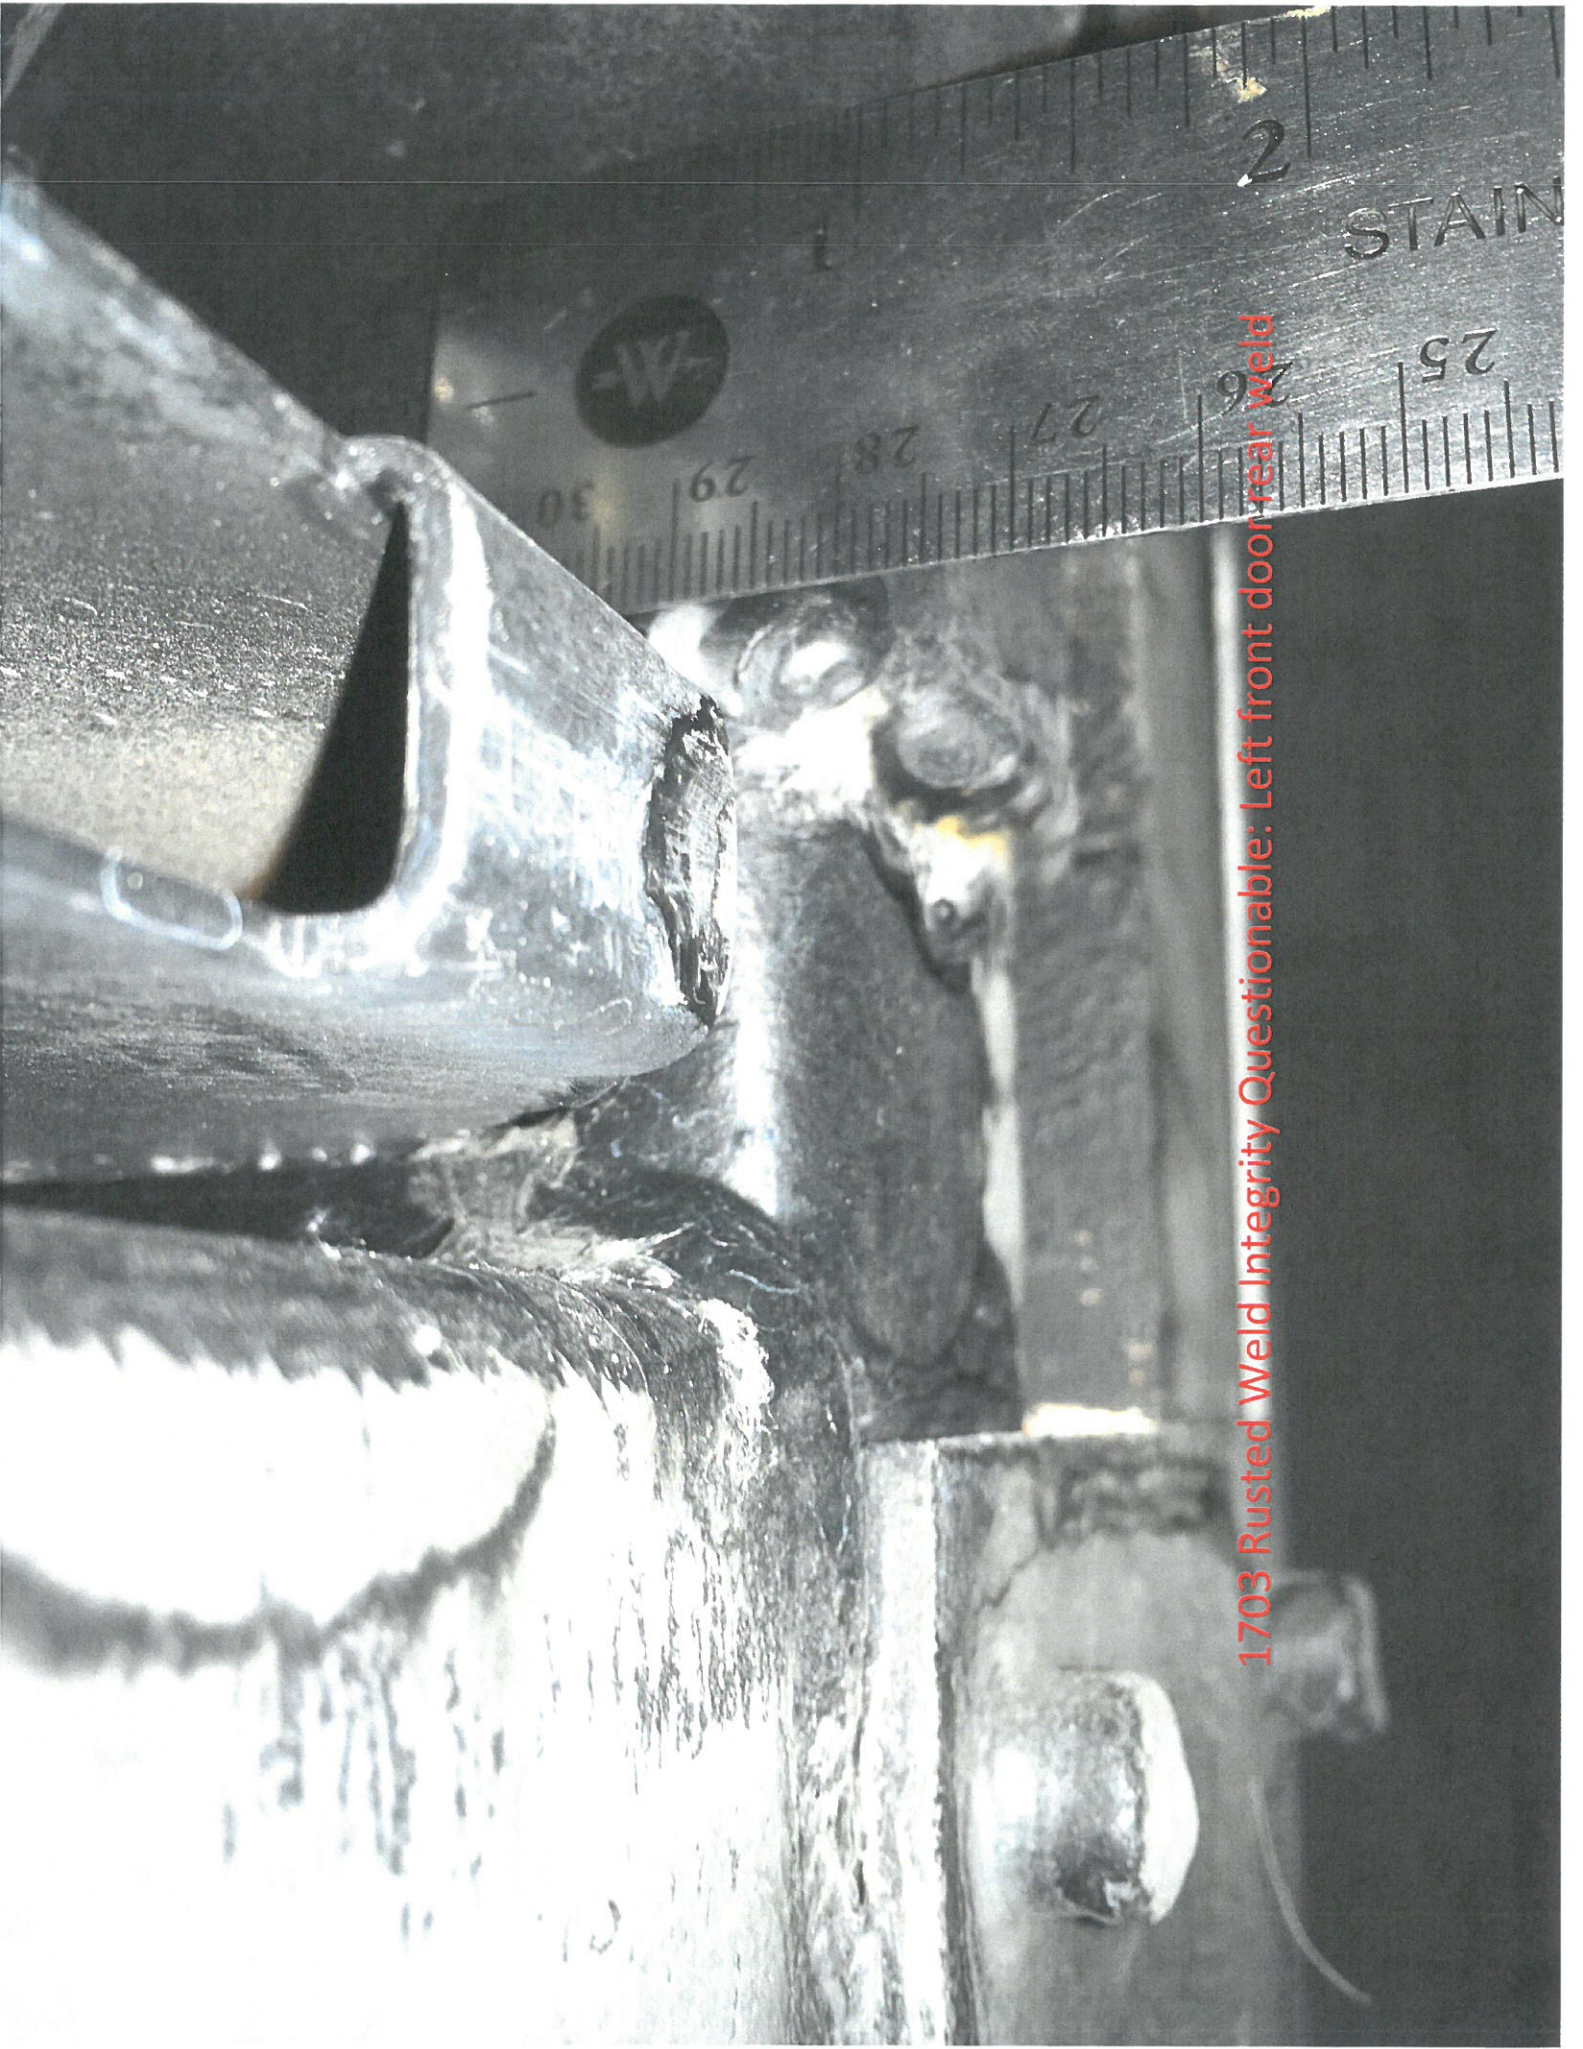
1703 Rusted Weld Integrity Questionable: Left front door rear weld

1703 all lines and hoses exposed to road debris

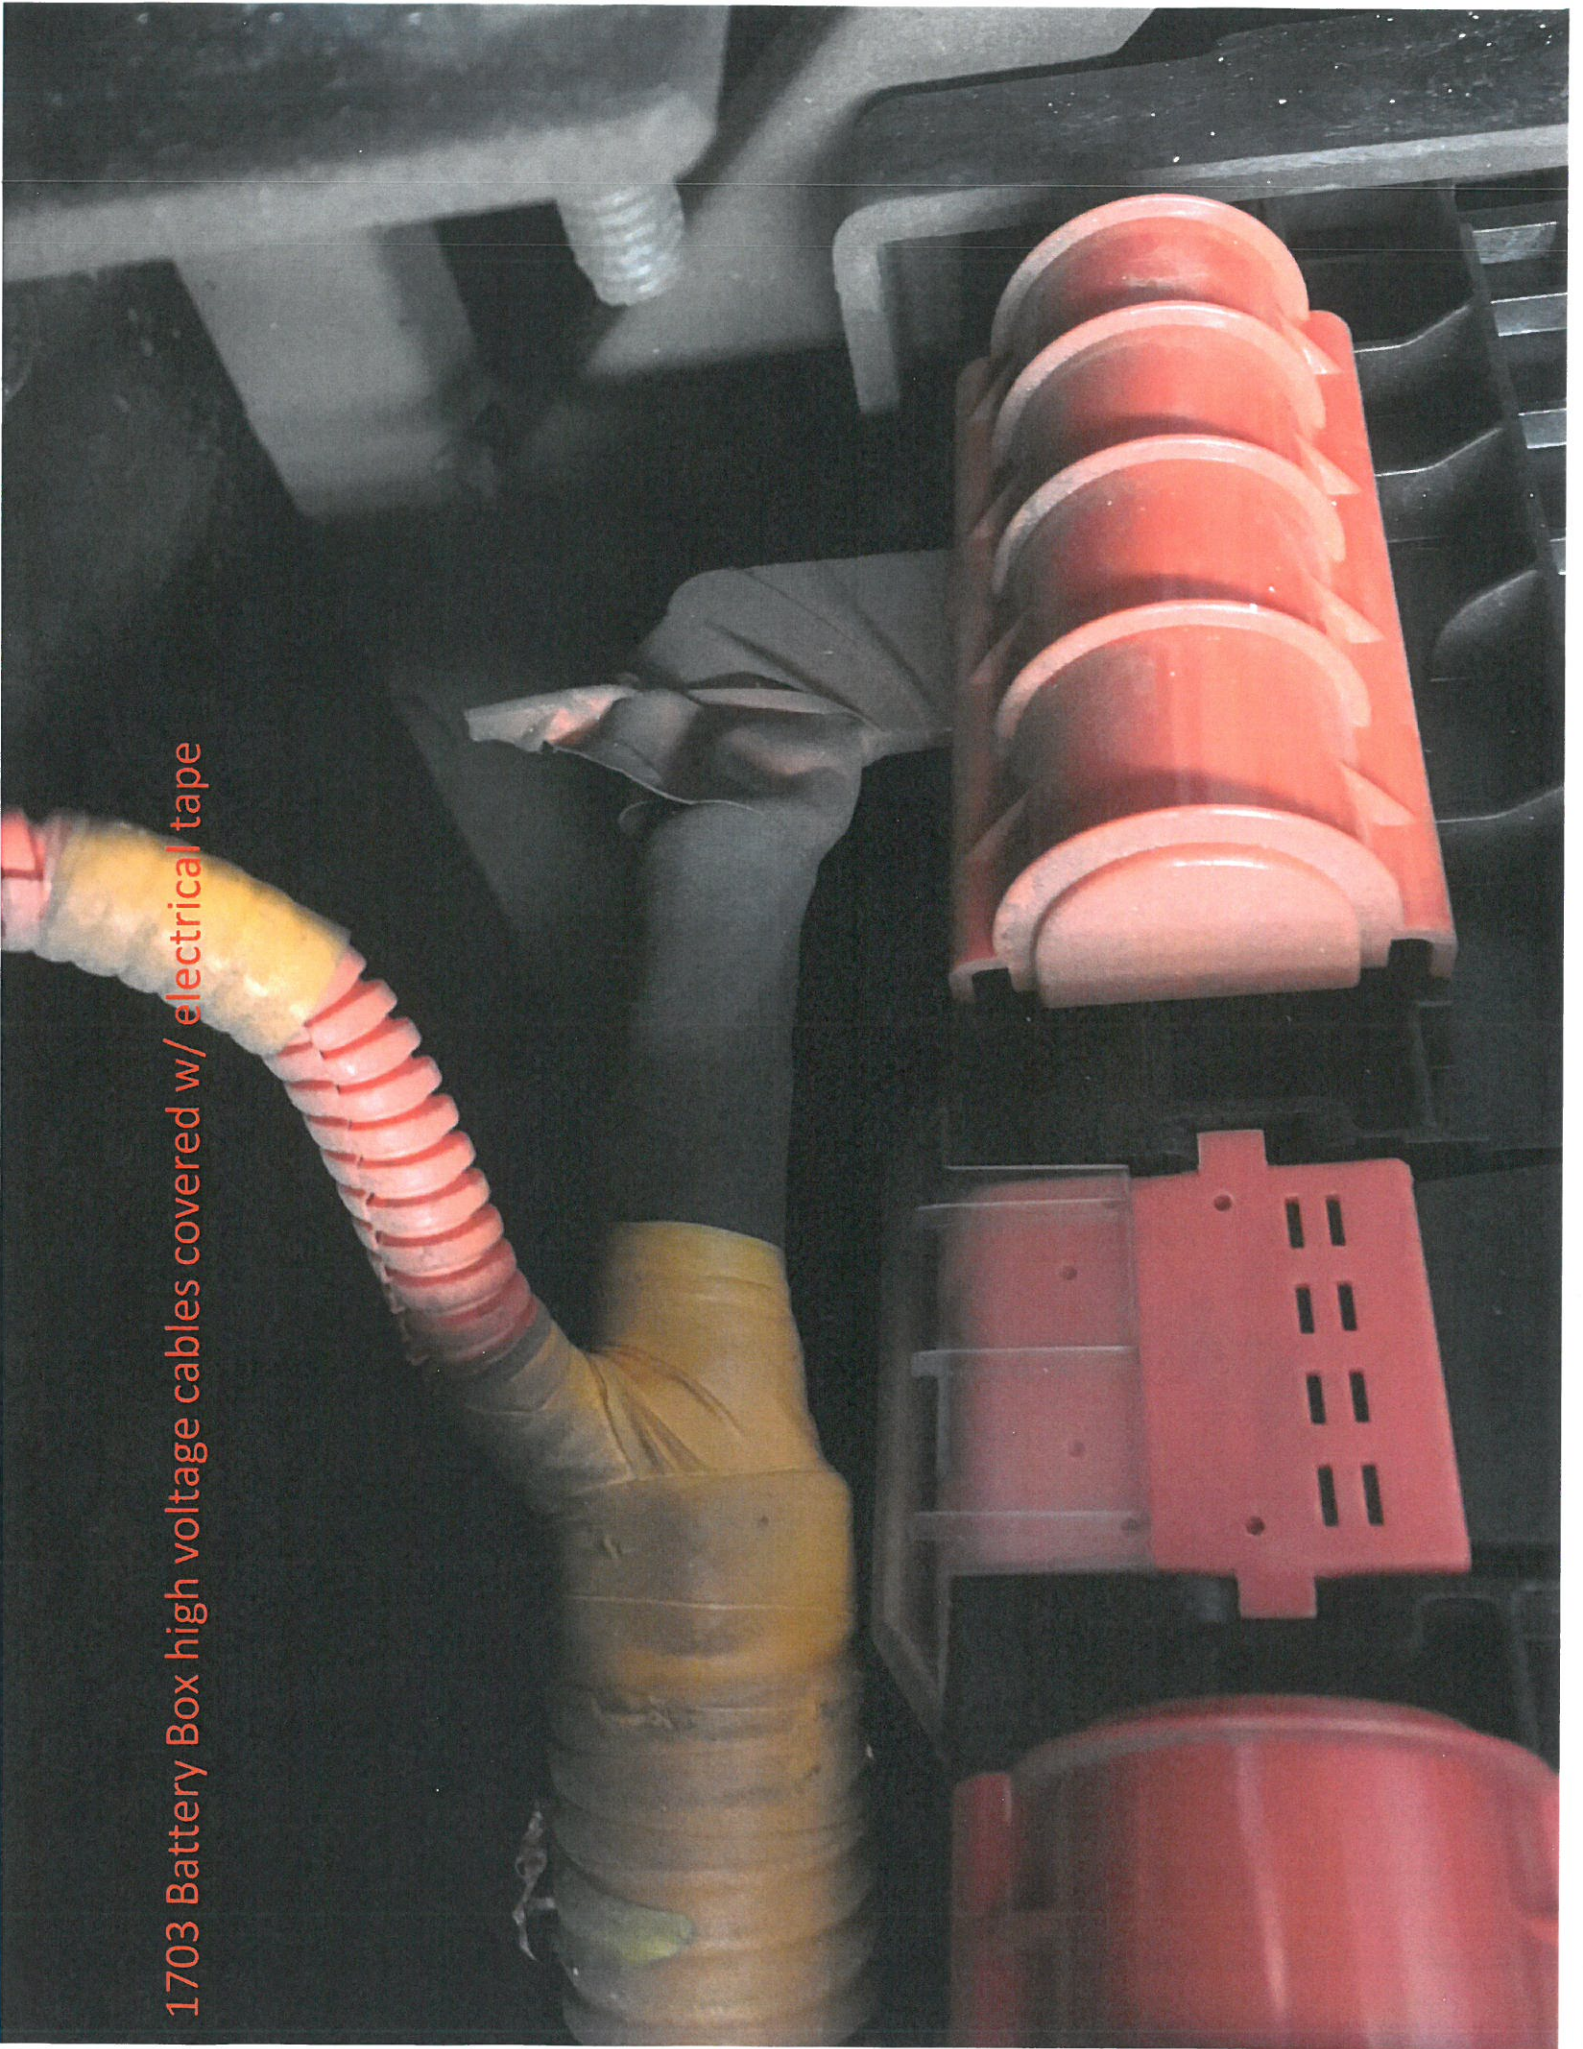
1703 Left rear panel cracking, behind joint

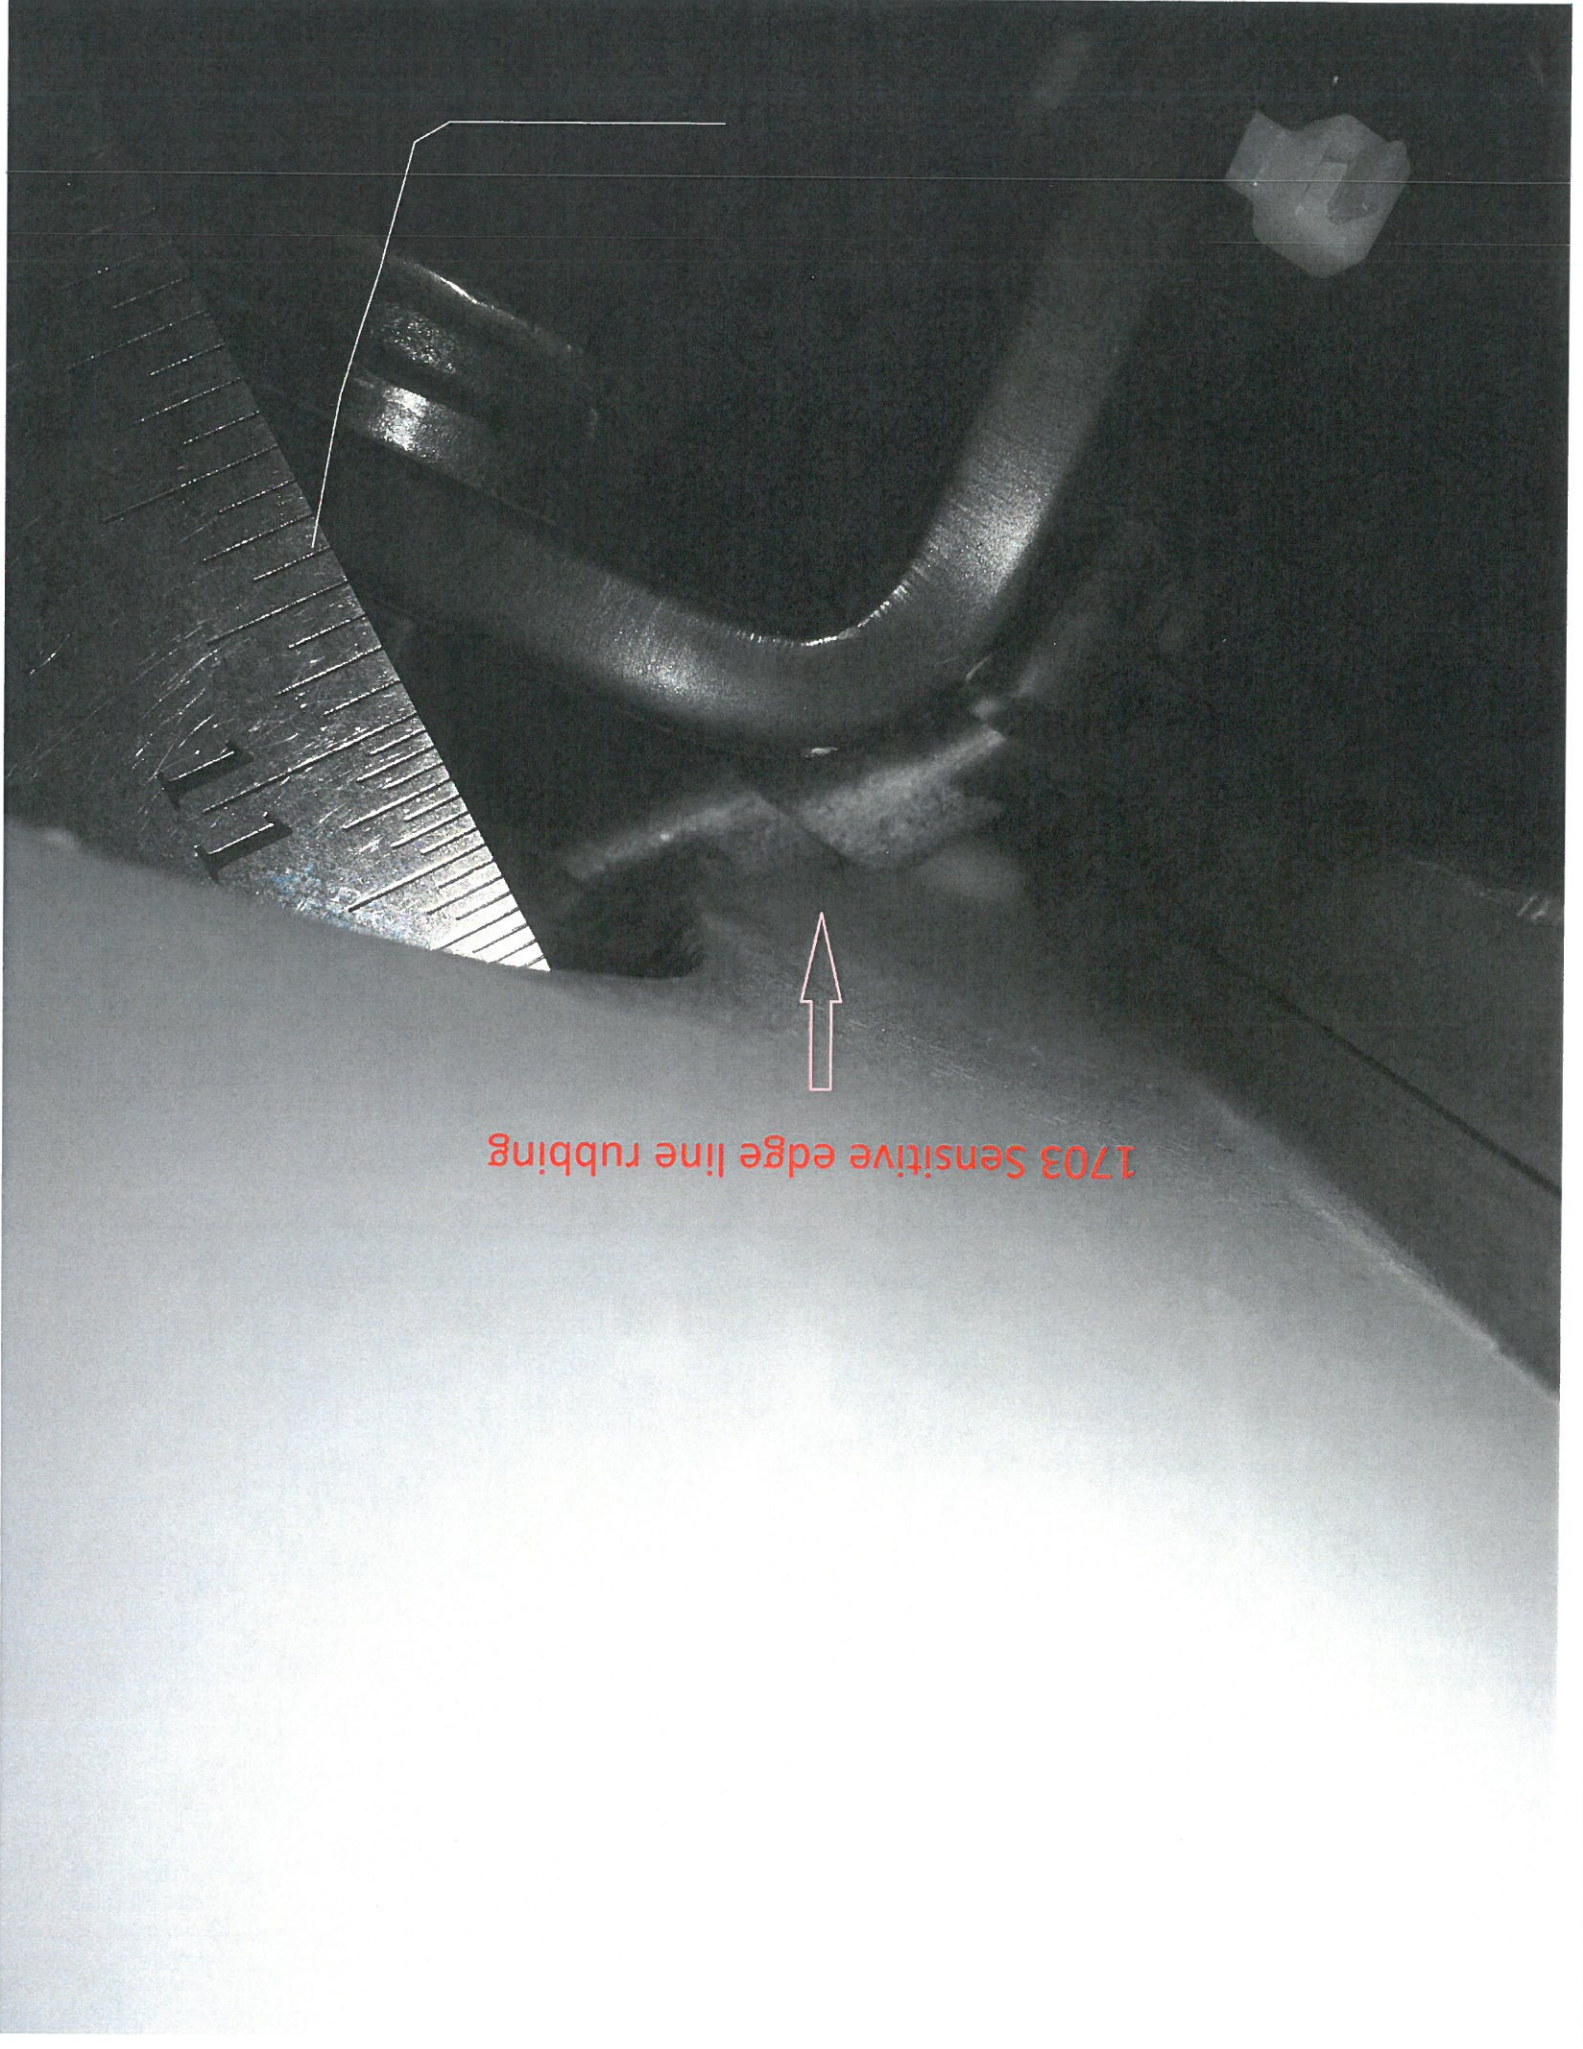
1703 Sensitive edge line rubbing

1703 Brake Lines Rubbing brake chamber

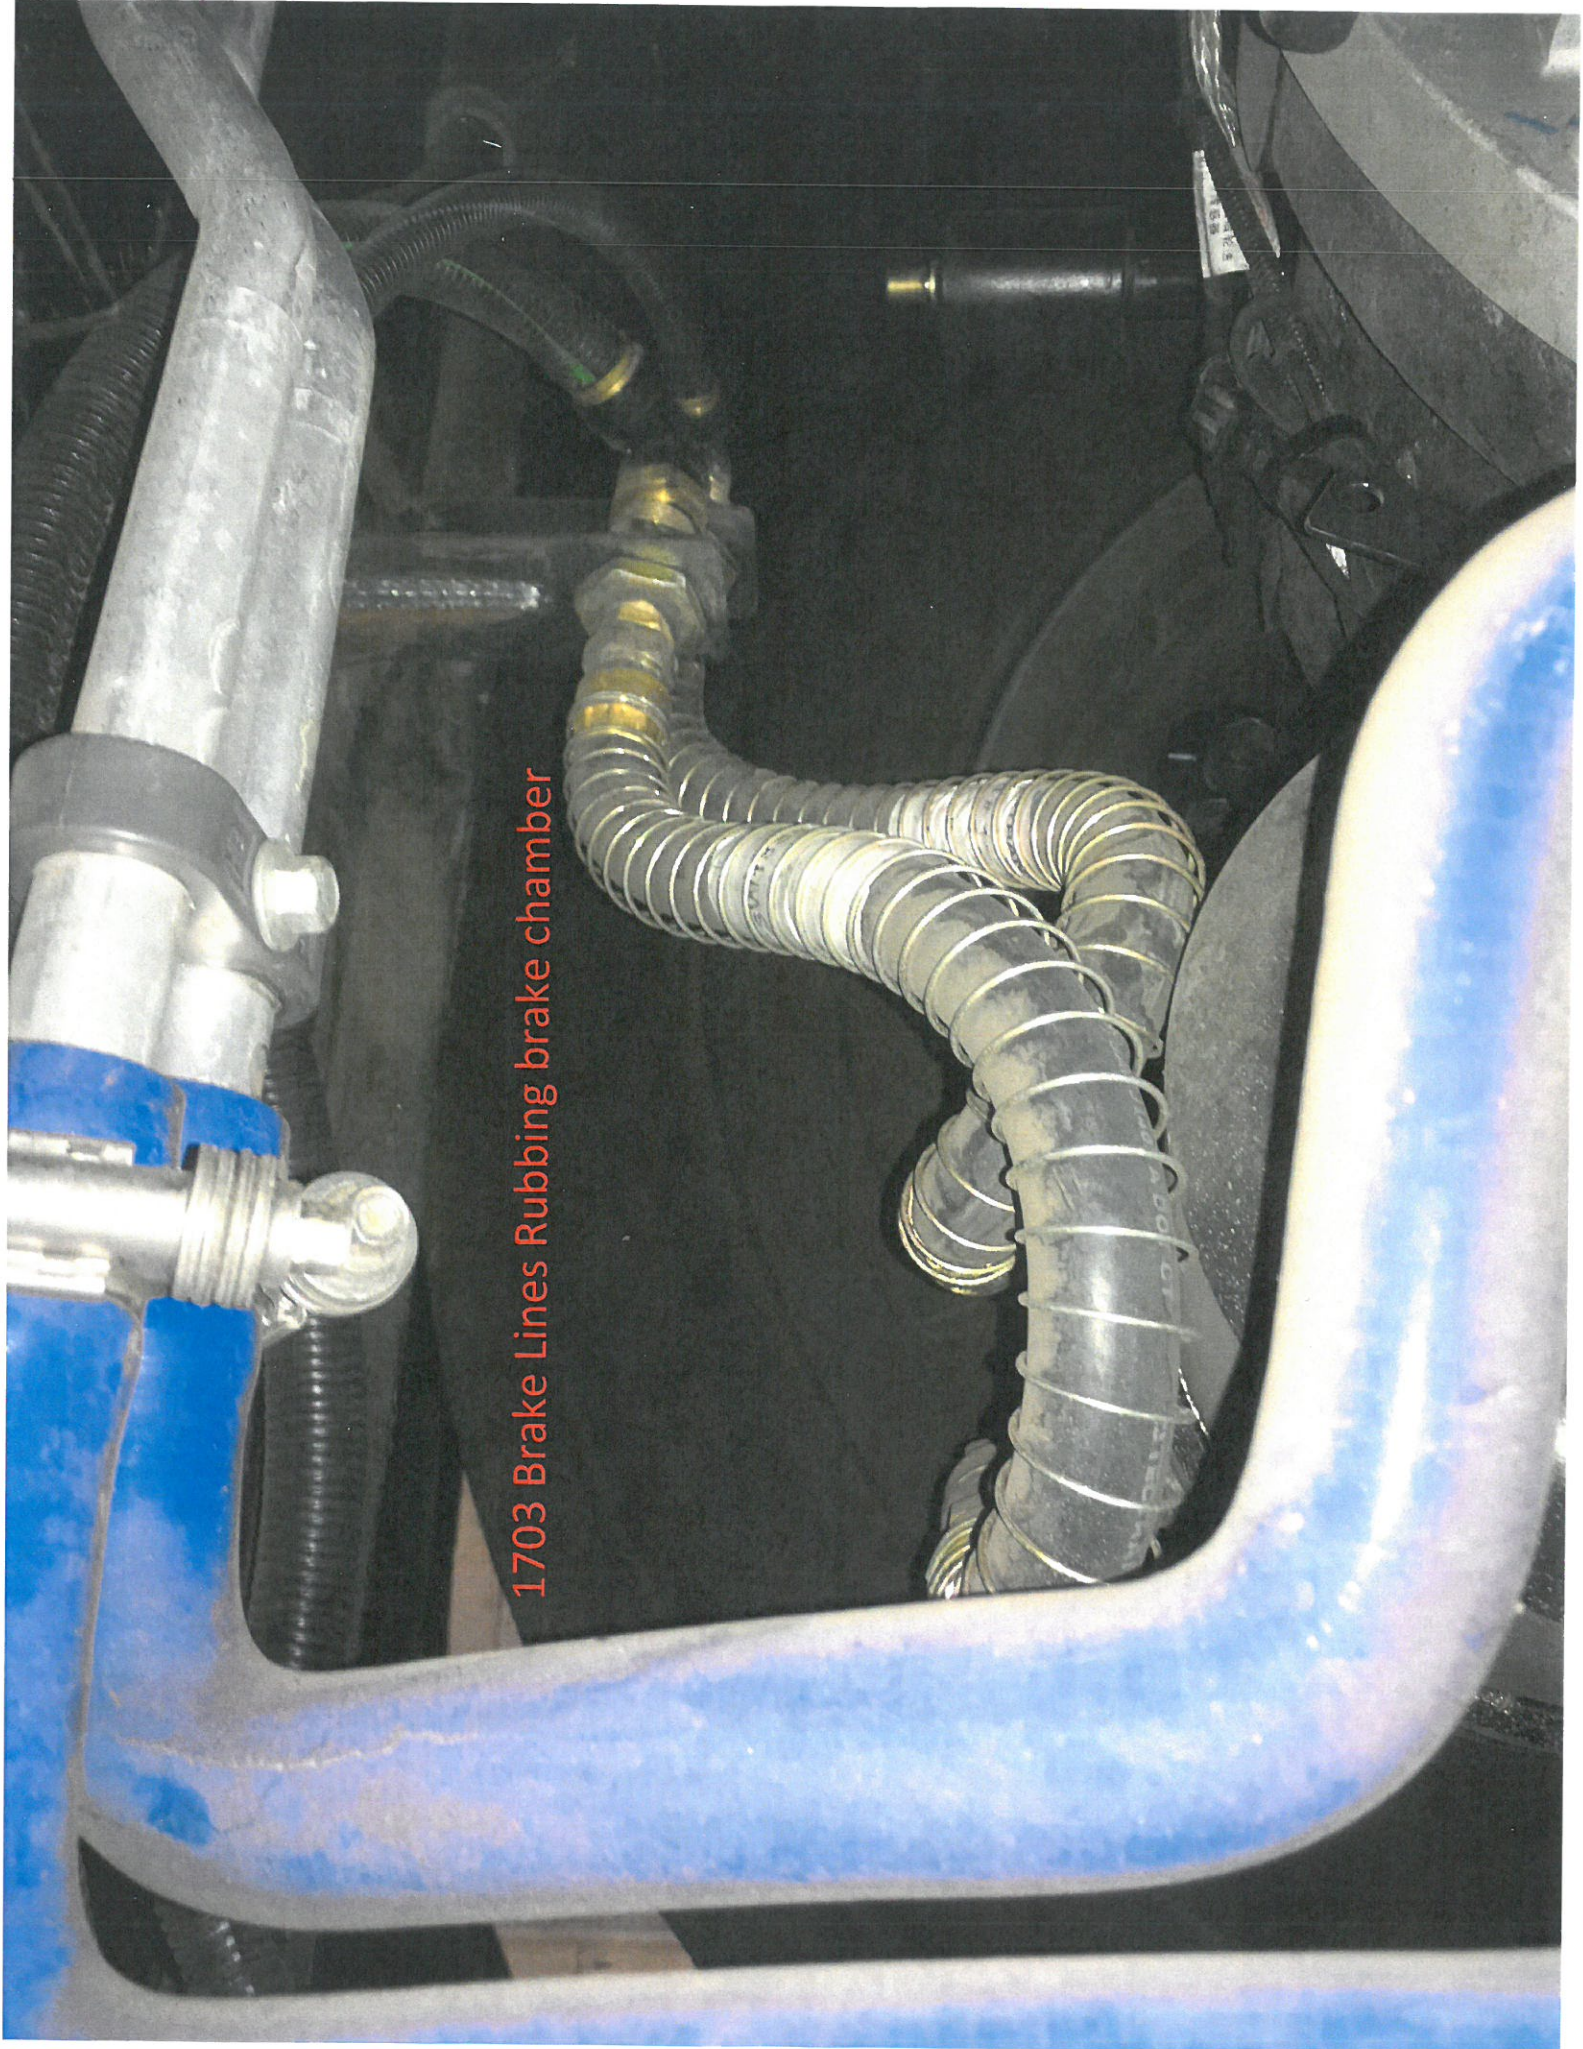
Rubbing on Frame

1703 In front of rear axle

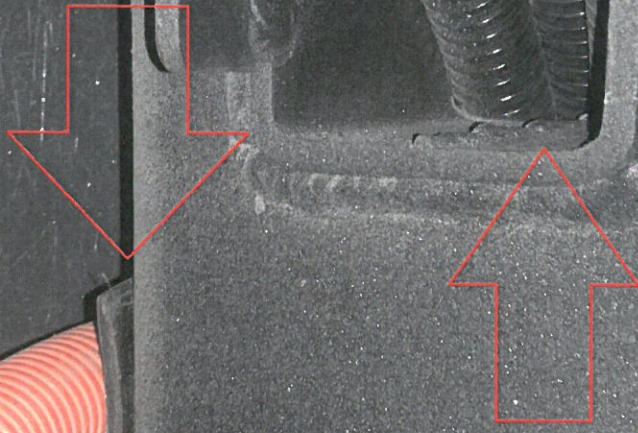
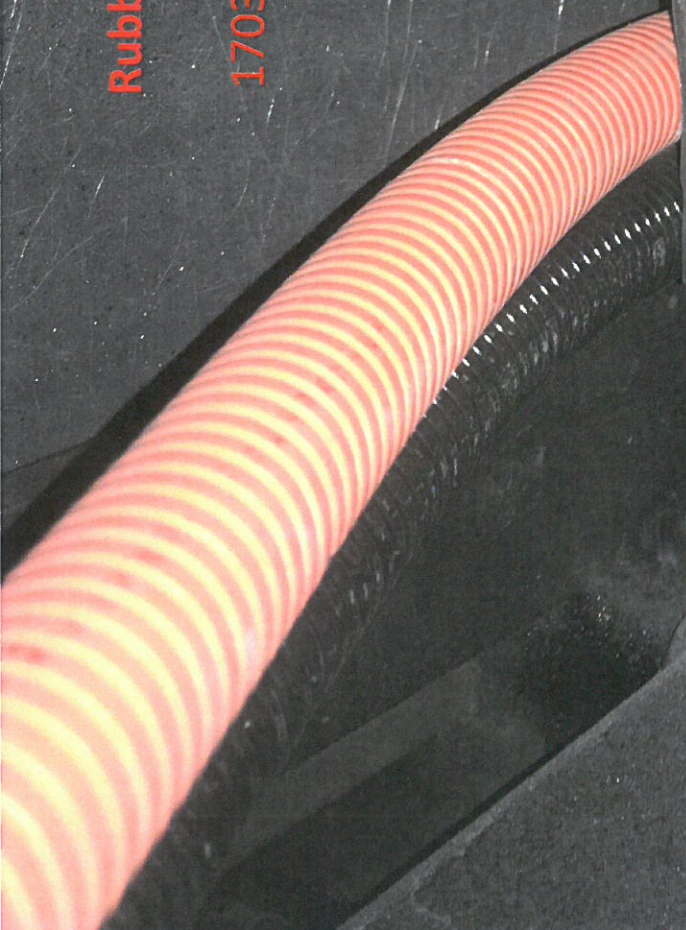
1703 air tank in front of center axle: connector and wire rubbing on panel

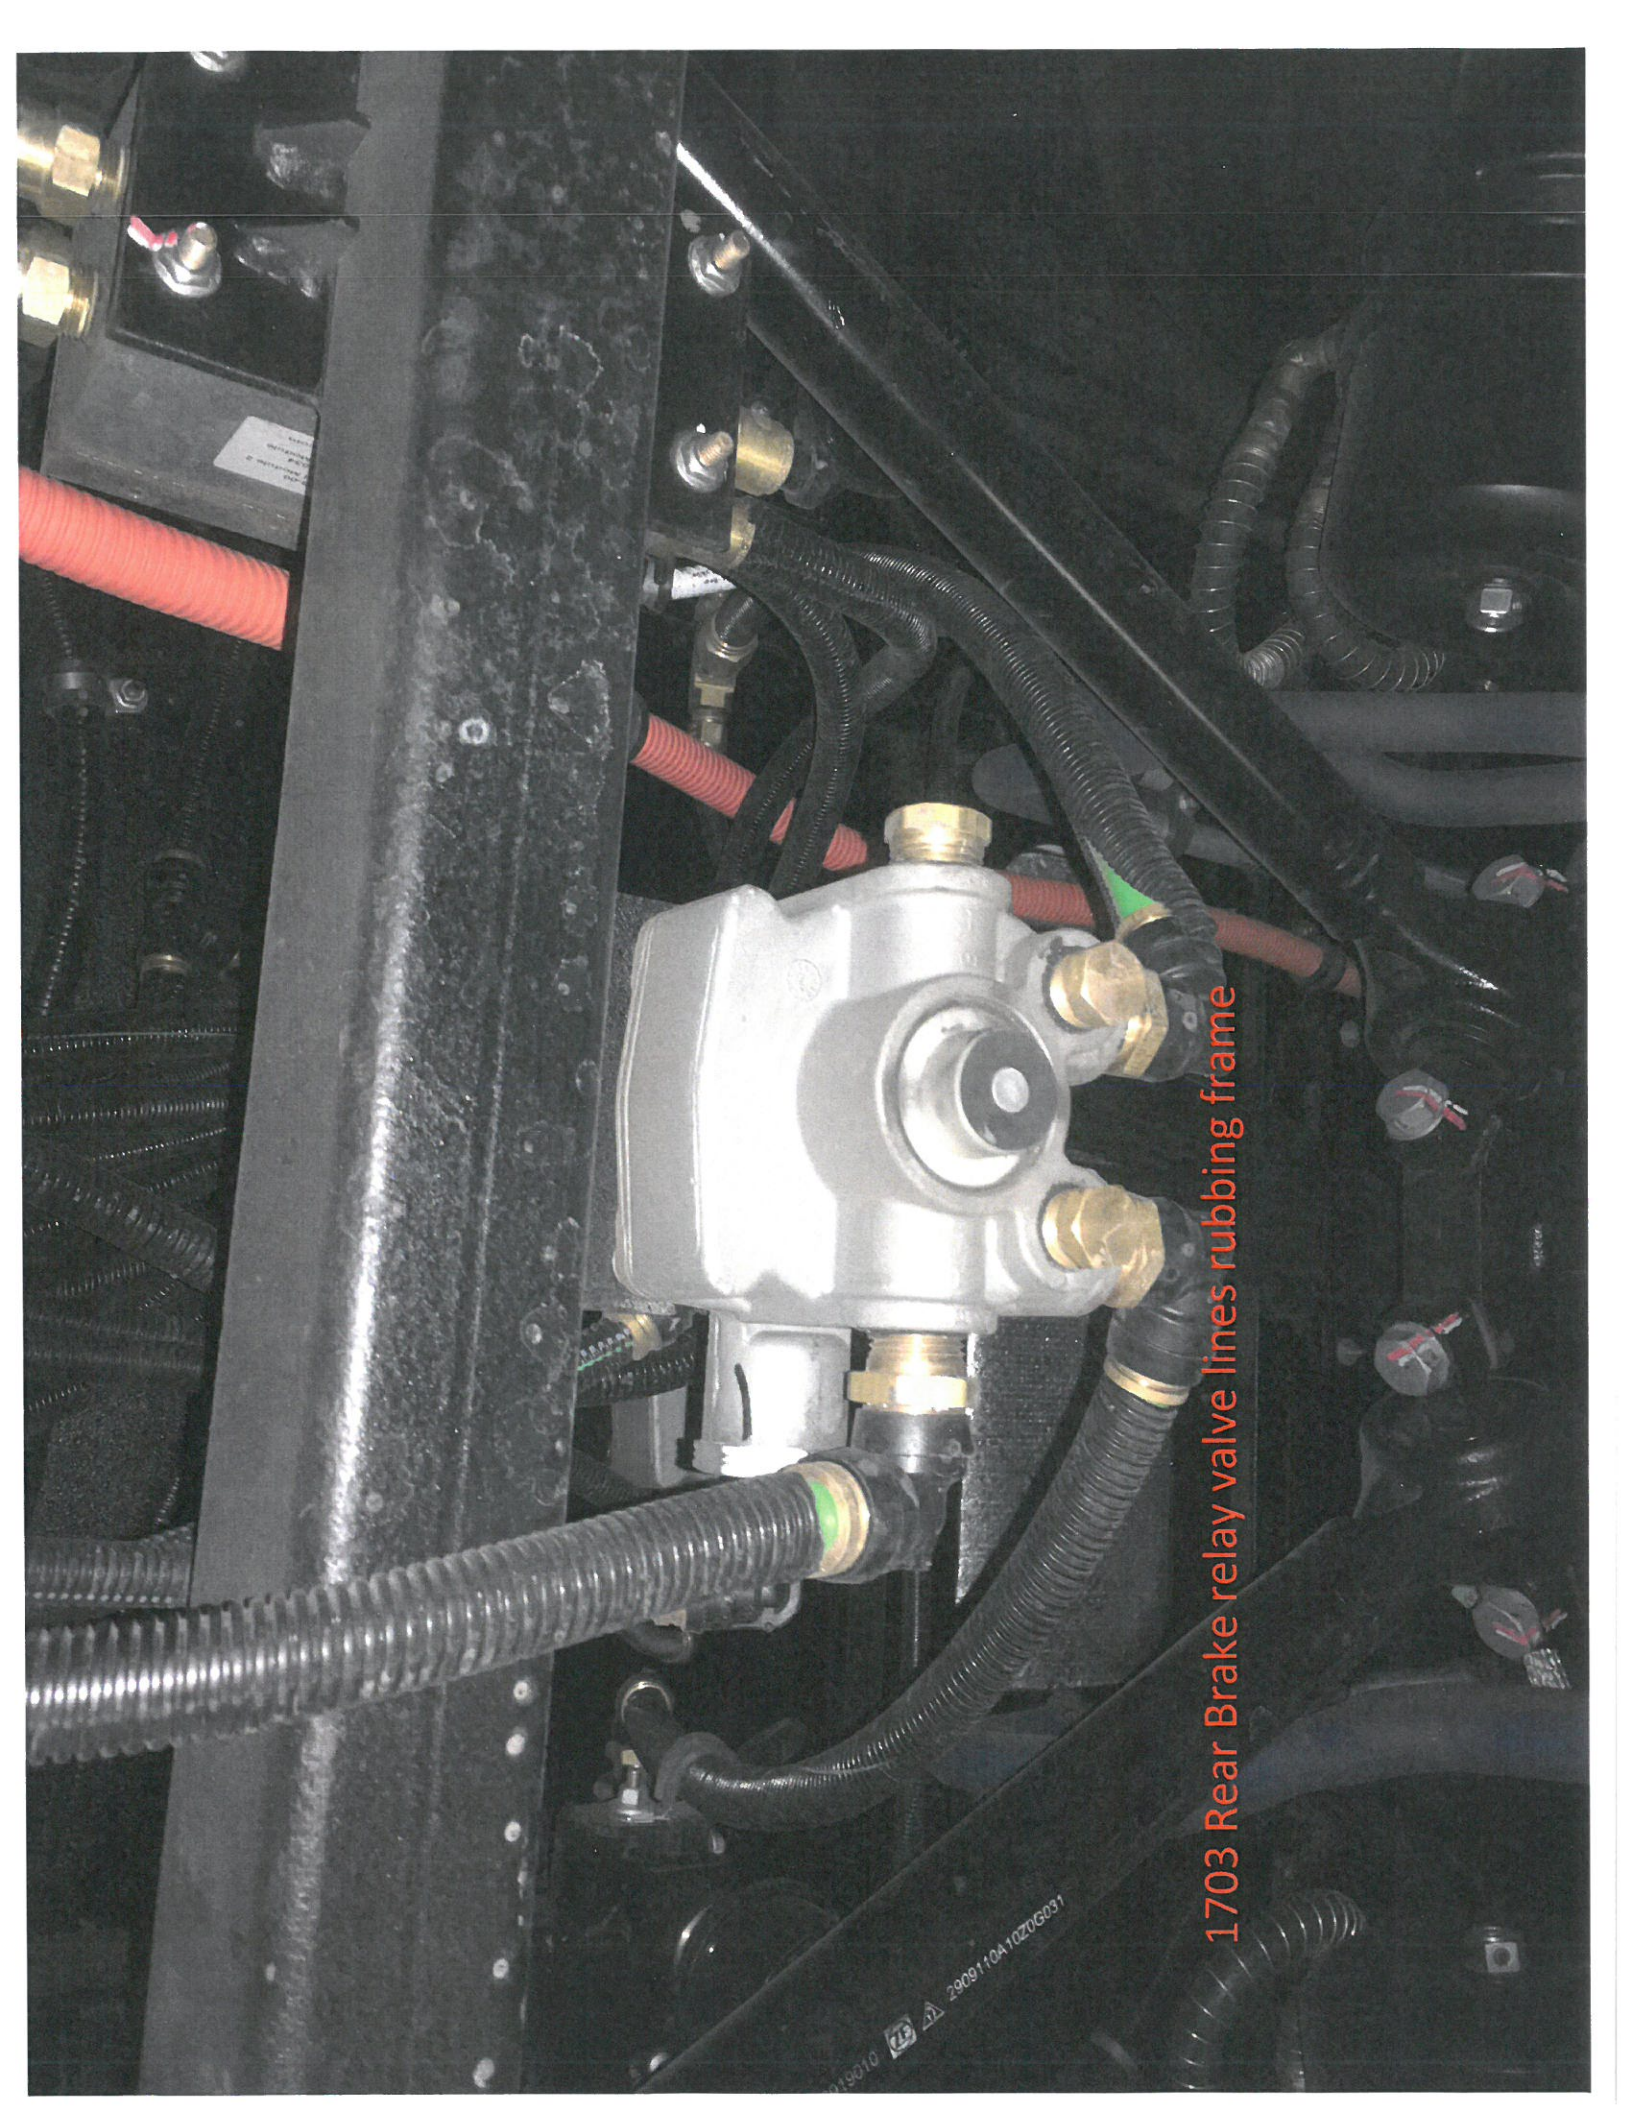
1703 Rear Brake relay valve lines rubbing frame
