1703

A R T

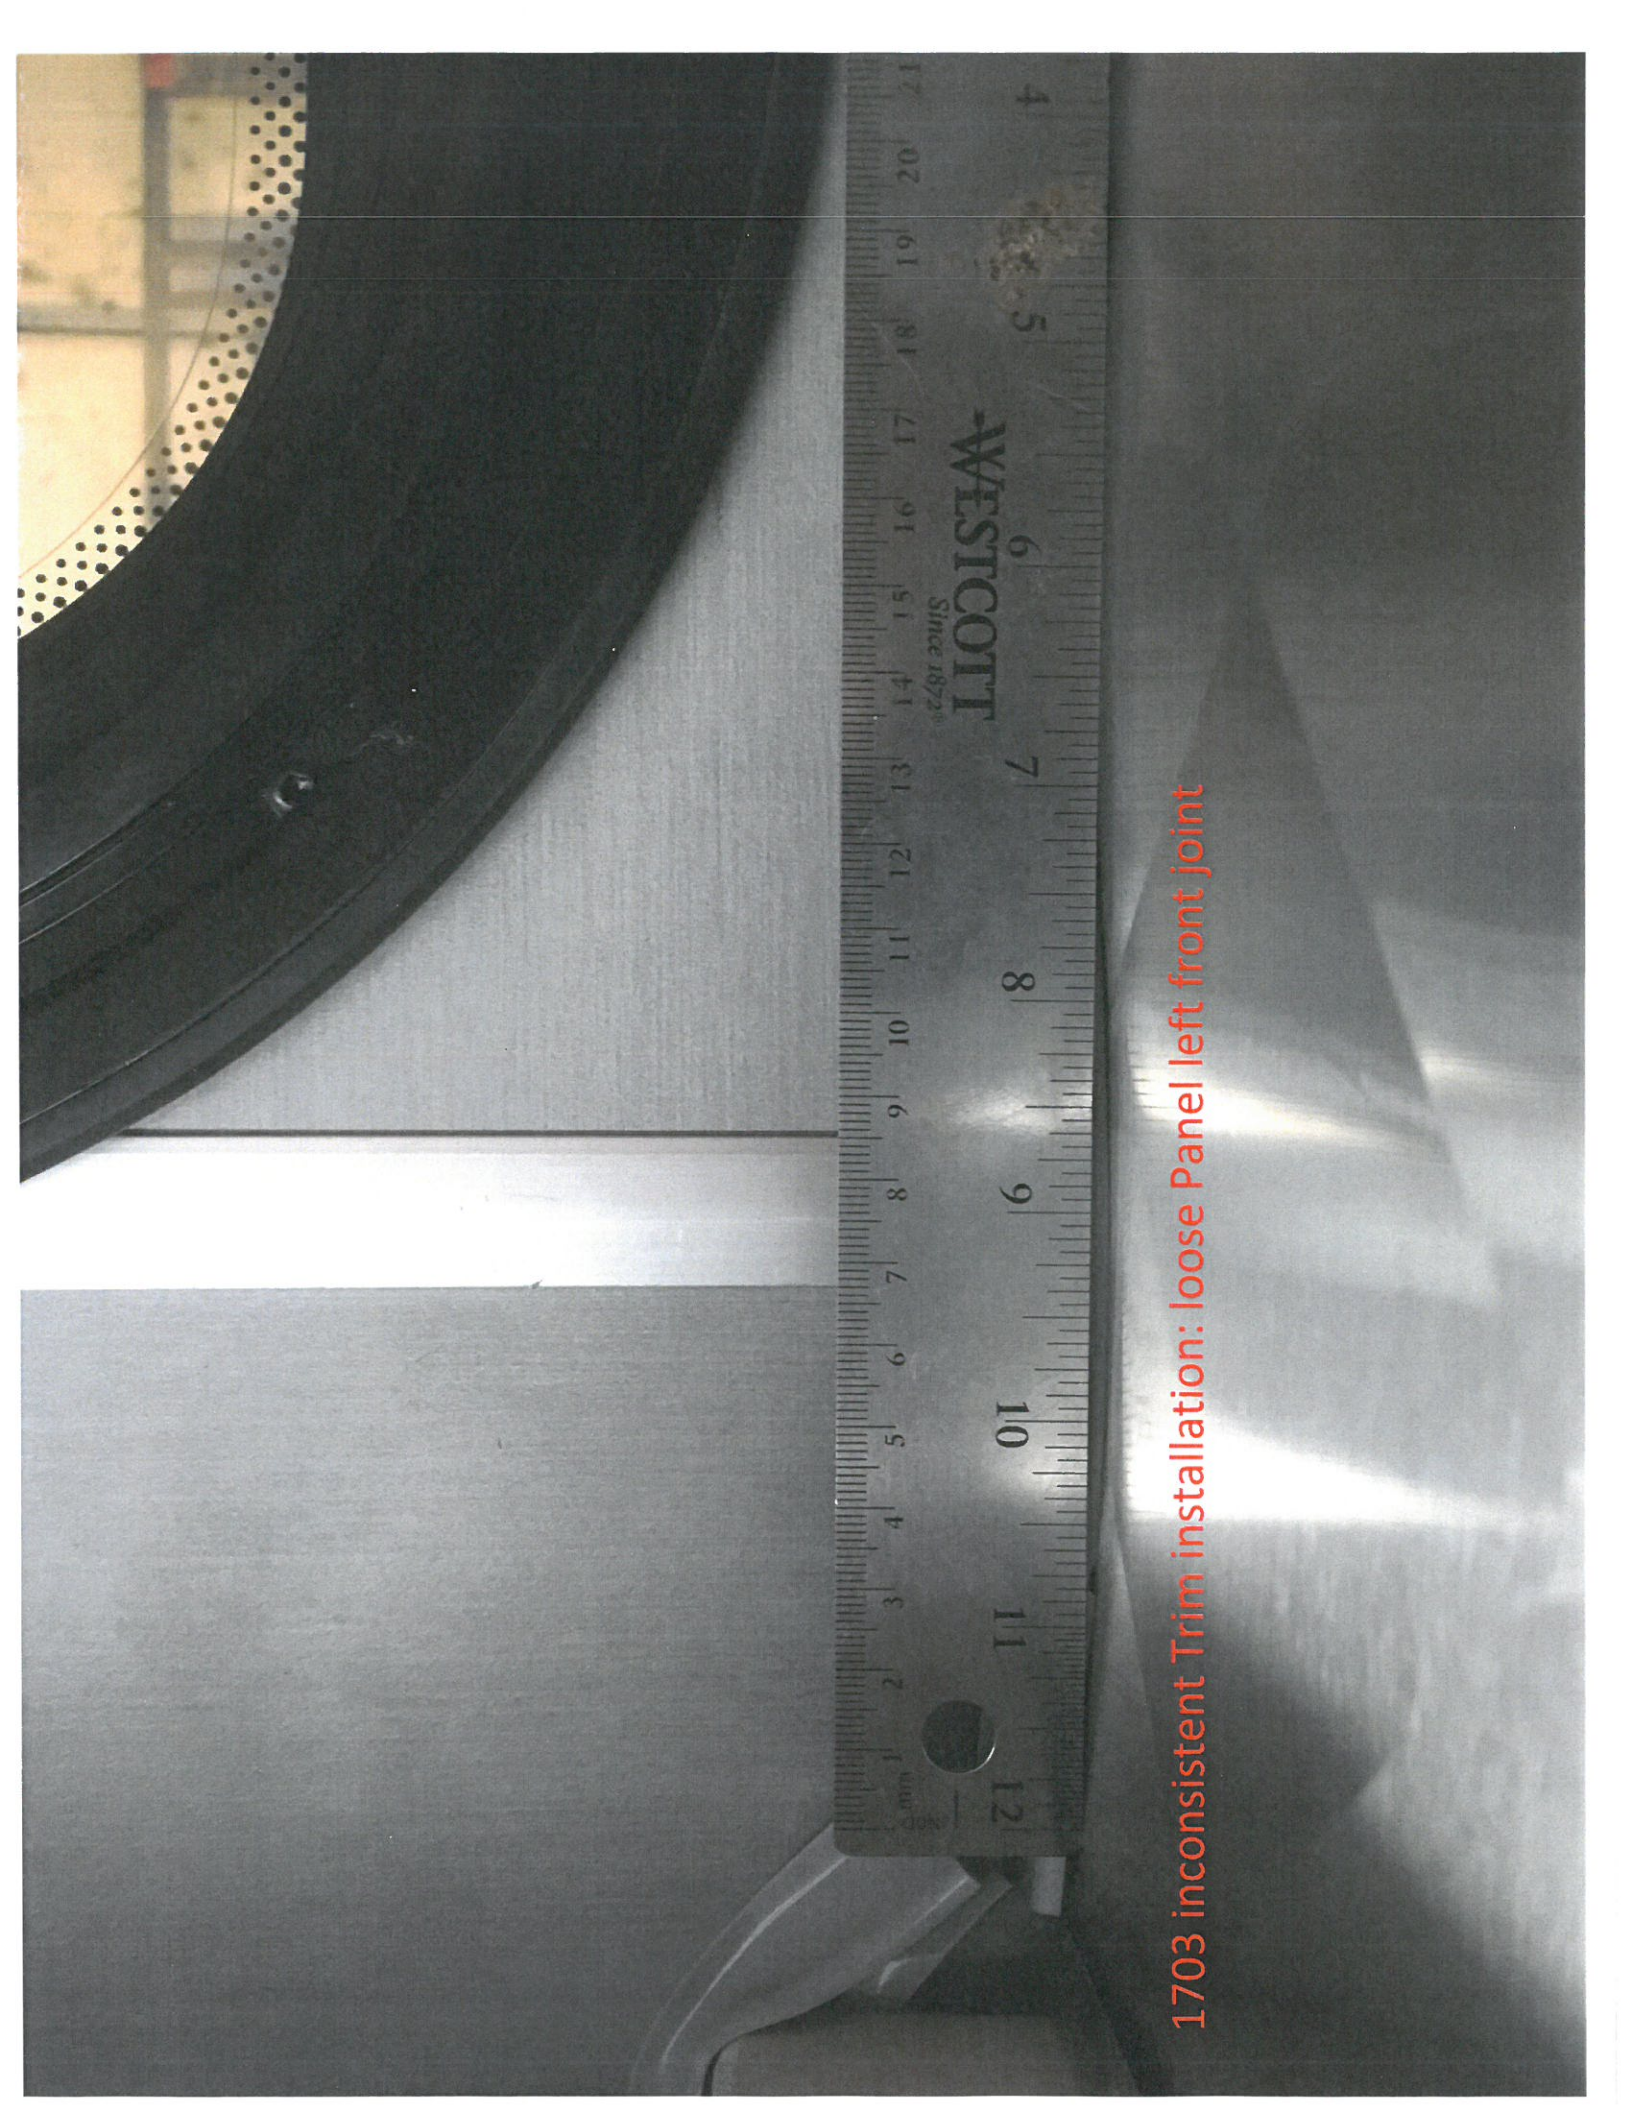
1703 inconsistent Trim installation: loose Panel left front joint

1703 behind left rear door: no foot space

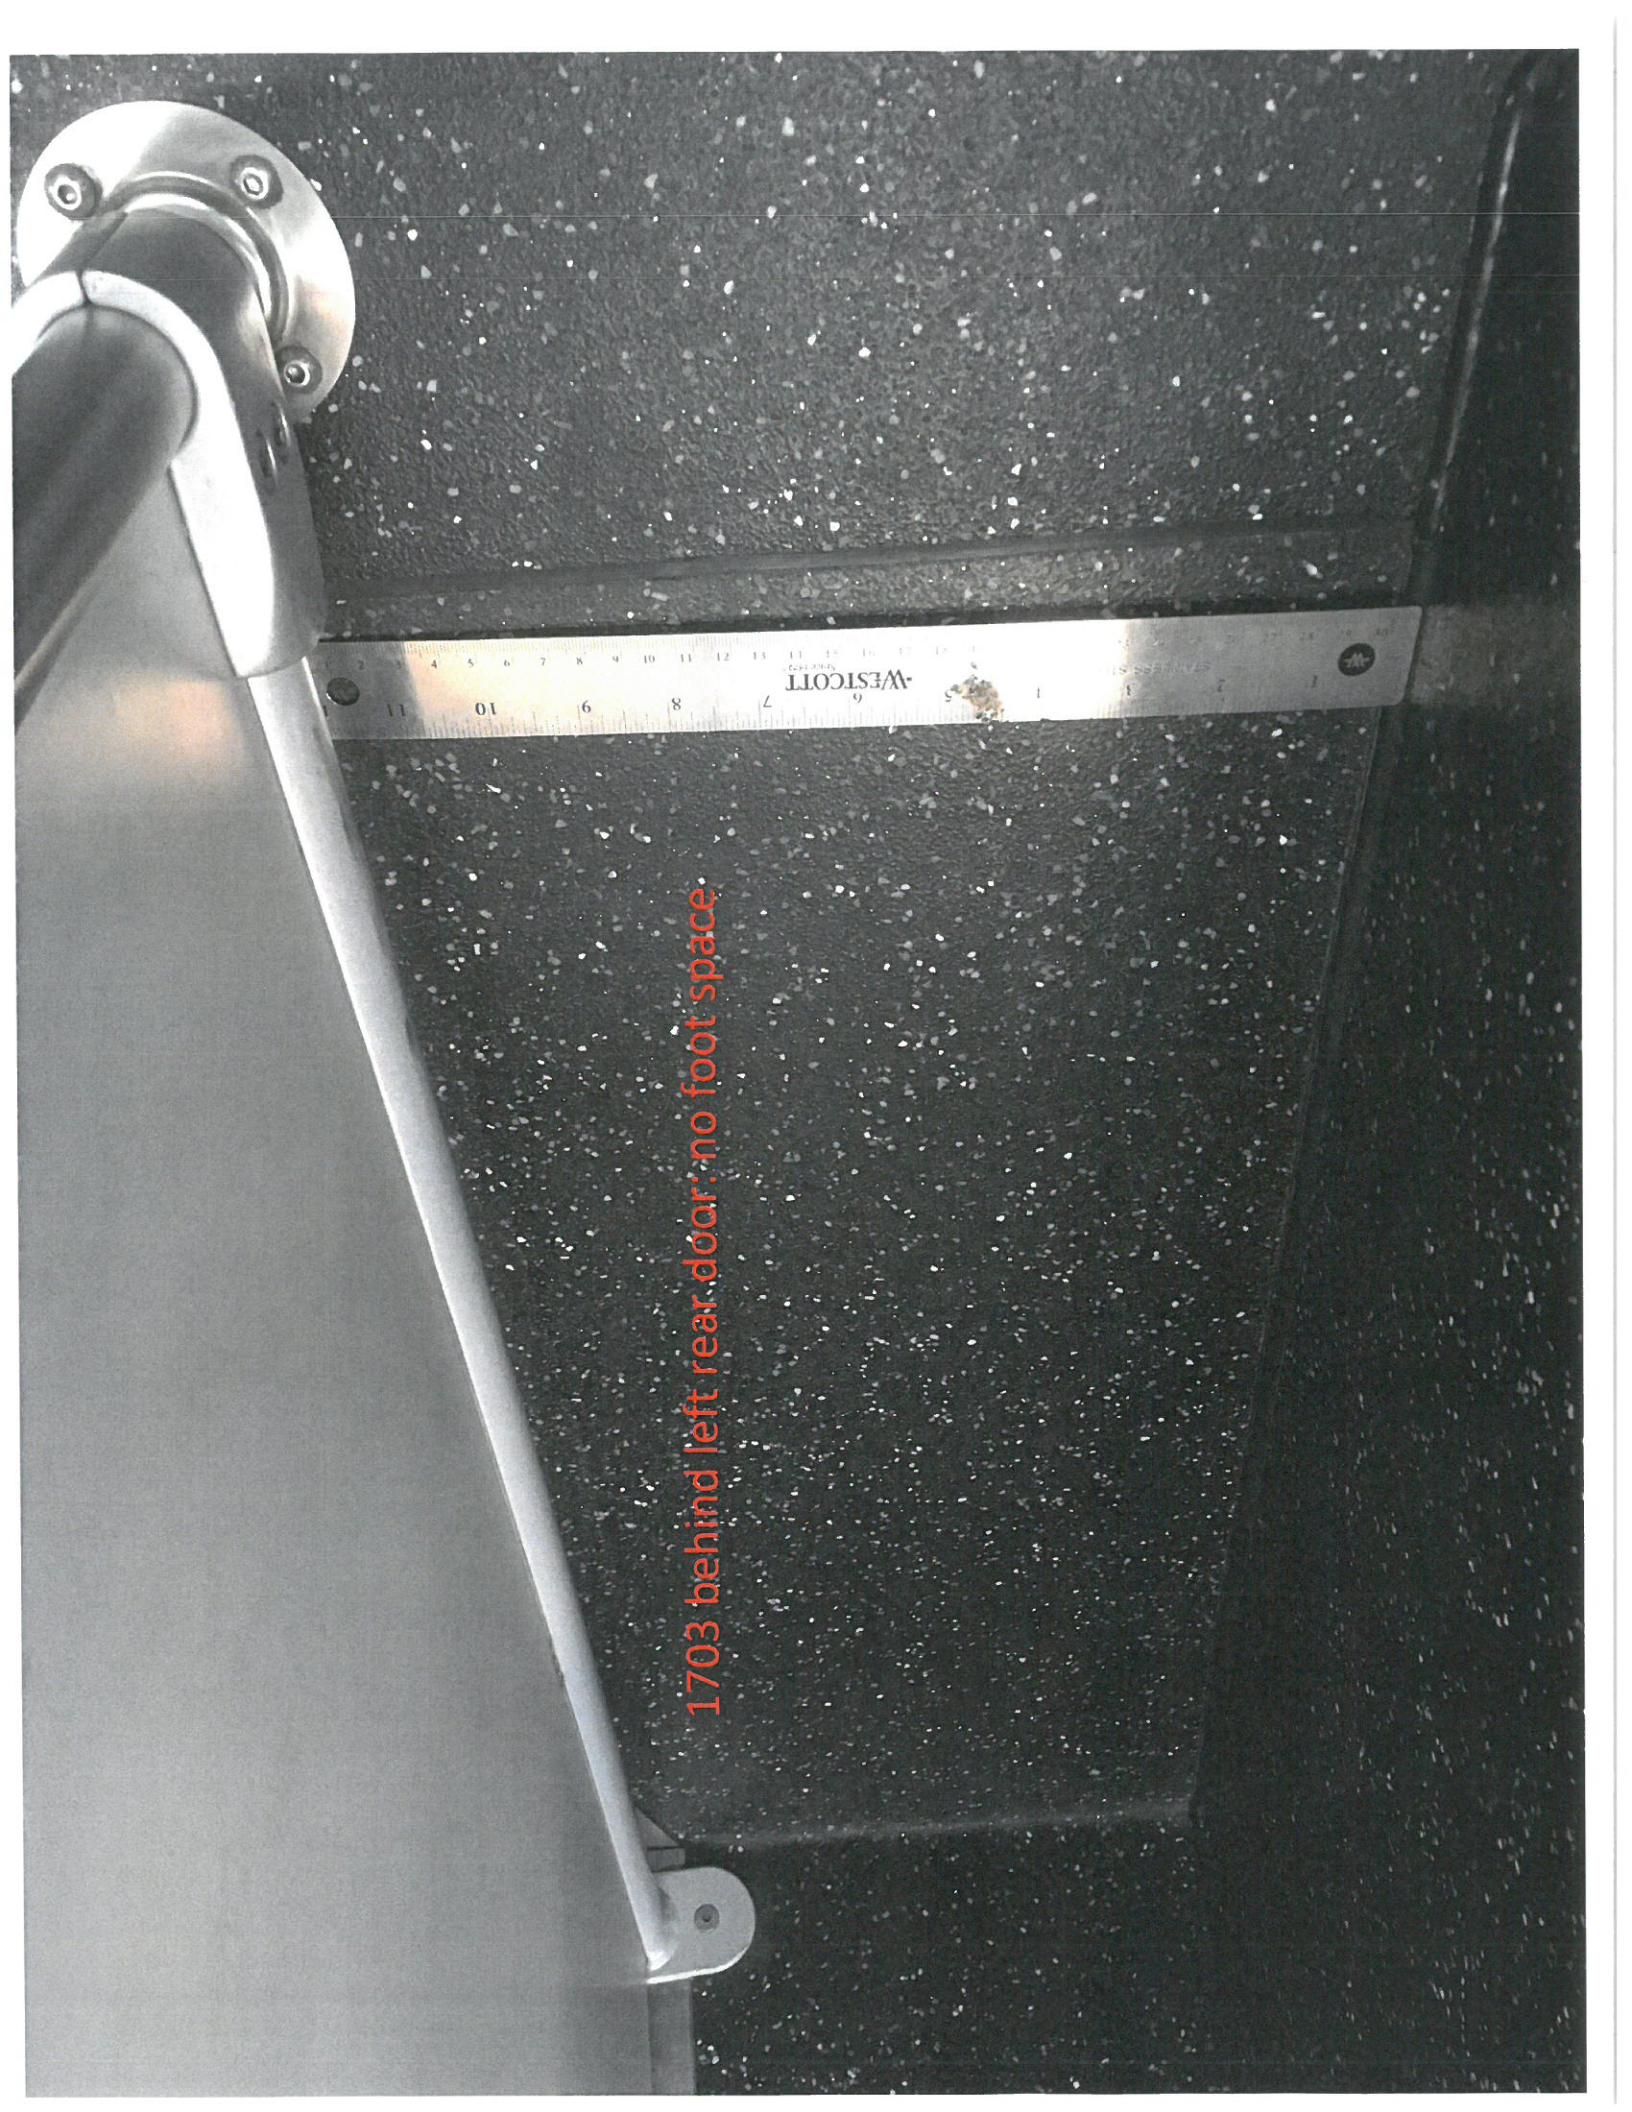
1703 Left rear compartment Fire suppression line rubbing on frame

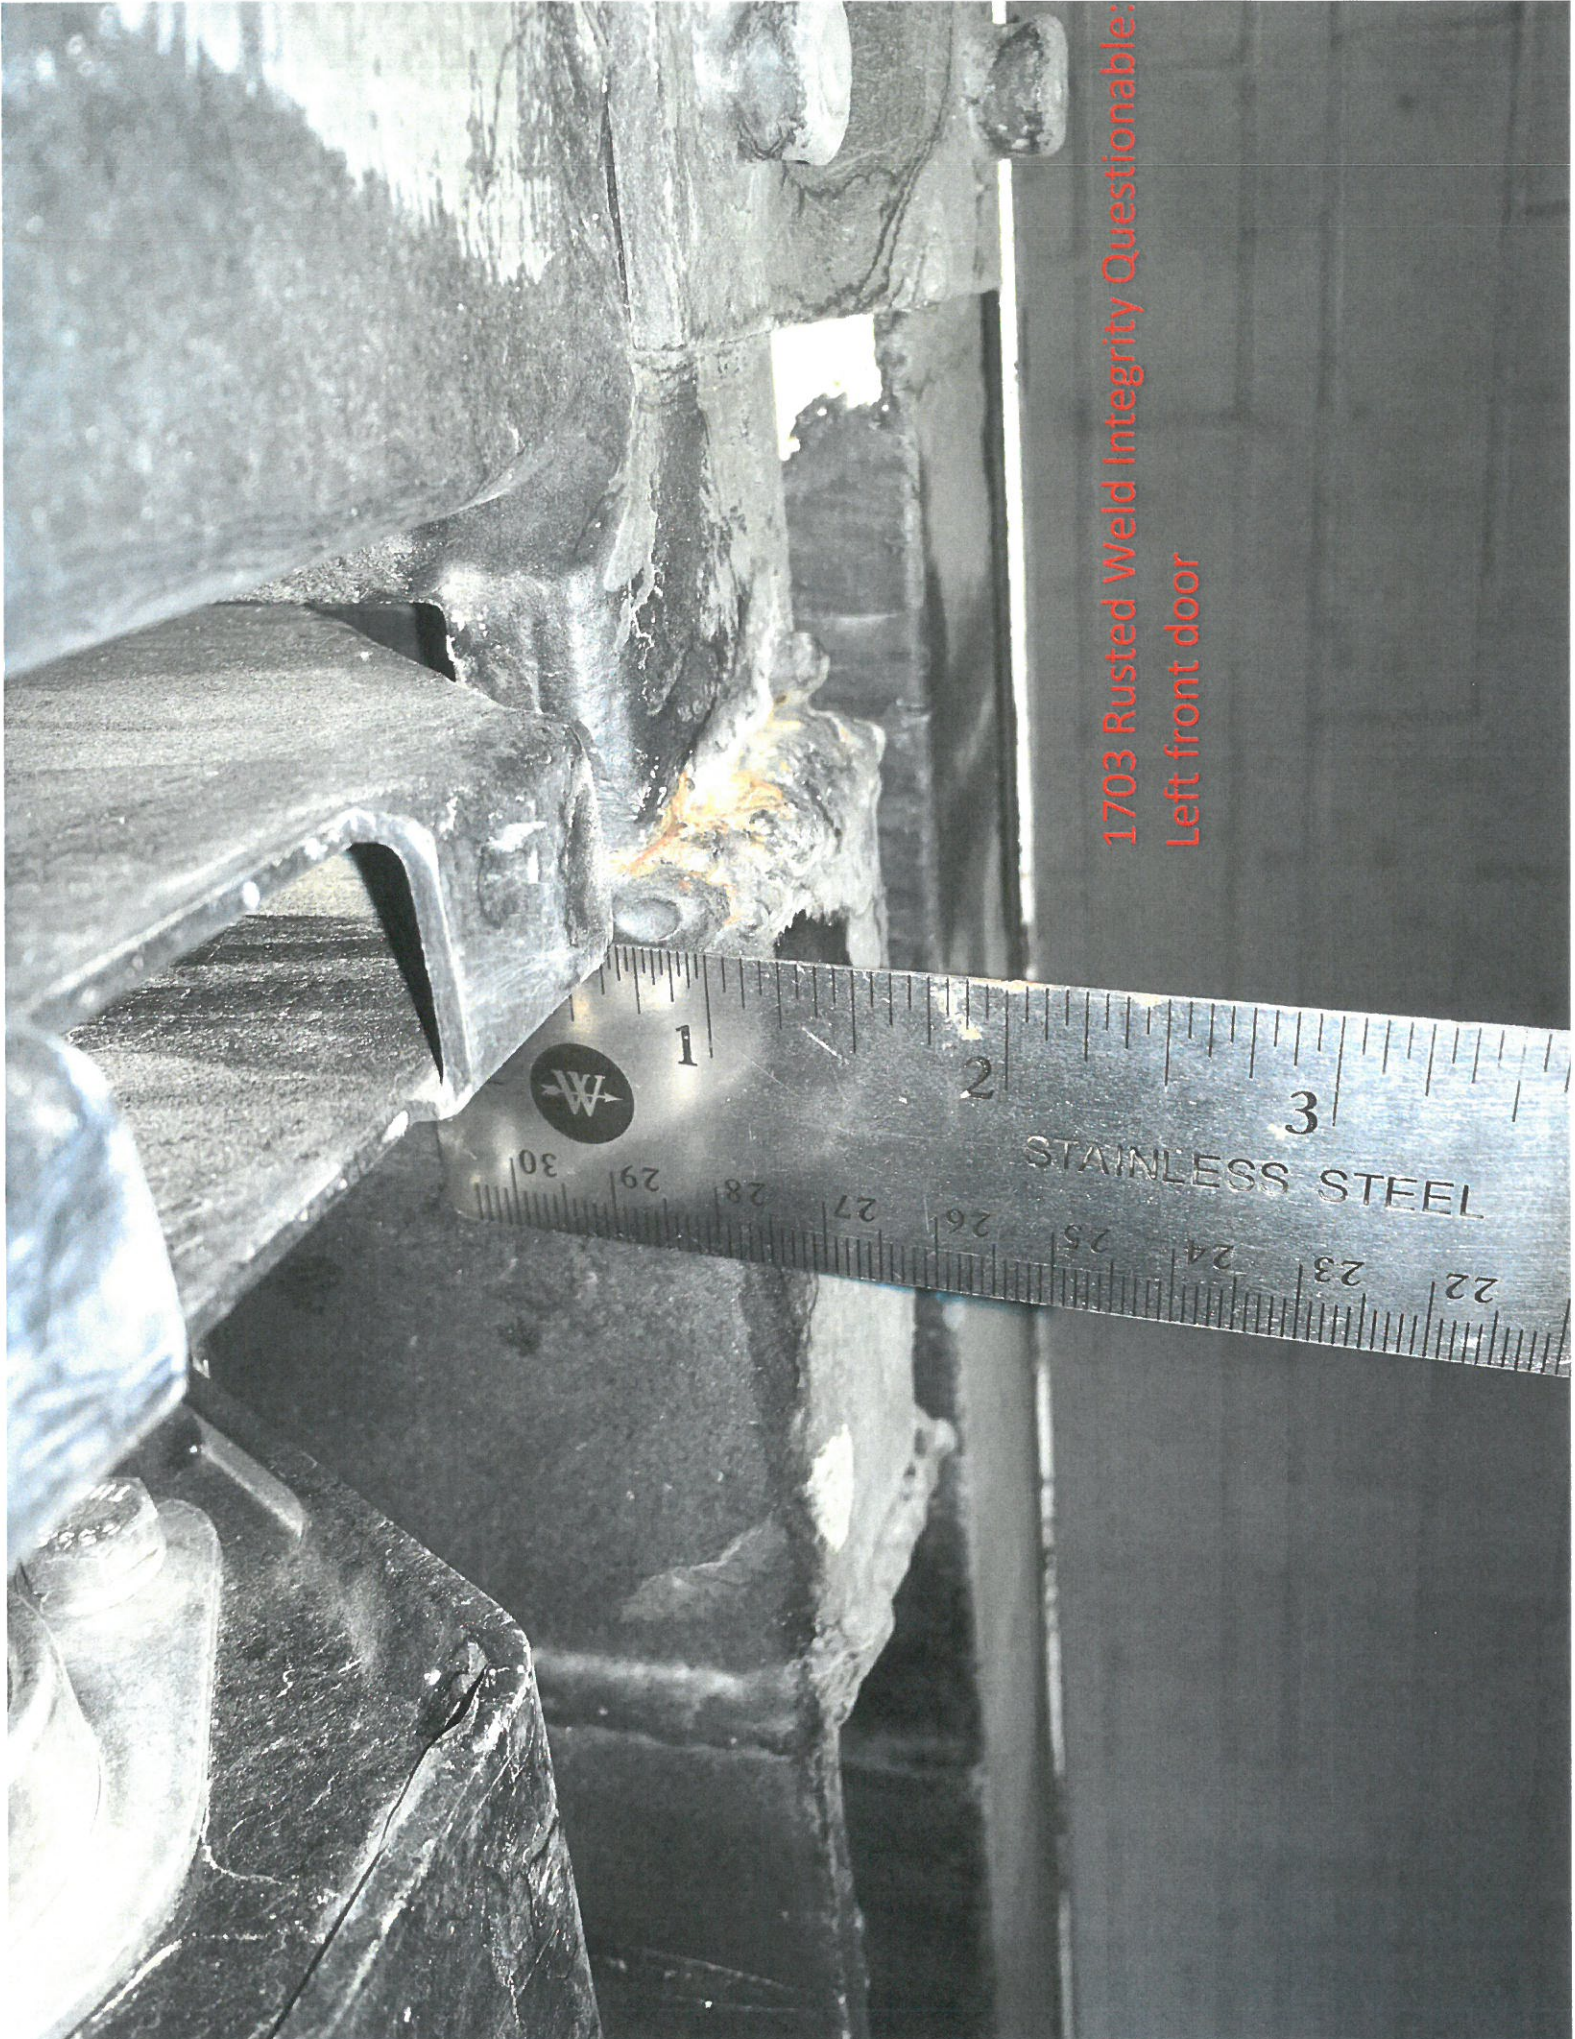
1703 Rusted Weld Integrity Questionable:
Left front door

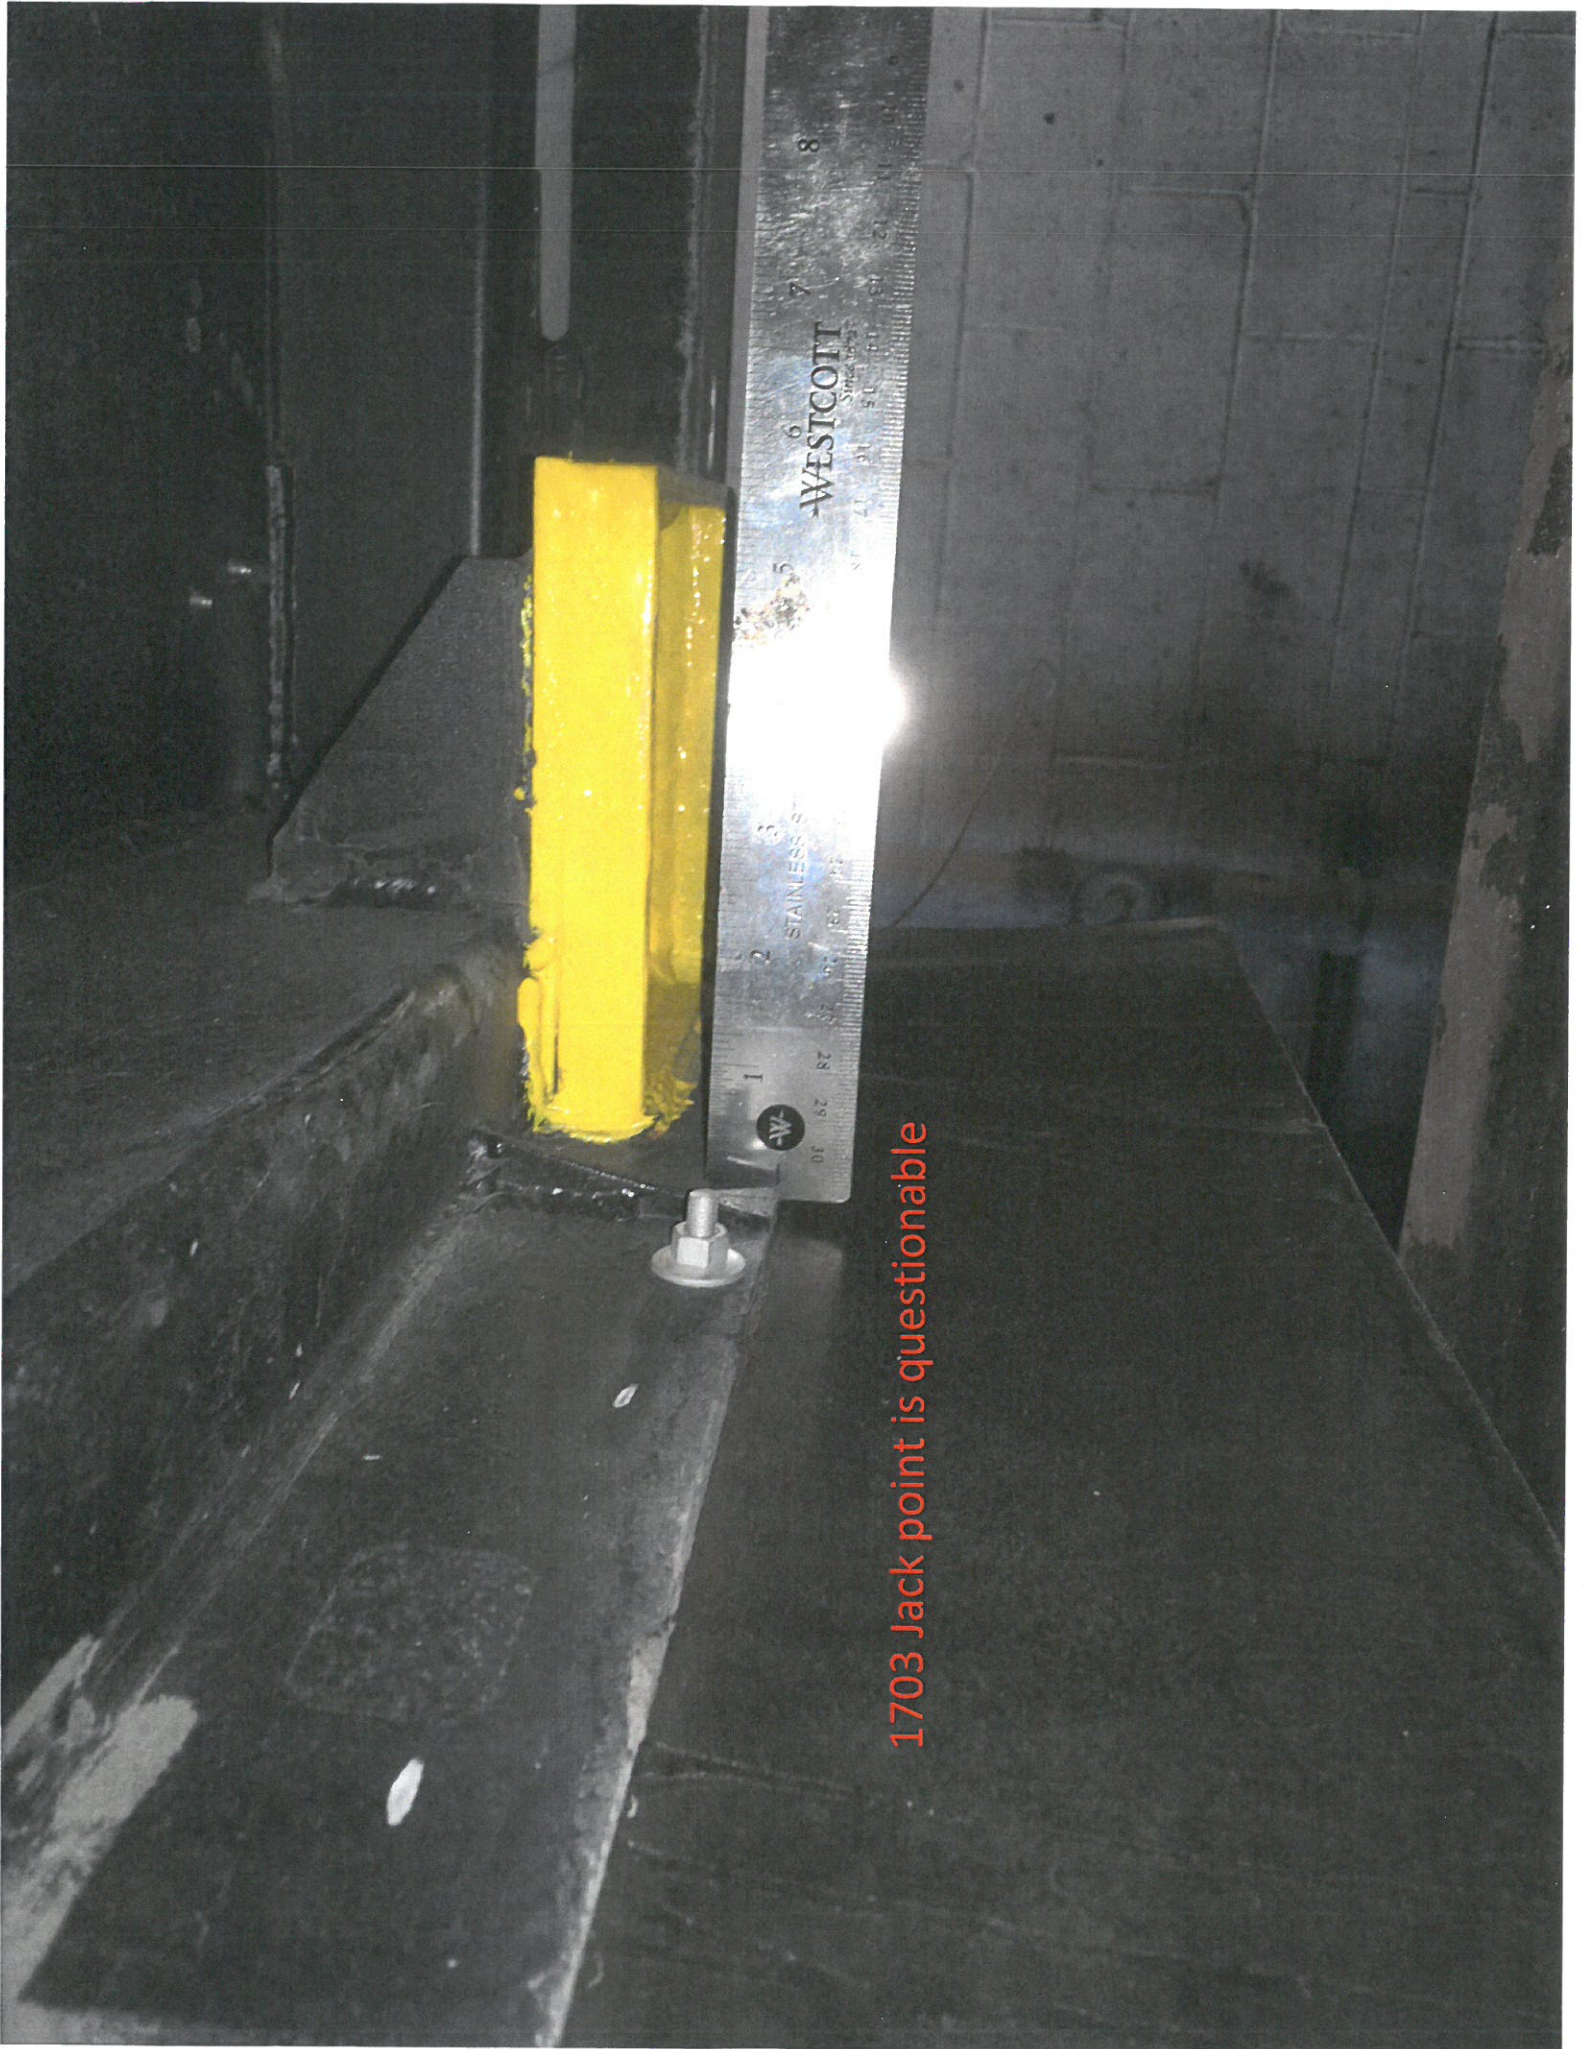
1703 Jack point is questionable
