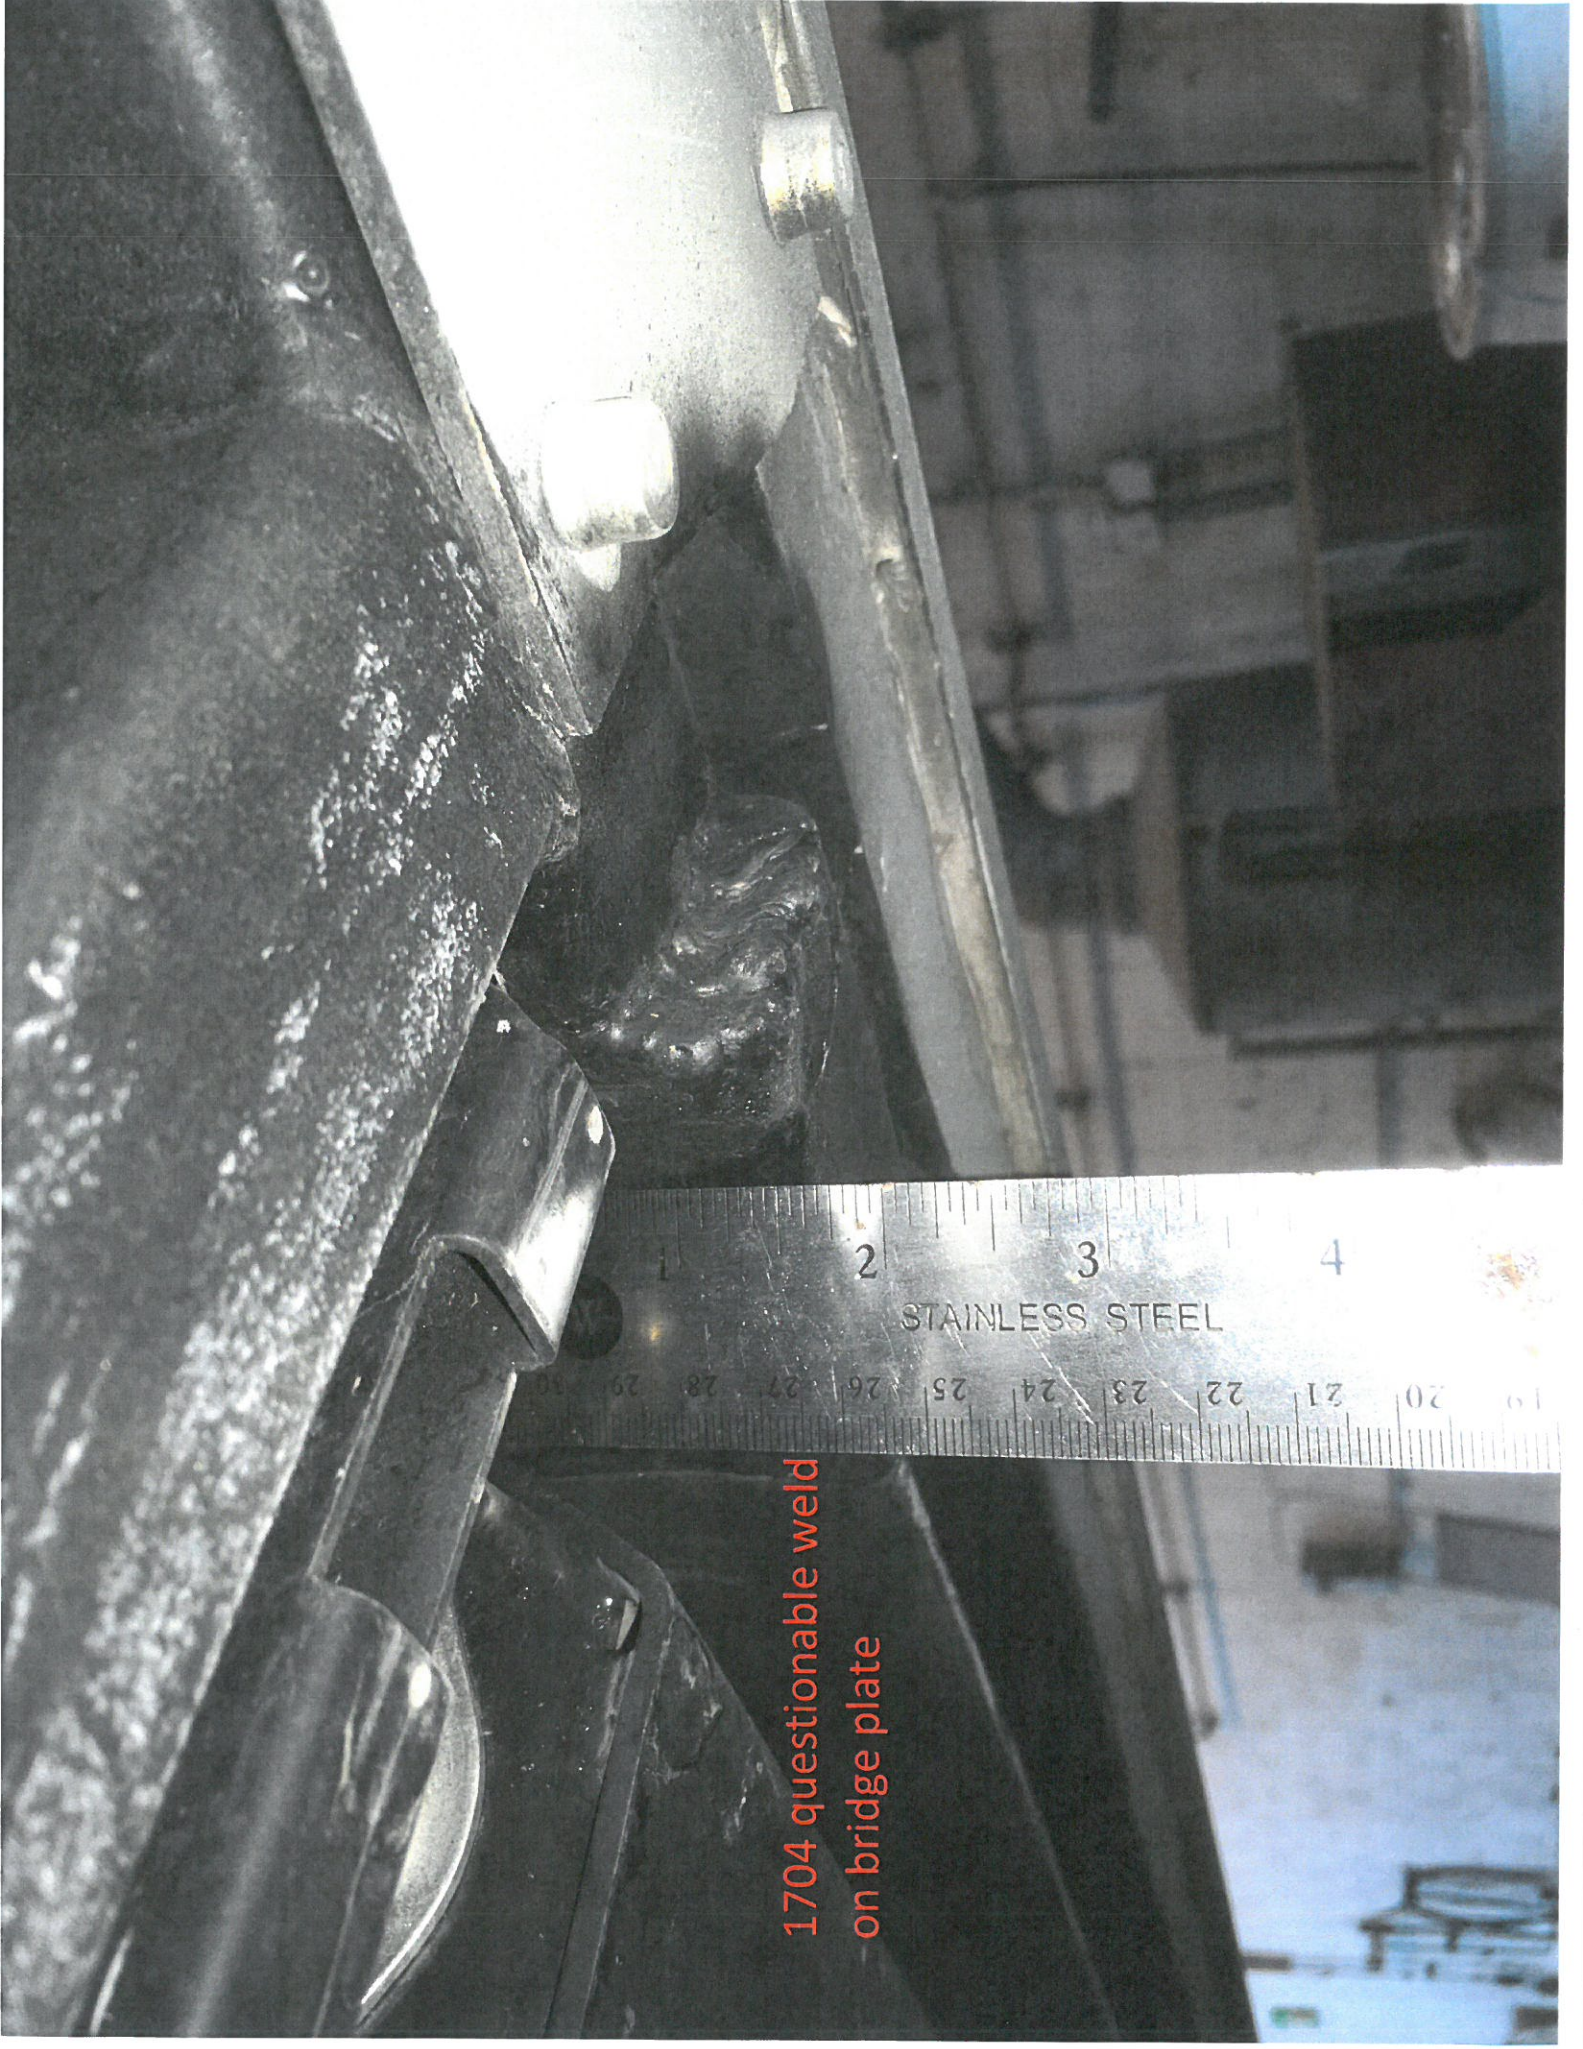
1704 questionable weld
on bridge plate

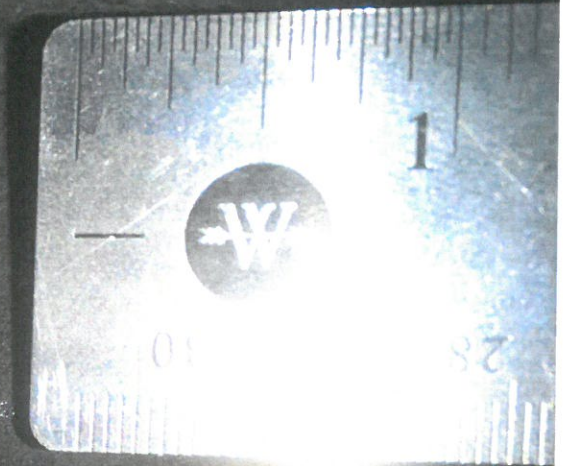
1704 Incomplete weld

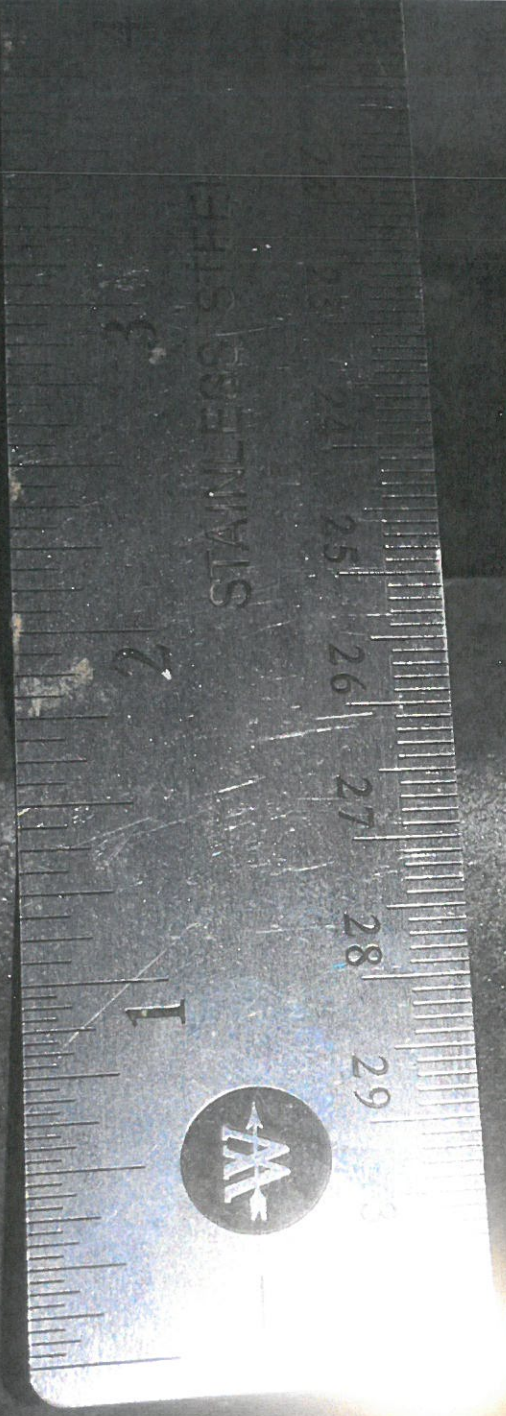
1704 Incomplete weld

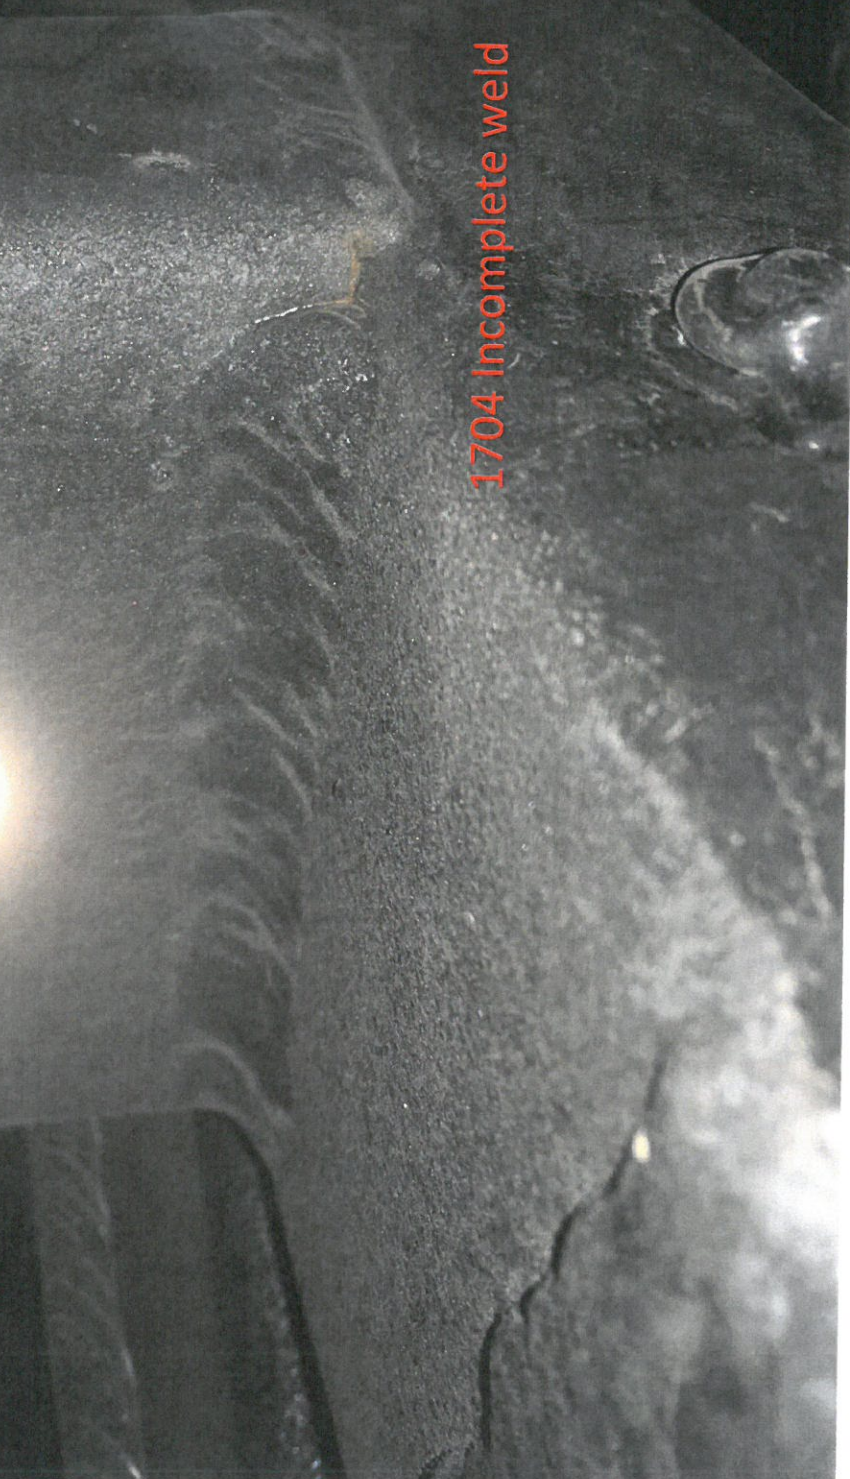
1704 Incomplete weld

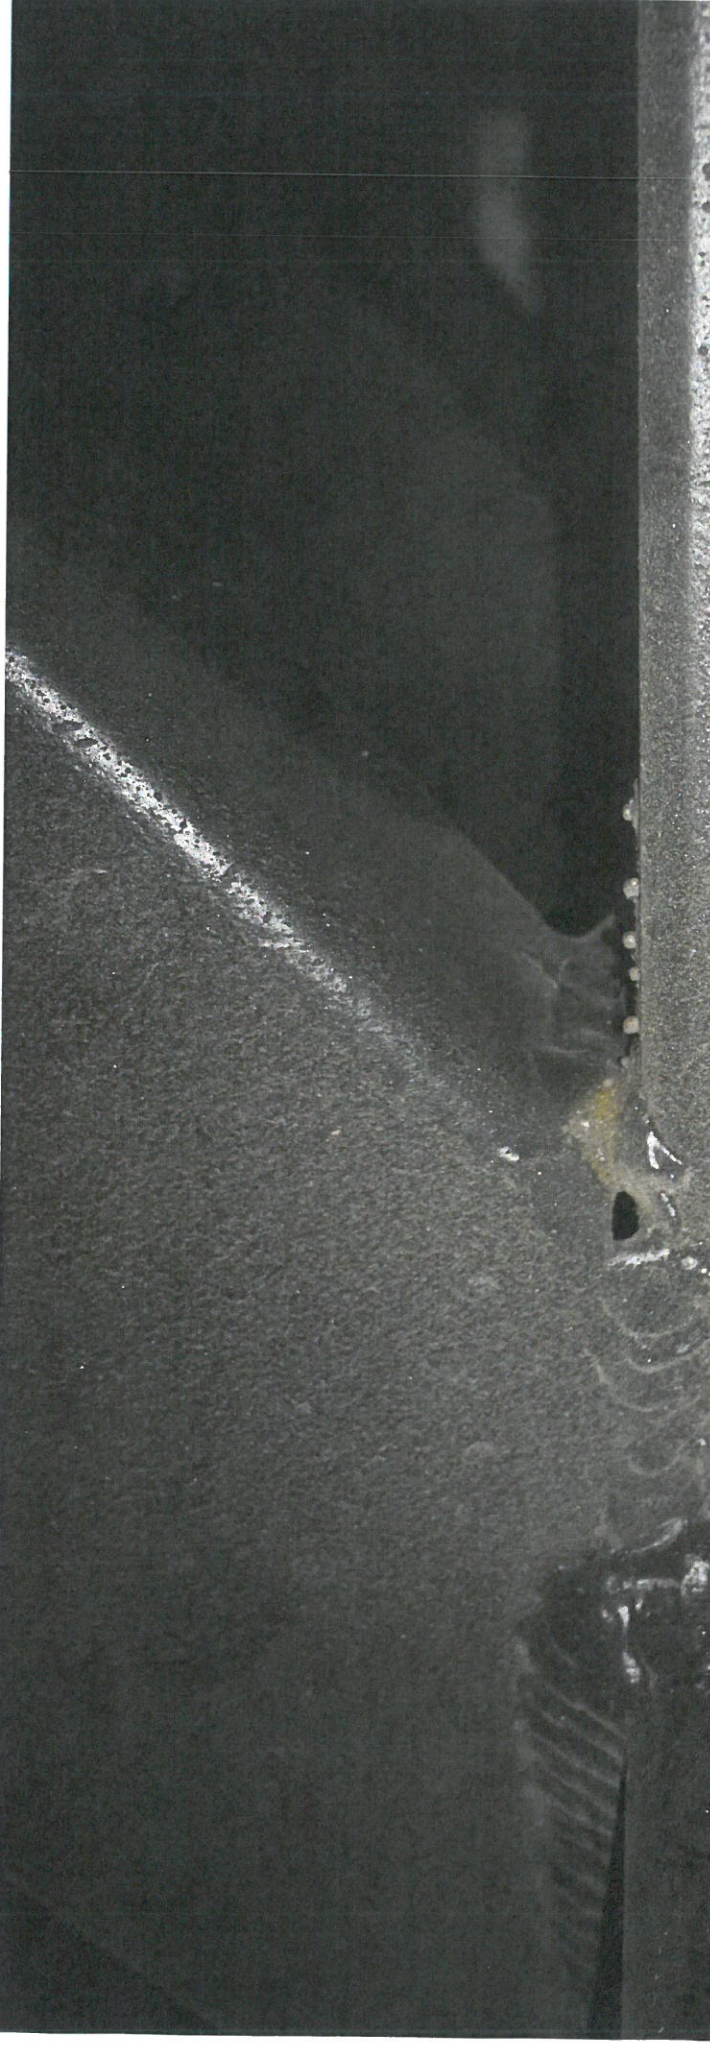
1704 Brake chamber line rubbing

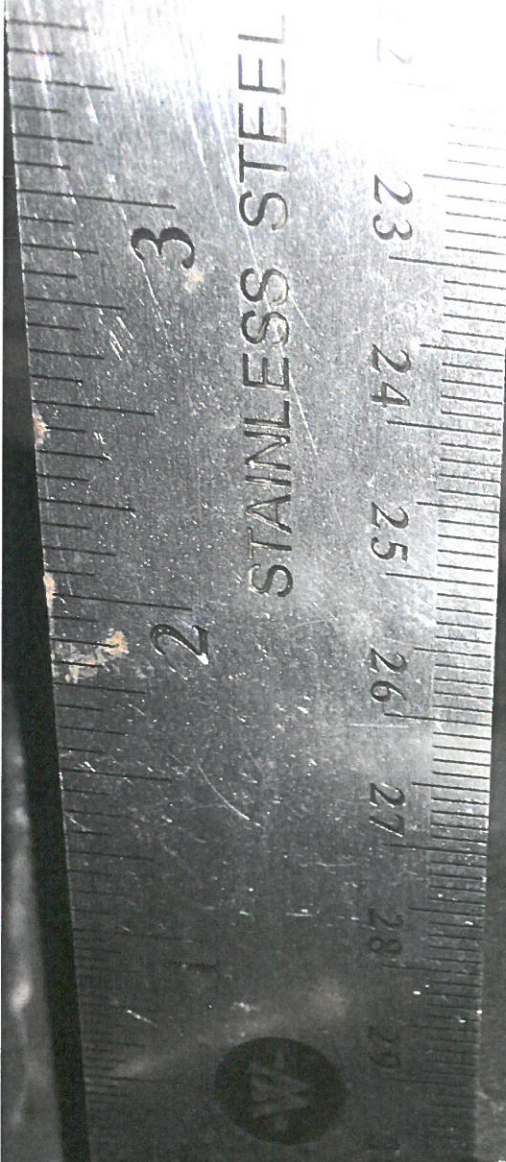
1704 Missing weld

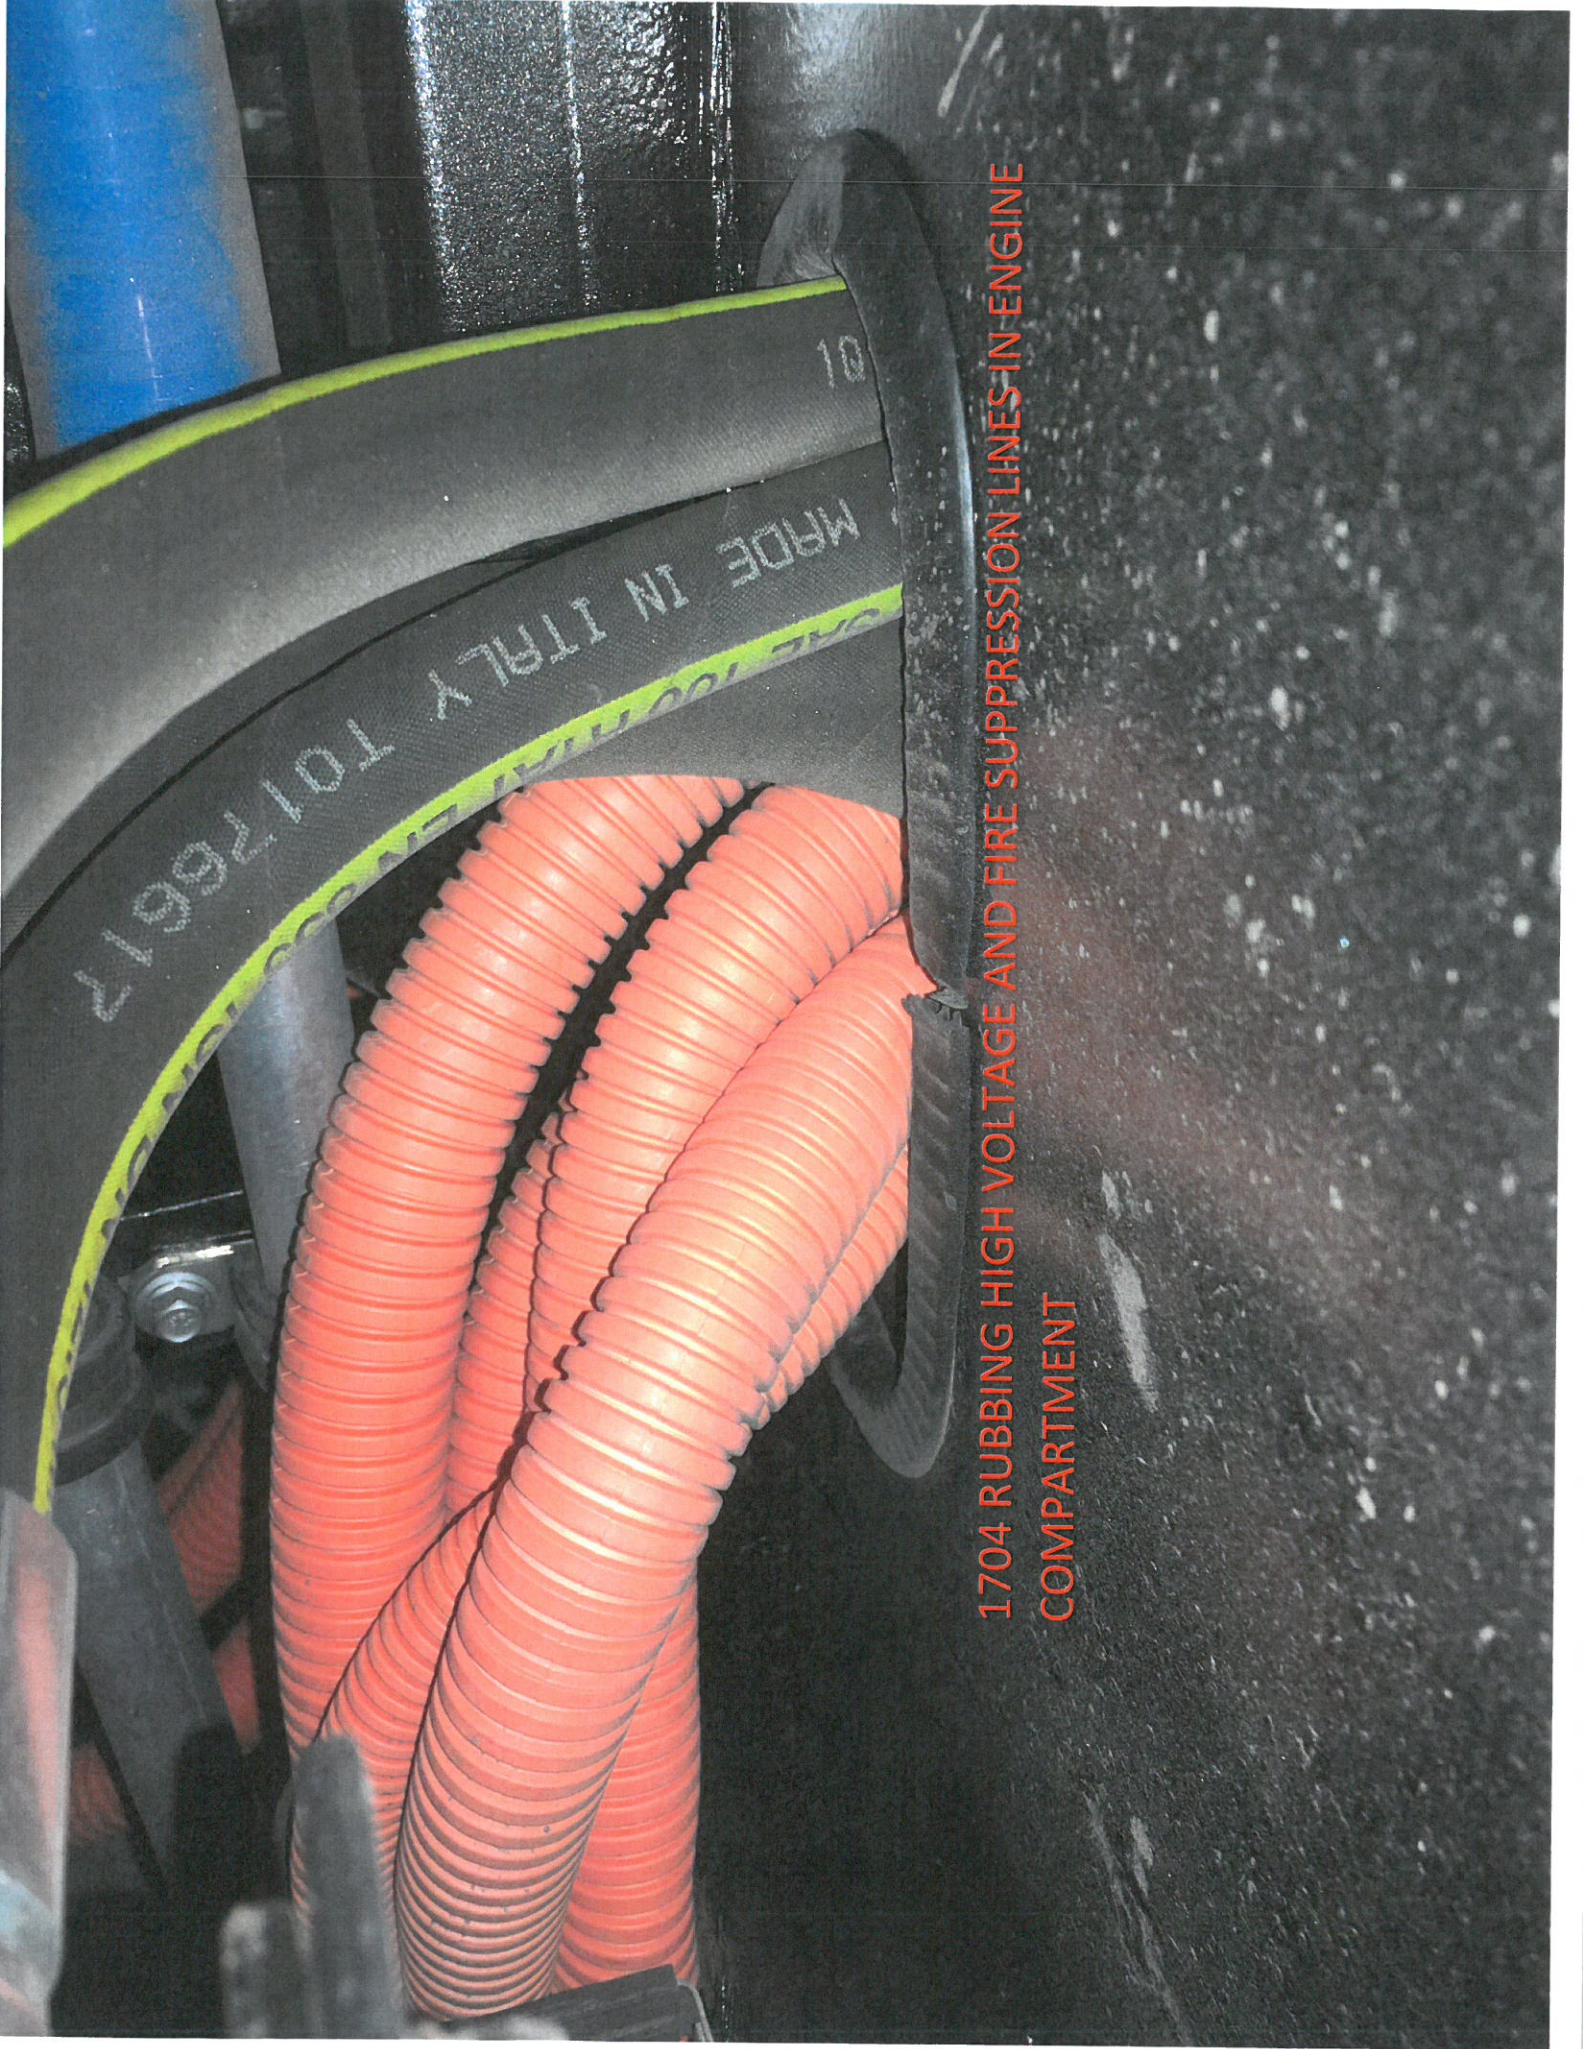
1704 RUBBING HIGH VOLTAGE AND FIRE SUPPRESSION LINES IN ENGINE COMPARTMENT

1704 RUBBING HIGH VOLTAGE AND COOLANT LINES IN ENGINE COMPARTMENT

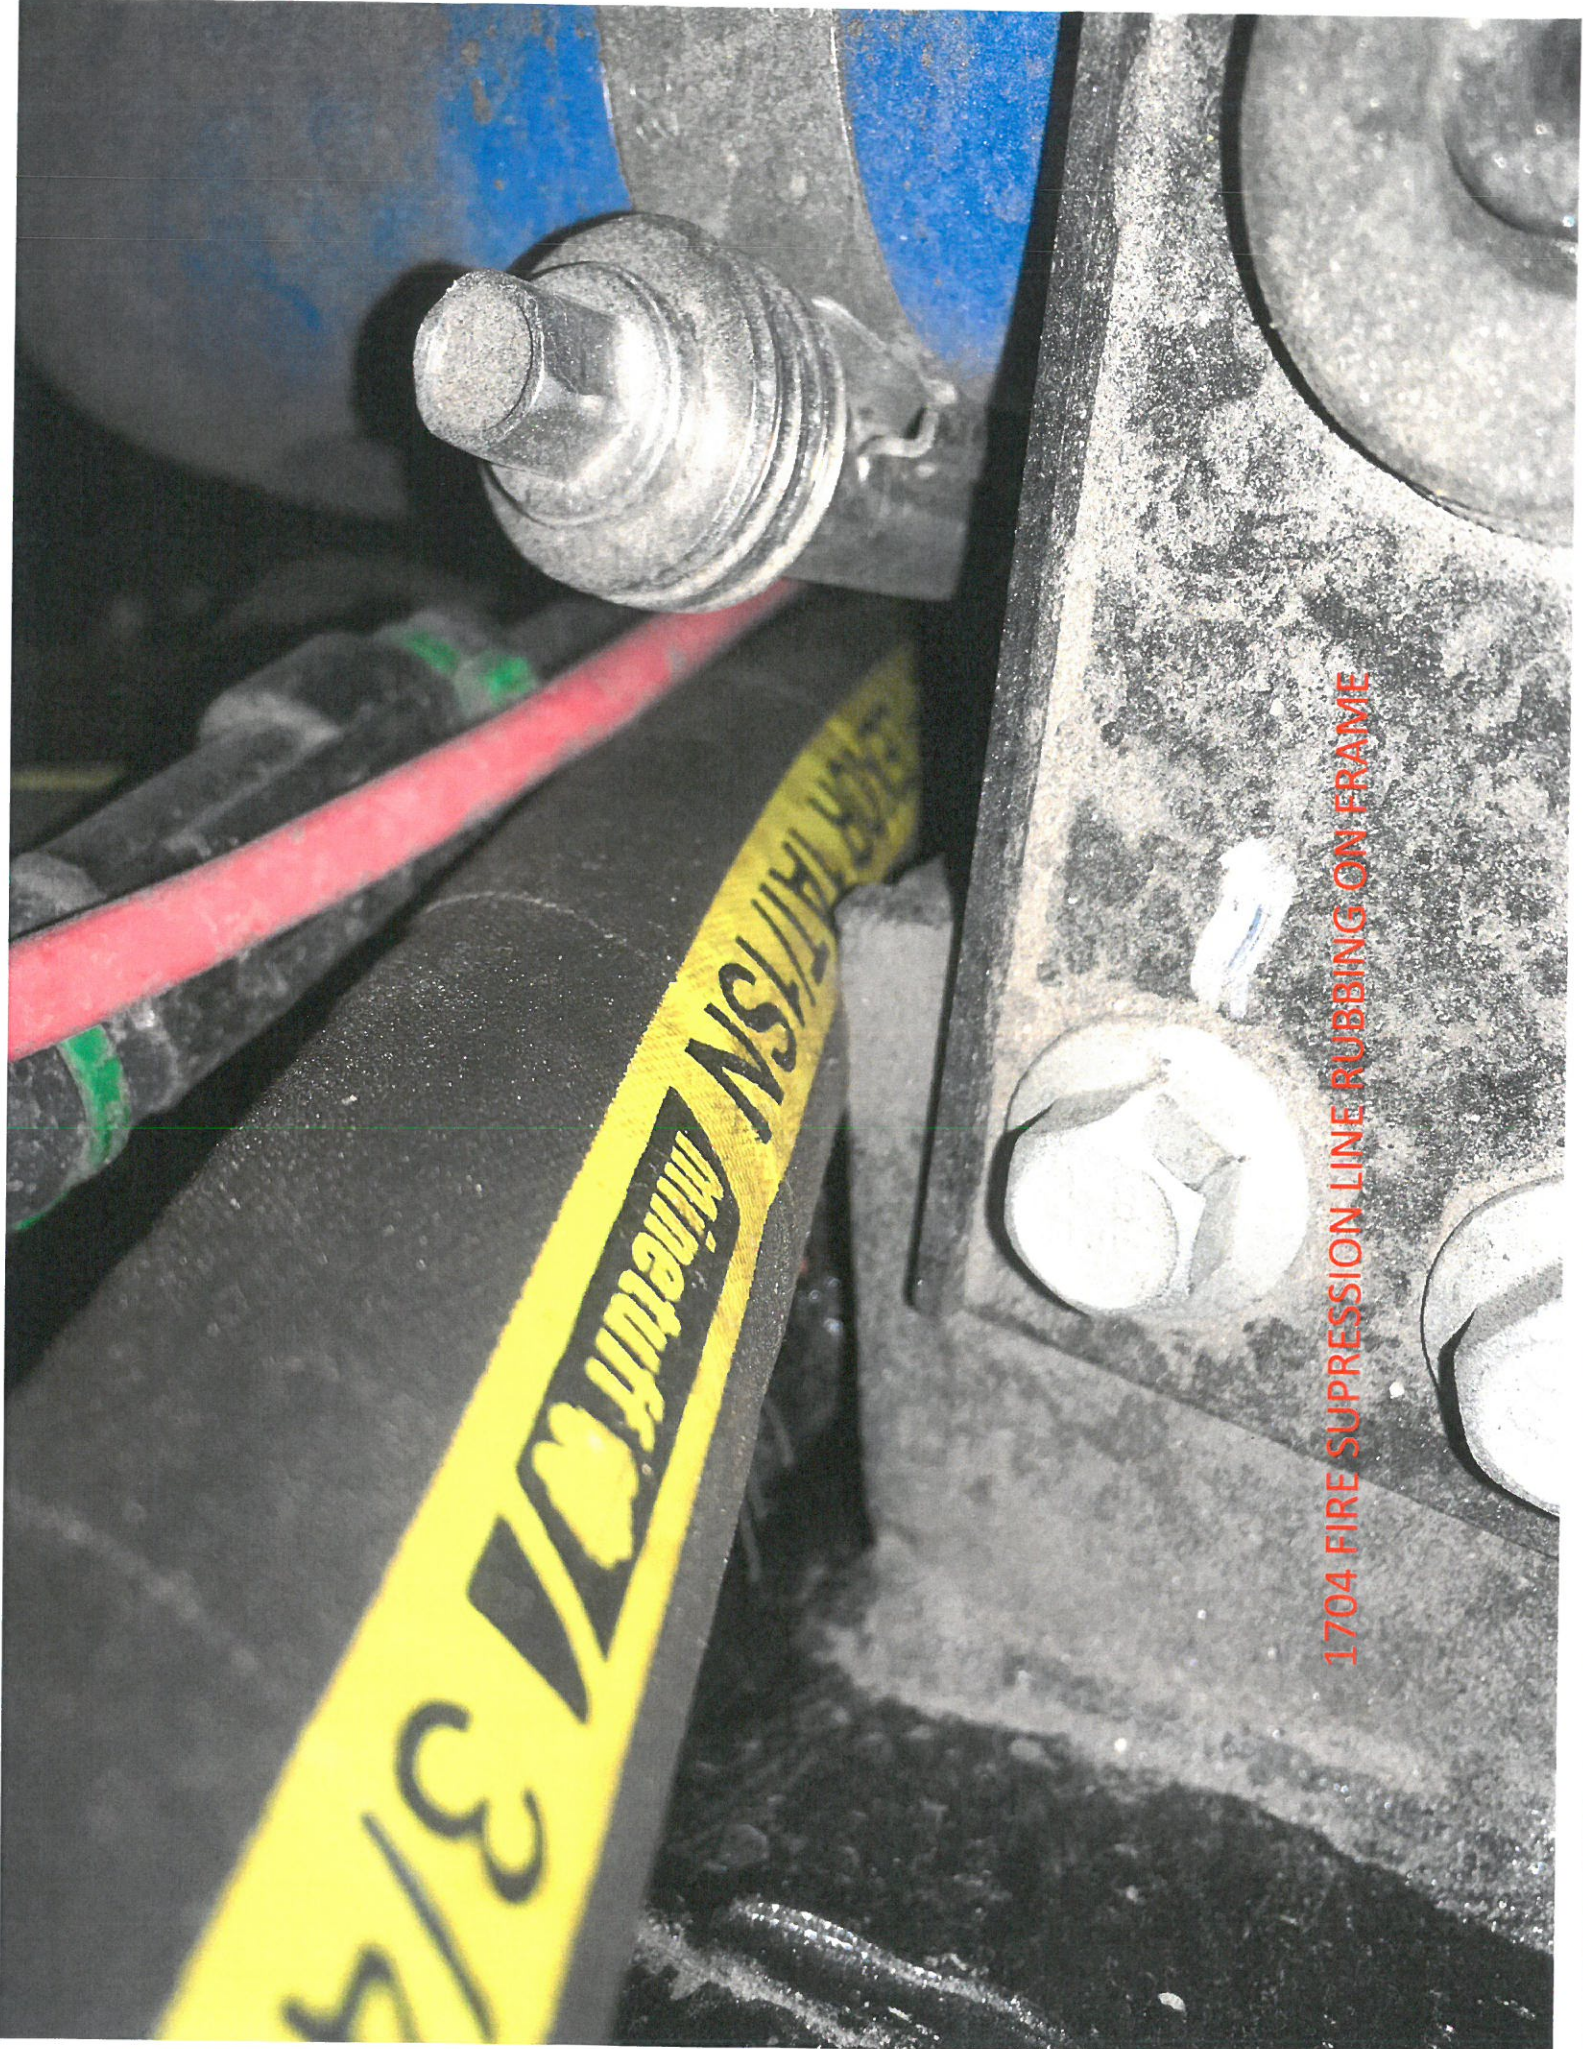
1704 FIRE SUPPRESSION LINE RUBBING ON FRAME

1704 HIGH VOLTAGE LINES RUBBING

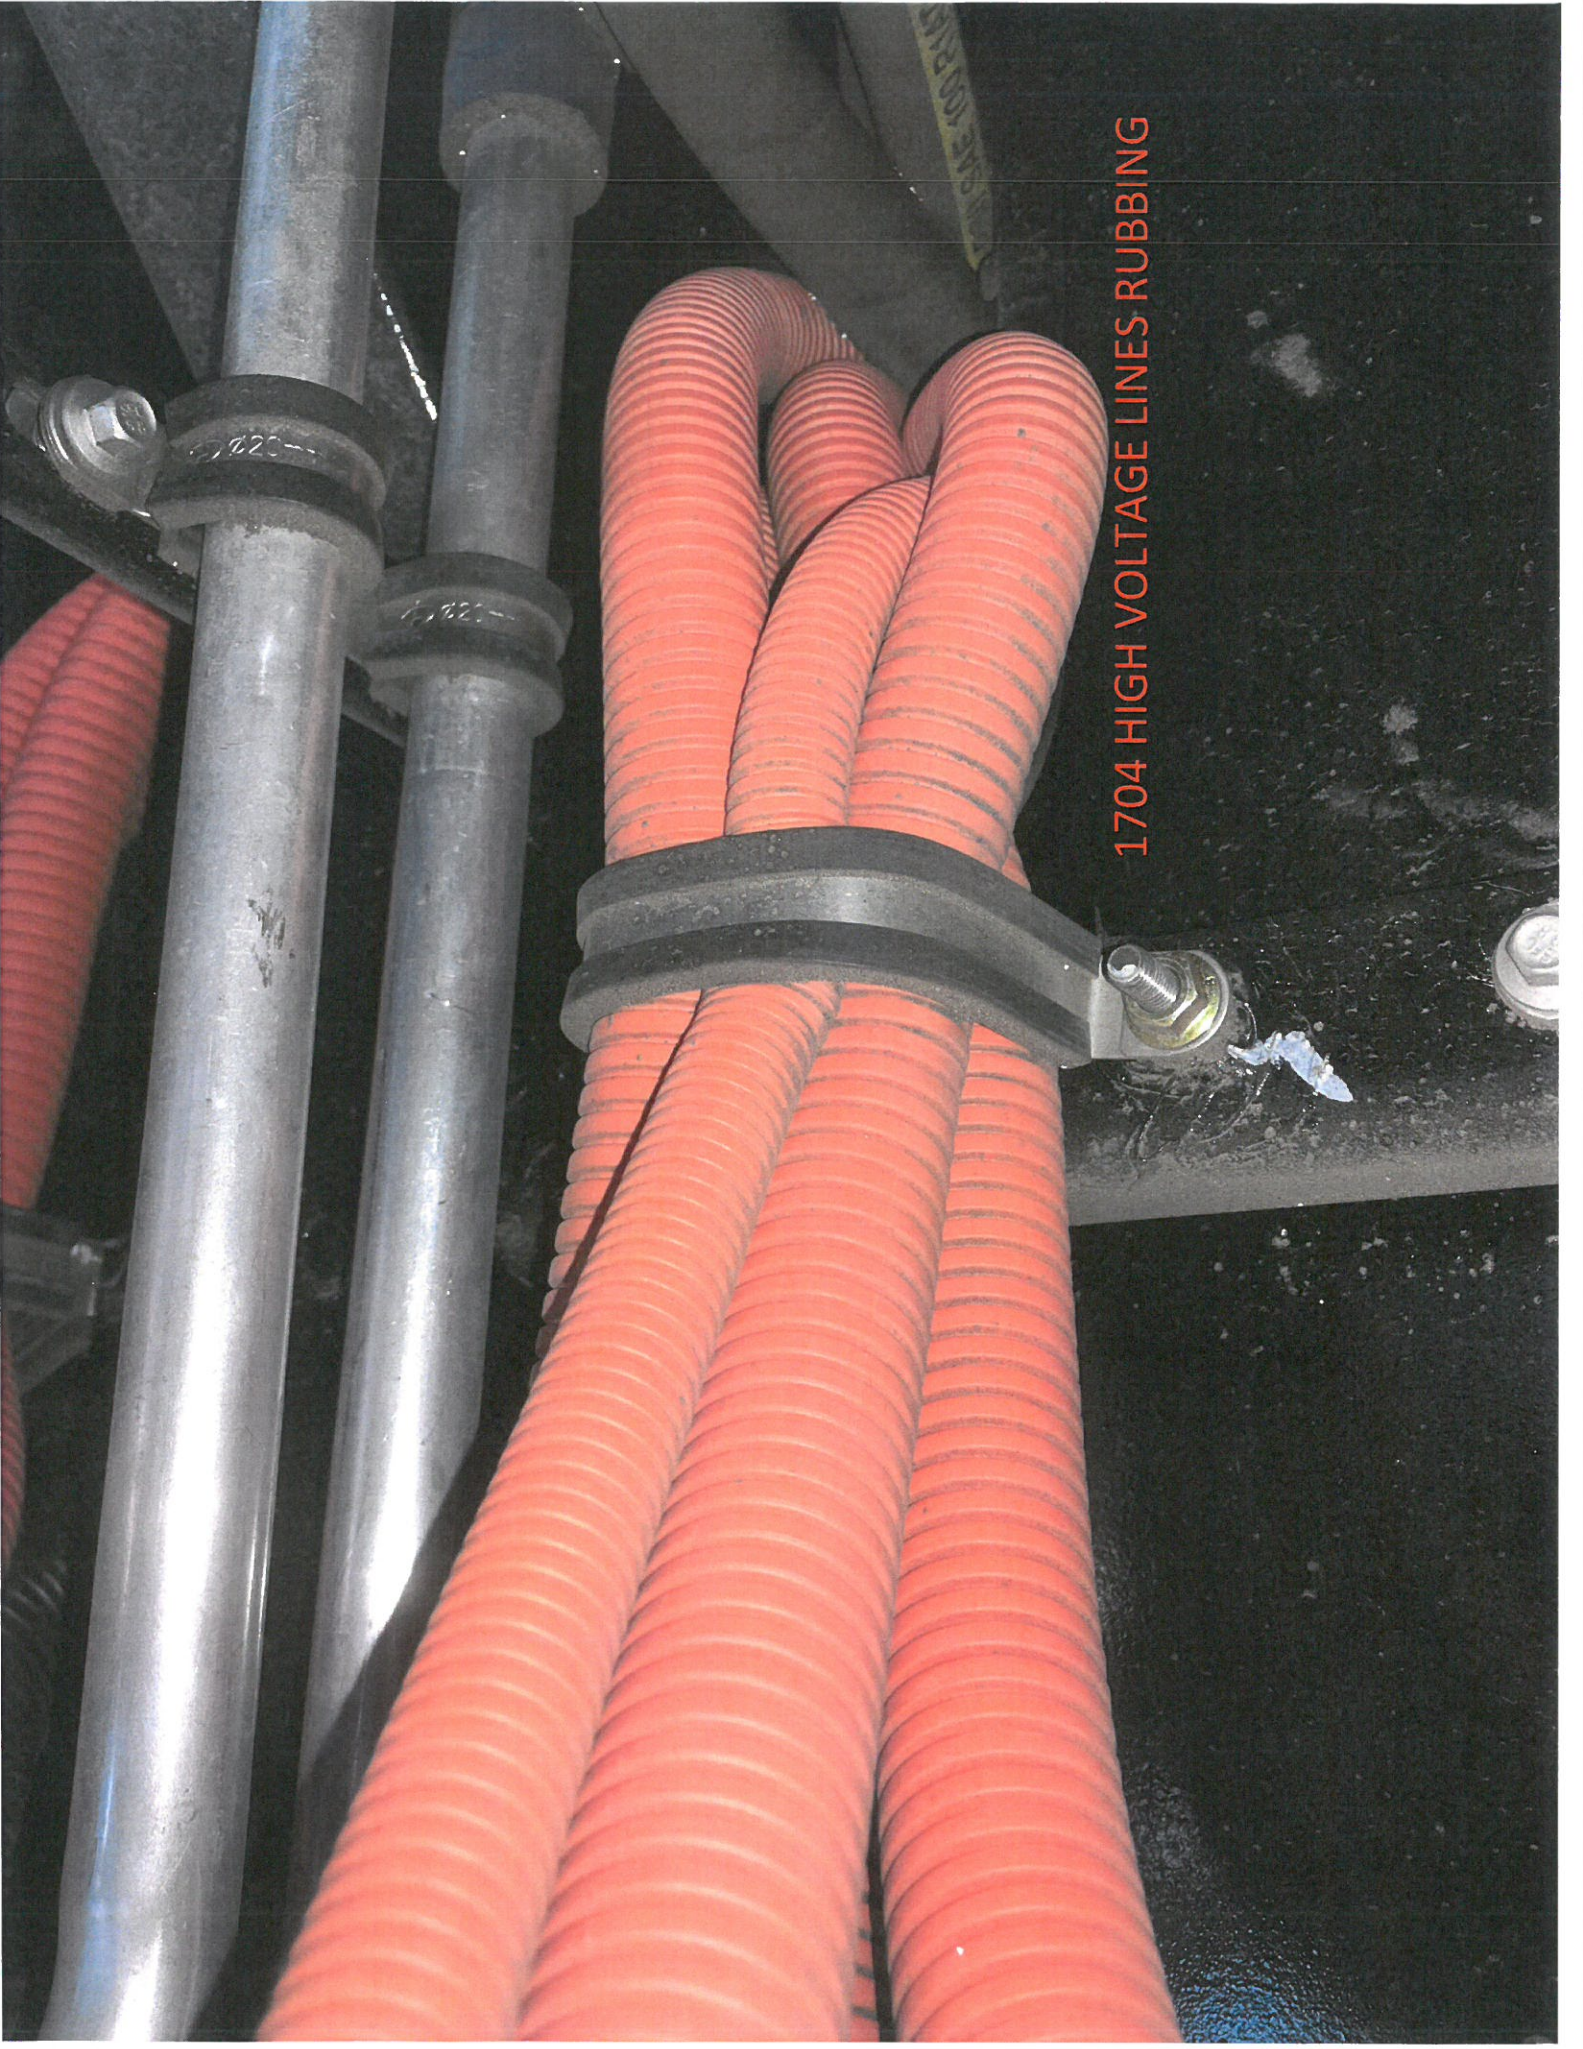
1704 HIGH VOLTAGE LINES RUBBING

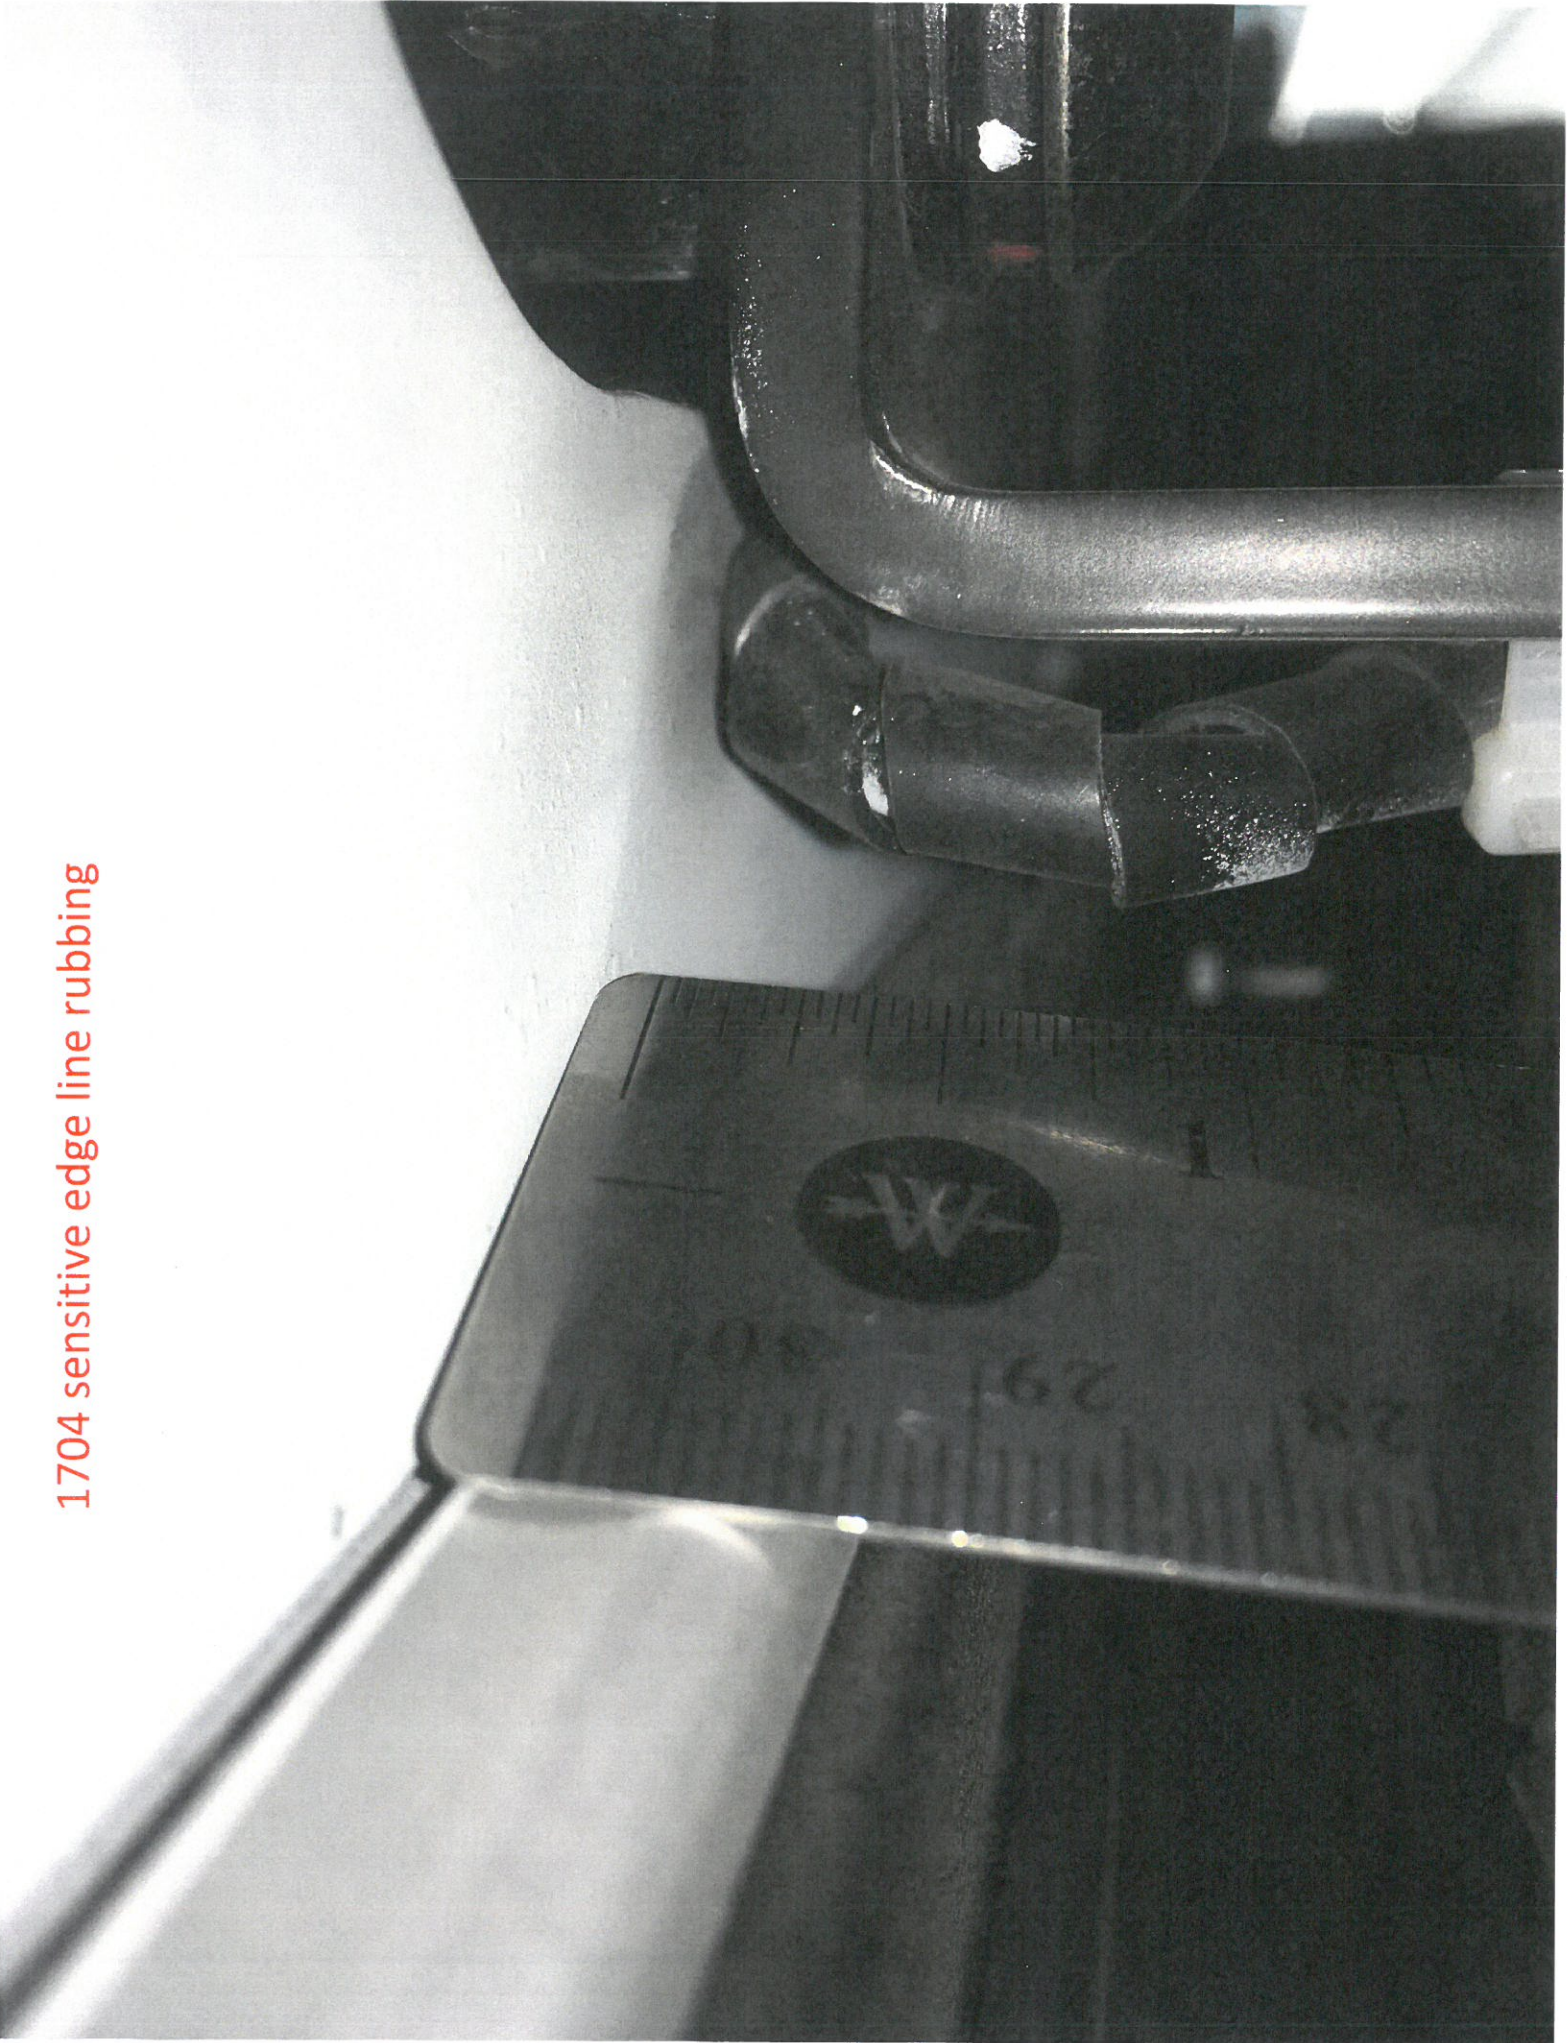
1704 sensitive edge line rubbing
