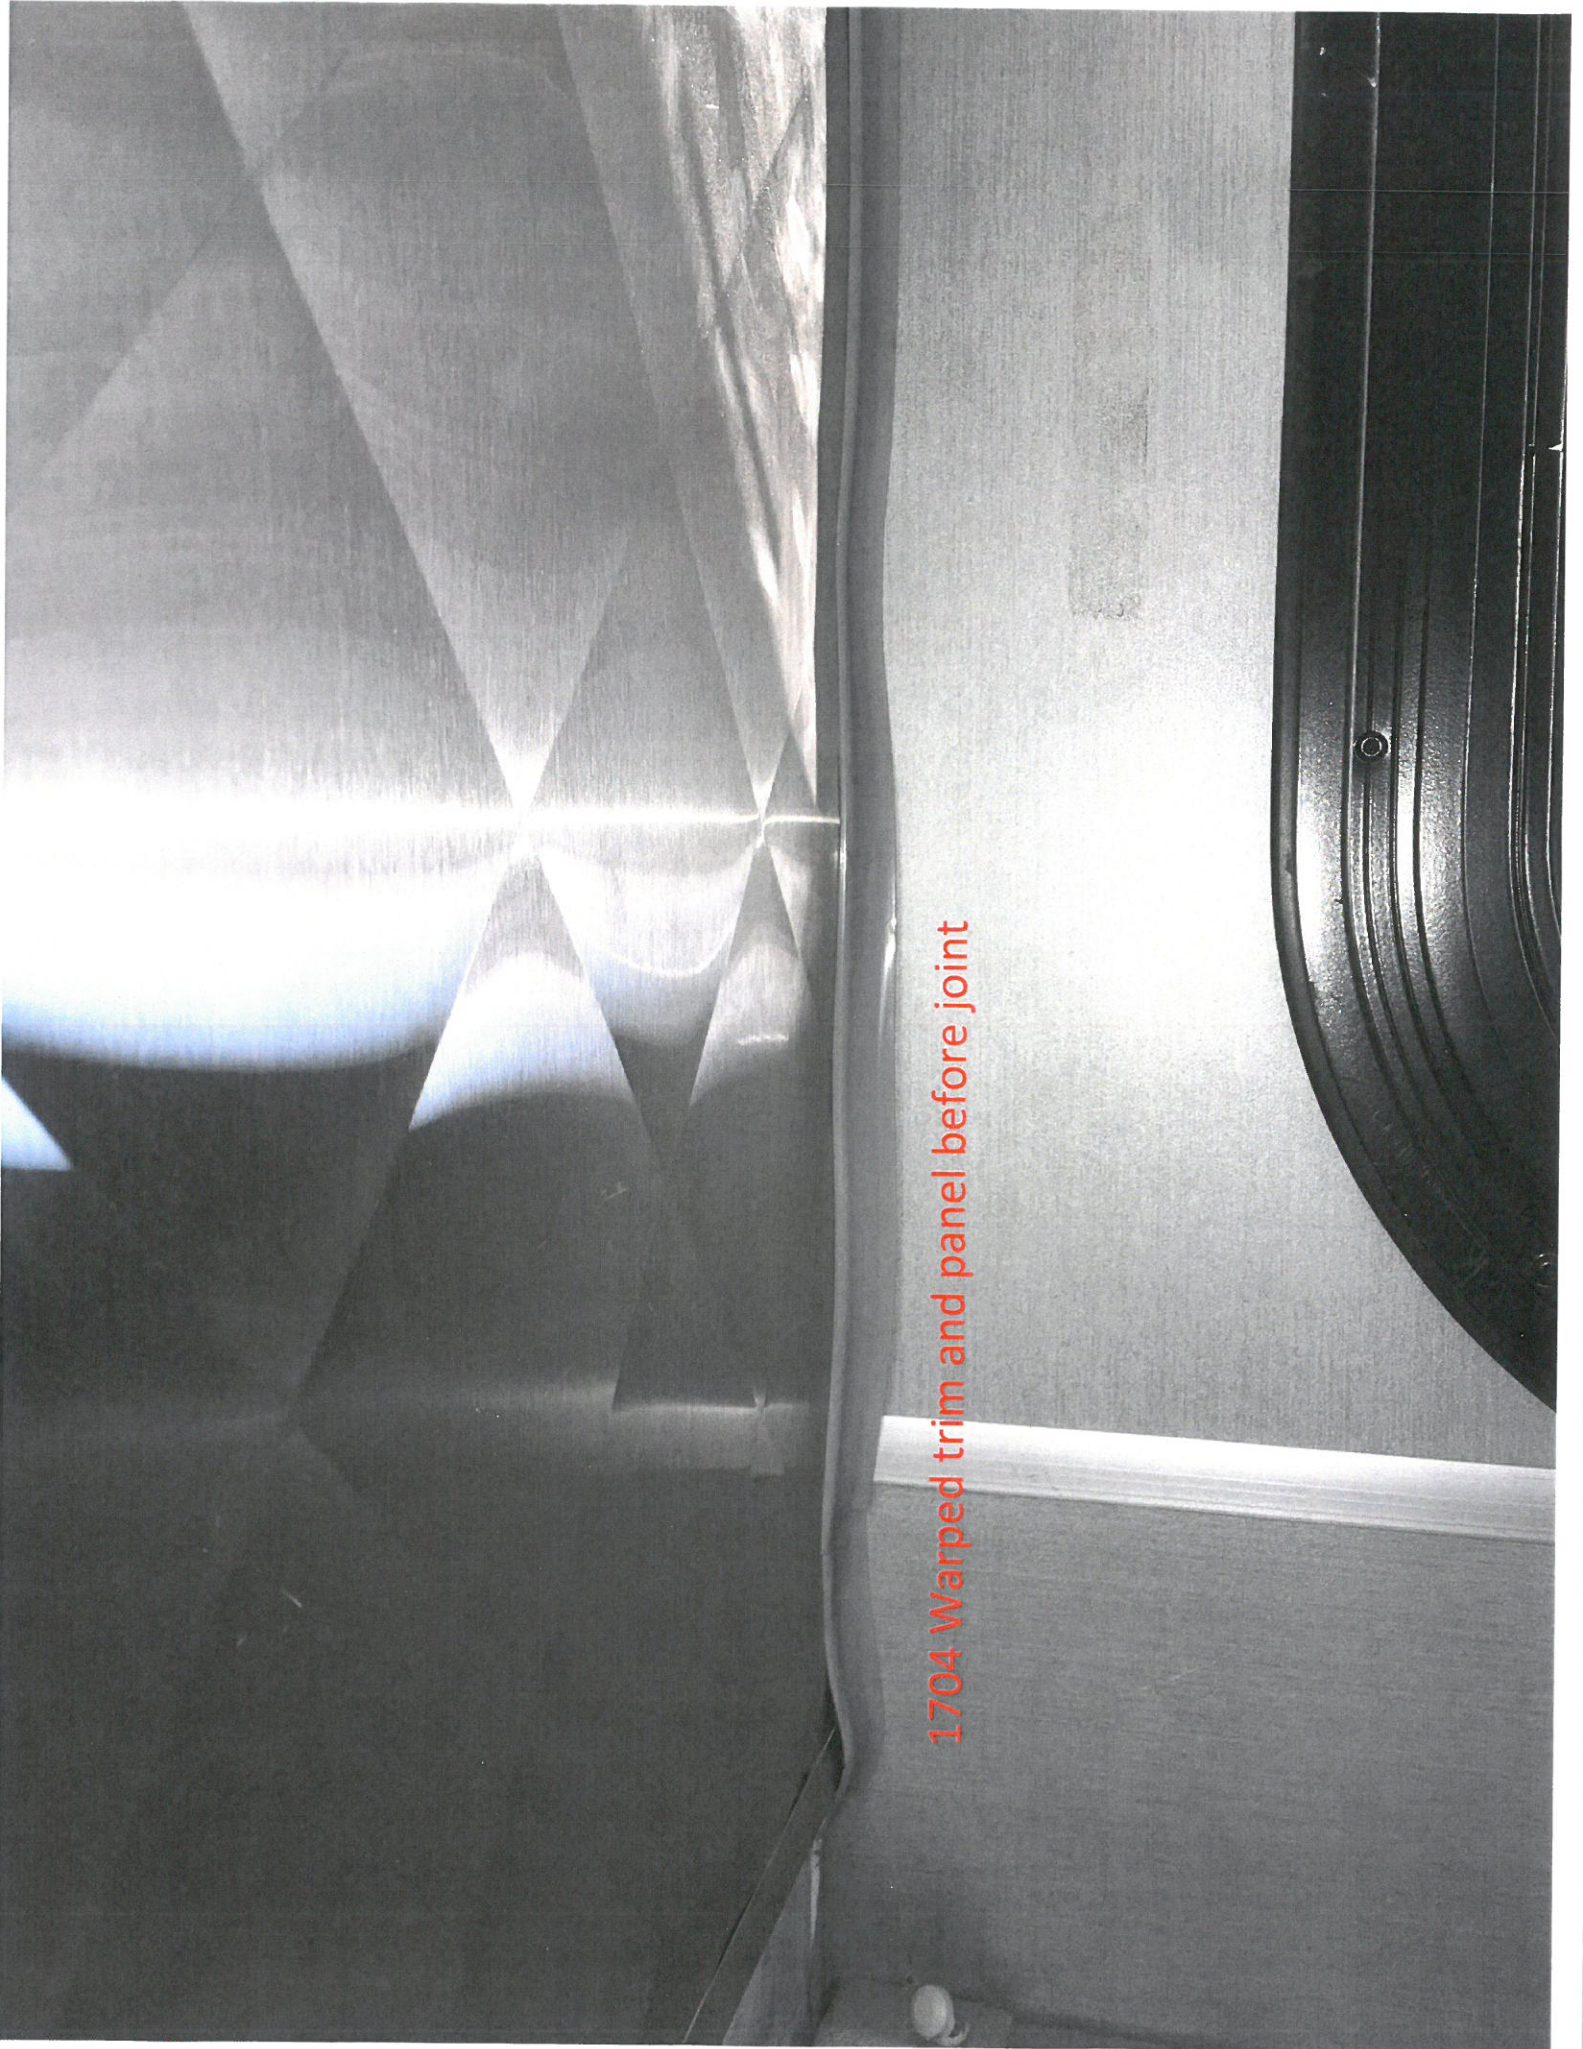
1704 Warped trim and panel before joint

1704 panel separating rear of joint

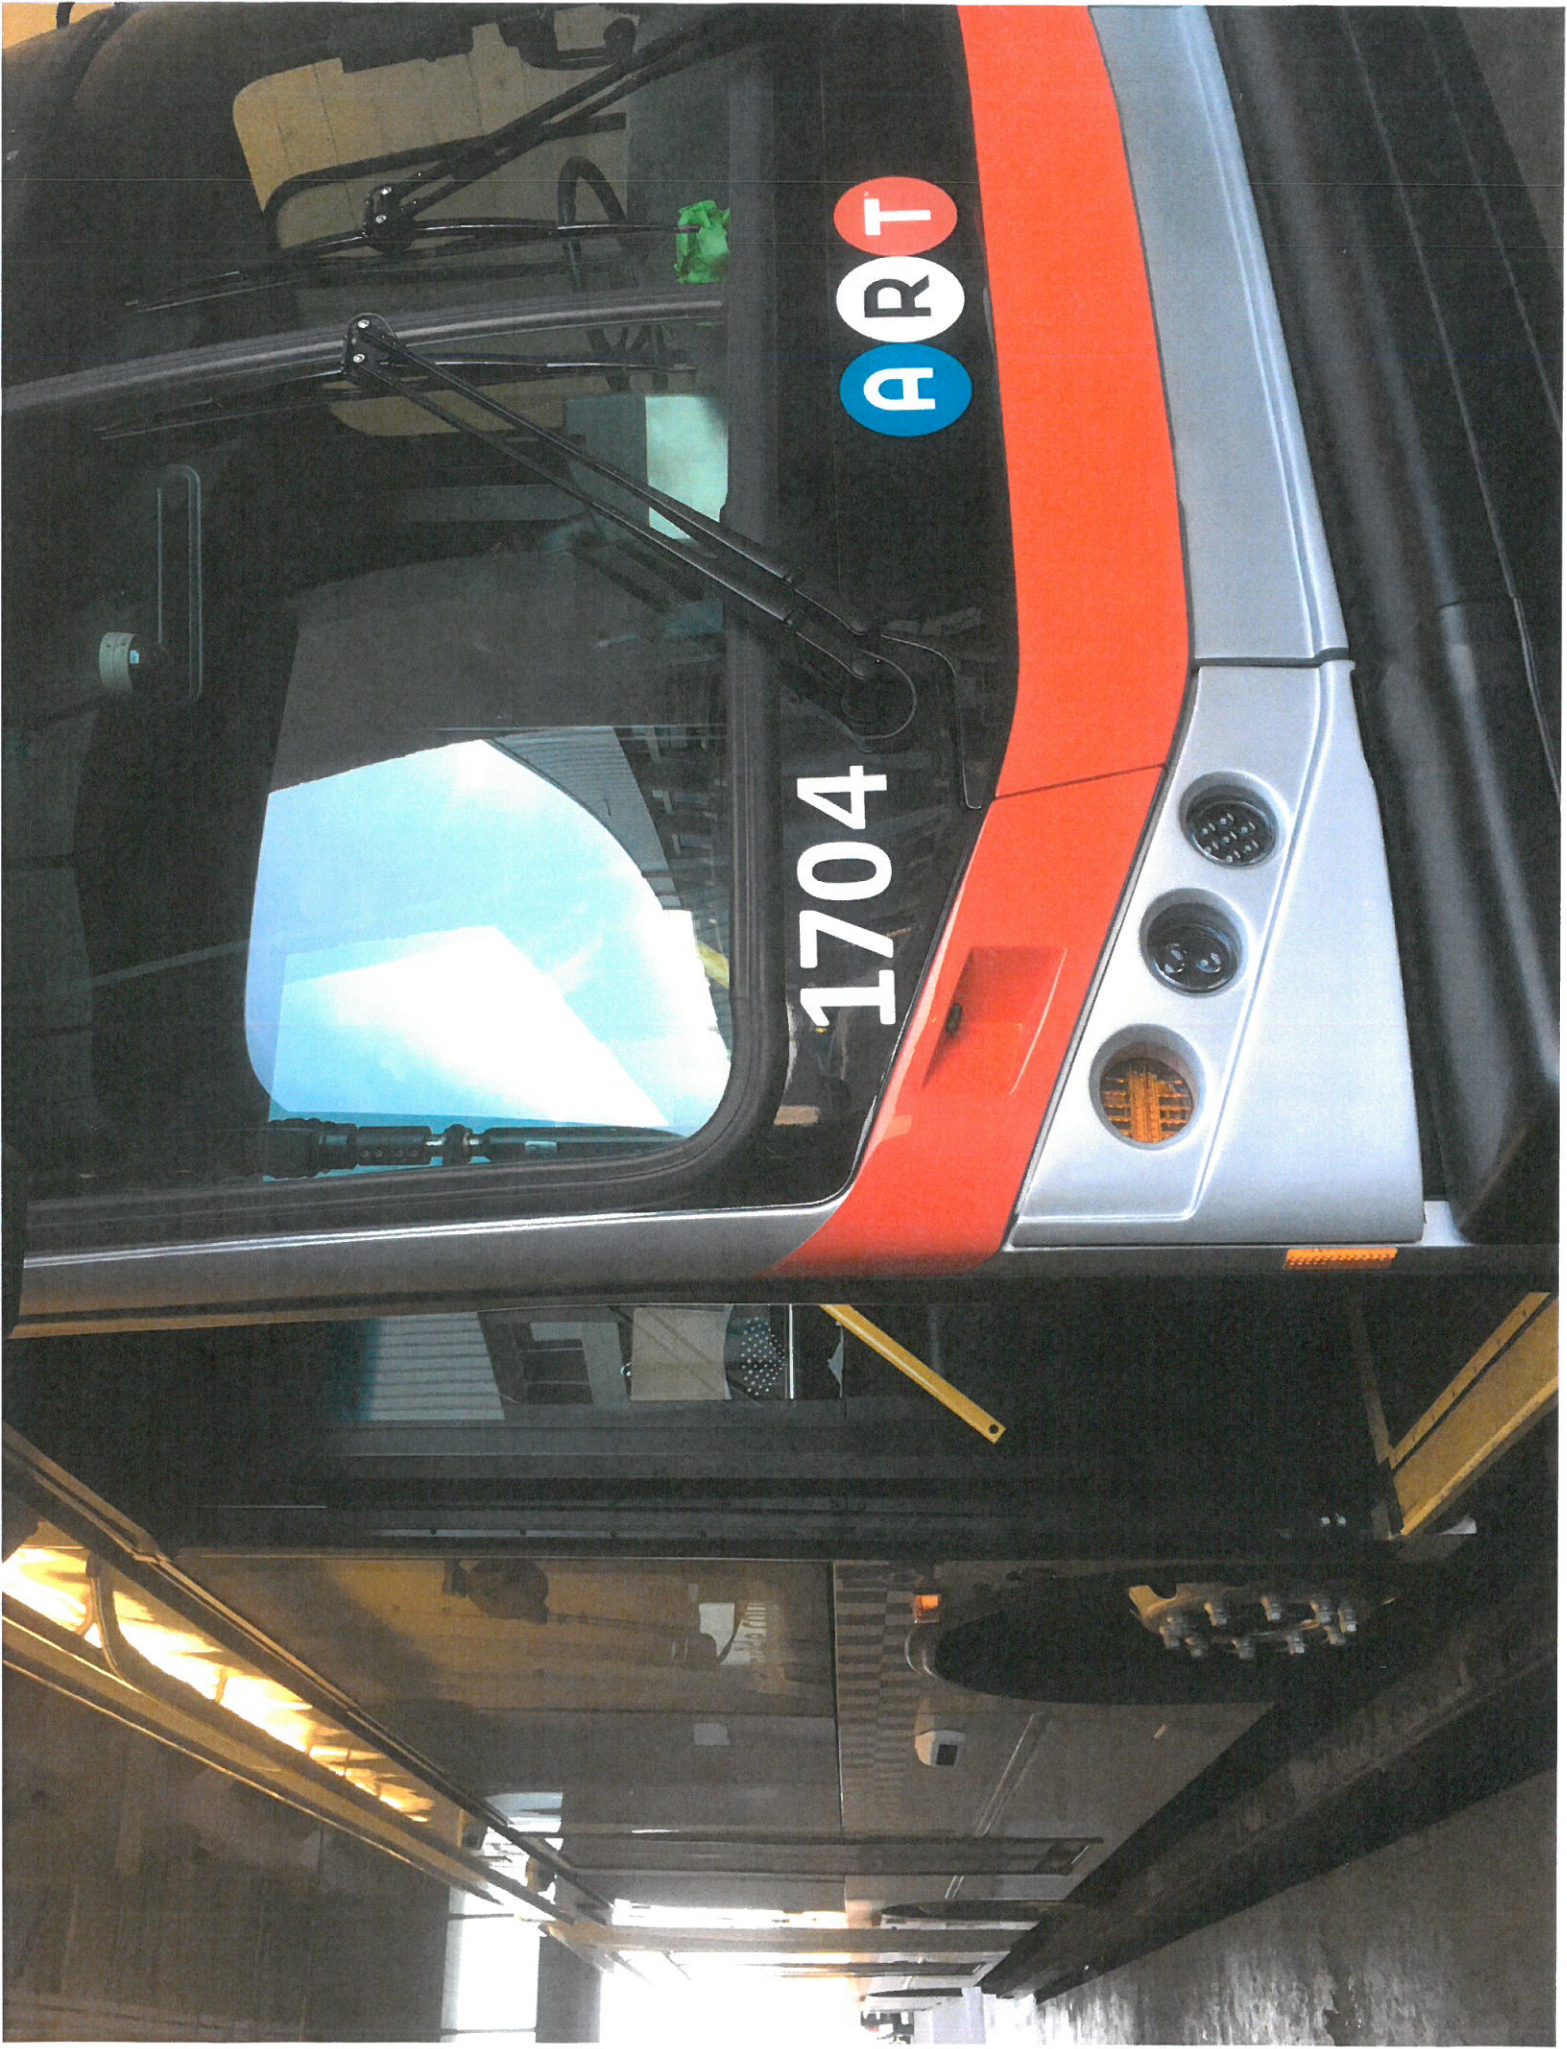
1704 lines and cables exposed to road hazards

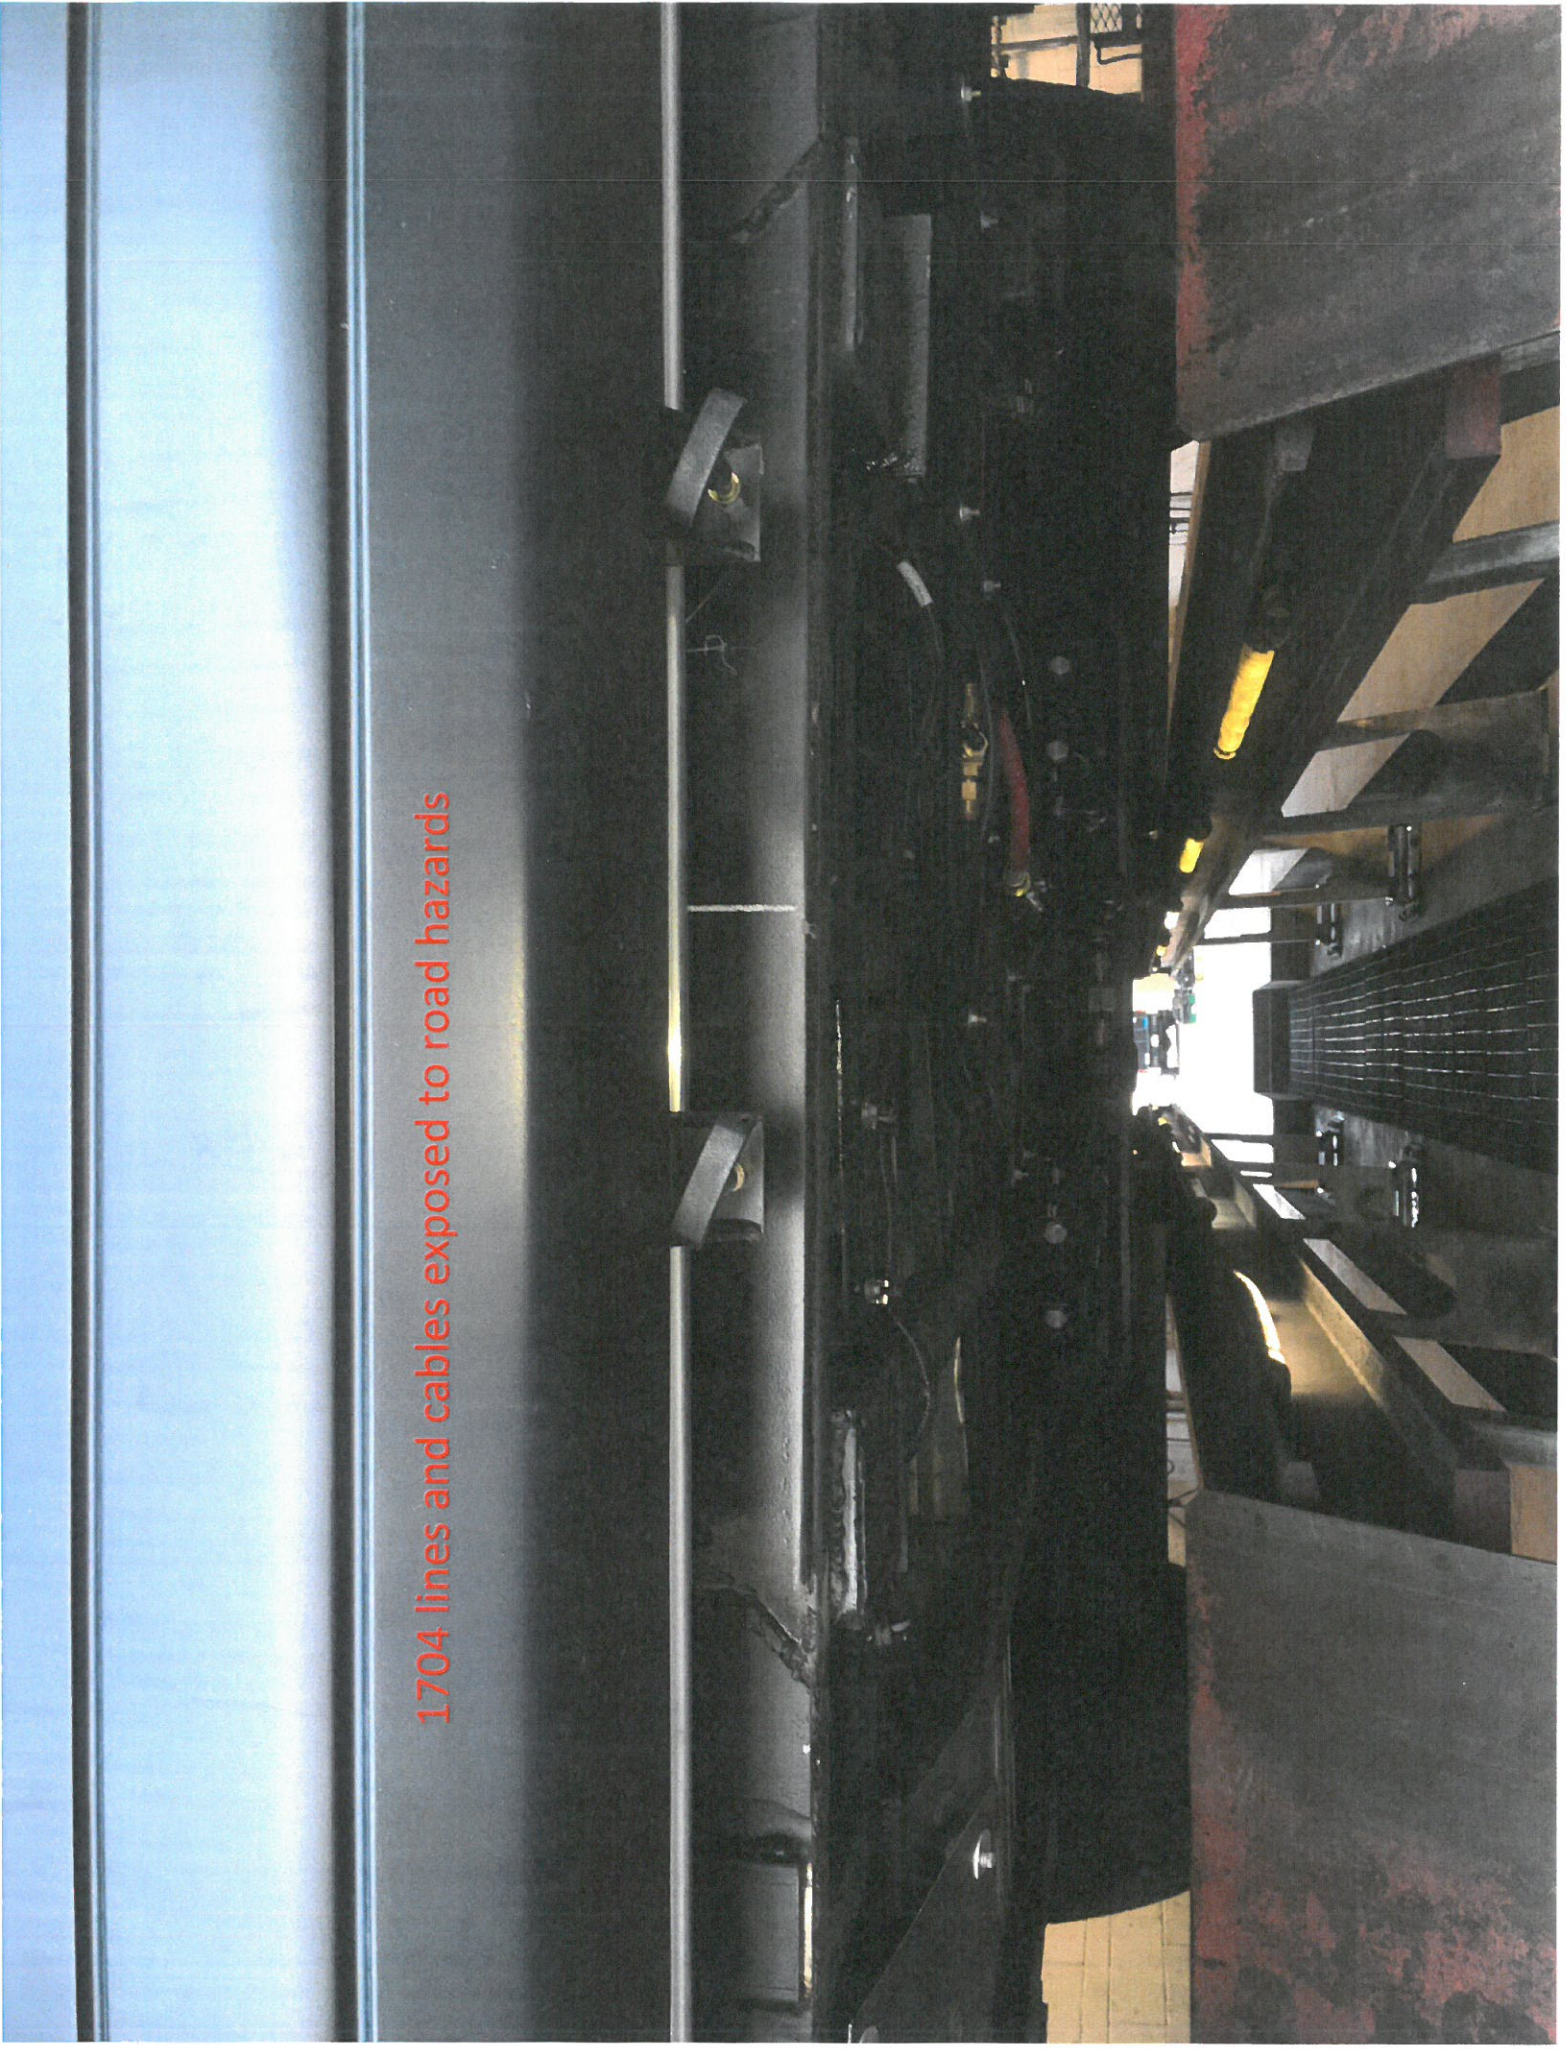
1704 jack point has questionable integrity
