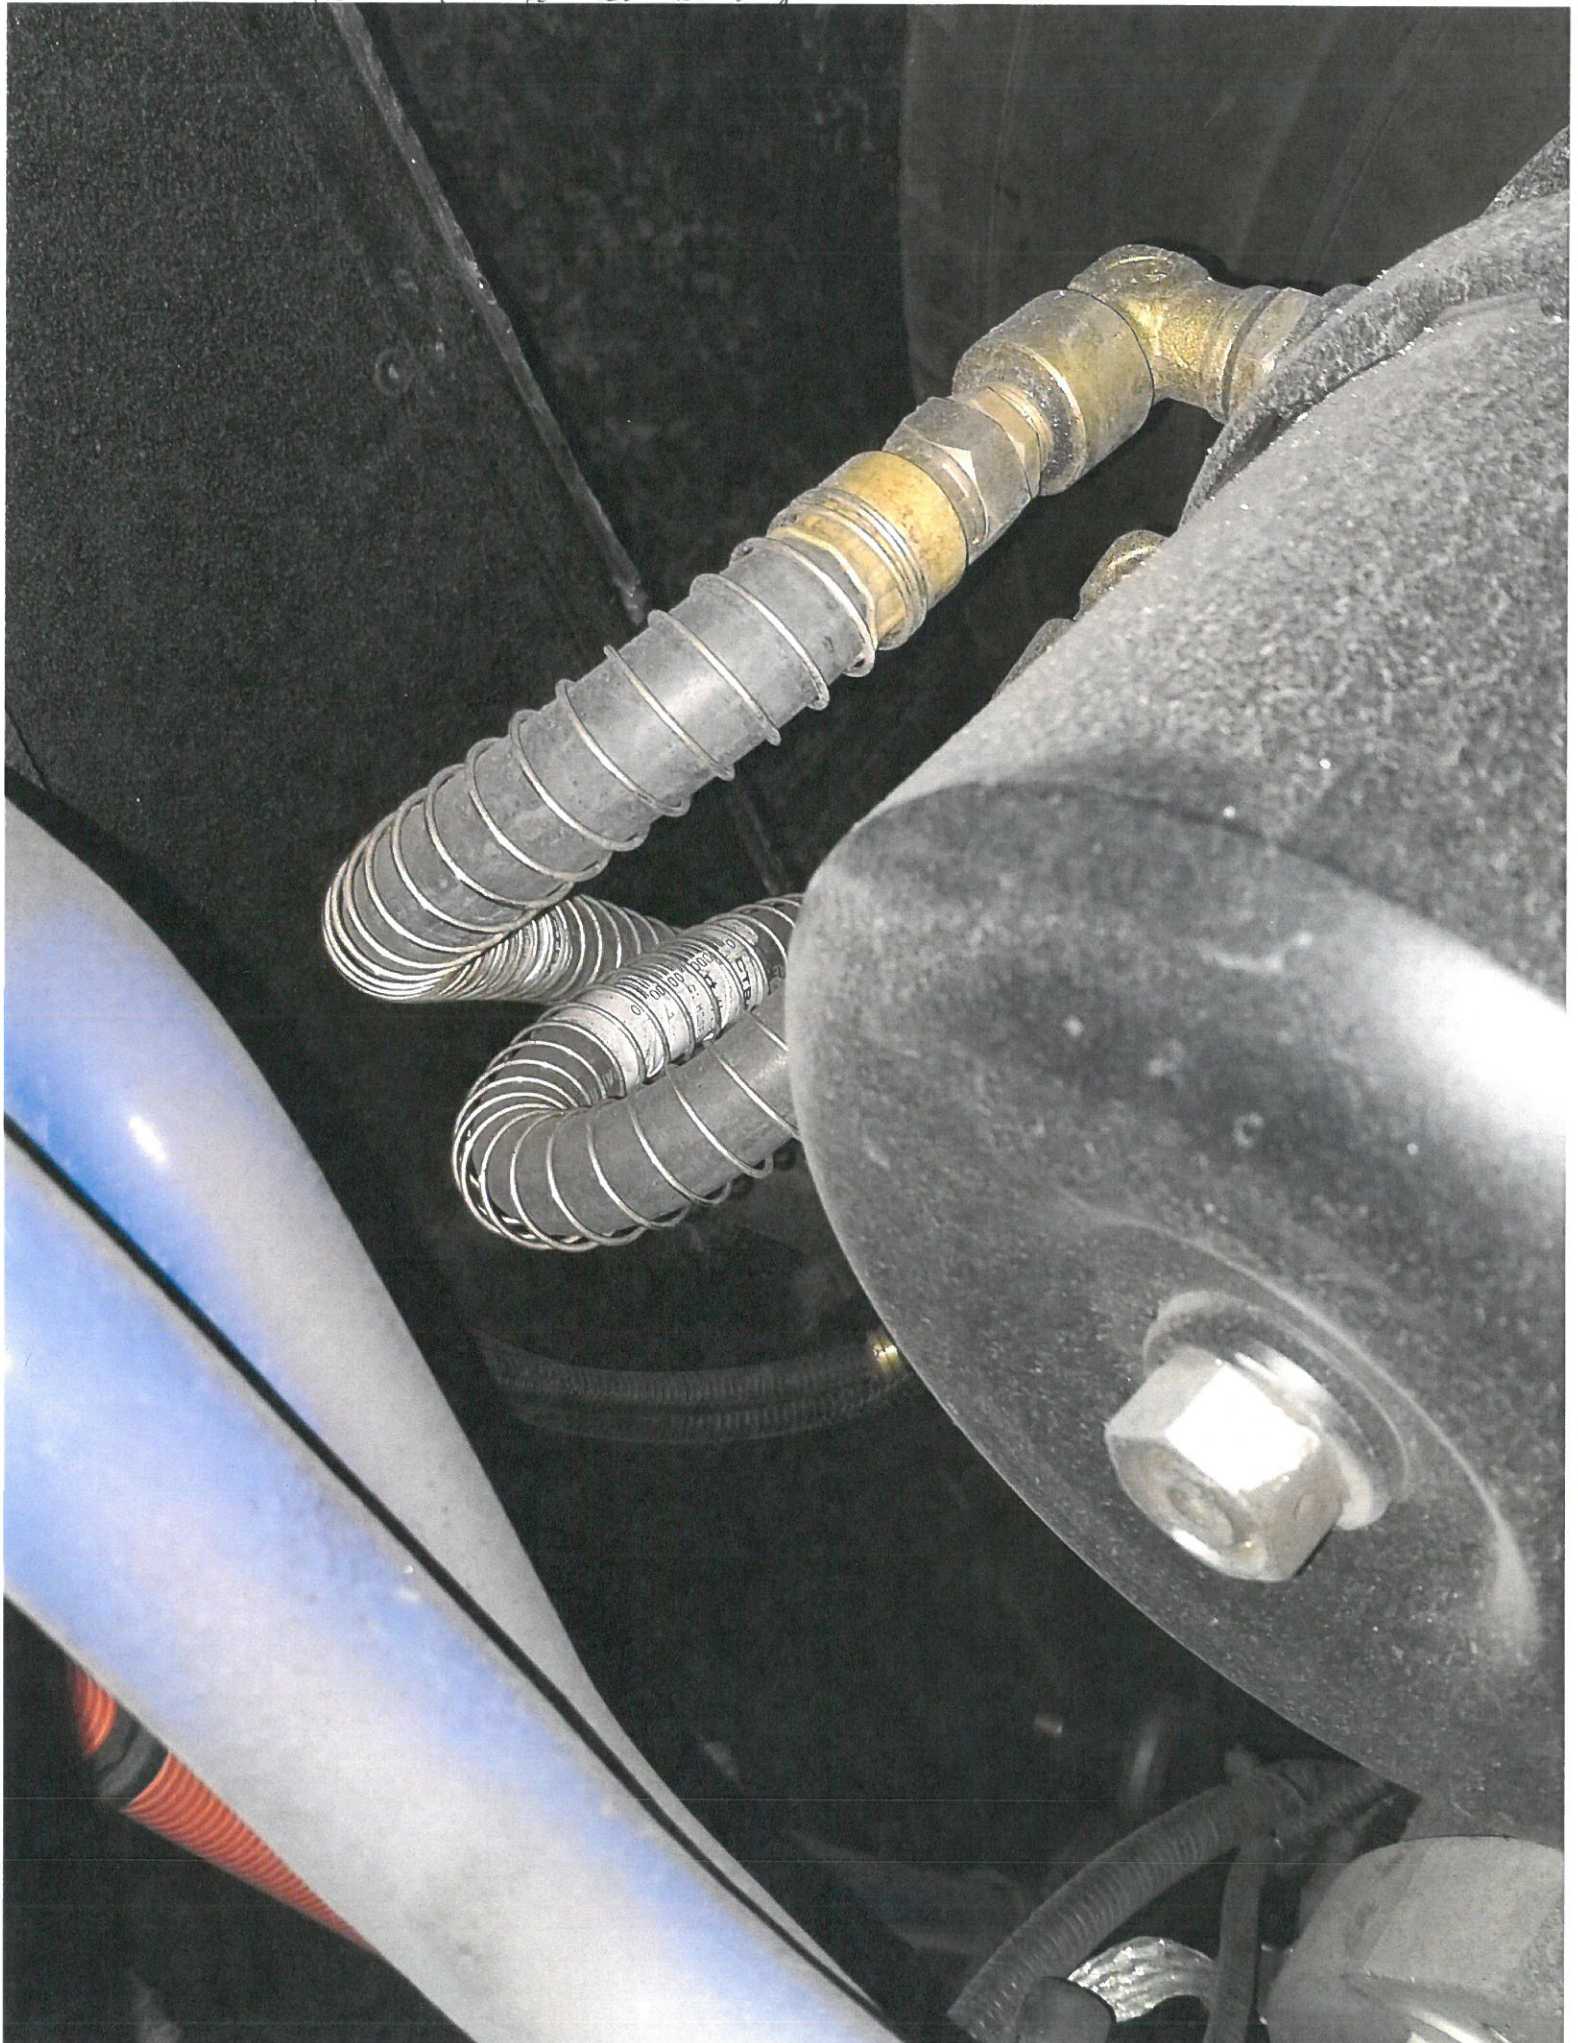
1706 C/S Rreq Brake lines Rubbing

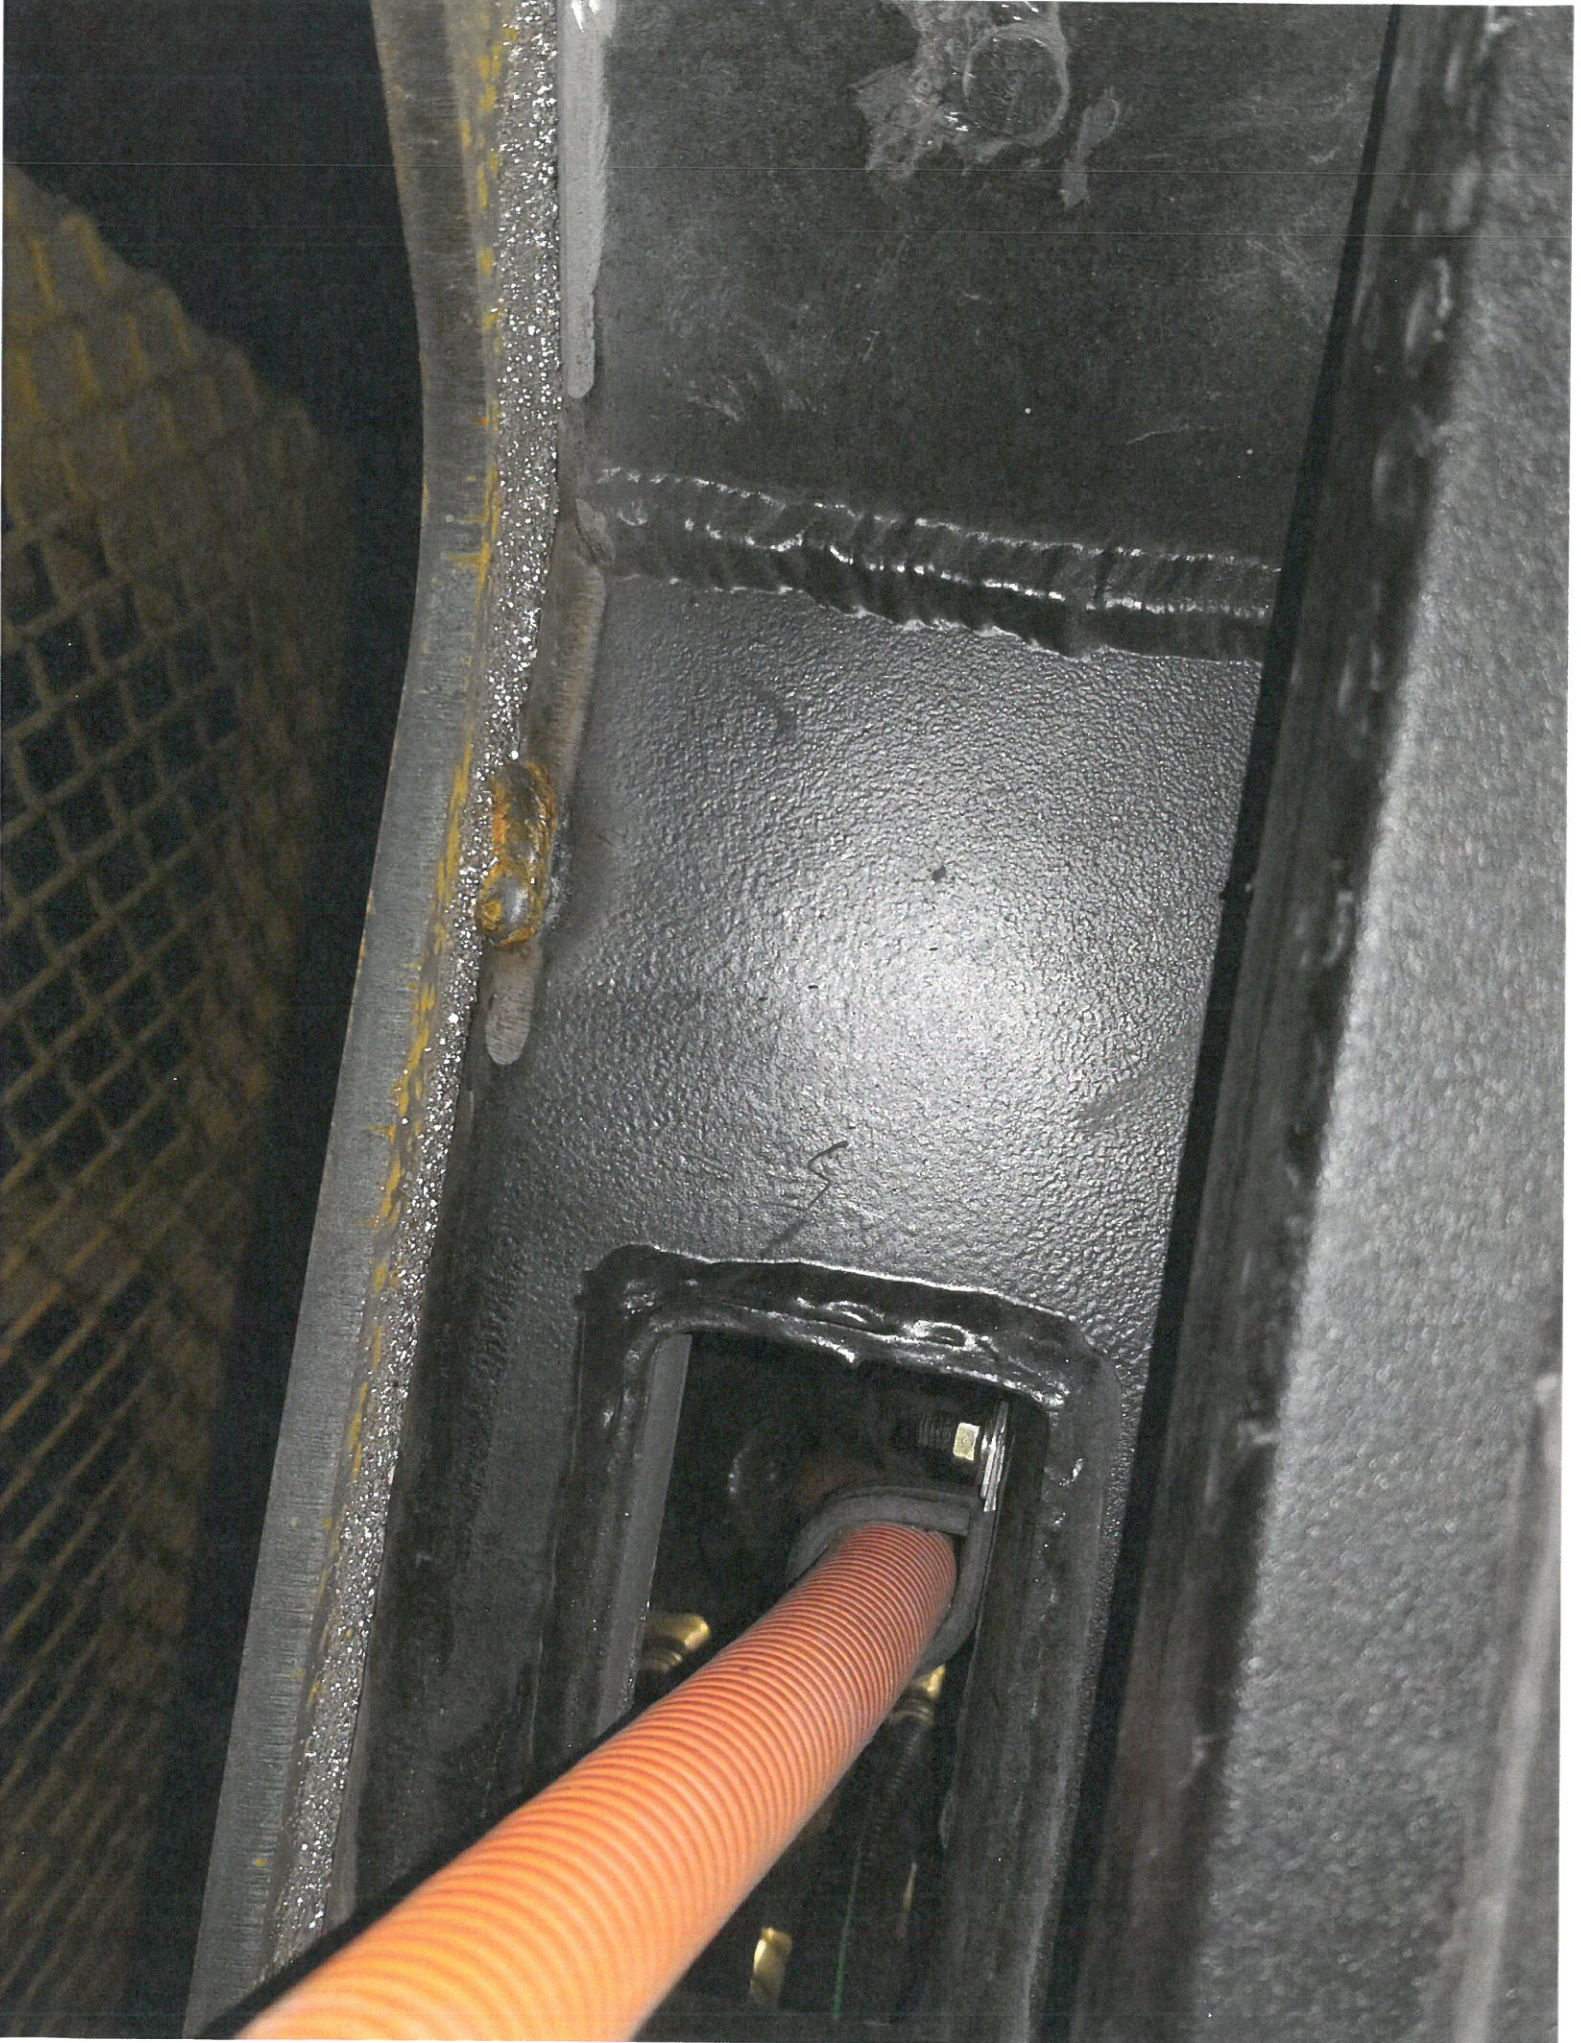
1706 rust on rear frame crossbar

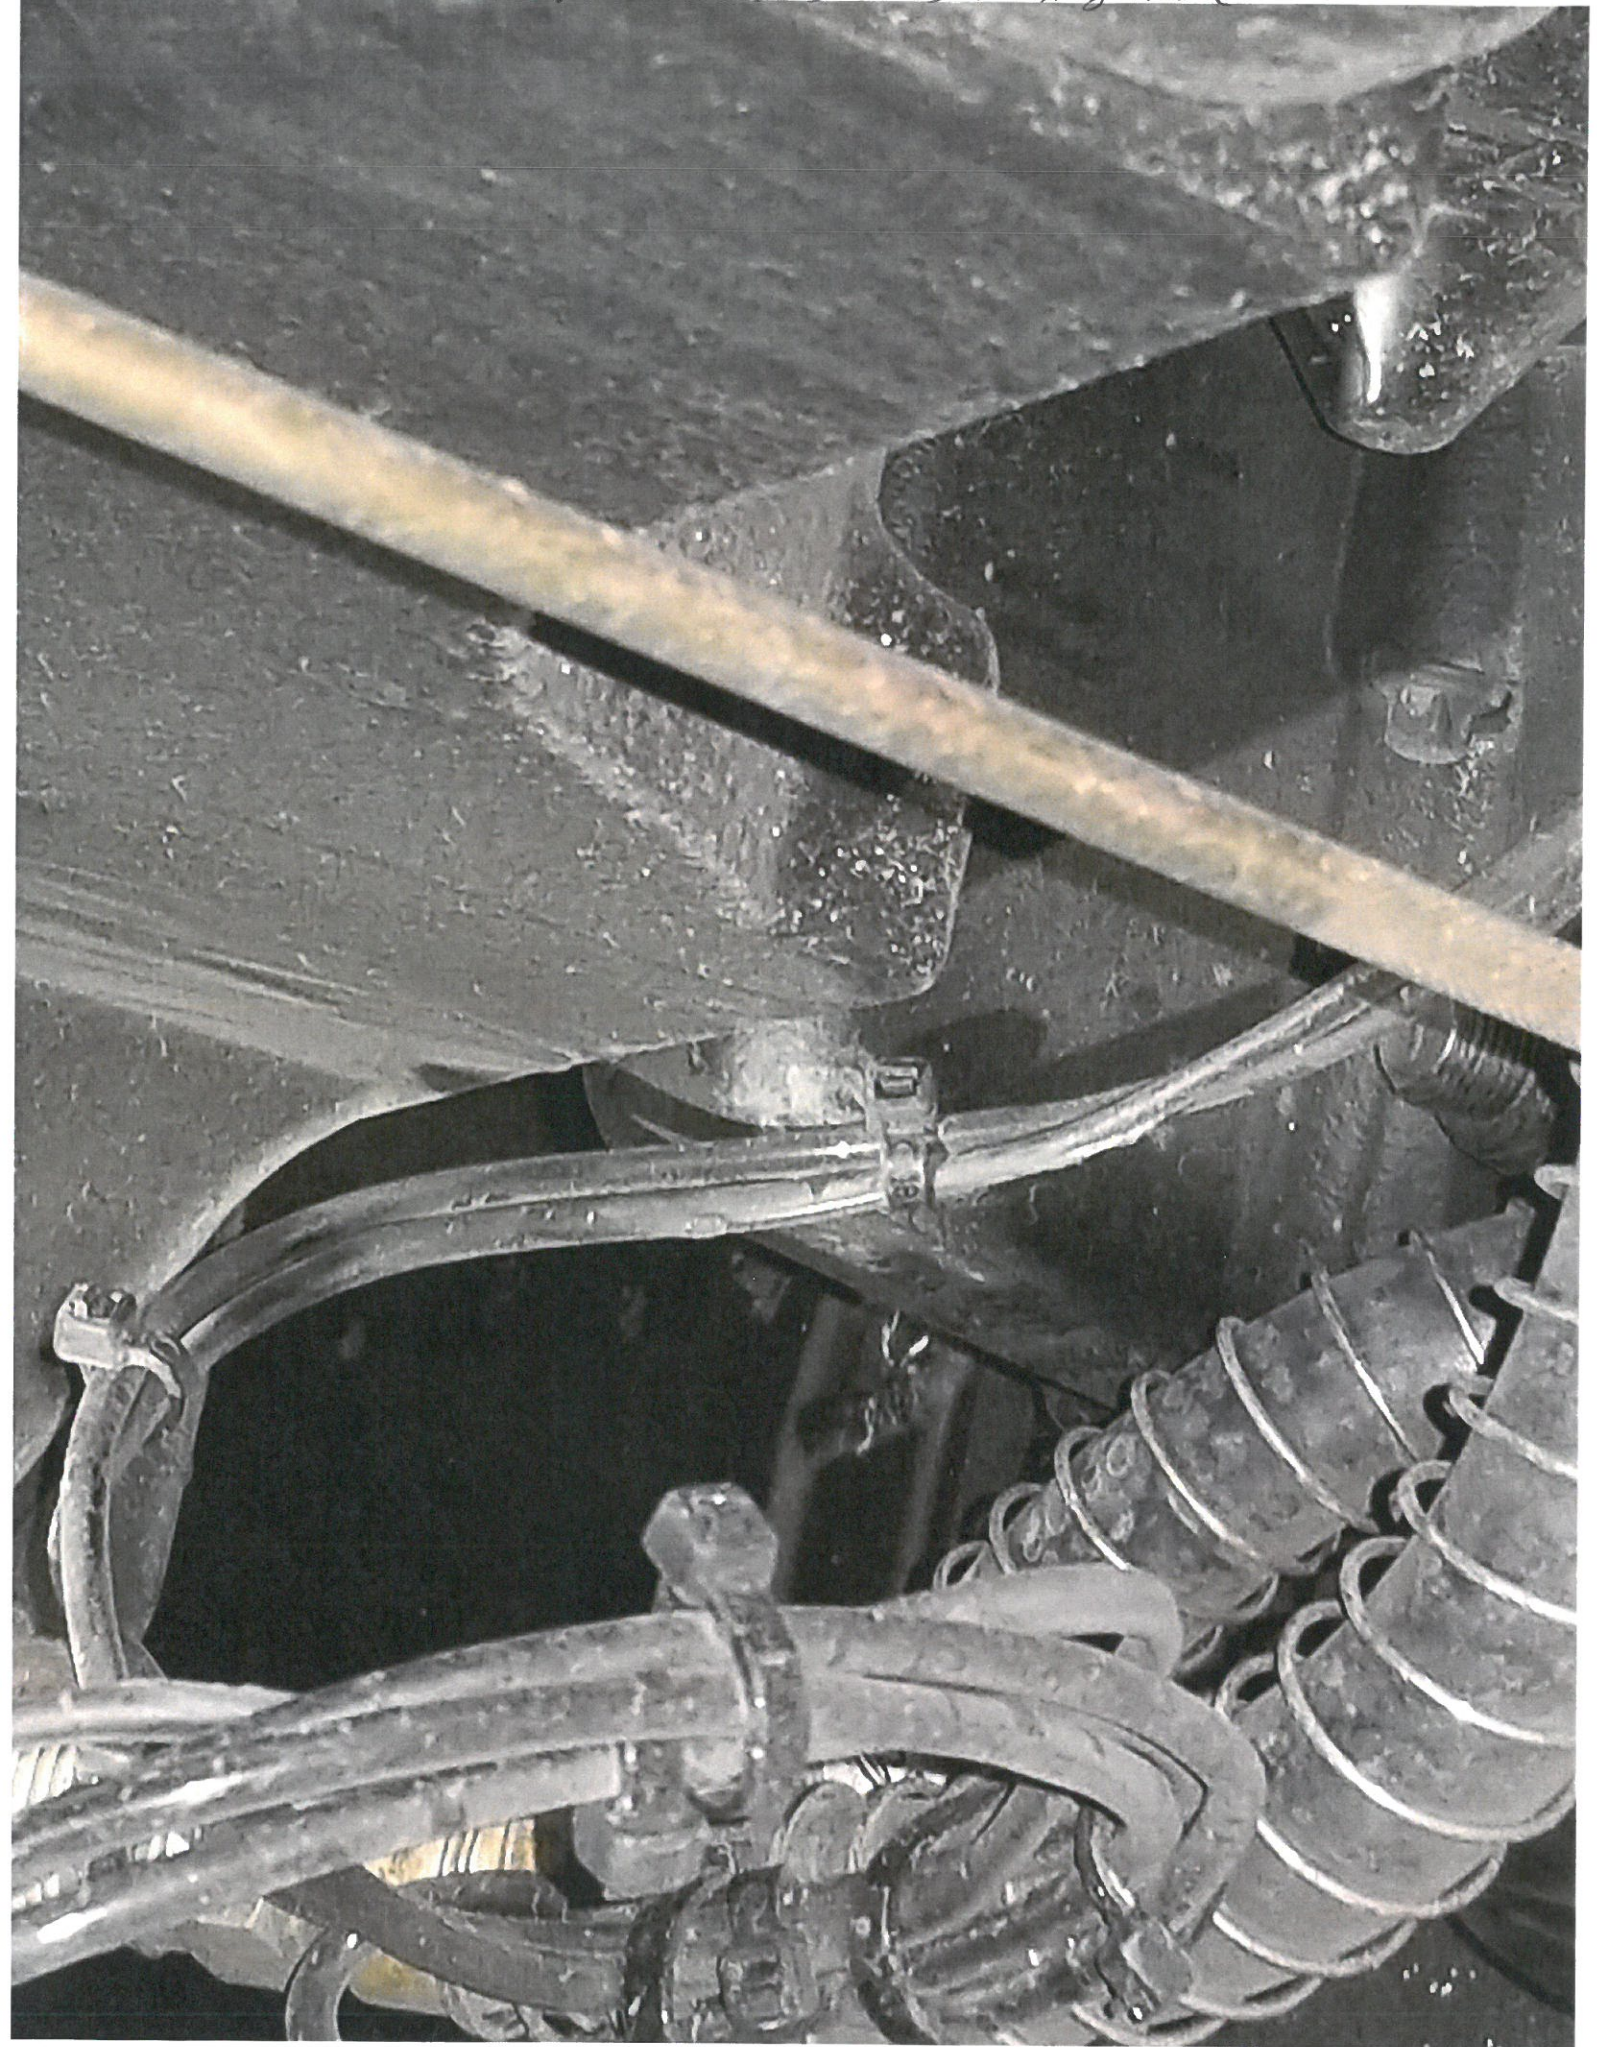
1706- S/S center wheel speed sensor/ABS lines rubbing frame

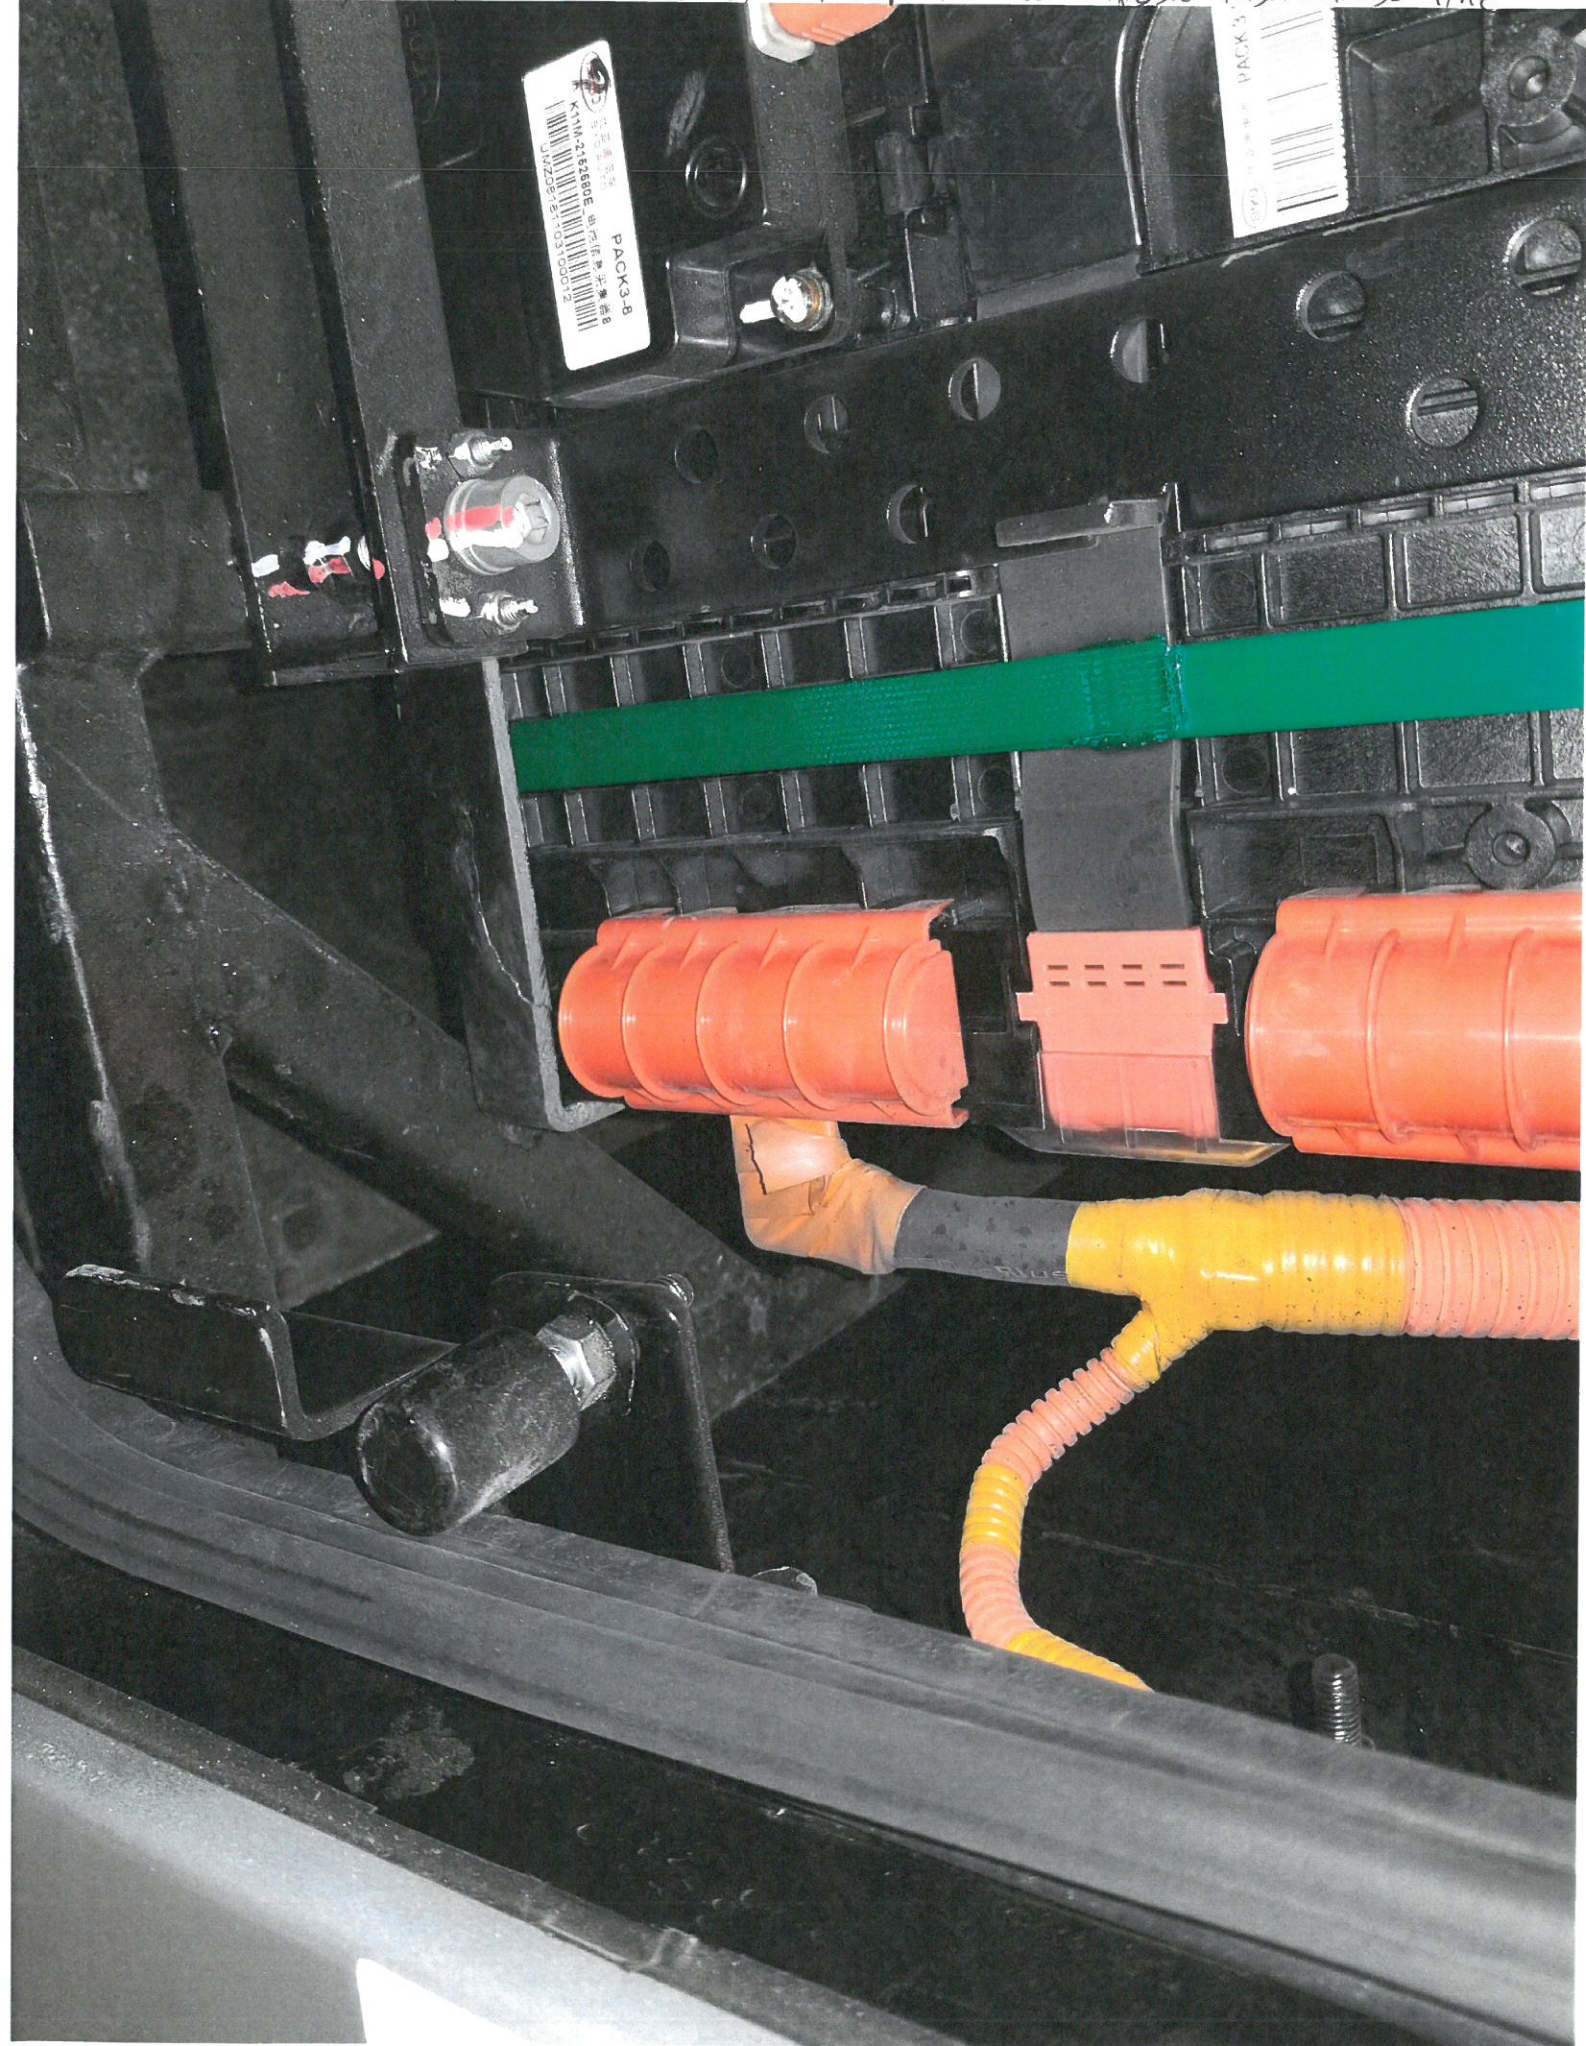
1706 - SLS Battery Box Middle Use Electrical Tape to Cover Exposed High Voltage Line

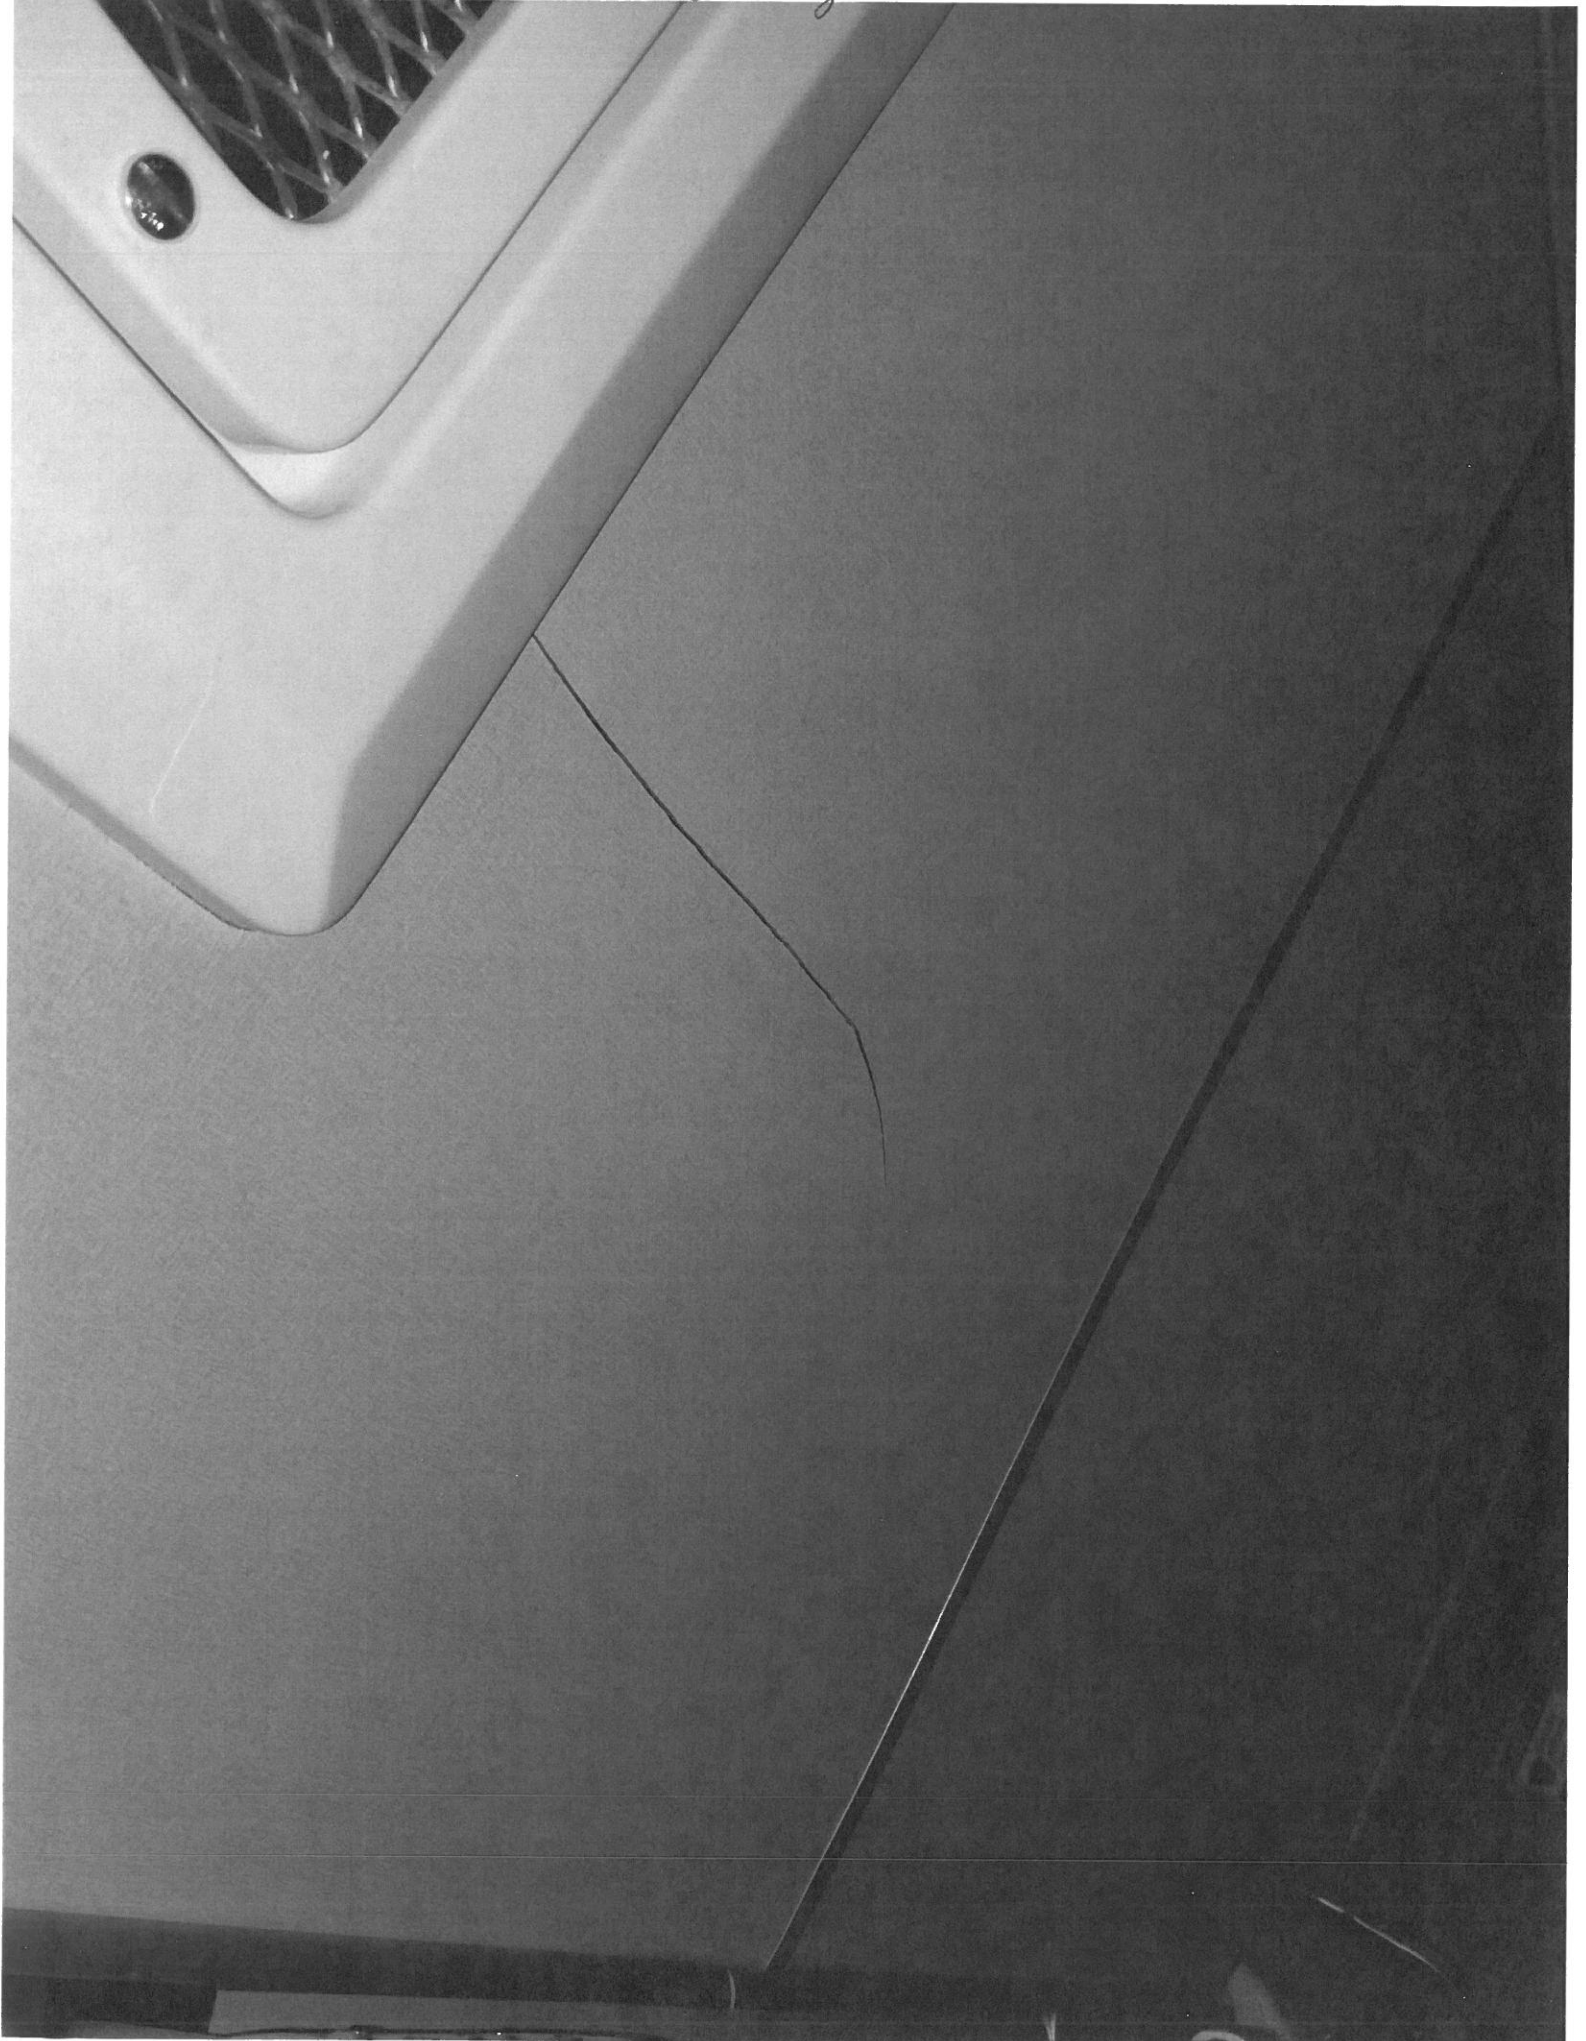
1706 - rear by Euro Filter Roof cracking

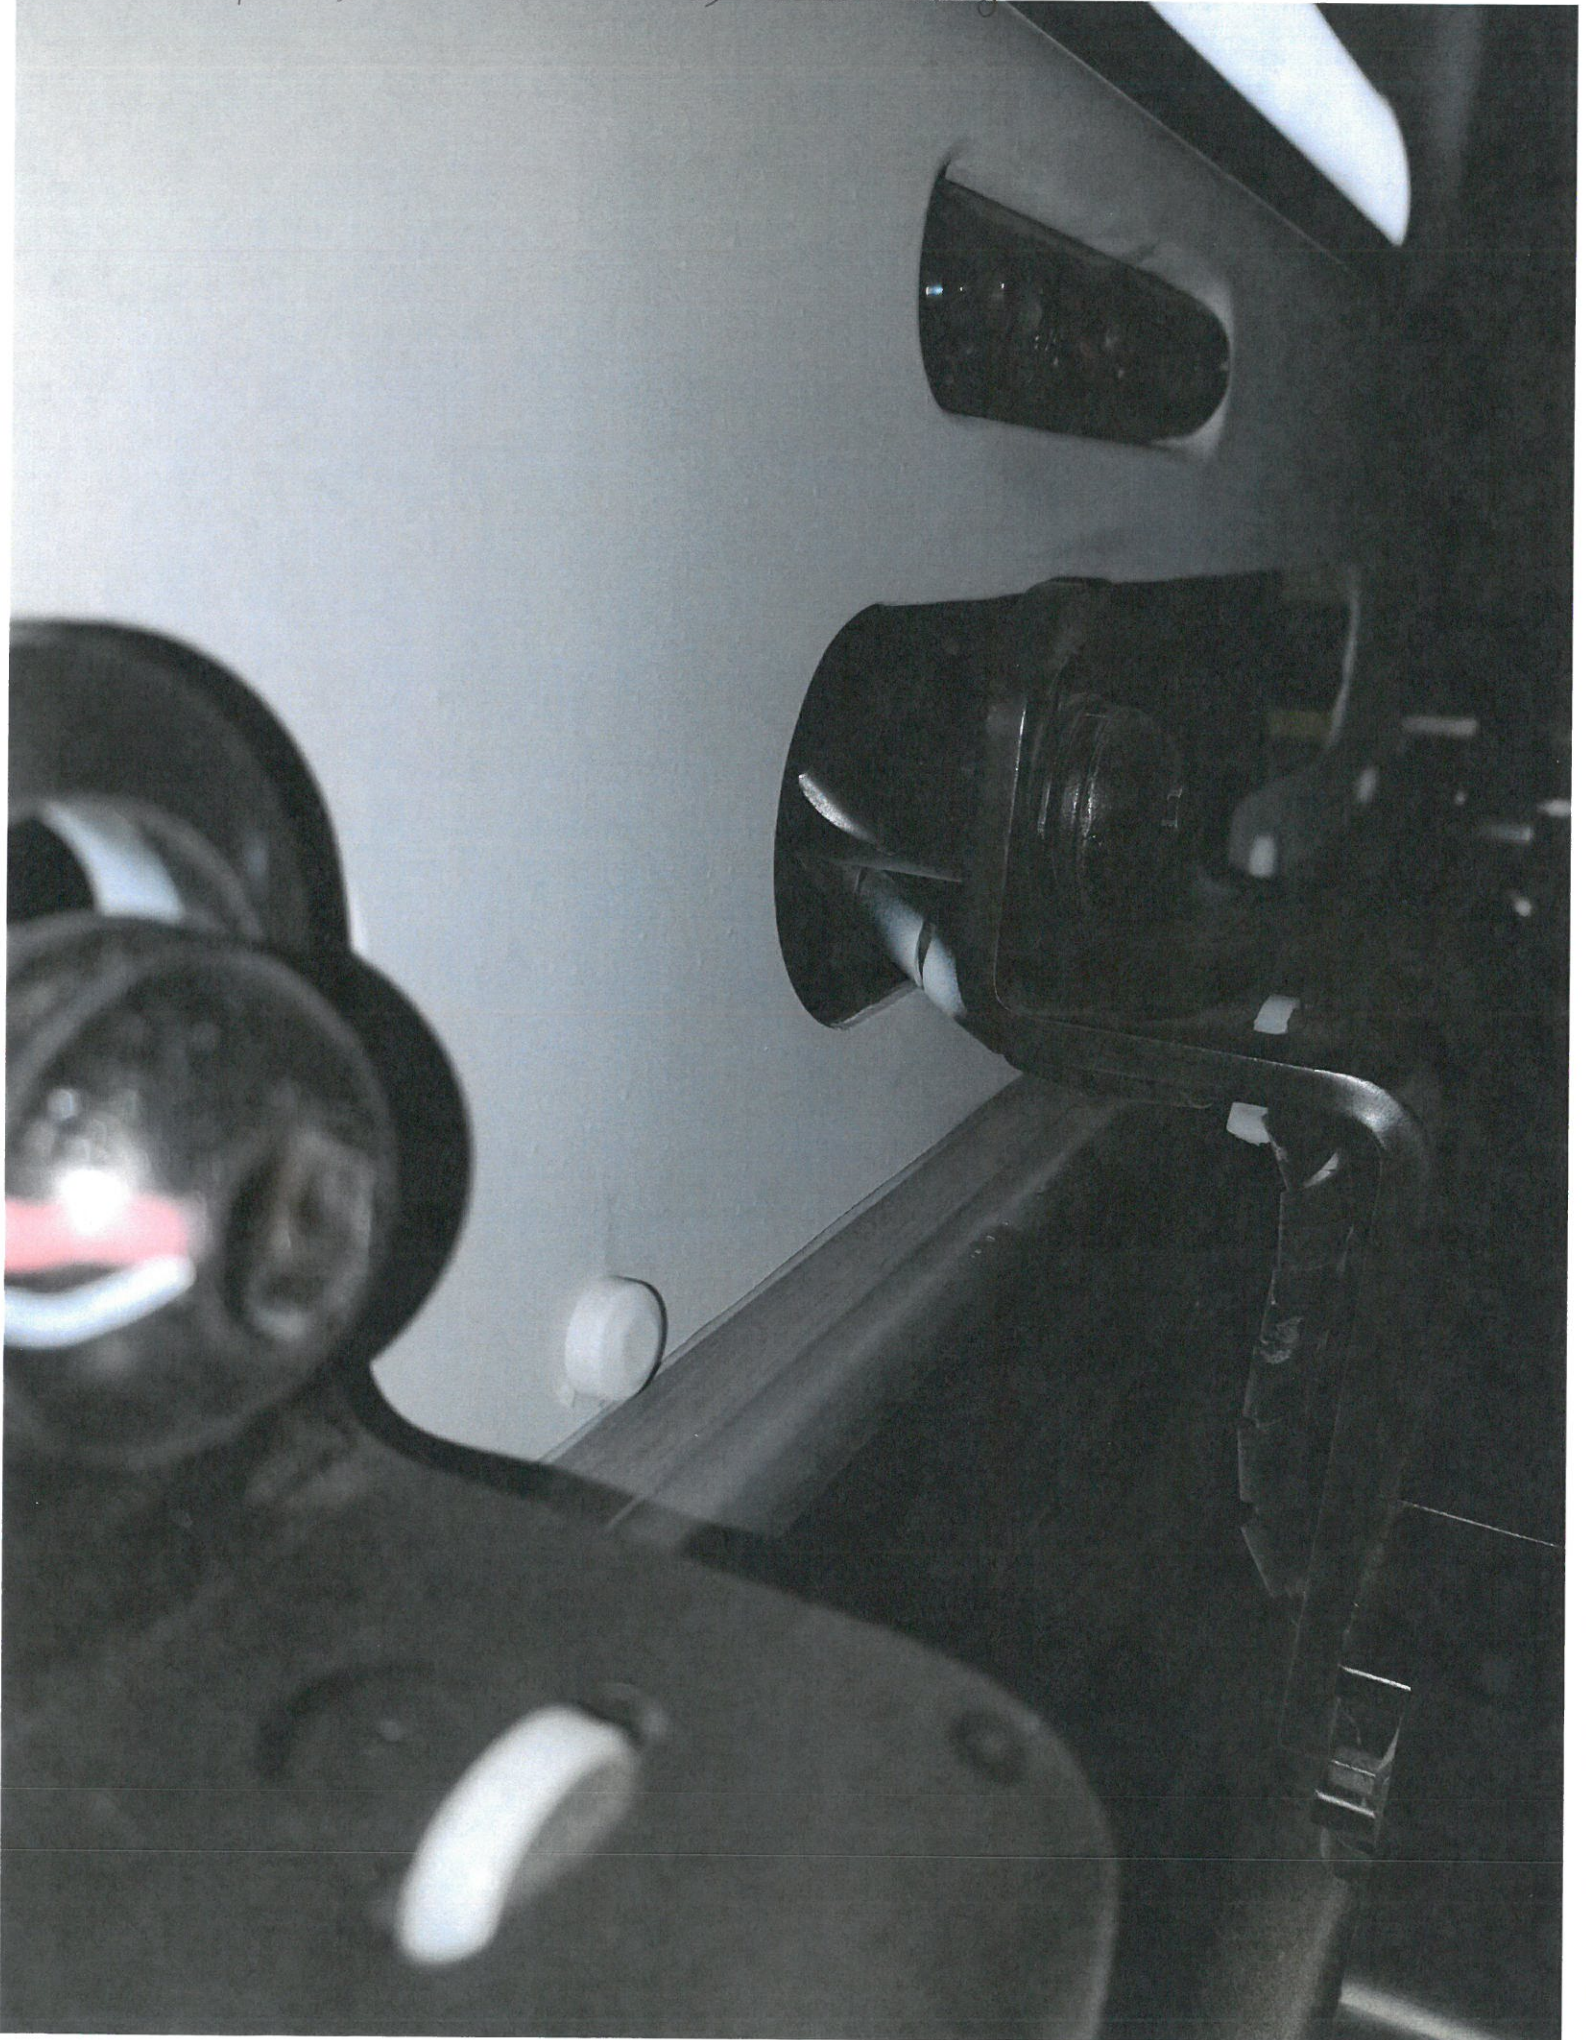
1706 - all passenger door sensitive Edge lines rubbing

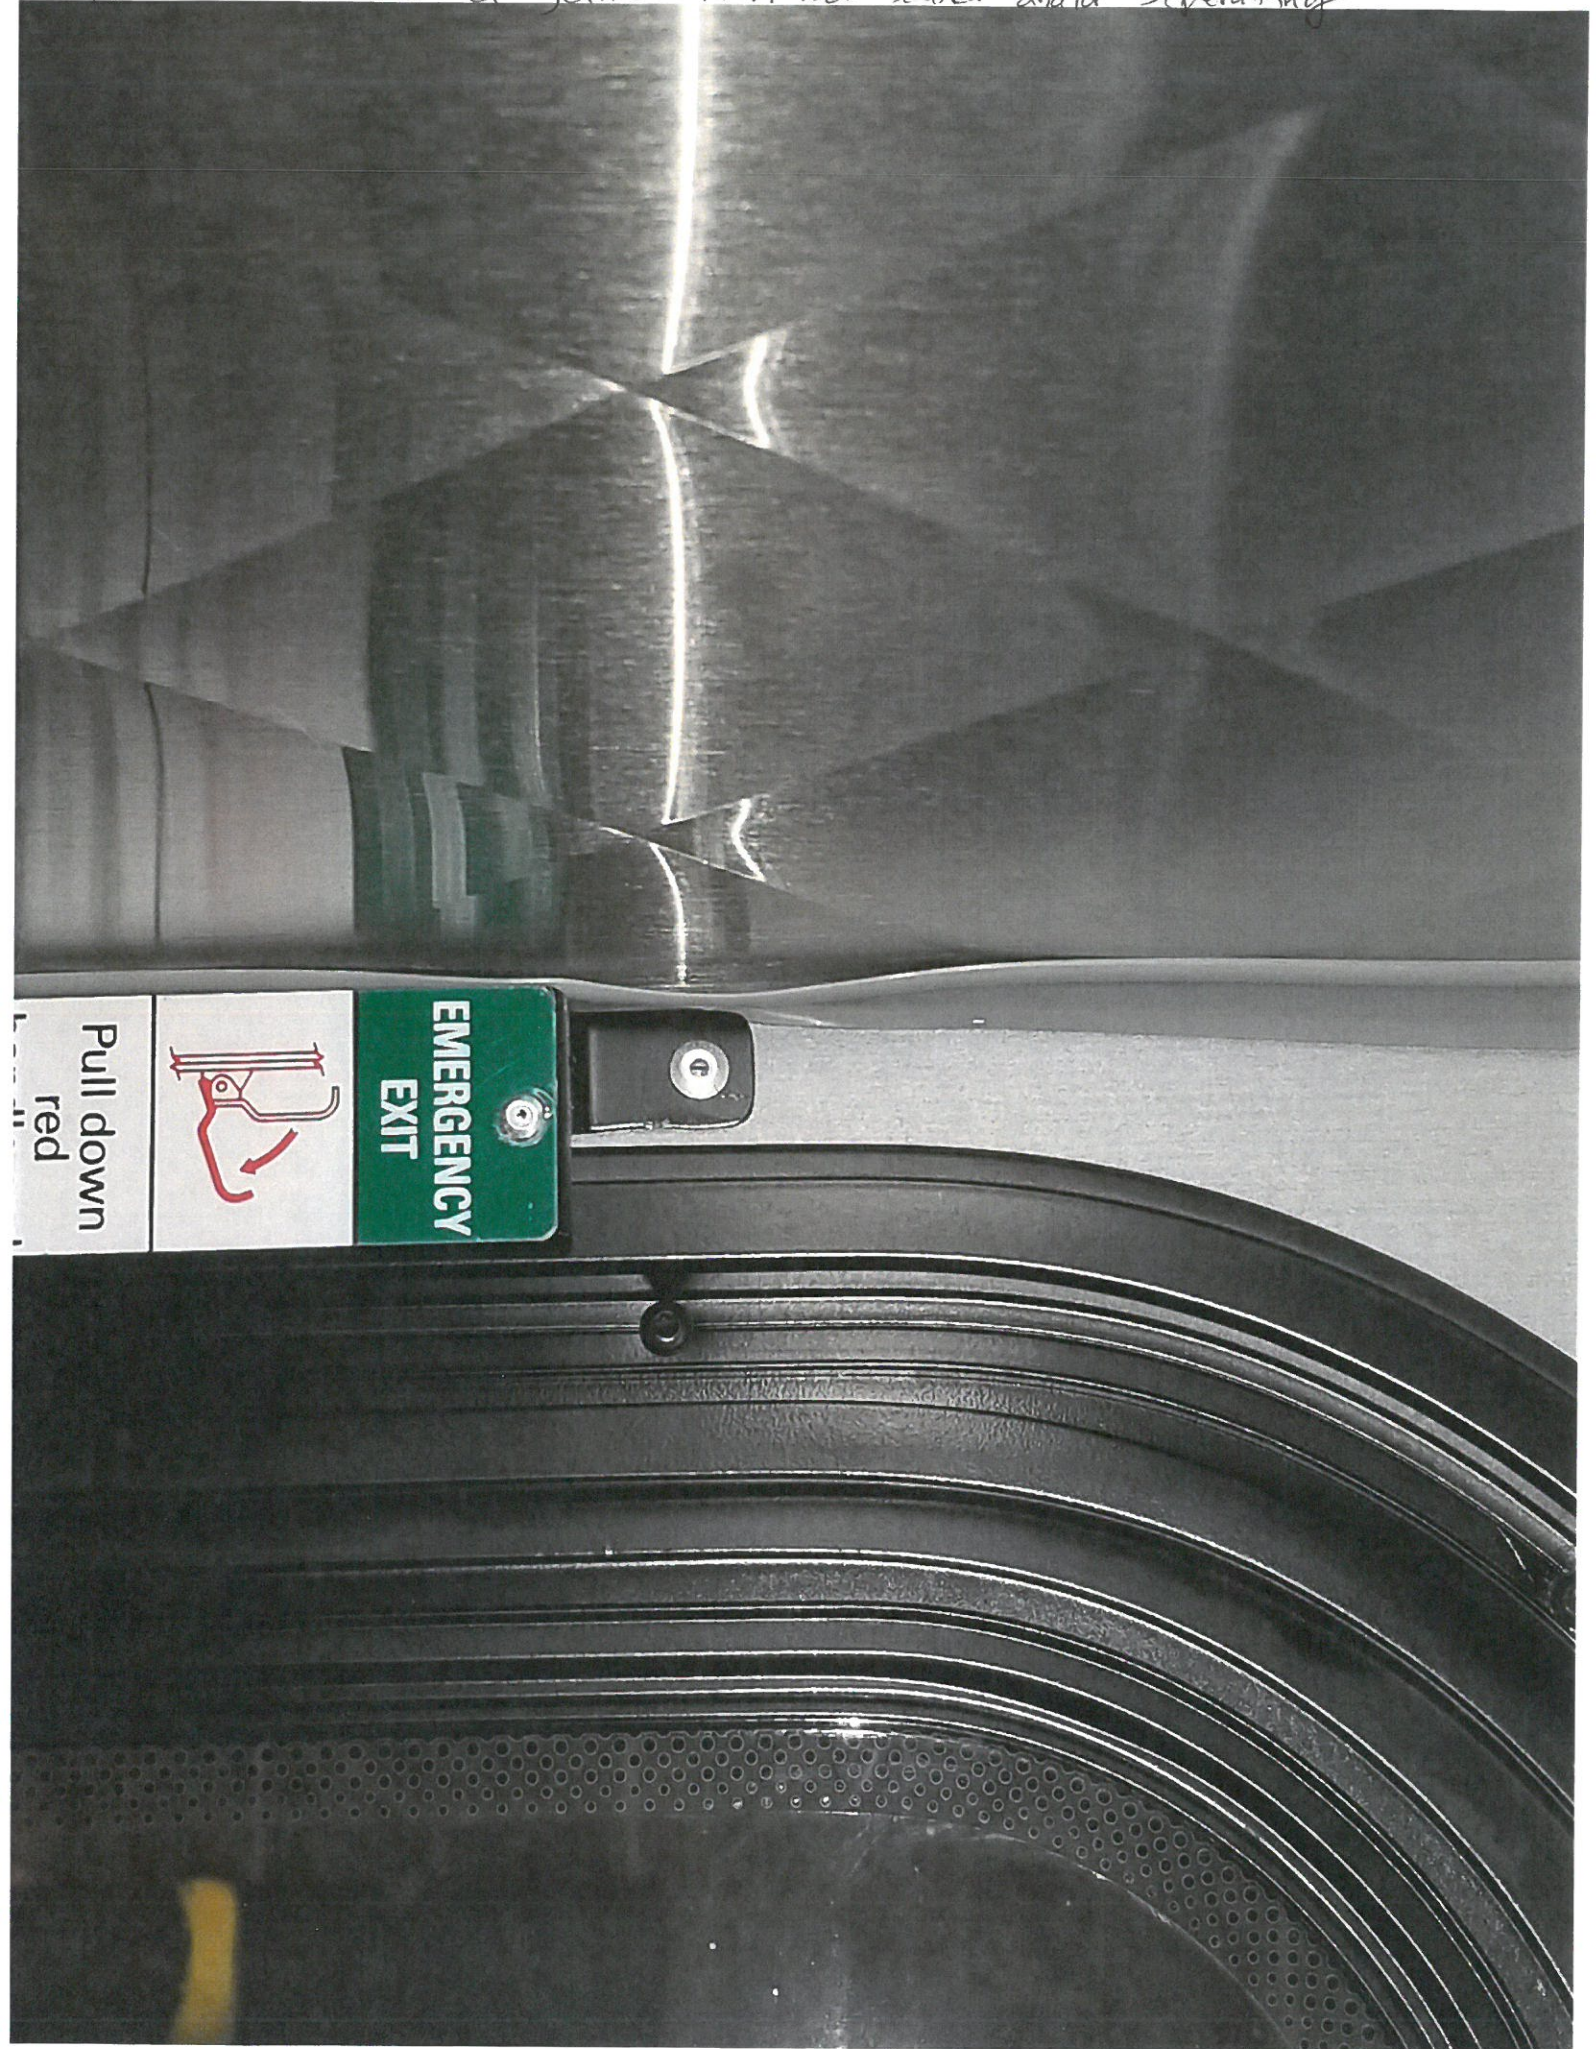
1706 S/S in front of joint Trim not sealed and/or separating
