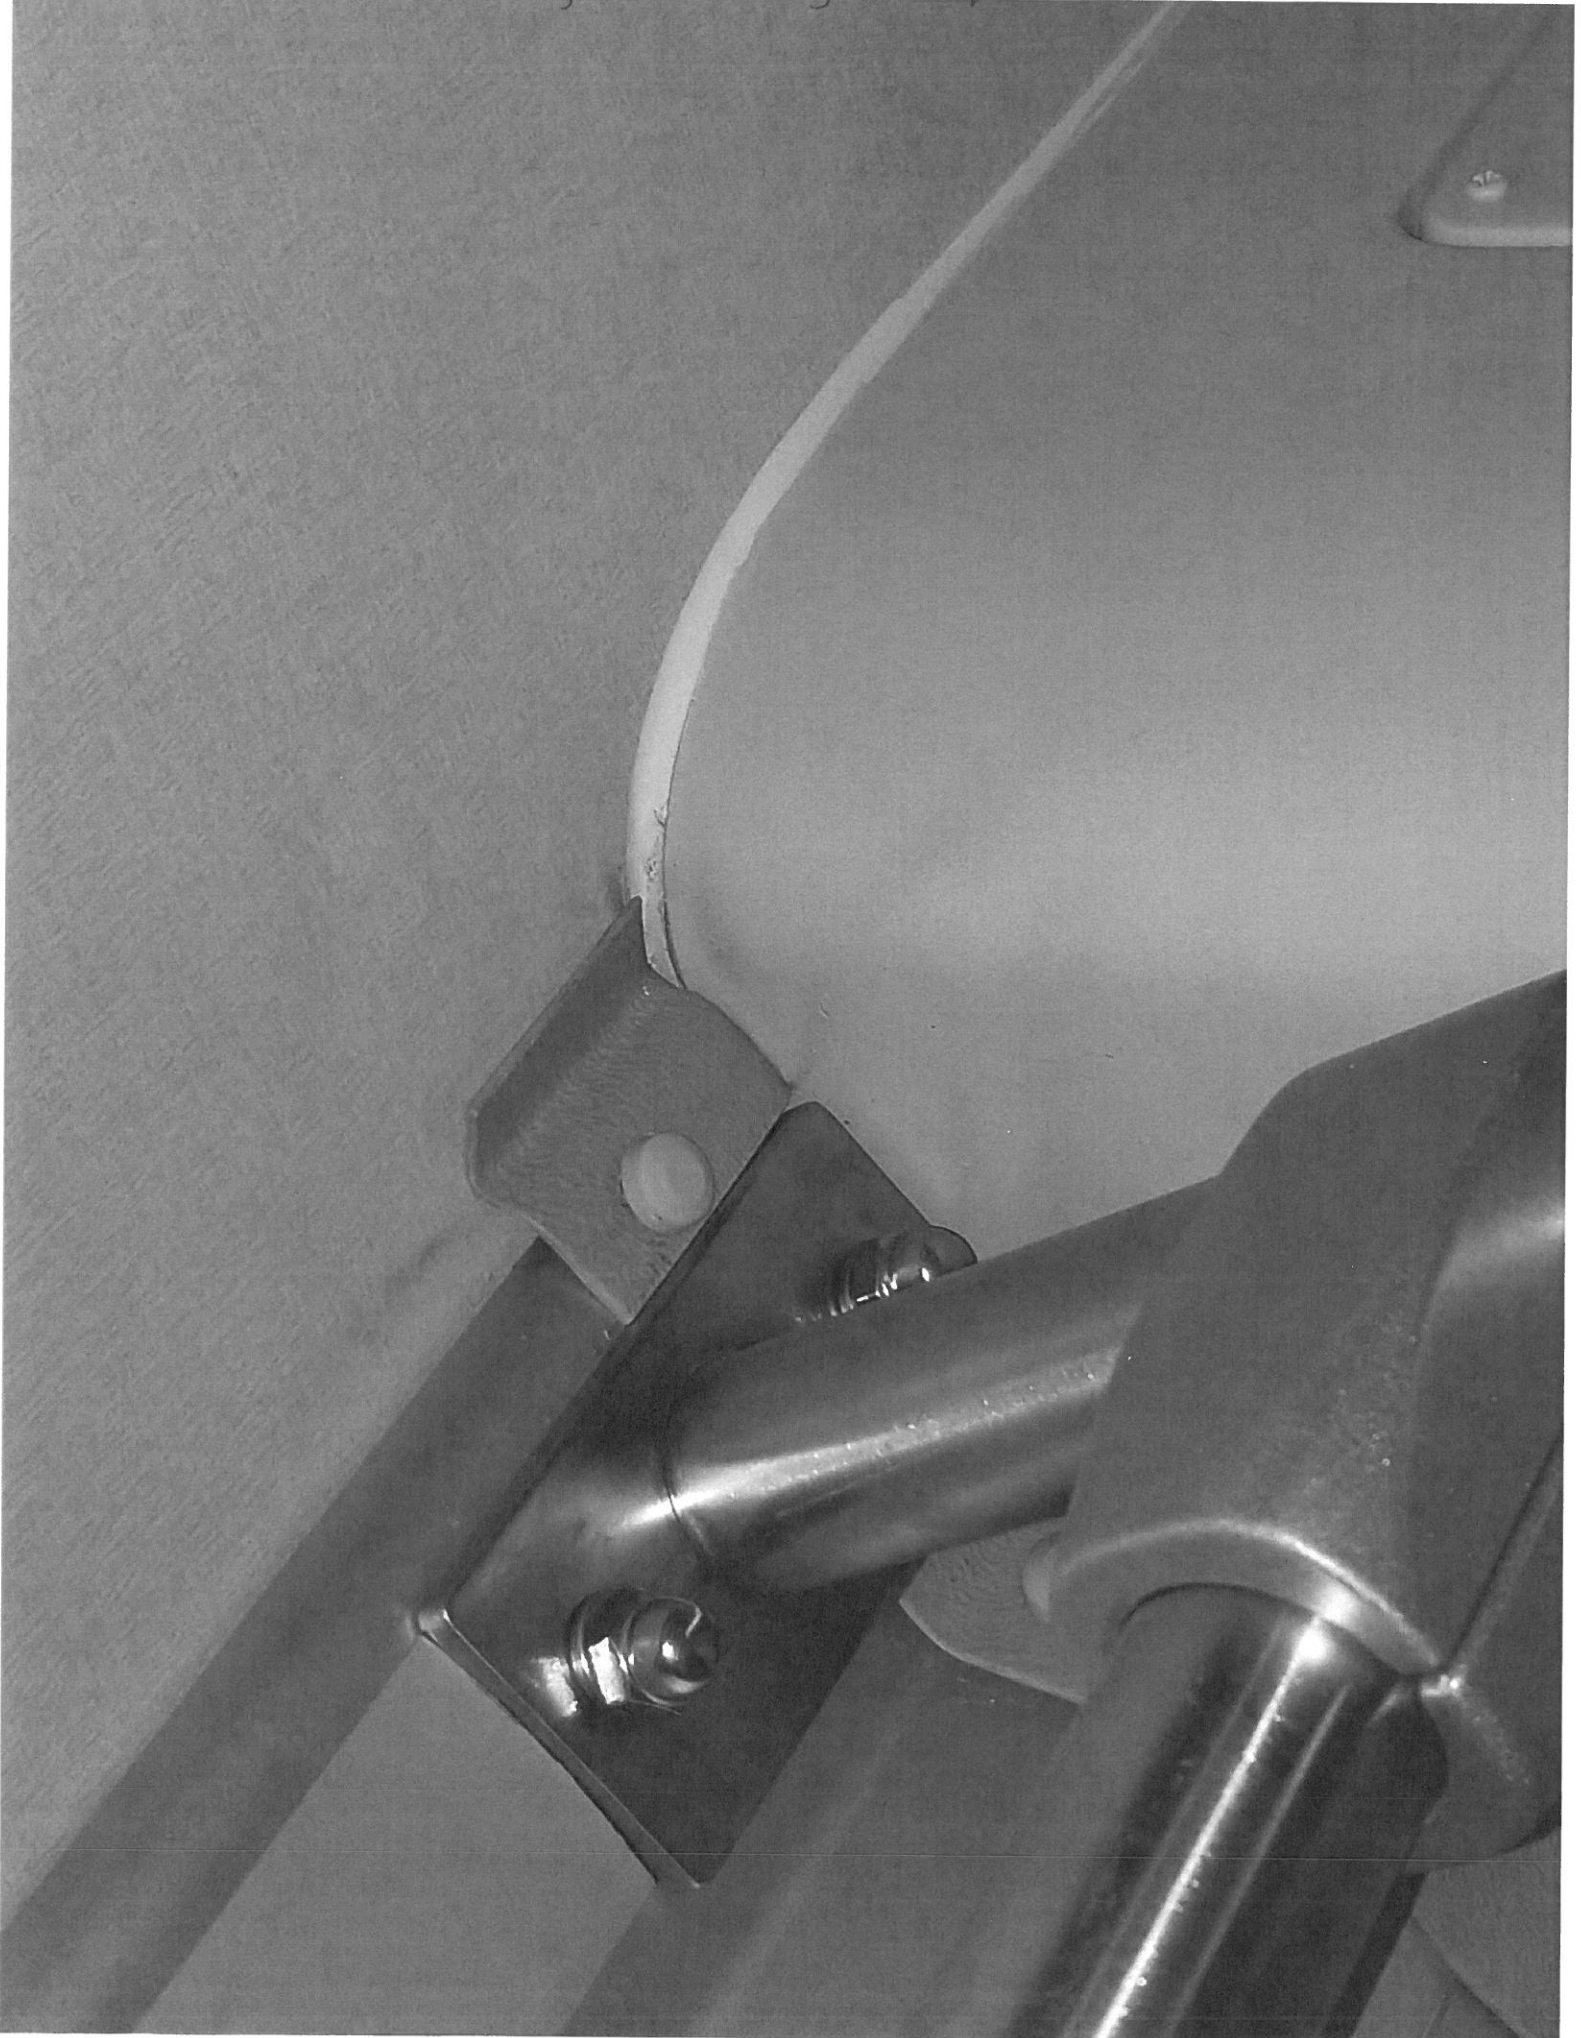
1706 S/S in front of joint starting to separate

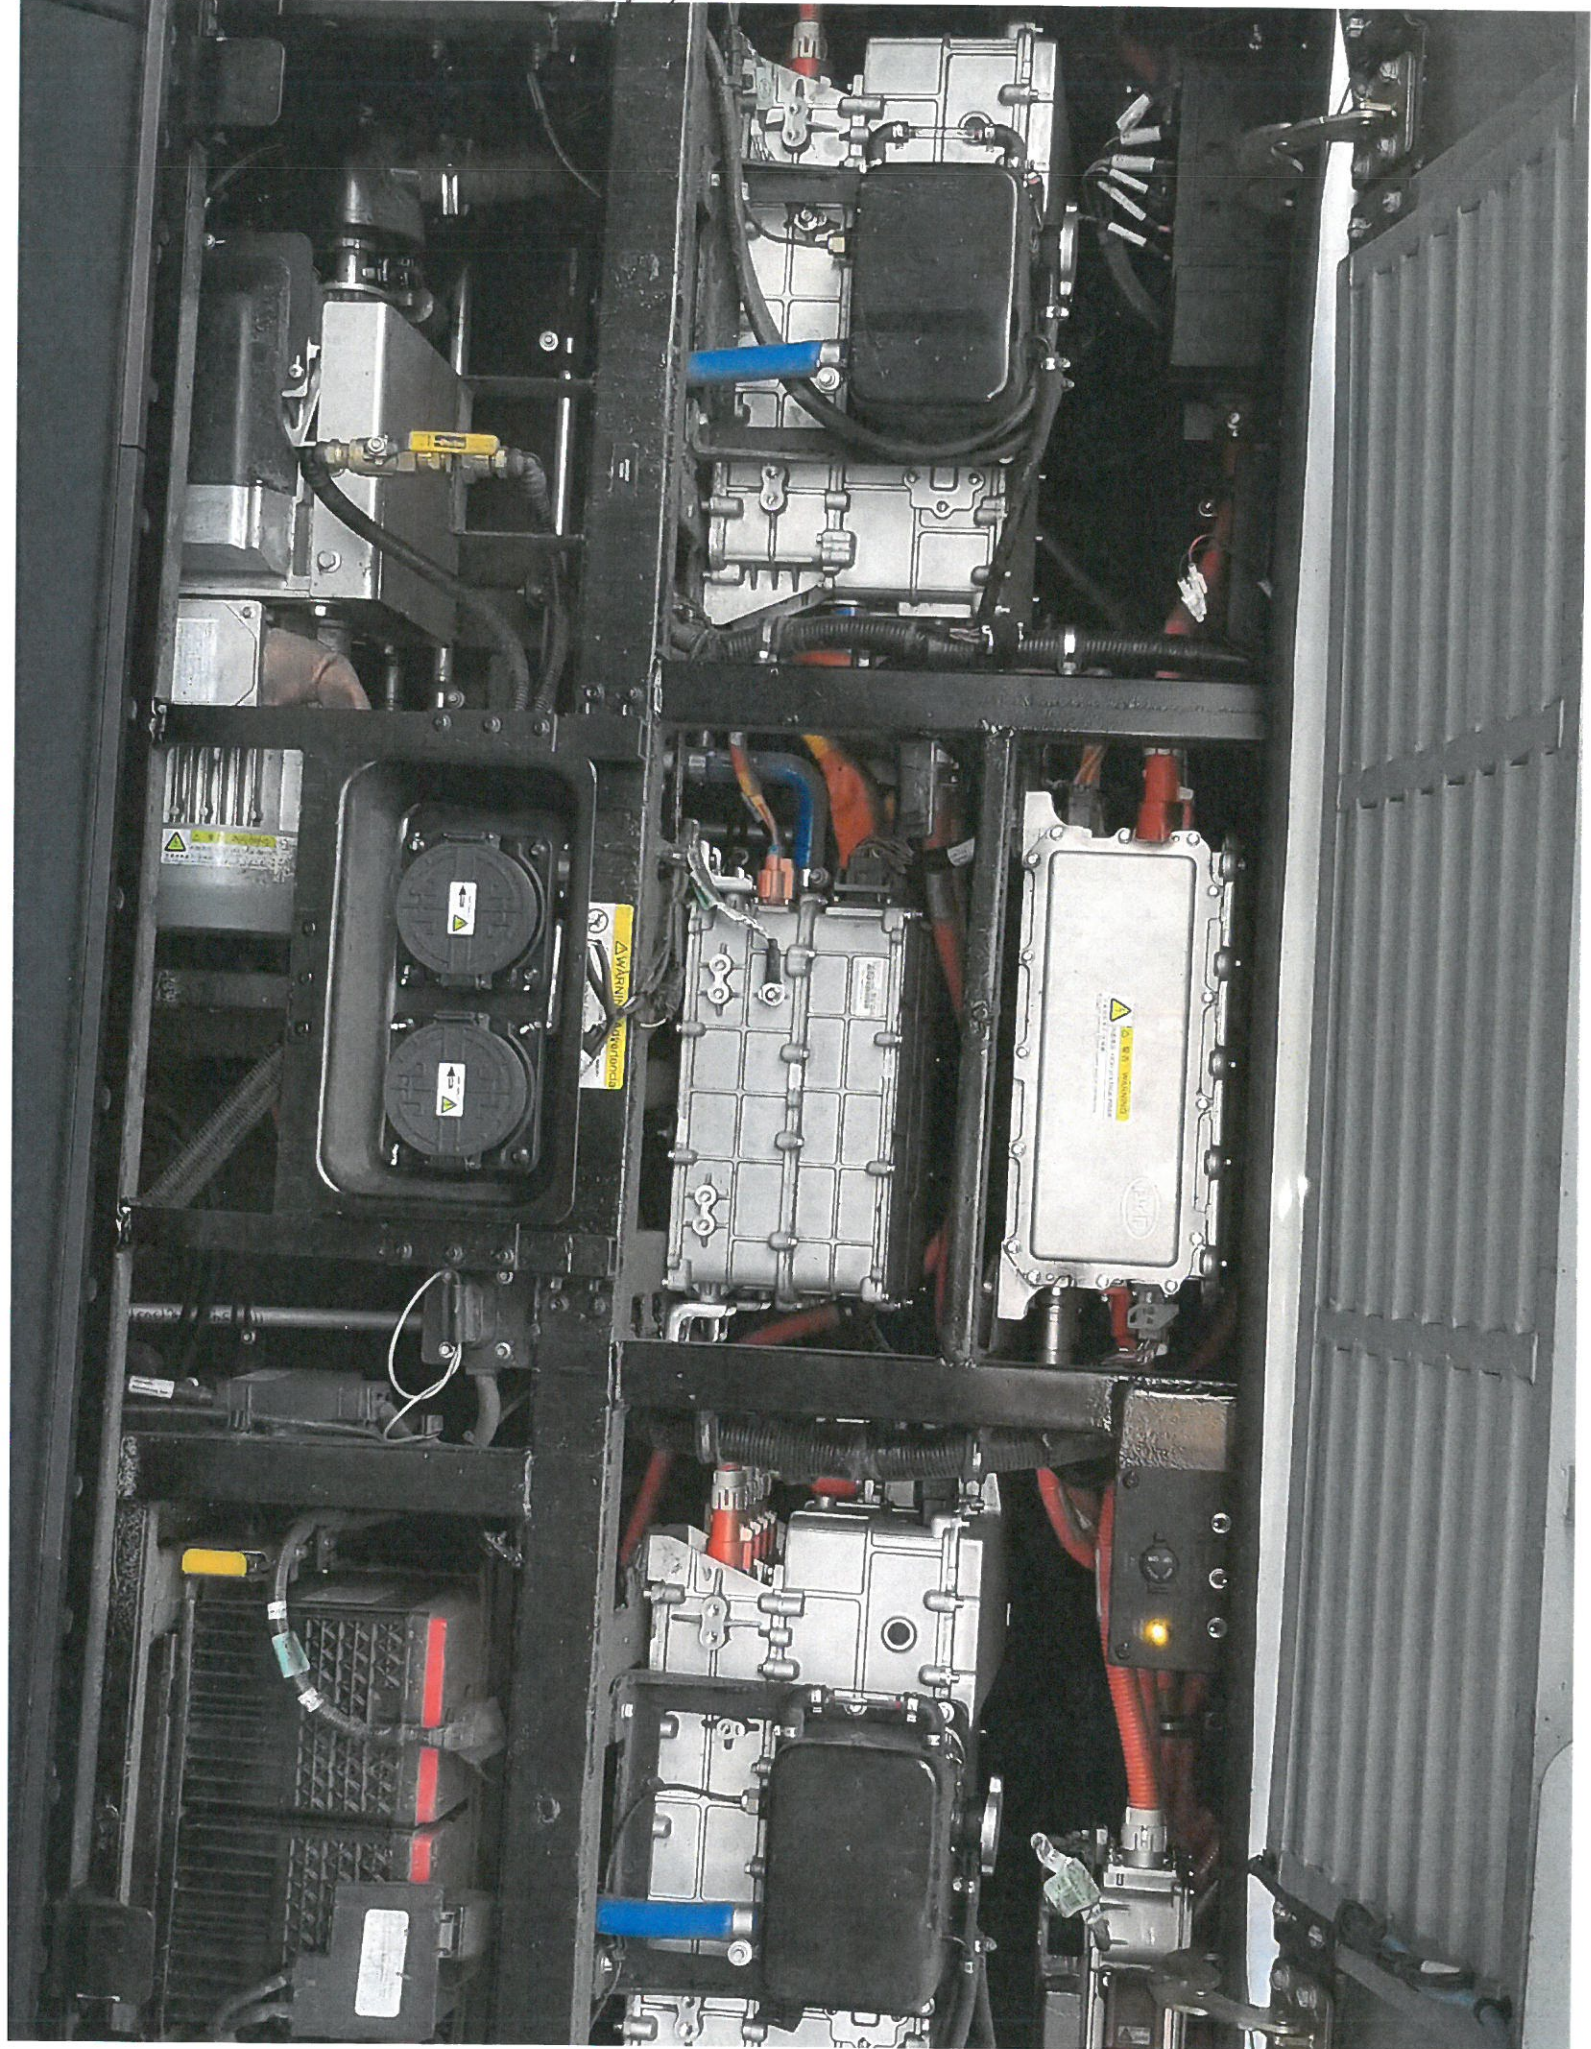
1706 - Coolant reservoirs Empty

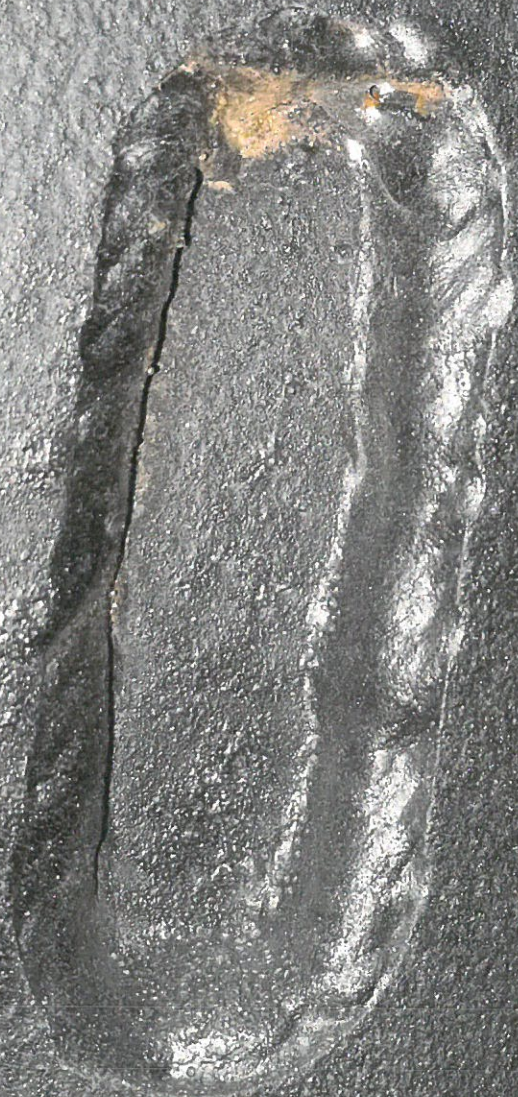
1706 - center cross over plate rusting

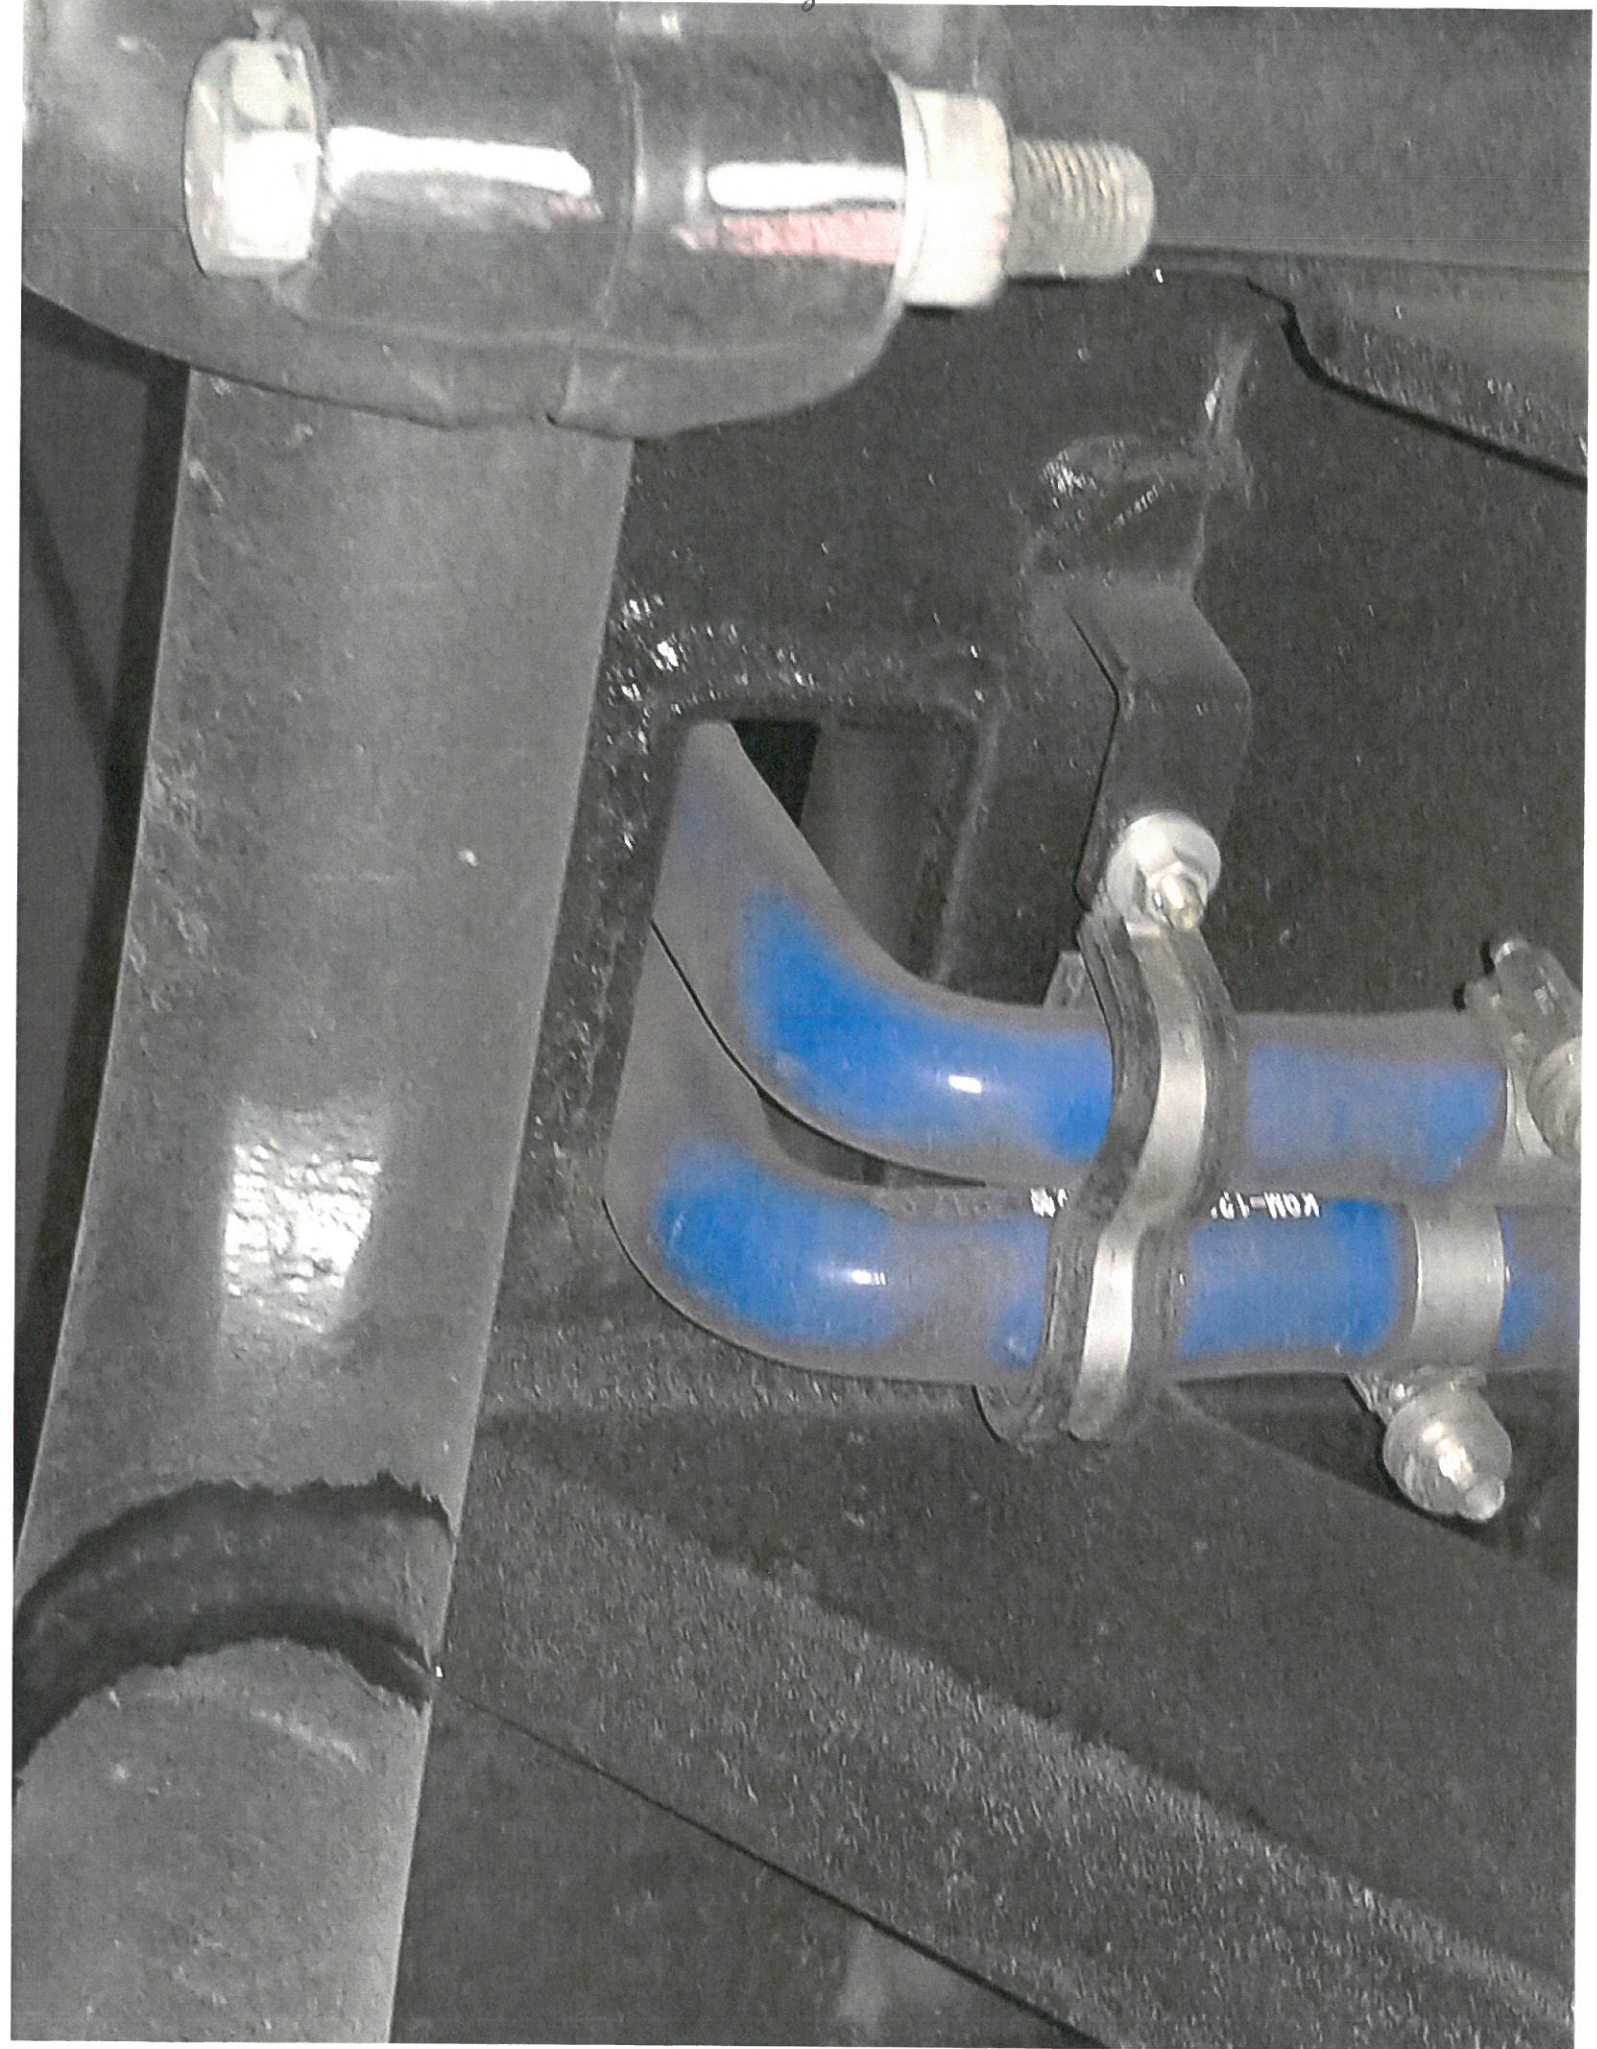
1706 c/s rear Heater hoses rubbing

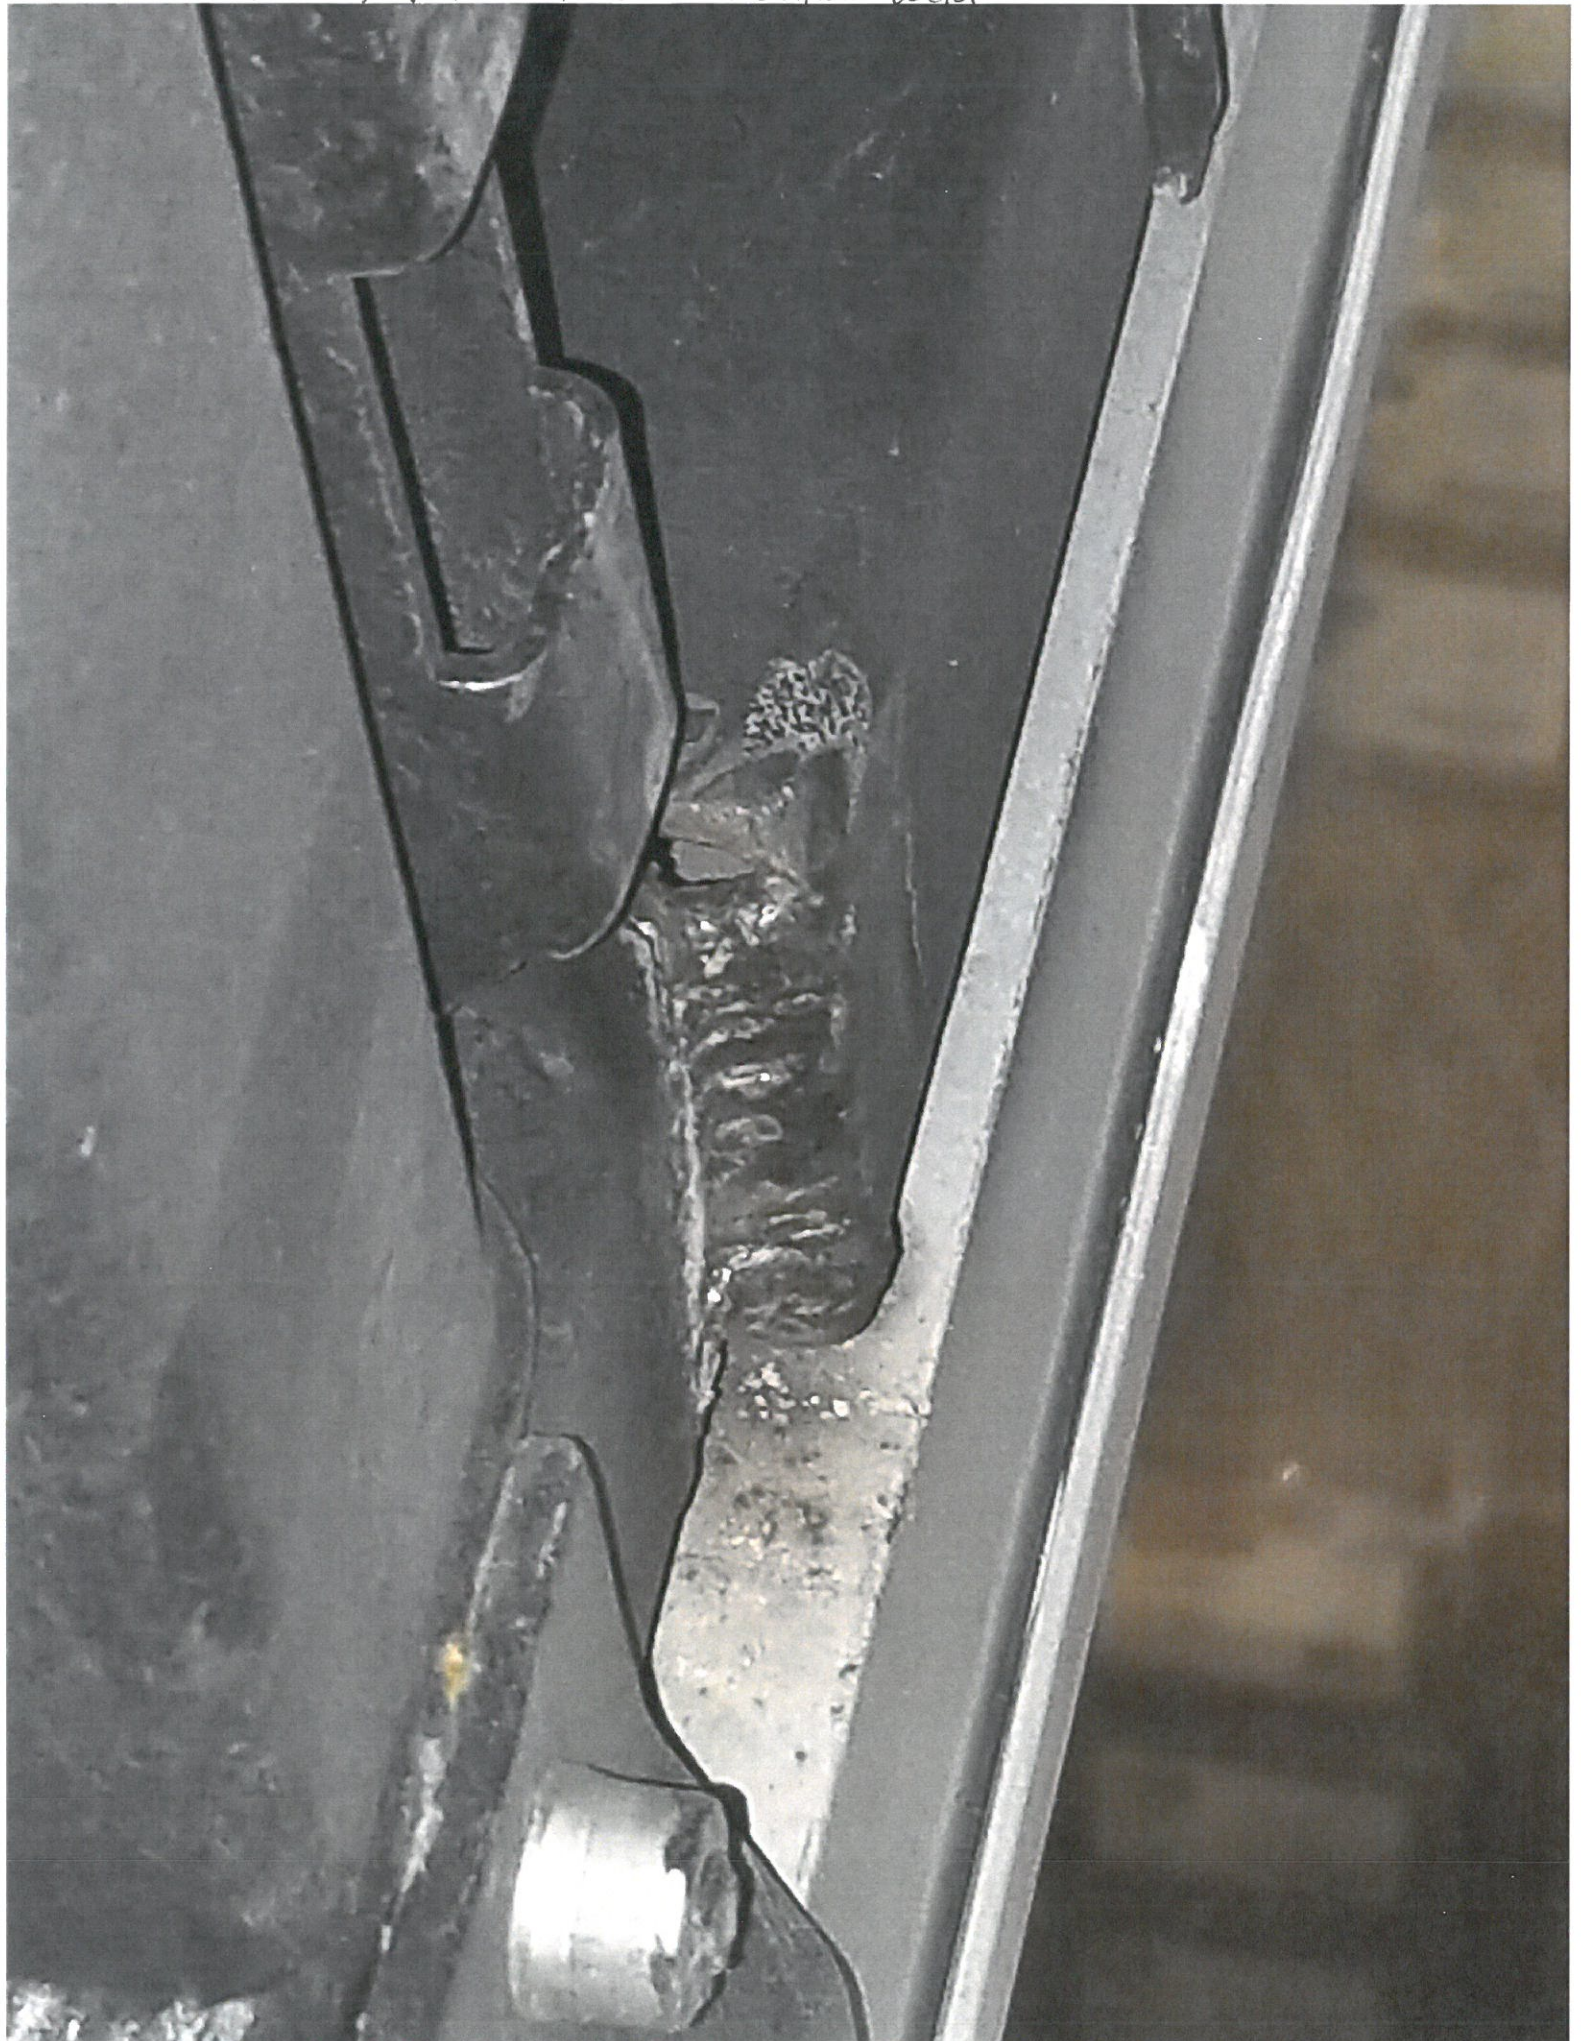
1706 C/S Bridge plate Center door incomplete weld

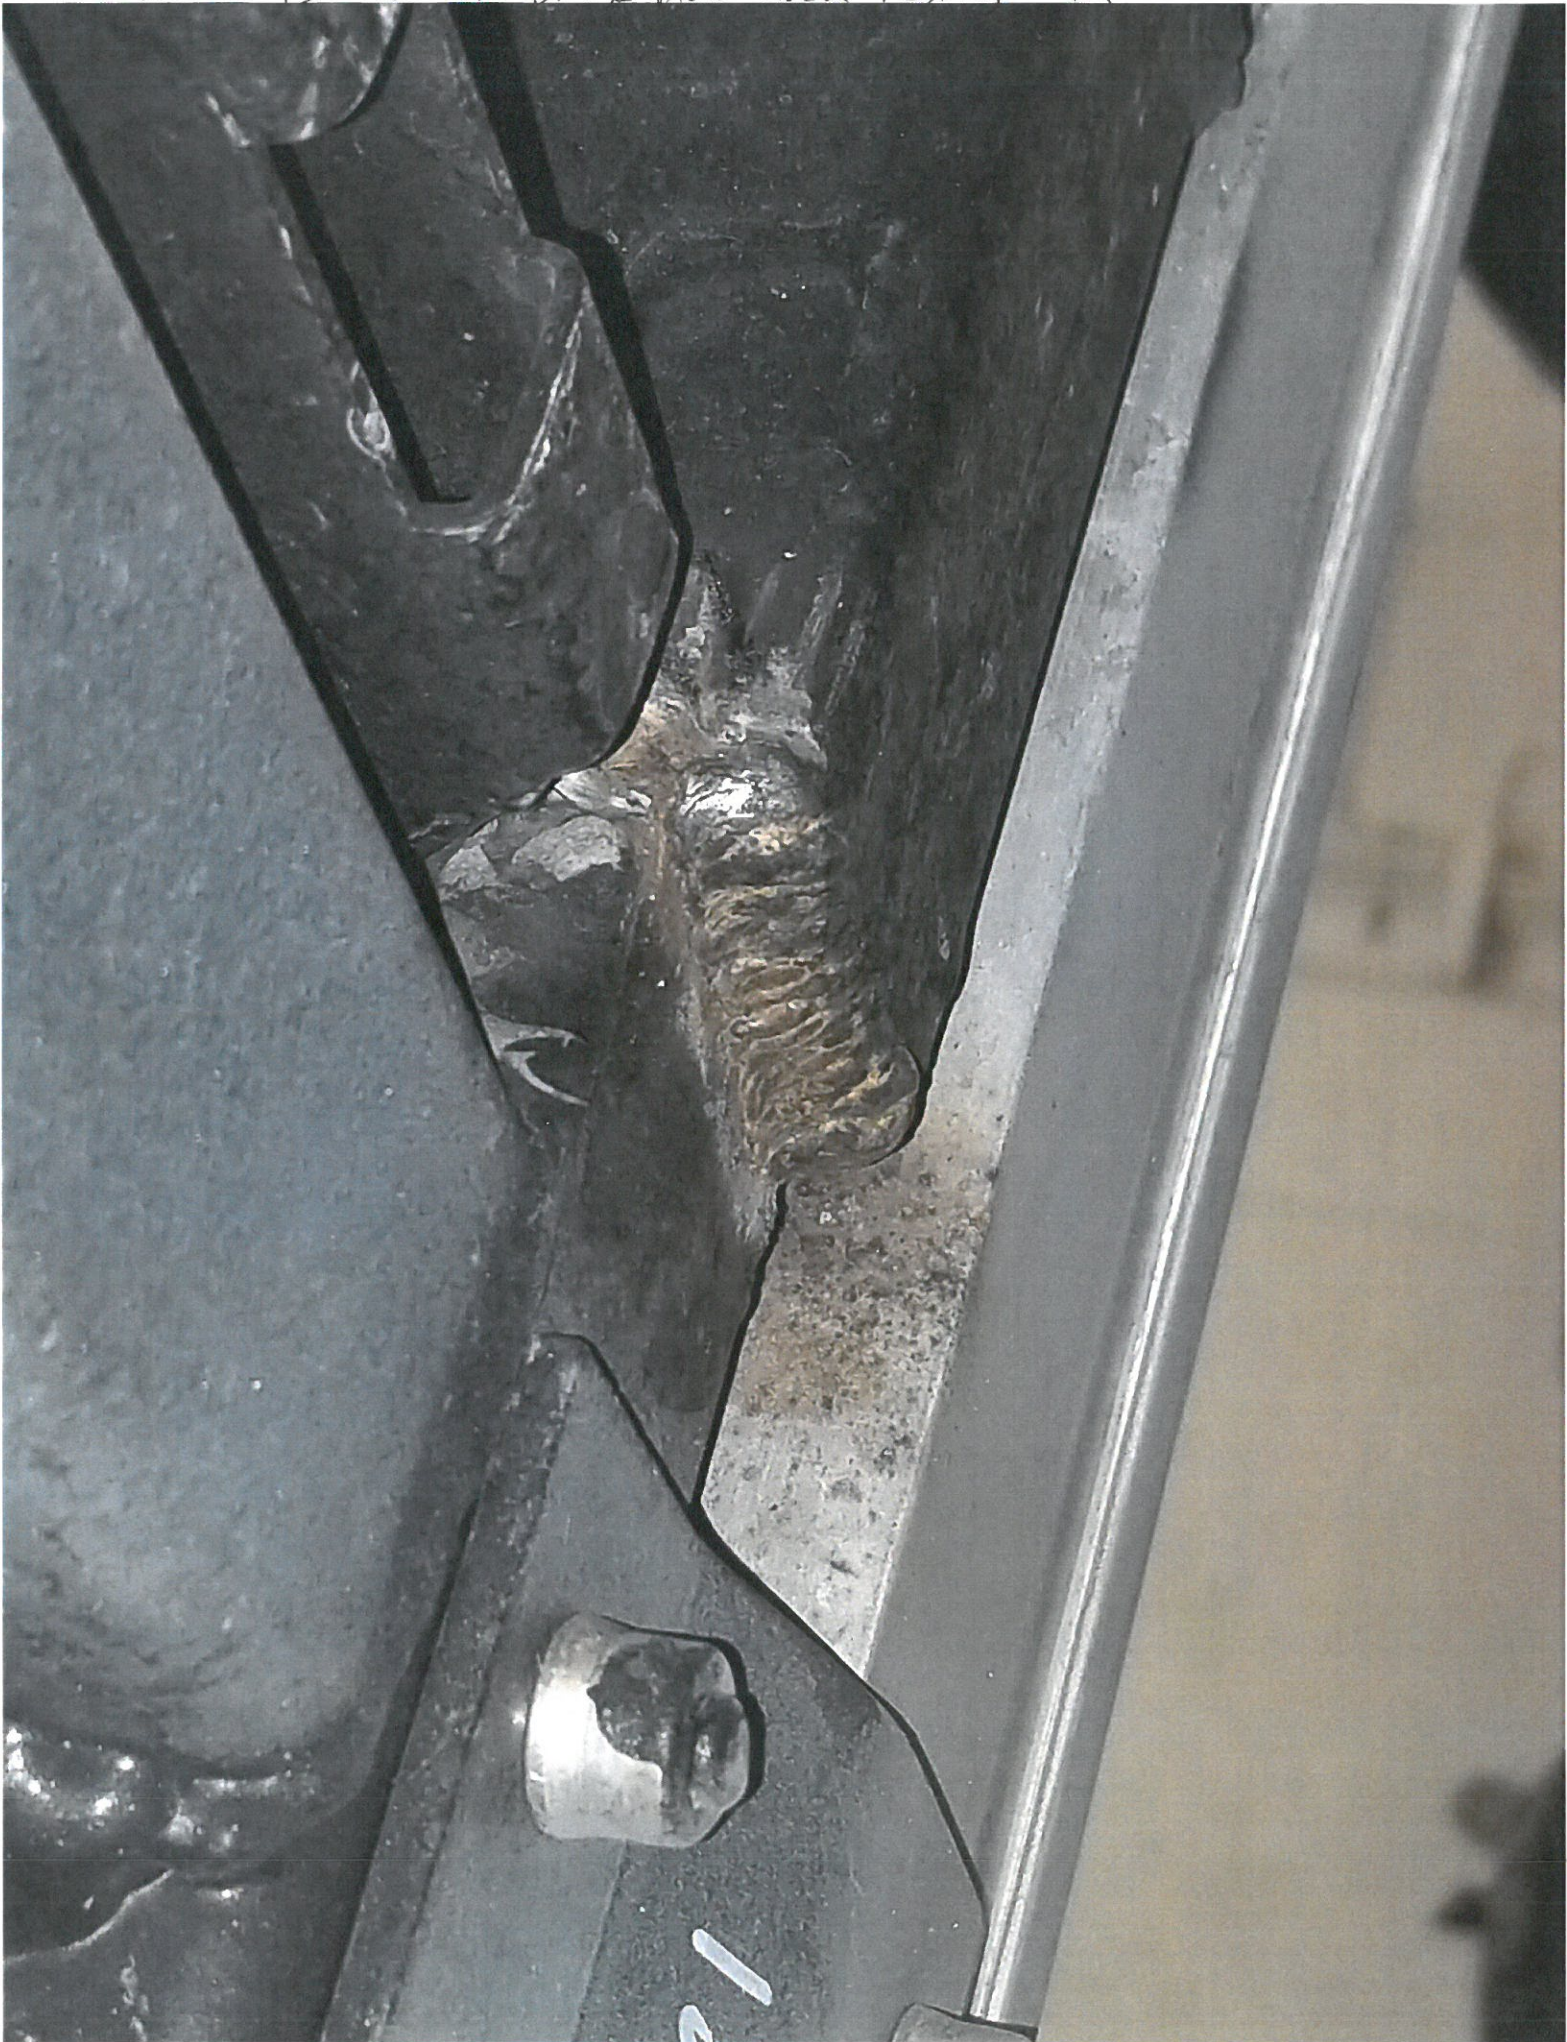
1706 - C/S Weld on Bridge Plate area rusting weld

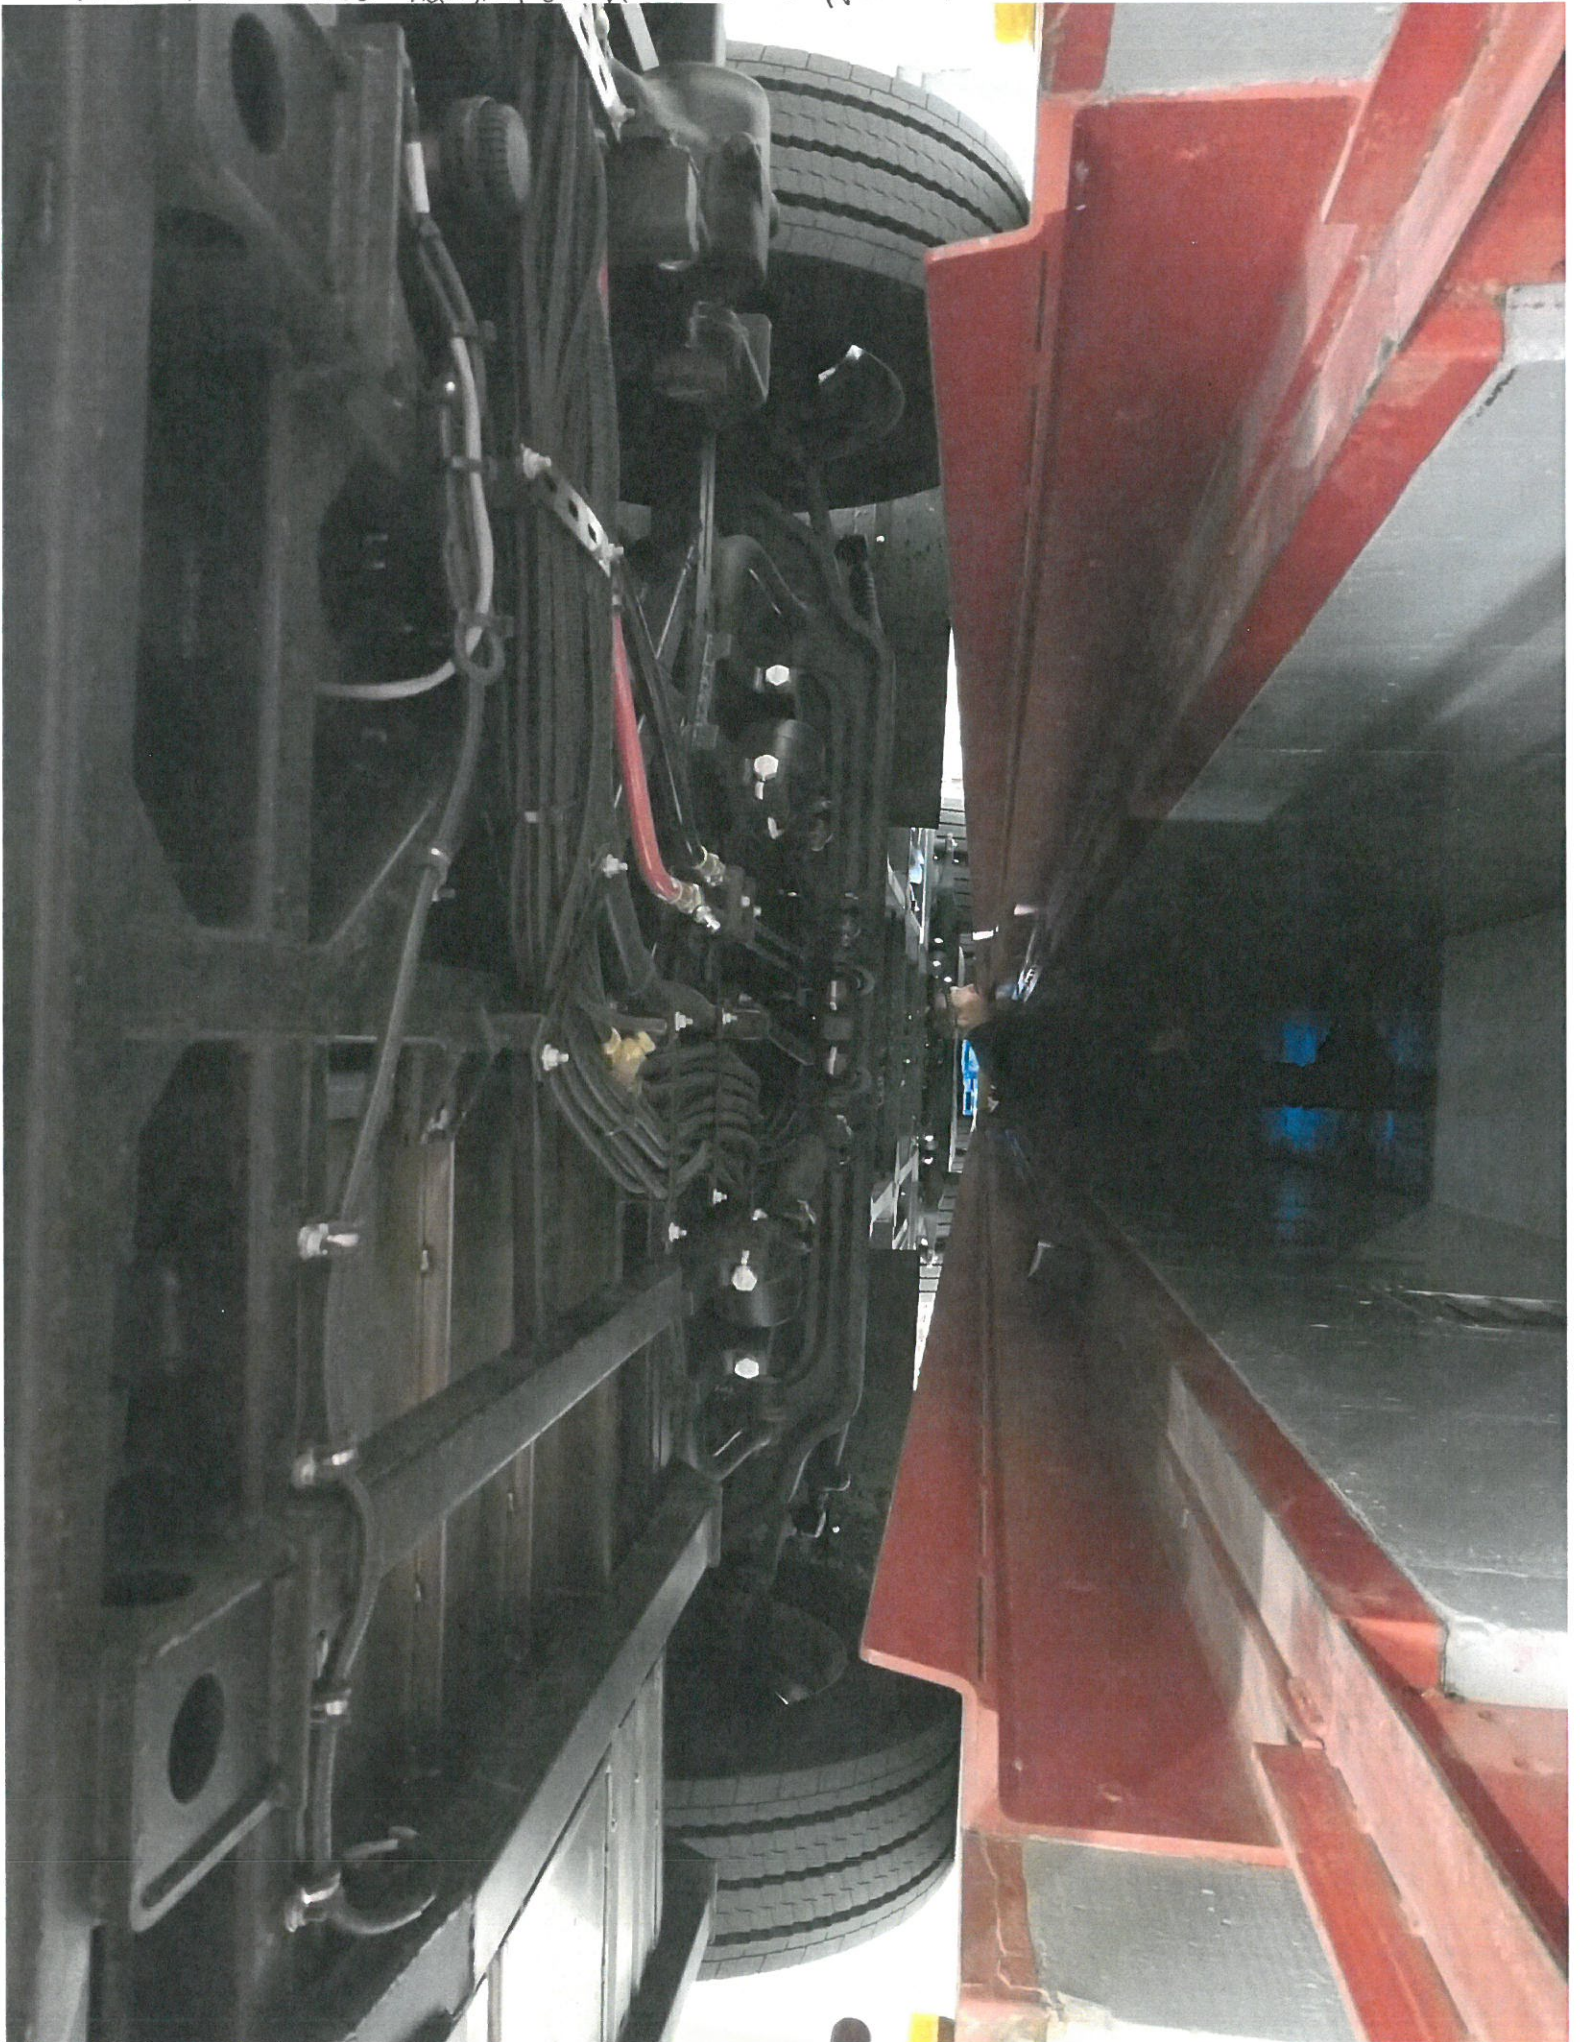
1706 - Front lines Hanging down + not supported

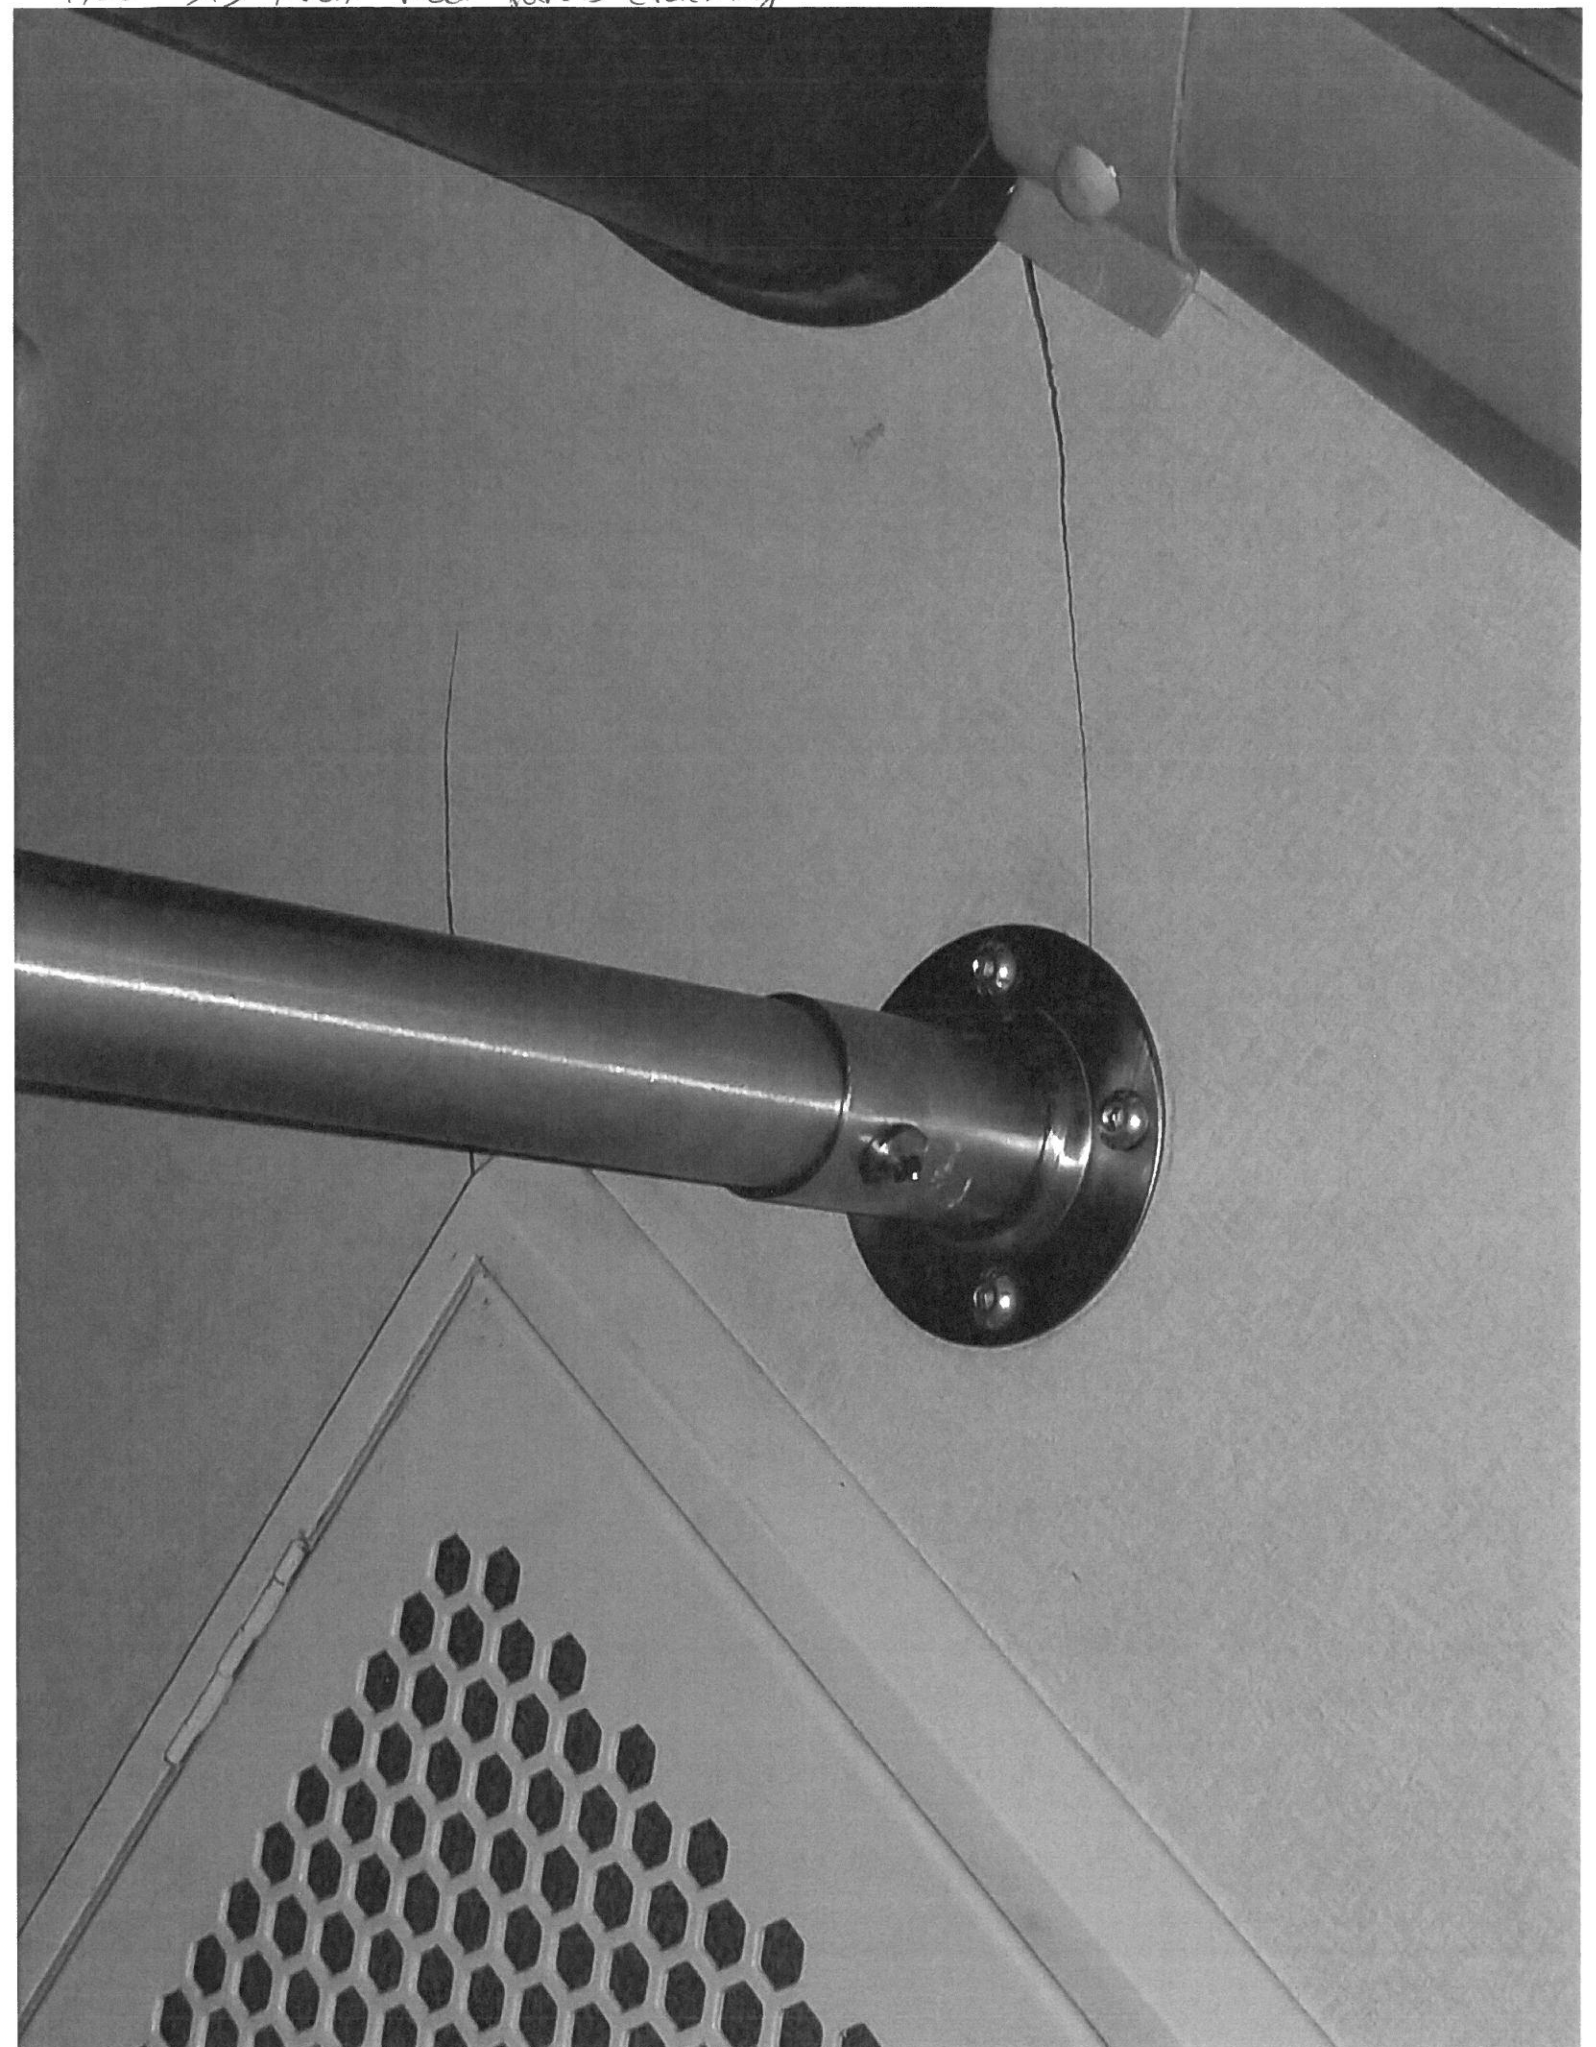
1706 - S/S Front Roof Panels Cracking
