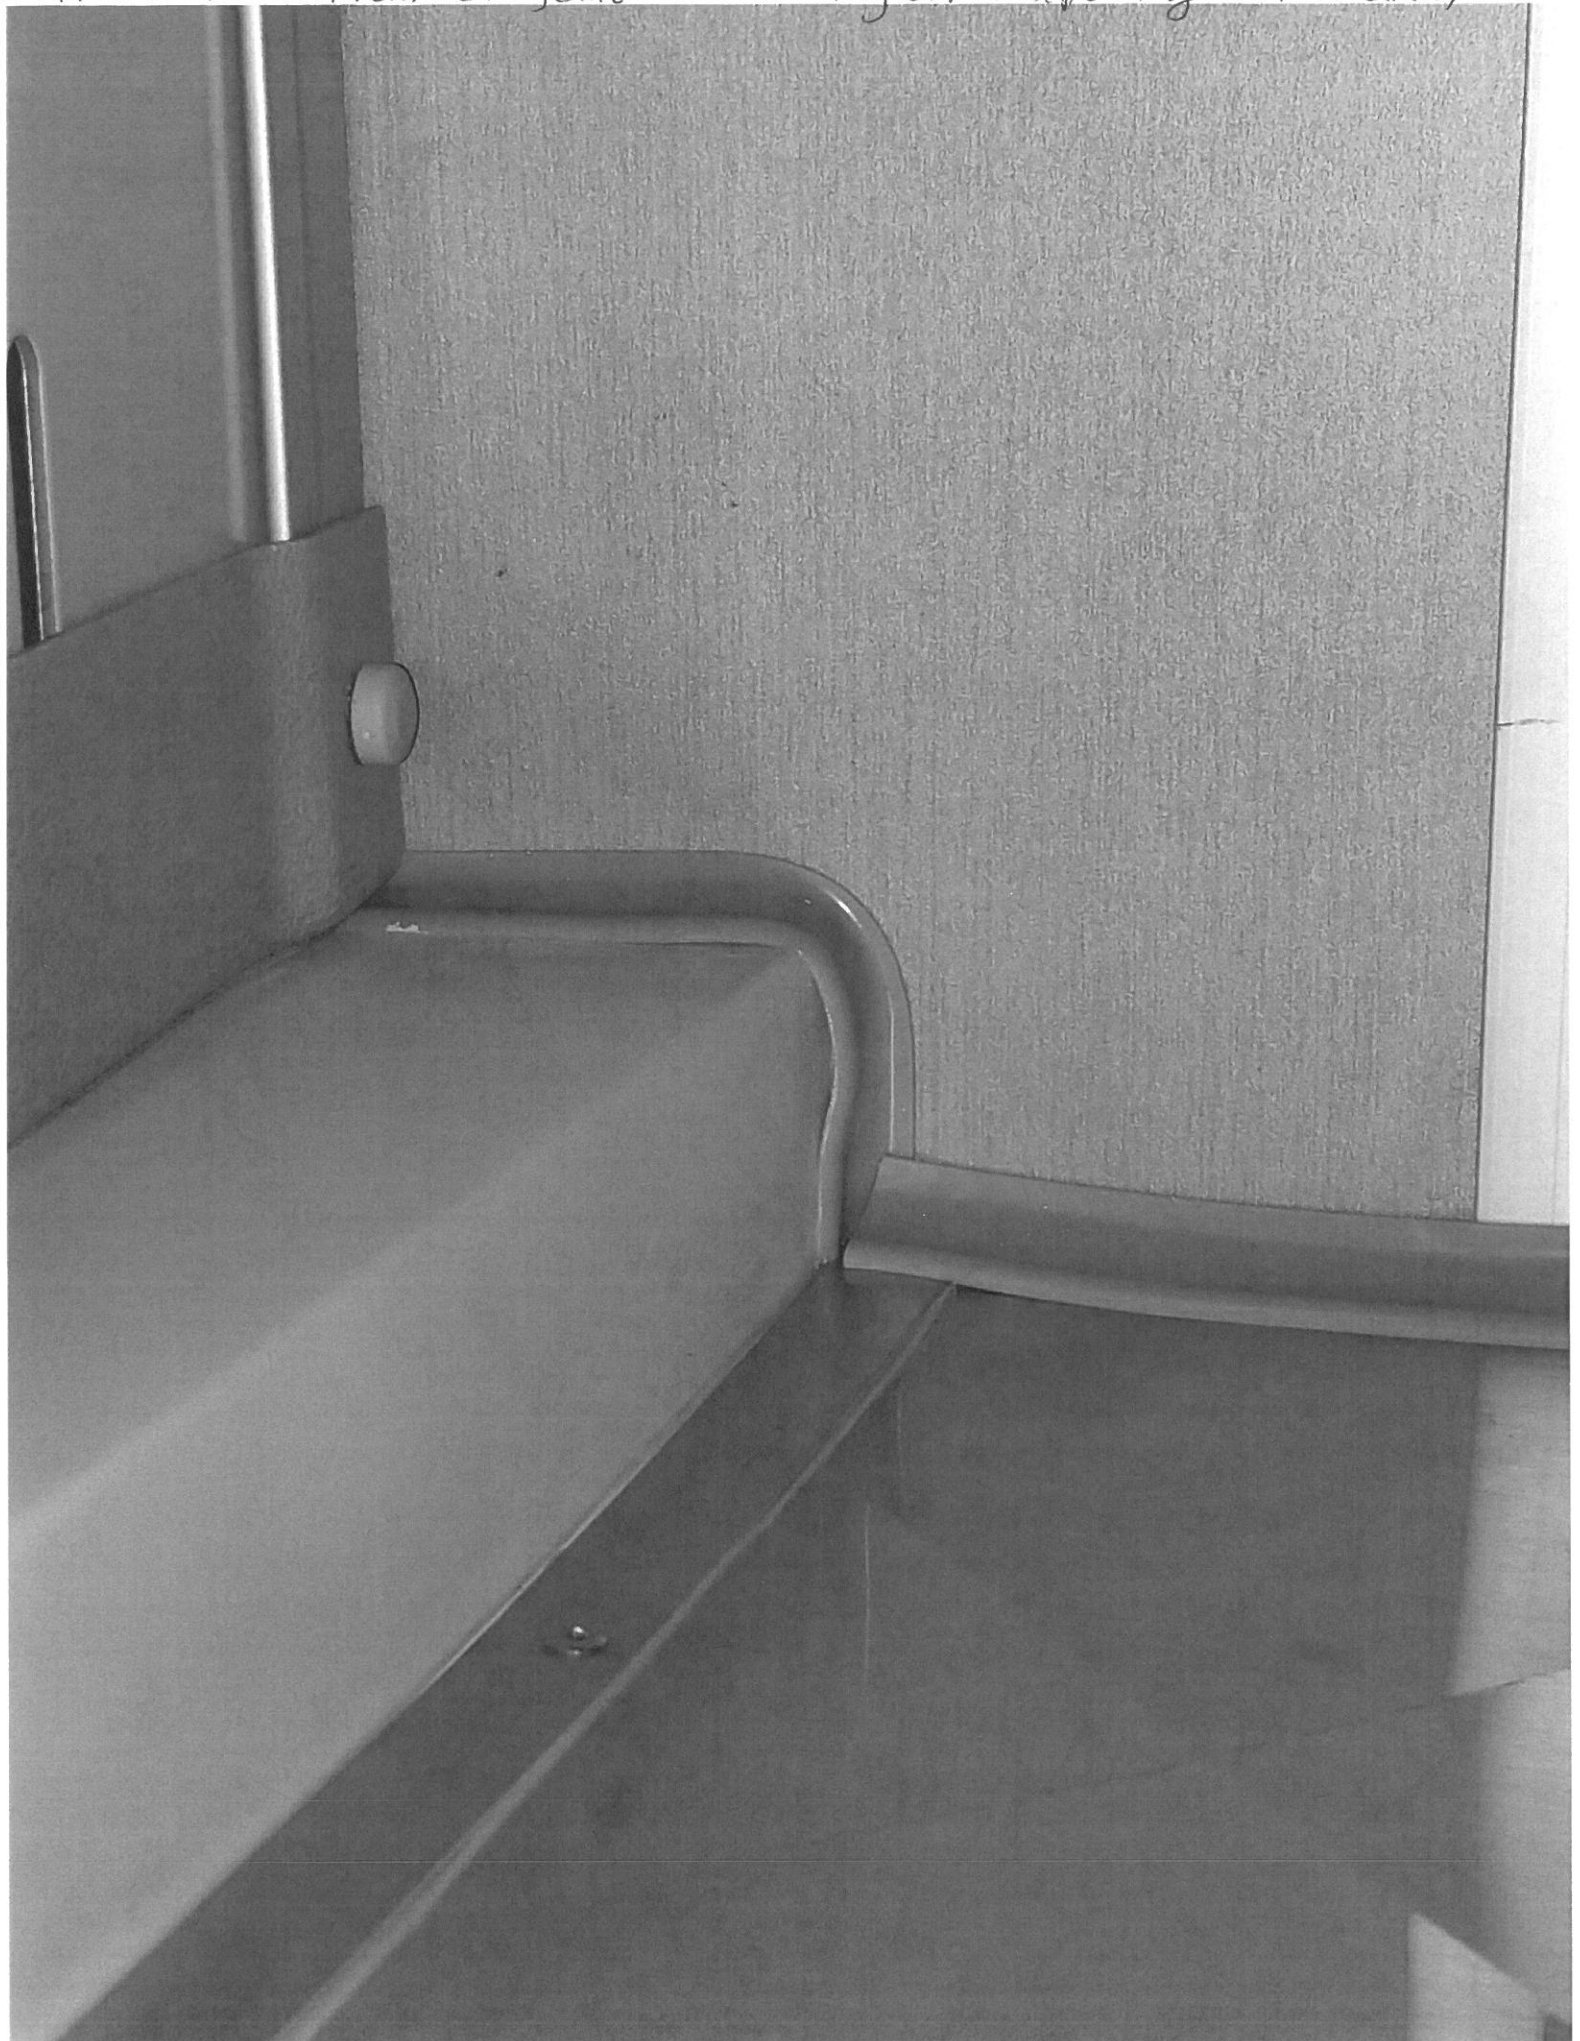
1706 - S/S in Front of Joint Trim Falling off + Separating on Rxt areas

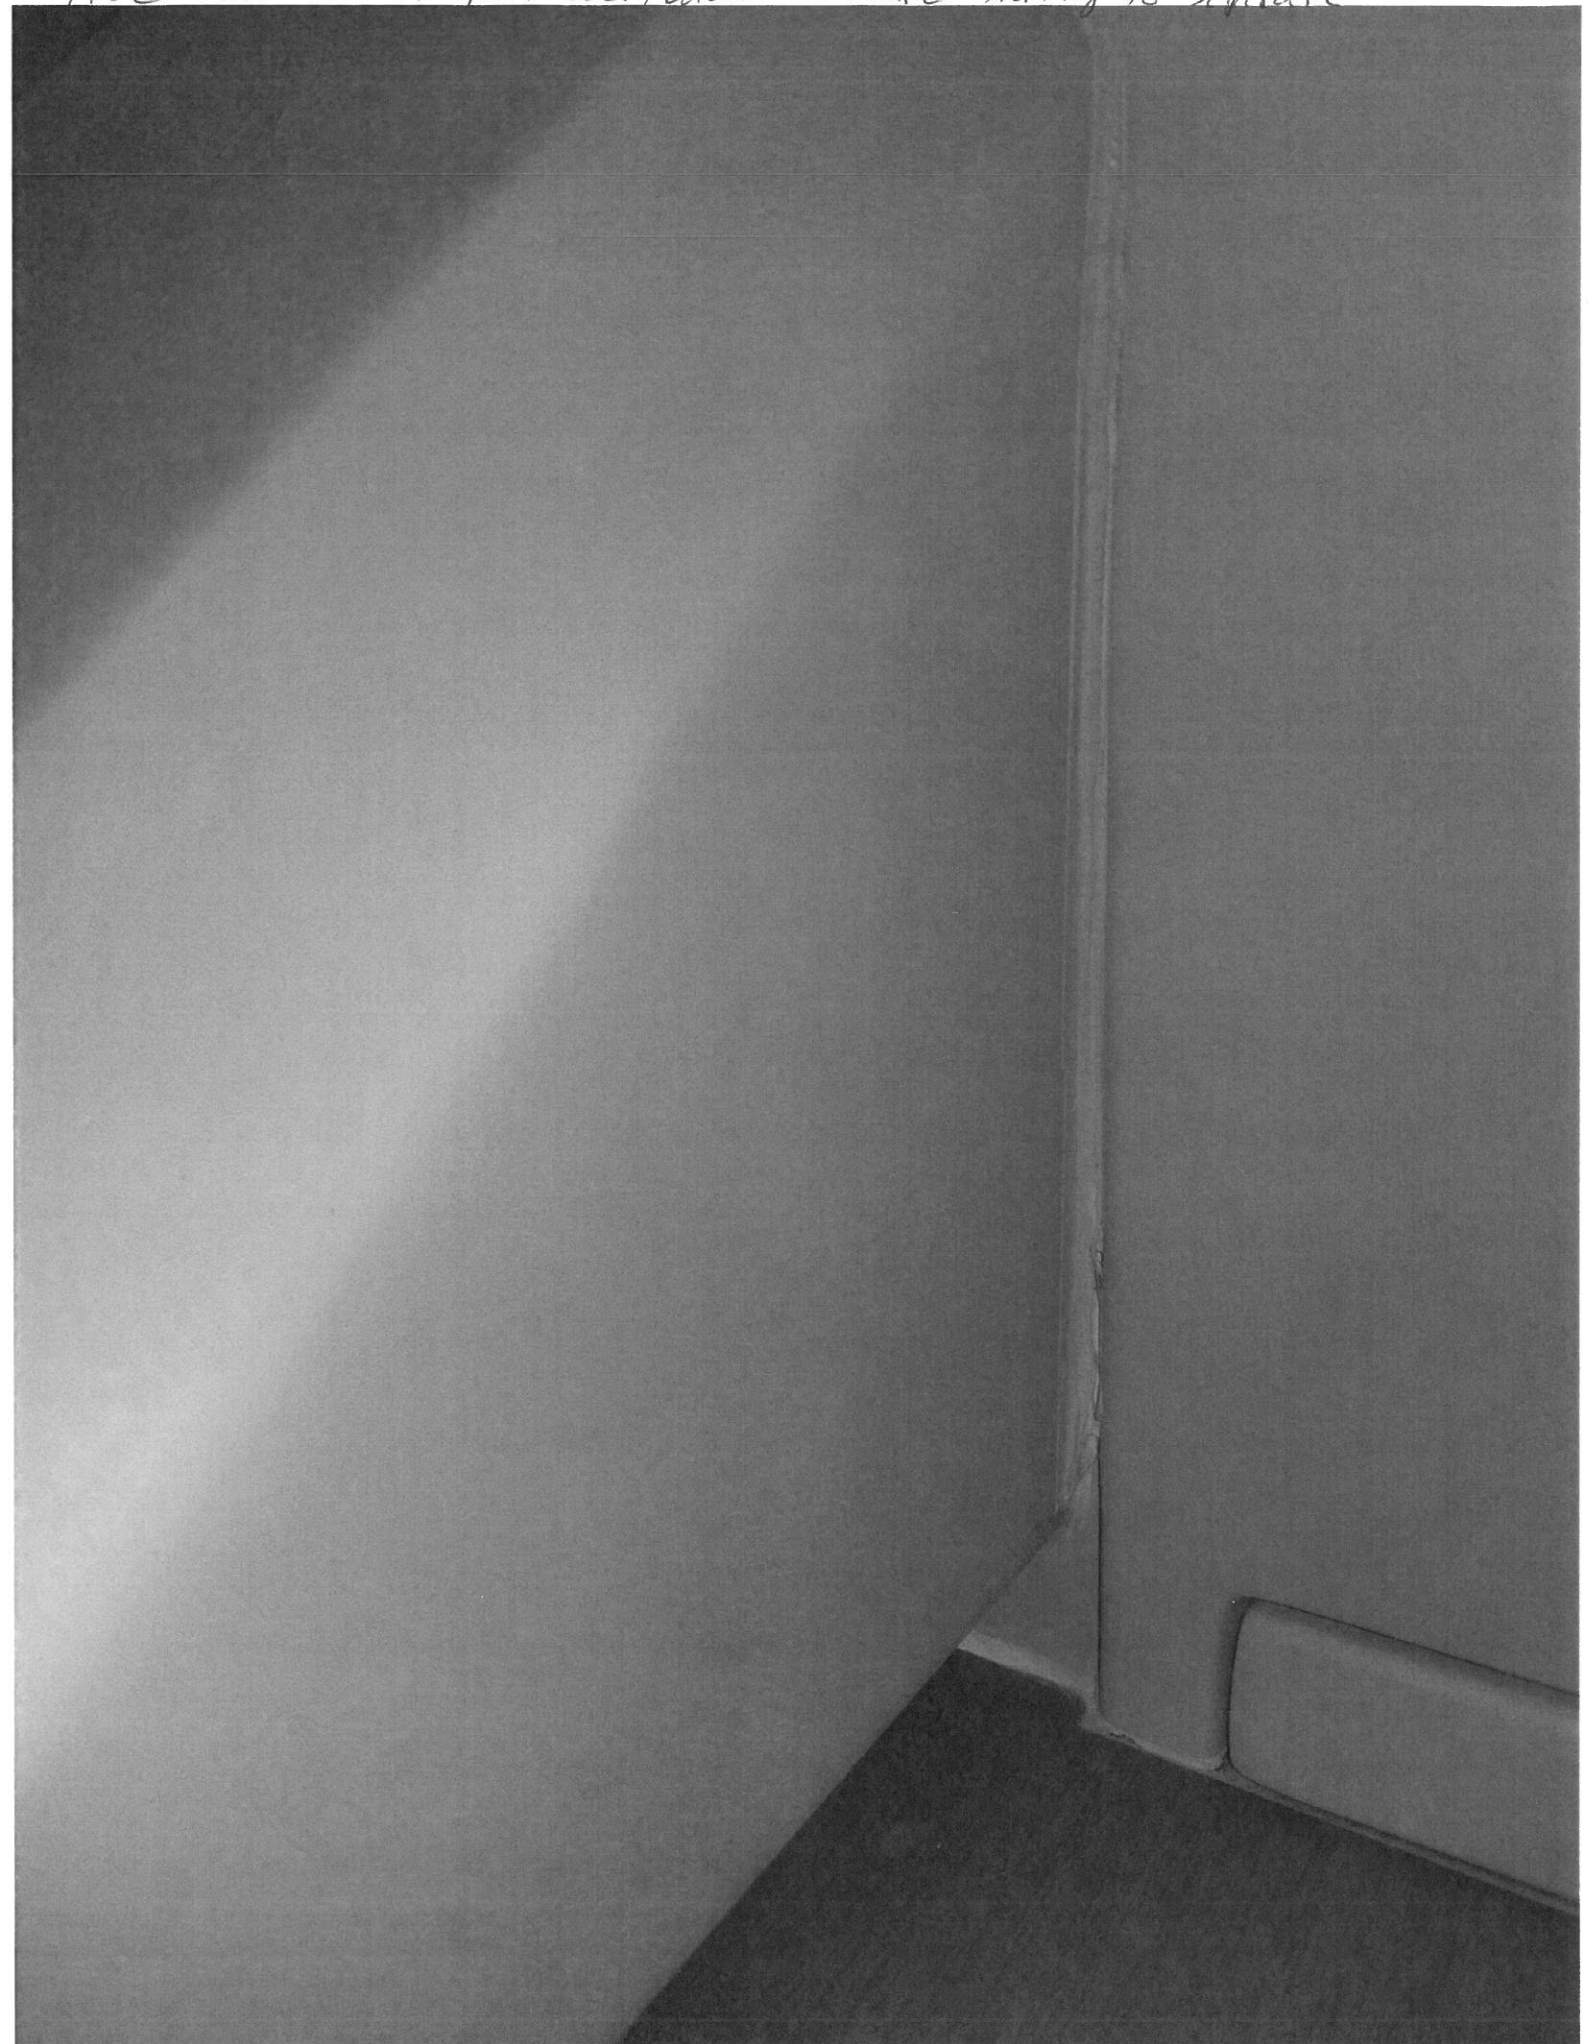
1706 - C/S rear of joint roof, Coloumn & Frame starting to separate

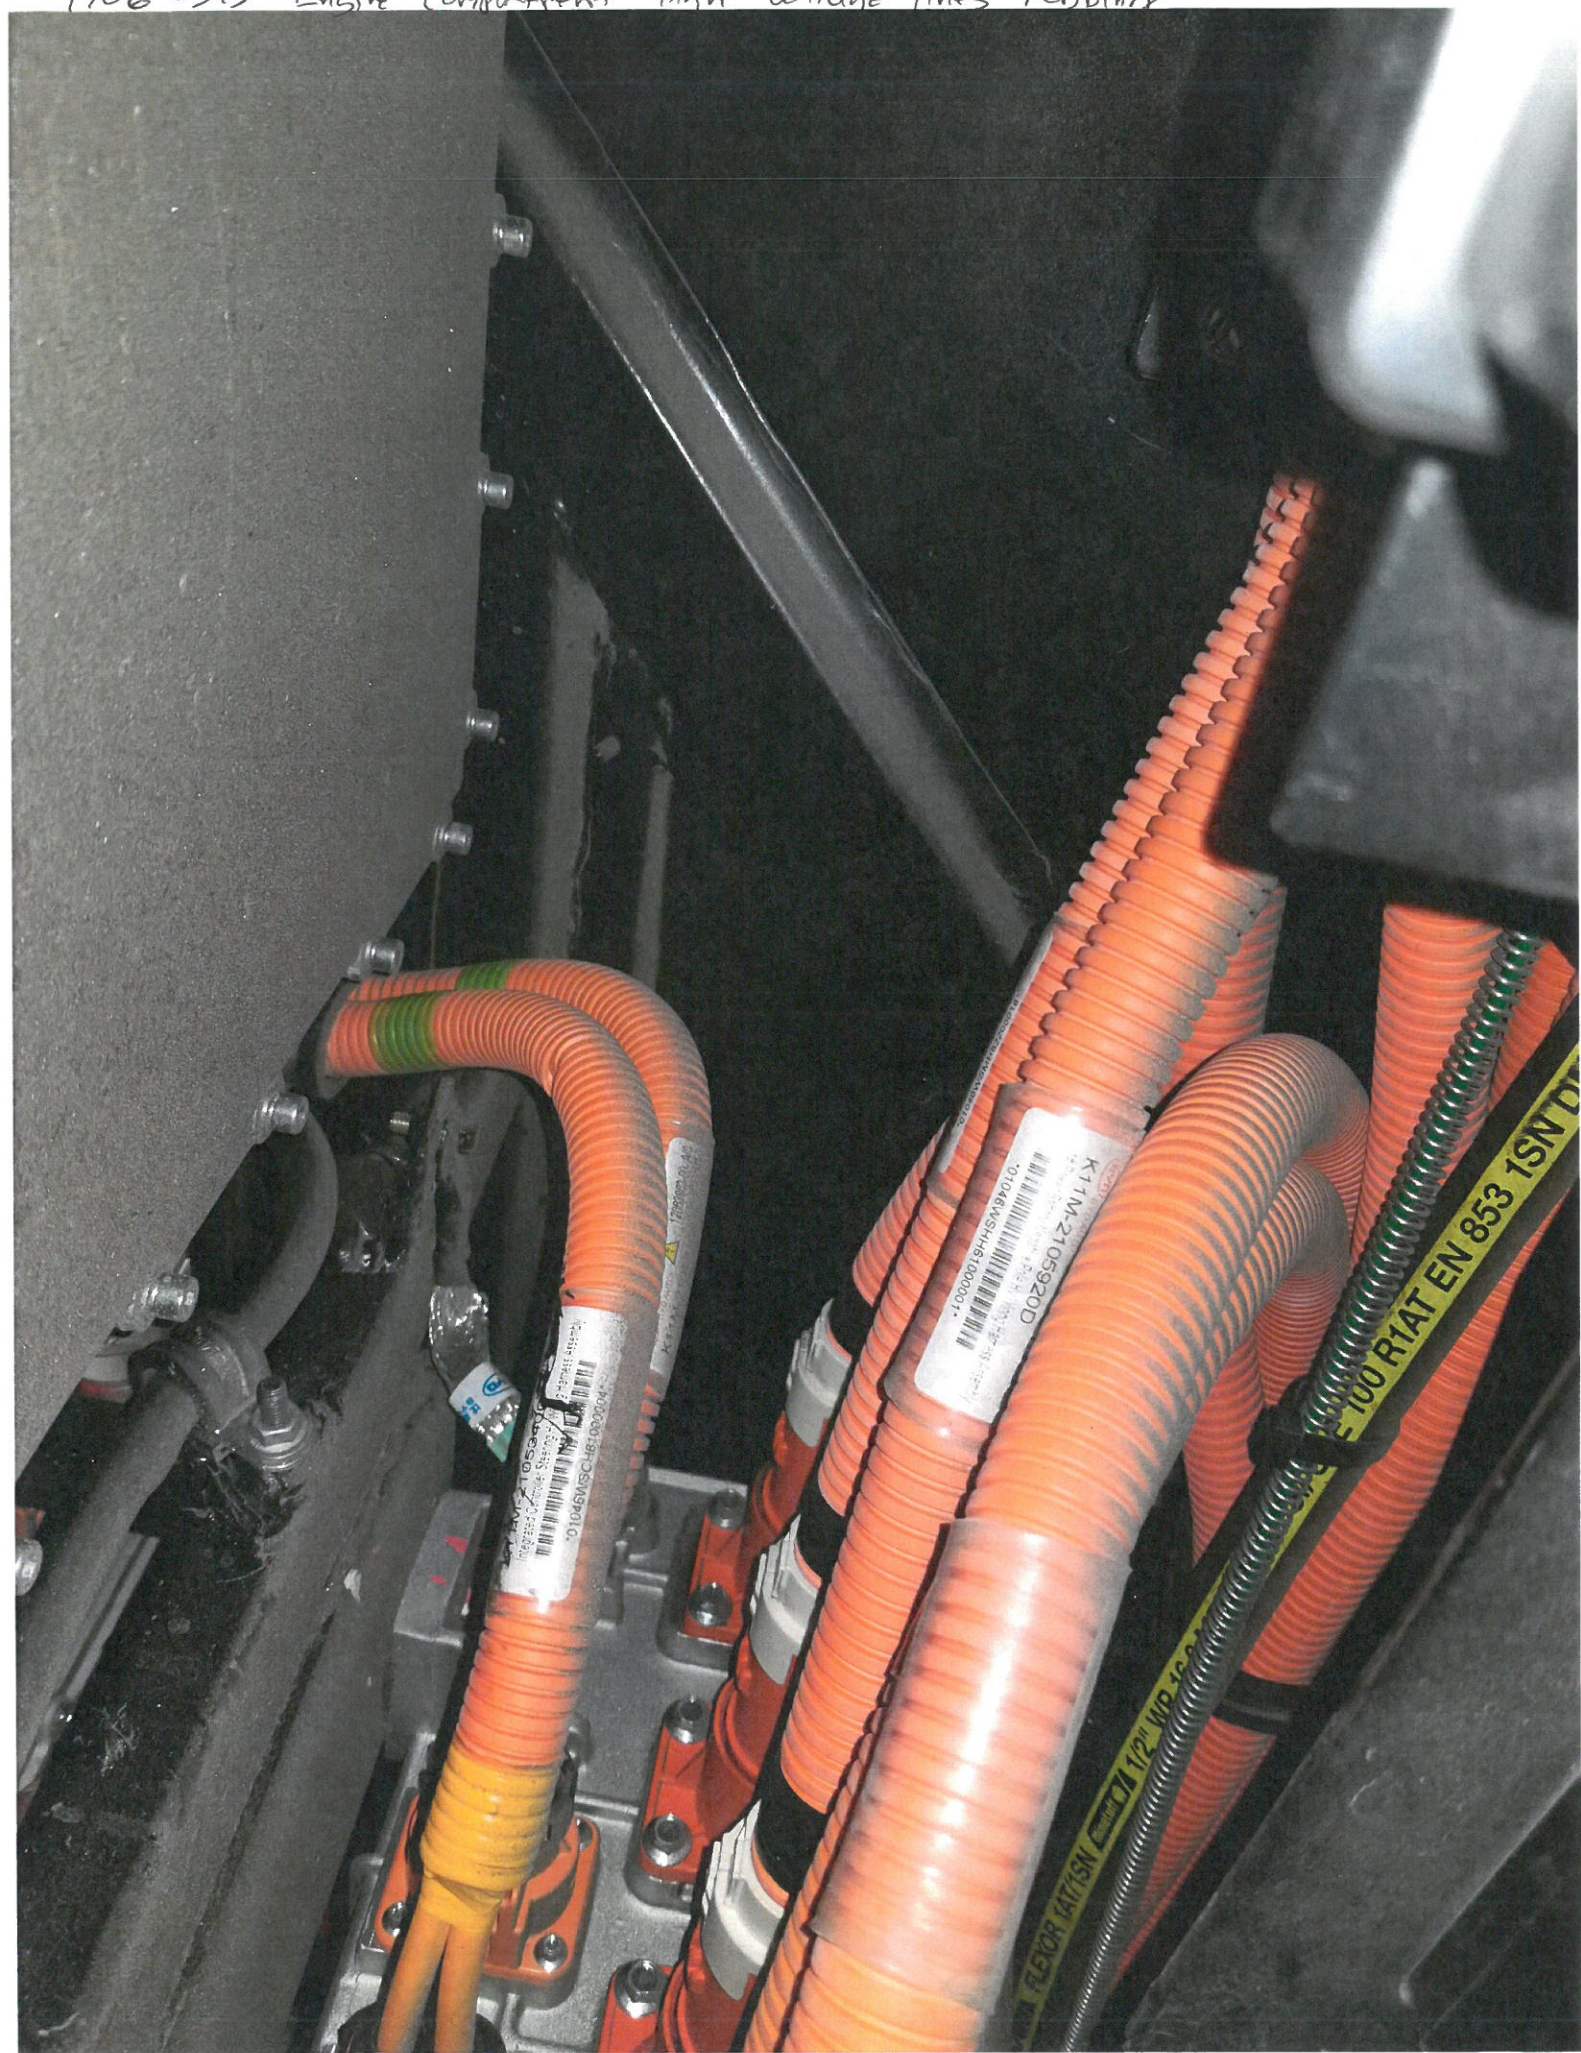
1706 - S/S Engine Compartment High voltage lines ribbunny

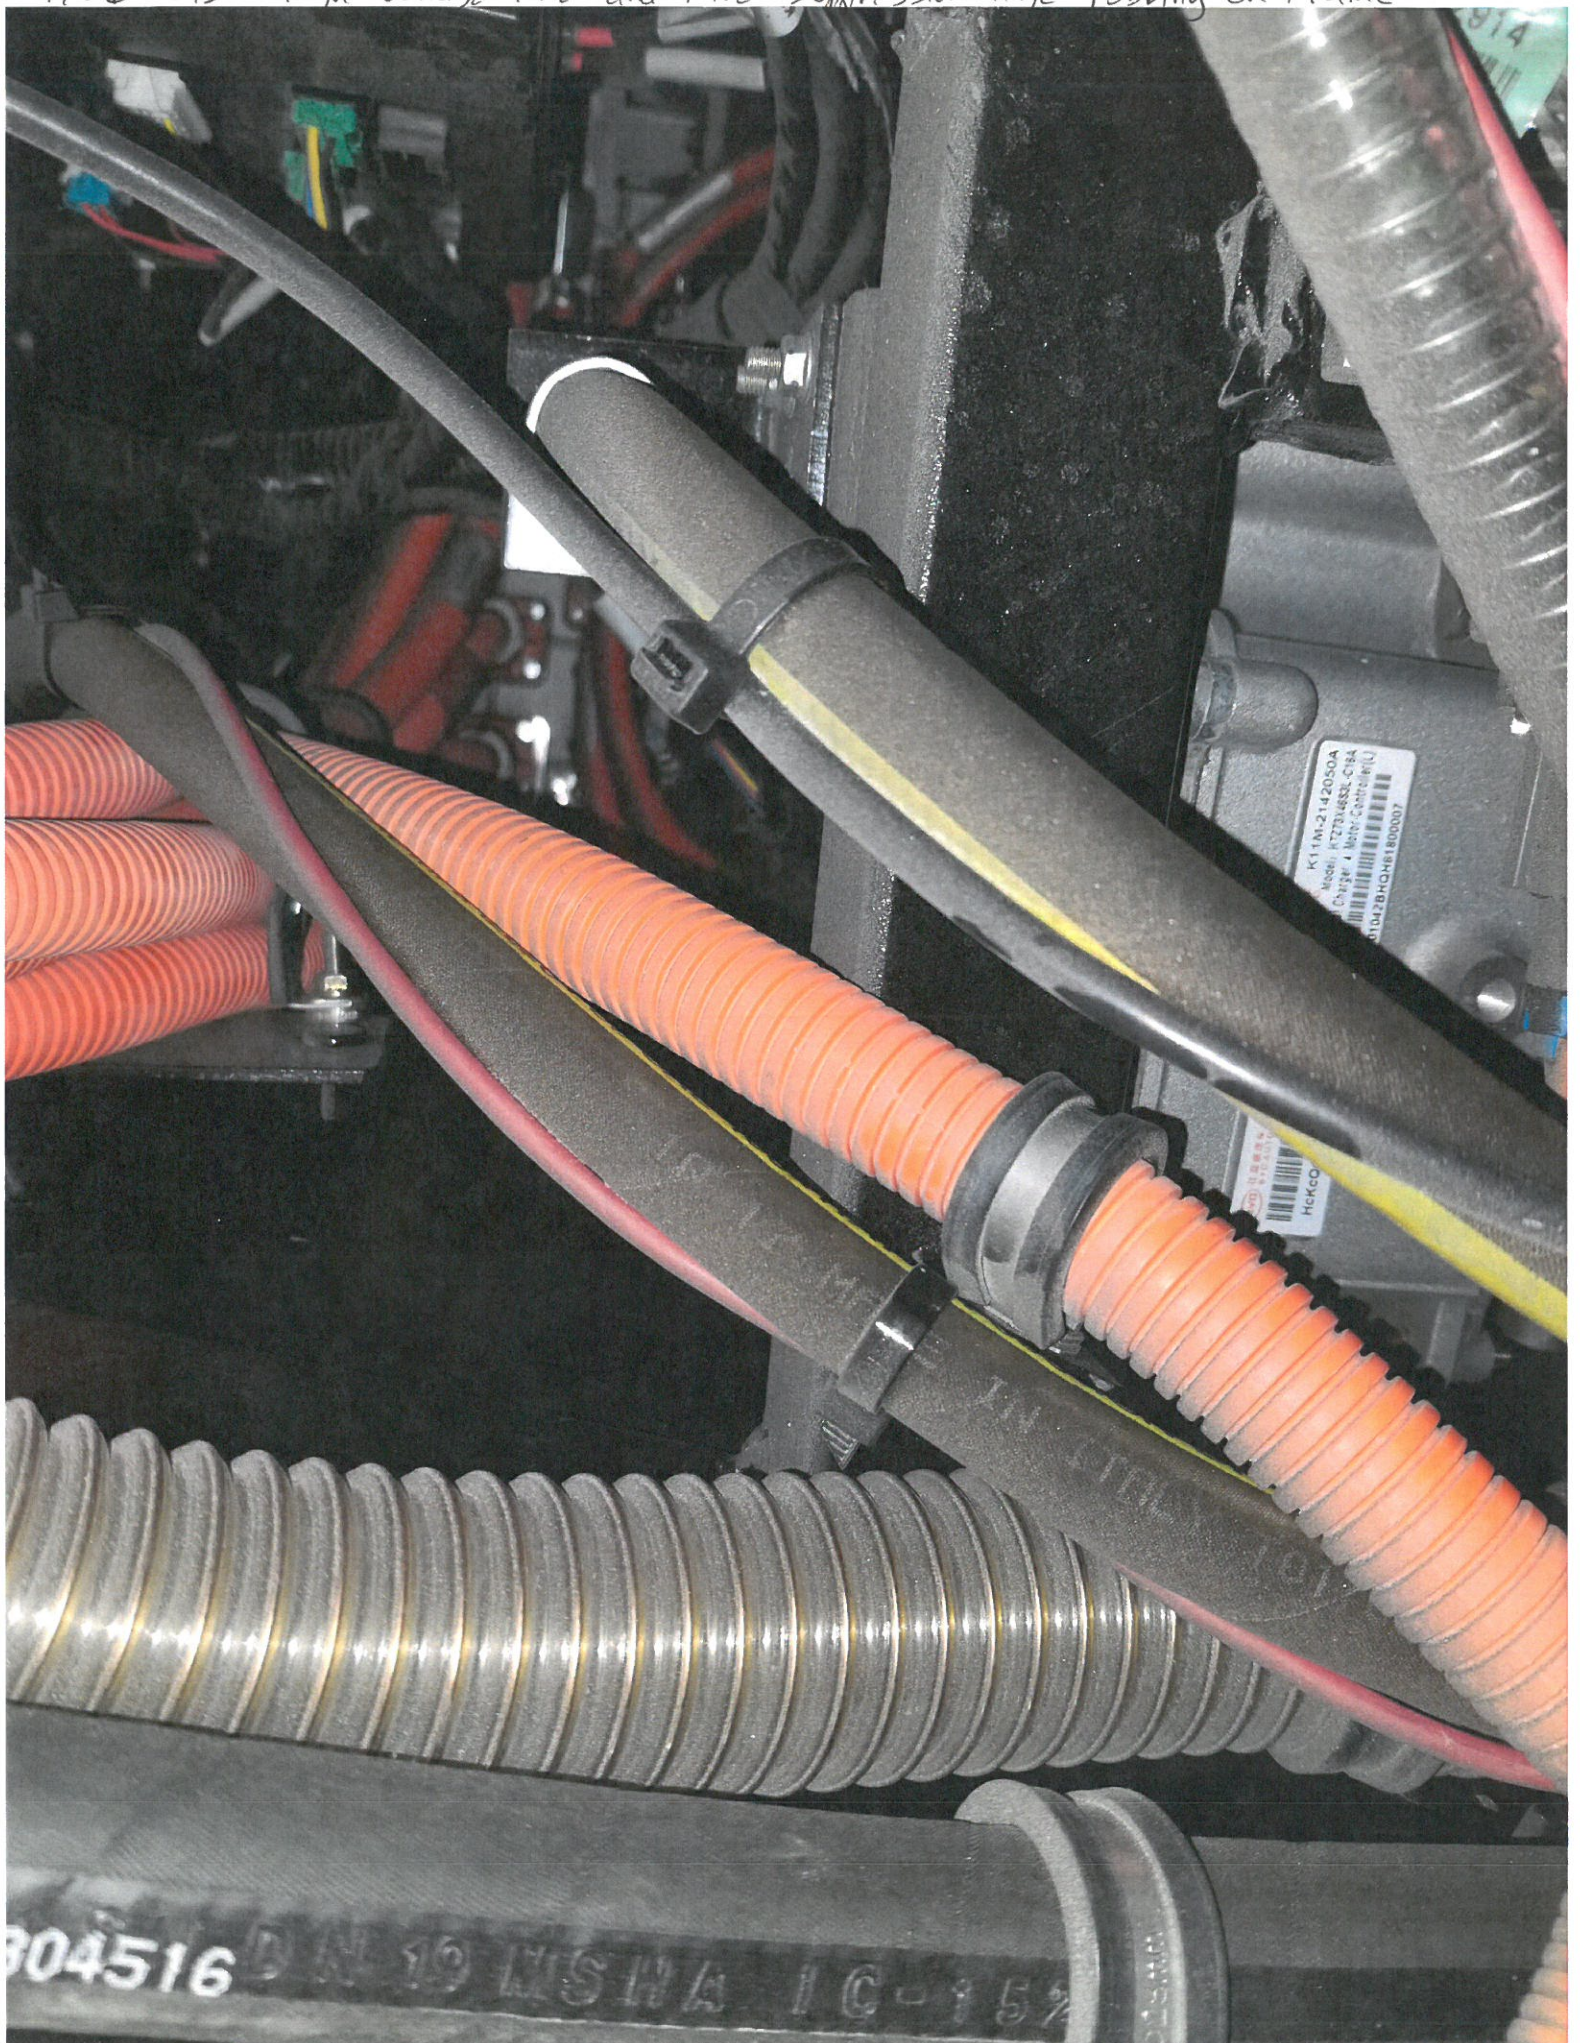
1706-C/S High voltage line and Fire Suppression line rubbing on Frame

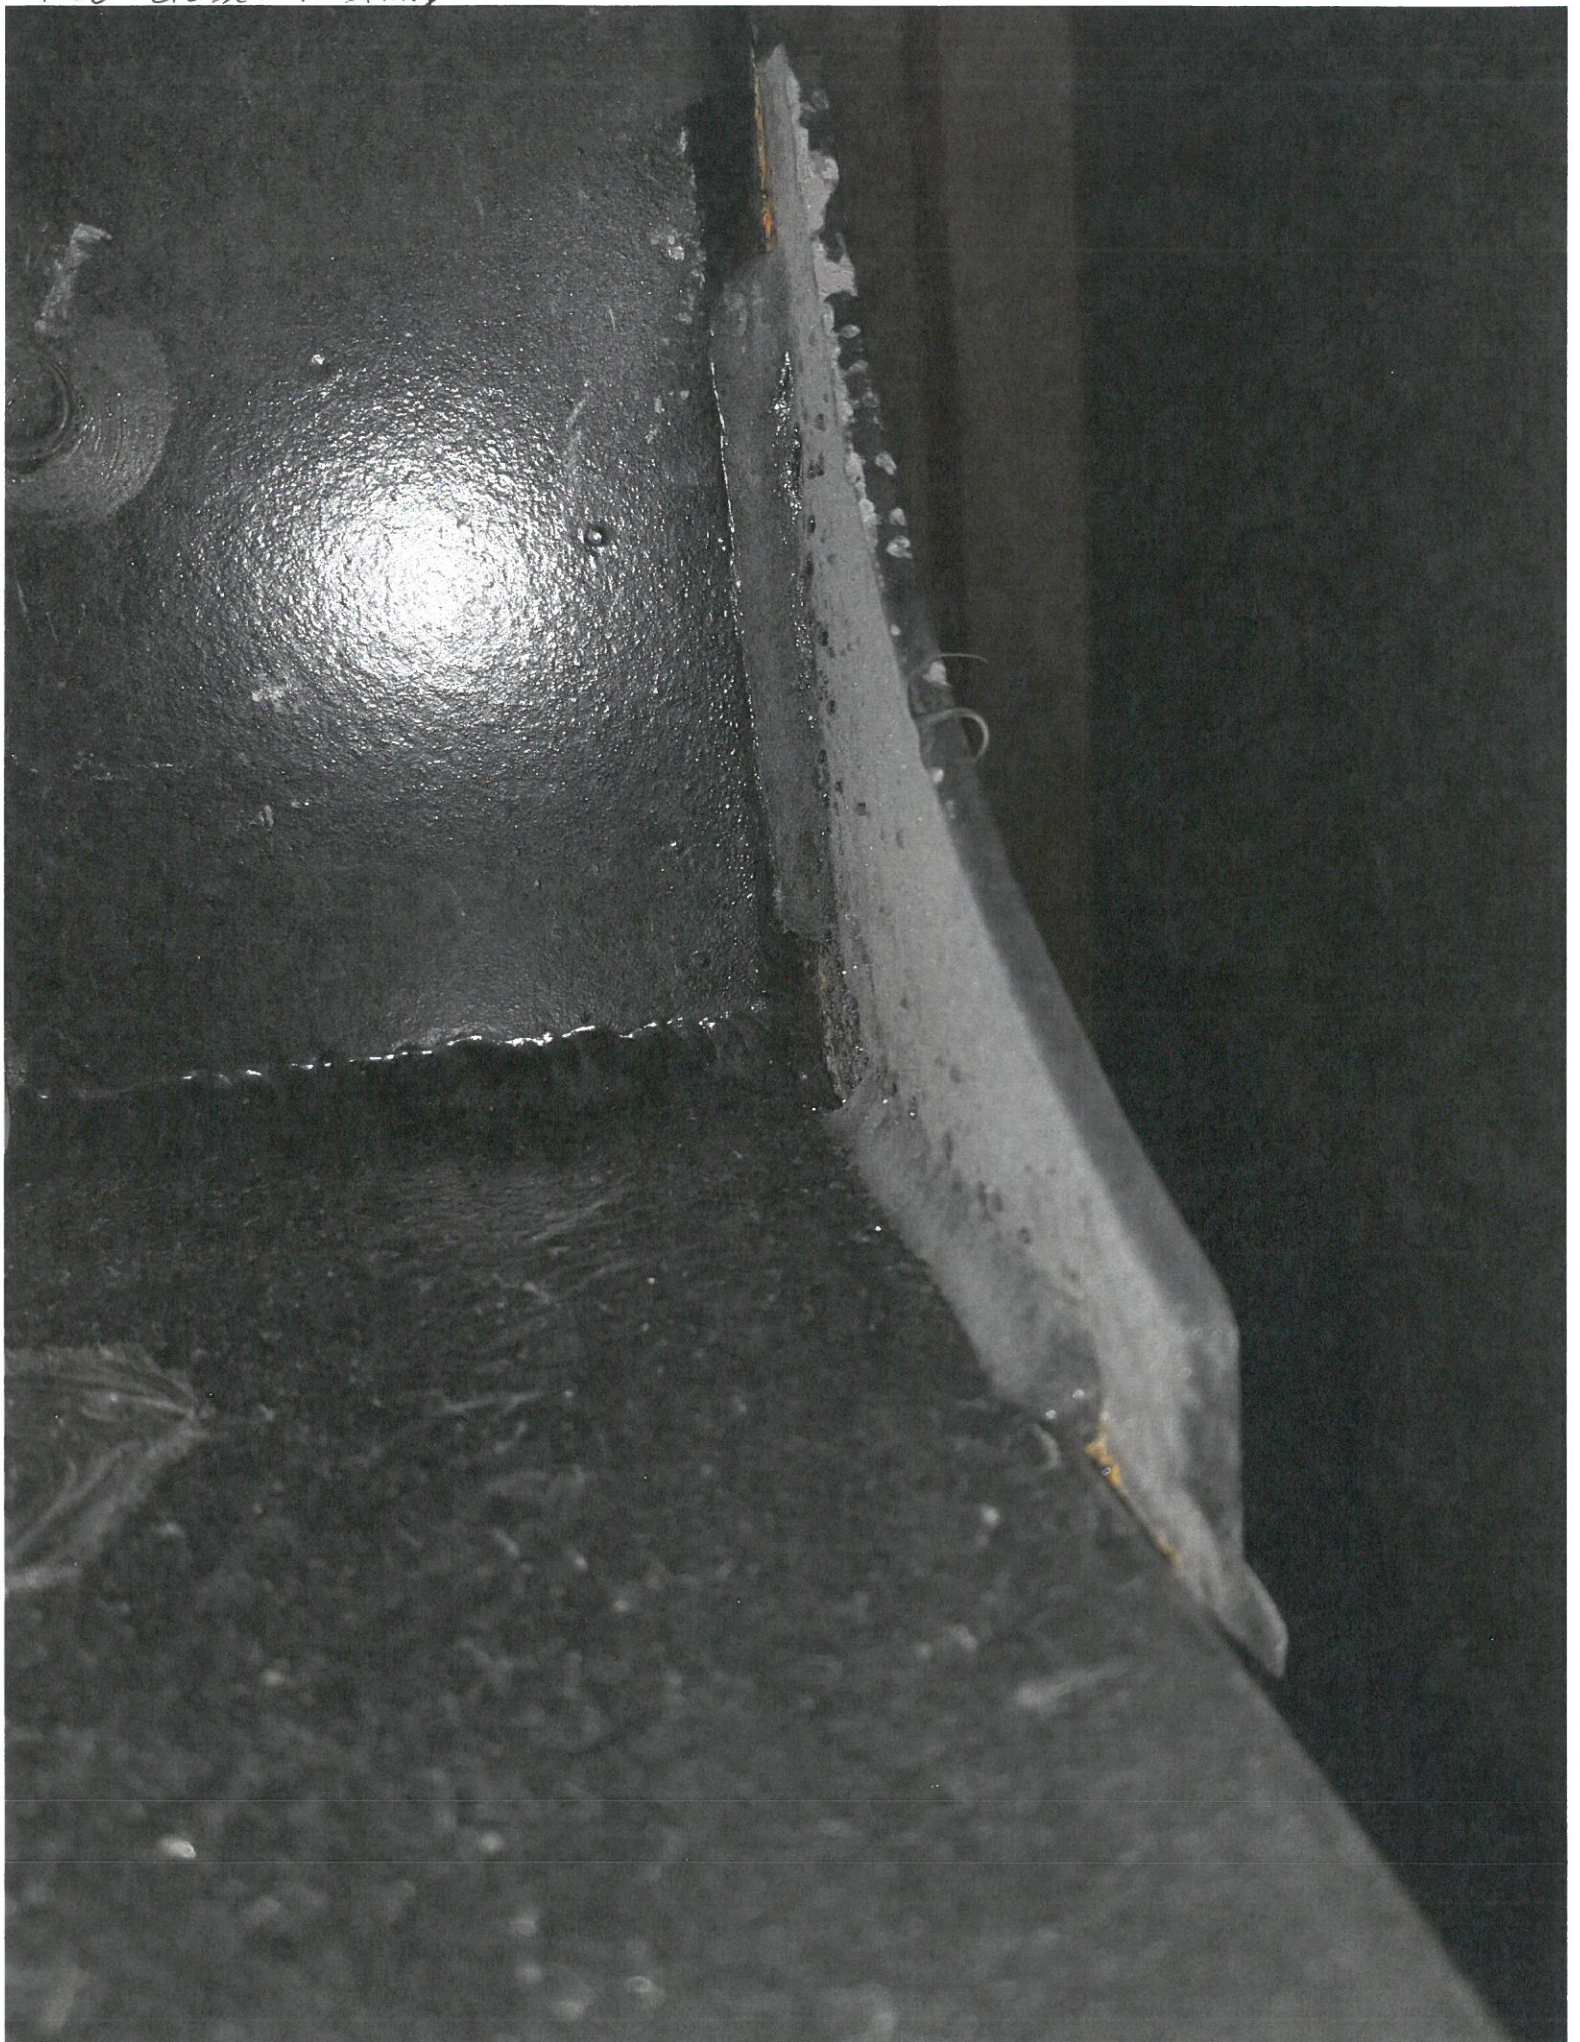
1706 Gusset Rusty

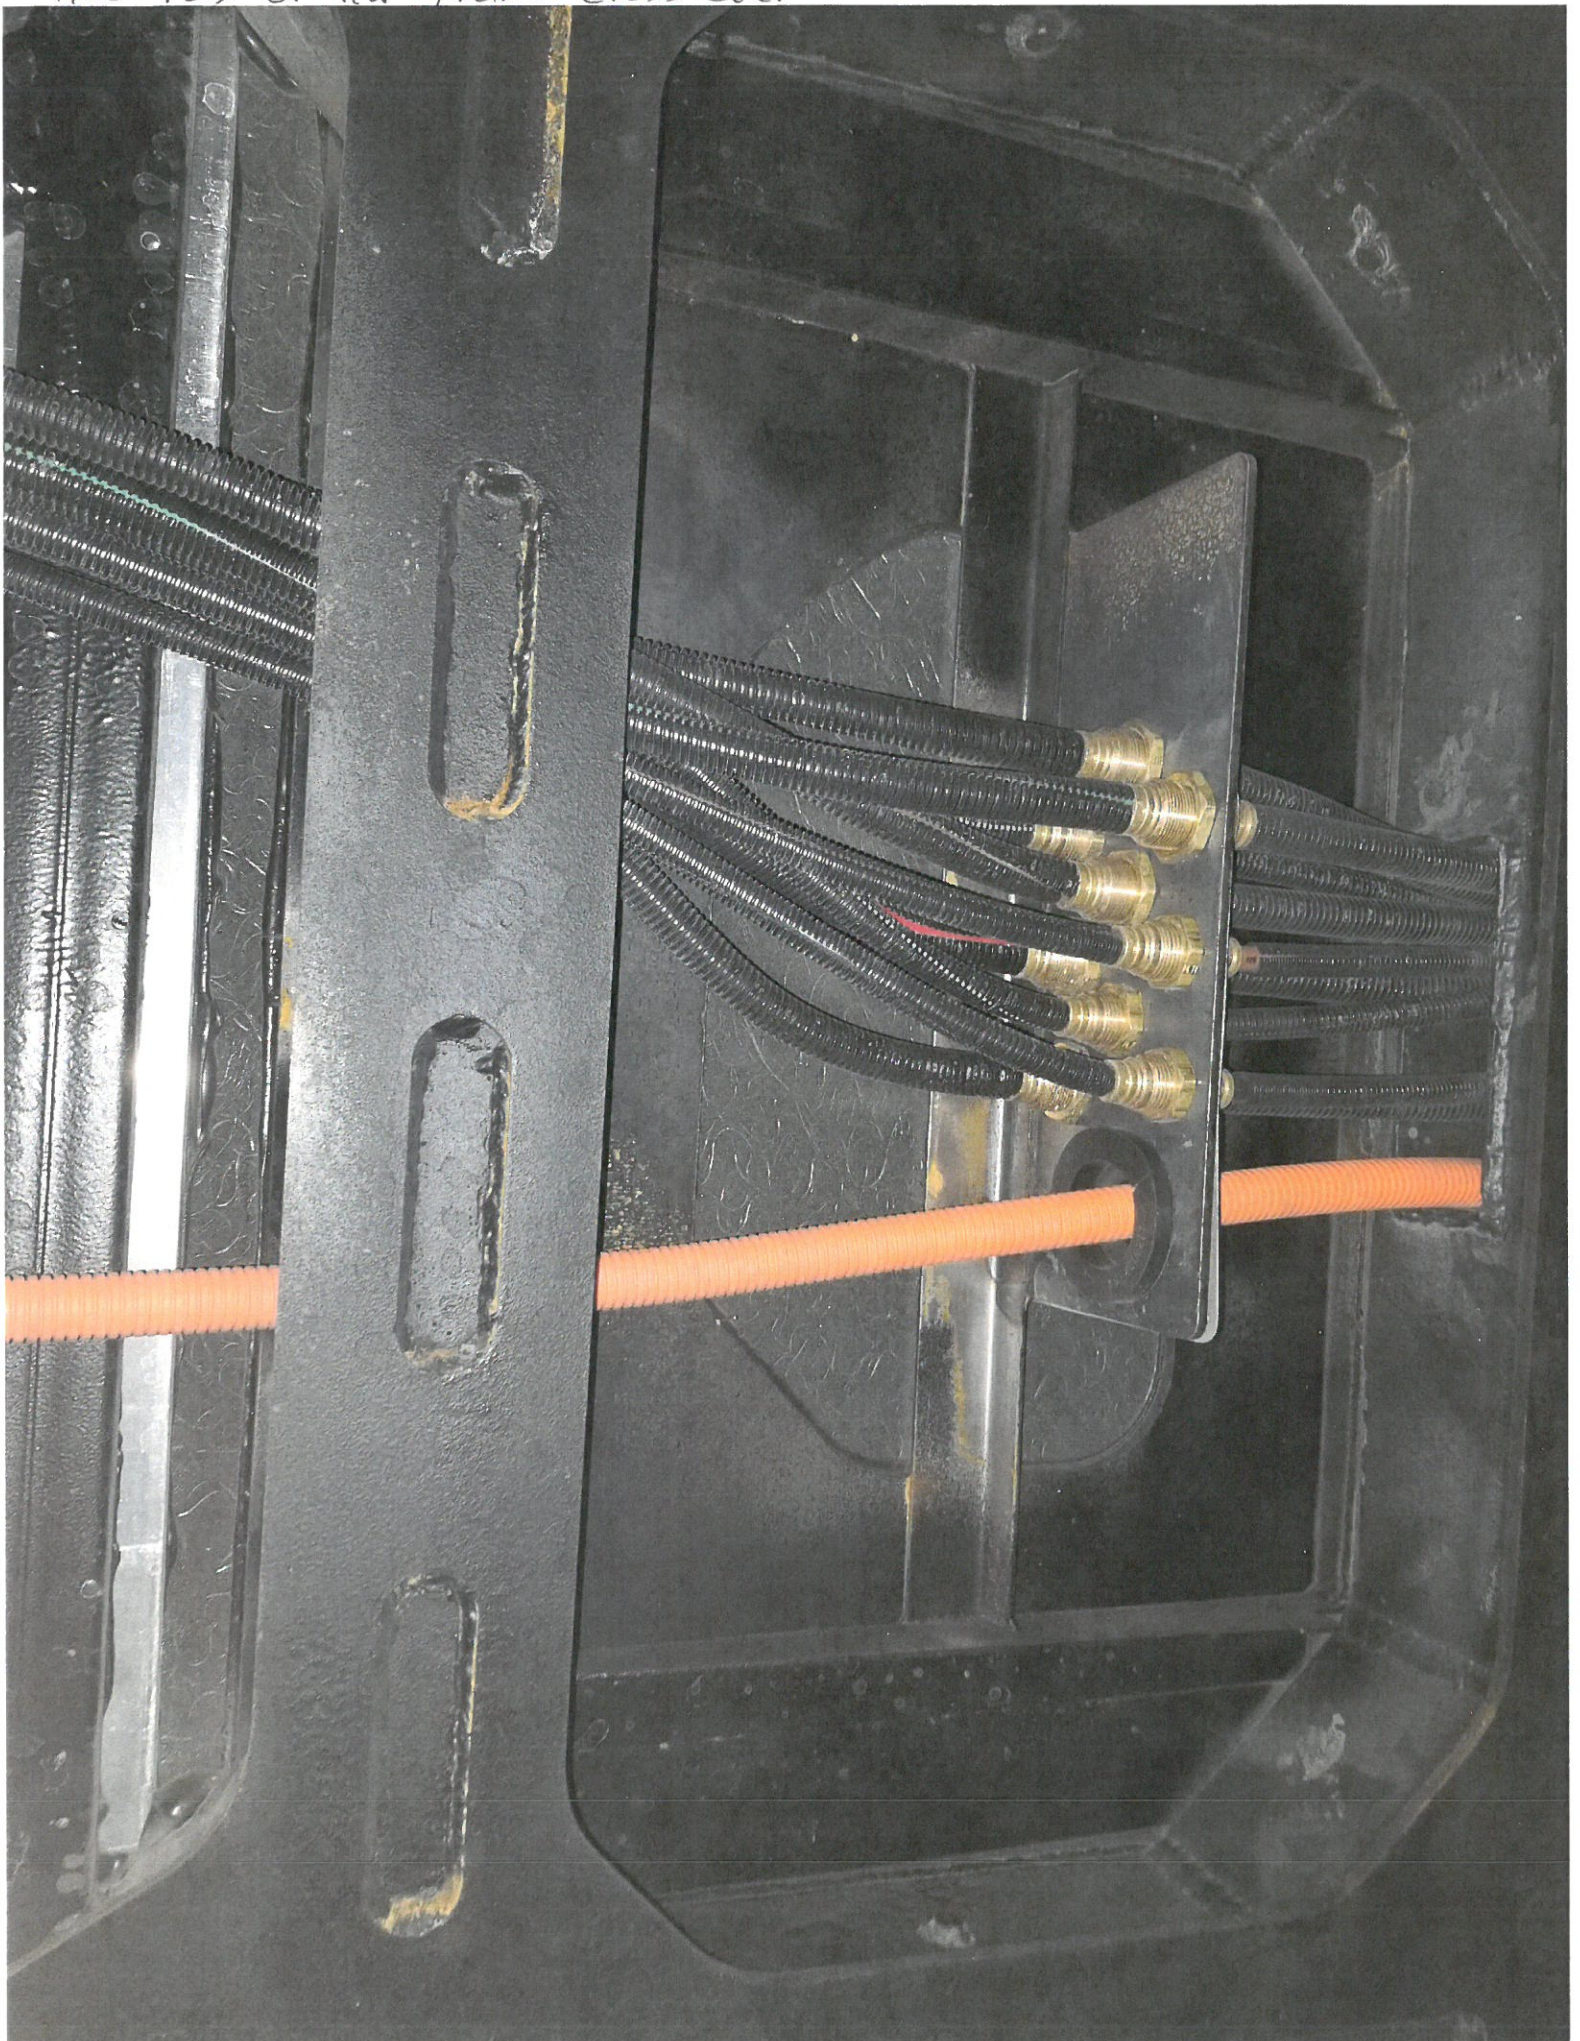
1706 - rust on rear Frame Cross over
