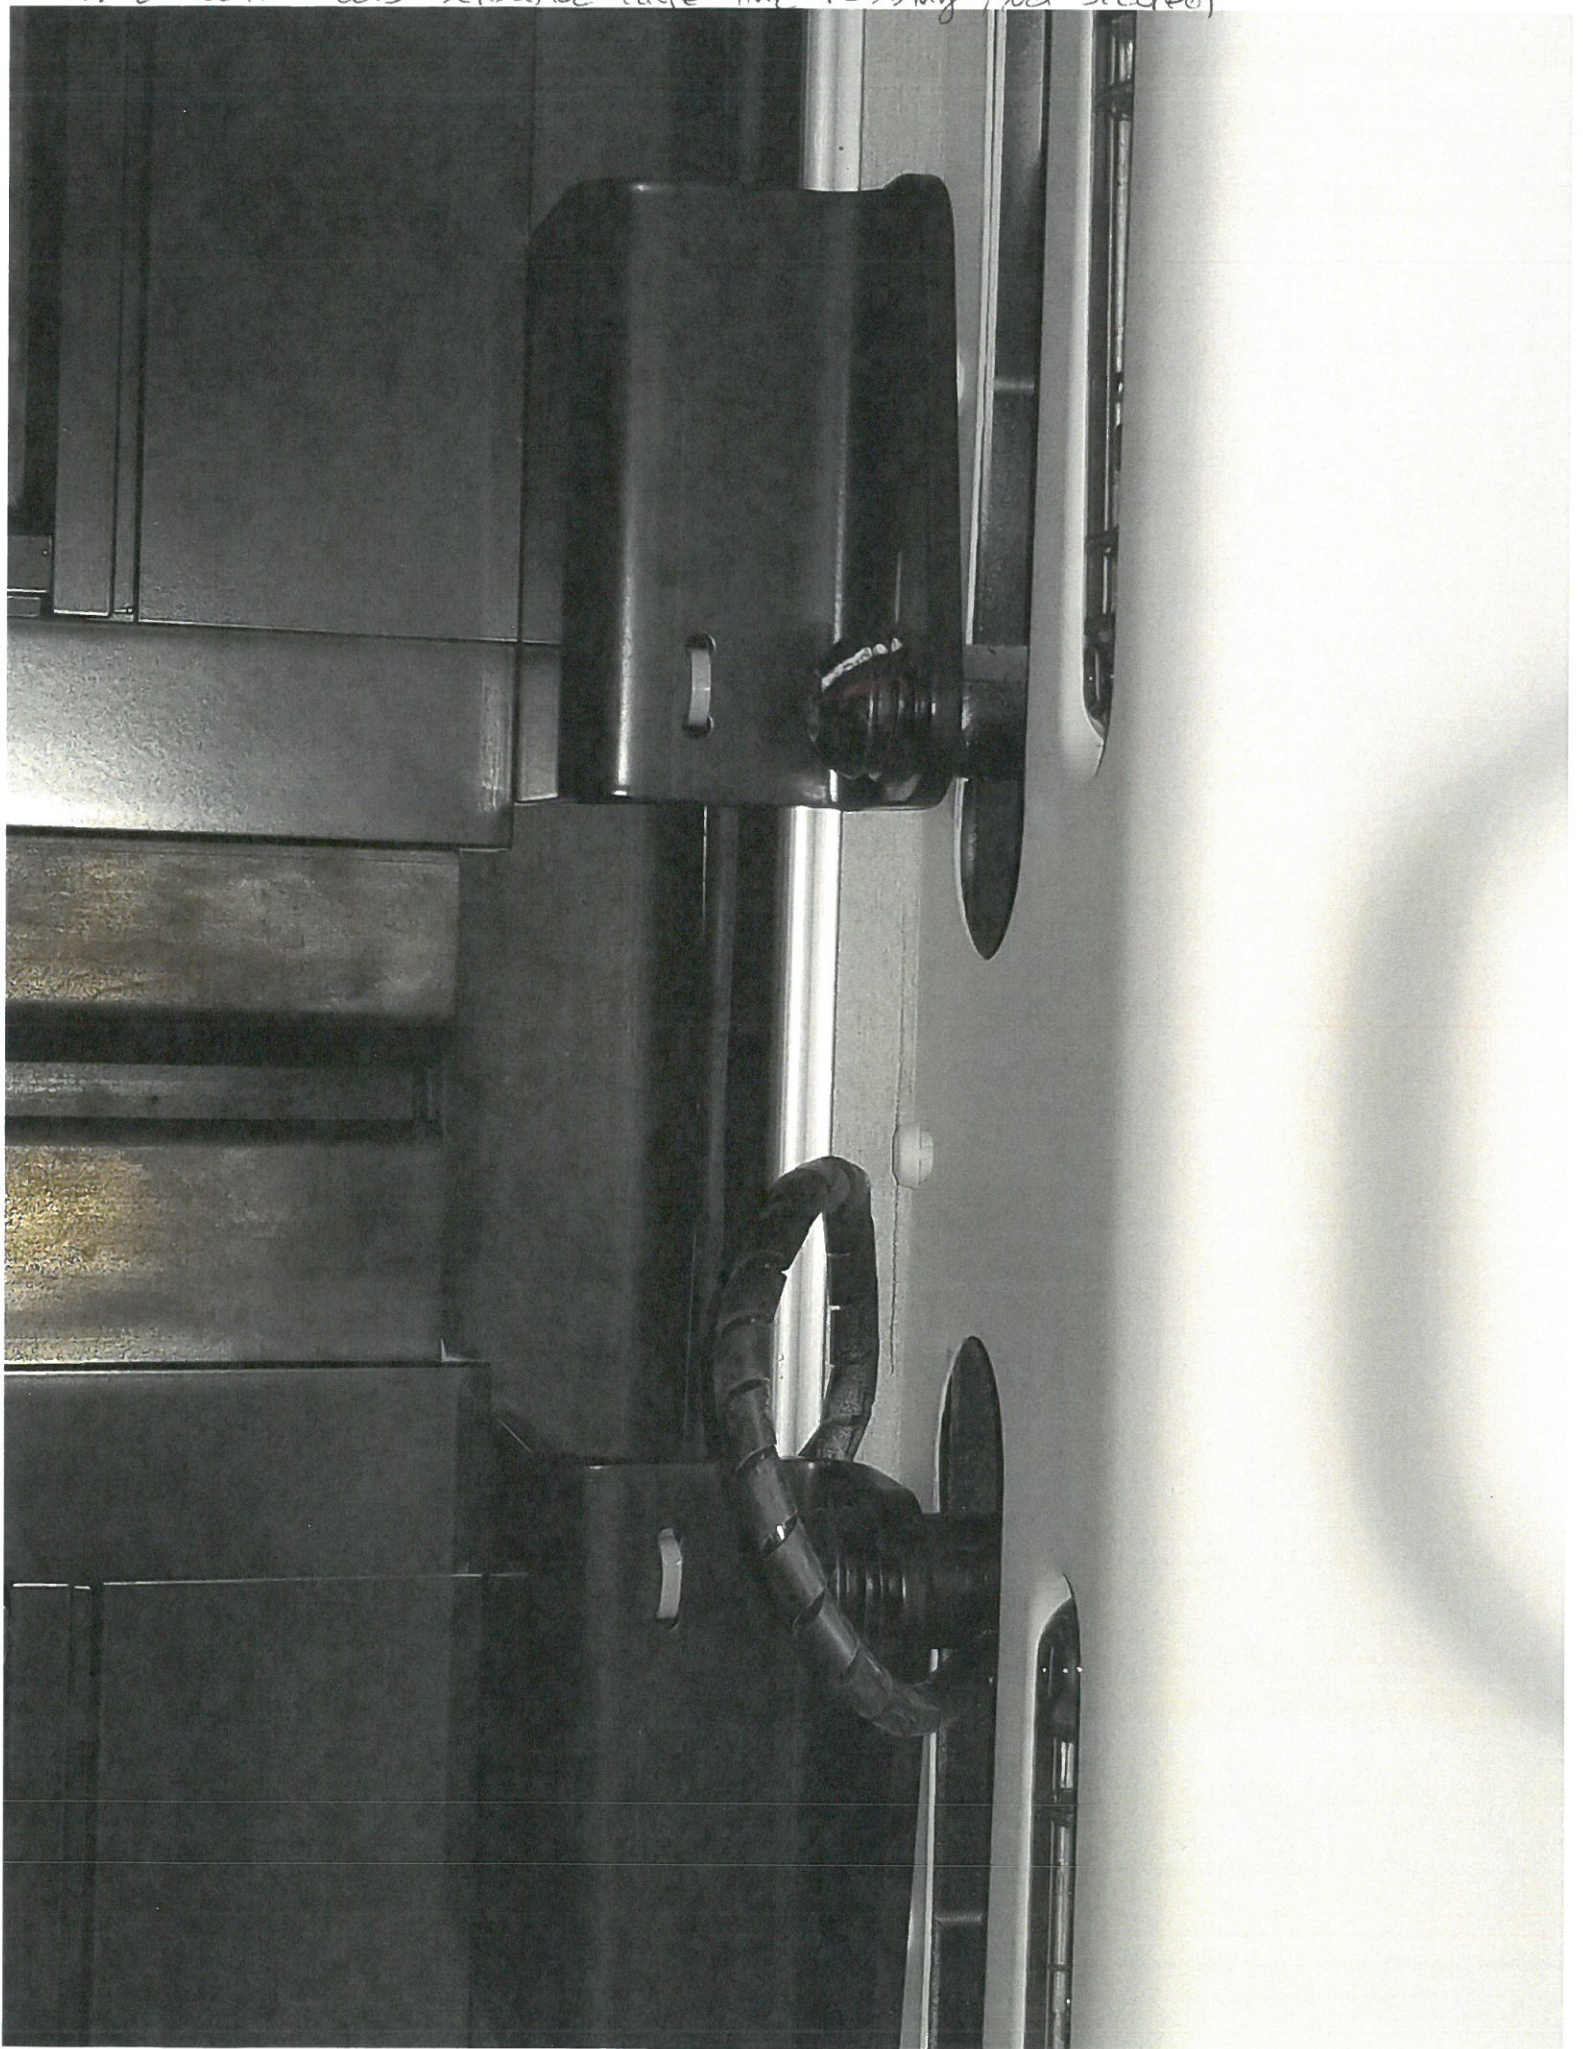
1708 - center doors sensitive edge line Ribbing, not secured)

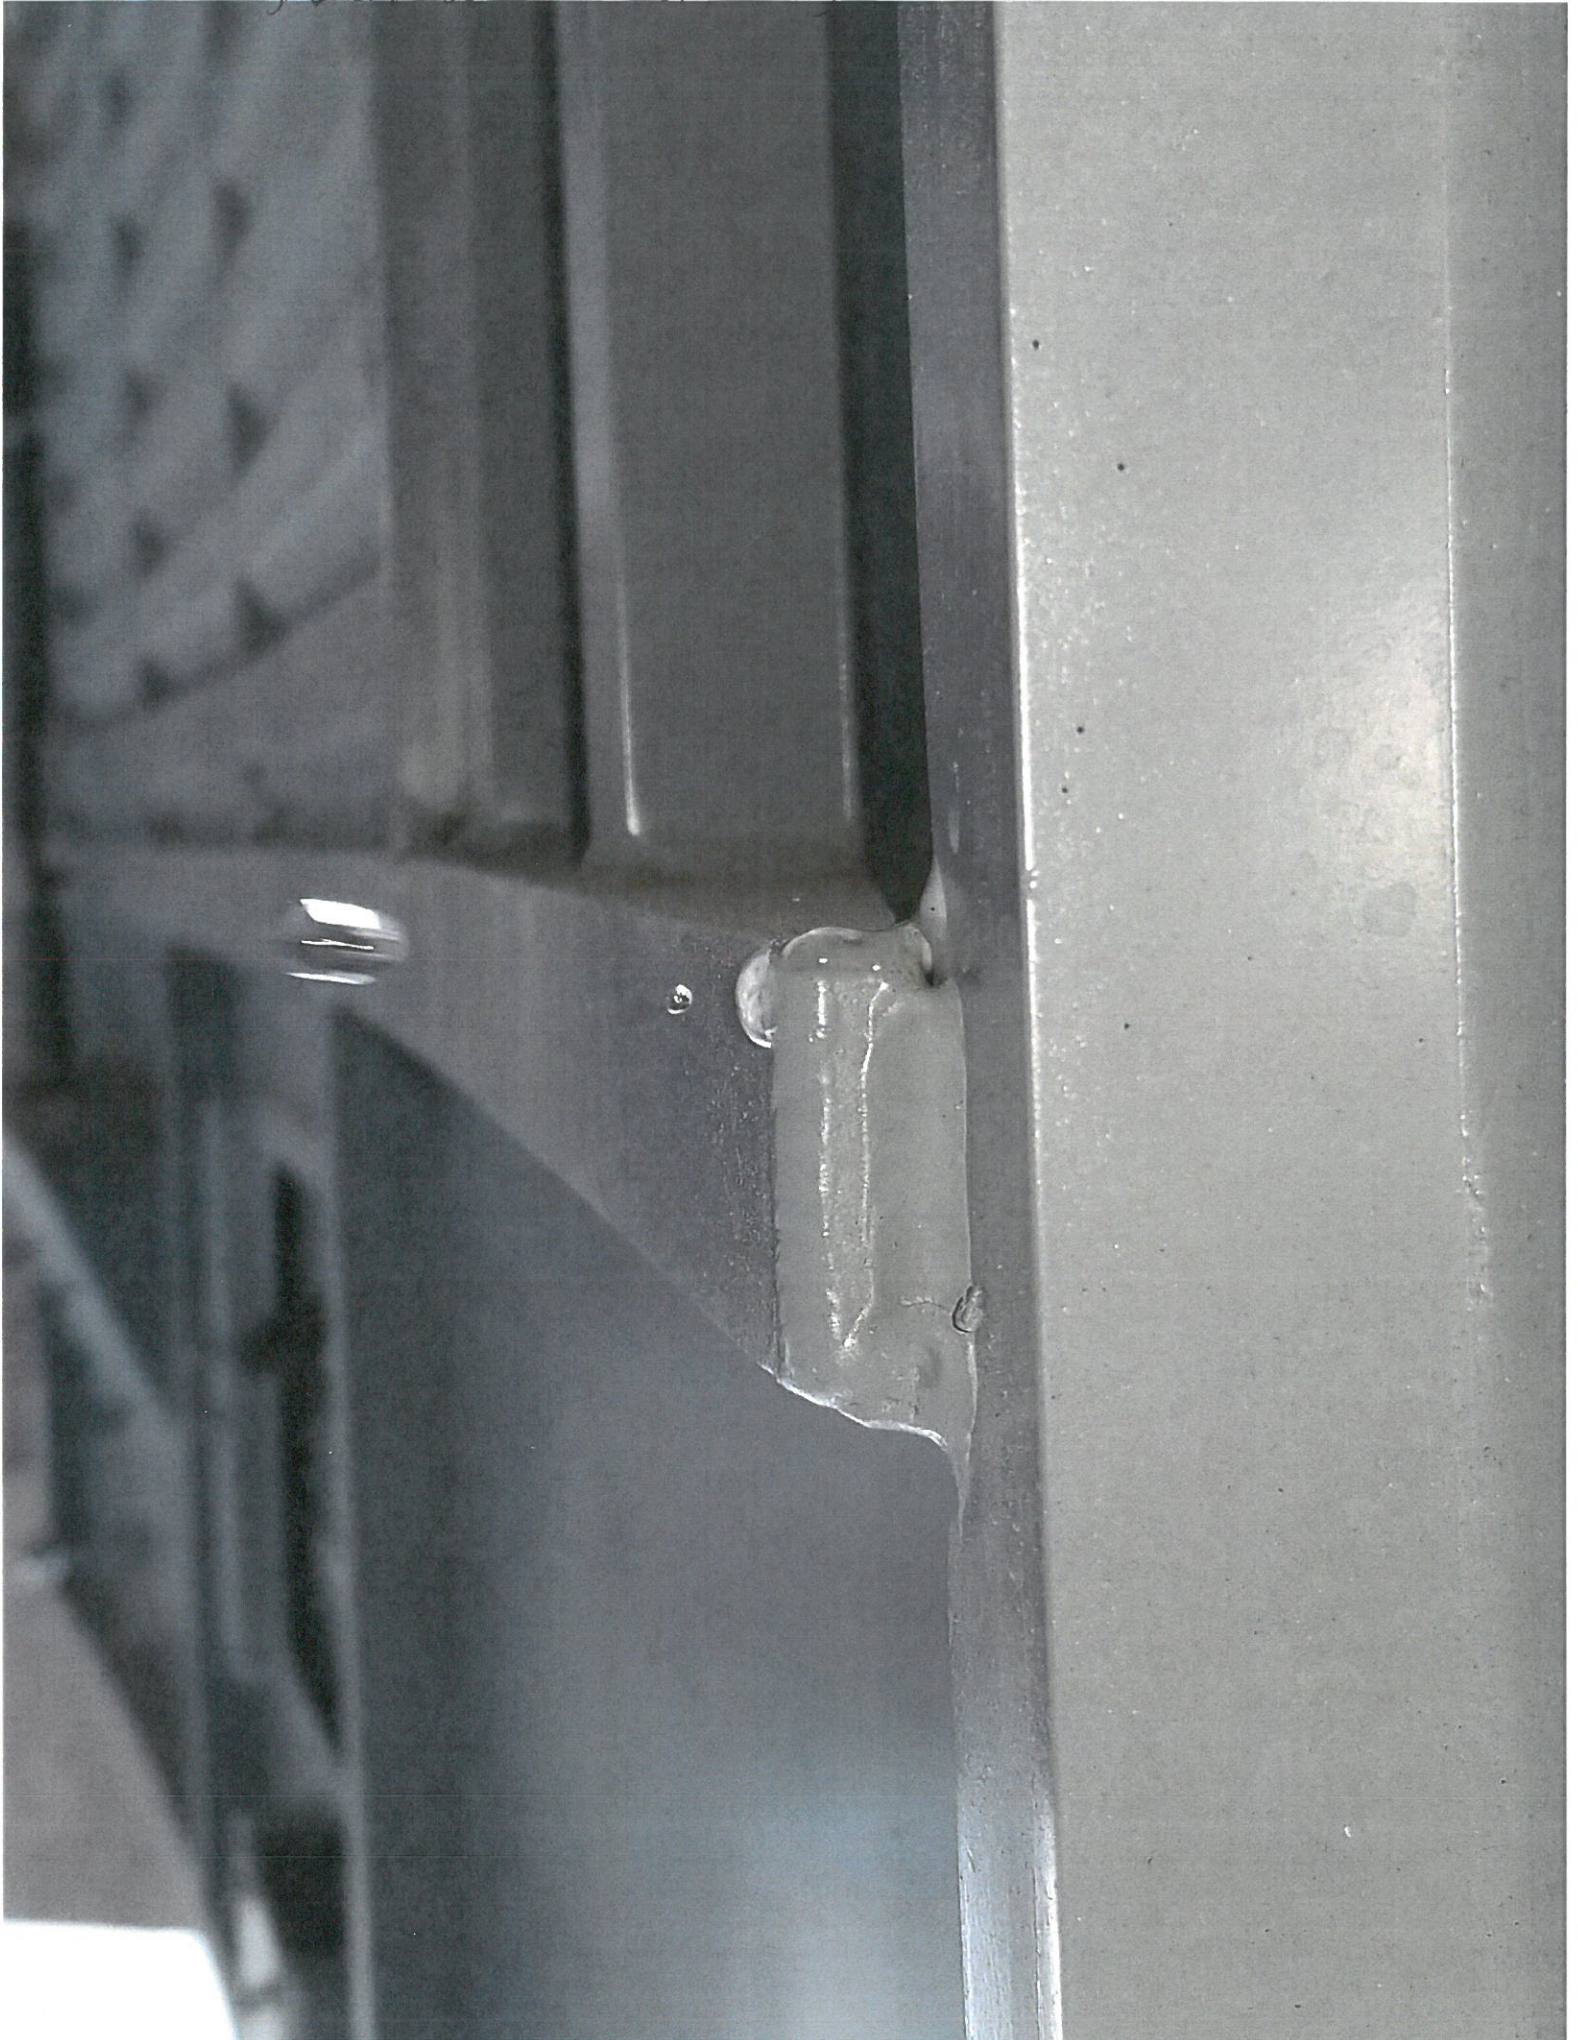
1708- Engine Comp Door weld S/S leaking water

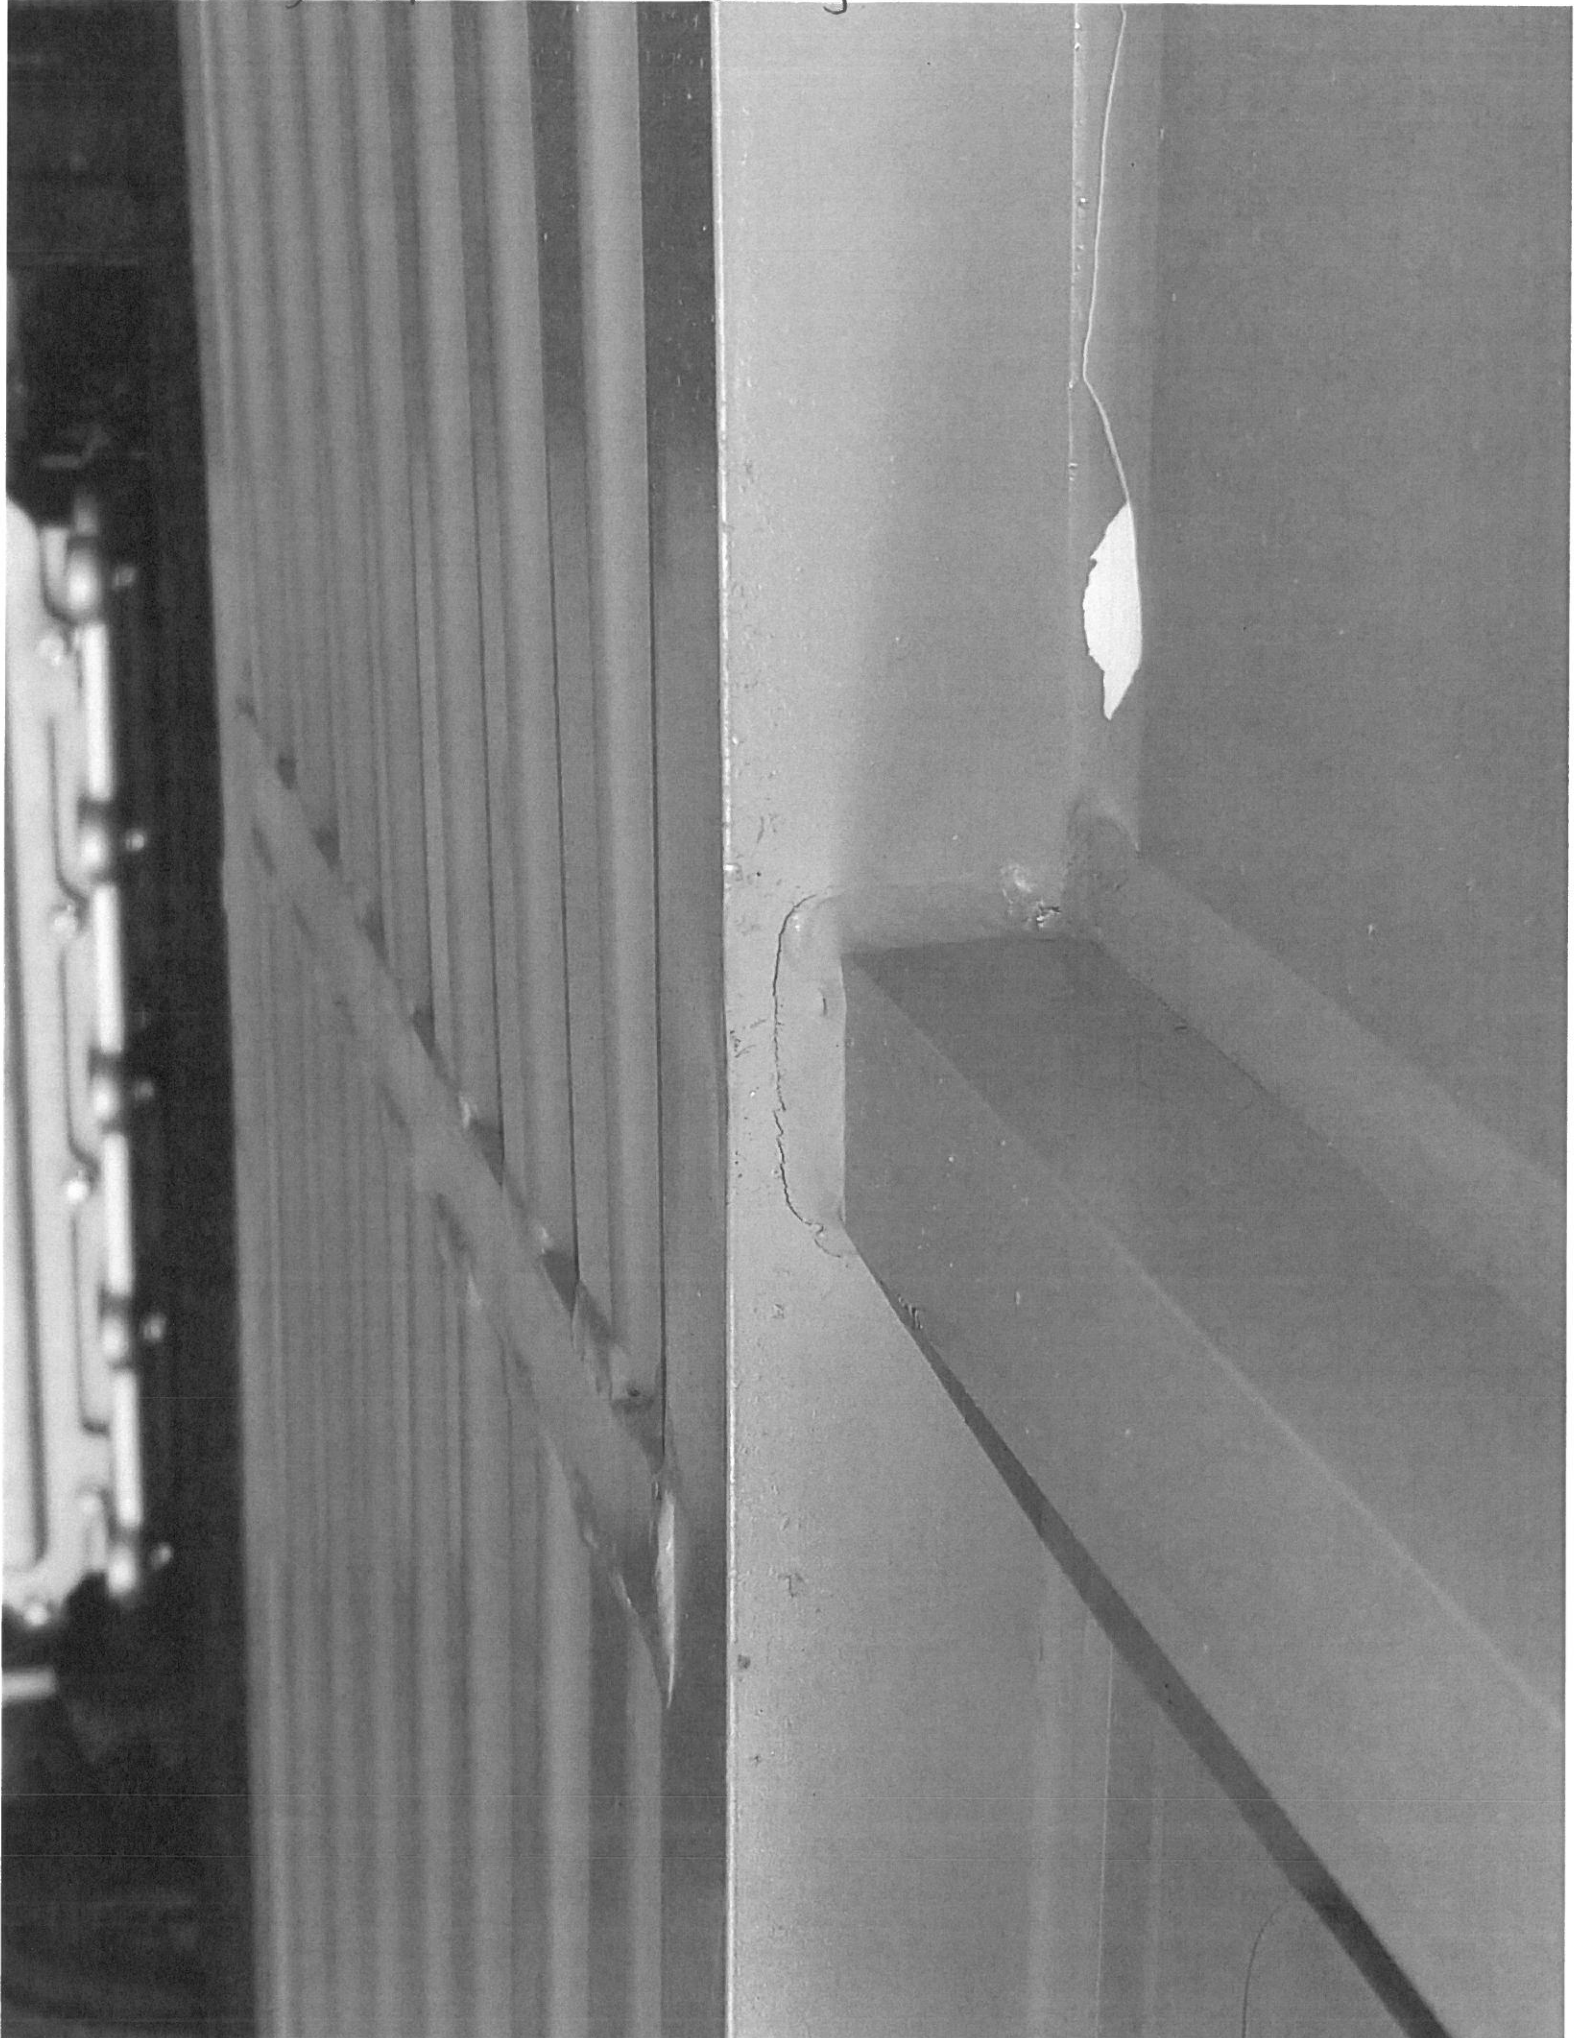
1708- Engine Cnpt Door welds cracking

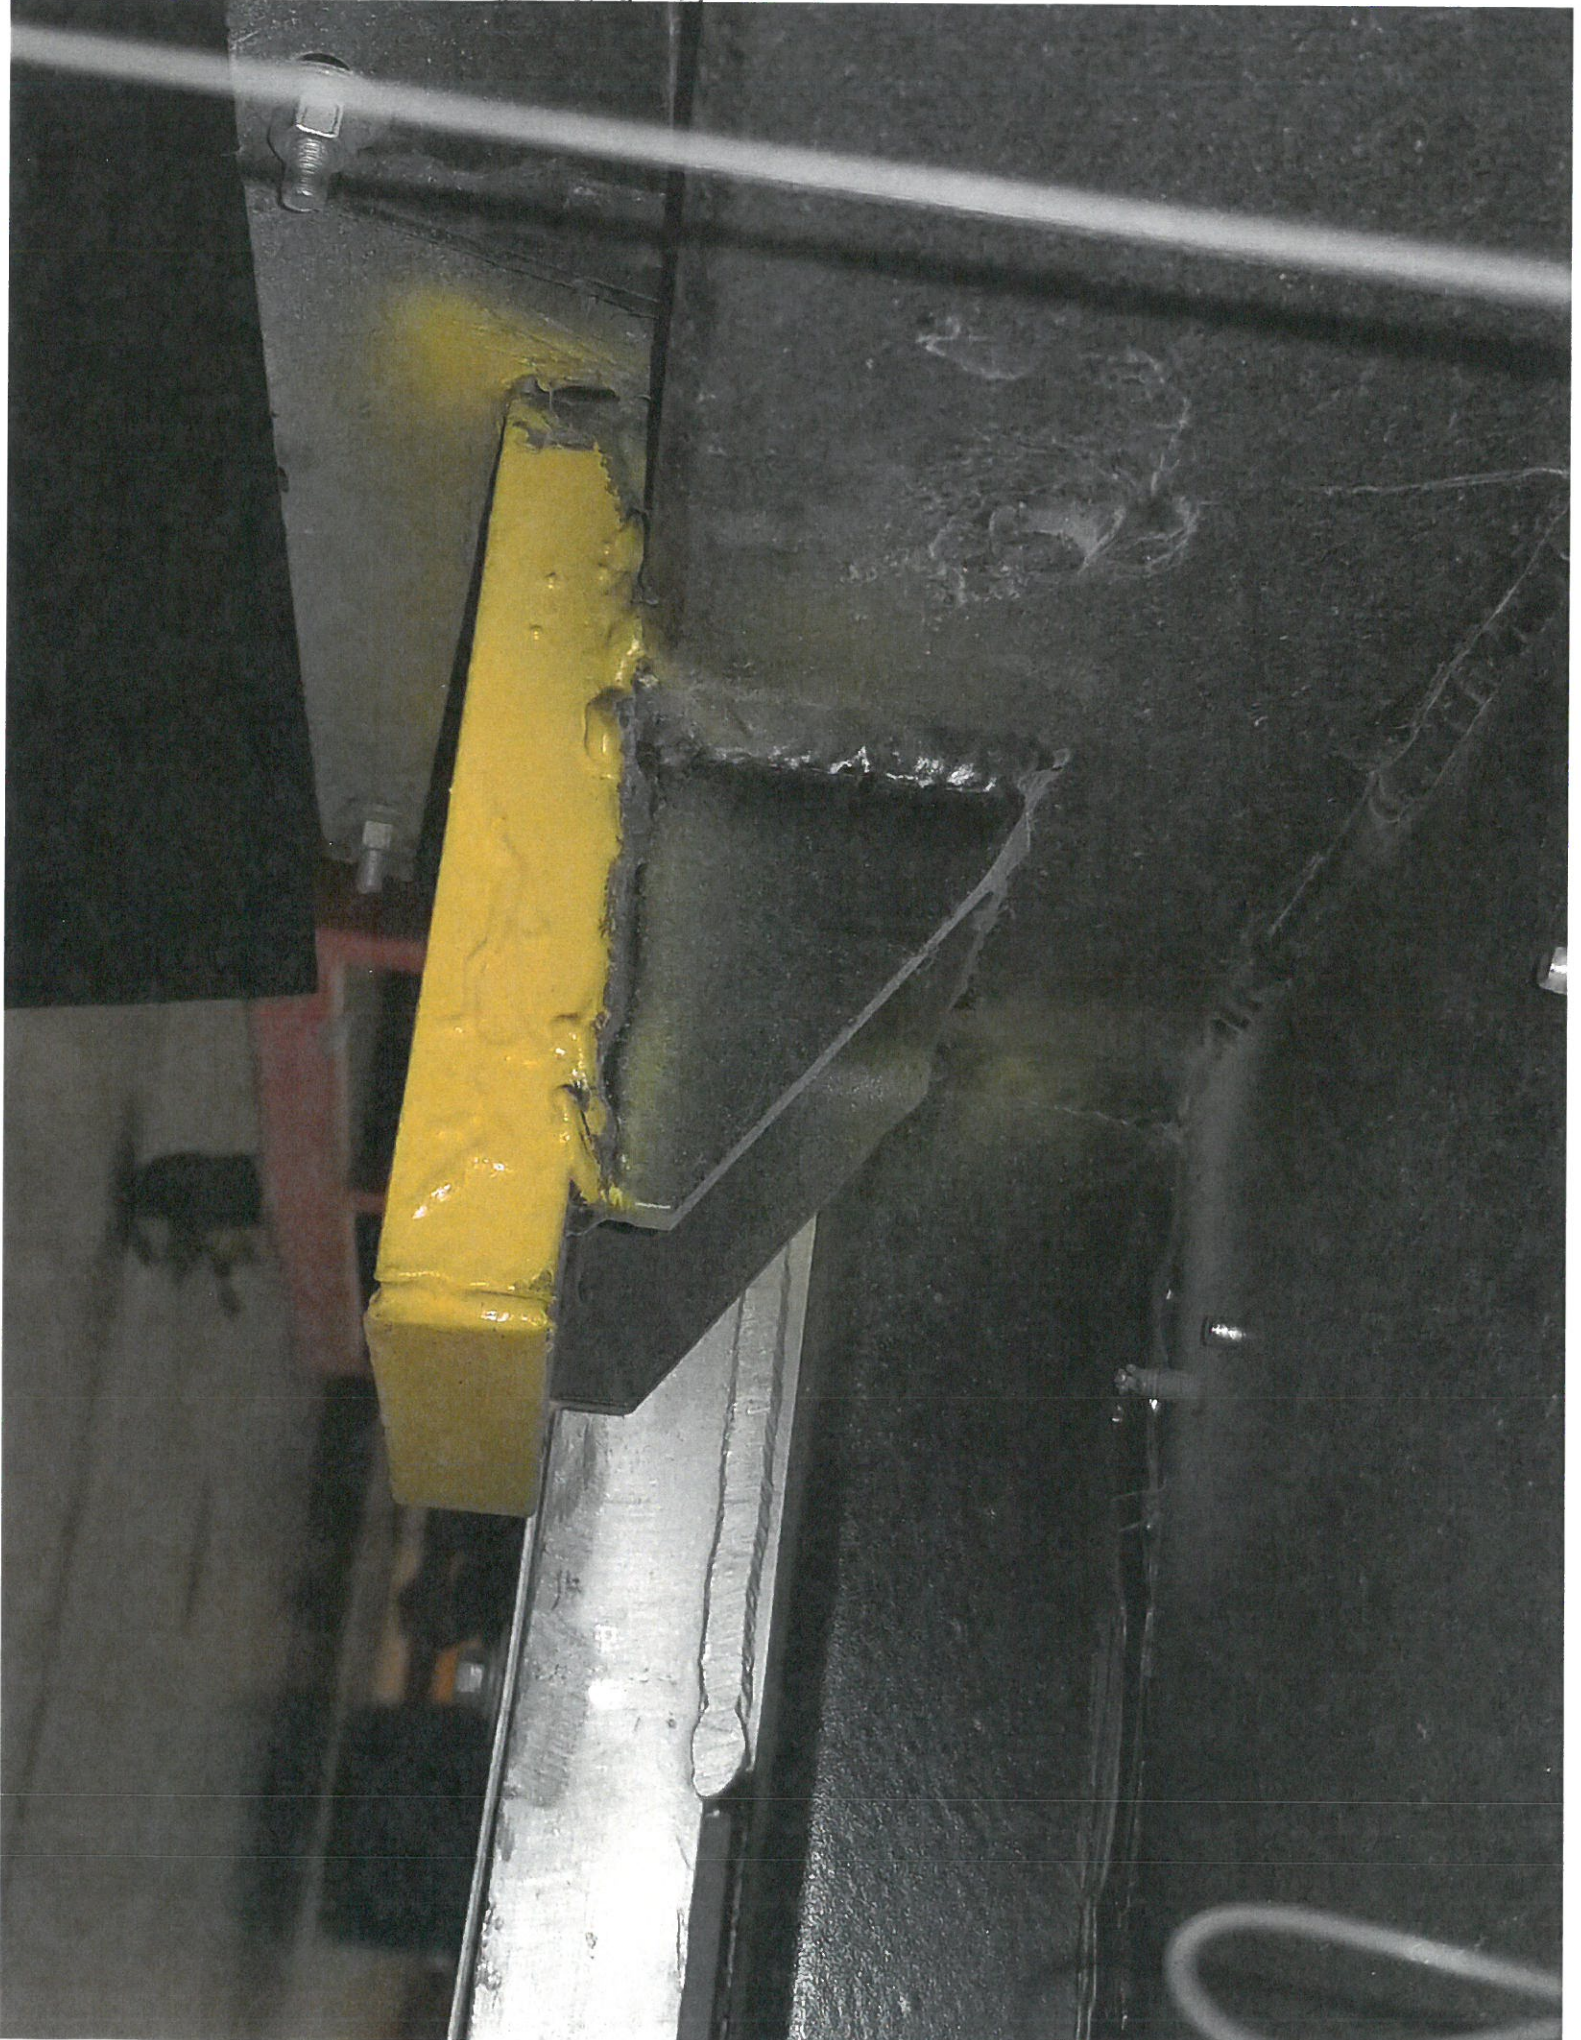
1708 Questionable strength of jack point

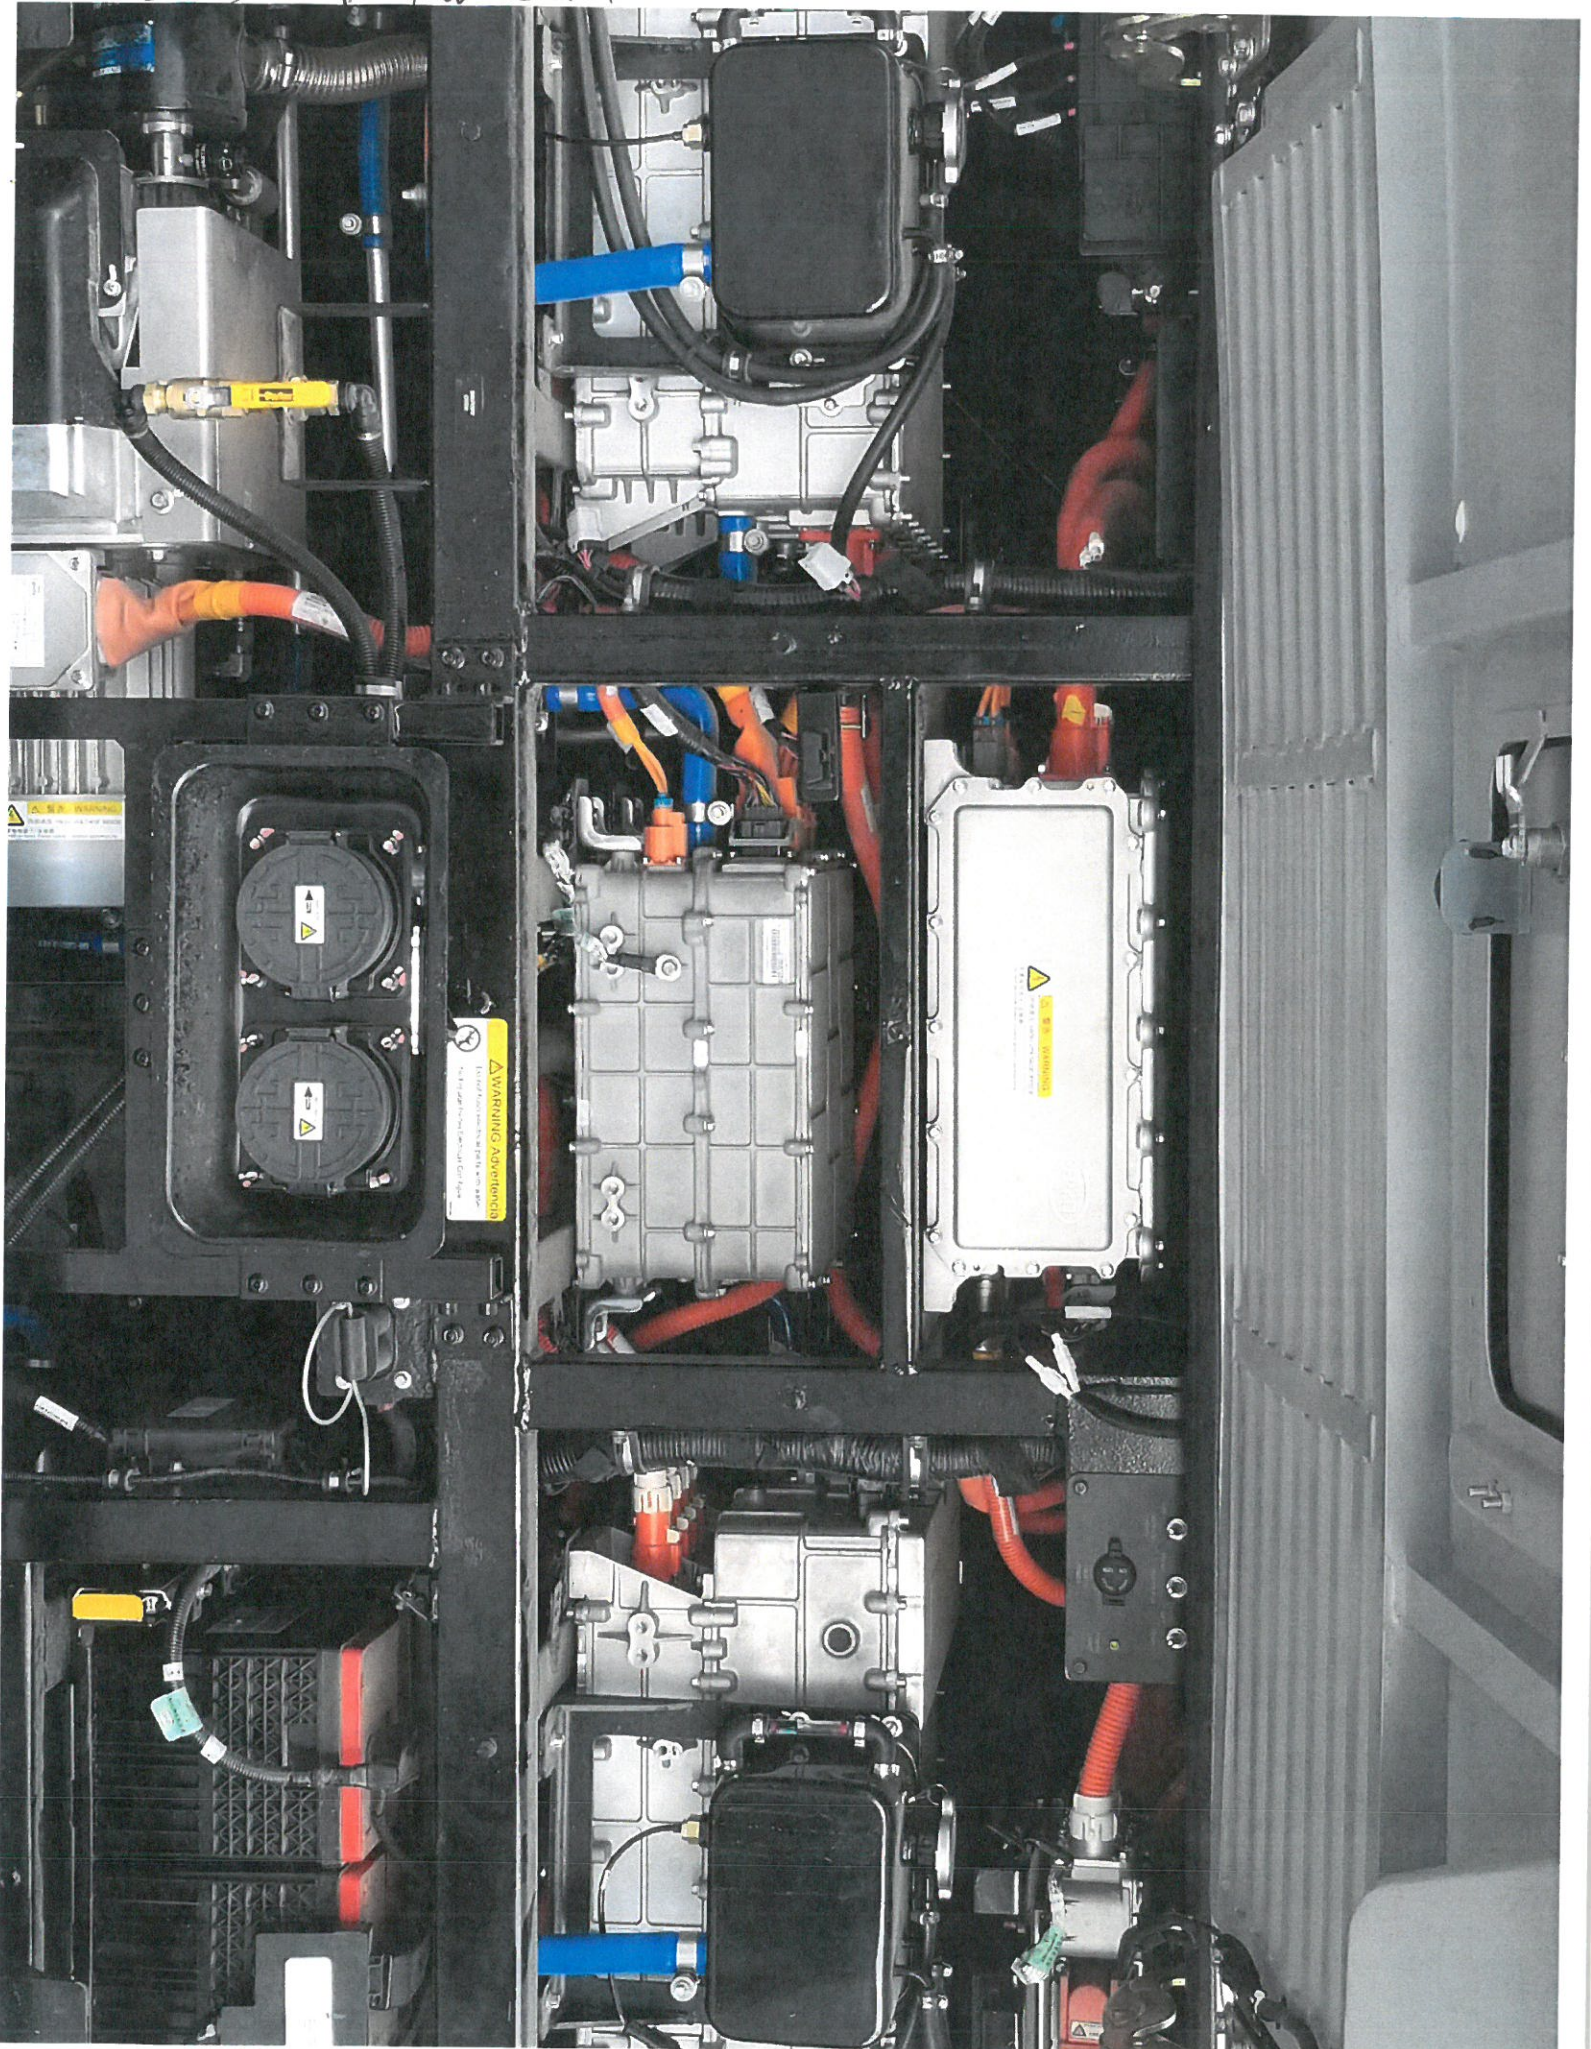
1708 Engine Crpt - low coolant

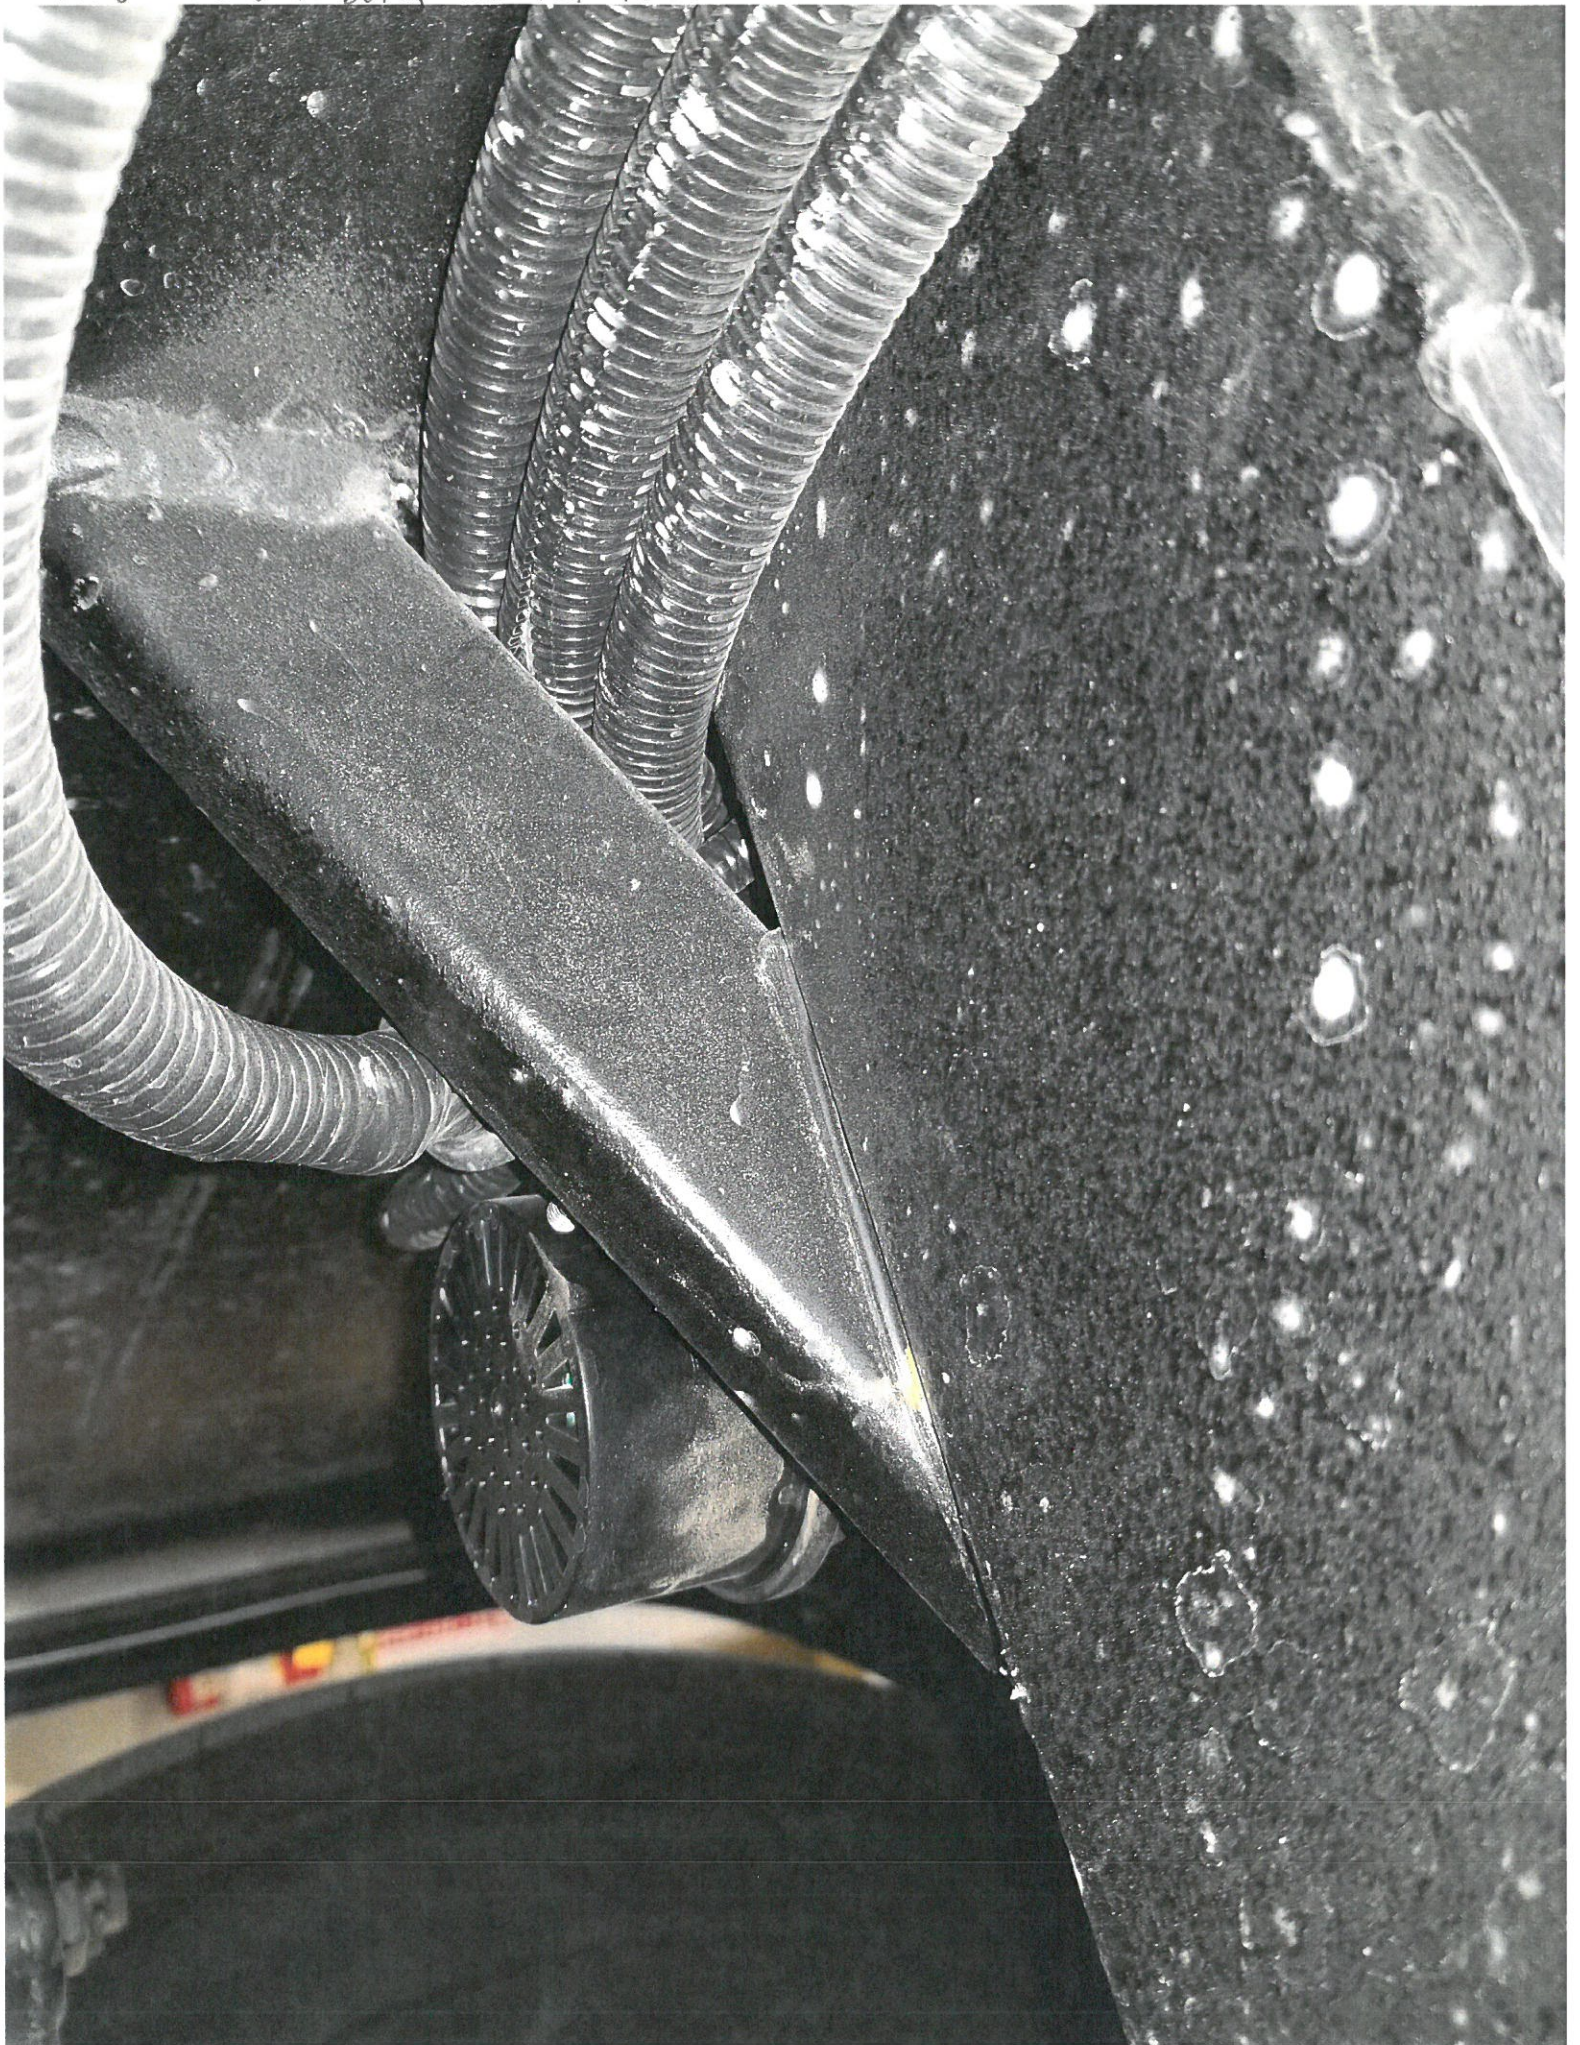
1708 lines rubbing and rust from weld

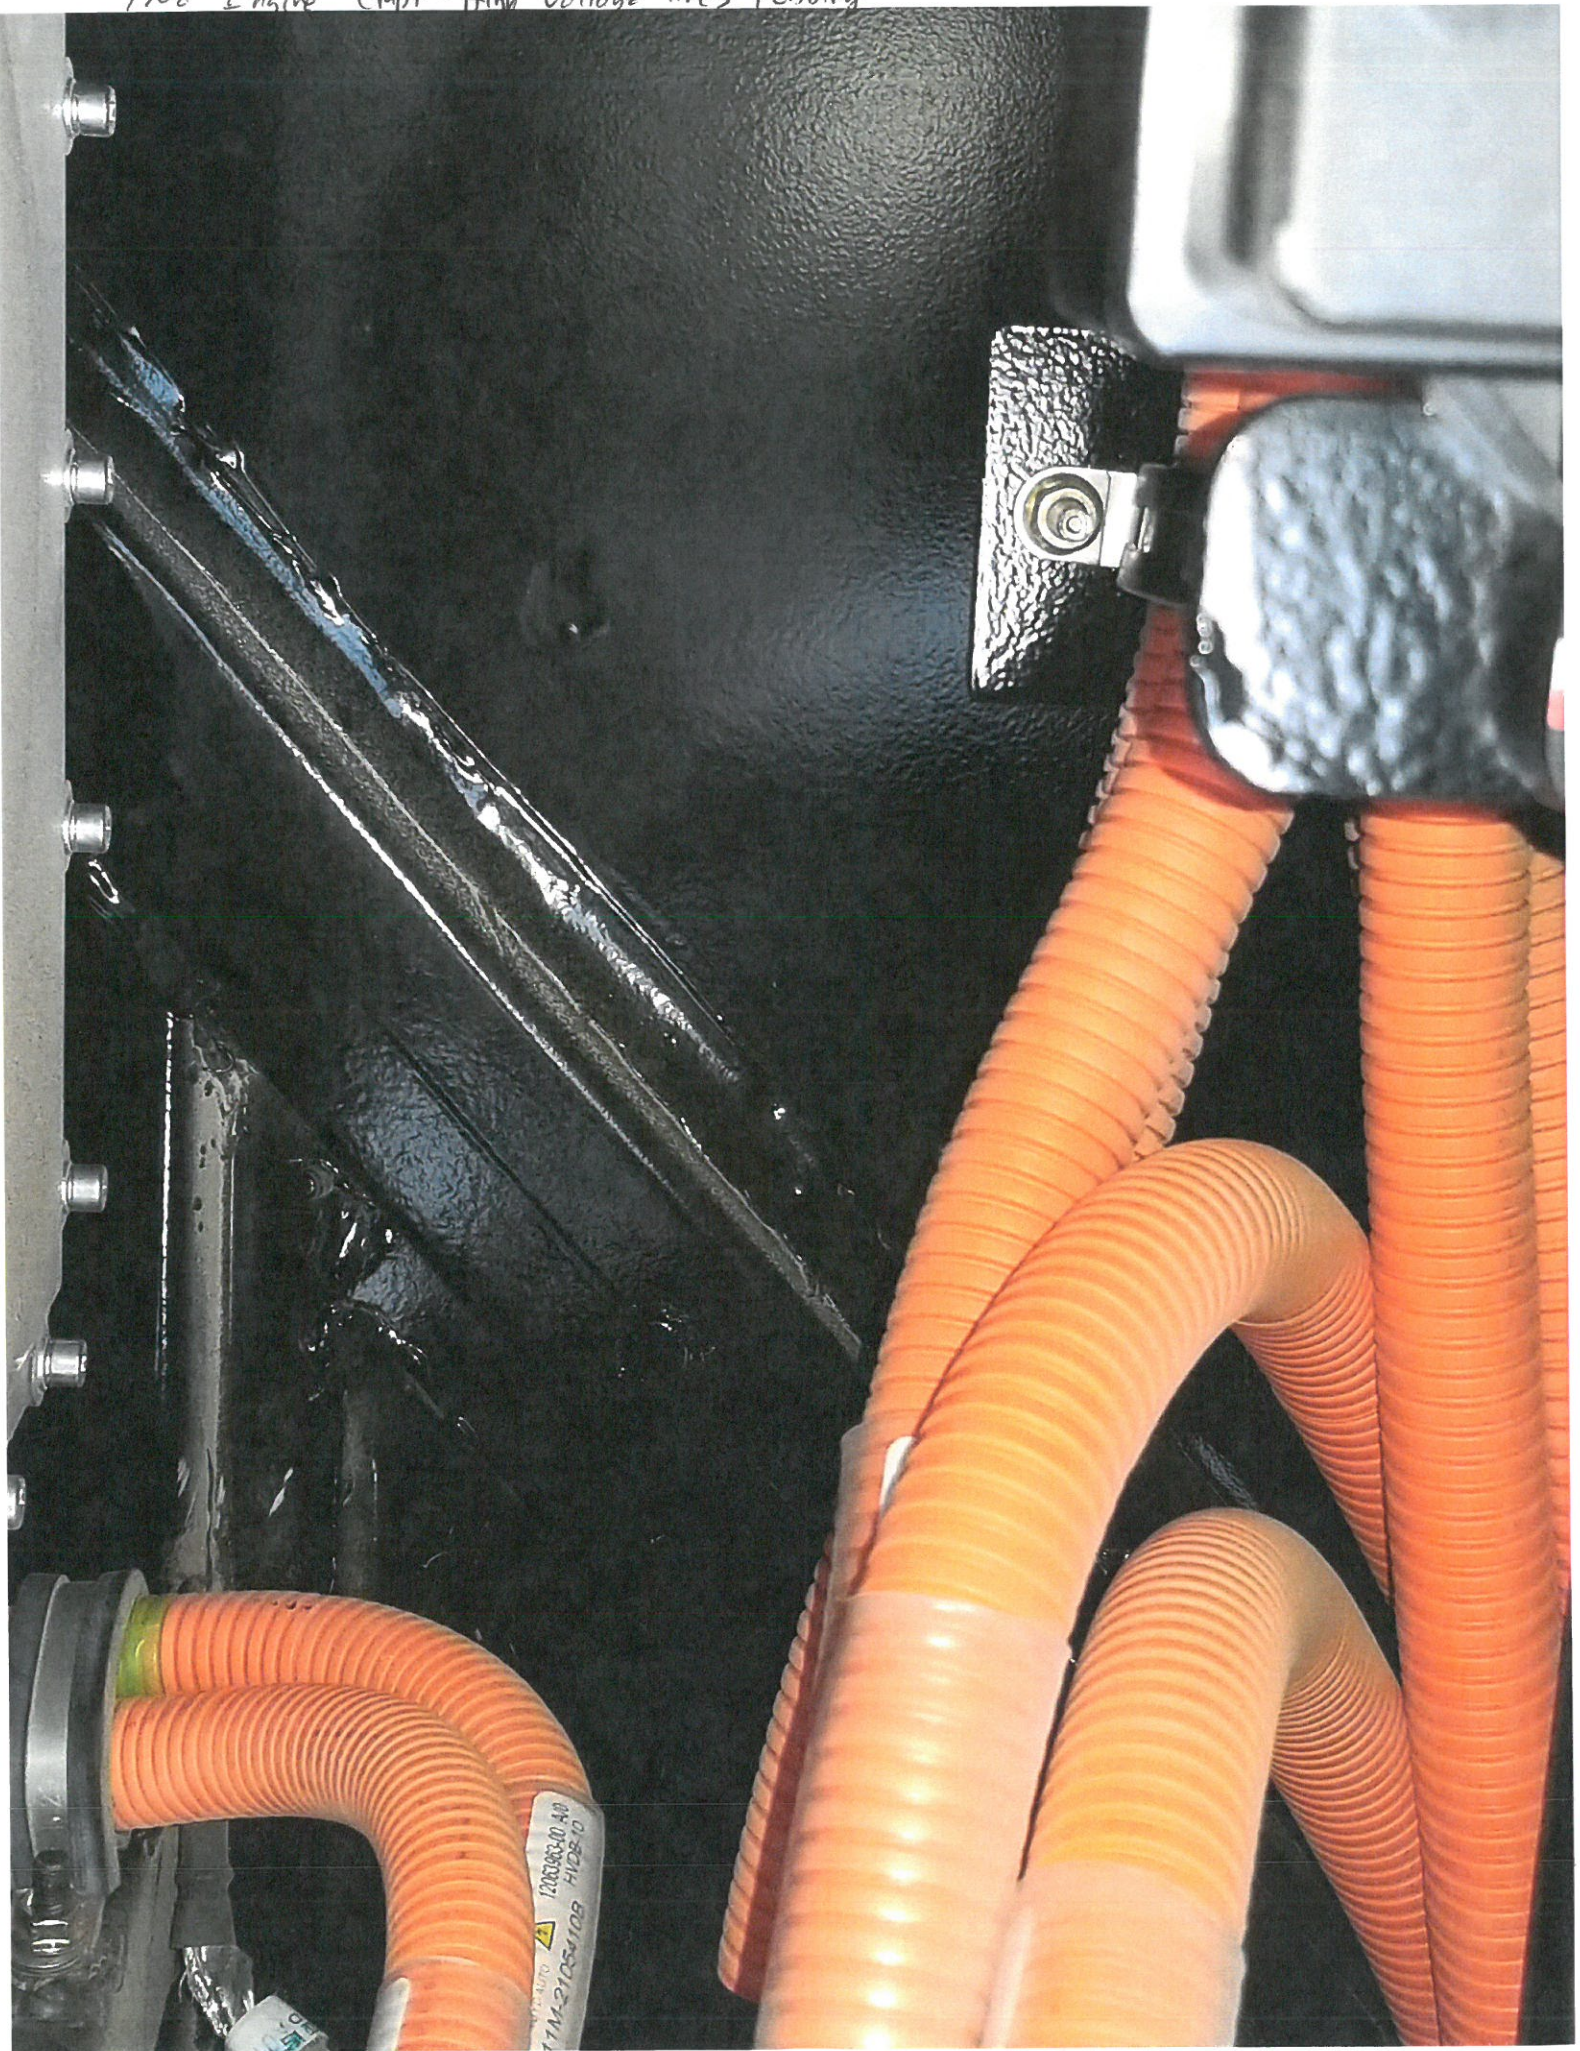
1708 Engine Cmpnt - High voltage lines rubbing
