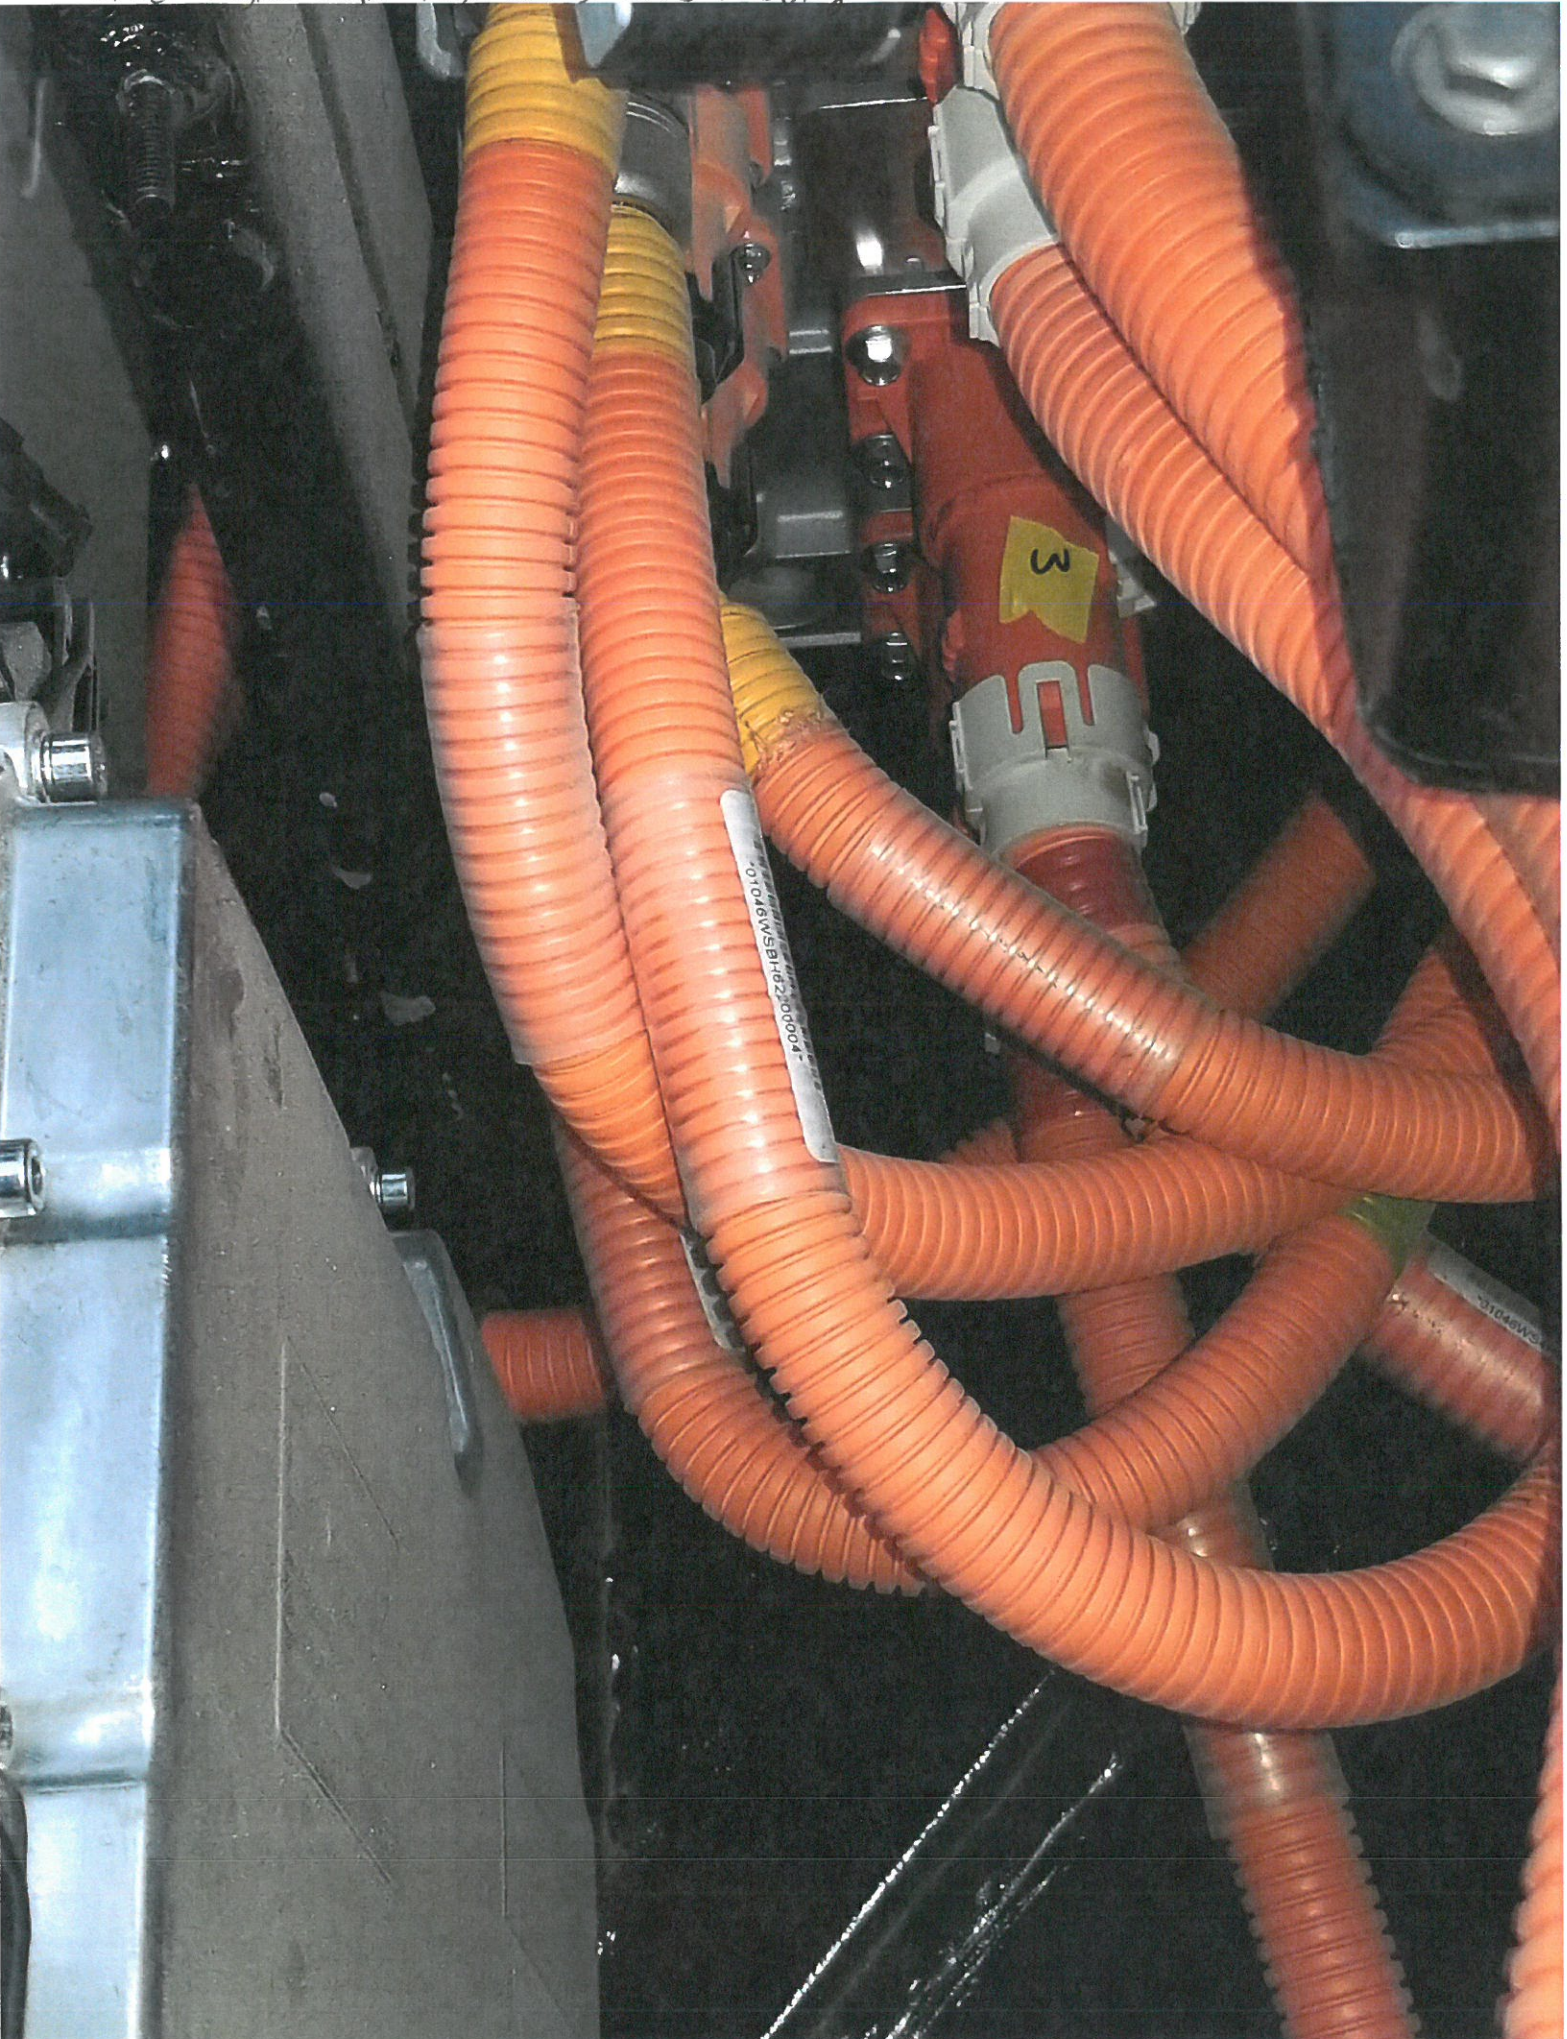
1708- Engine Crpt High Voltage lines rebbing

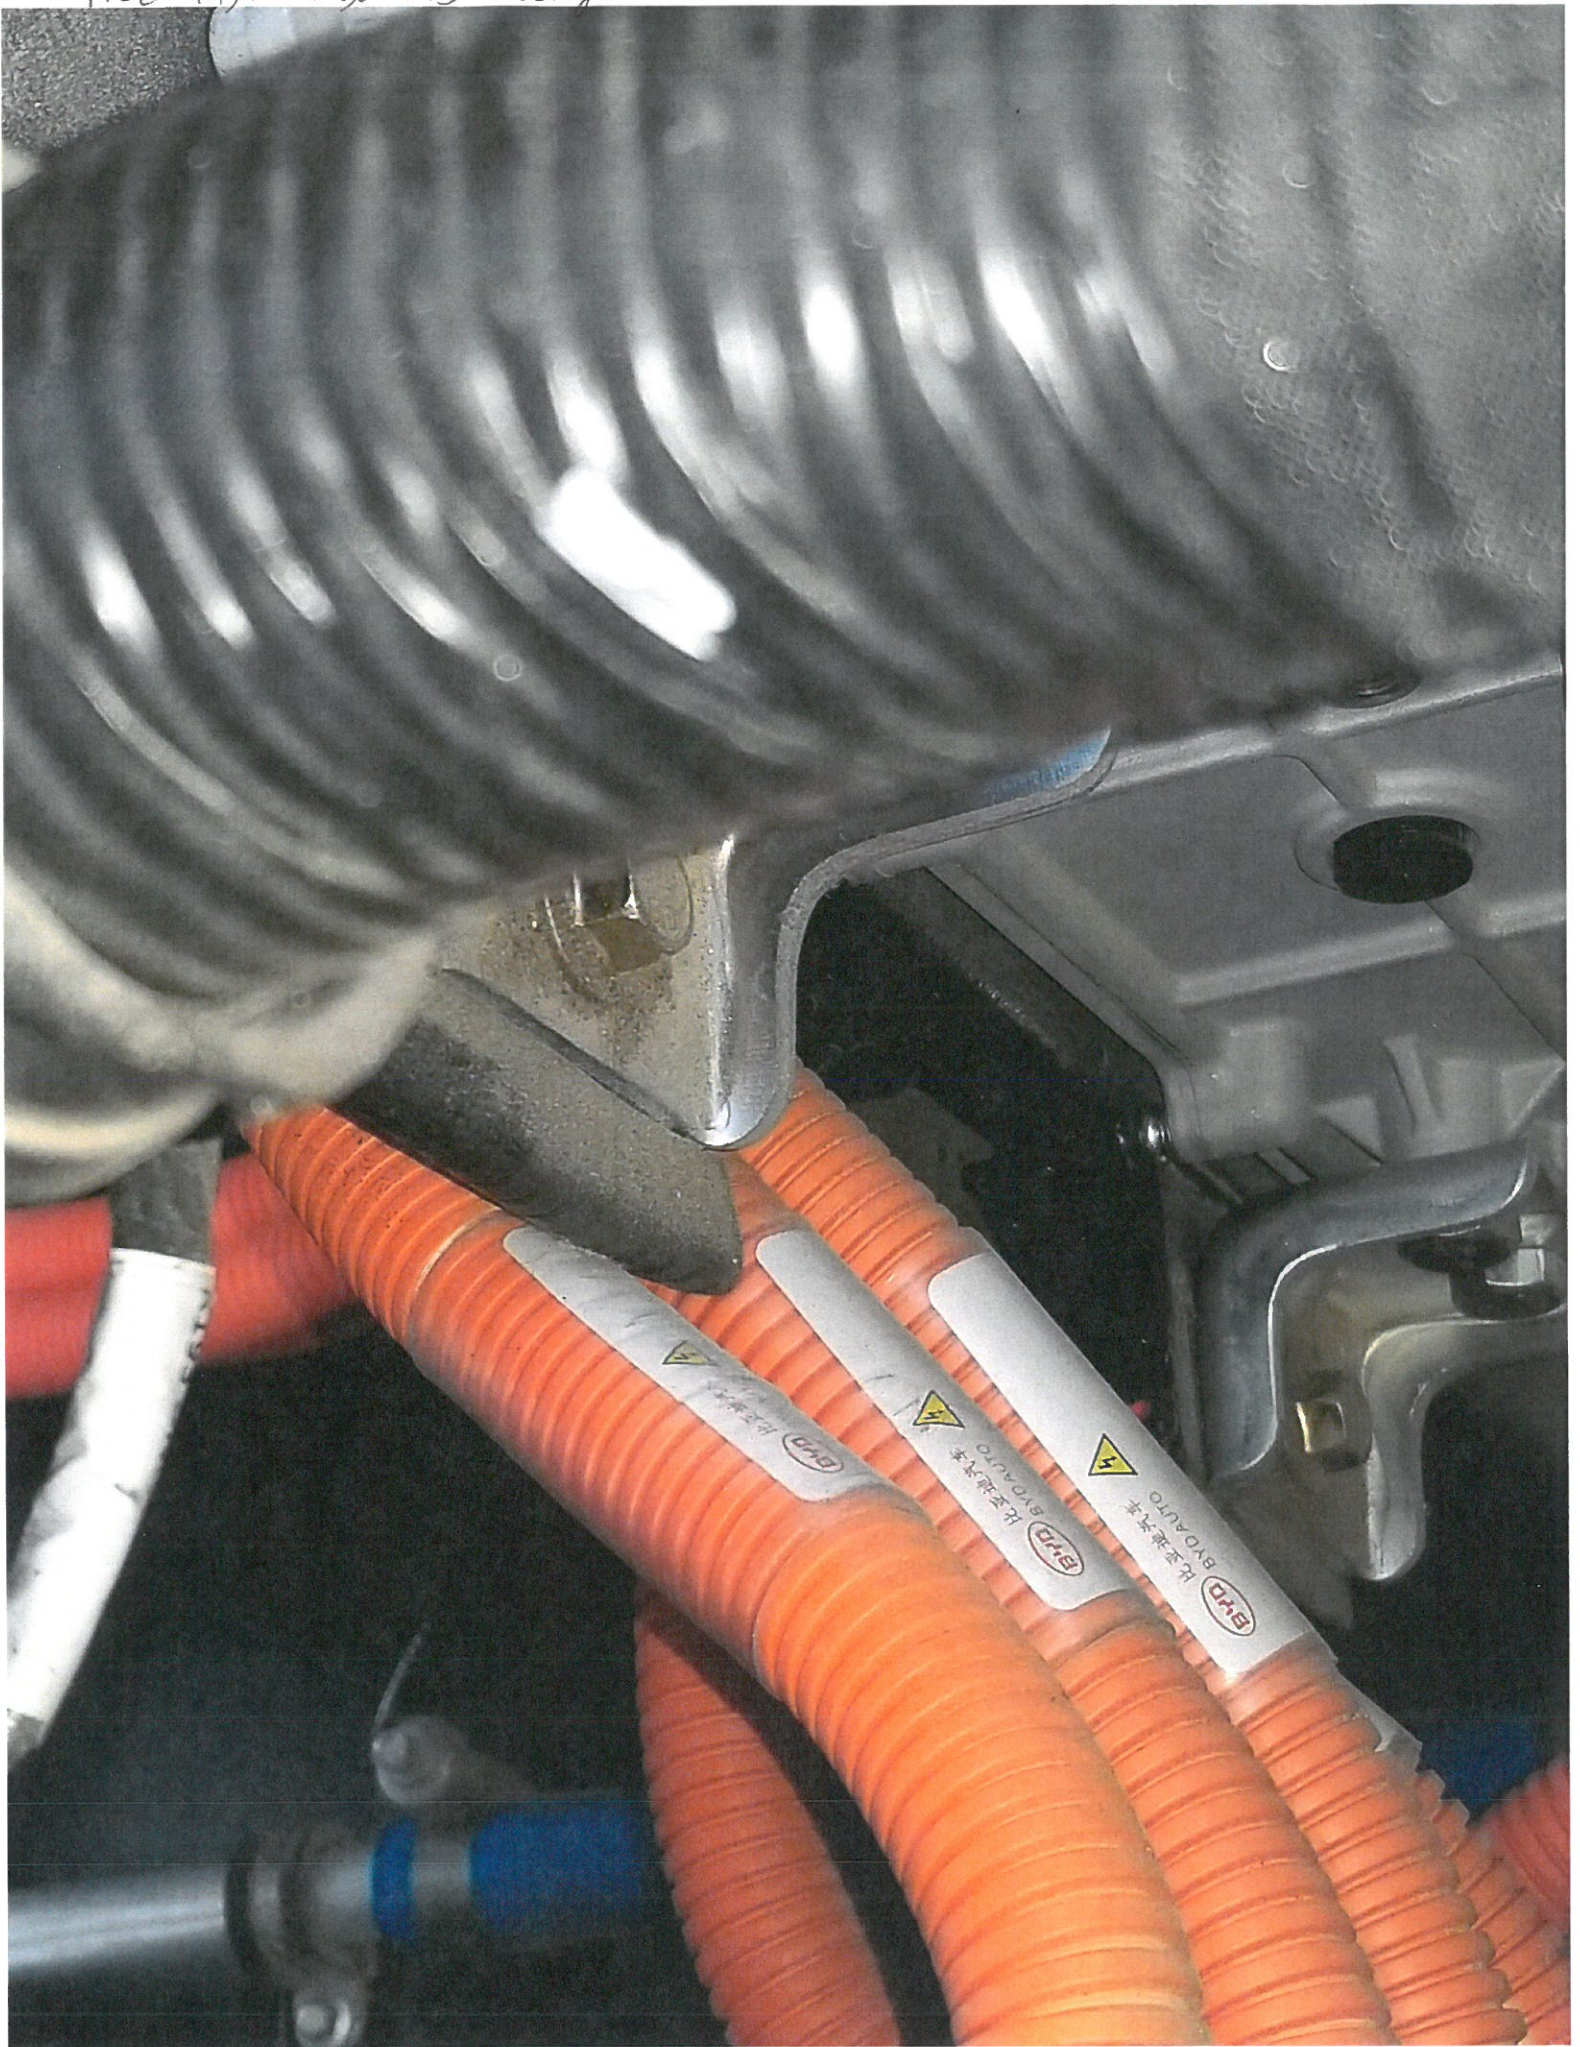
1708 - High voltage wires reblending

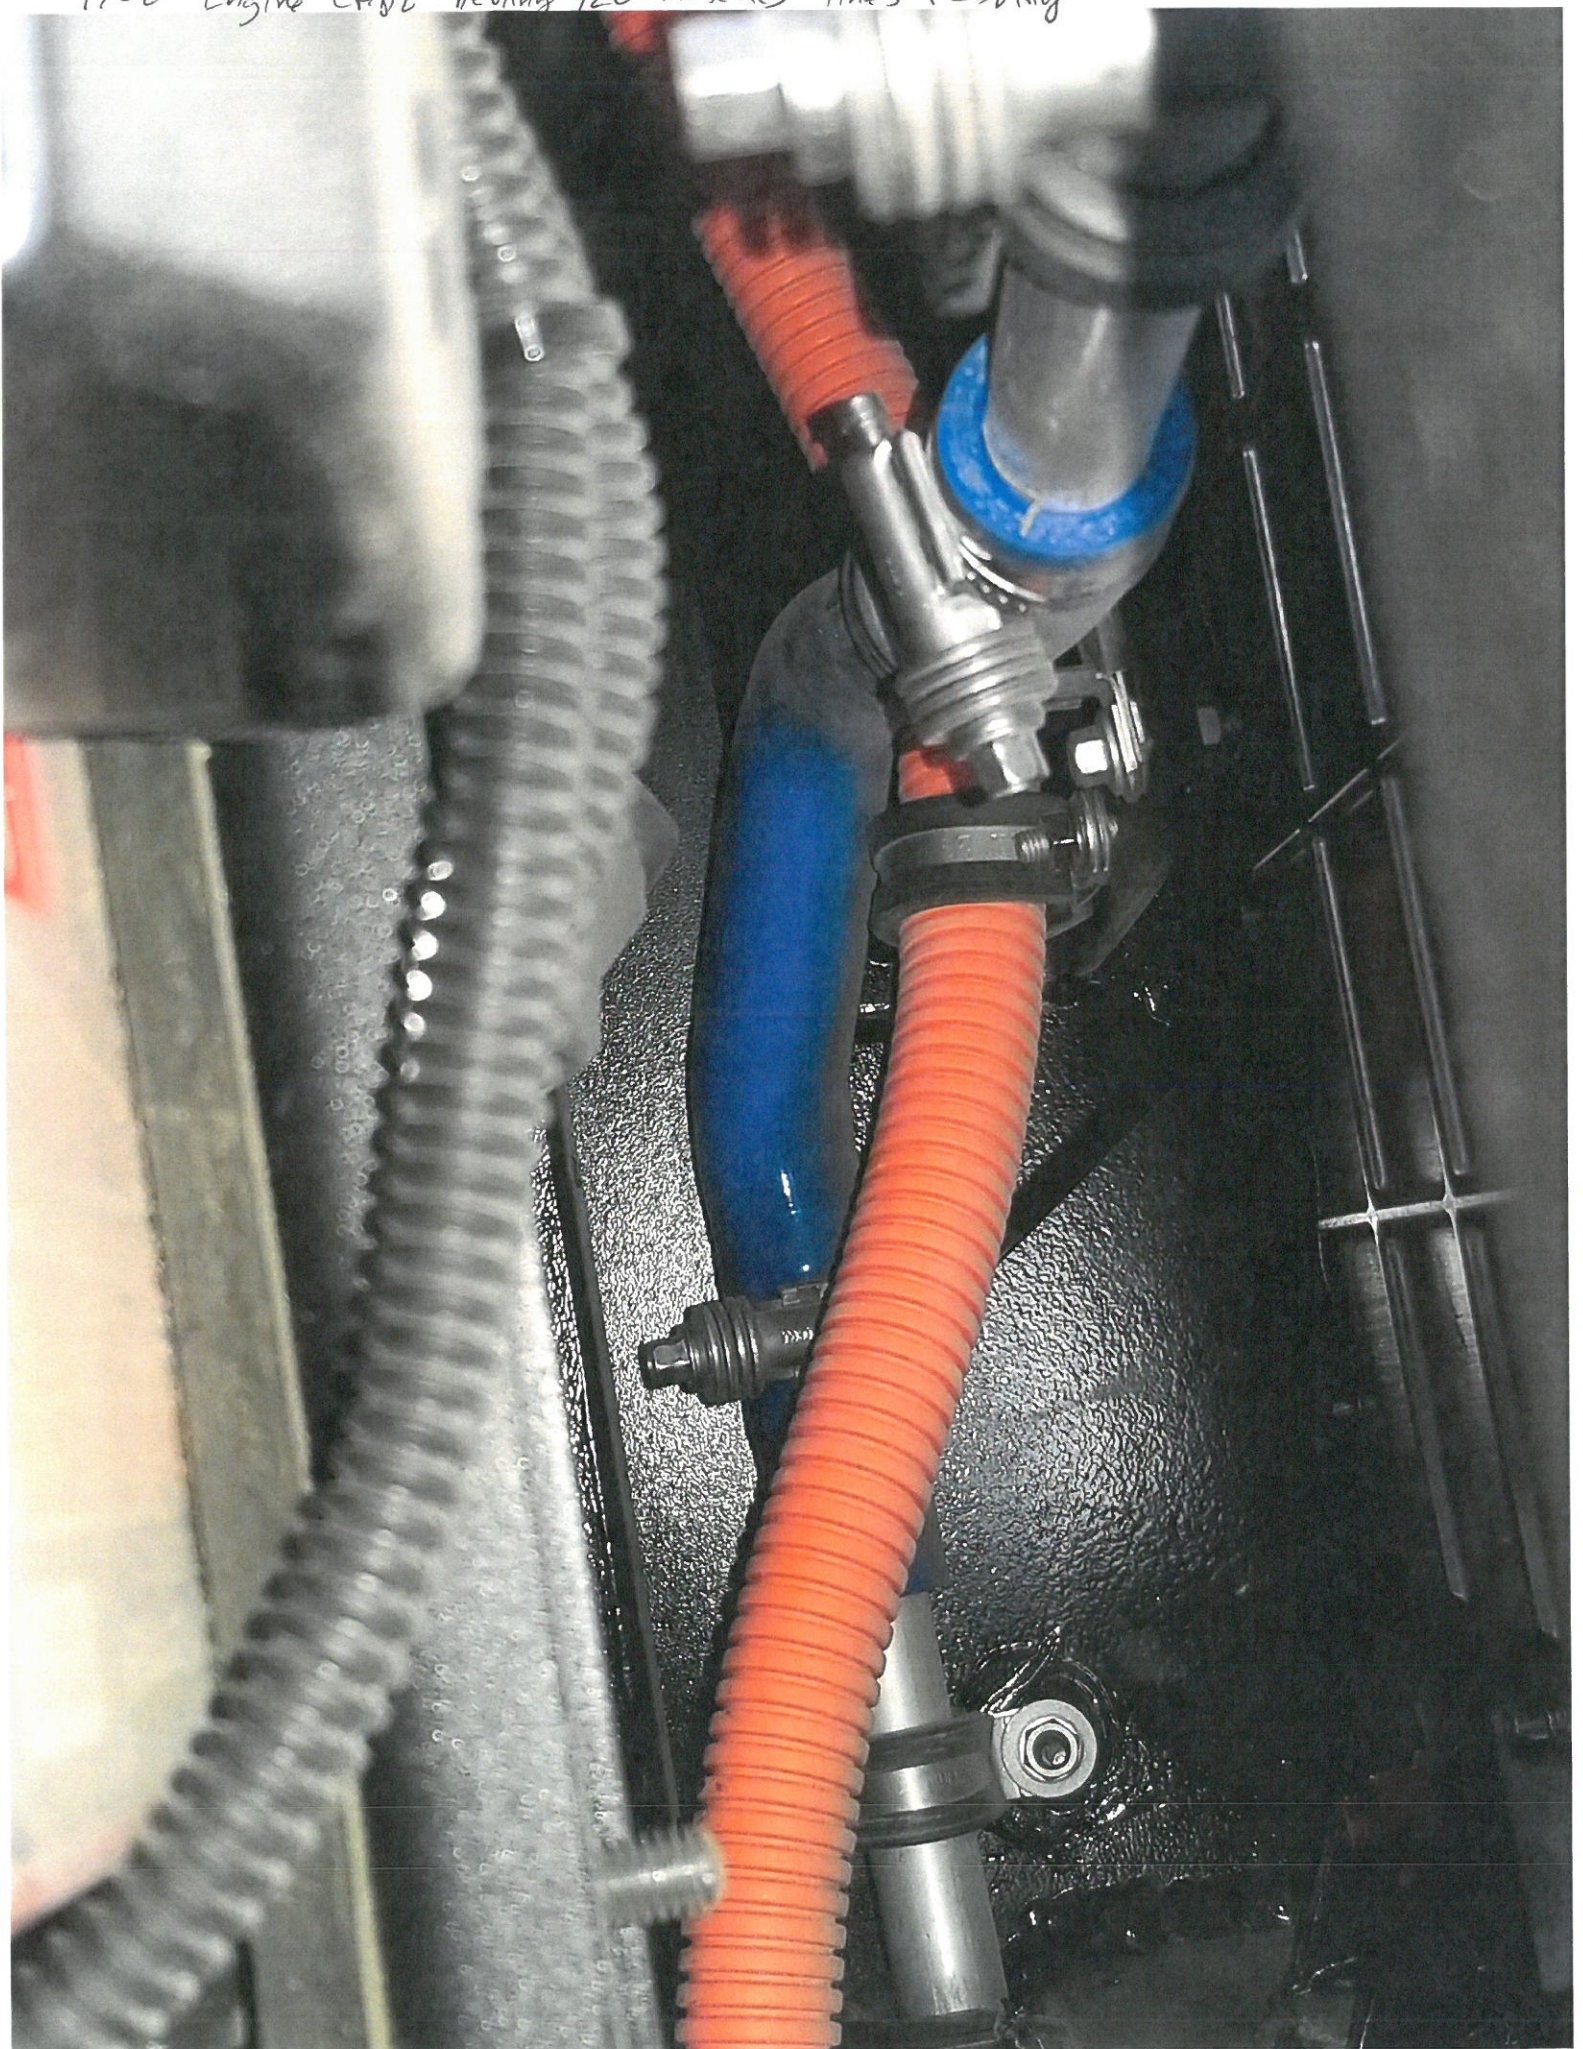
1700 - Engine Comp helping 12v batteries lines rubbing

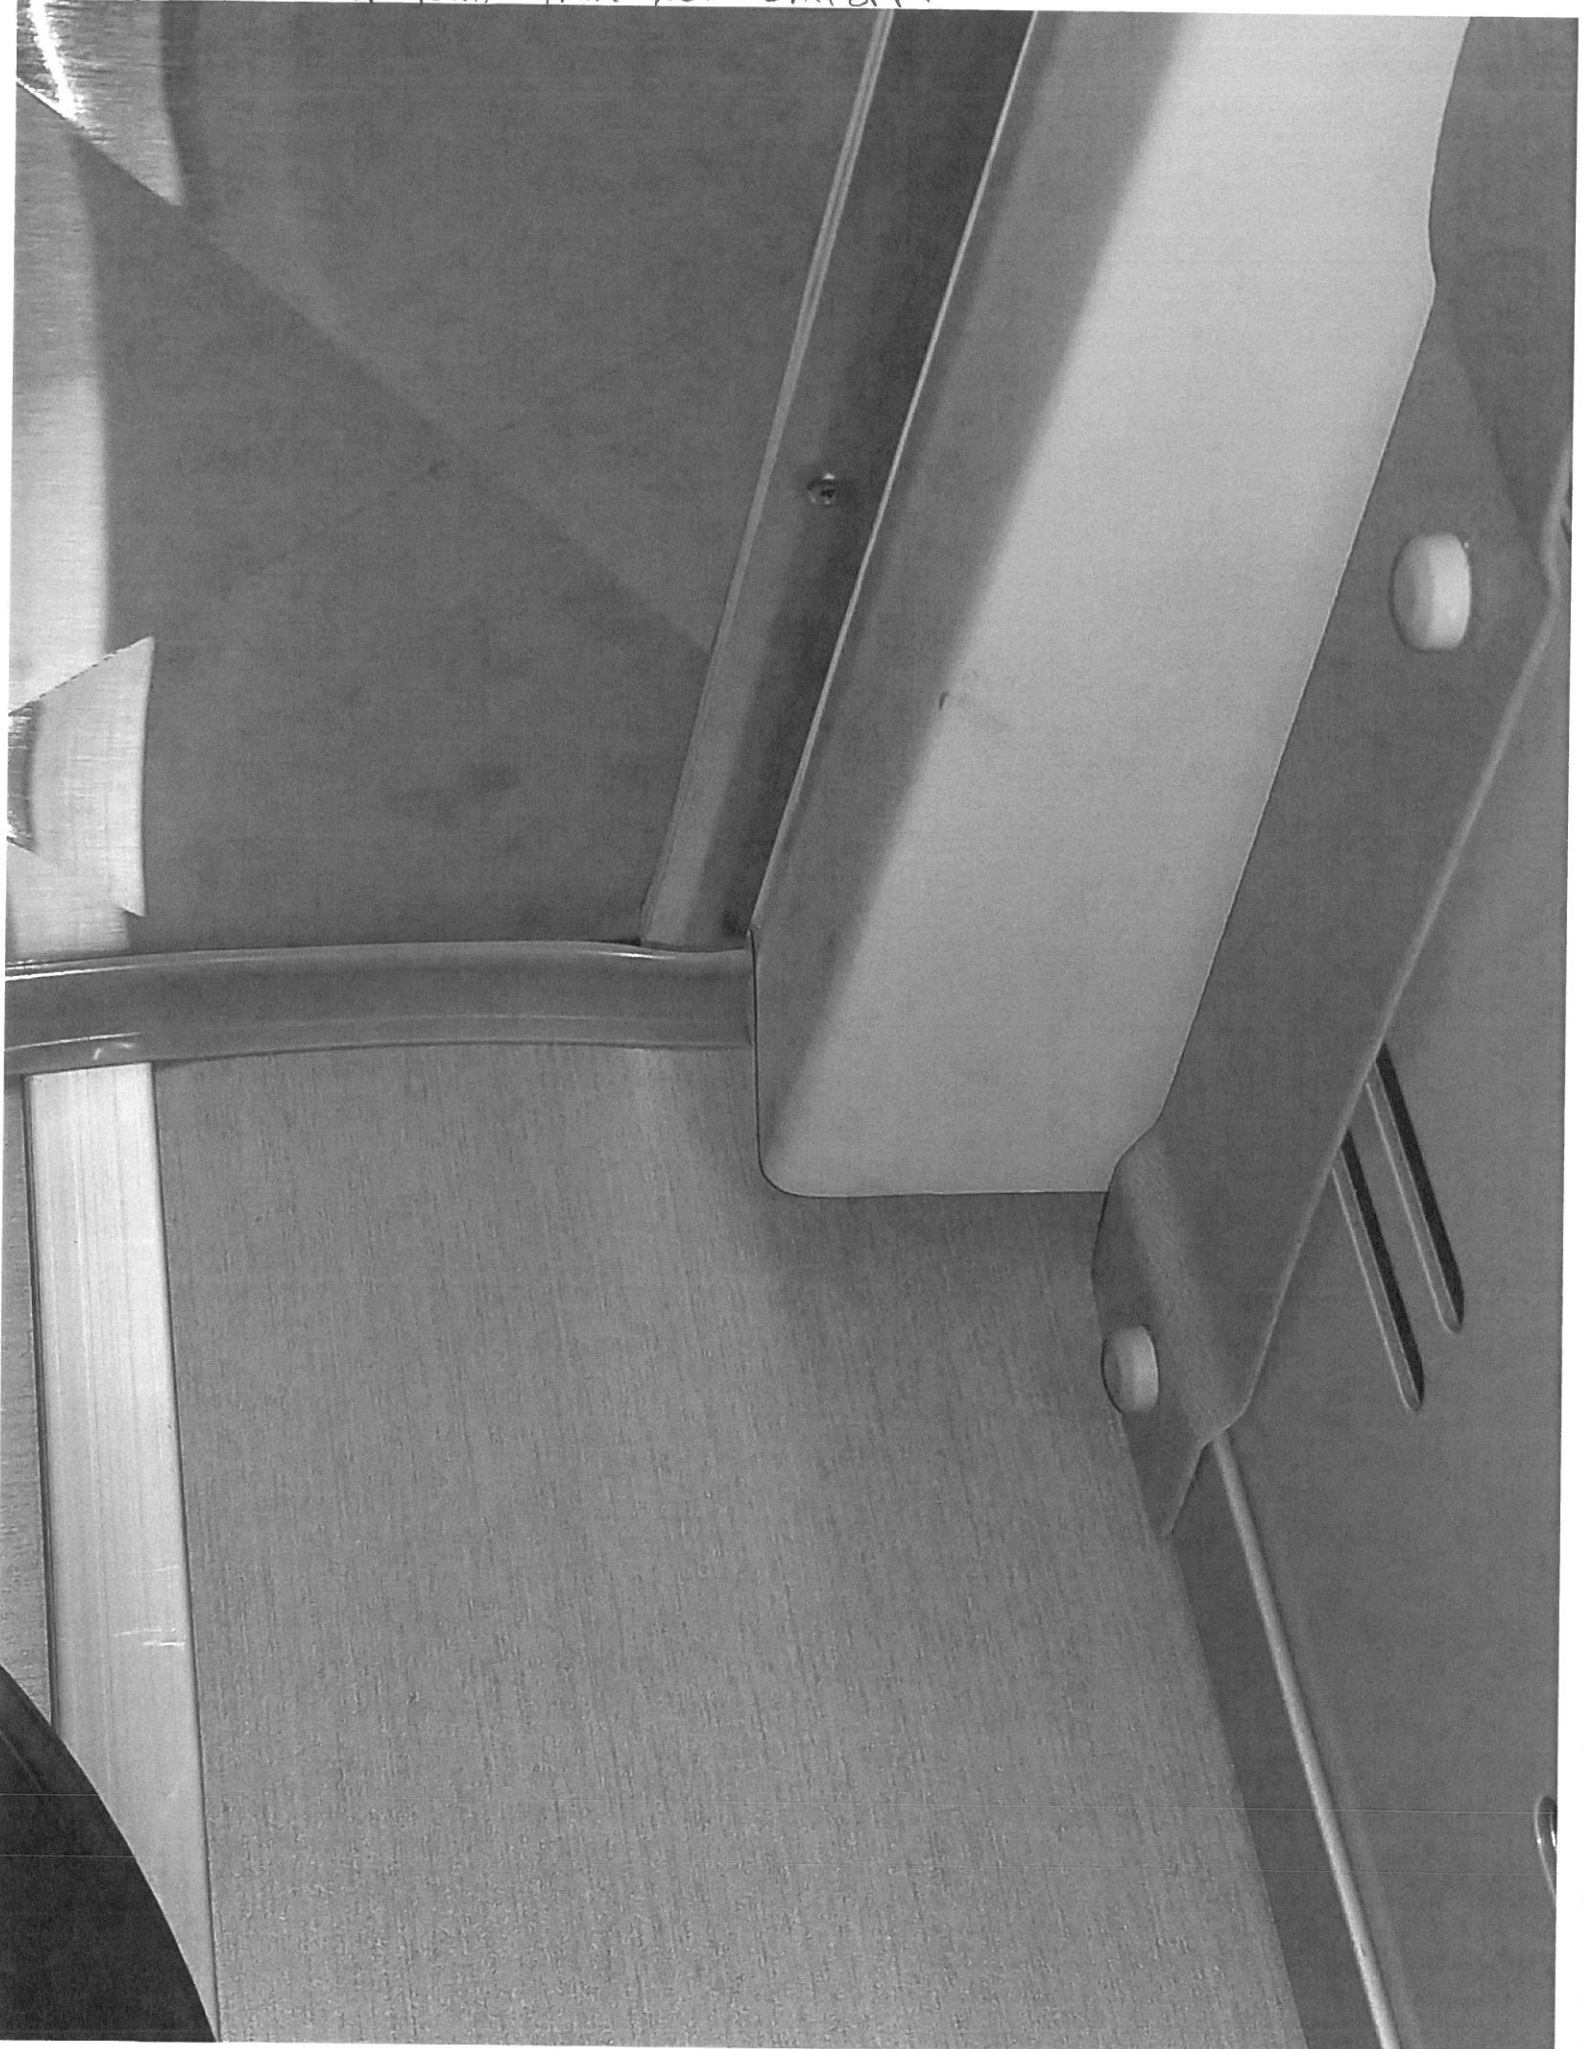
1/08 - S/S before joint trim not uniform

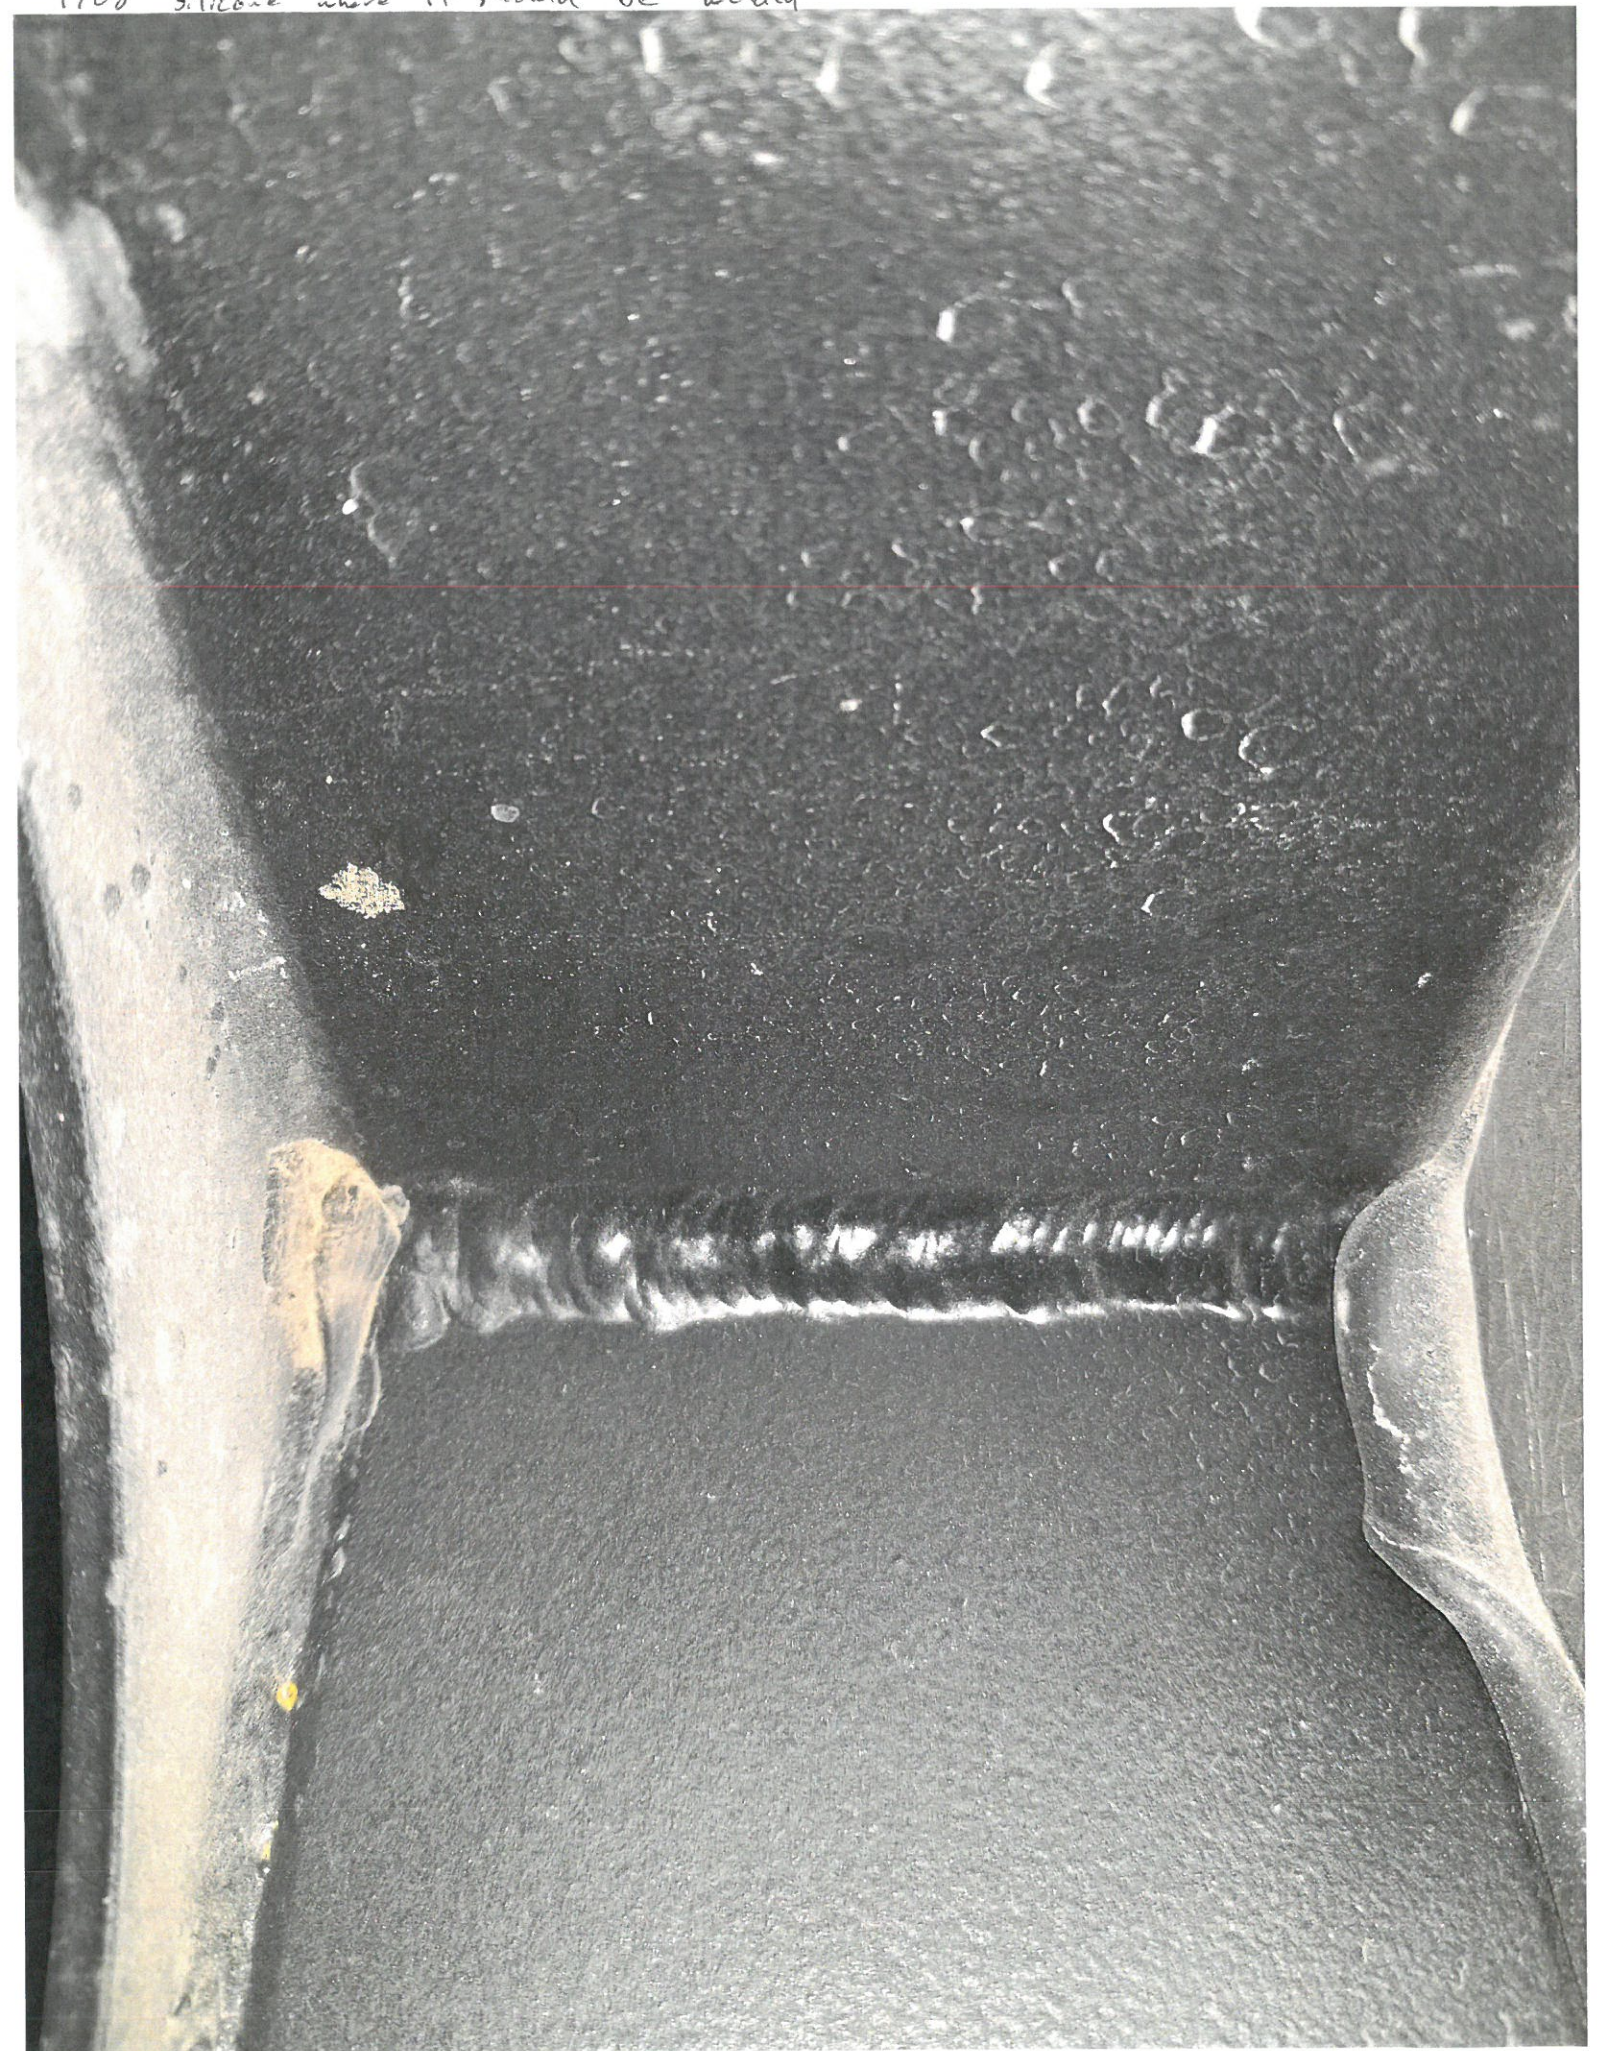
1708 silicone where it should be welded

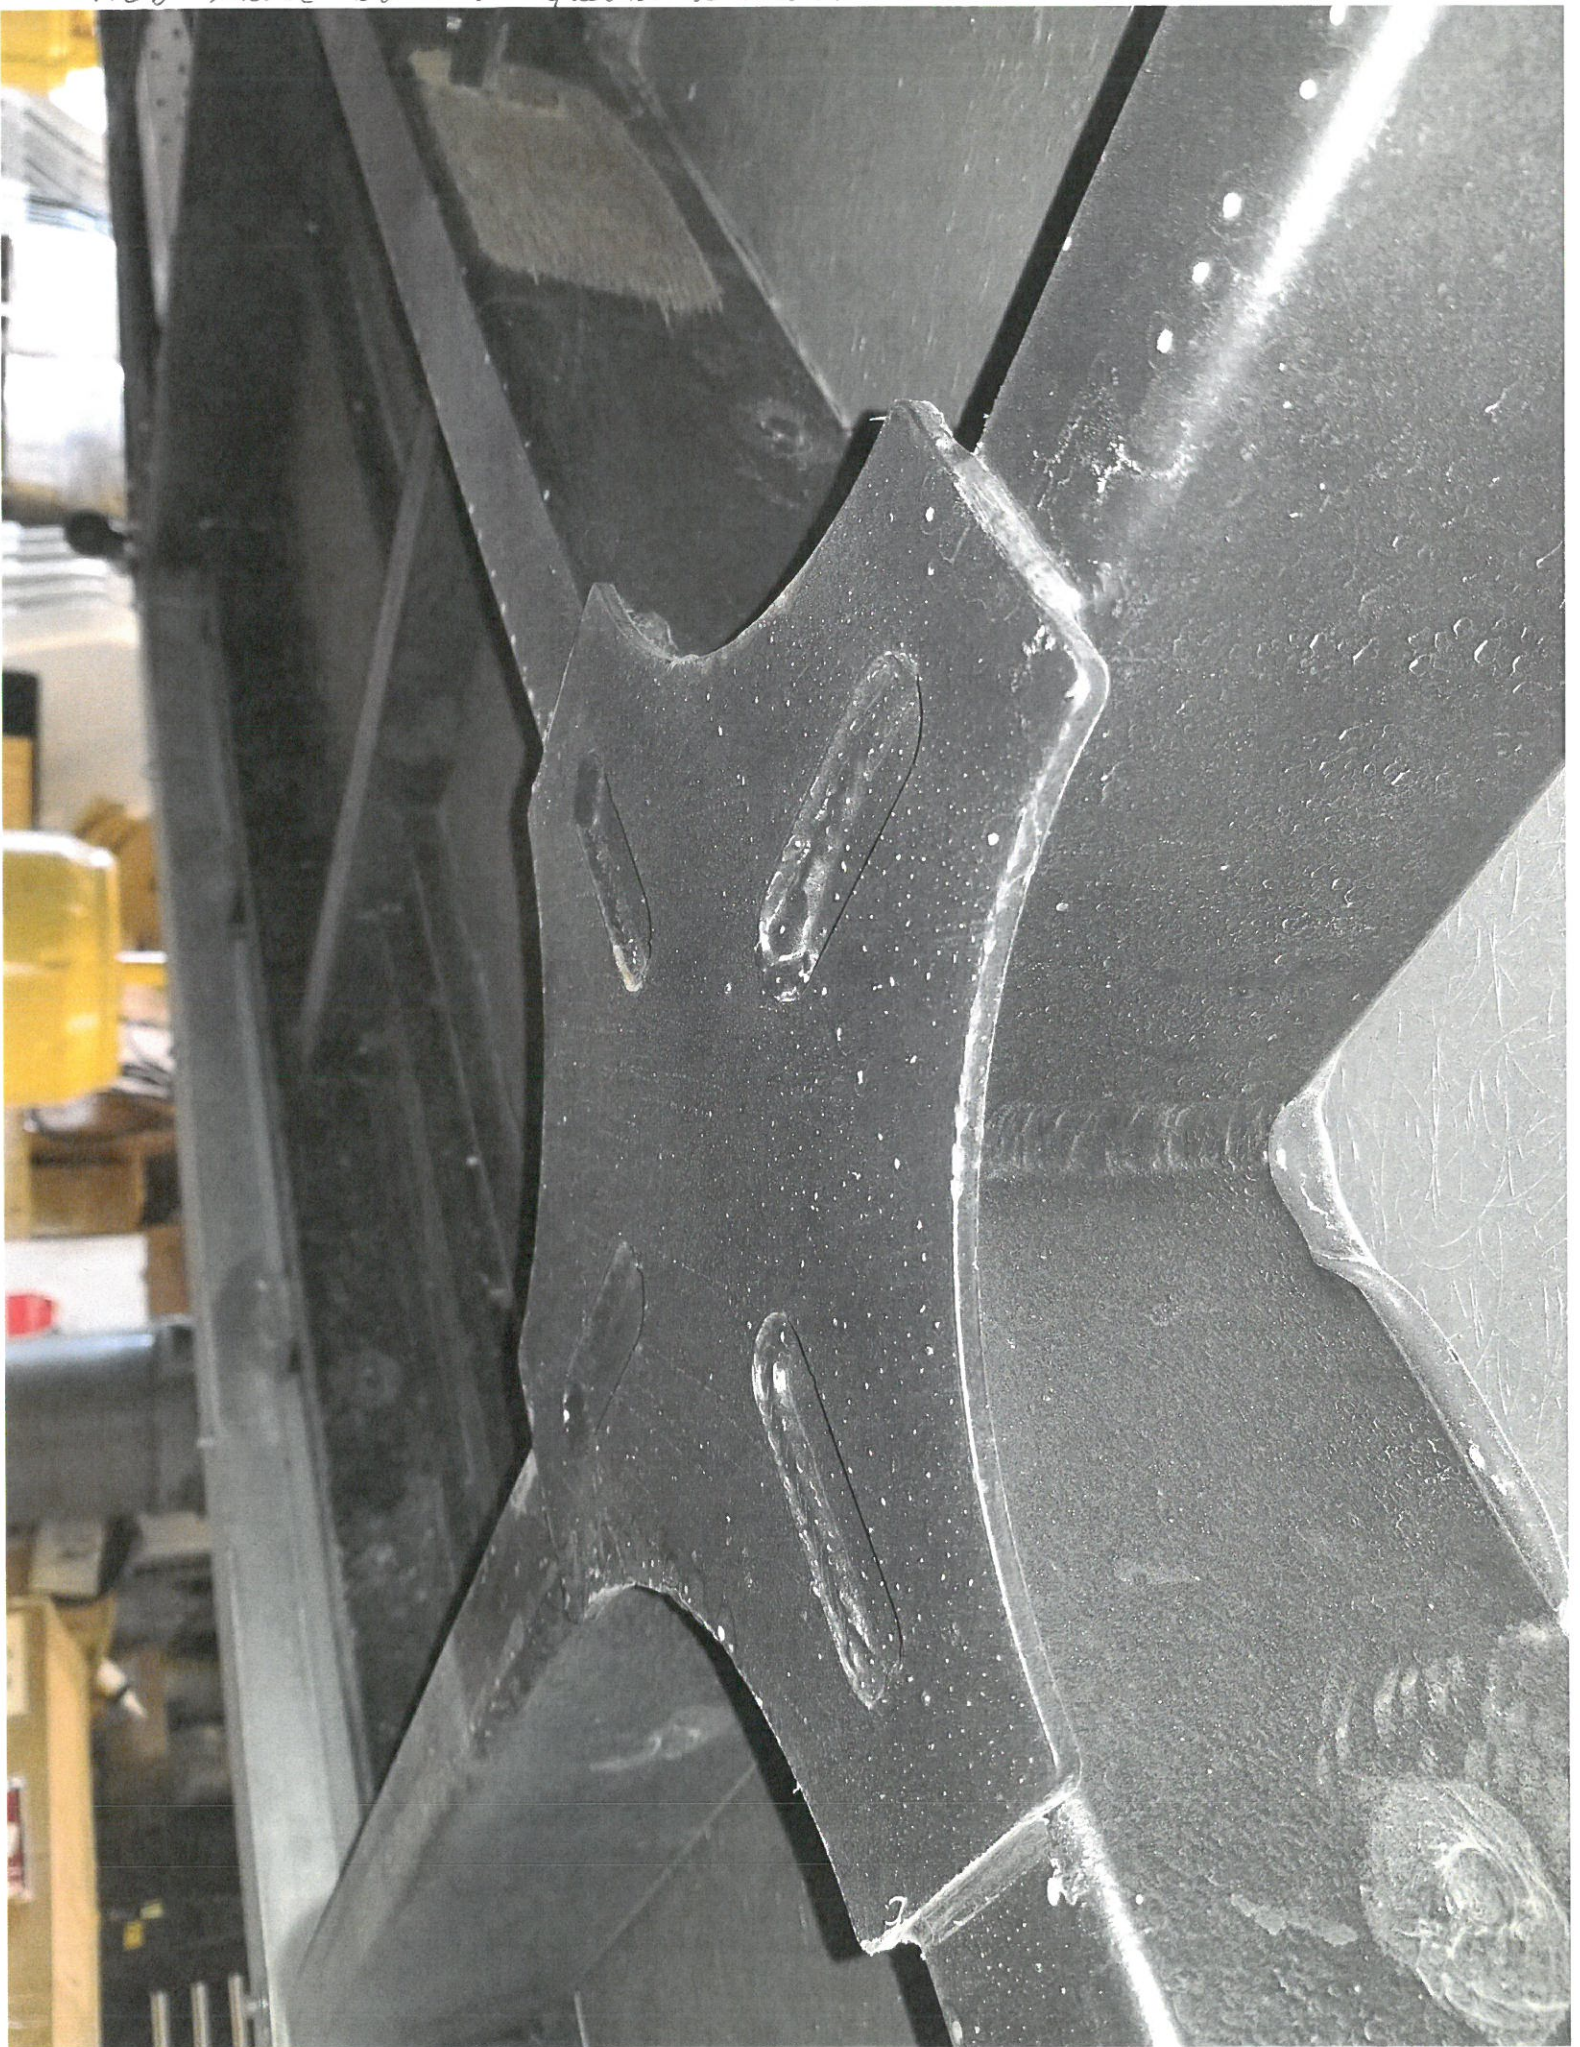
1708 silicone where it should be welded

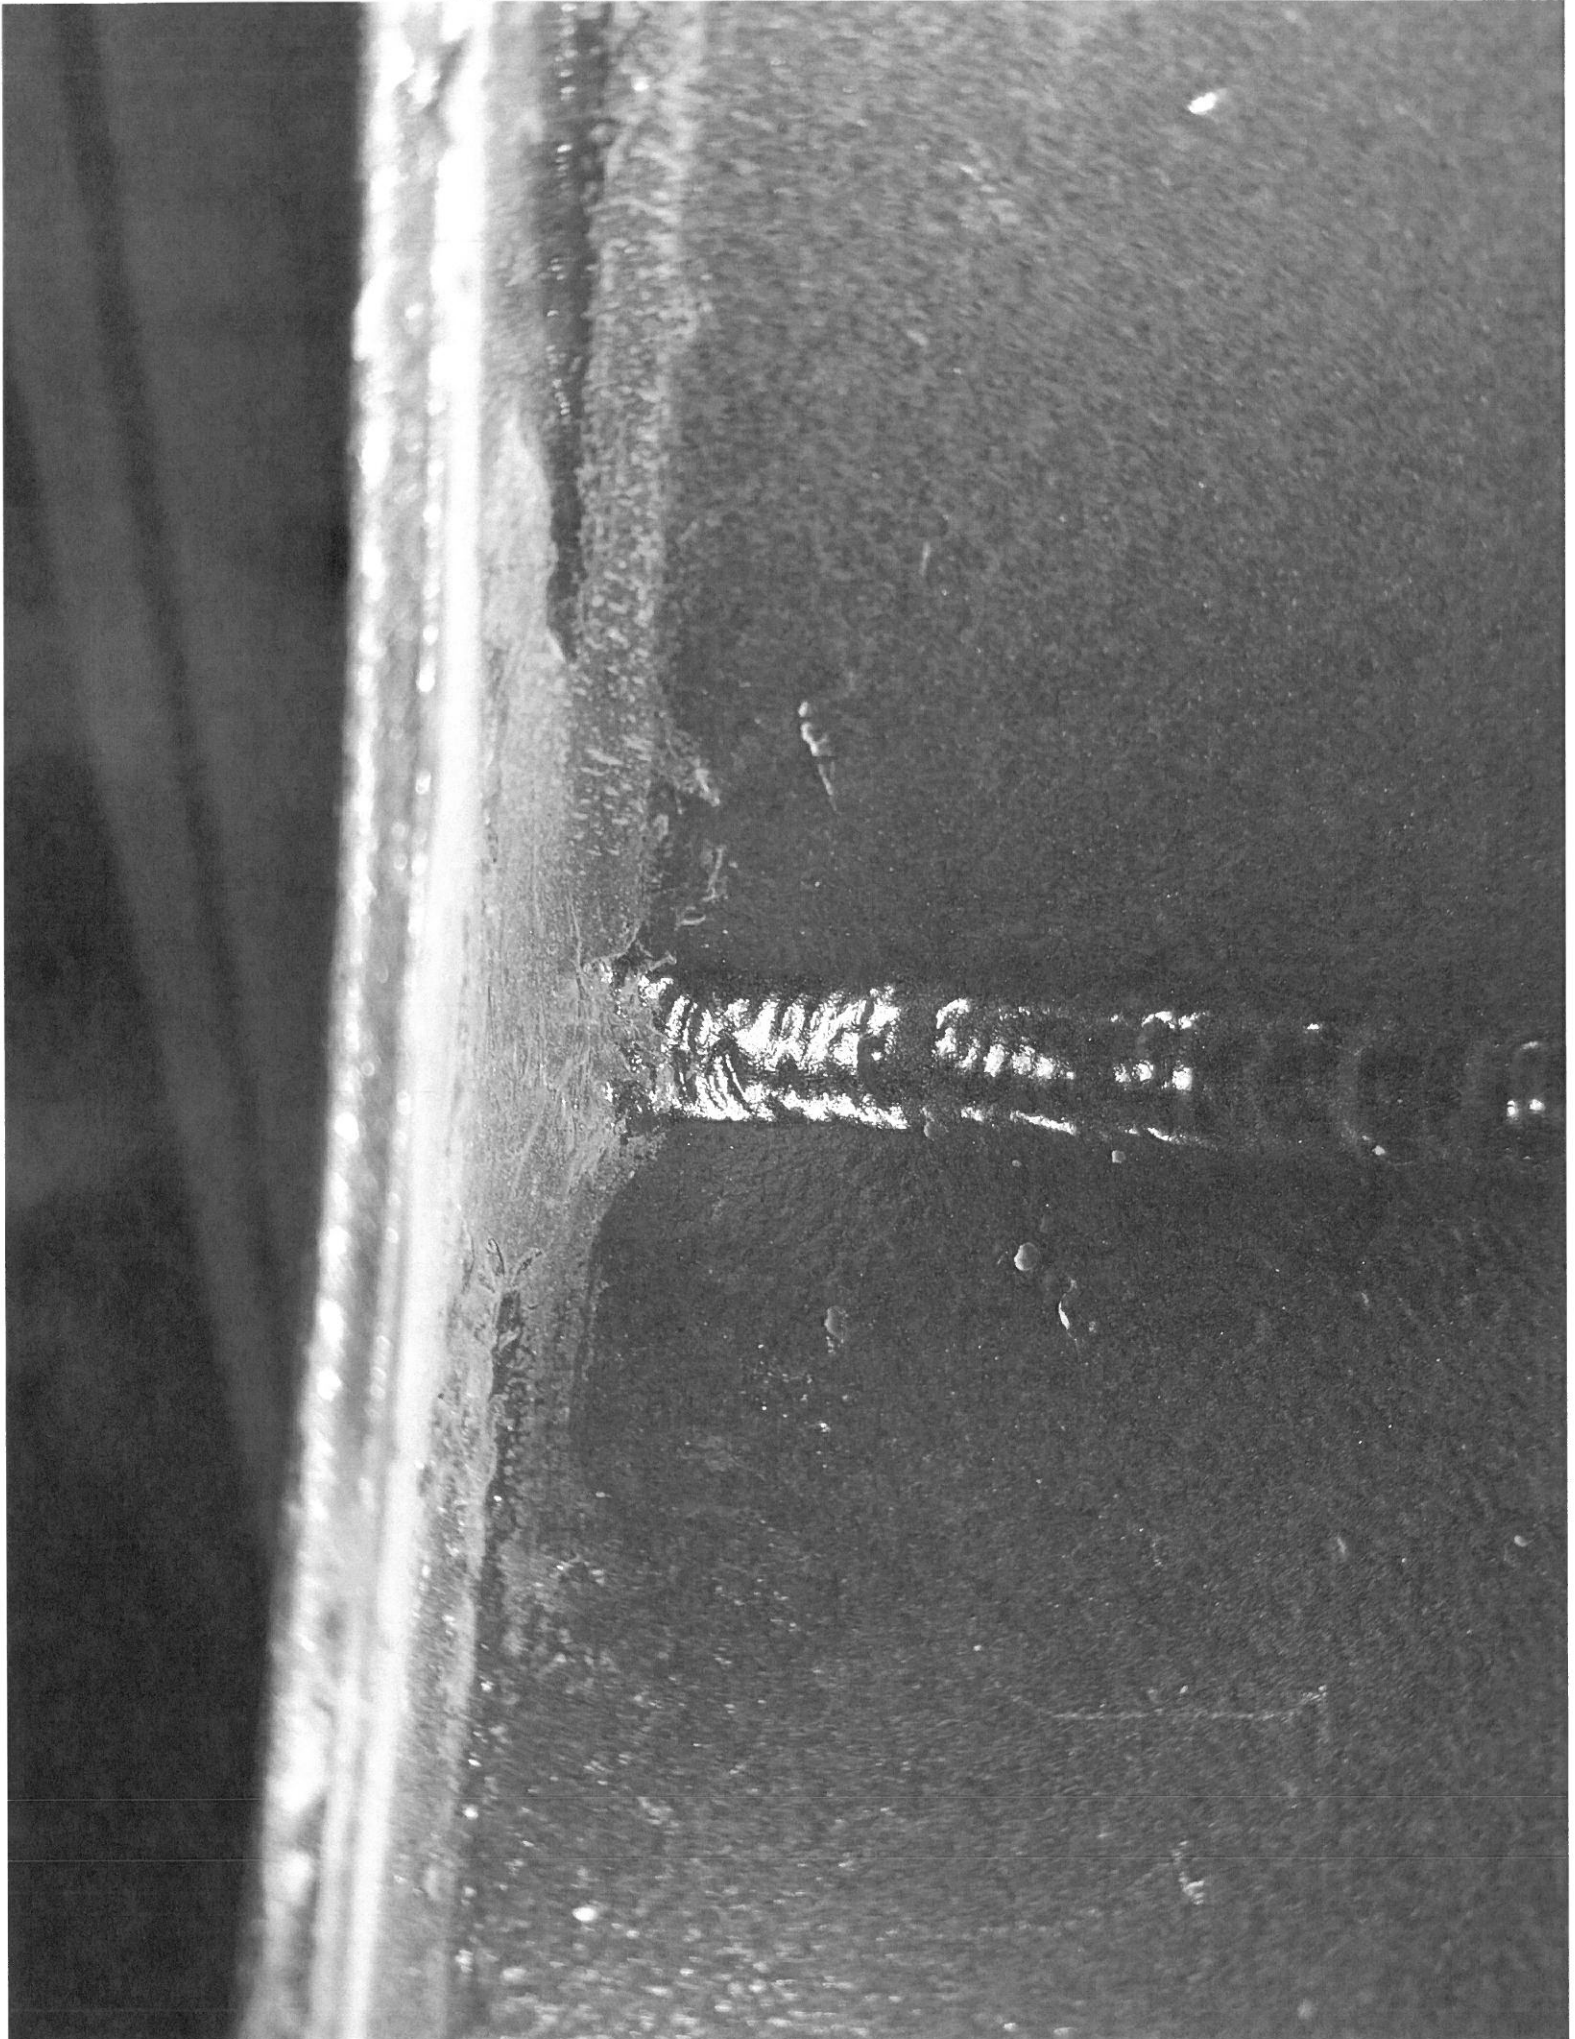
1708 silicone where it should be welded
