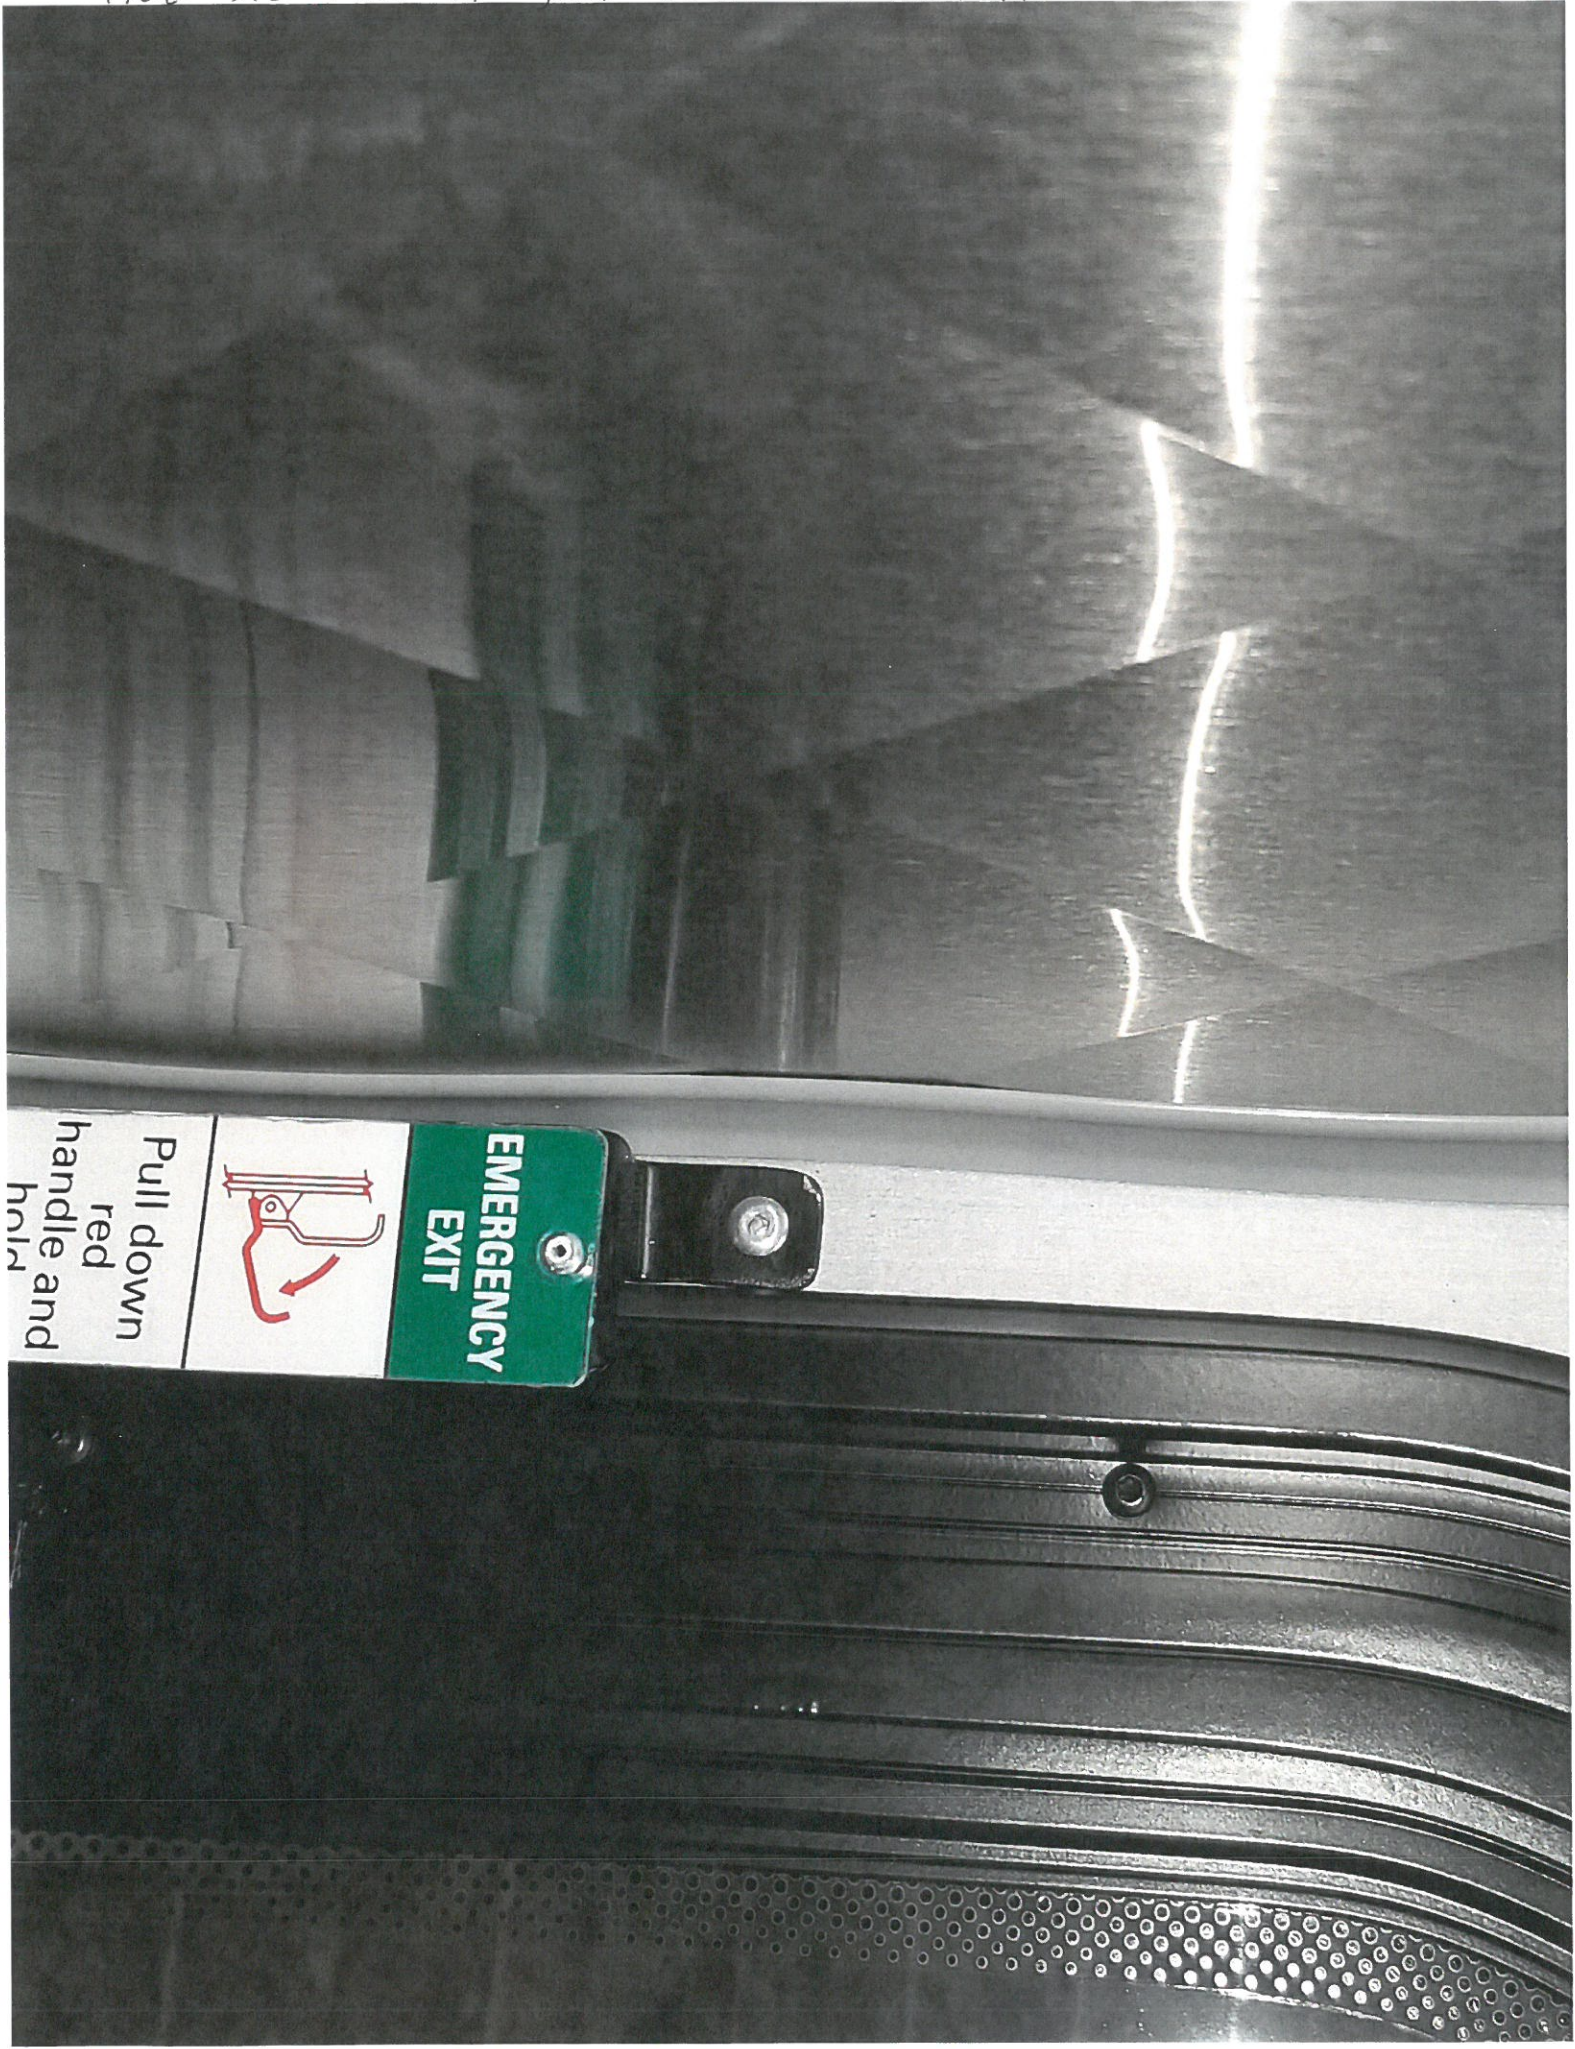
1708-515 Front of joint trim not uniform

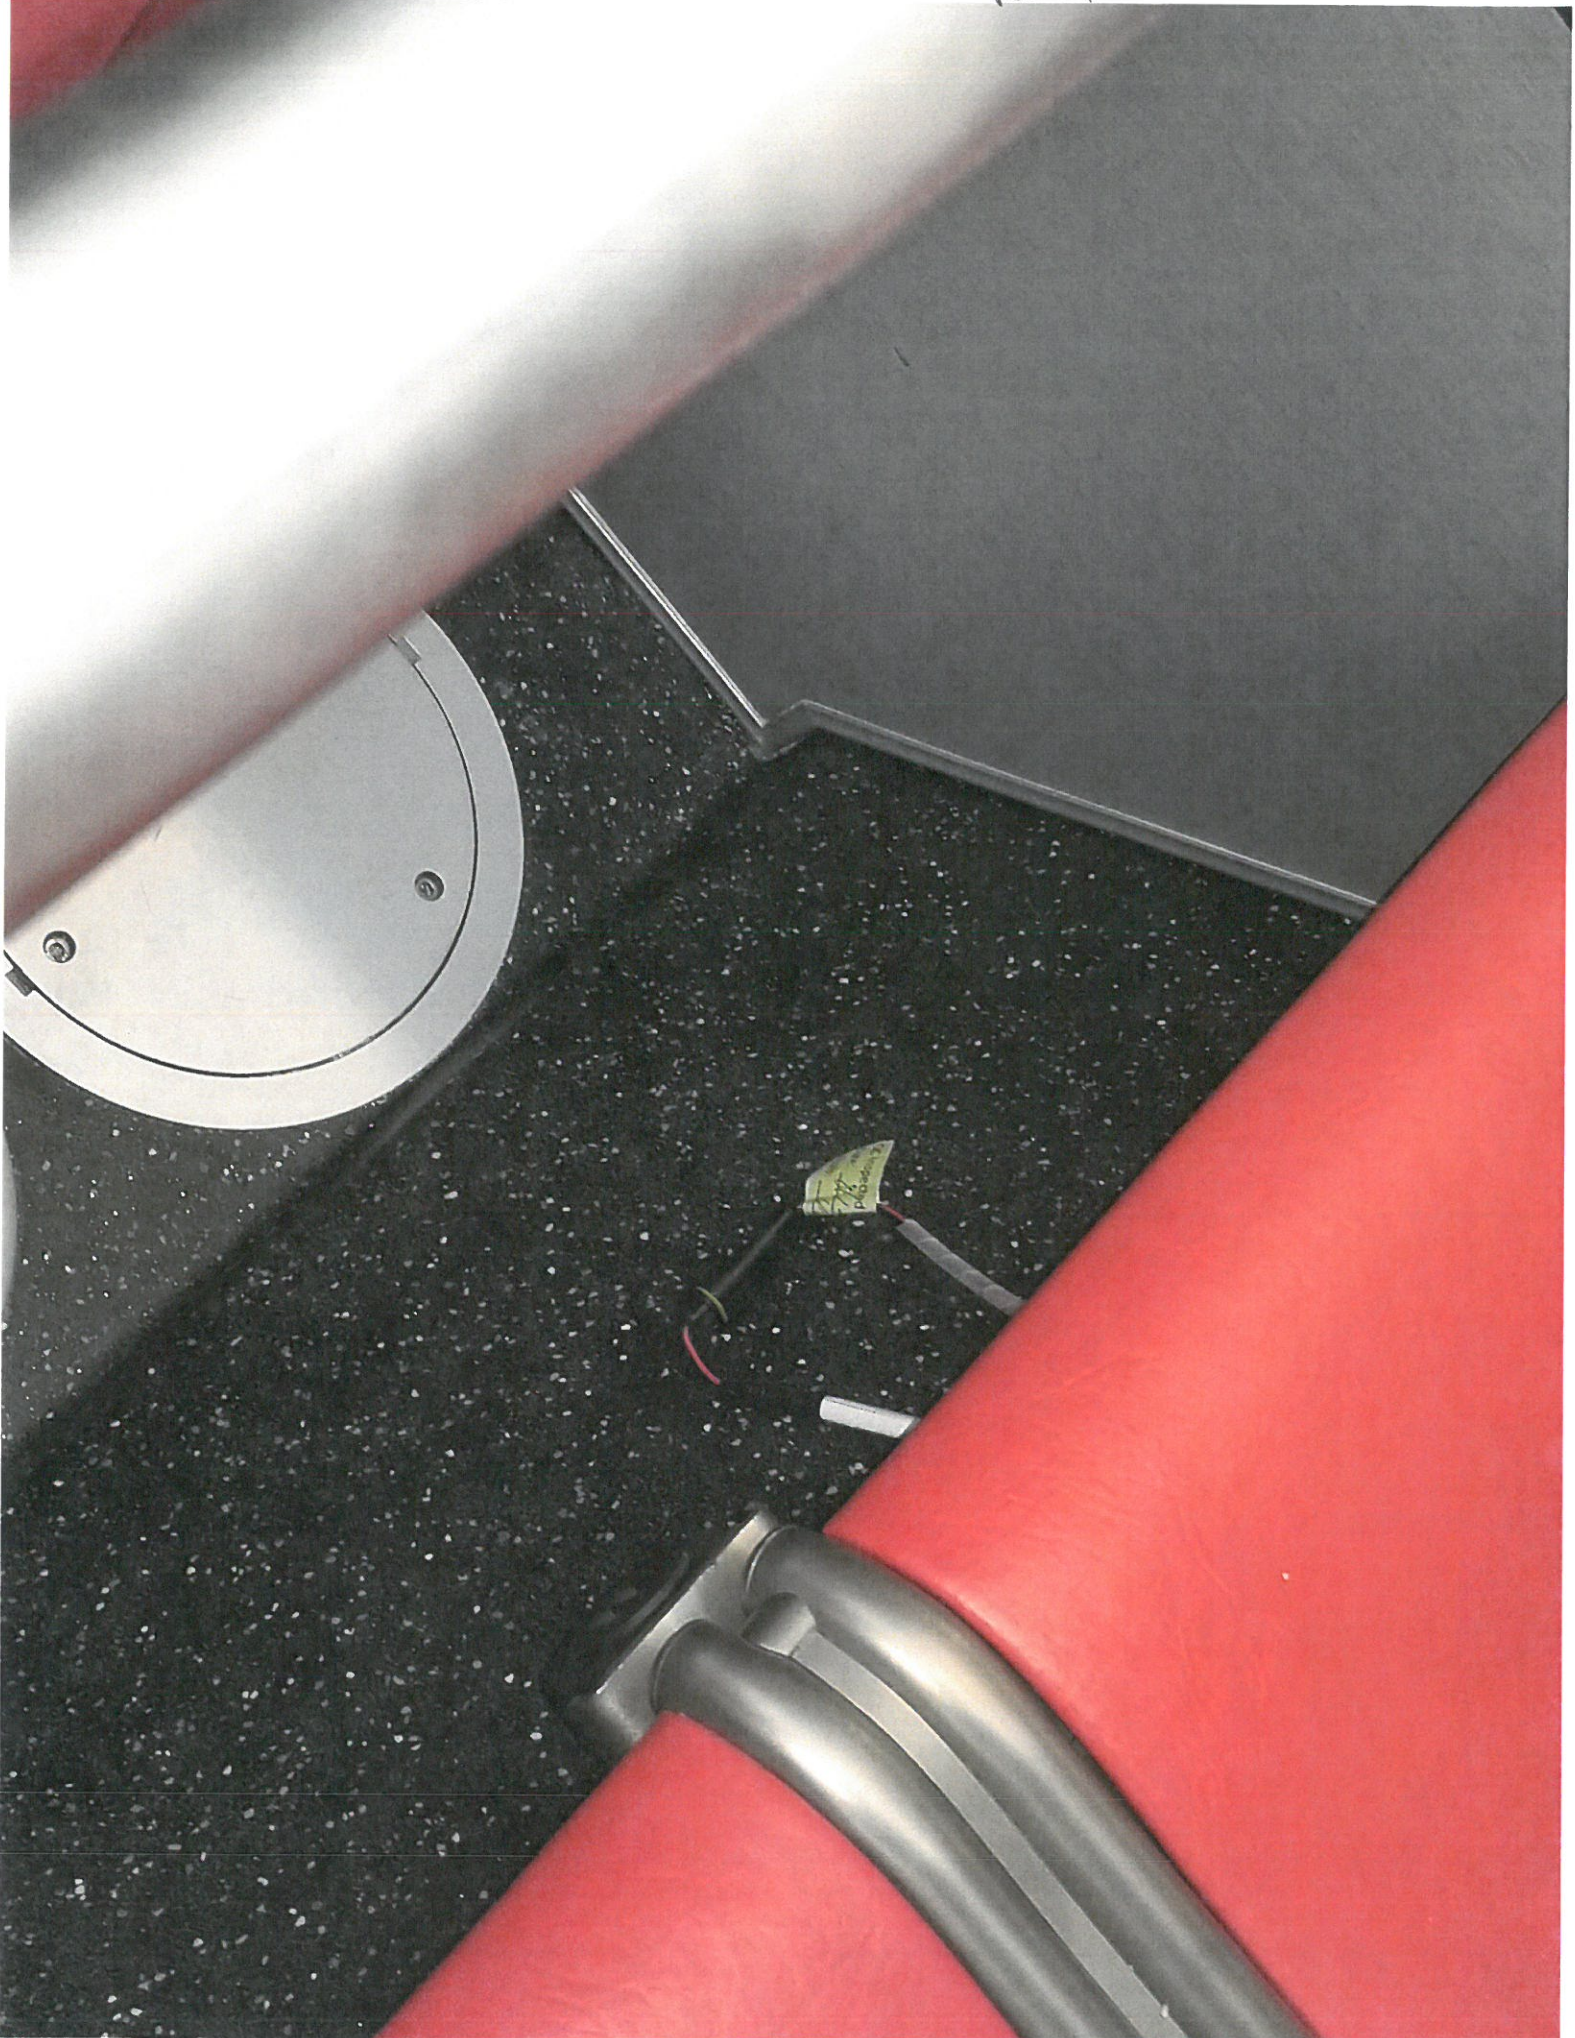
1708 - center c/s seats wires + connectors exposed

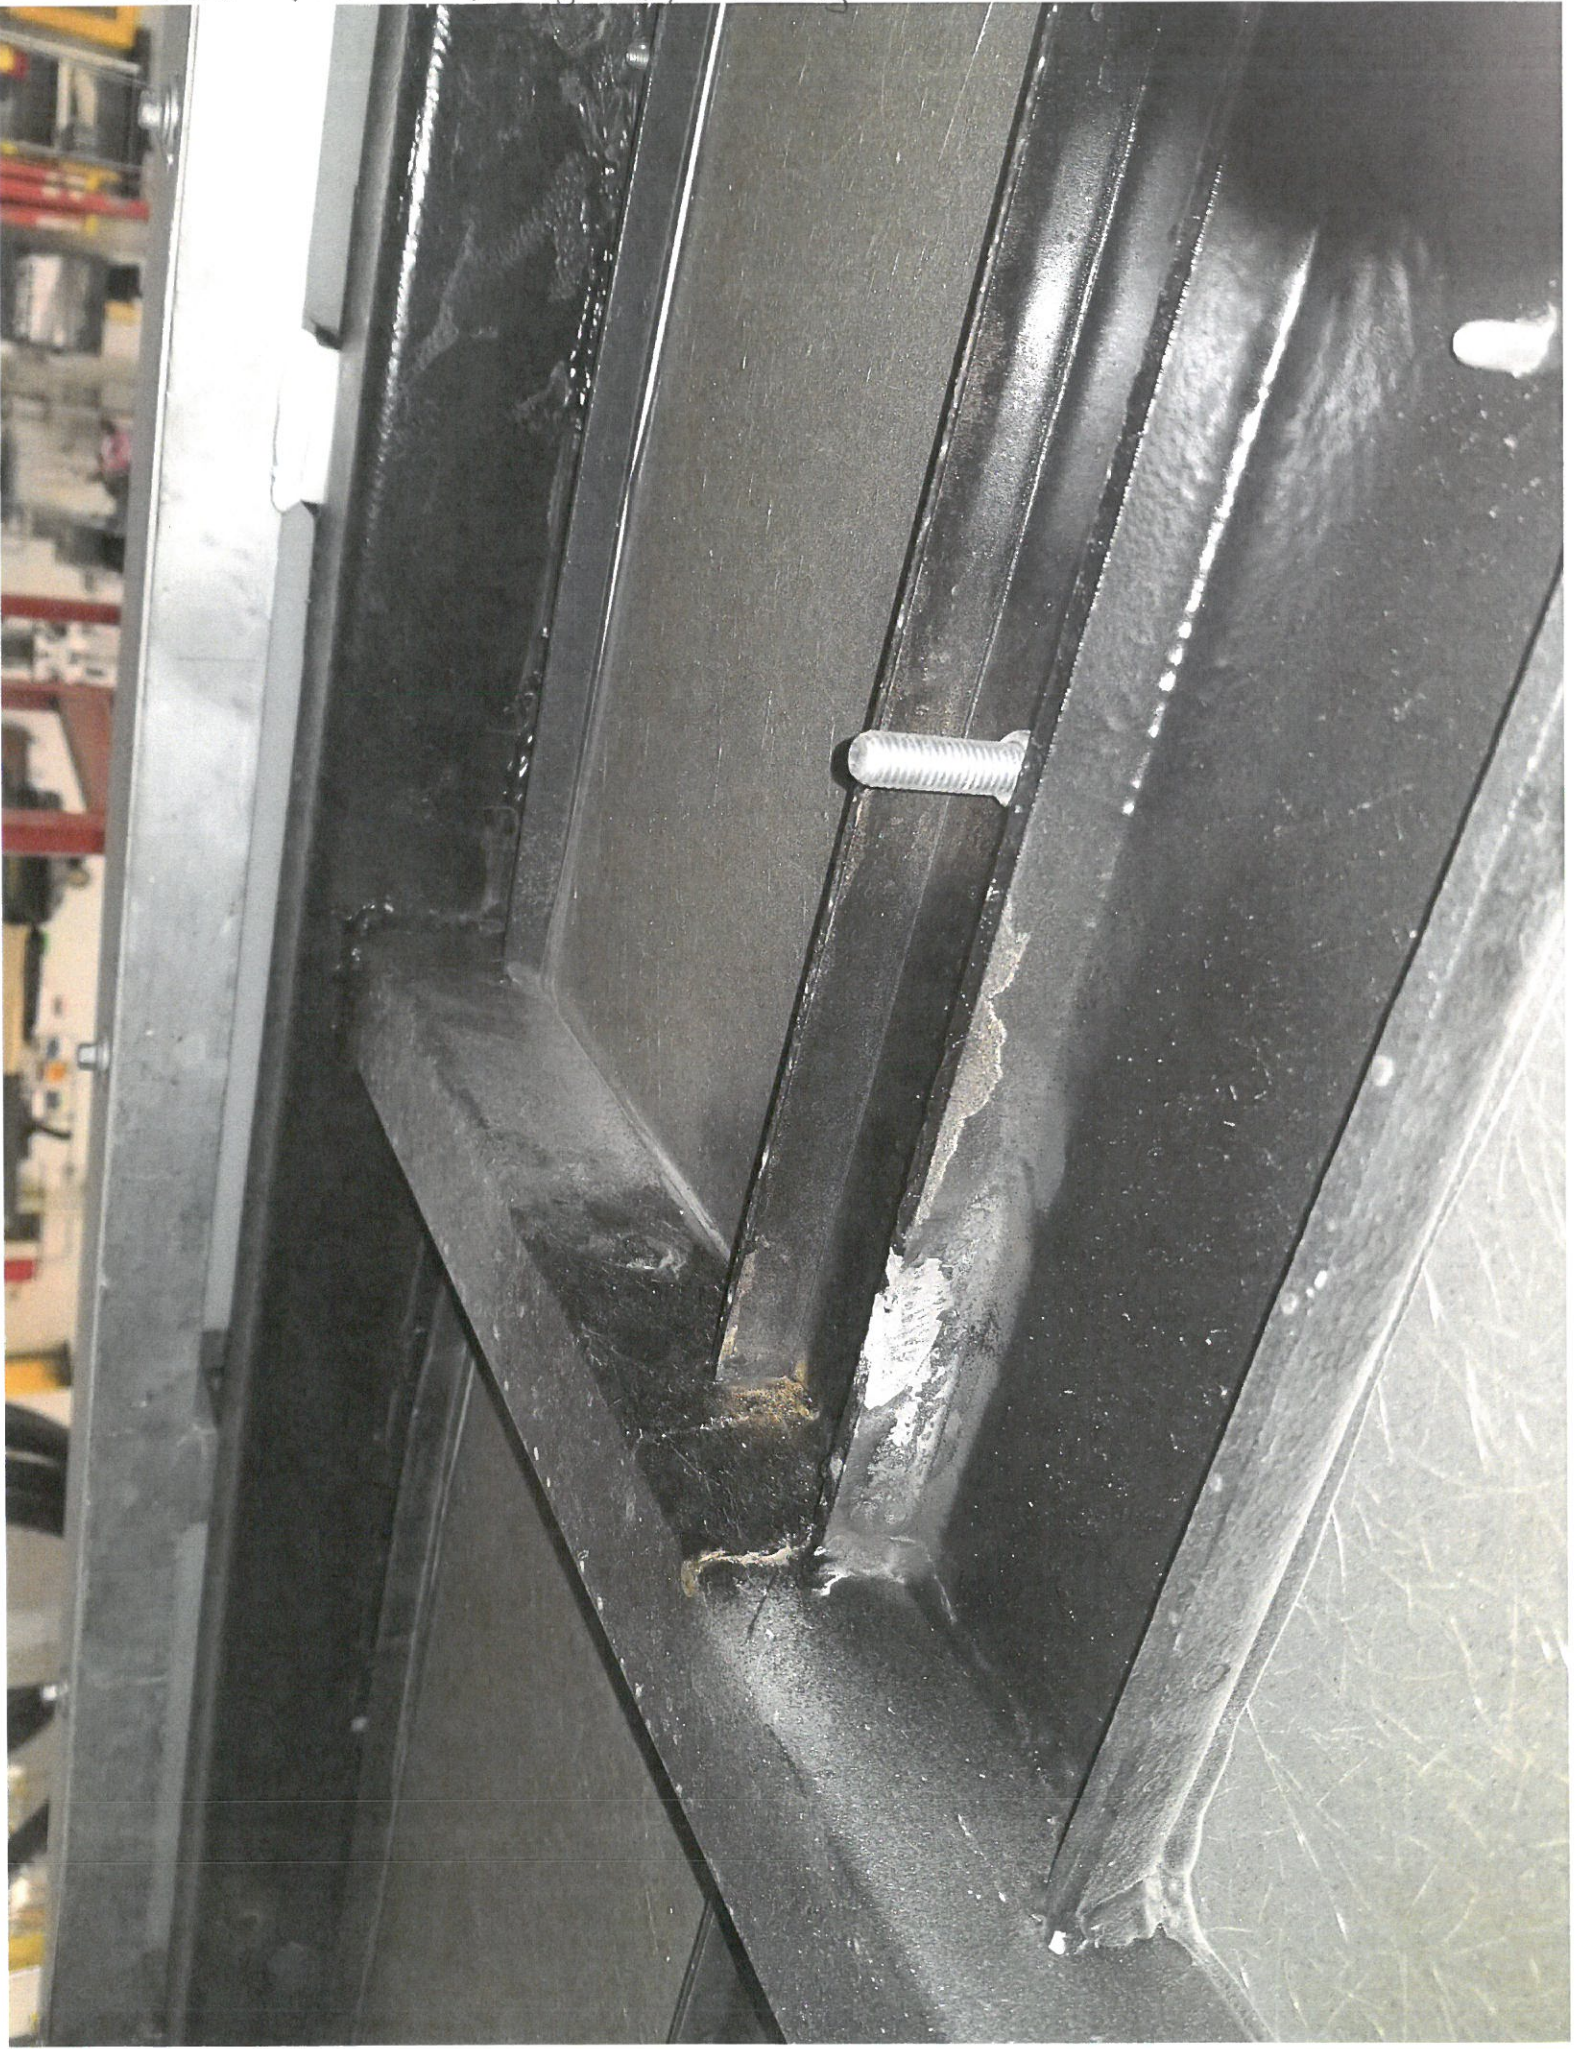
1708 poor and missing welds - rusting

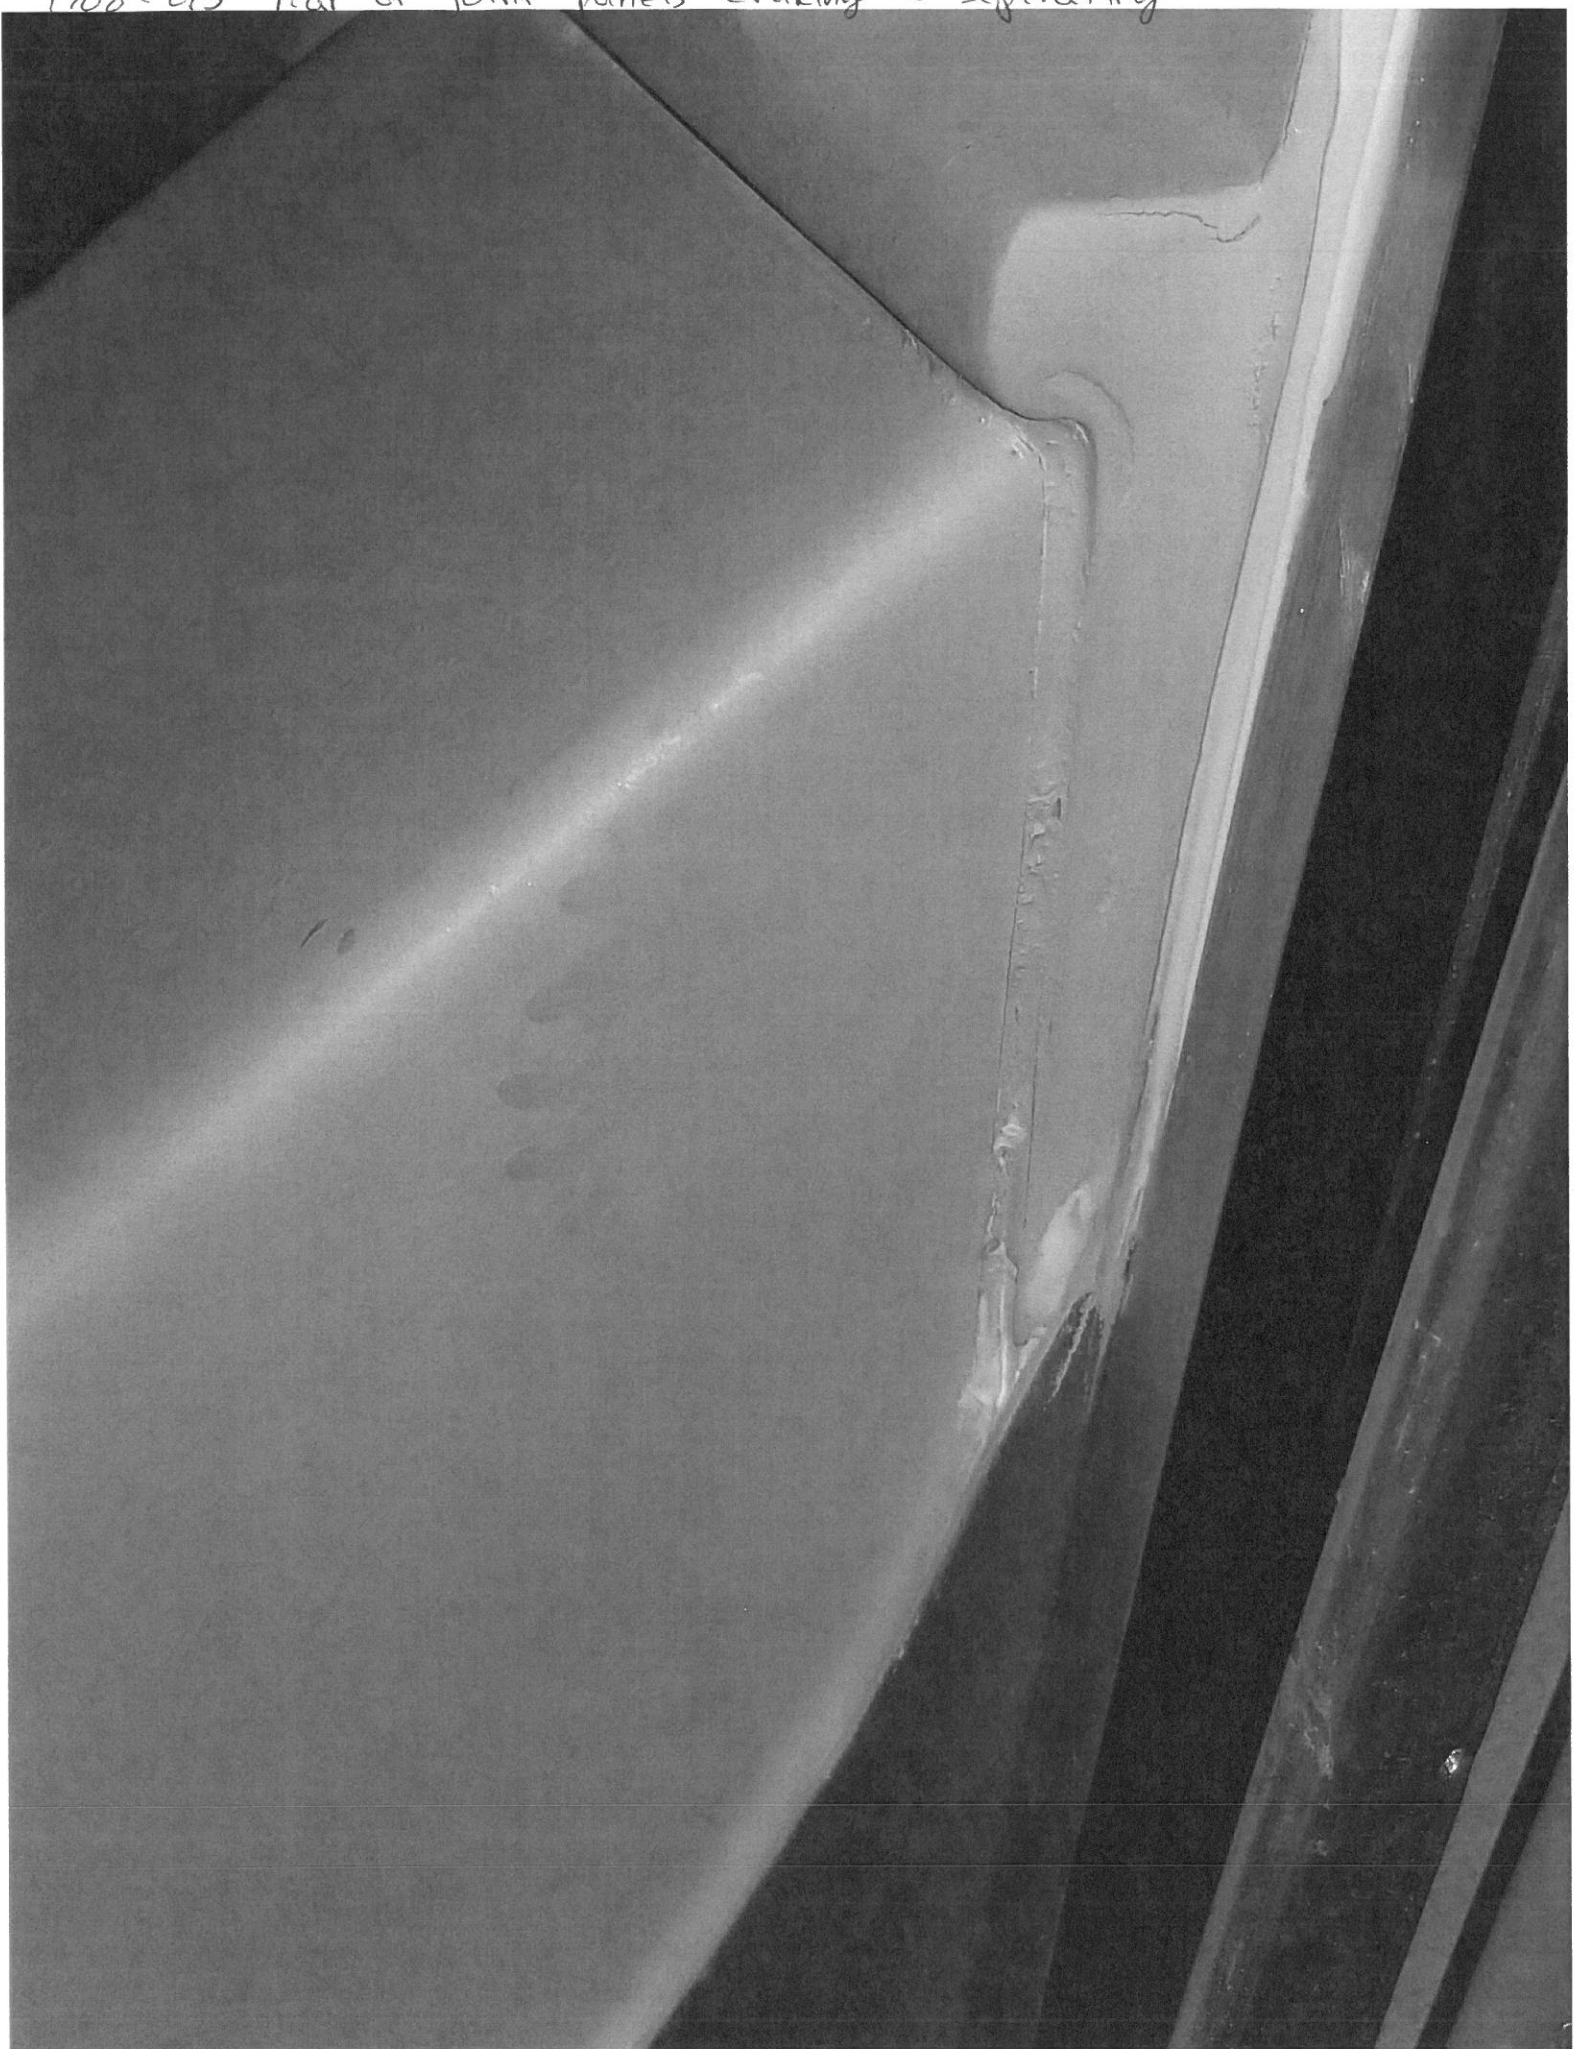
1708 - c/s rear of joint panels cracking + separating

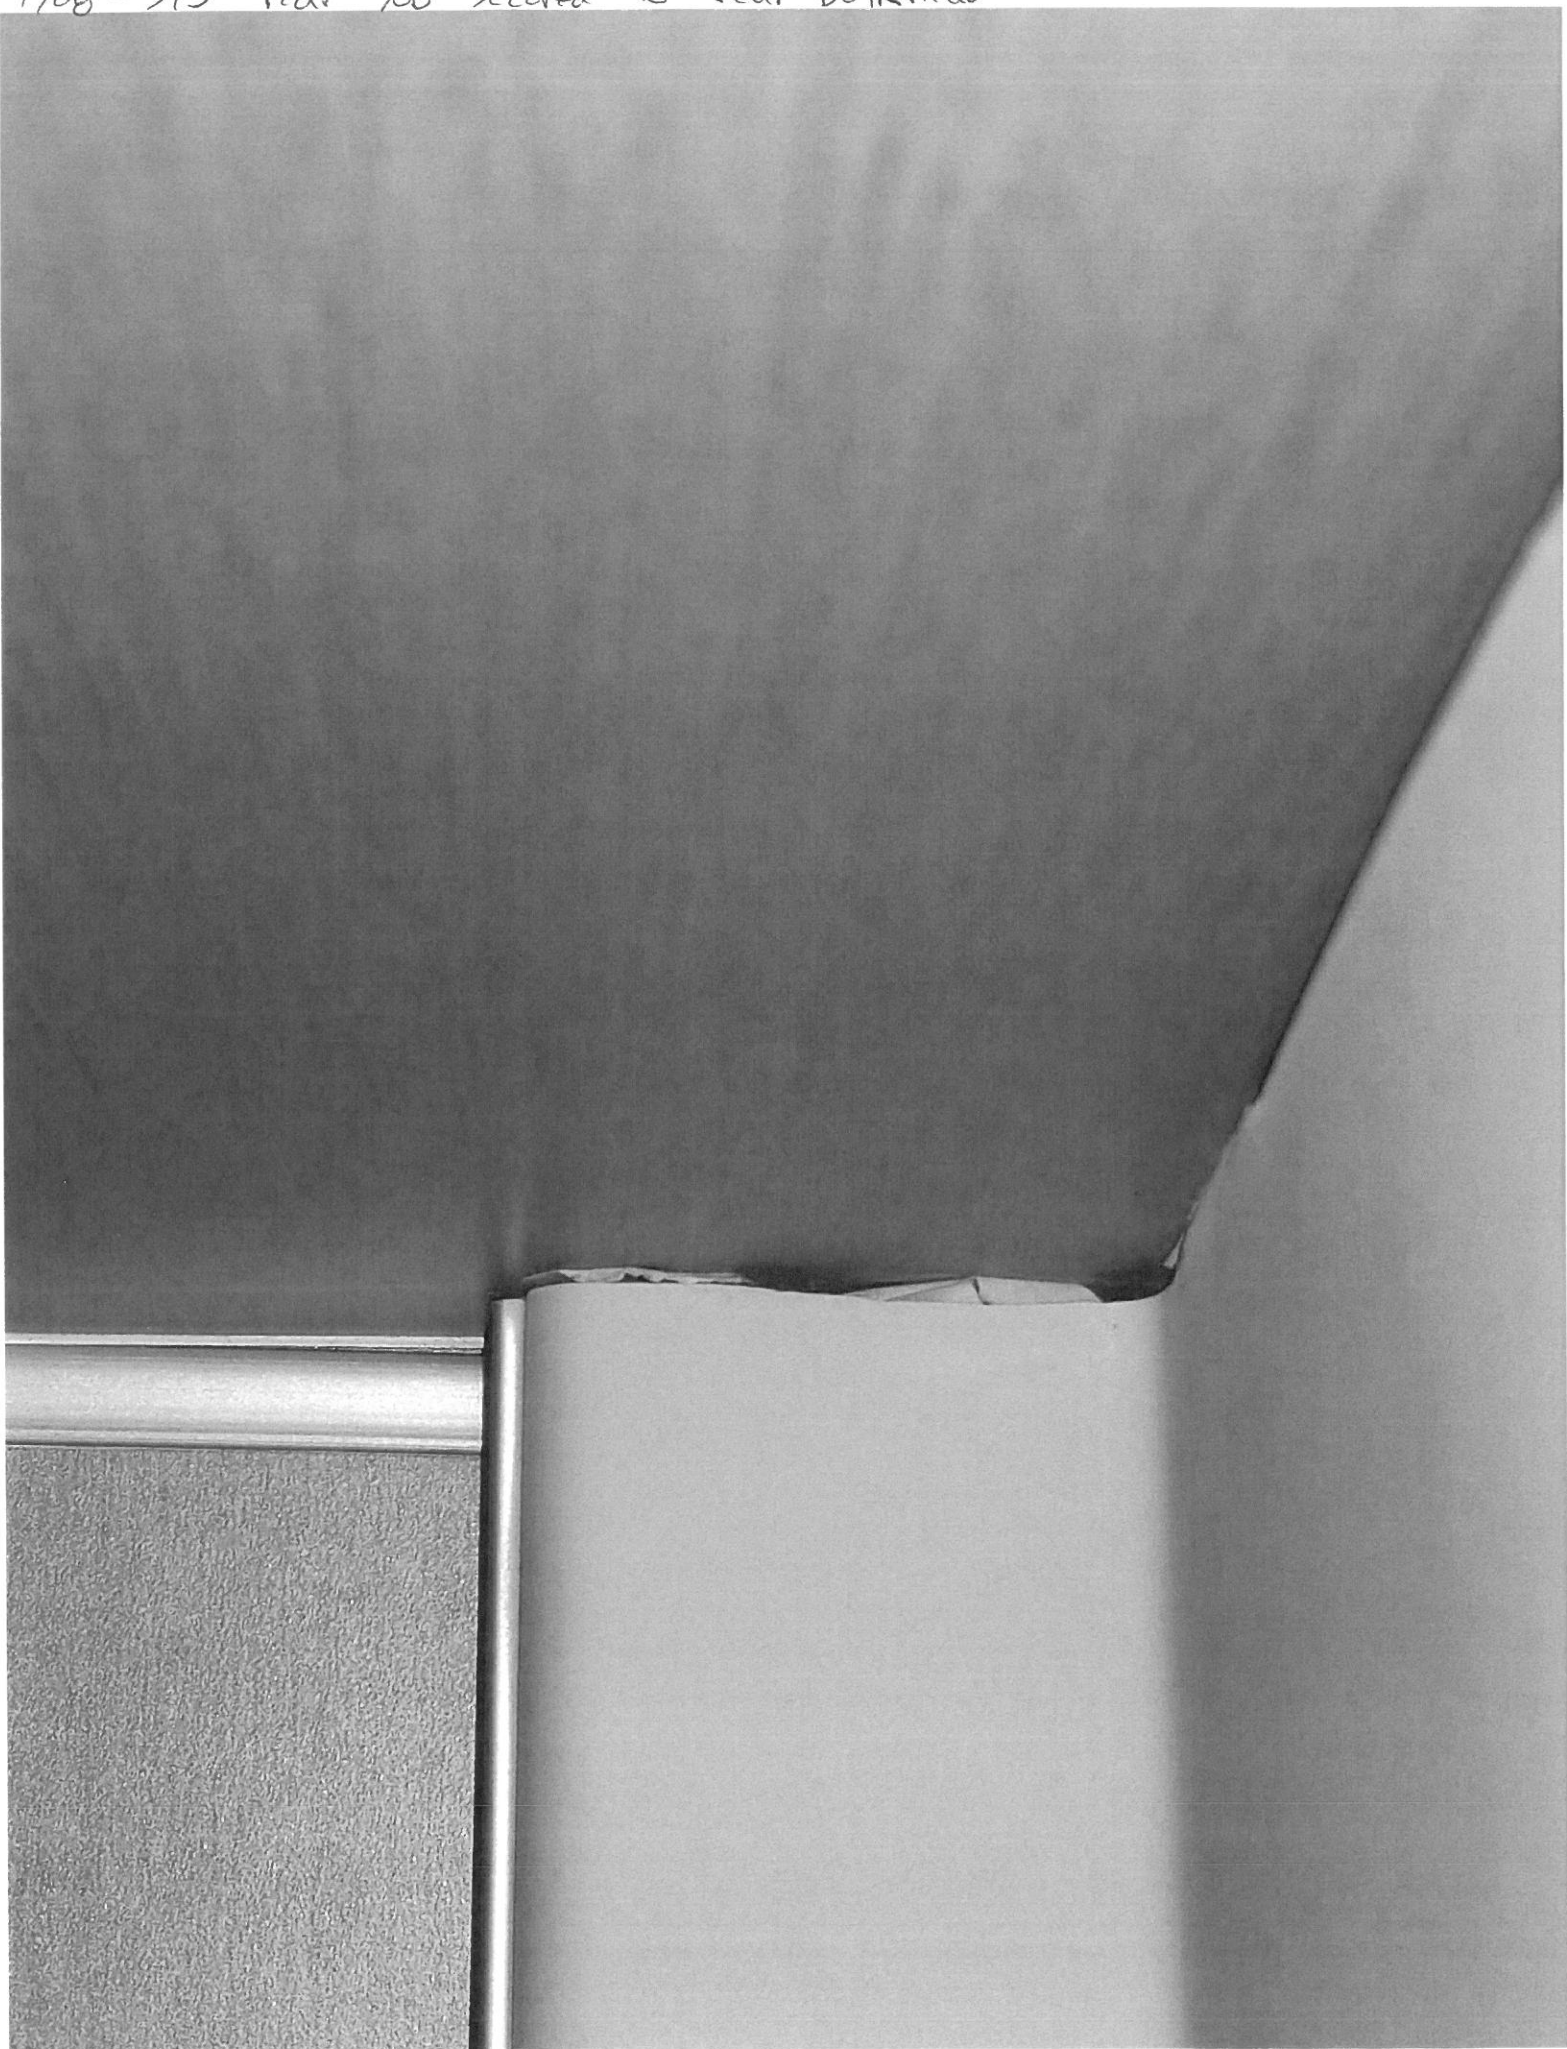
1708 - S/S Rear No secured to rear bulkhead

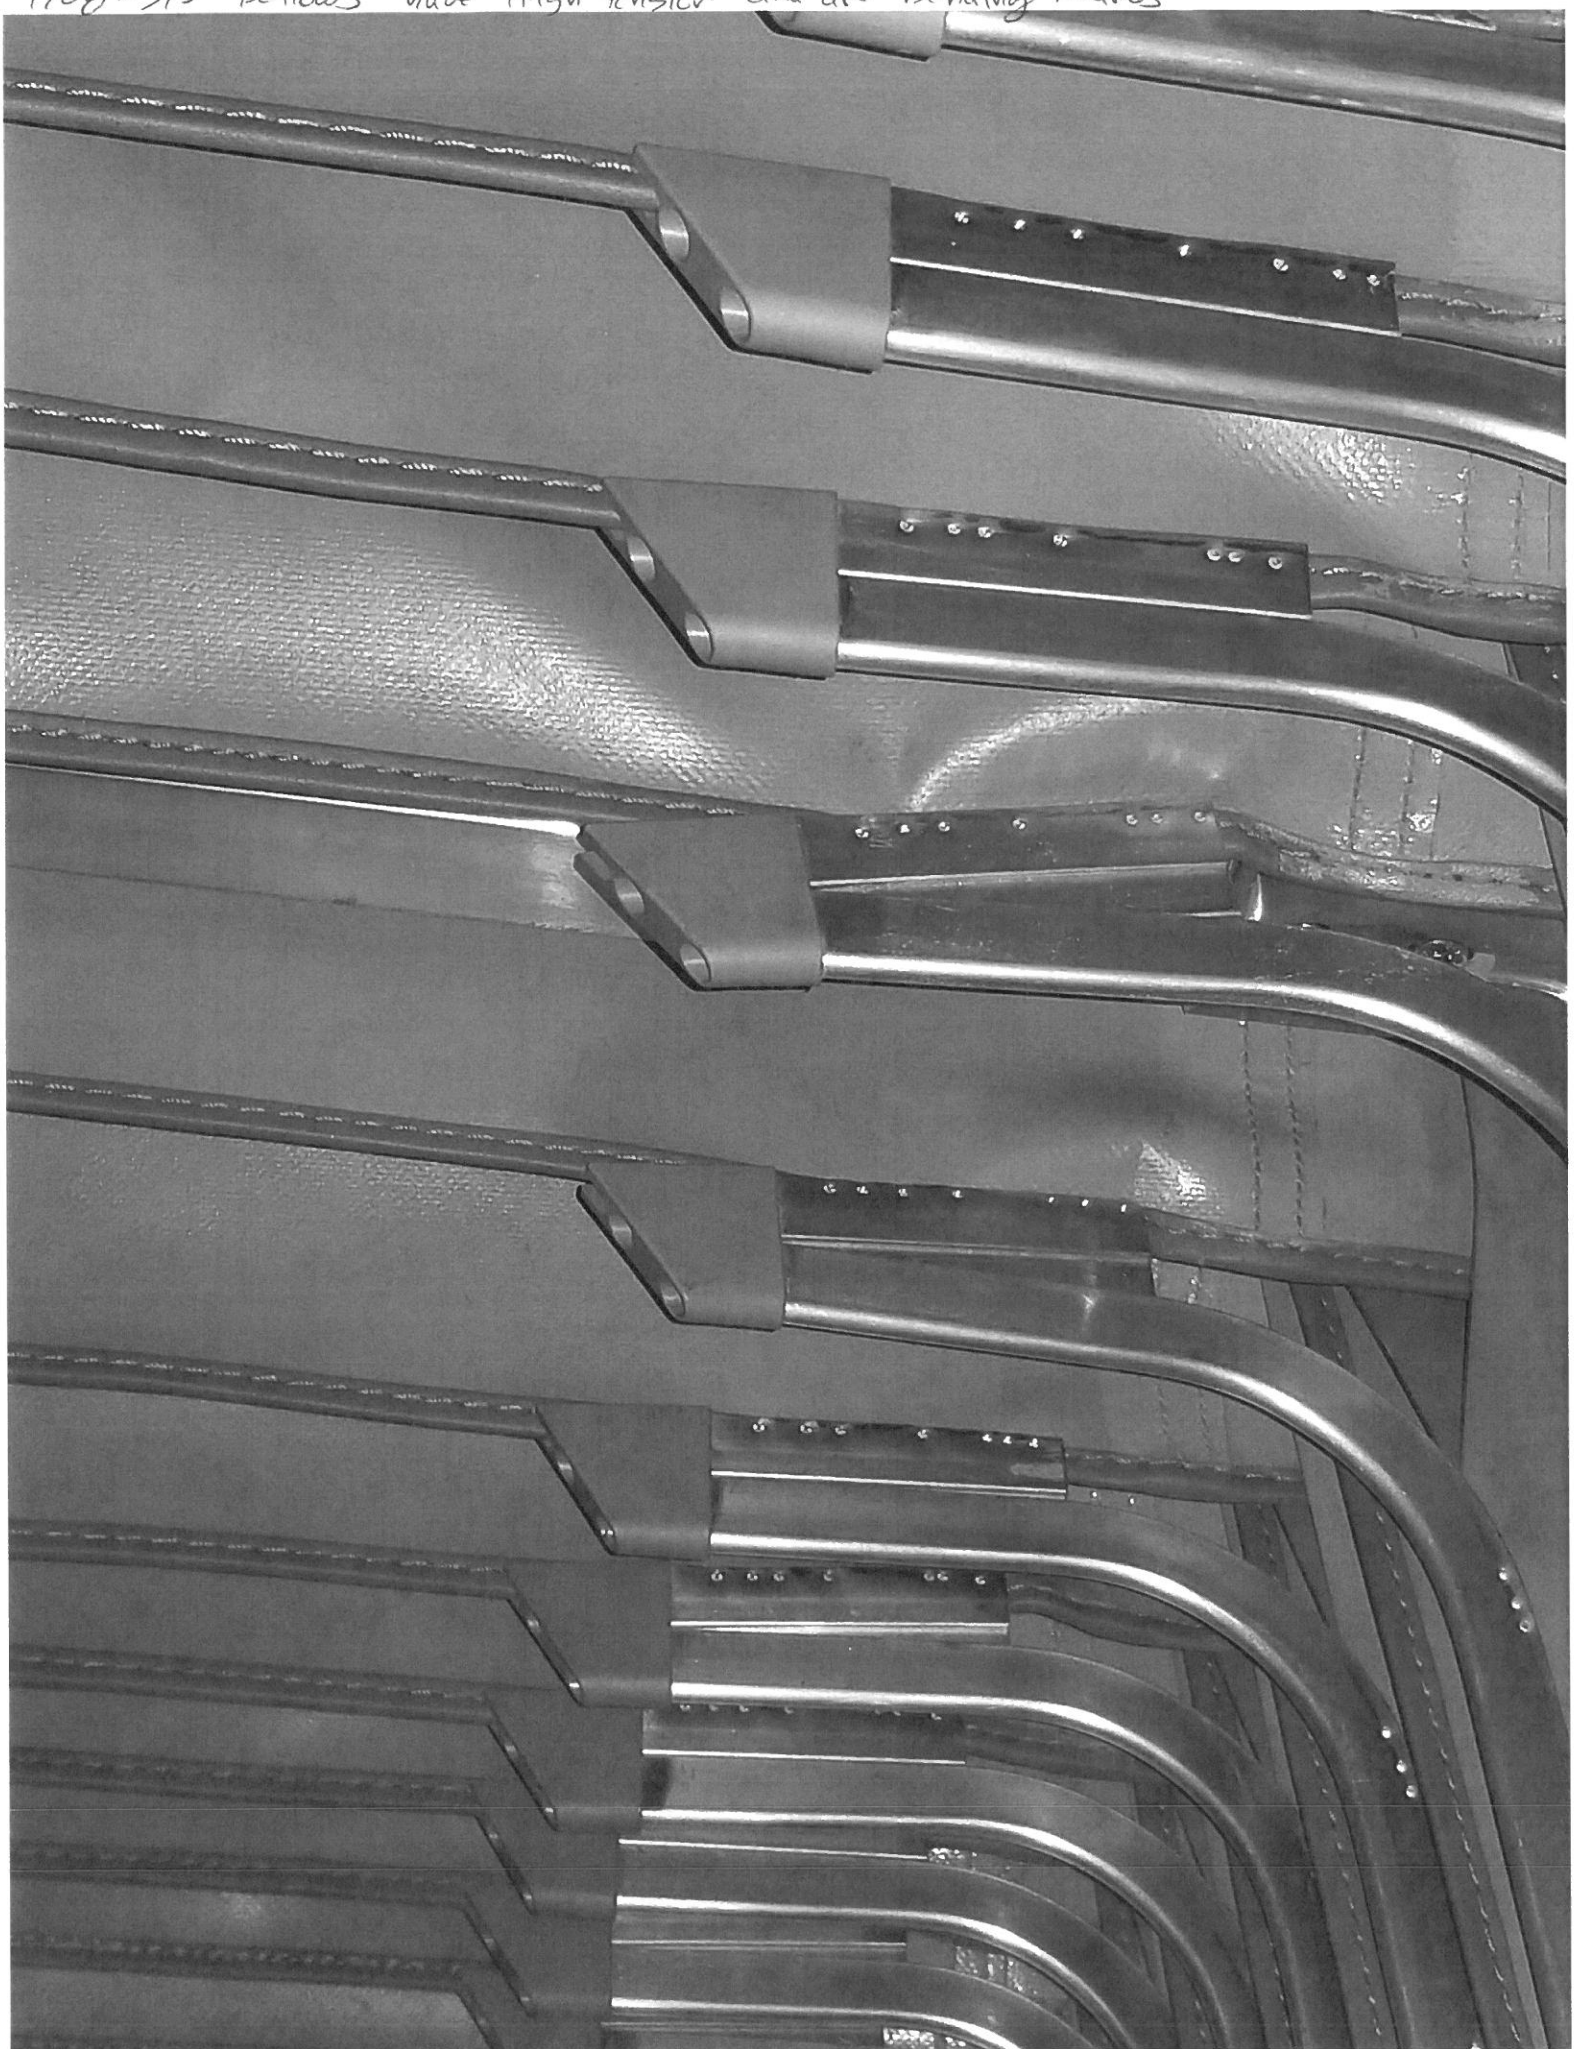
1708-S/S Bellows have high tension and are bending Frames

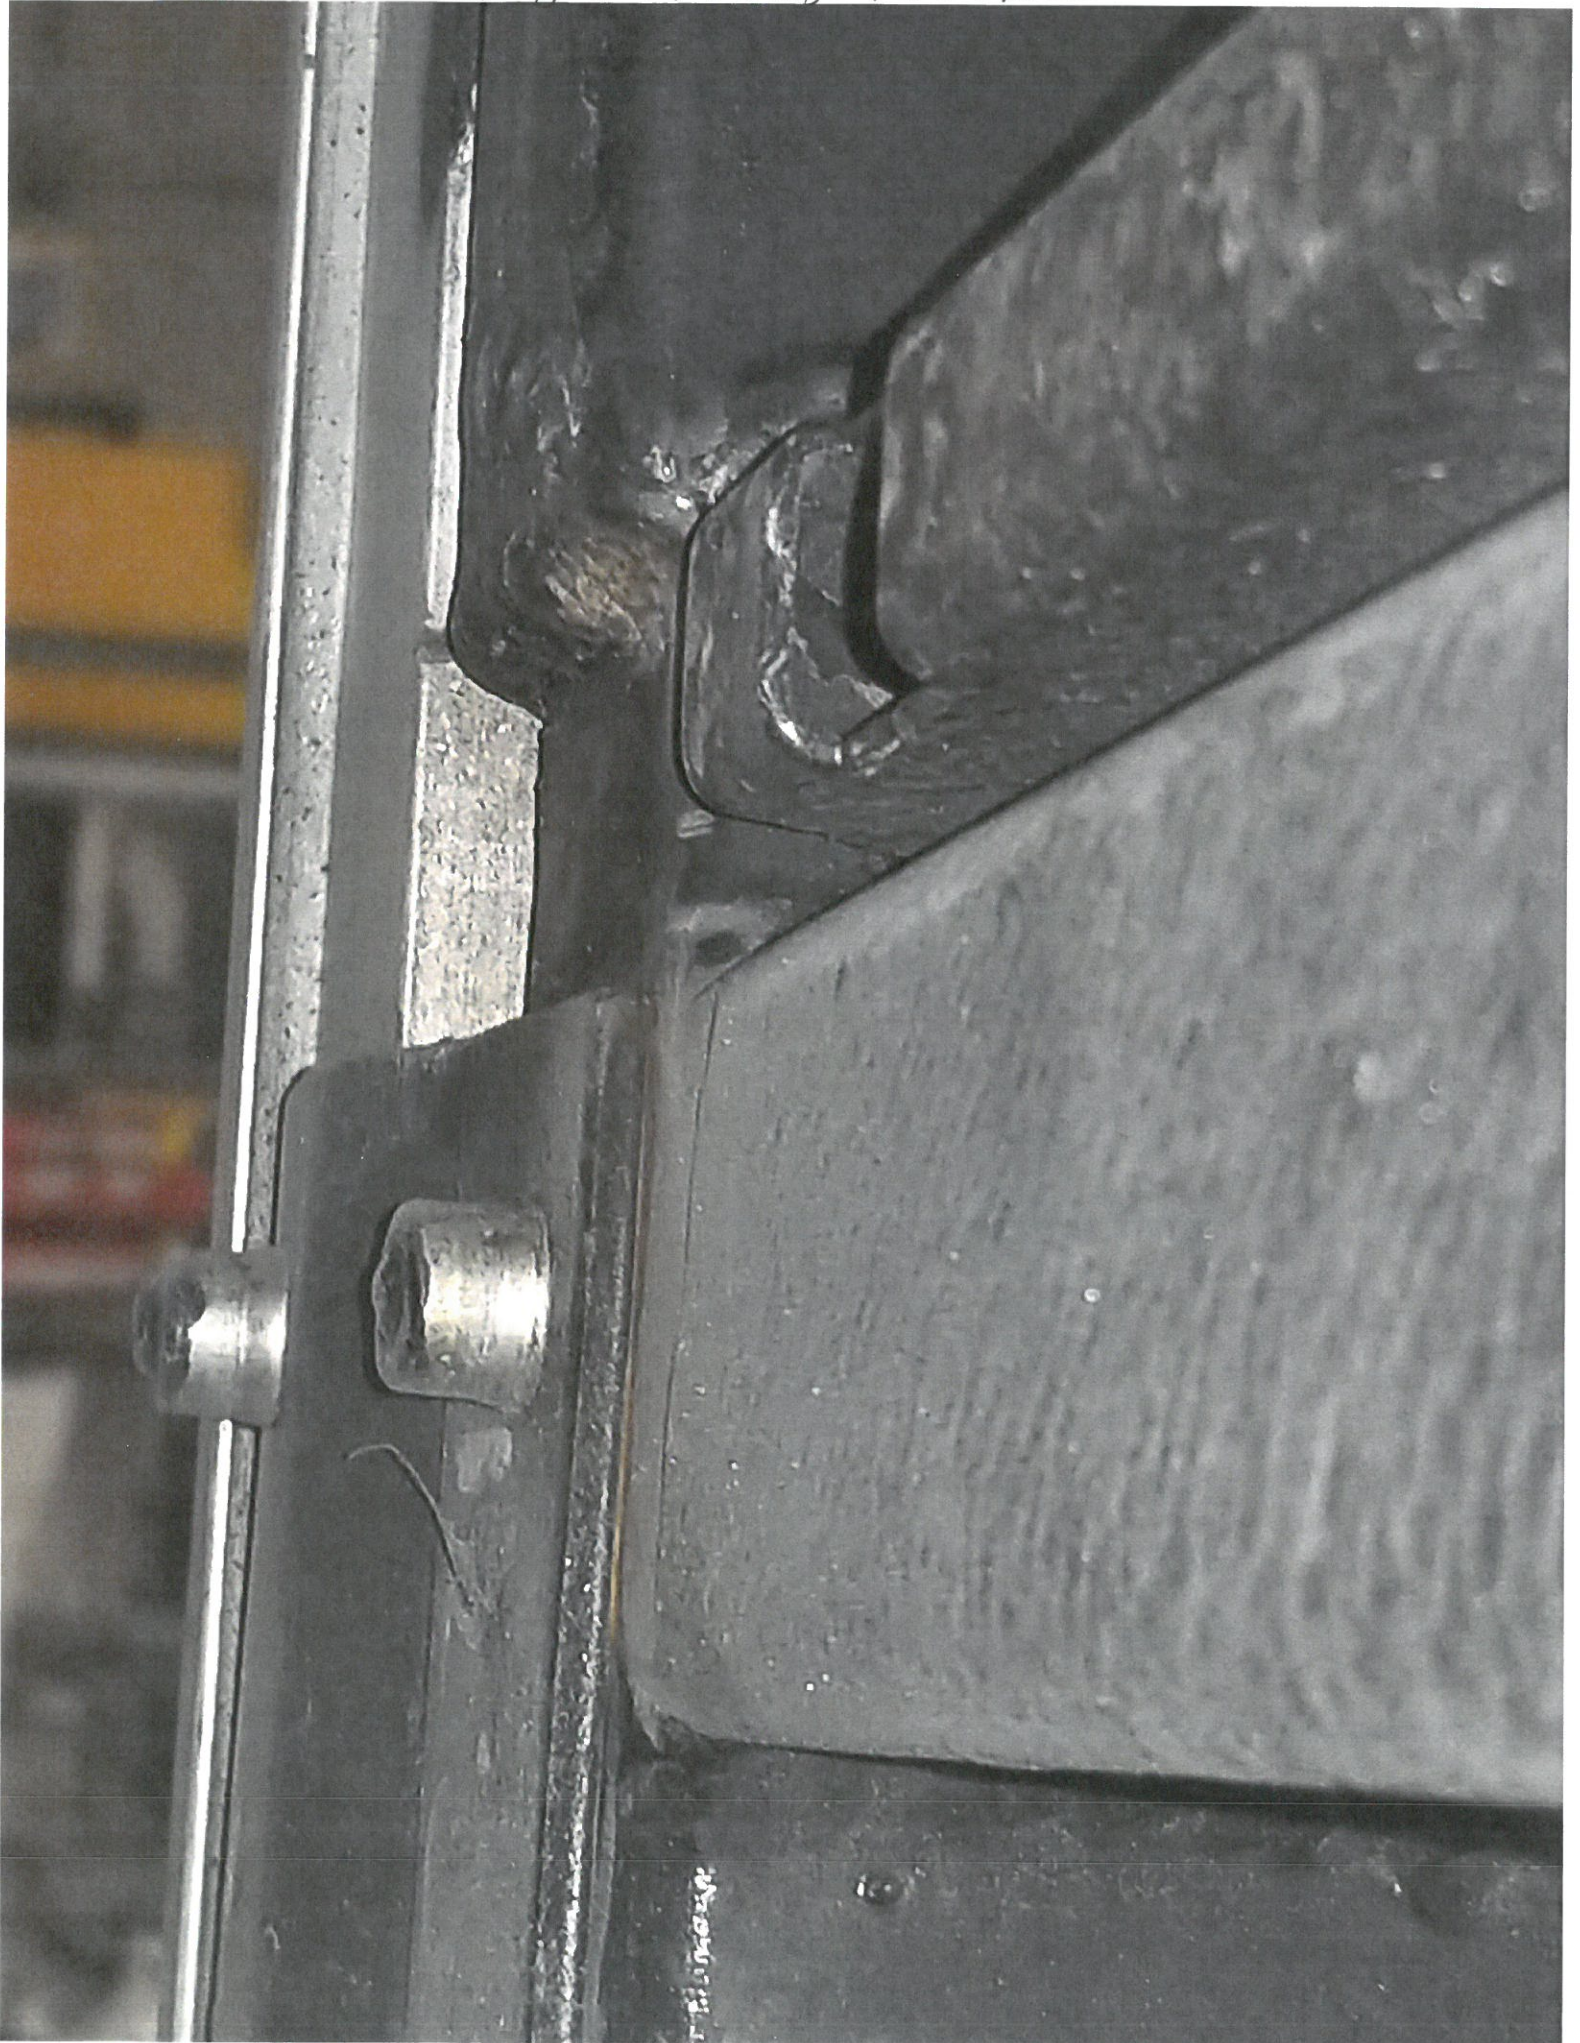
1708 poor and rusty welds. Bridge plate frame
