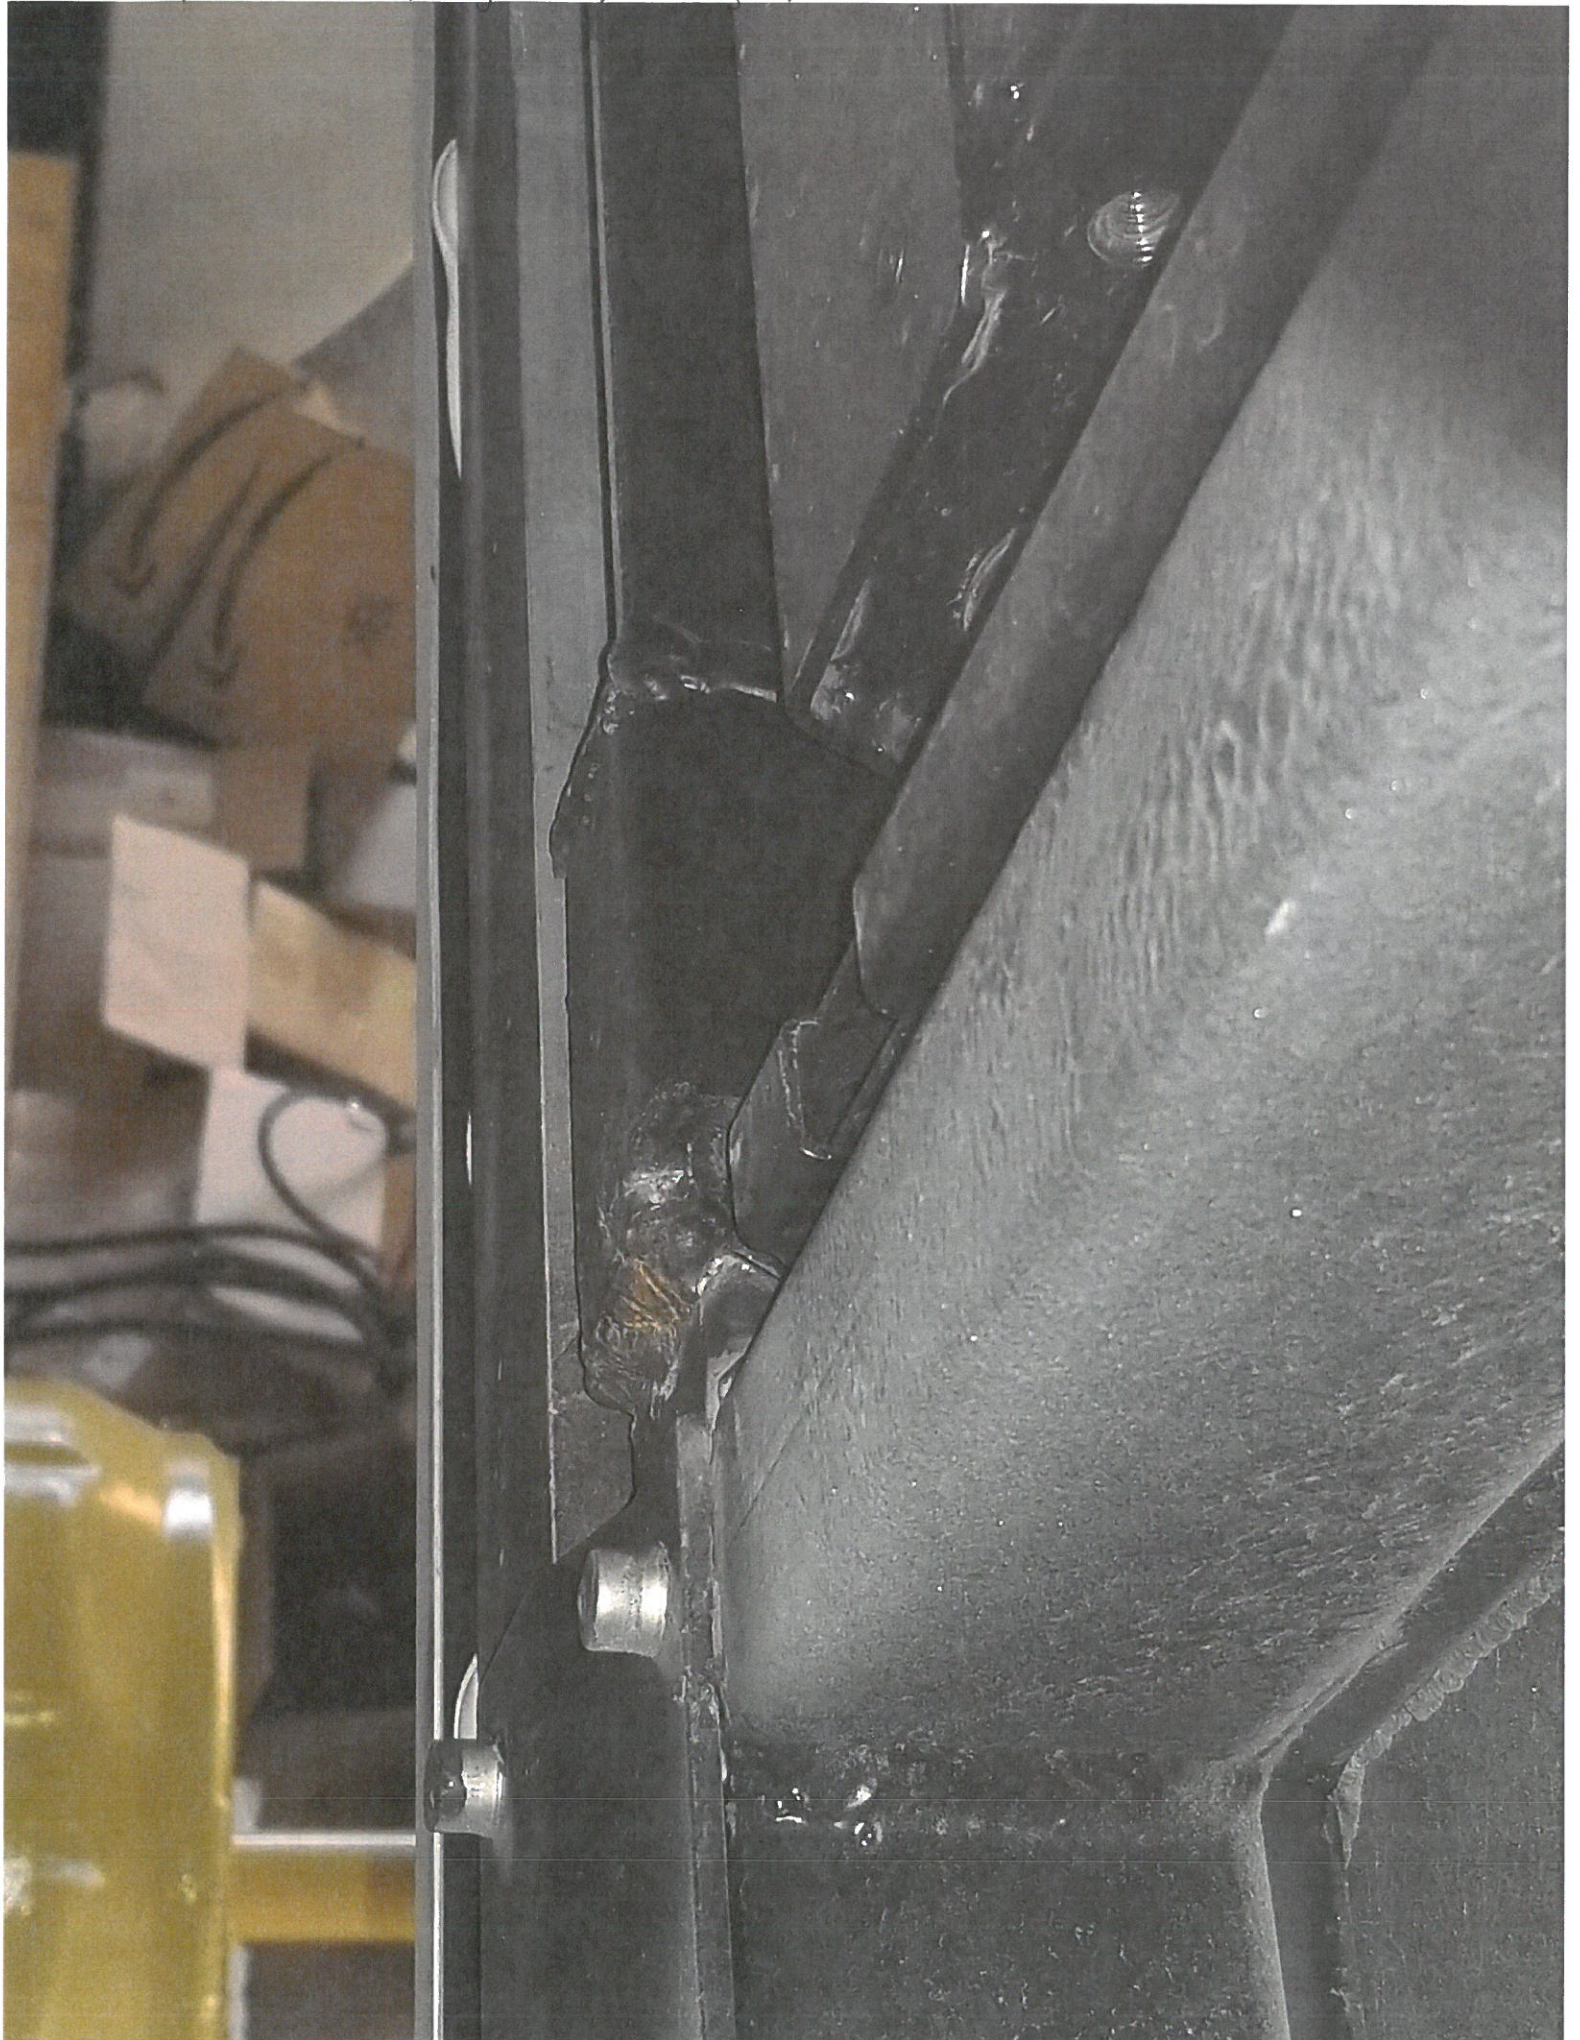
1708 poor and rusting welds, Bridge plate frame

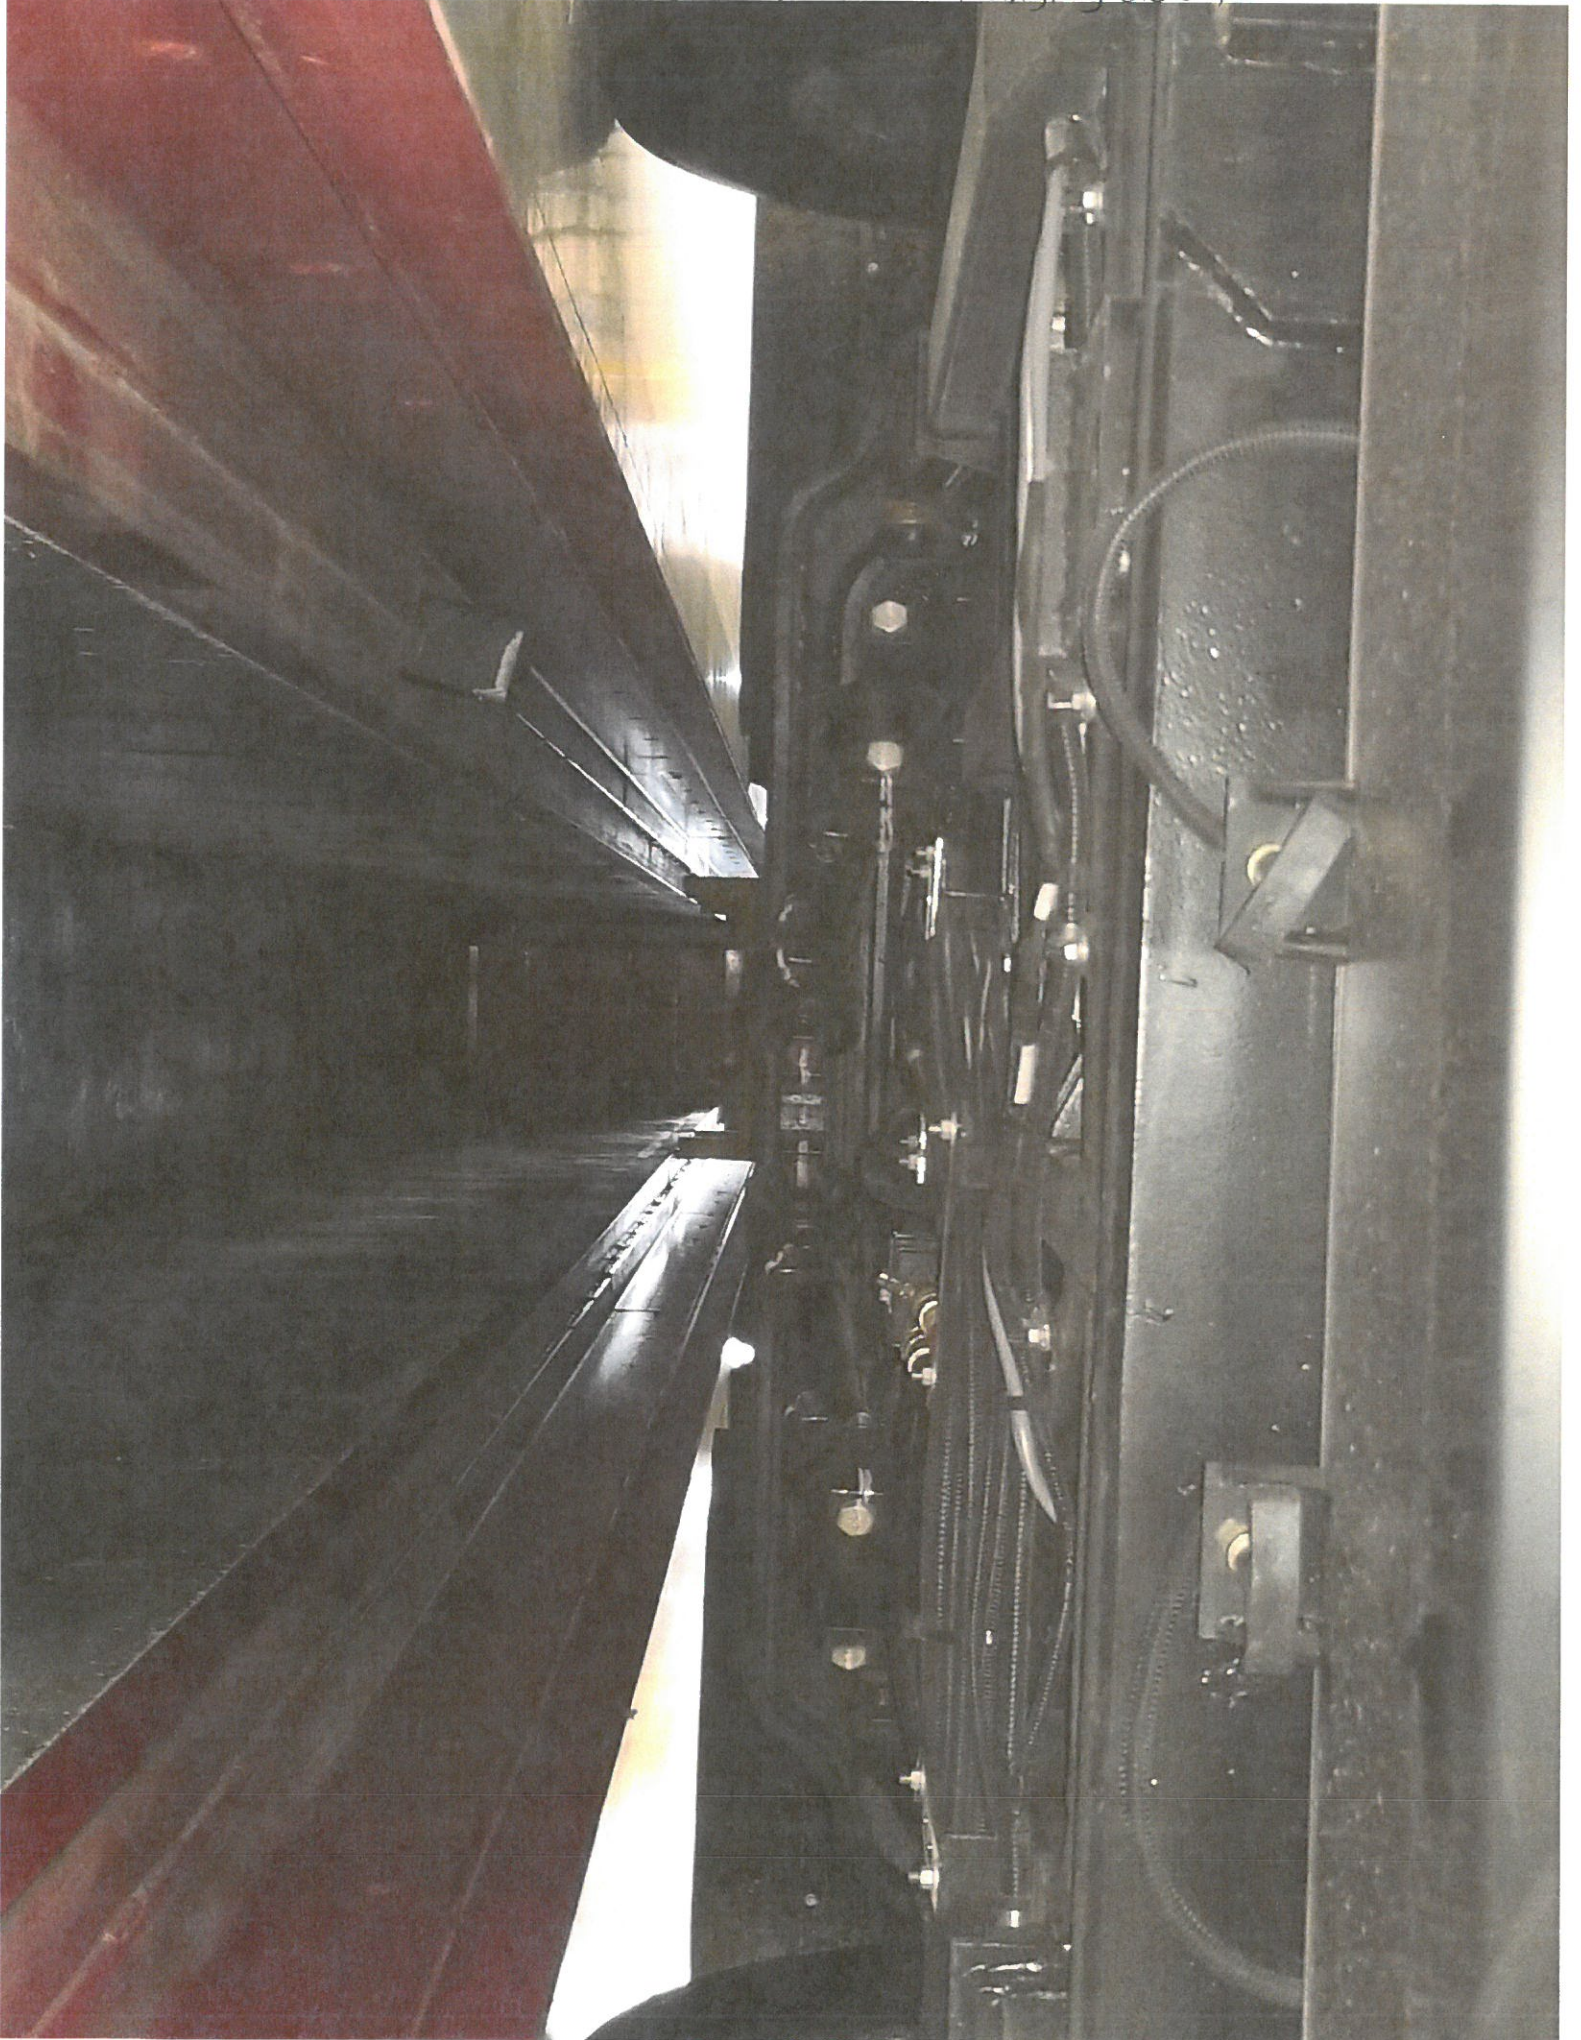
1708 - Front of bus shows lines and wires hanging down

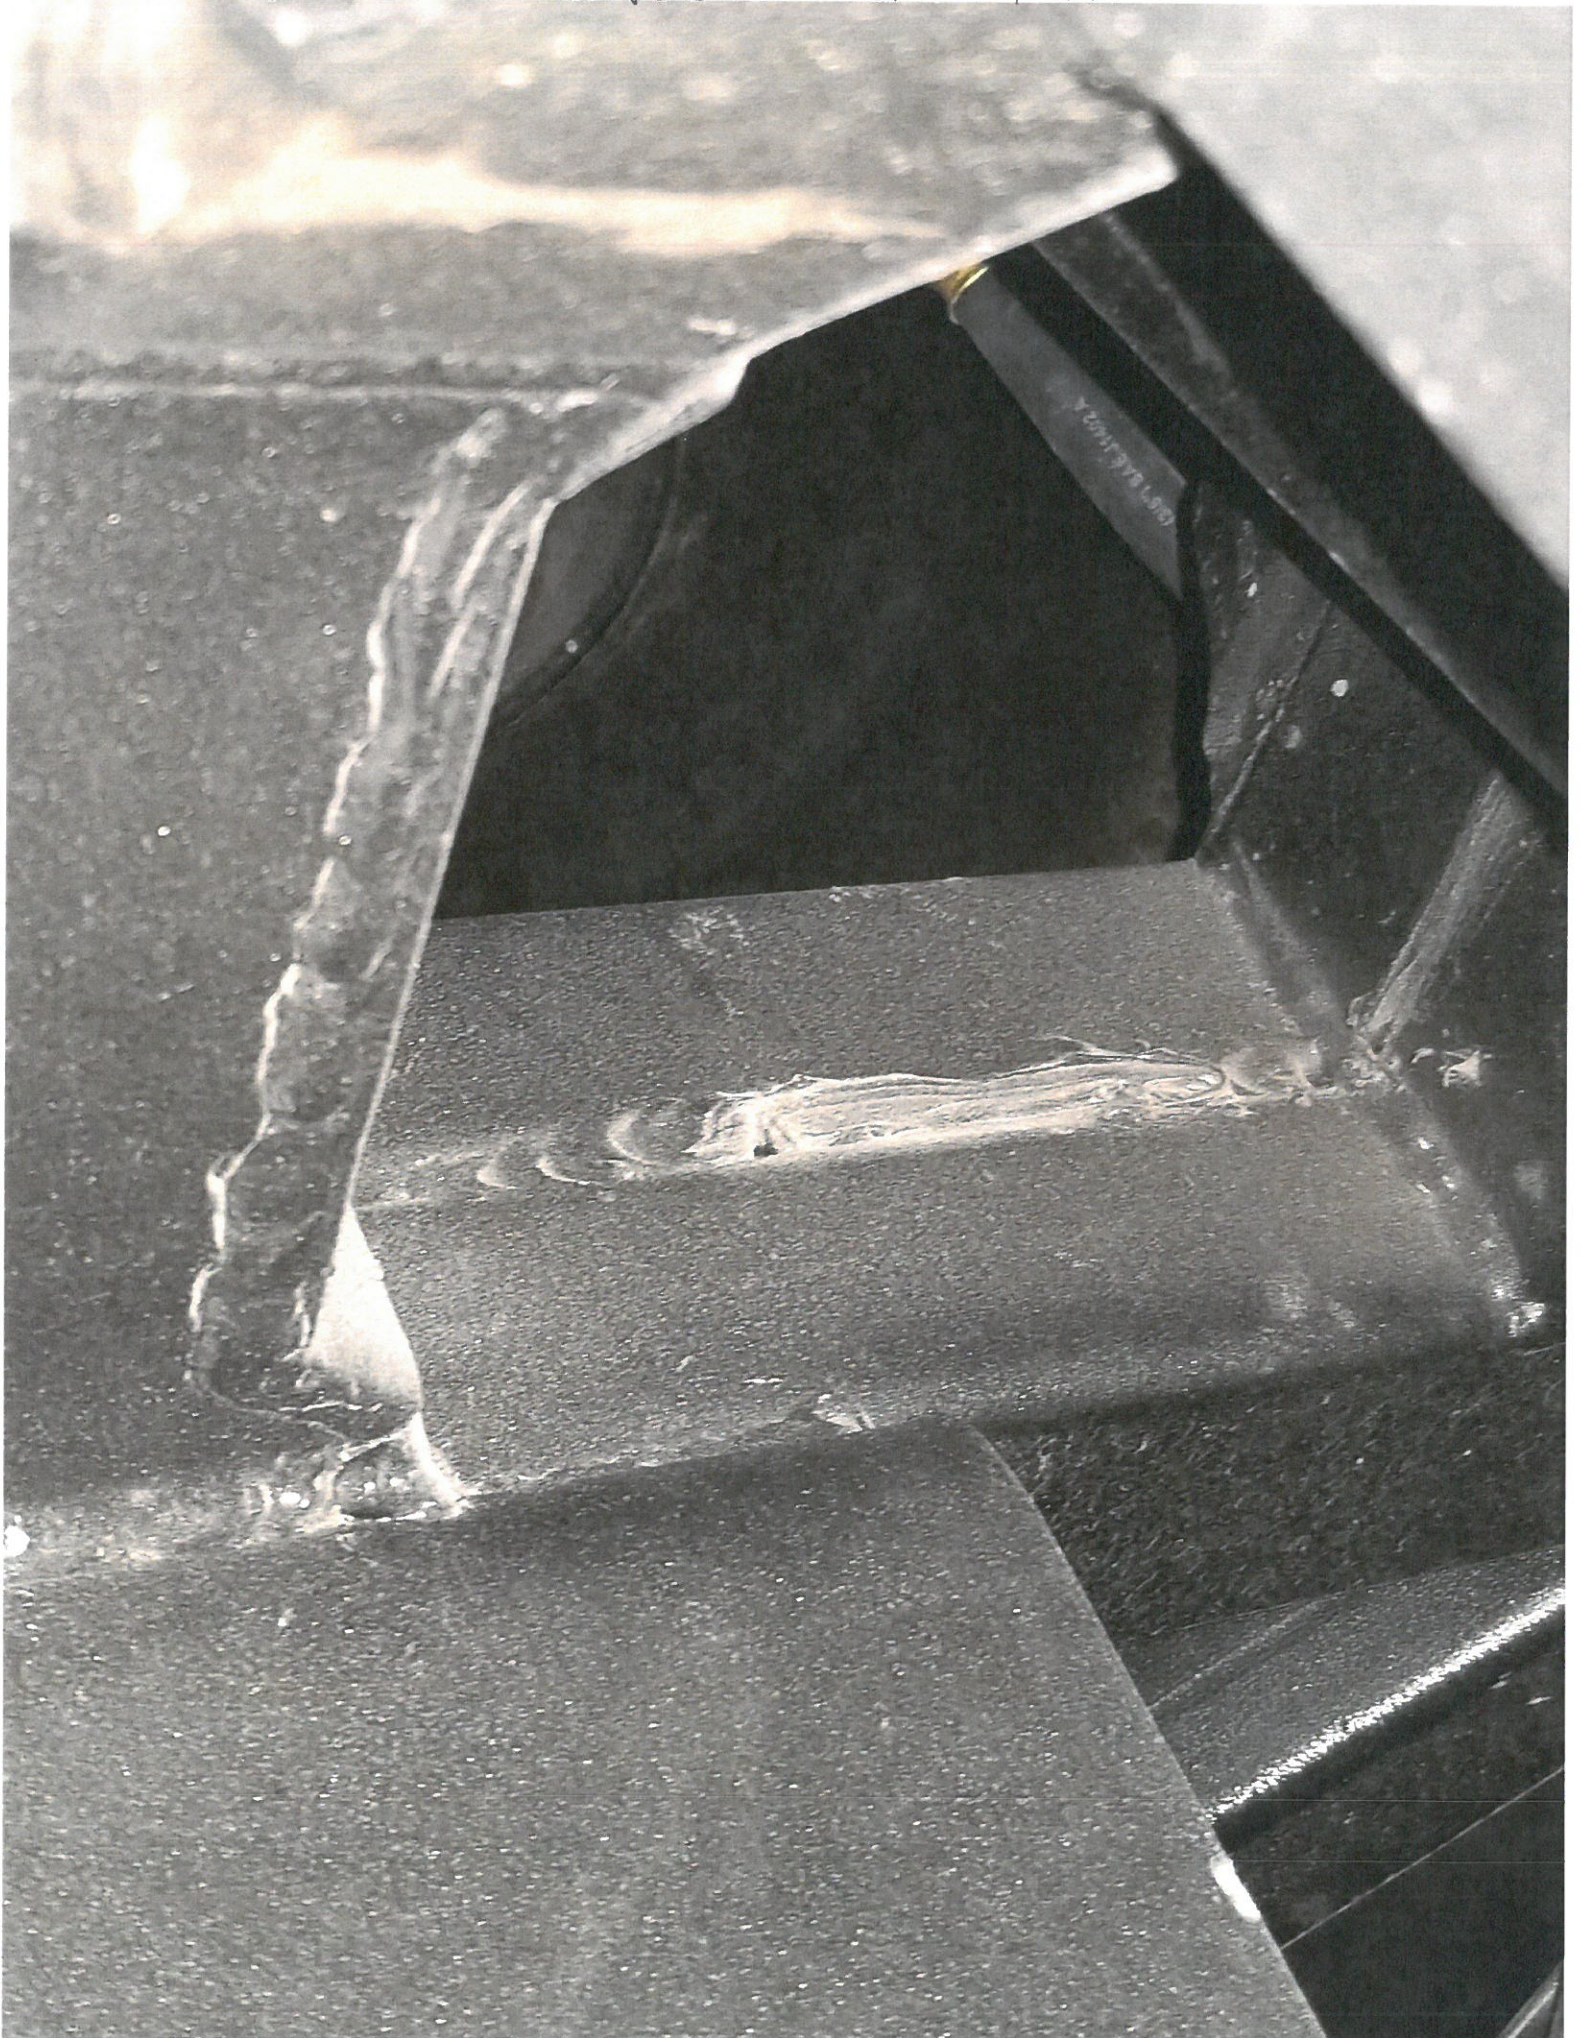
1708. S/S Front weld incomplete and covered w/ silicone

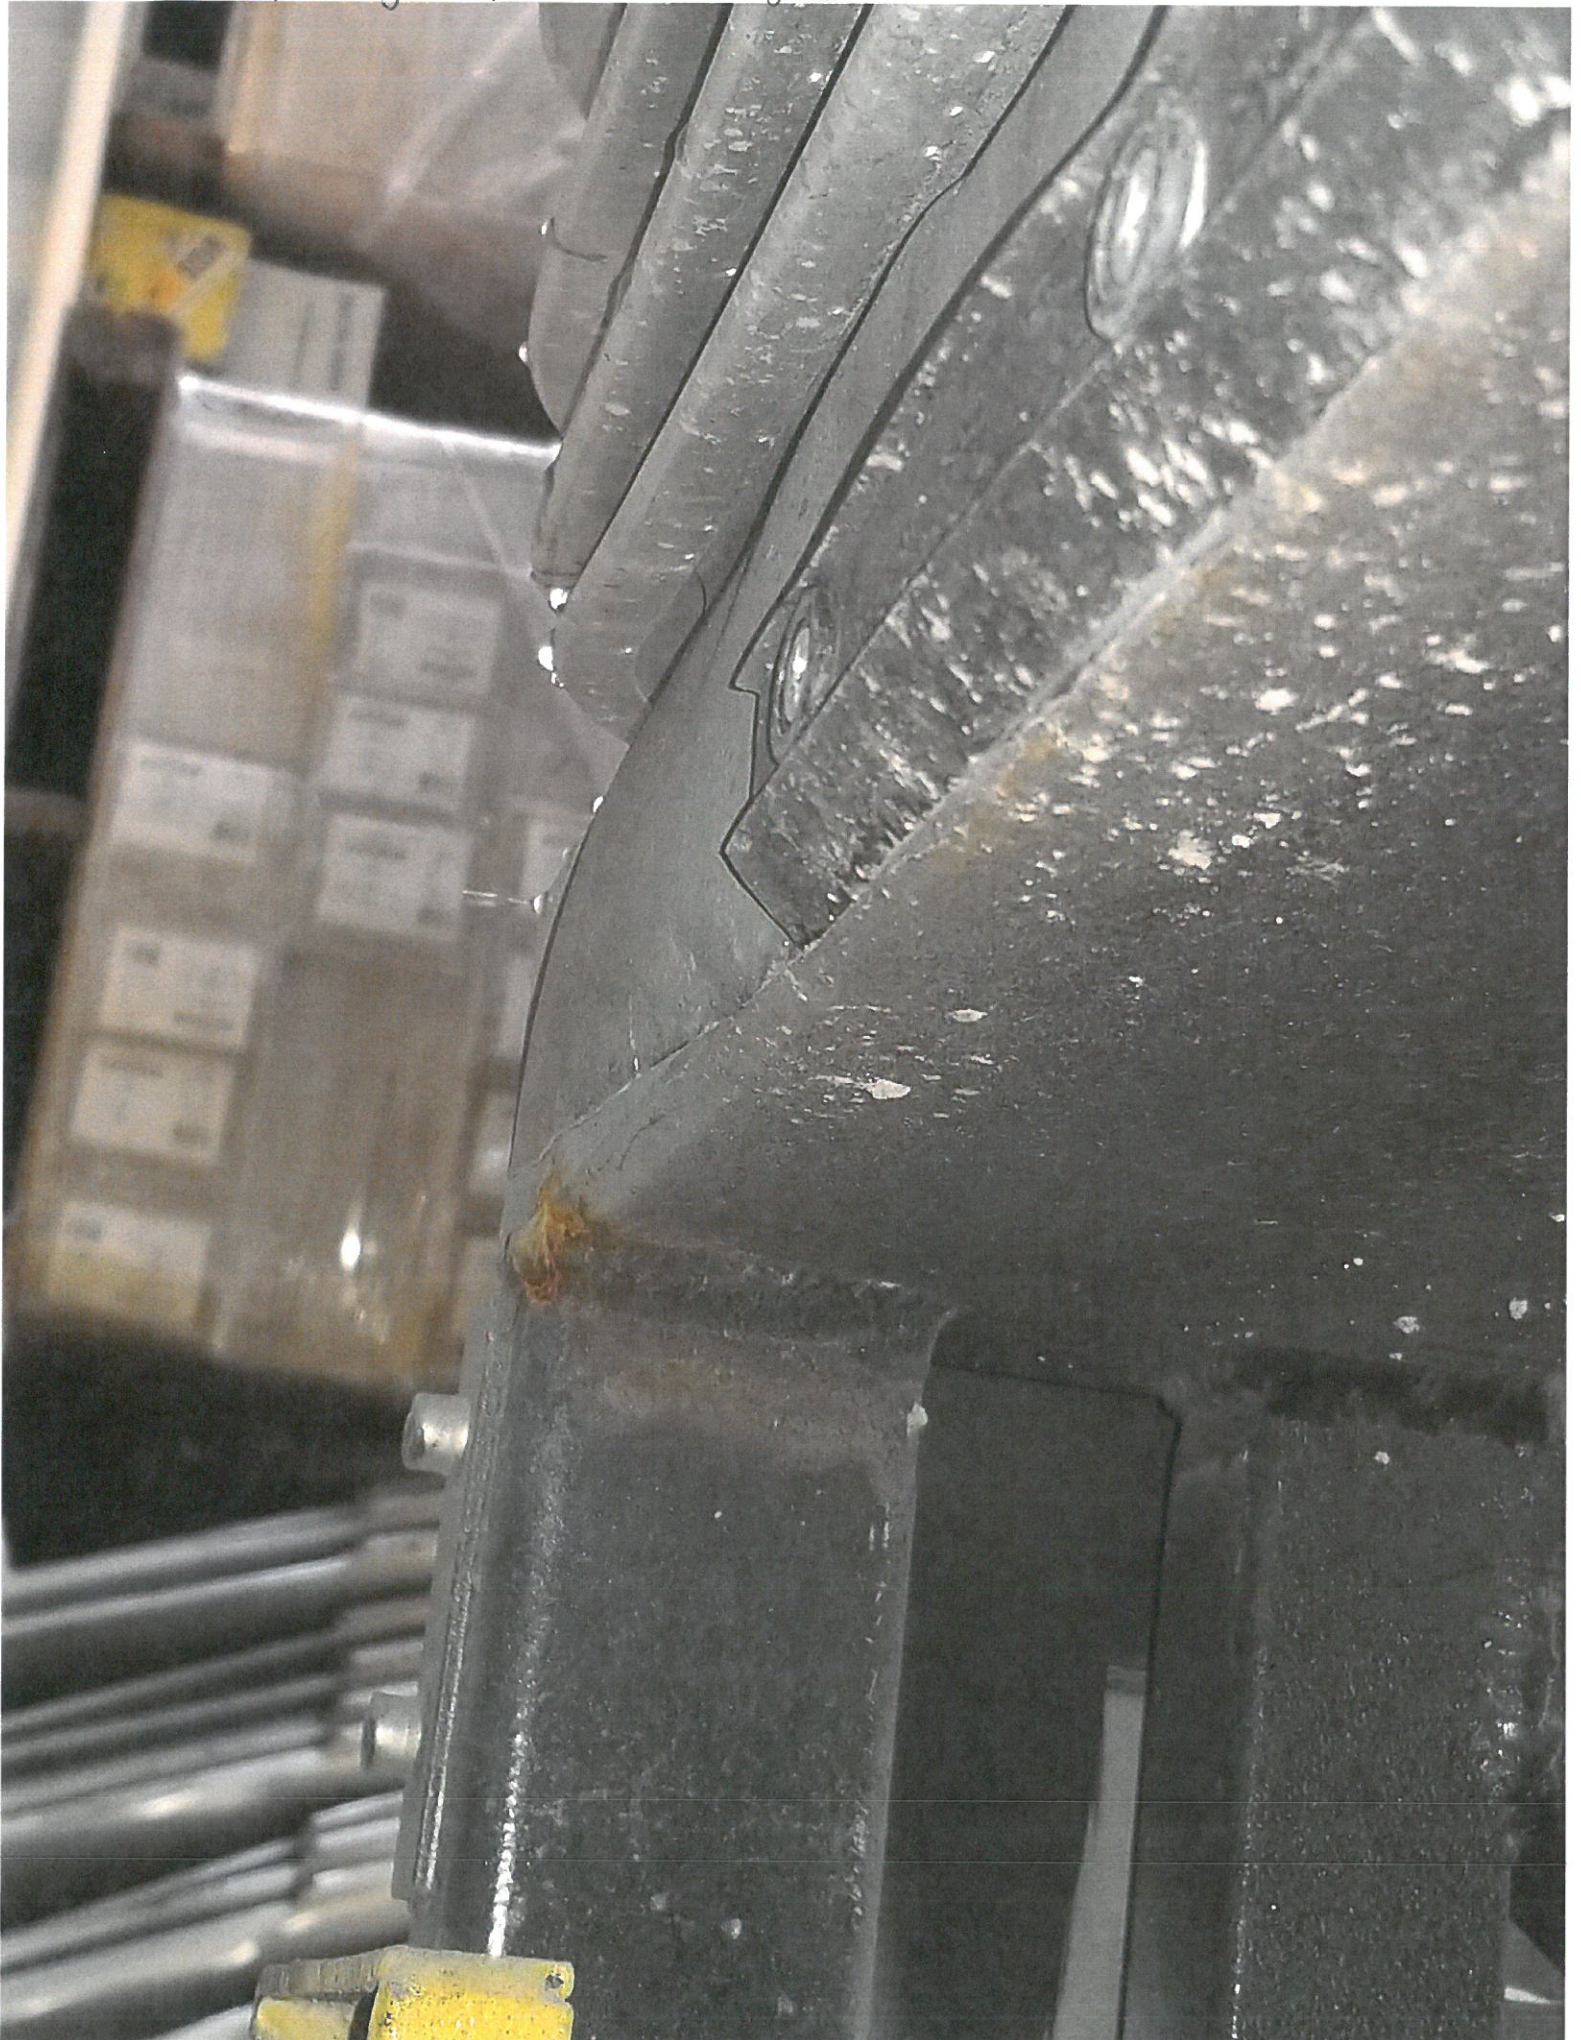
1708 poor, rusting welds. rear of joint

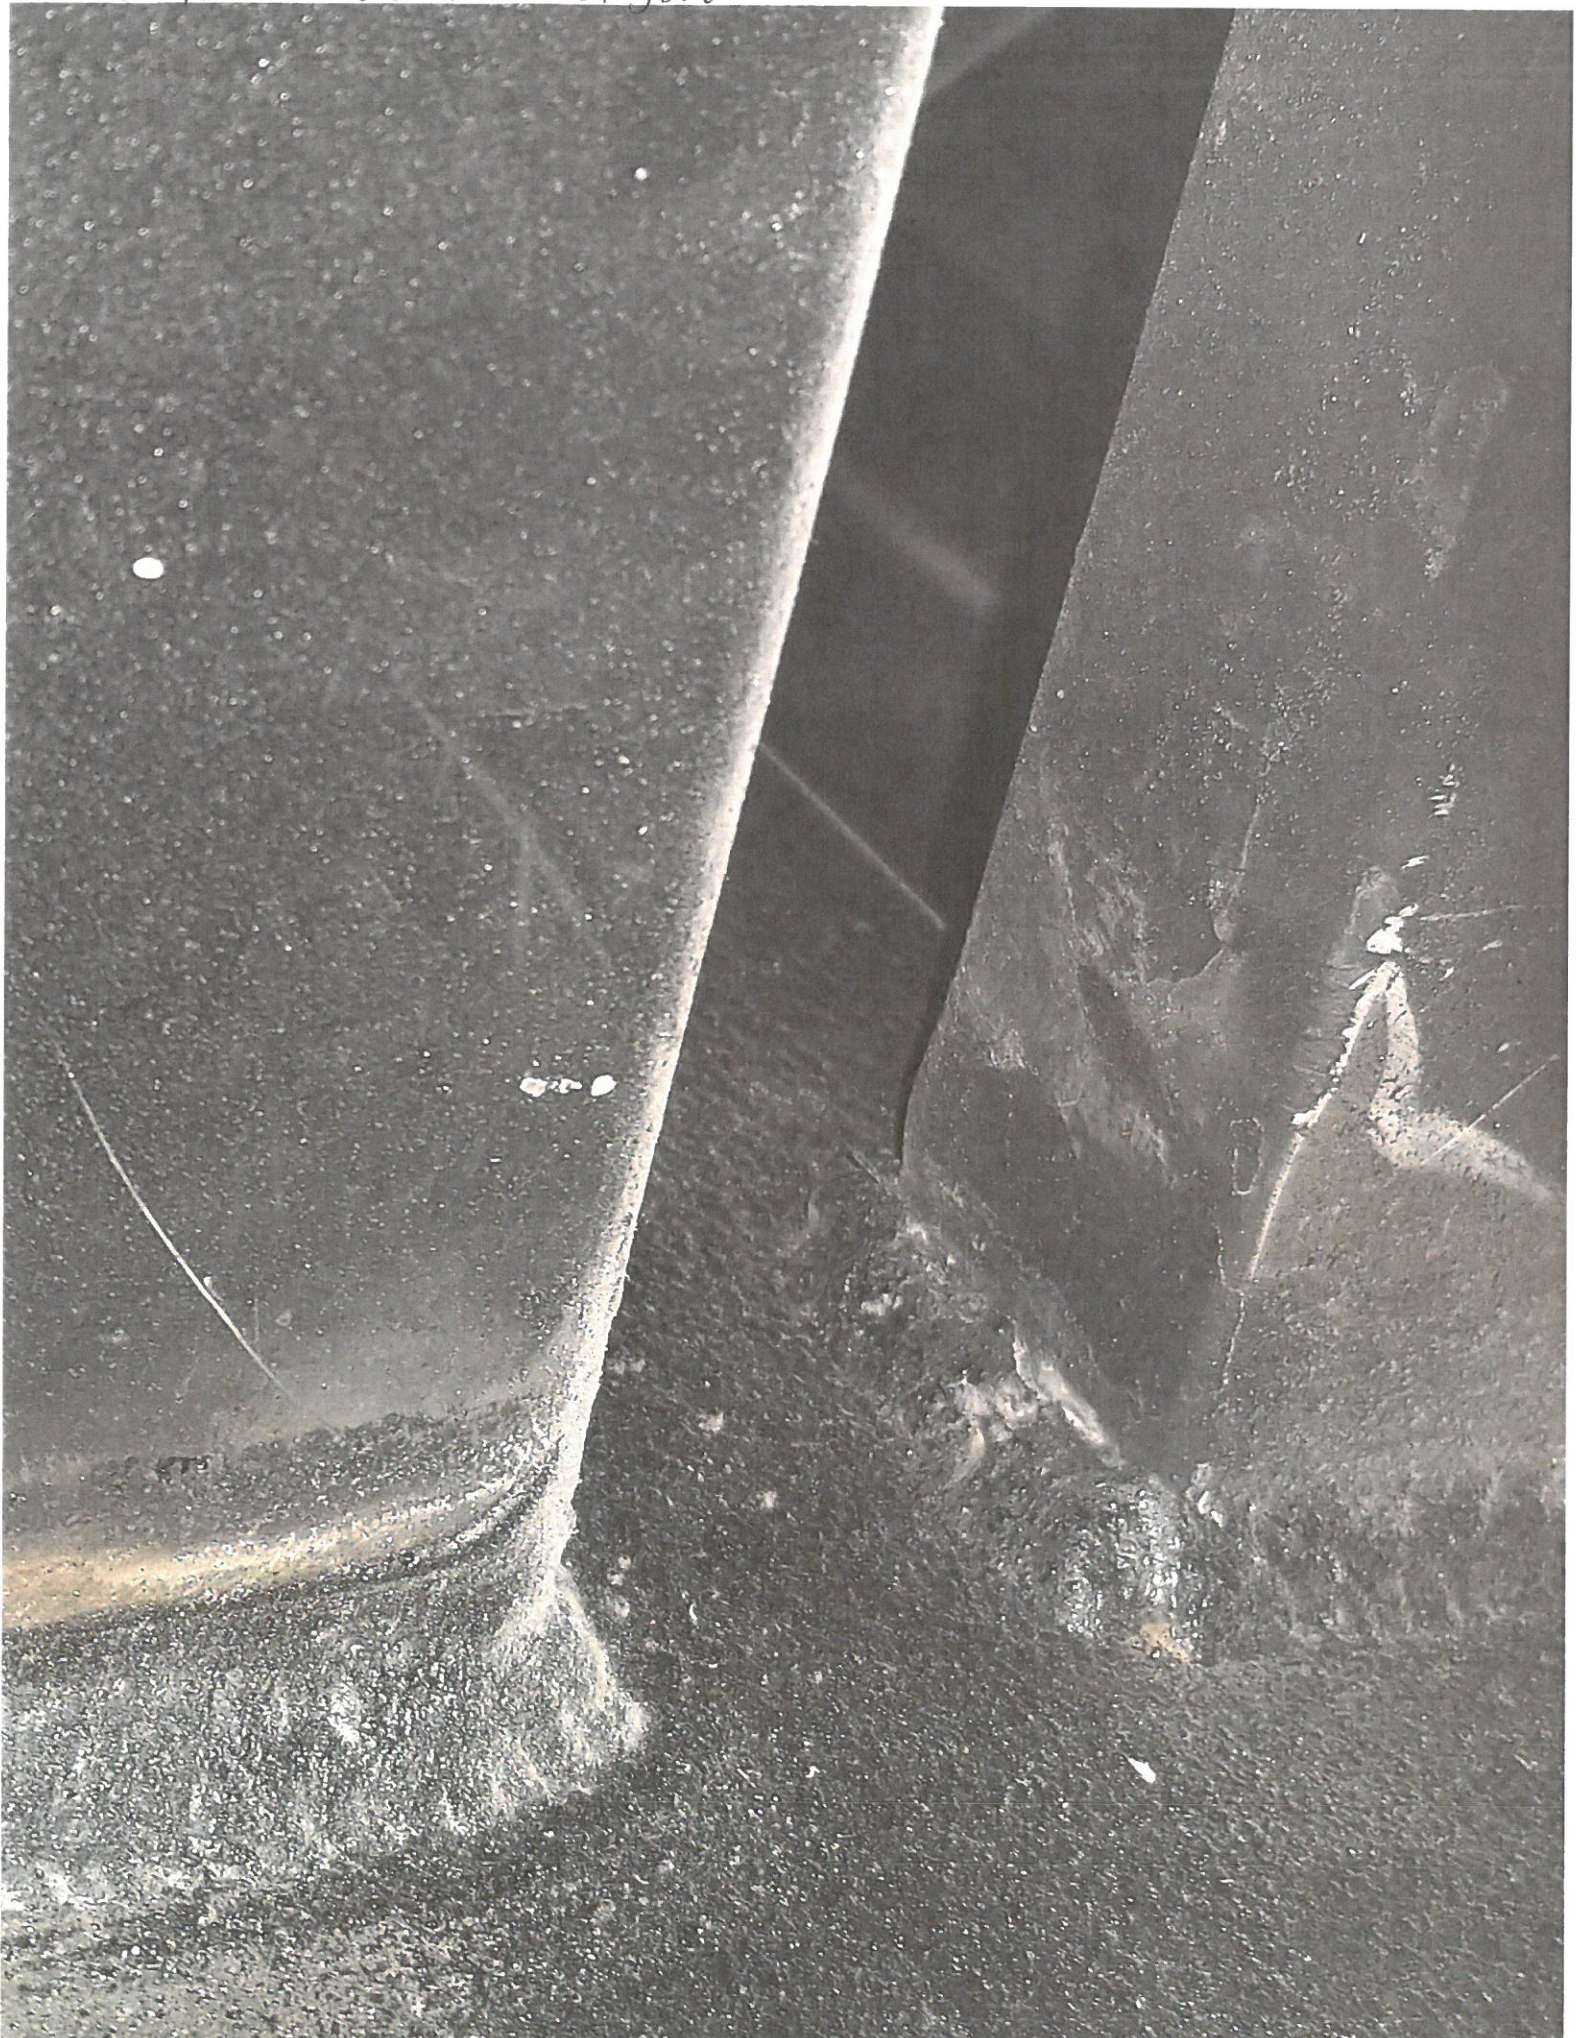
1708 poor welds, rear of joint

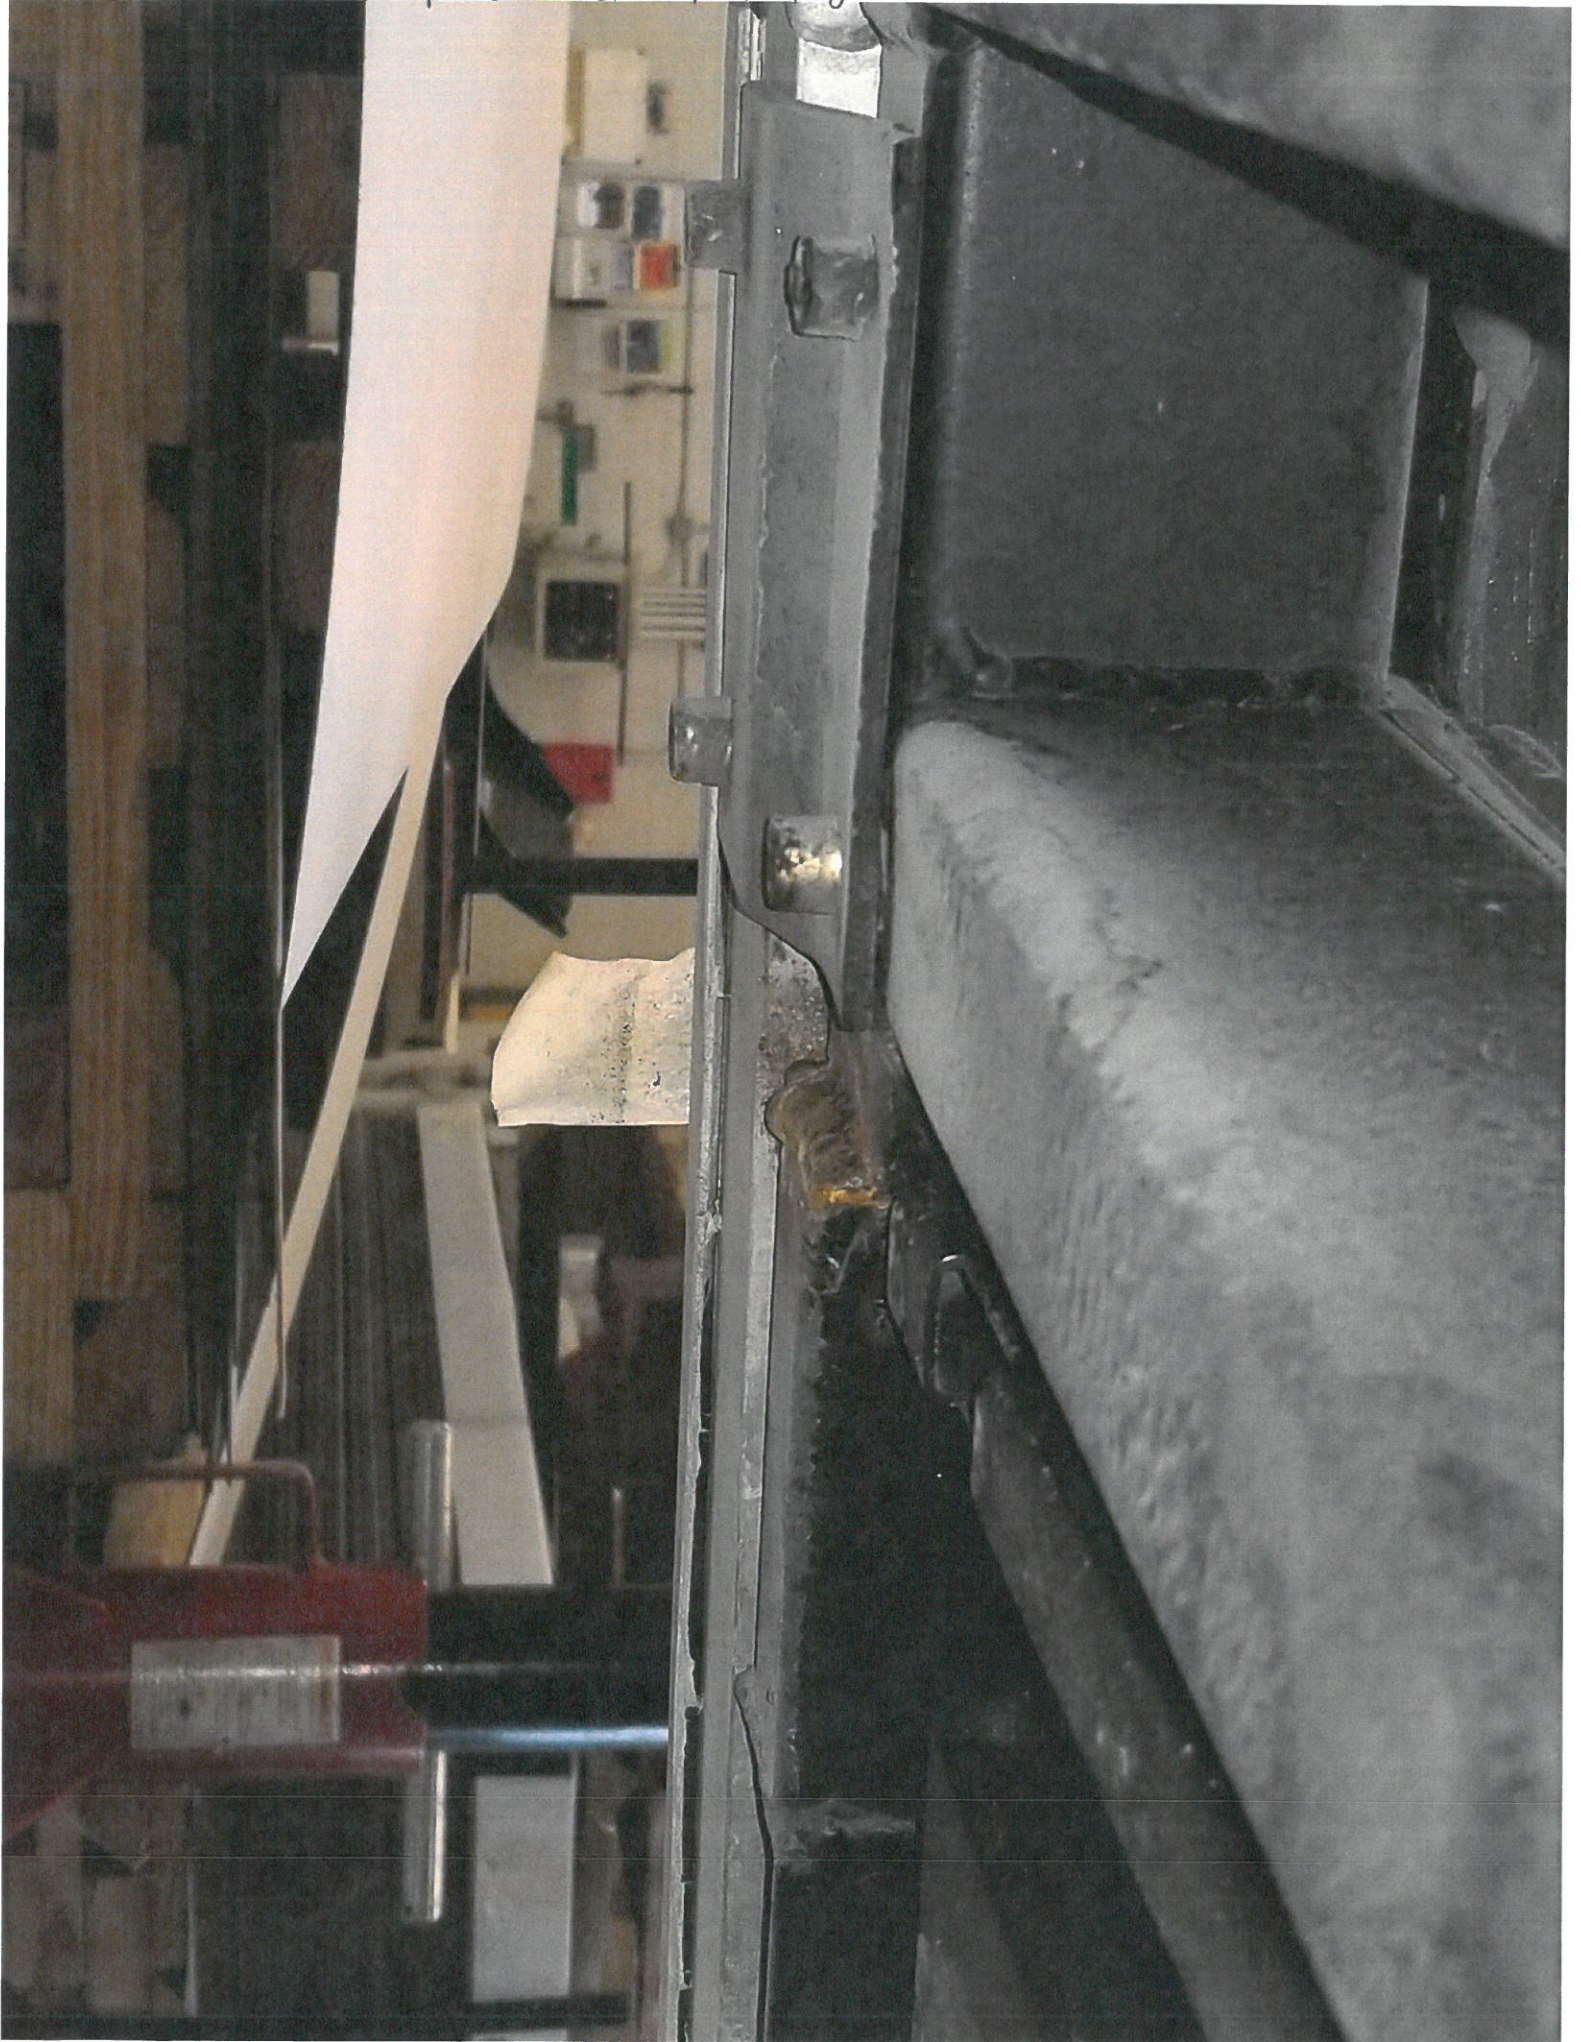
1708 CLS Bridge plate welds rusting

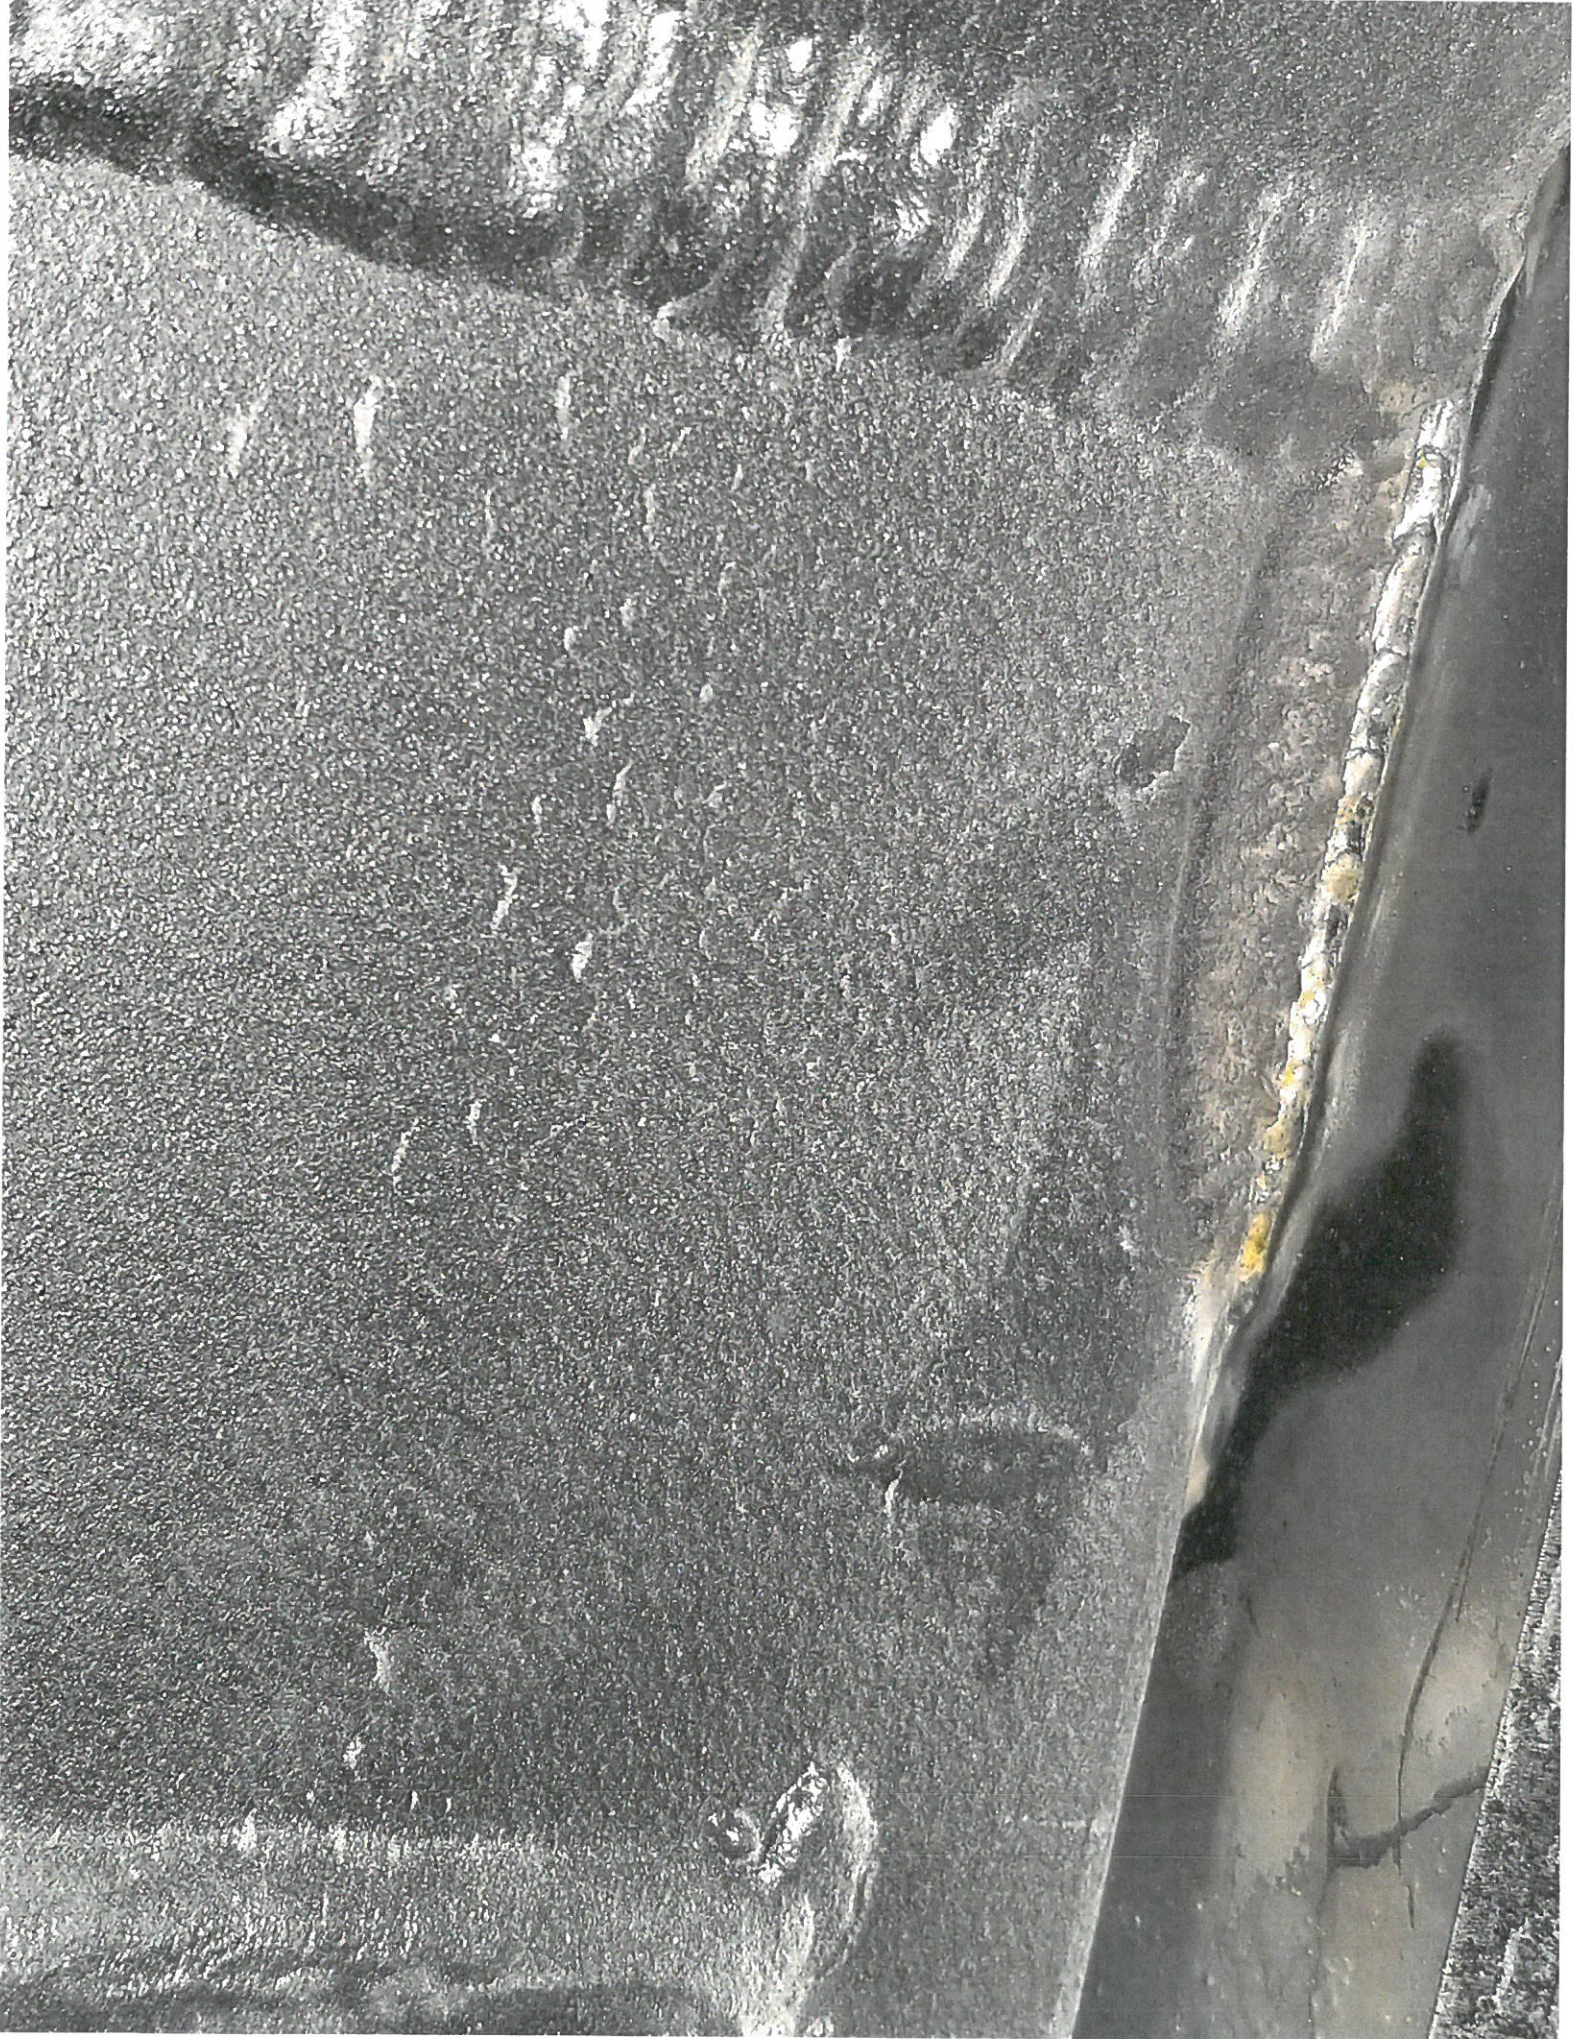
1708 - Rear Frame cross plate rusting and welds are not bonded
