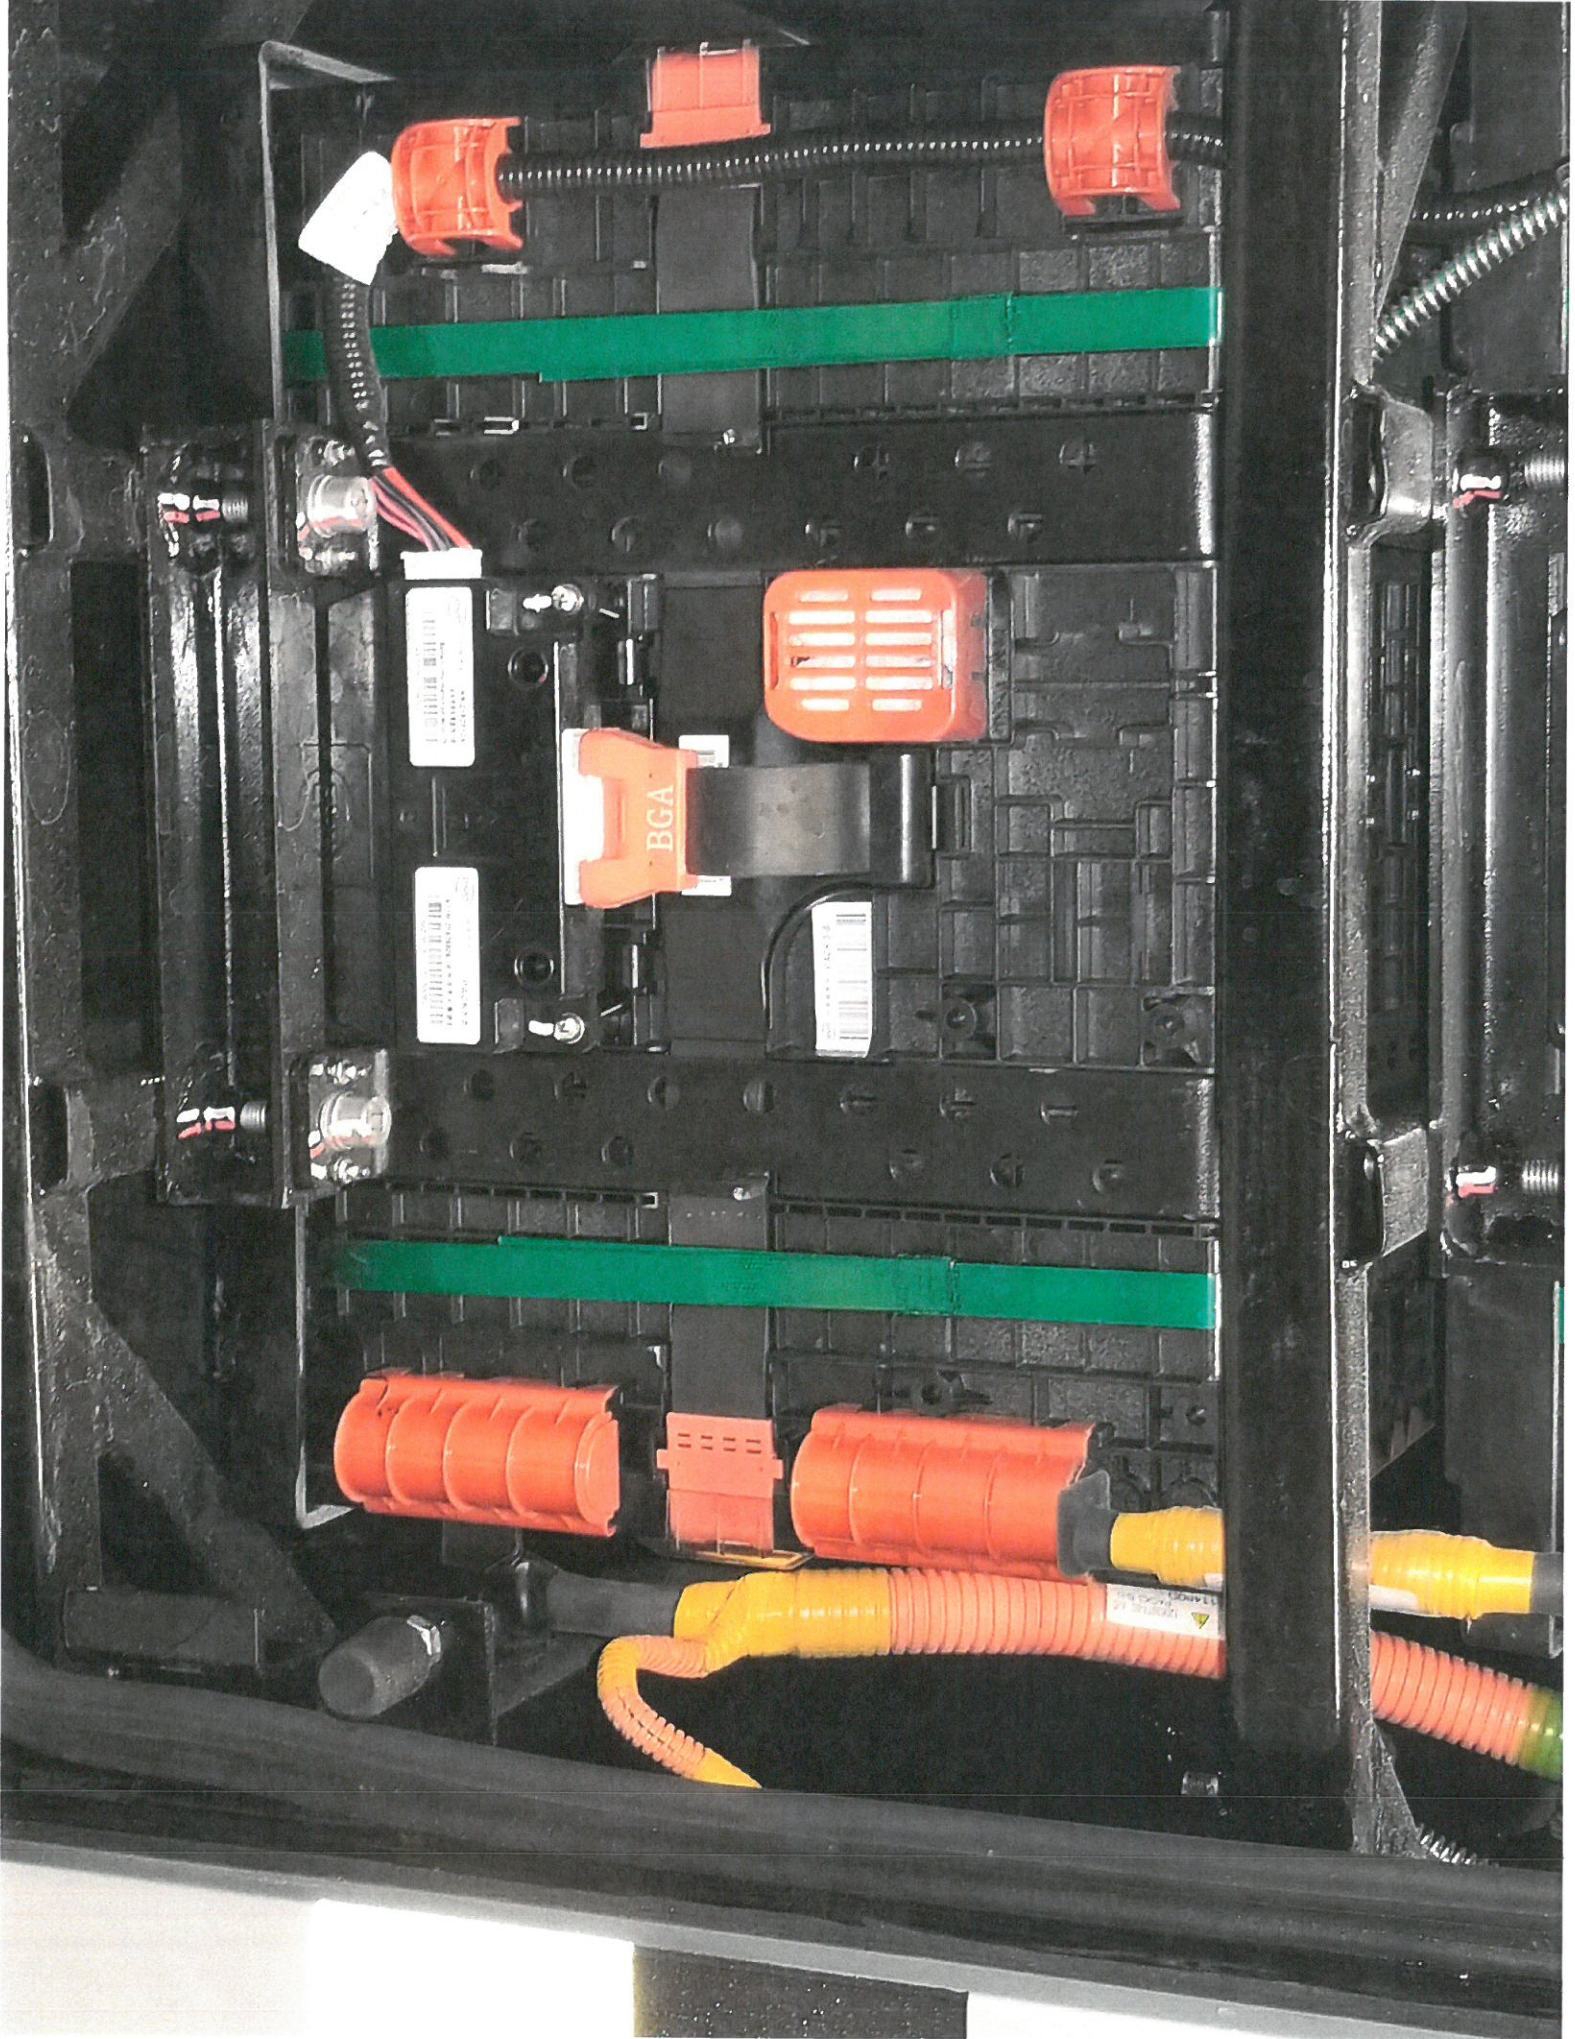
1708 exposed High voltage terminal

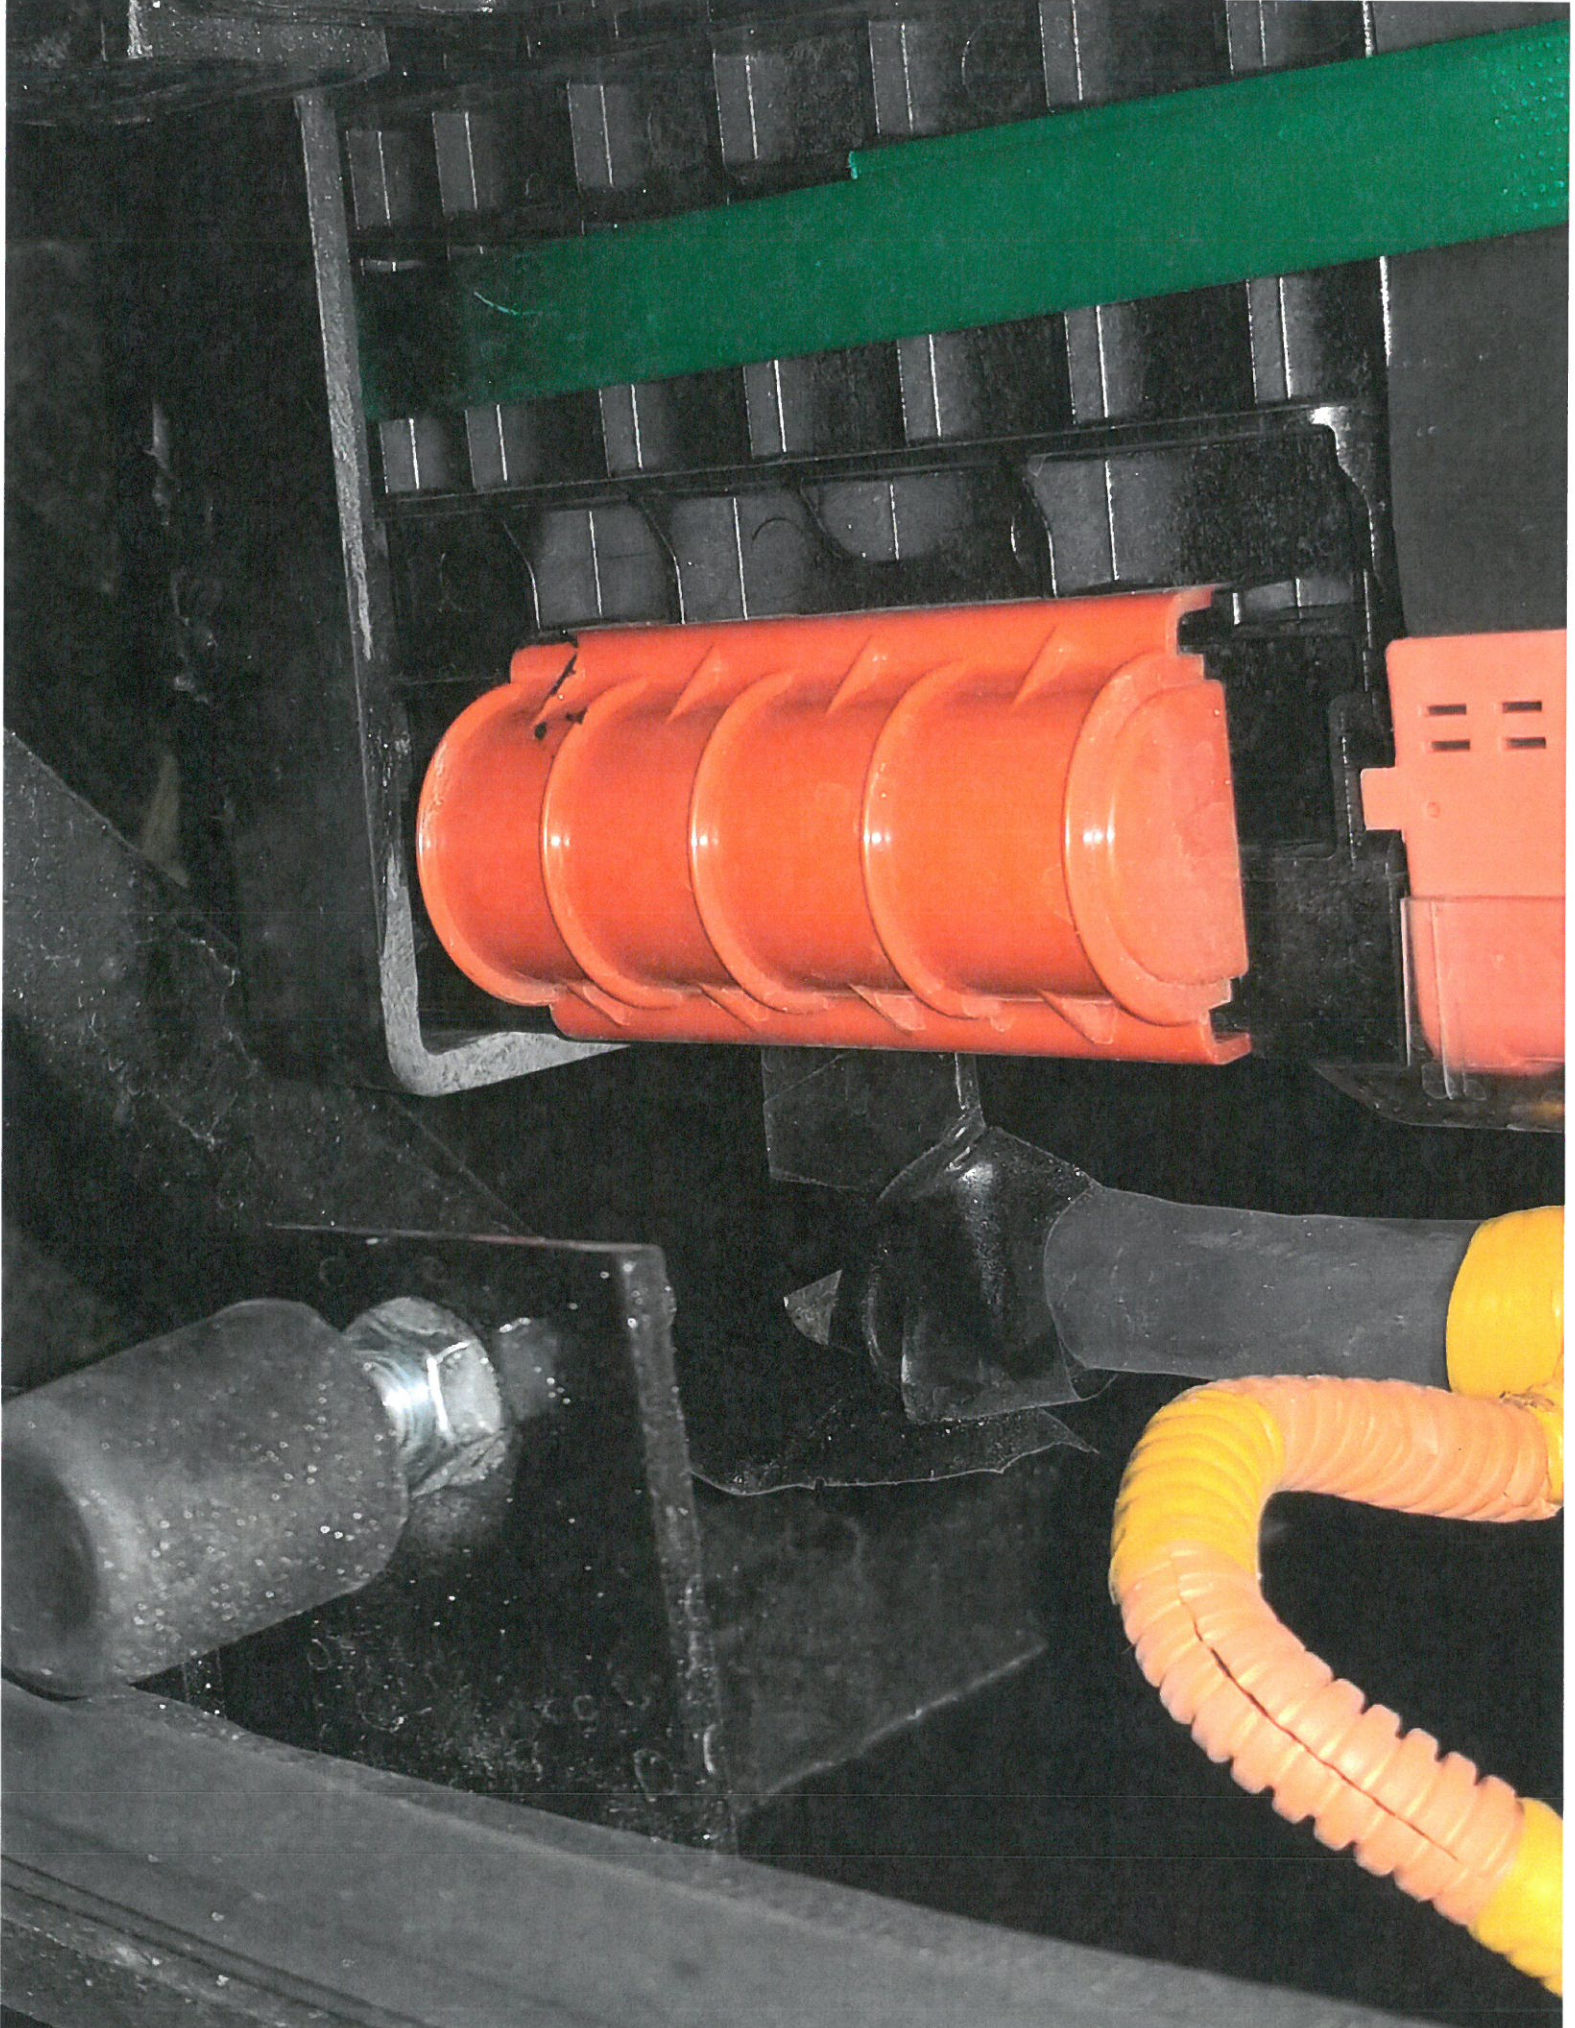
1708 - Exposed High Voltage line

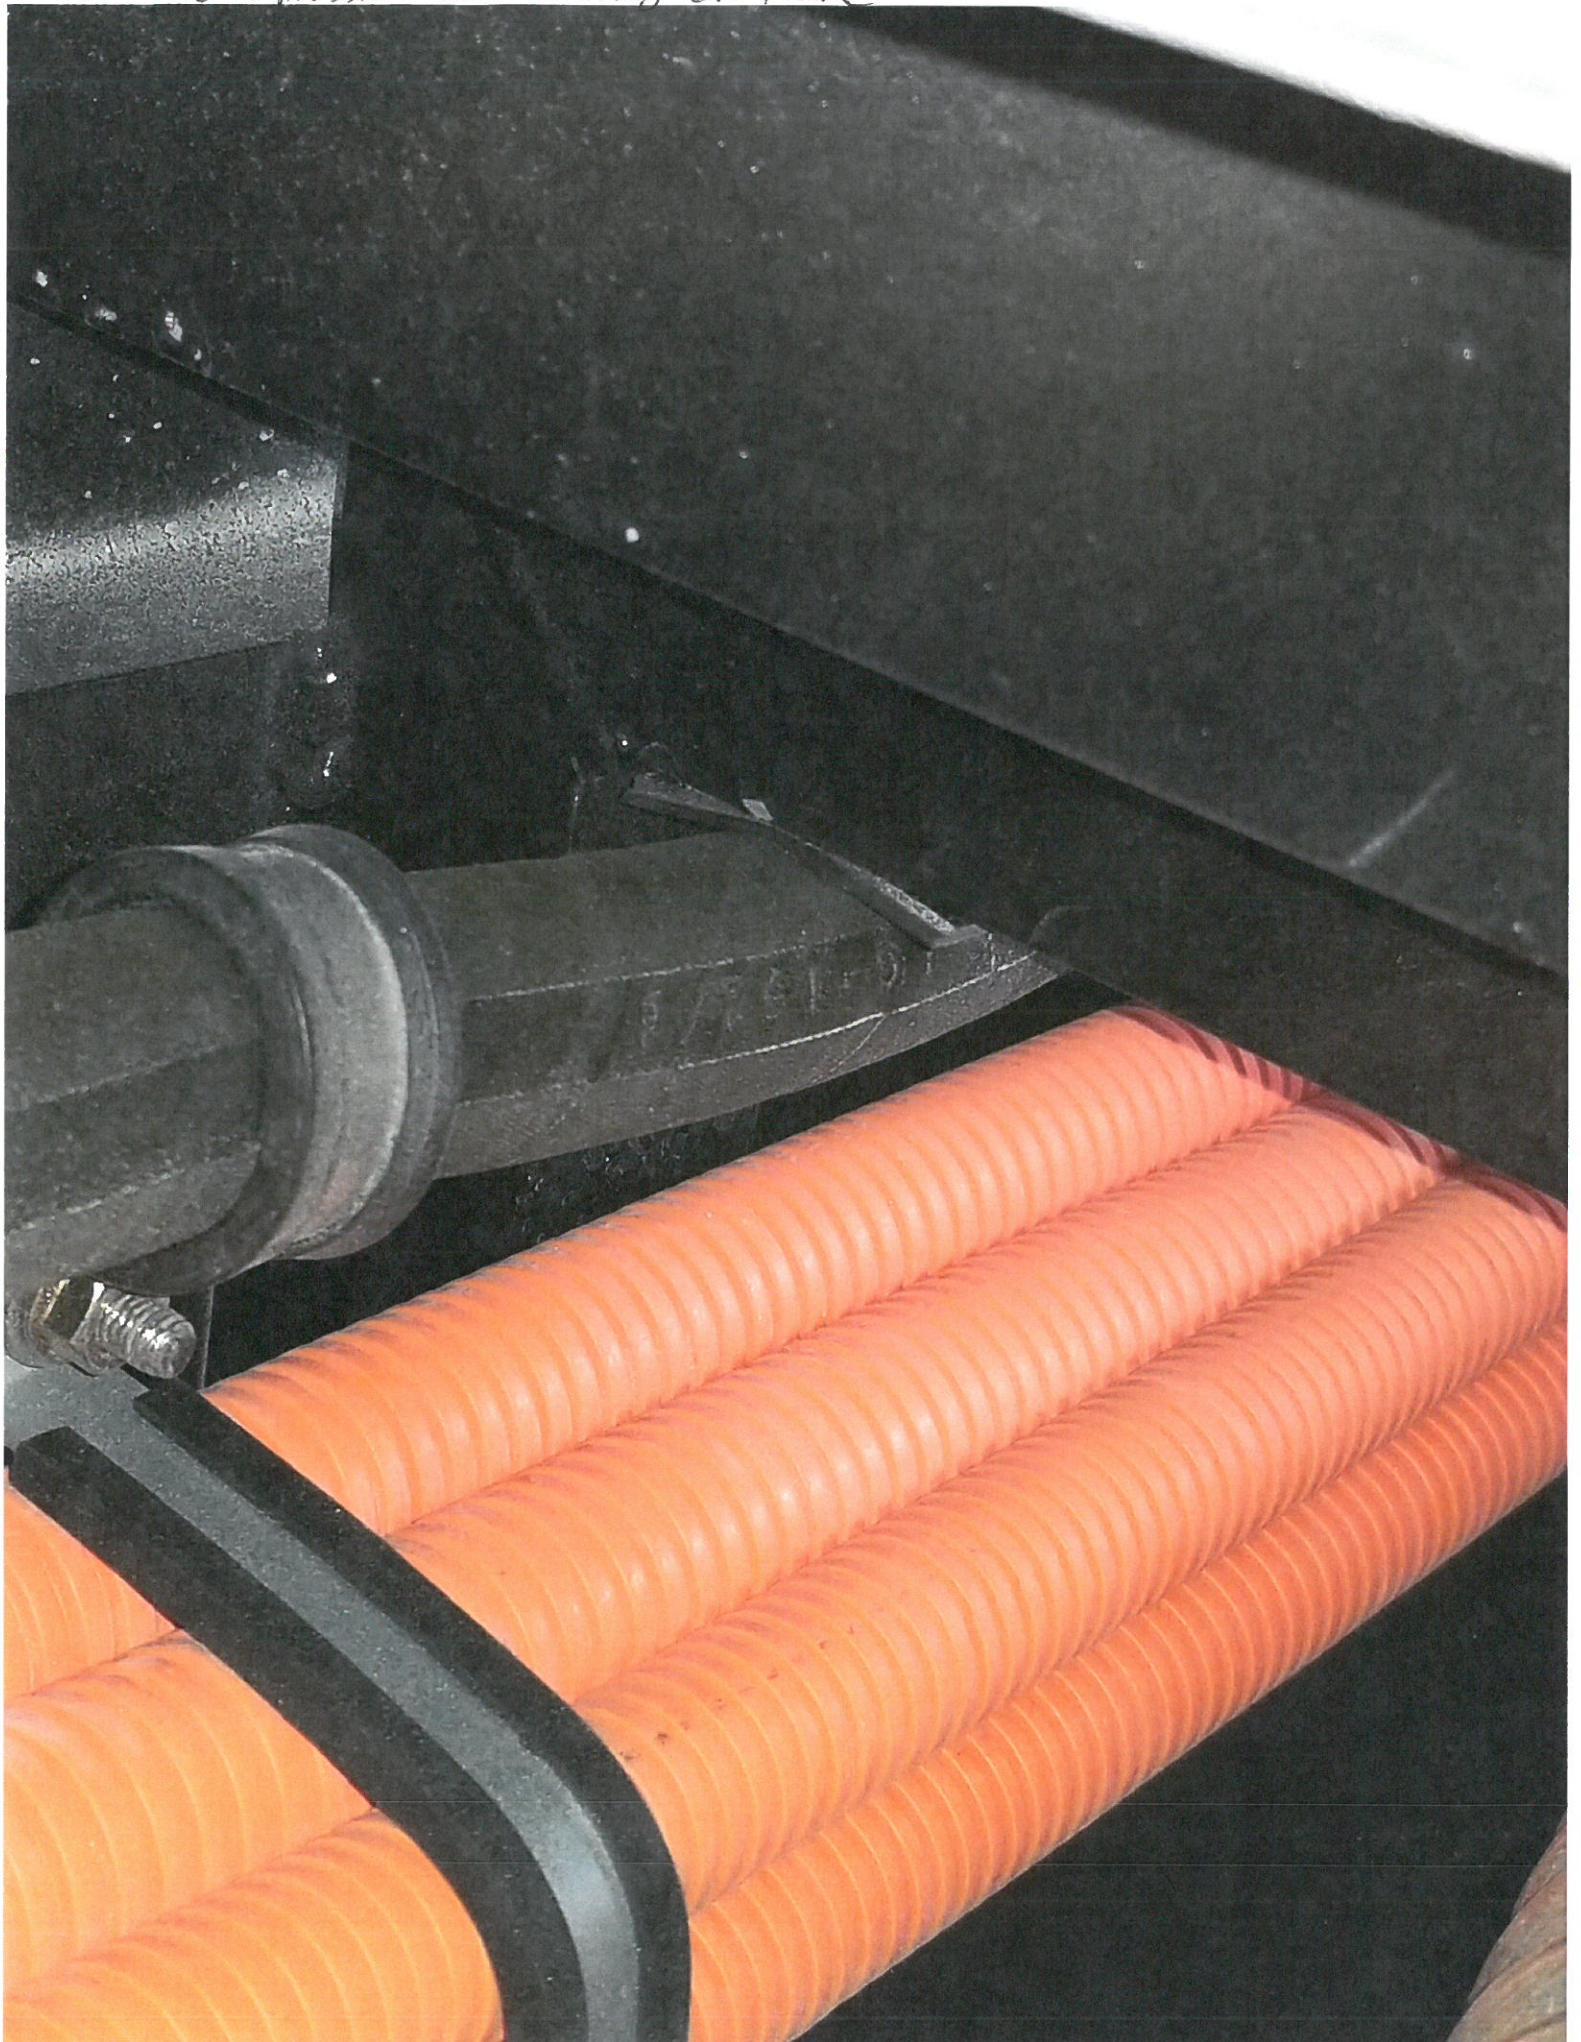
1708- Fire Suppression line rubbing on Frame

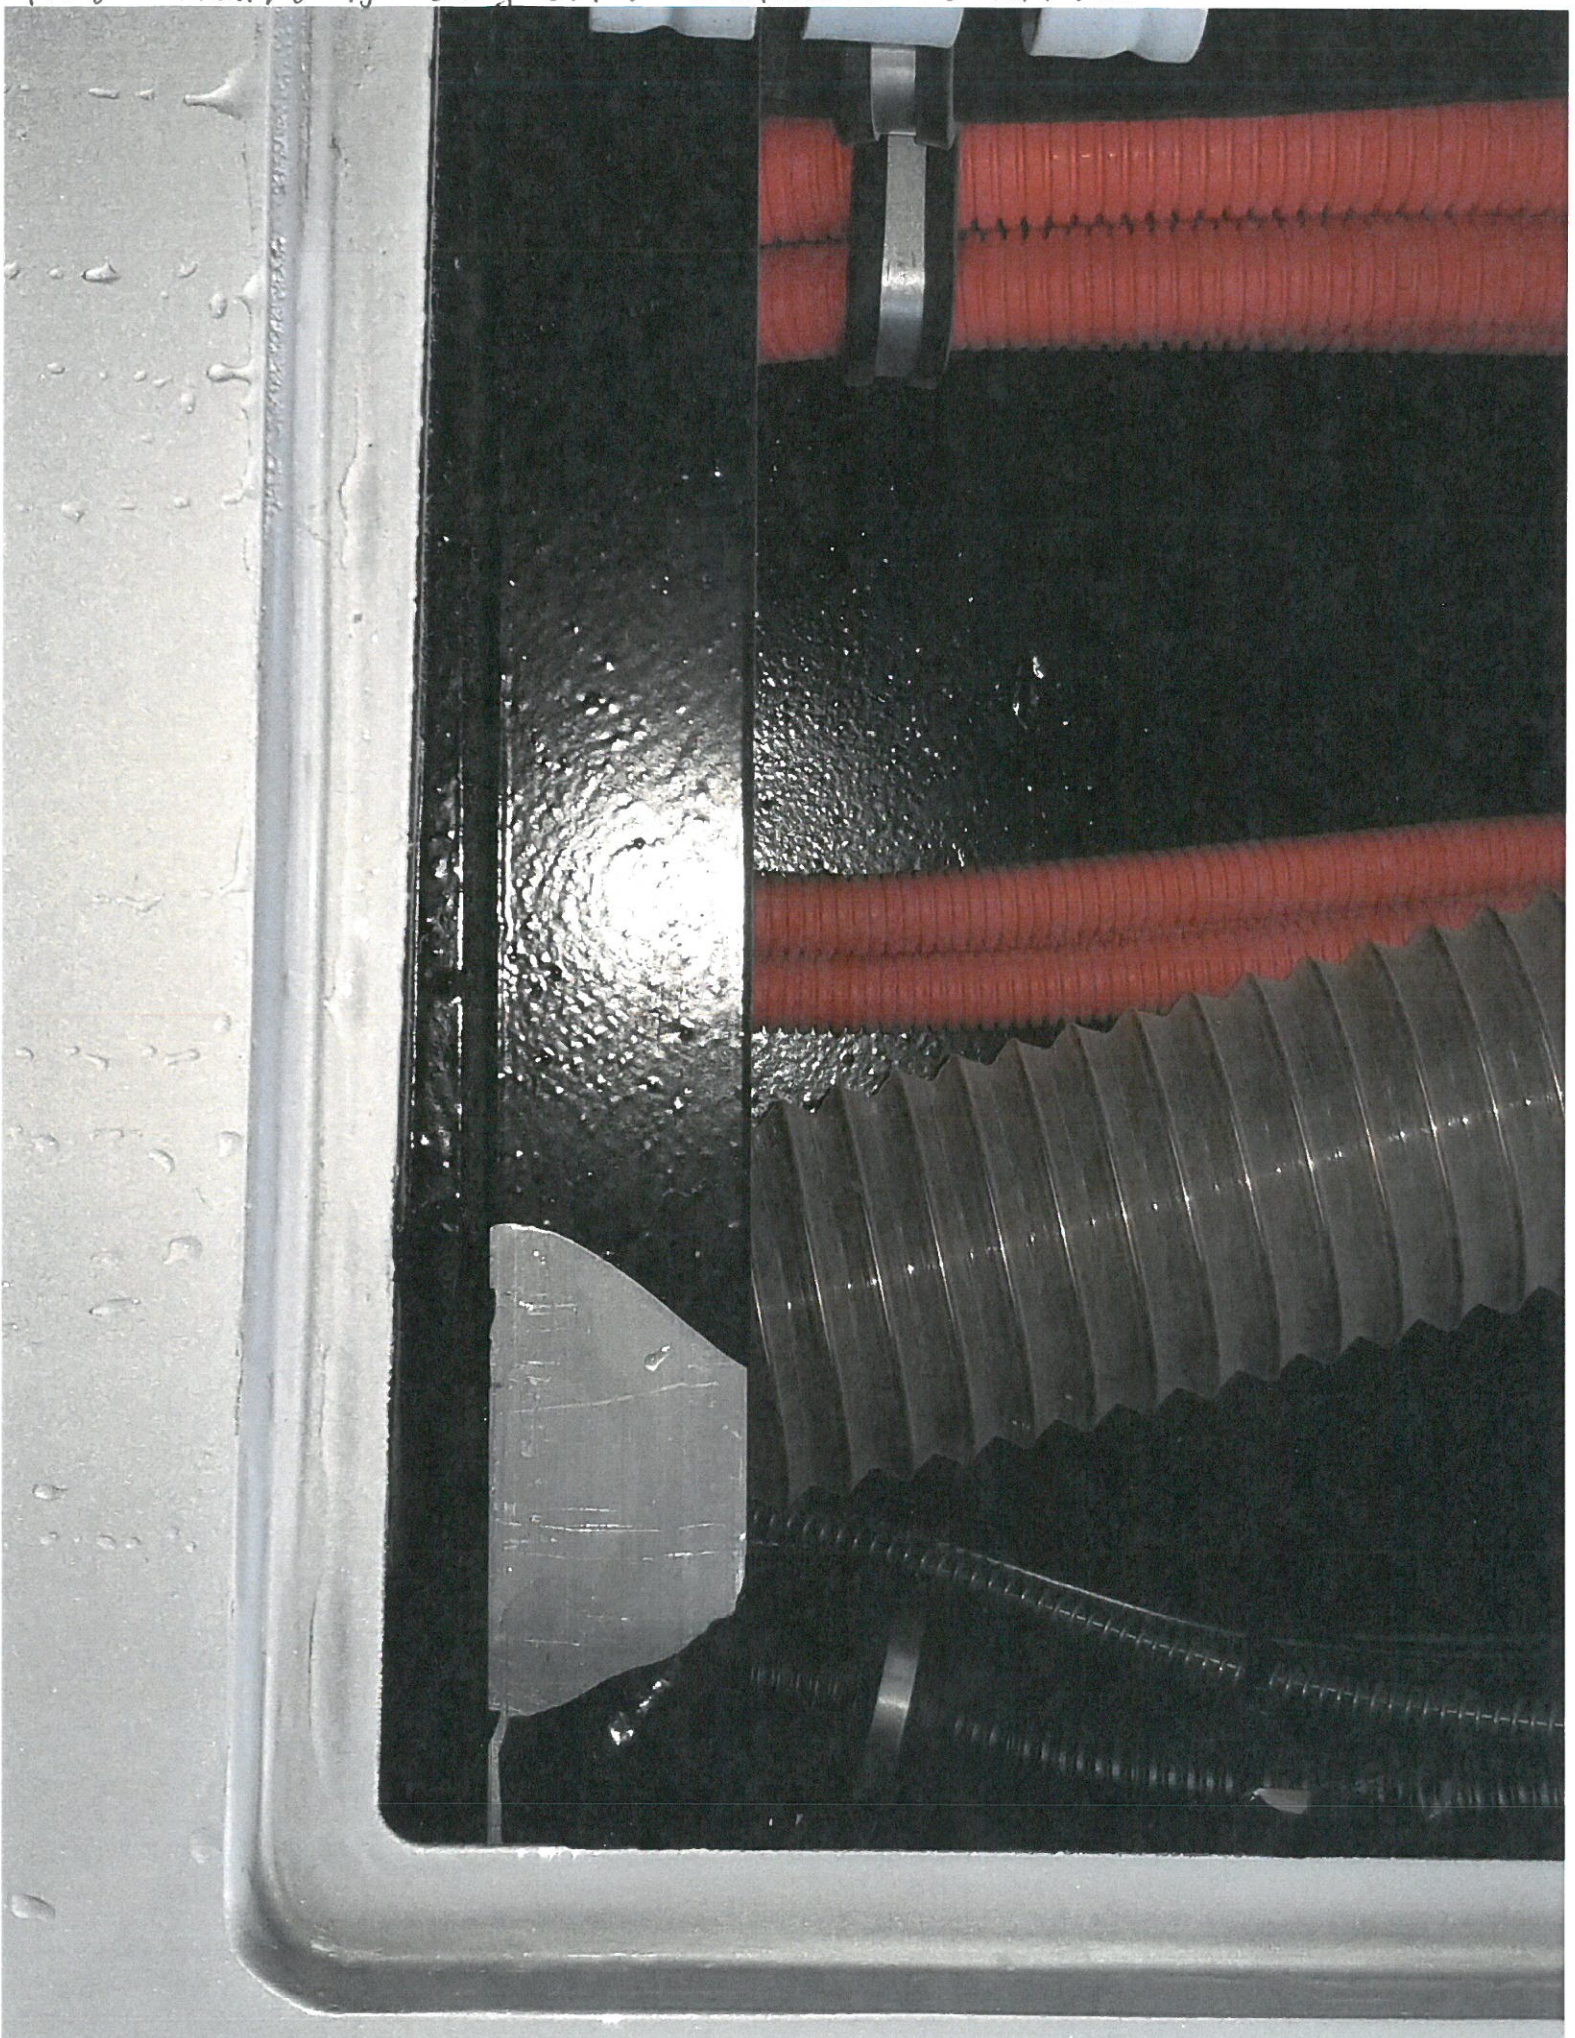
1708 Rinnish is coming off. compartment in left rear

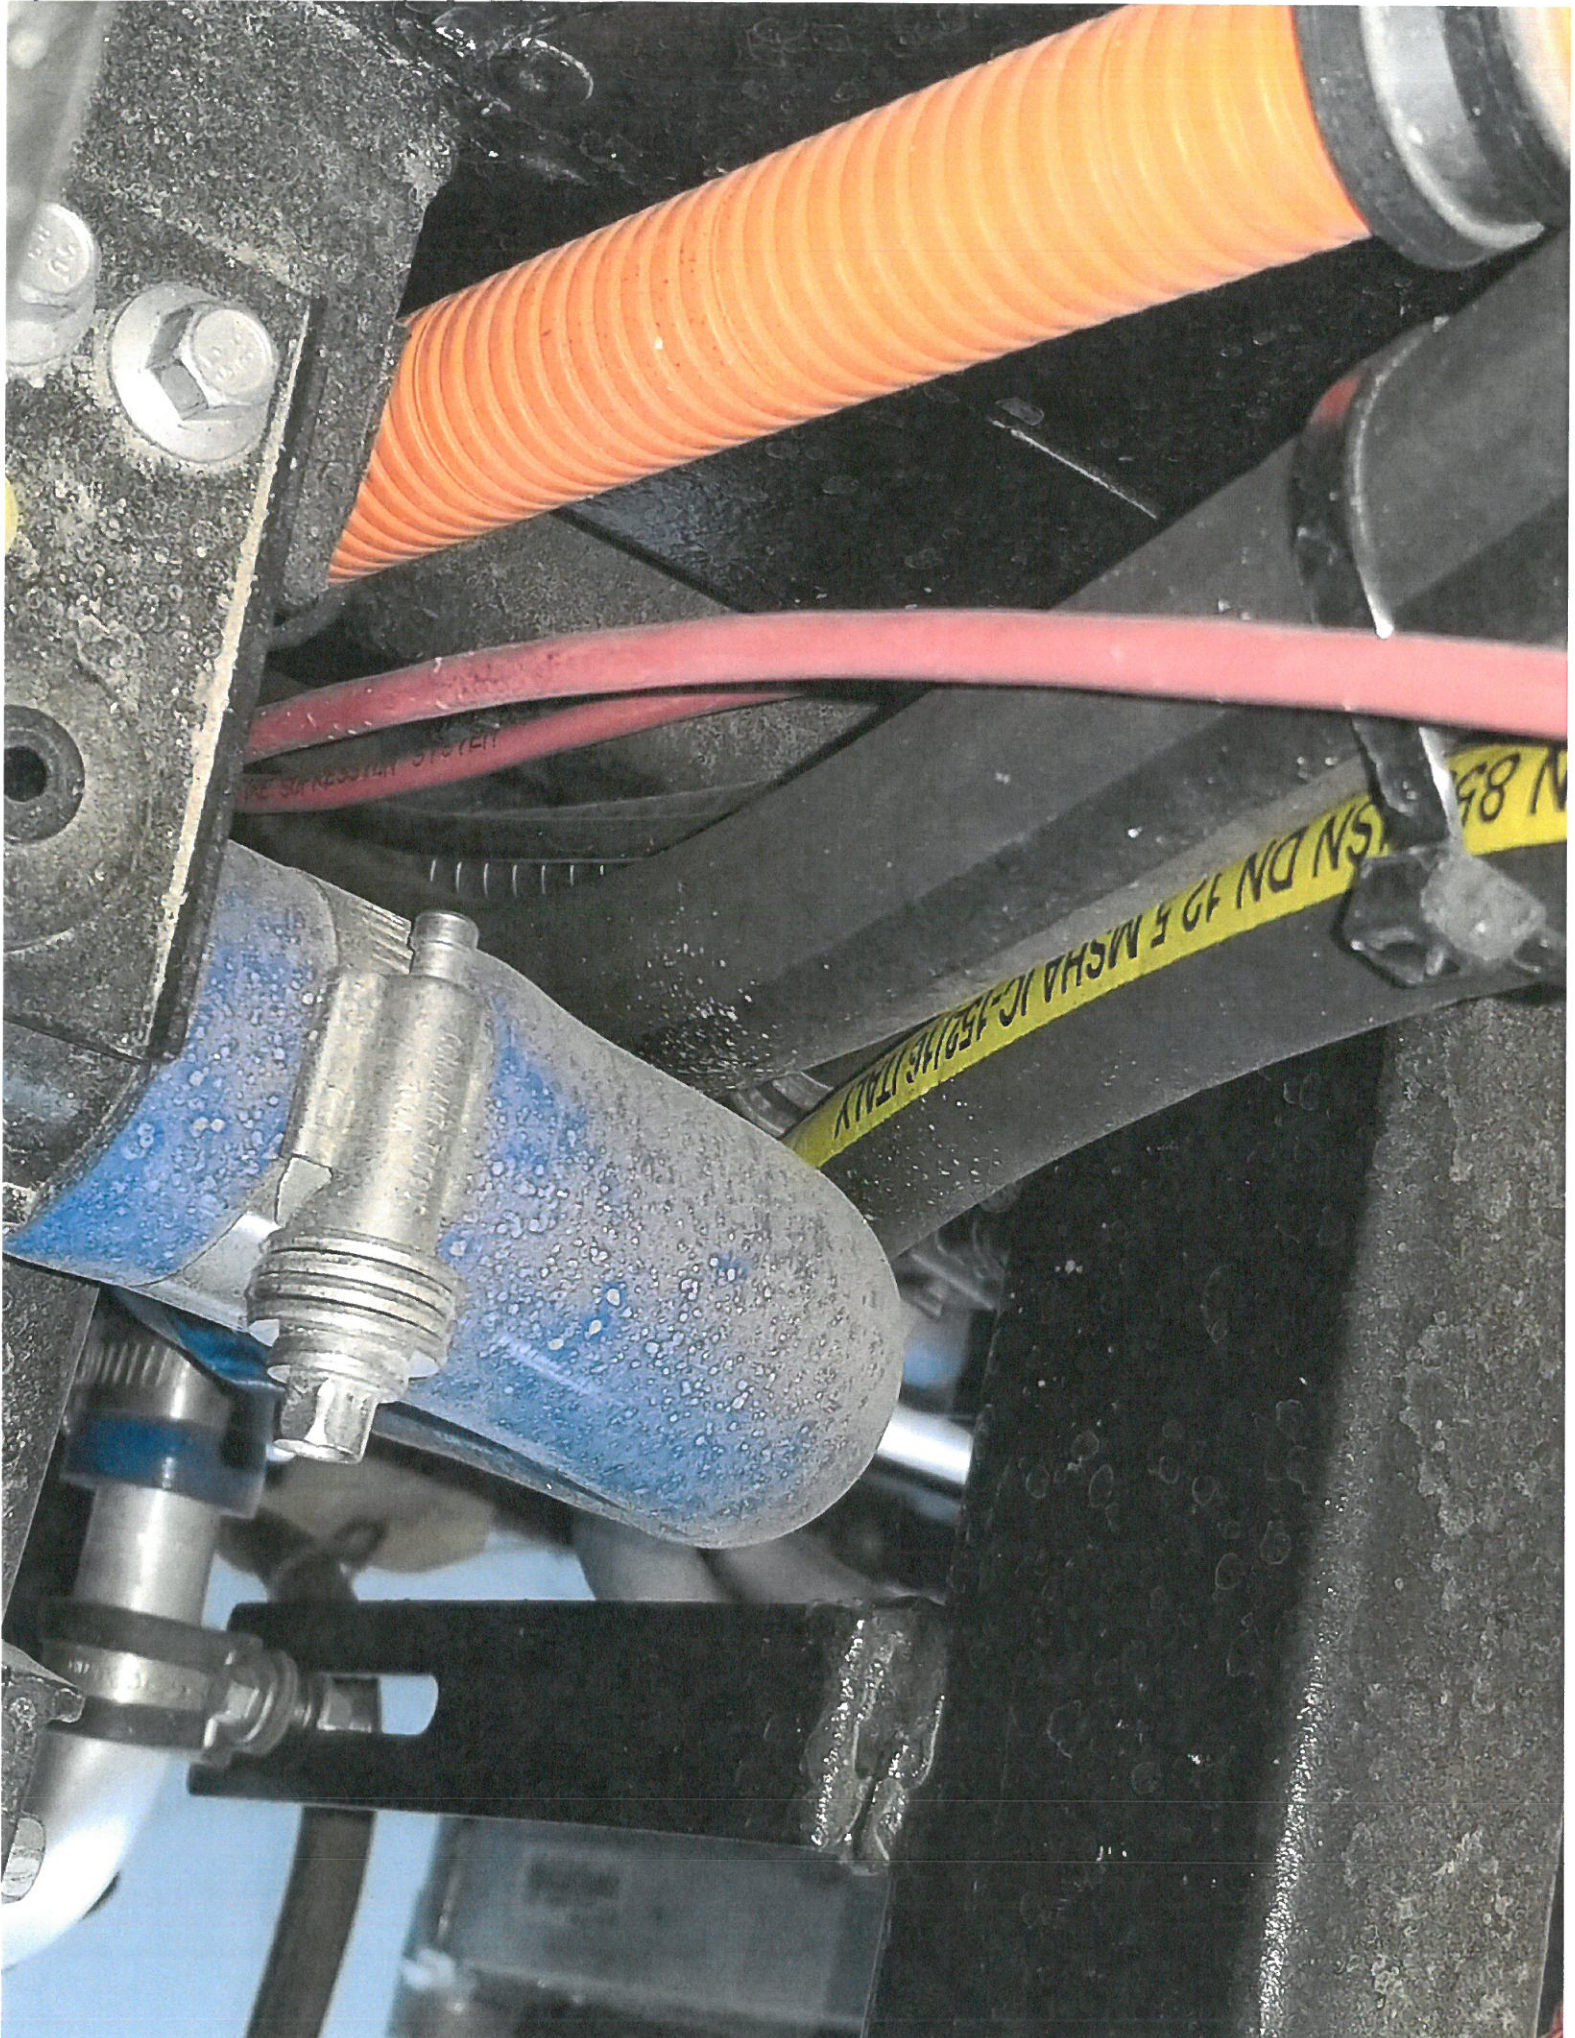
1708- lines rubbing everywhere
