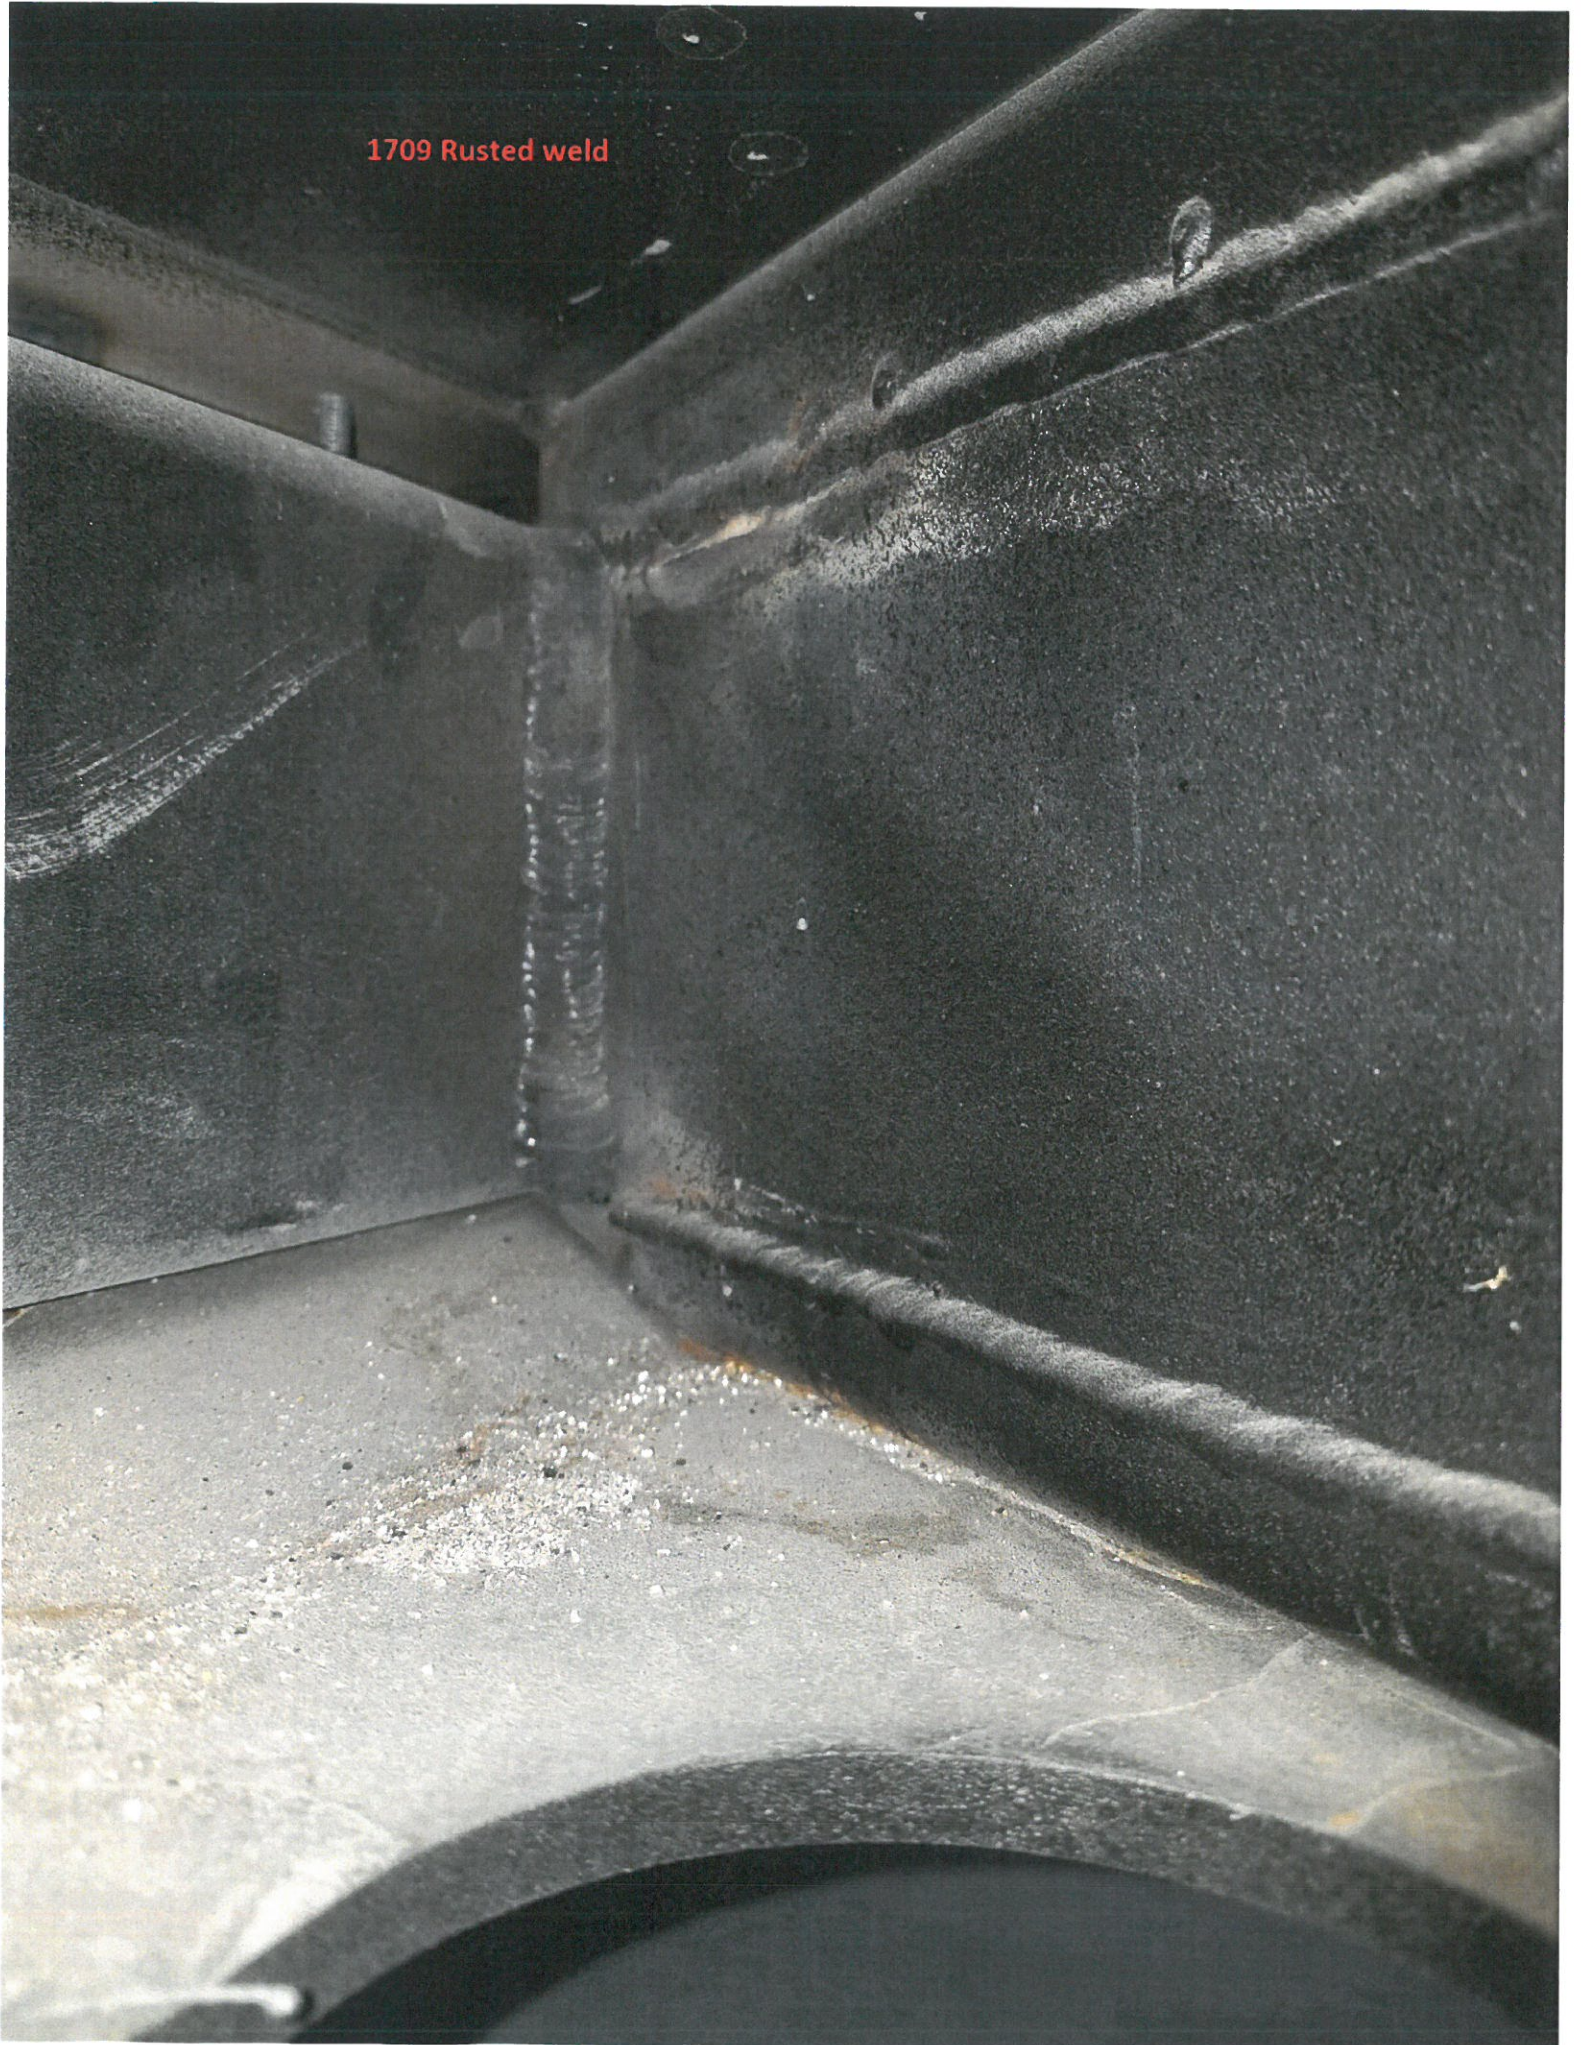
1709 Rusted weld

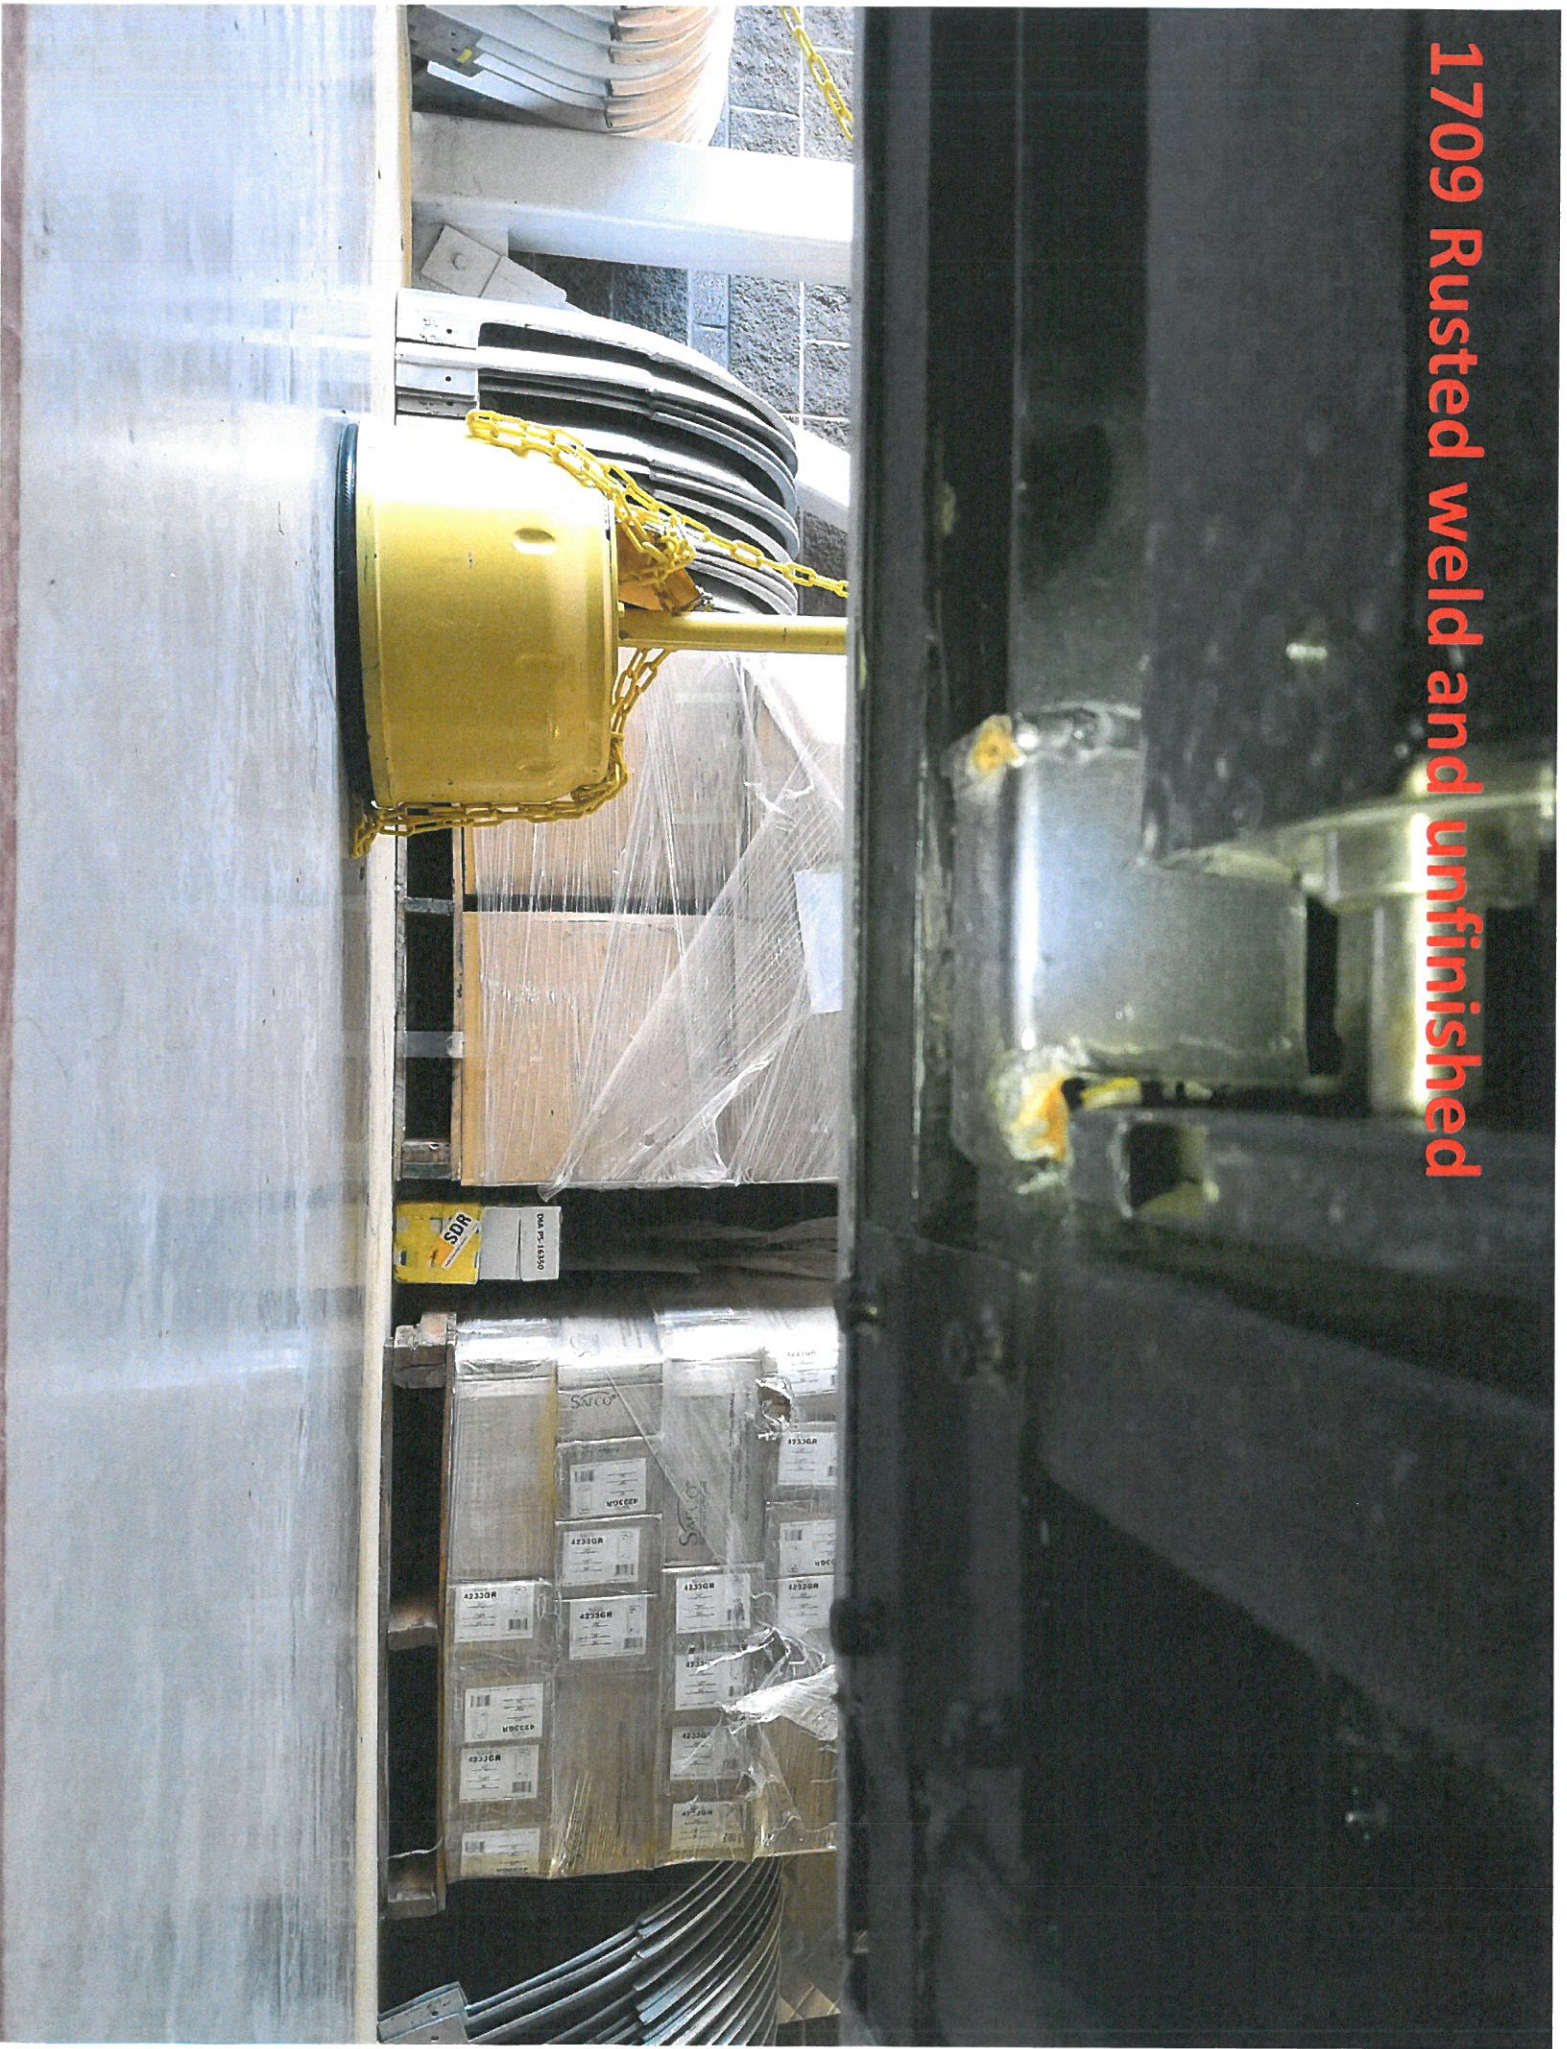
1709 Rusted weld and unfinished

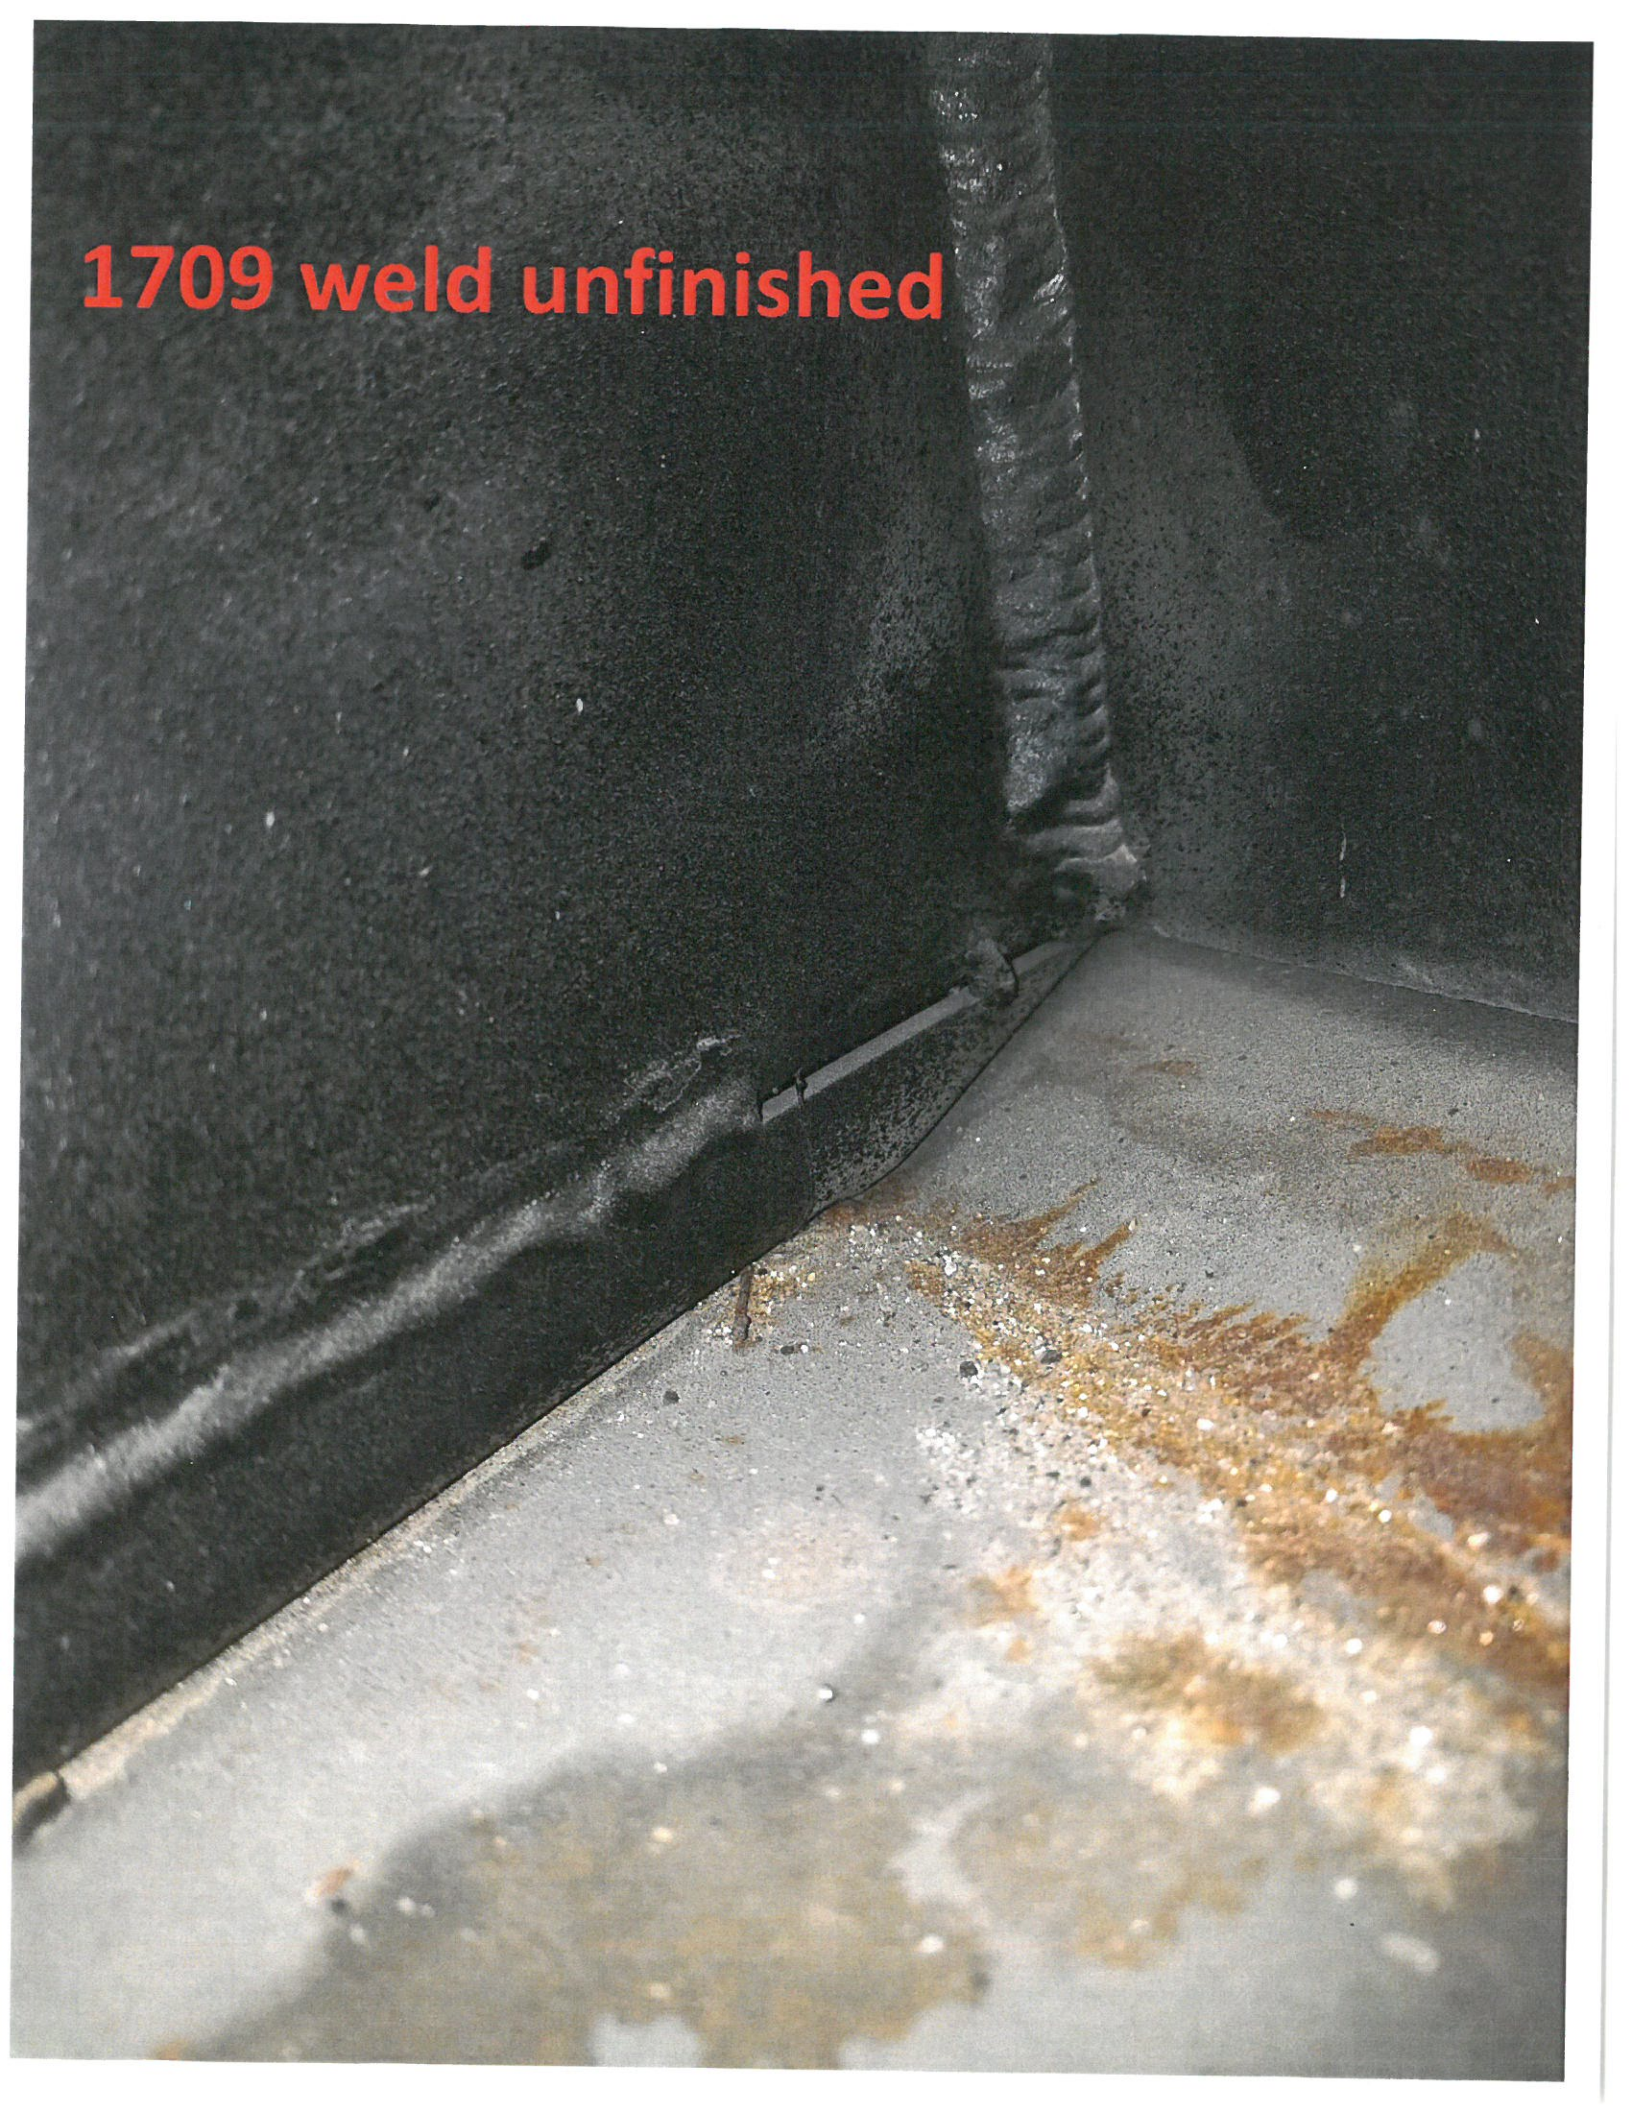
1709 weld unfinished

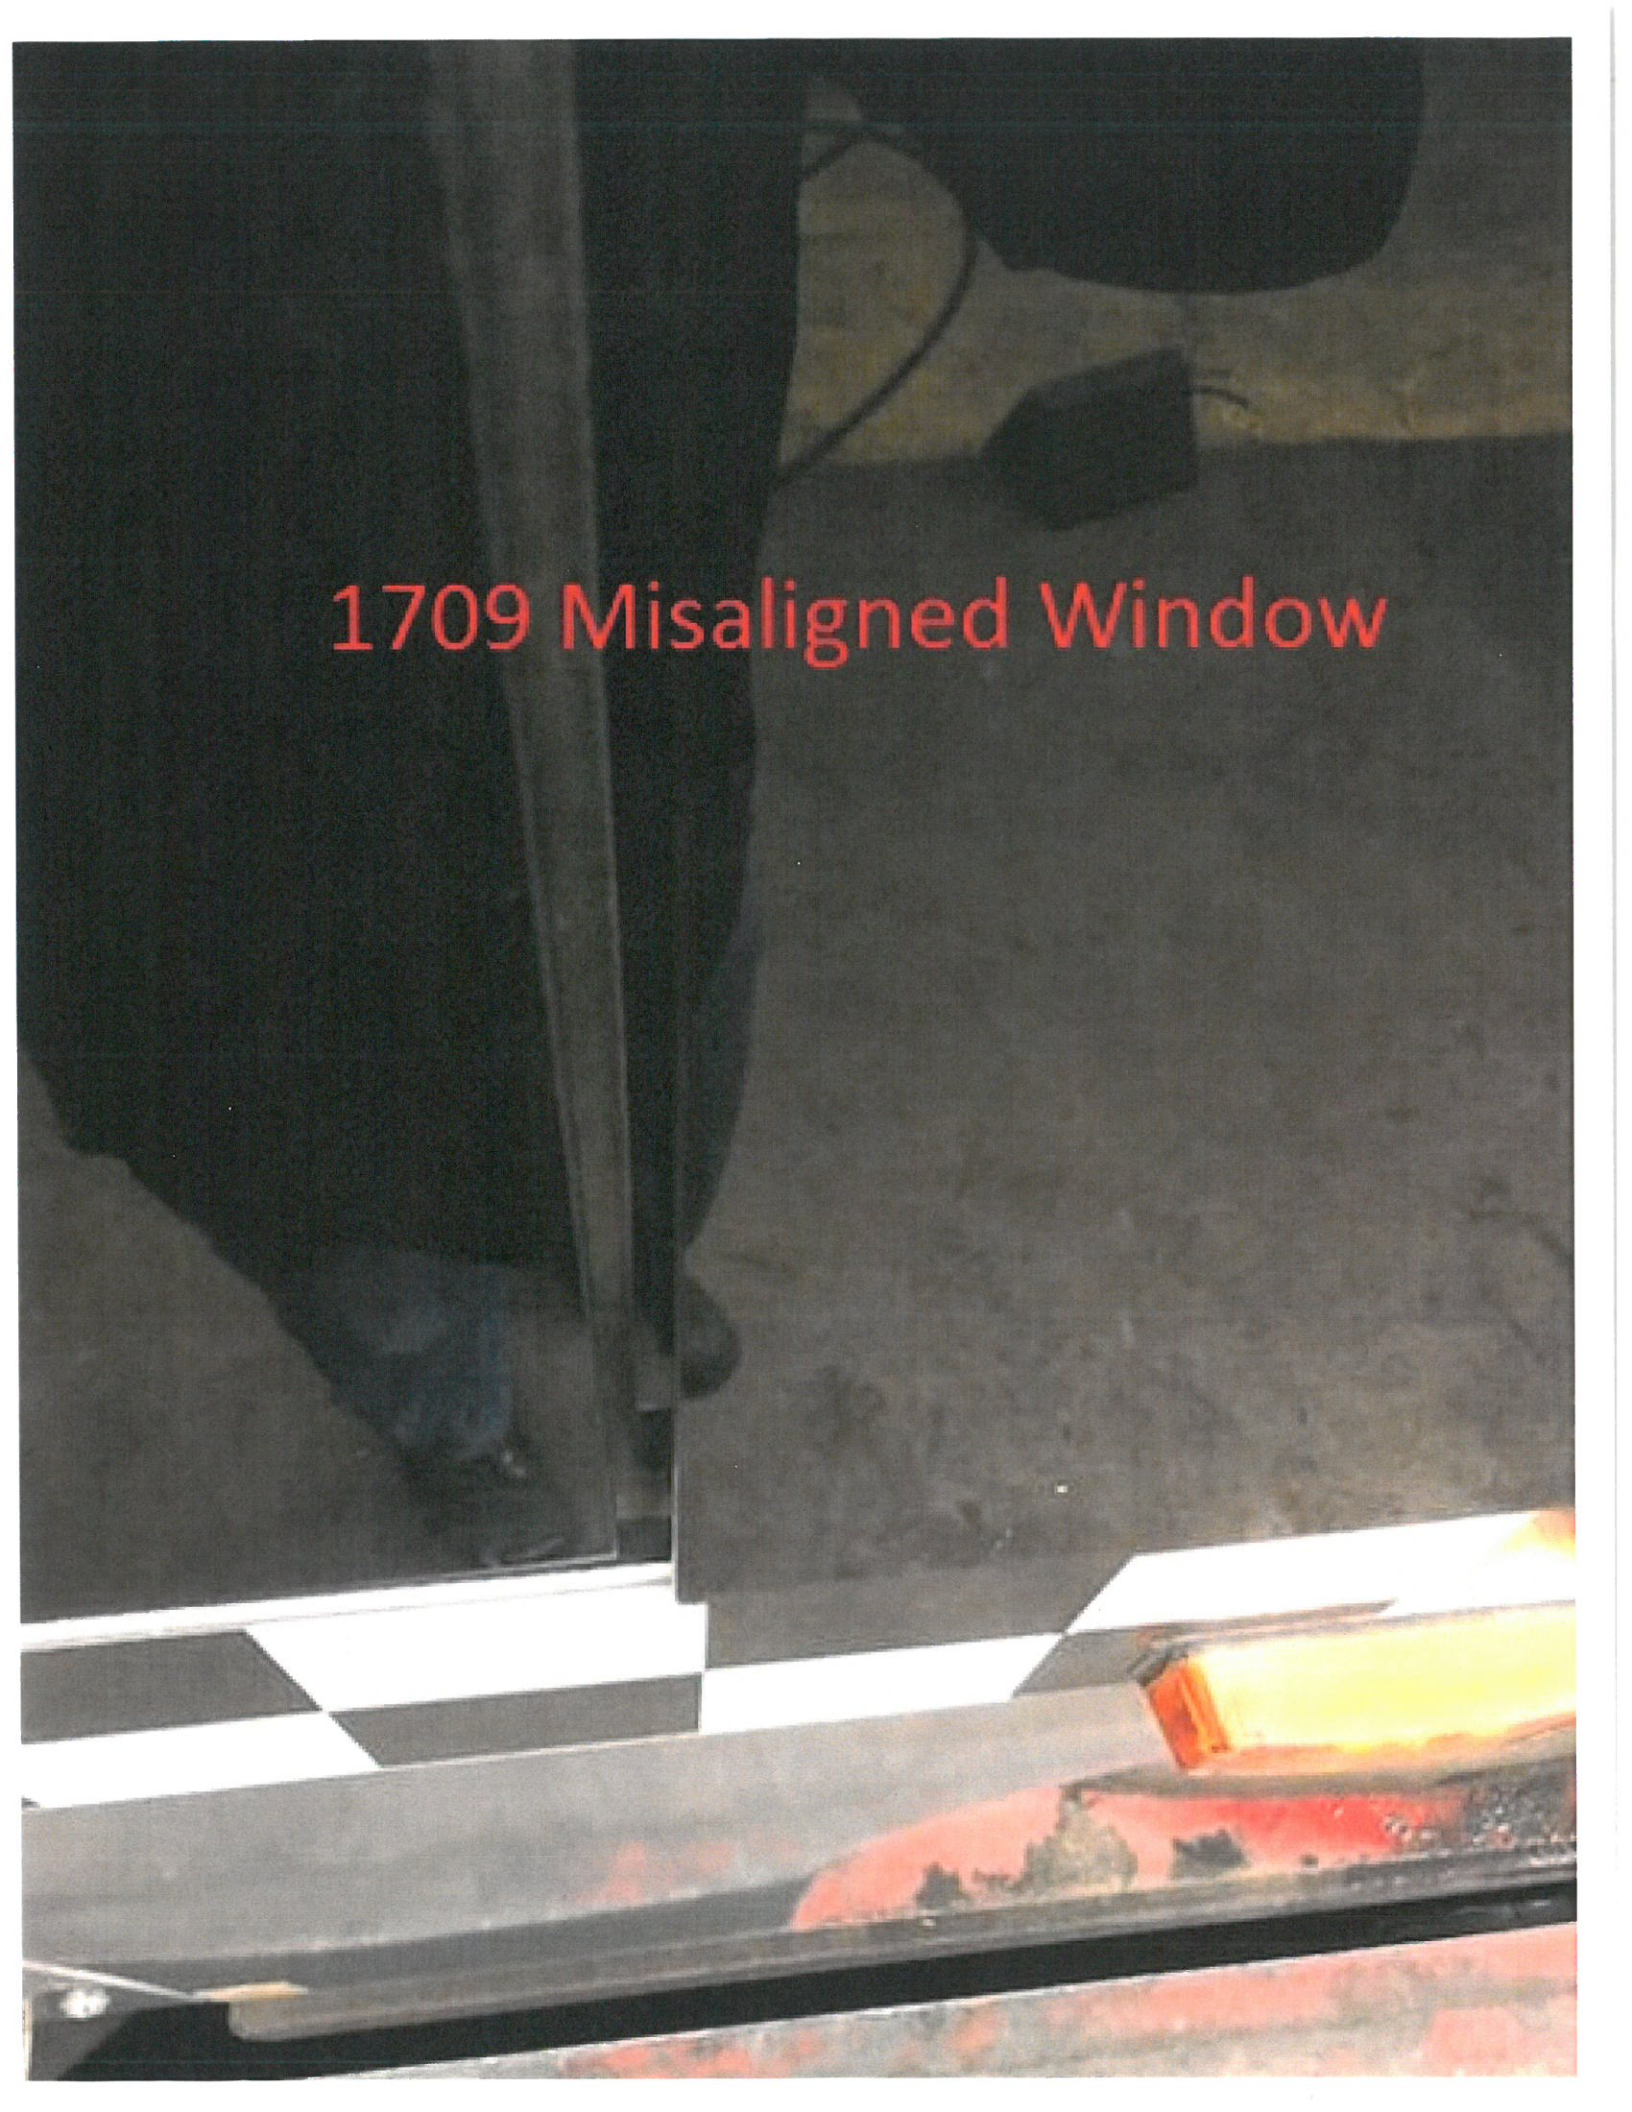
1709 Misaligned Window

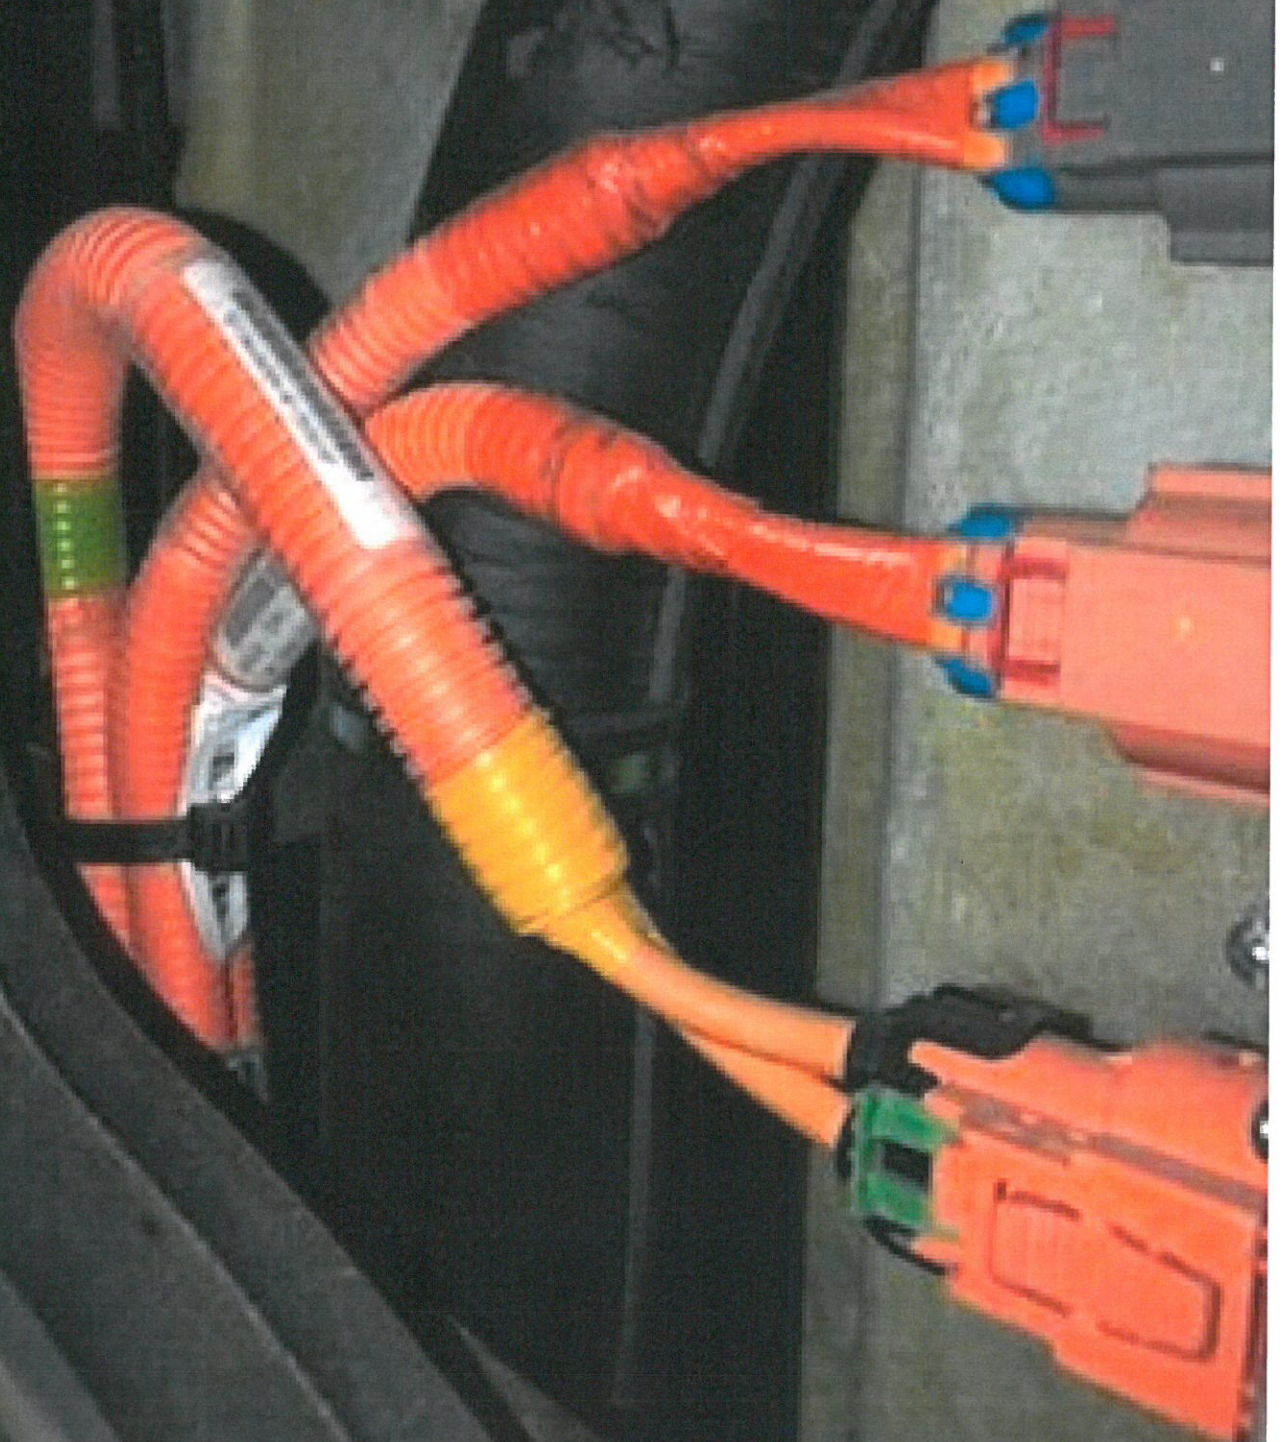
1709 high Voltage Lines rubbing

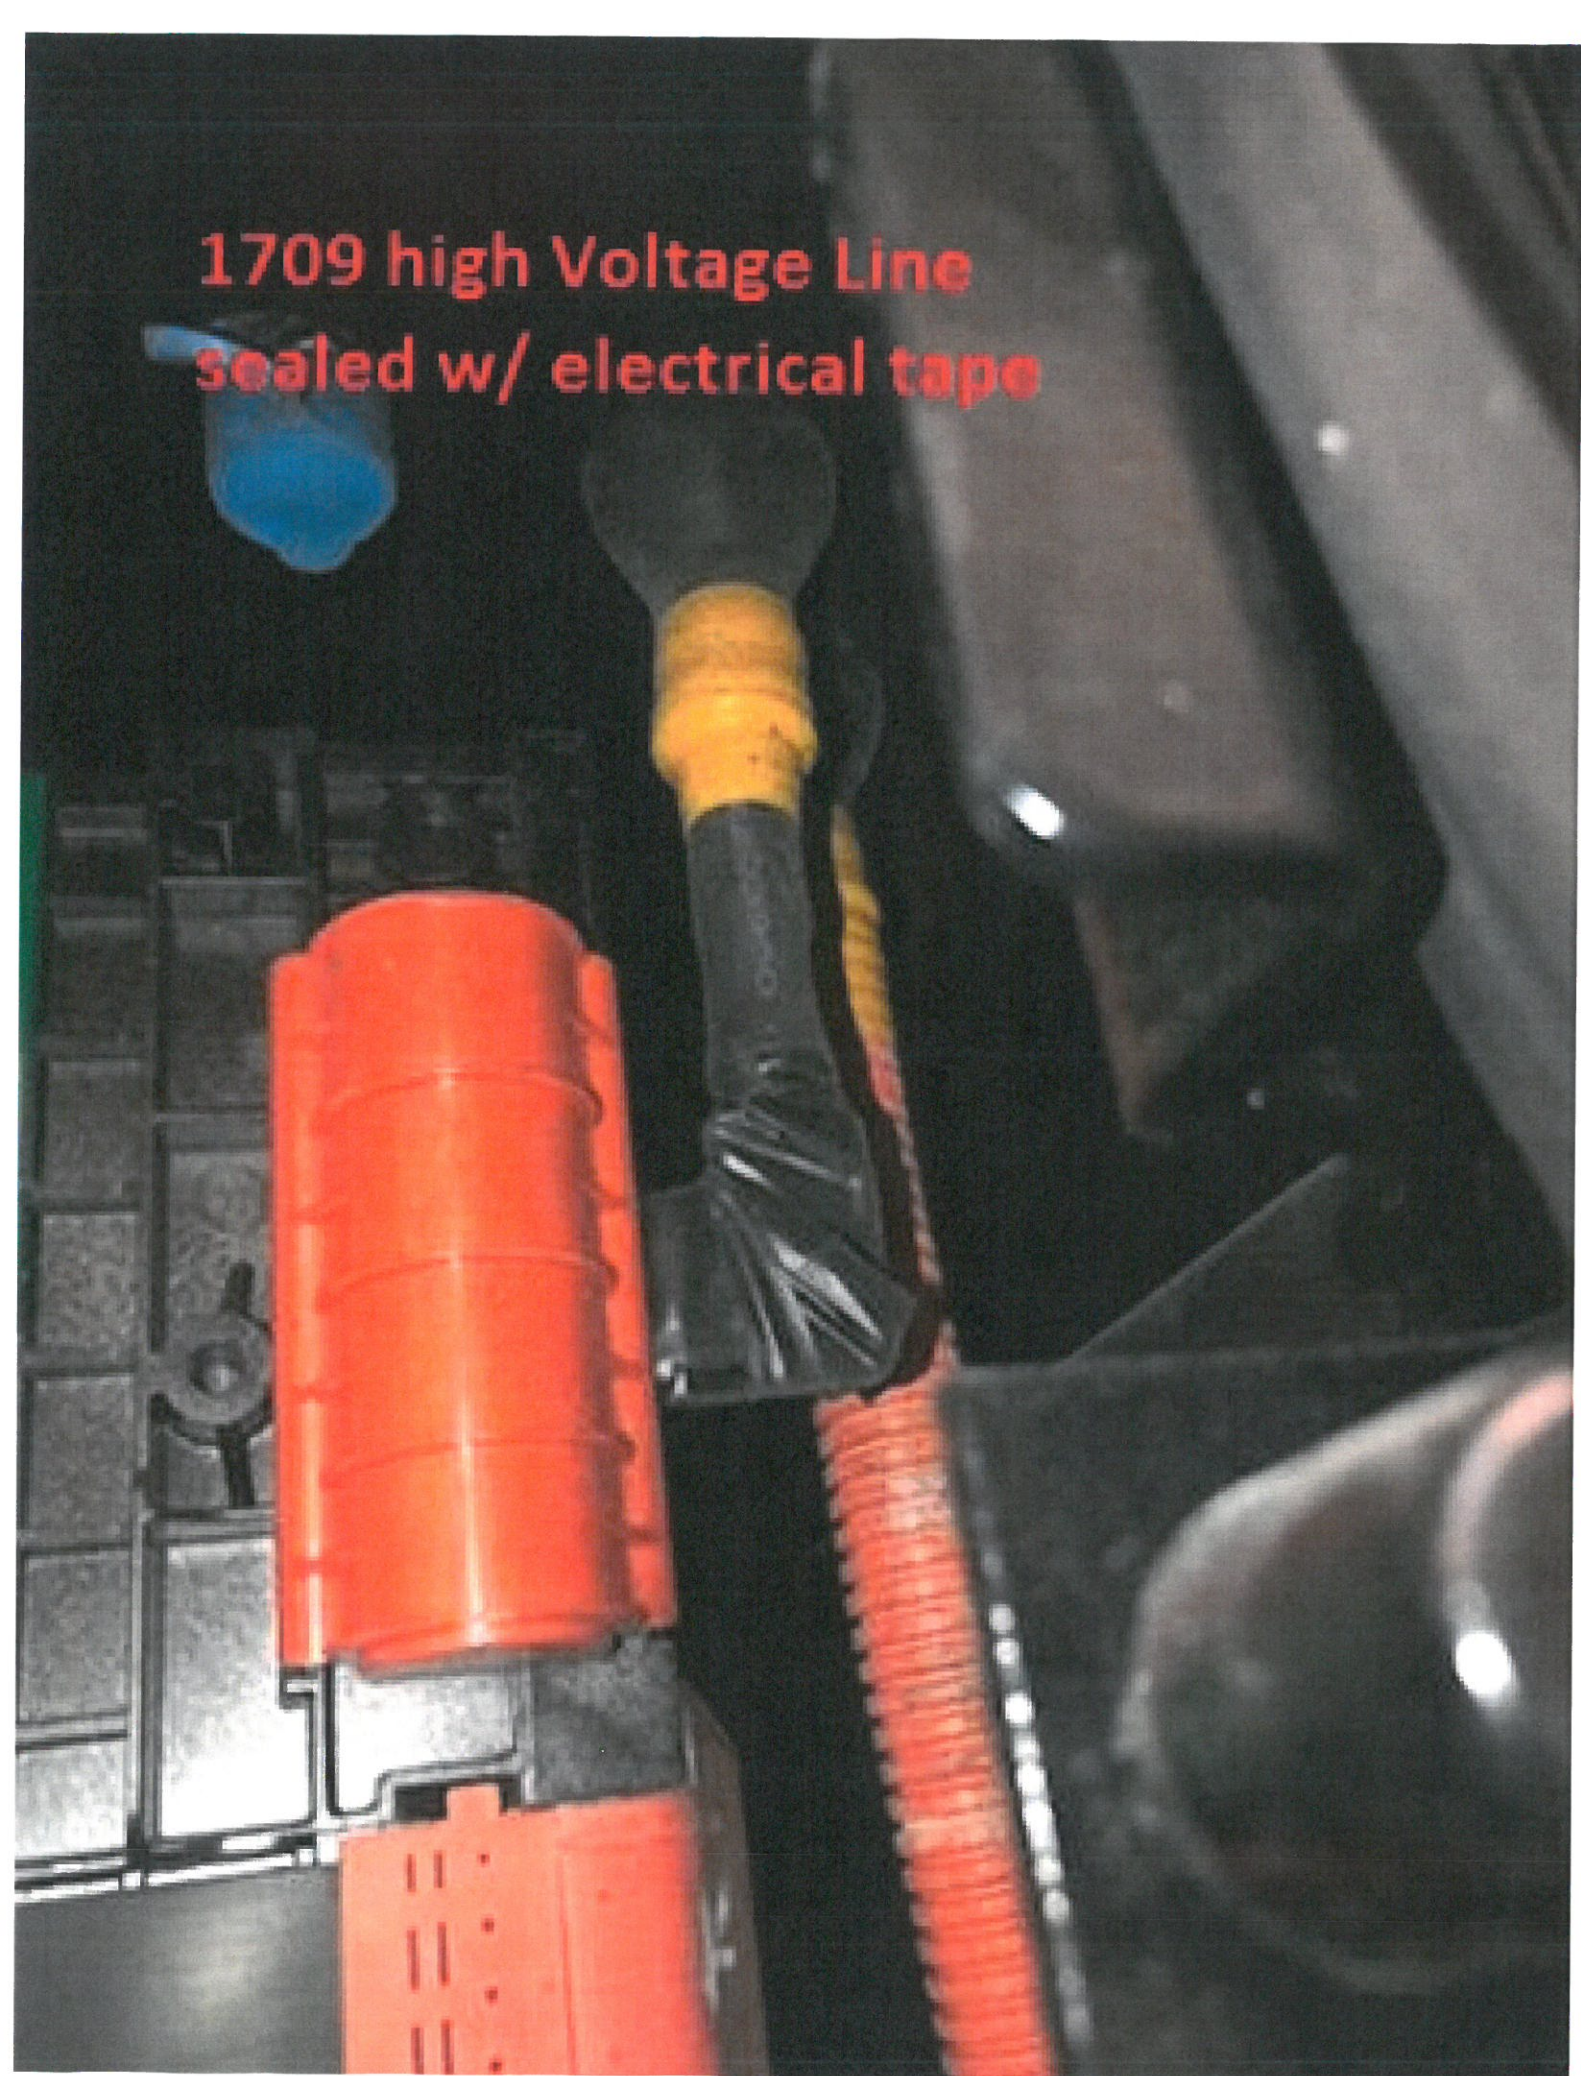
1709 high Voltage Line
sealed w/ electrical tape

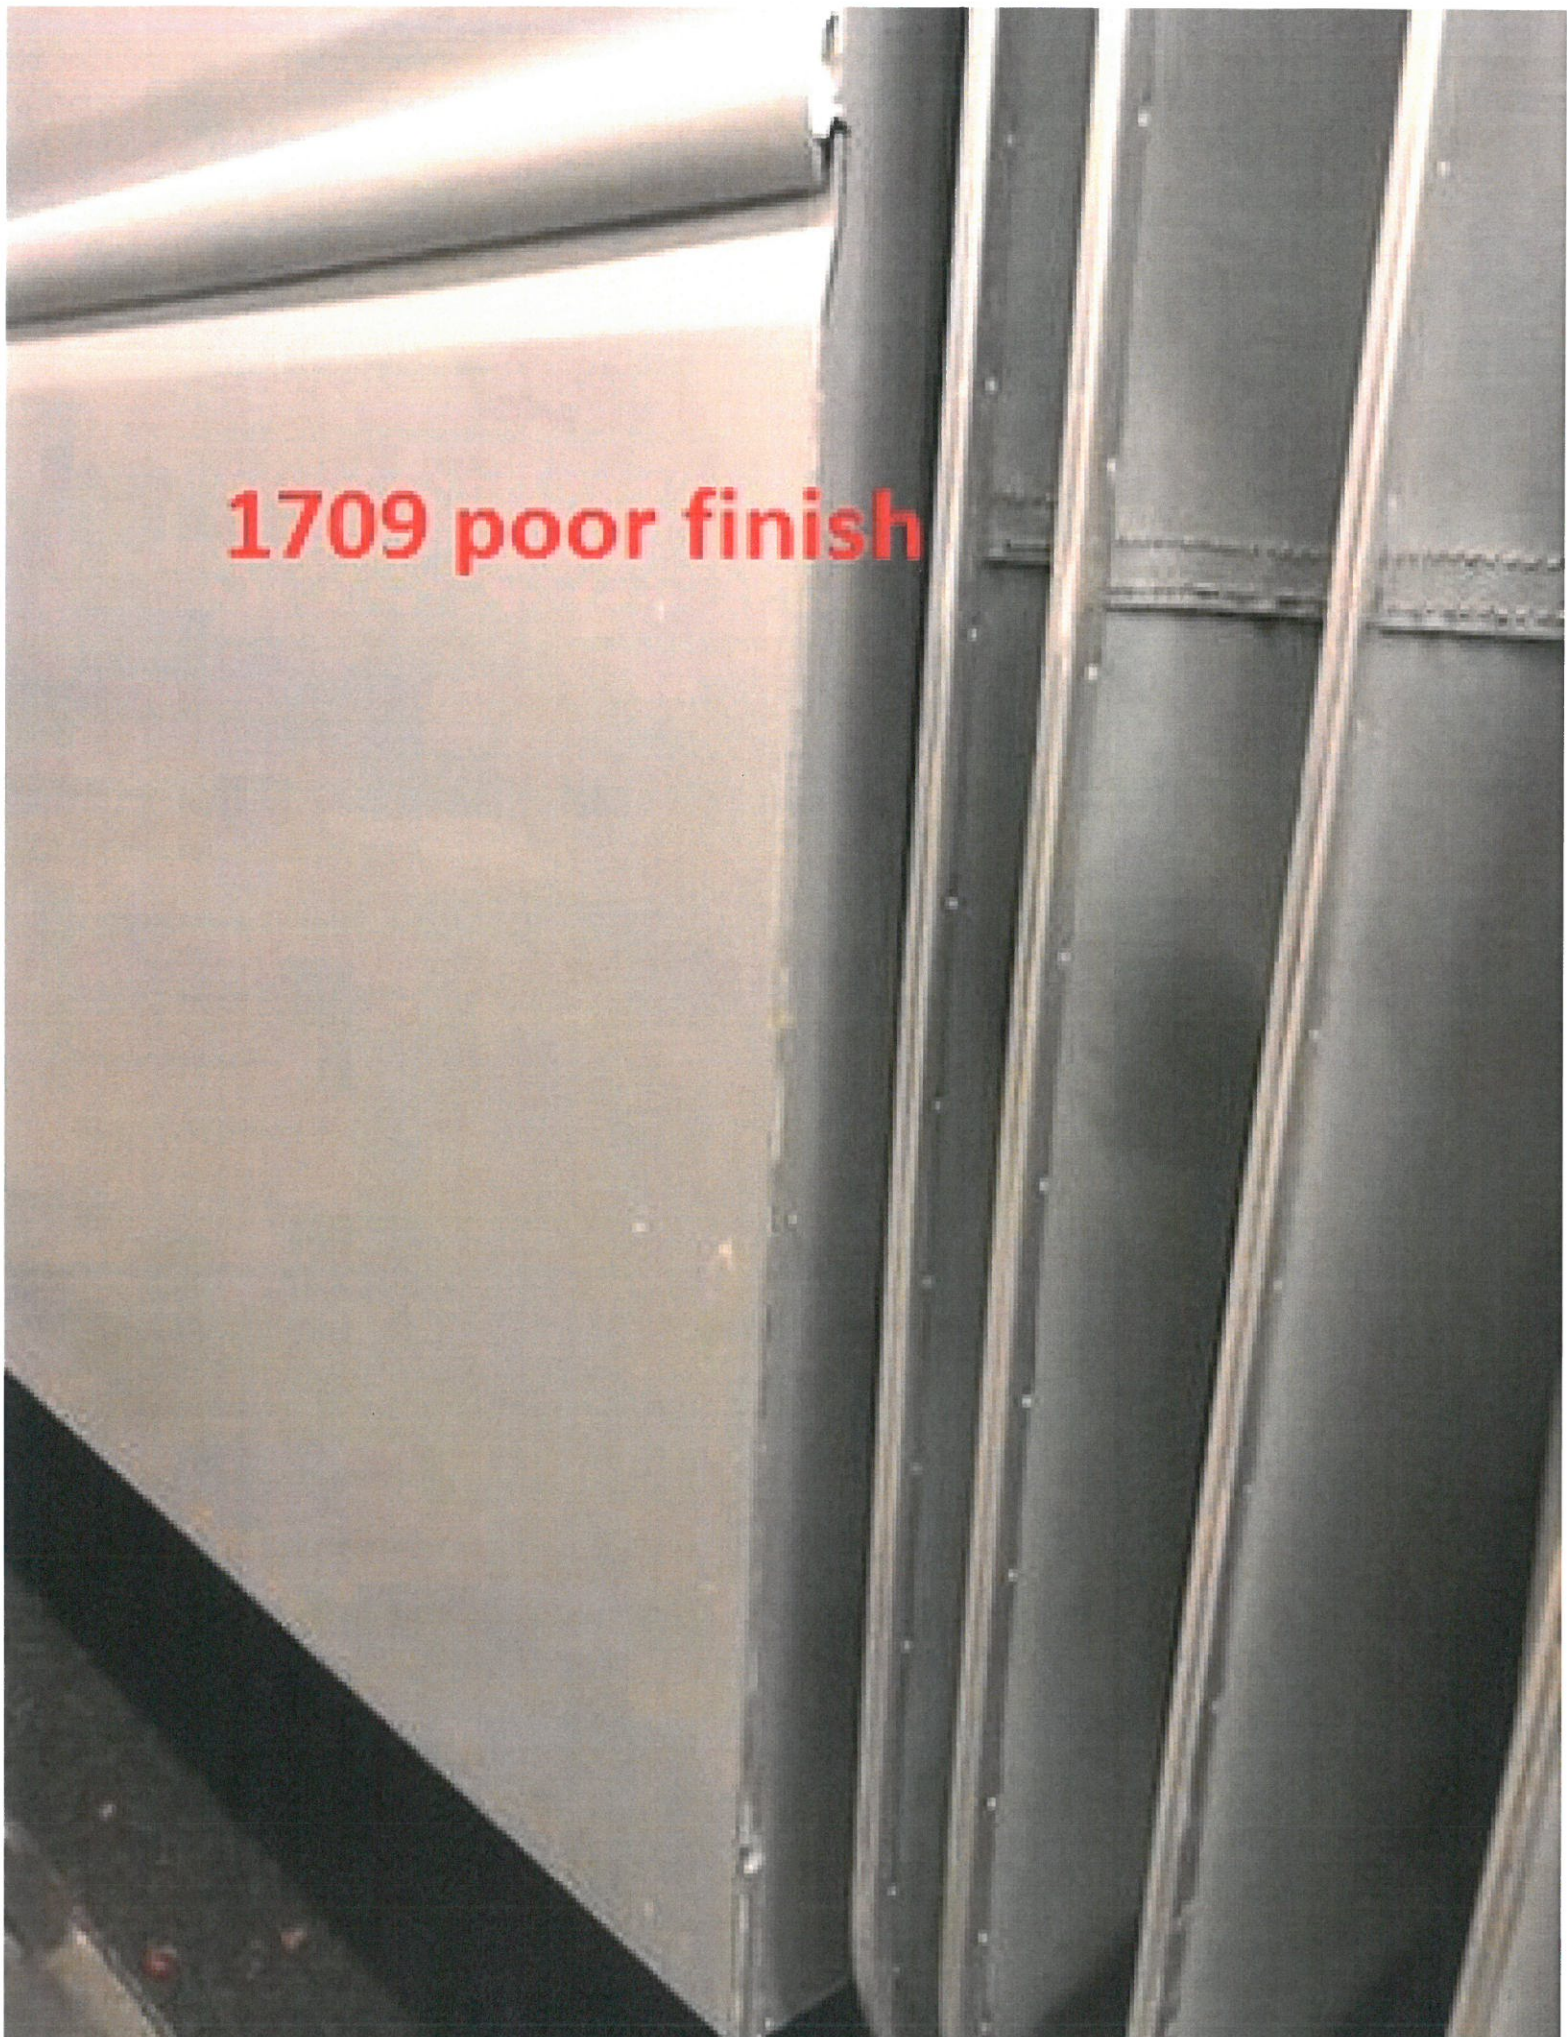
1709 poor finish
