1710

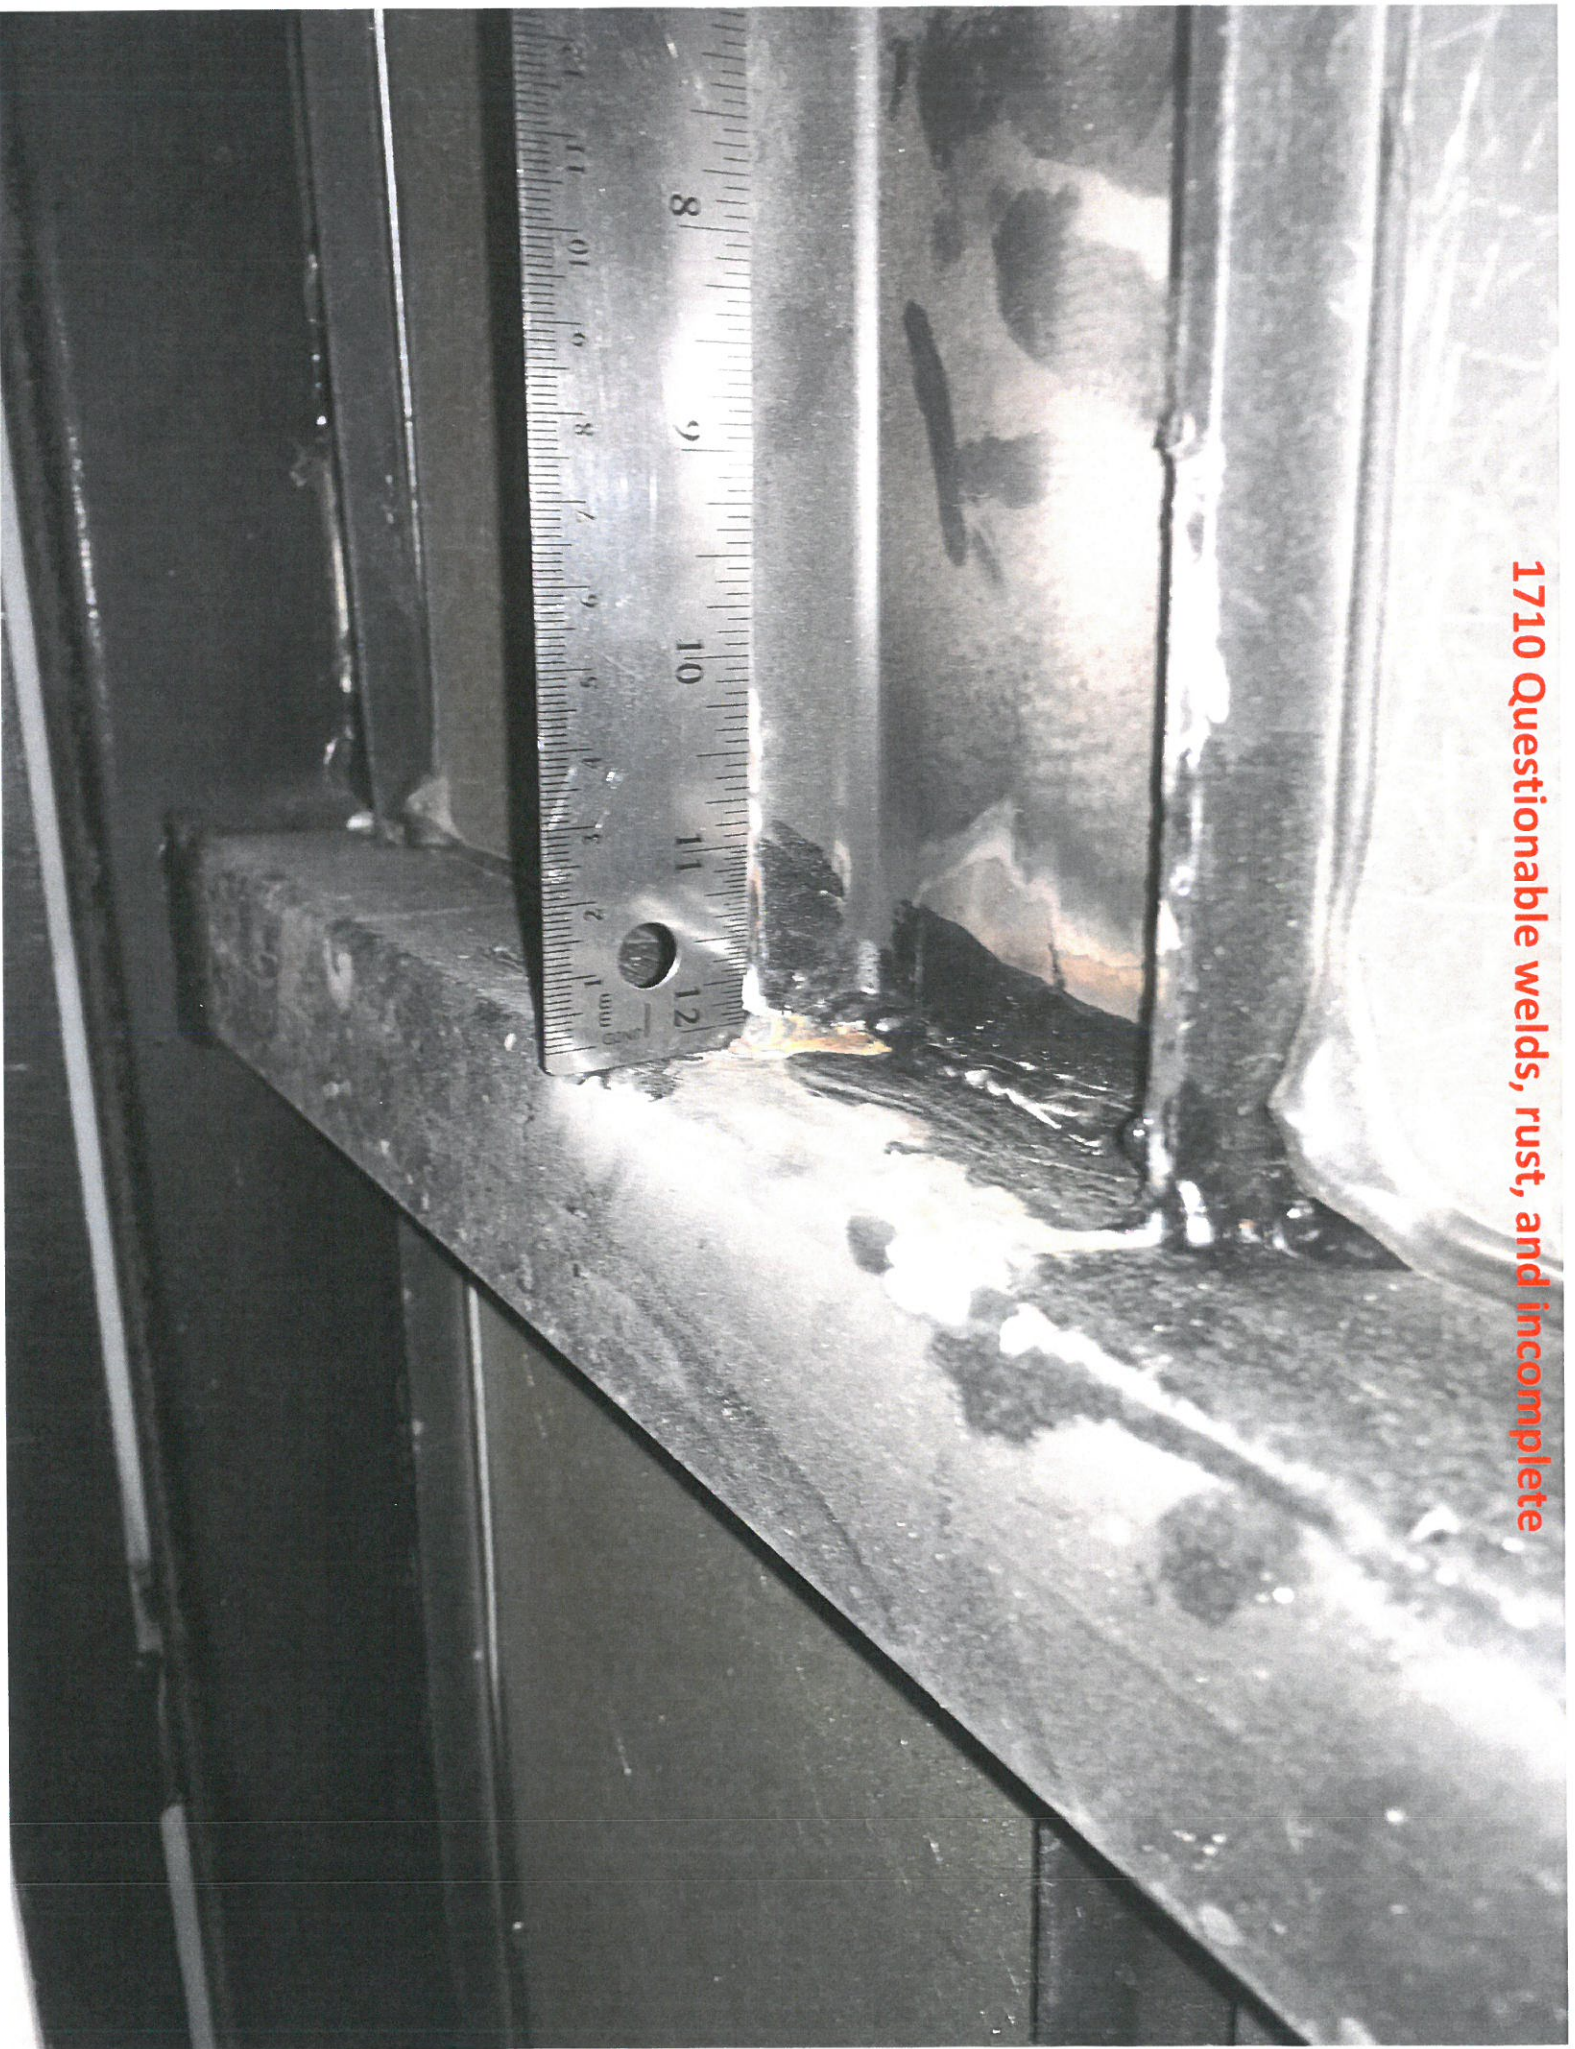
1710 Questionable welds, rust, and incomplete

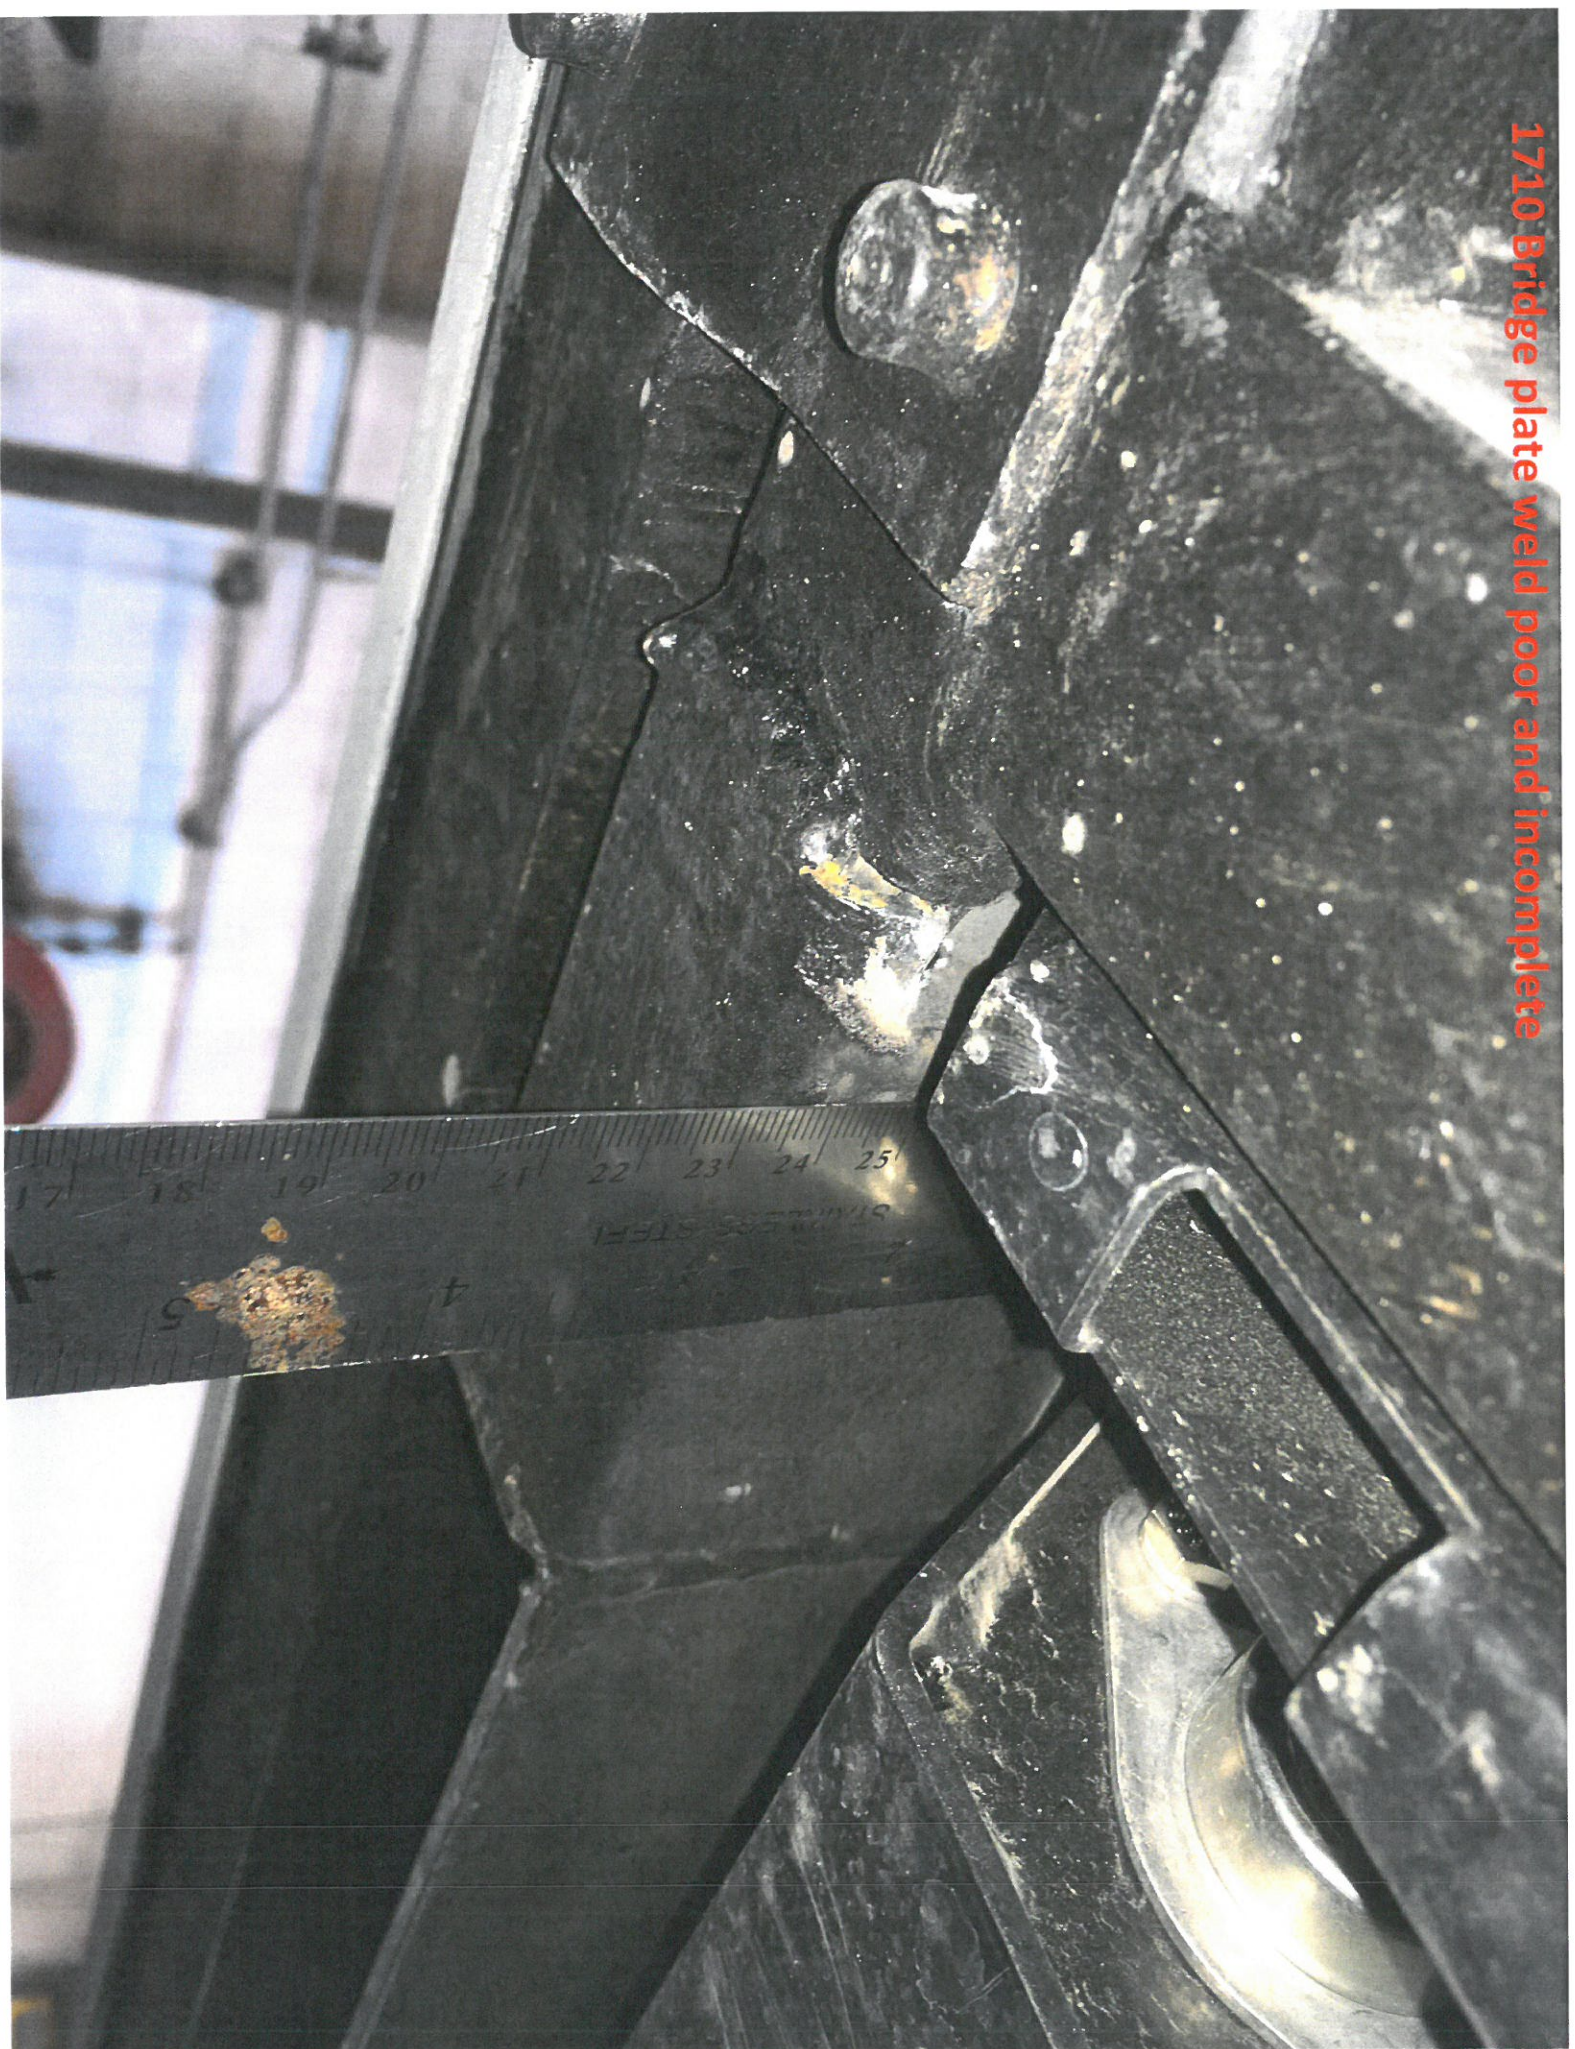
1710 Bridge plate weld poor and incomplete

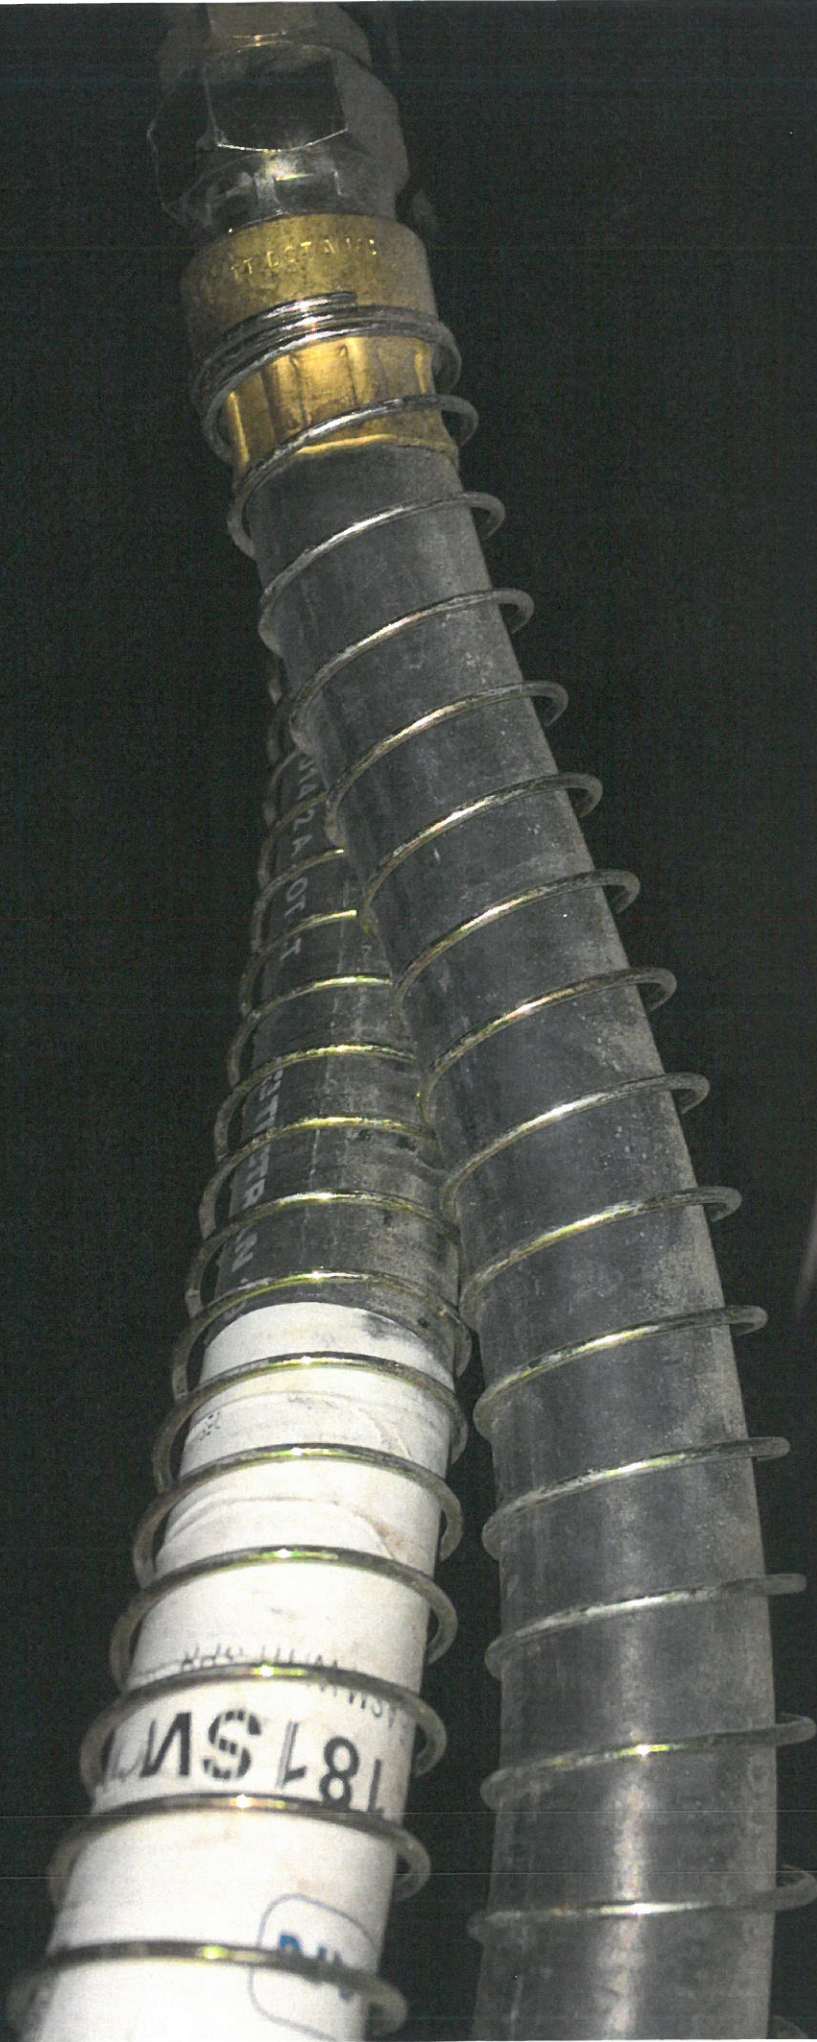
1710 brake chamber air

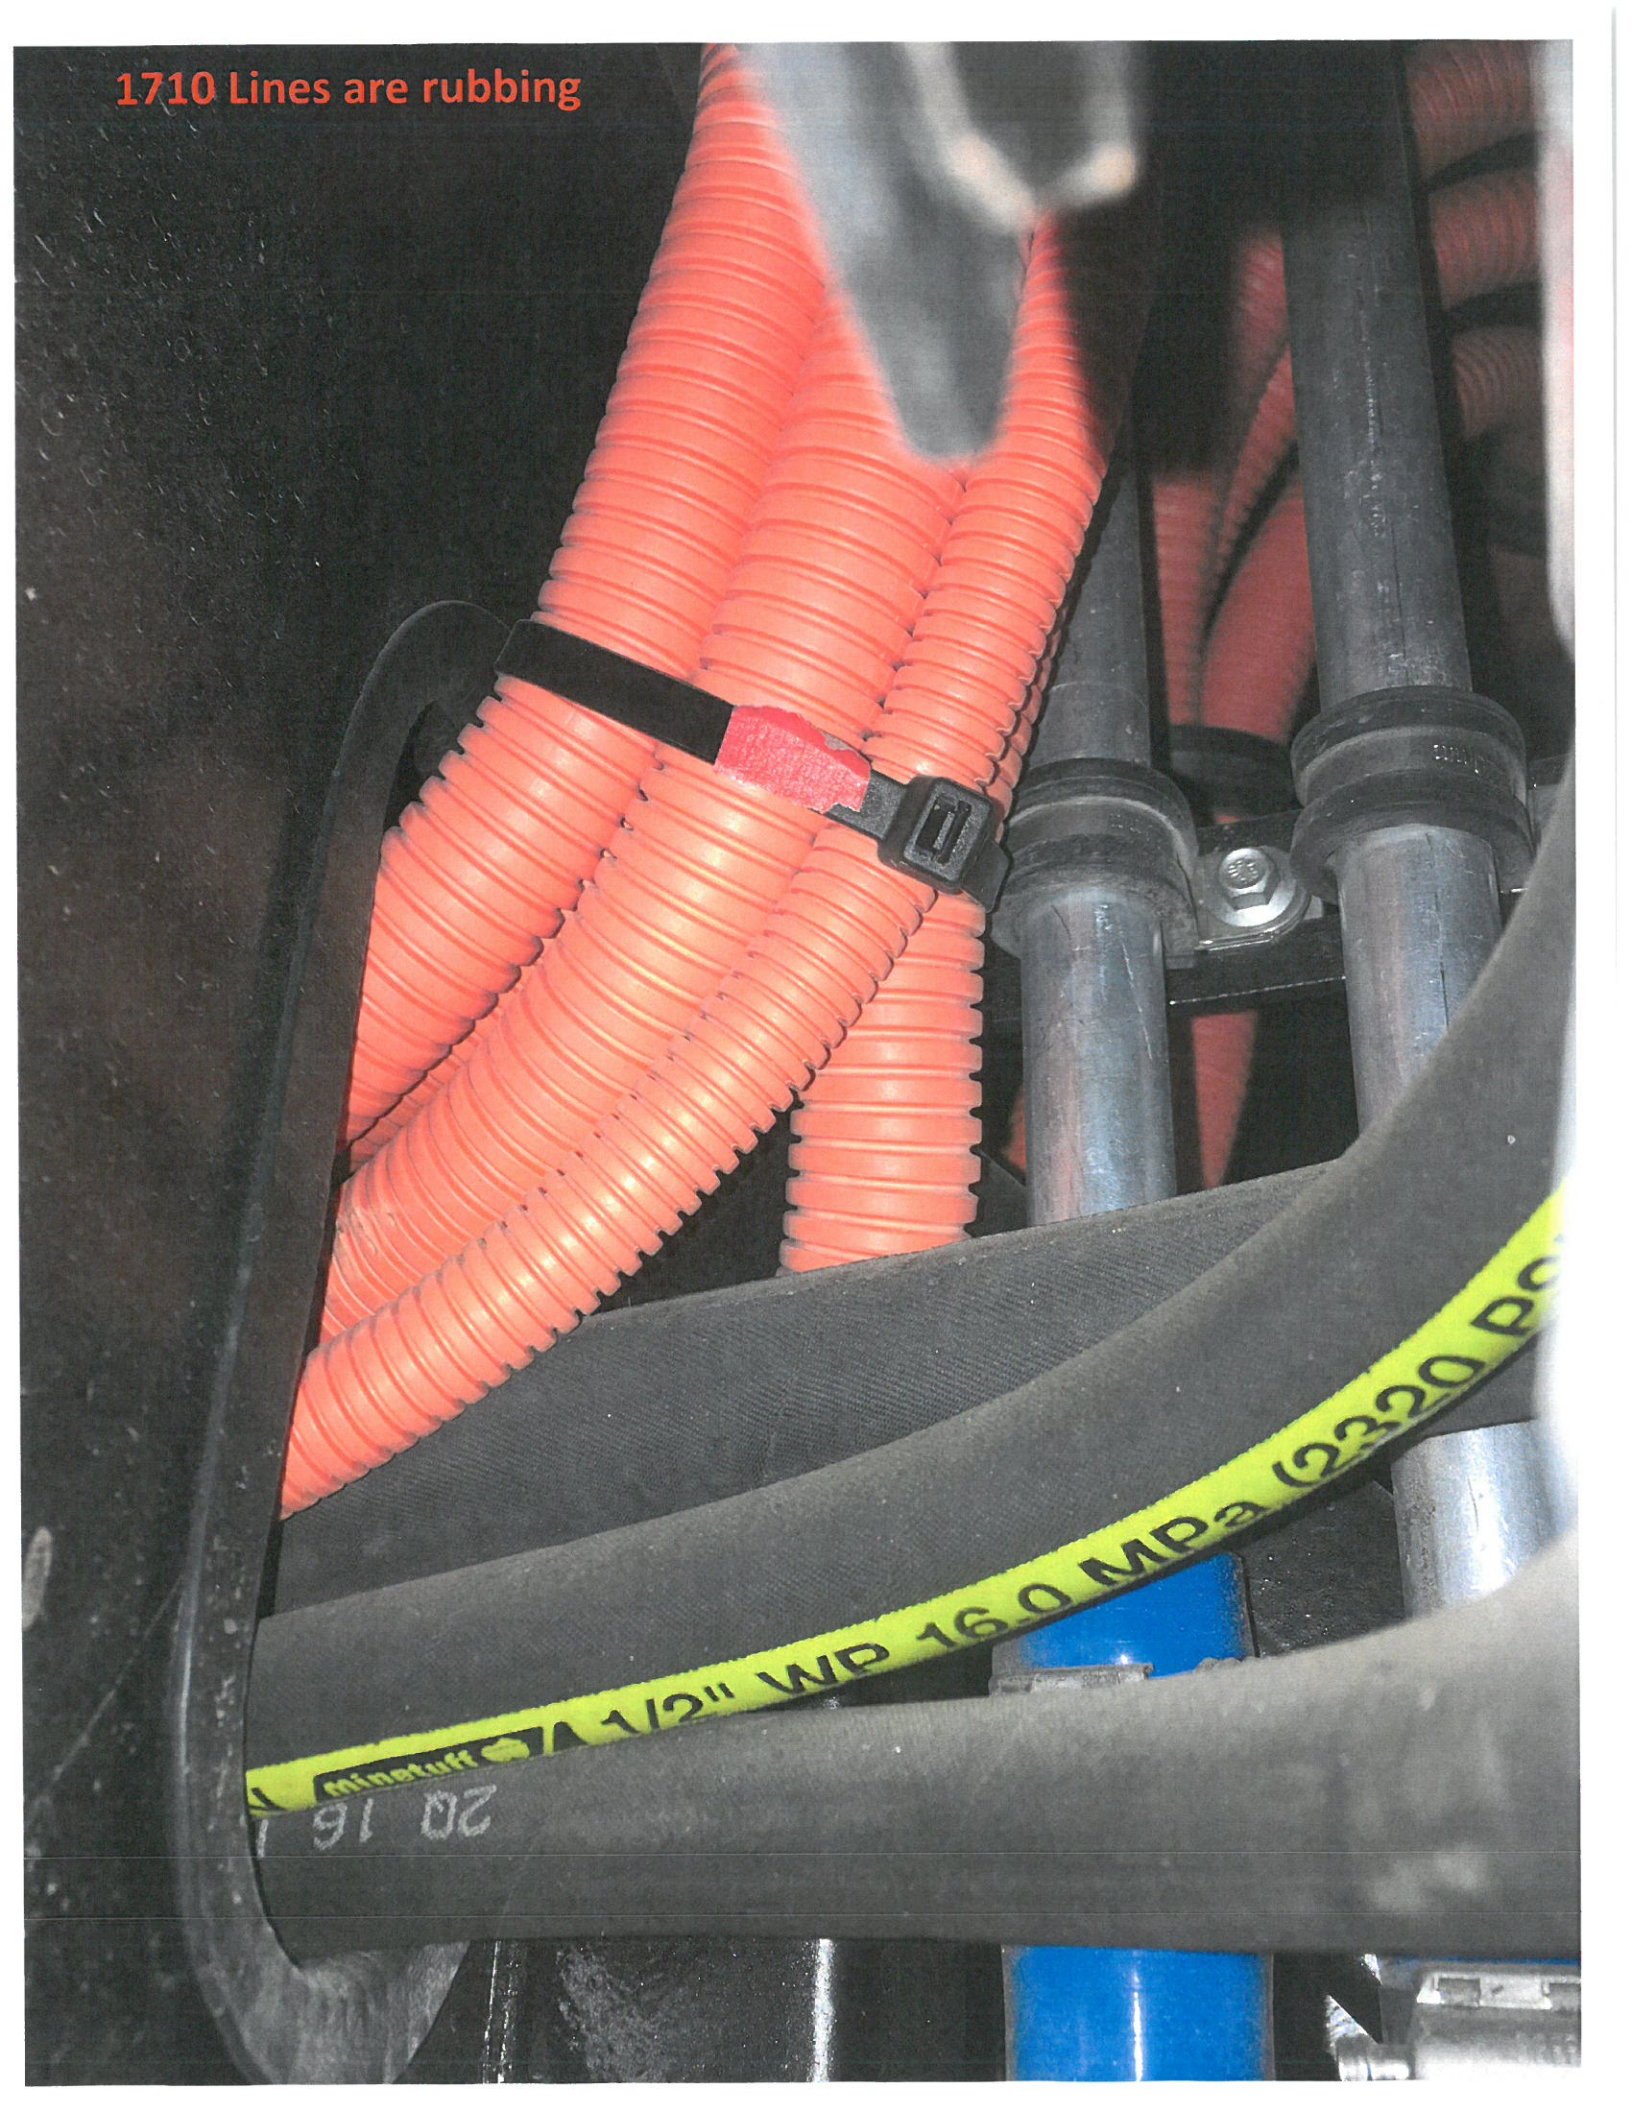
1710 Lines are rubbing

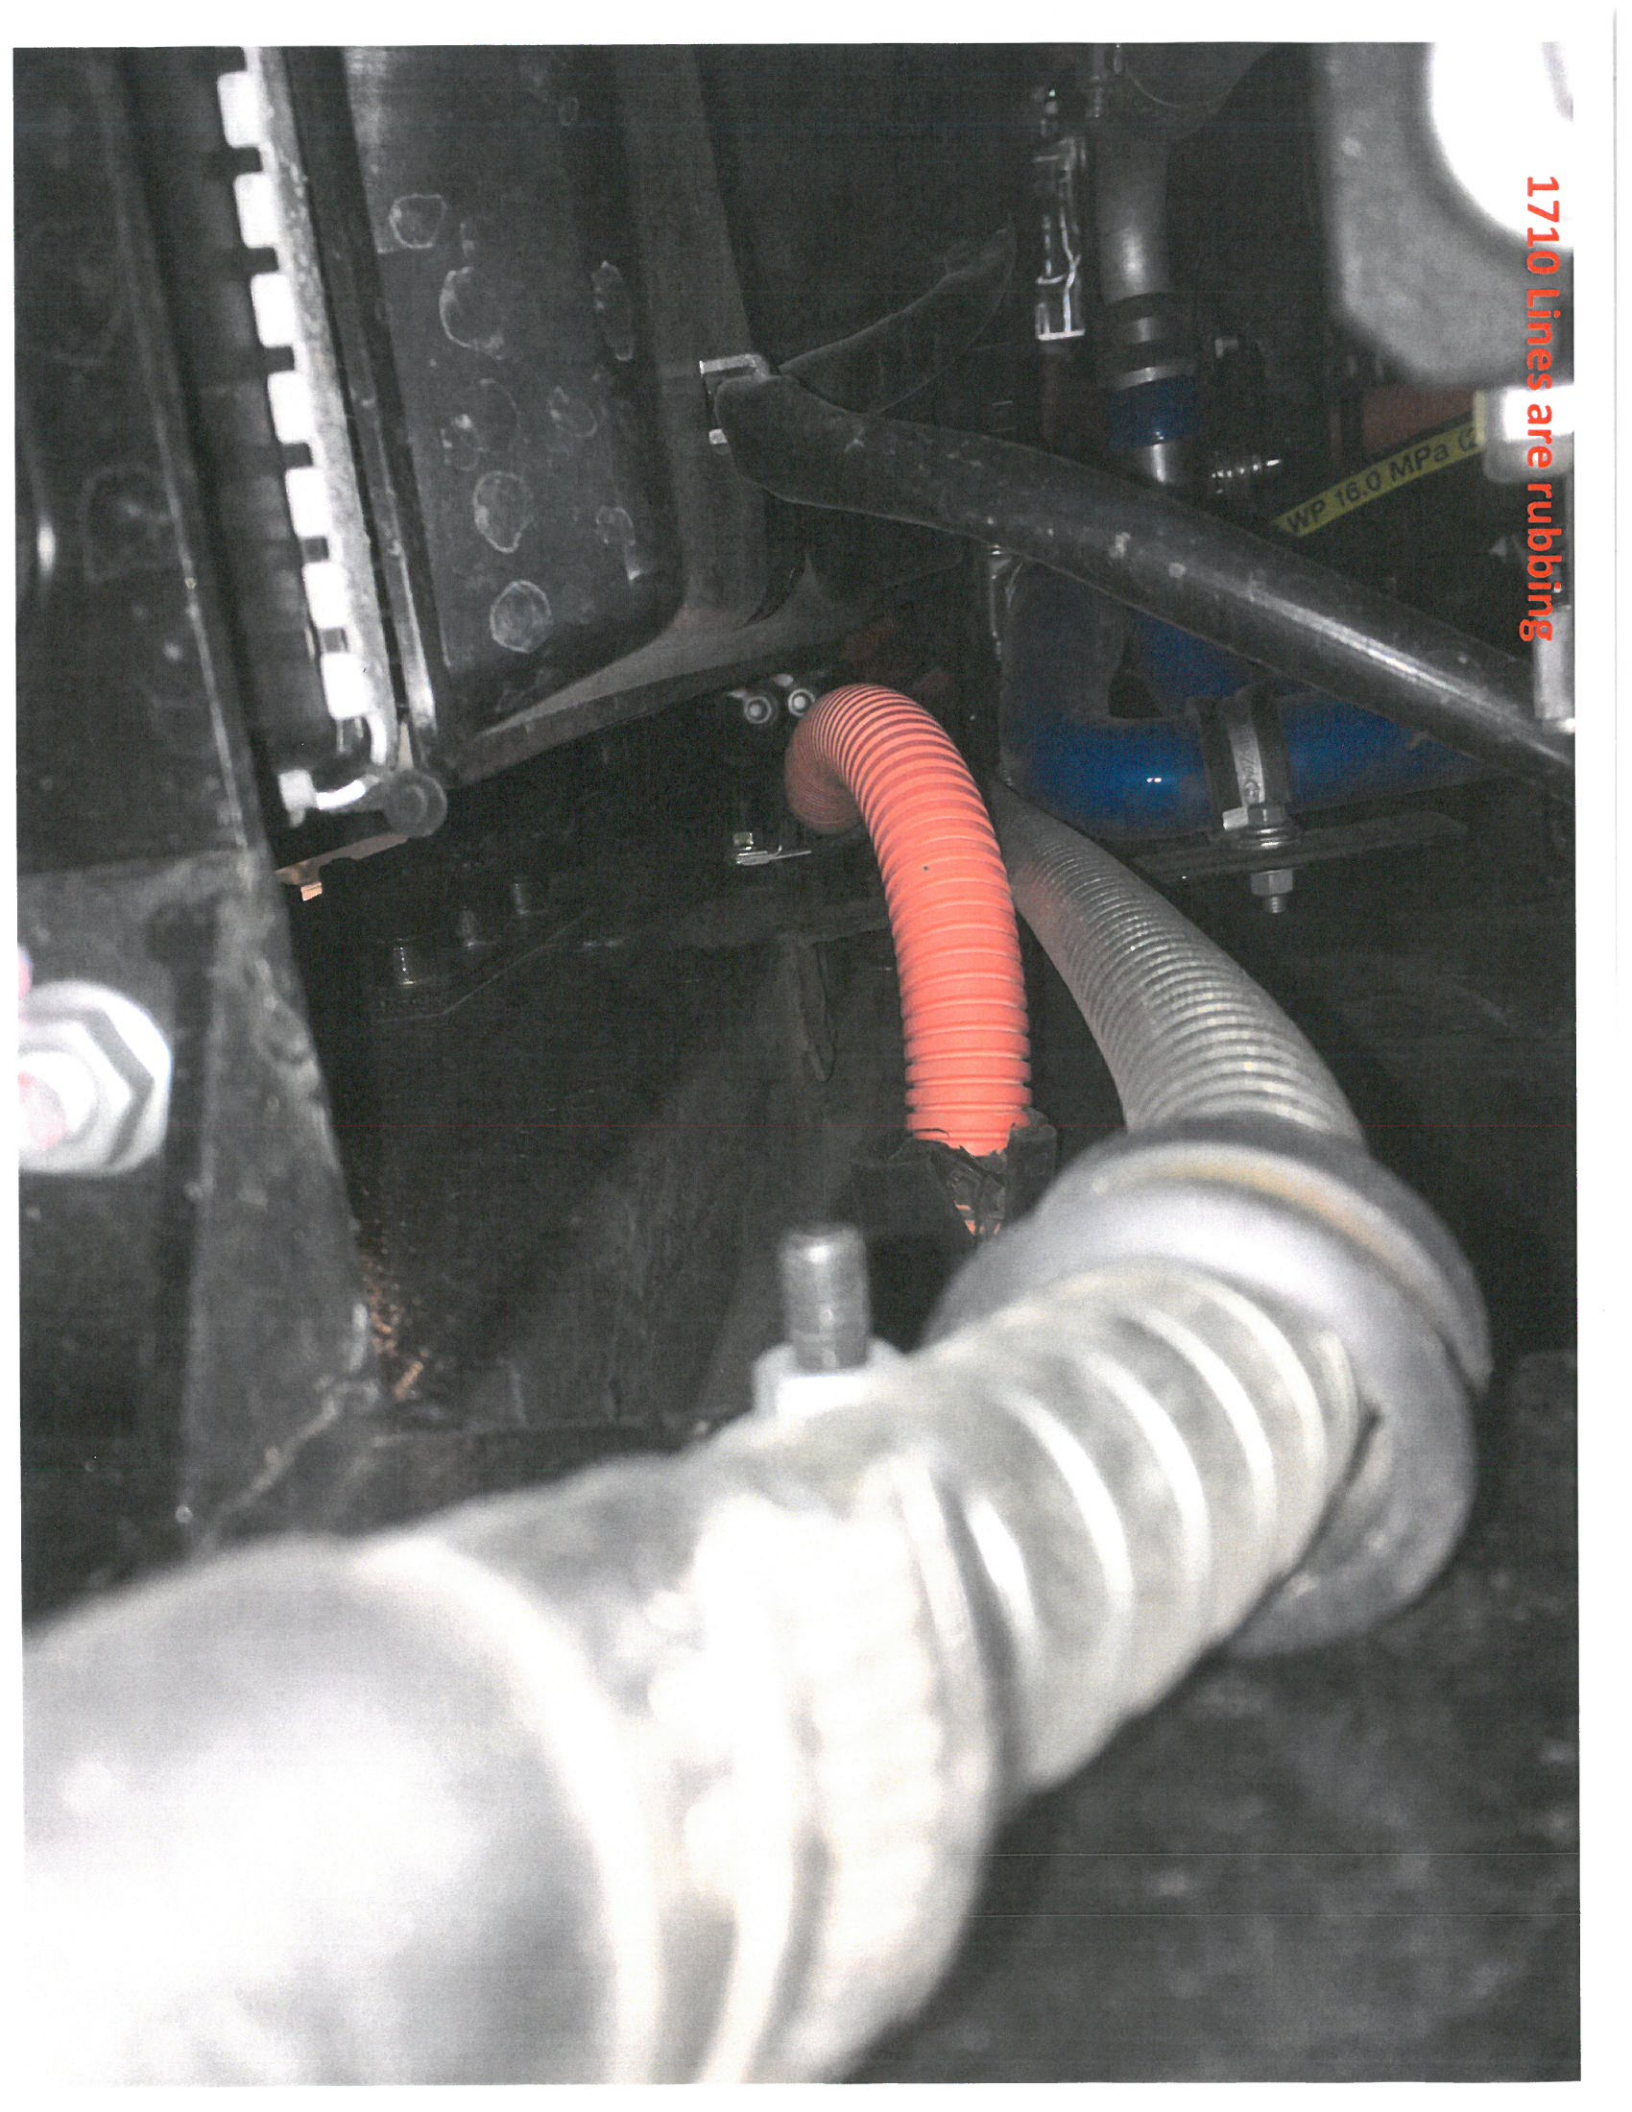
1710 Lines are rubbing

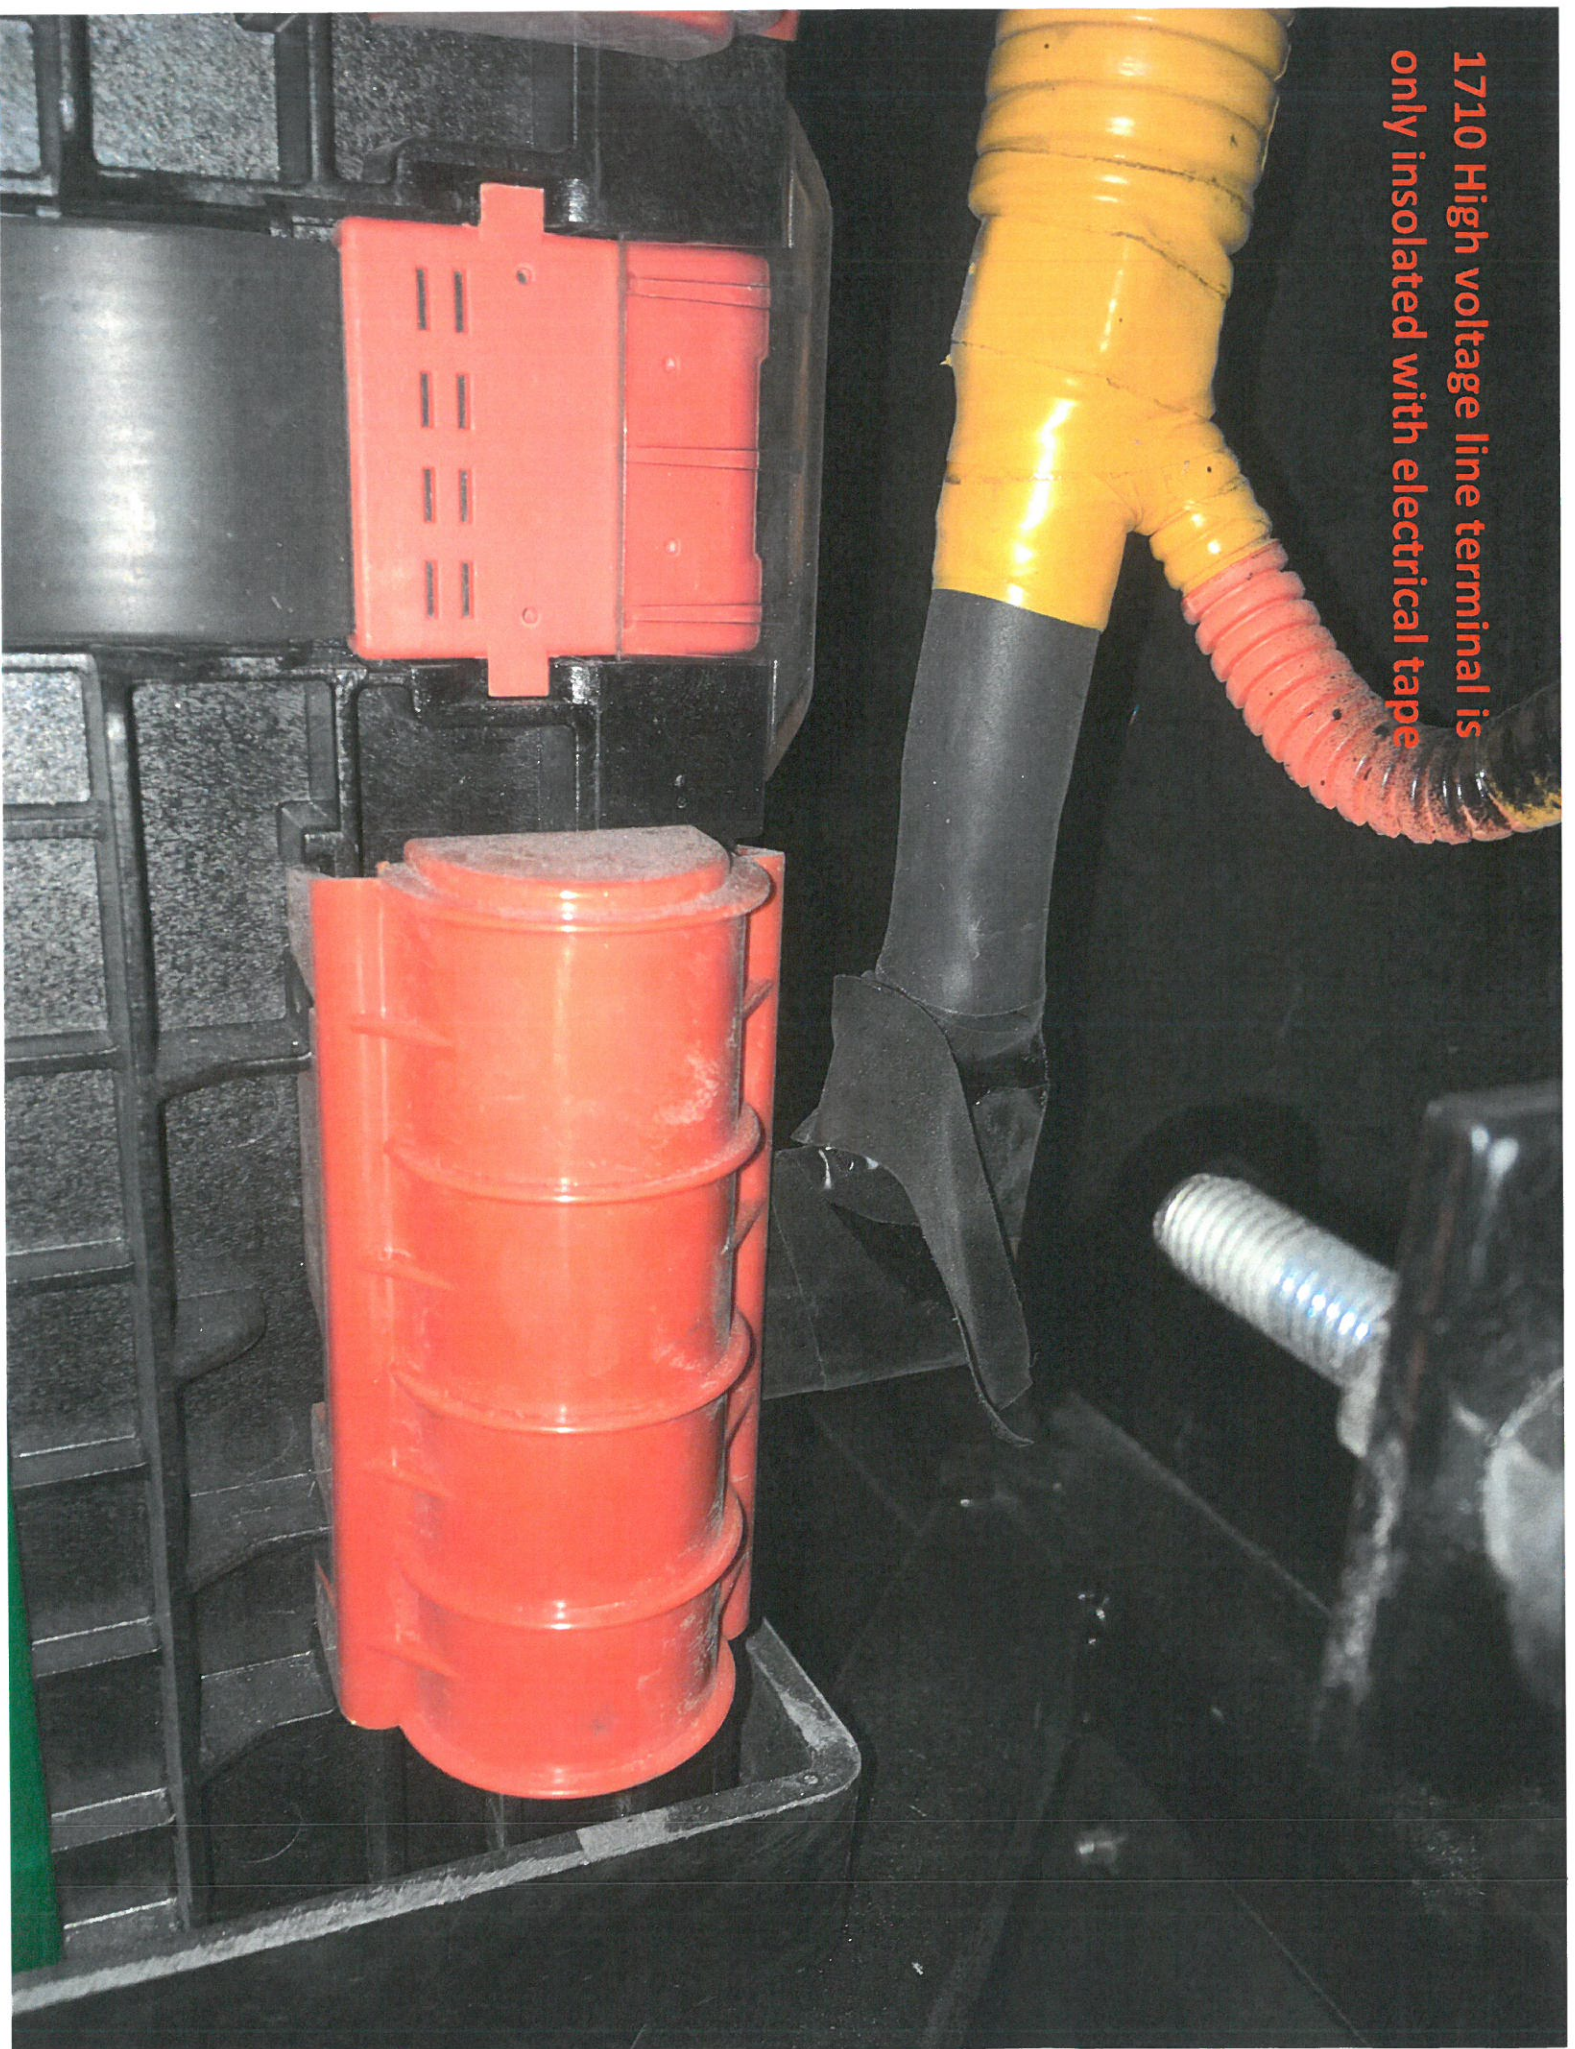
1710 High voltage line terminal is only insulated with electrical tape

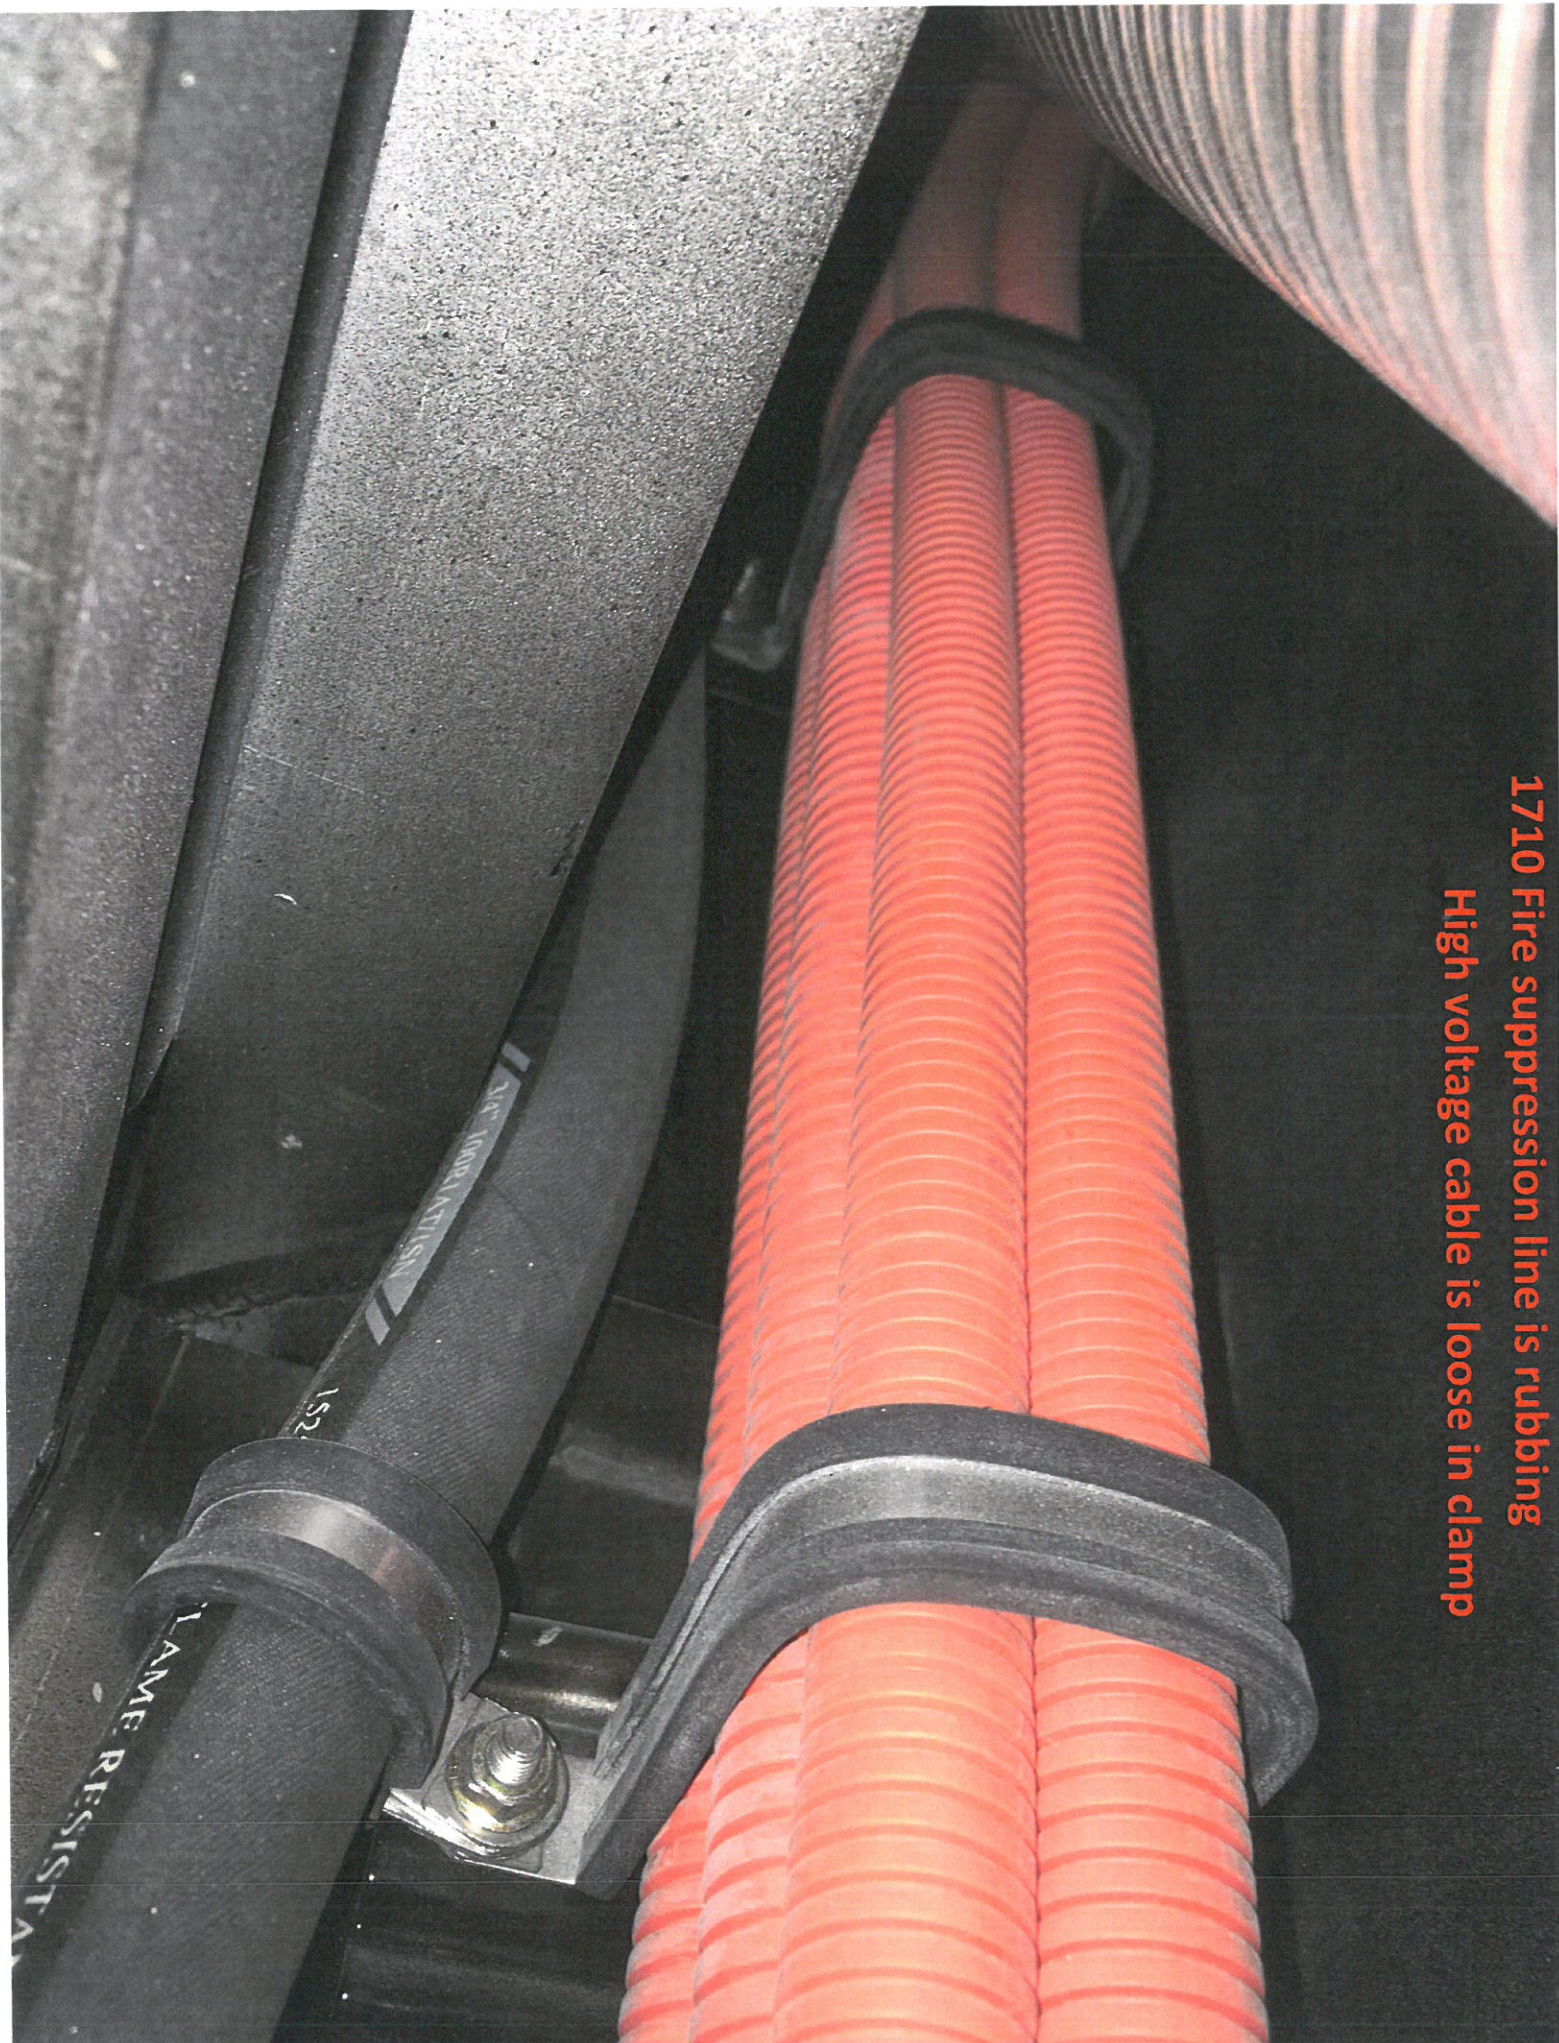
1710 Fire suppression line is rubbing
High voltage cable is loose in clamp
