1710

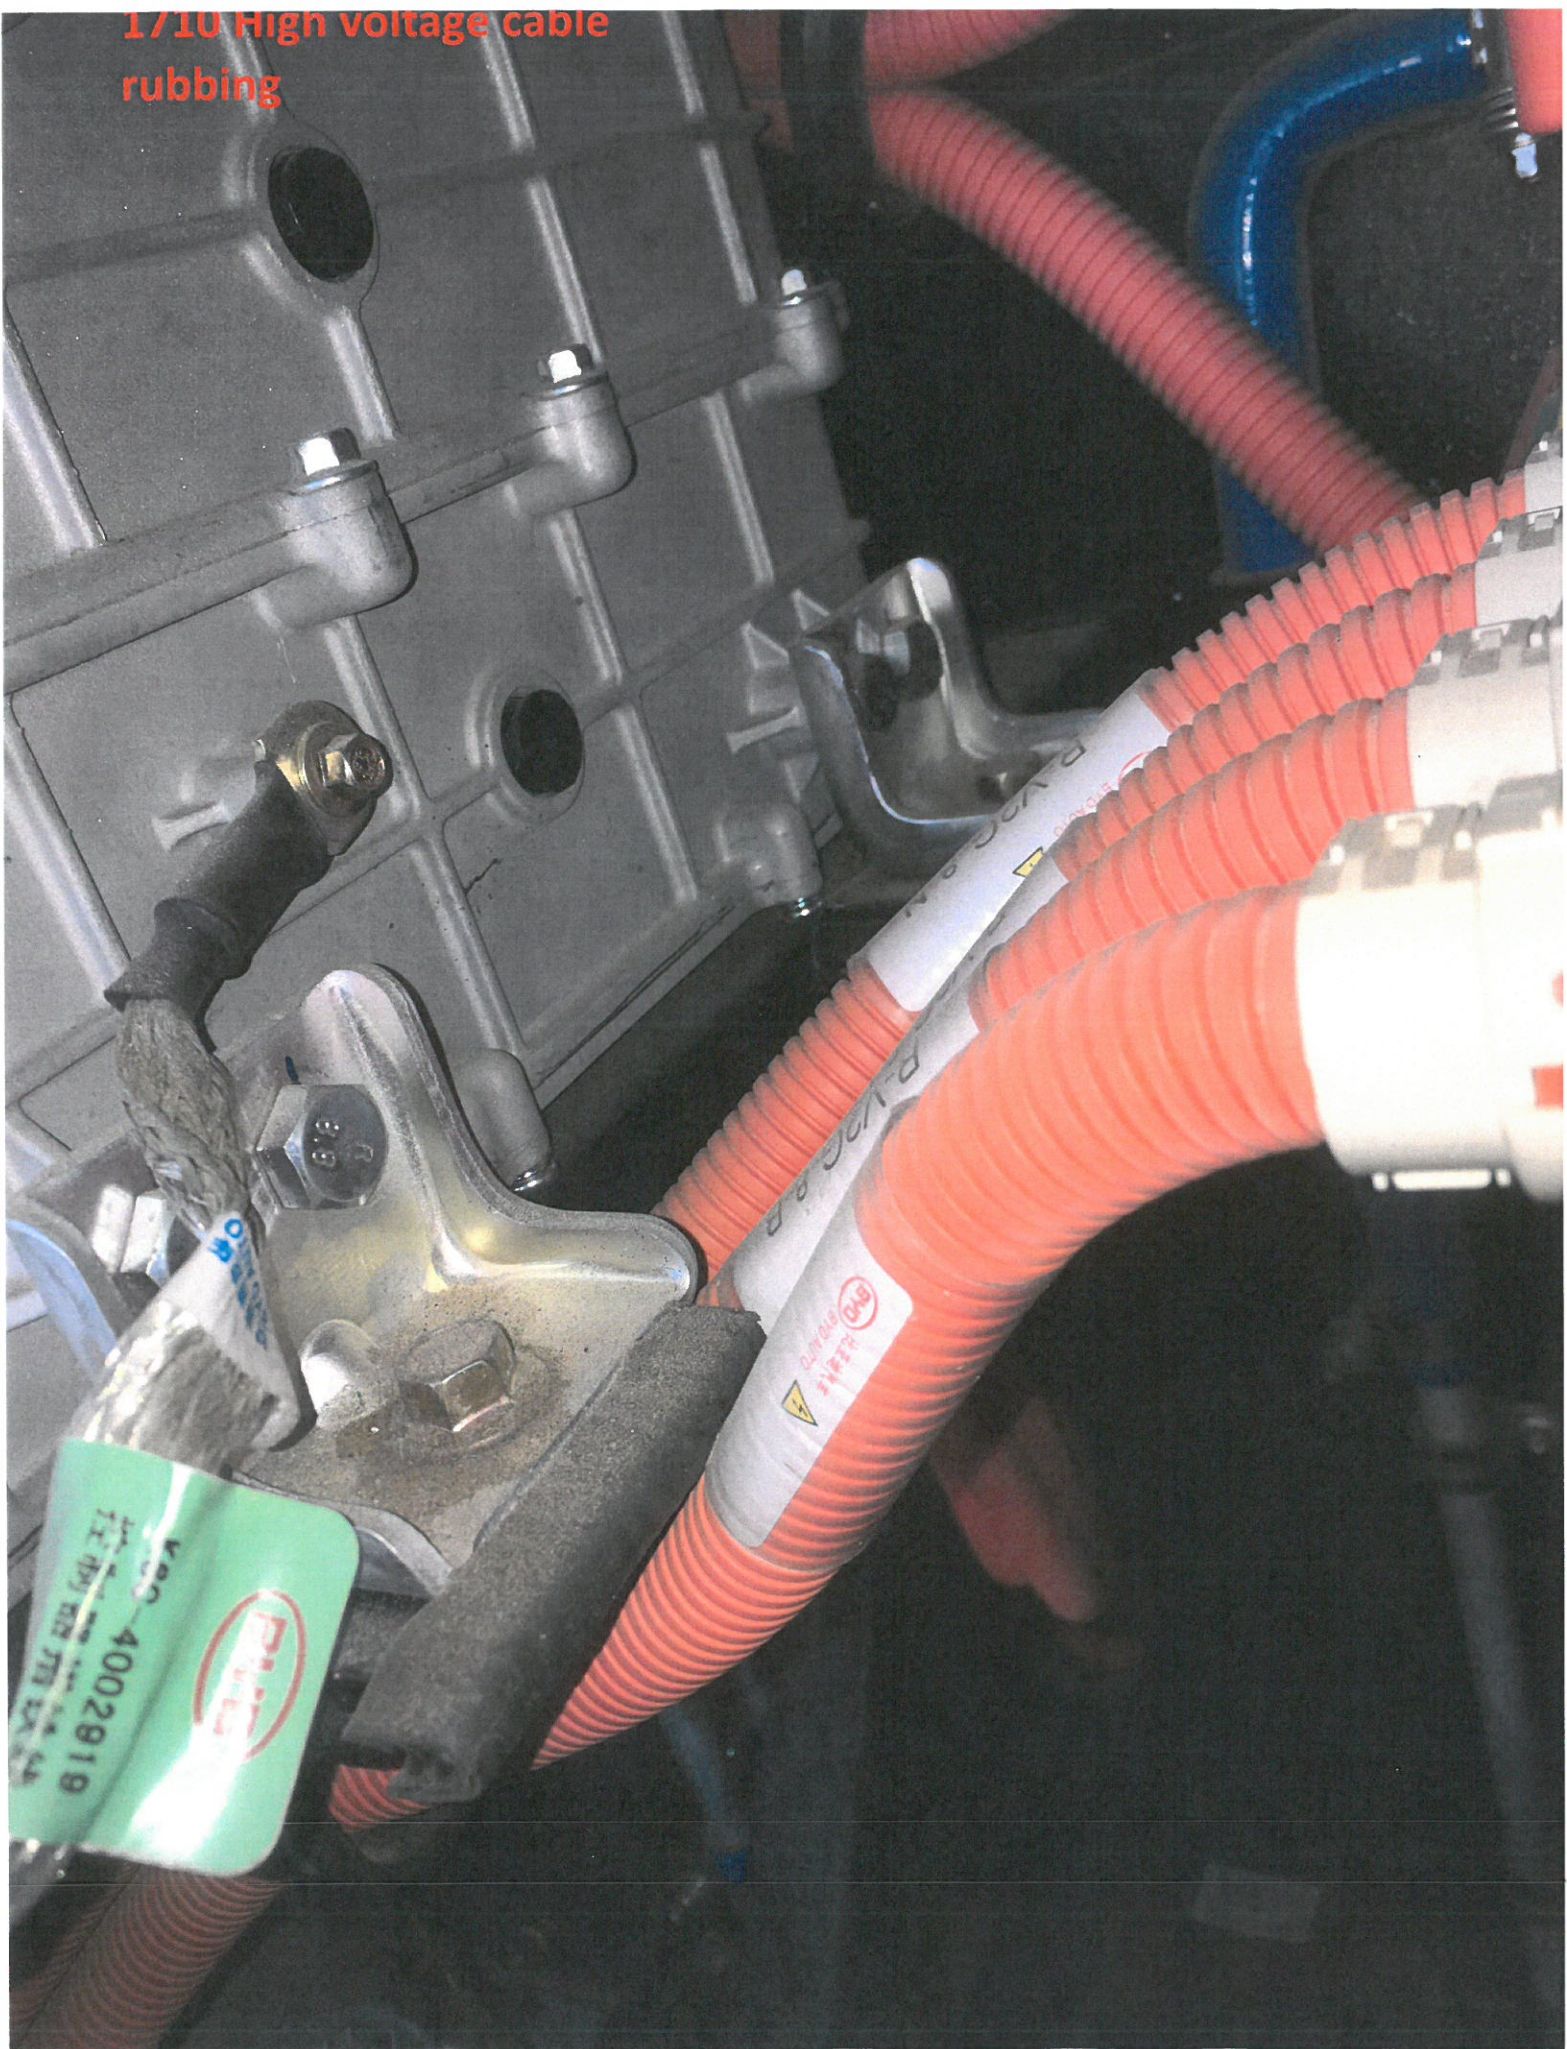
1710 High voltage cable
rubbing

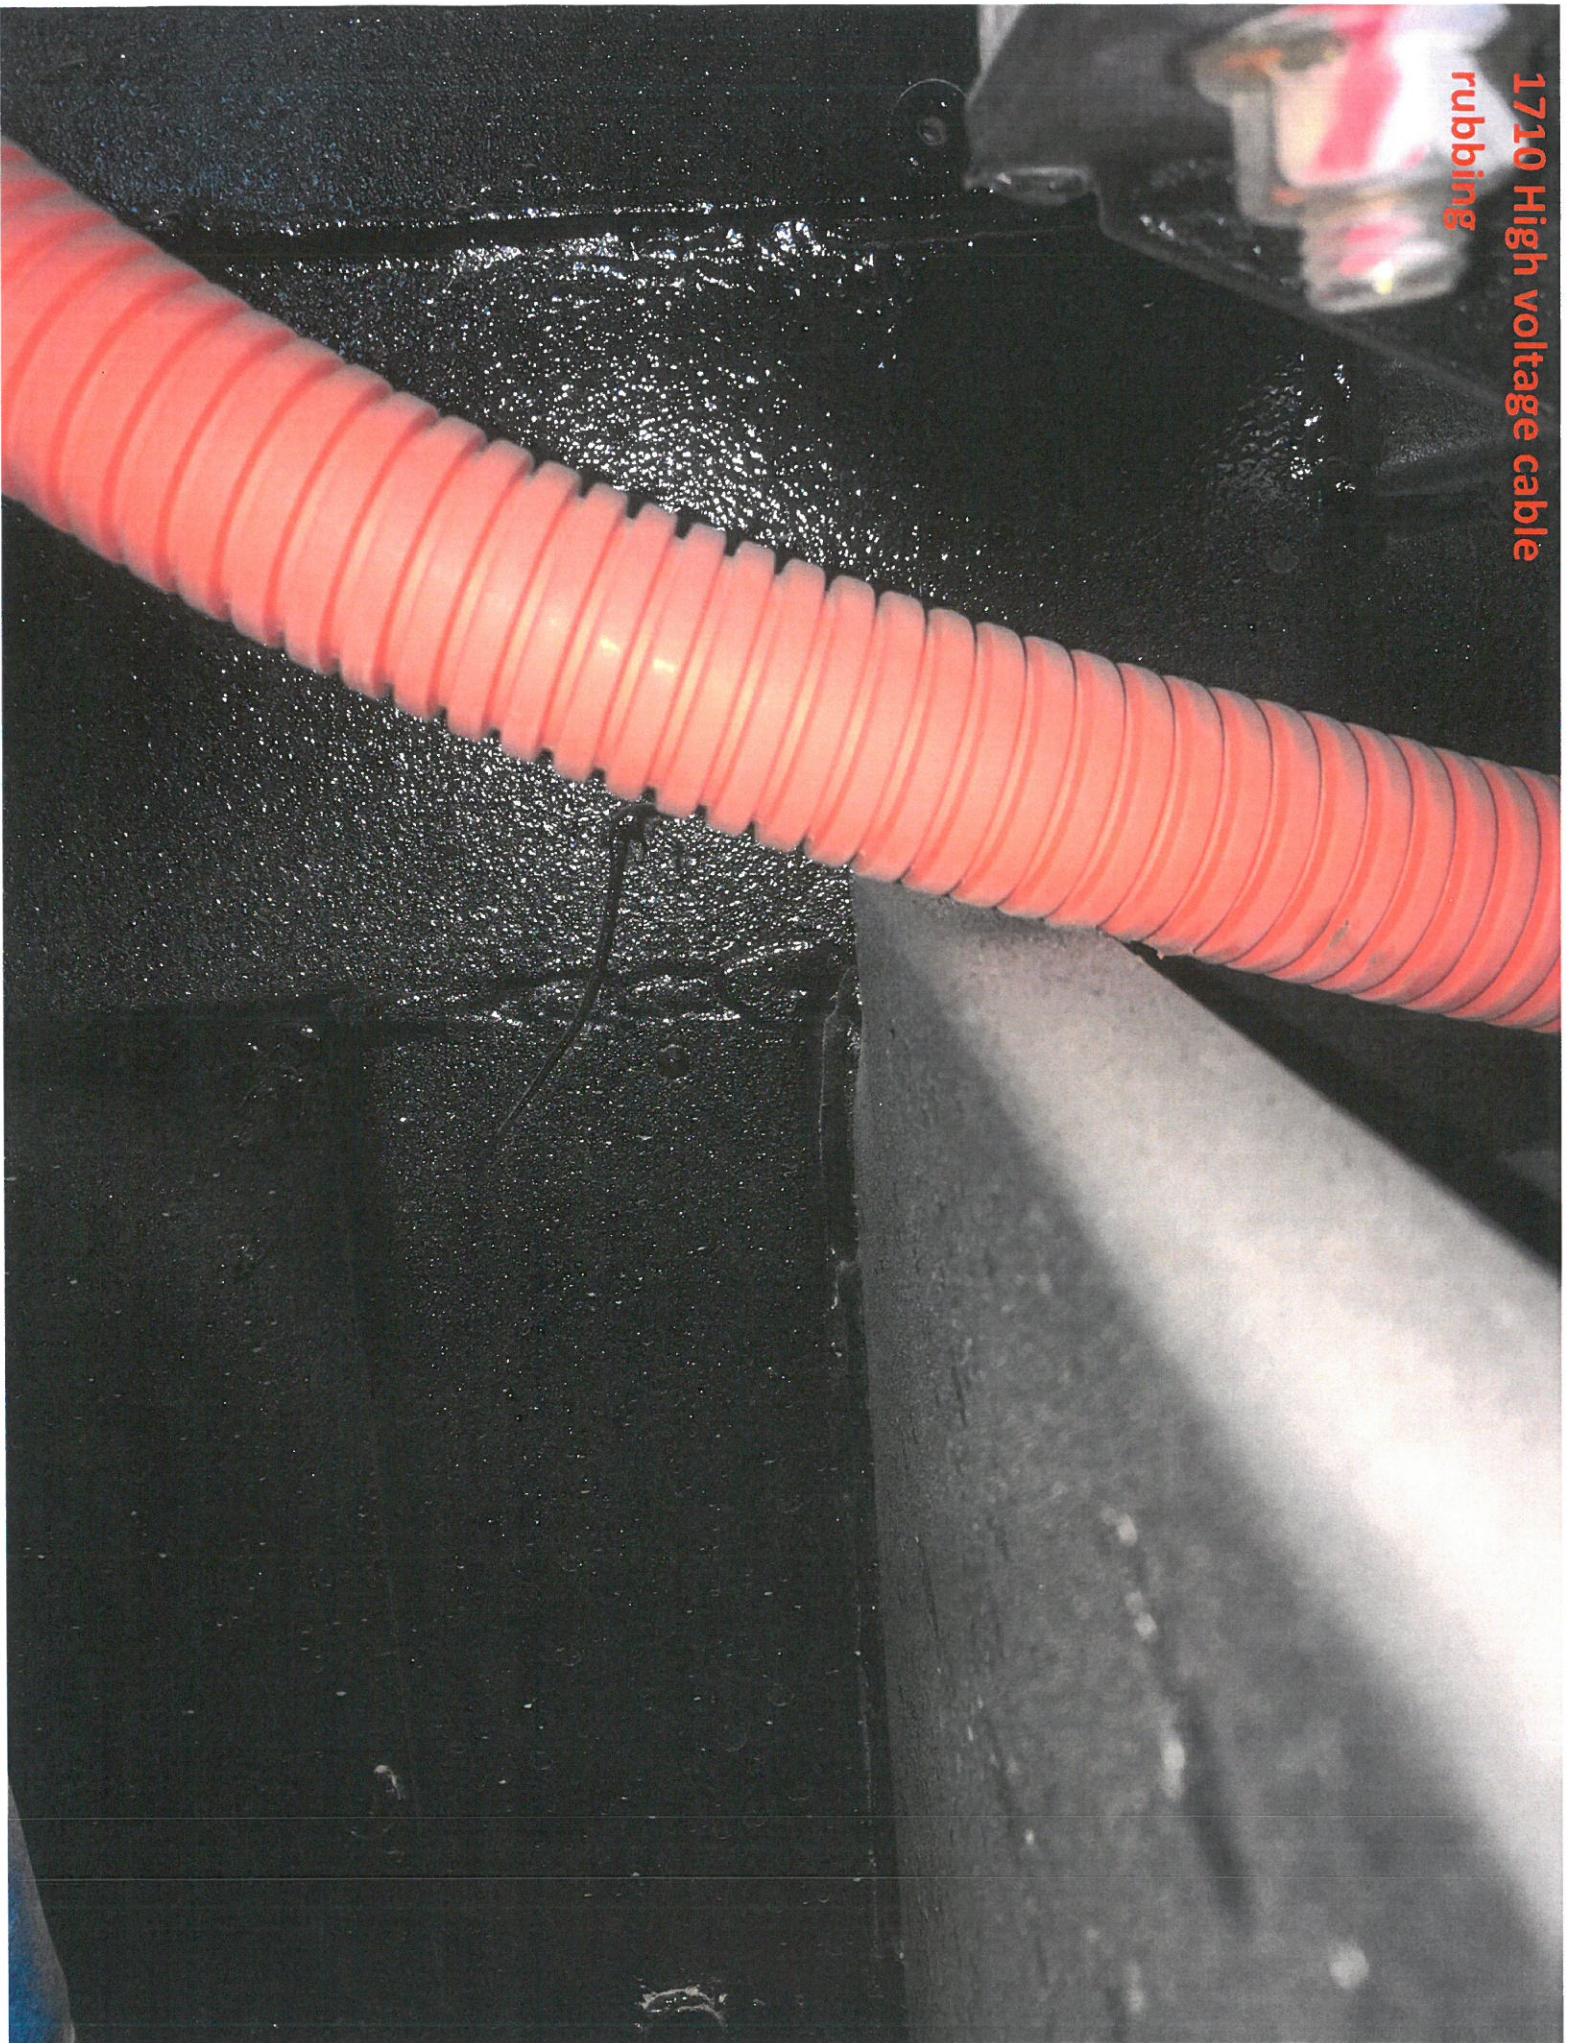
1710 High voltage cable
rubbing

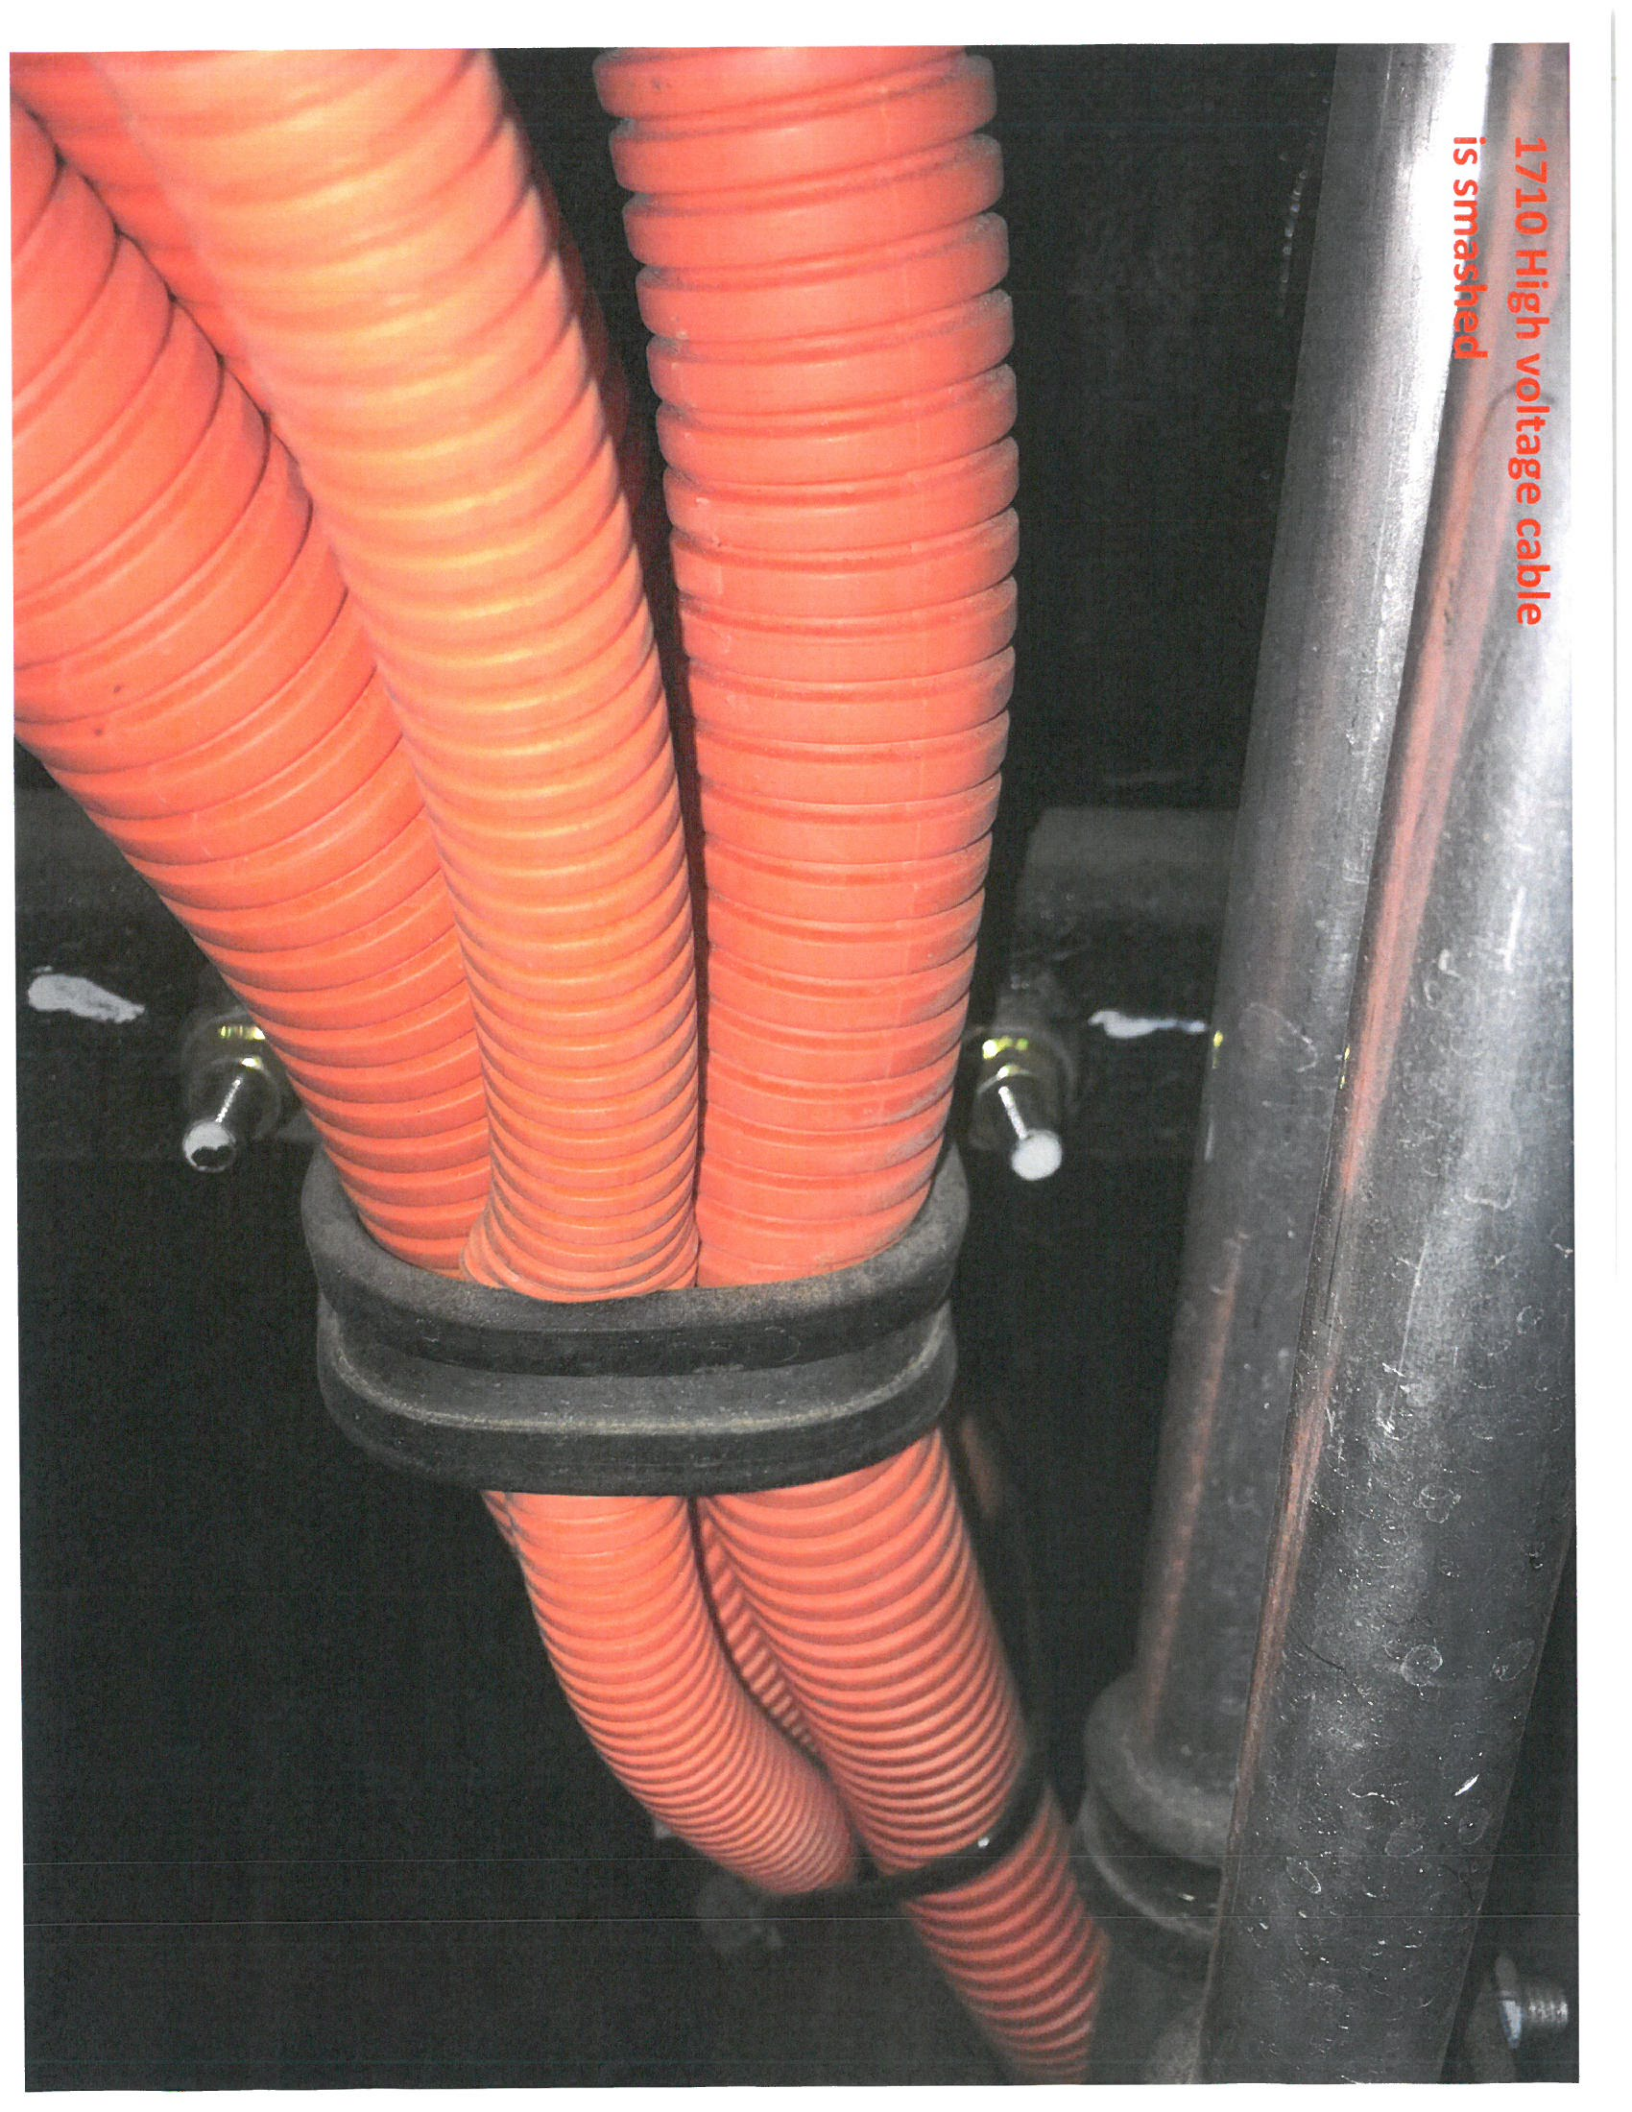
1710 High voltage cable
is smashed

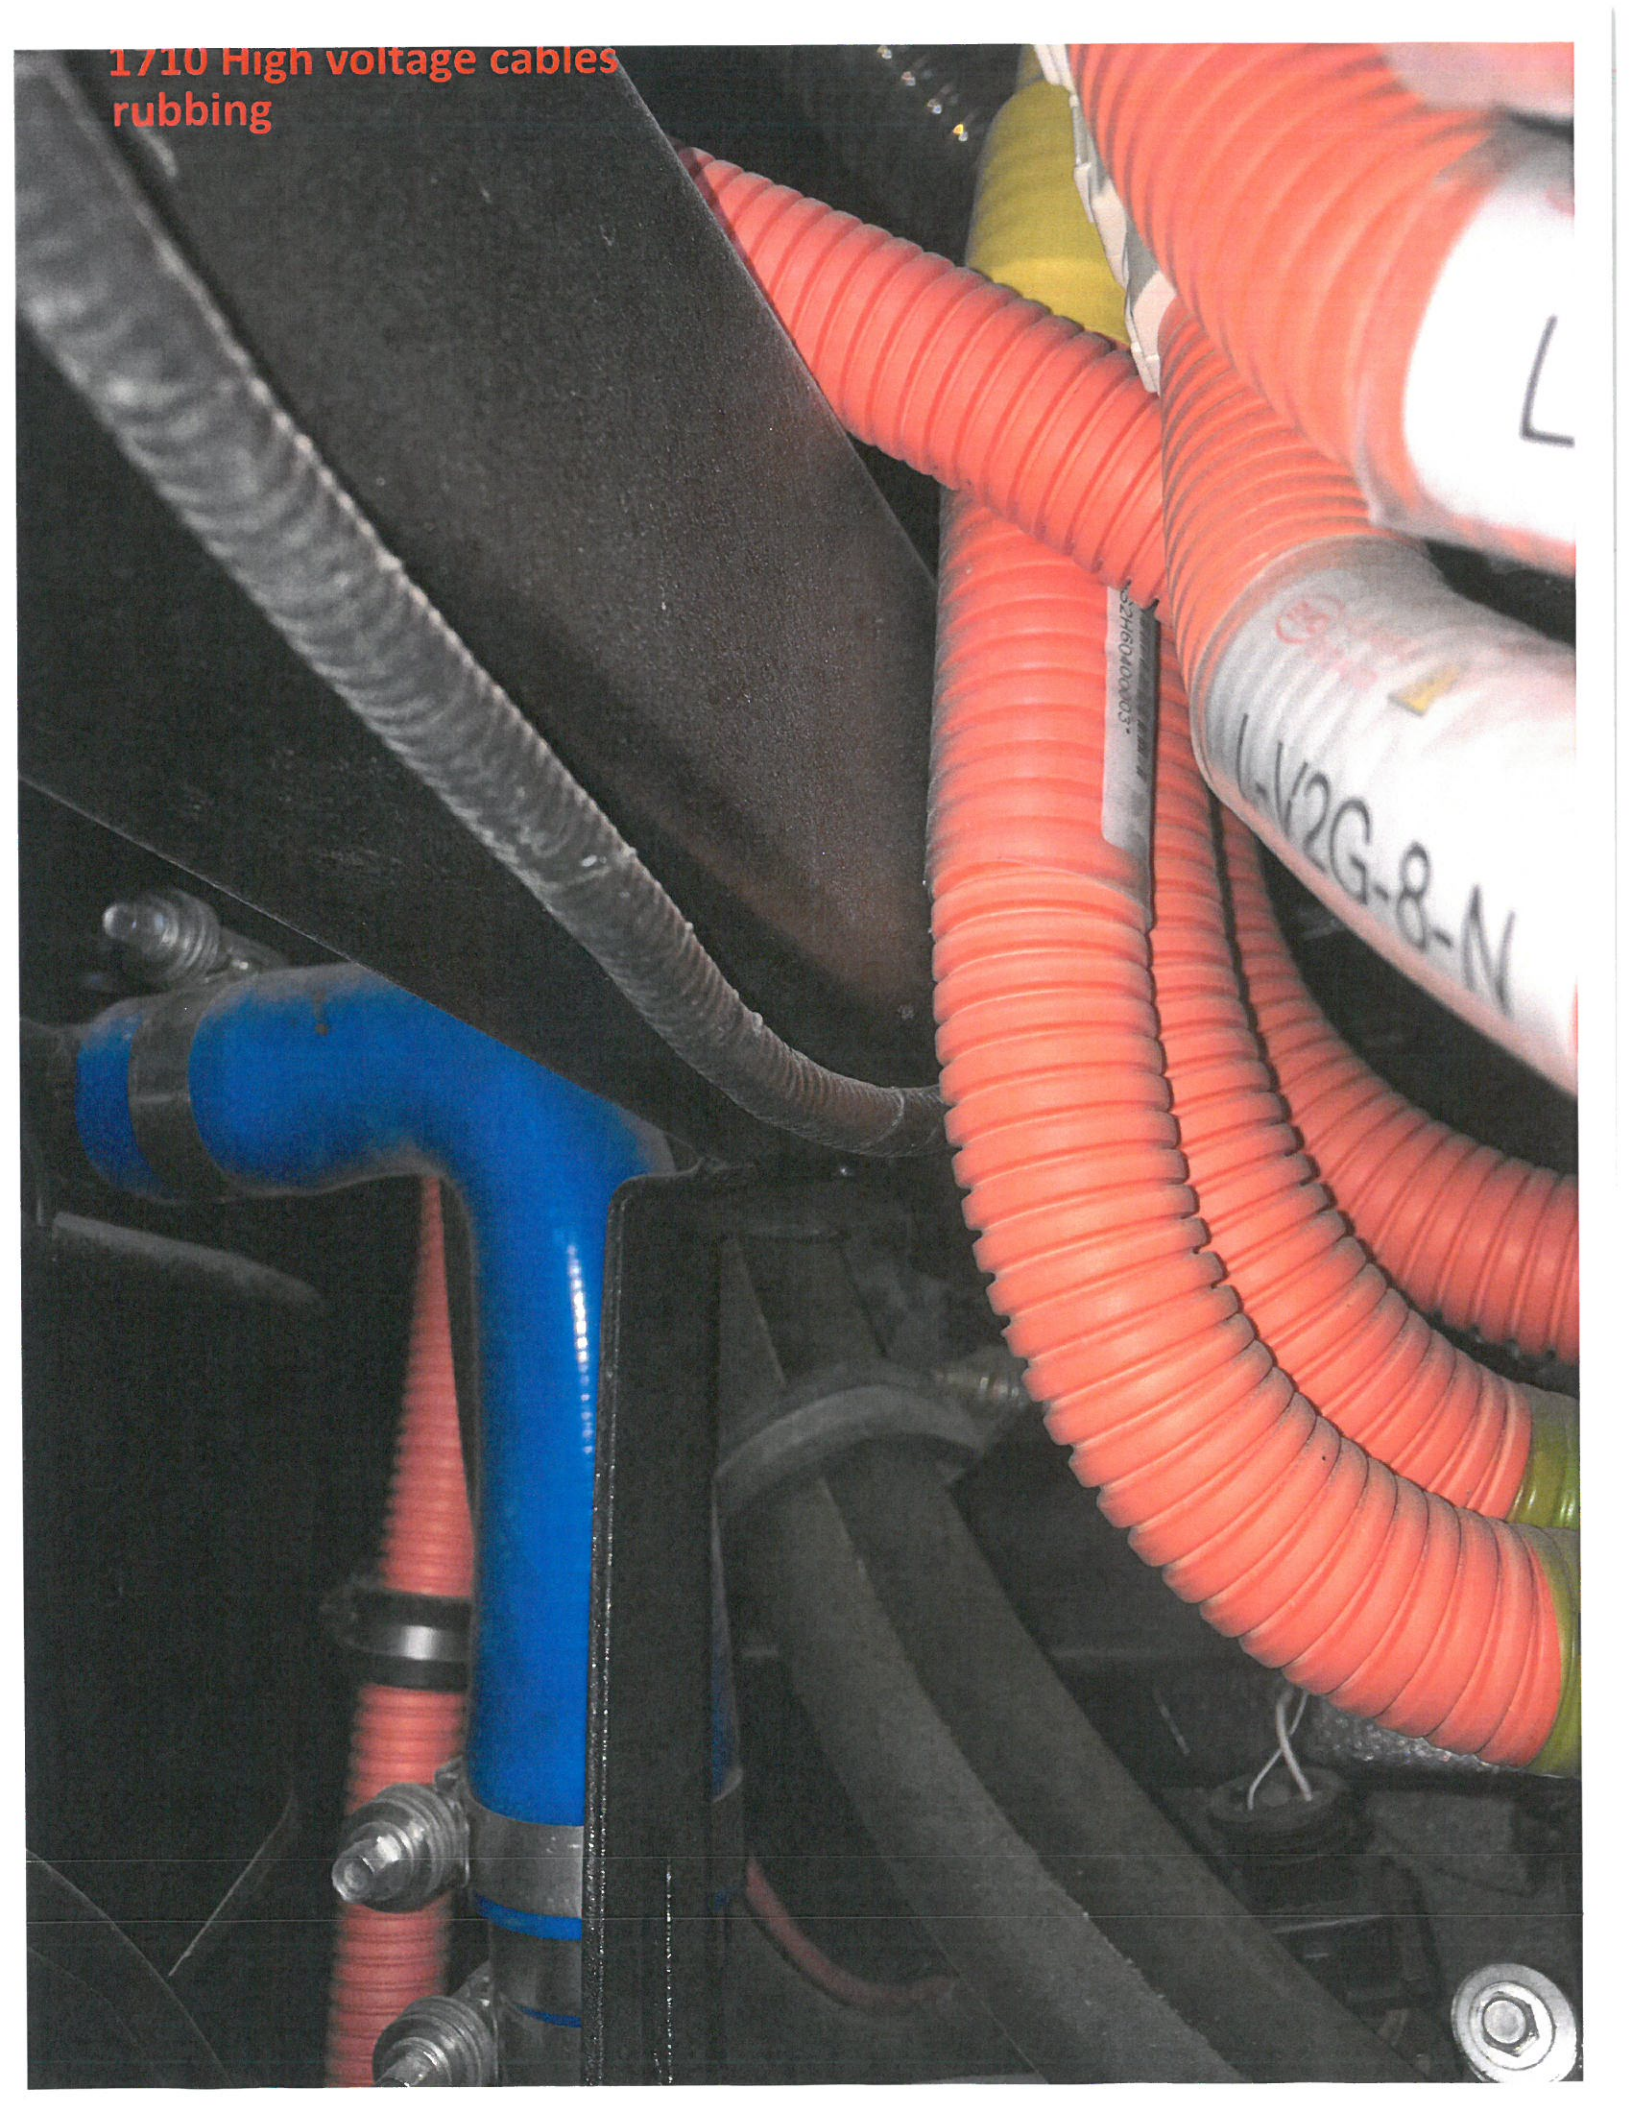
1710 High voltage cables
rubbing

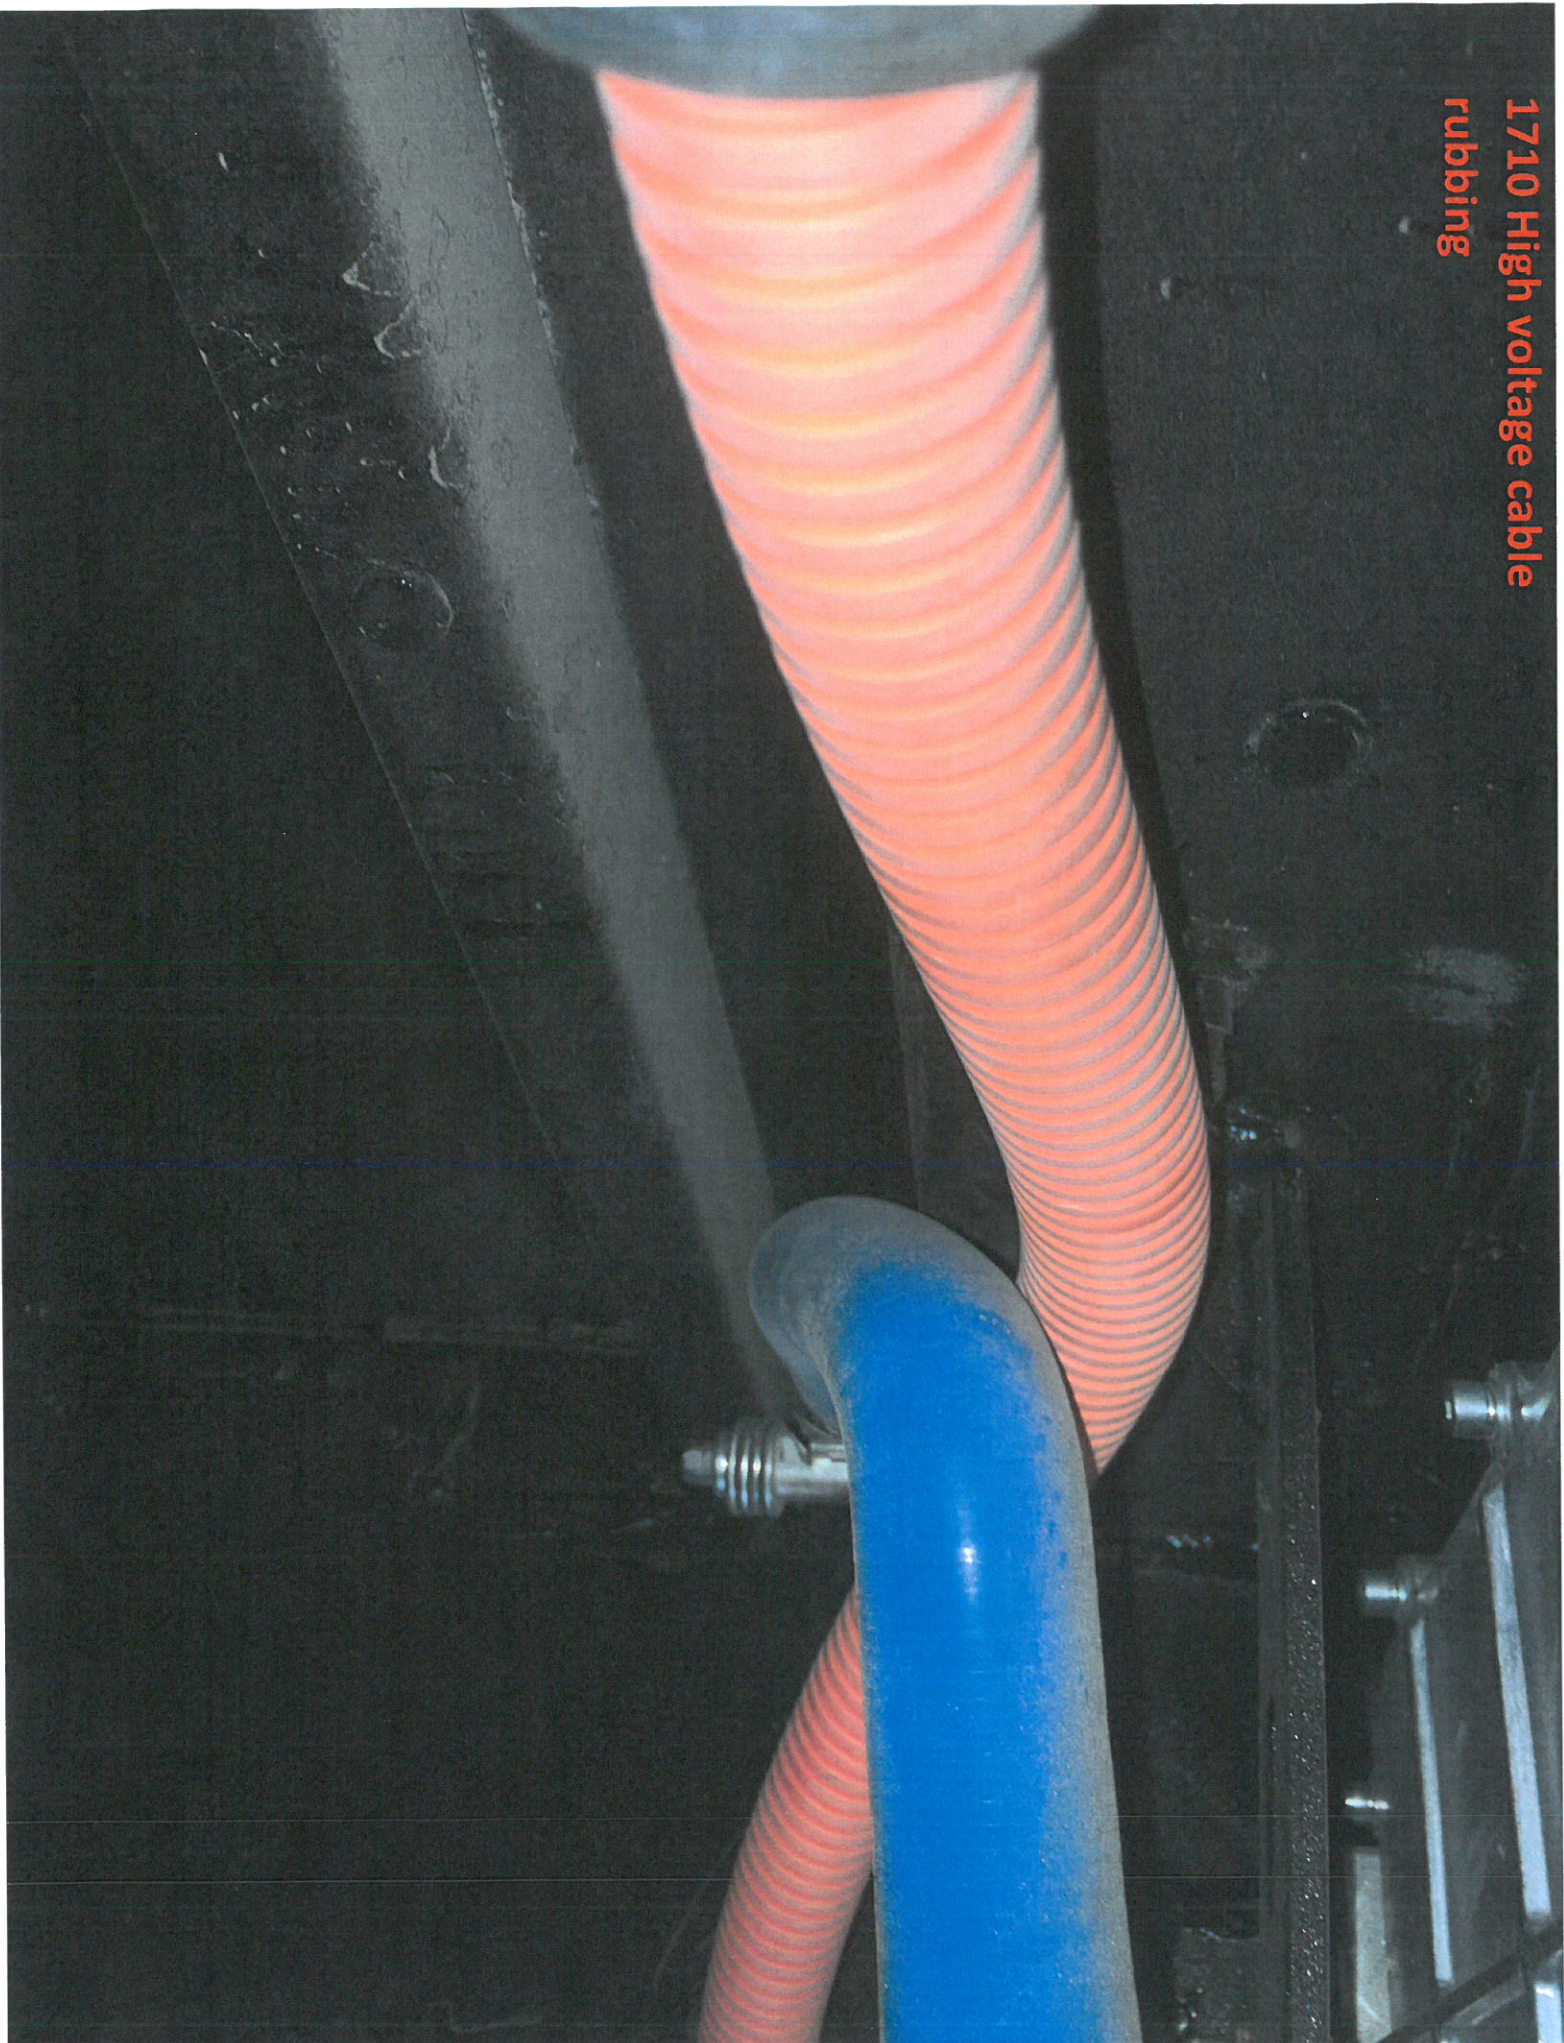
1710 High voltage cable
rubbing

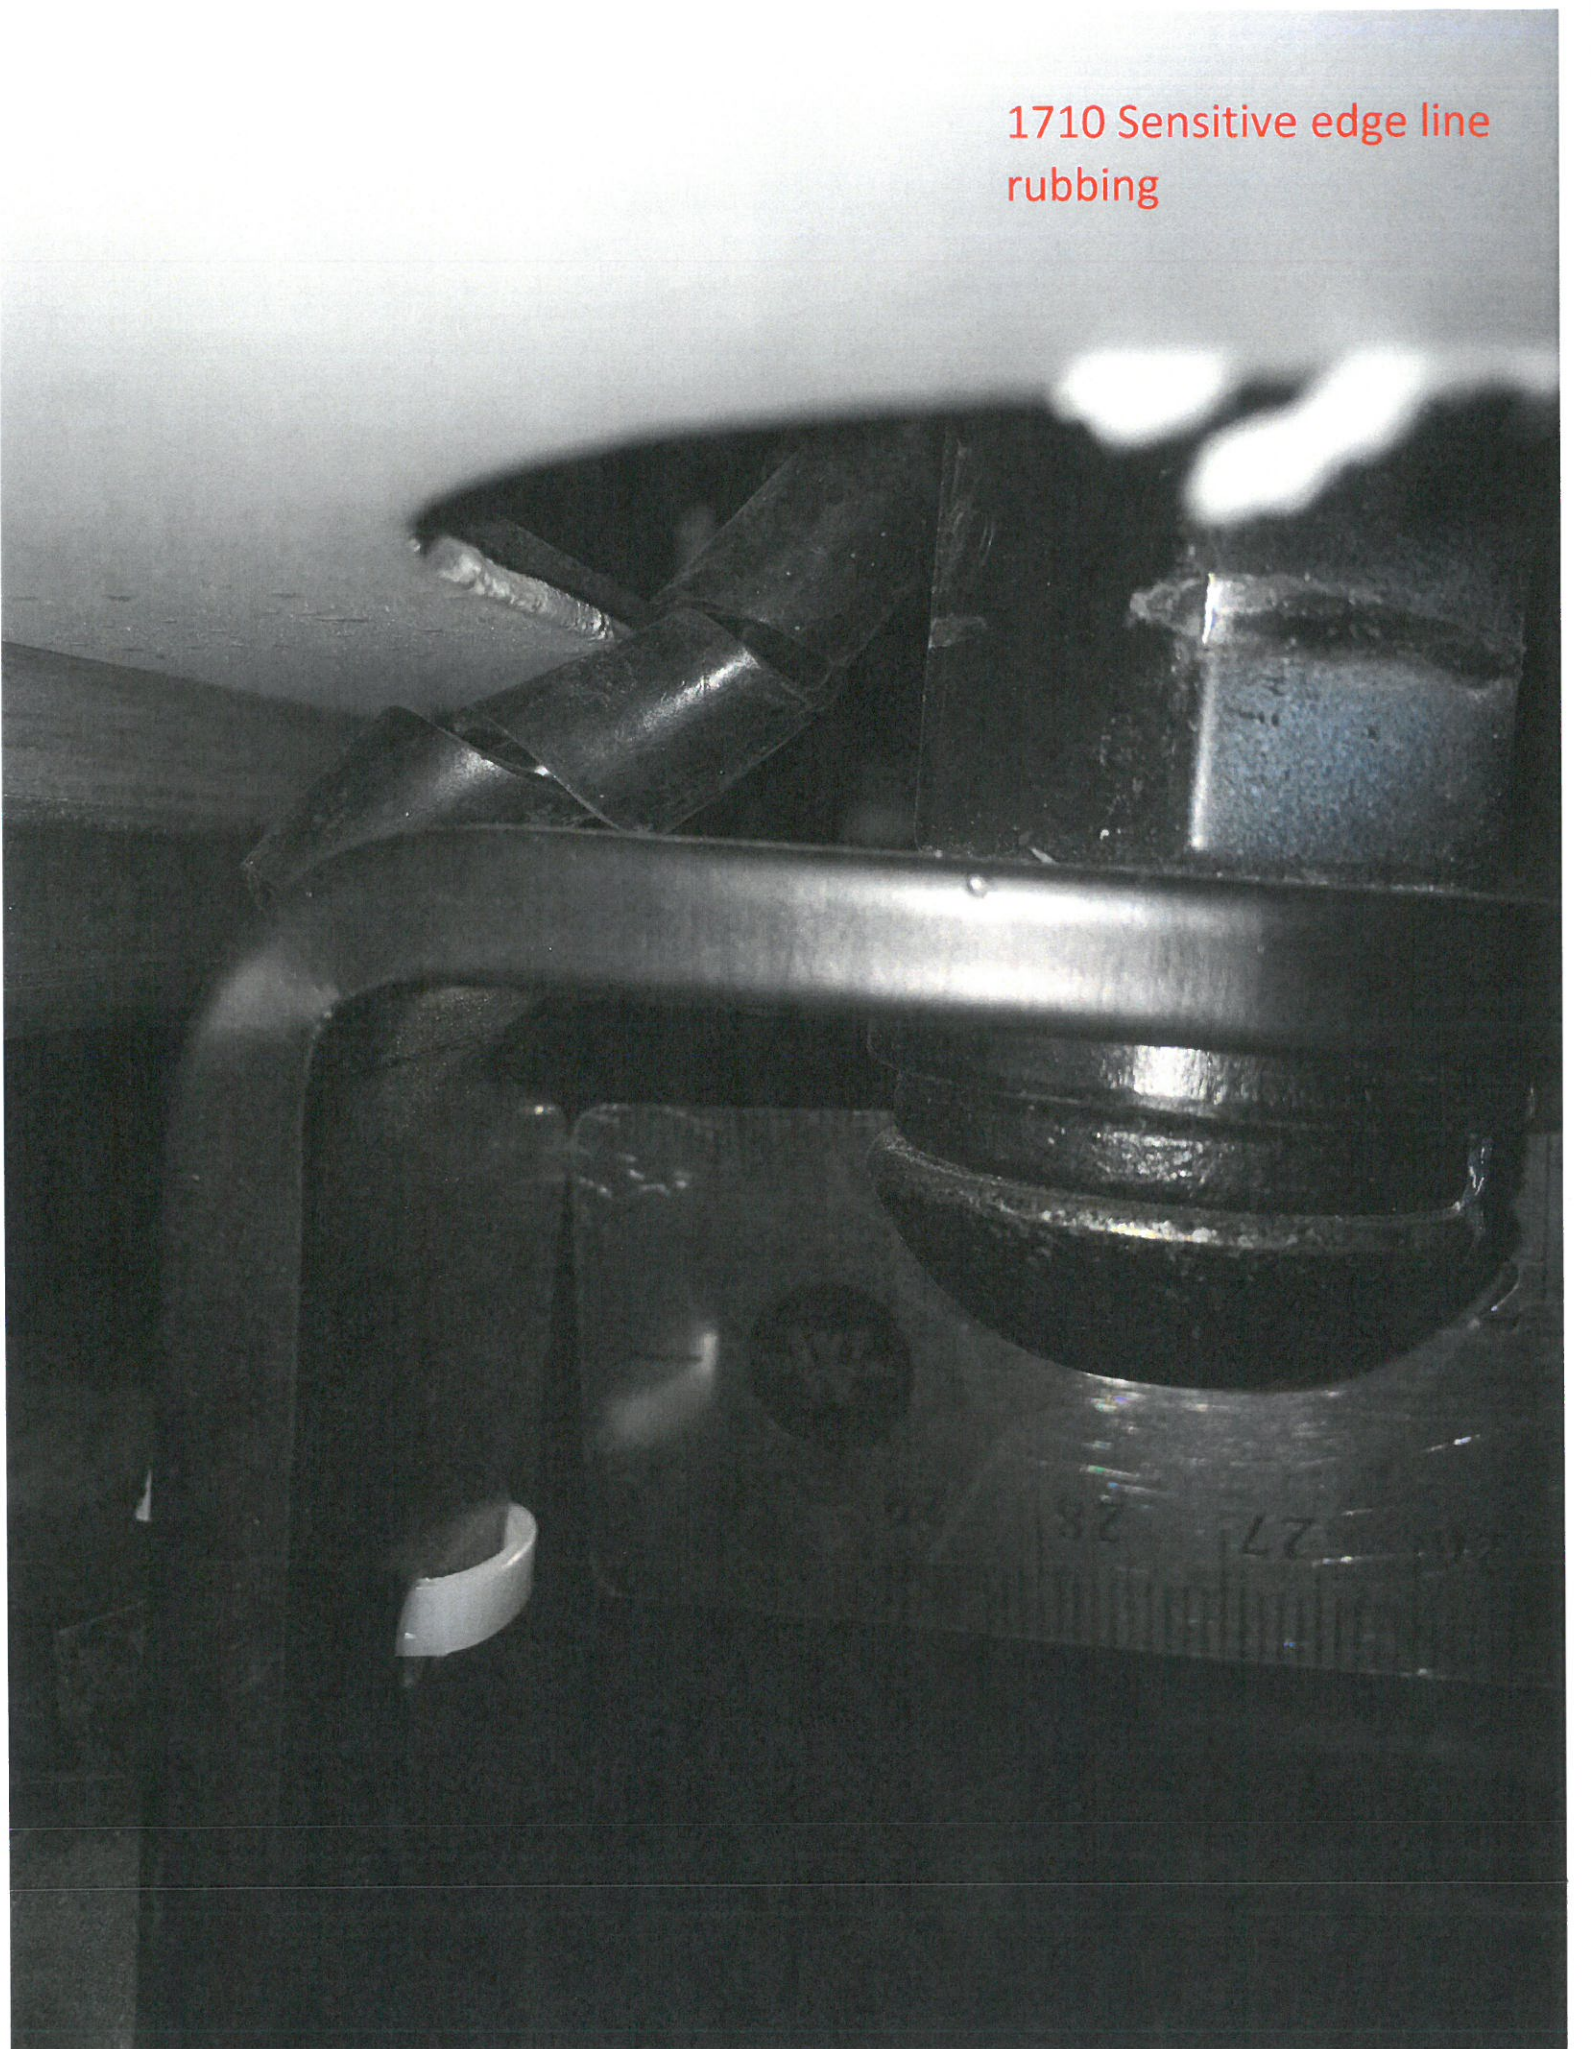
1710 Sensitive edge line
rubbing

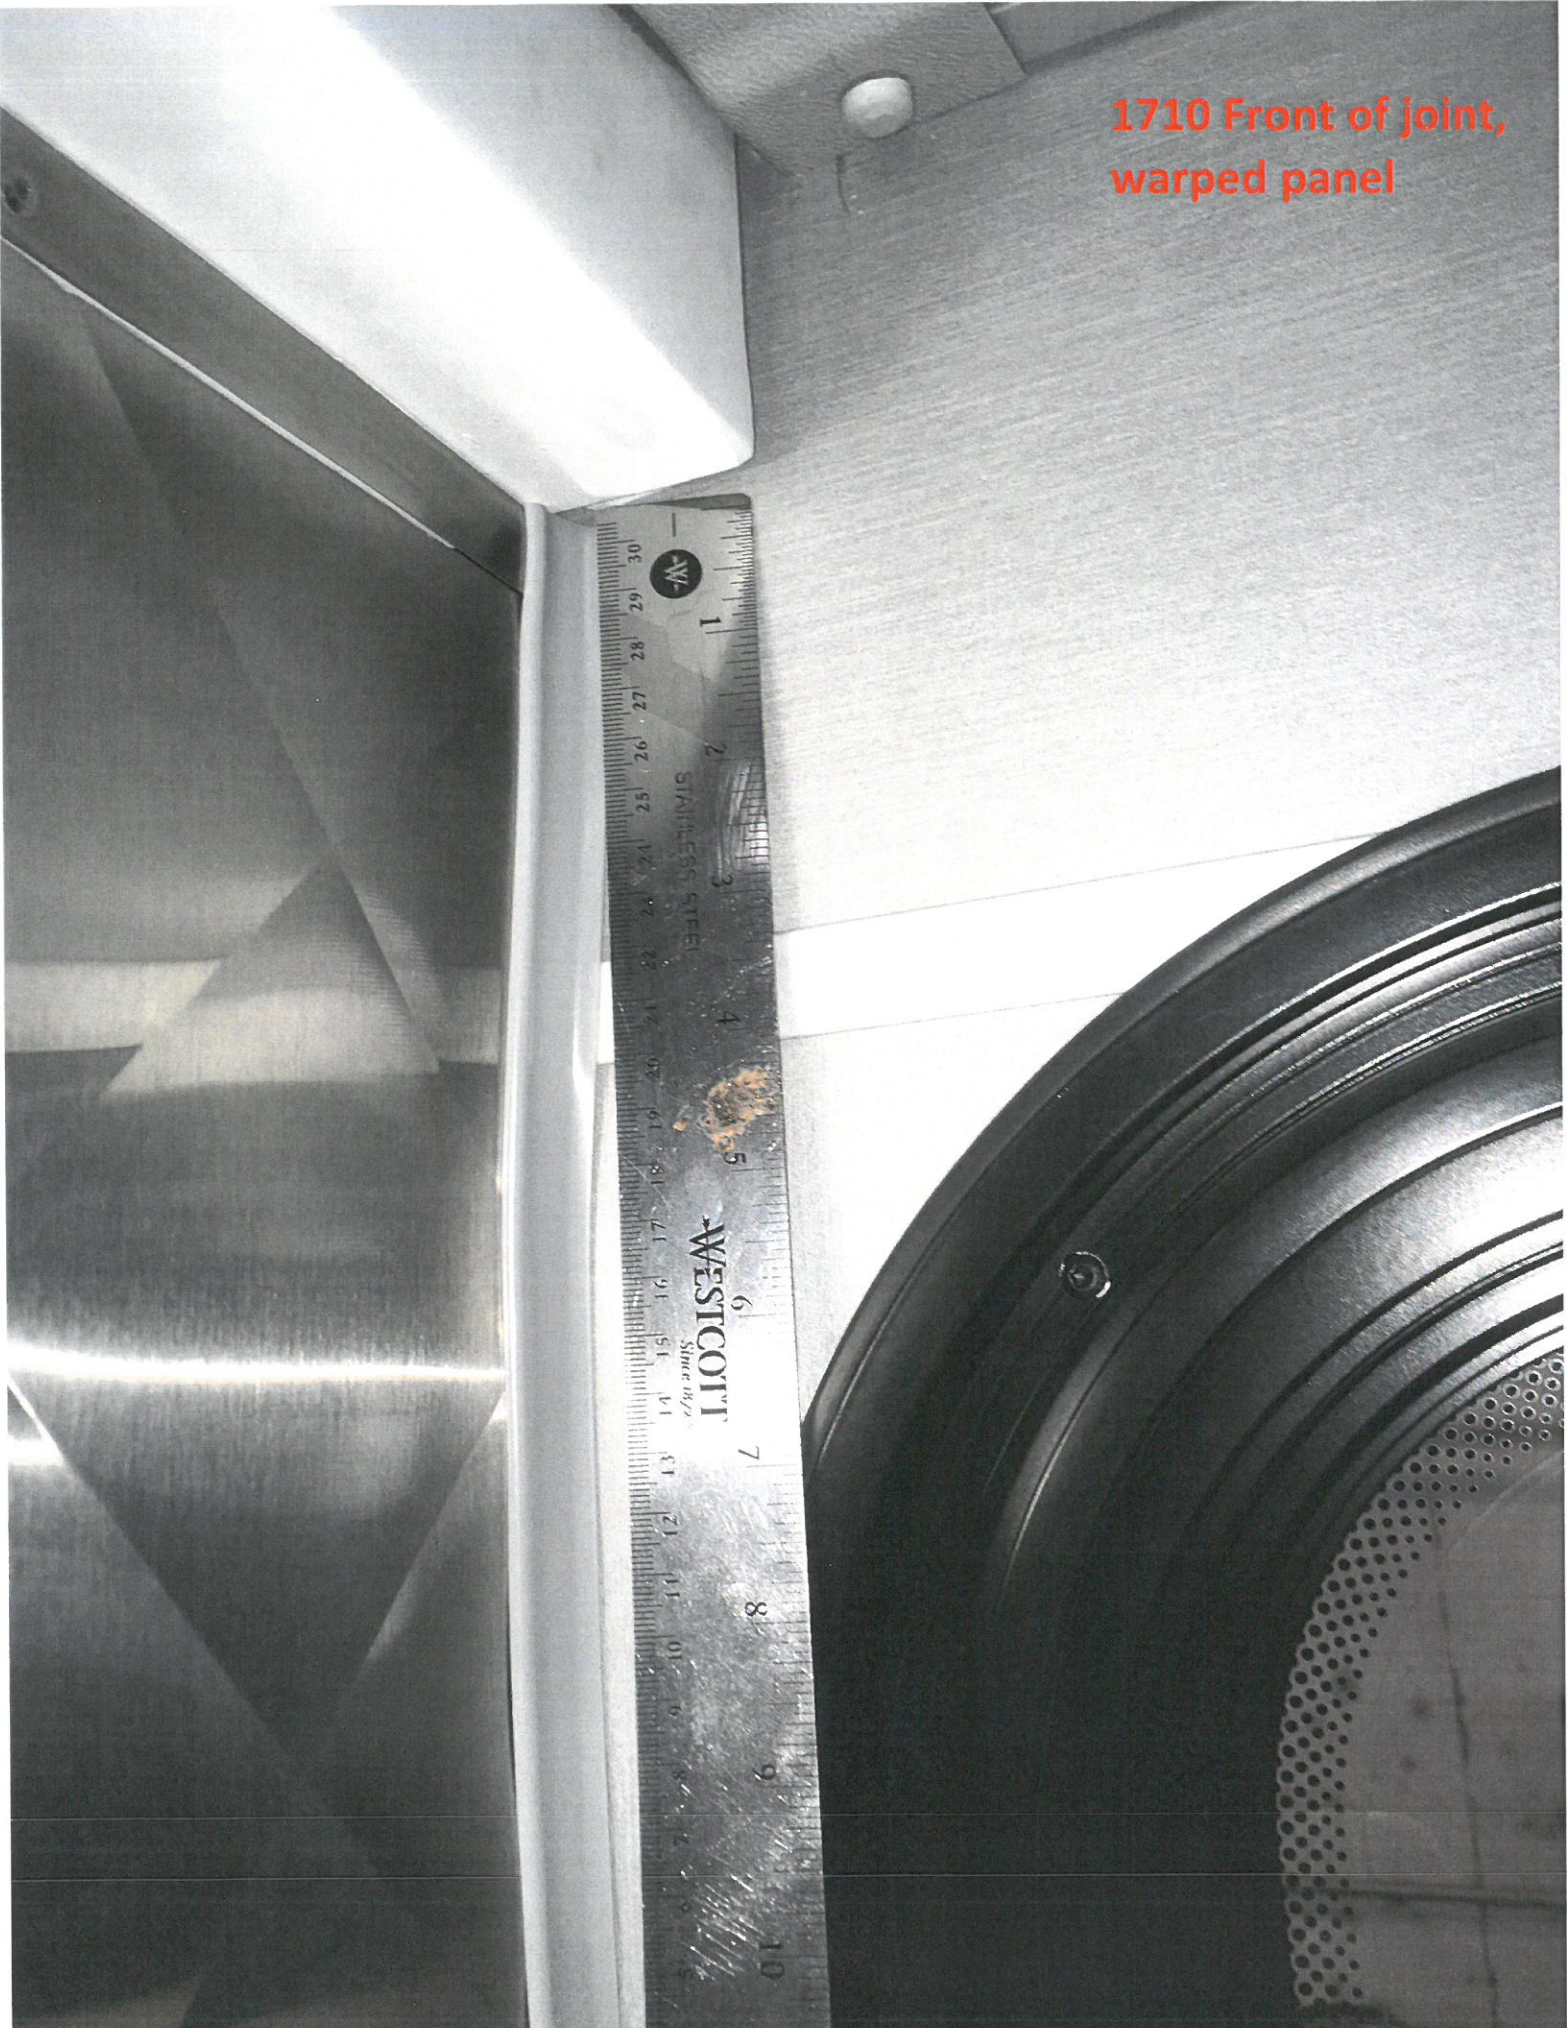
1710 Front of joint,
warped panel
