1710

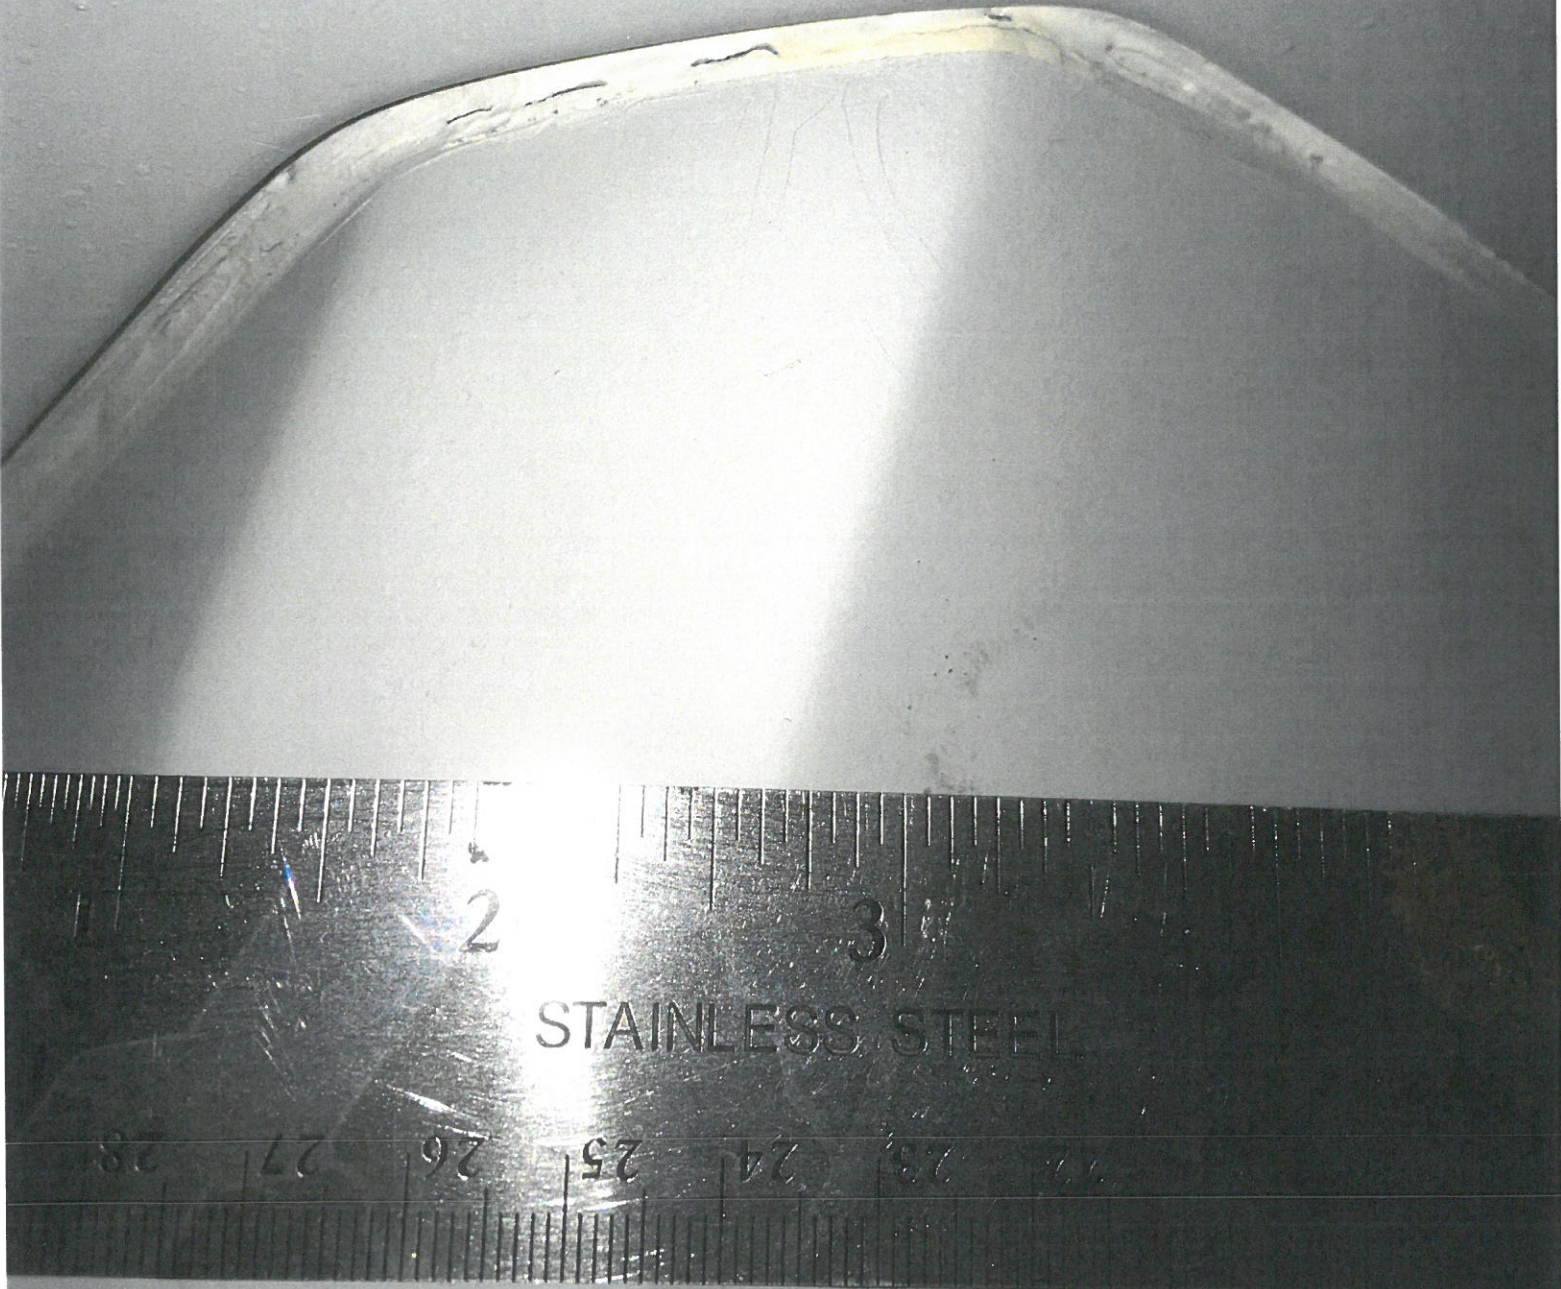
1710 Cracking panel
