1711

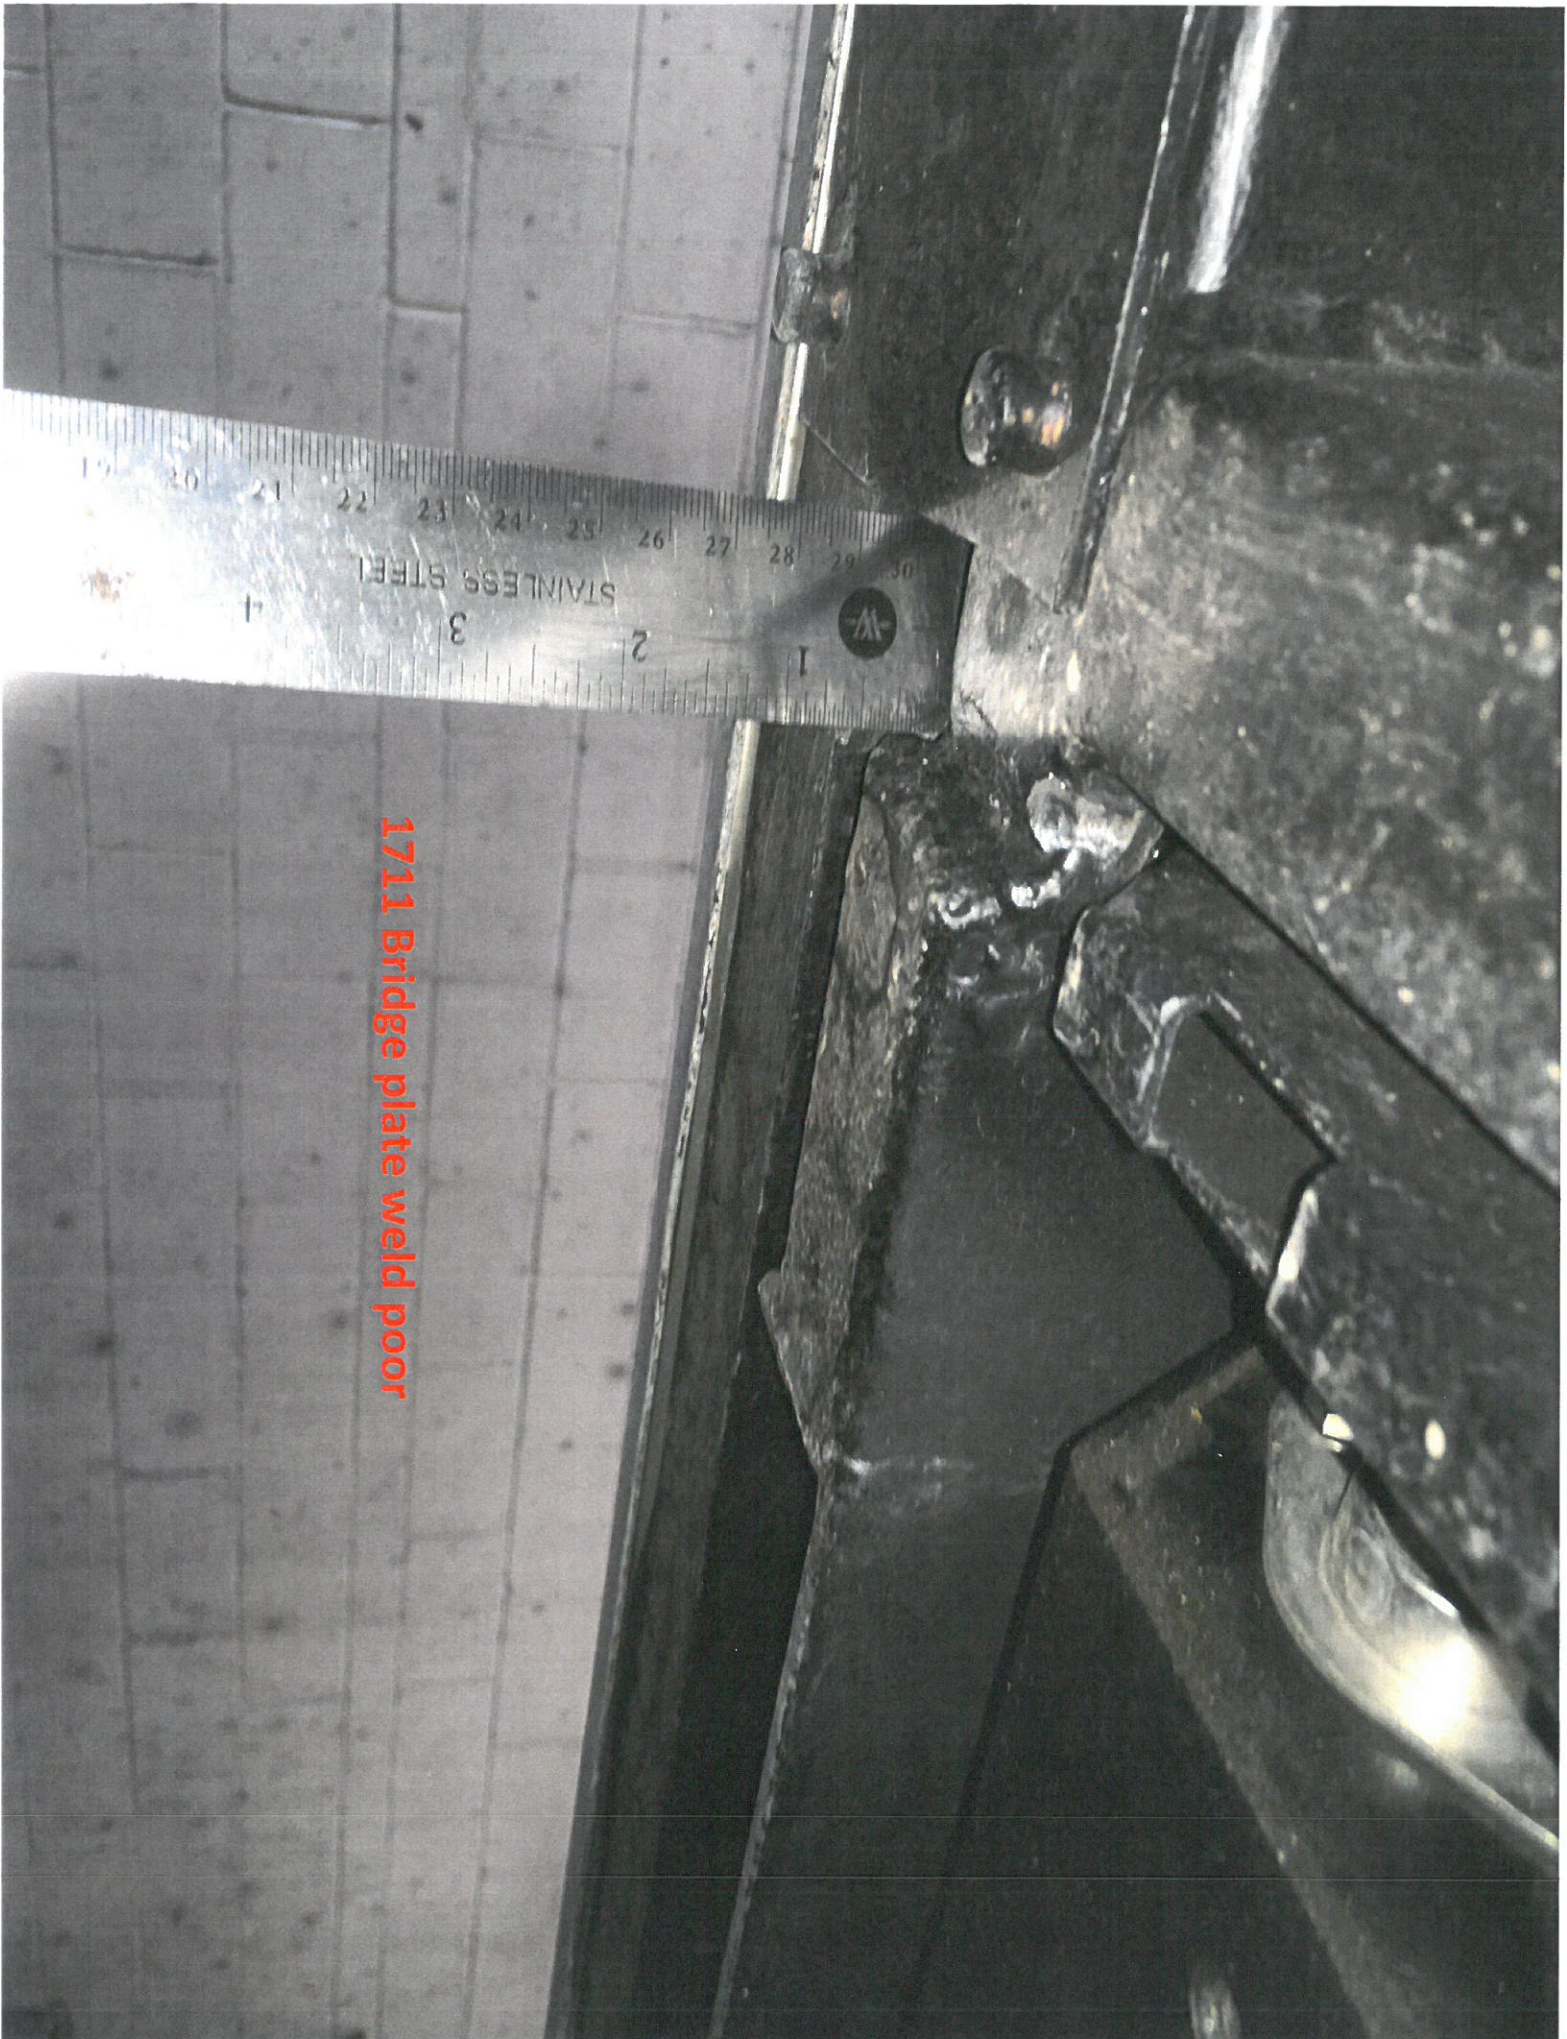
1711 Bridge plate weld poor

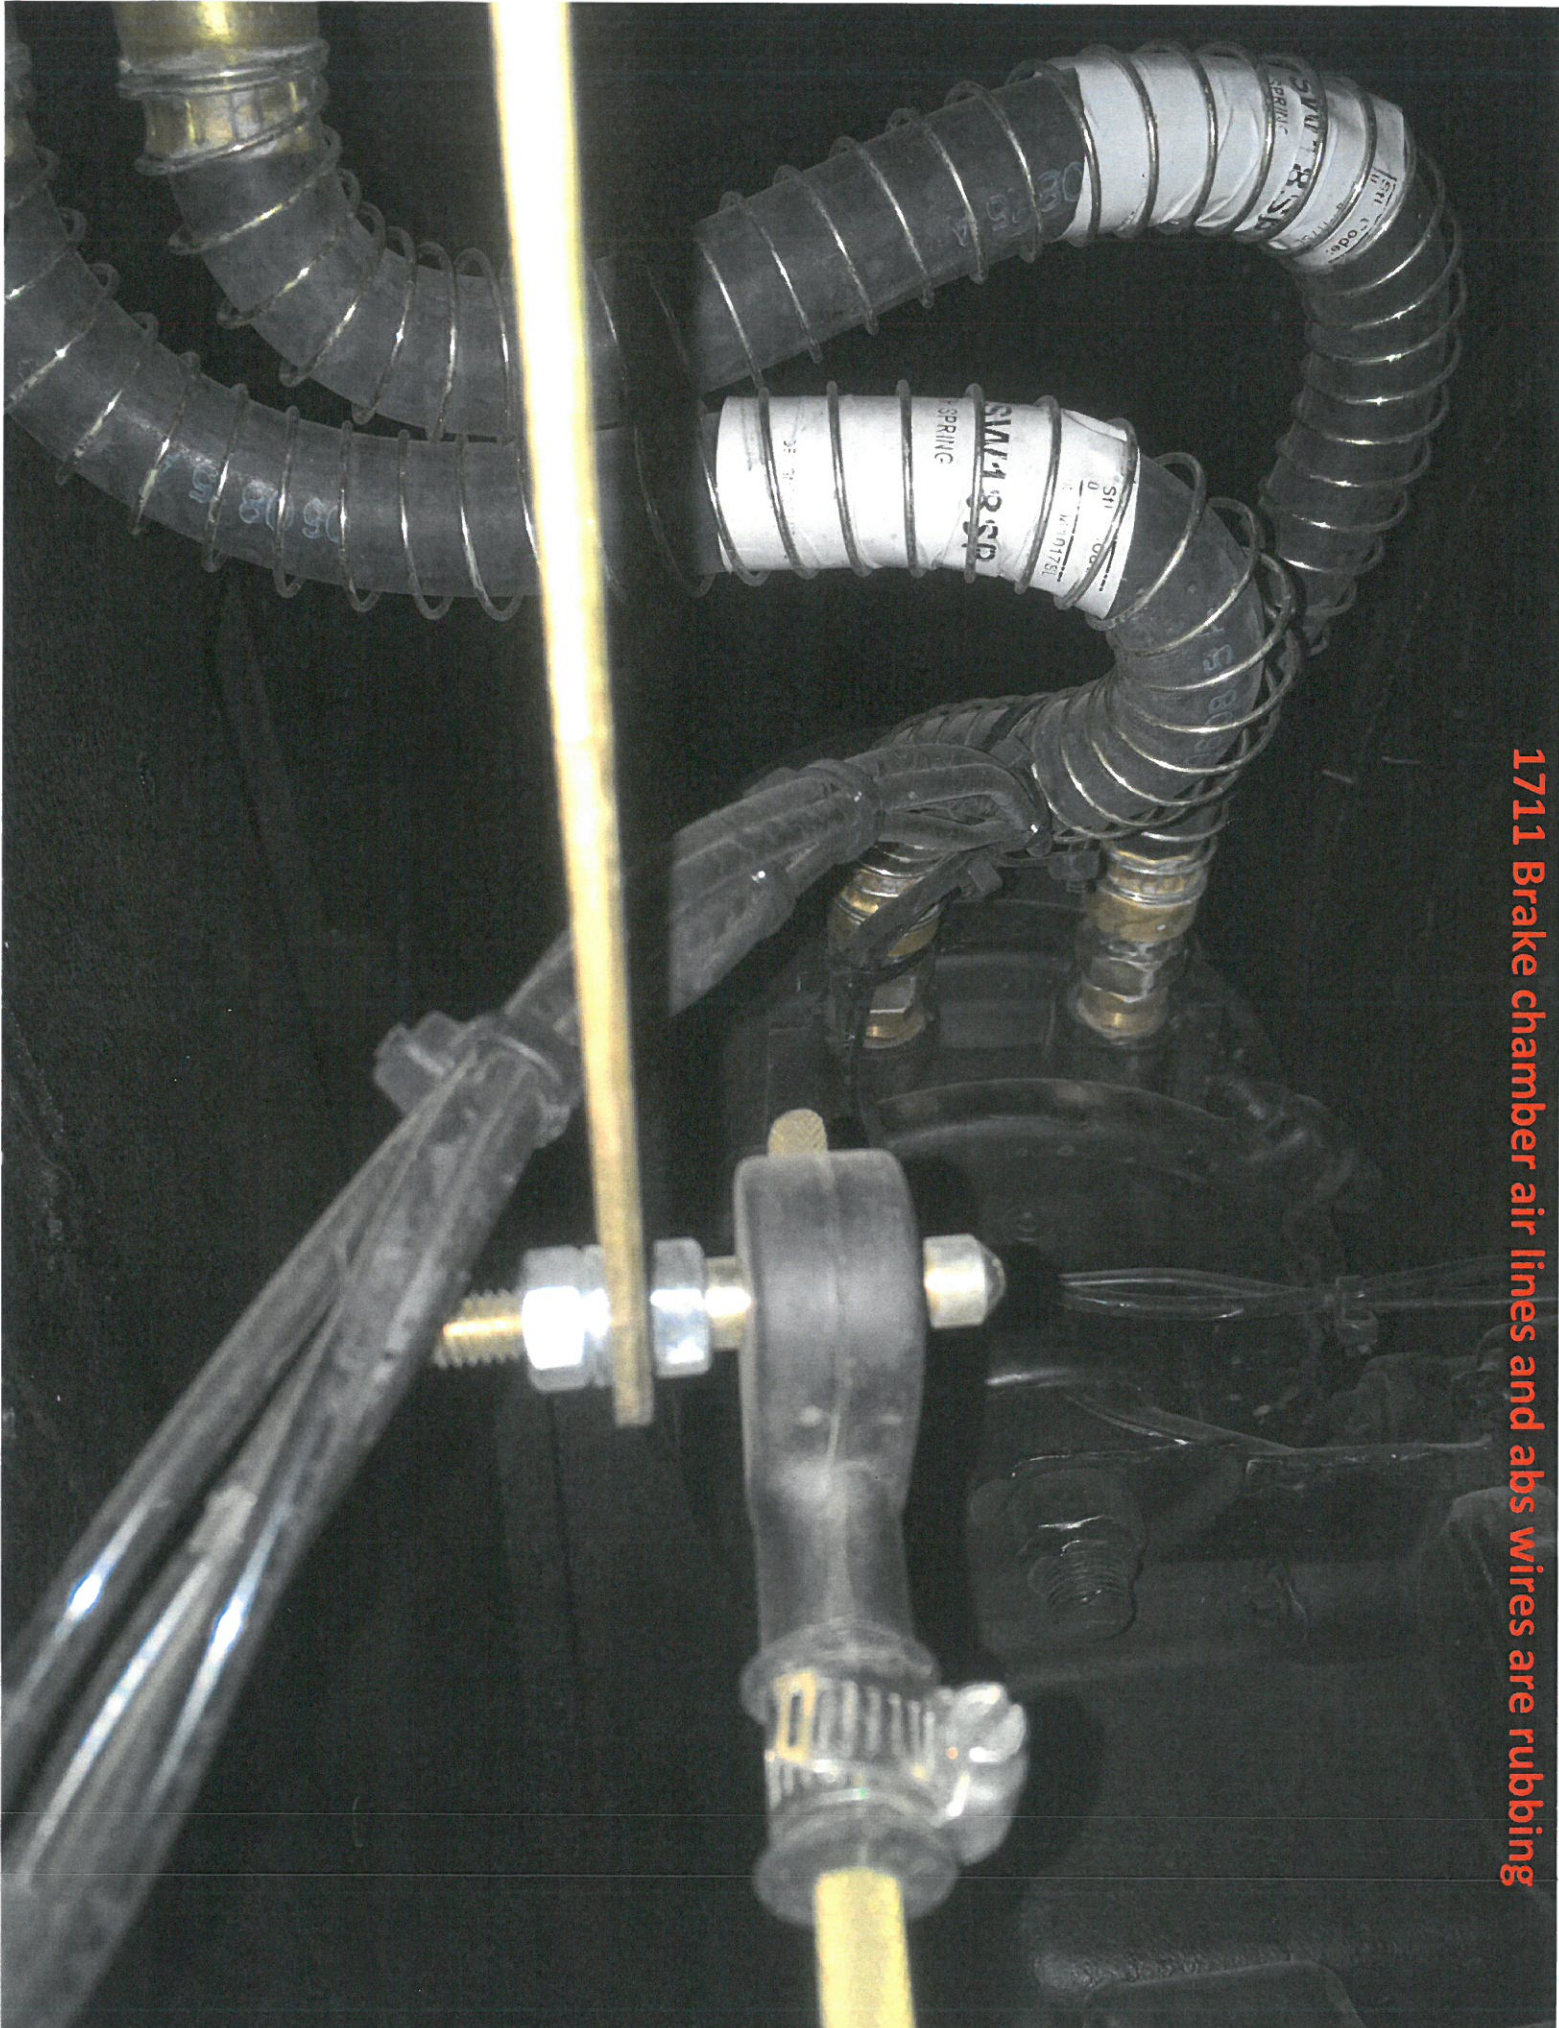
1711 Brake chamber air lines and abs wires are rubbing

1711 Lines are rubbing

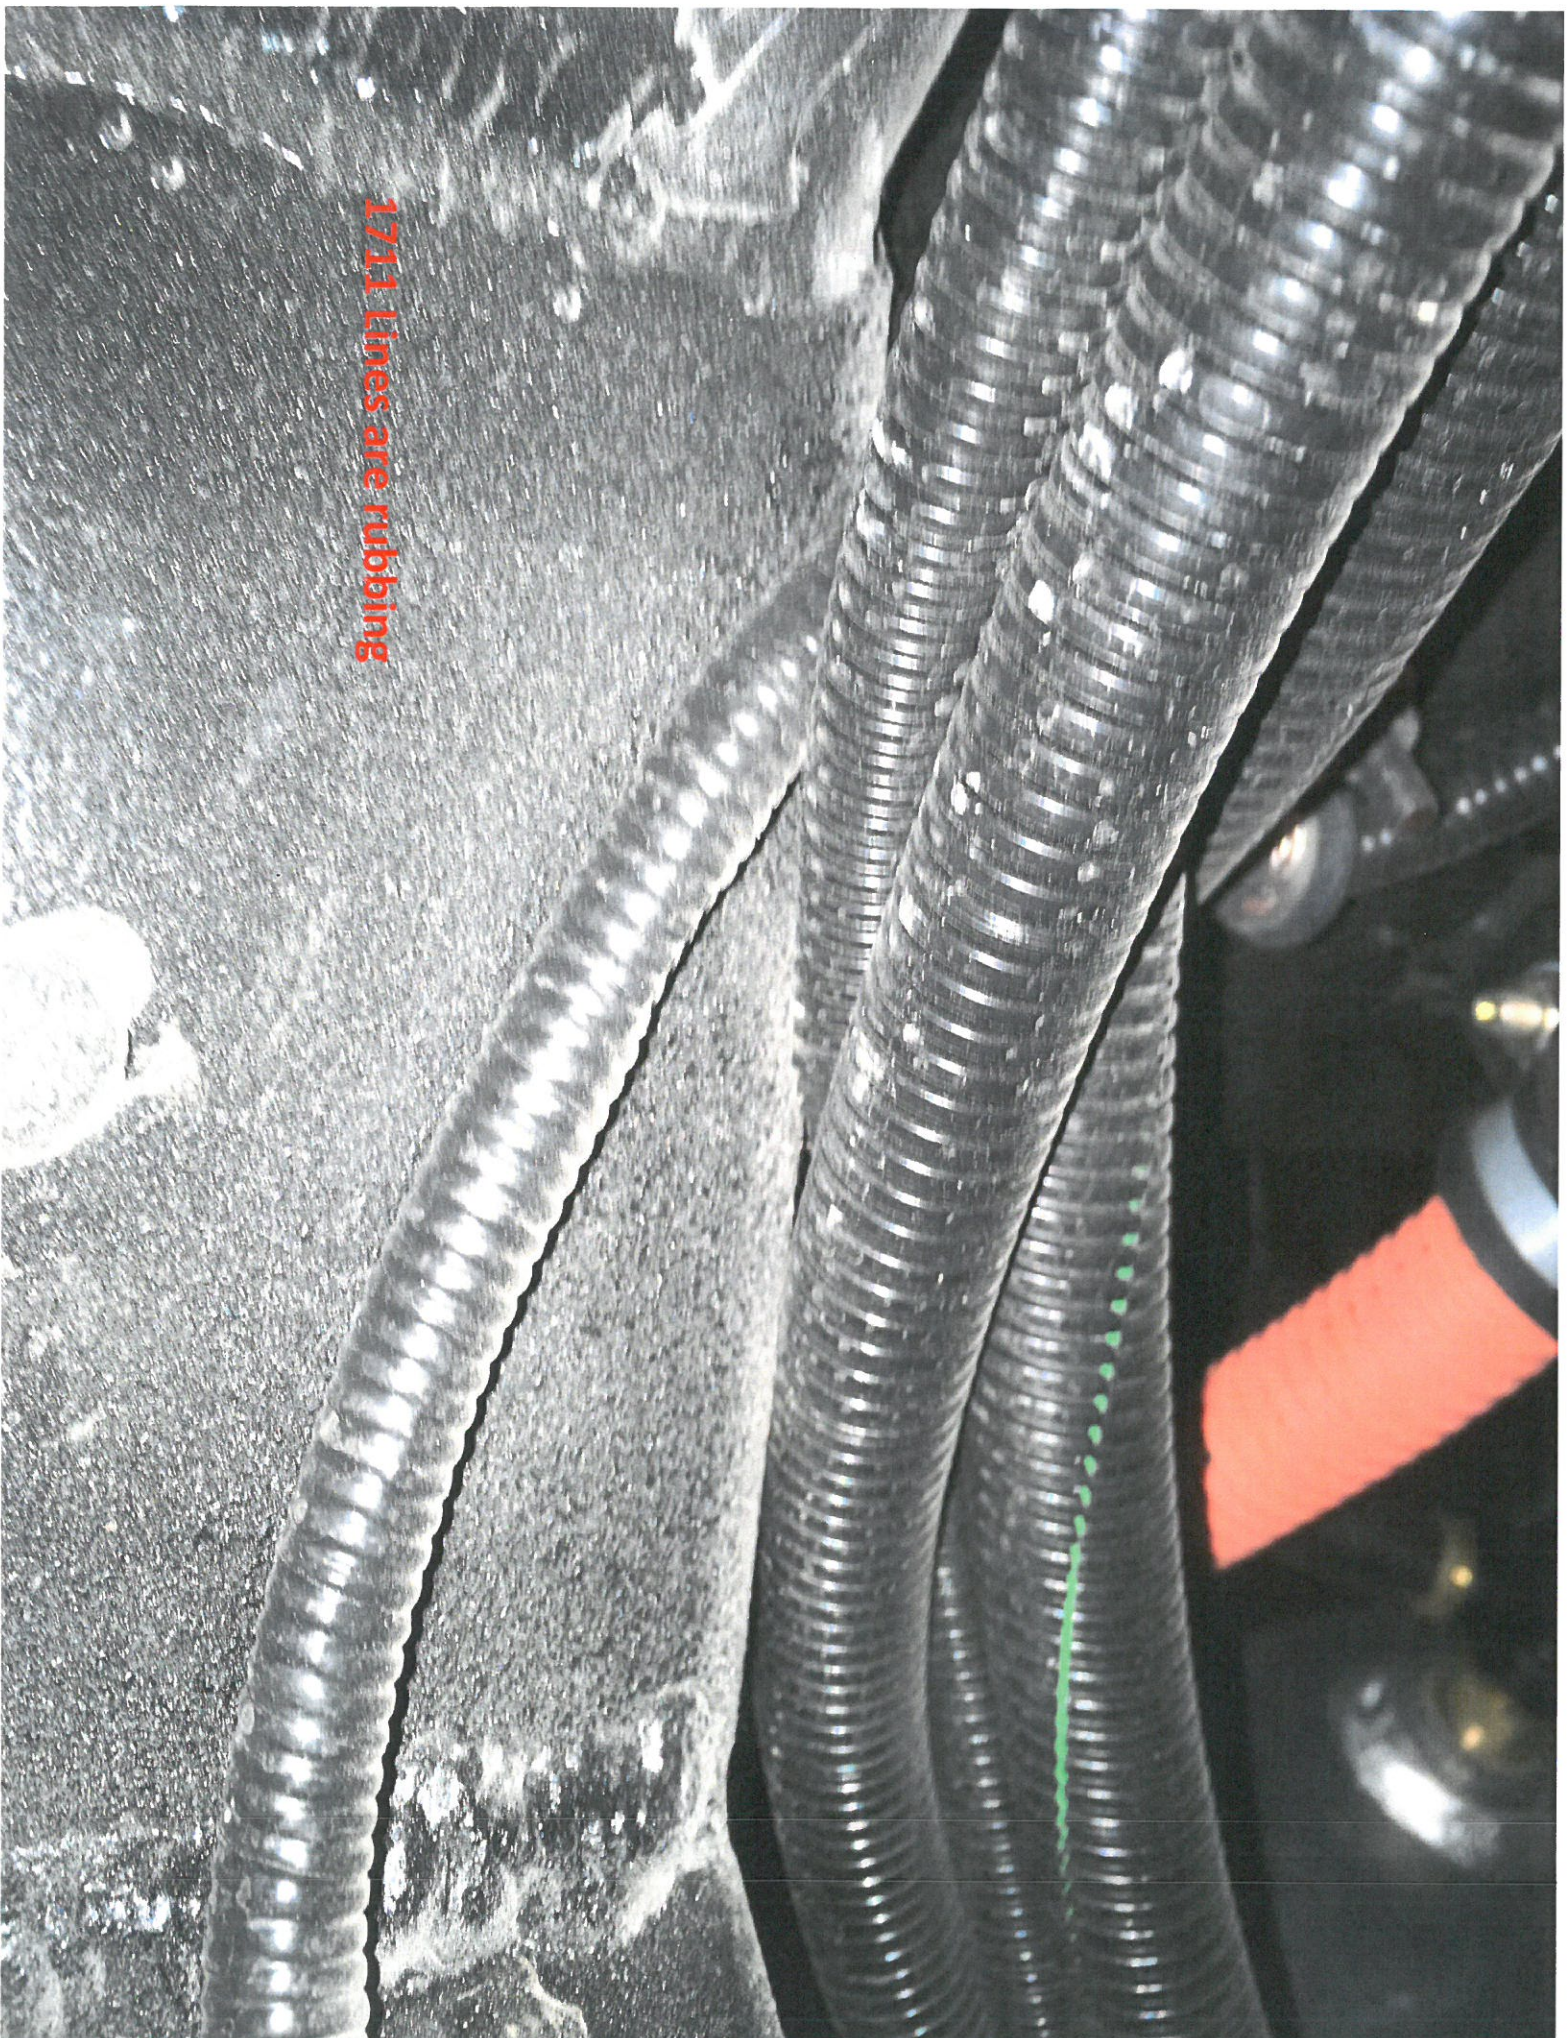
1711 Lines are rubbing

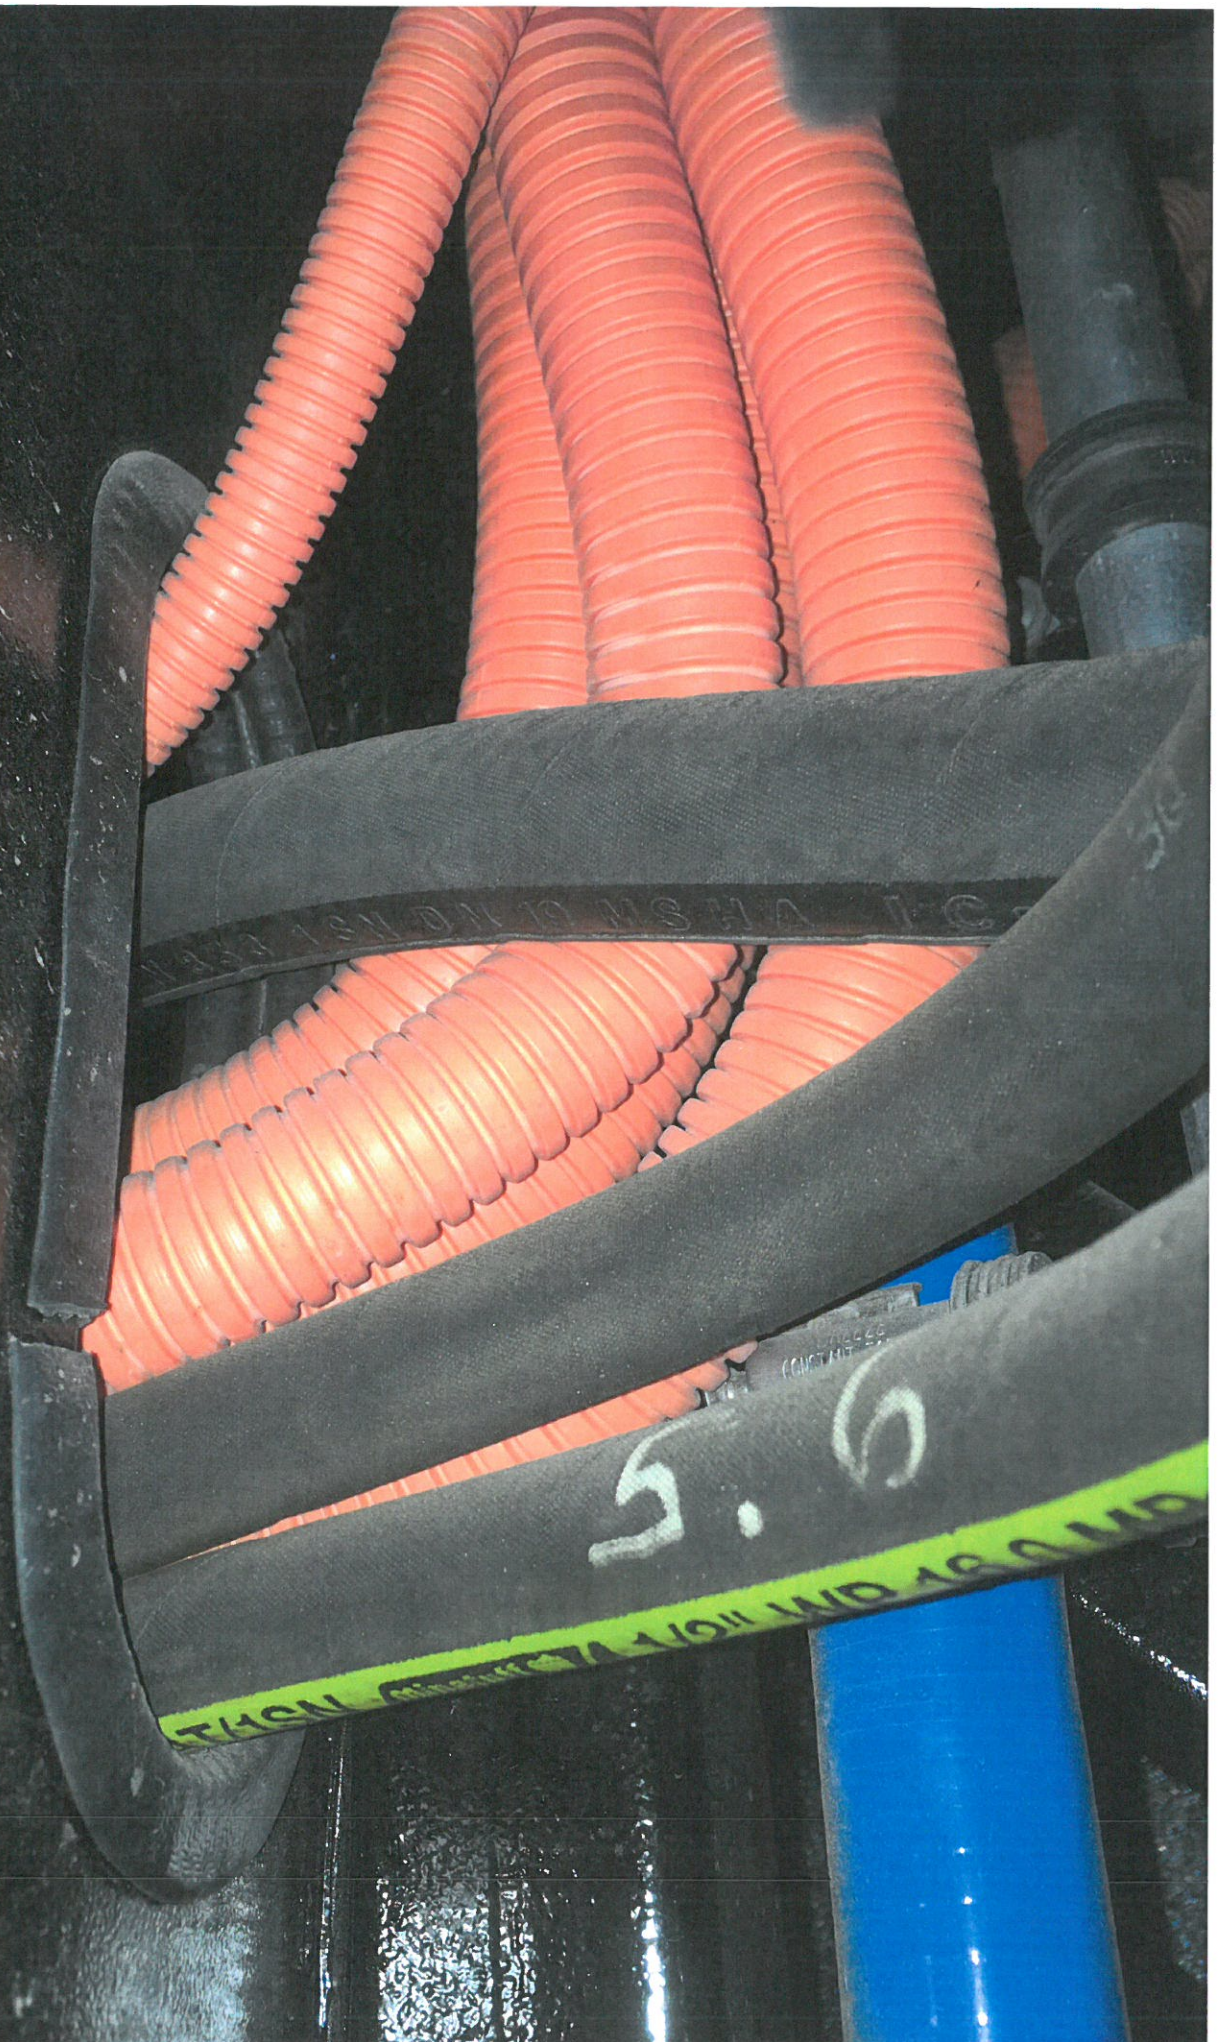
1711 High voltage line terminal is only insulated with electrical tape

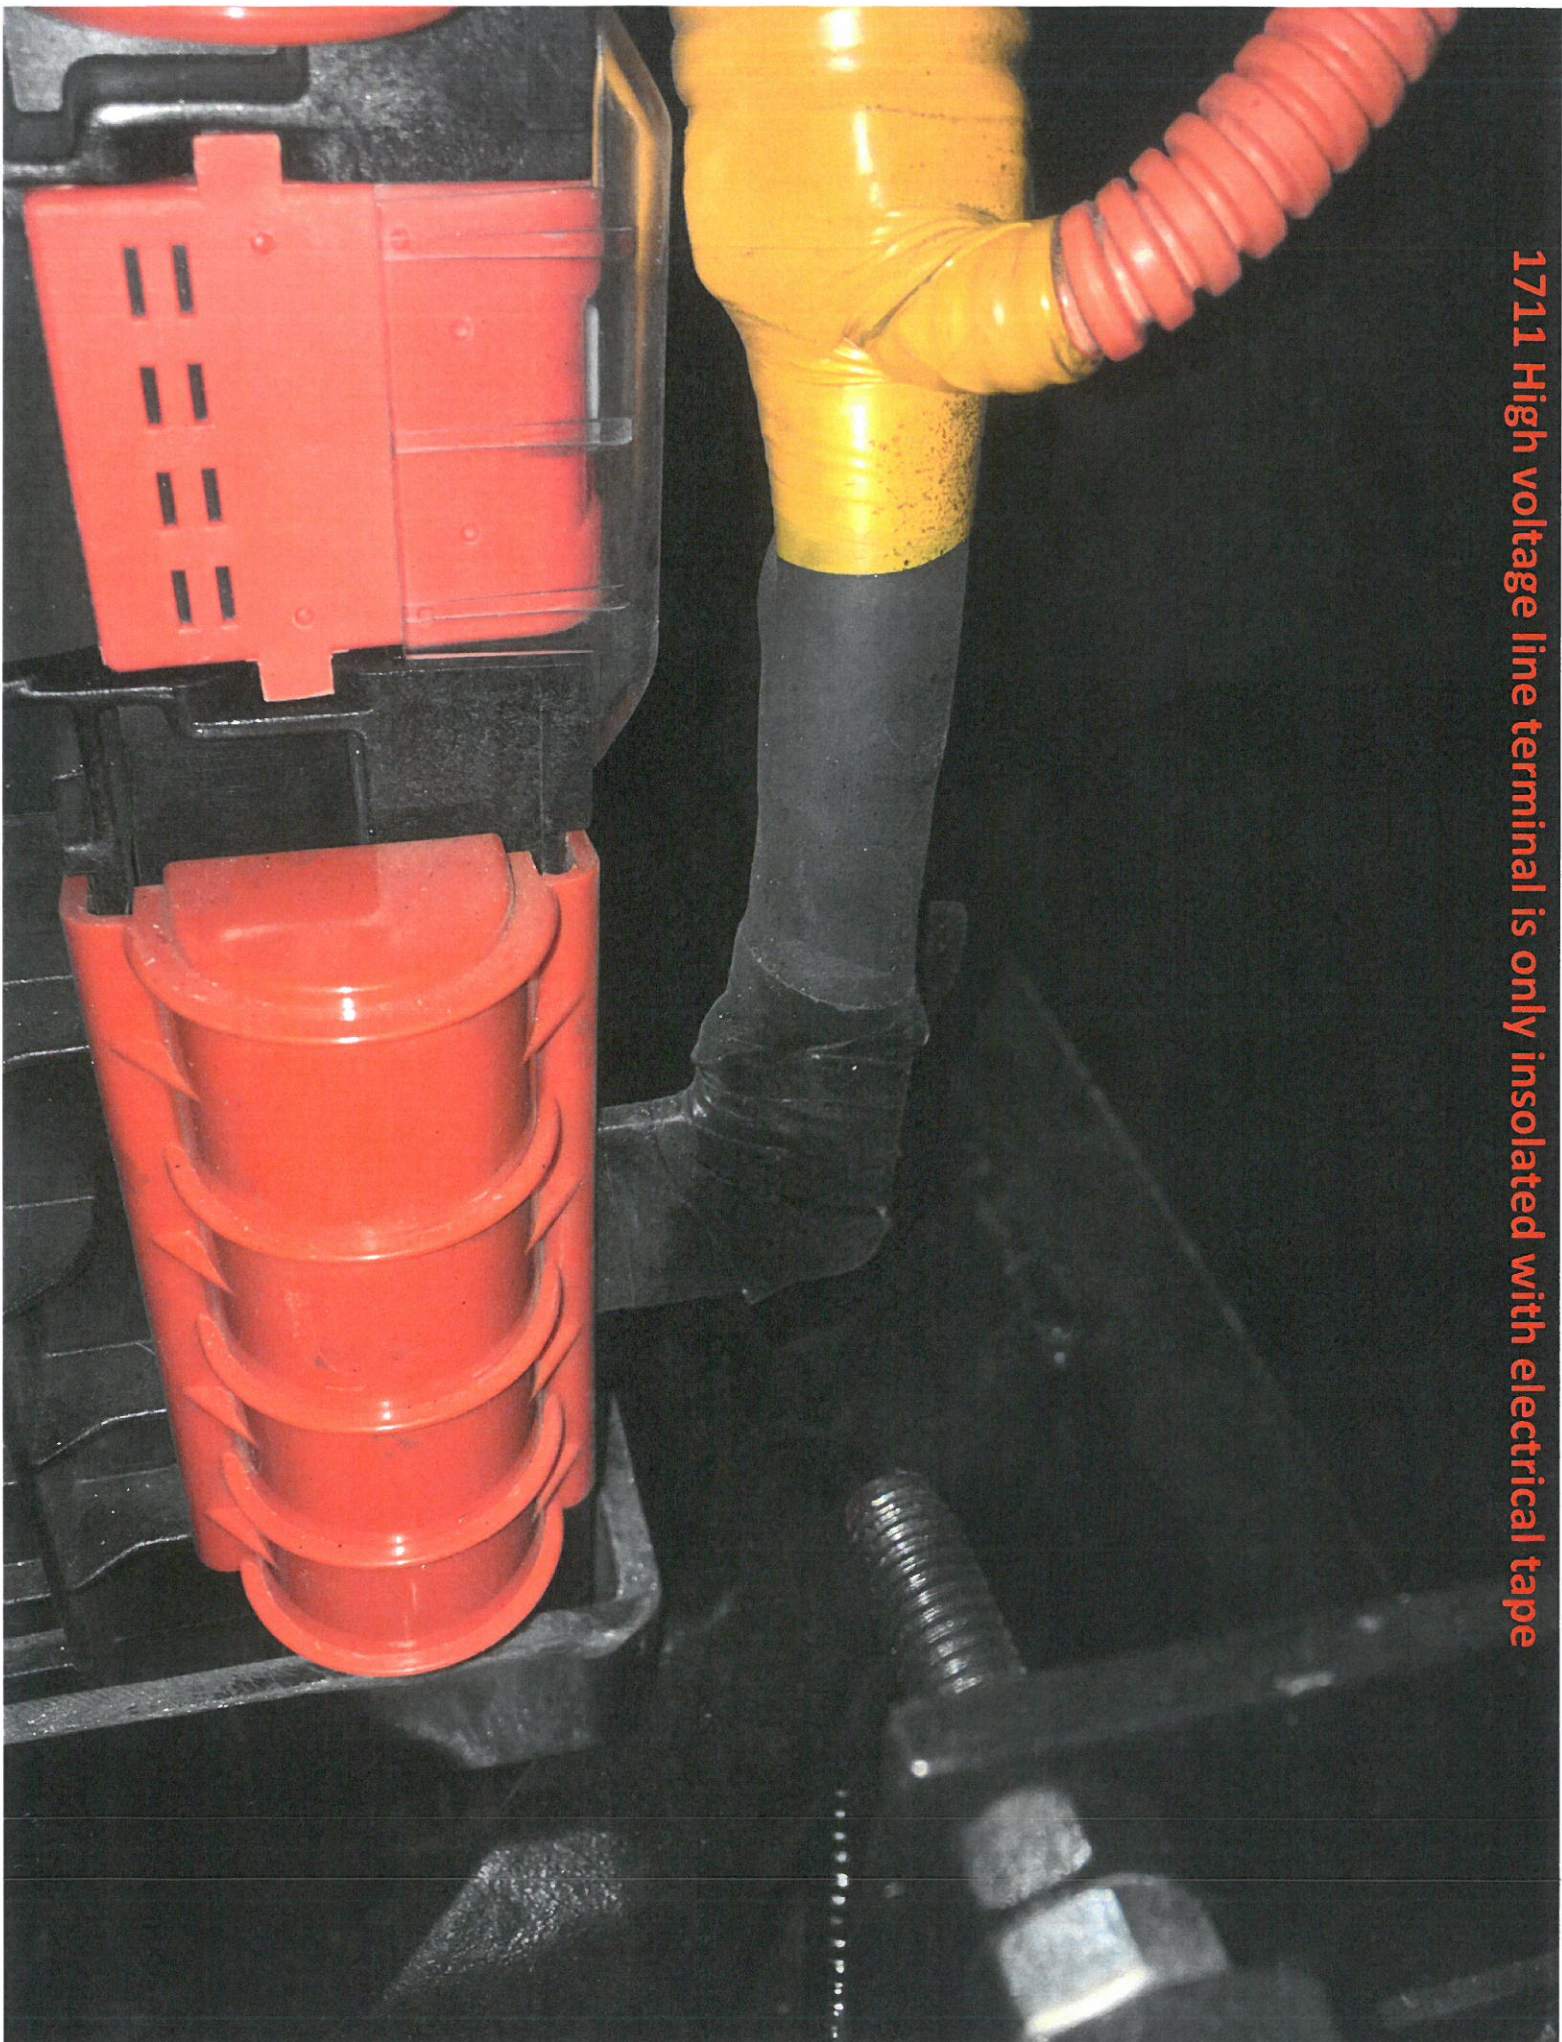
1711 High voltage cable rubbing

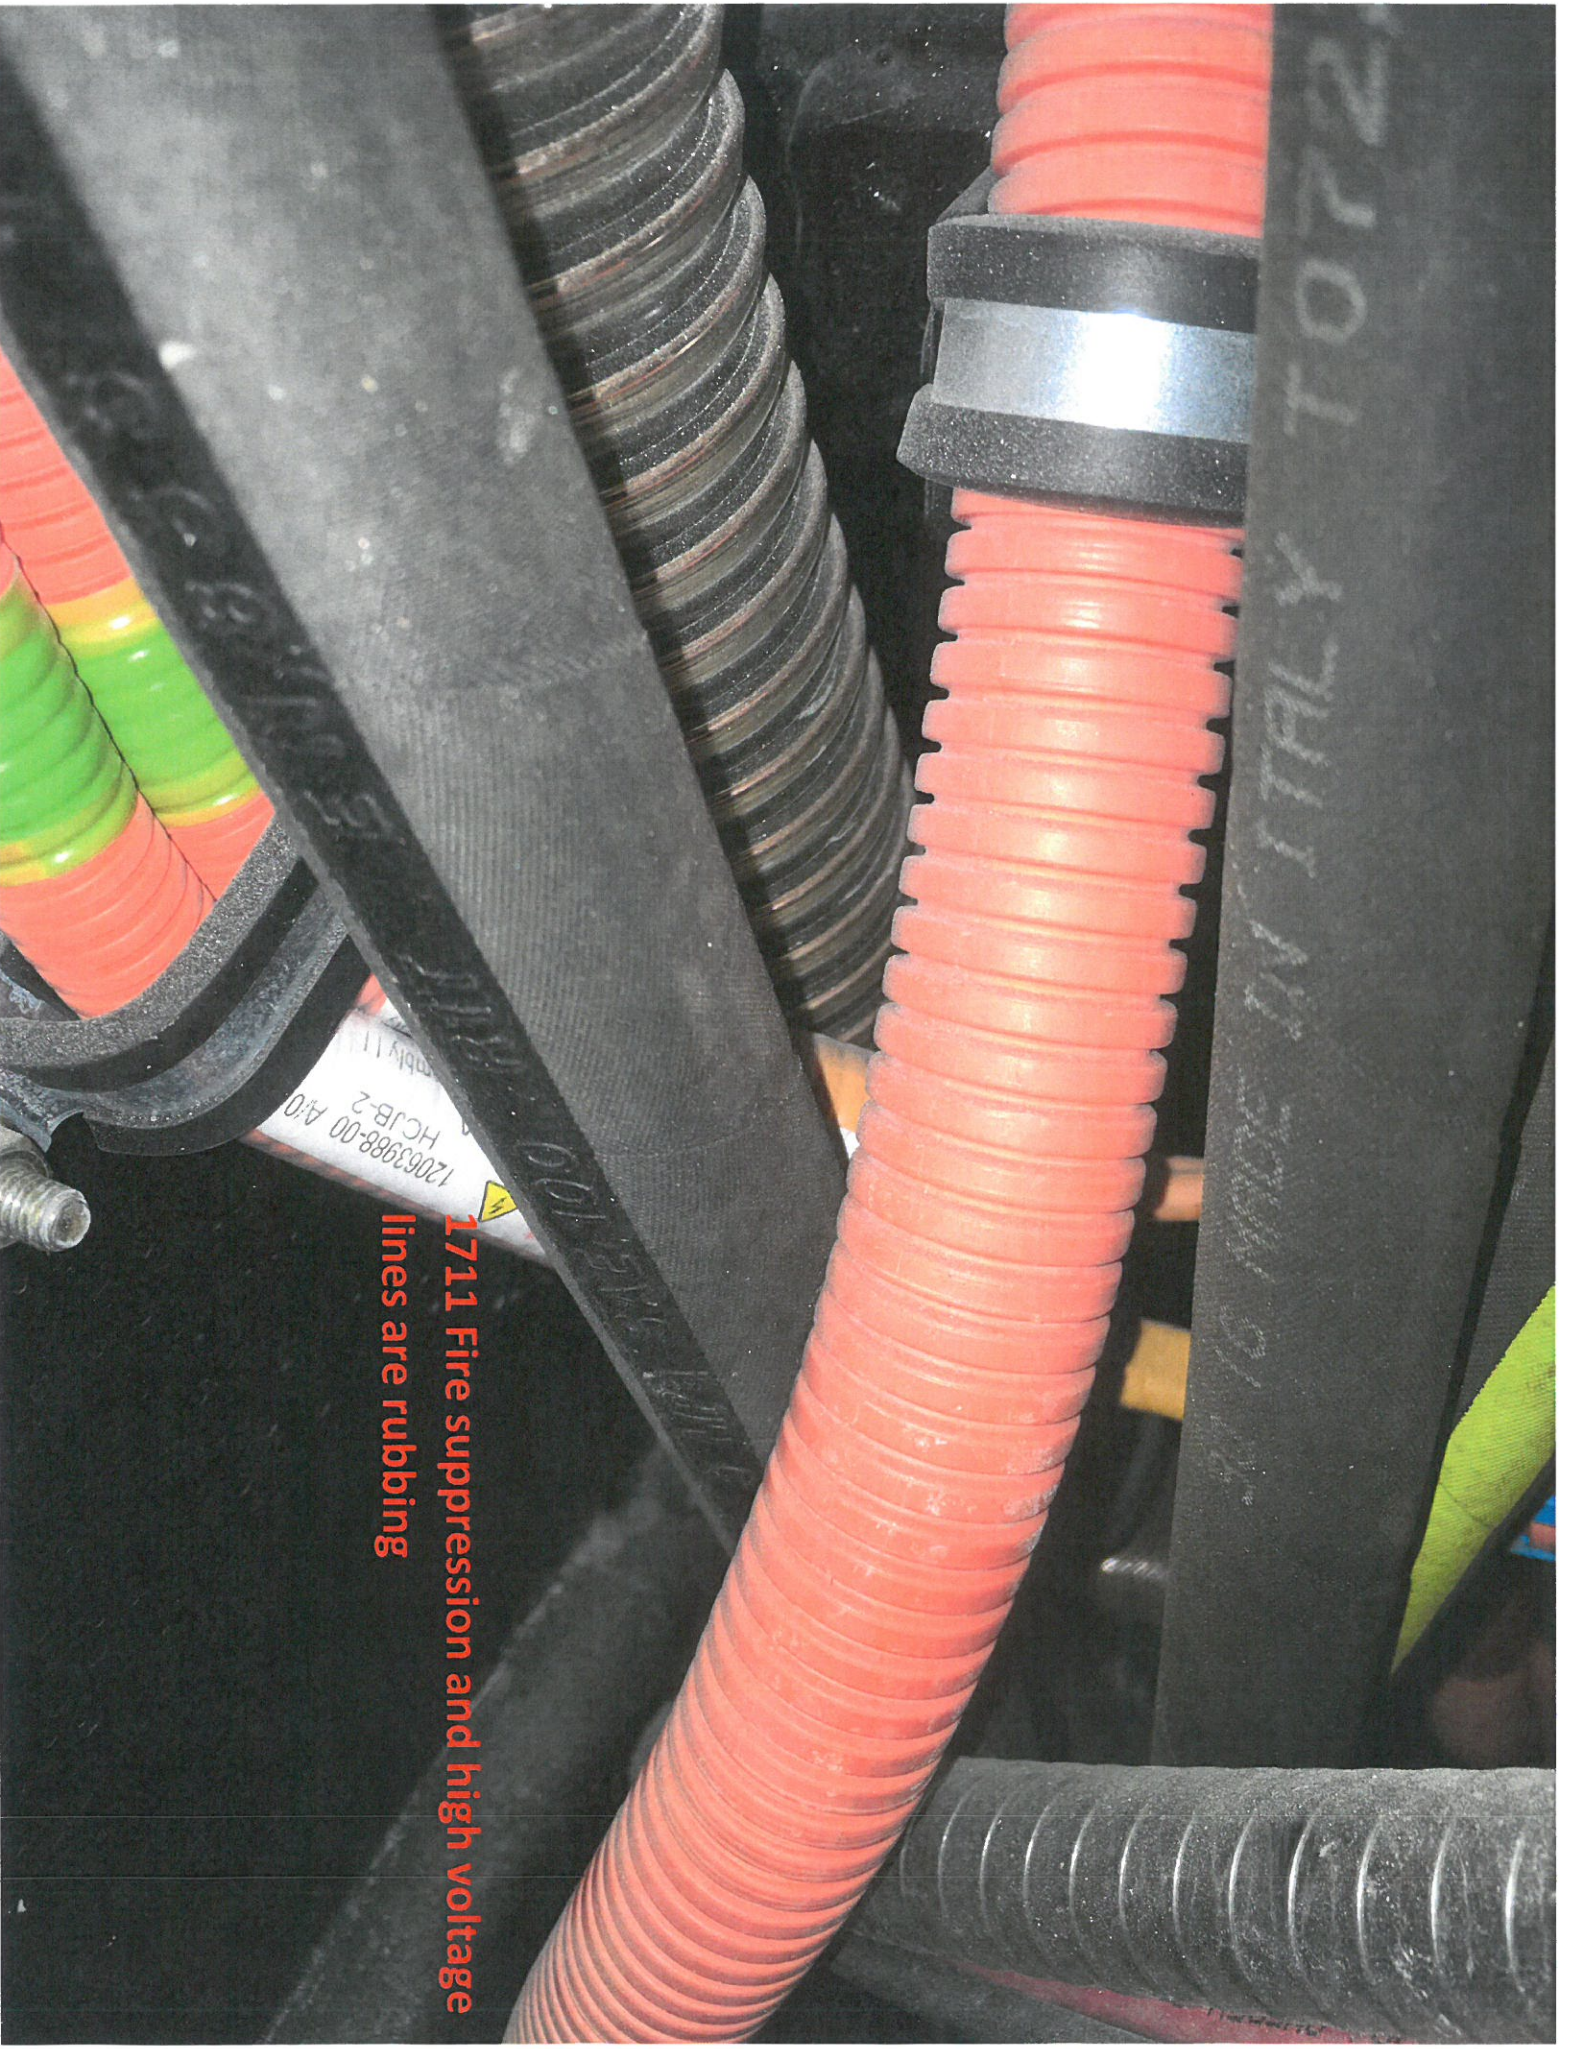
1711 Fire suppression and high voltage lines are rubbing

1711 High voltage cable
rubbing

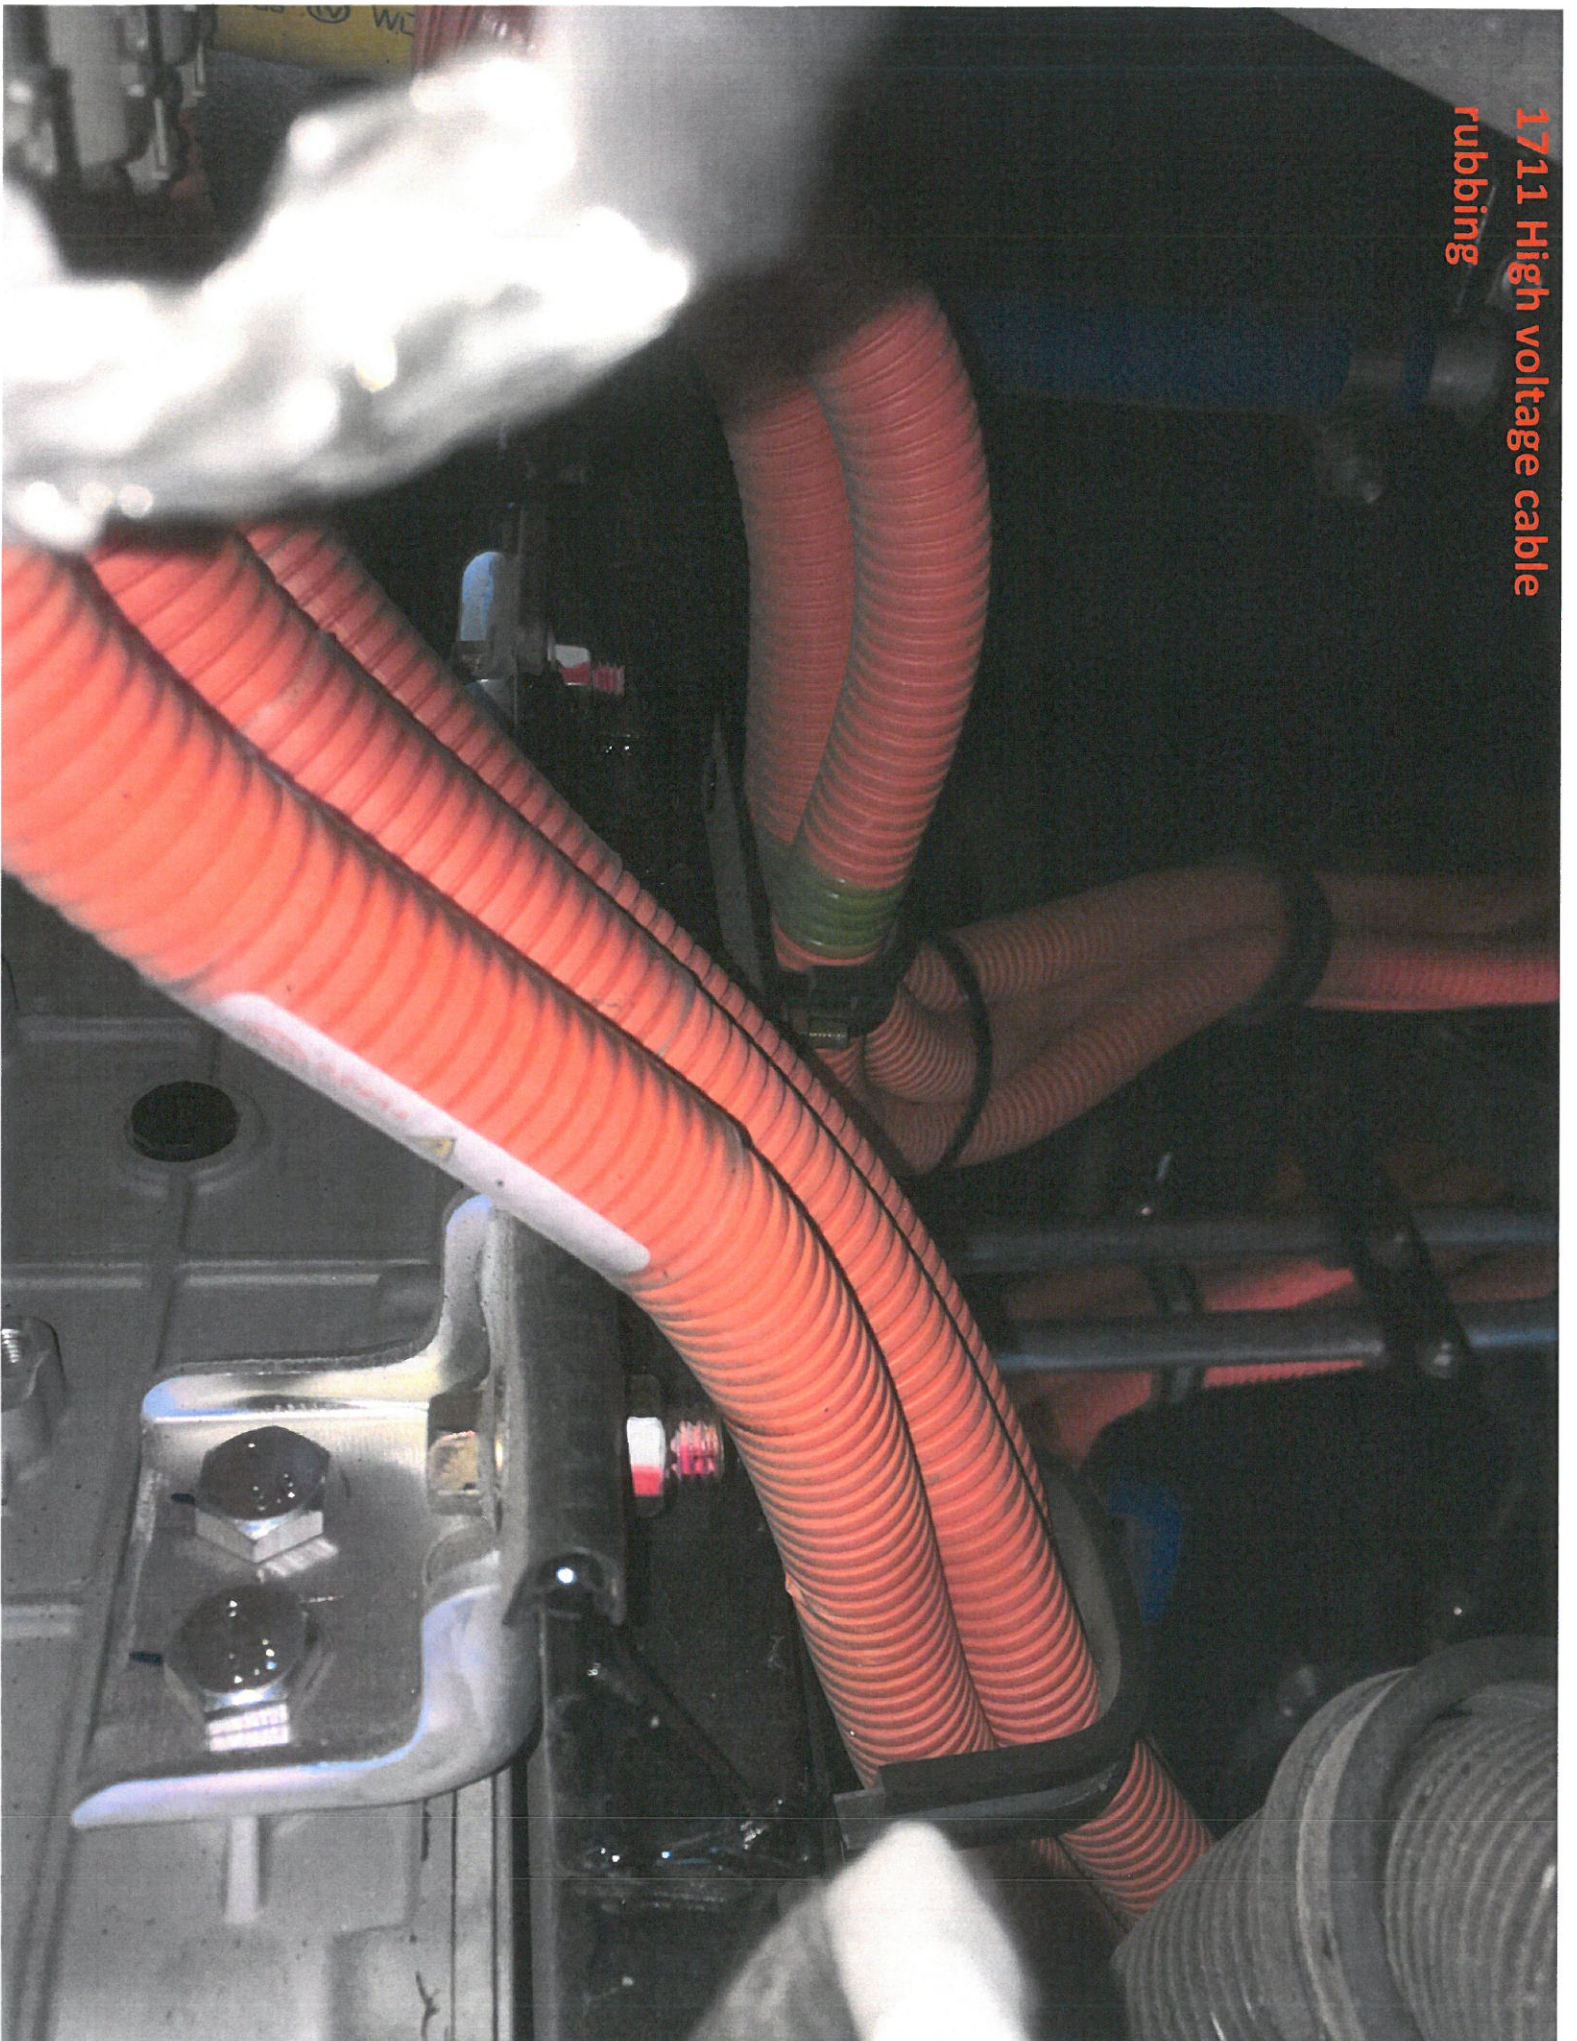
1711 High voltage cable rubbing
