1711

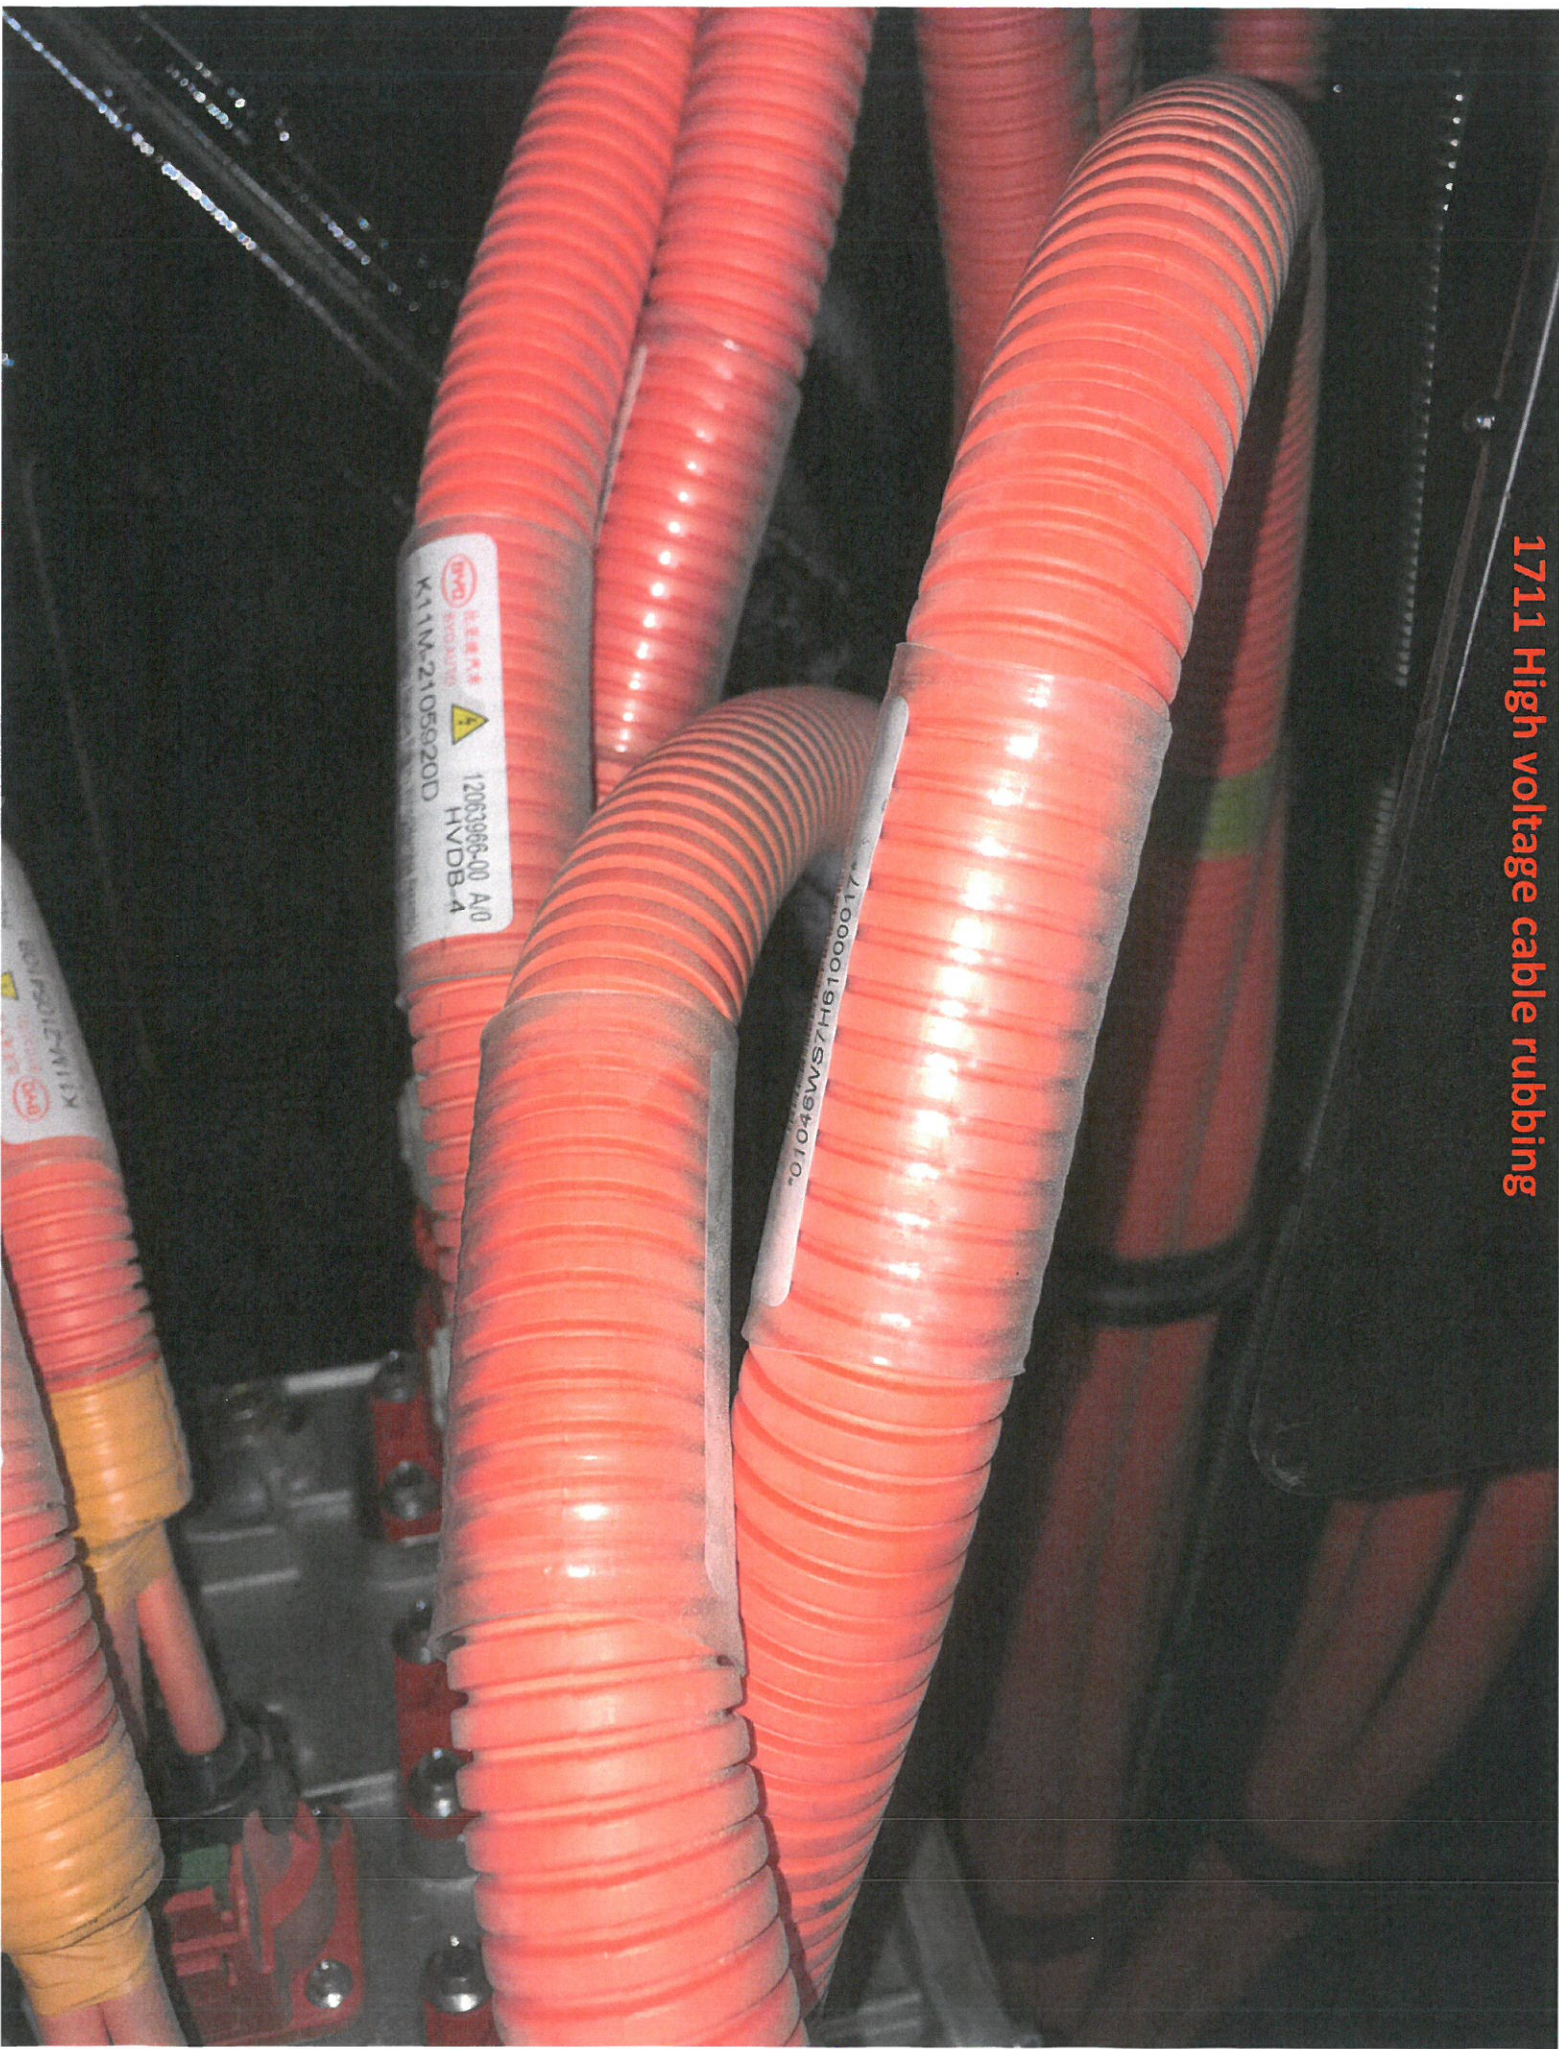
1711 Cracked weld

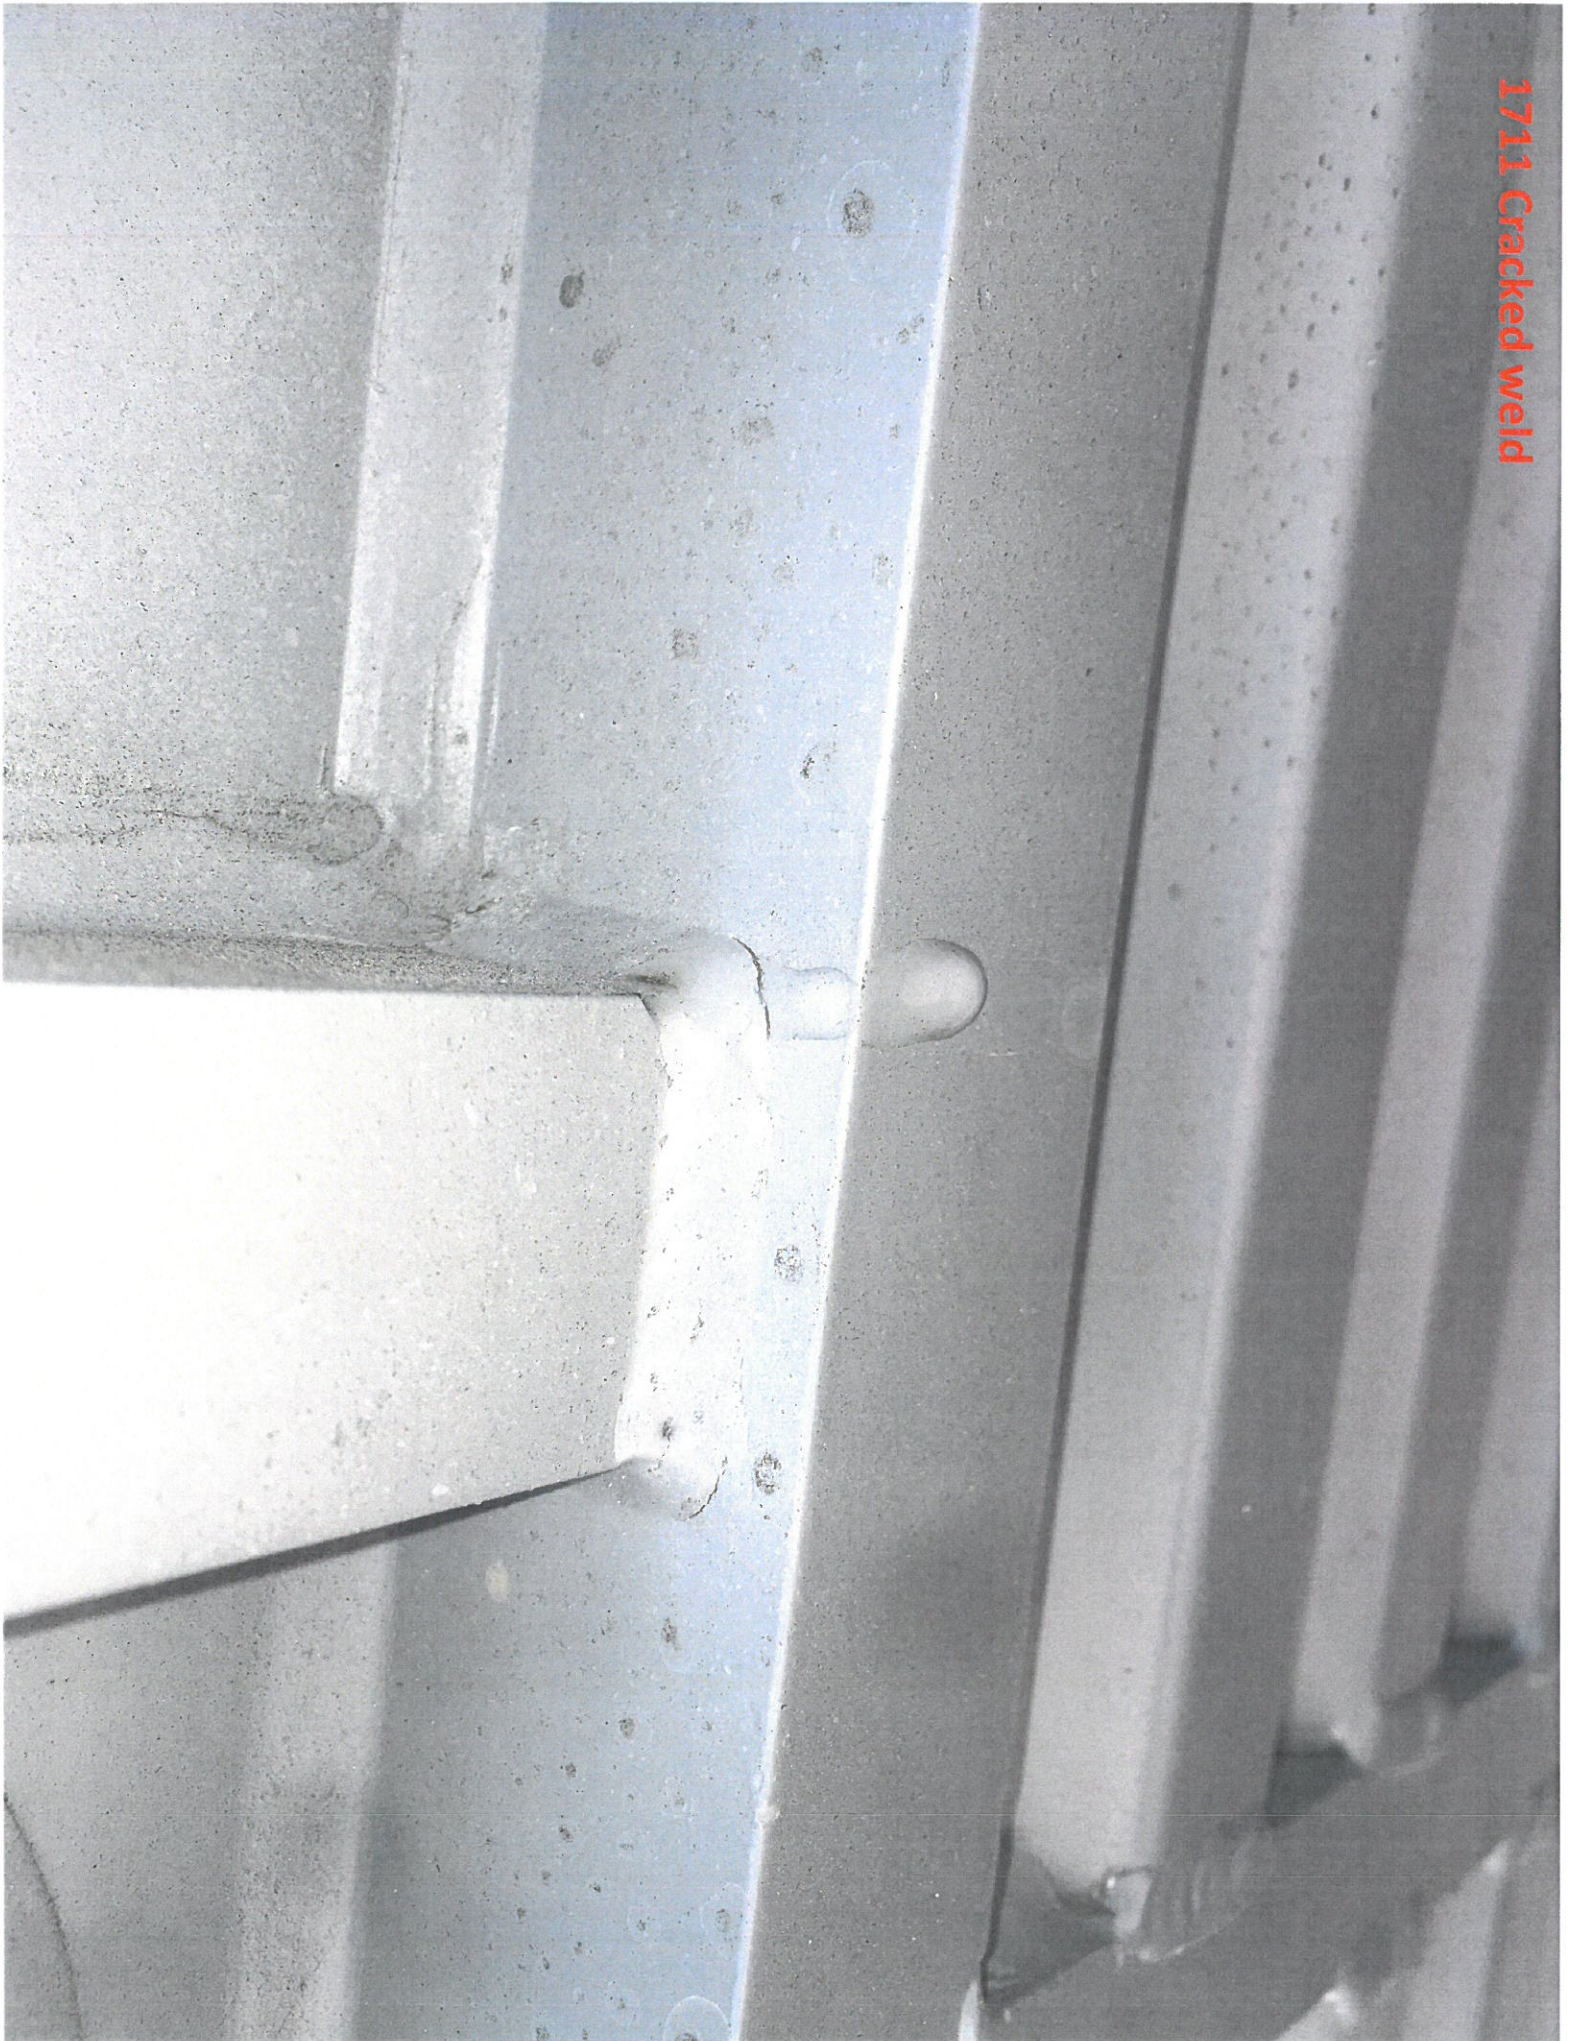
1711 Cracked weld

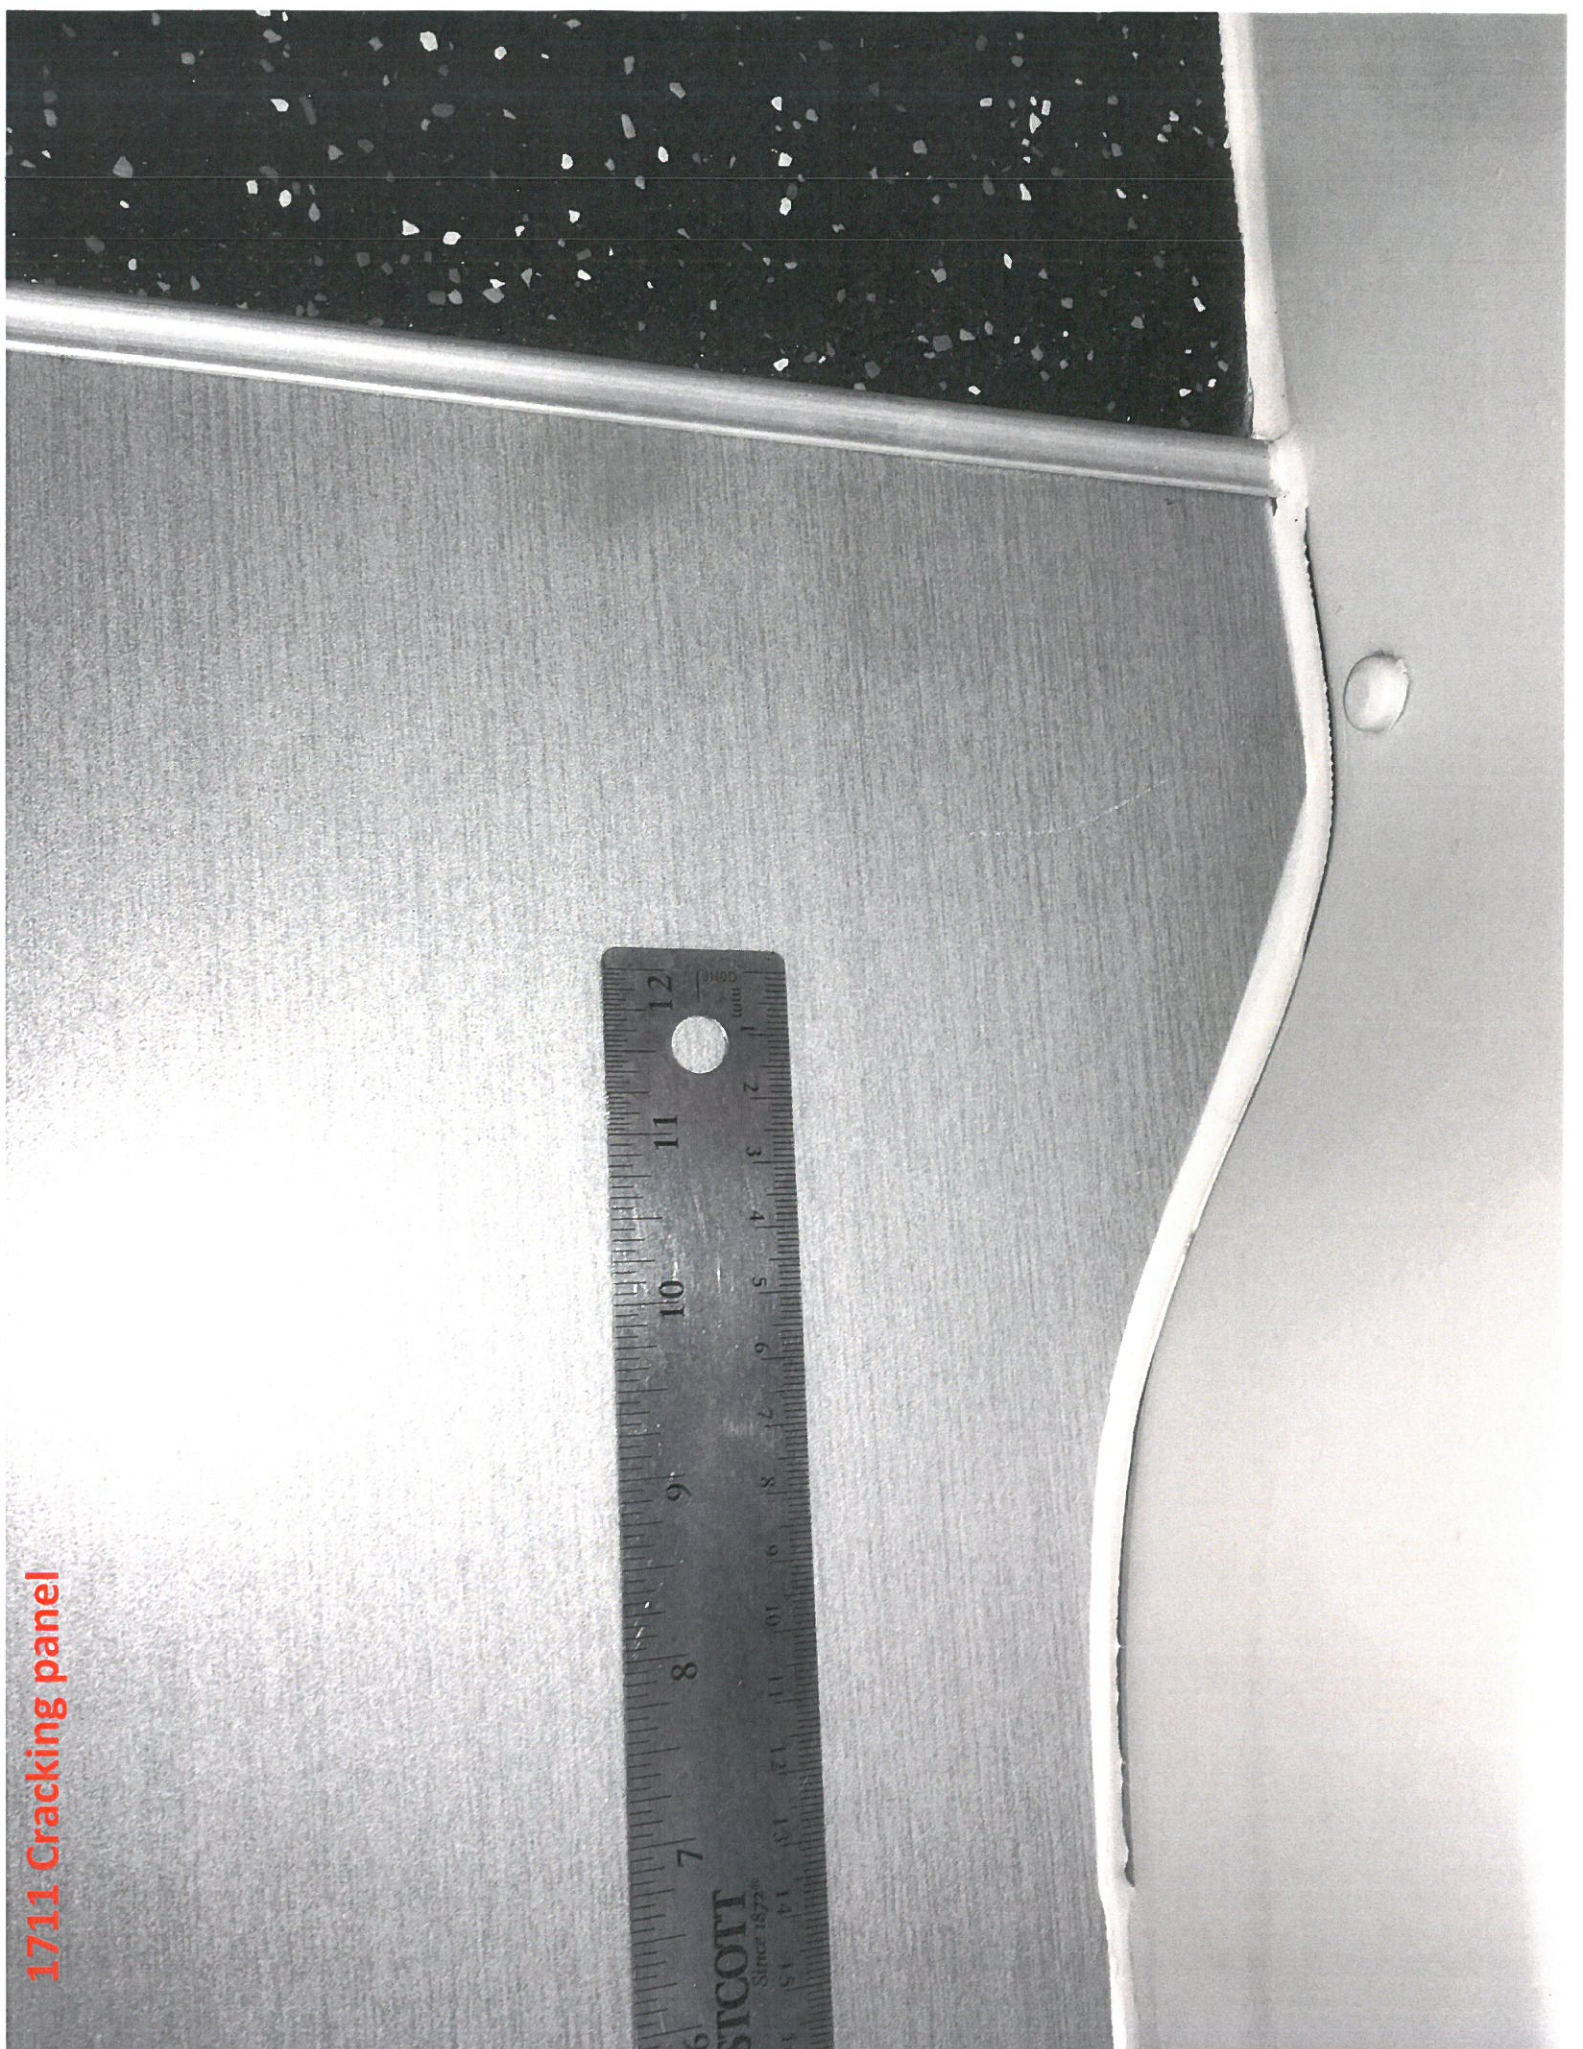
1711 Front of joint,
warped panel

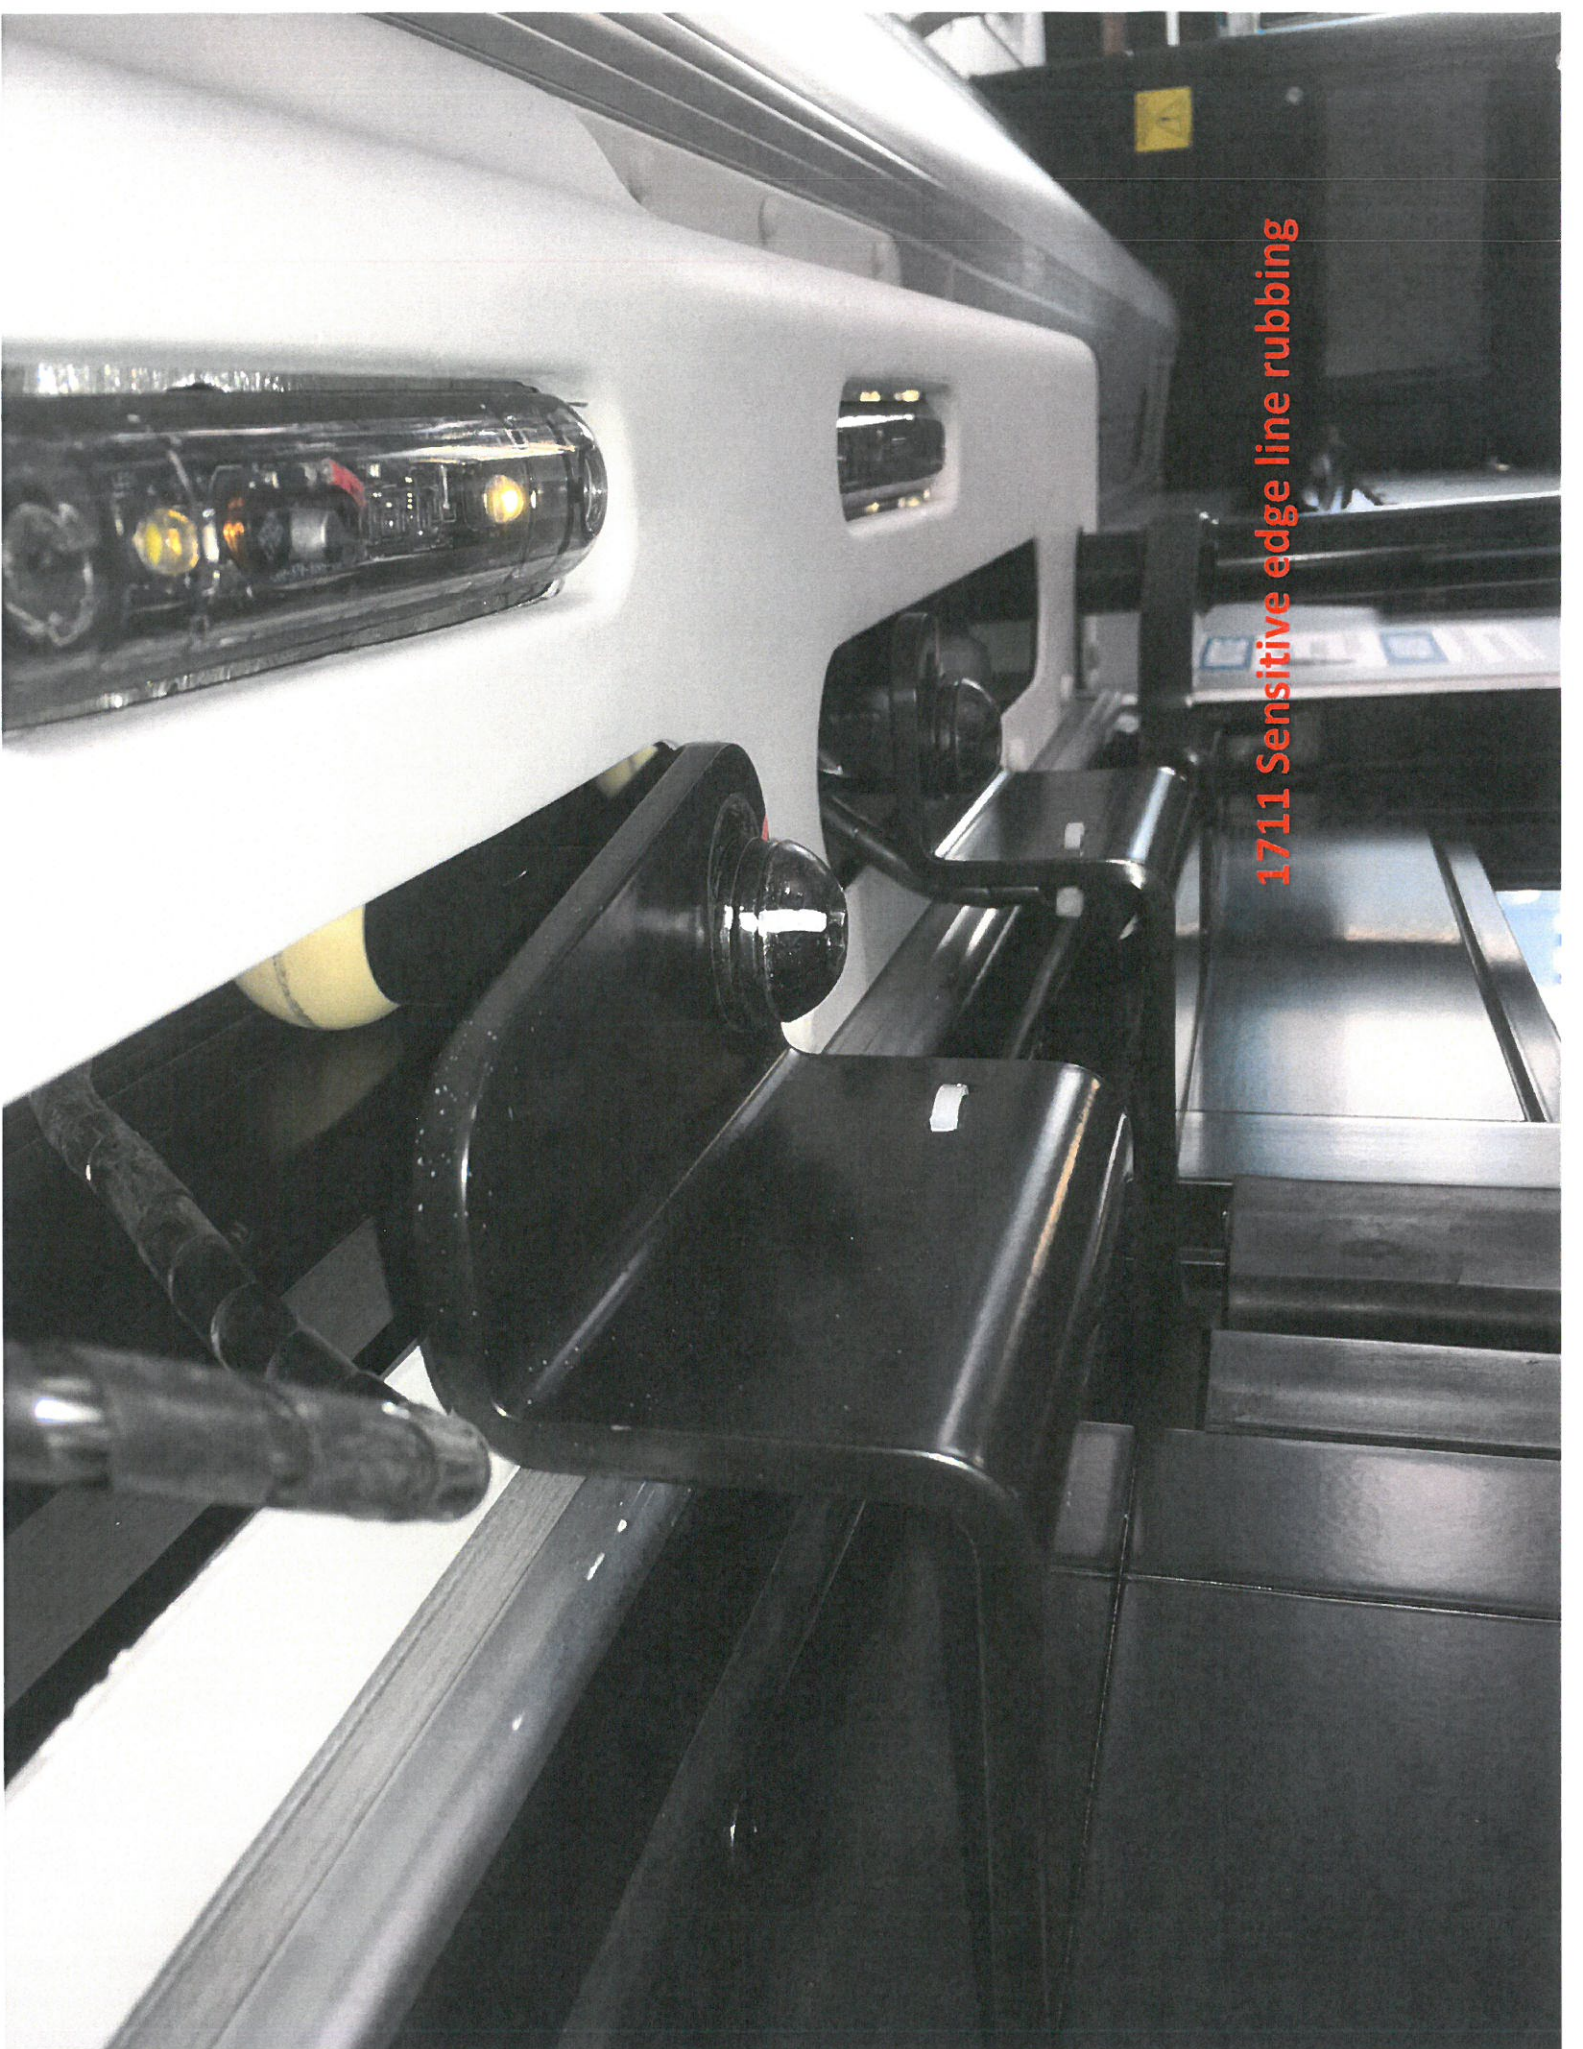
1711 Sensitive edge line rubbing
