1712

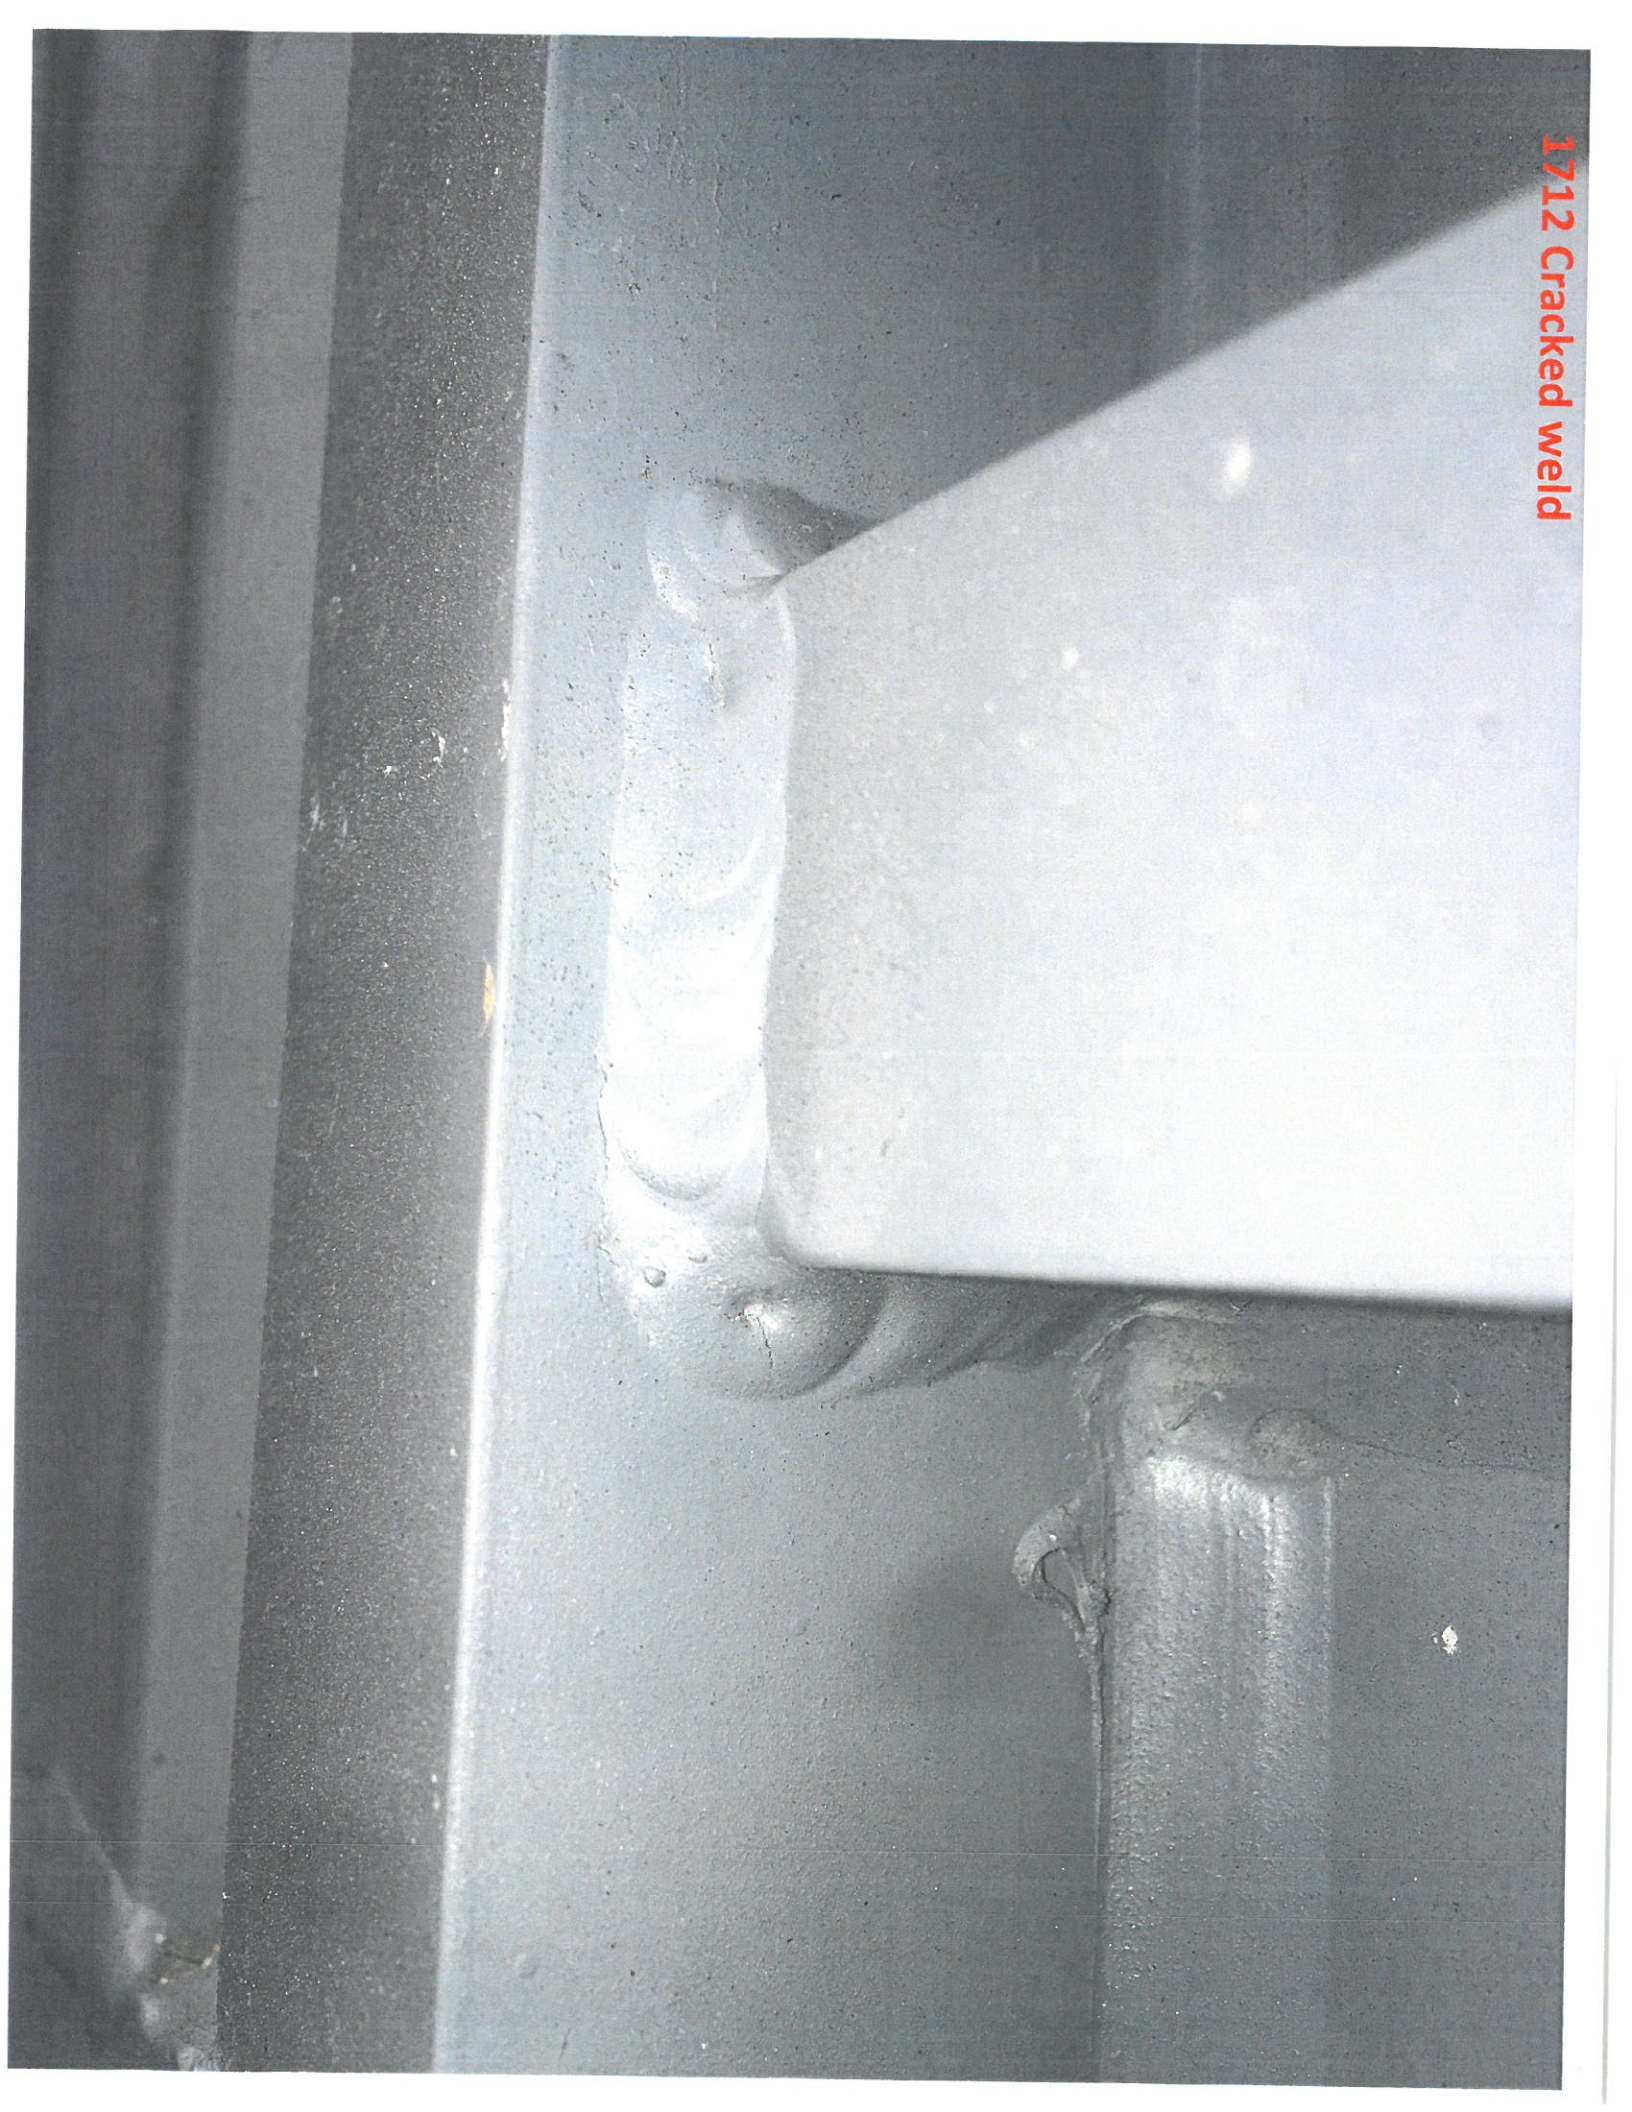
17112 Cracked weld

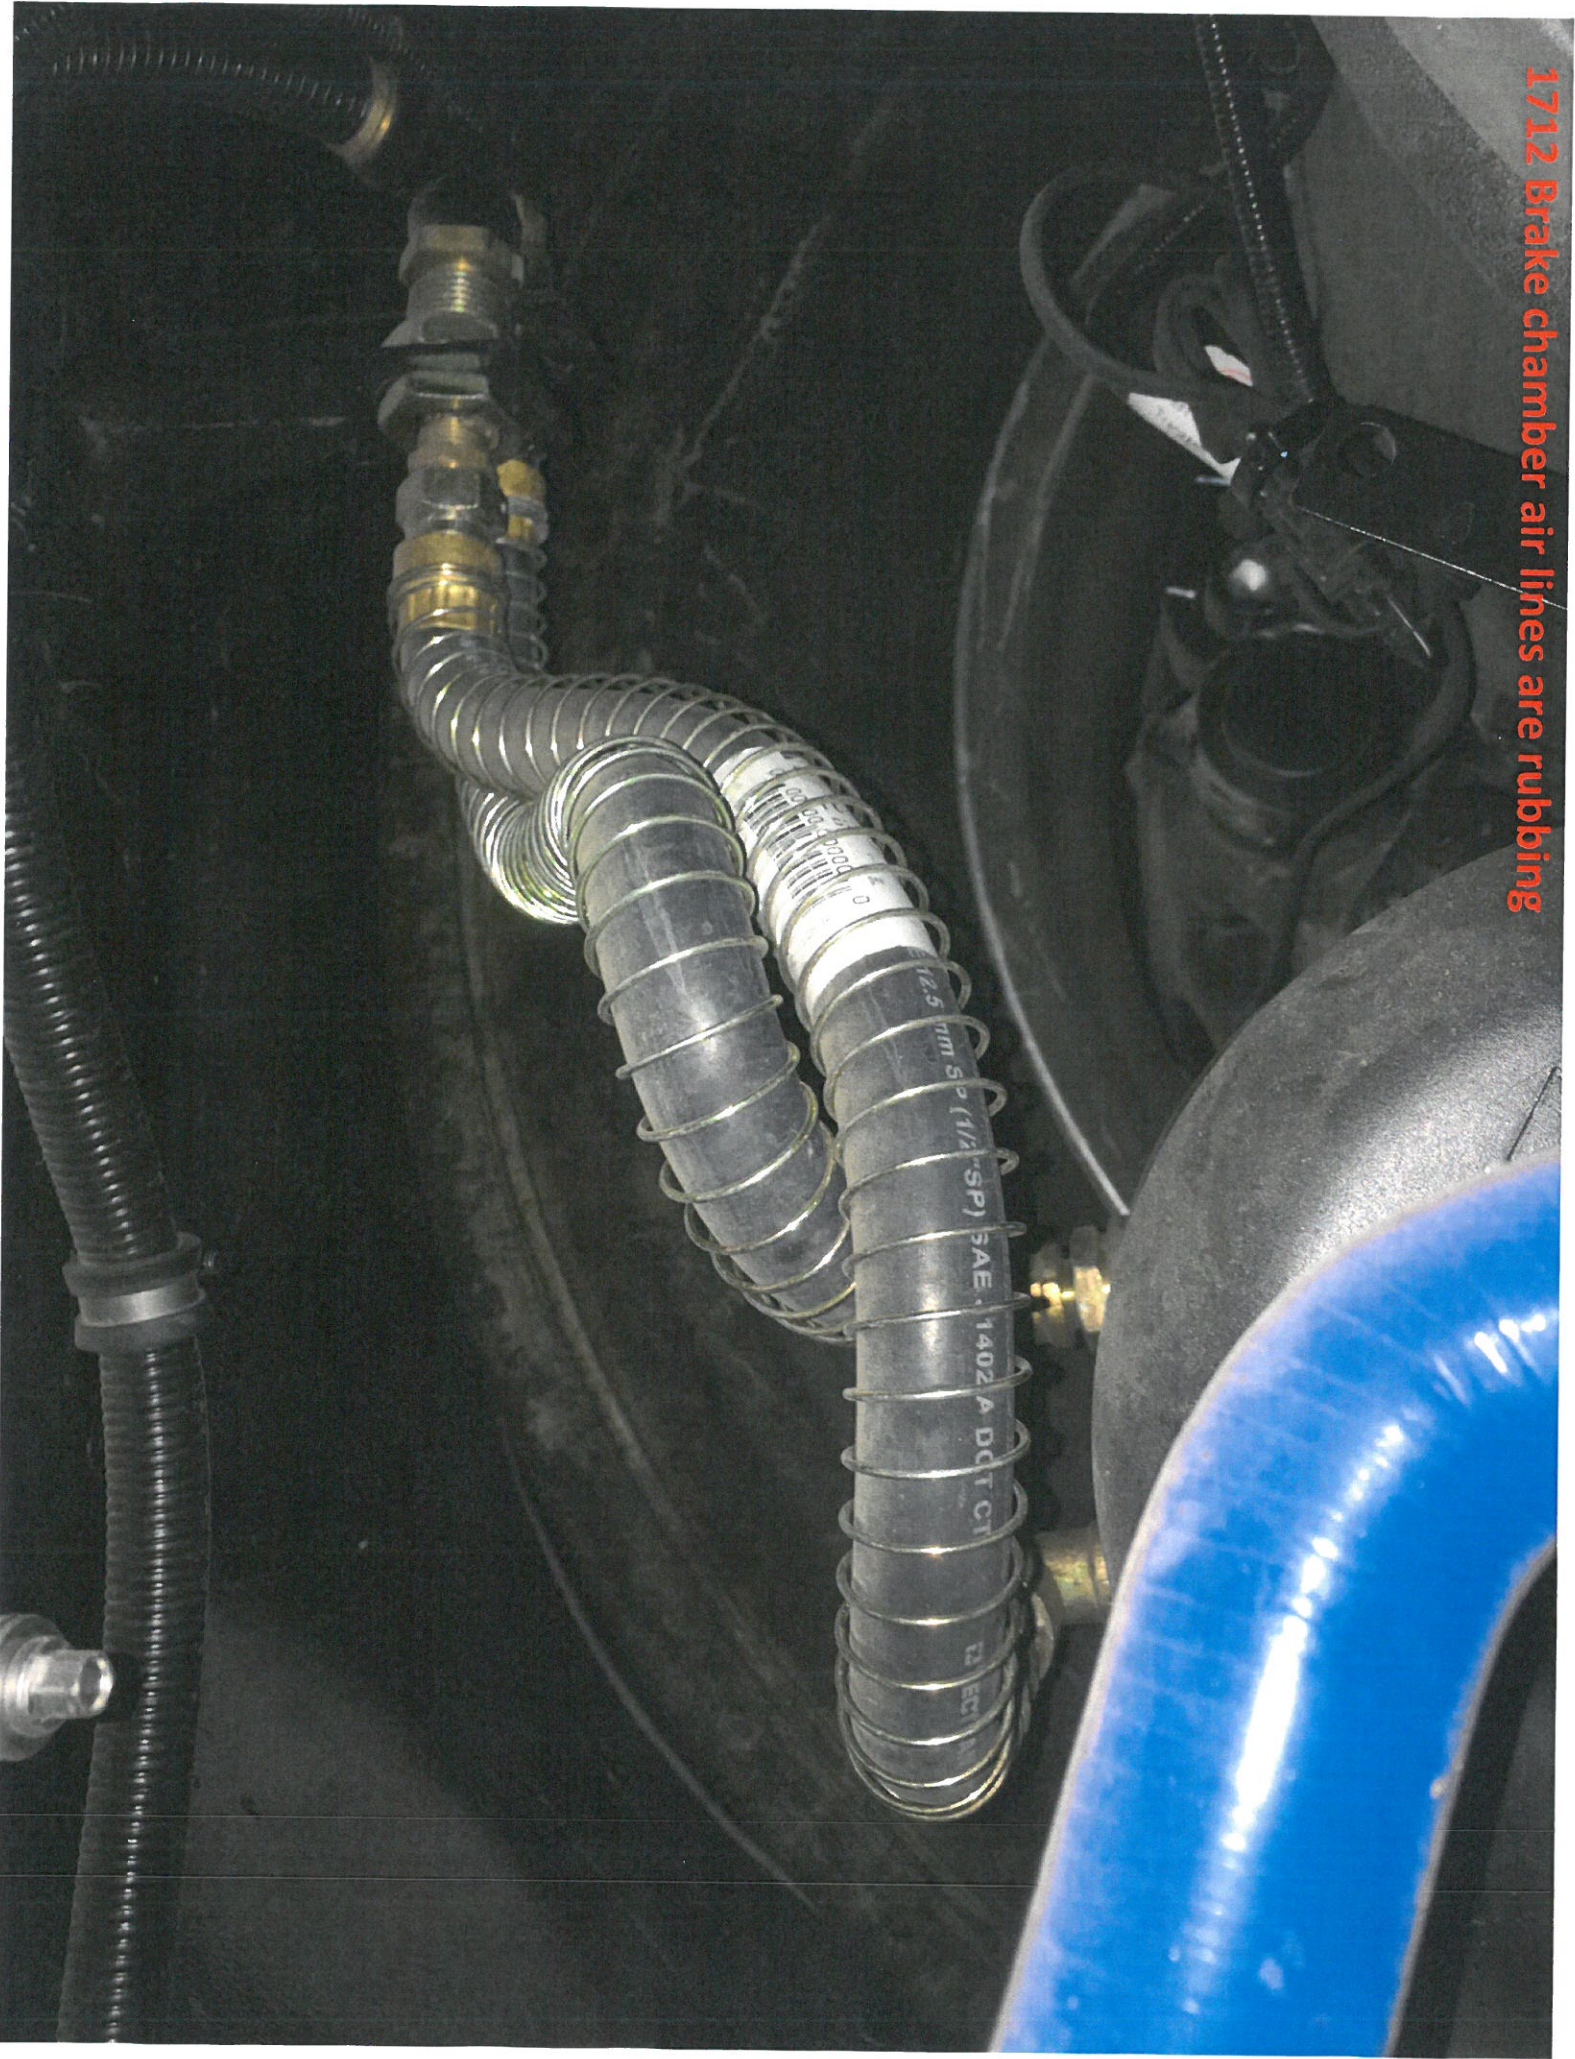
1712 Brake chamber air lines are rubbing

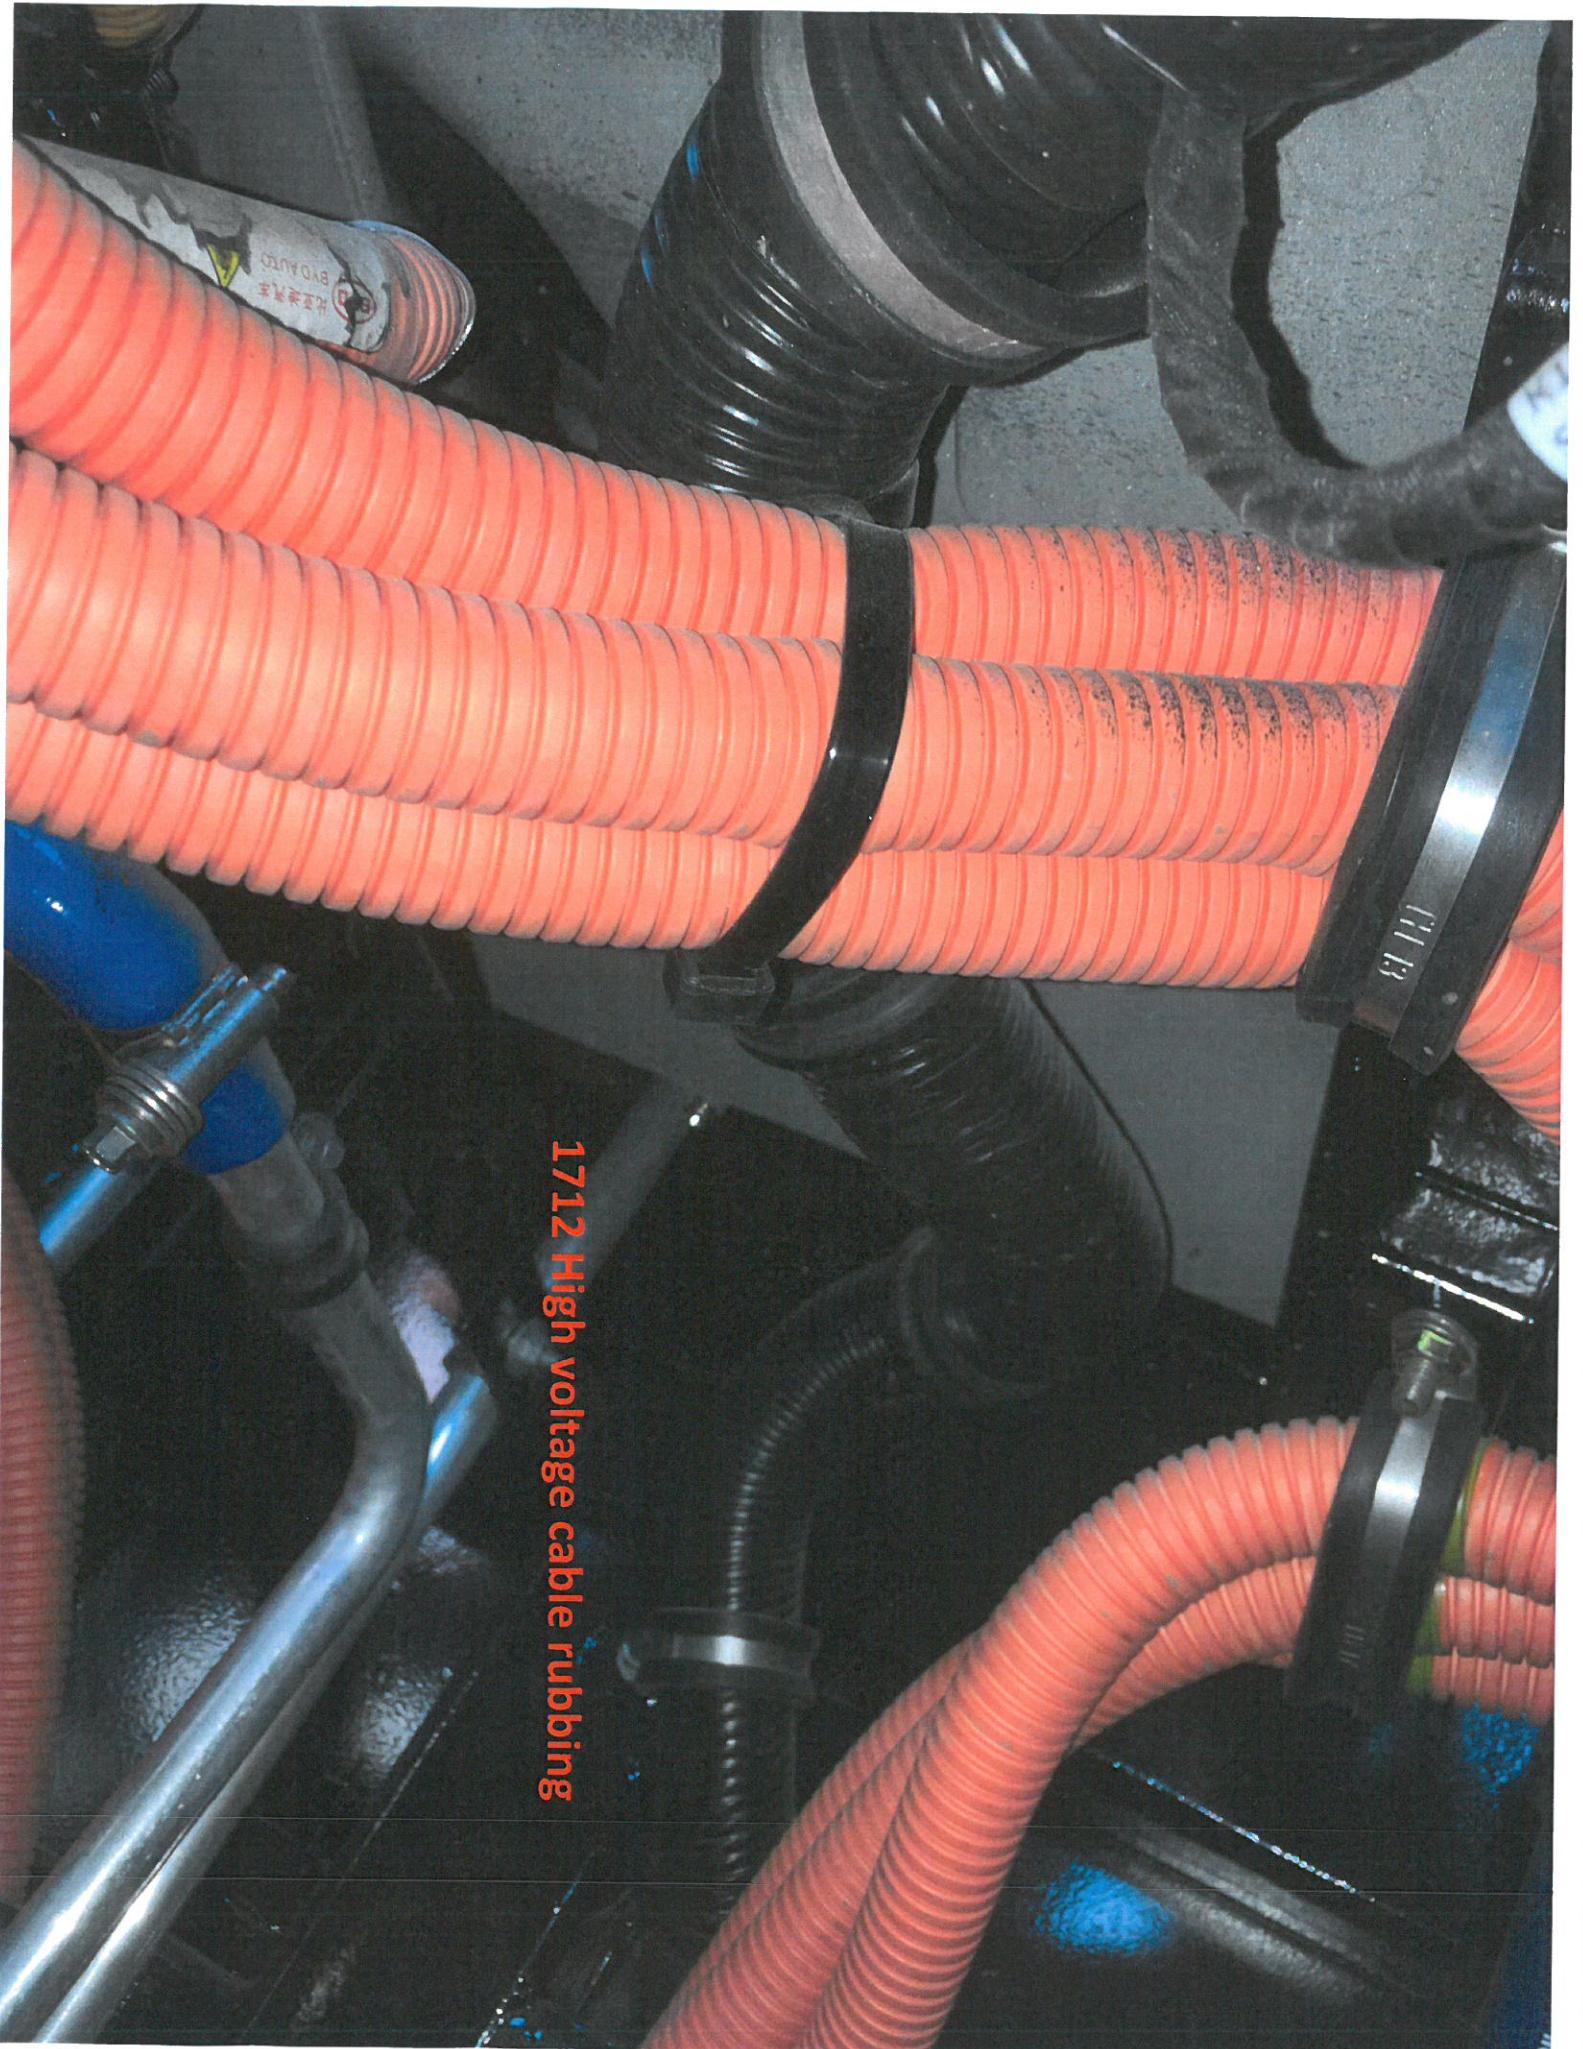
1712 High voltage line terminal is only insulated with electrical tape

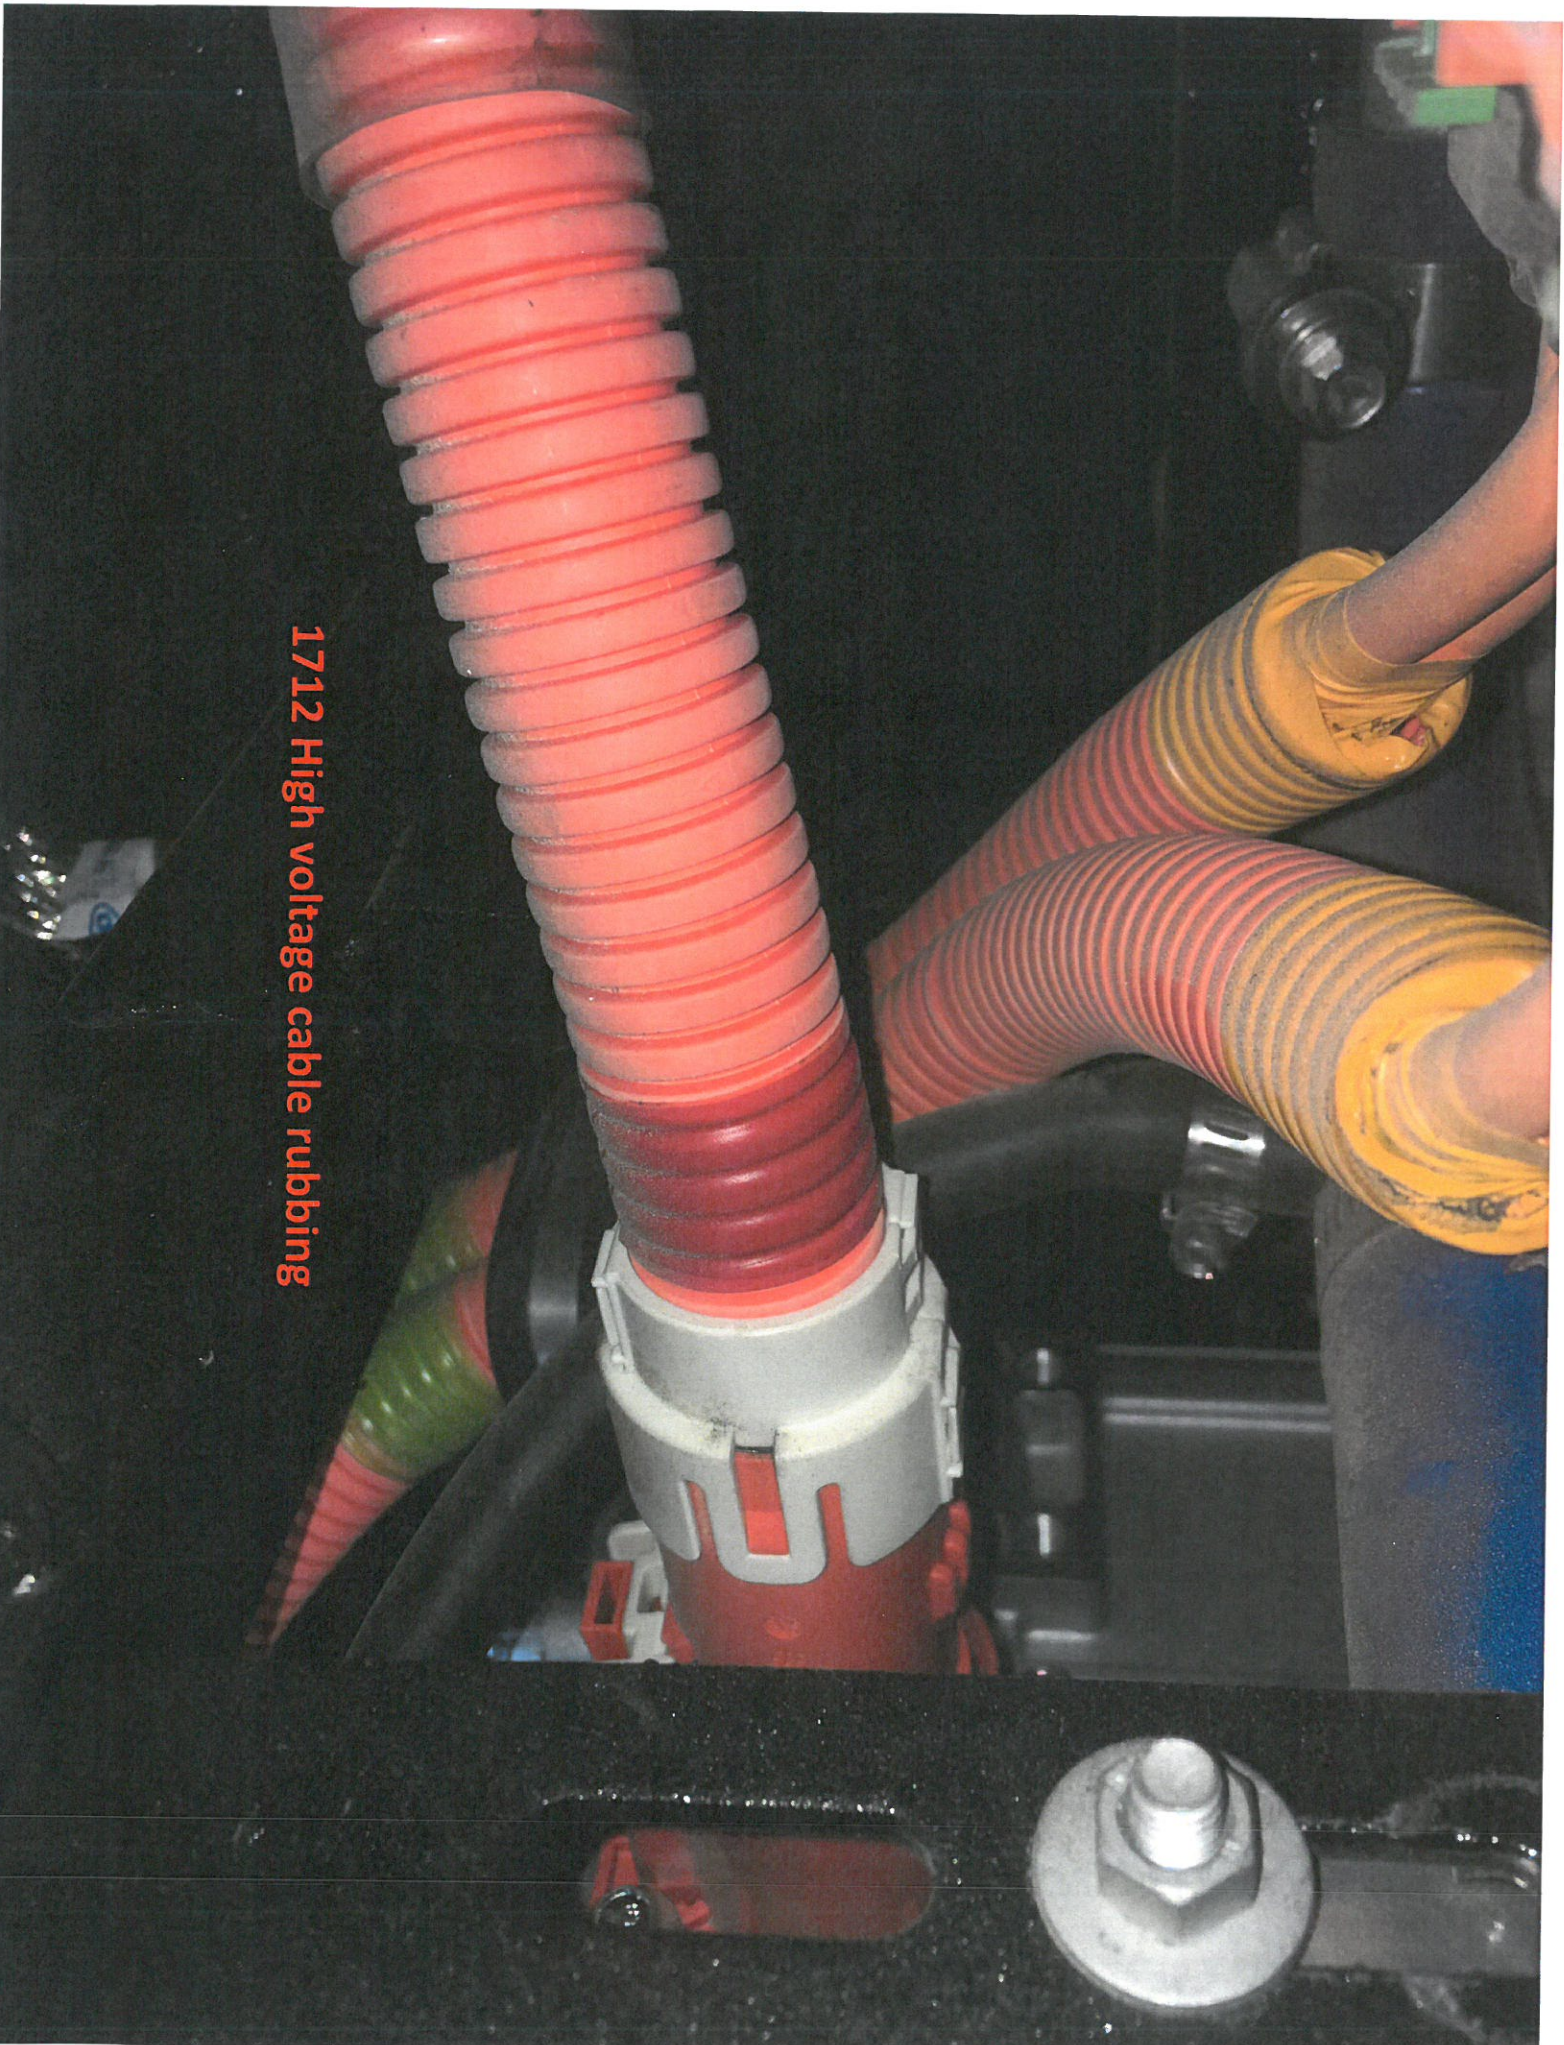
1712 High voltage cable rubbing

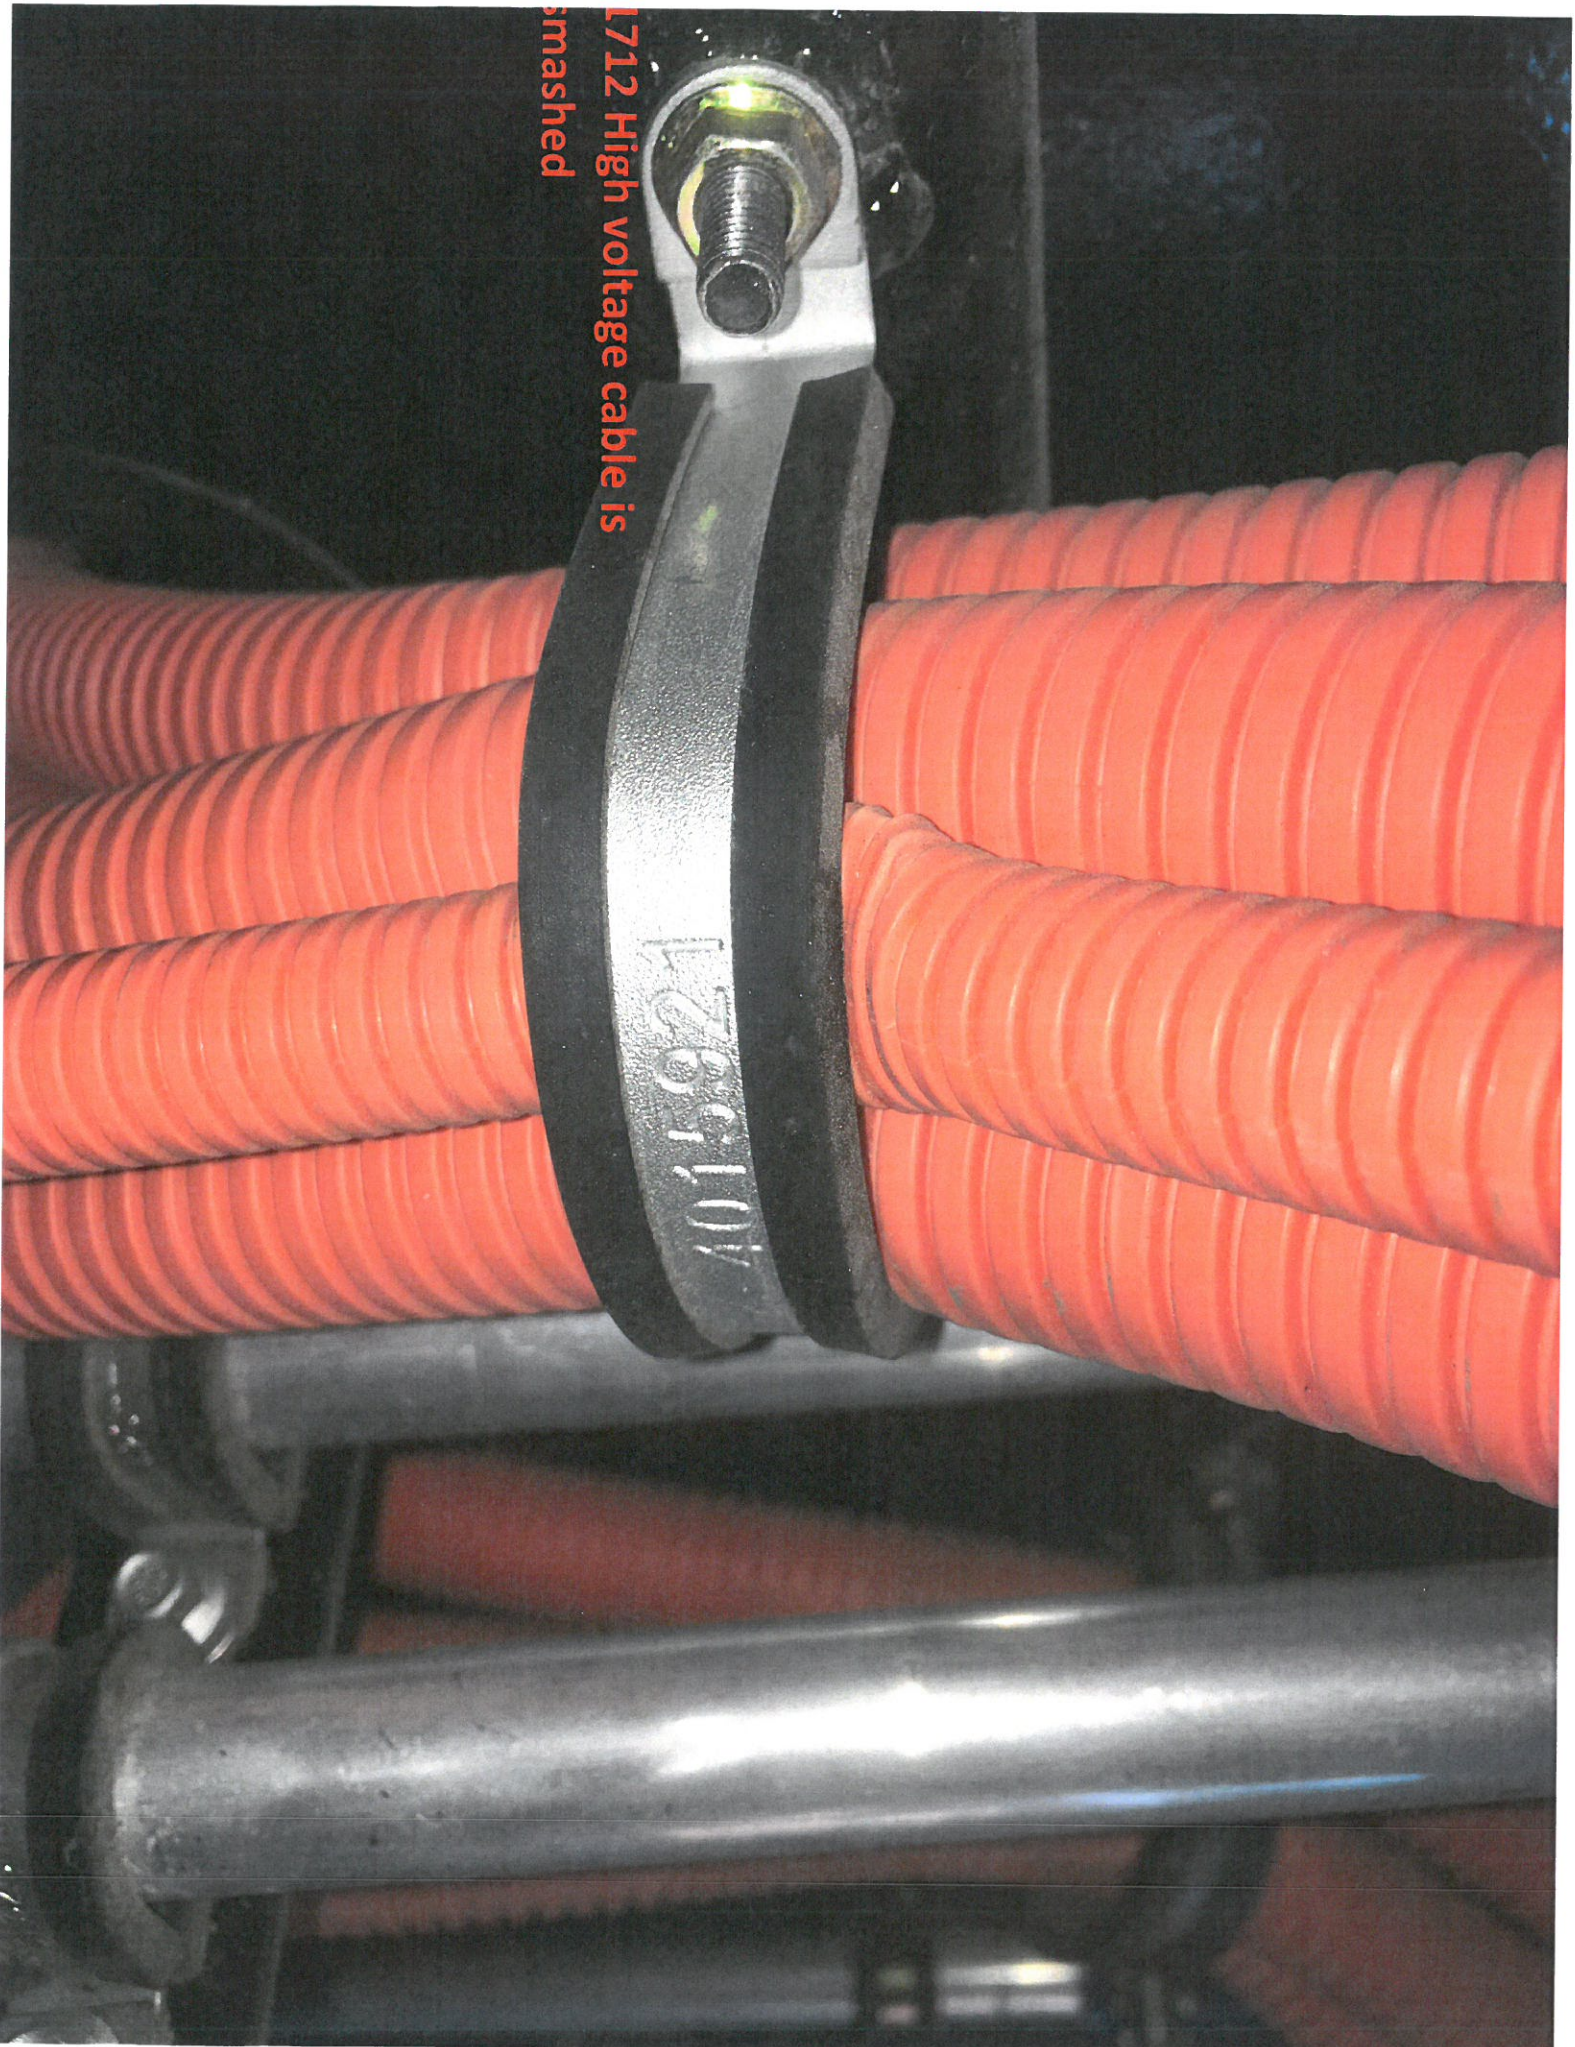
1712 High voltage cable is  
smashed

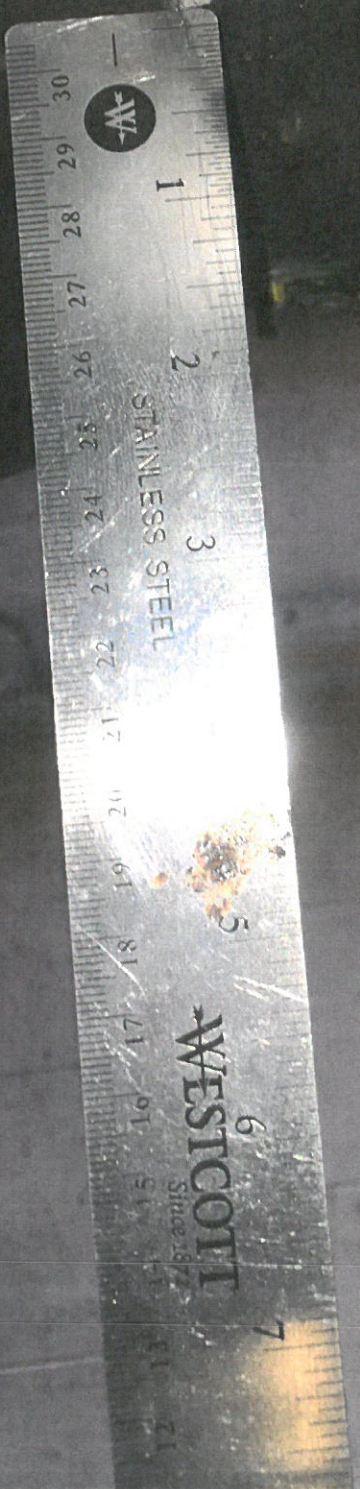
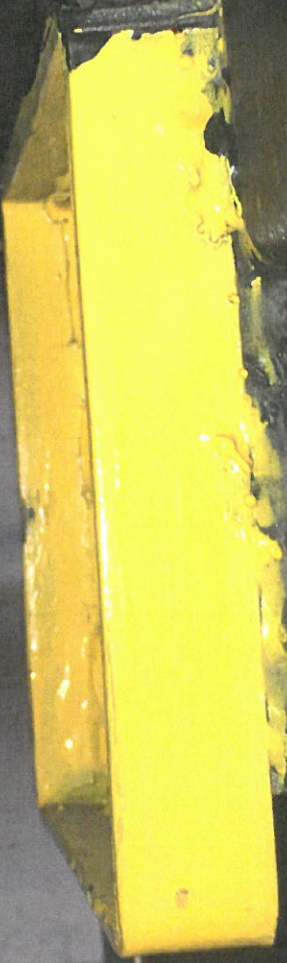
1712 Jack point is questionable

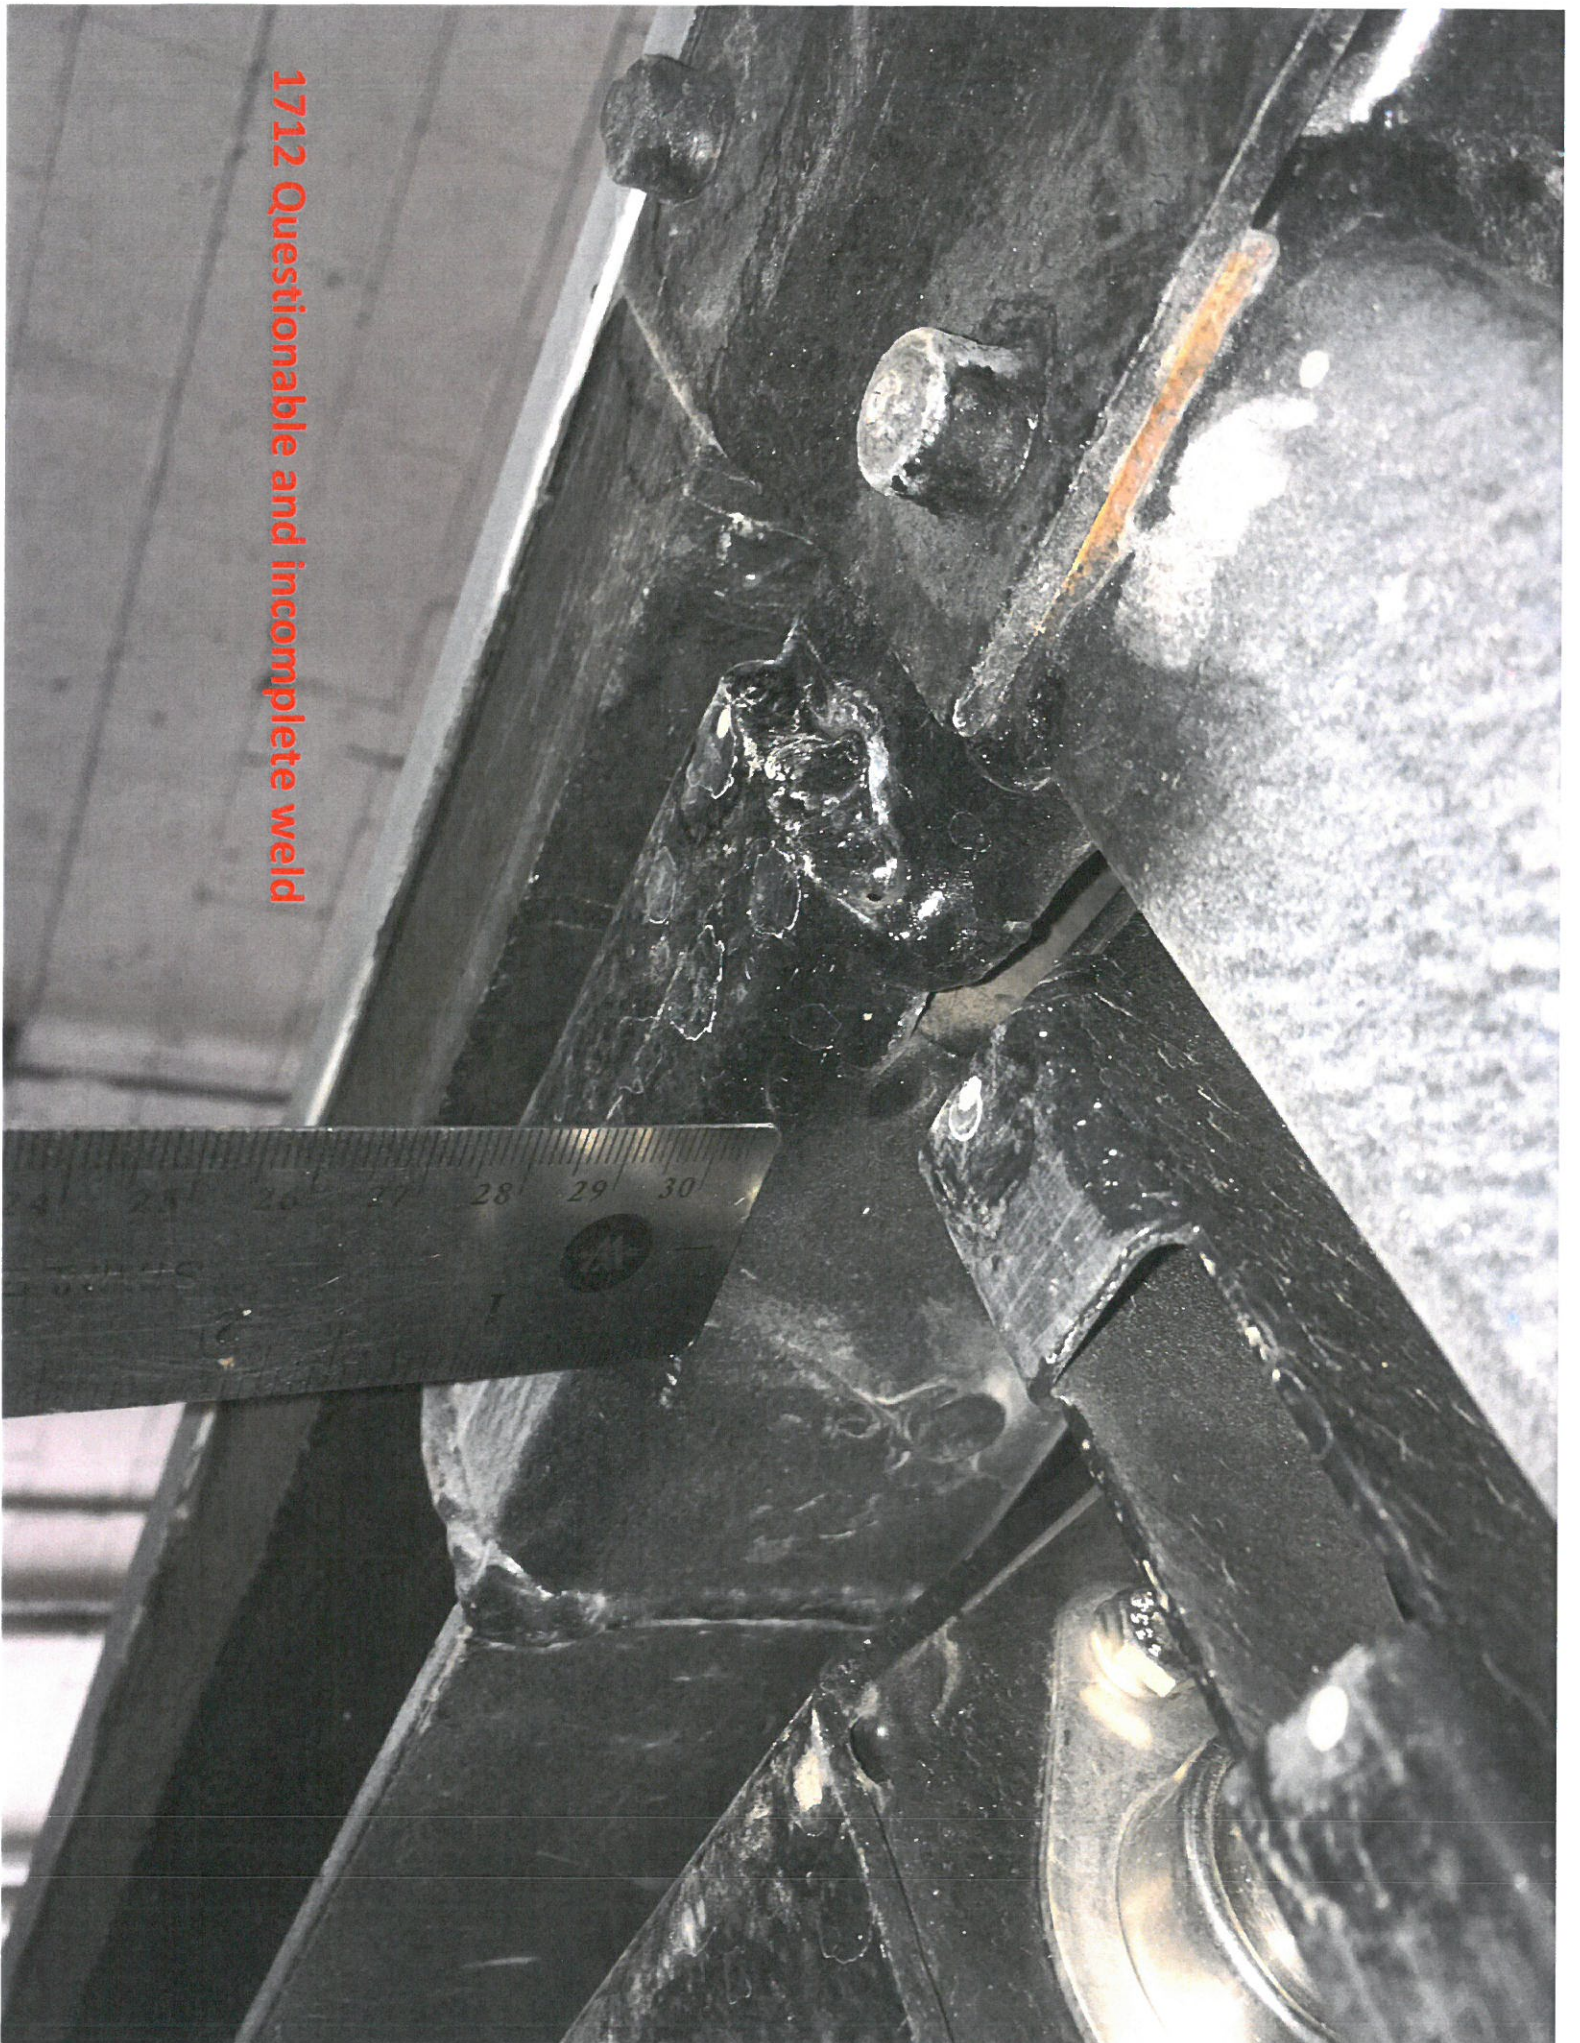
1712 Questionable and incomplete weld
