1712

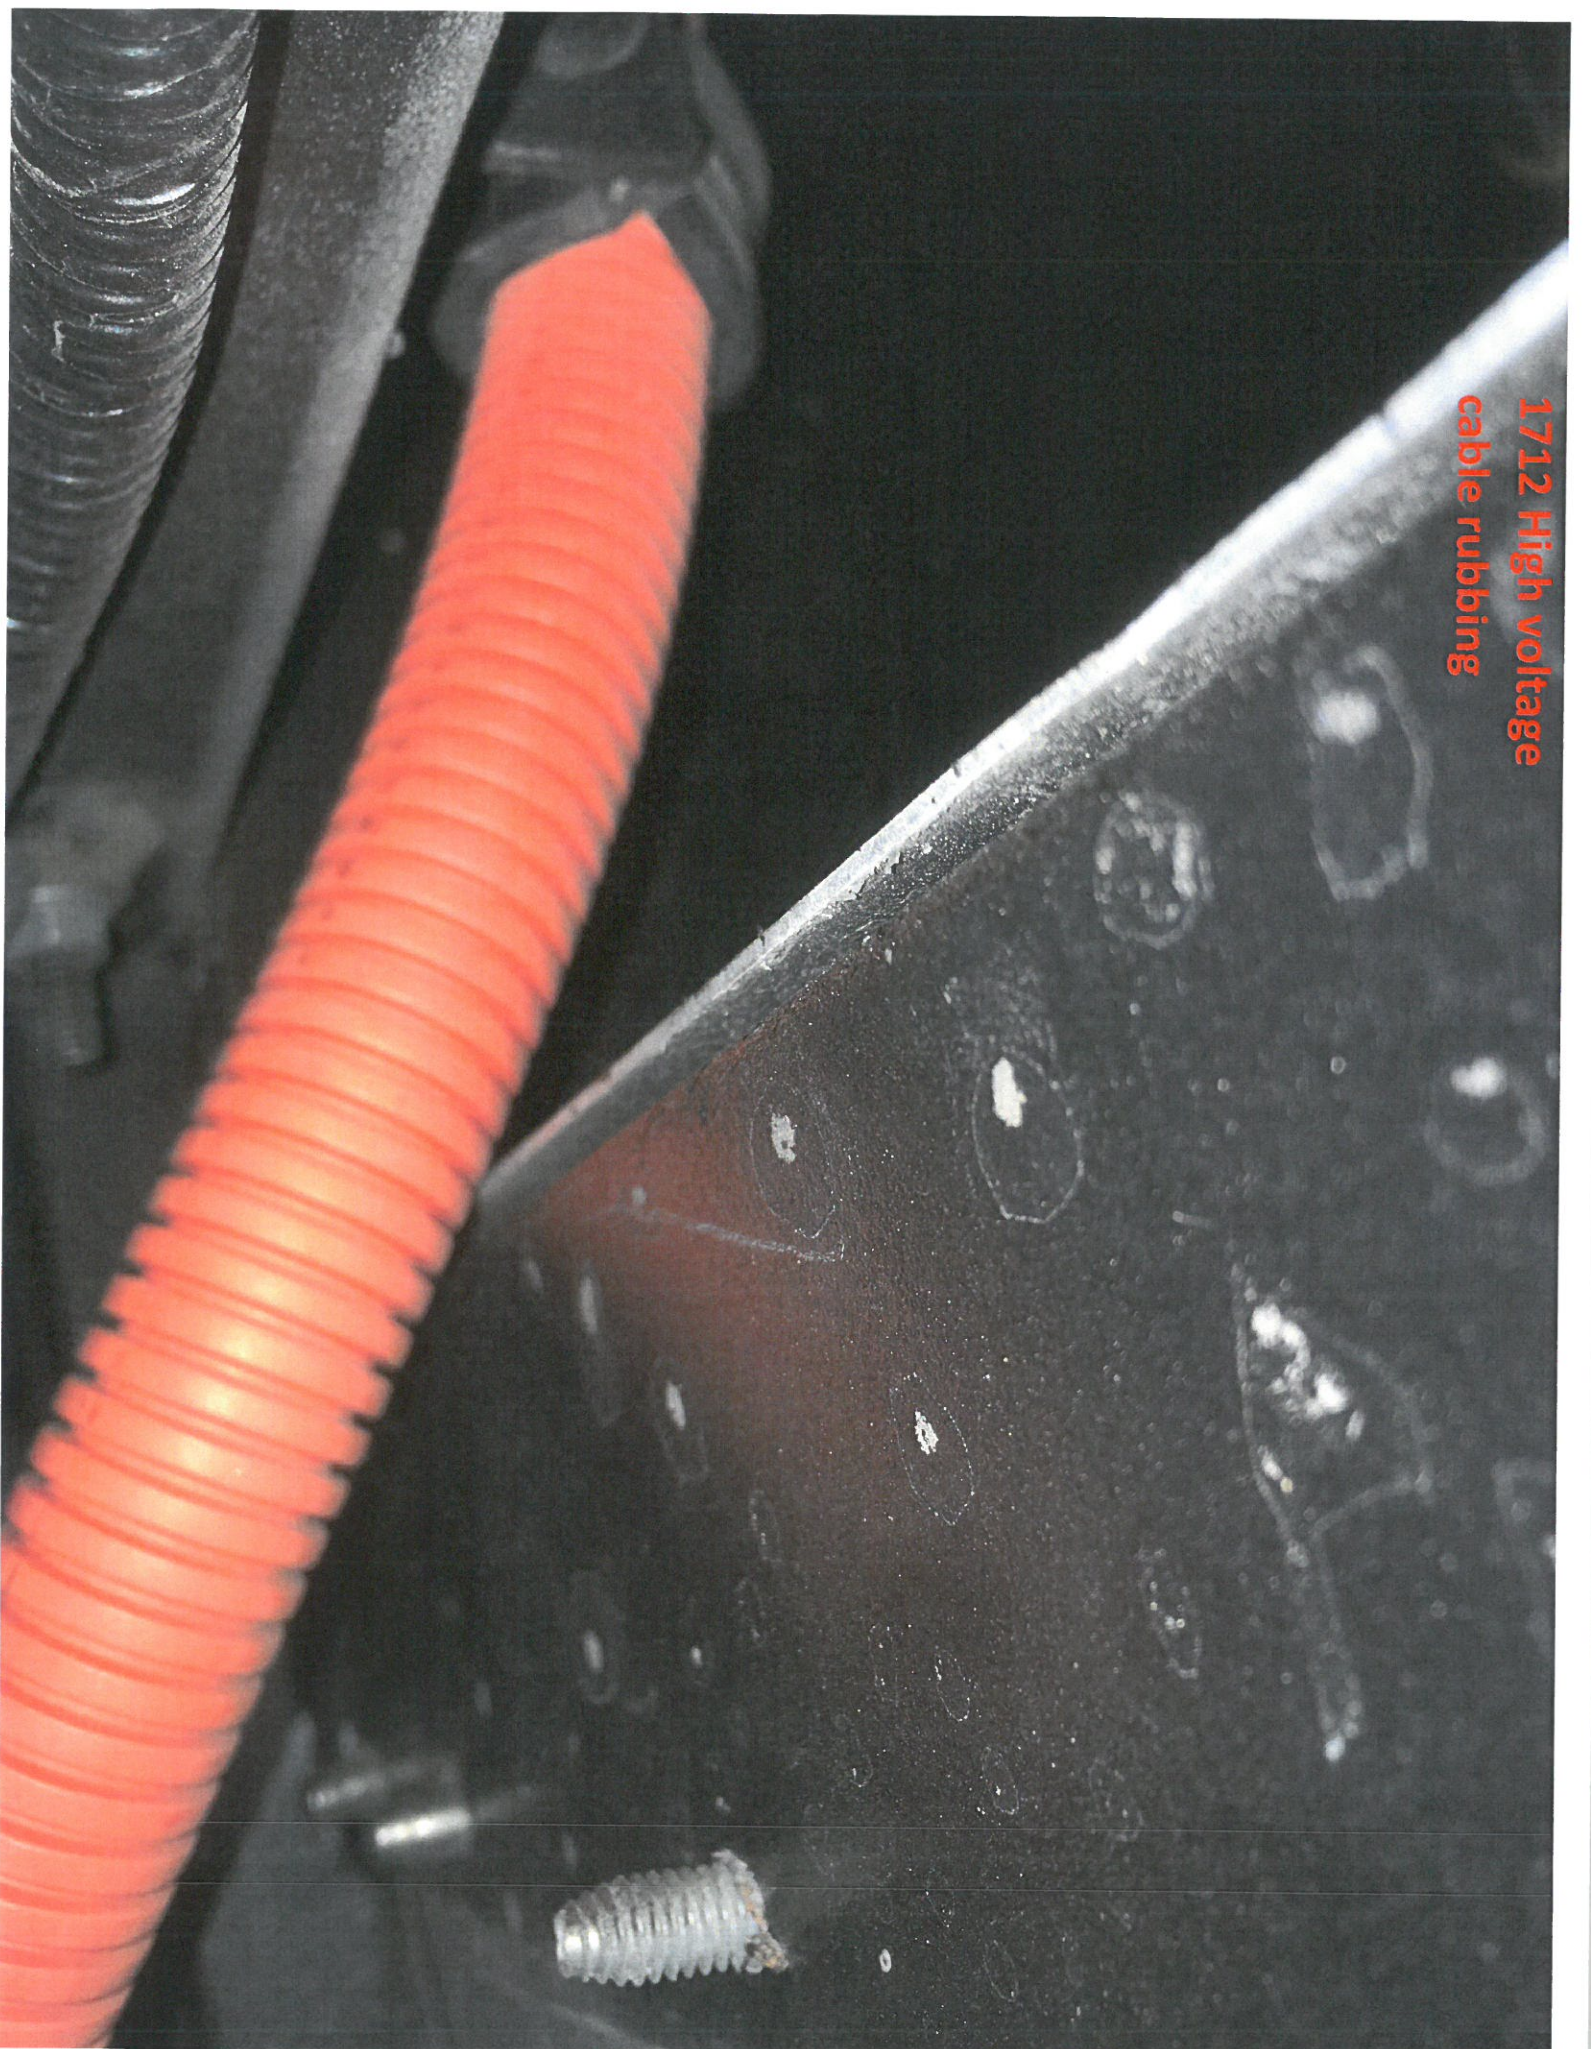
1712 High voltage  
cable rubbing

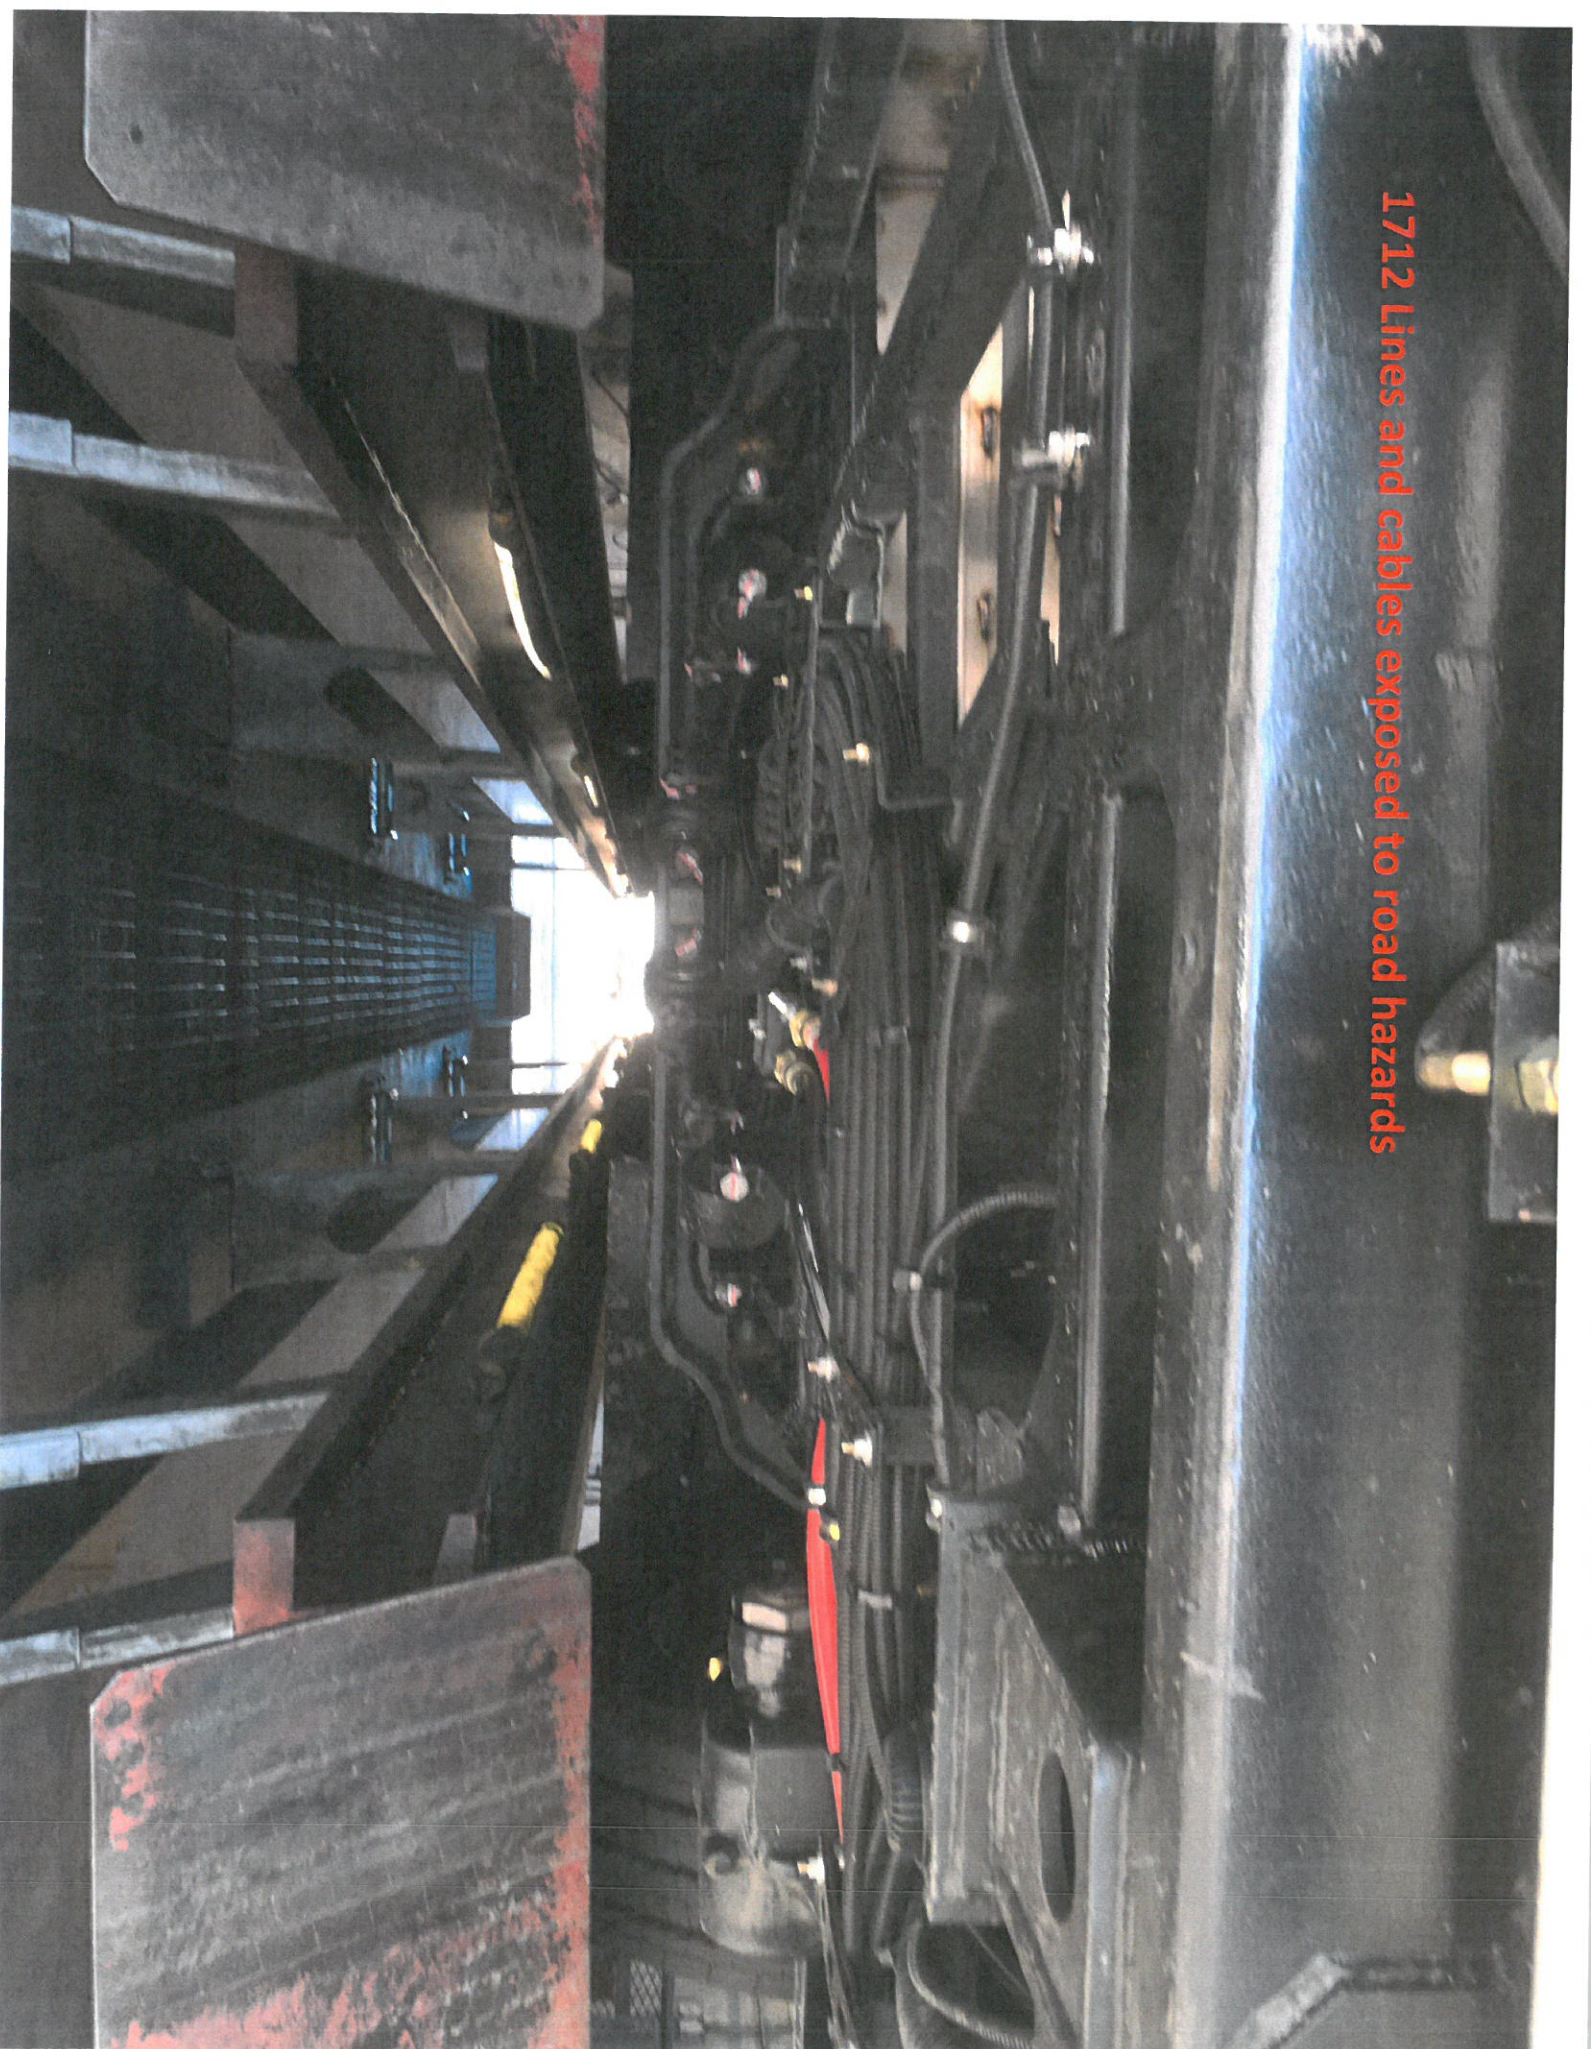
1712 Lines and cables exposed to road hazards

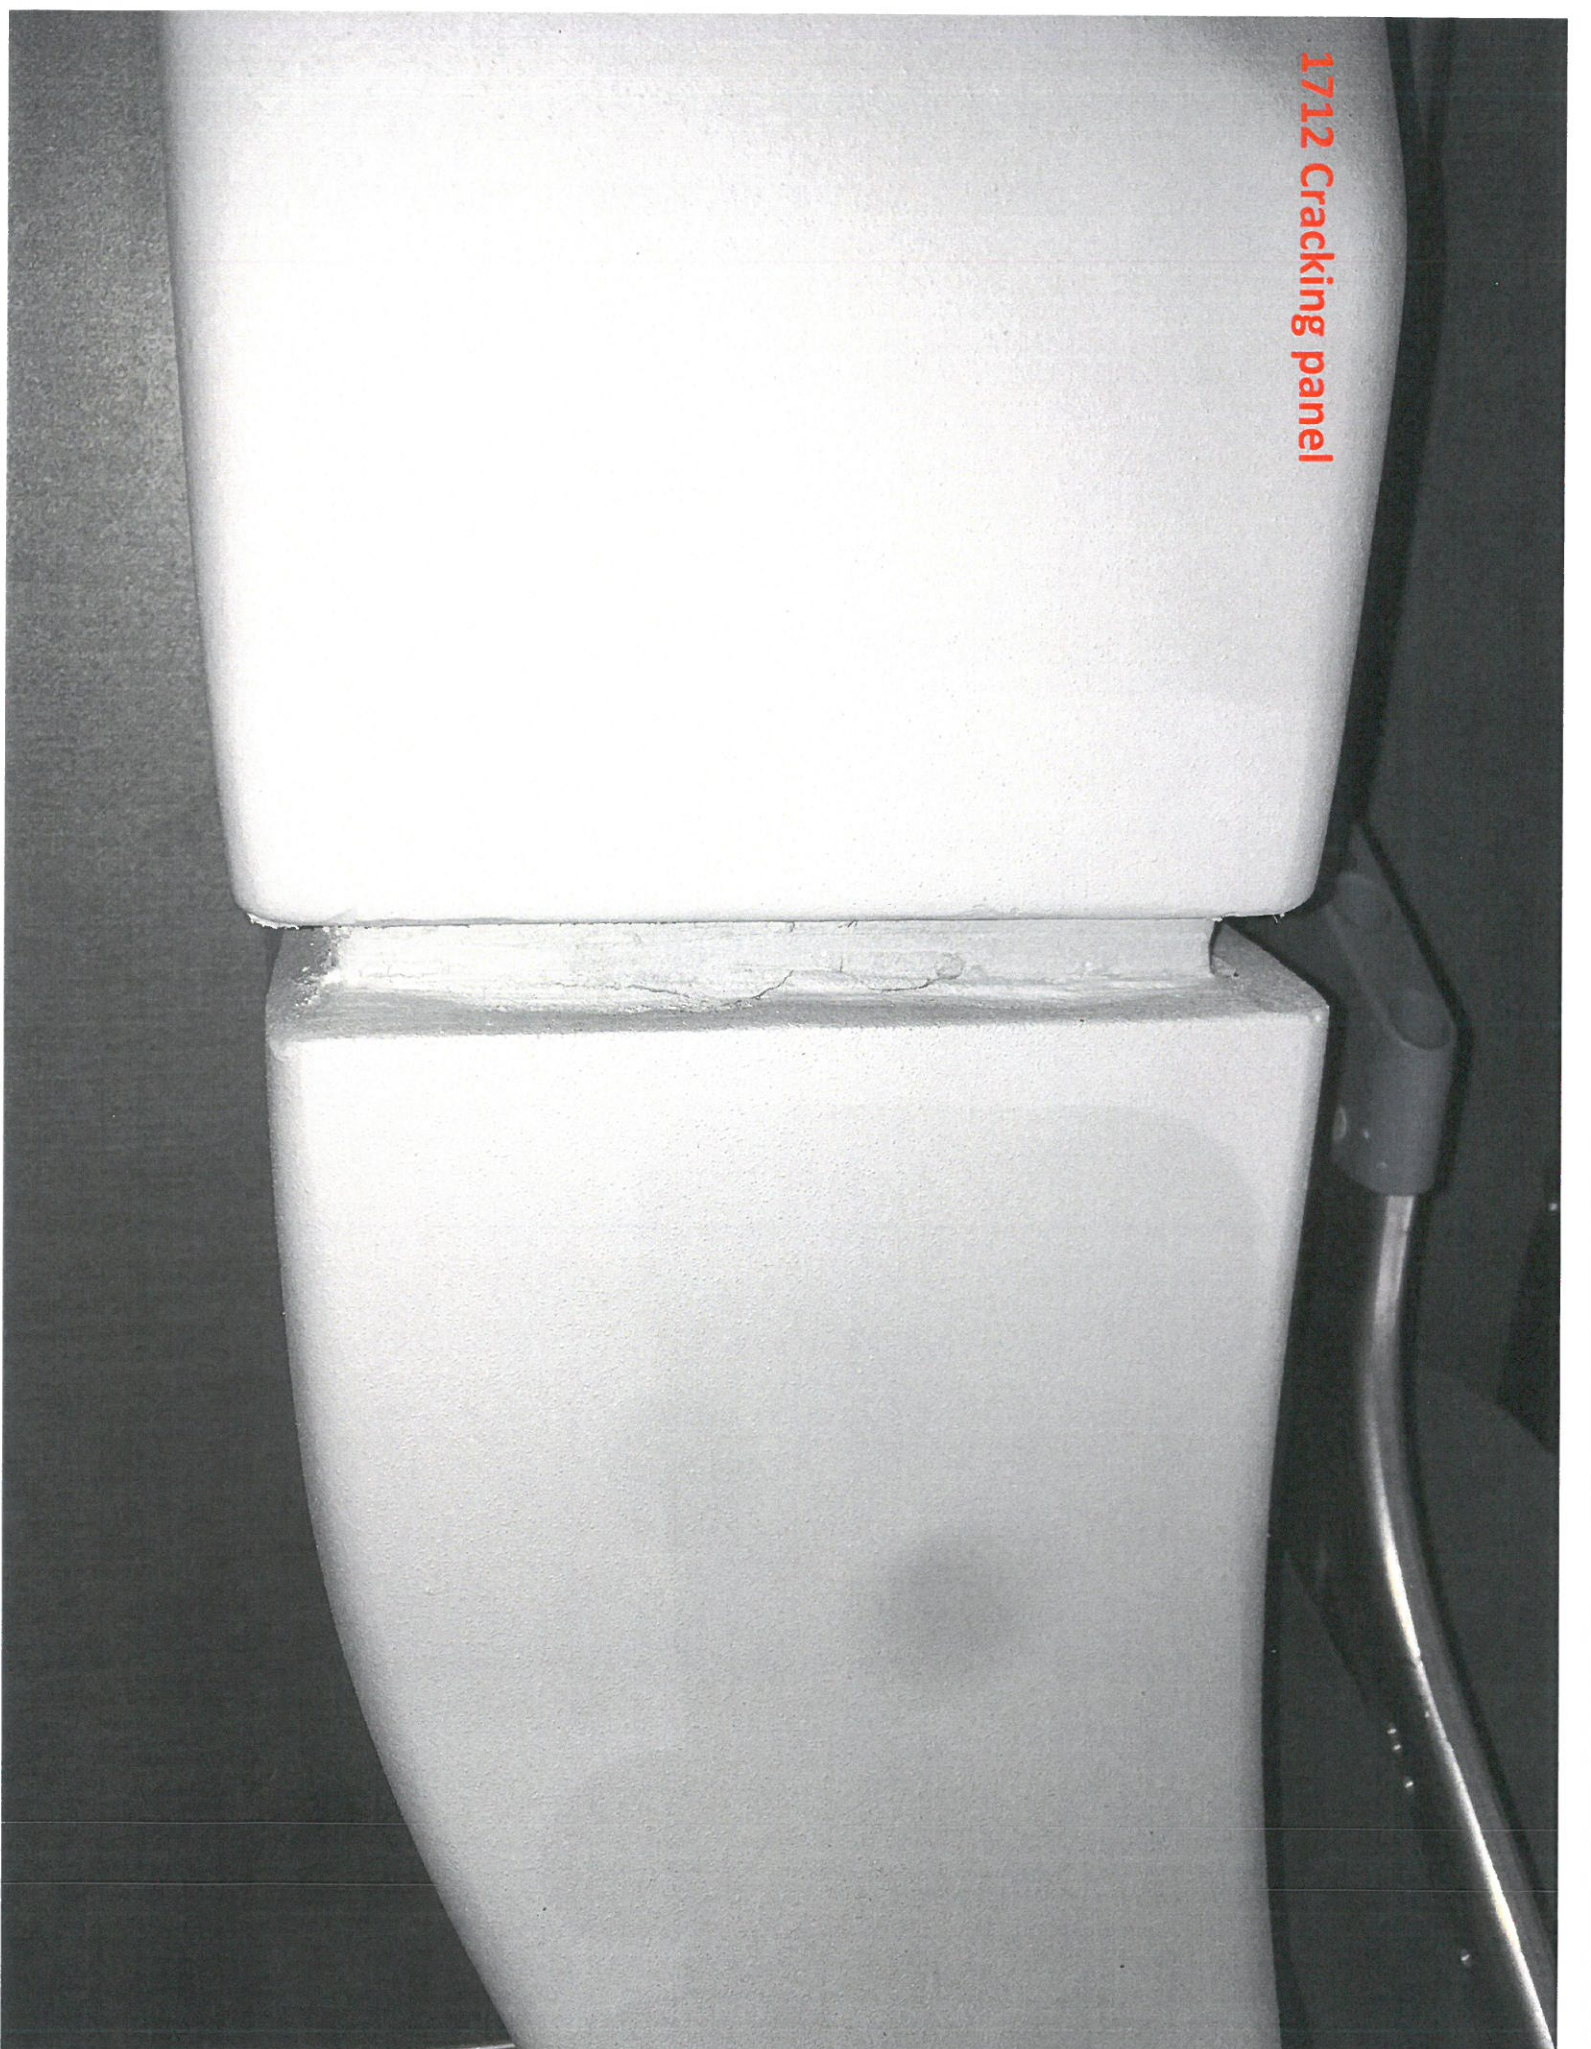
1712 Cracking panel

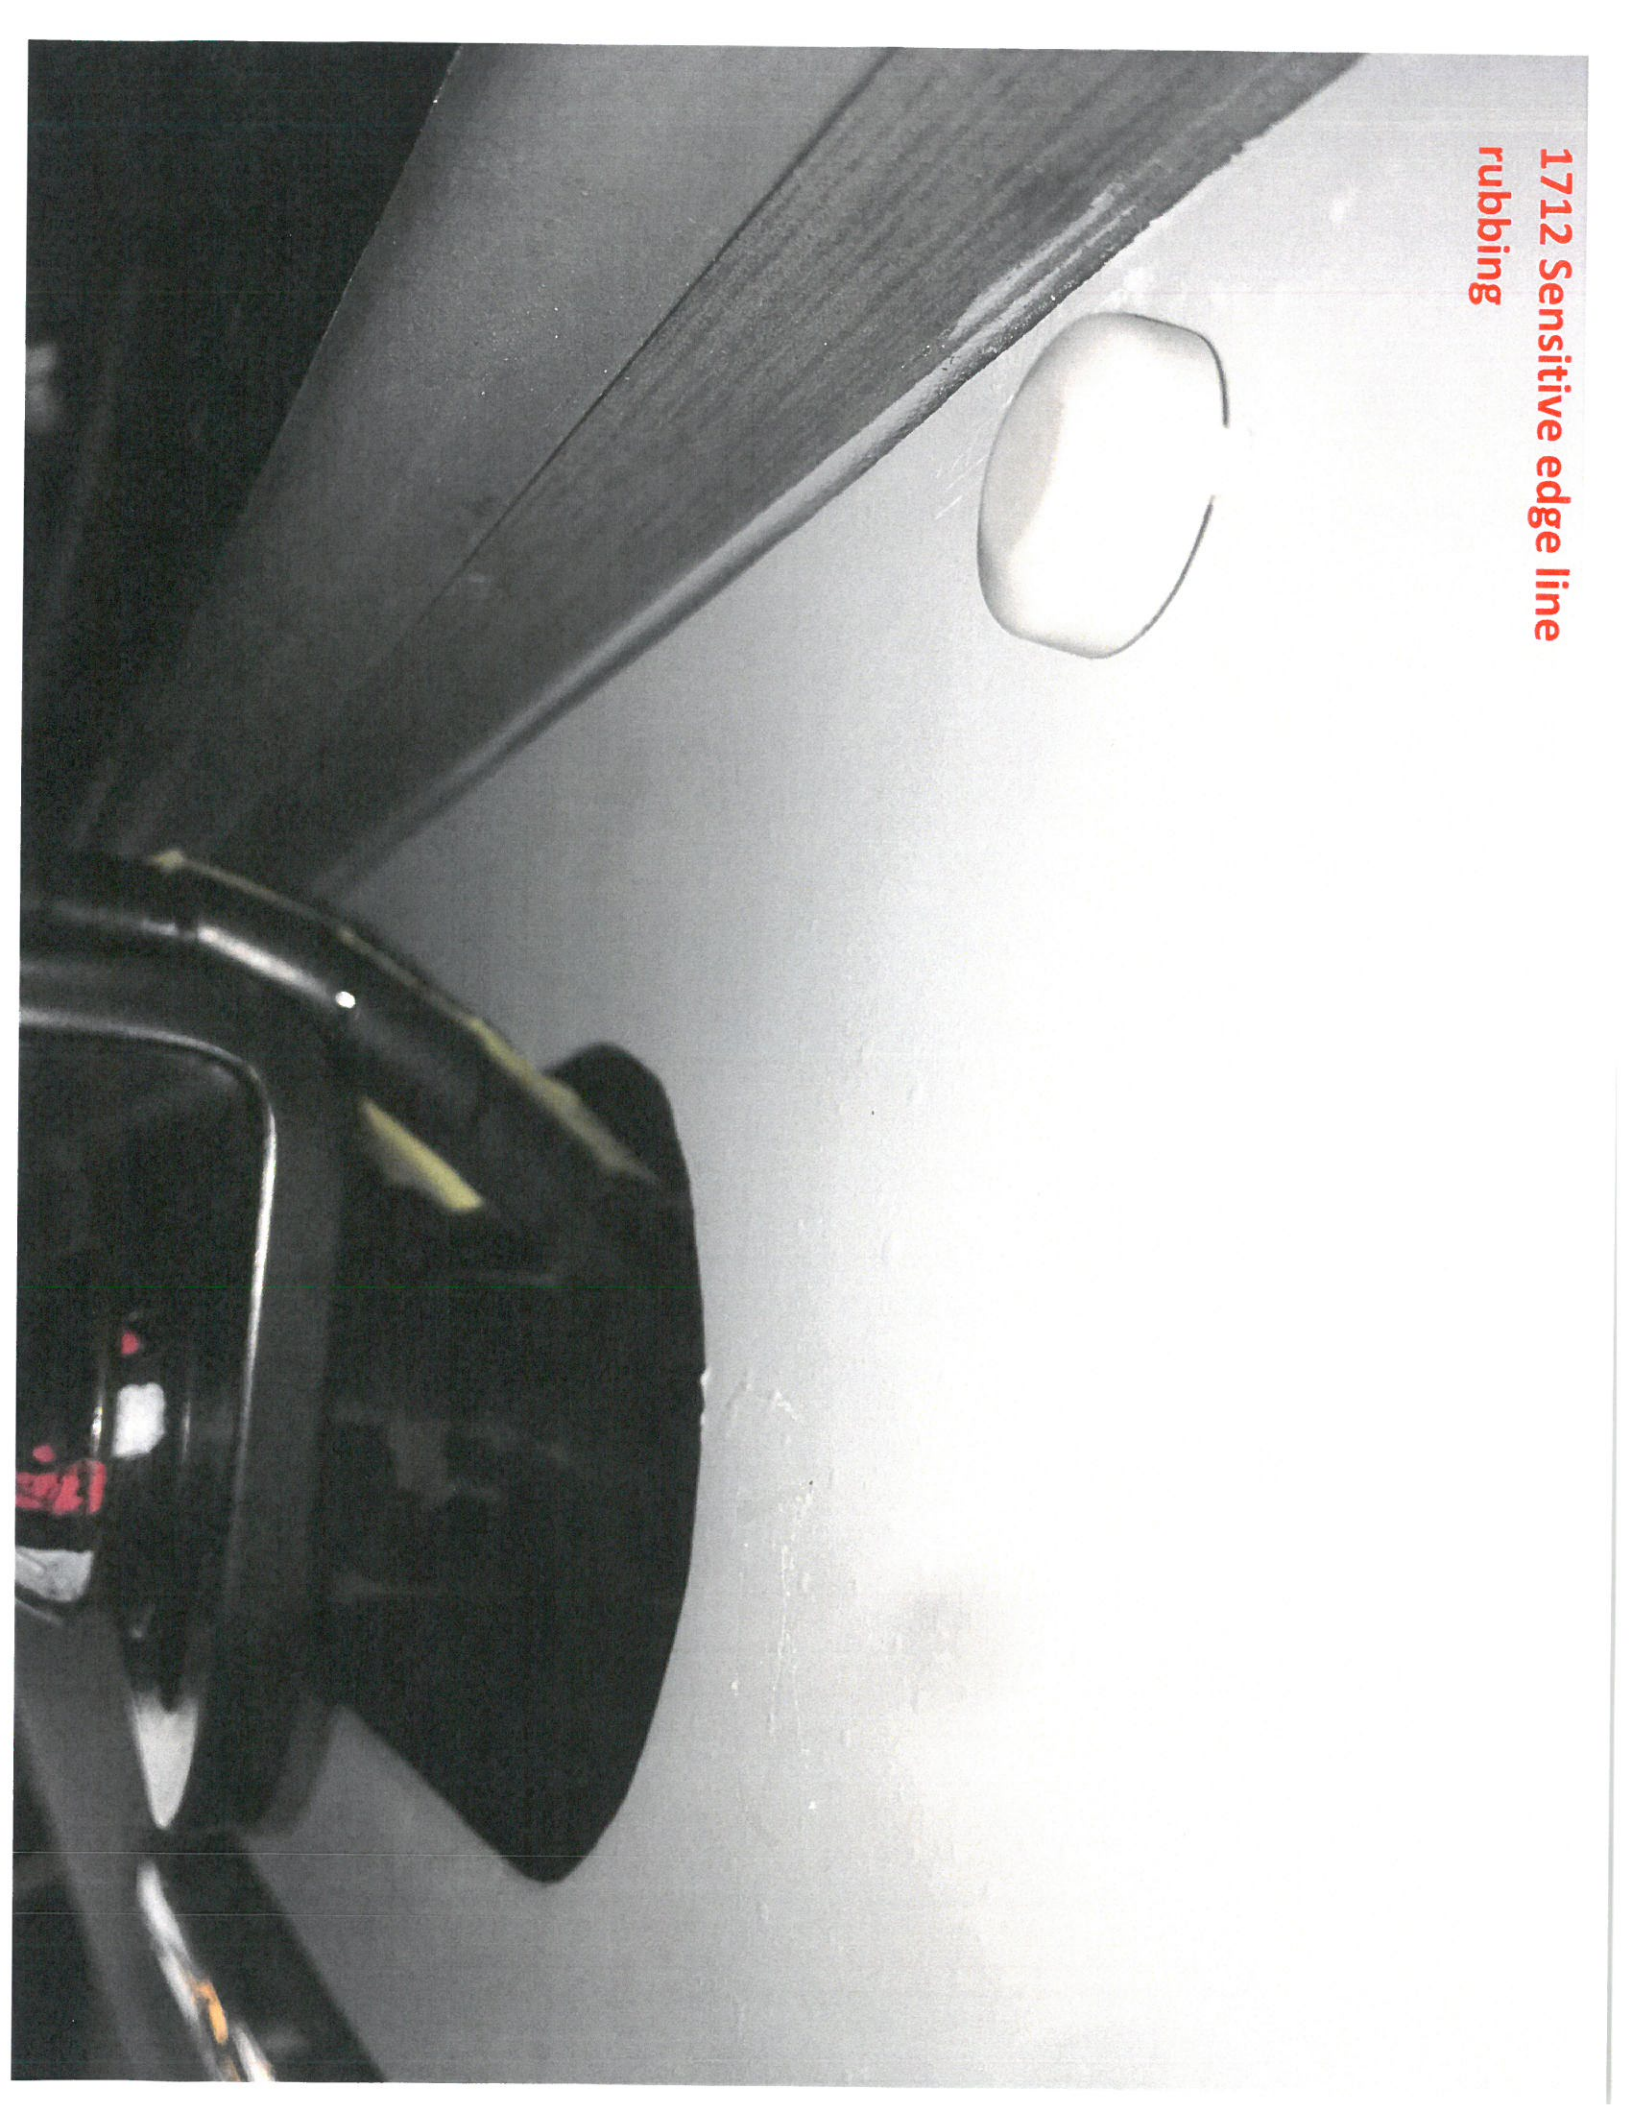
1712 Sensitive edge line  
rubbing
