1713

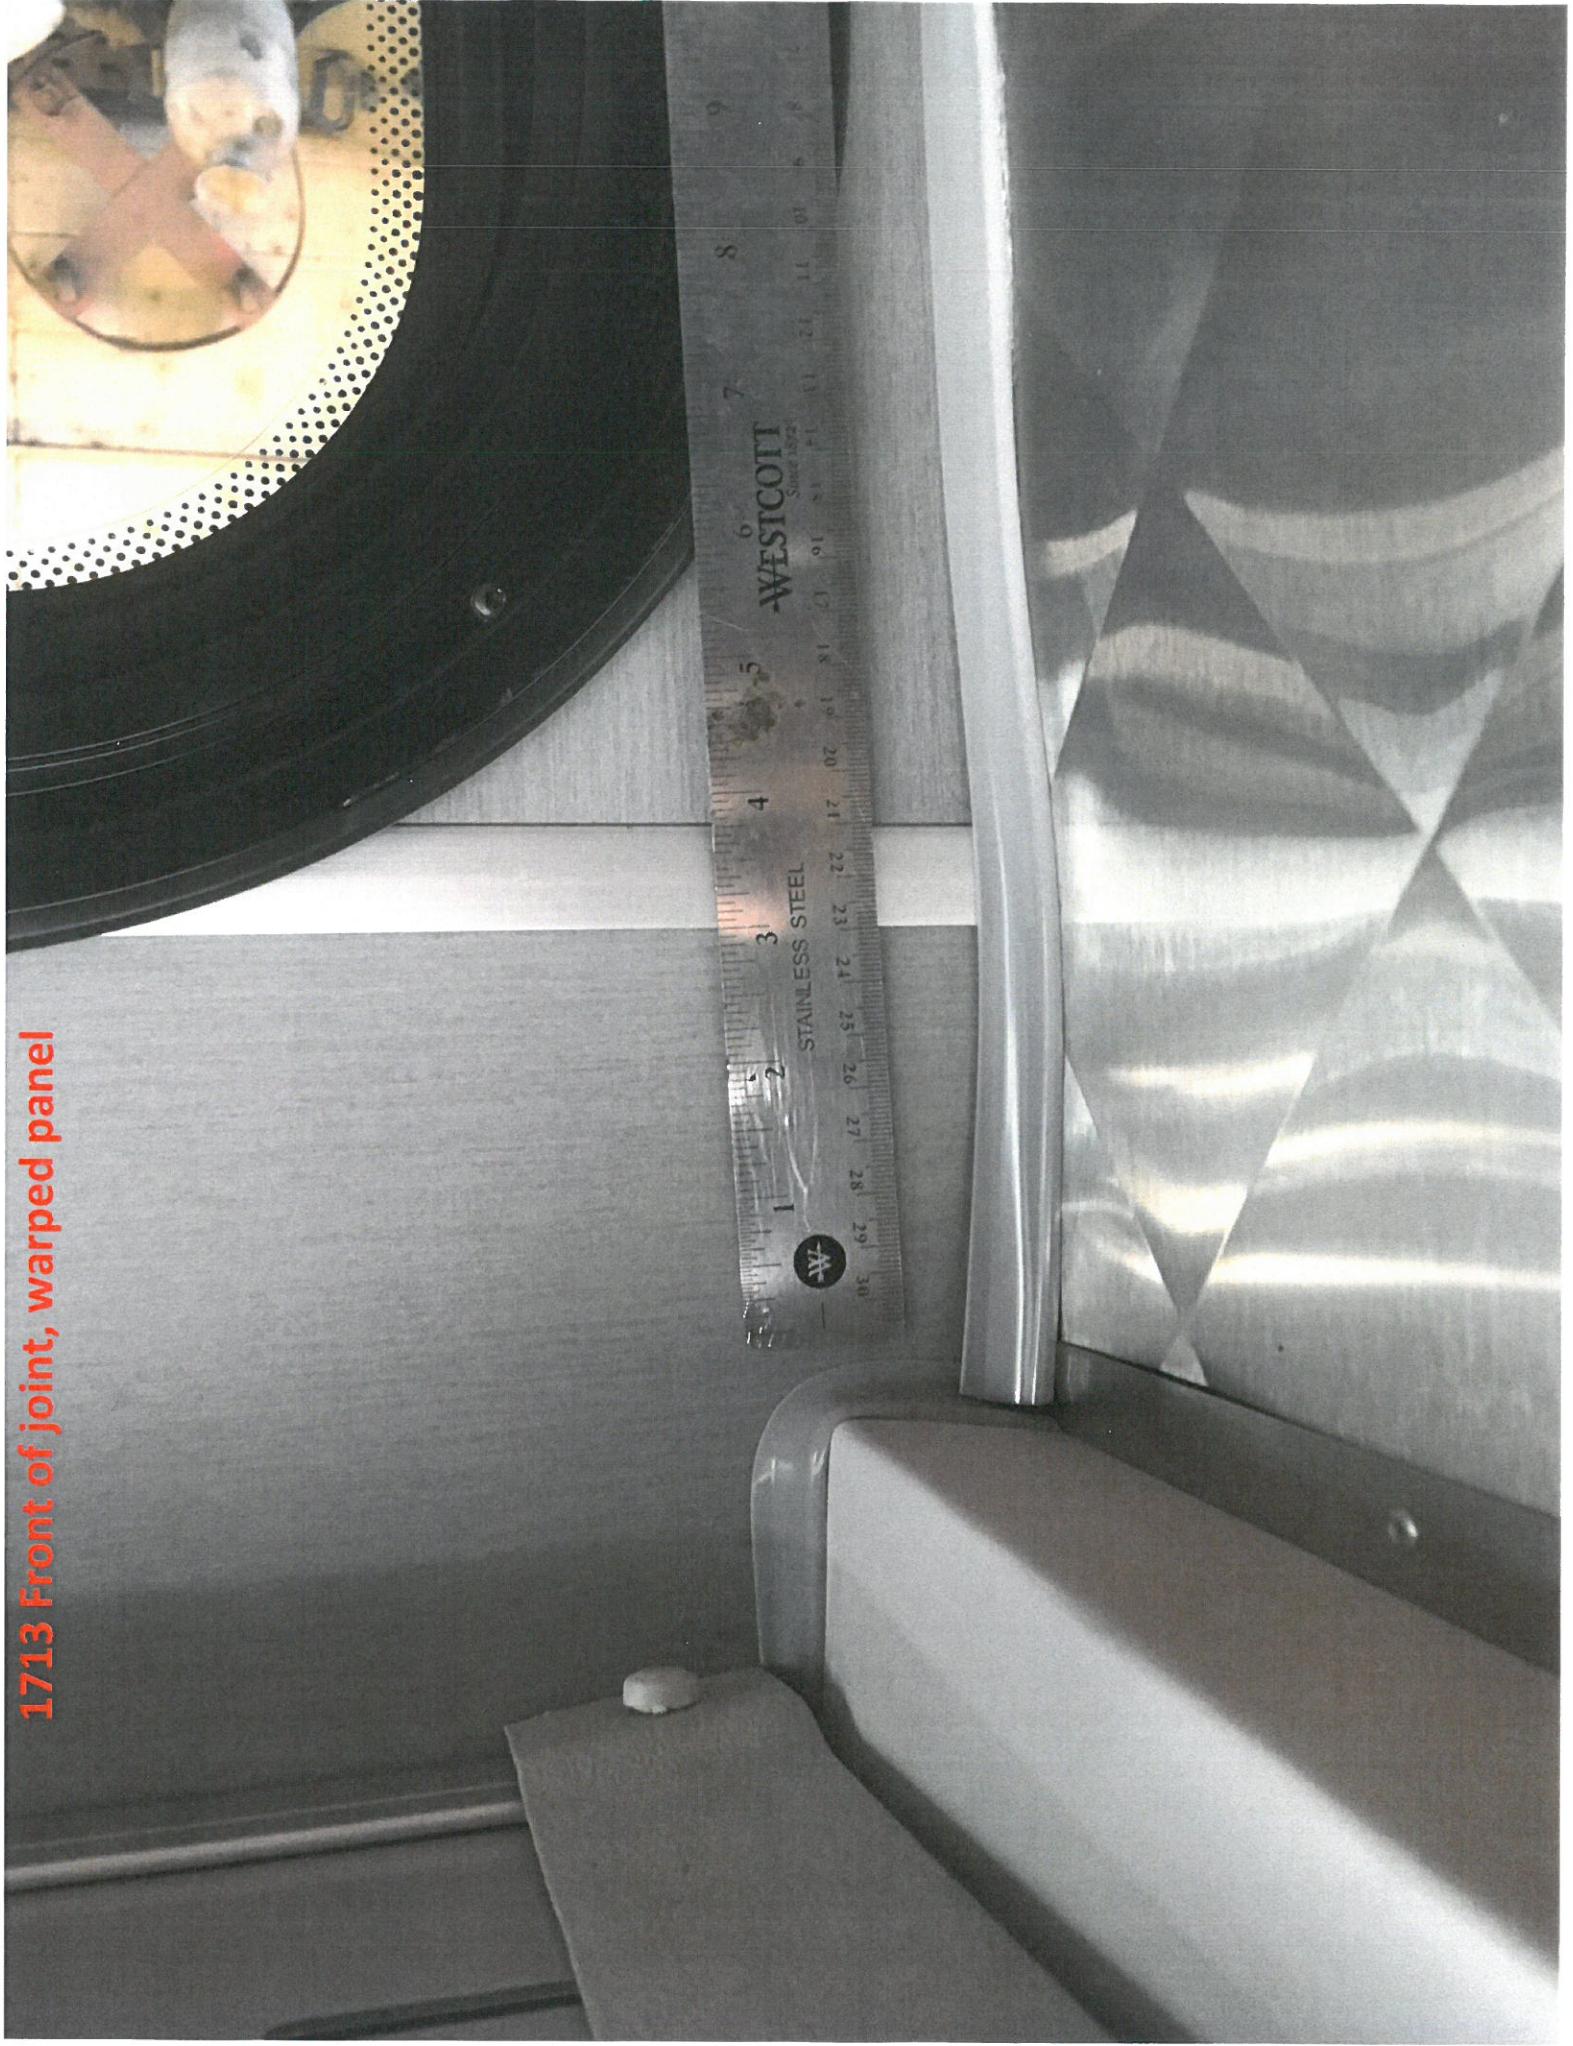
1713 Front of joint, warped panel

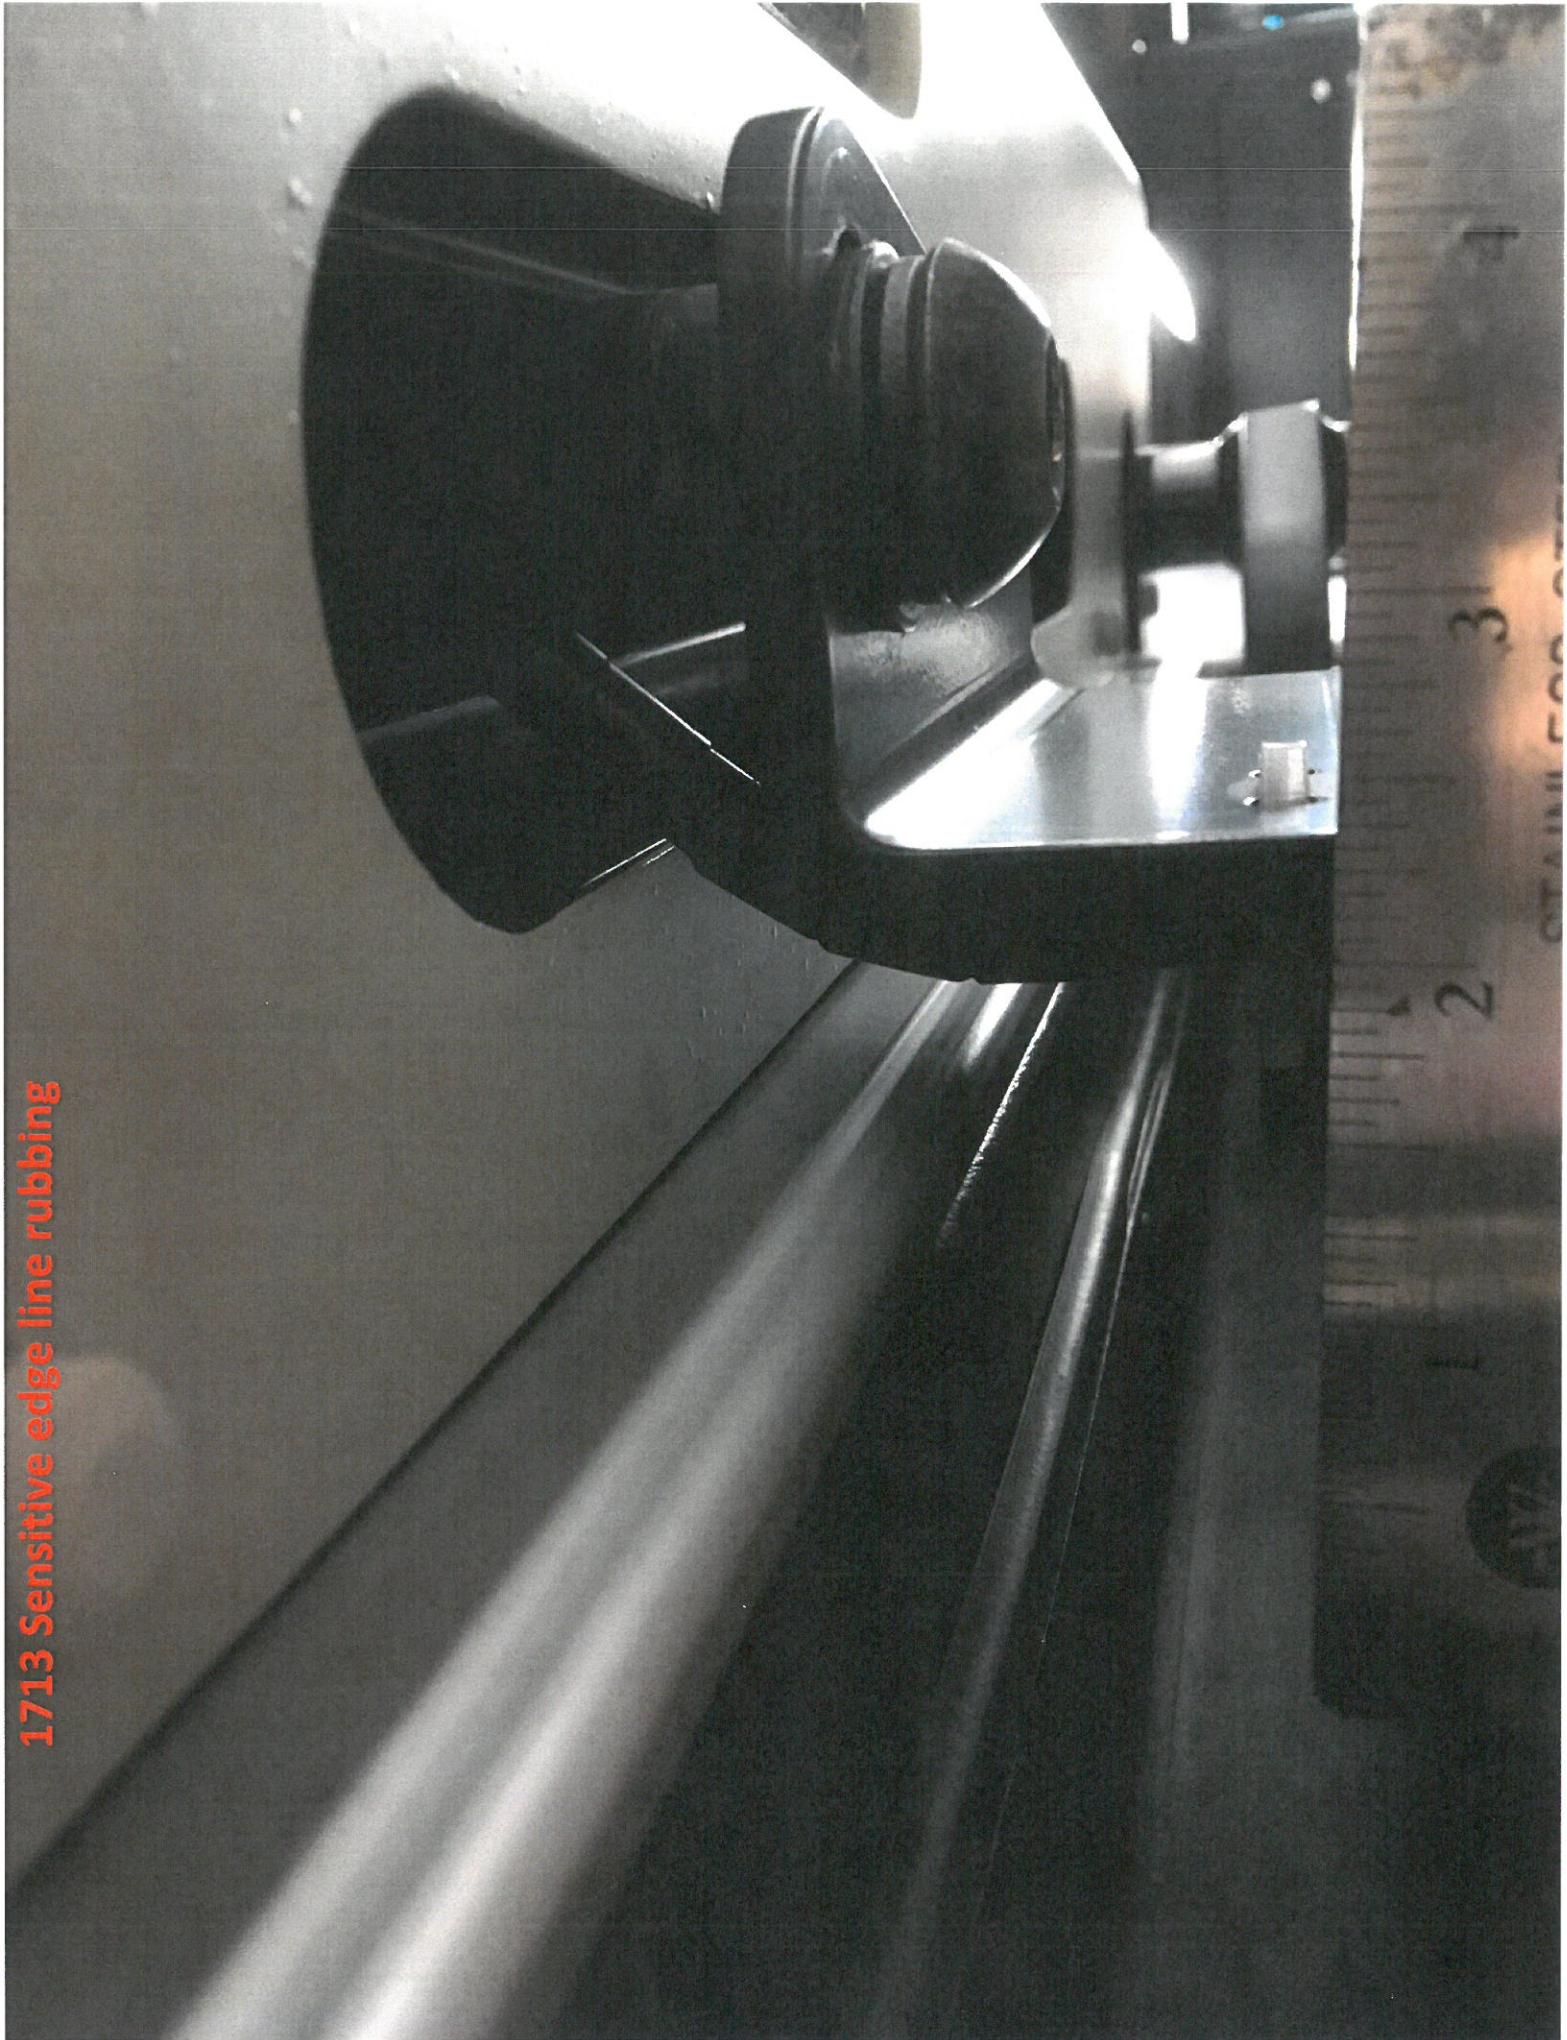
1713 Sensitive edge line rubbing

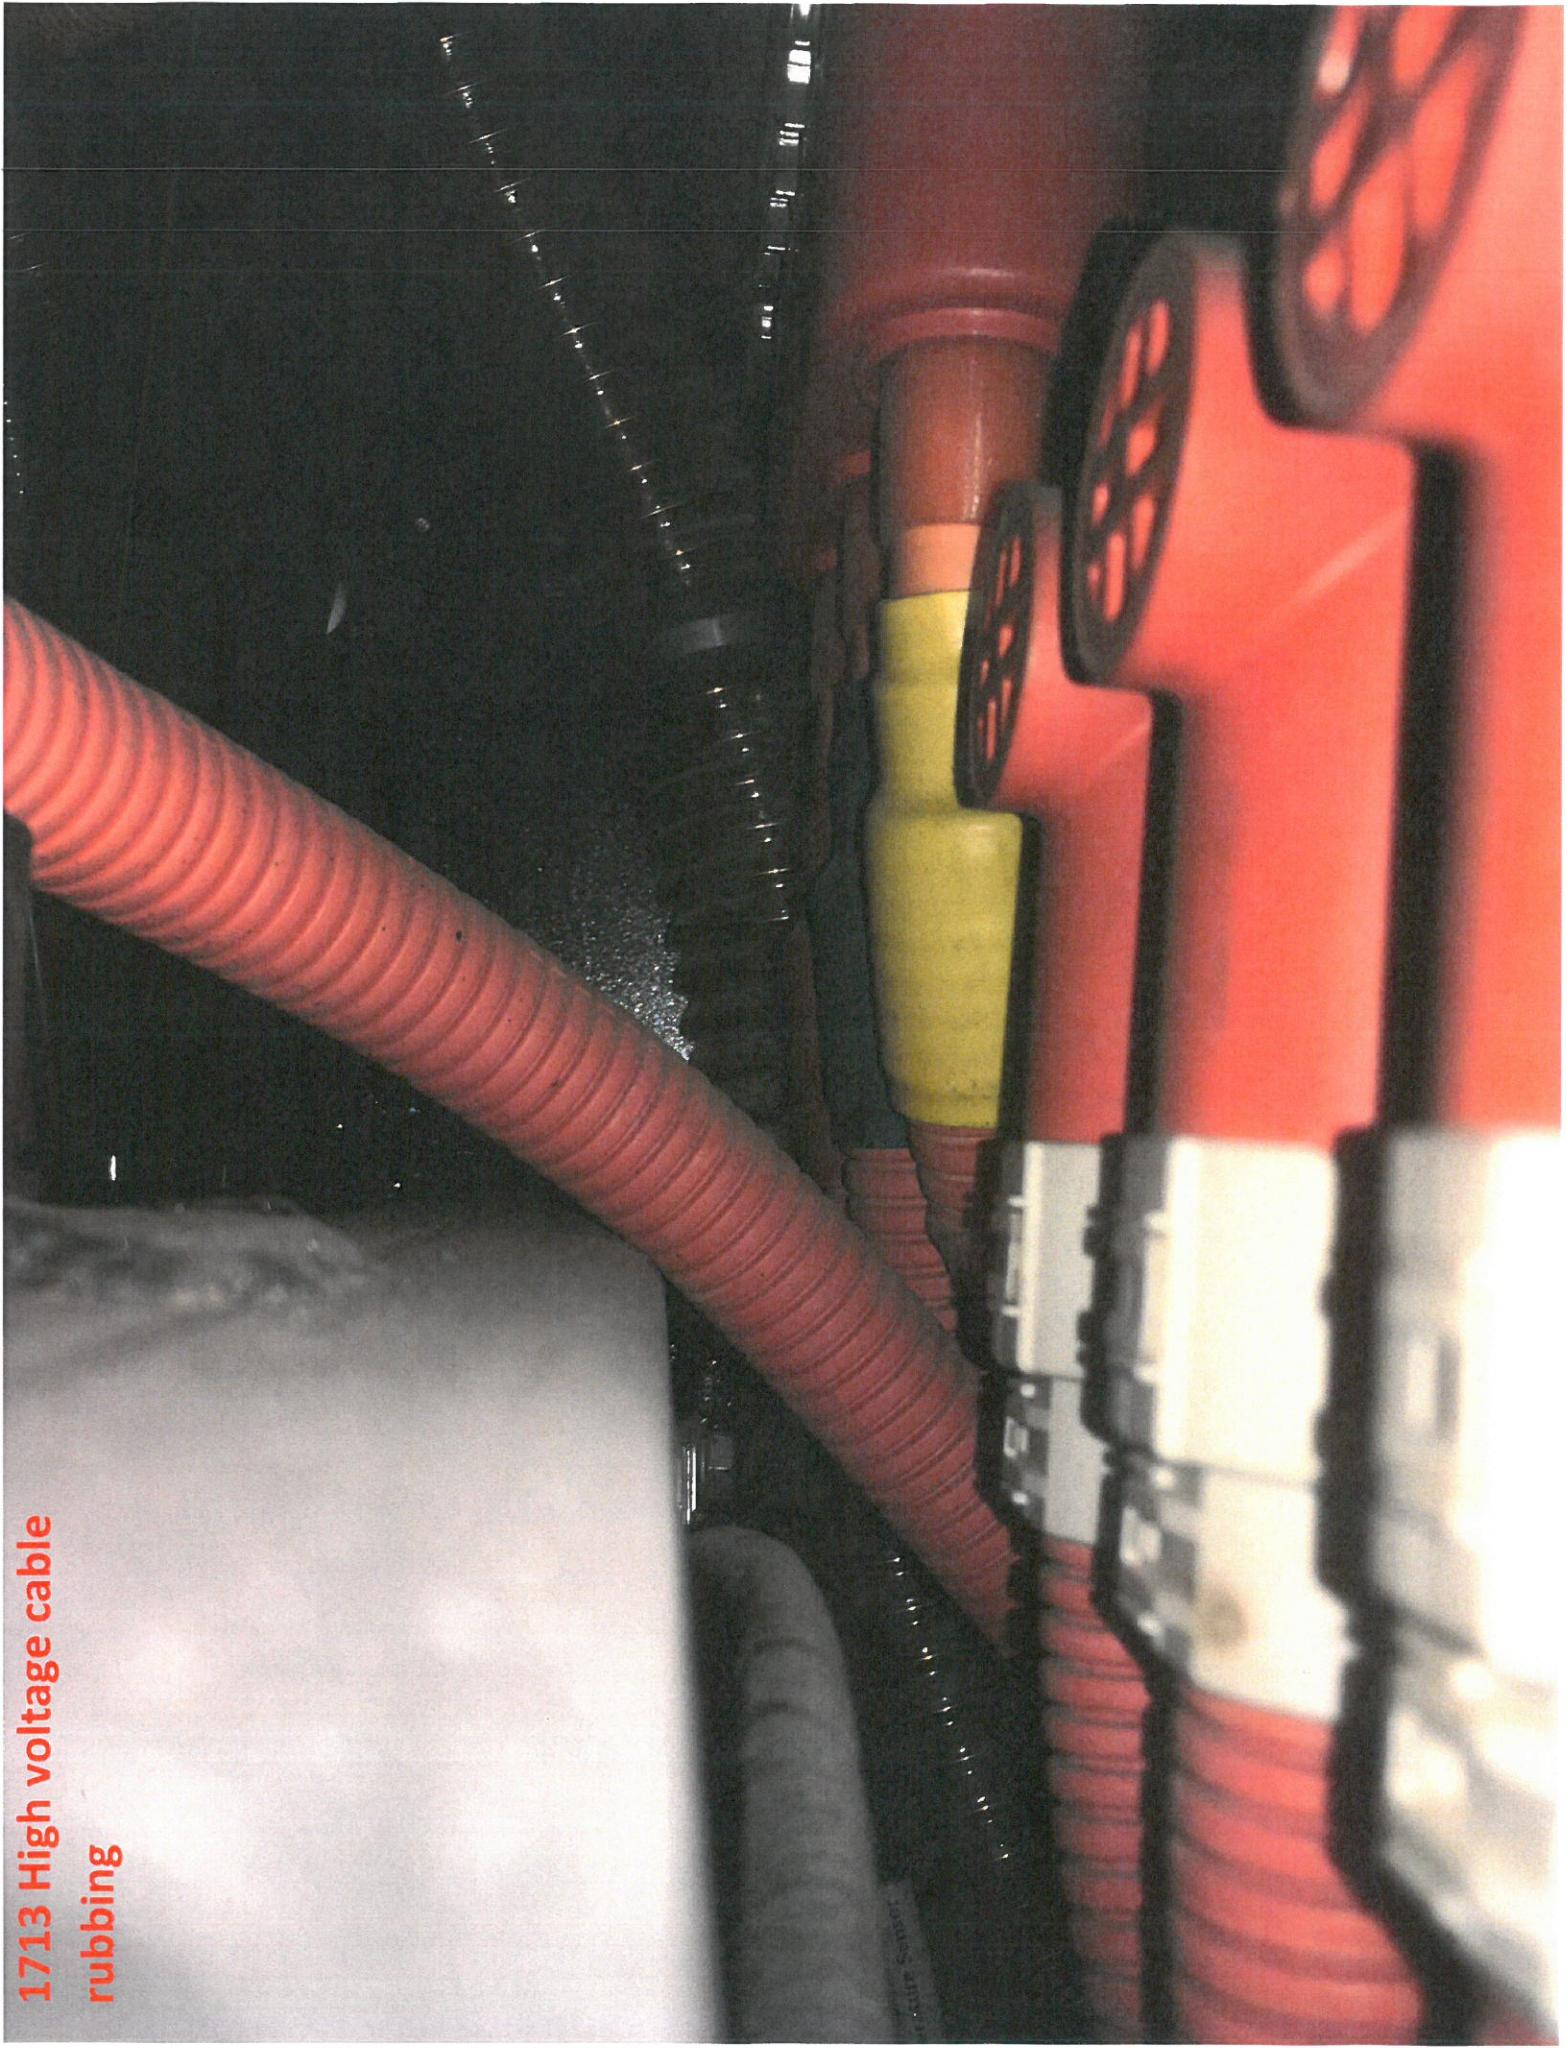
1713 High voltage cable
rubbing

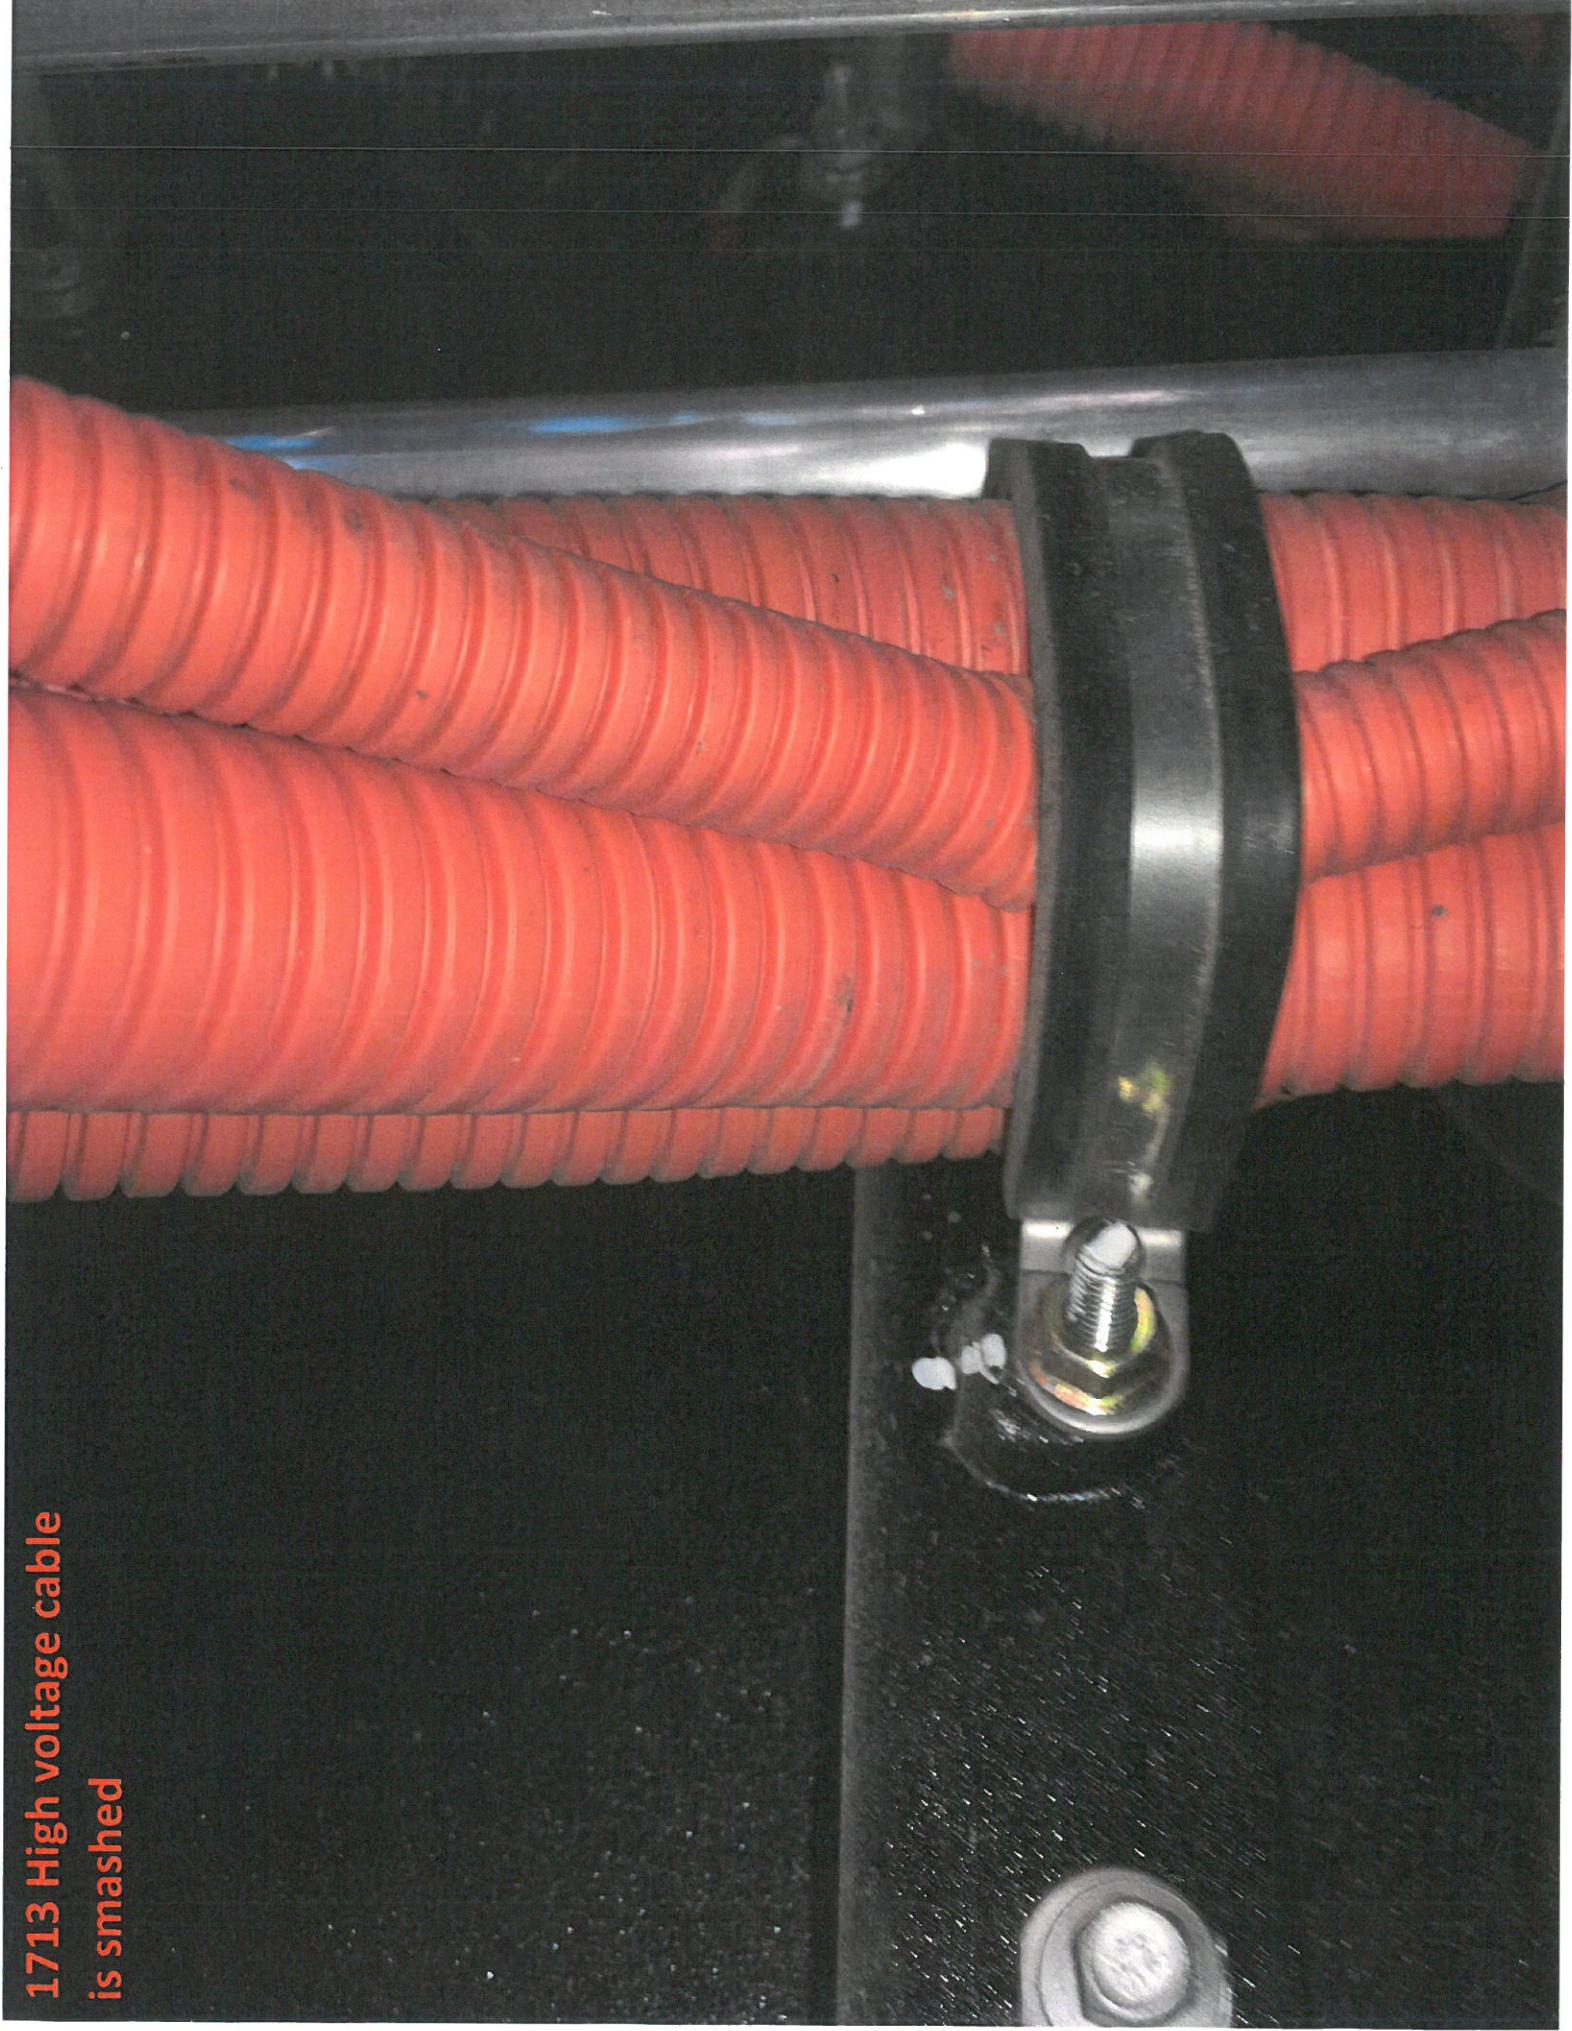
1713 High voltage cable
is smashed

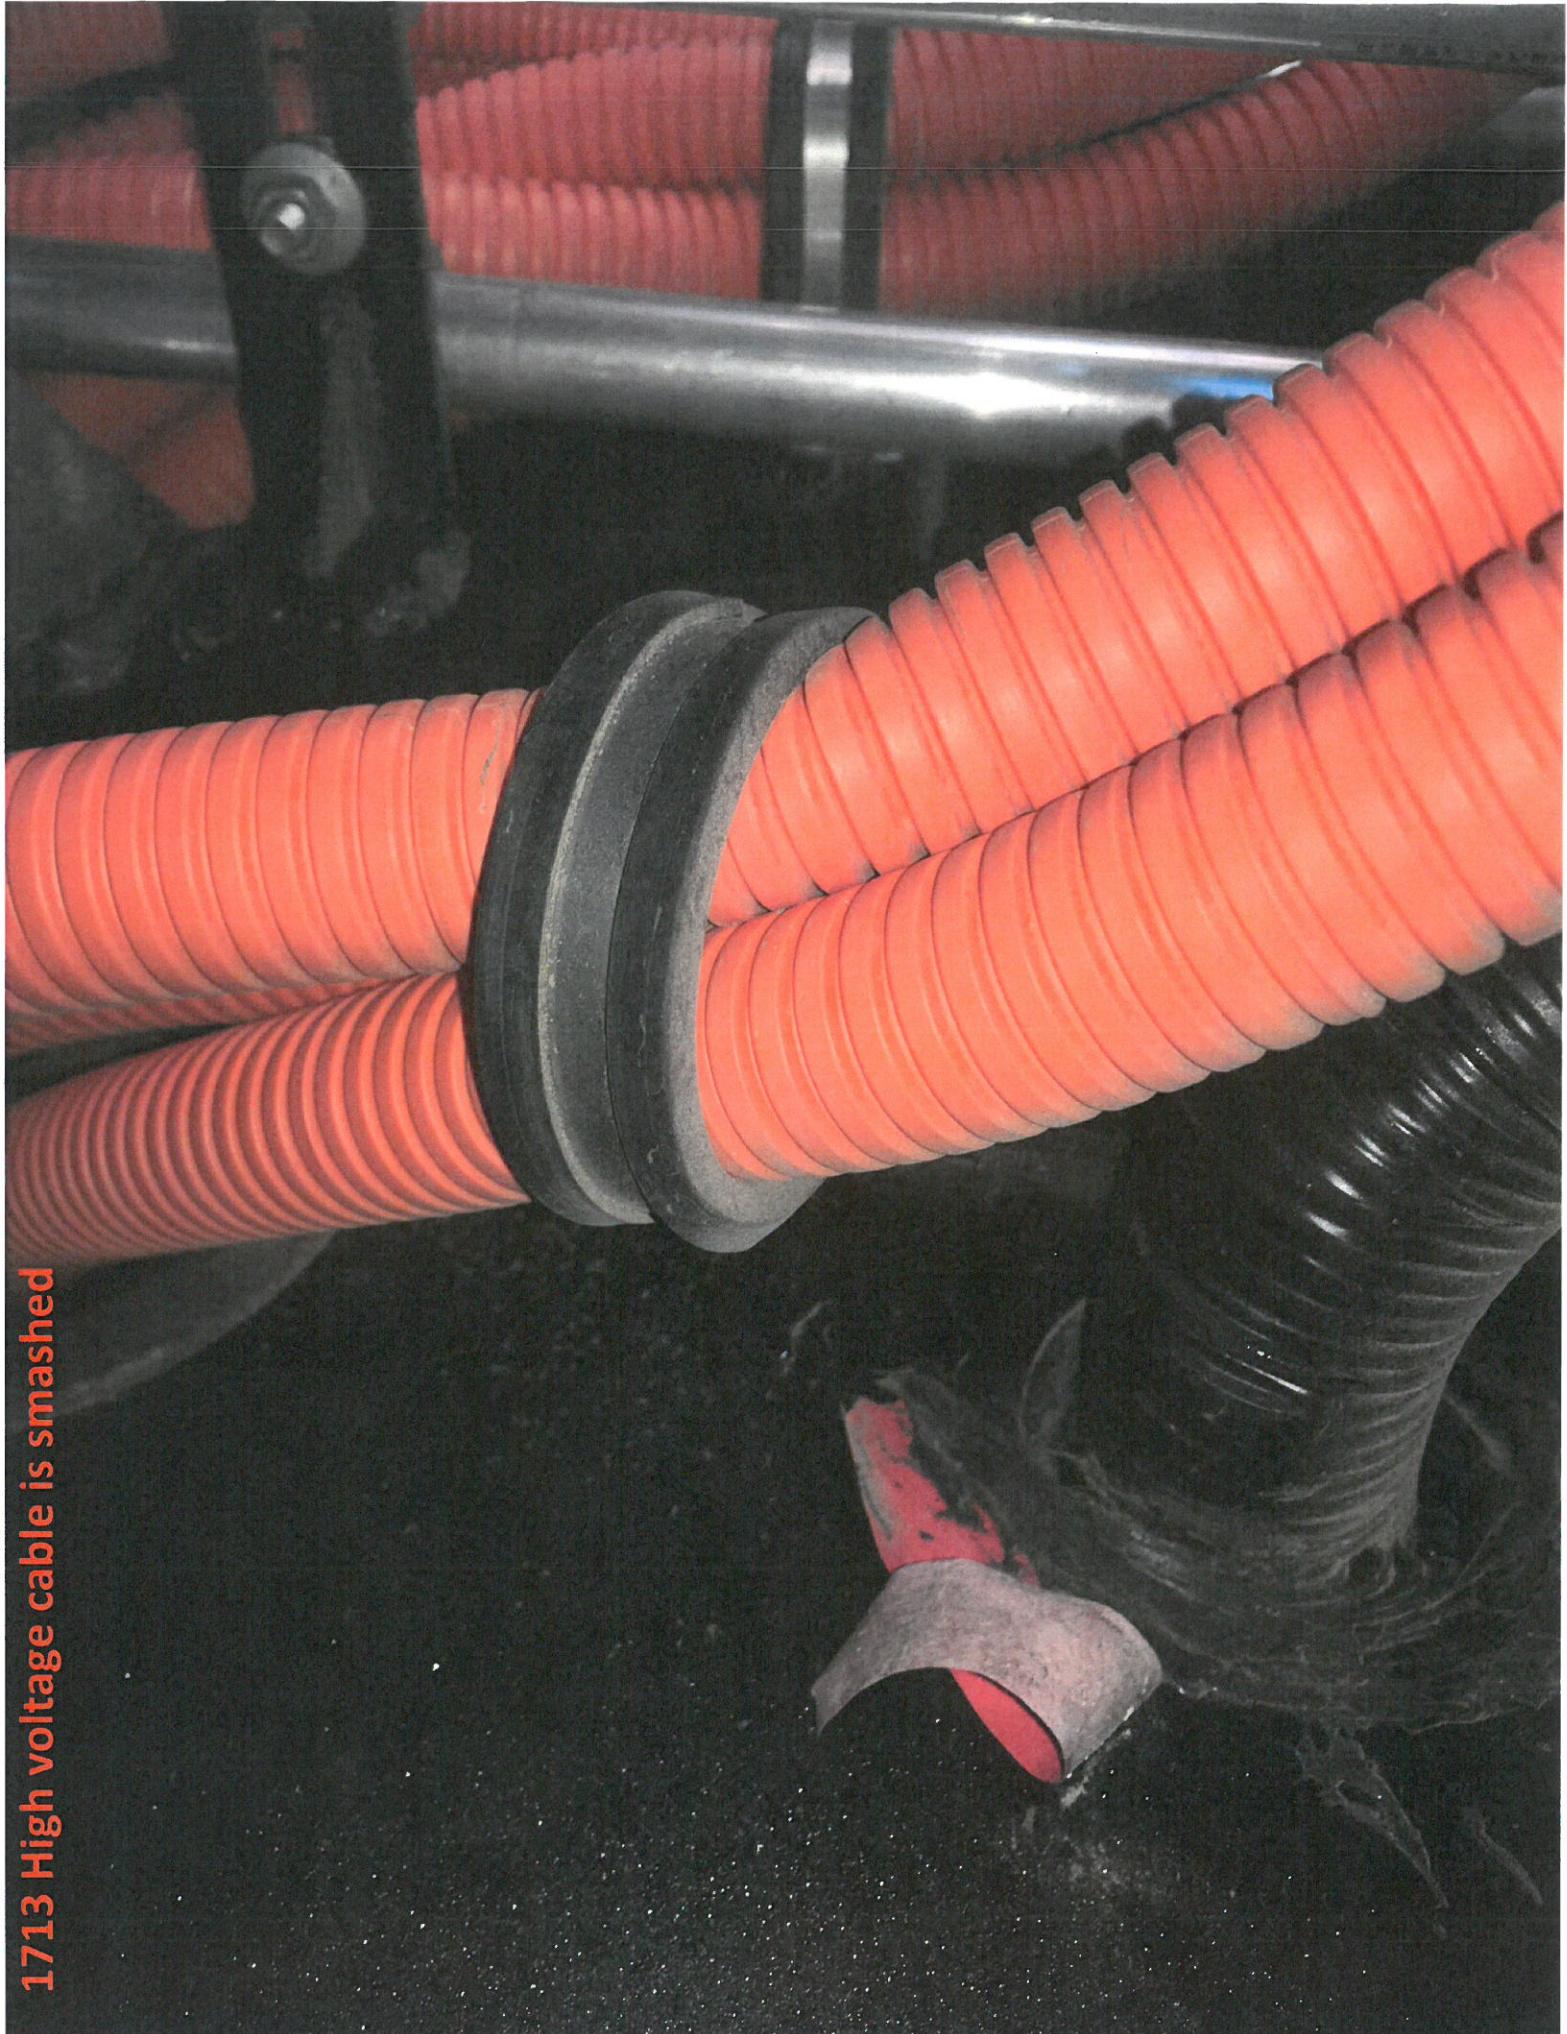
1713 High voltage cable is smashed

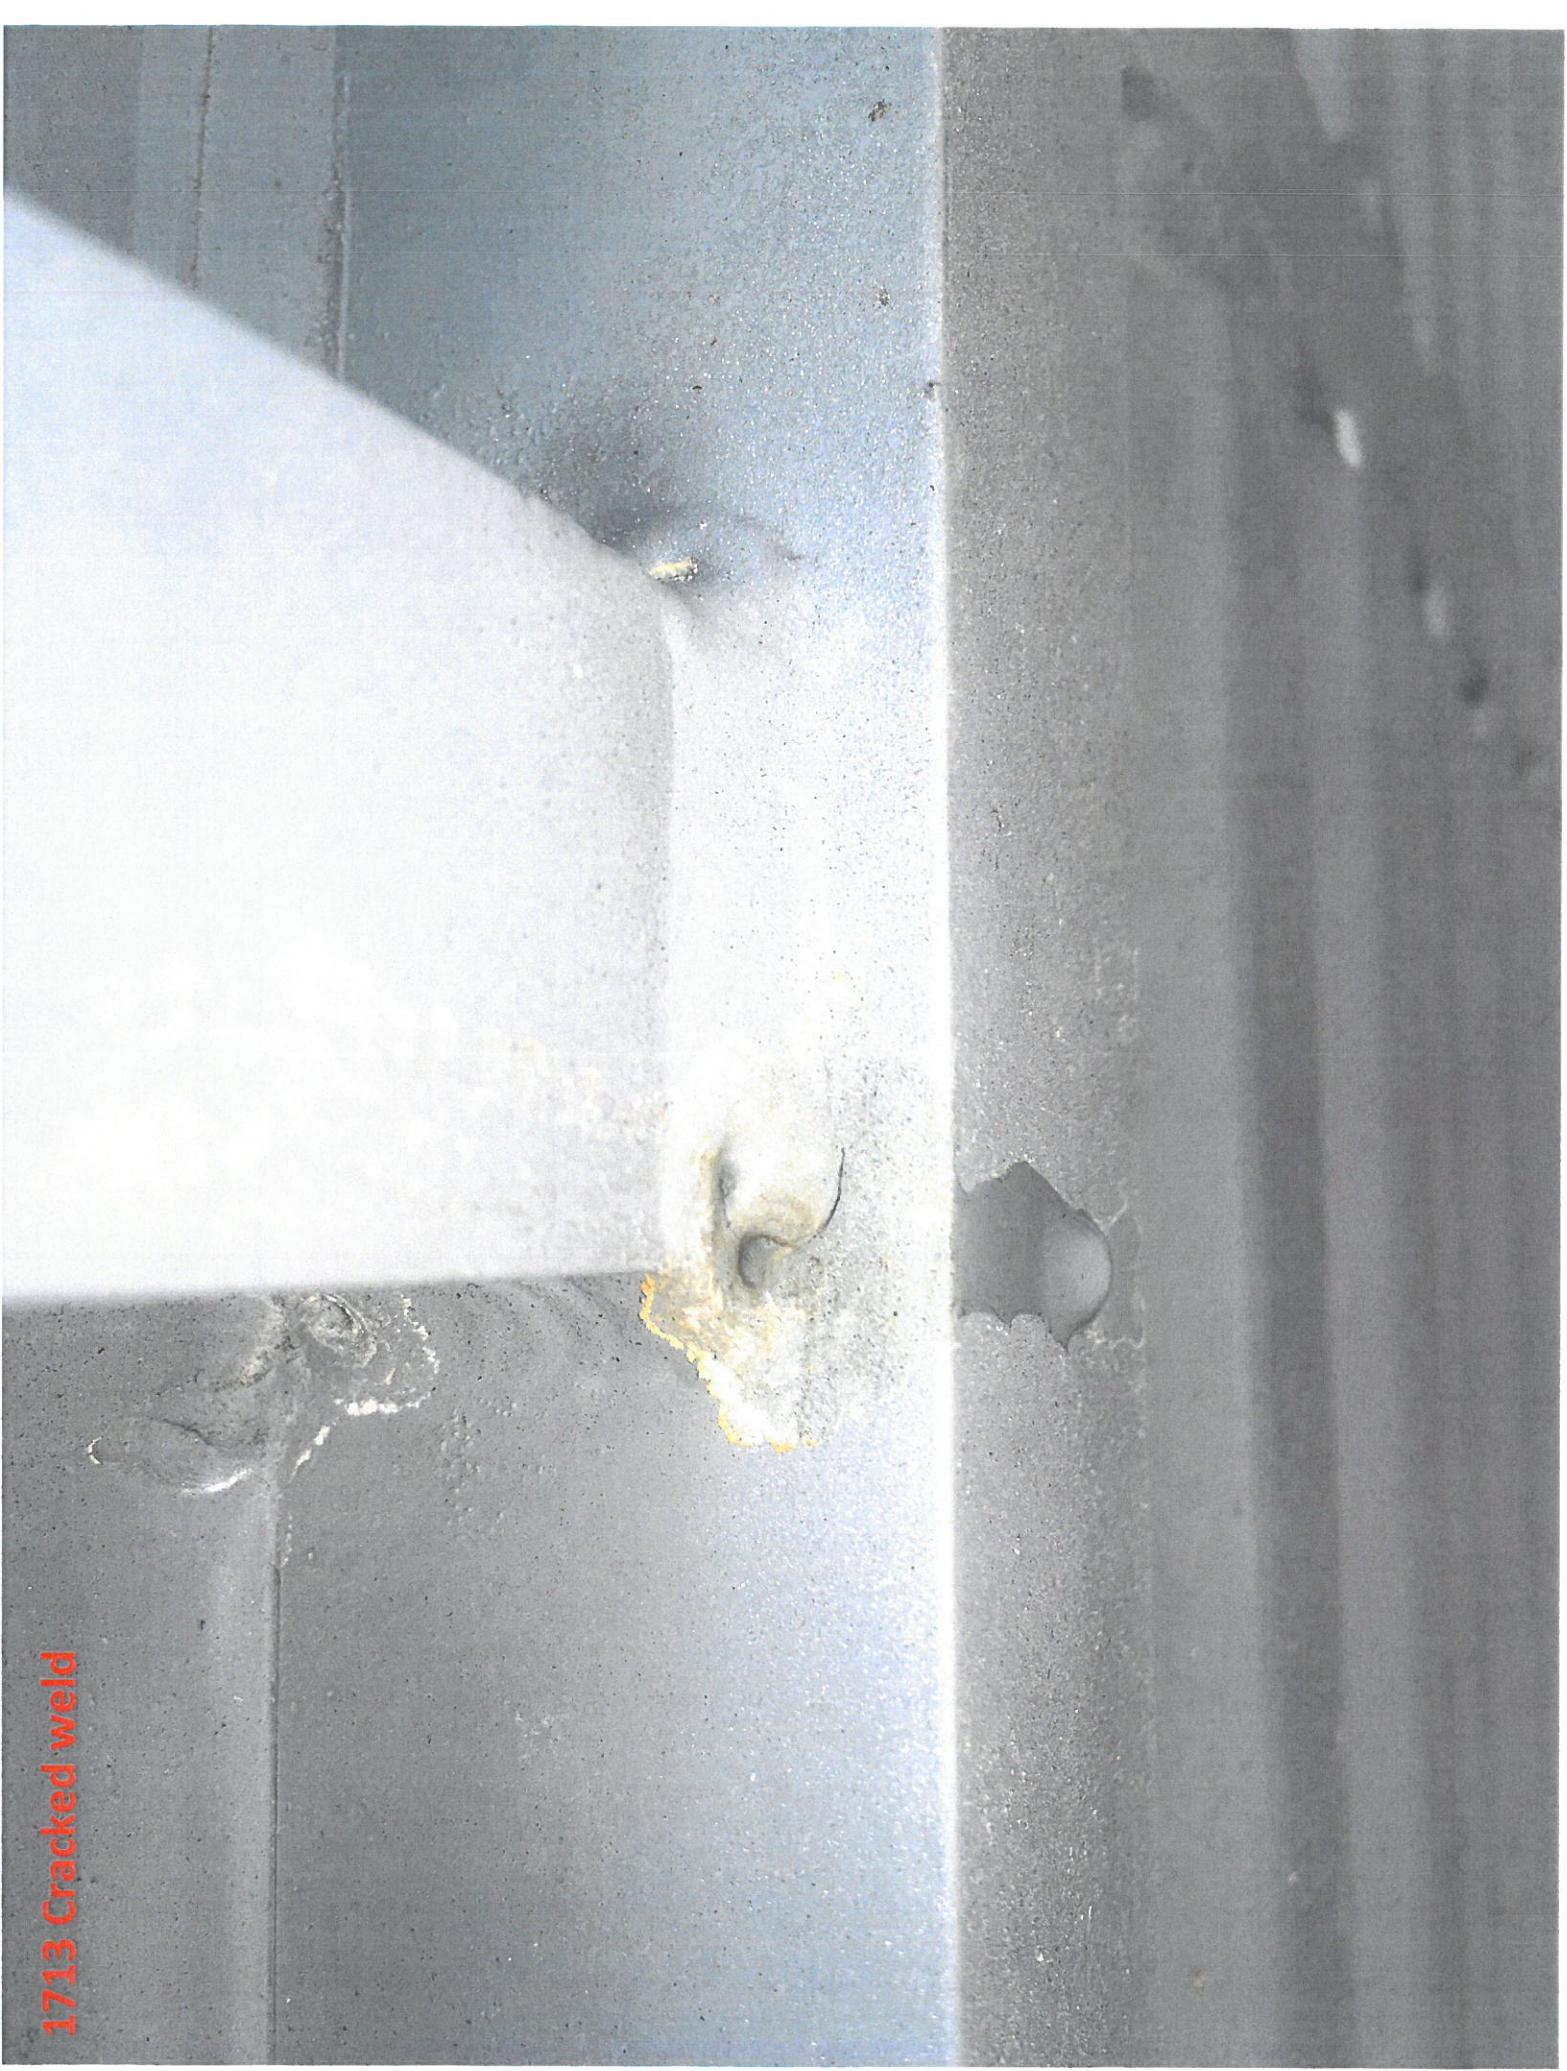
1713 Cracked weld

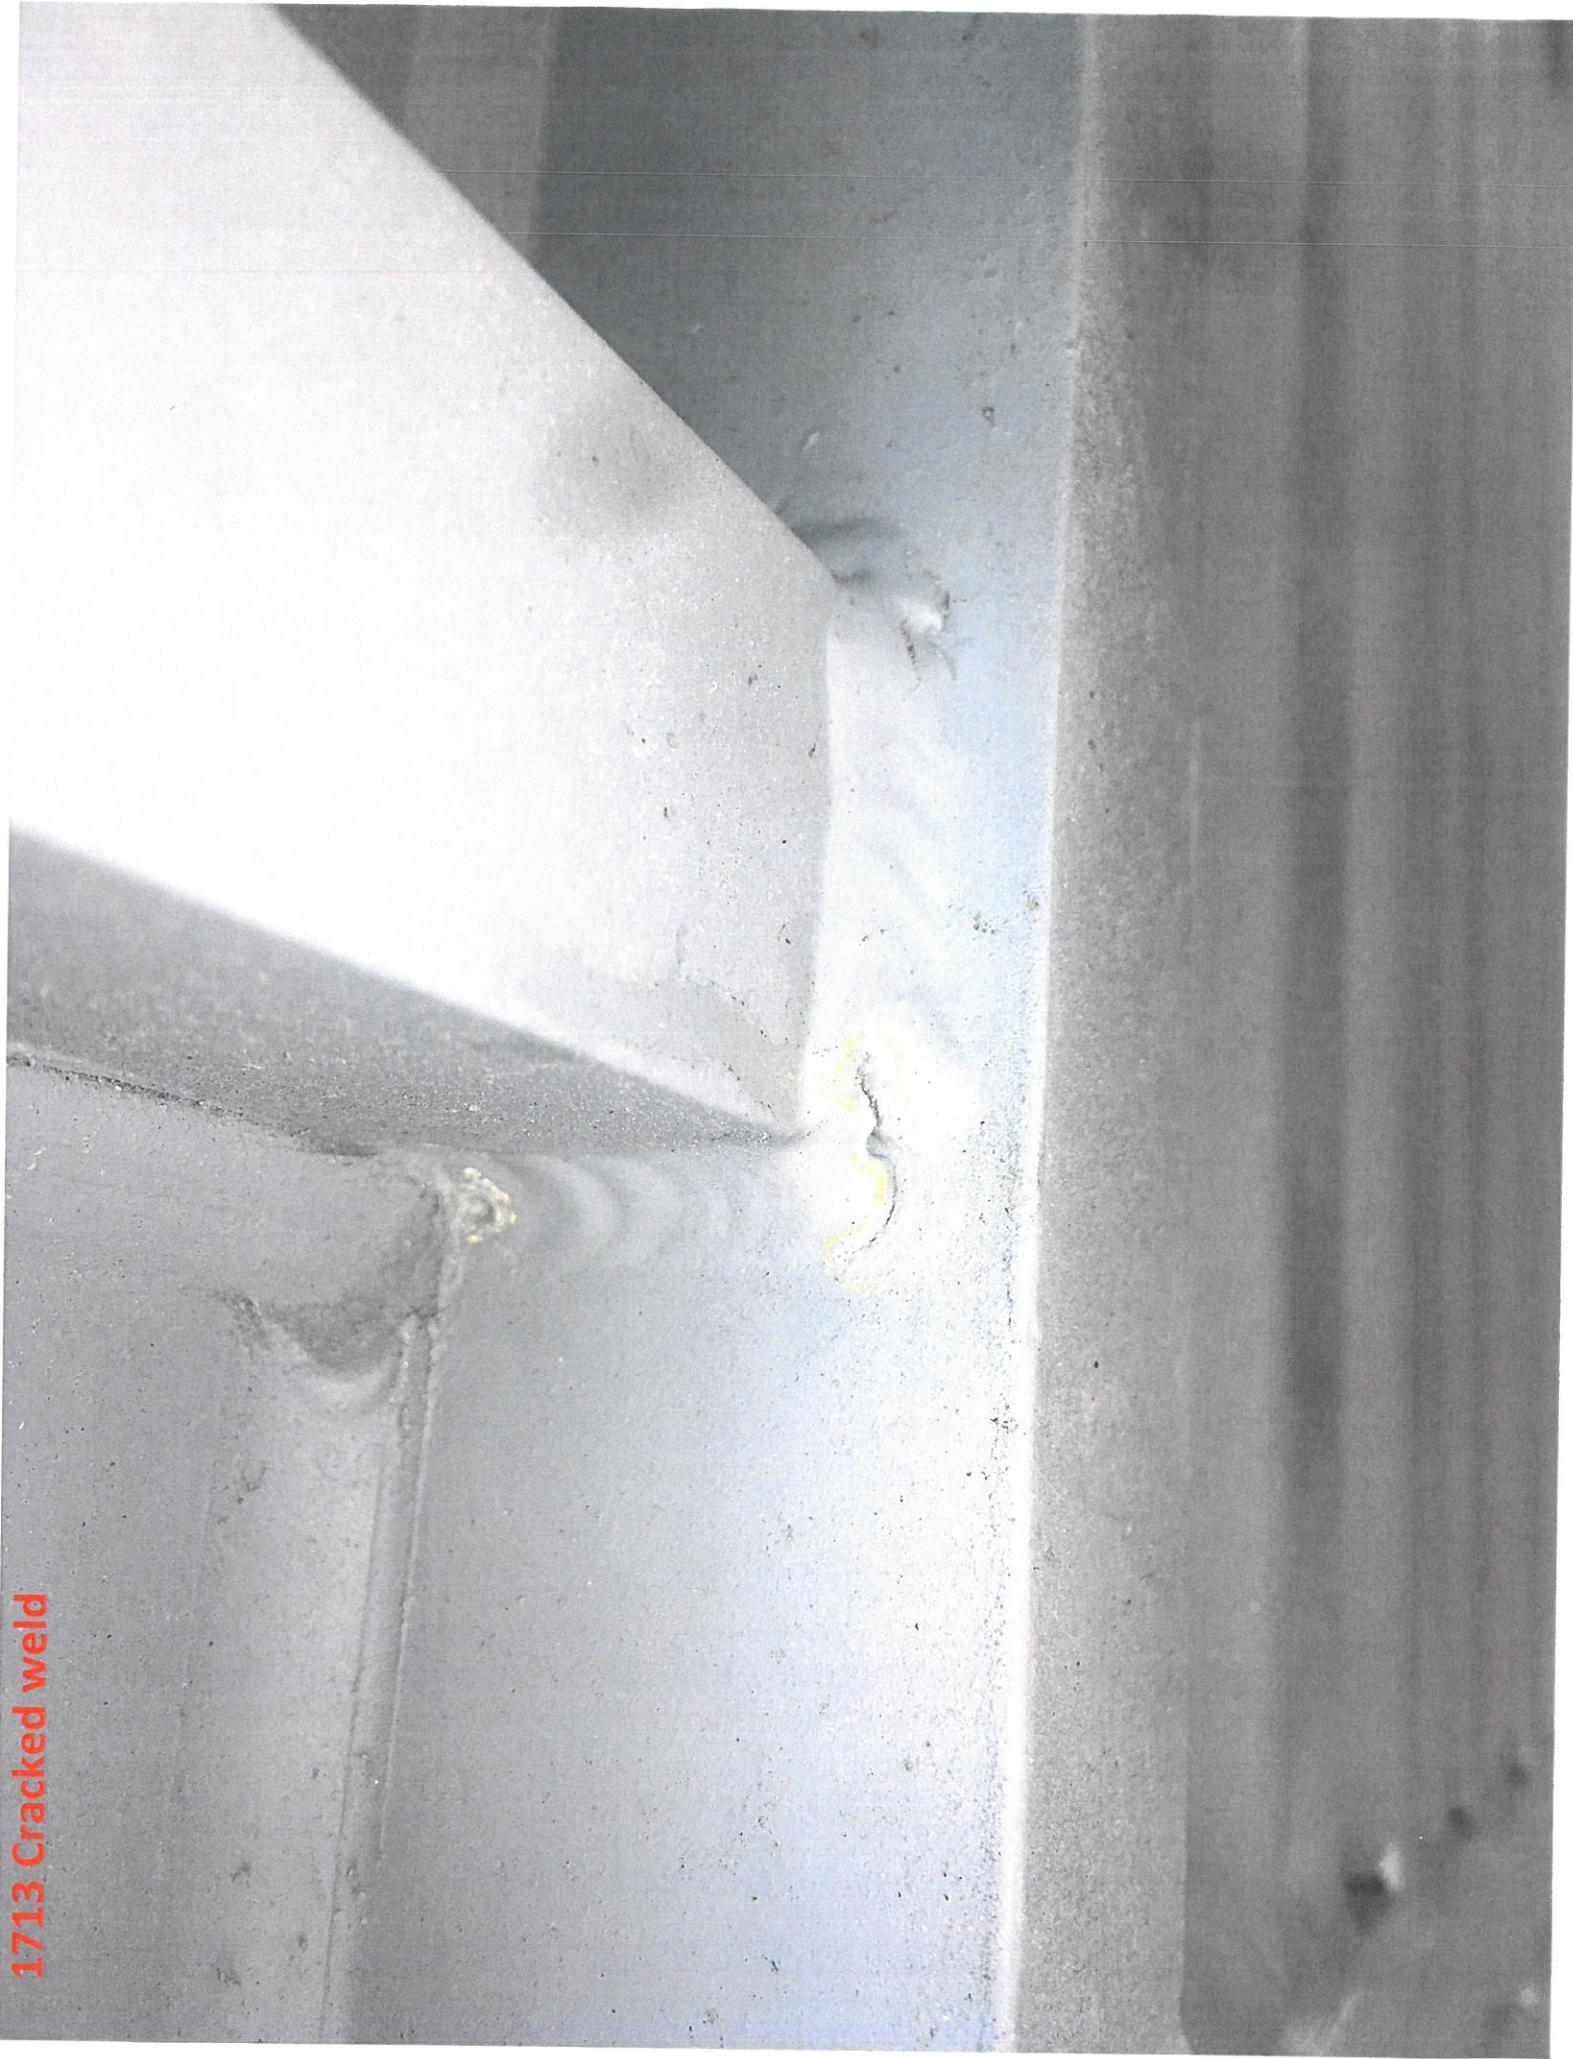
1713 Cracked weld
