1713

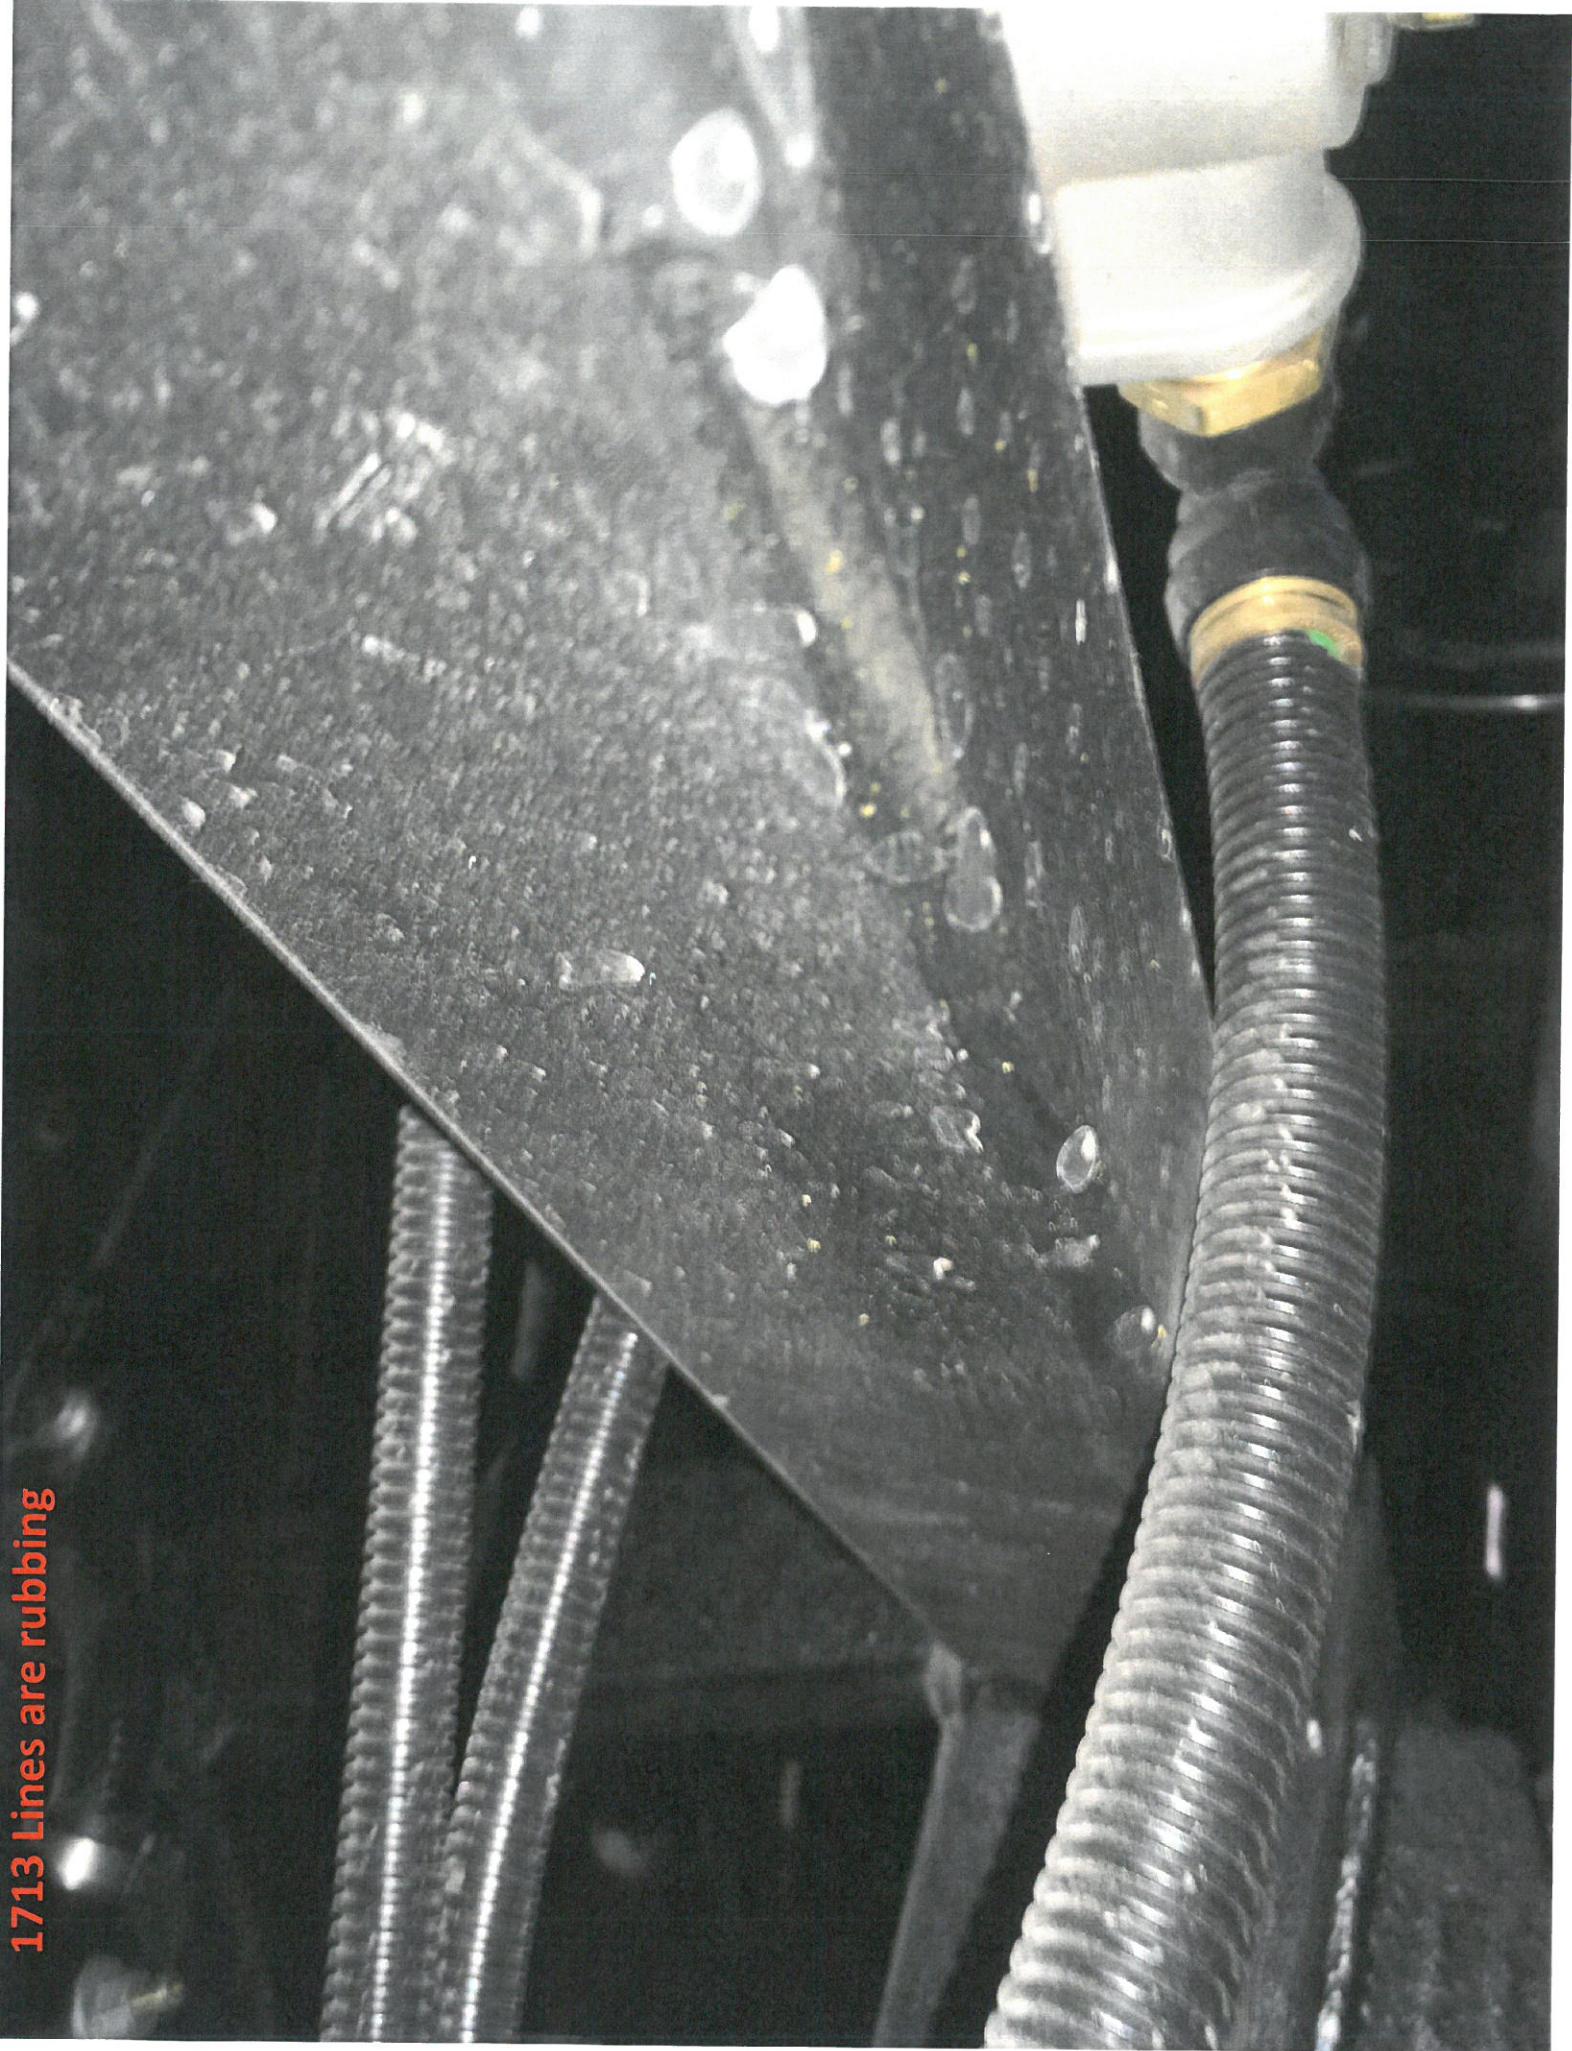
1713 Lines are rubbing

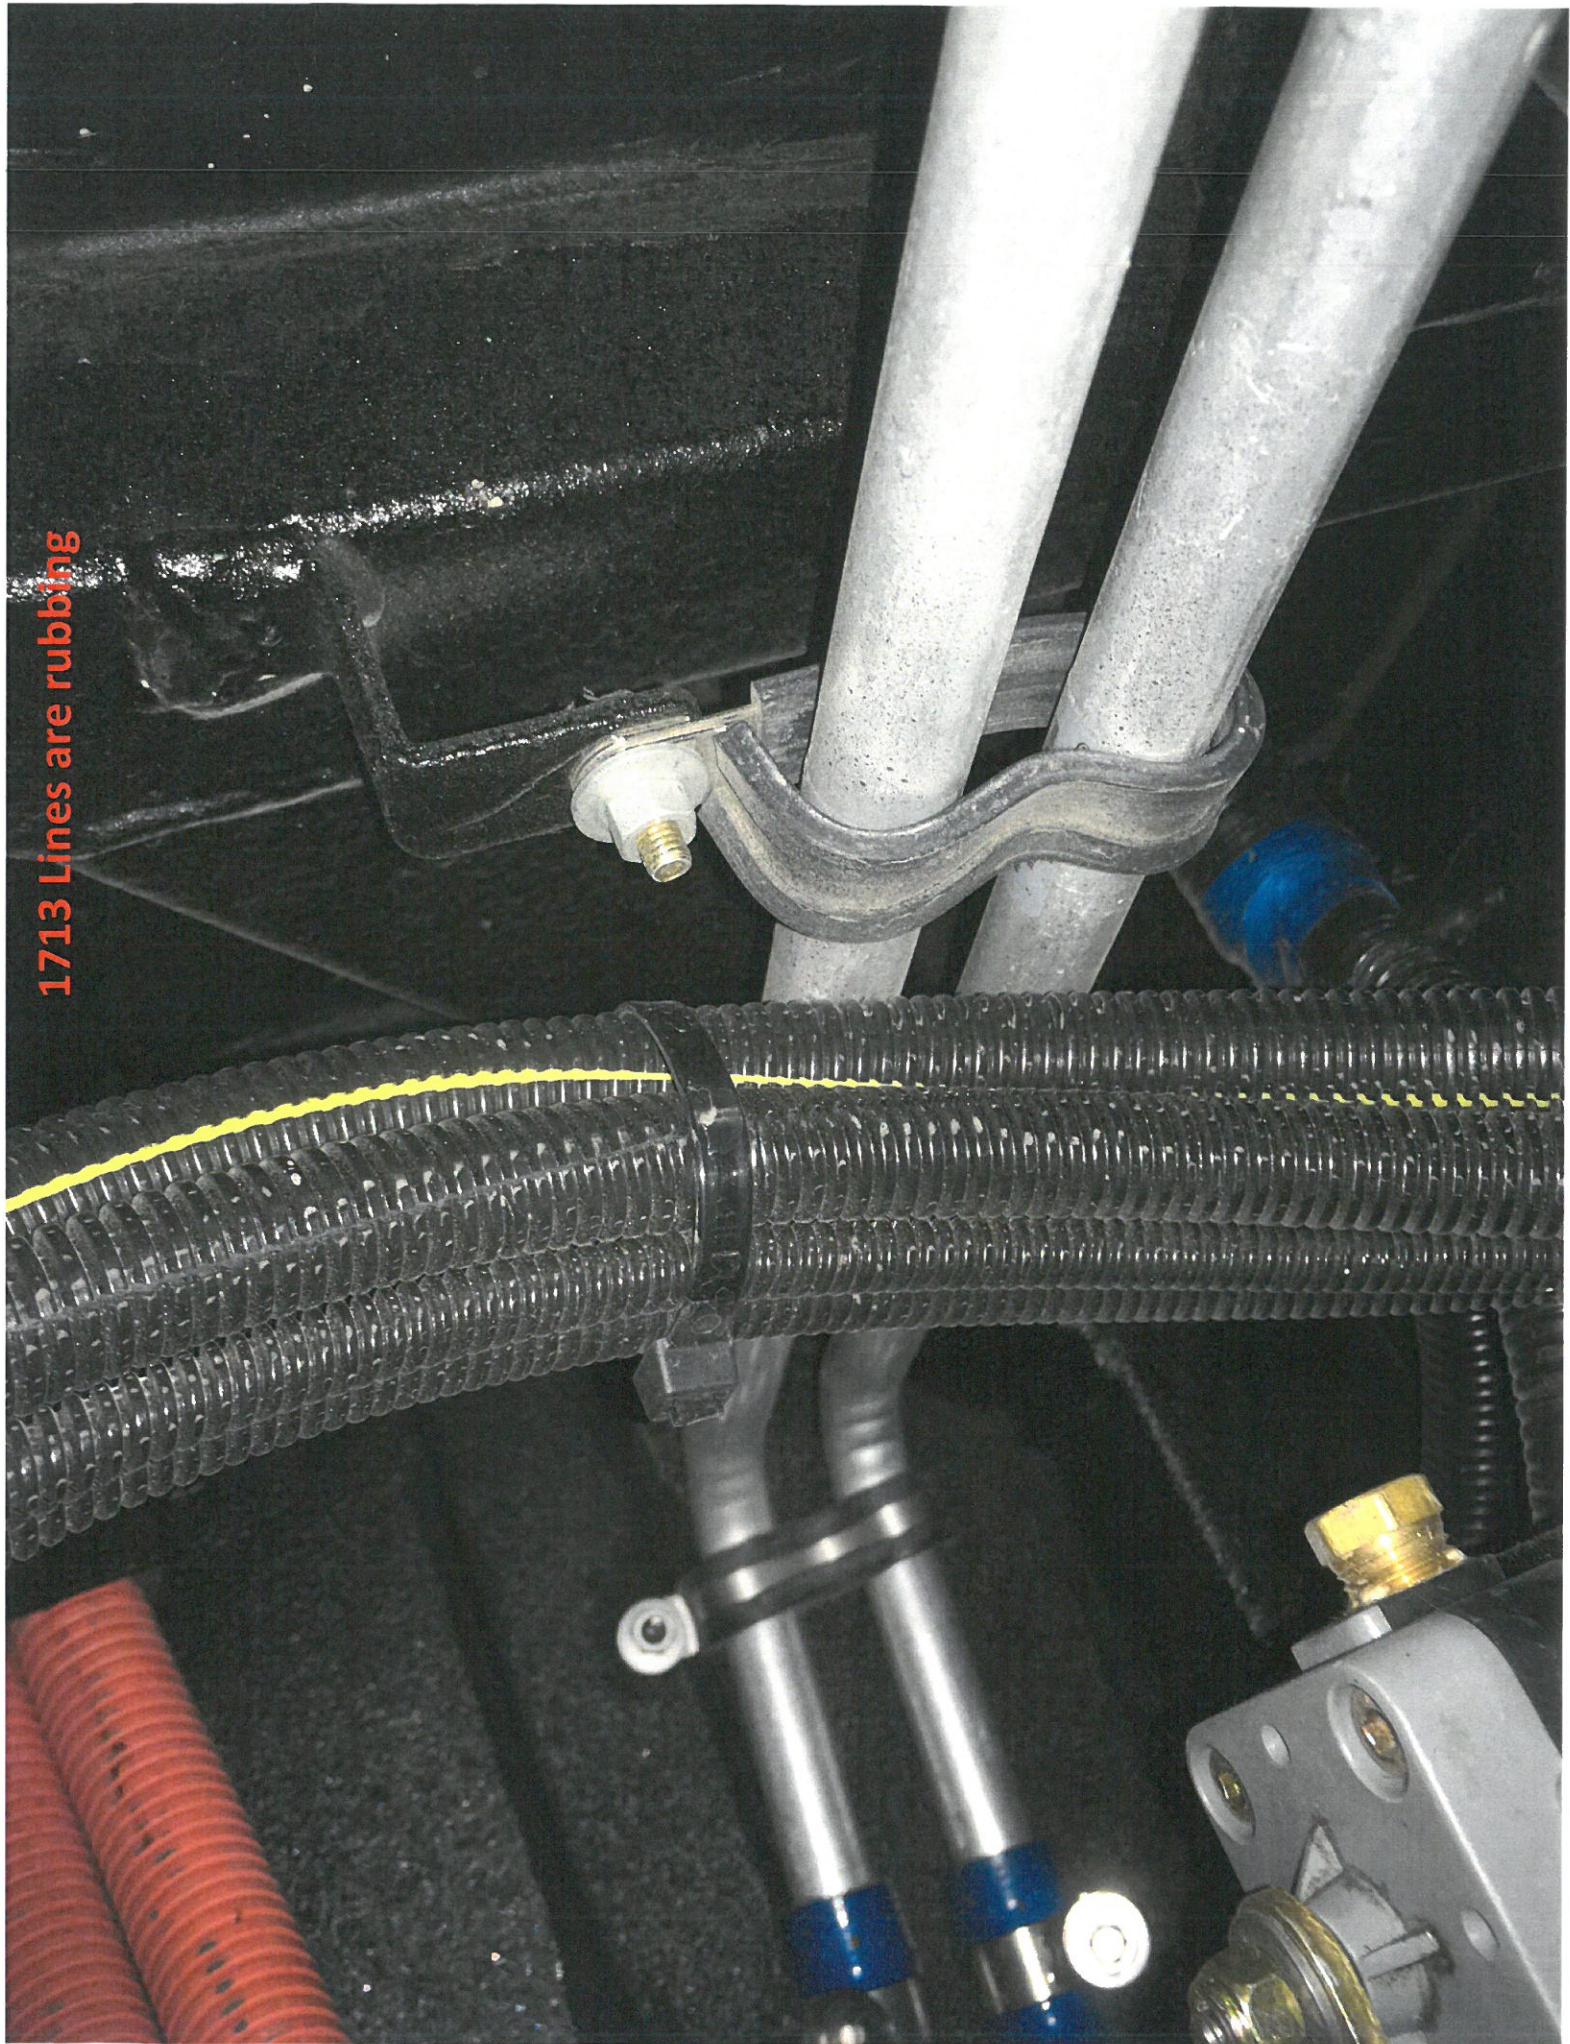
1713 Lines are rubbing

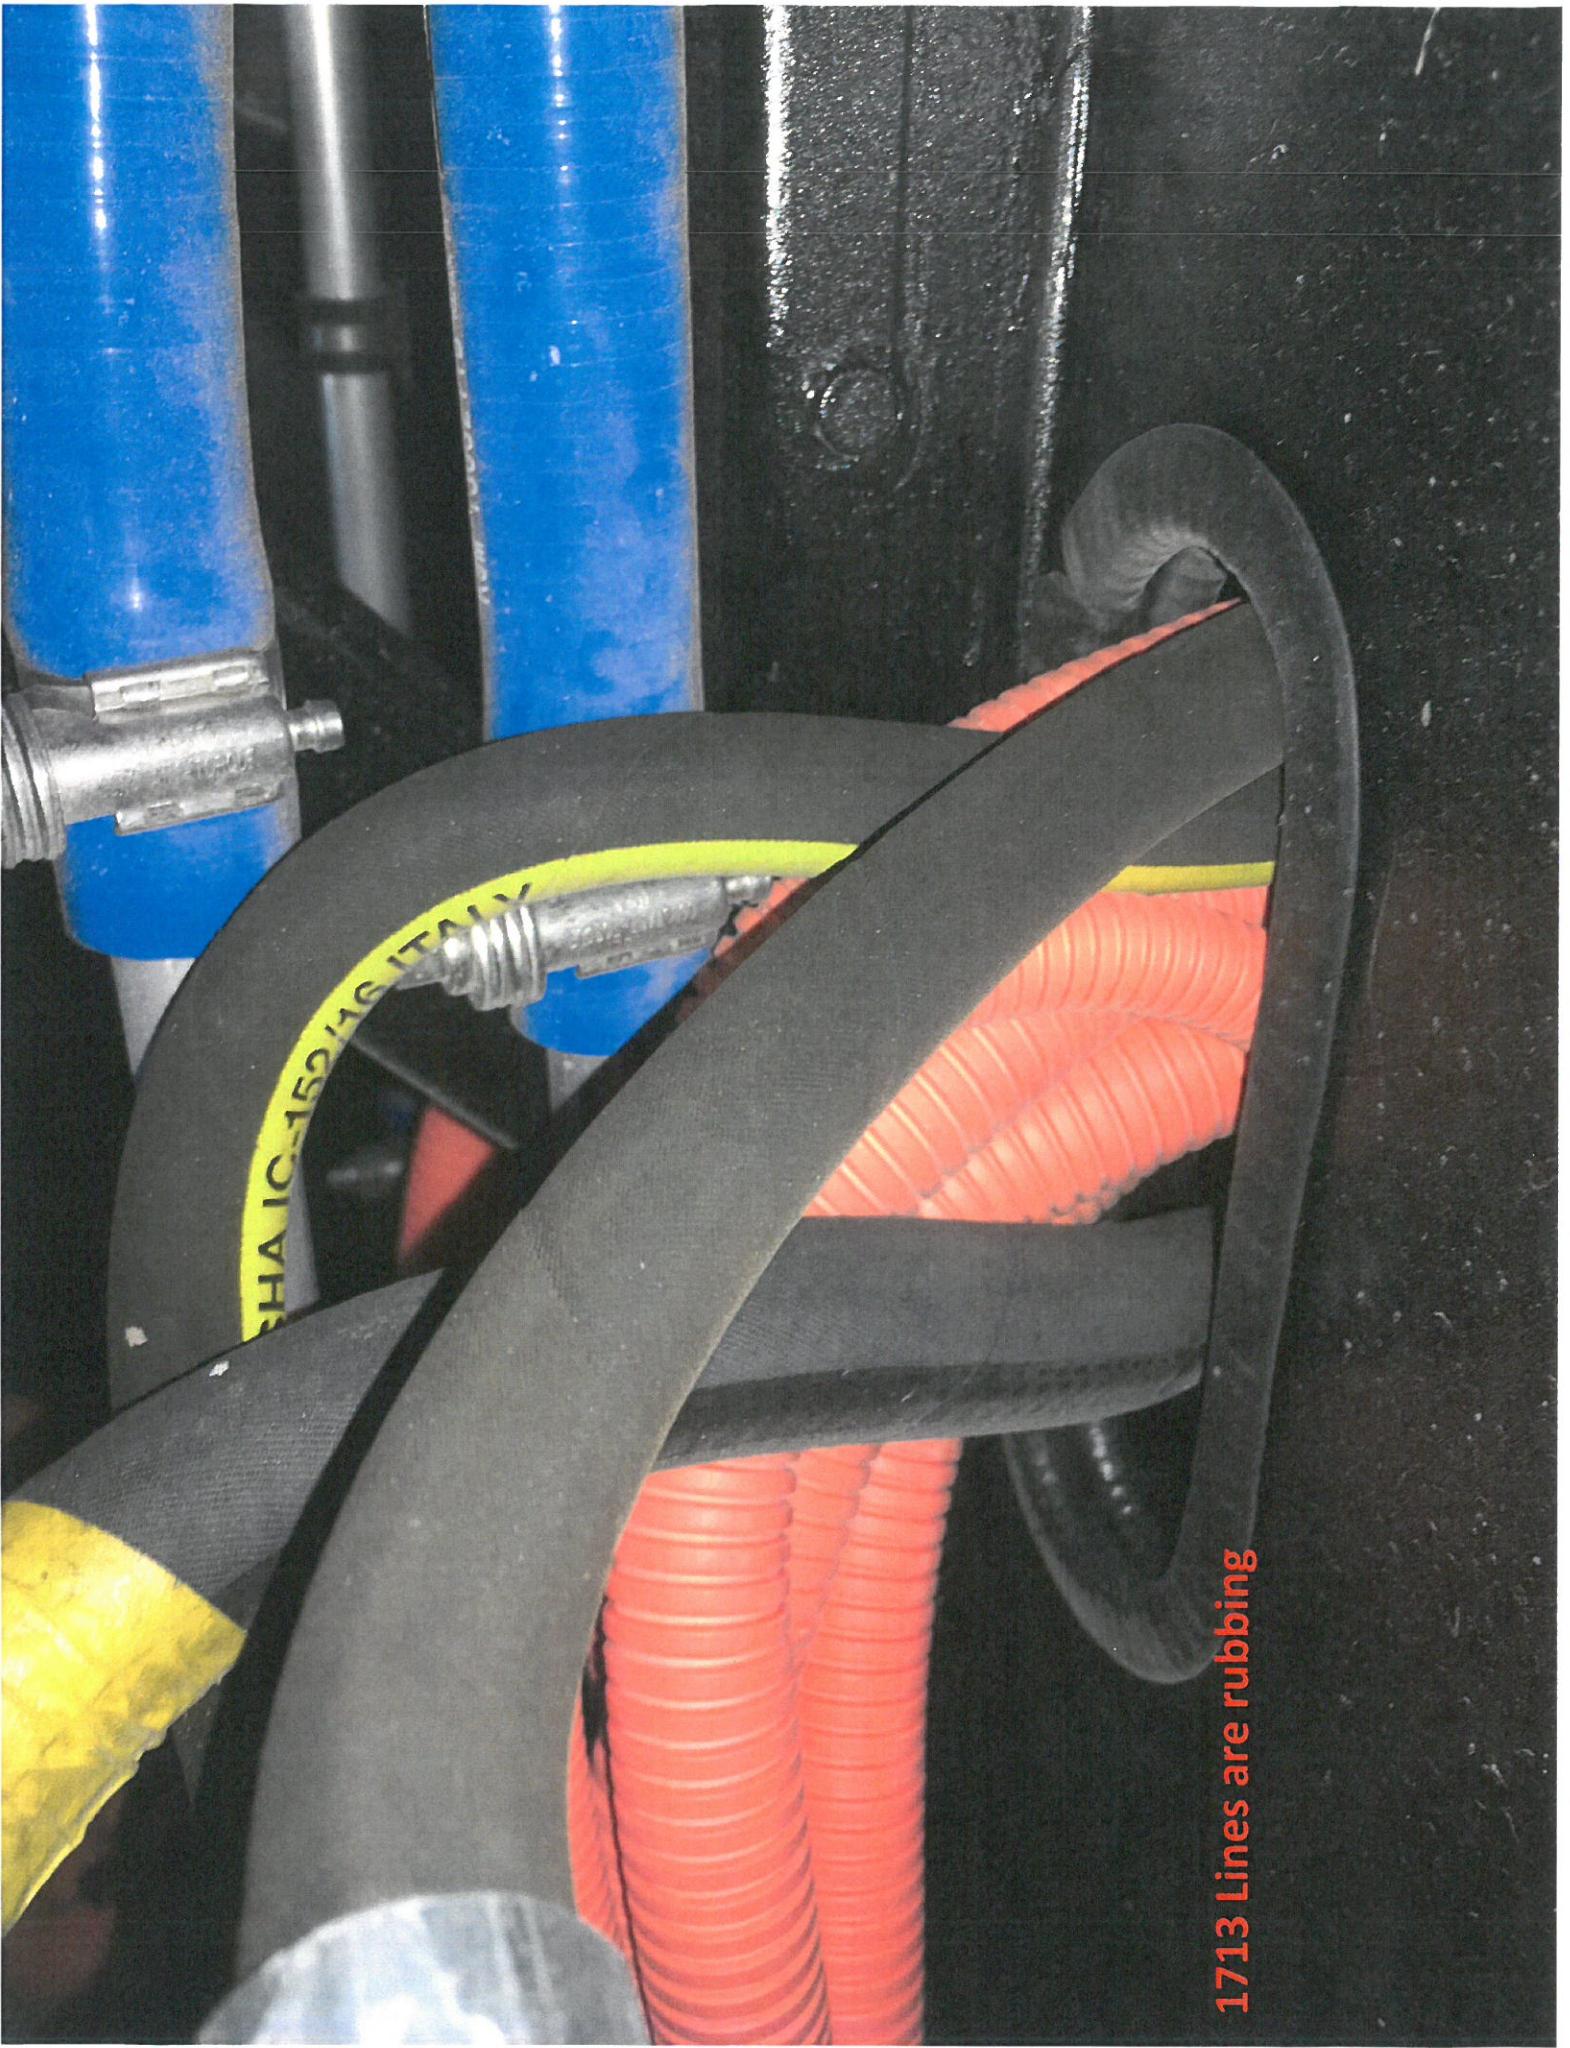
1713 Lines are rubbing

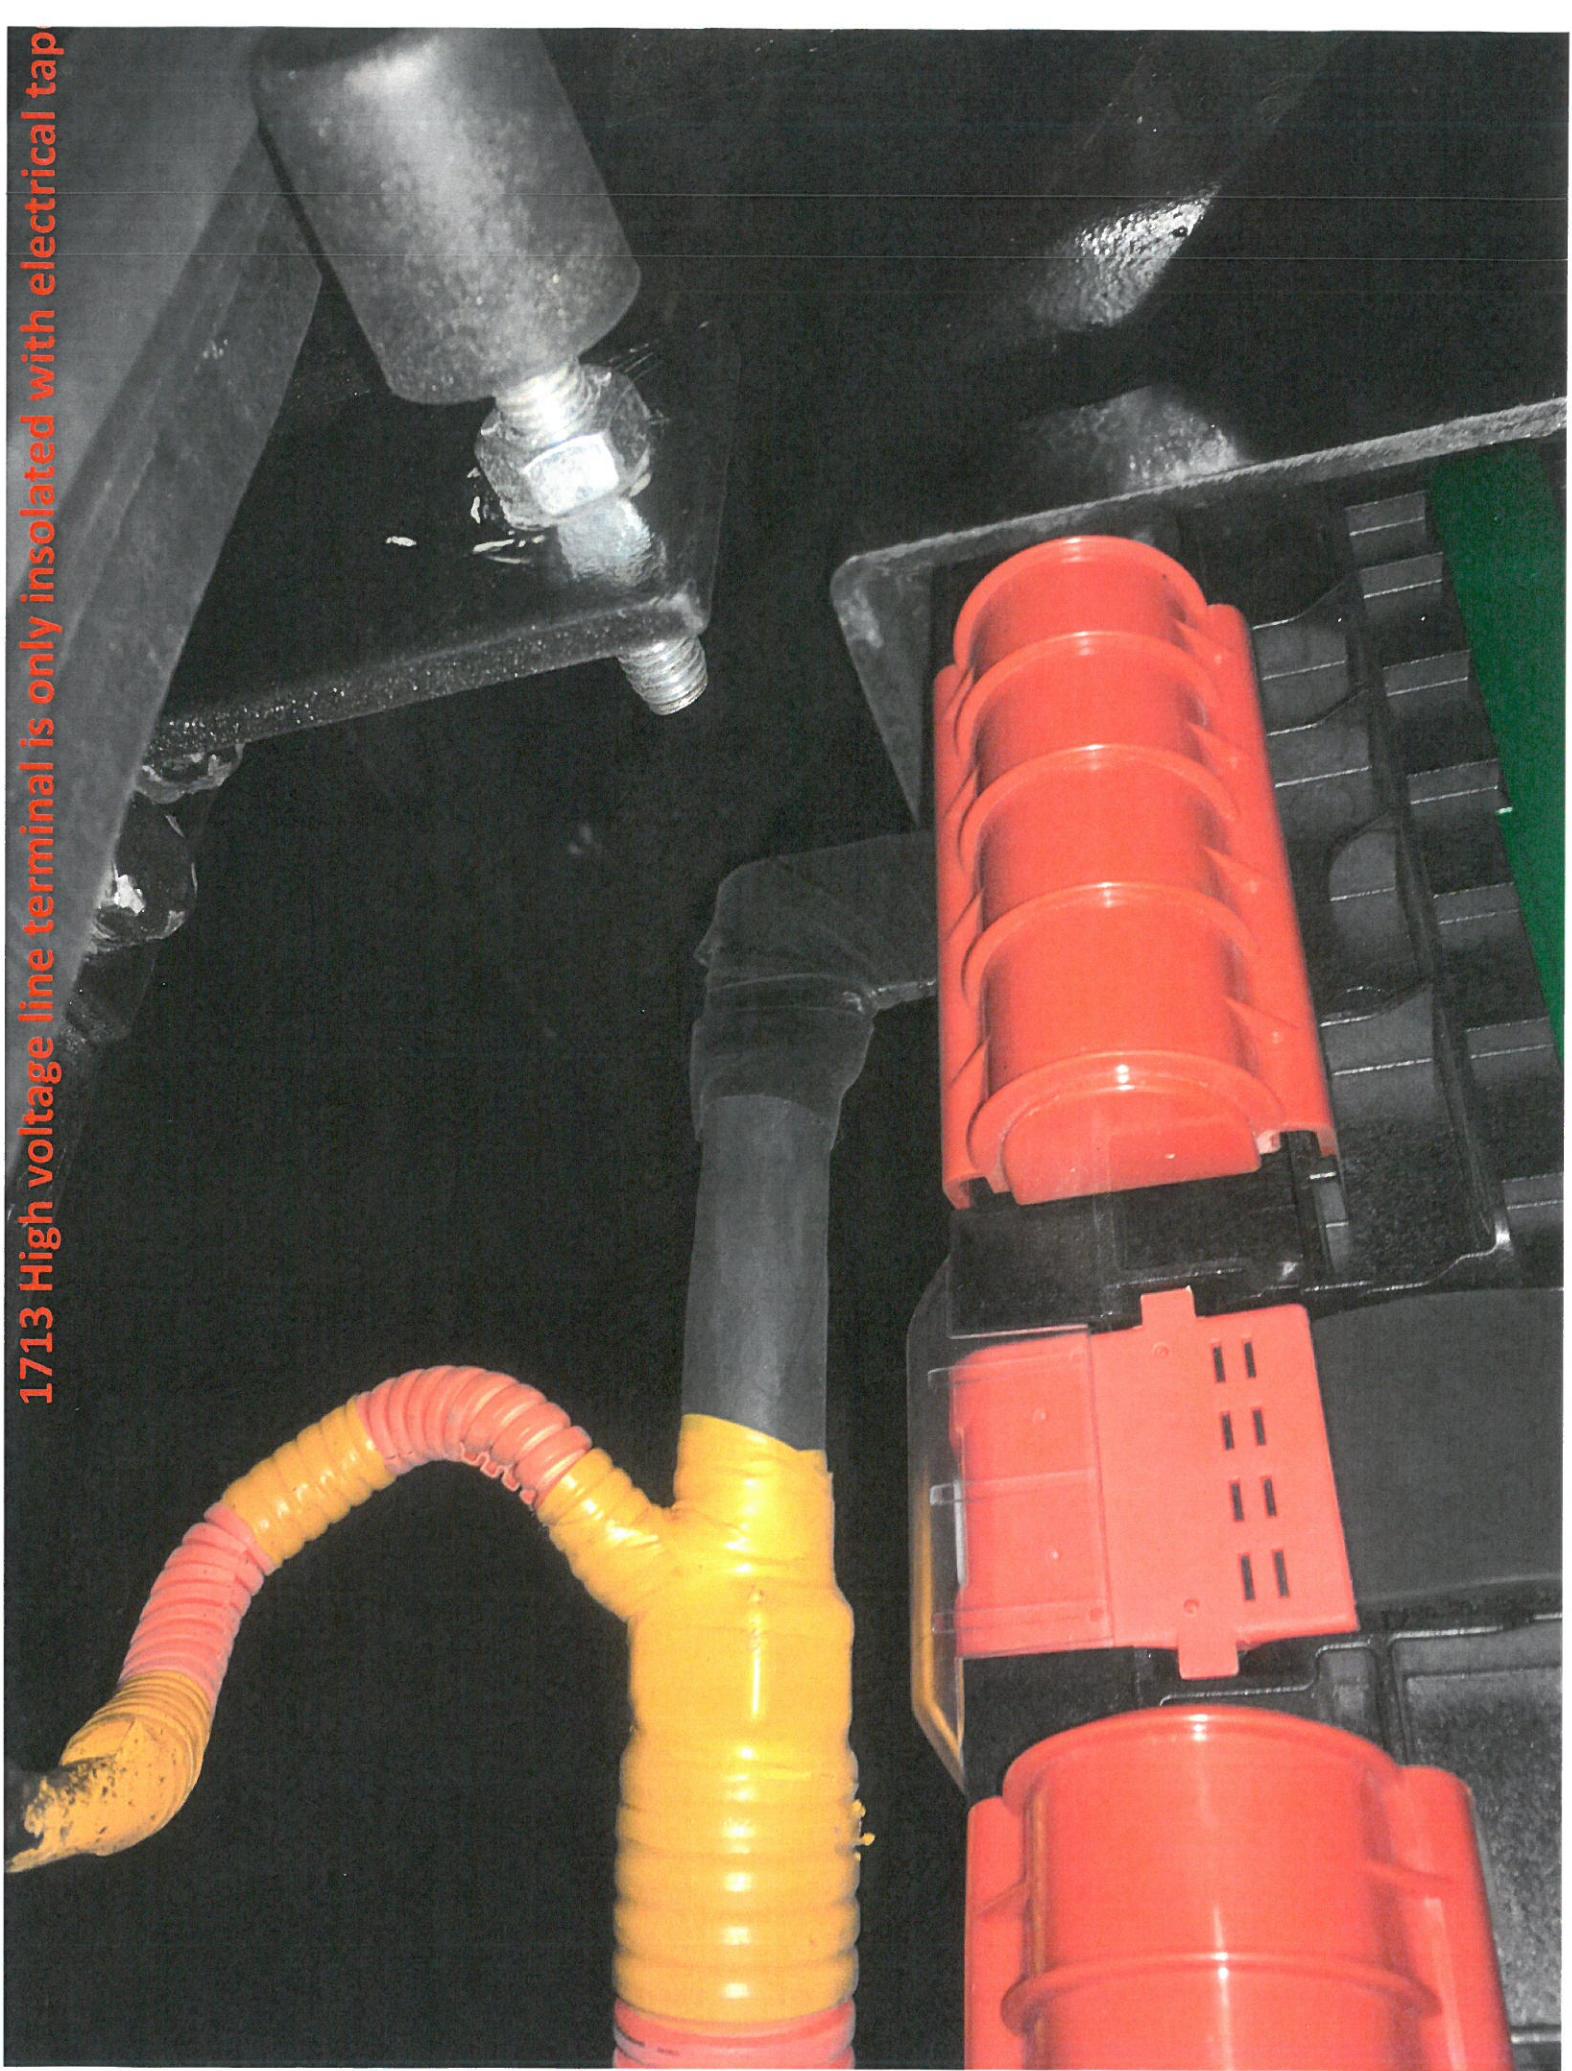
1713 High voltage line terminal is only insulated with electrical tape

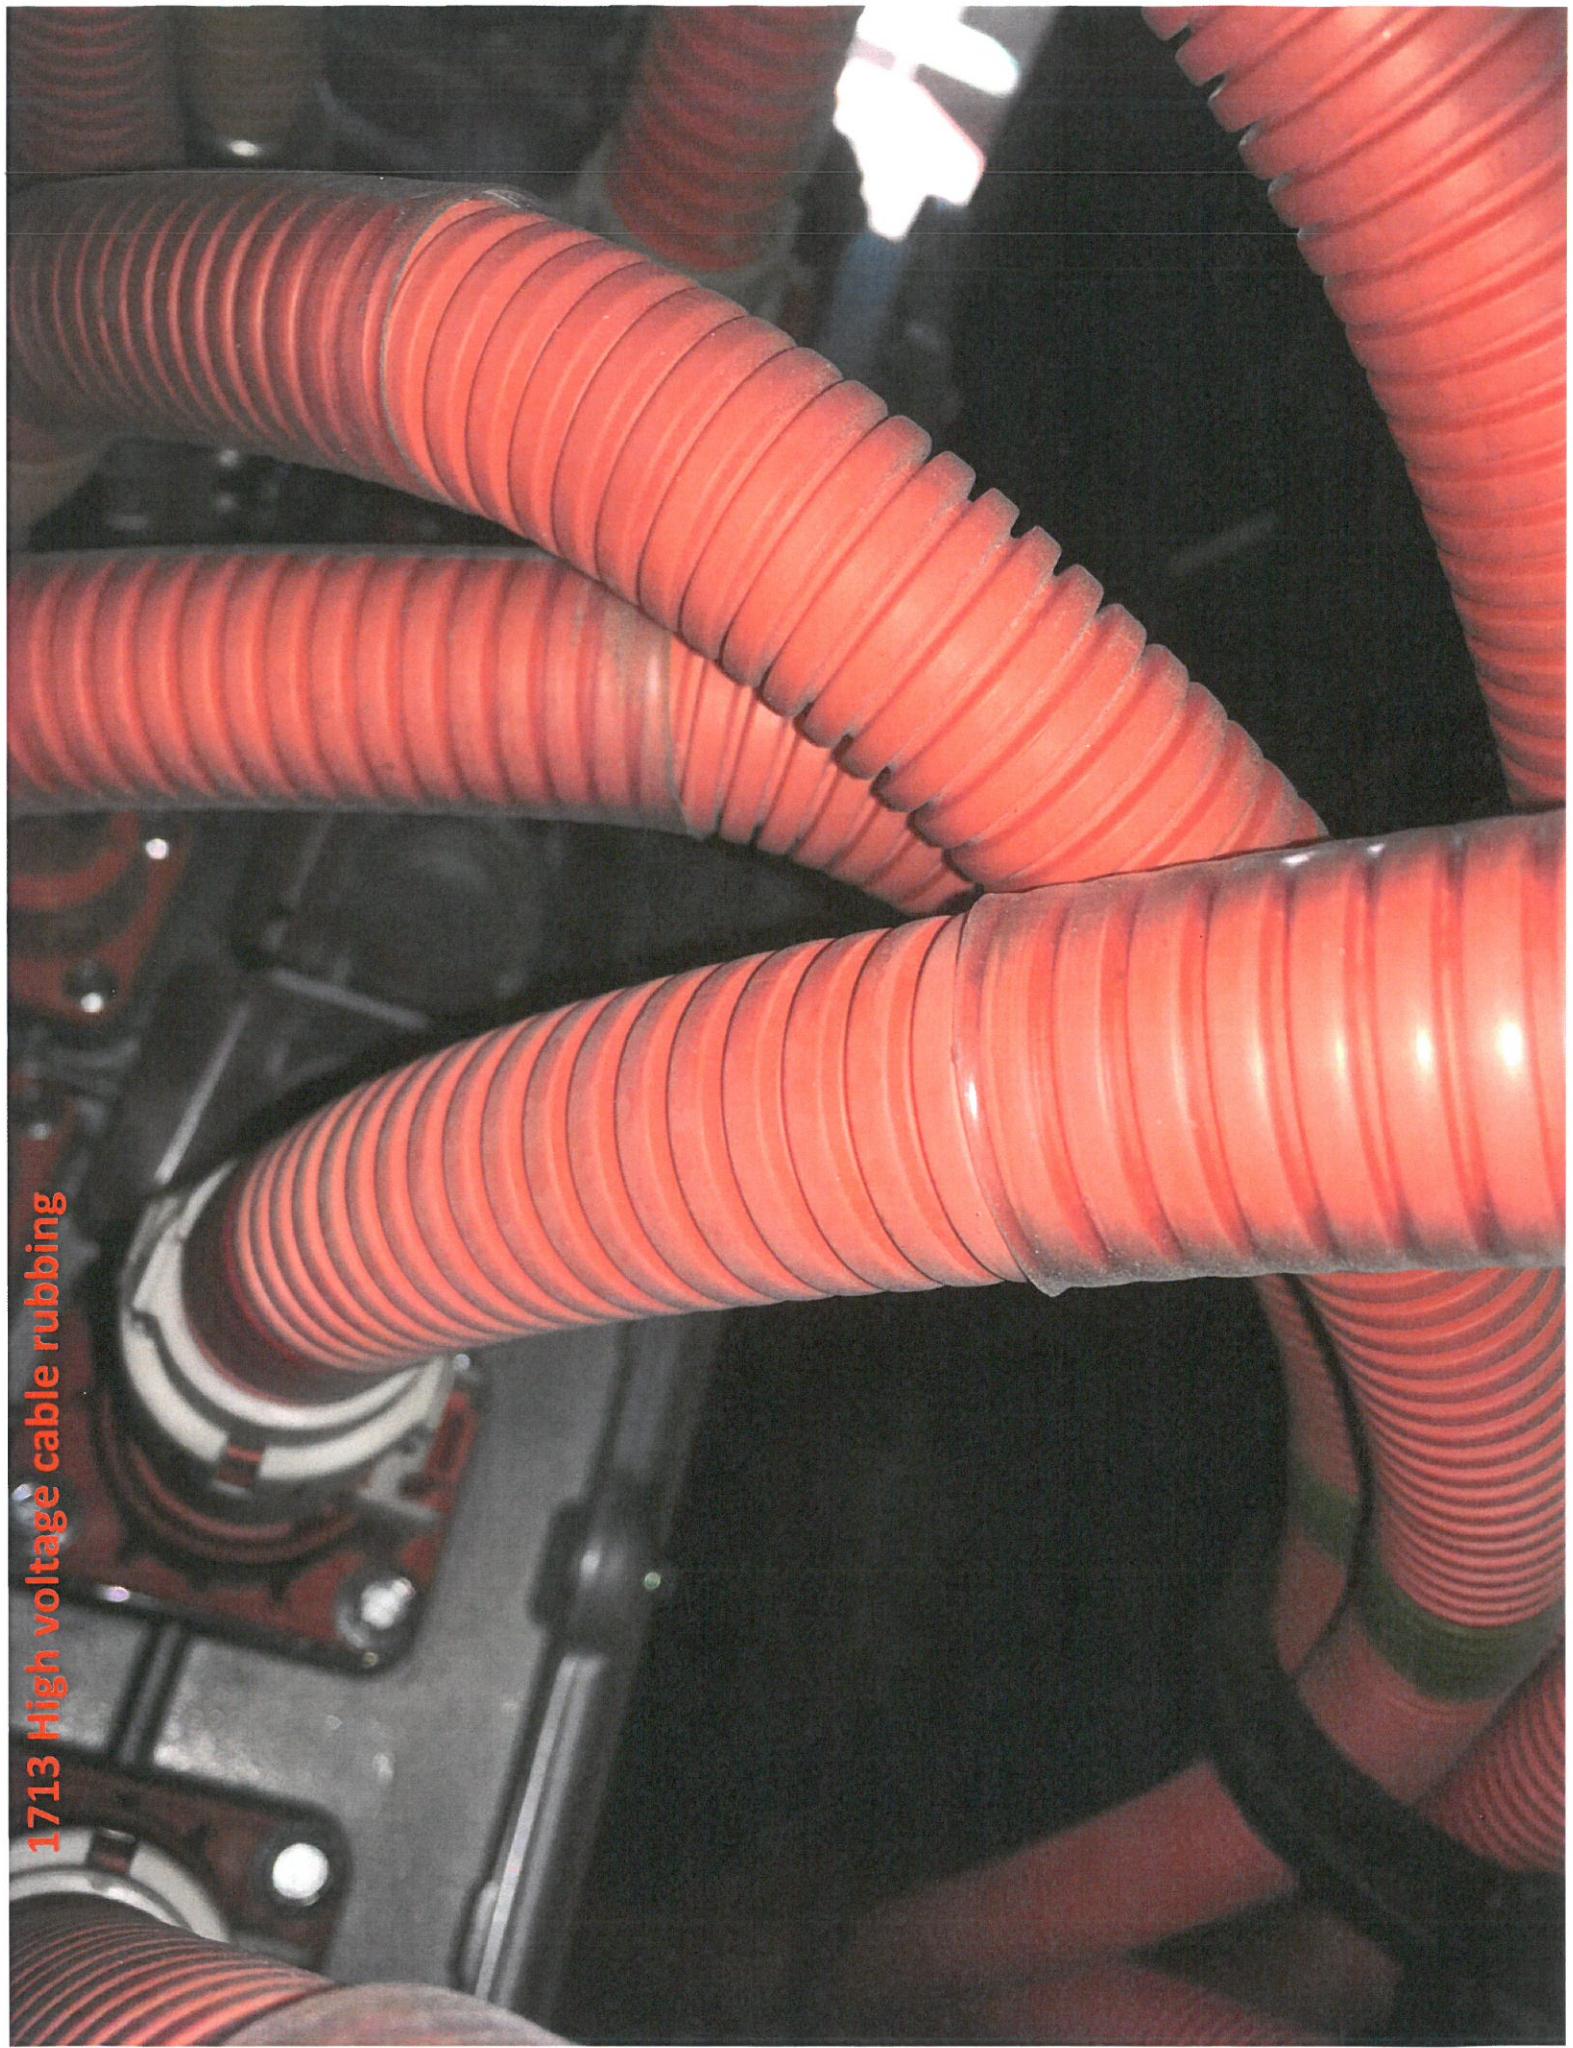
1713 High voltage cable rubbing

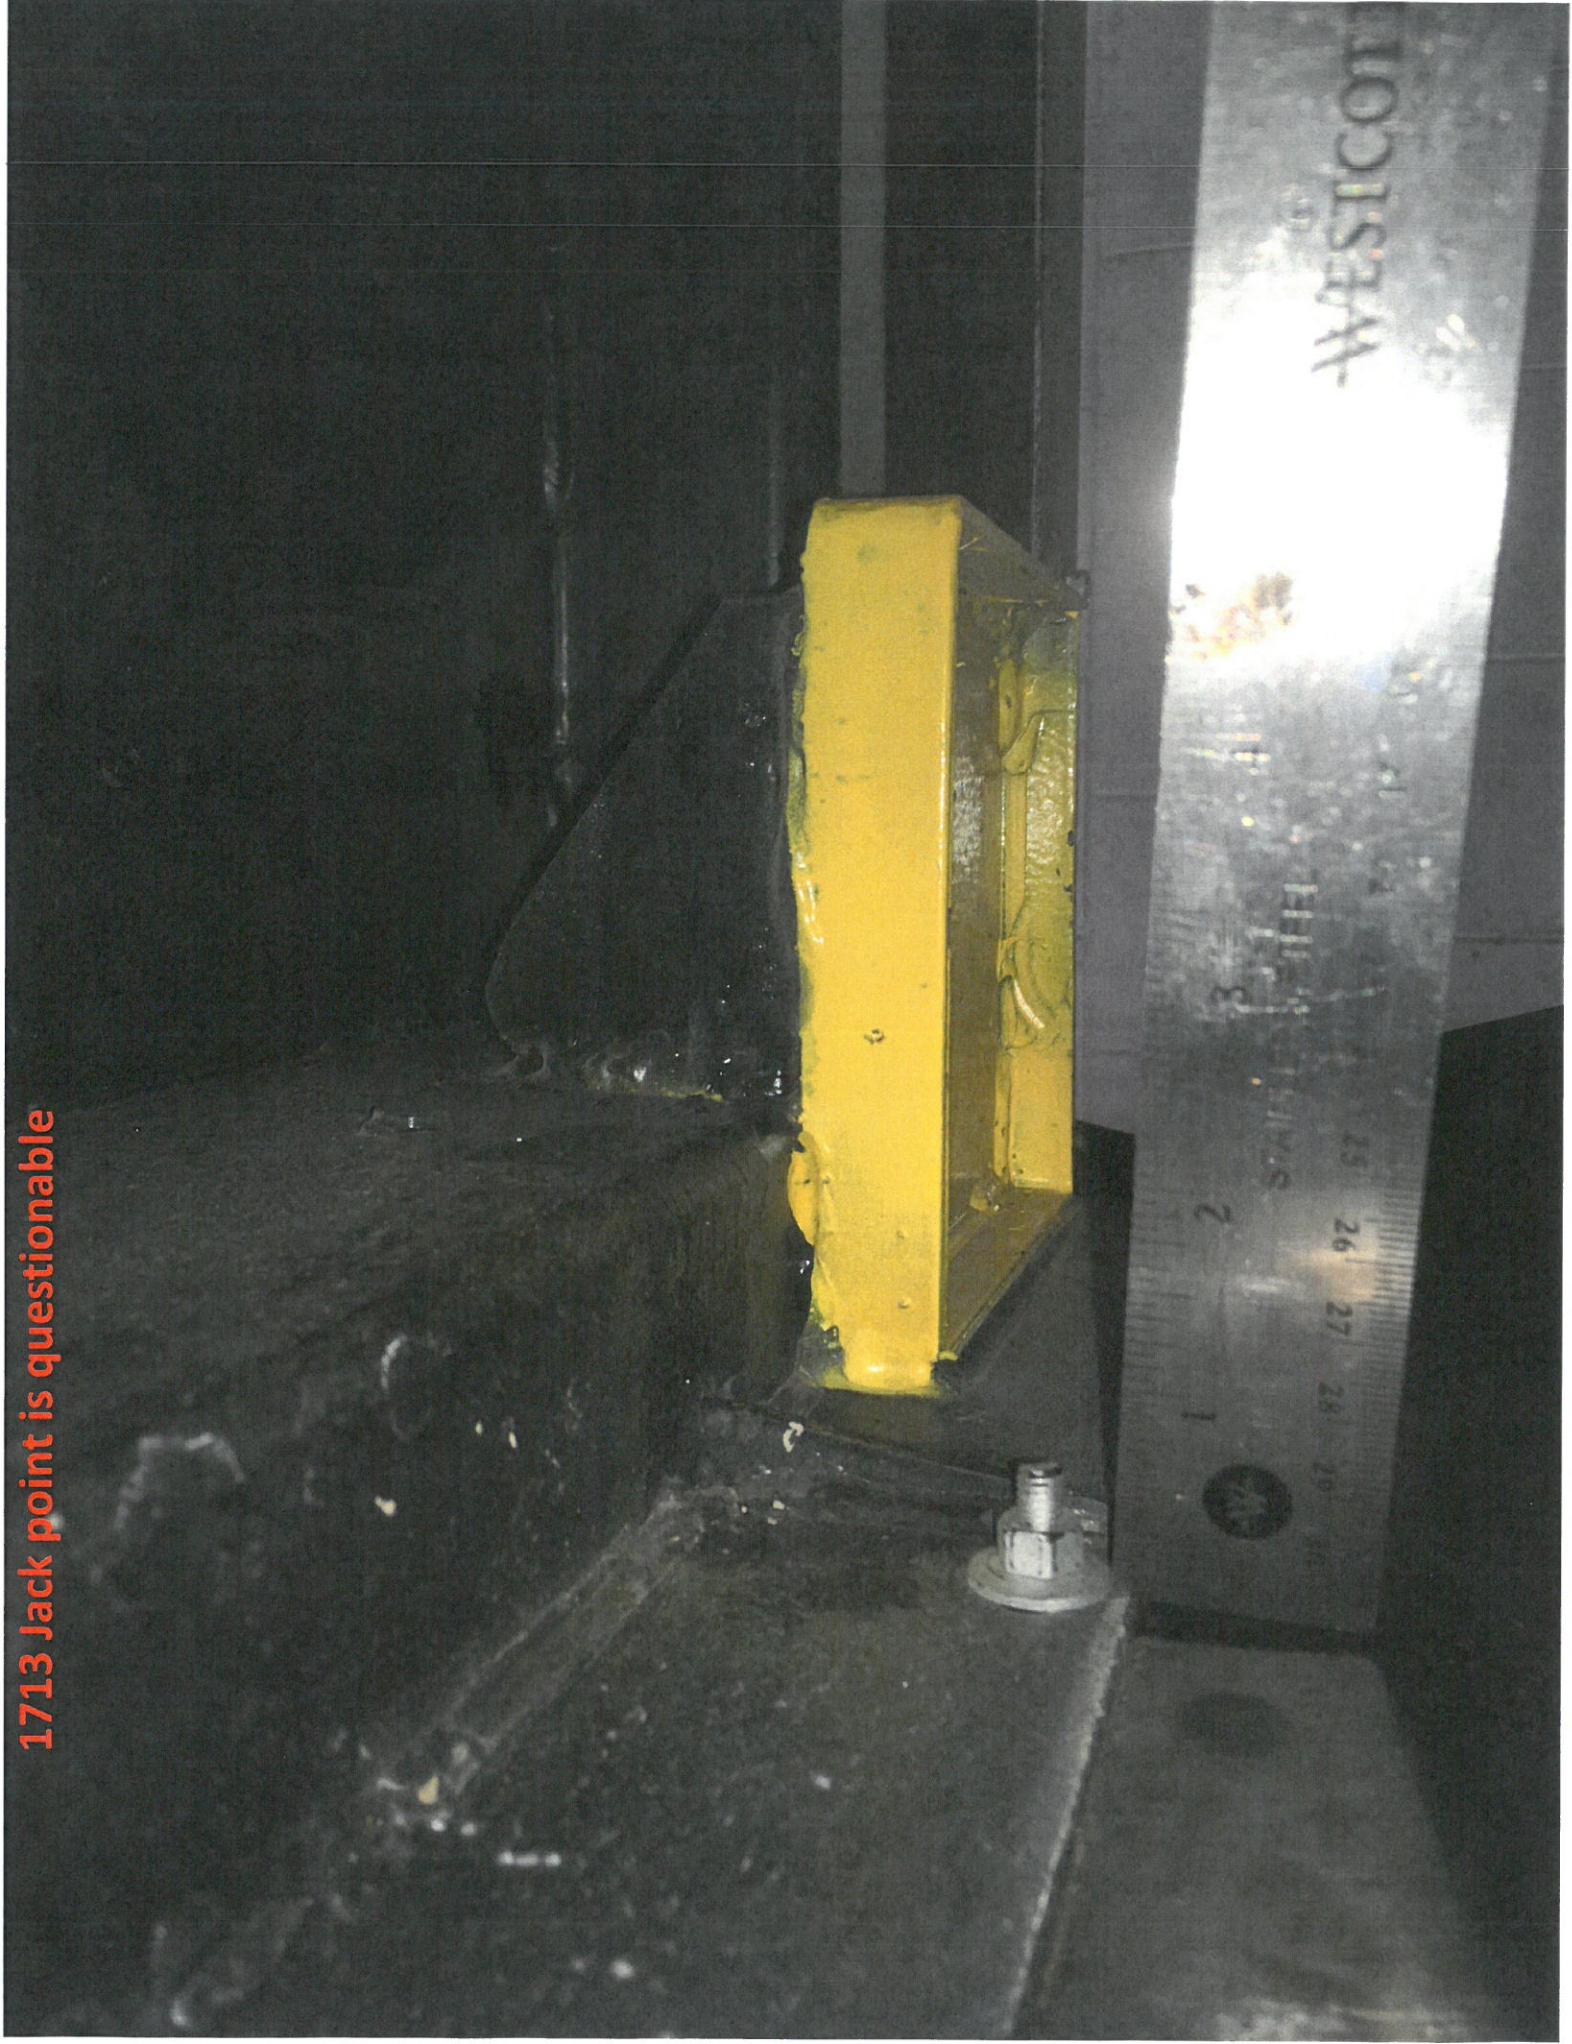
1713 Jack point is questionable

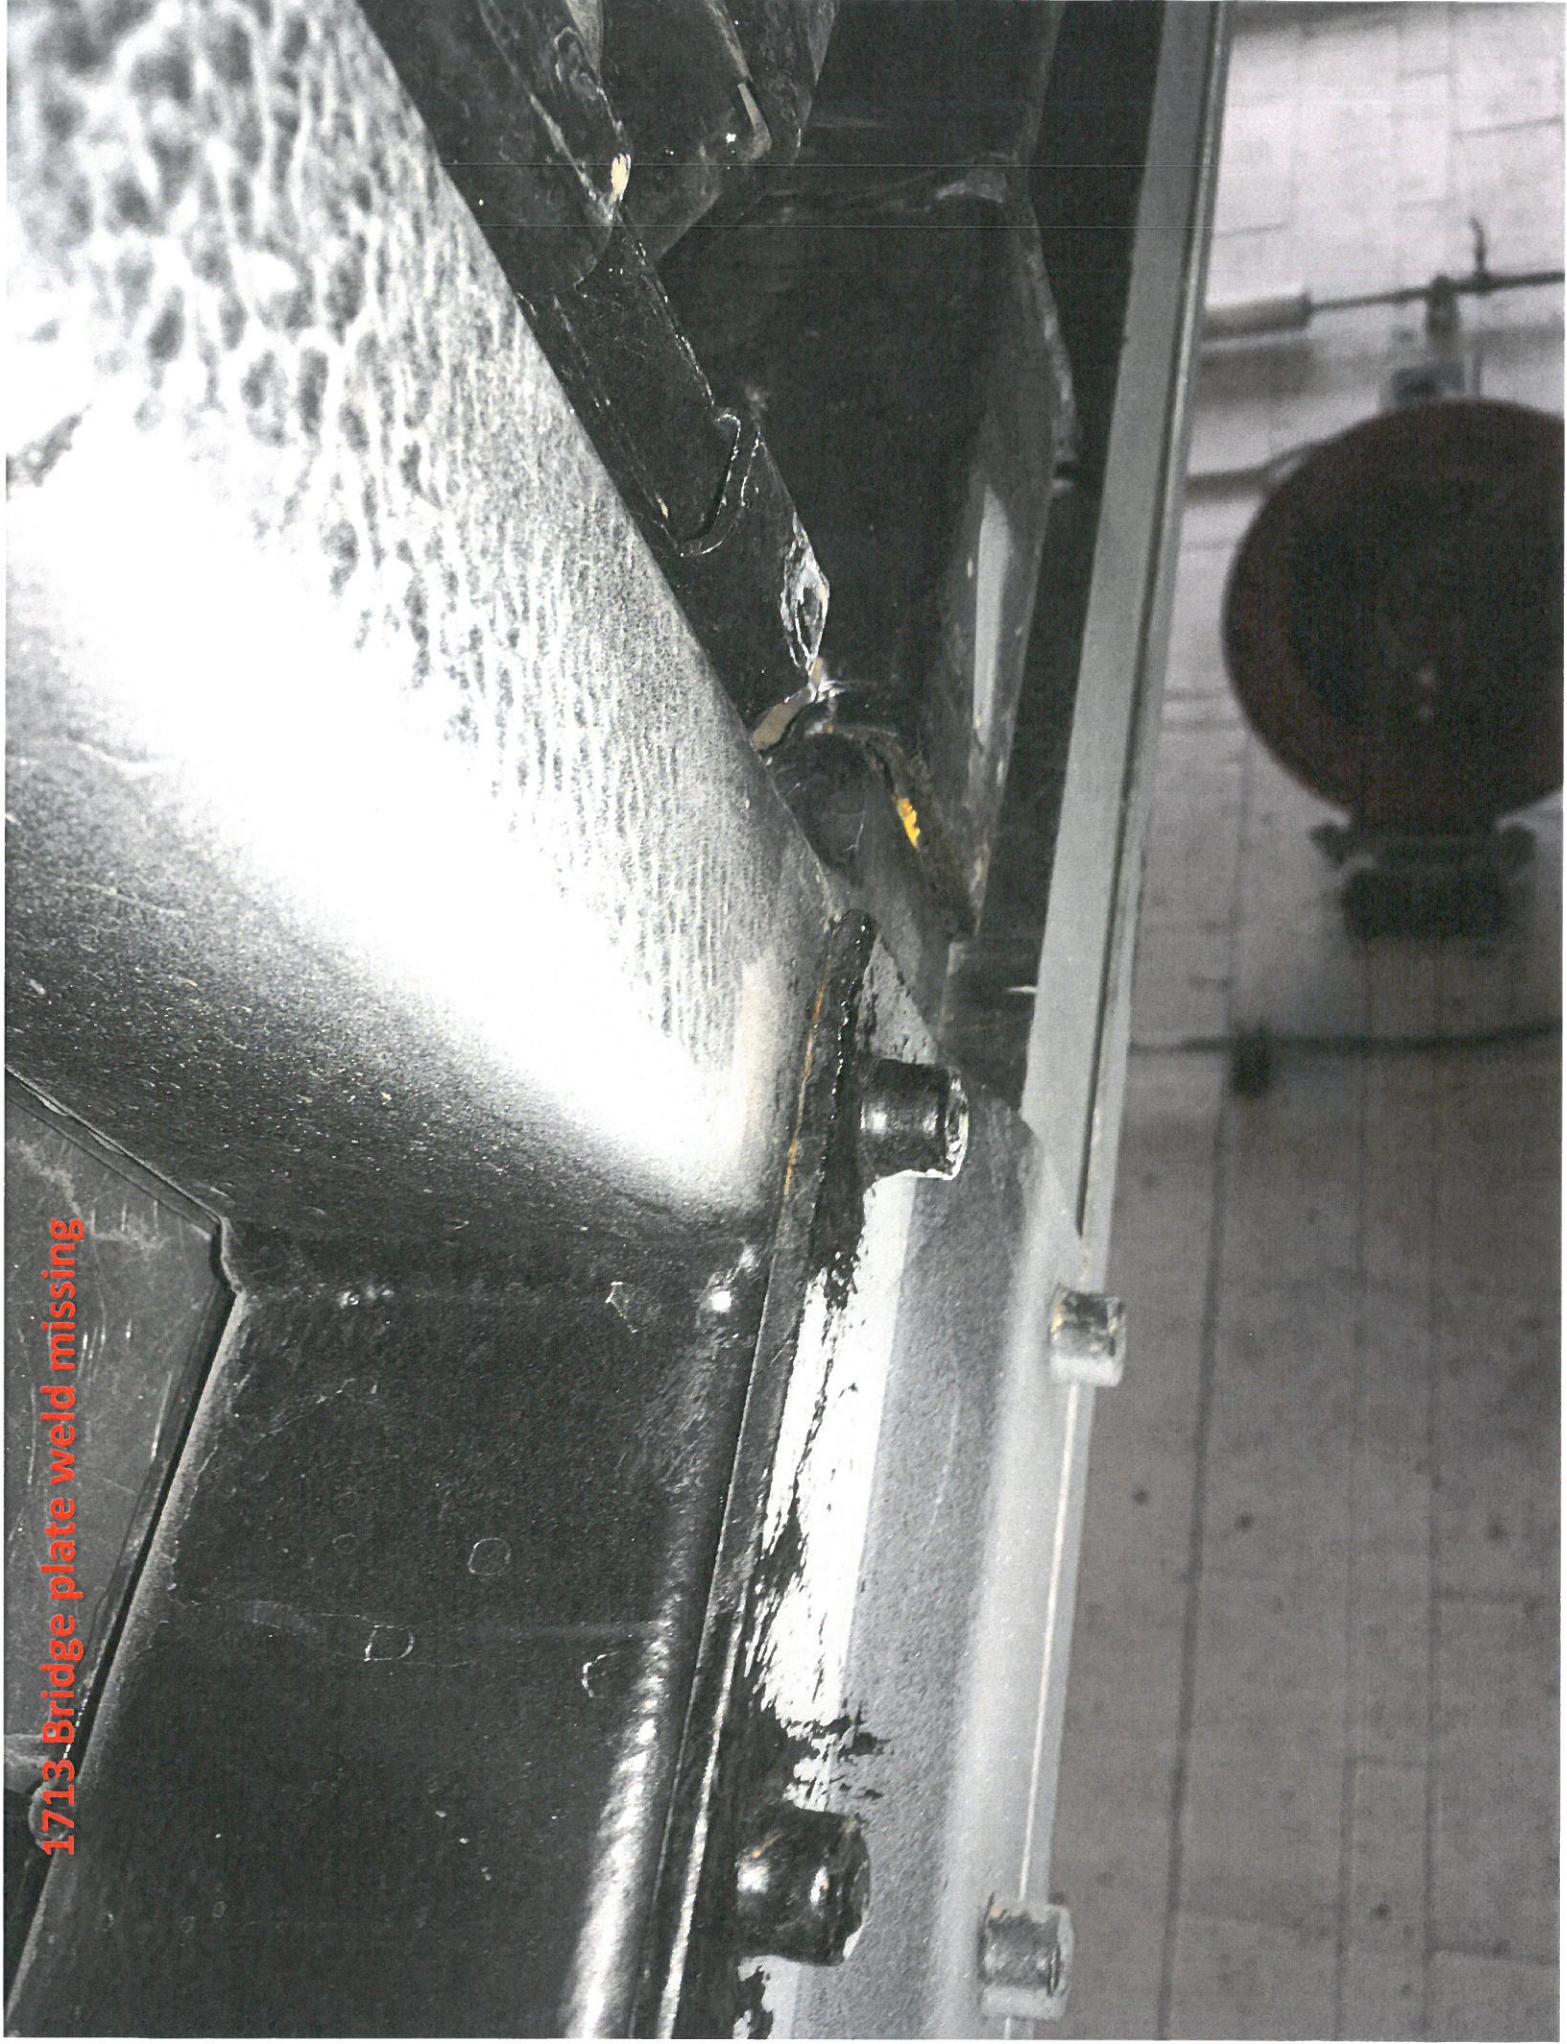
1713 Bridge plate weld missing
