1713

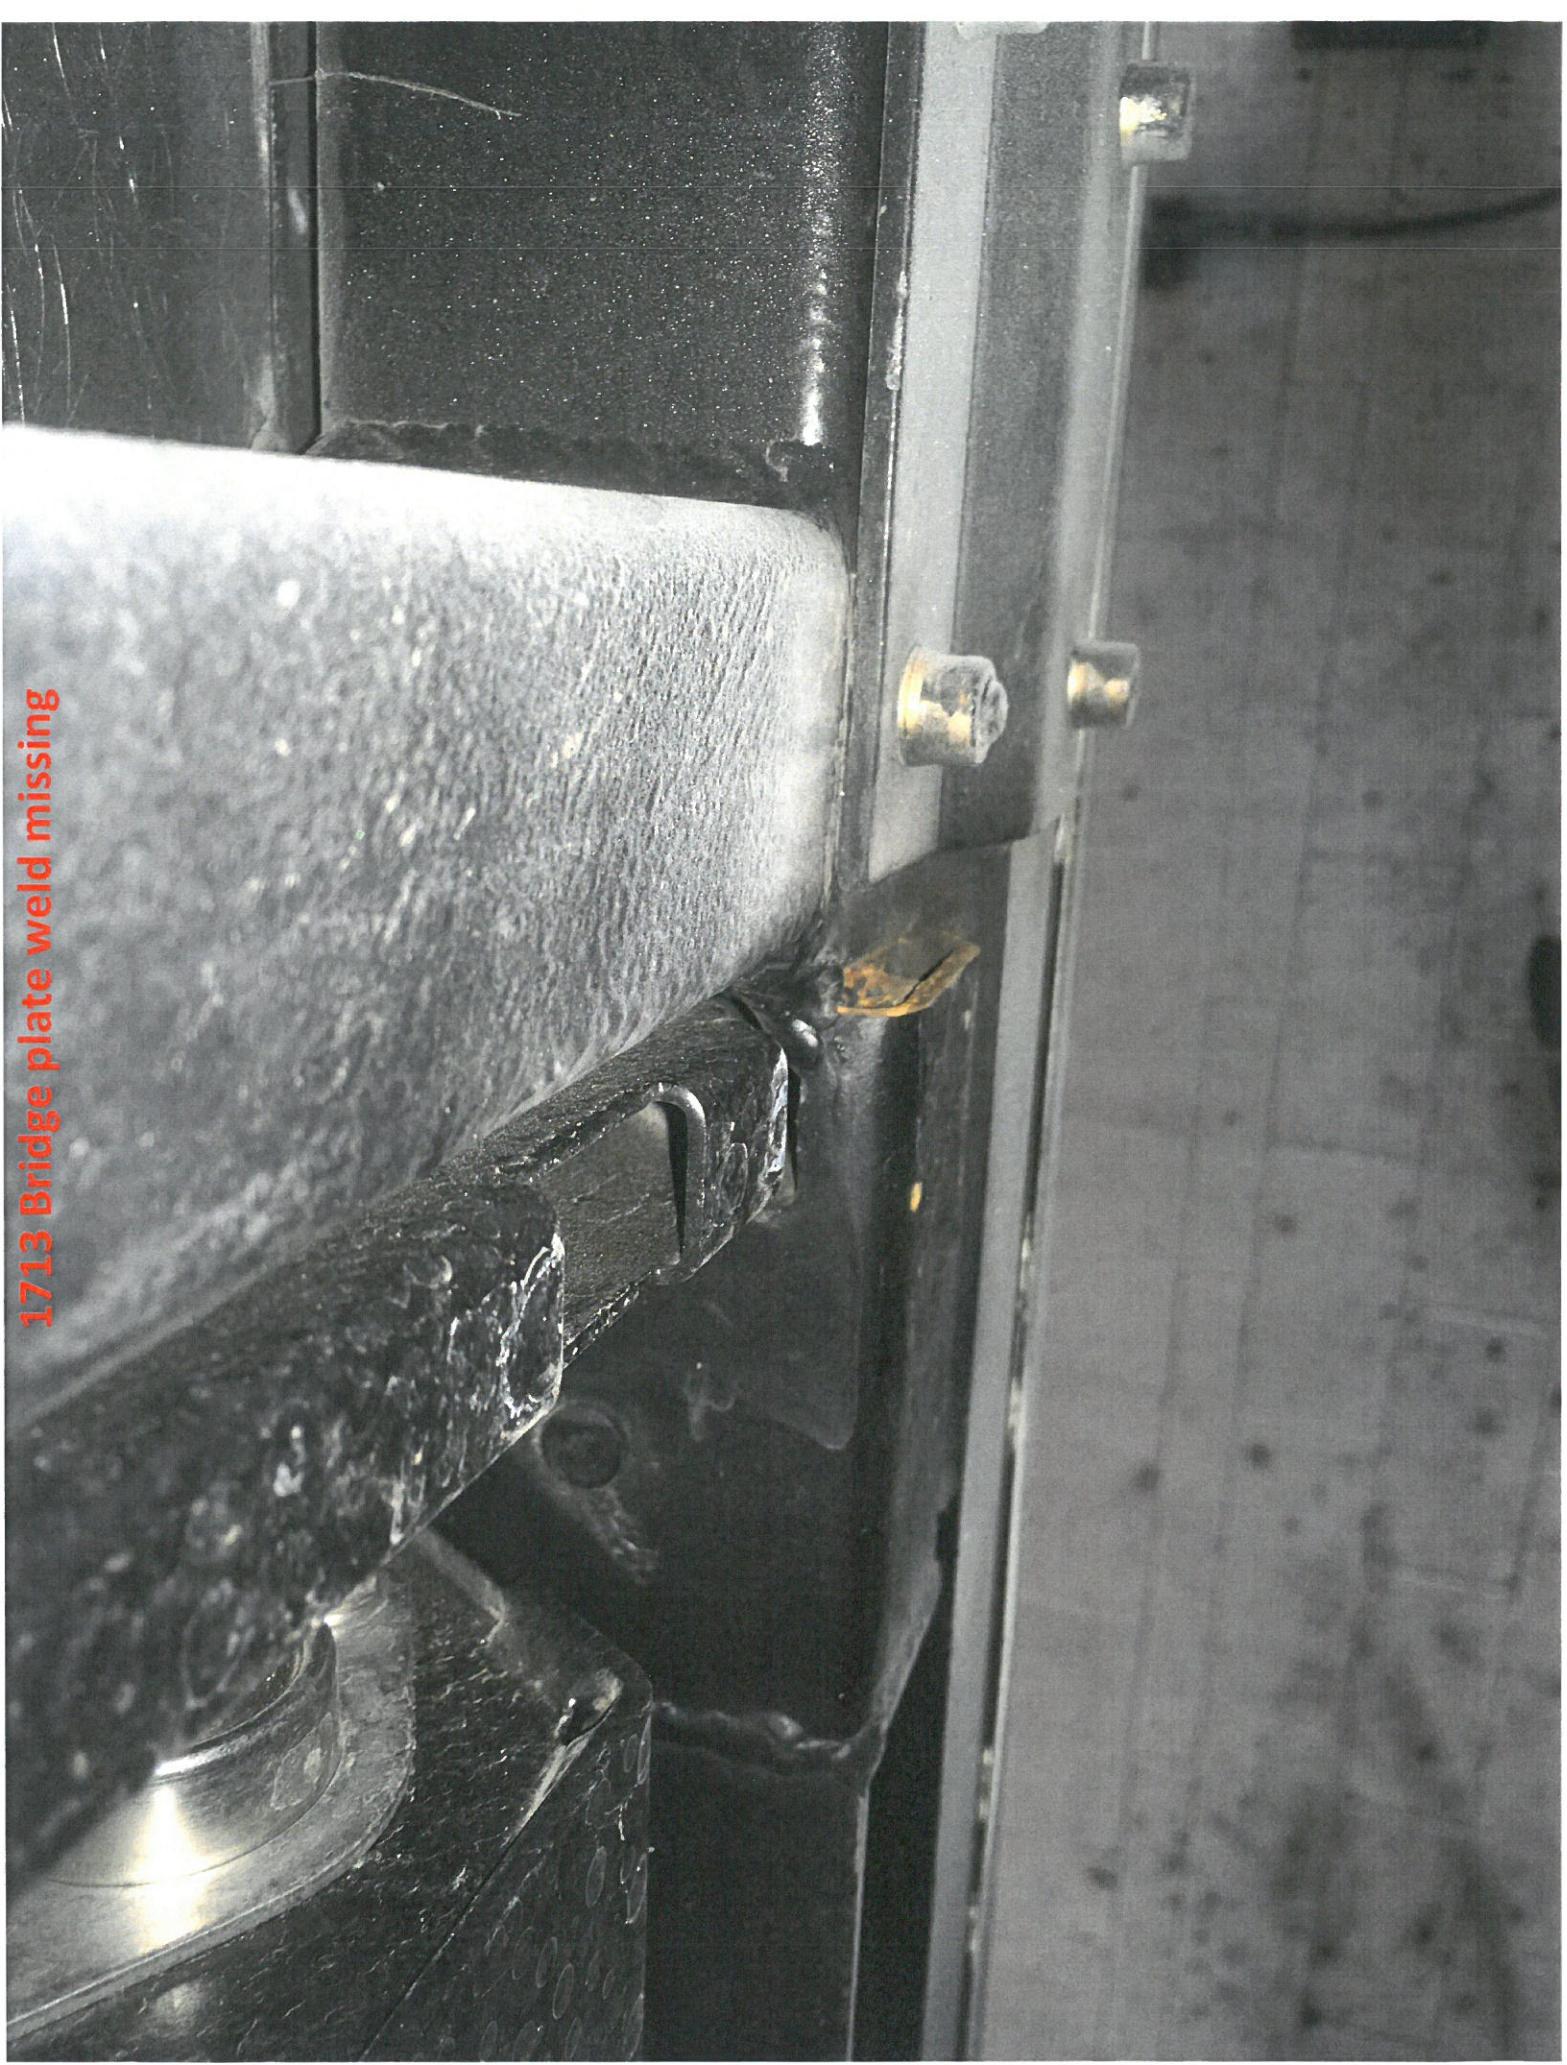
1713 Bridge plate weld missing
