1714

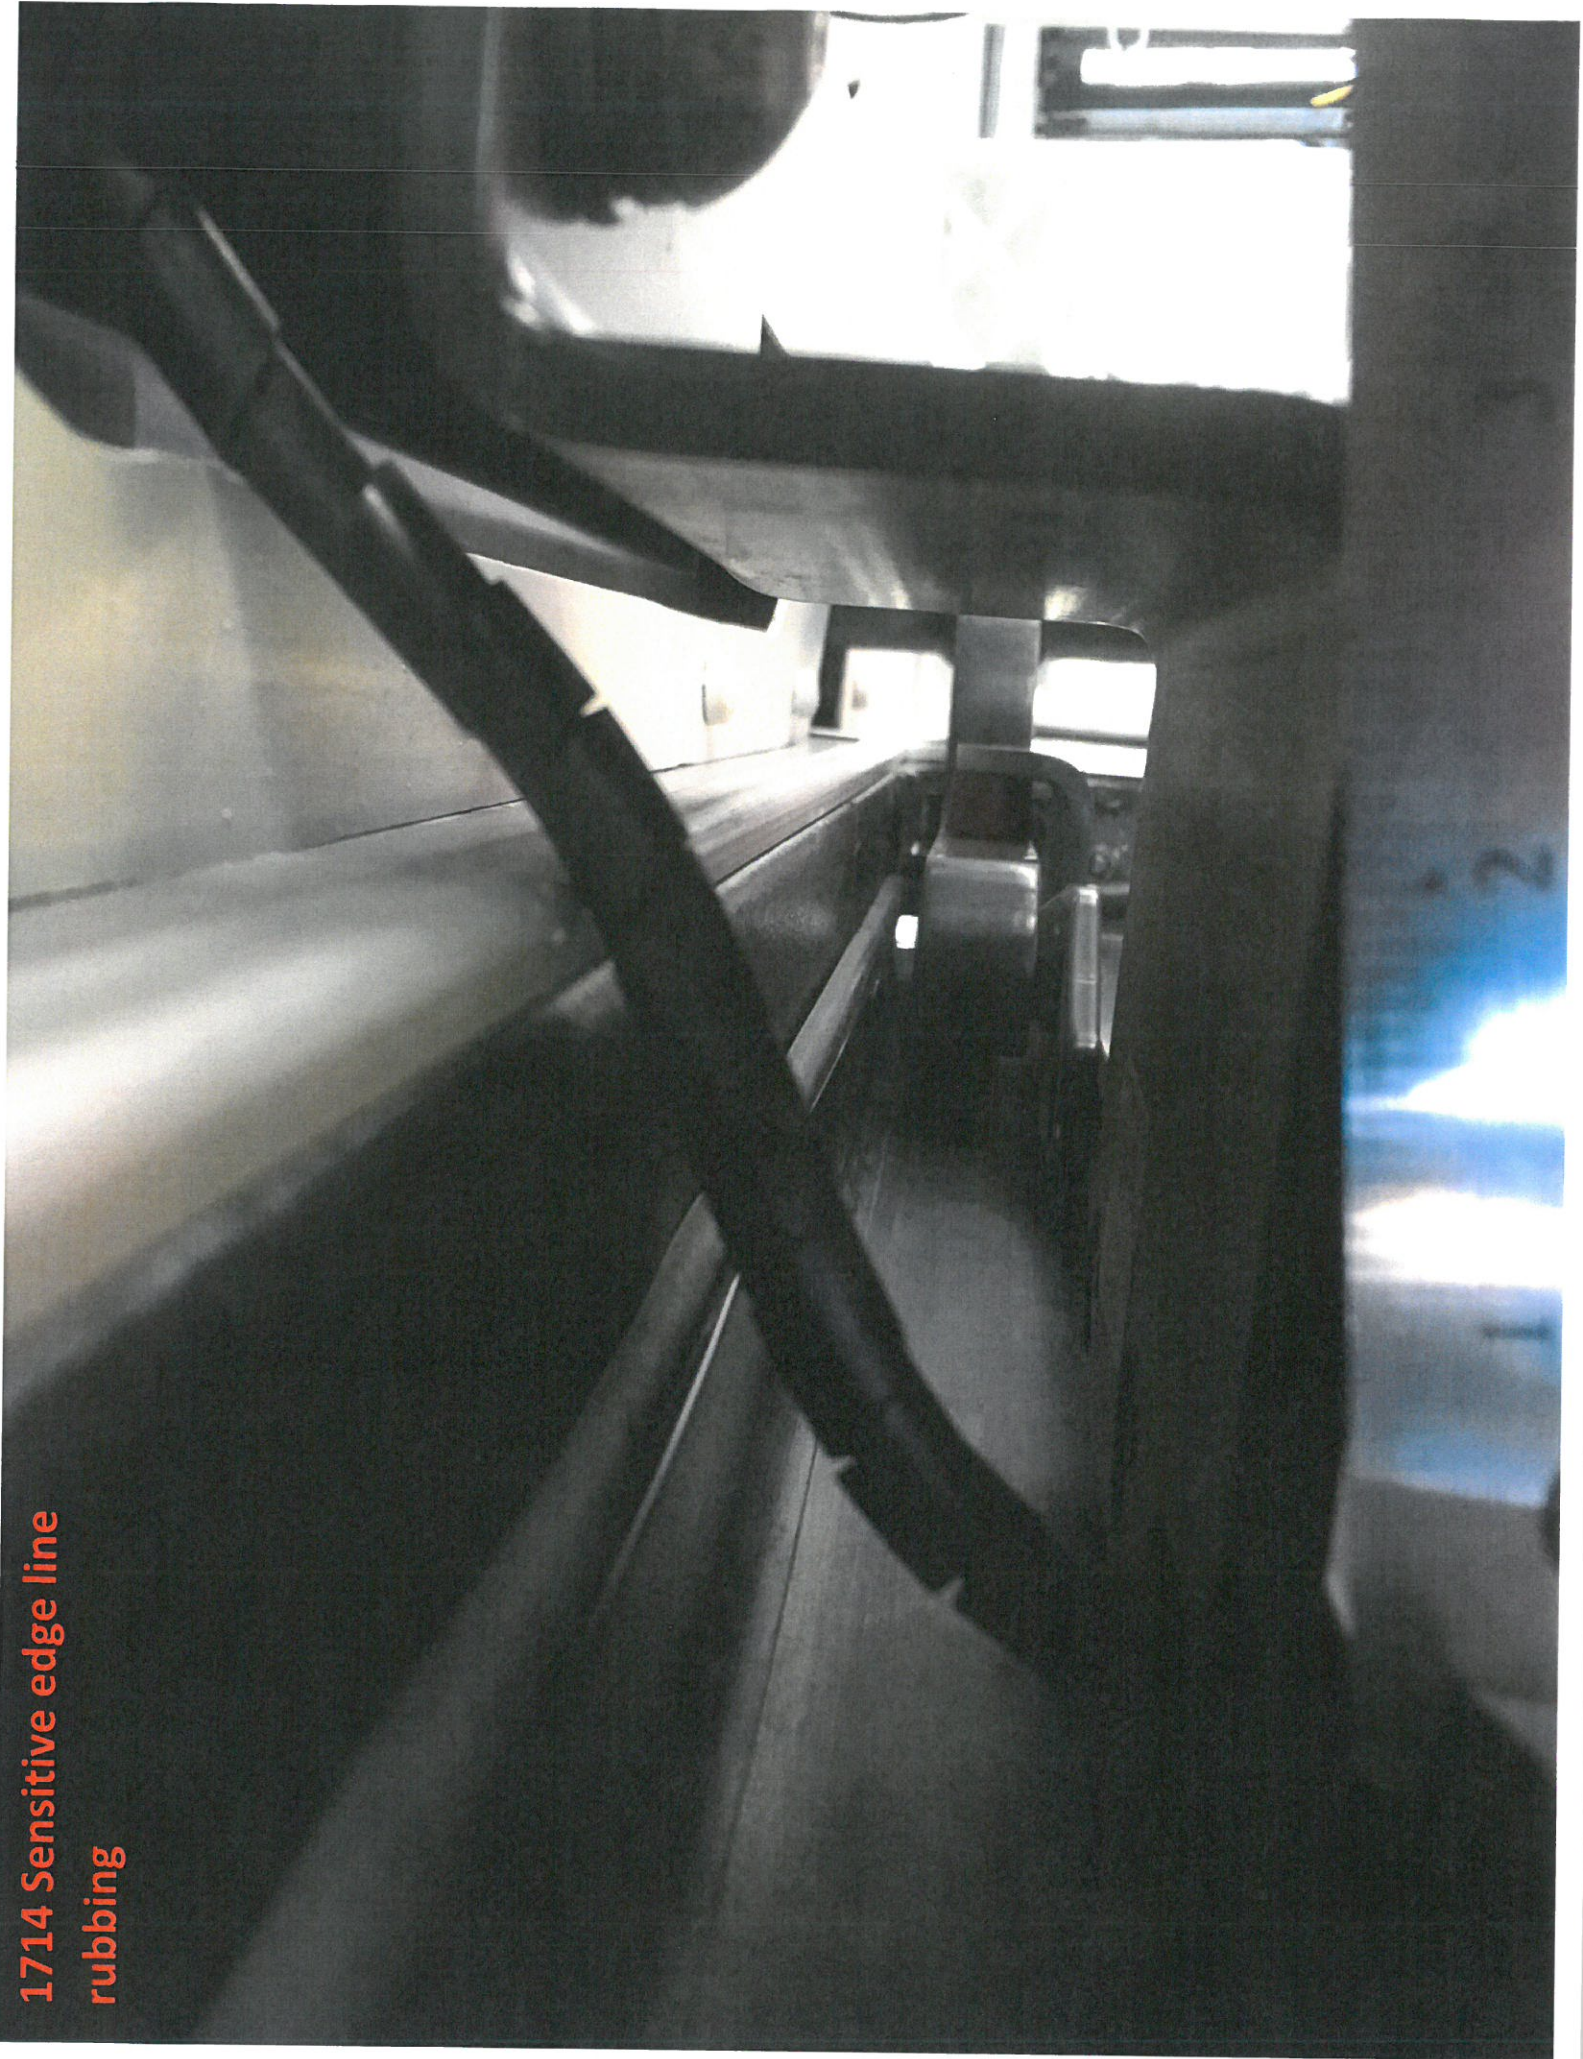
1714 Sensitive edge line
rubbing

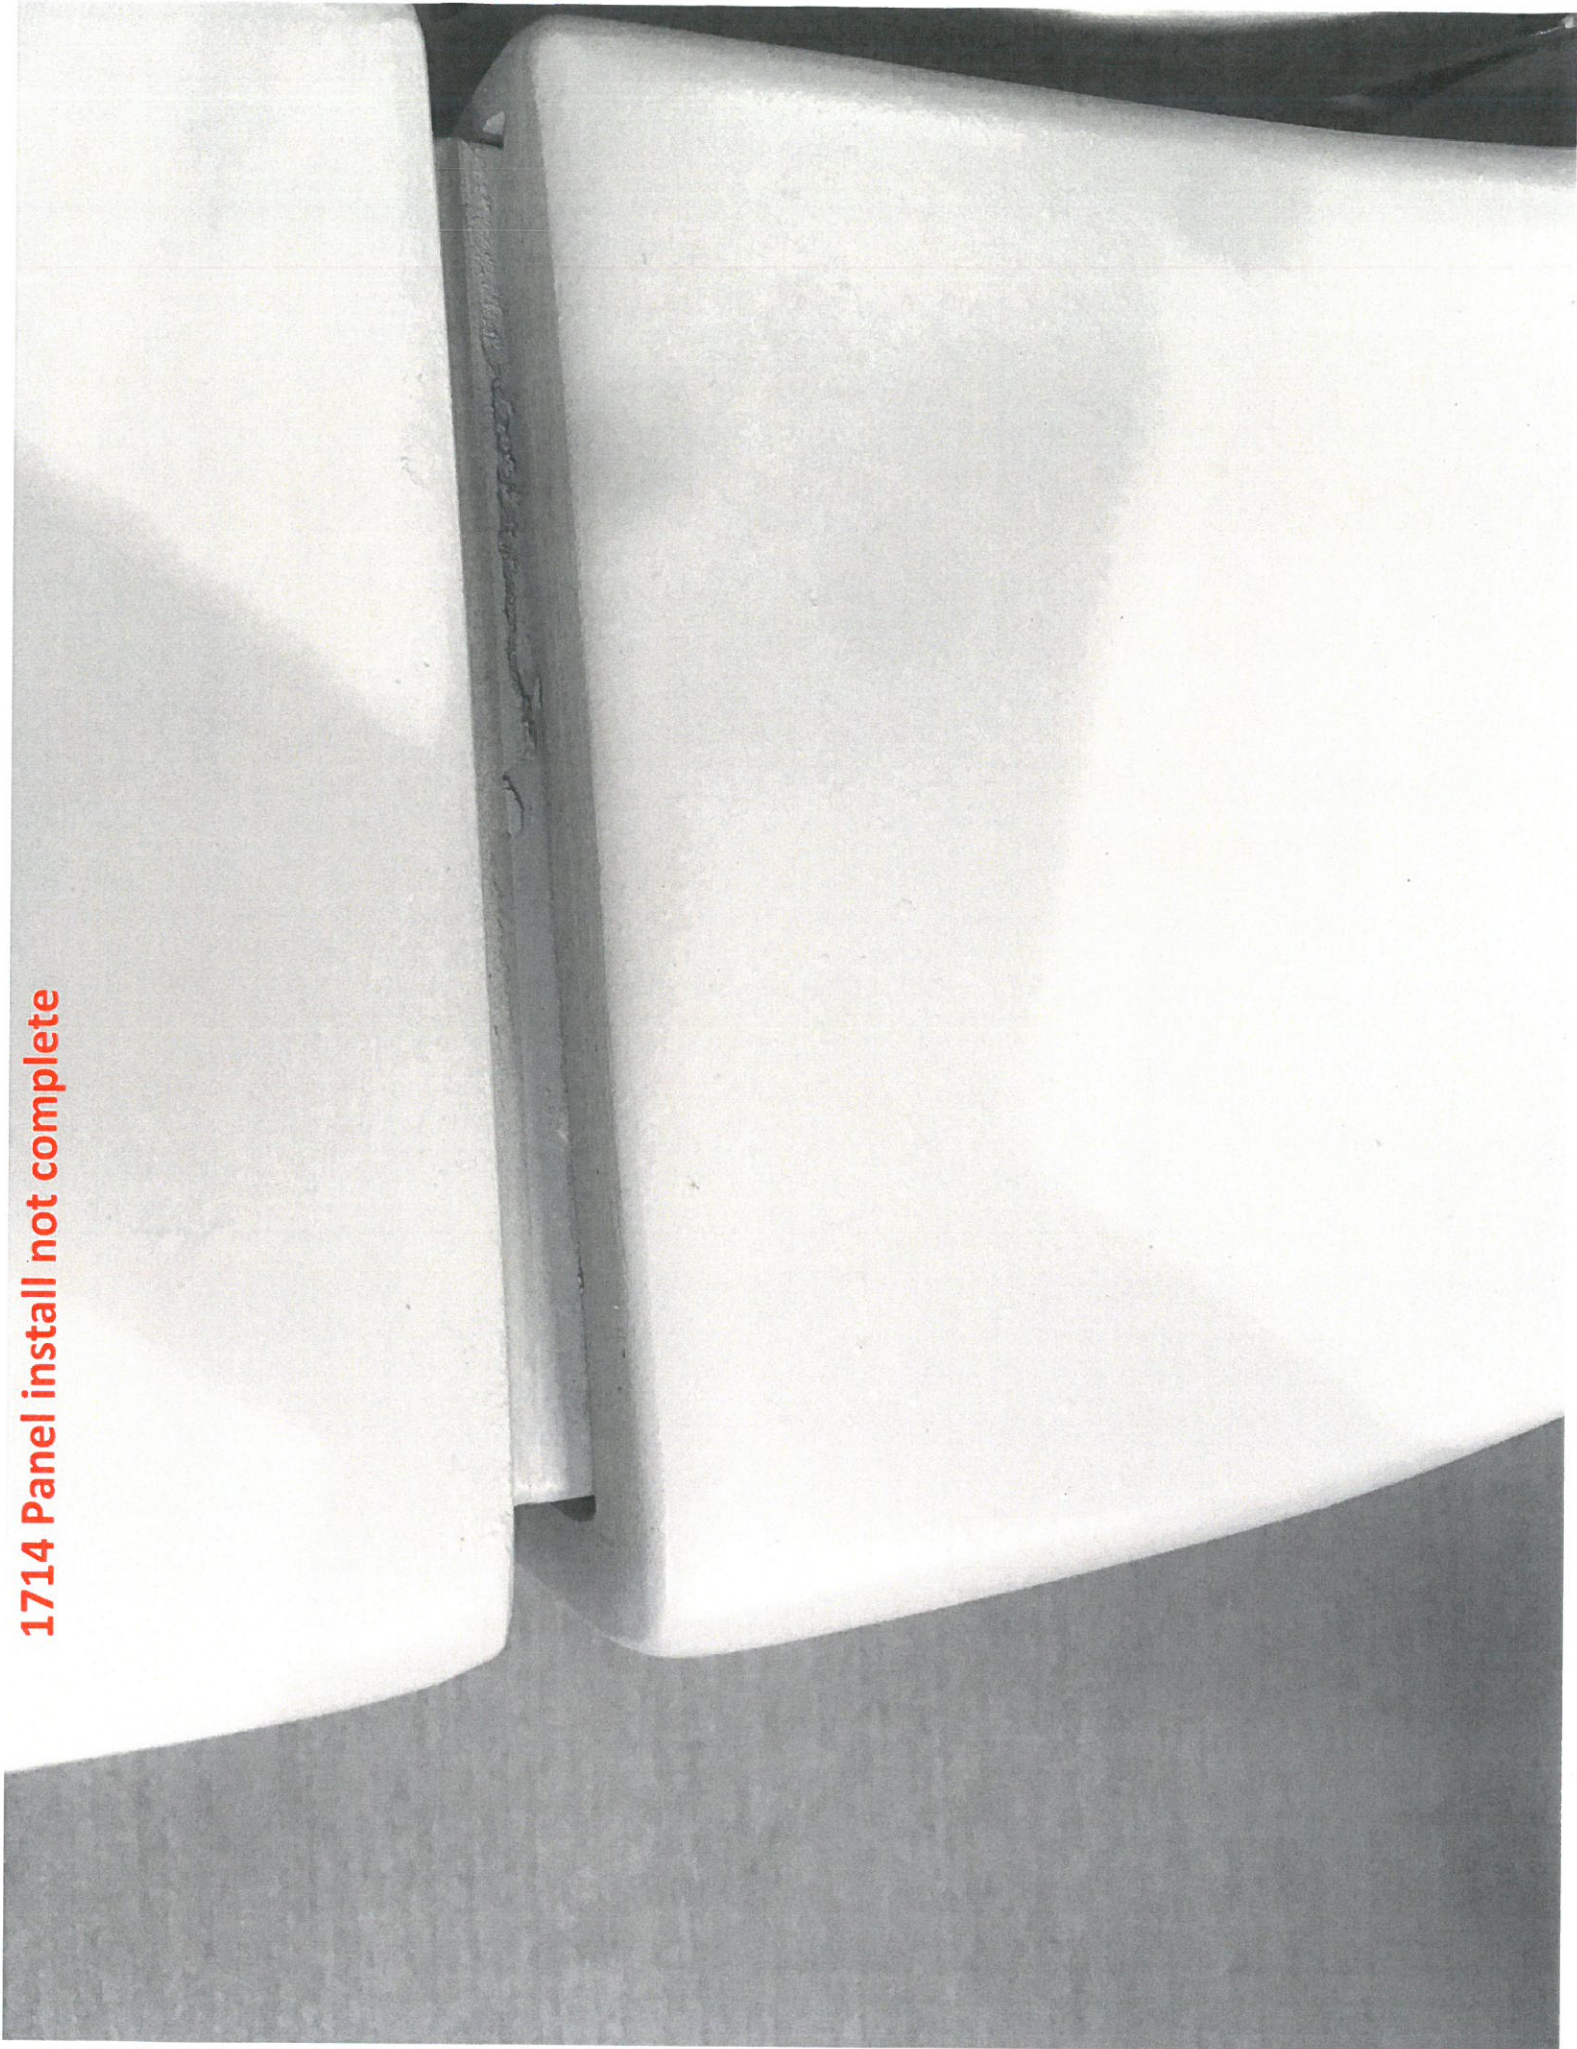
1714 Panel install not complete

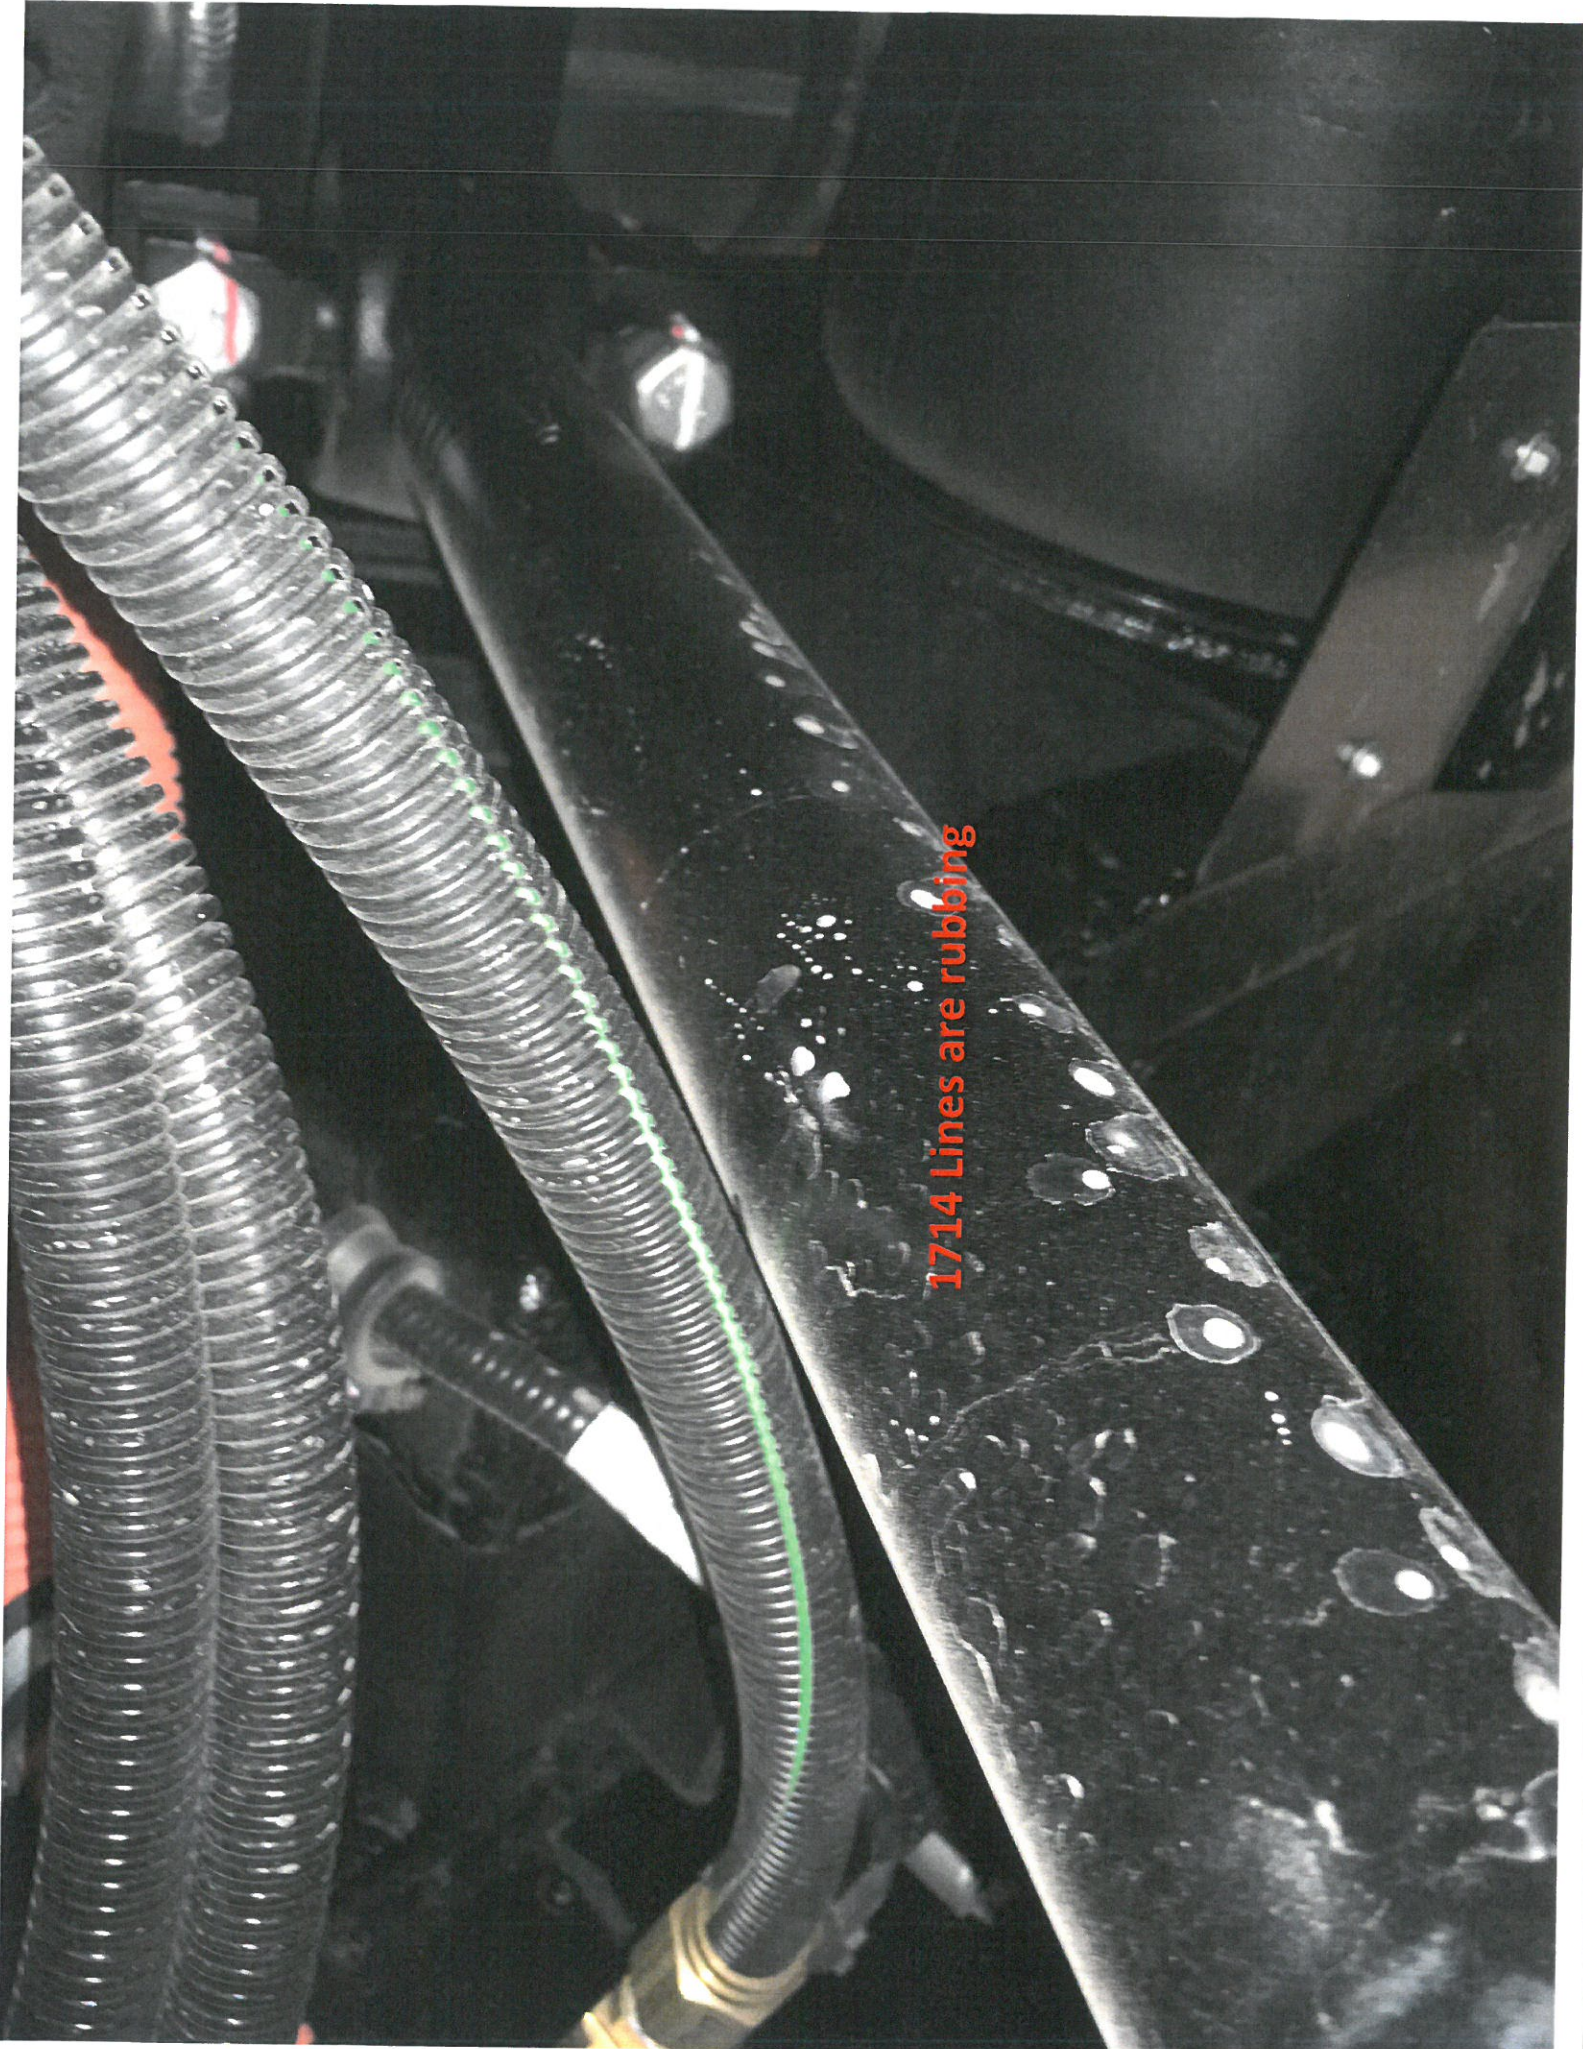
1714 Lines are rubbing

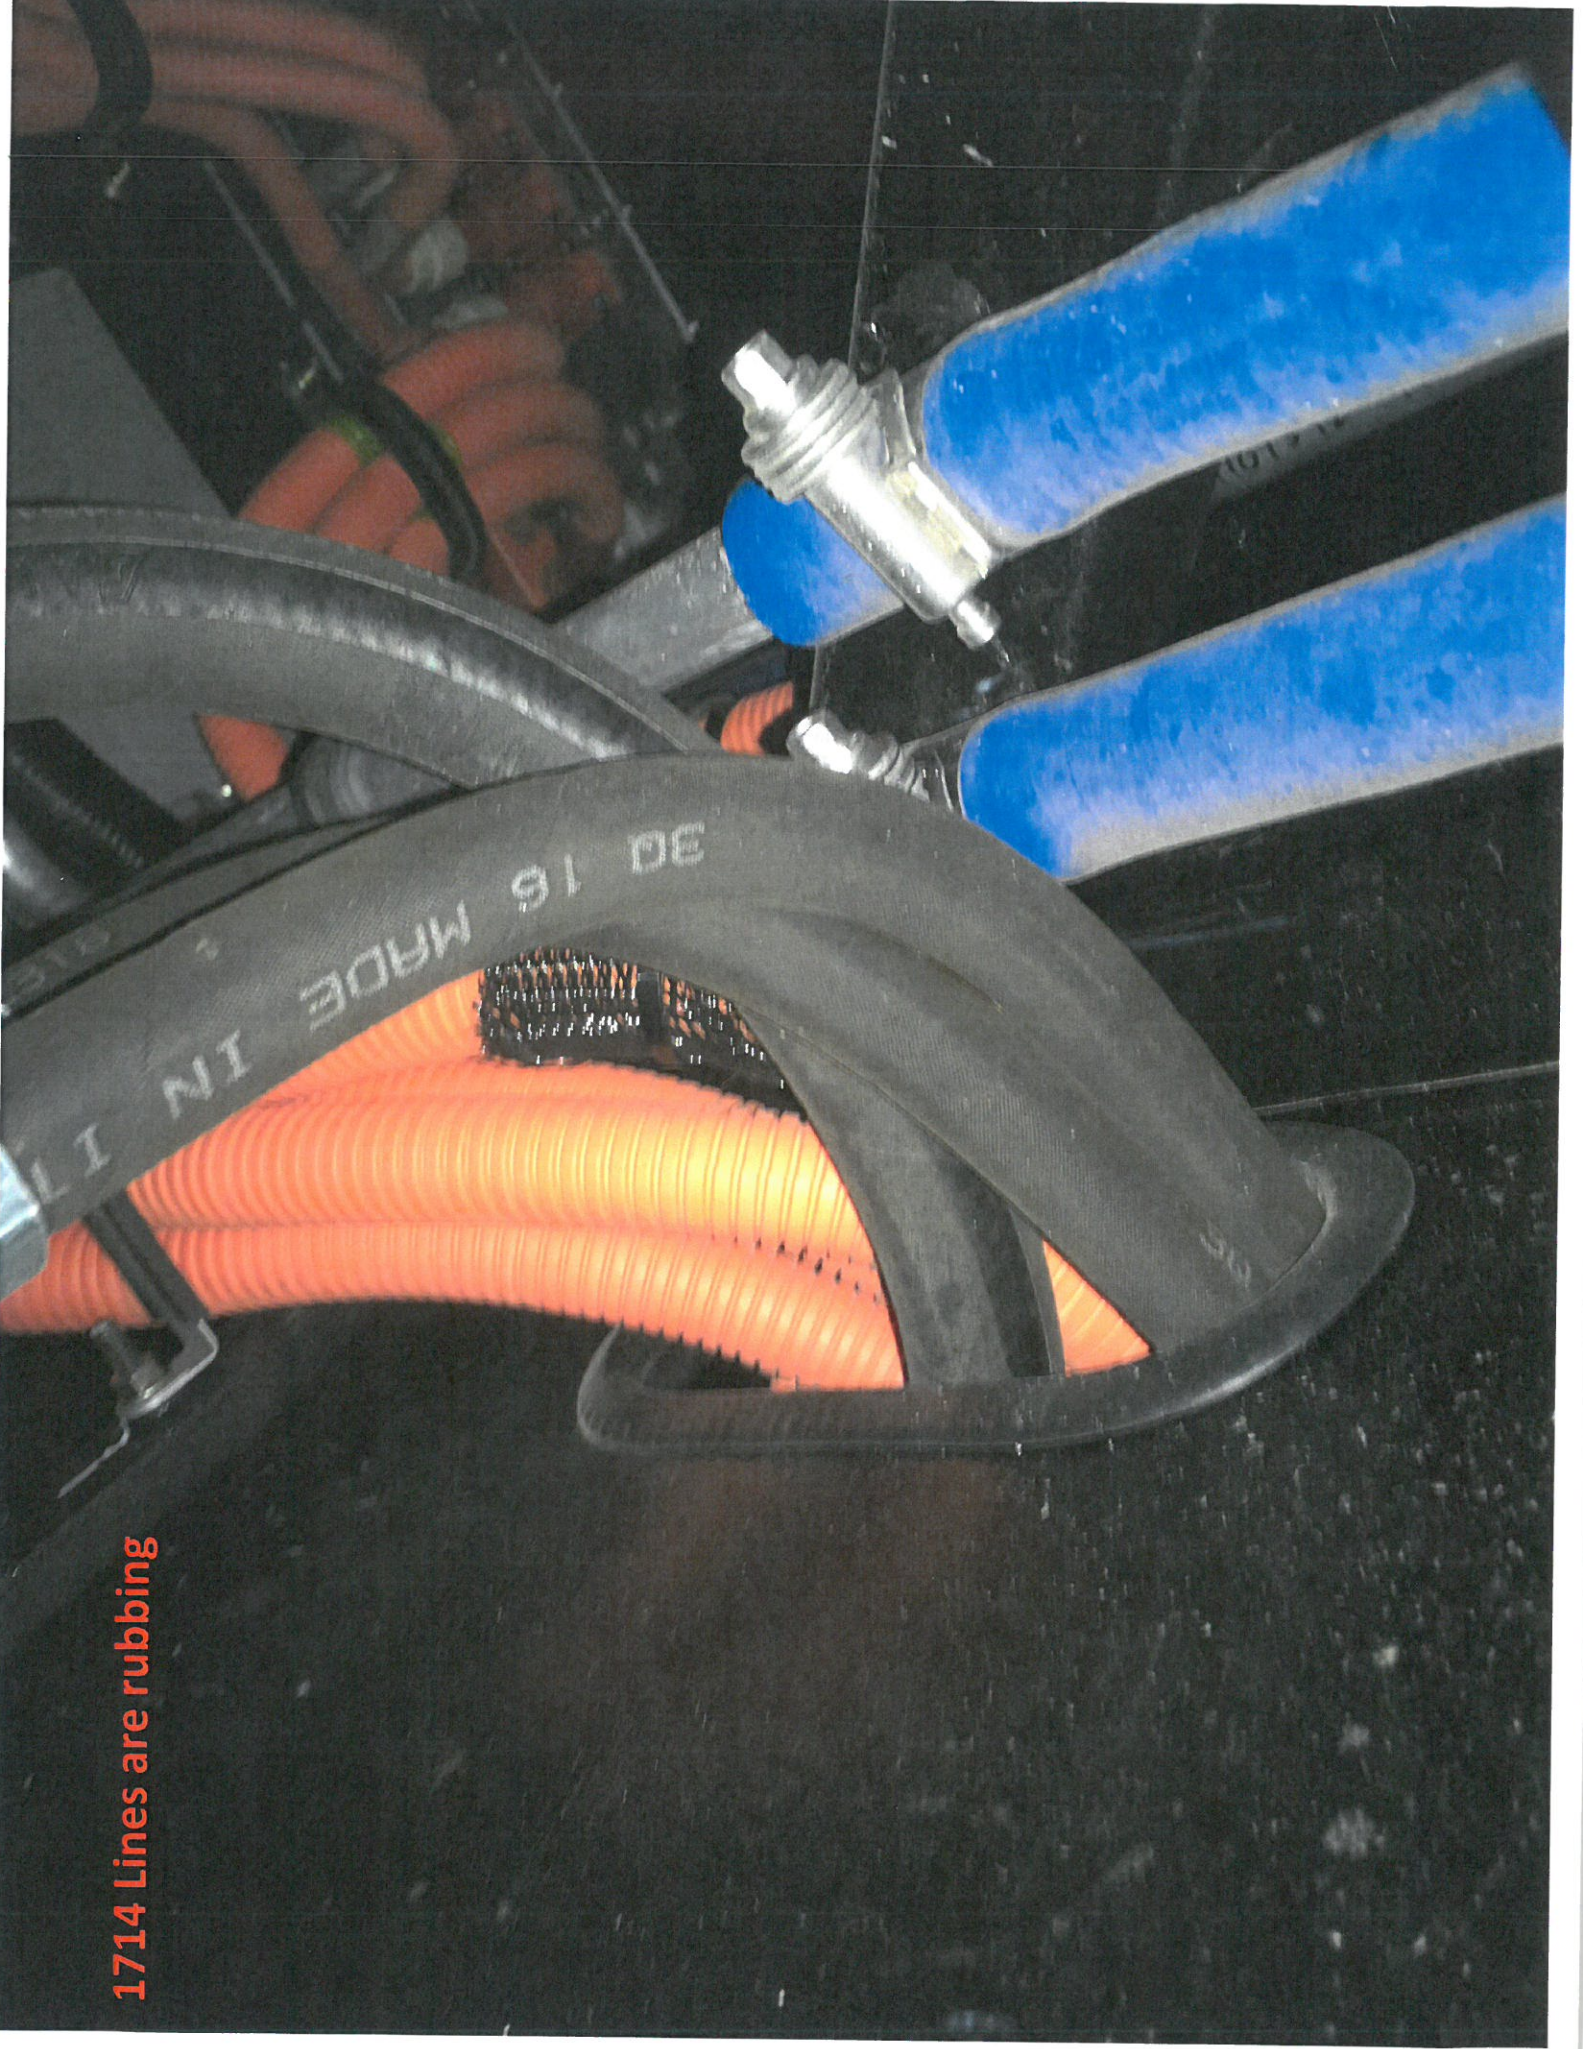
1714 Lines are rubbing

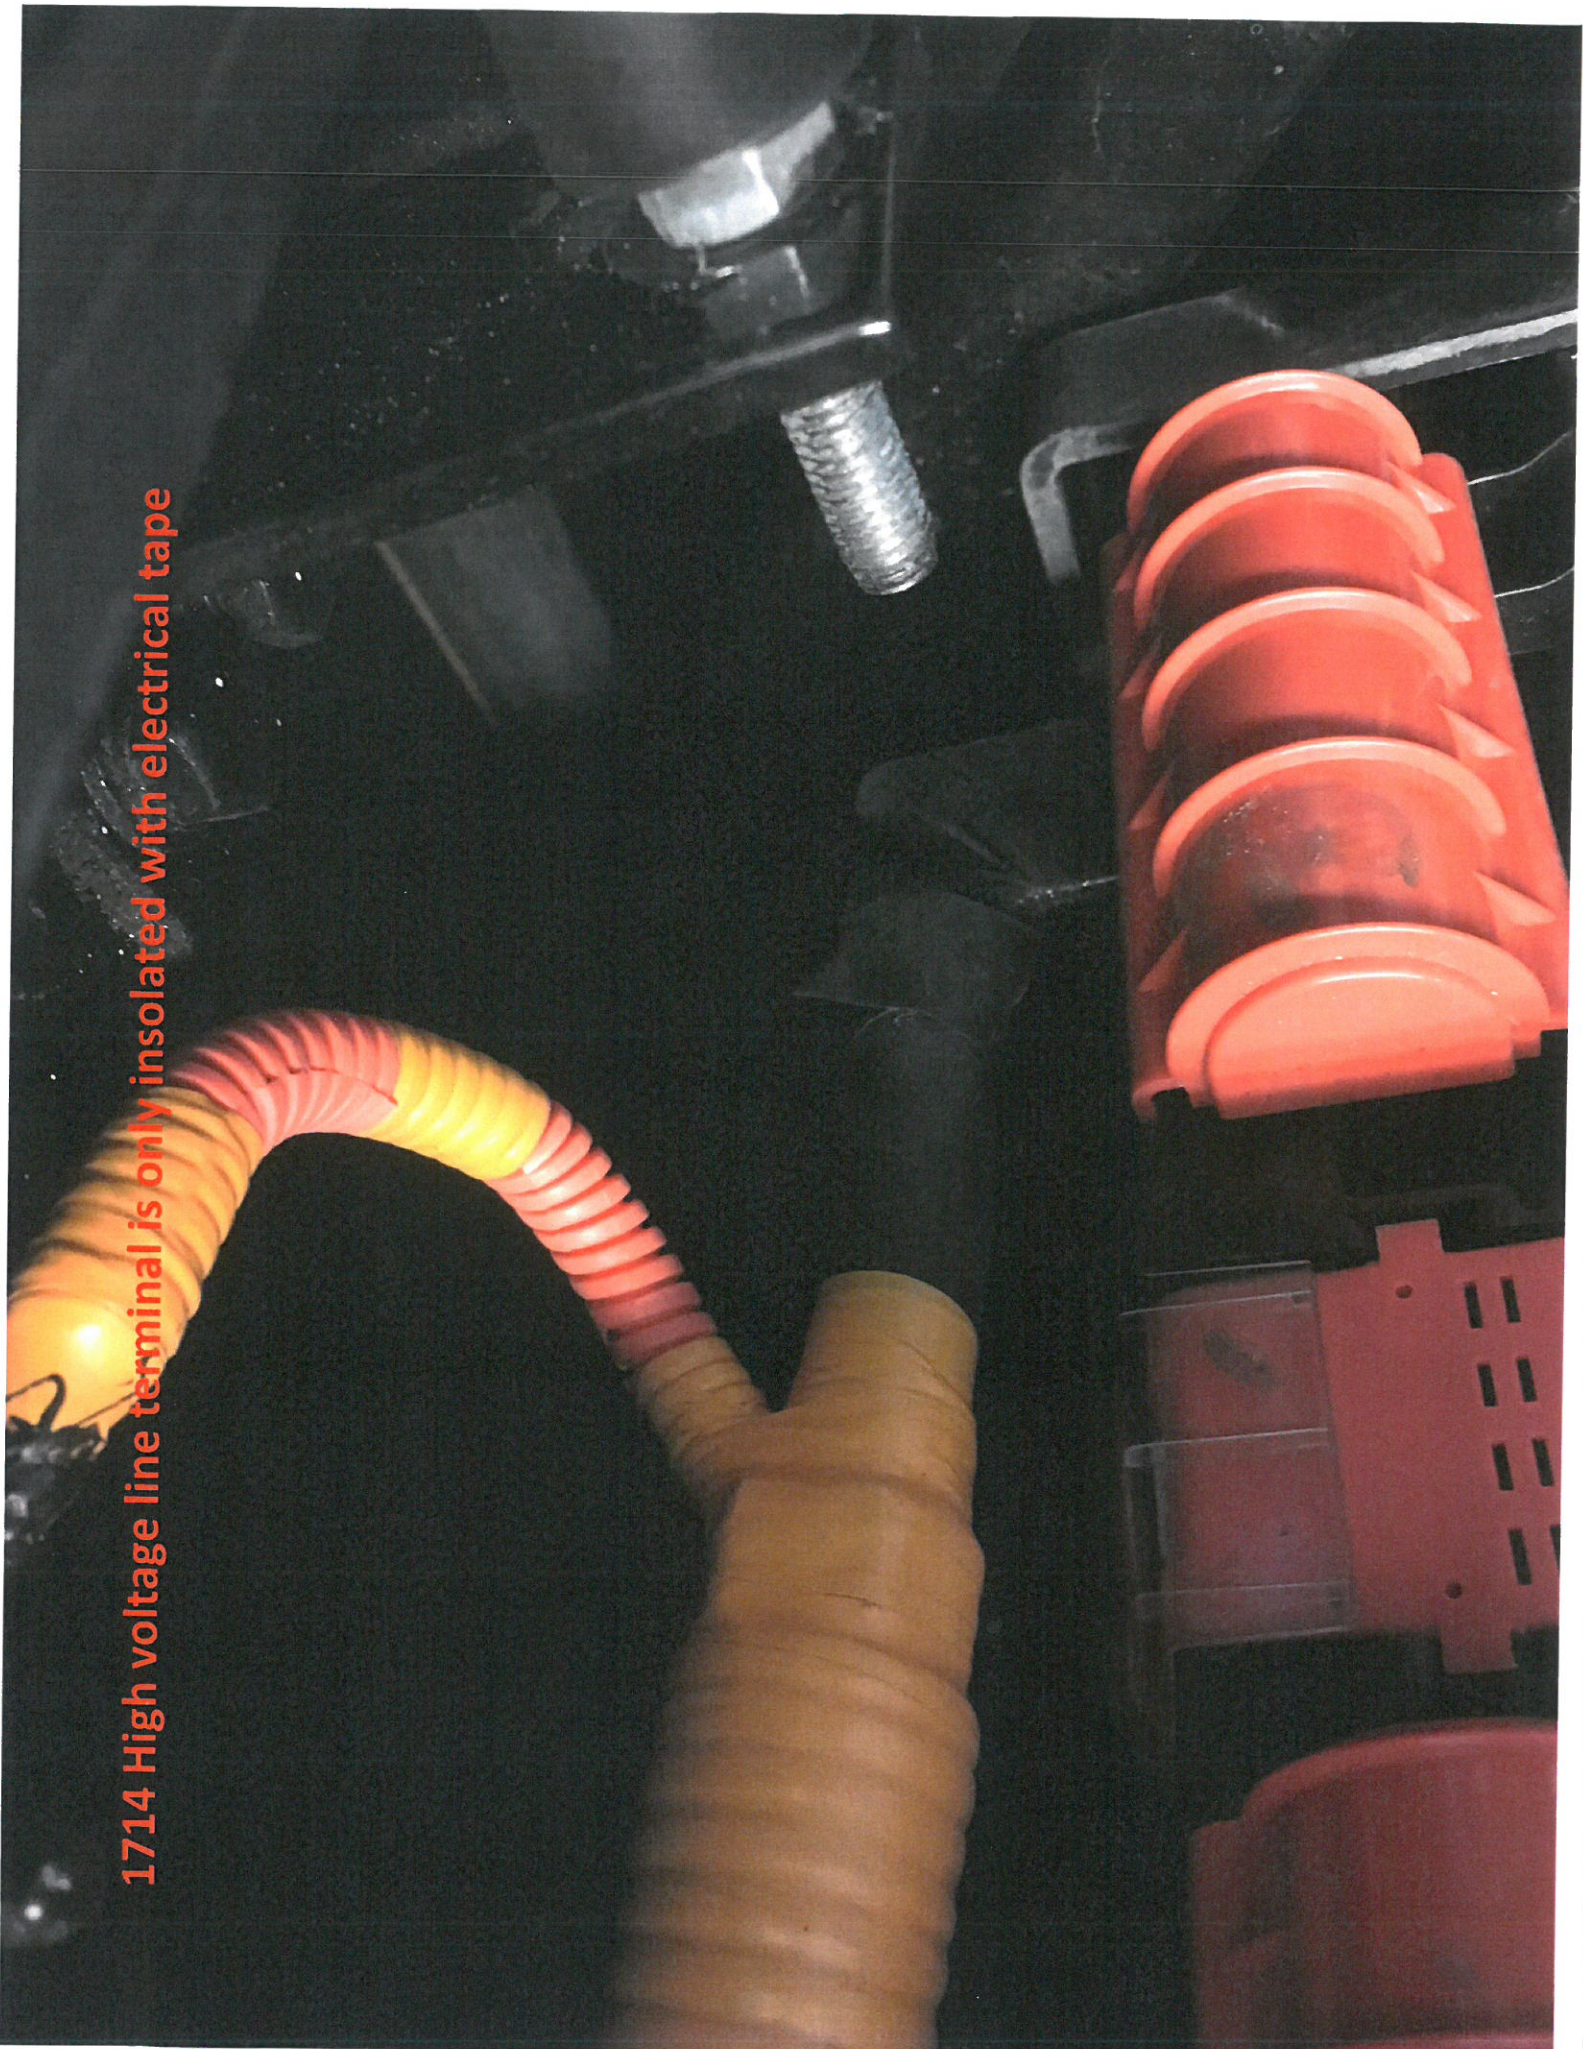
1714 High voltage line terminal is only insulated with electrical tape

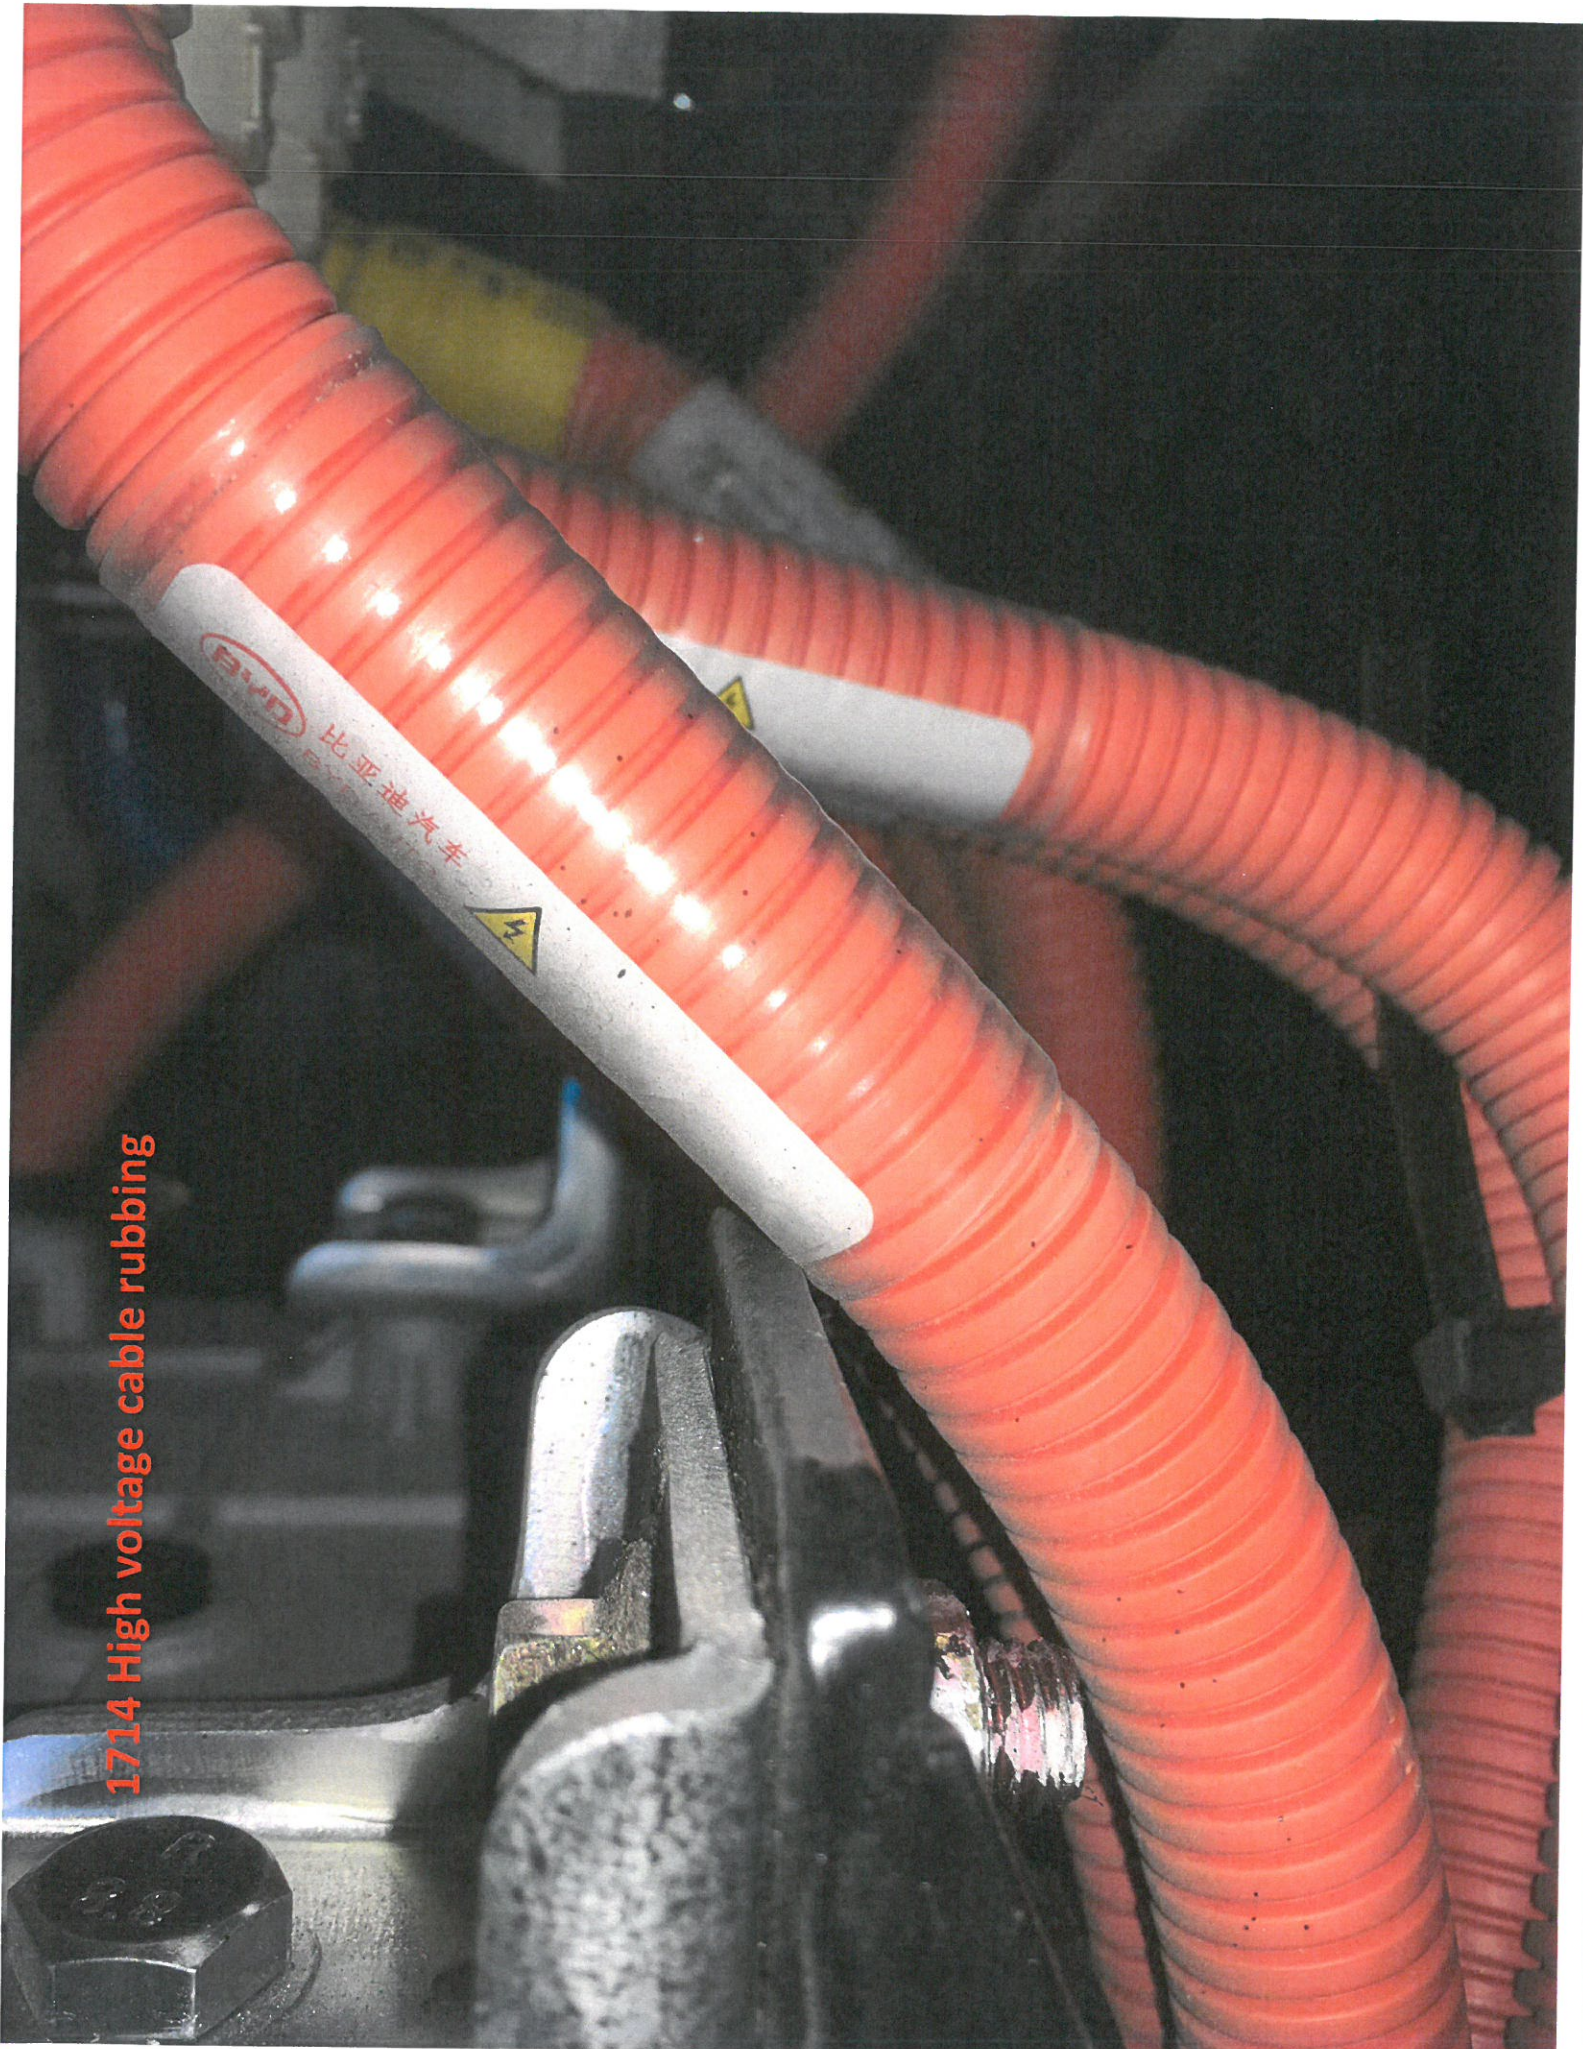
1714 High voltage cable rubbing

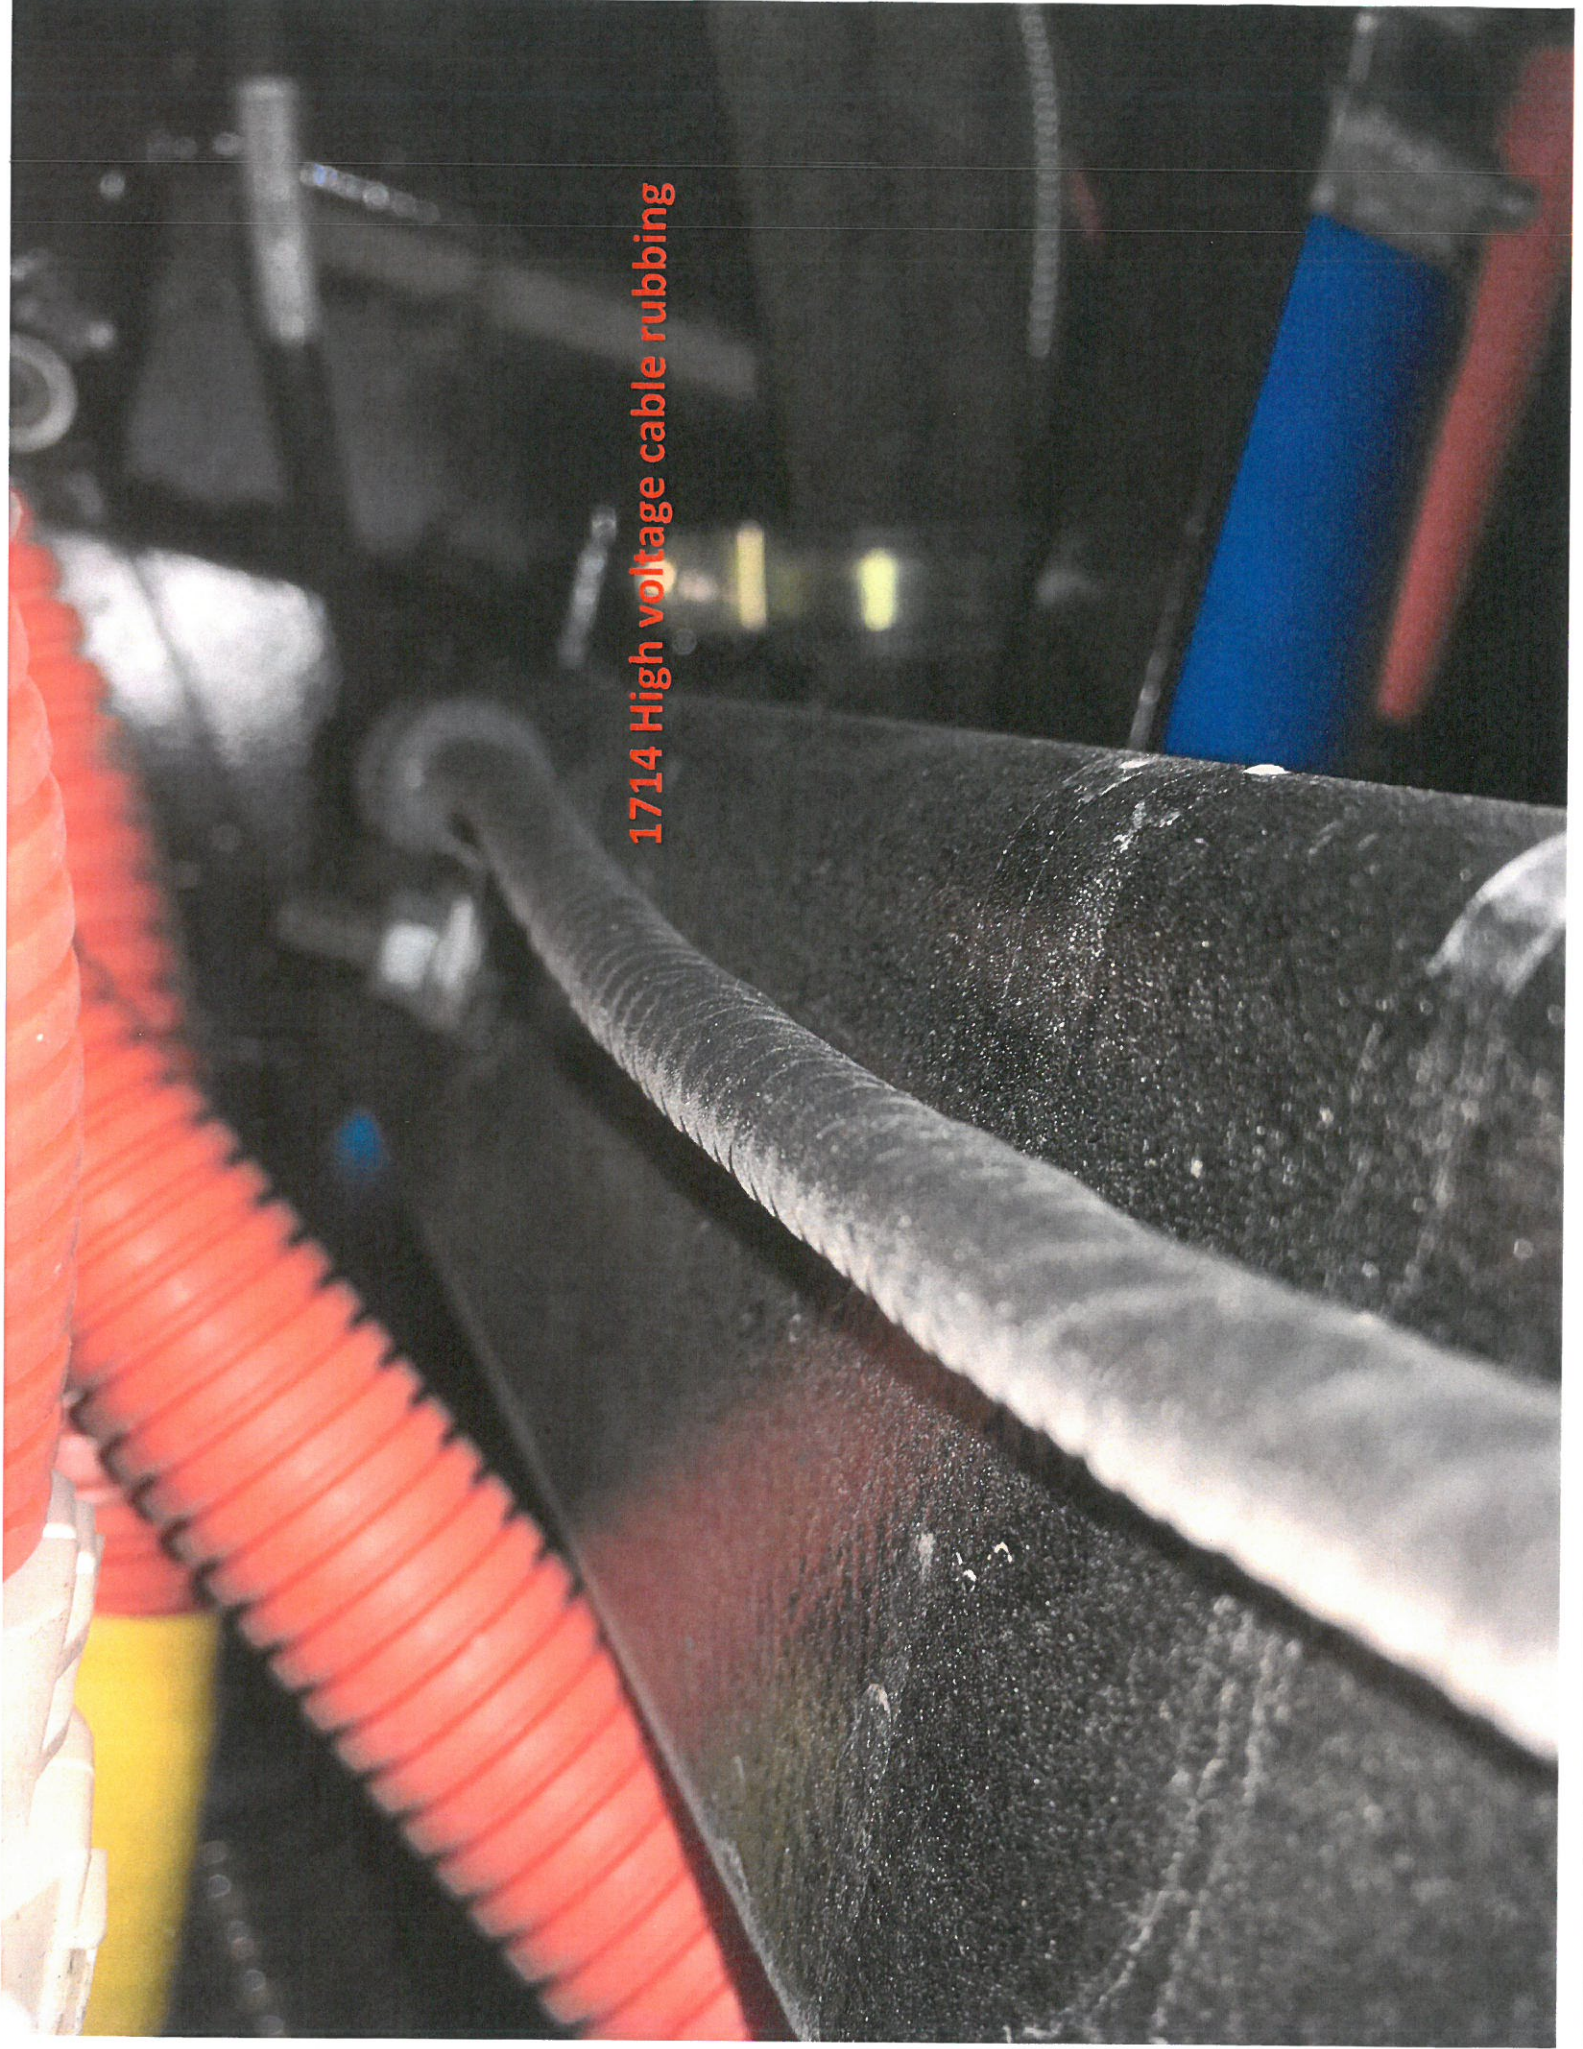
1714 High voltage cable rubbing
