1714

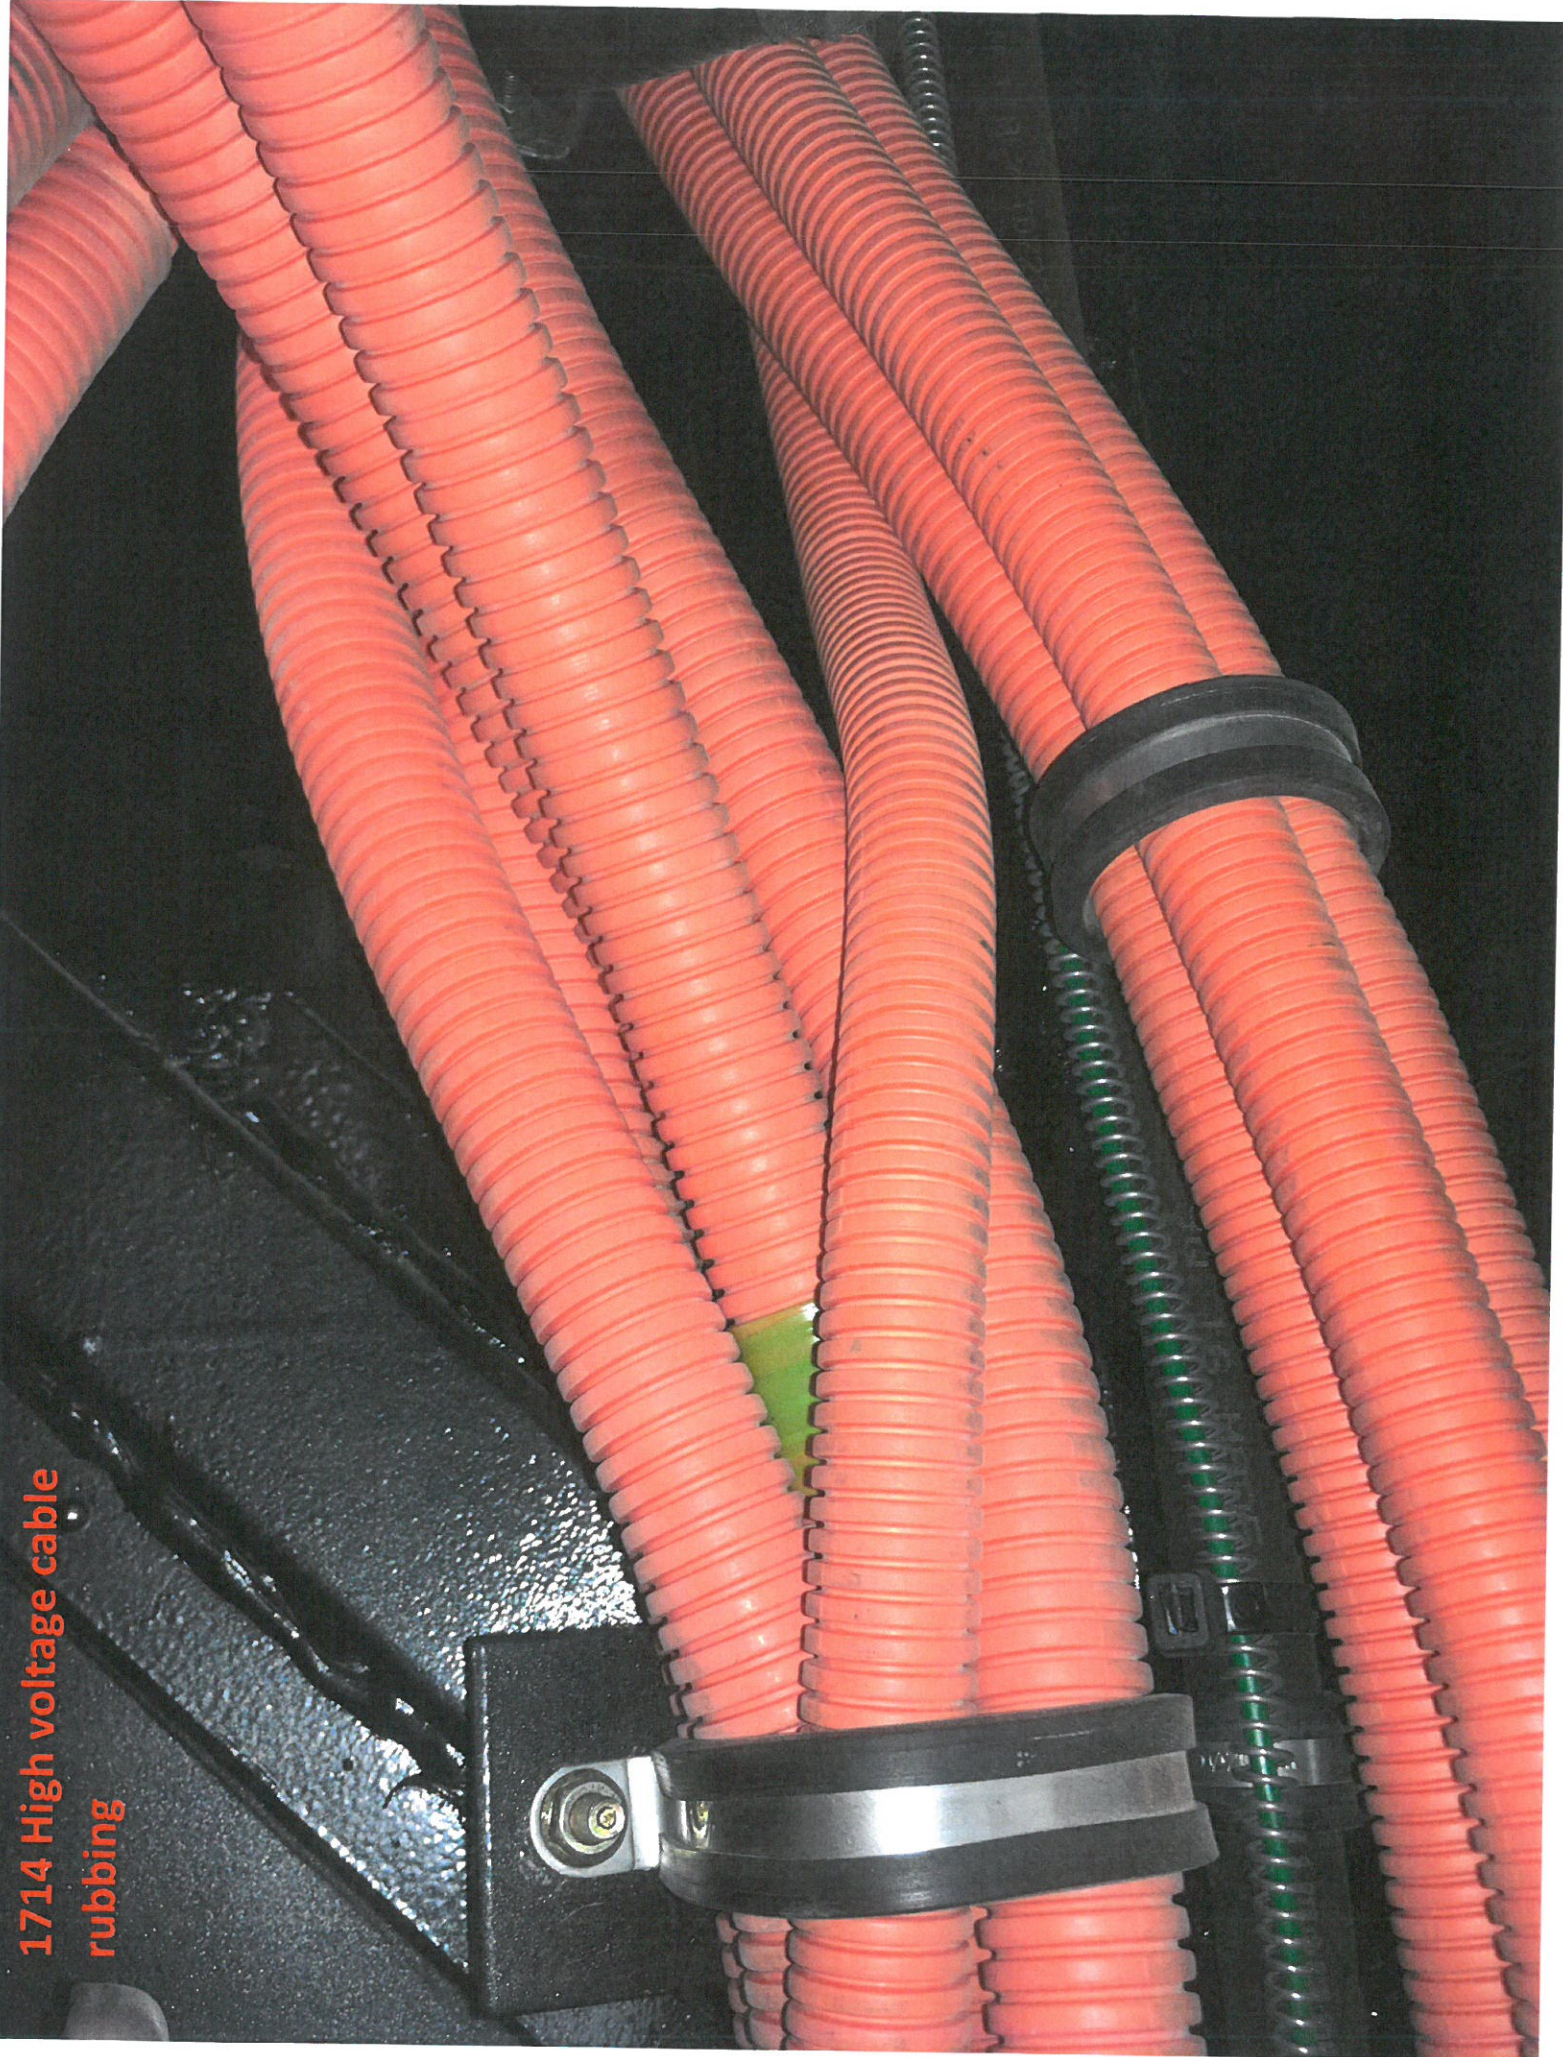
1714 High voltage cable
rubbing

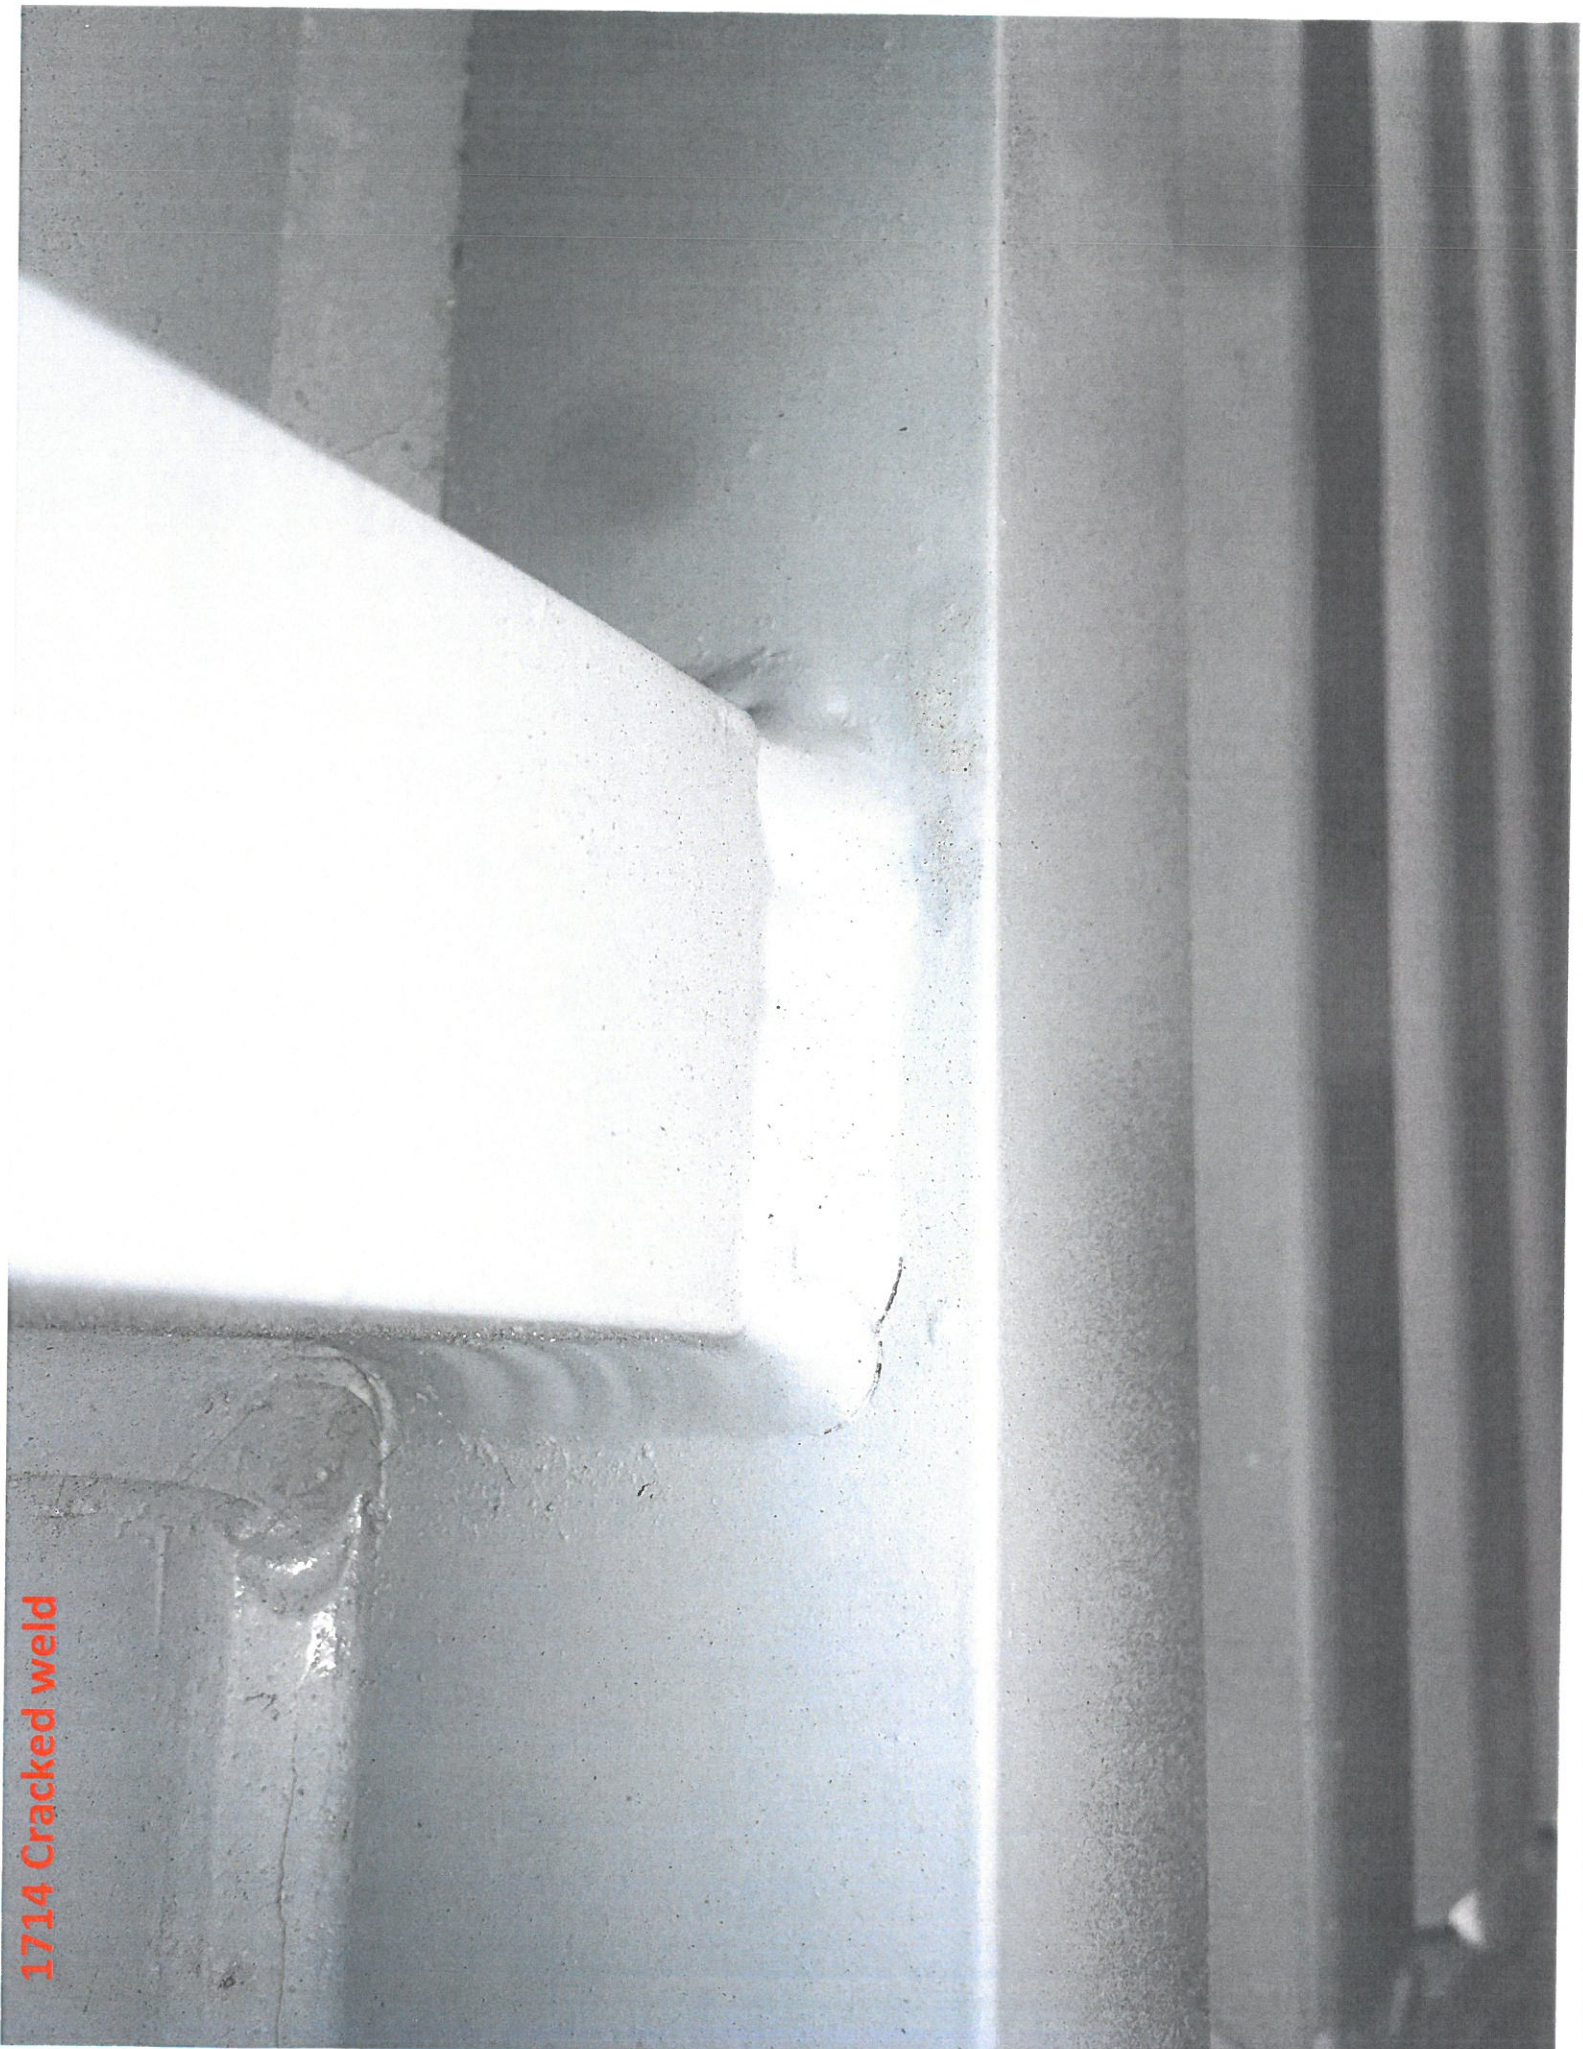
1714 Cracked weld

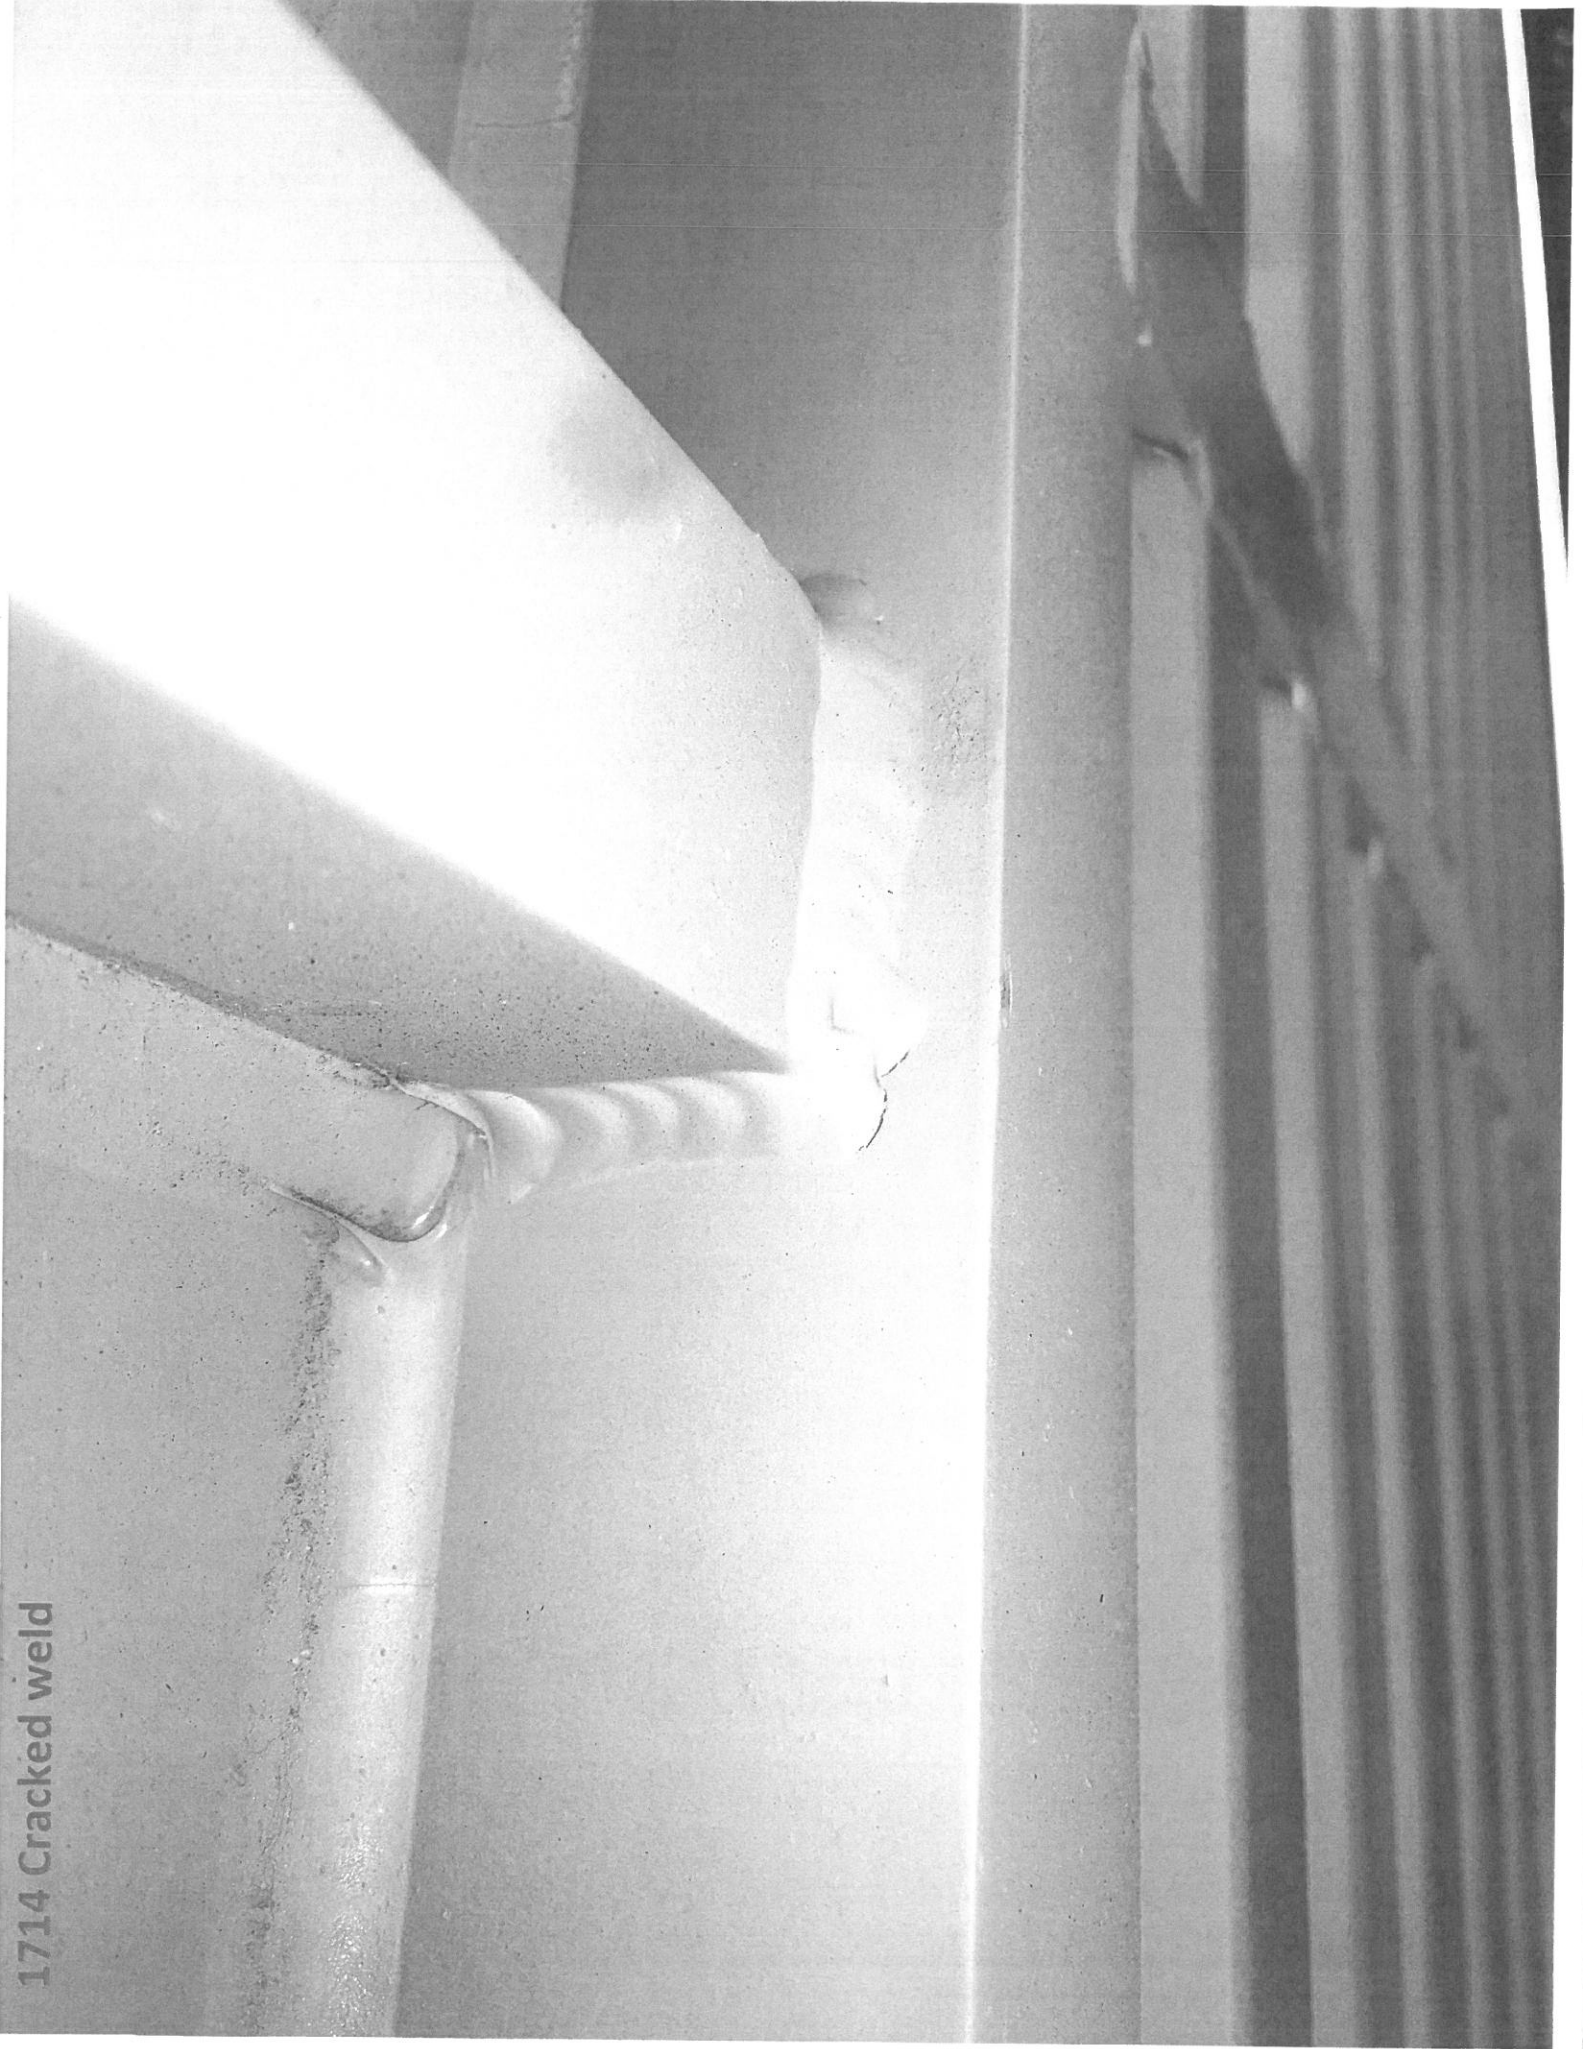
1714 Cracked weld

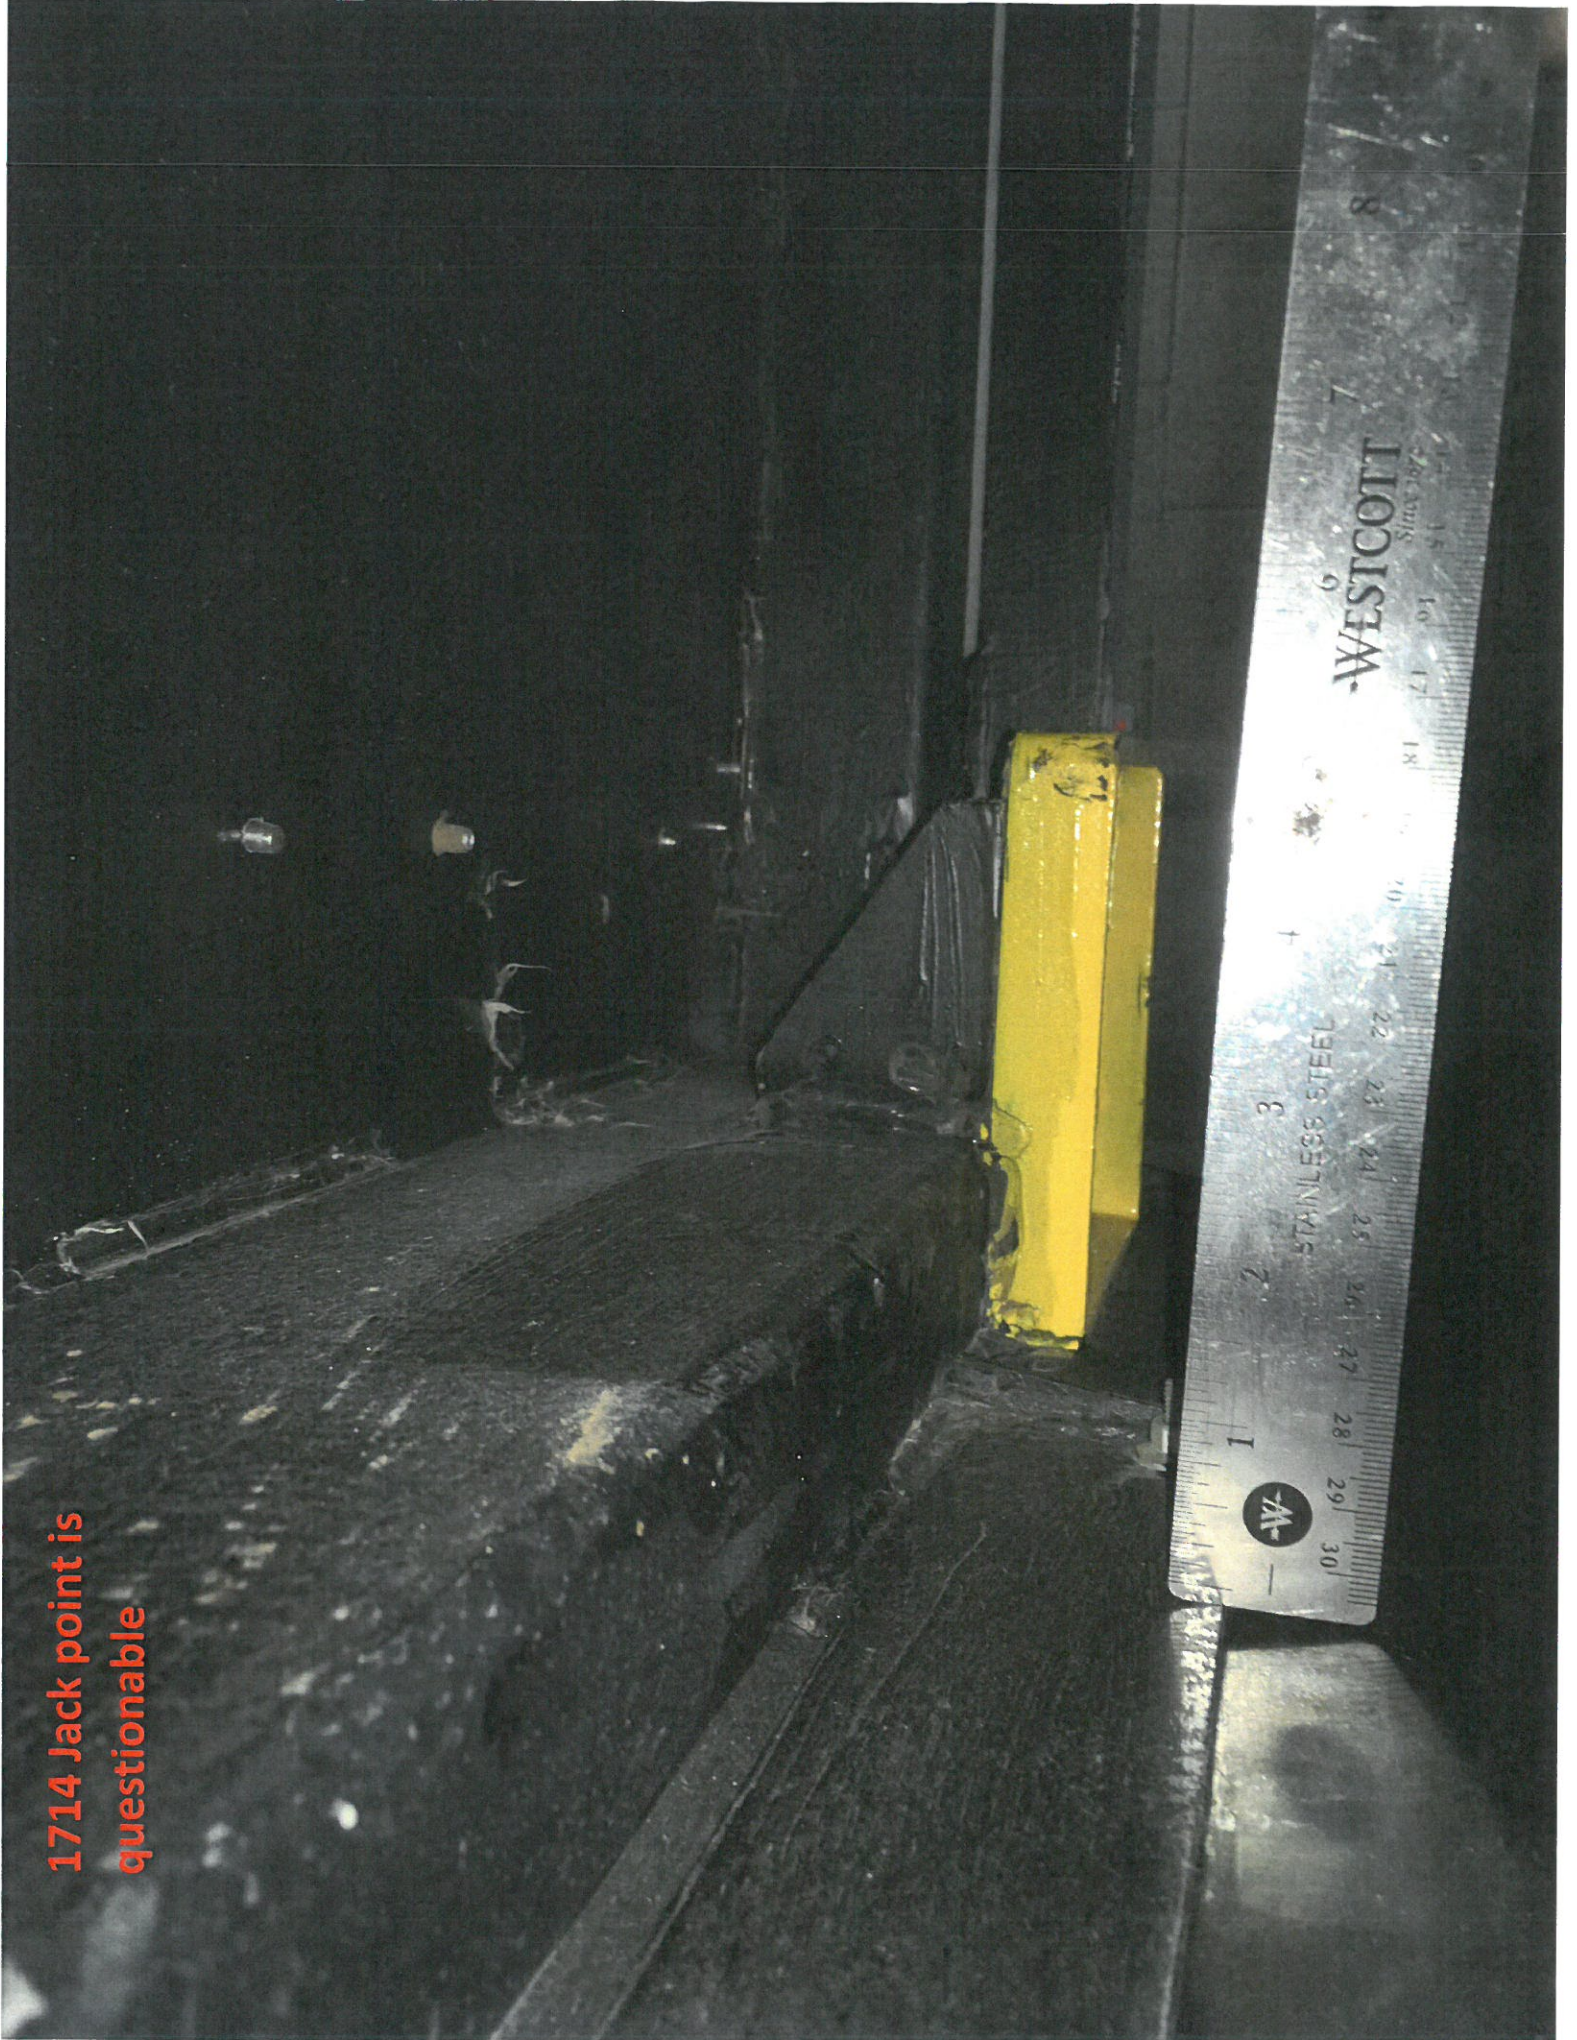
1714 Jack point is
questionable

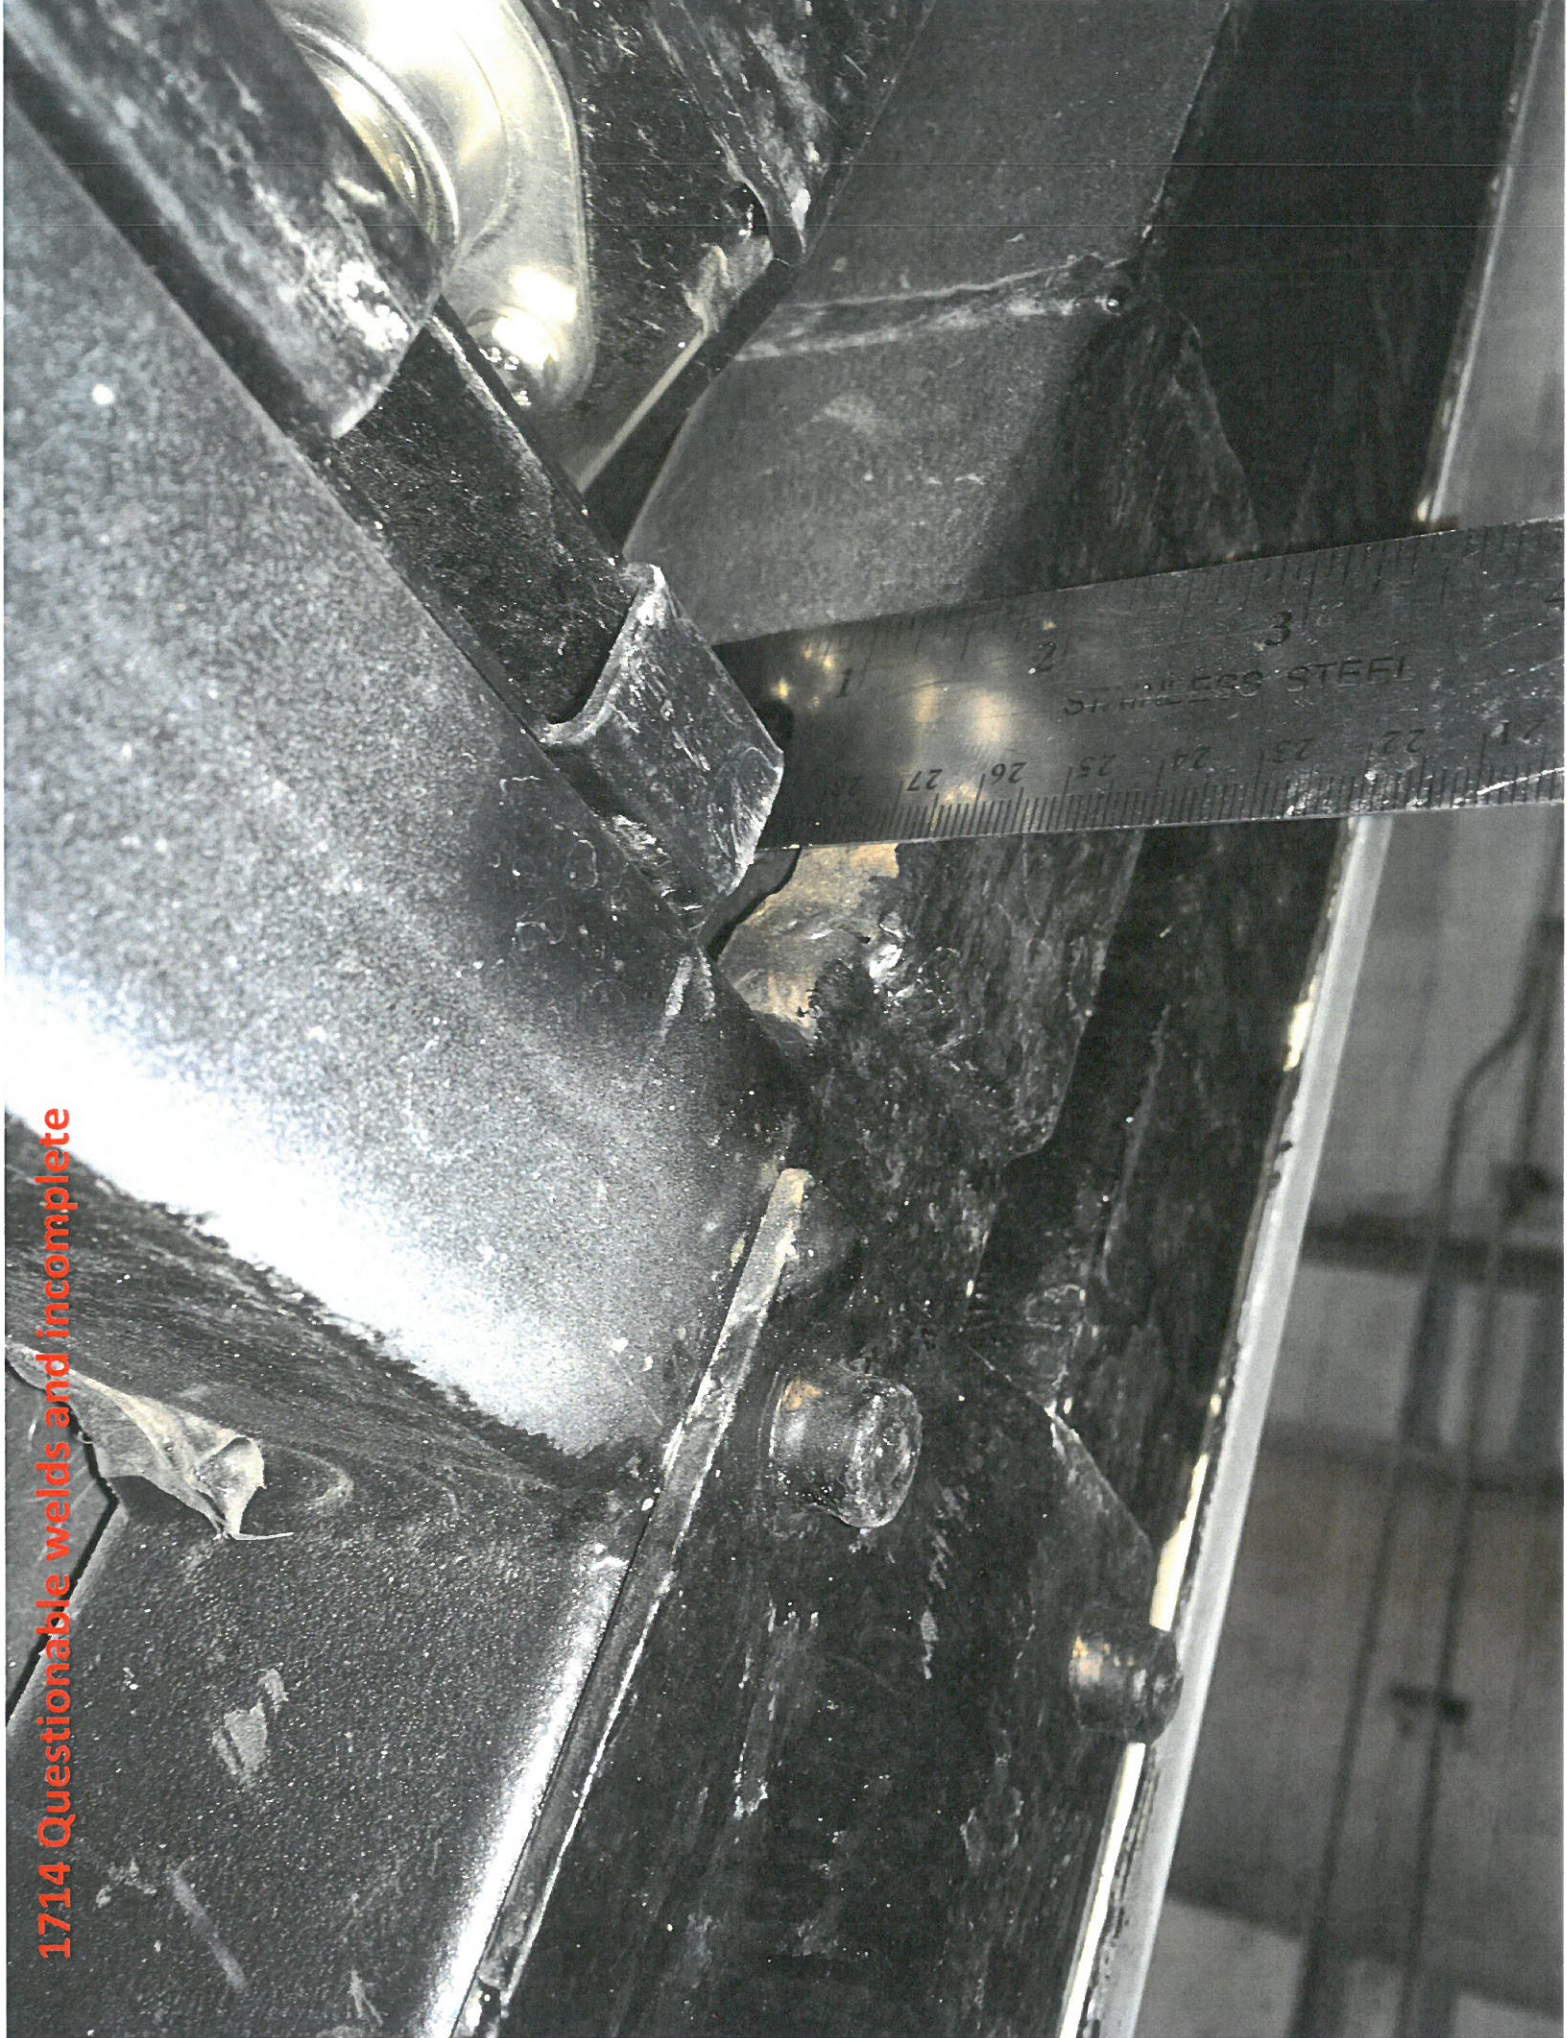
1714 Questionable welds and incomplete

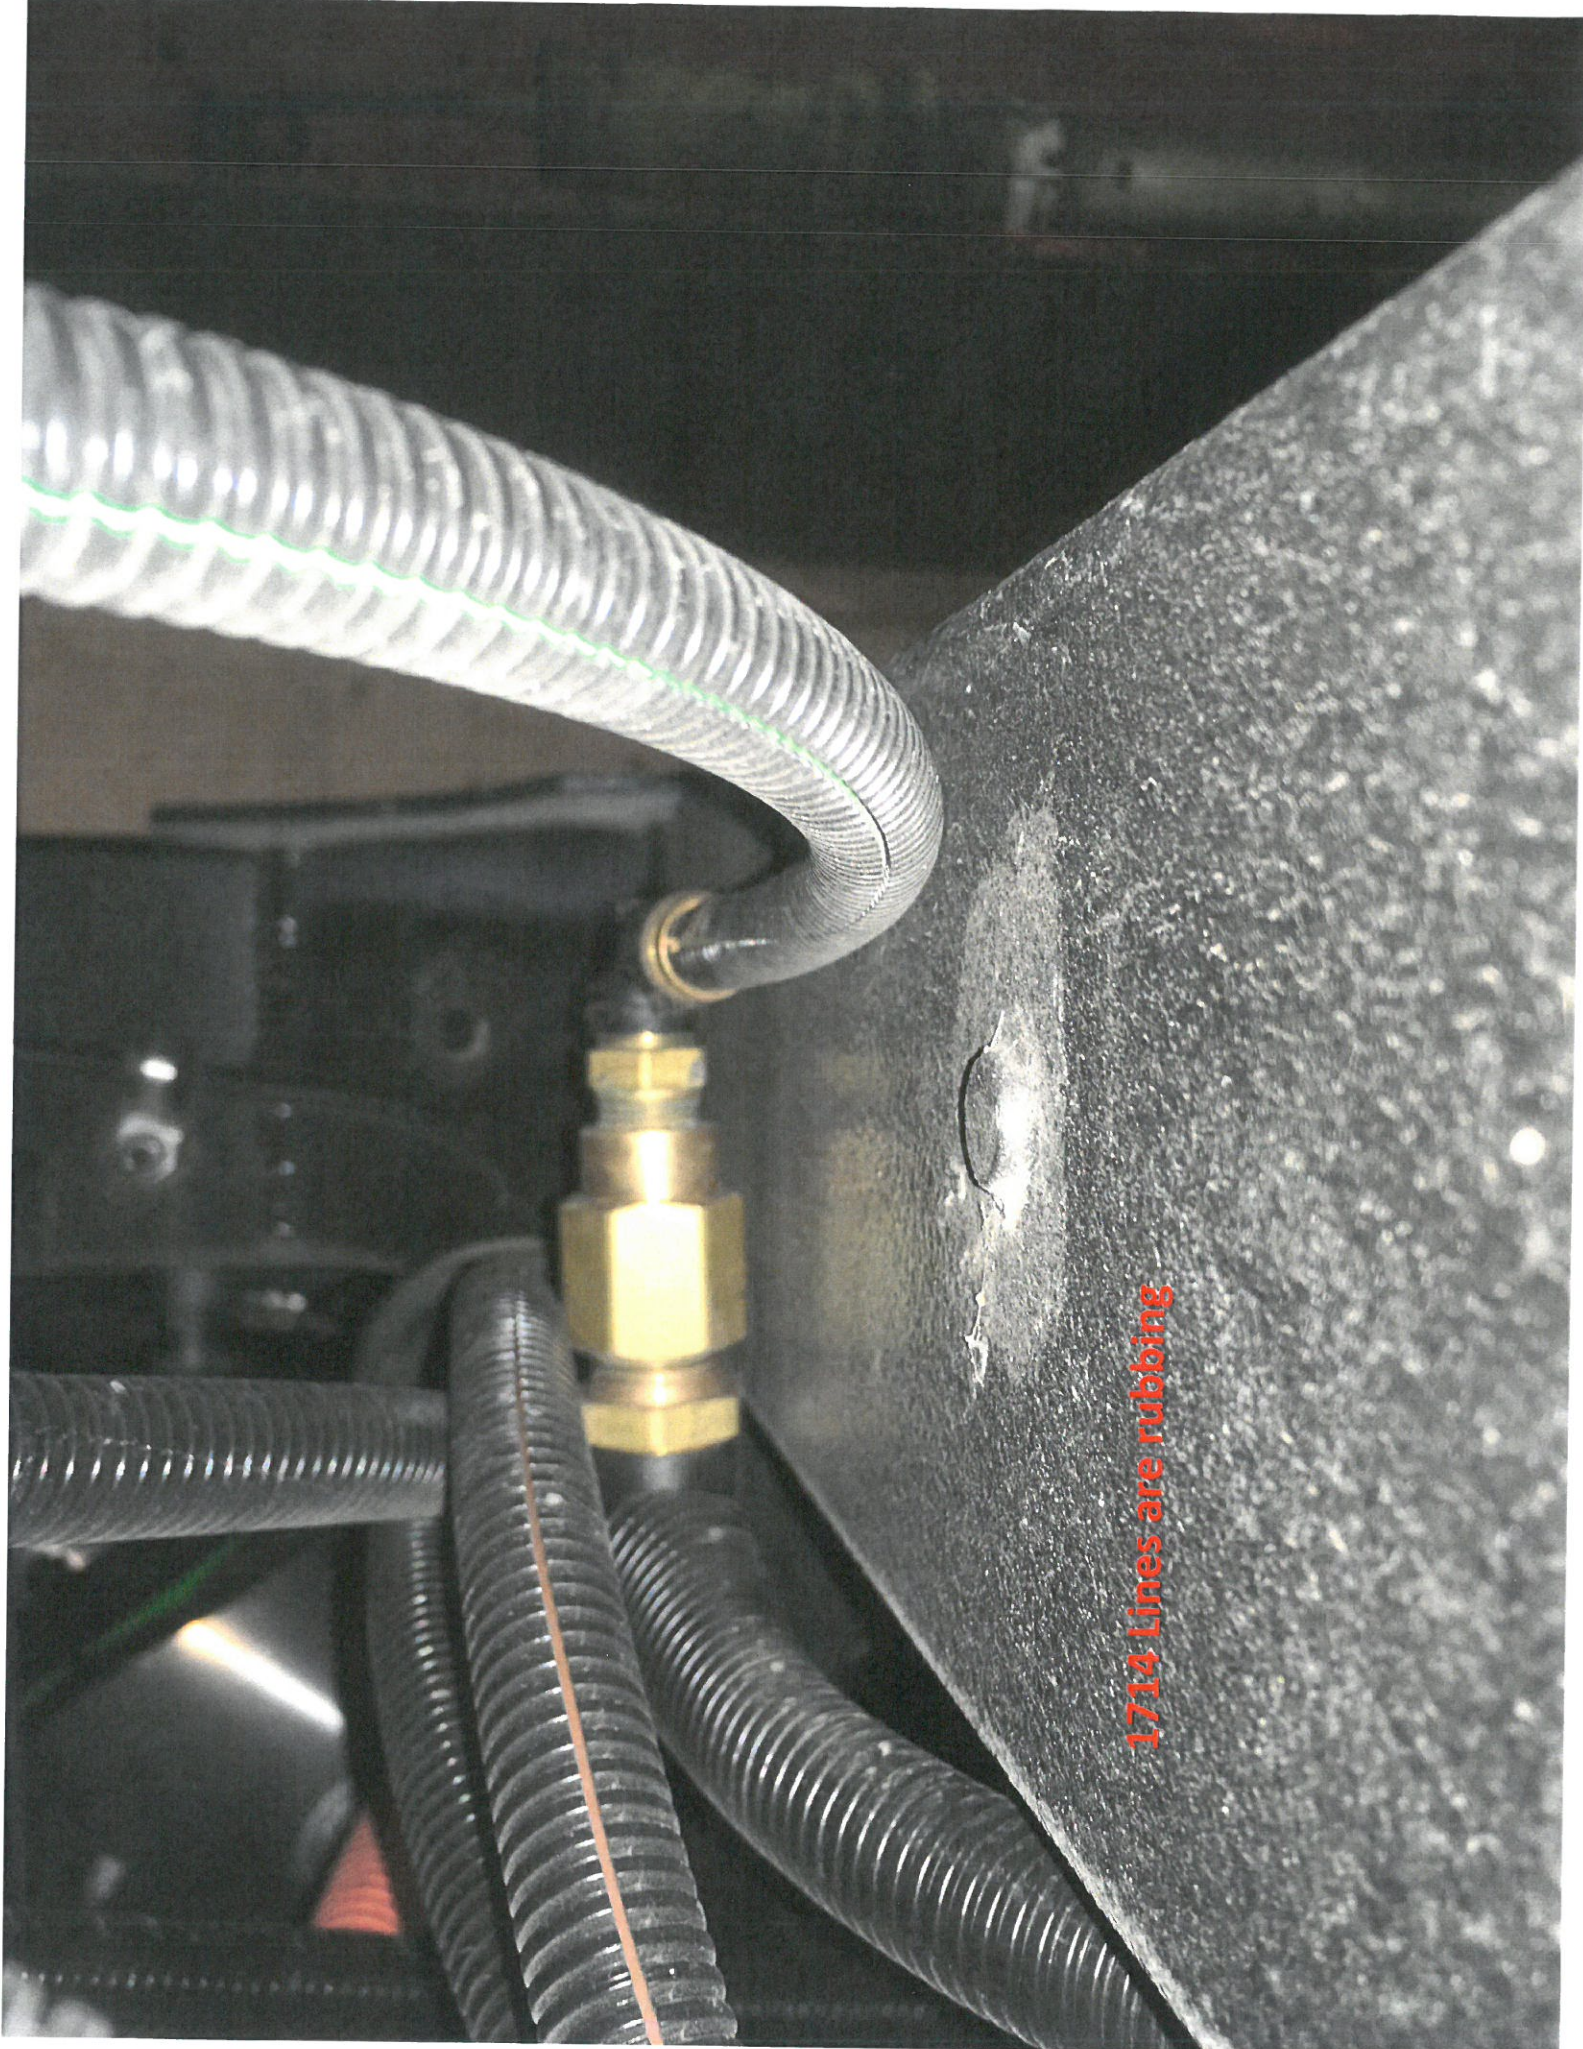
1714 Lines are rubbing

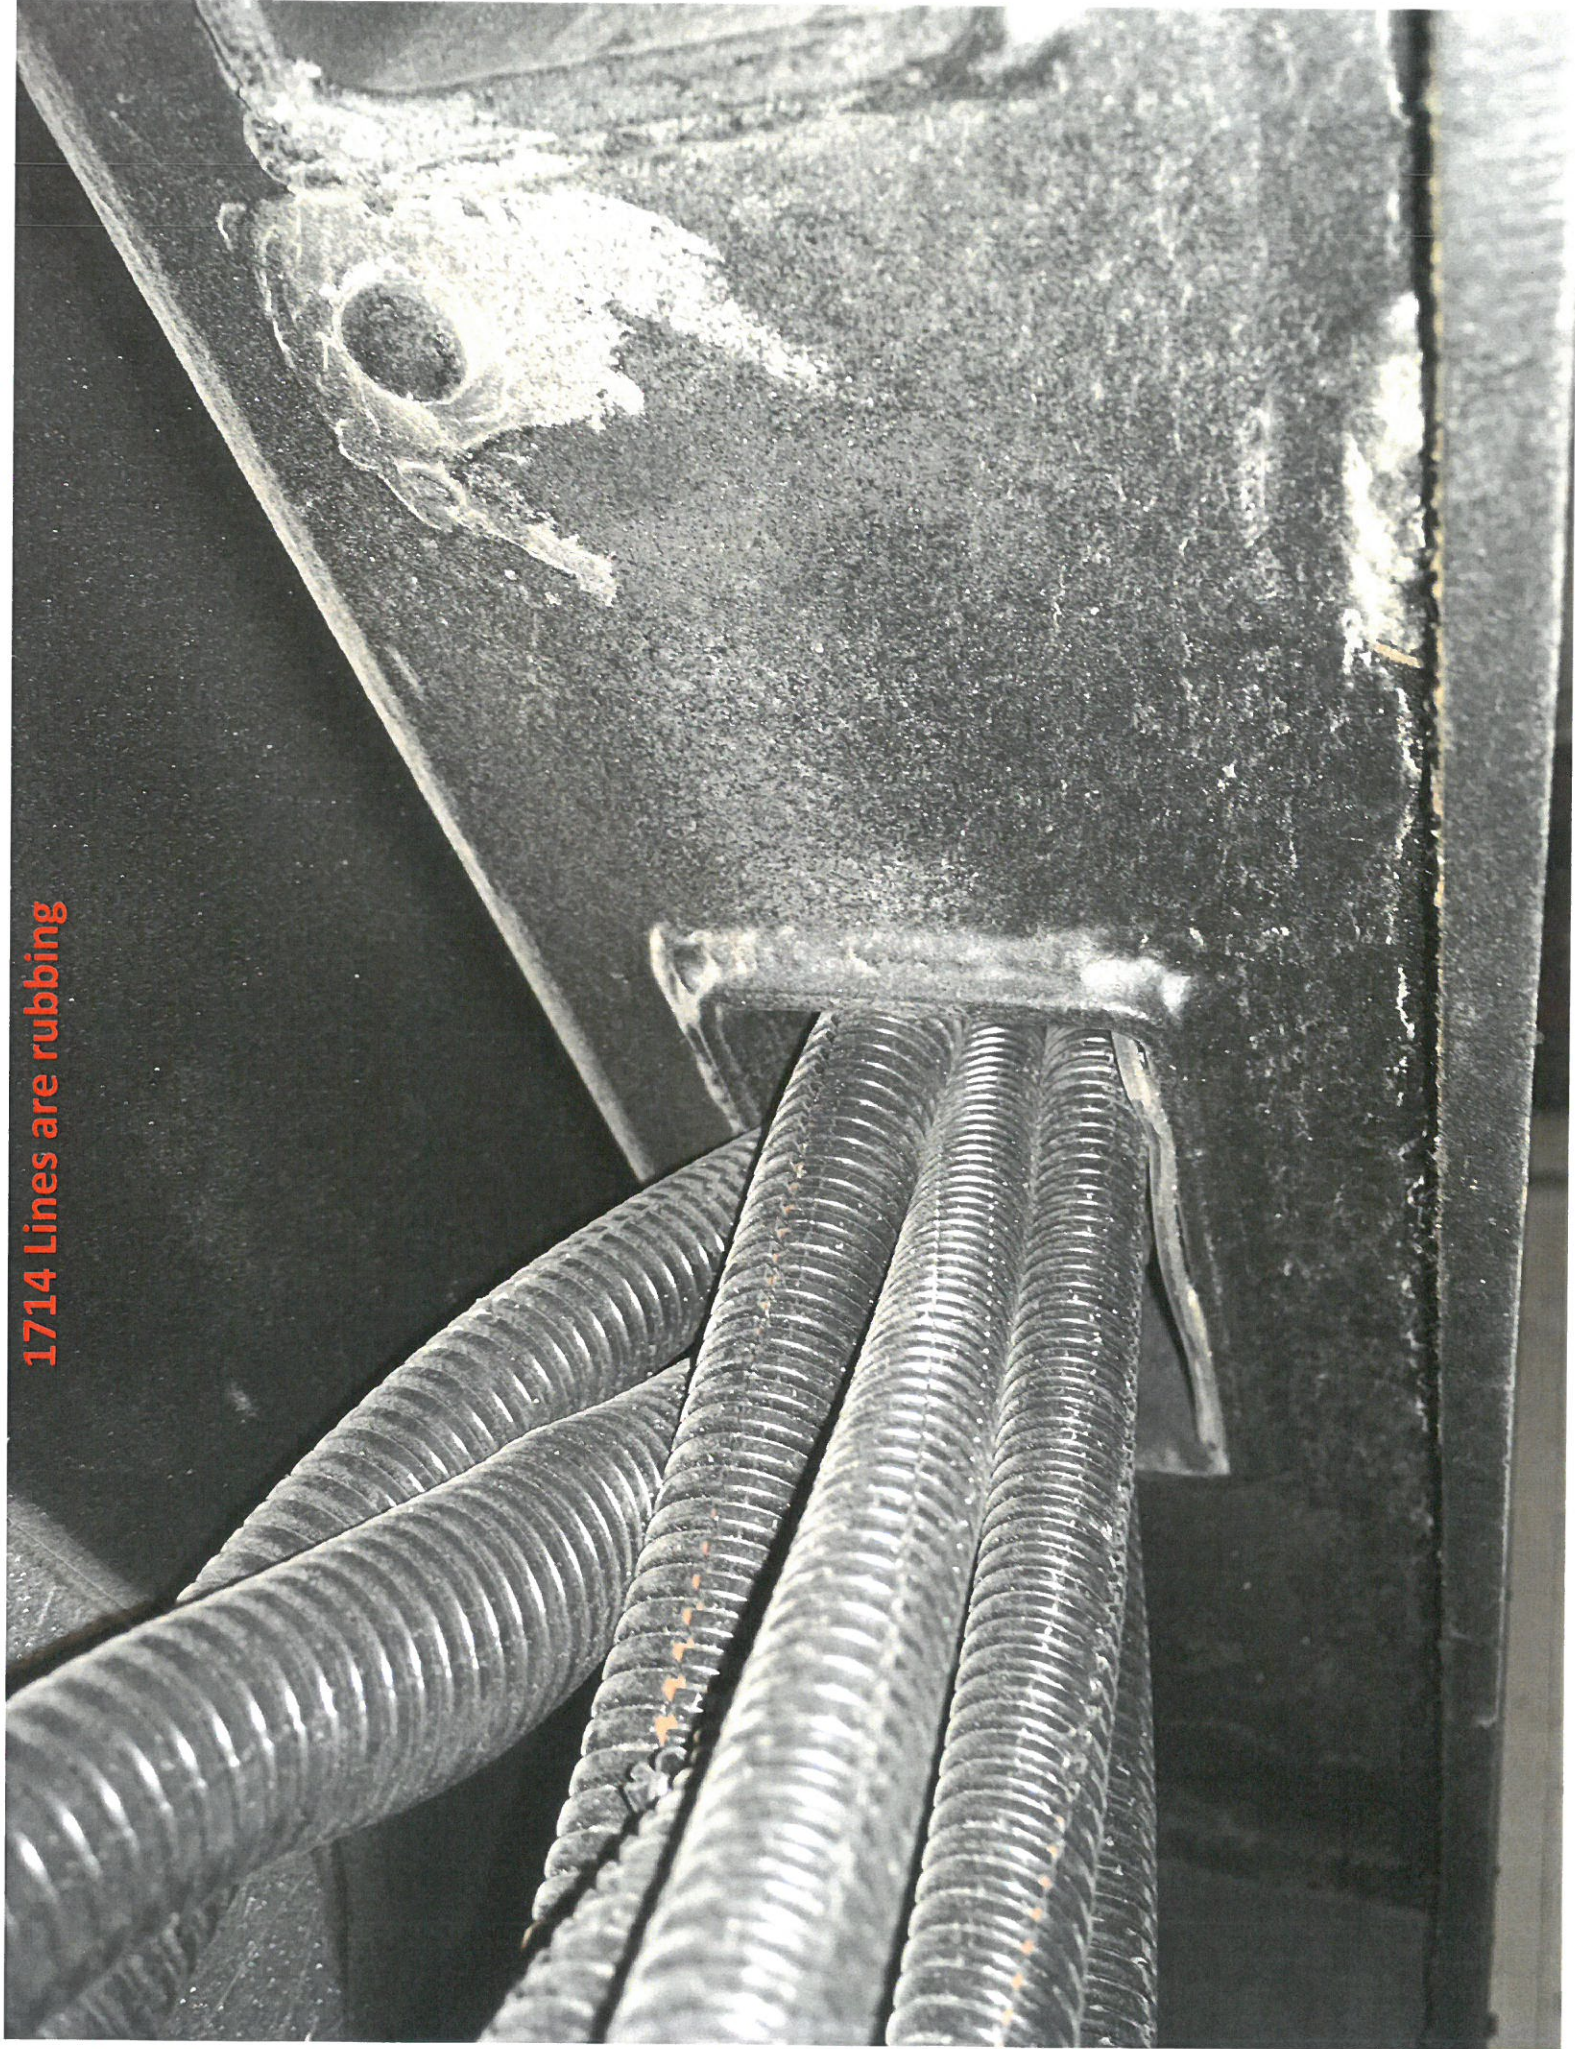
1714 Lines are rubbing
