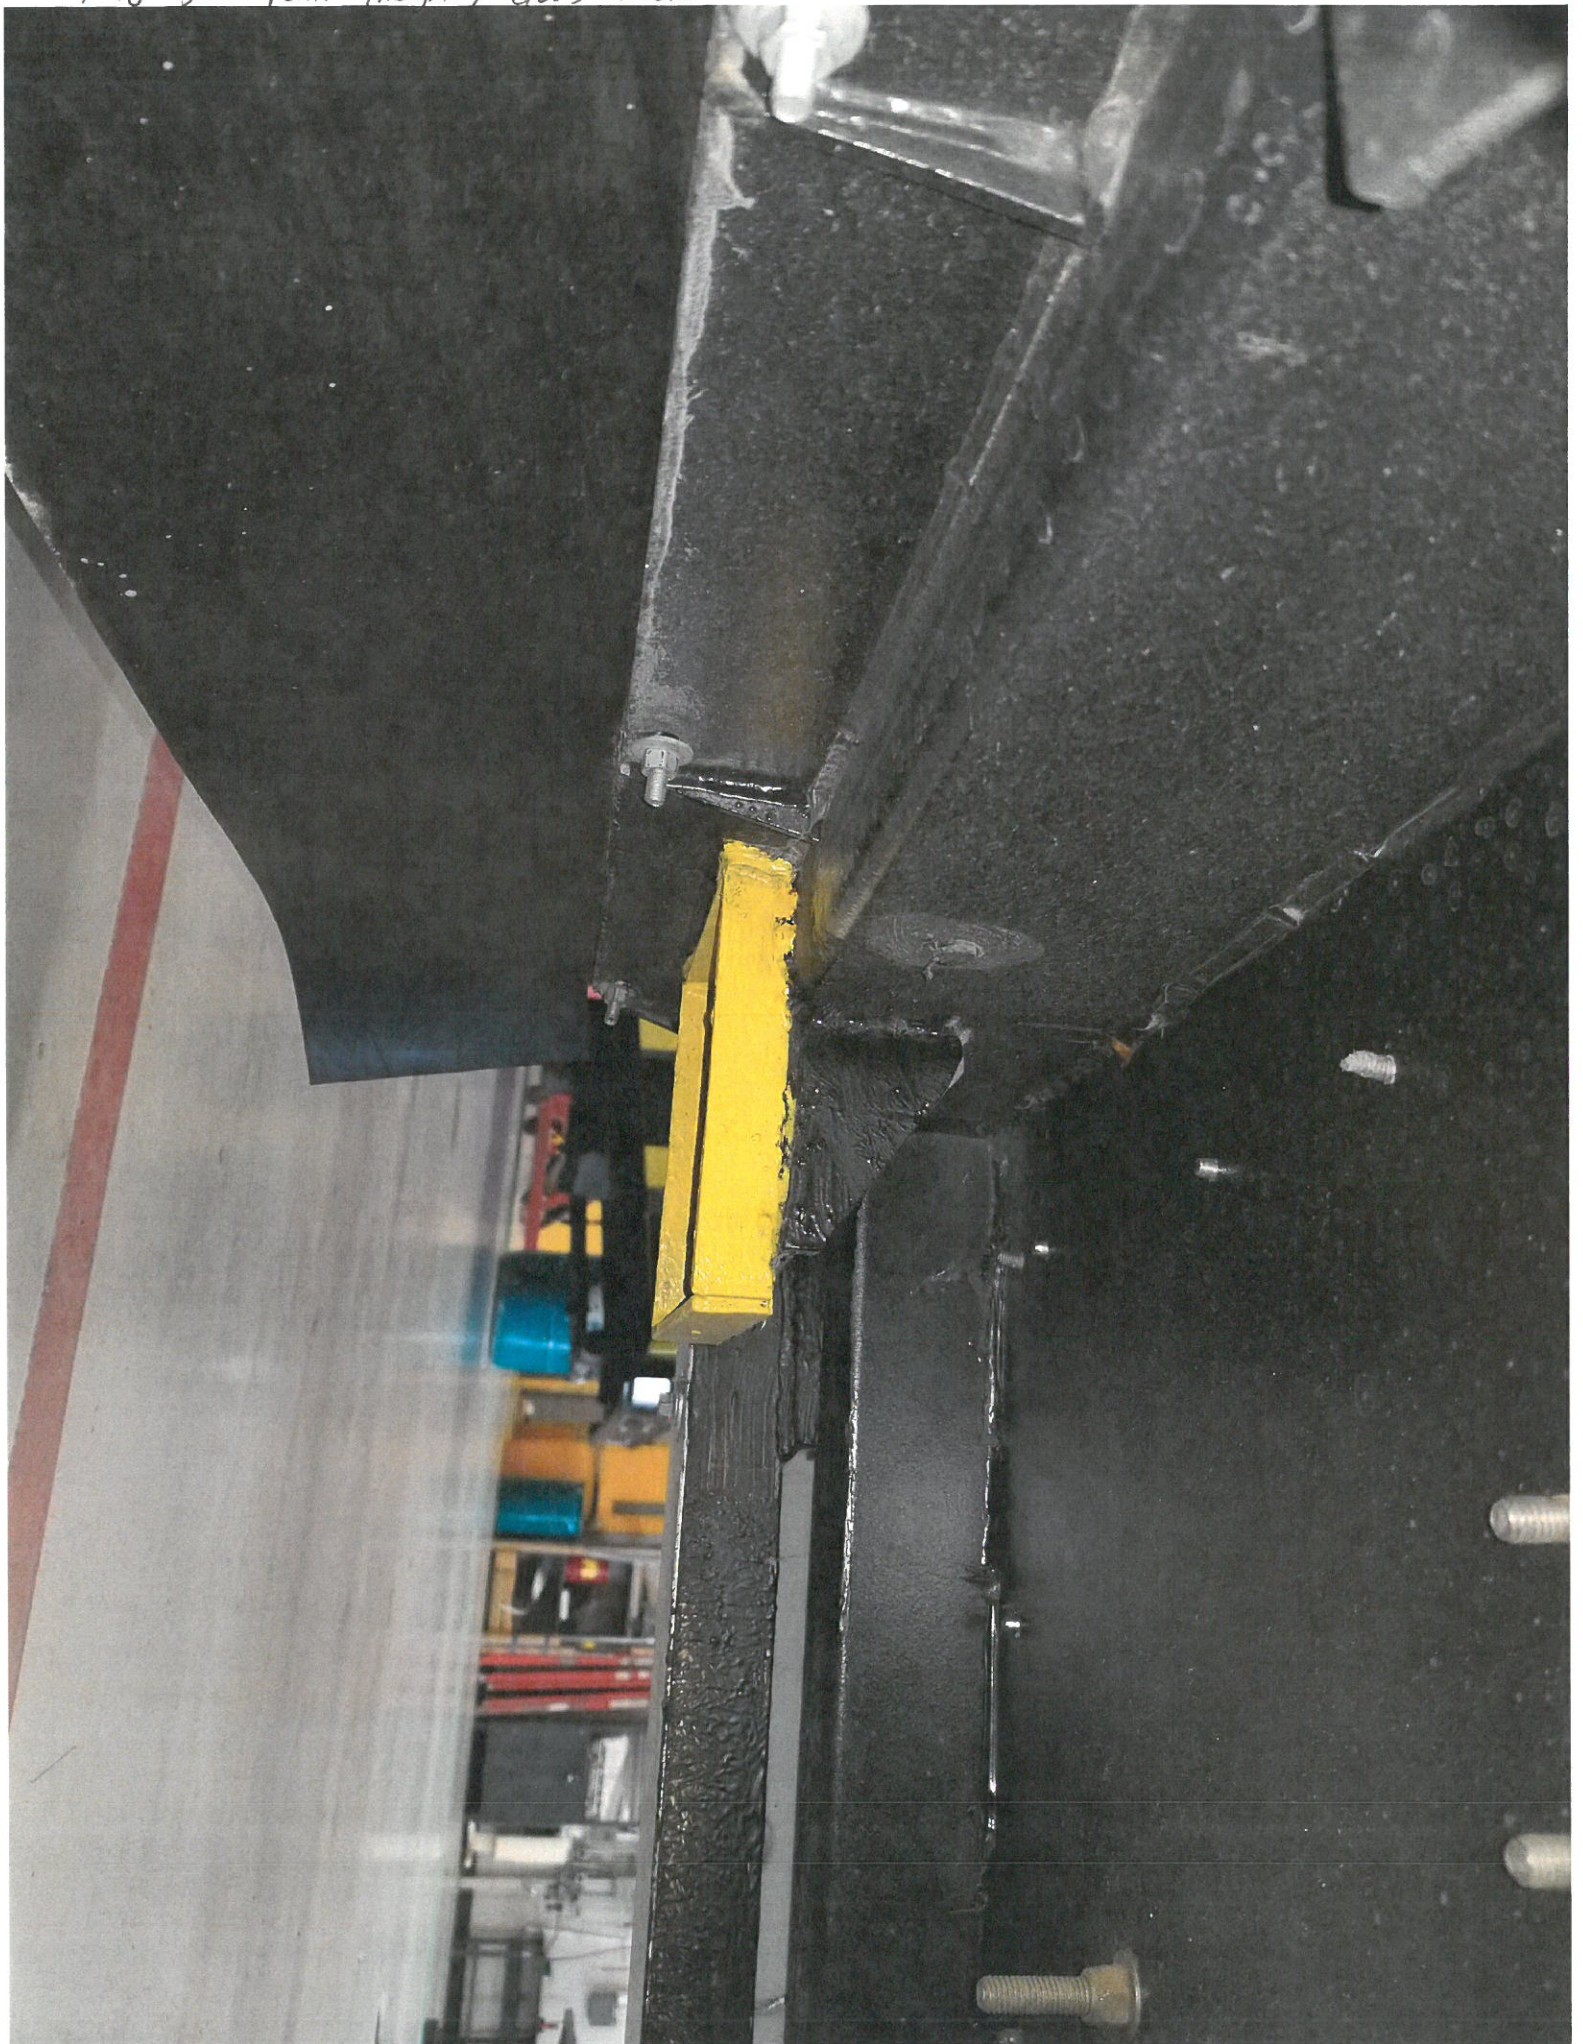
1716 - Jack point integrity questionable

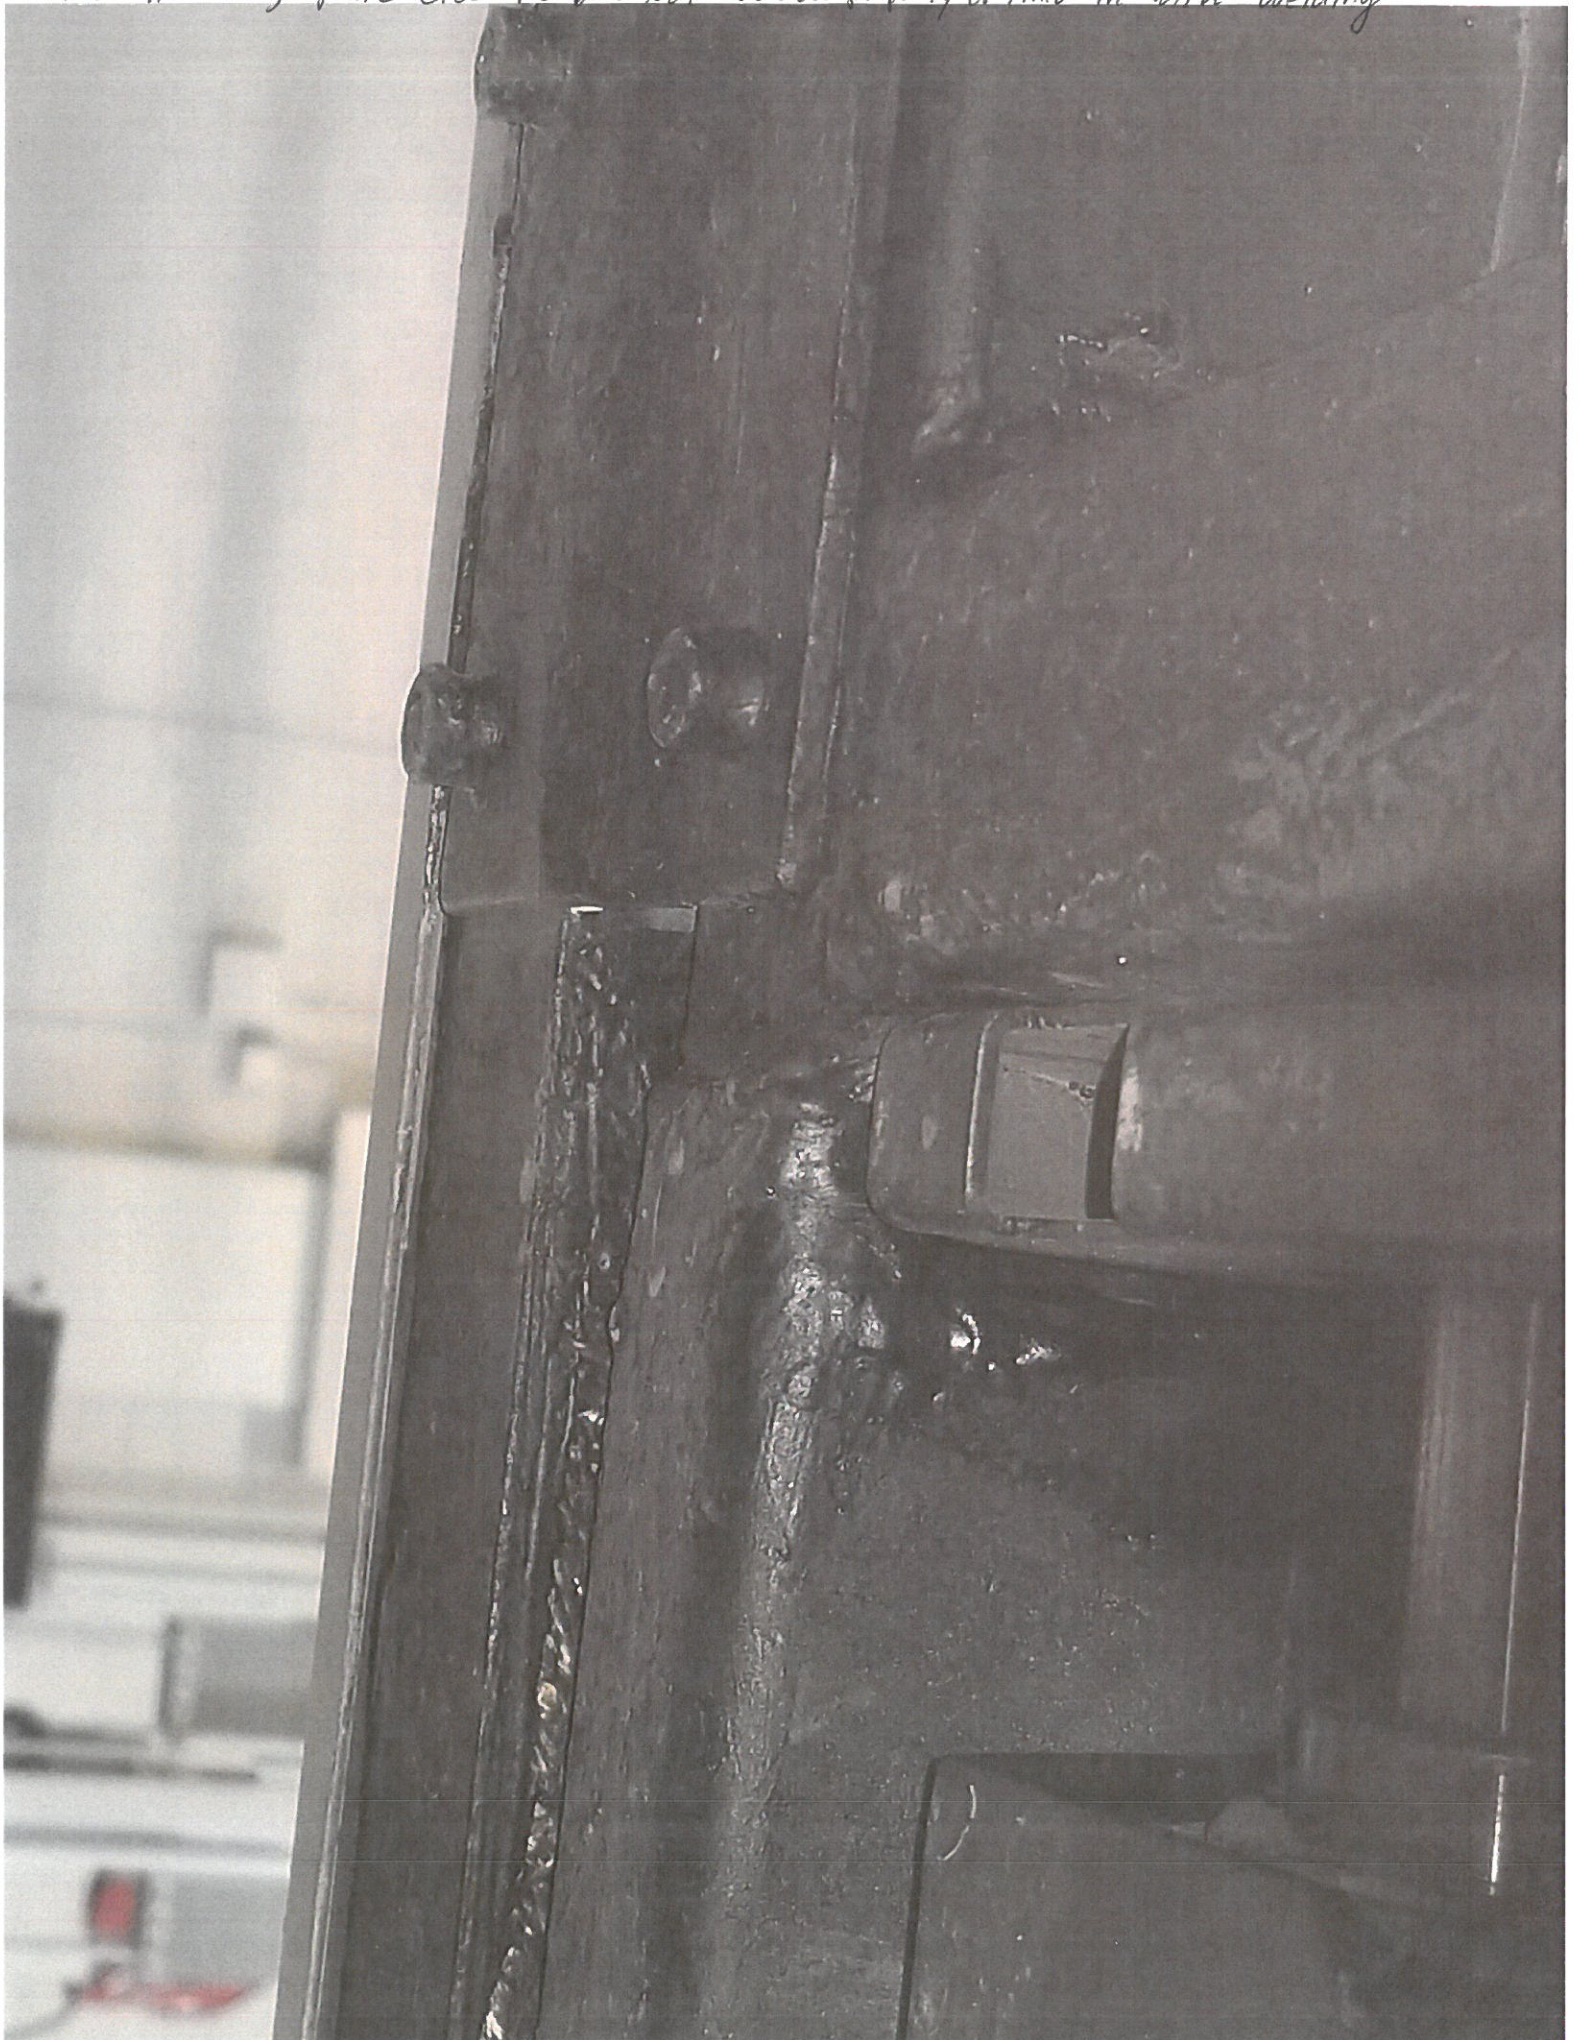
1716 - All bridge plate cross members not welded properly or filled in with welding

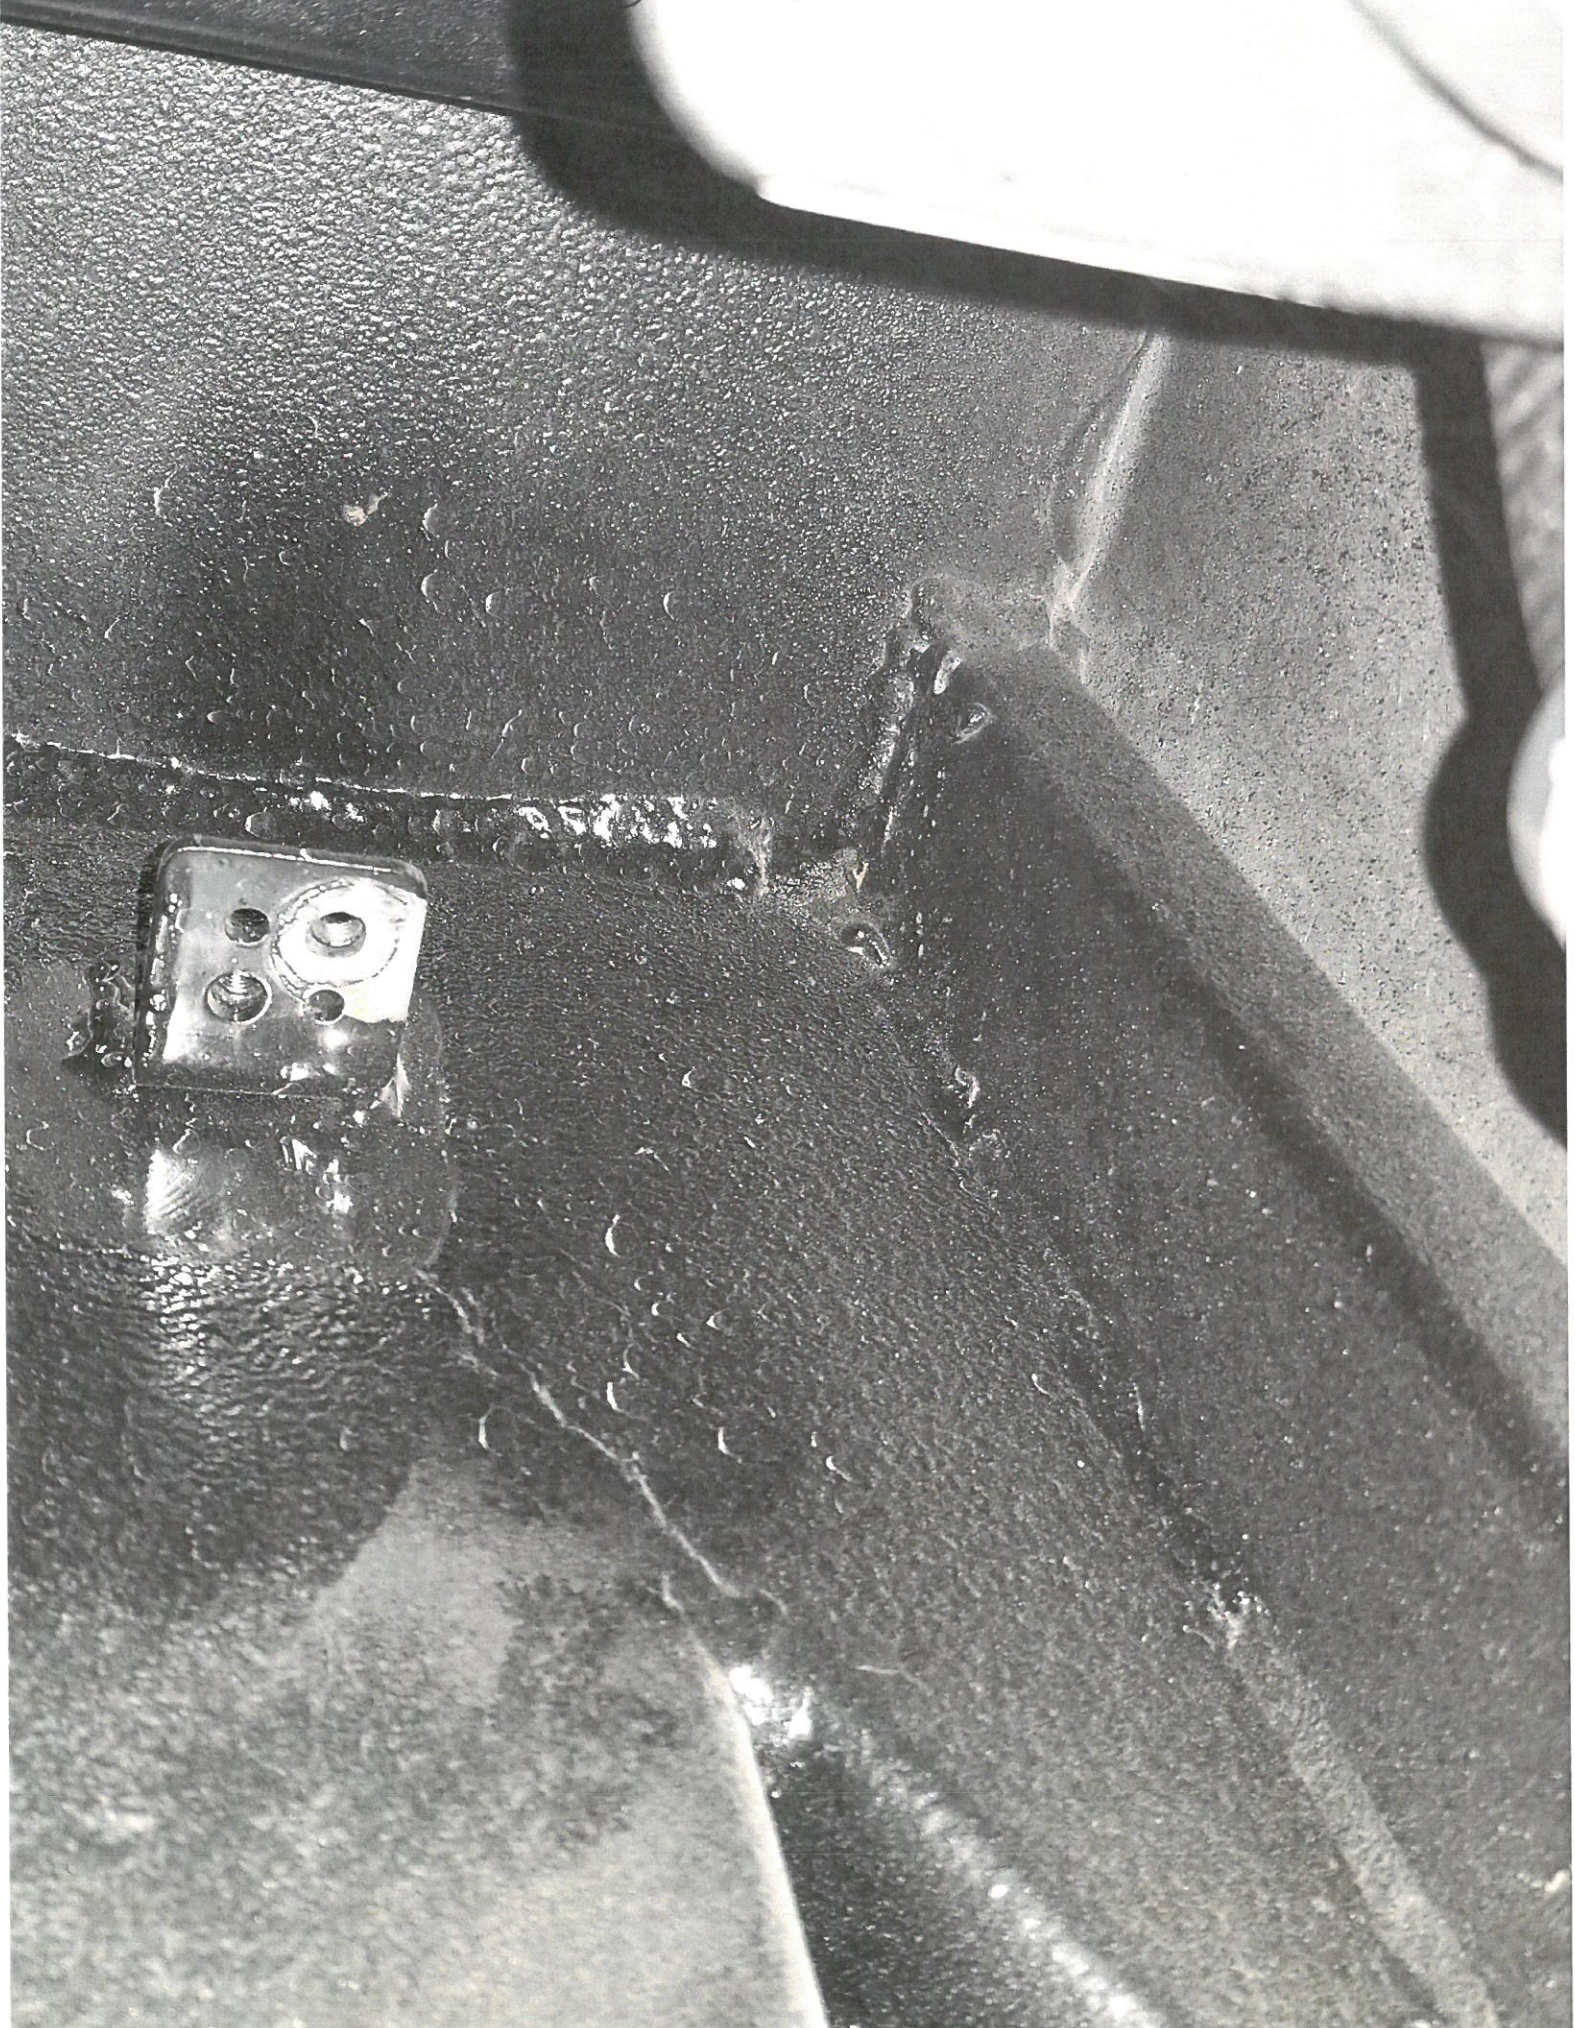
1716 - Front C/S Frame weld missing/not completed

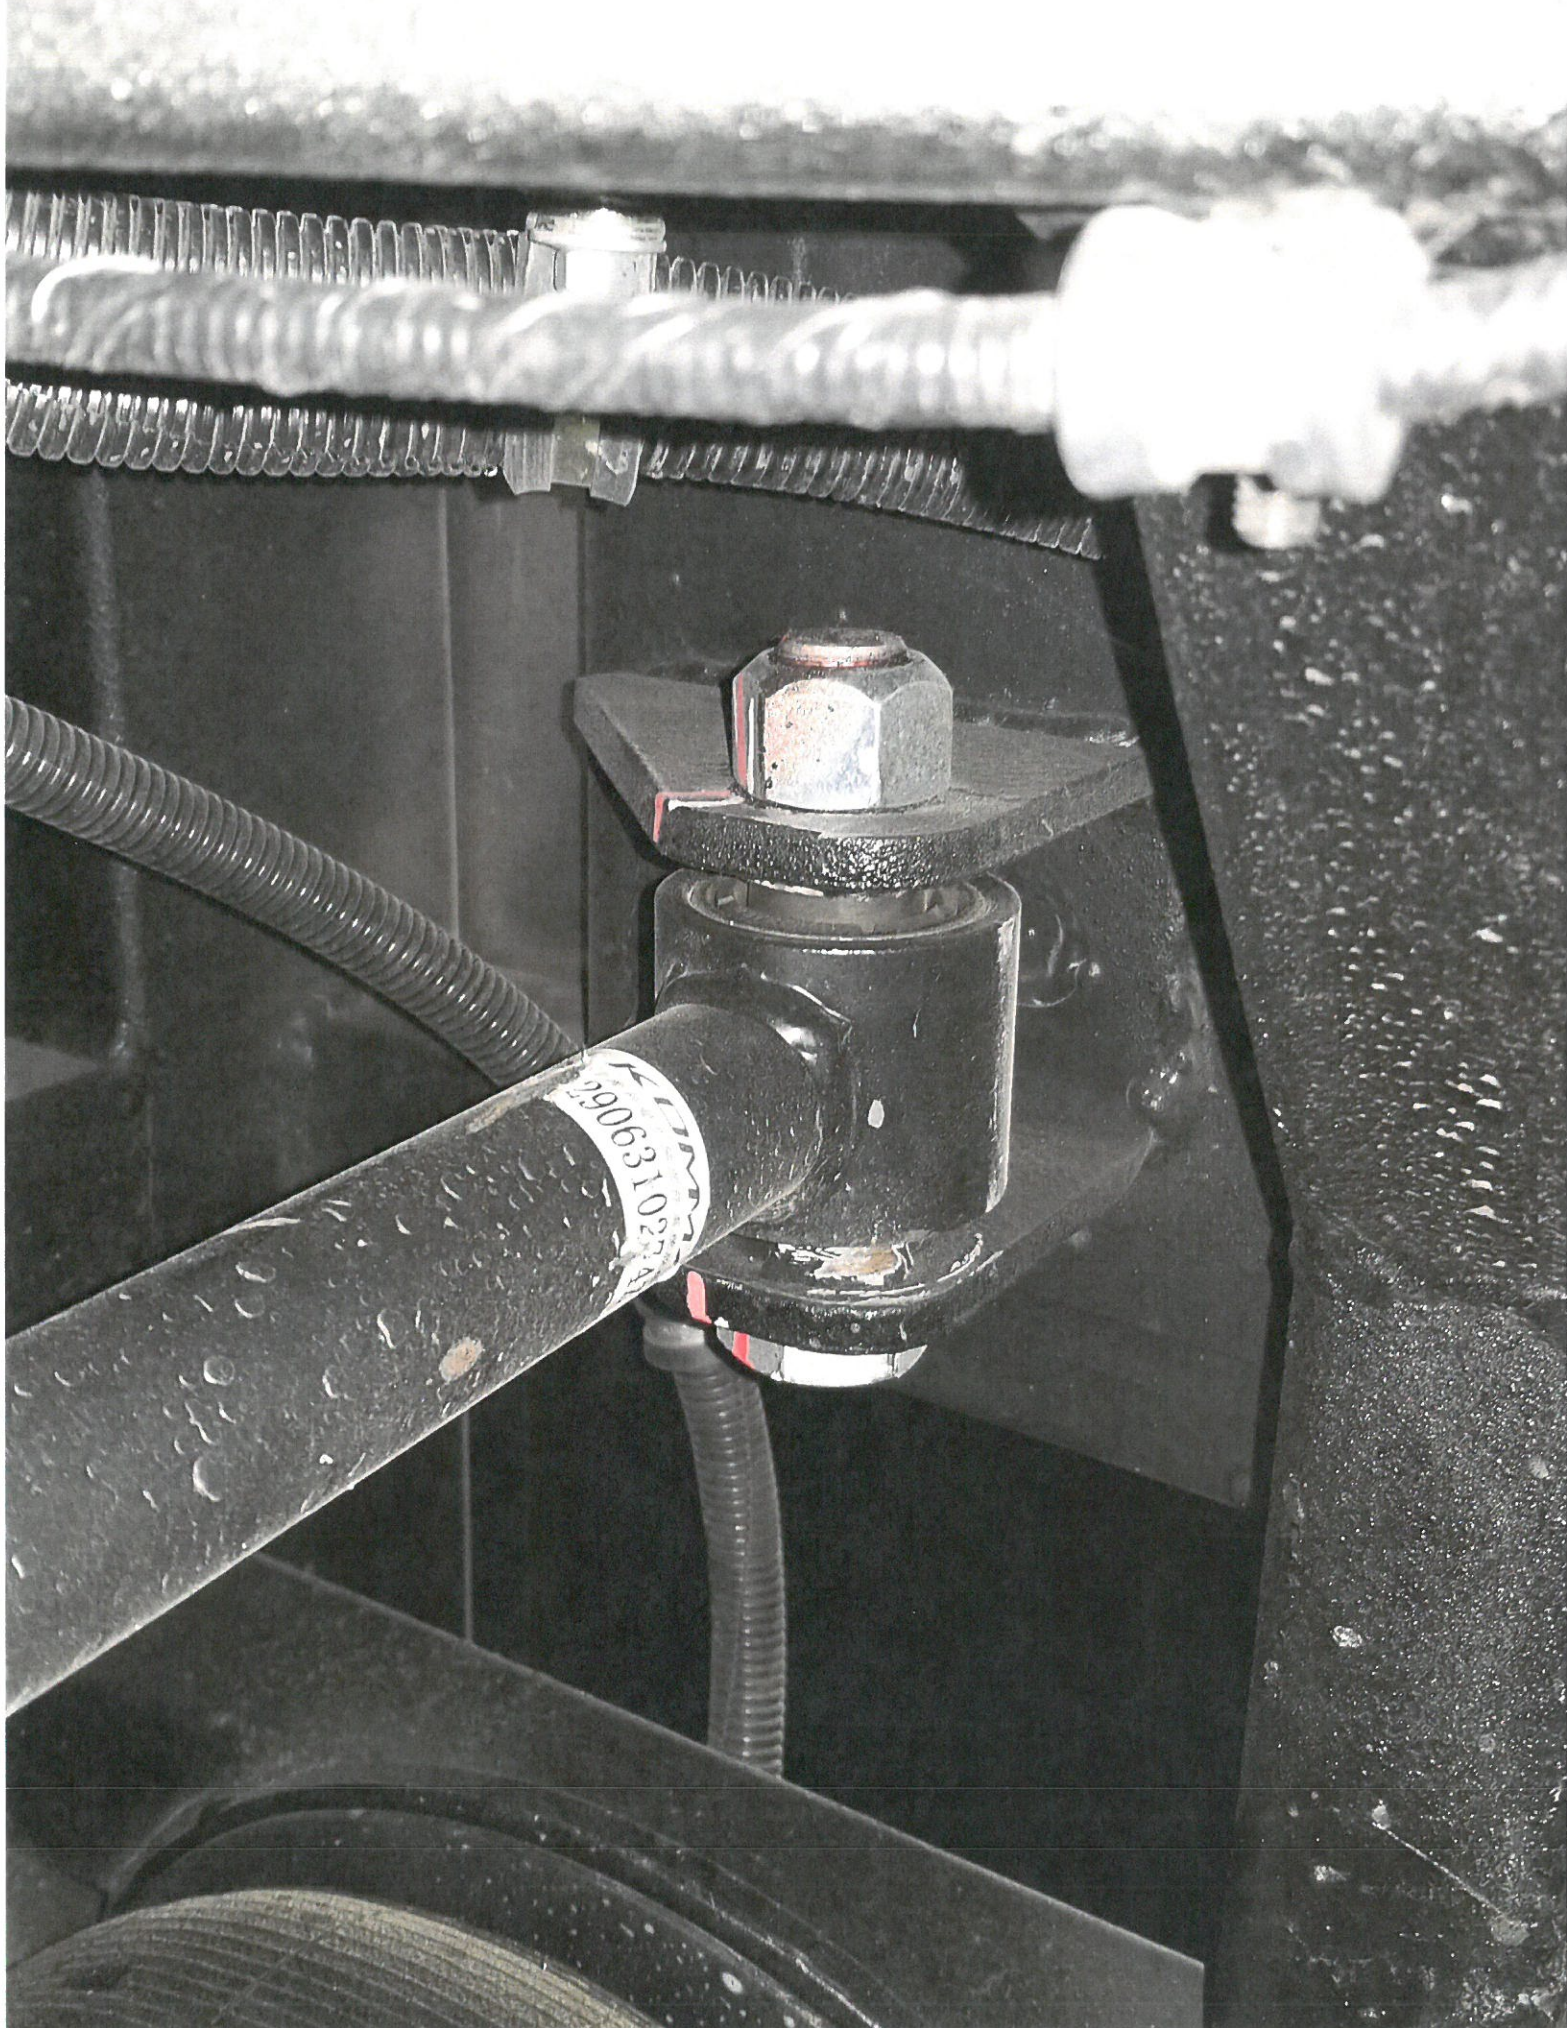
1716-UB sway bar mount weld integrity questionable

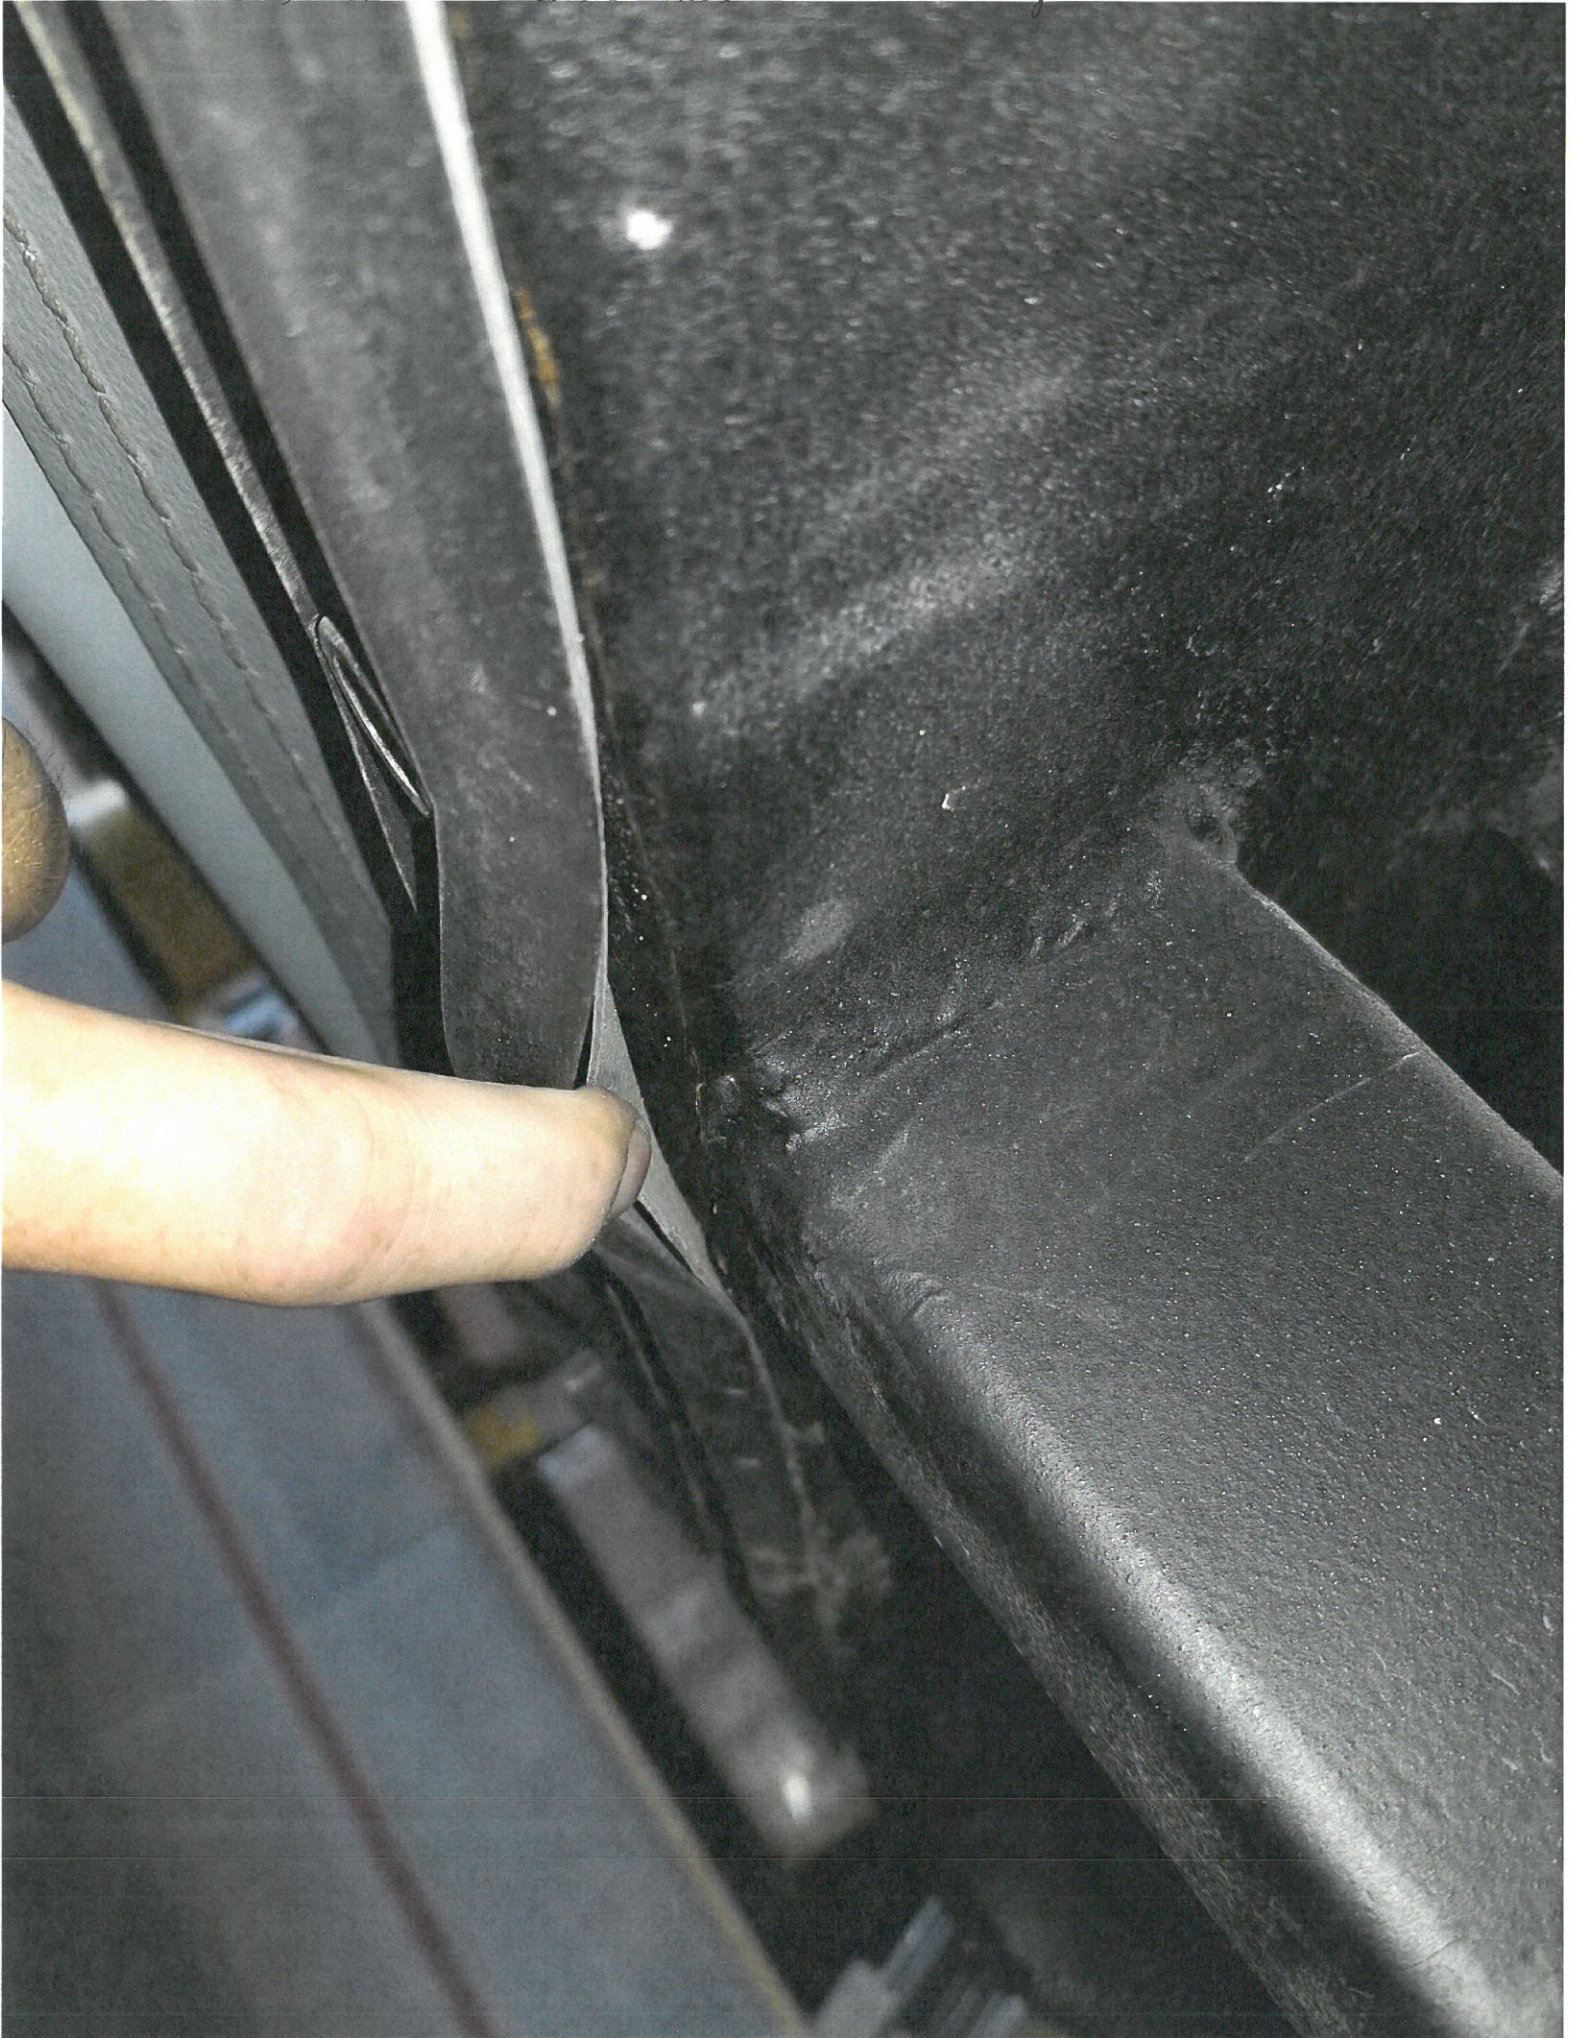
1716- Front of joint/bellows welds questionable & rusting

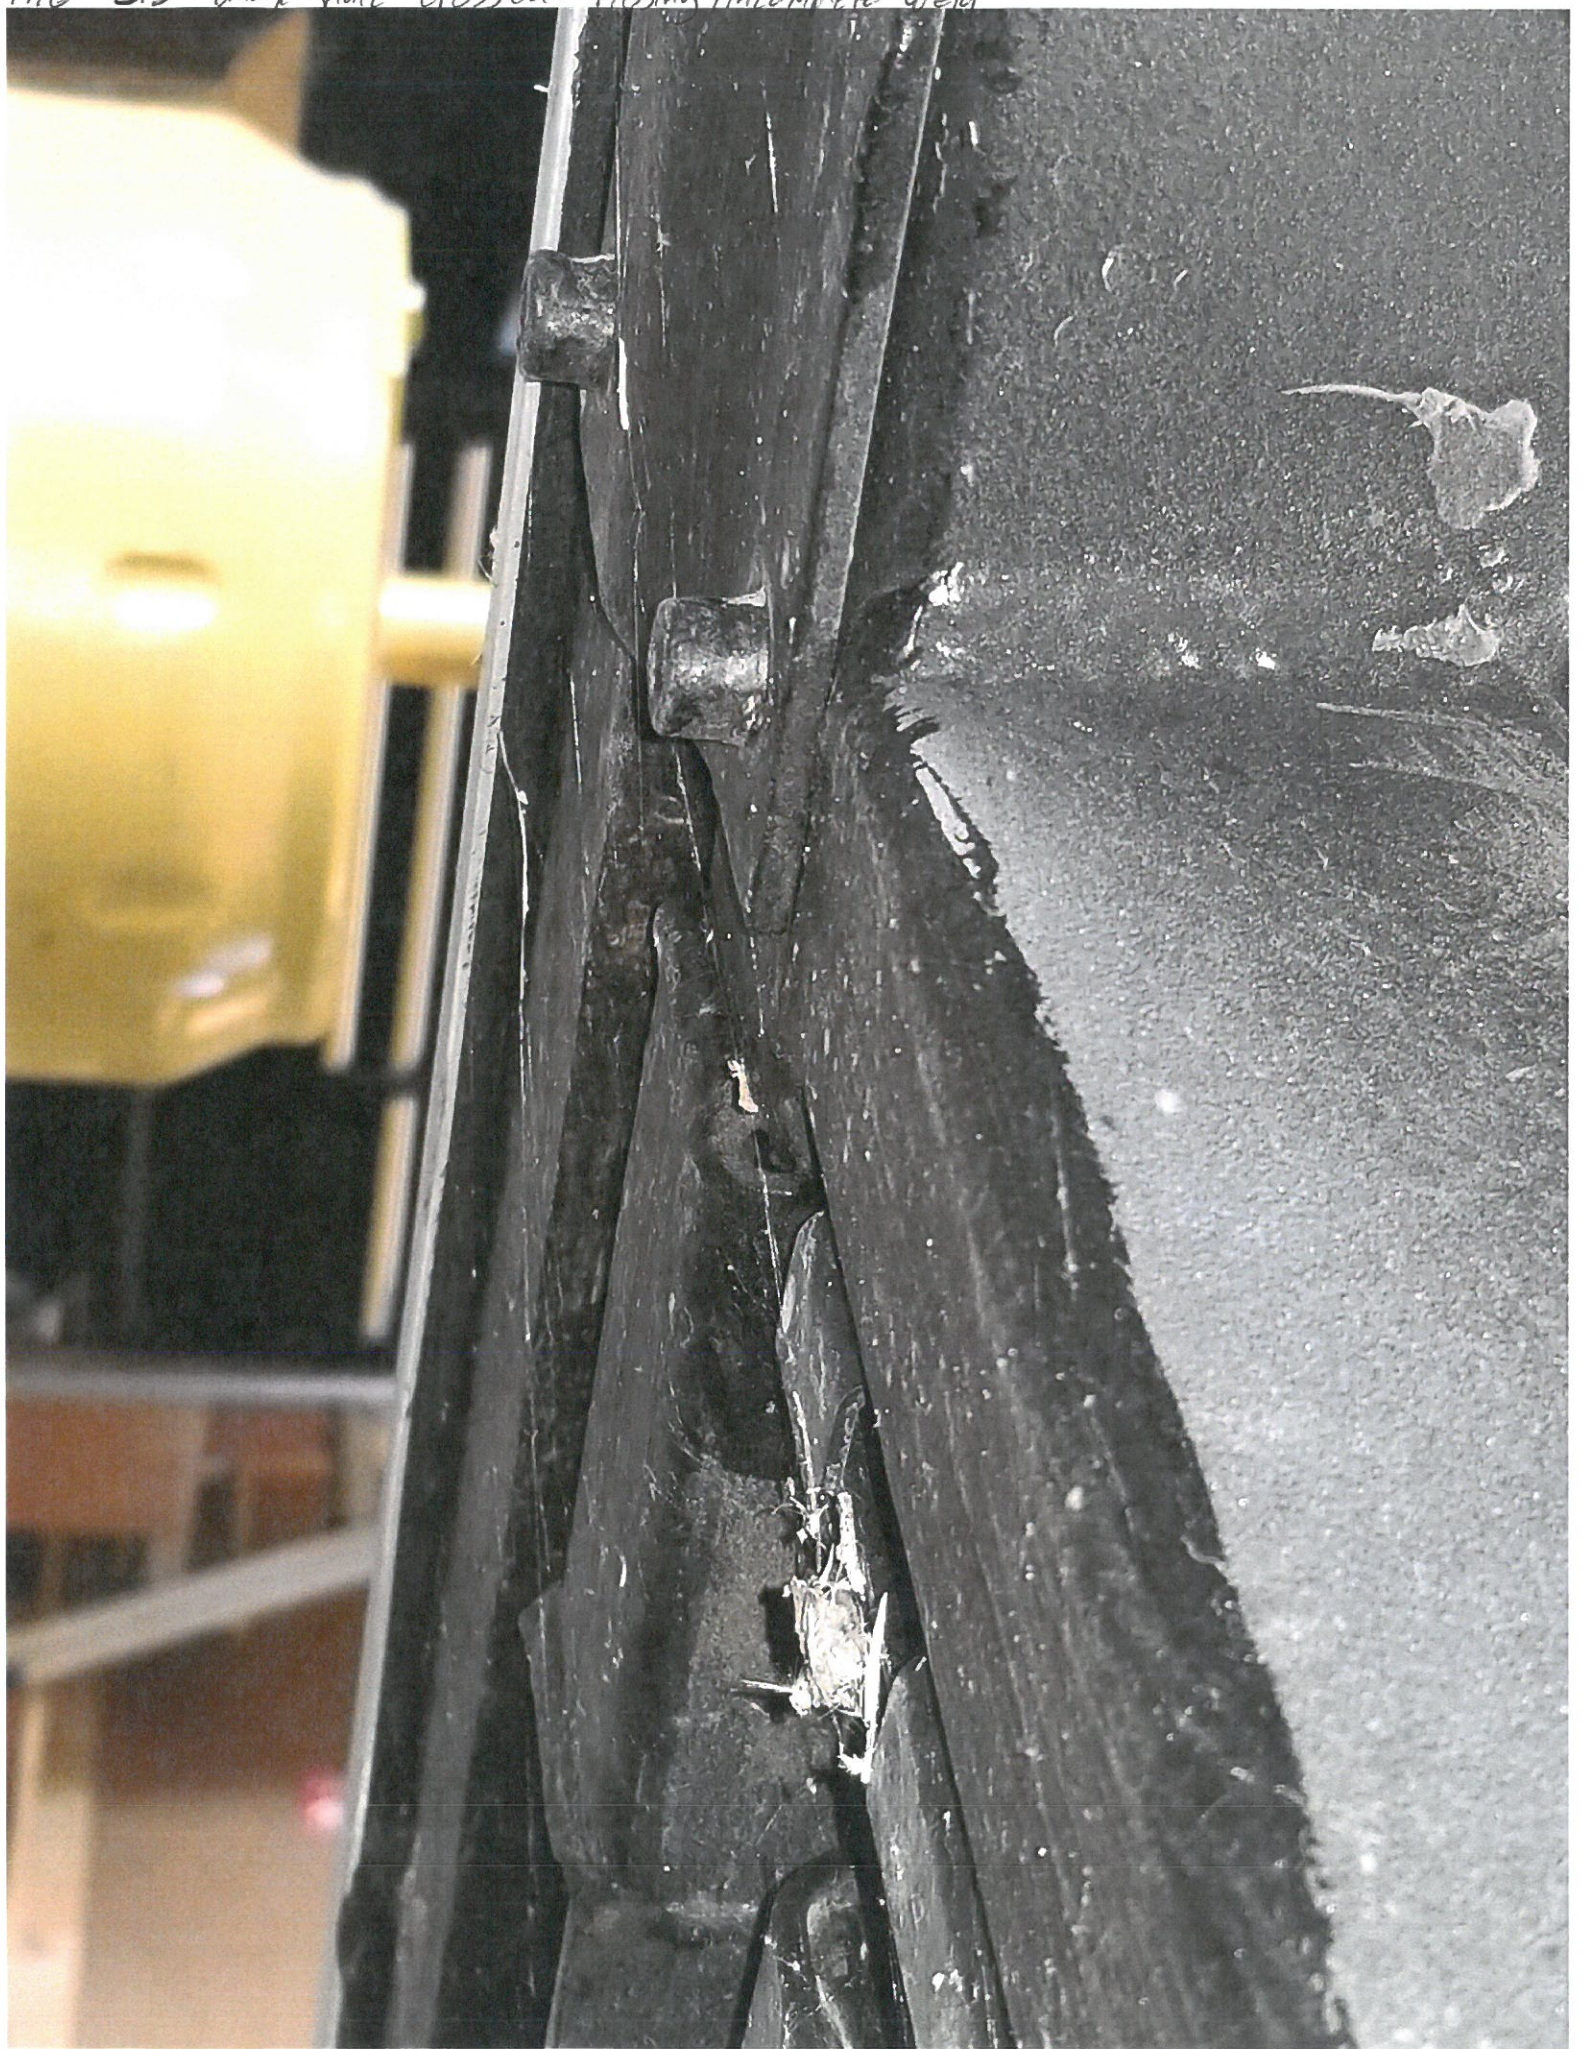
1716 - 8/5 Bridge Plate Crossover missing/incomplete weld

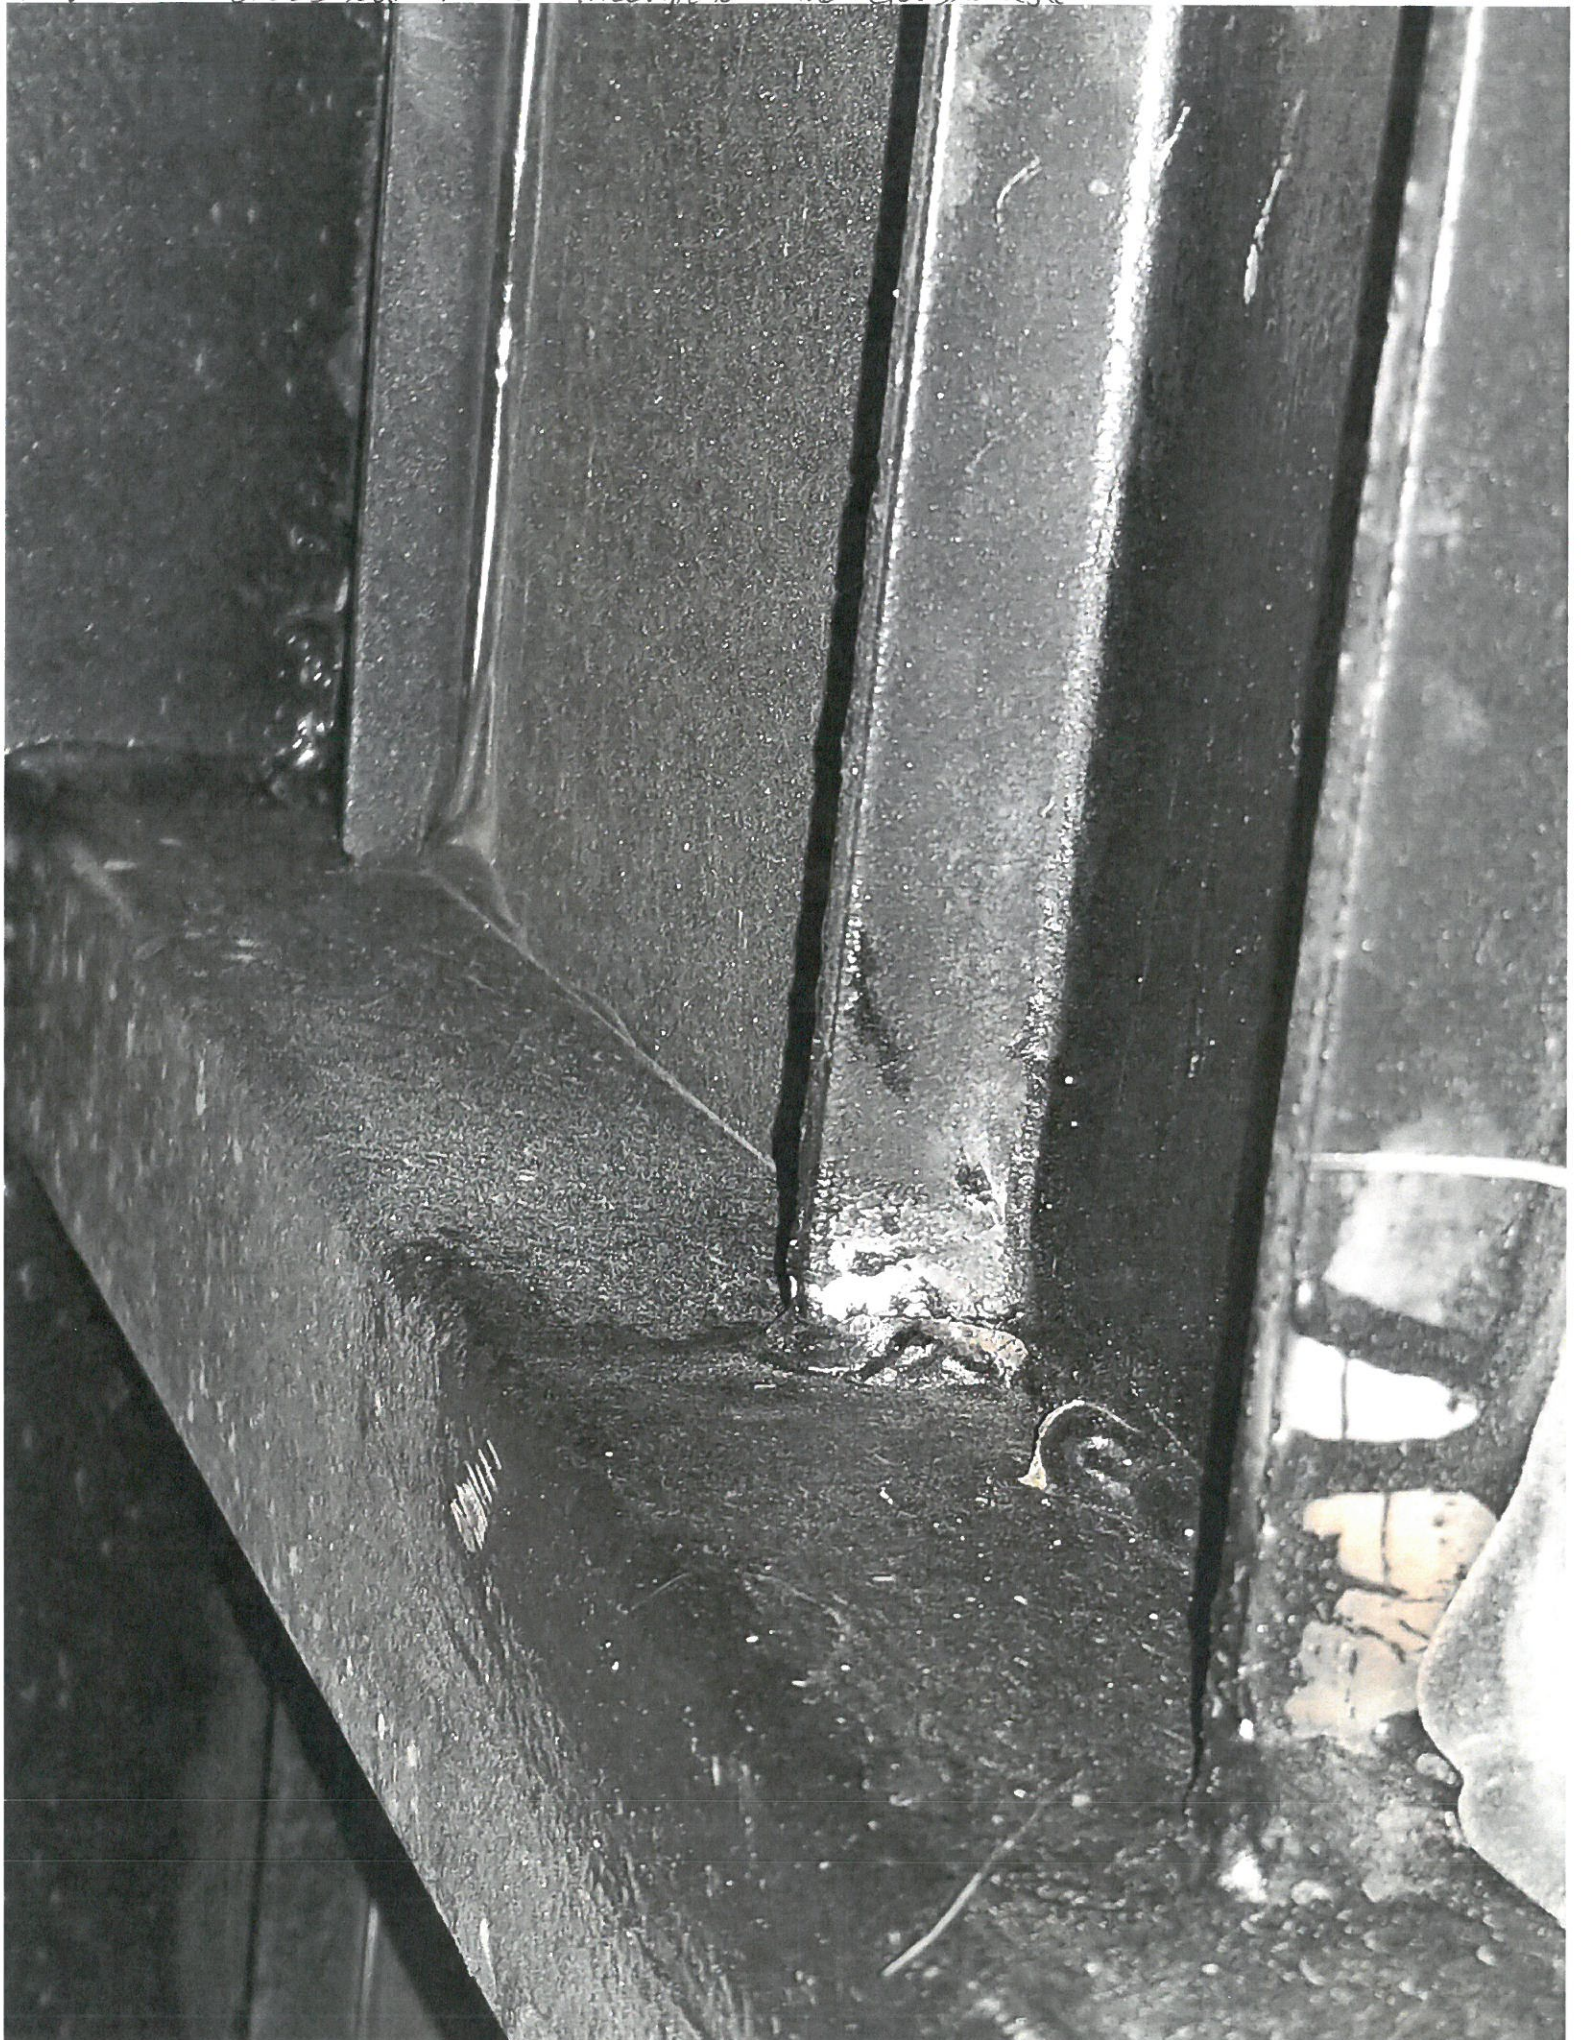
1716- Front cross beam welds incomplete and questionable
