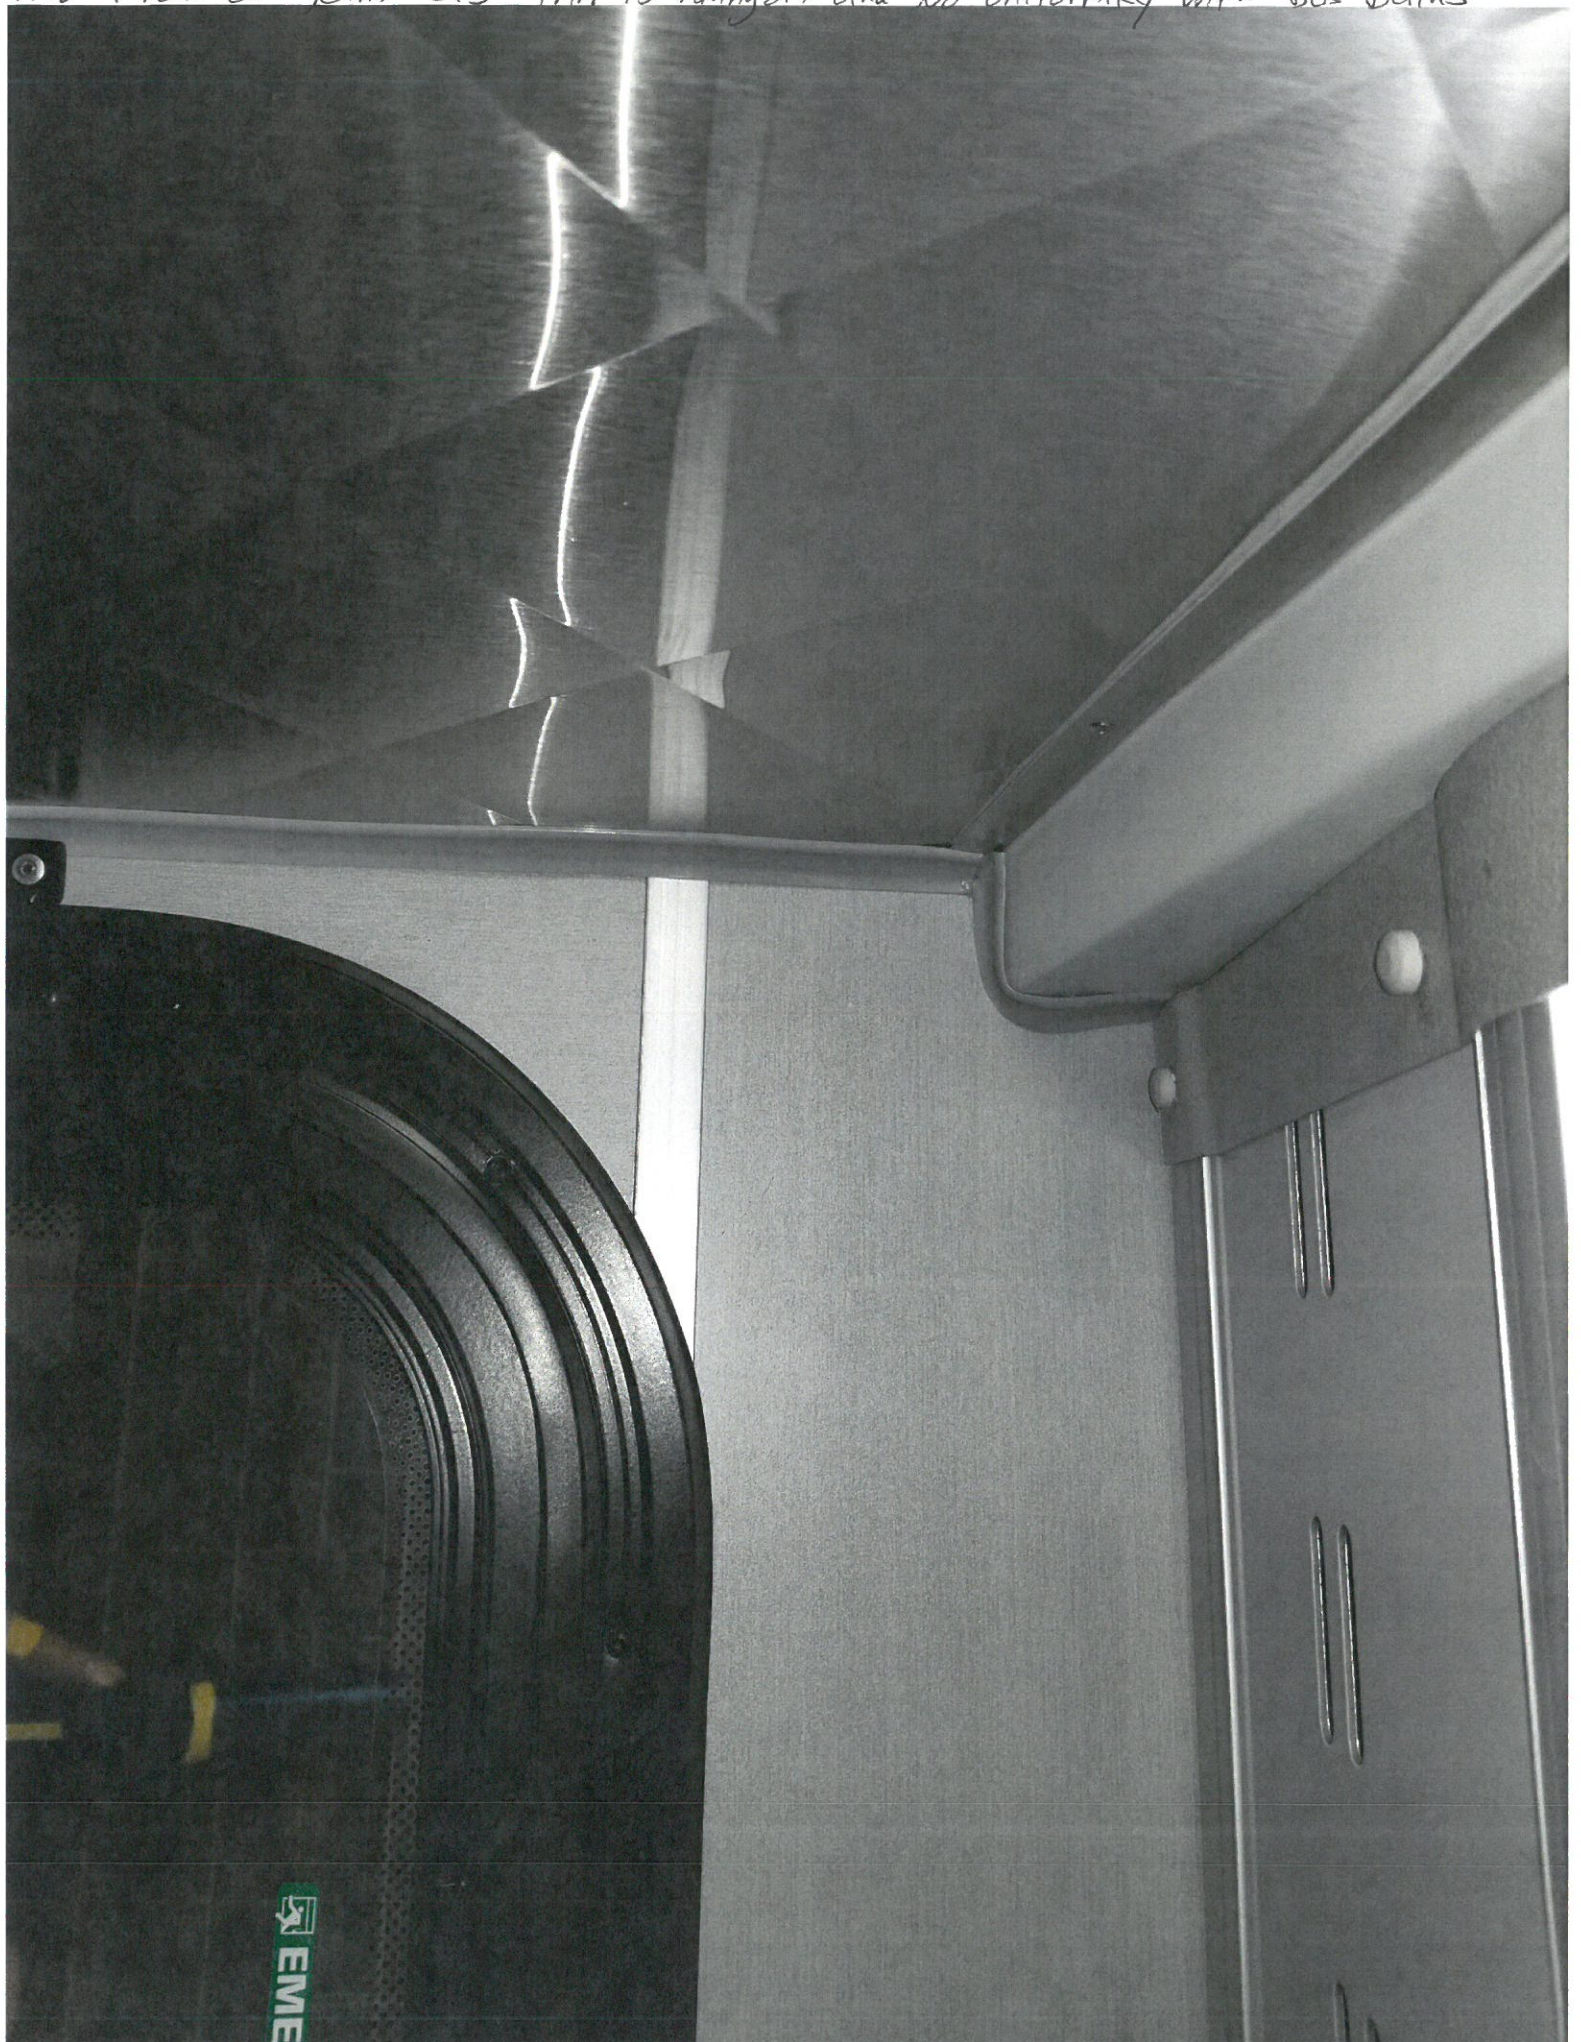
1716 - Front of joint cls trim is Falling off and No uniformity with Bus Builds

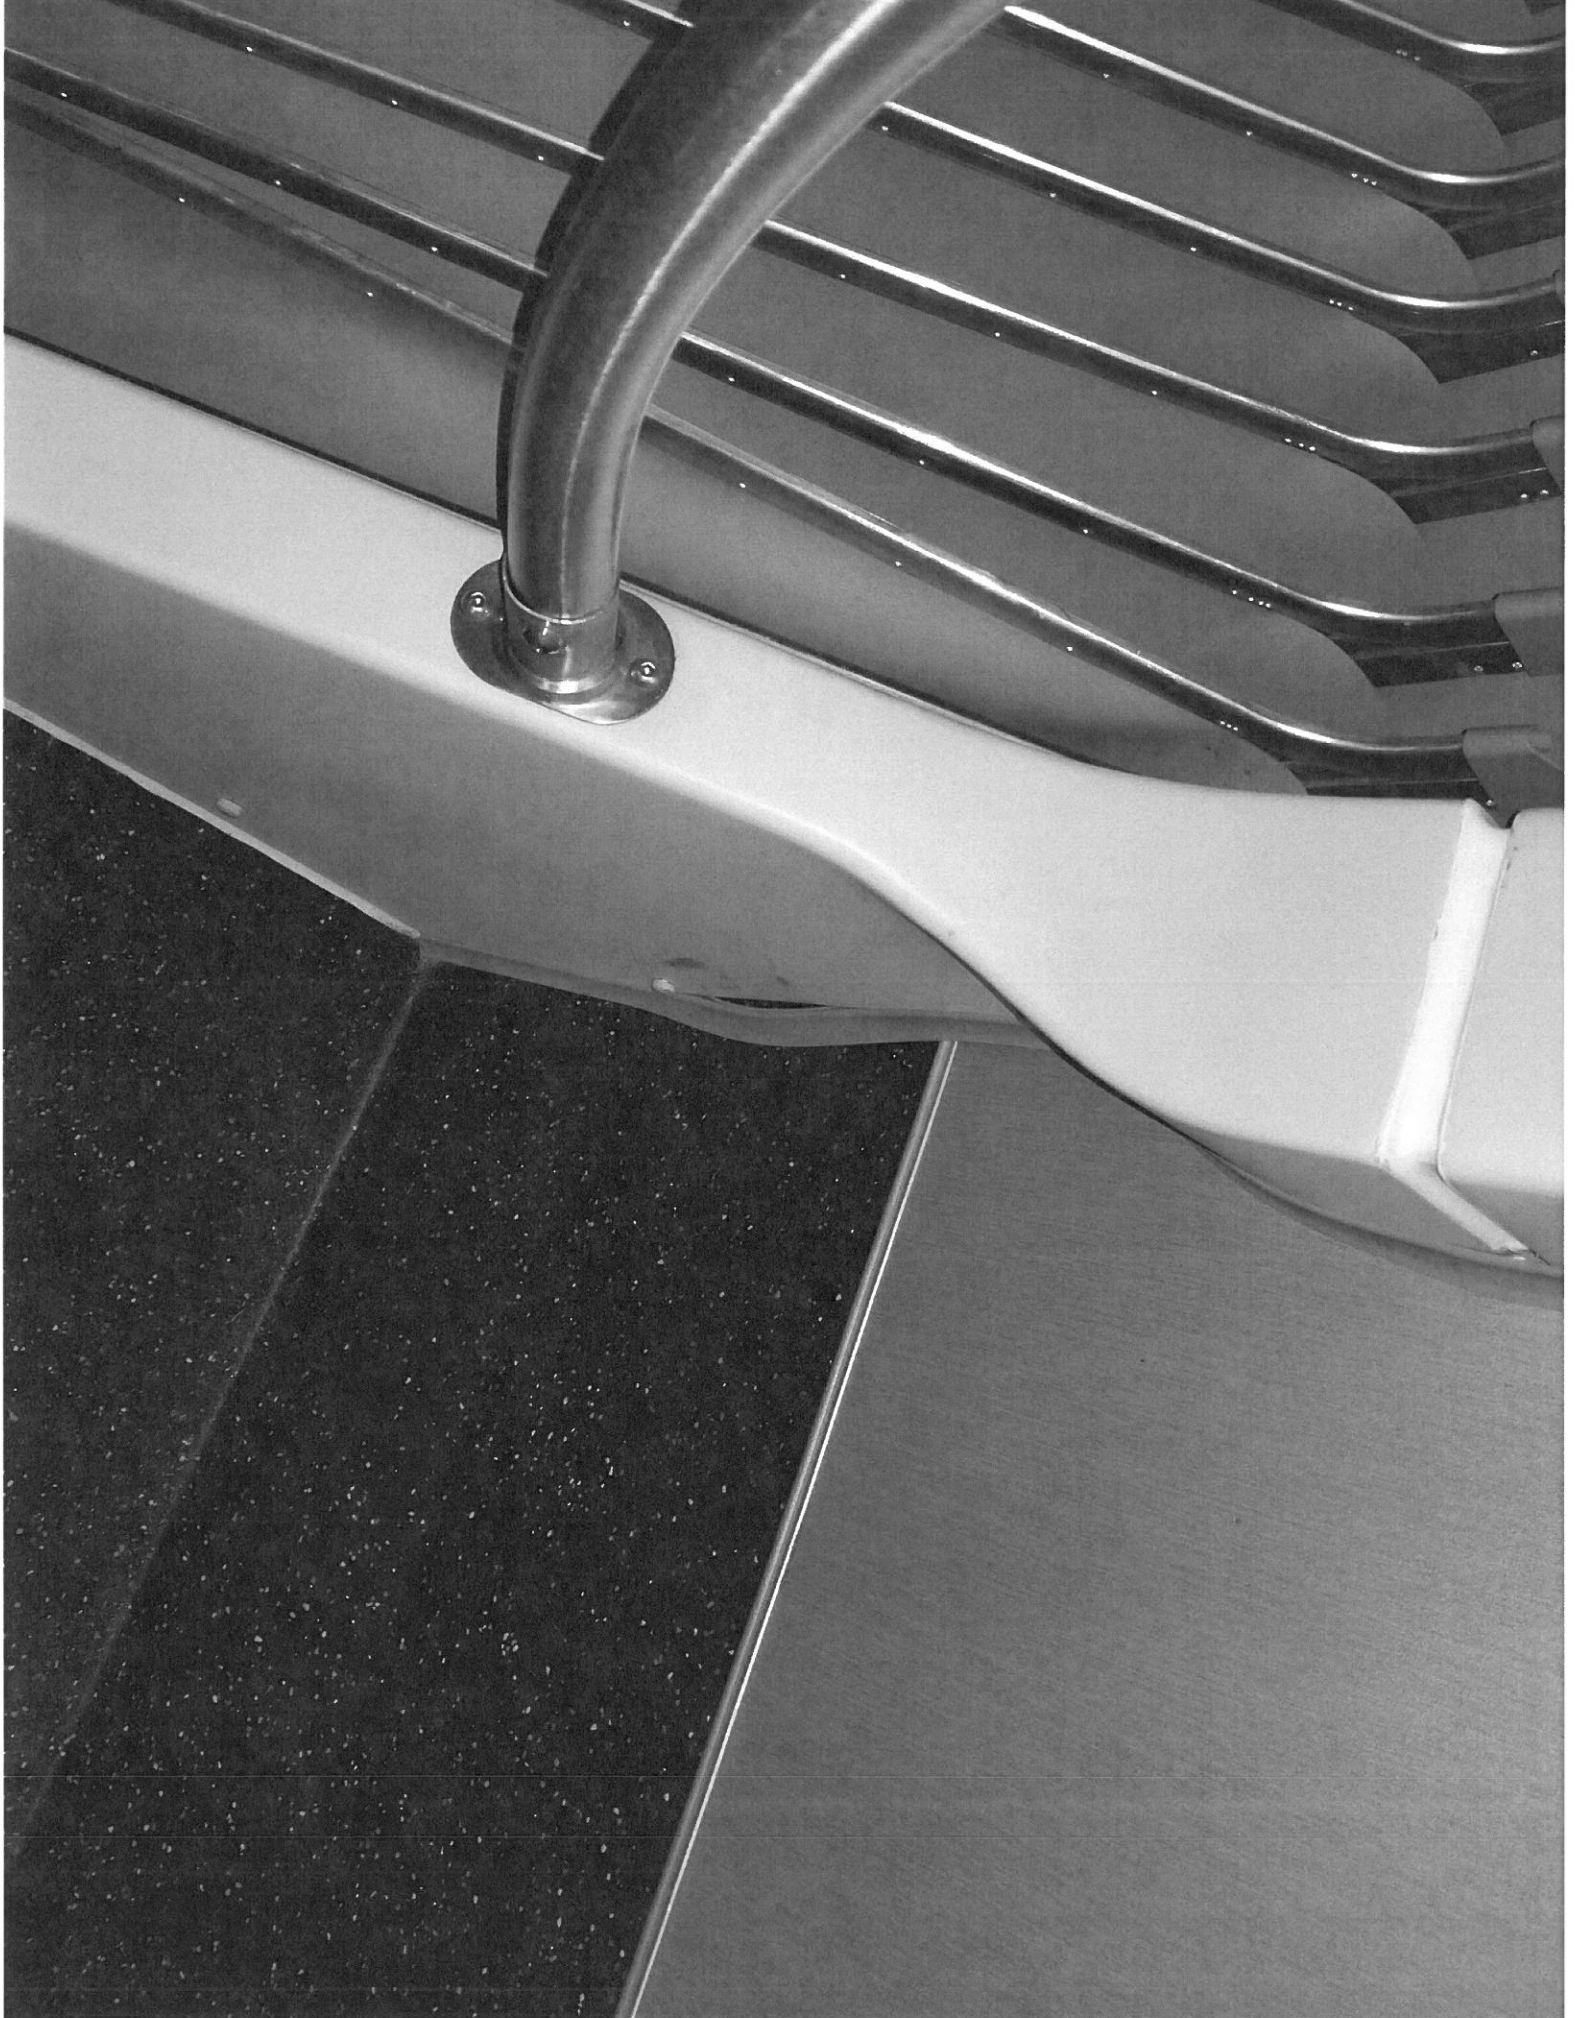
1716 - rear of joint trim falling off, some have trim pieces some have coating at unit.

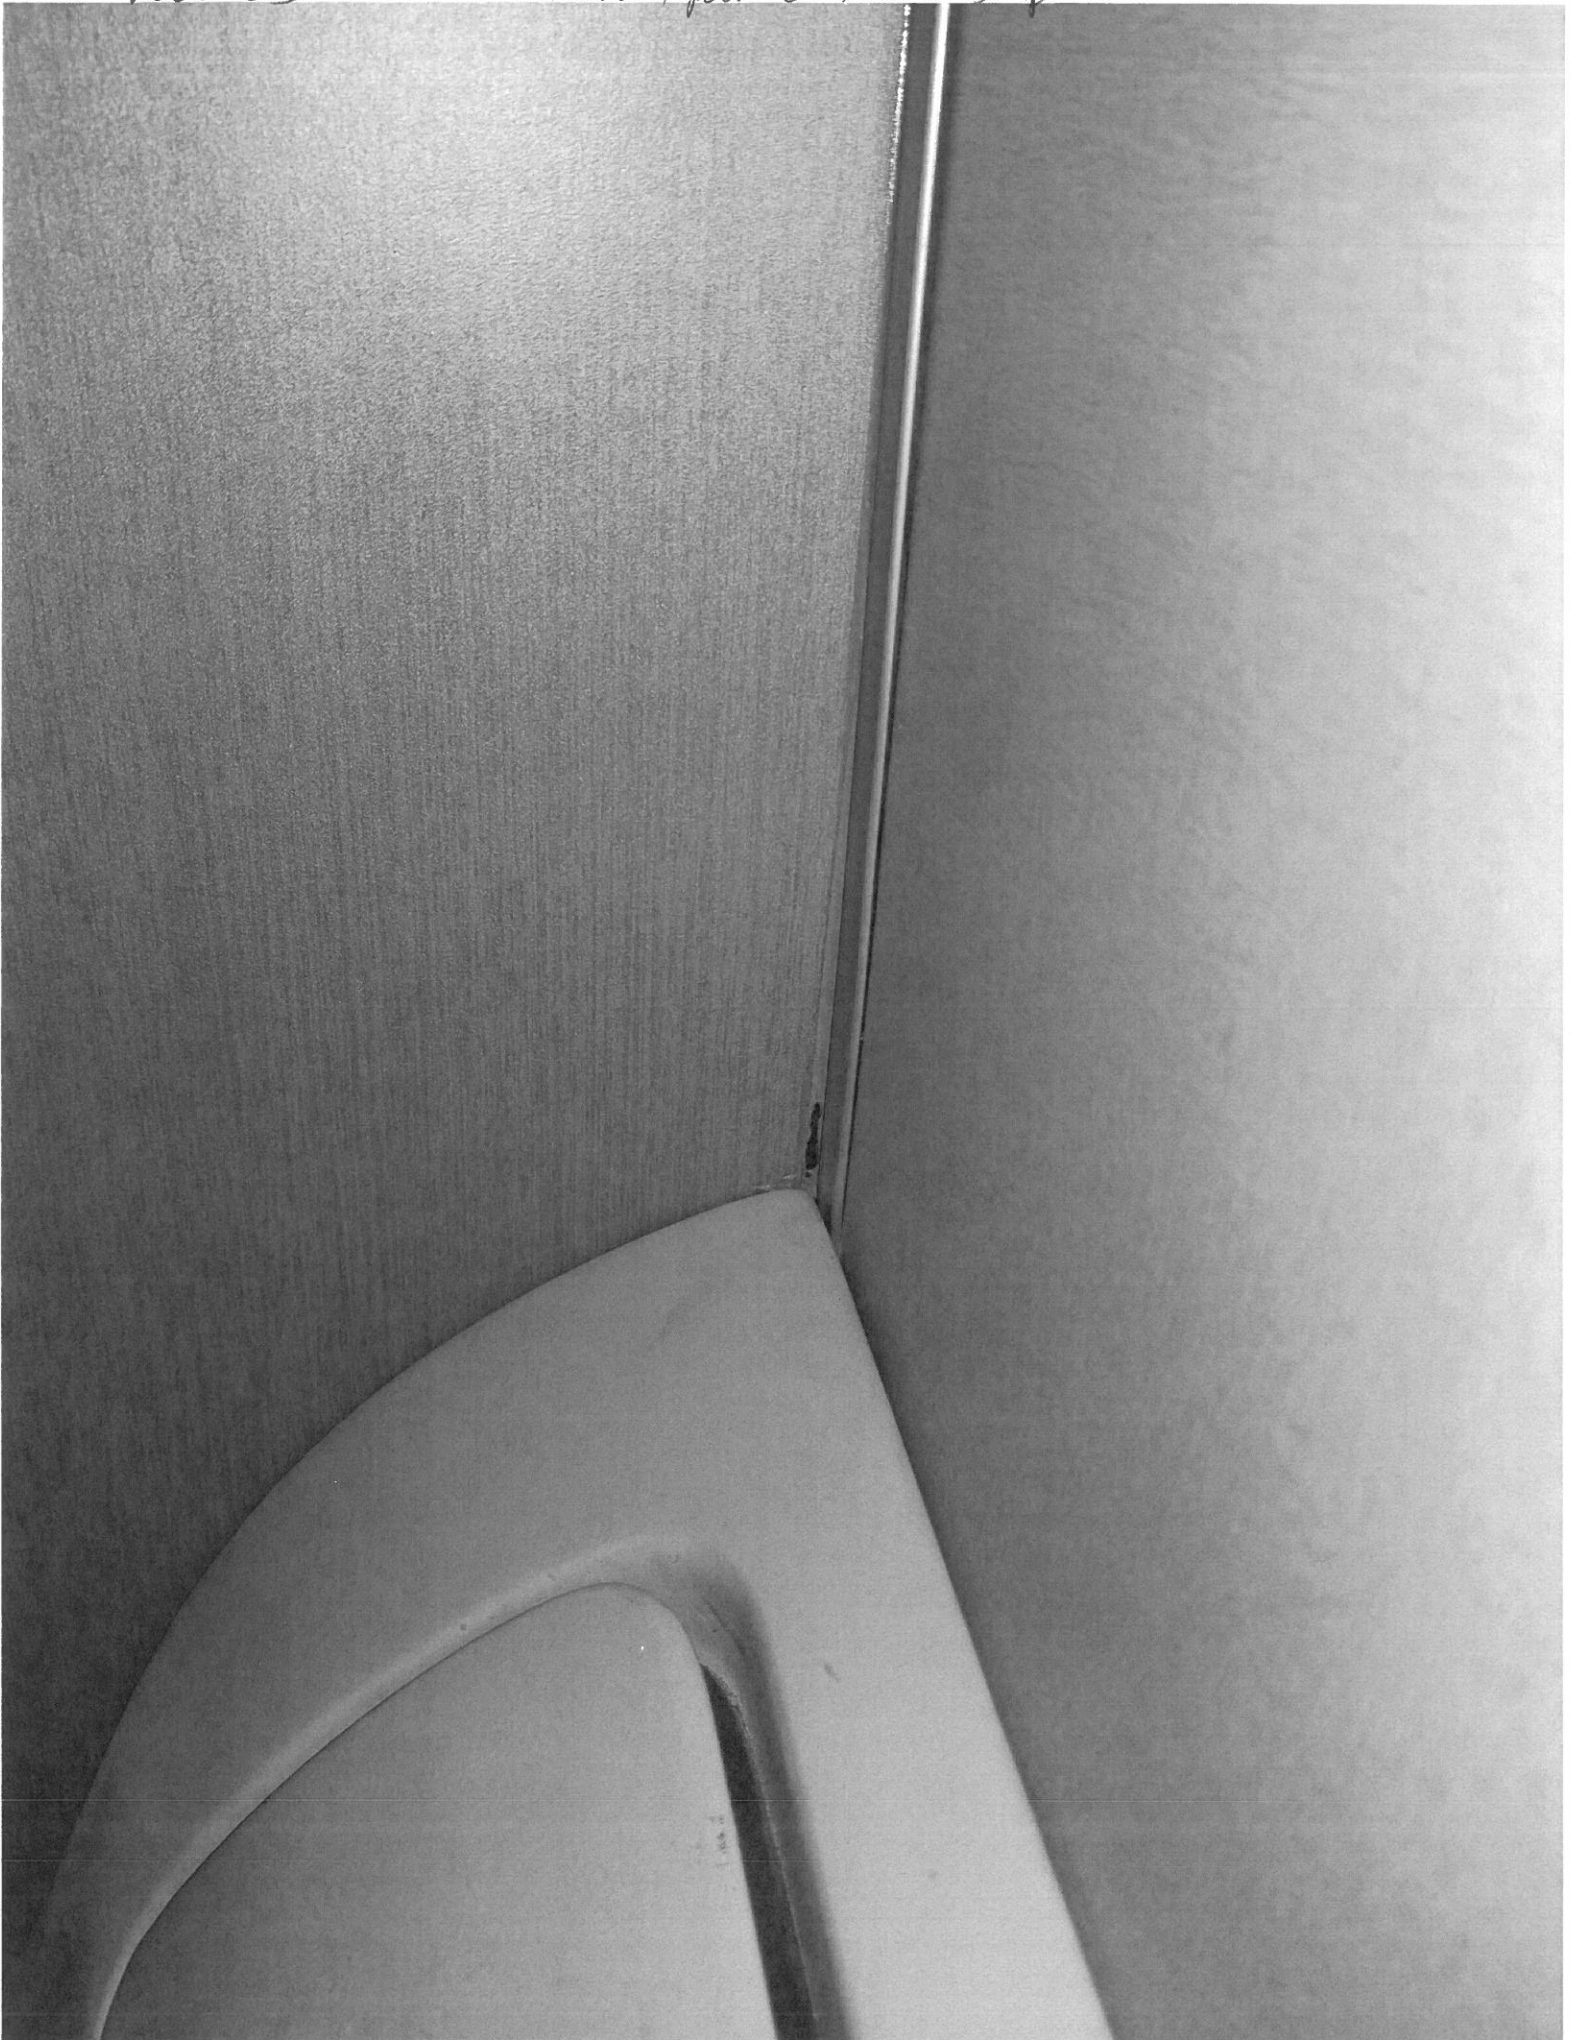
17/6. Rear S/S hole in silicone, poor craftsmanship

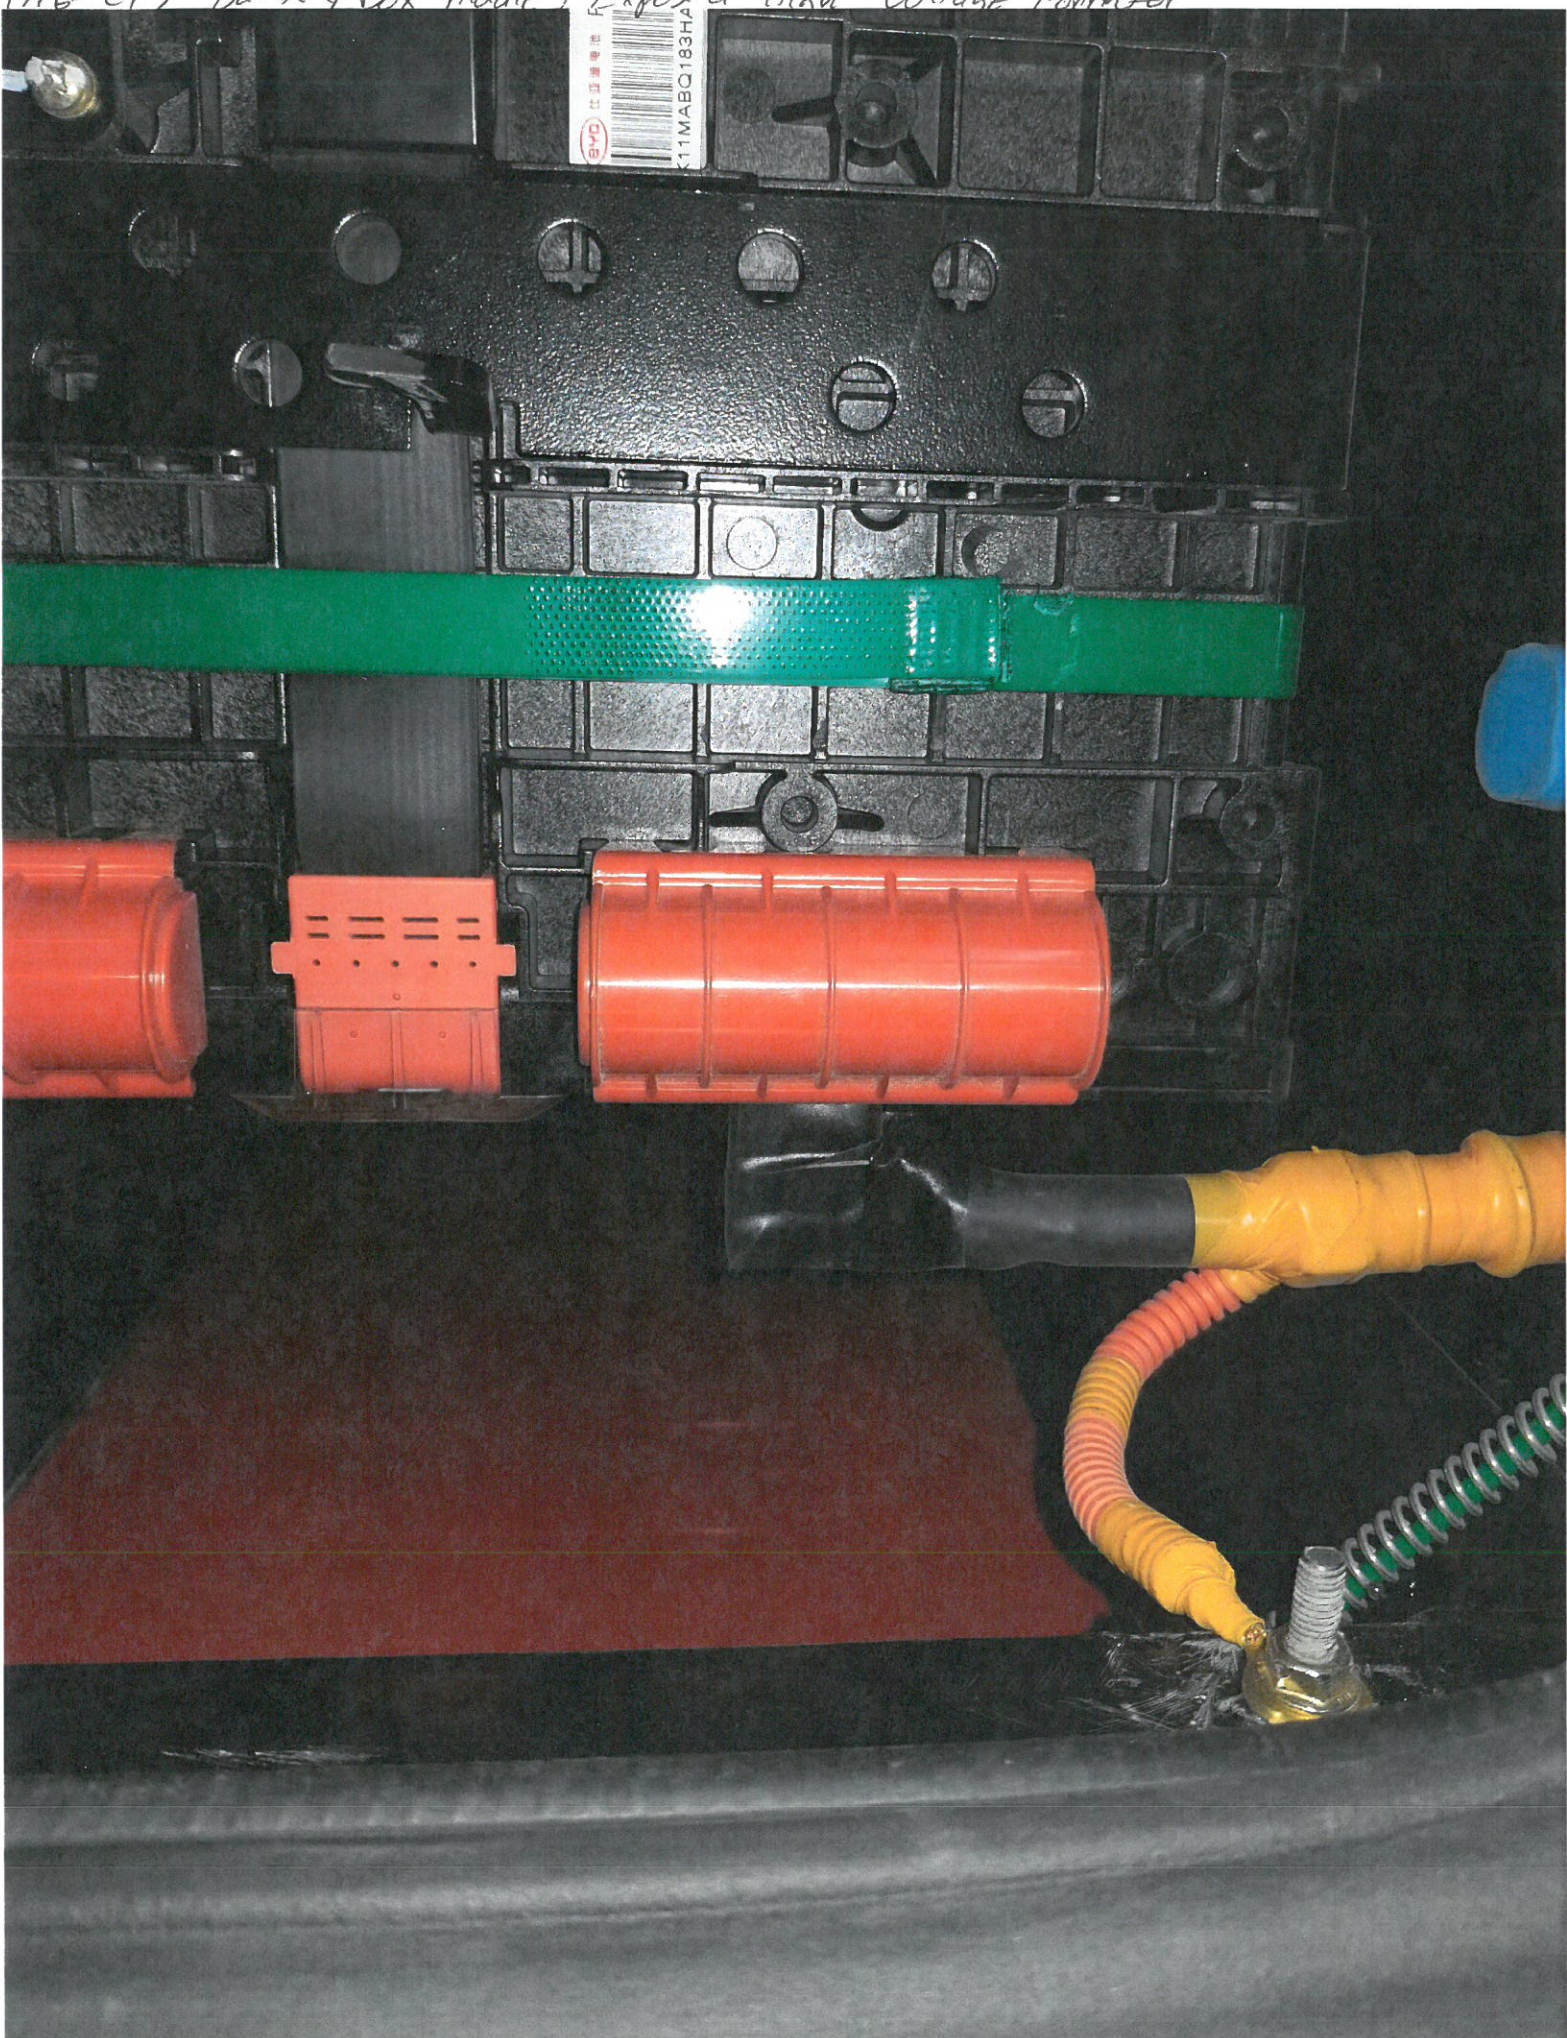
1716- C/S Battery Box middle, Exposed High voltage connector

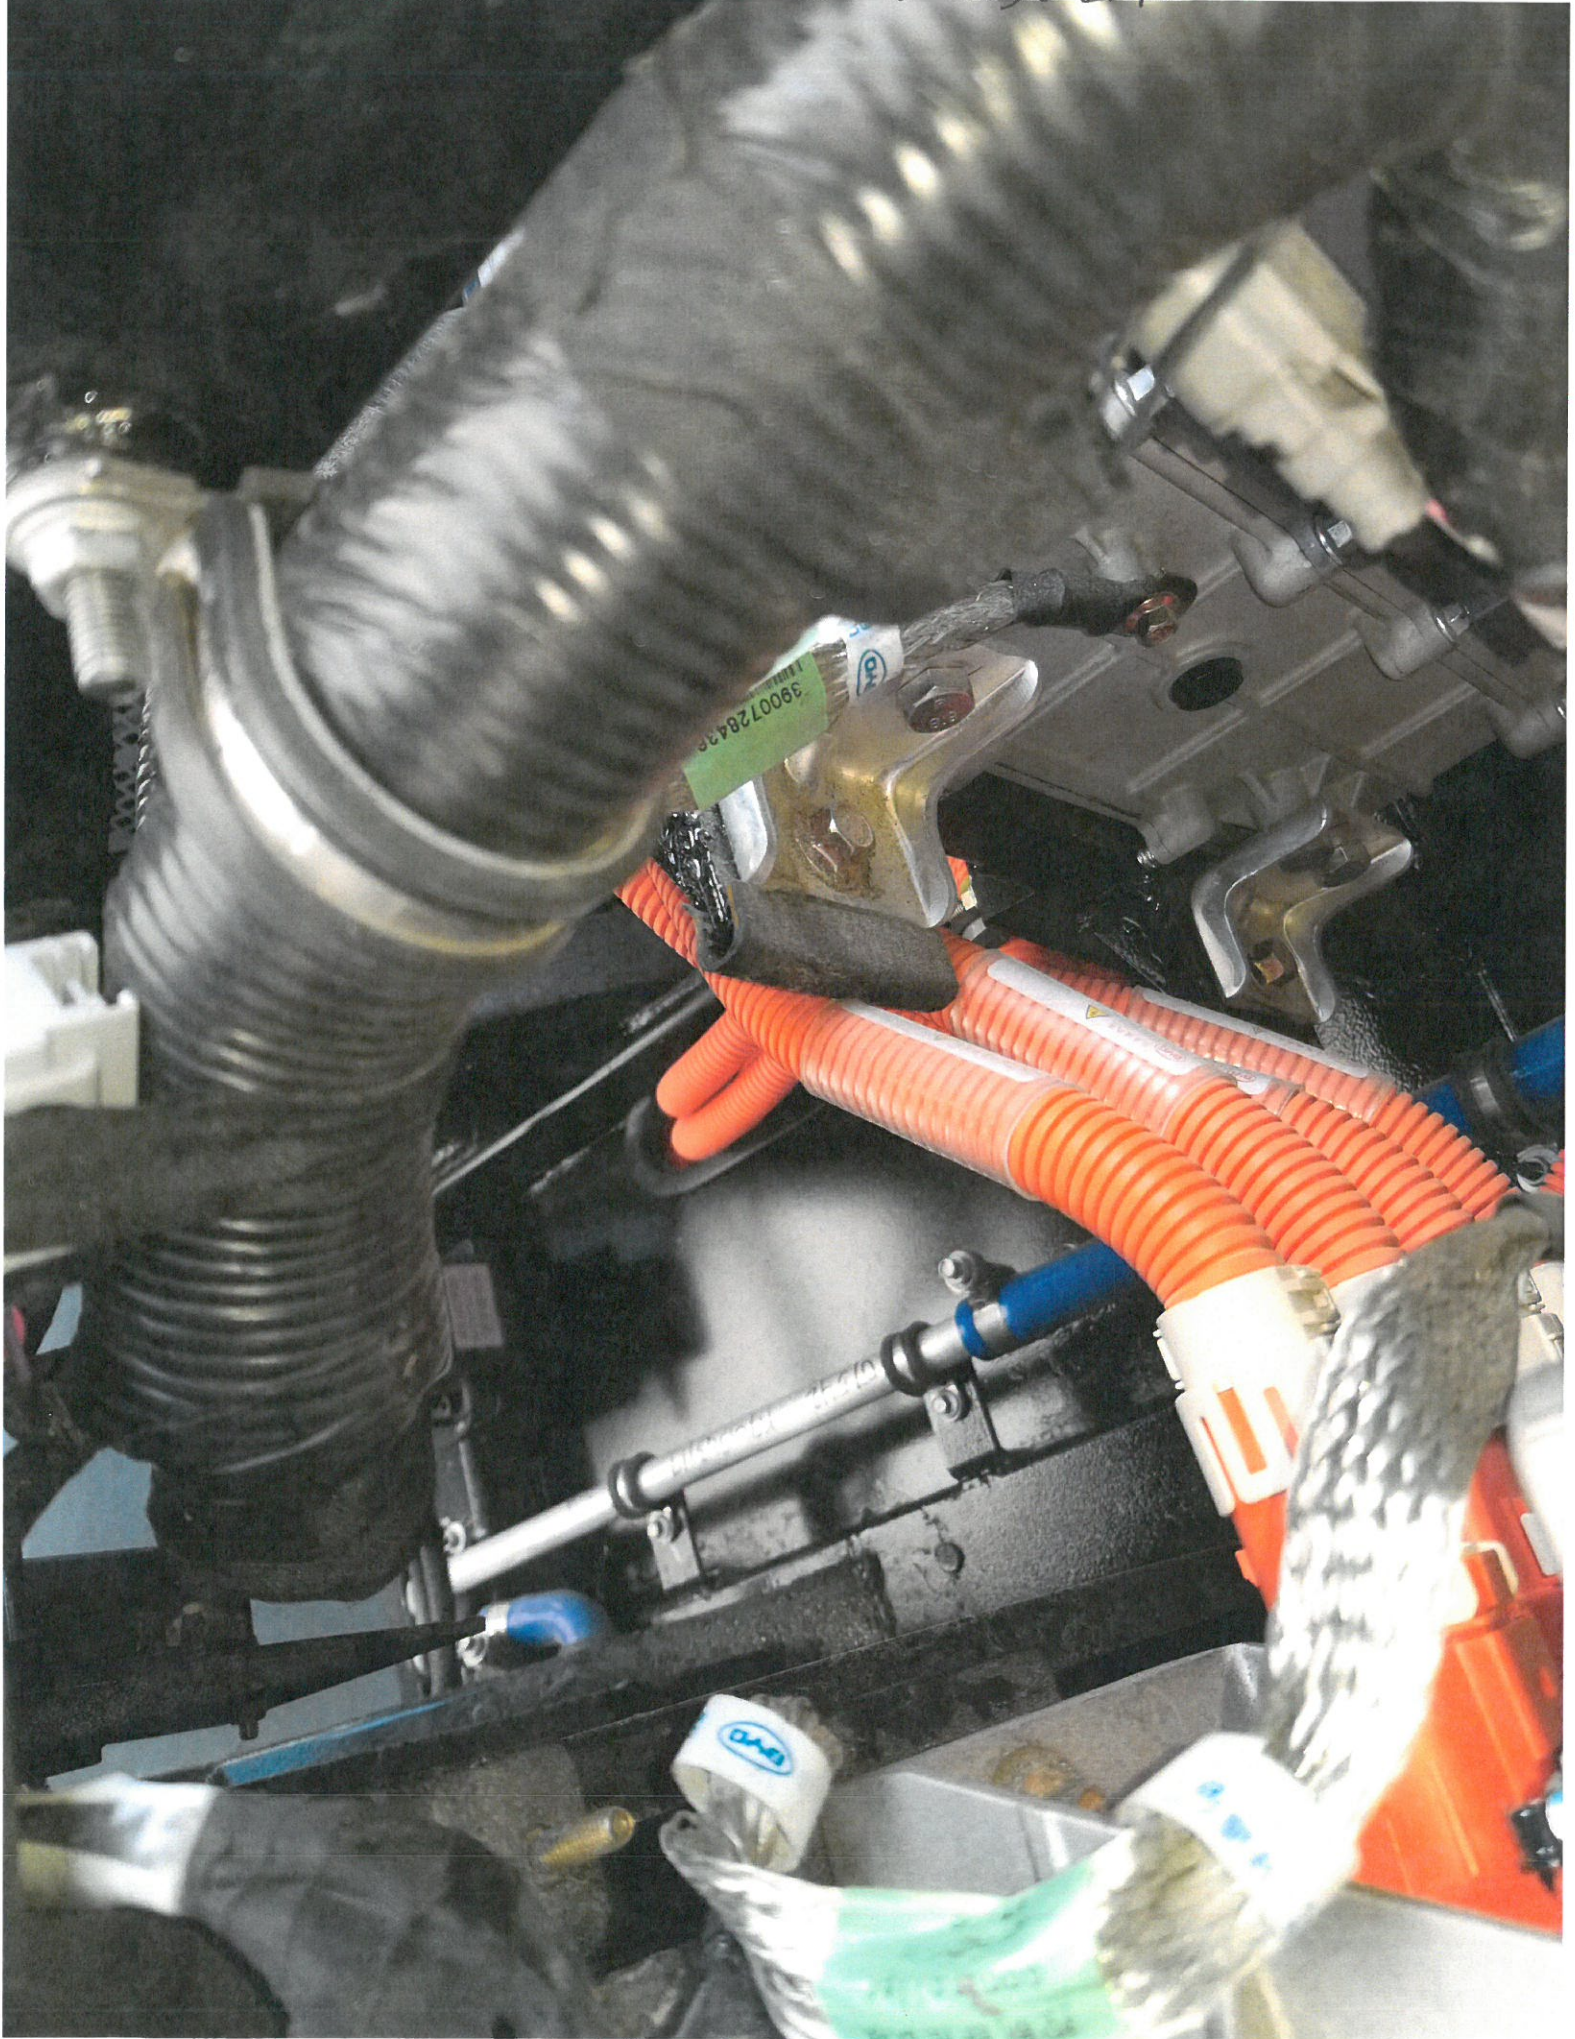
1716- High voltage cables rubbing Frames c13 Engine empty

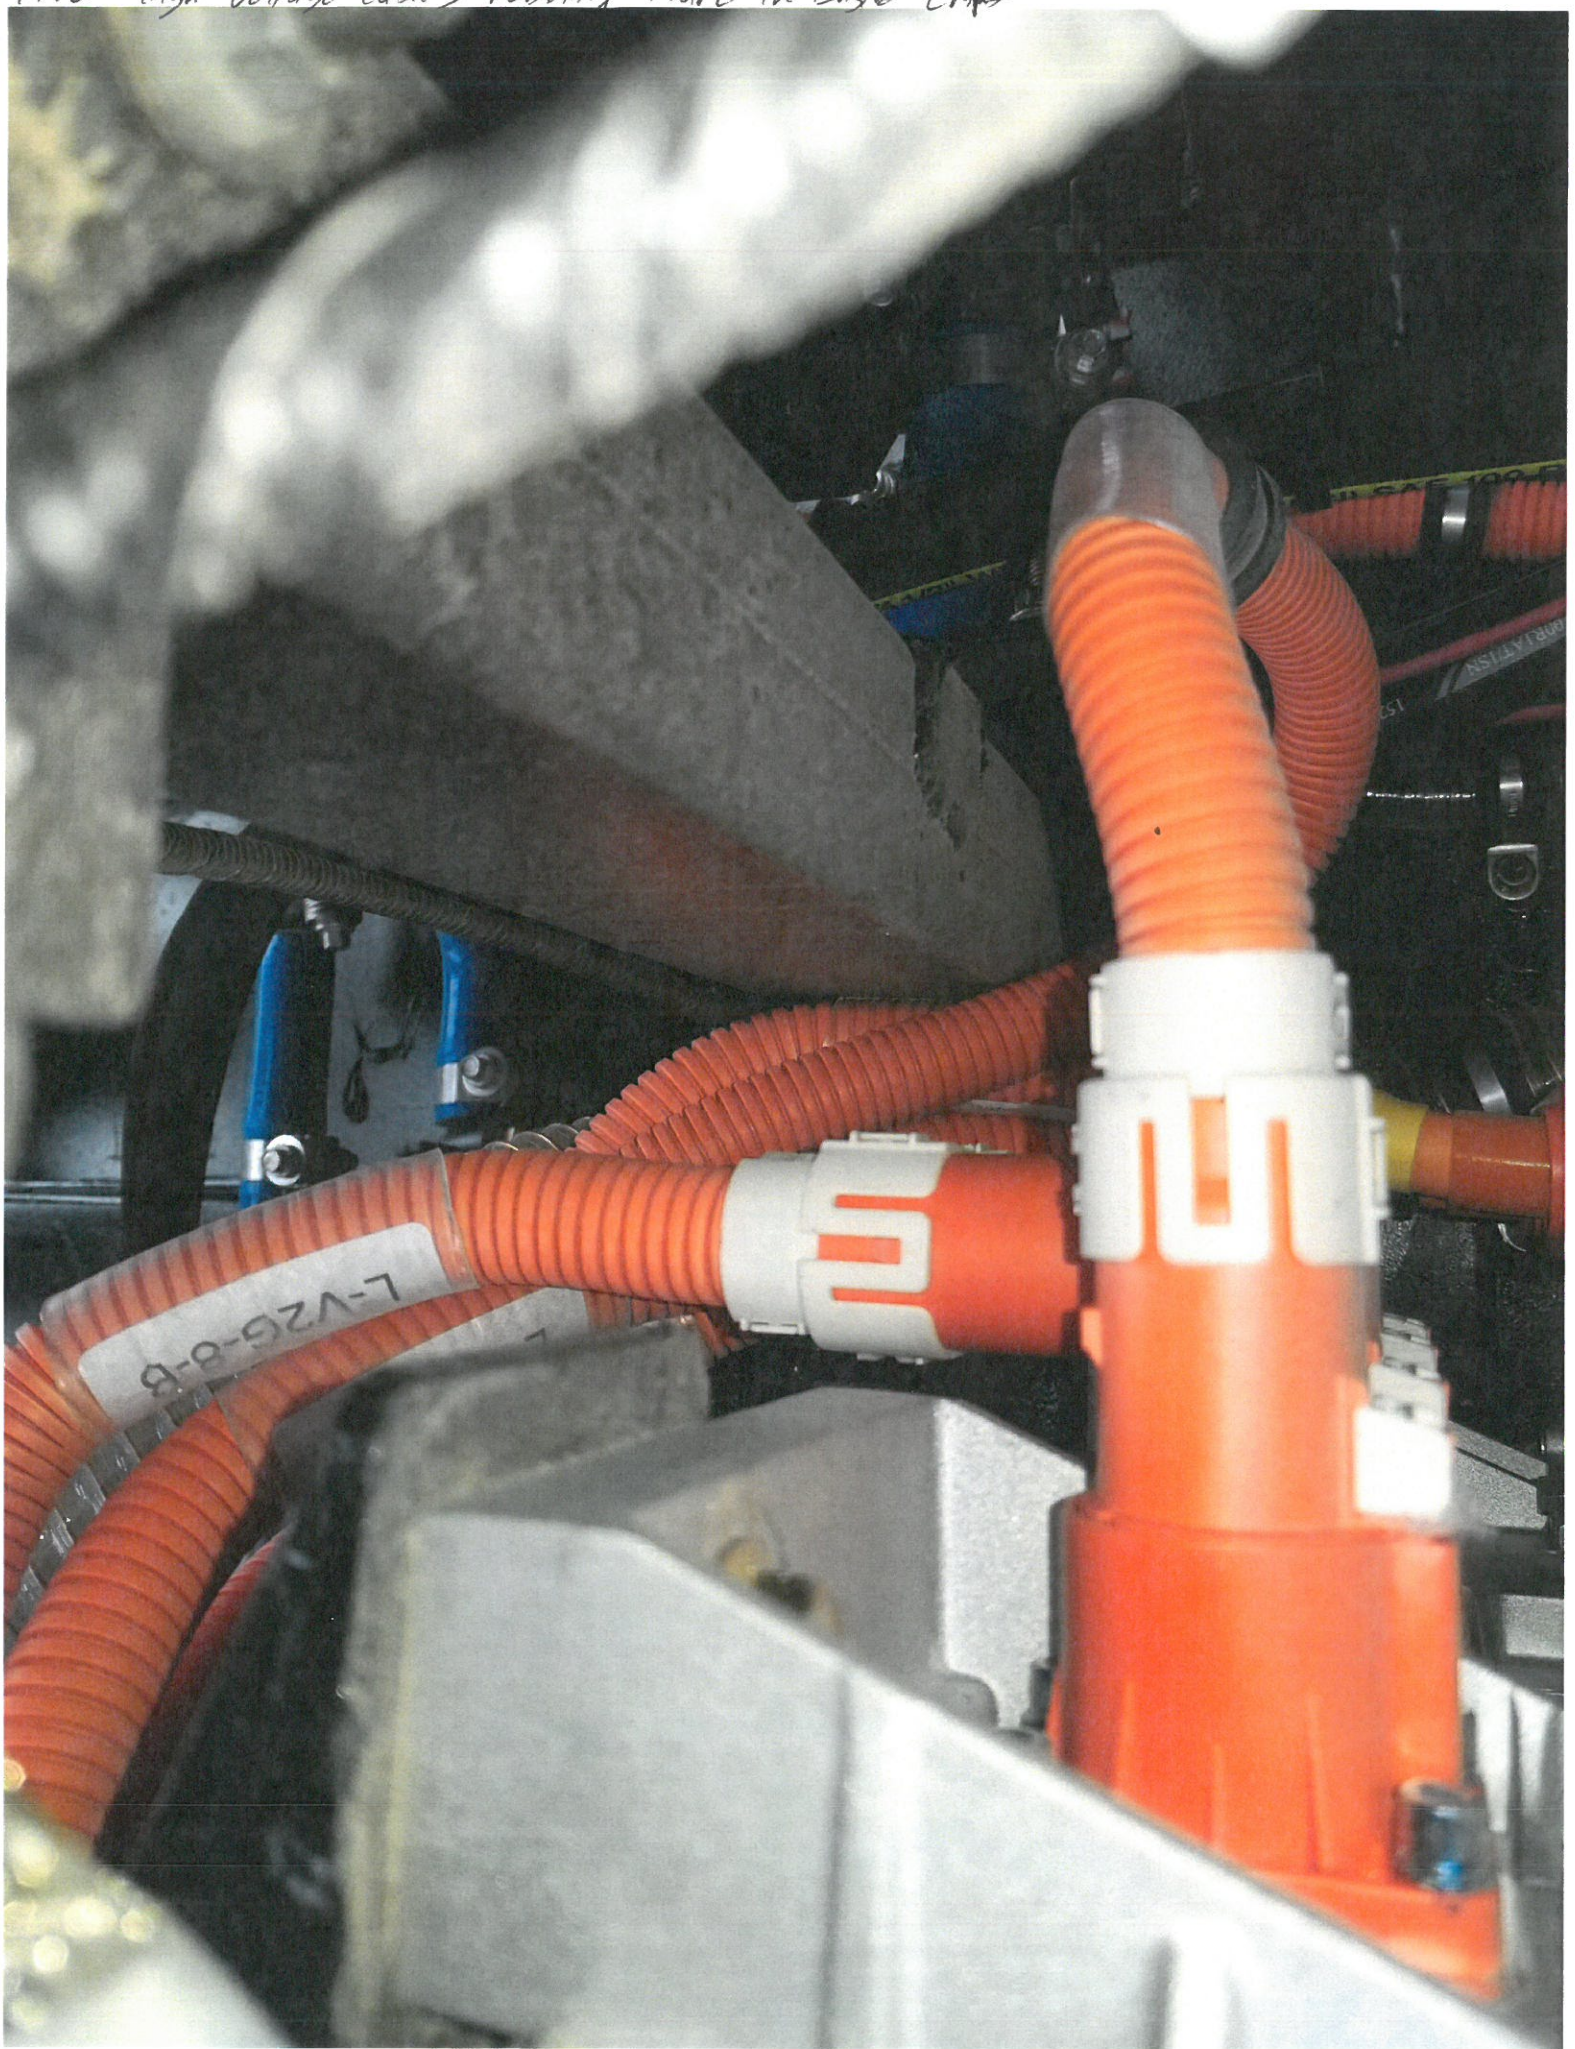
1716 - High Voltage cables rubbing Frame in Engine Comp

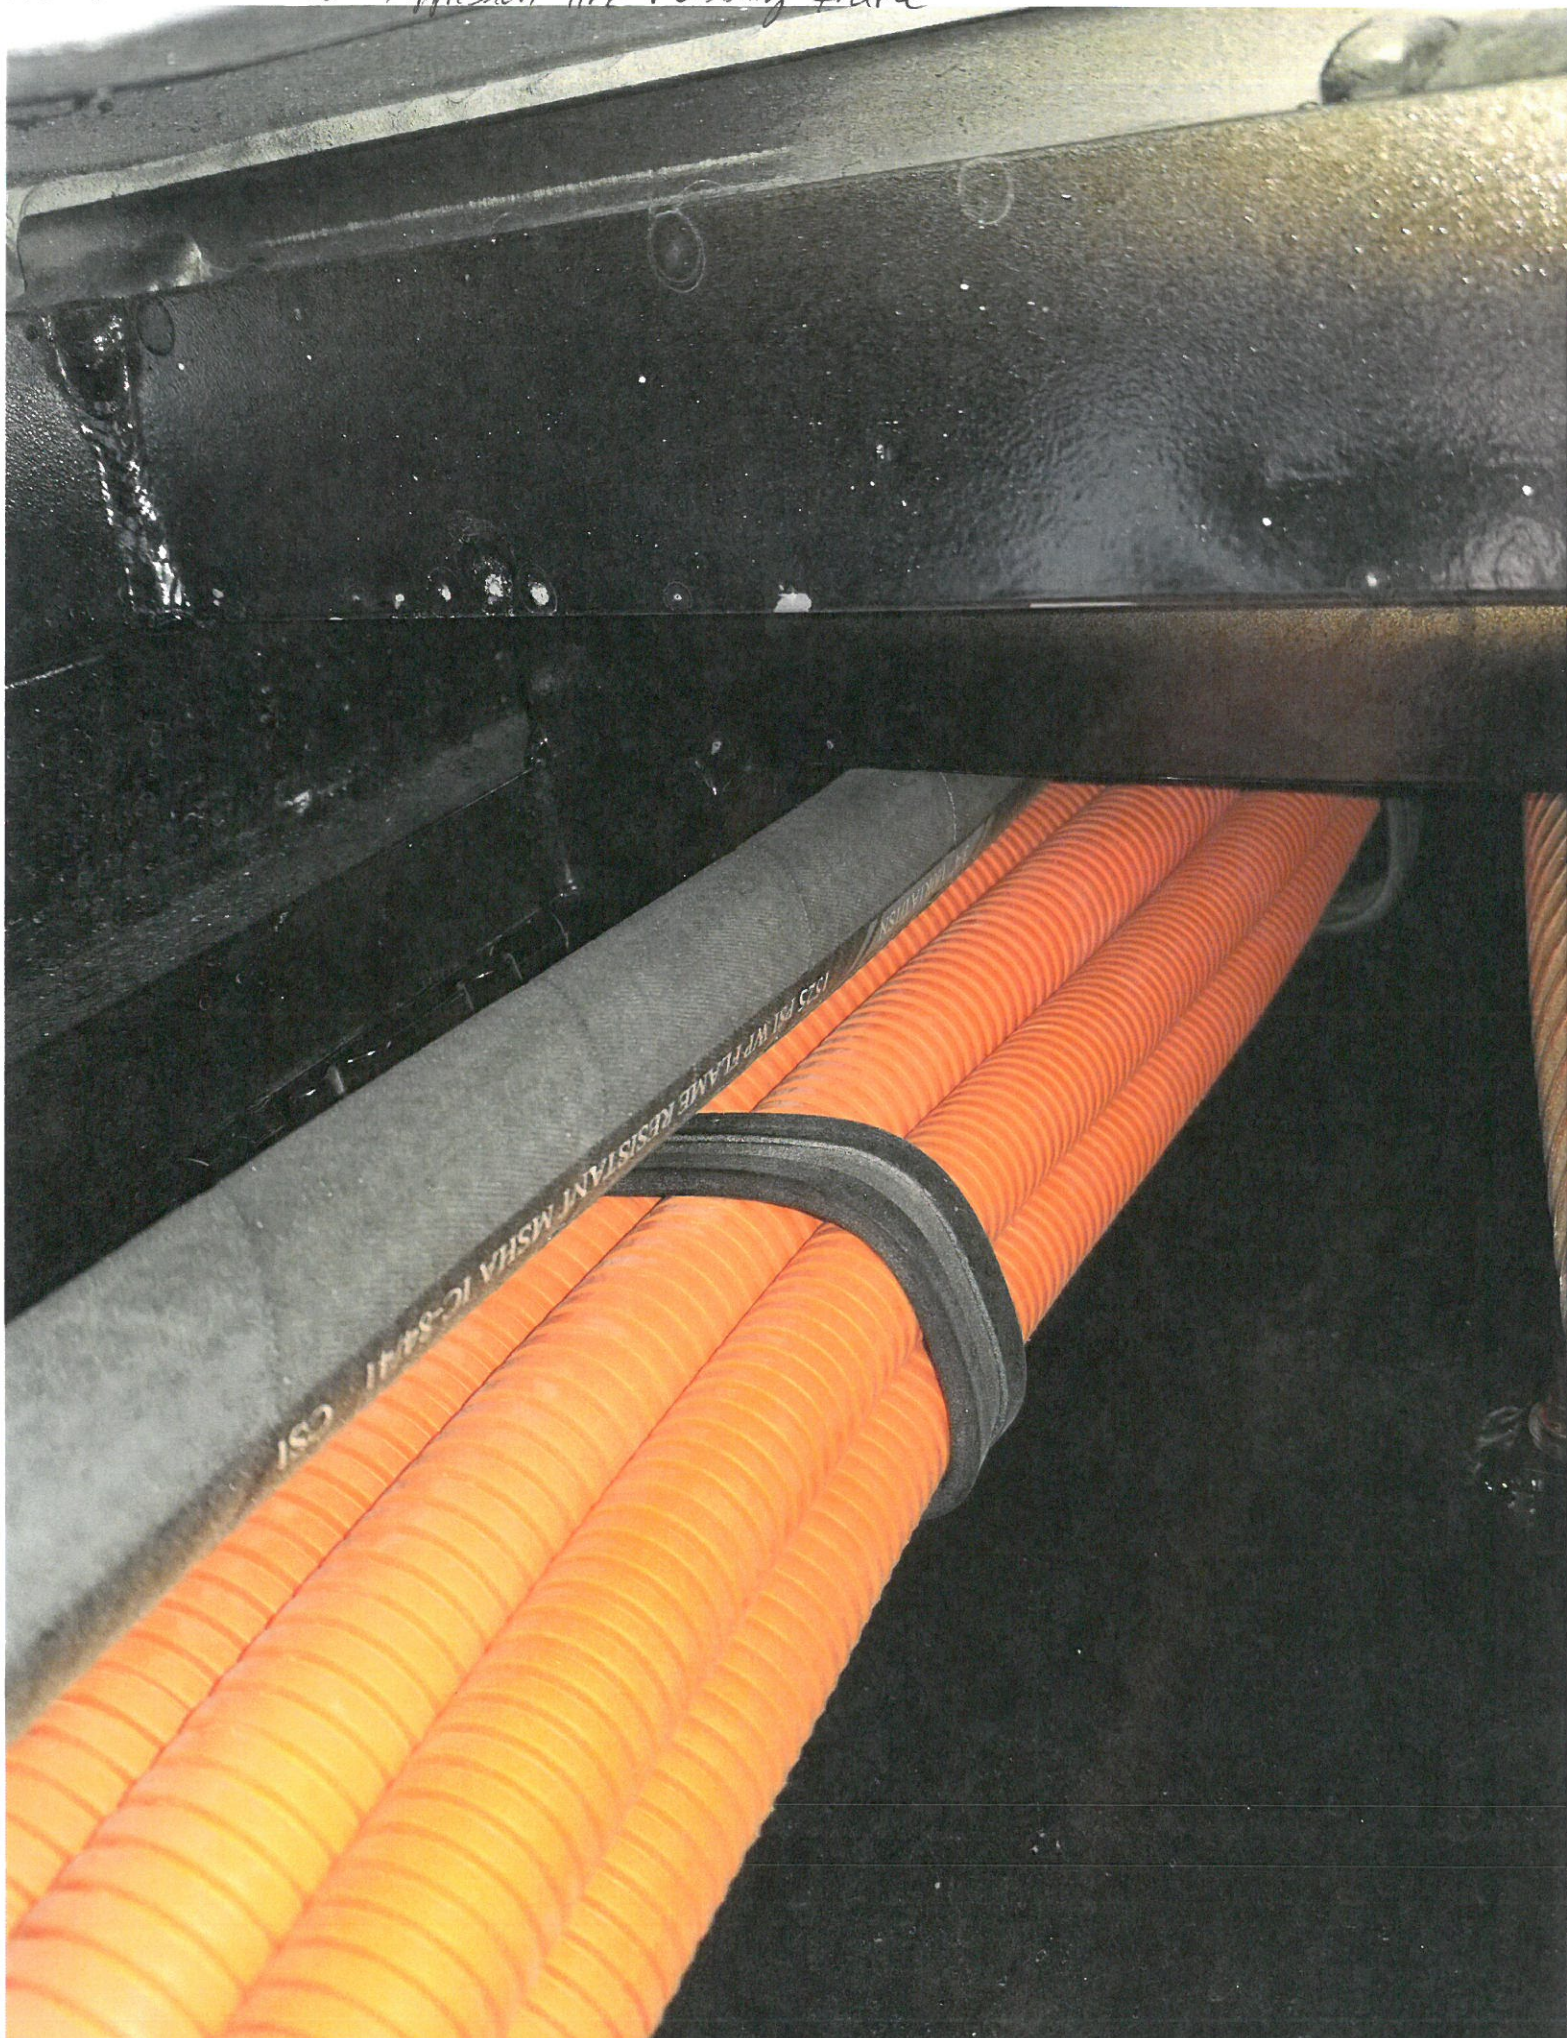
1716 - S/S rear Fire Suppression line rubbing frame
