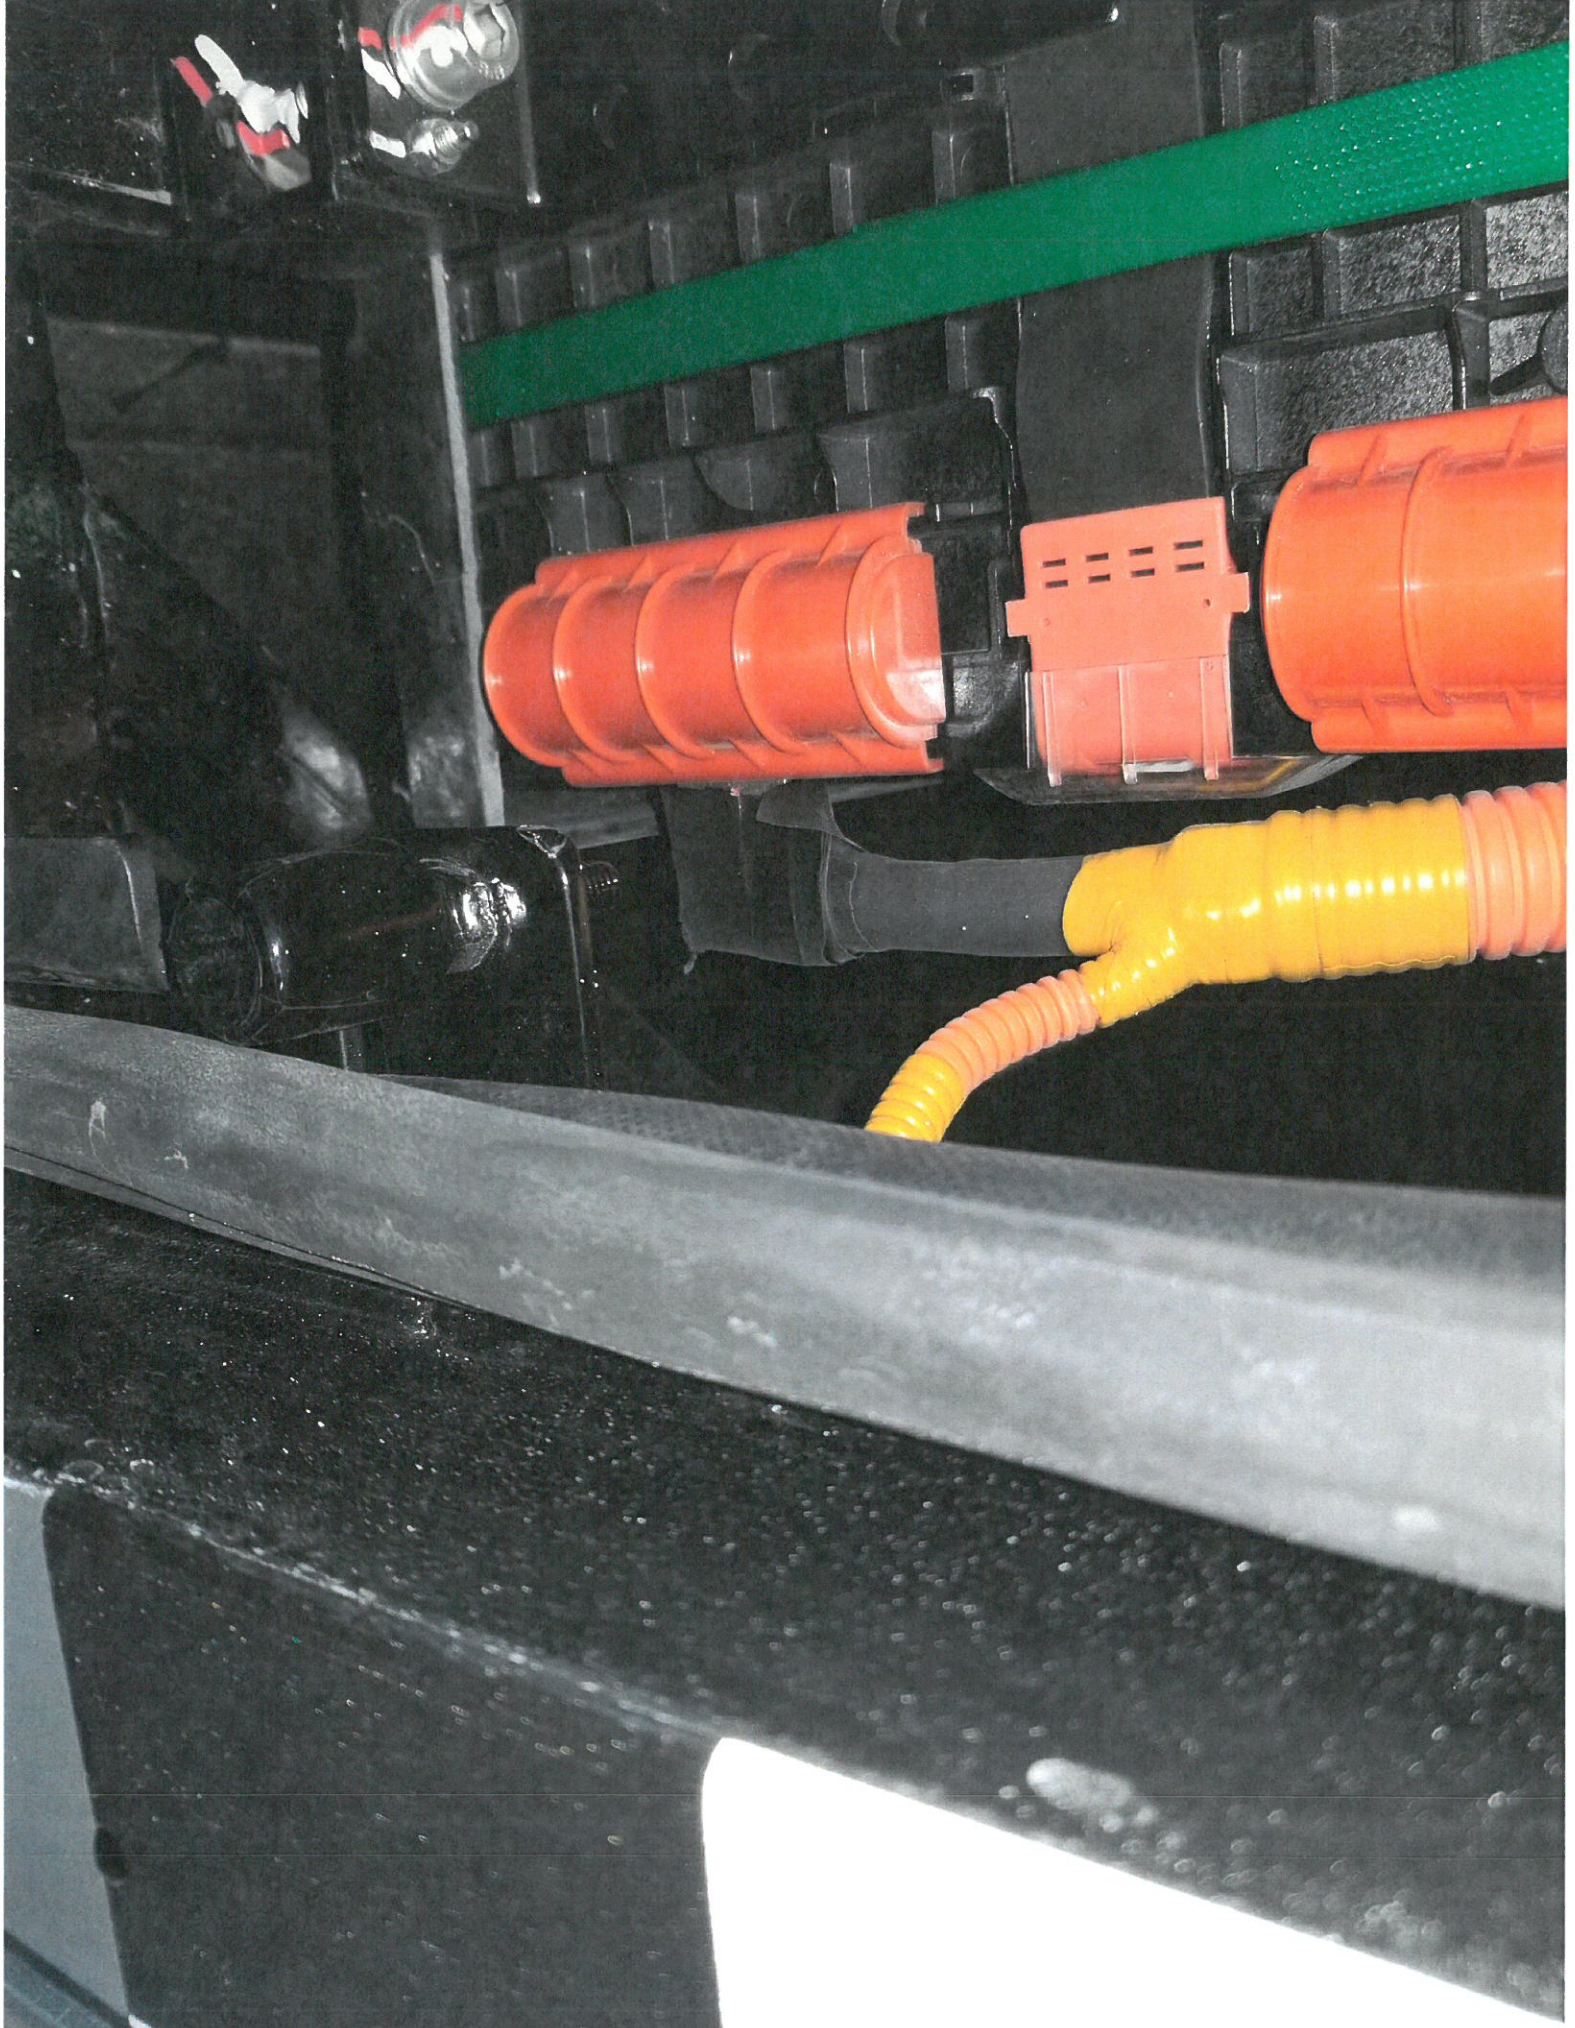
1716 - Exposed High Voltages & Connector Exposed c/s Batt CML

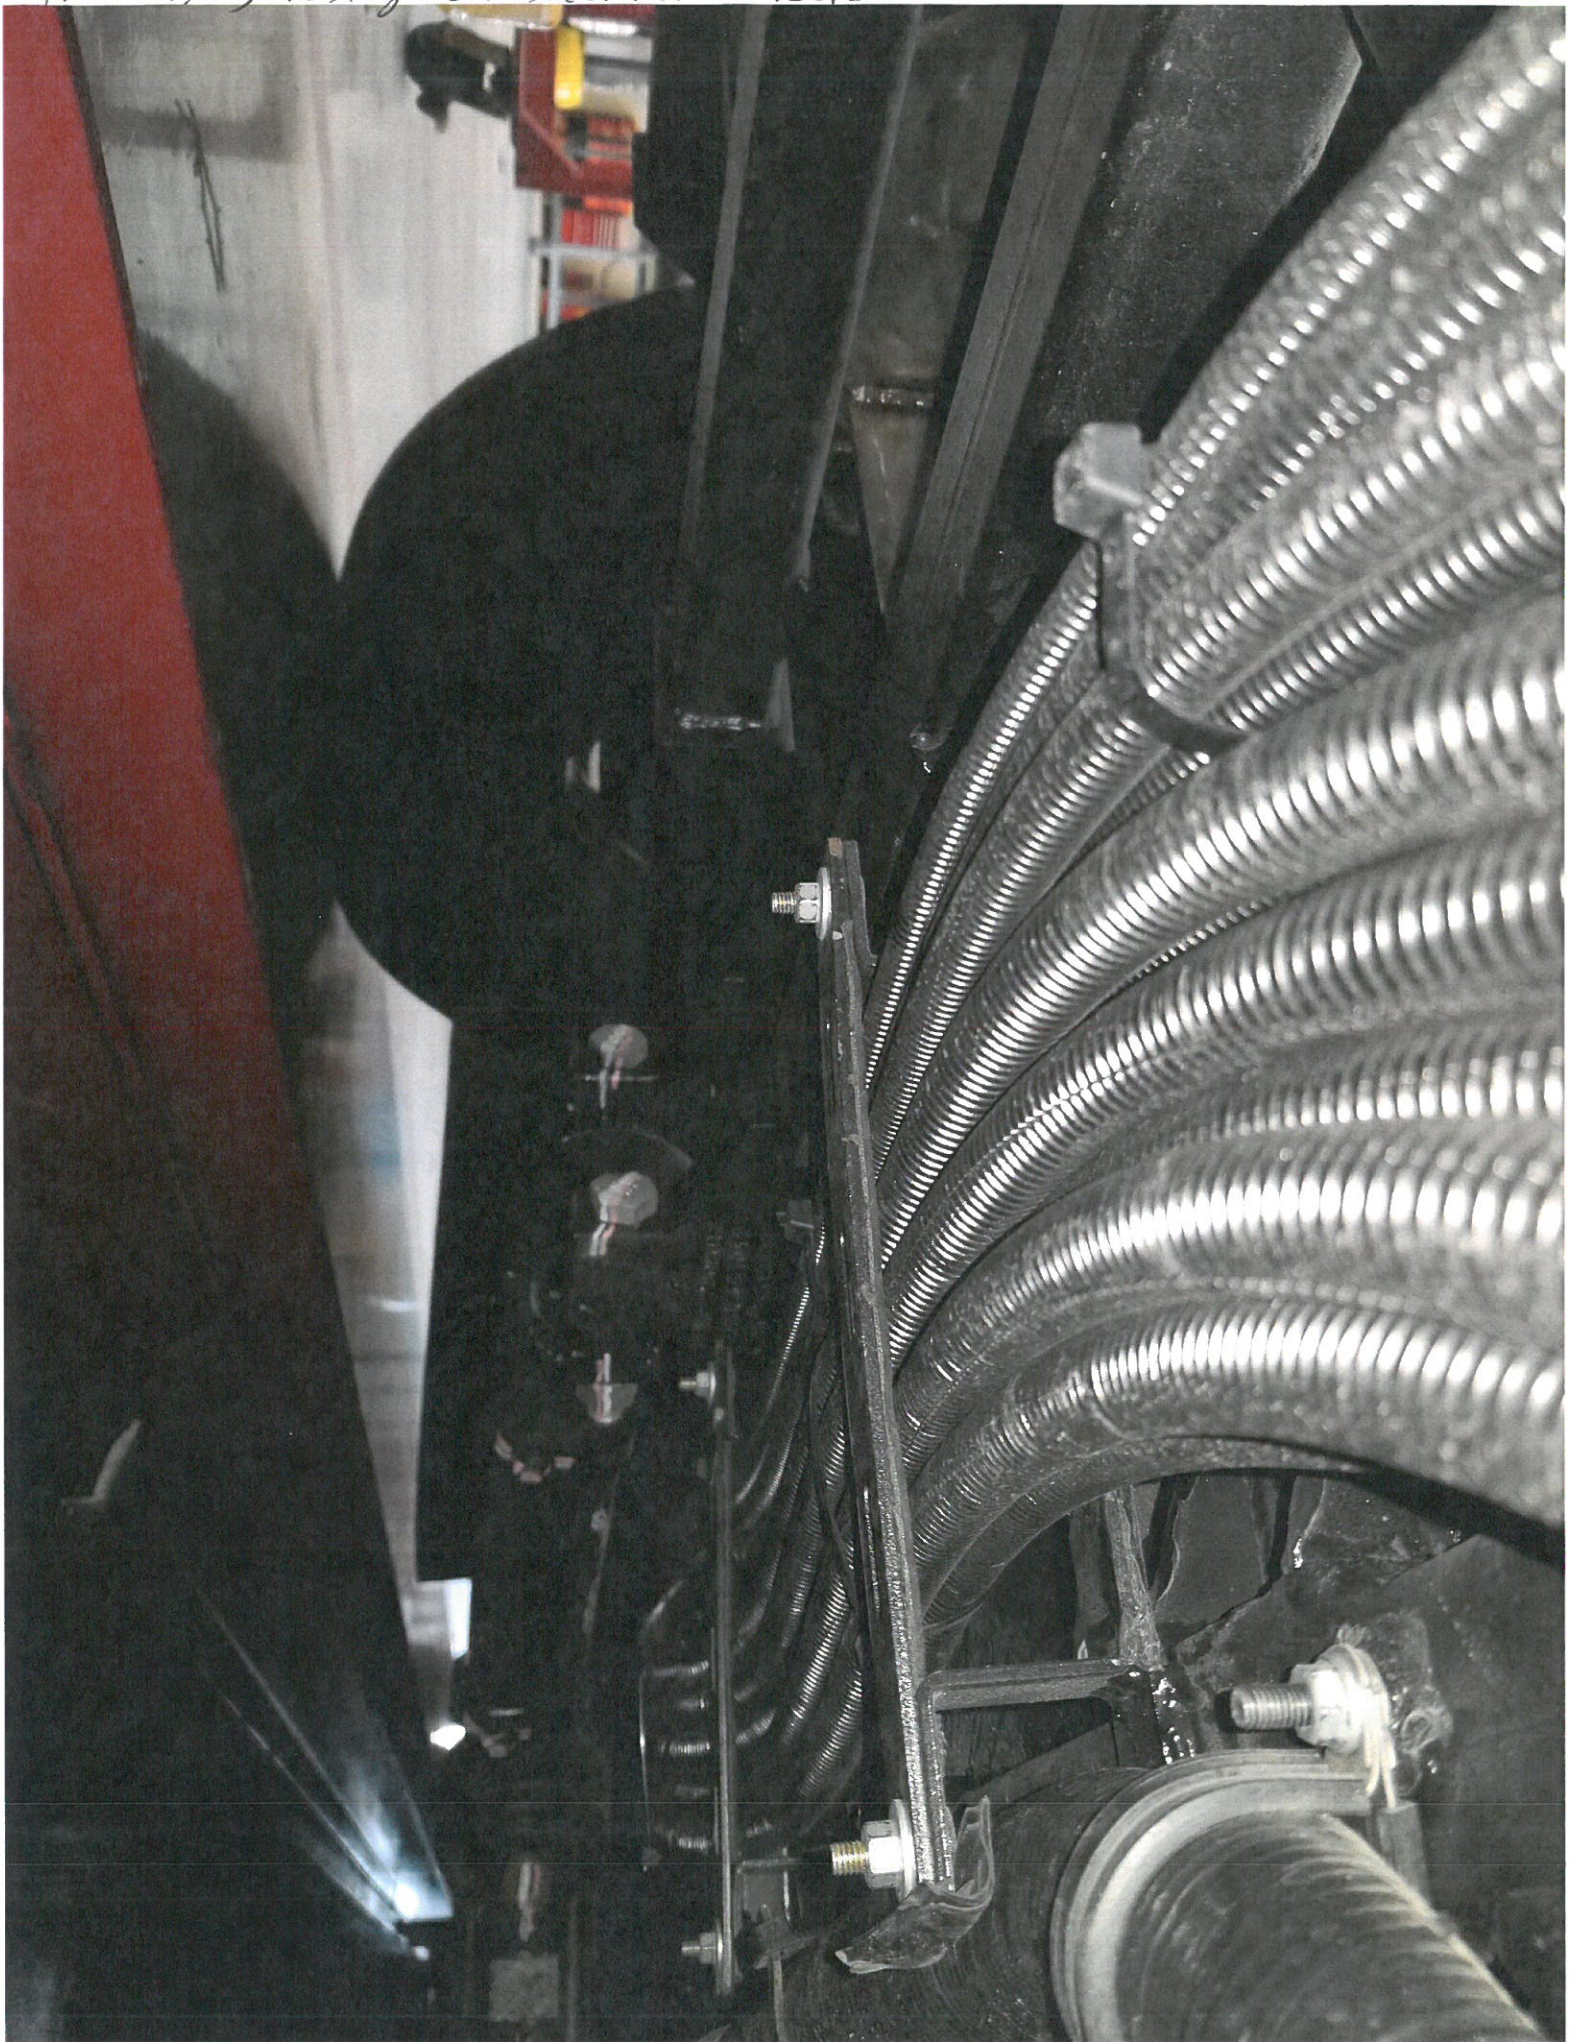
1716-Cables rubbing on Securement brackets

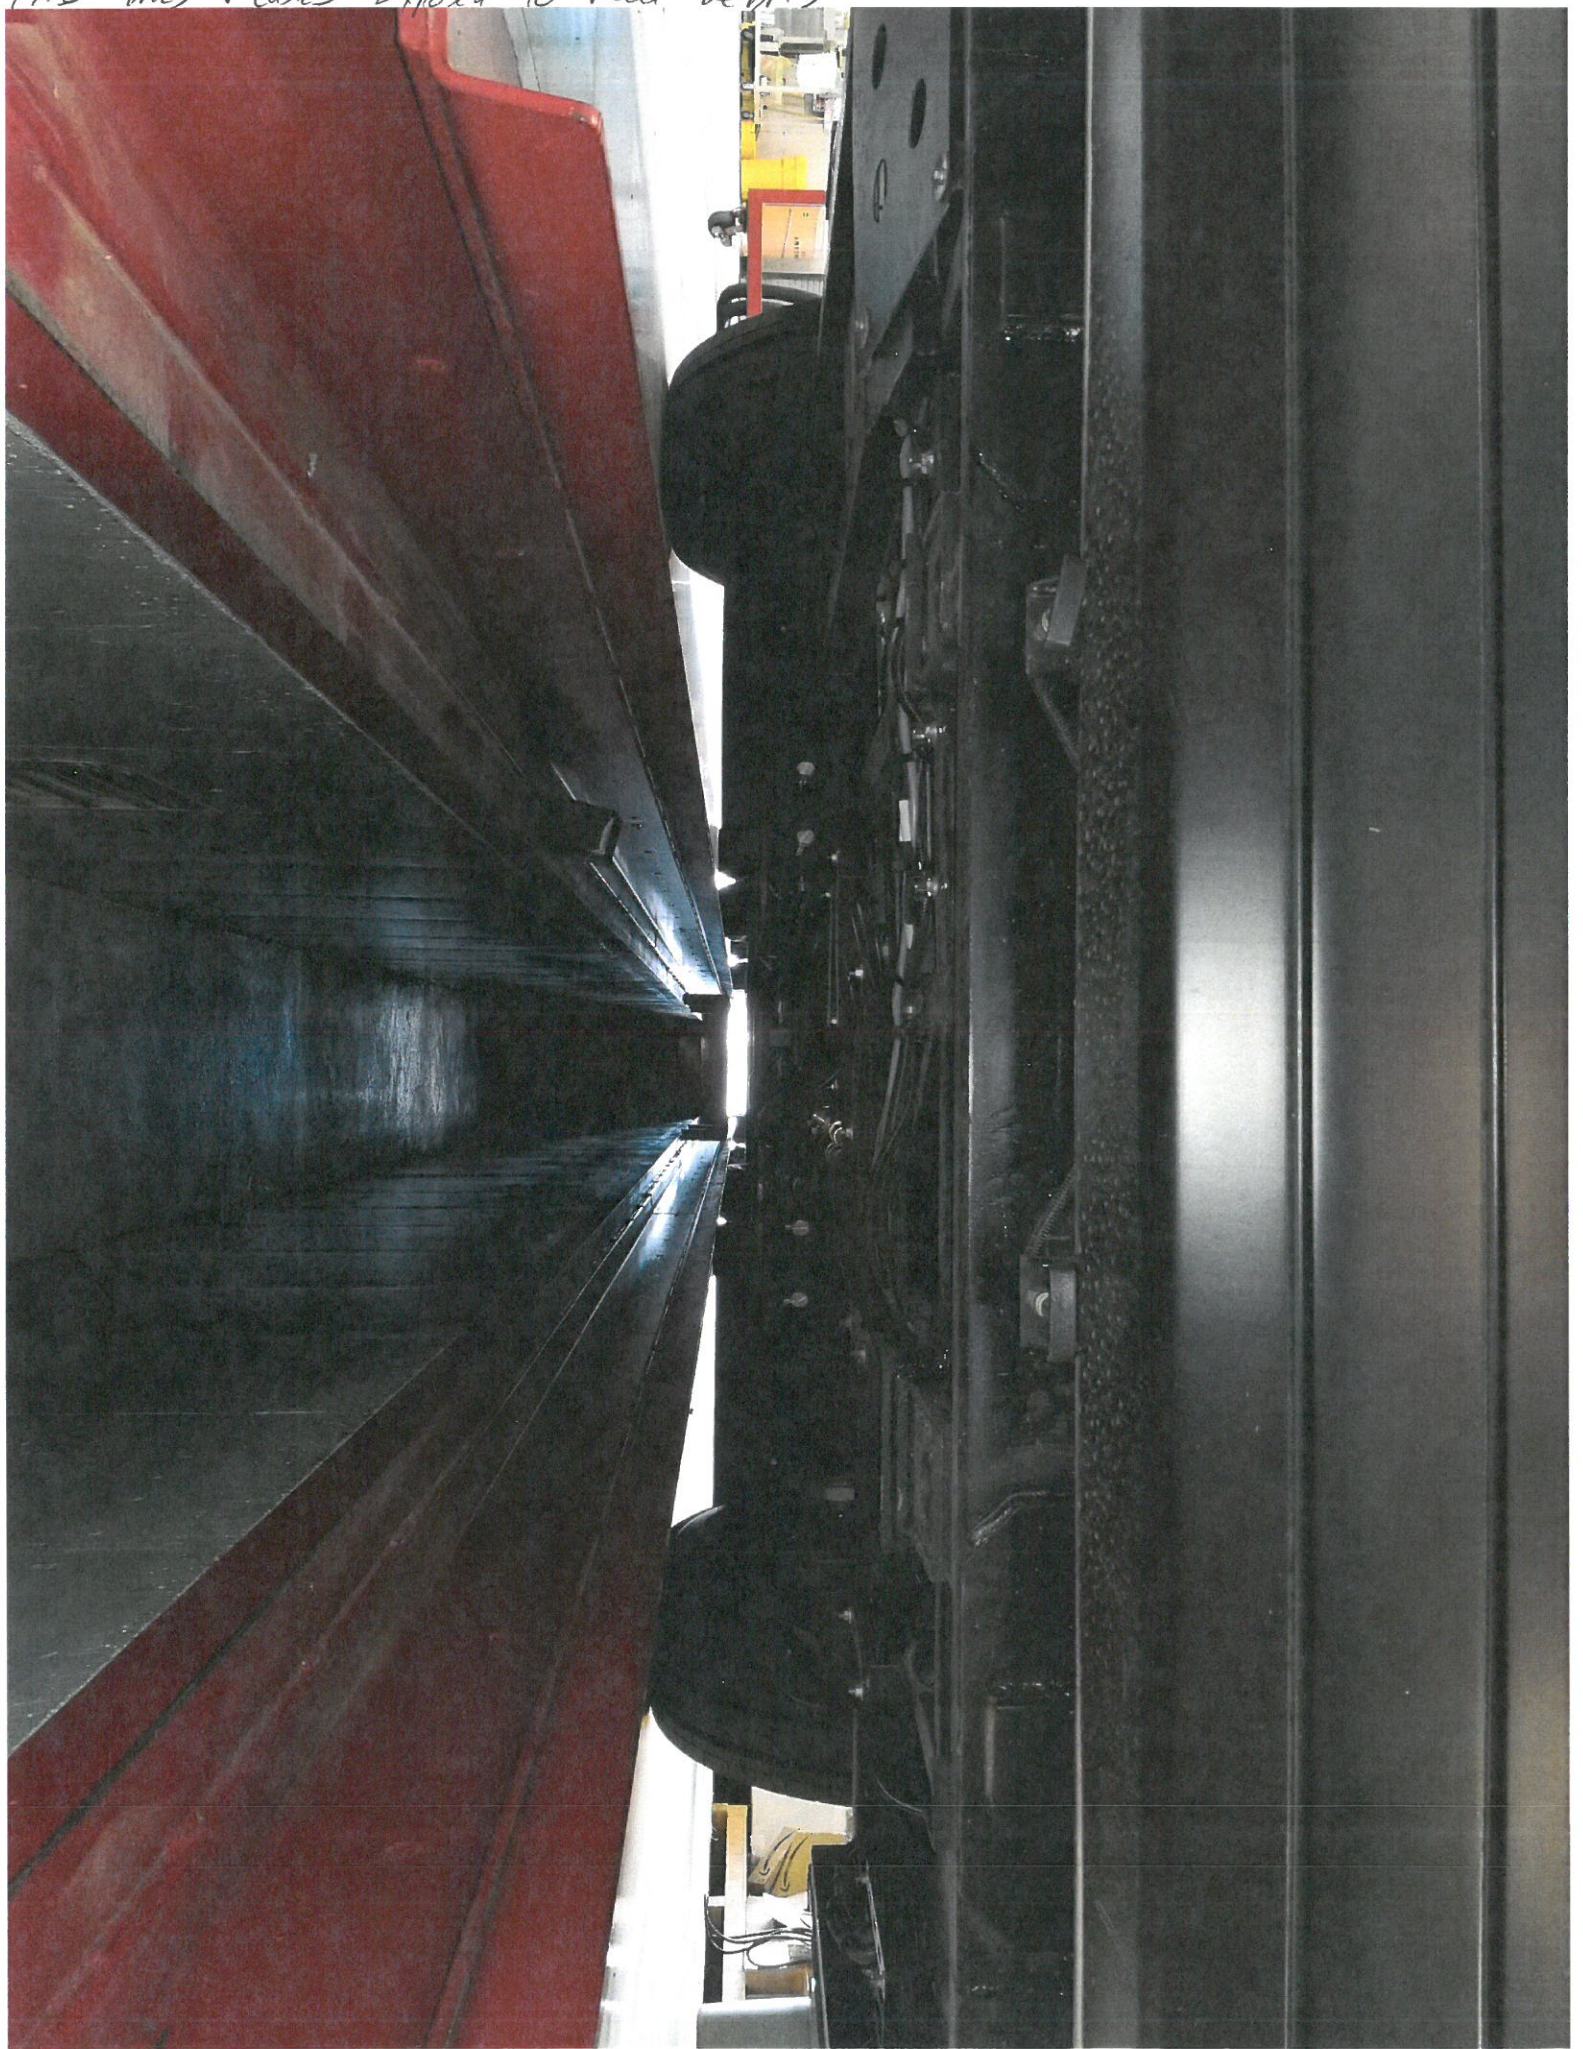
17/L - lines + cables Exposed to Road Debris
