Exhibit H Rail Yards Environmental Status Summary for Subject Site

Summary

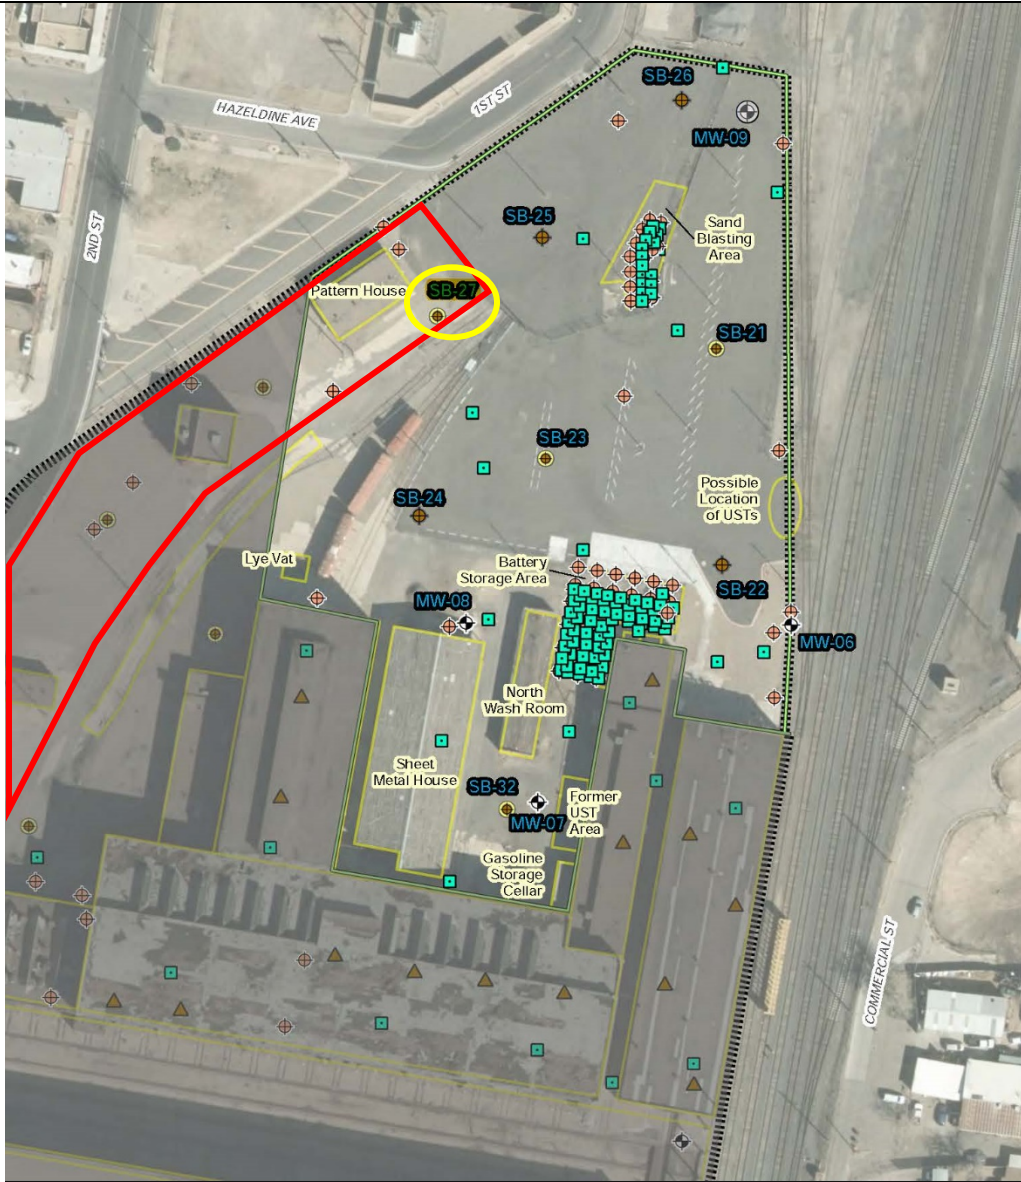
Figure 2 – Soil Gas Sample Location for SB-27

- Potential for soil vapor intrusion was tested in three locations:
 - (1) approximately 30 feet to the southeast of the Pattern House (identified as SB 27 in Figure 2);
 - (2) approximately 36 feet to the northeast of the Fire house (identified as SB 28 in Figure 3), and
 - (3) approximately 70 feet southwest of the Fire House (identified as SB 29 in Figure 3).
- Naphthalene was detected in the soil sample from SB-29 with a concentration of 19.48 $\mu\text{g}/\text{m}^3$, which is above NMED's VISL of 8.26 $\mu\text{g}/\text{m}^3$. The presence of naphthalene indicates that there is a potential for soil vapor intrusion into any of the buildings constructed within the Project Site.

Based on the environmental investigation conducted at the Rail Yards Site, there is a potential for vapor intrusion within the Project Site. Engineering controls to prevent vapor intrusion should be evaluated and selected to eliminate exposure pathways in the existing buildings and in any future developments within the Project Site.
