**CONDITIONS ASSESSMENT  
and  
CONSERVATION TREATMENT RECOMMENDATIONS  
for the  
SHALAKO PROCESSION MURALS  
DE ANZA MOTOR COURT,  
ALBUQUERQUE, NM**

*Submitted:*  
April 24, 2007

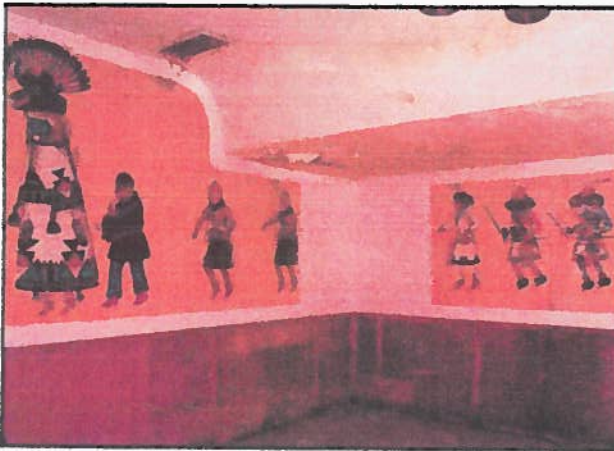
Fig. 1. Drop ceiling for plumbing, electrical and HVAC. Fig. 2. Triangular grate and 2 inch concrete dam.  
Note also vent to exterior in ceiling above north mural (left).

The only significant architectural feature within the room is this mechanical crawlspace, a section of drop ceiling 2' high and 5'6" wide that runs along the east wall to provide passage for plumbing, electrical, and HVAC.

- Long-term upgrade for HVAC. (see Environmental Concerns section below)
- Dismantle the soffit of the crawlspace along the east wall removing all water damaged materials as it may extend into adjacent ceiling materials, remove obsolete plumbing and pipes from the crawlspace, reconstruct the damaged plaster and lath of the crawlspace and adjacent ceiling materials.

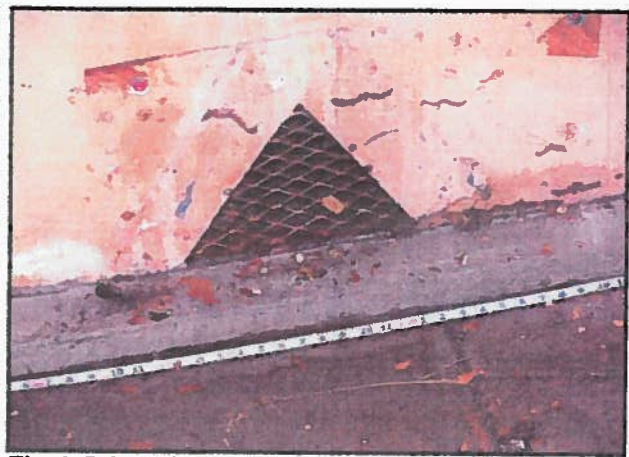
Two vents above grade provide fresh air ventilation for the room. On the north wall there is a triangular penetration through the exterior wall at grade. This is connected by a short duct to a grate in the ceiling above the painting (Sketch A-1 location F-14). This vent at grade must have readily emerged as a problem due to flooding. The building is designed so that all water drains off the roofs of the guest rooms, via *canales*, into the alleyway and then out to either end of the building. On the north it drains out onto flagstone pavement at grade, i.e. at the level of the vent. Either the flagstone was not properly graded or it has settled, so that water running out of the alleyway pooled in front of the vent. Damage to the corresponding interior wall indicates that water actually flowed into the vent -- probably on more than one occasion. At some point a concrete curb was constructed to prevent further flooding through the vent. Roughly 2" high, it runs

along the exterior of the north wall, extending beyond the building to dam roughly 2/3 of the entrance to the alleyway. It then turns at a 90° angle, damming off the flagstone in front of the vent and directing the water from the alleyway out into the parking lot. The duct appears to have been filled to the level of the dam behind the grate, as well.

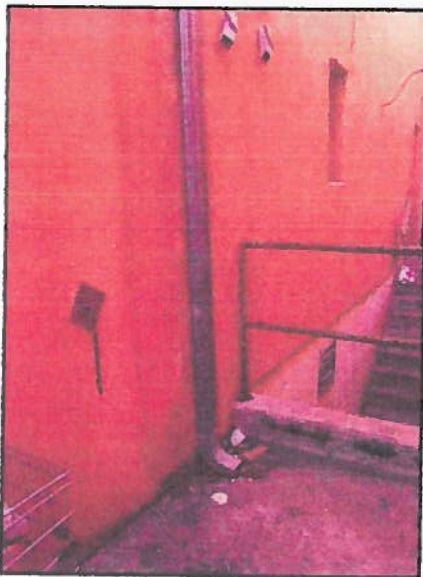
Fig. 4. Gutter spilling into alleyway.

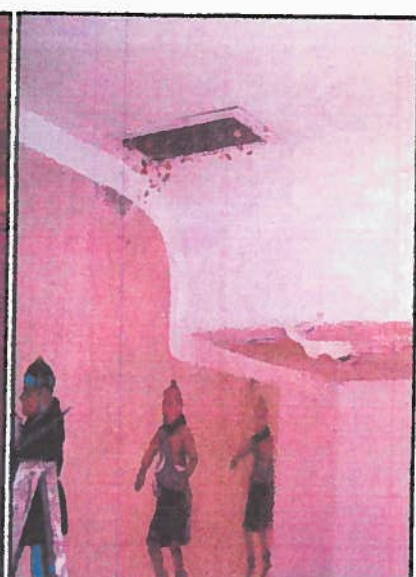
Fig. 6. Debris coming from vent grate.

Neither vent contains a filter and leaves and other debris were found on the inside of the interior grate of the north wall.

Although no water appears to be entering via the ventilation ducts at this point, they obviously remain a significant source of pollution and debris, carried through the unobstructed and unfiltered duct directly into the room.

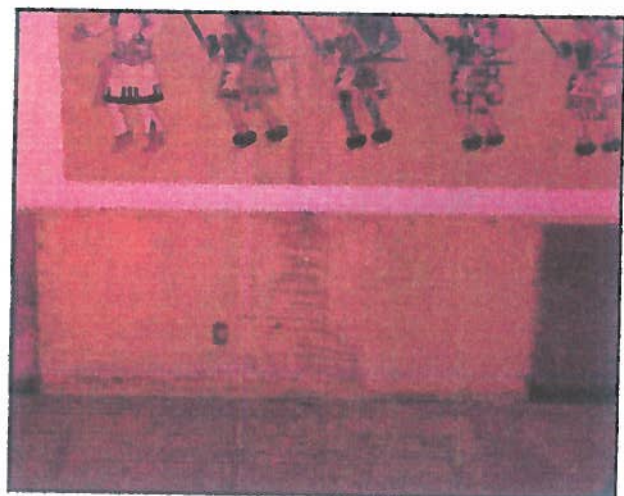
Fig. 7. East wall with section of wainscot removed showing overall yellow wall color and water damage and mold growth at base of wall.

The wooden wainscot is damaged and rotted on both walls and may contain active mold spores. The floor materials in the northeast corner are also loose and cracked.

- Repair/replace water damaged plywood wainscot if deemed by further research to be original/significant to the finishing of the room.
- Clean/repair/replace as necessary original floor tiles in the north east corner of the room damaged by water infiltration (note: concrete sub-floor materials should be inspected and repaired as necessary)

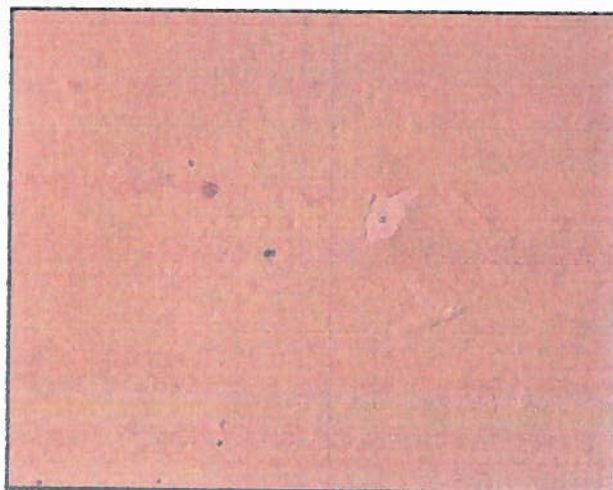
Fig. 12. Loss to plaster patch in yellow ground reveals earlier yellow paint. Note also raised texture of plaster patch.

The only exception to this was cleavage and flaking paint observed in numerous locations on the north wall. Here the paint was lifting from the support in broad, foliate flakes. Losses in these areas consistently exposed a white, plaster-like surface rather than the yellow ground or the concrete of the wall. In fact, it was the observation of the white in these losses that first alerted us to the presence of the fills. Unfortunately, the fill material or its finishing does not appear to have provided good adhesion for the paints as they dried and aged. Examples of this kind of flaking are seen in Figure 3 (North, C5, C6, D6). There are many areas of insecure paint on the north wall at risk of further loss. Consolidation to prevent further loss is urgently recommended prior to the installation of the site protection.

- Stabilization and consolidation of painted surface prior to installation of mural protection. This may also require/incorporate salt mitigation, as salt efflorescence is the primary cause of paint loss.

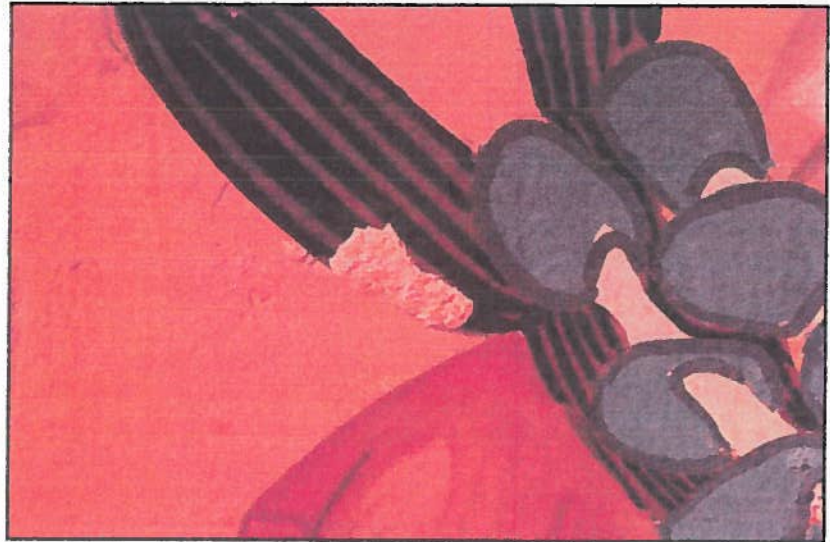
Fig. 13. Cleavage and loss of plaster patch in figure.

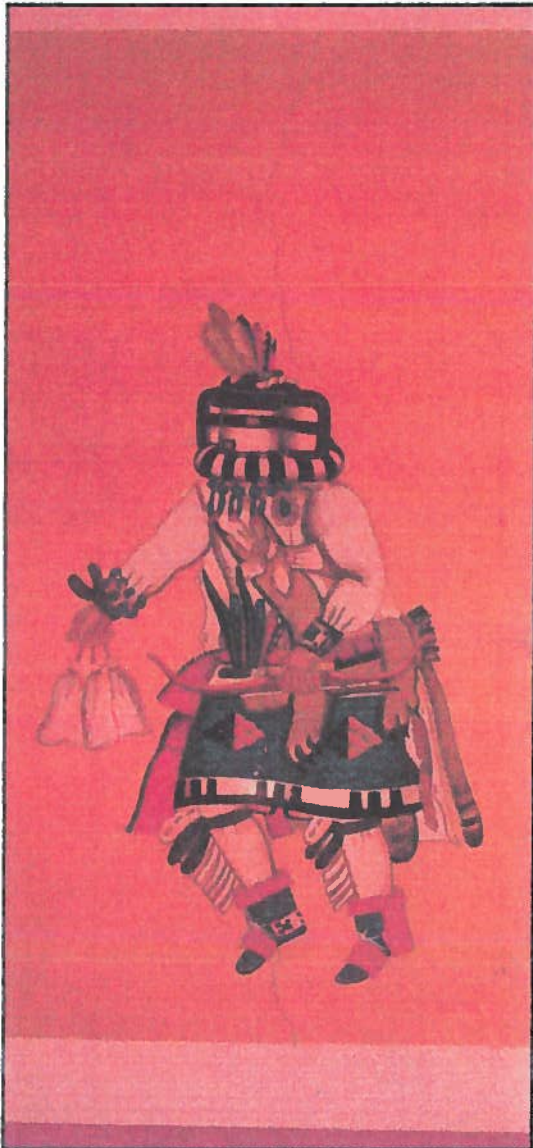
A prominent settling crack extends the entire height of the north wall, passing through the fourth figure from the left (North, A8-9:F8-9). There is some insecure paint and minor losses along the crack. It has been painted over above and below the mural. While it is visually intrusive, the crack does not appear to pose a significant risk to the painting. However, it is advisable to monitor this crack during construction, visually and perhaps with strain gauges (see recommendations).

Fig. 17. *Left*, Overall view of crack extending entire height of north wall and passing through fourth figure from the left of the north wall group.

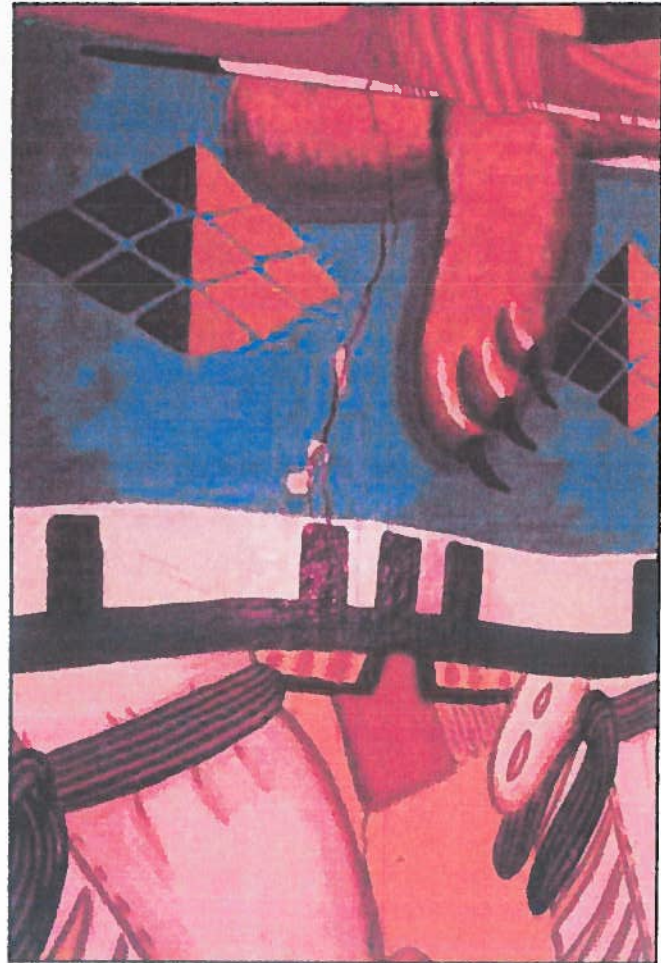
Fig. 18. *Above*, Detail of crack through the skirt of the of the fourth figure. Note also paint losses along the crack.

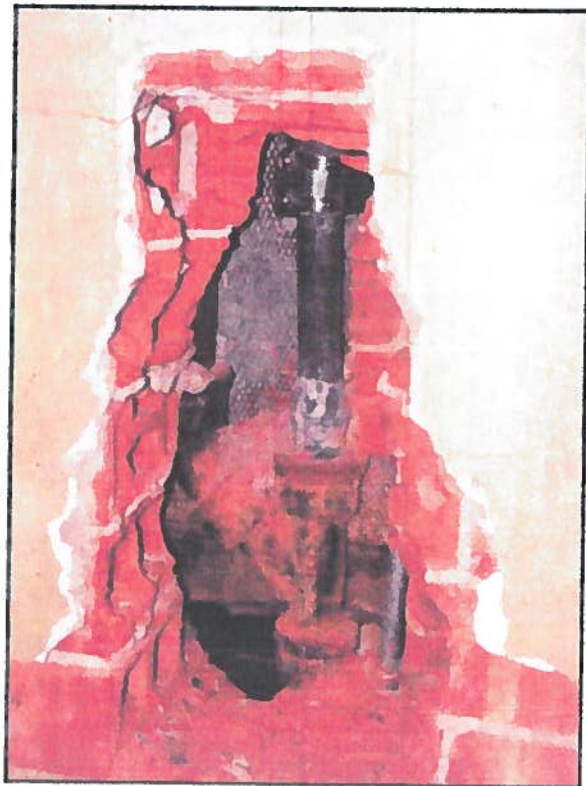
Fig. 20. Opening in exterior wall and bathroom pipes.

- Immediately close and seal exterior opening in the east wall associated with plumbing repair. If the plumbing issues are resolved the wall should be replaced with appropriate masonry and plaster.

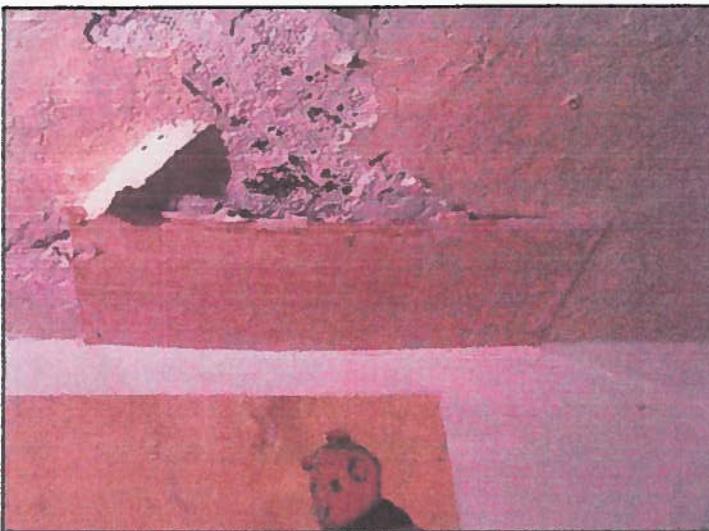
The most severe and significant damage has been sustained where water has penetrated the structure and been allowed to run down the painted surface for a prolonged period(s) of time. This was the result of a broken drainpipe from the bathroom sink of the guestroom above. Through a still-open penetration in the exterior wall two repairs to the pipe were observed, suggesting more than a single event. As can be seen in Fig. 20, this pipe descends below grade outside of the cast concrete floor above the mural room. This meant that water from the leaking pipe drained directly into the mechanical crawl space in the mural room. From there, much of it percolated directly down through the ceiling (the crawl space) and ran down the east wall (East, A3-5:D3-5). Some flowed and pooled at the north end of the crawl space, eventually percolating through the ceiling to run down the surface of the north wall (North, A18:D18). Expanded metal lathe was severely corroded and the plaster badly degraded in the process. A considerable area of lost and detached paint and plaster extends from the north wall along the ceiling of the crawl space. It is not clear whether a large hole at the north end currently covered with a piece of vinyl sheet is the result of mechanical failure and collapse or was opened up to allow the water to drain. These iron oxides may account for much of the staining observed in tide lines and salt formations.

Fig. 21. *Above*, Detail of water damage to east wall.

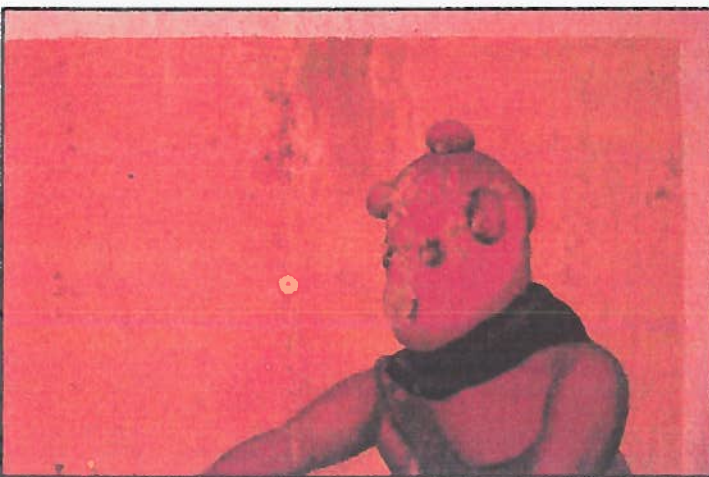
Fig. 23. *Lower Left*, Detail of water damage to Mudhead figure.

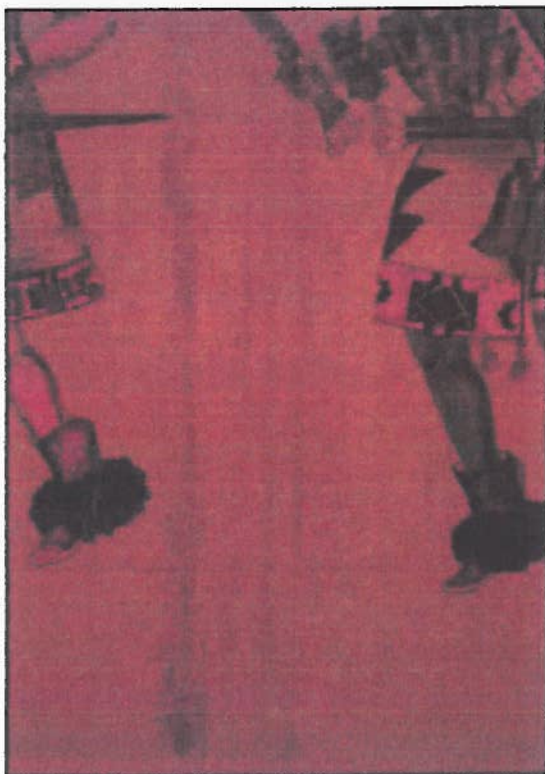
Fig. 24. Detail of staining between figures on east wall .

- Remove/reduce general grime, salt efflorescence, iron oxide and other staining and non-original surface accretions.
- Treat locally as necessary to remove/reduce scuffs, spatters, etc.

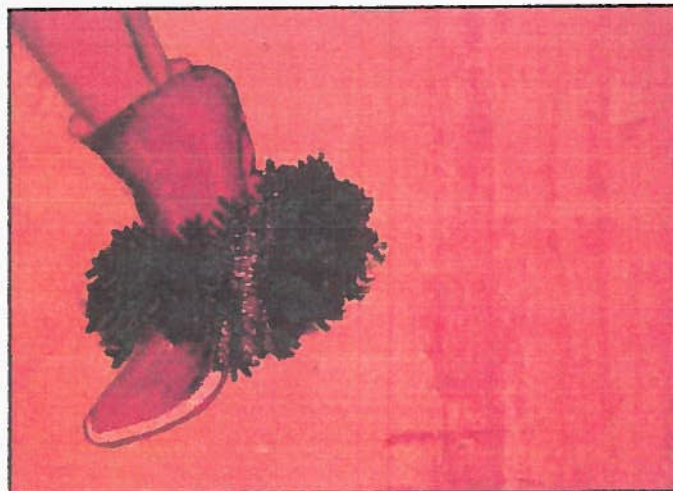
At its worst, where the water flowed over the surface of the painting it has dissolved/eroded the paint and ground to expose the concrete substrate. The last figure on the north wall and the first three figures on the east wall are severely affected by such damage. The surrounding paint is discolored from a variety of causes: leaching of material from the paints, blanching of the paints, salt formation and staining from soluble material in the water, i.e. iron oxide from corroded expanded metal lathe. Water percolating through the wall has evaporated at the painted surface and has deposited white salt efflorescence over a much larger area, concentrated at the tops of the walls (North D18, East D3-5). The crystallization of these salts has disrupted and dislodged the paint, resulting in large areas of extremely fragile, salt-laden paint and considerable extensive loss. This condition is most severe between the second and third figures on the east wall (a 12 square foot area), both of which have sustained extensive loss and remain extremely fragile. However, its effects extend to the corner of the room in one direction, where losses due to damp/salt formation are observed in the ground in front of the leading figure, and to the fourth figure in the other, where distinct salt efflorescence has formed

Fig. 25. Detail of east wall showing paint loss and exposed concrete.

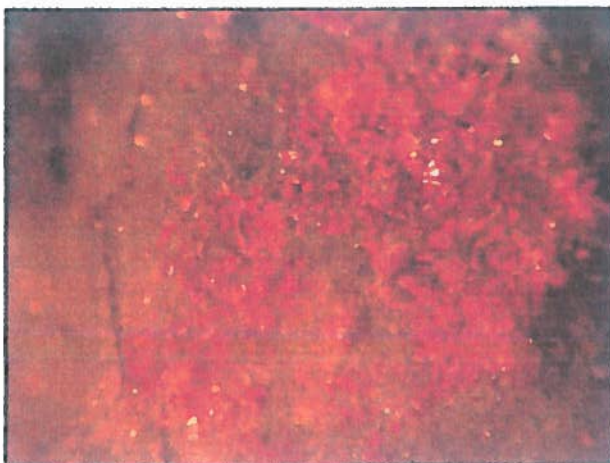
Fig. 26. Iron oxides located on the painted surface of Mudhead figure, north wall.

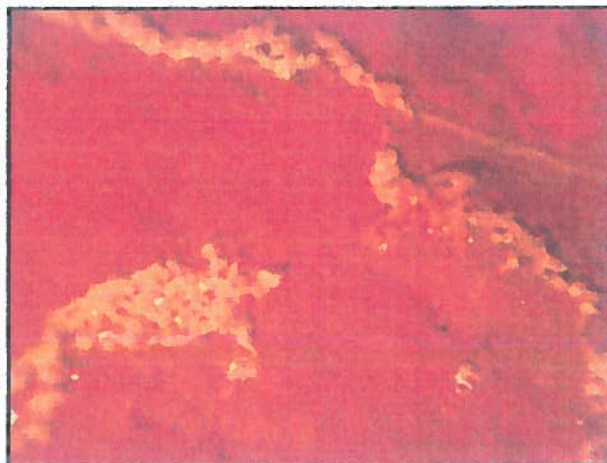
Fig. 27. Salt crystals and blister forming on painted surface of Mudhead figure, north wall.

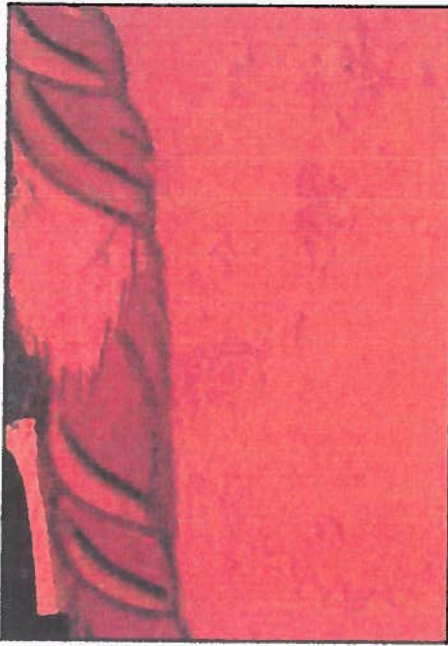
Fig. 28. *Left*, Adhesive residue on third figure from left, north wall.

- Treat locally to remove adhesive residues from tape.
- Fill and inpaint areas of loss as necessary to compensate for damage and loss of paint and

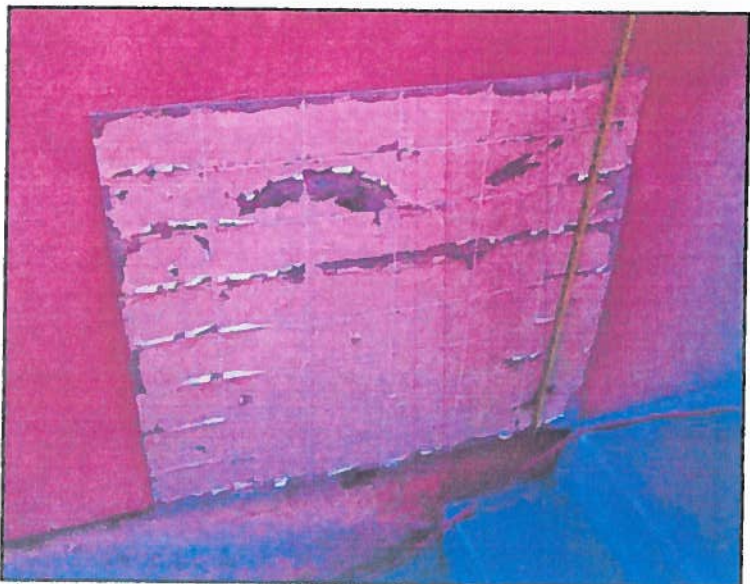
The penetration made for the plumbing repair remains open, covered only with a piece of coated masonite sheet (the type used to line baths and showers) which is loosely screwed to the surface of the exterior plaster wall.

In this state it poses a very serious ongoing risk to the murals, providing an opening for entry of water at a location of known potential for damage.

Fig. 30. Coated masonite sheet covering plumbing repair on exterior plaster wall.
