# Louisiana Boulevard, Albuquerque, NM Pedestrian Road Safety Assessment Report

July 8-9, 2020

The purpose of this study was to complete a road safety assessment (RSA), focusing on pedestrian safety, for Louisiana Boulevard from Gibson Boulevard SE to Lomas Boulevard NE (hereafter "study area"). The Federal Highway Administration (FHWA) supported the RSA through the Safe Transportation for Every Pedestrian (STEP) program. STEP is an innovation of the Every Day Counts (Rounds 4 and 5) initiative. Louisiana Blvd was selected per the request of the City of Albuquerque and in consultation with the FHWA New Mexico Division. The City of Albuquerque is home to approximately 560,000 people, and the City is responsible for operation and maintenance of the arterial corridor's roadways.

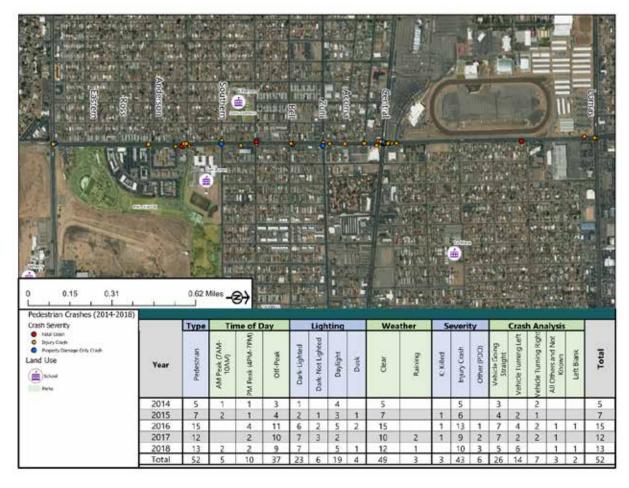
Figure 2 - Reported Pedestrian Crashes, 2014-2018

The majority of the reported pedestrian crashes occurred near signalized intersections with marked crosswalks and pedestrian signal heads. Crash clusters (locations with three or more crashes) occurred in Segments 2, 3, 4, and 5, which are all areas with pedestrian-oriented land uses, transit access, and higher density multifamily housing (relative to the rest of the corridor). Most crashes occurred outside of peak traffic hours, during dry and clear roadway conditions, and in dark or lowlight conditions (63% dark/lighted/unlighted vs 37% daytime). However, while most of the non-daylight crashes were reported as Lighted Roadway, the nighttime field review revealed low to non-existent pedestrian-focused lighting throughout the corridor. Non-fatal injury crashes were the most common at 82%, with 12% as Property Damage Only (PDO) crashes, and 6% Fatal. The reported Crash Analysis indicated *Vehicle Going Straight* as the most frequent vehicle movement during the crash (50%), followed by Left Turns (27%), and Right Turns (13%). This indicates issues with pedestrians finding sufficient gaps and opportunities to cross the roadway as well as visibility at intersections with turning vehicles.

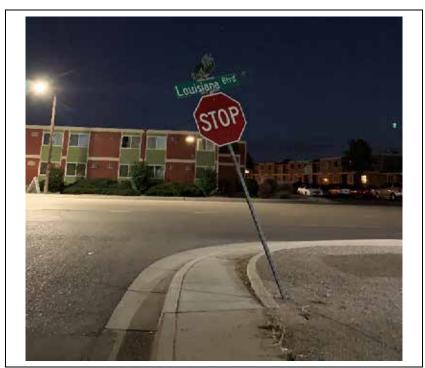
- o There is an unmarked crossing location at Eastern Ave SE and an ABQ transit stop with reported higher ridership at Veterans Park.
- Eastern Ave SE and Ross Ave SE were both identified as midblock crossing locations in the 2018 International District Pedestrian Safety Action Plan (IDPSAP).

- Frequent driveway cuts are not ADA compliant nor level.

Above Image: A photo, looking east from Ross Ave SE, showing an uncontrolled crossing location during the nighttime field review. Credit – City of Albuquerque.

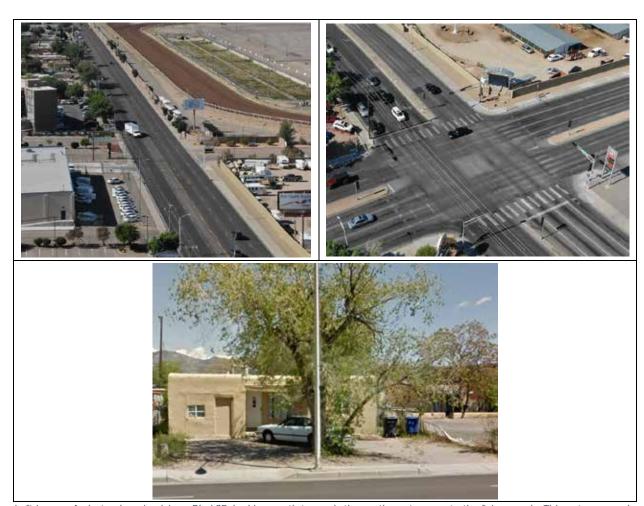
- Signalization
  - The signalized intersection is an 8-phase intersection with protected permitted lefts all around, three of the four crosswalk legs are marked with continental patterns, and pedestrian signal heads have countdown timers. There is no LPI nor turning vehicle restrictions.
- Land Use
  - o Pedestrian levels are lower in this area.

Left Image: A photo along Louisiana Blvd SE, looking south towards the northmost access to the fairgrounds. This entrance and exit was also reported as a location with turning vehicle conflicts. Credit – City of Albuquerque.

Right Image: A photo of the Lomas Blvd NE intersection, looking southwest, showing the signalized intersection and existing marked crosswalks. Credit – City of Albuquerque.
