Investigation of Potential Landfills in the Menaul Area

Presented to: City of Albuquerque Environmental Health Department

> July 2010 File No. 07209112.01

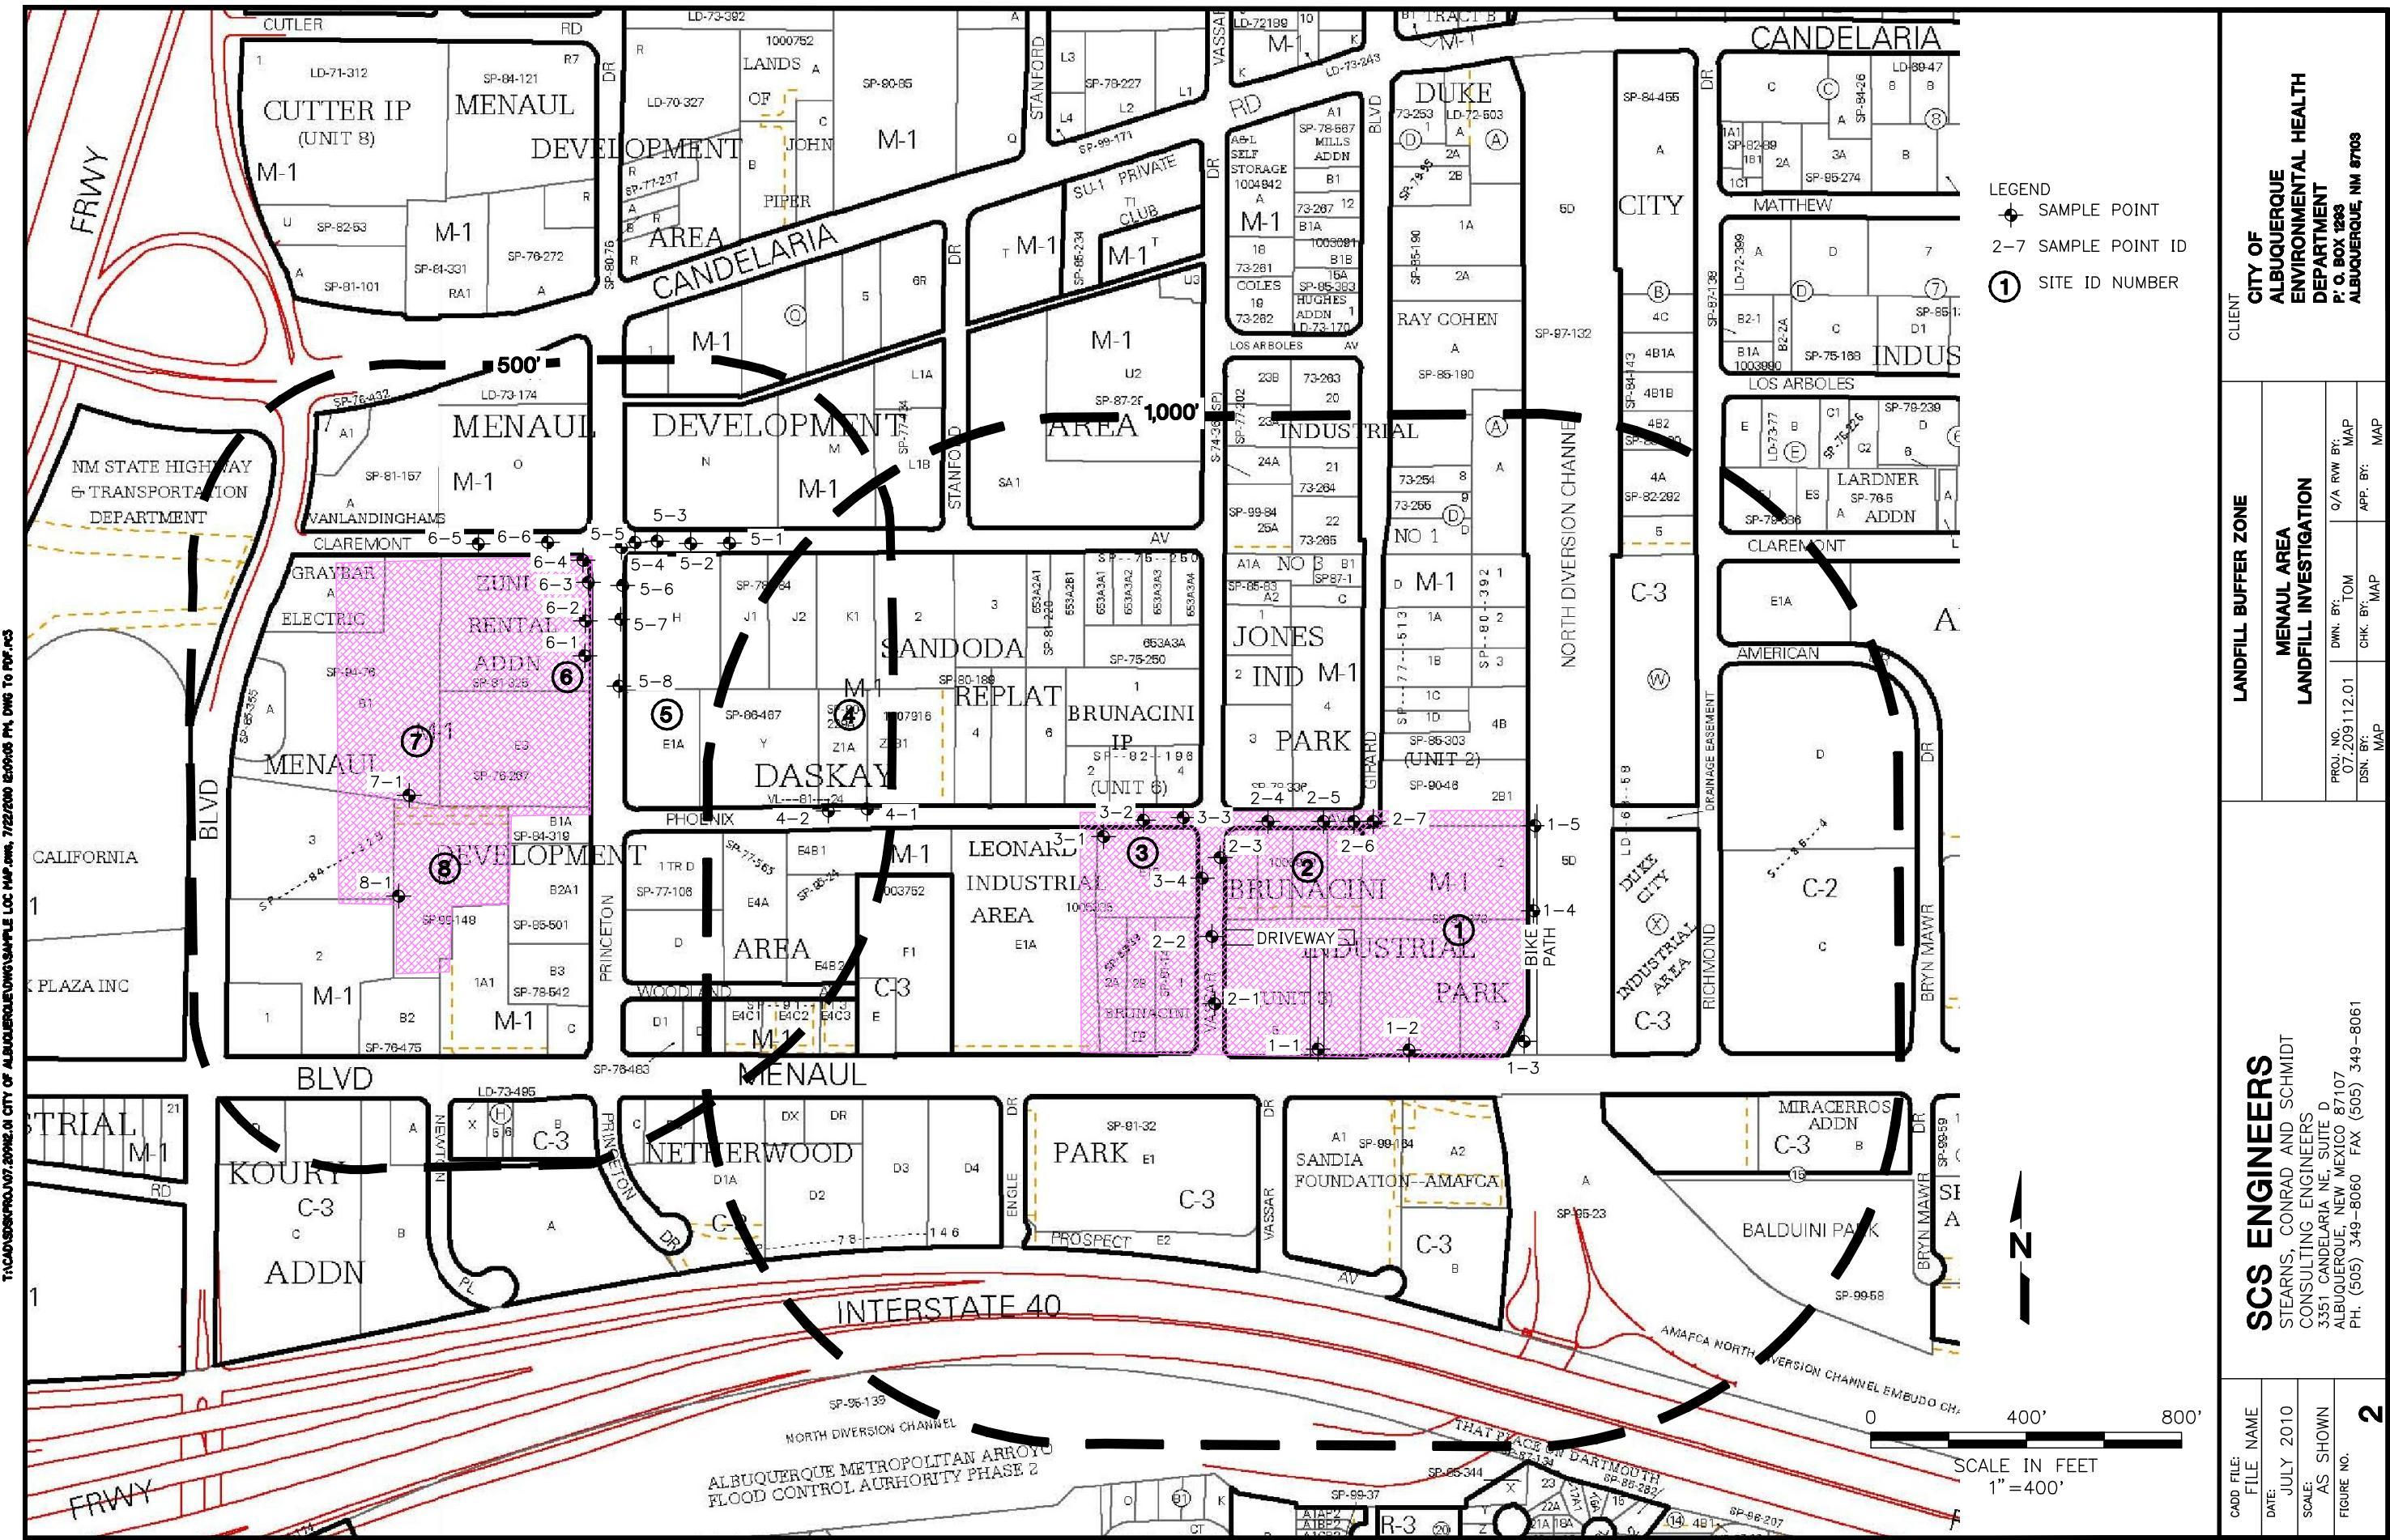
SCS performed limited fieldwork within the street right-of-way at all of the eight locations identified on Figure 1 and Table 1 Visual inspections of the properties was performed to identify any obvious areas of subsidence, distressed vegetation, or visible landfill debris. The fieldwork included monitoring any obvious subsurface cracks, water meter manholes, storm drain inlets, and holes in the ground within the street right-of-ways utilizing a GEM-2000 landfill gas meter and an Industrial Scientific M40 four gas meter. Both instruments were calibrated prior to each day's monitoring activities. The GEM was calibrated to 2.5 parts per million (ppm) methane. The four gas meter was calibrated to 25 ppm hydrogen sulfide, 100 ppm carbon monoxide, 25% LEL pentane, and 19.8% oxygen.

The sampling was performed in the afternoon to allow readings to be taken when atmospheric pressure was at a low. Tubing from the meters was inserted in cracks (greater than ½ inch deep), water meter manholes, storm drain inlets, and holes in the ground. The GEM was operated for approximately five minutes at each sample location and the readings were recorded in the field on a log sheet. None of the areas investigated contained methane gas or hydrogen sulfide gas. Results of the limited fieldwork are presented in Table 3. Two of the eight locations, Map IDs 5 and 6 showed potential evidence of subsidence. A small amount of apparent construction debris was noted at Map ID 1.

Based on the results of the investigation, SCS recommends the areas around Map ID 1, 2, and 3 contain a 1000 foot buffer as required by the City's Interim Guidelines due to the significant landfill gas detected by others as described in this report.

Based on the results of this investigation, Map IDs 5, 6, 7 and possibly Map ID 8 contain landfill materials but no known landfill gas at this time, SCS recommends that at least a 500 foot buffer be considered at this location.

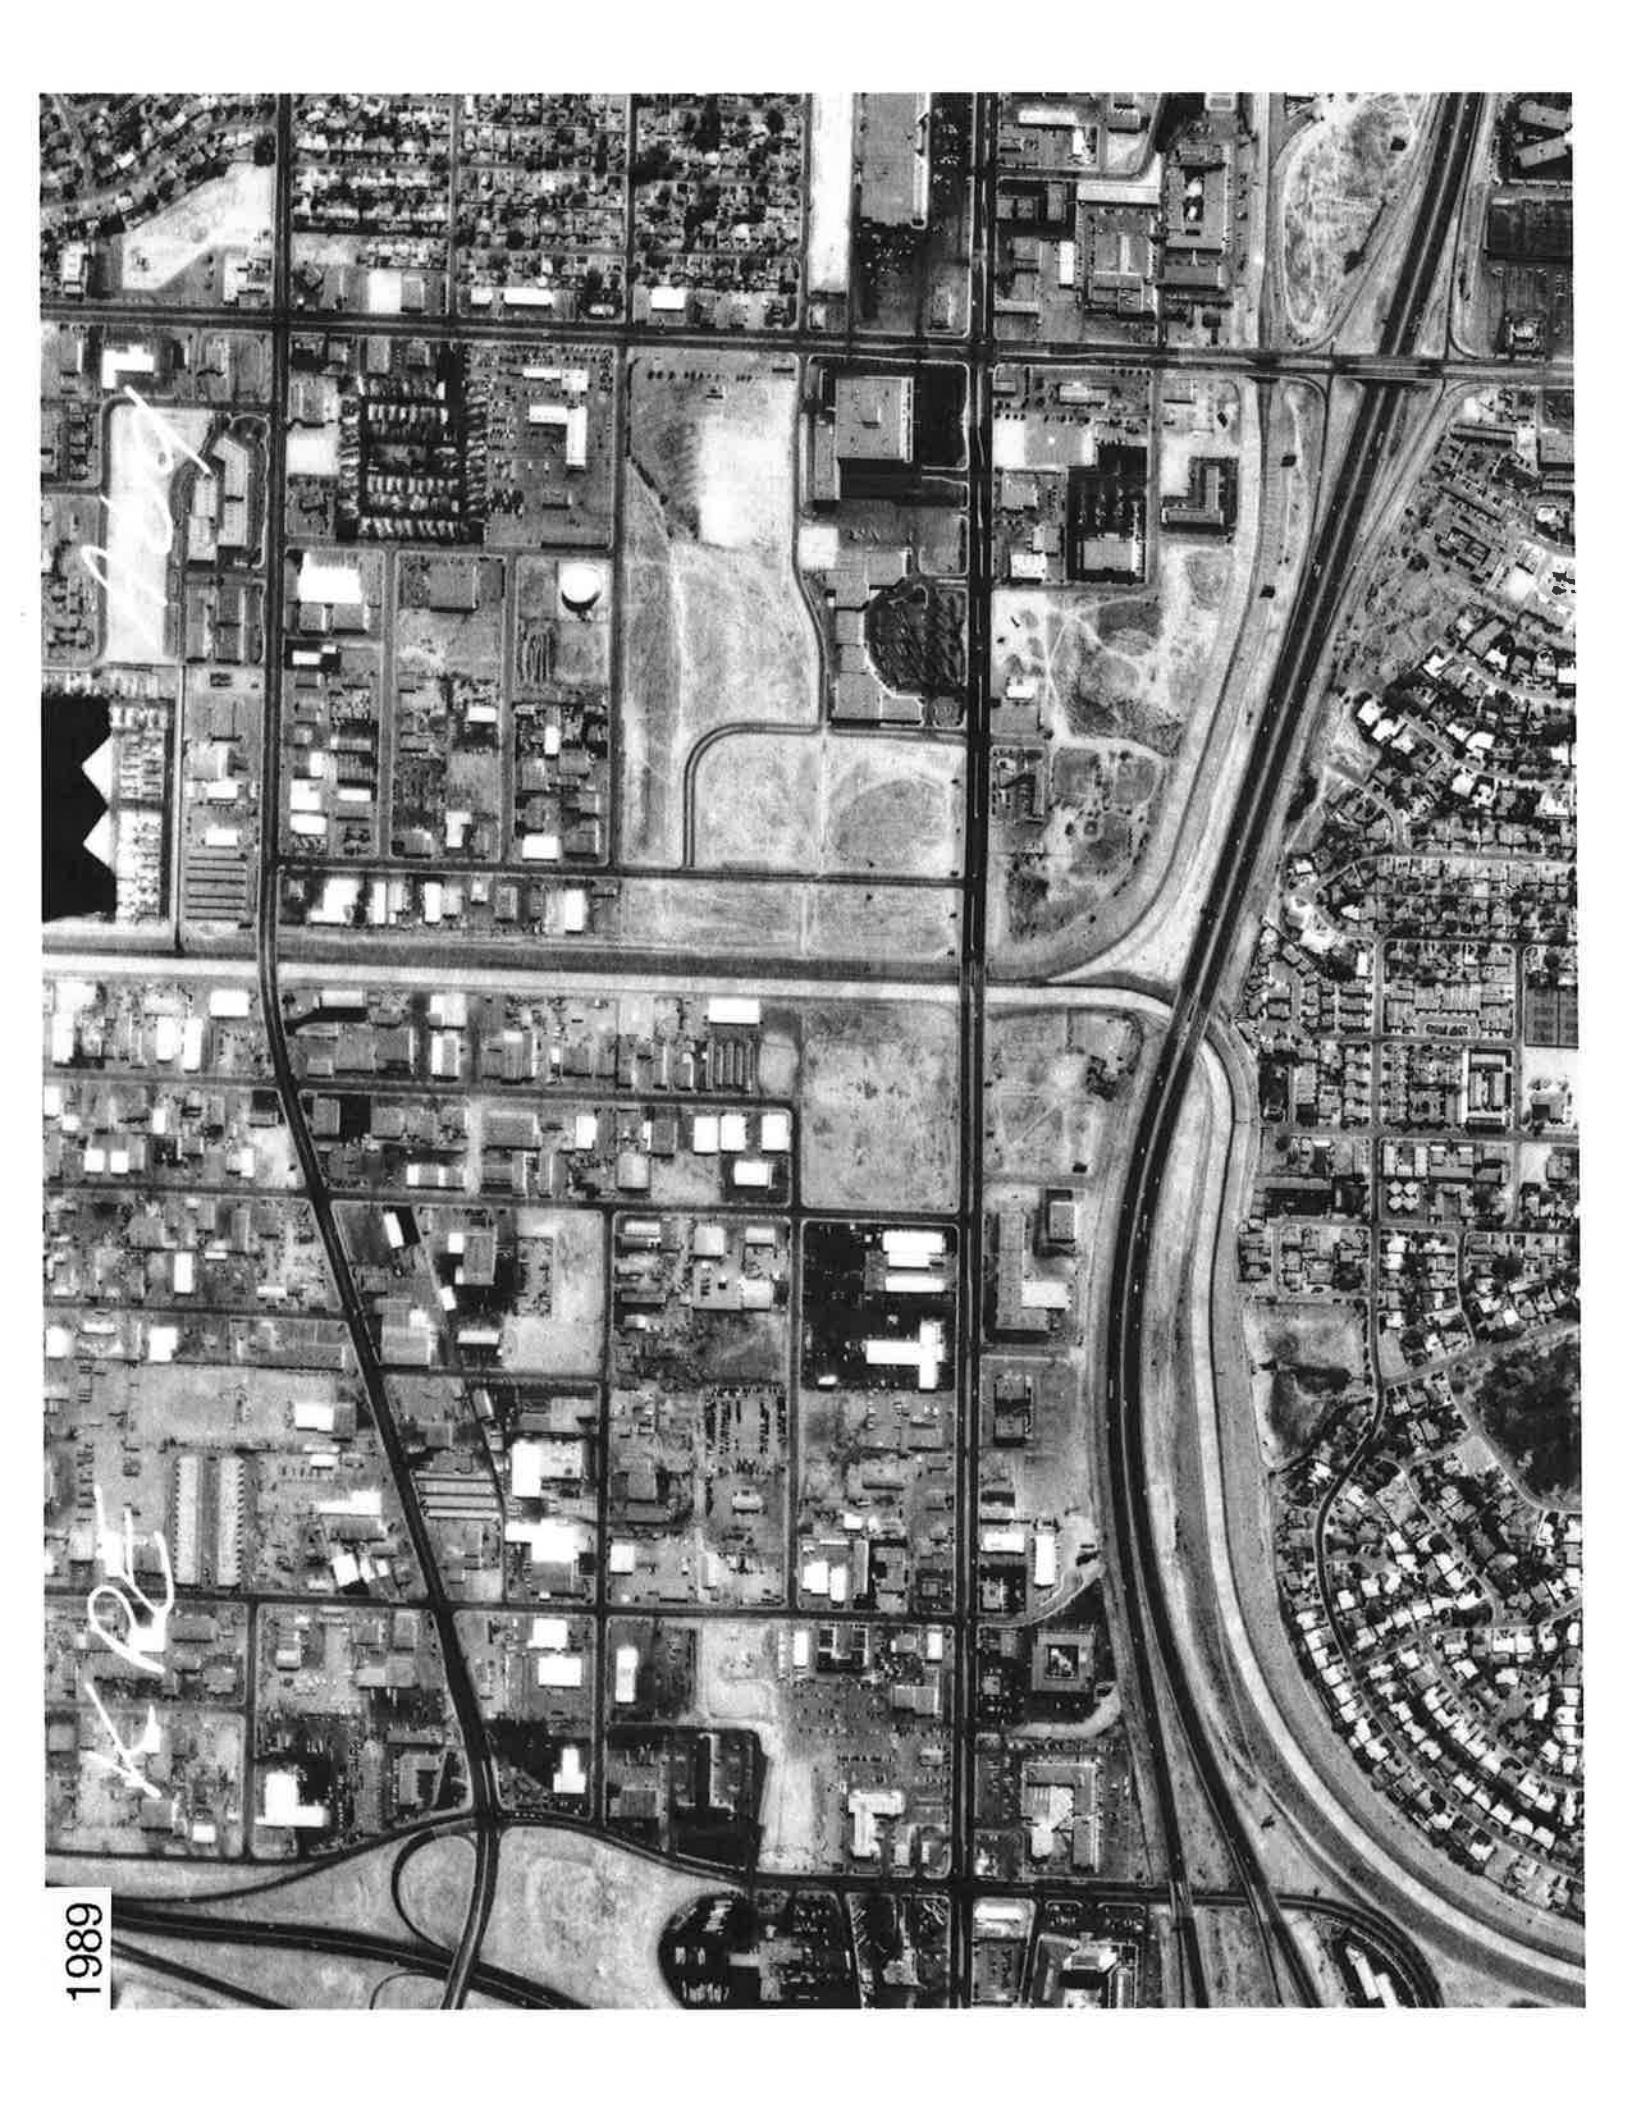
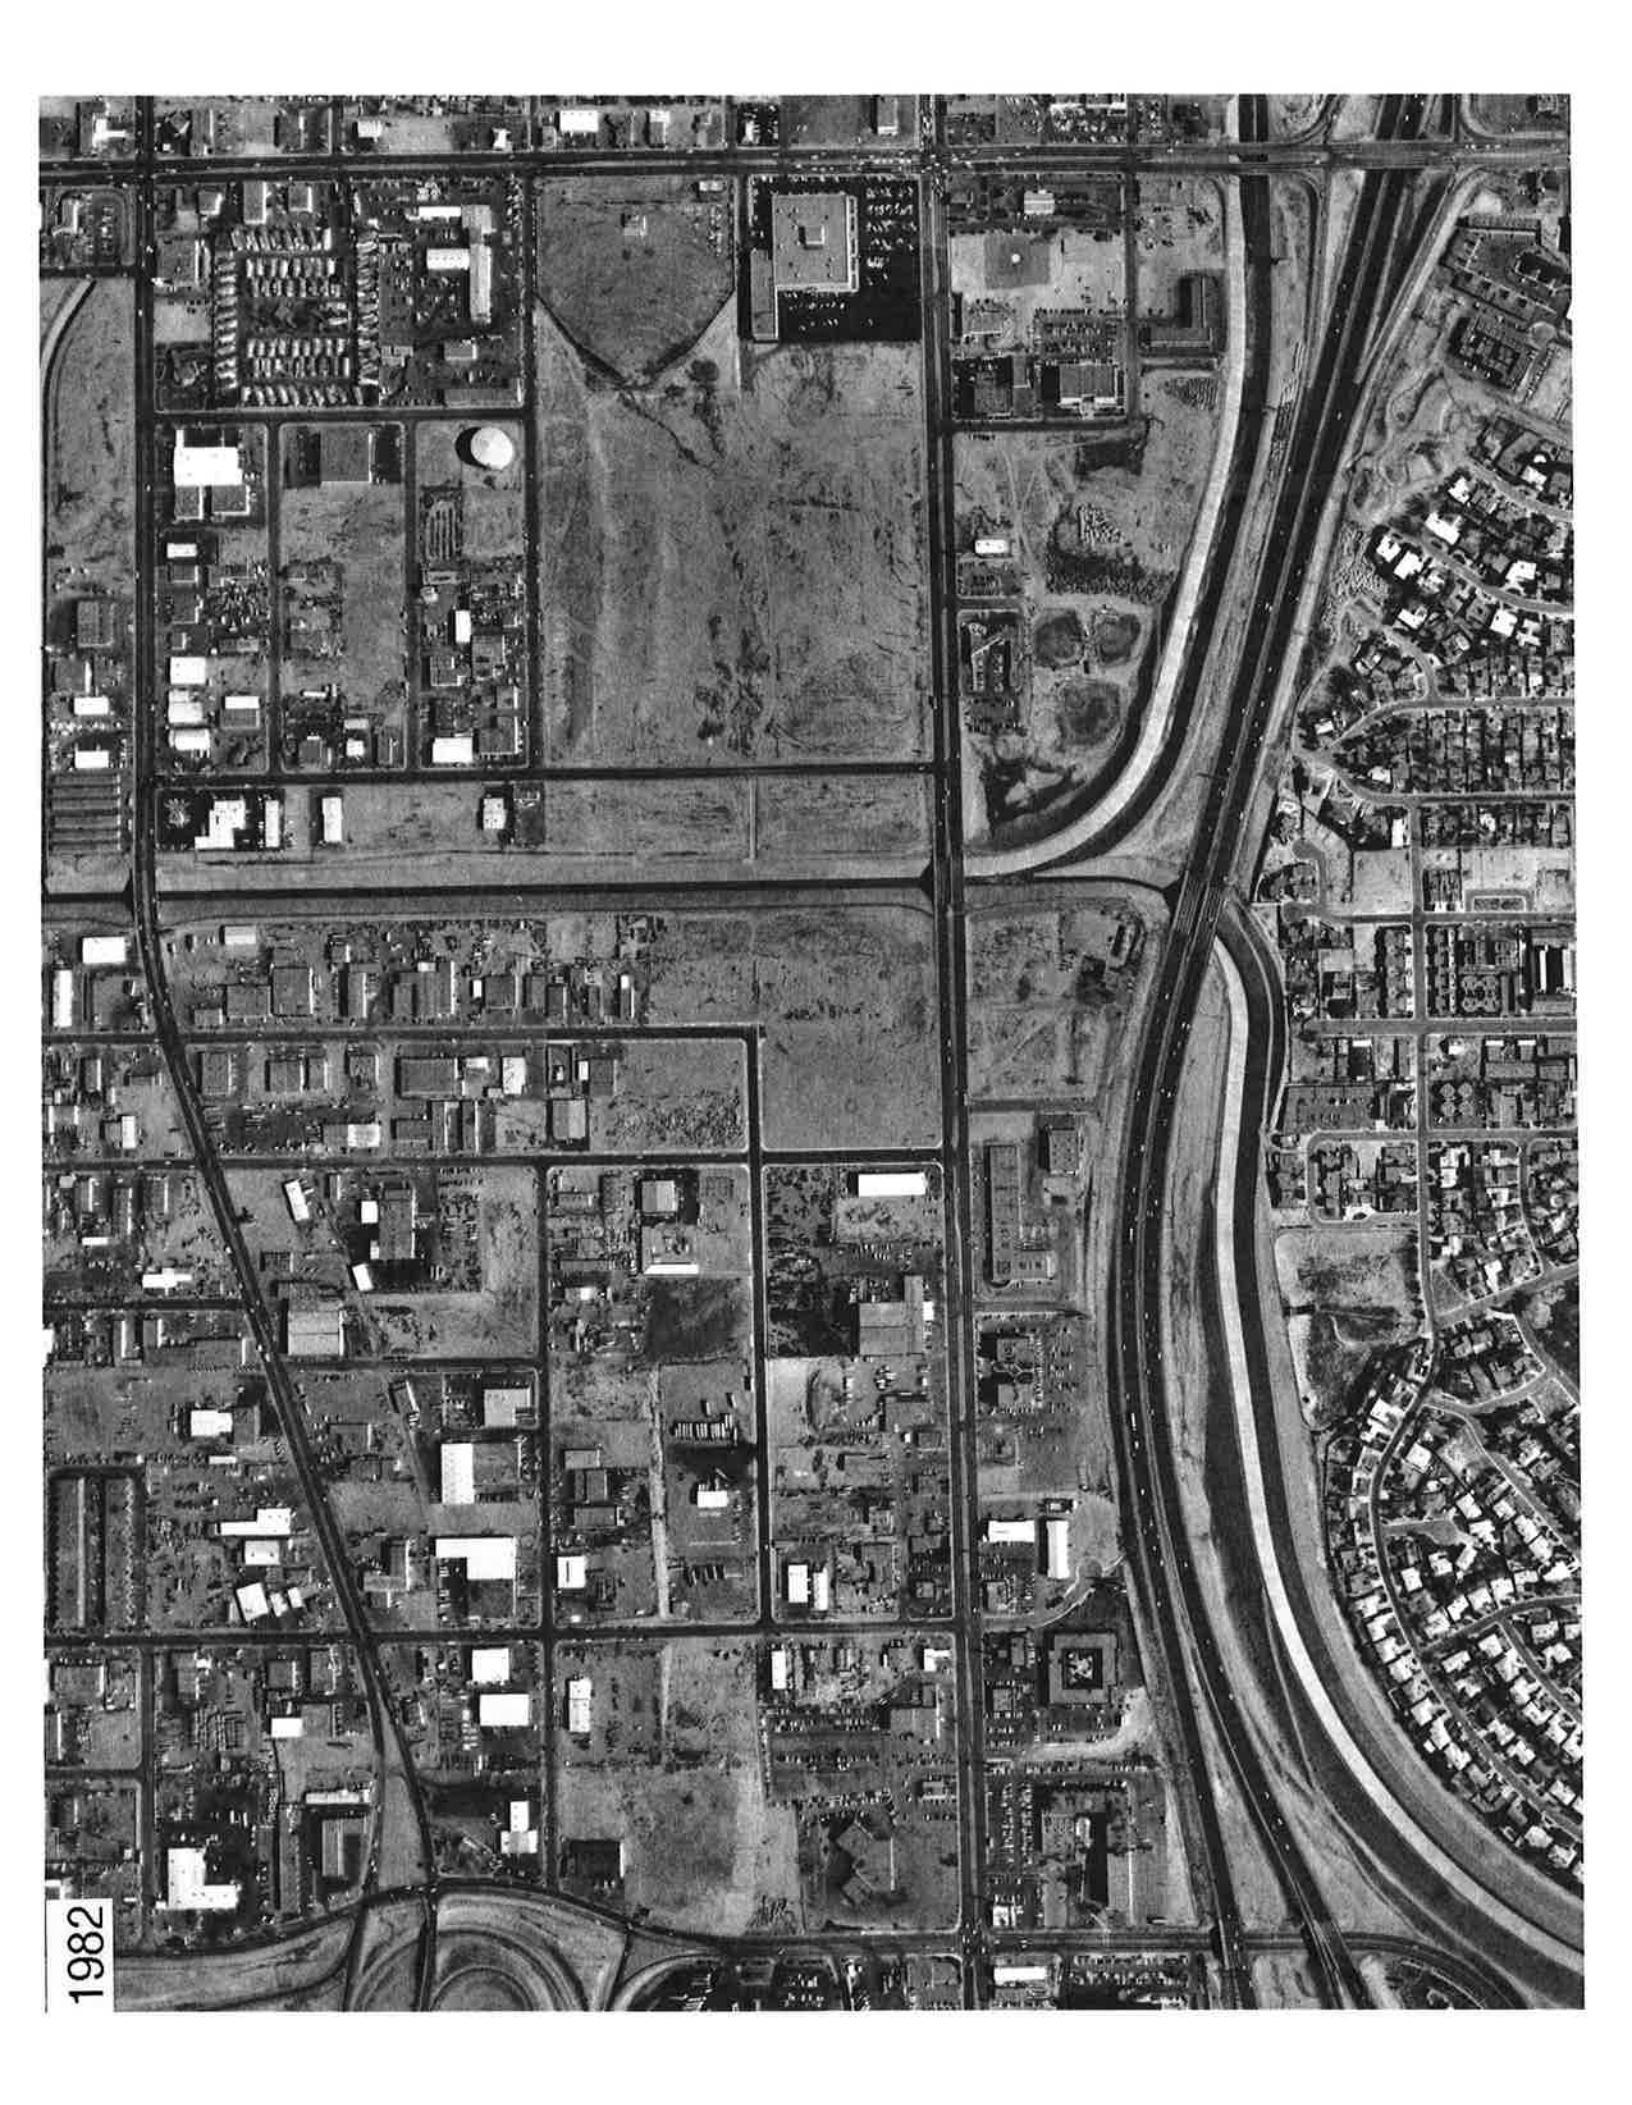
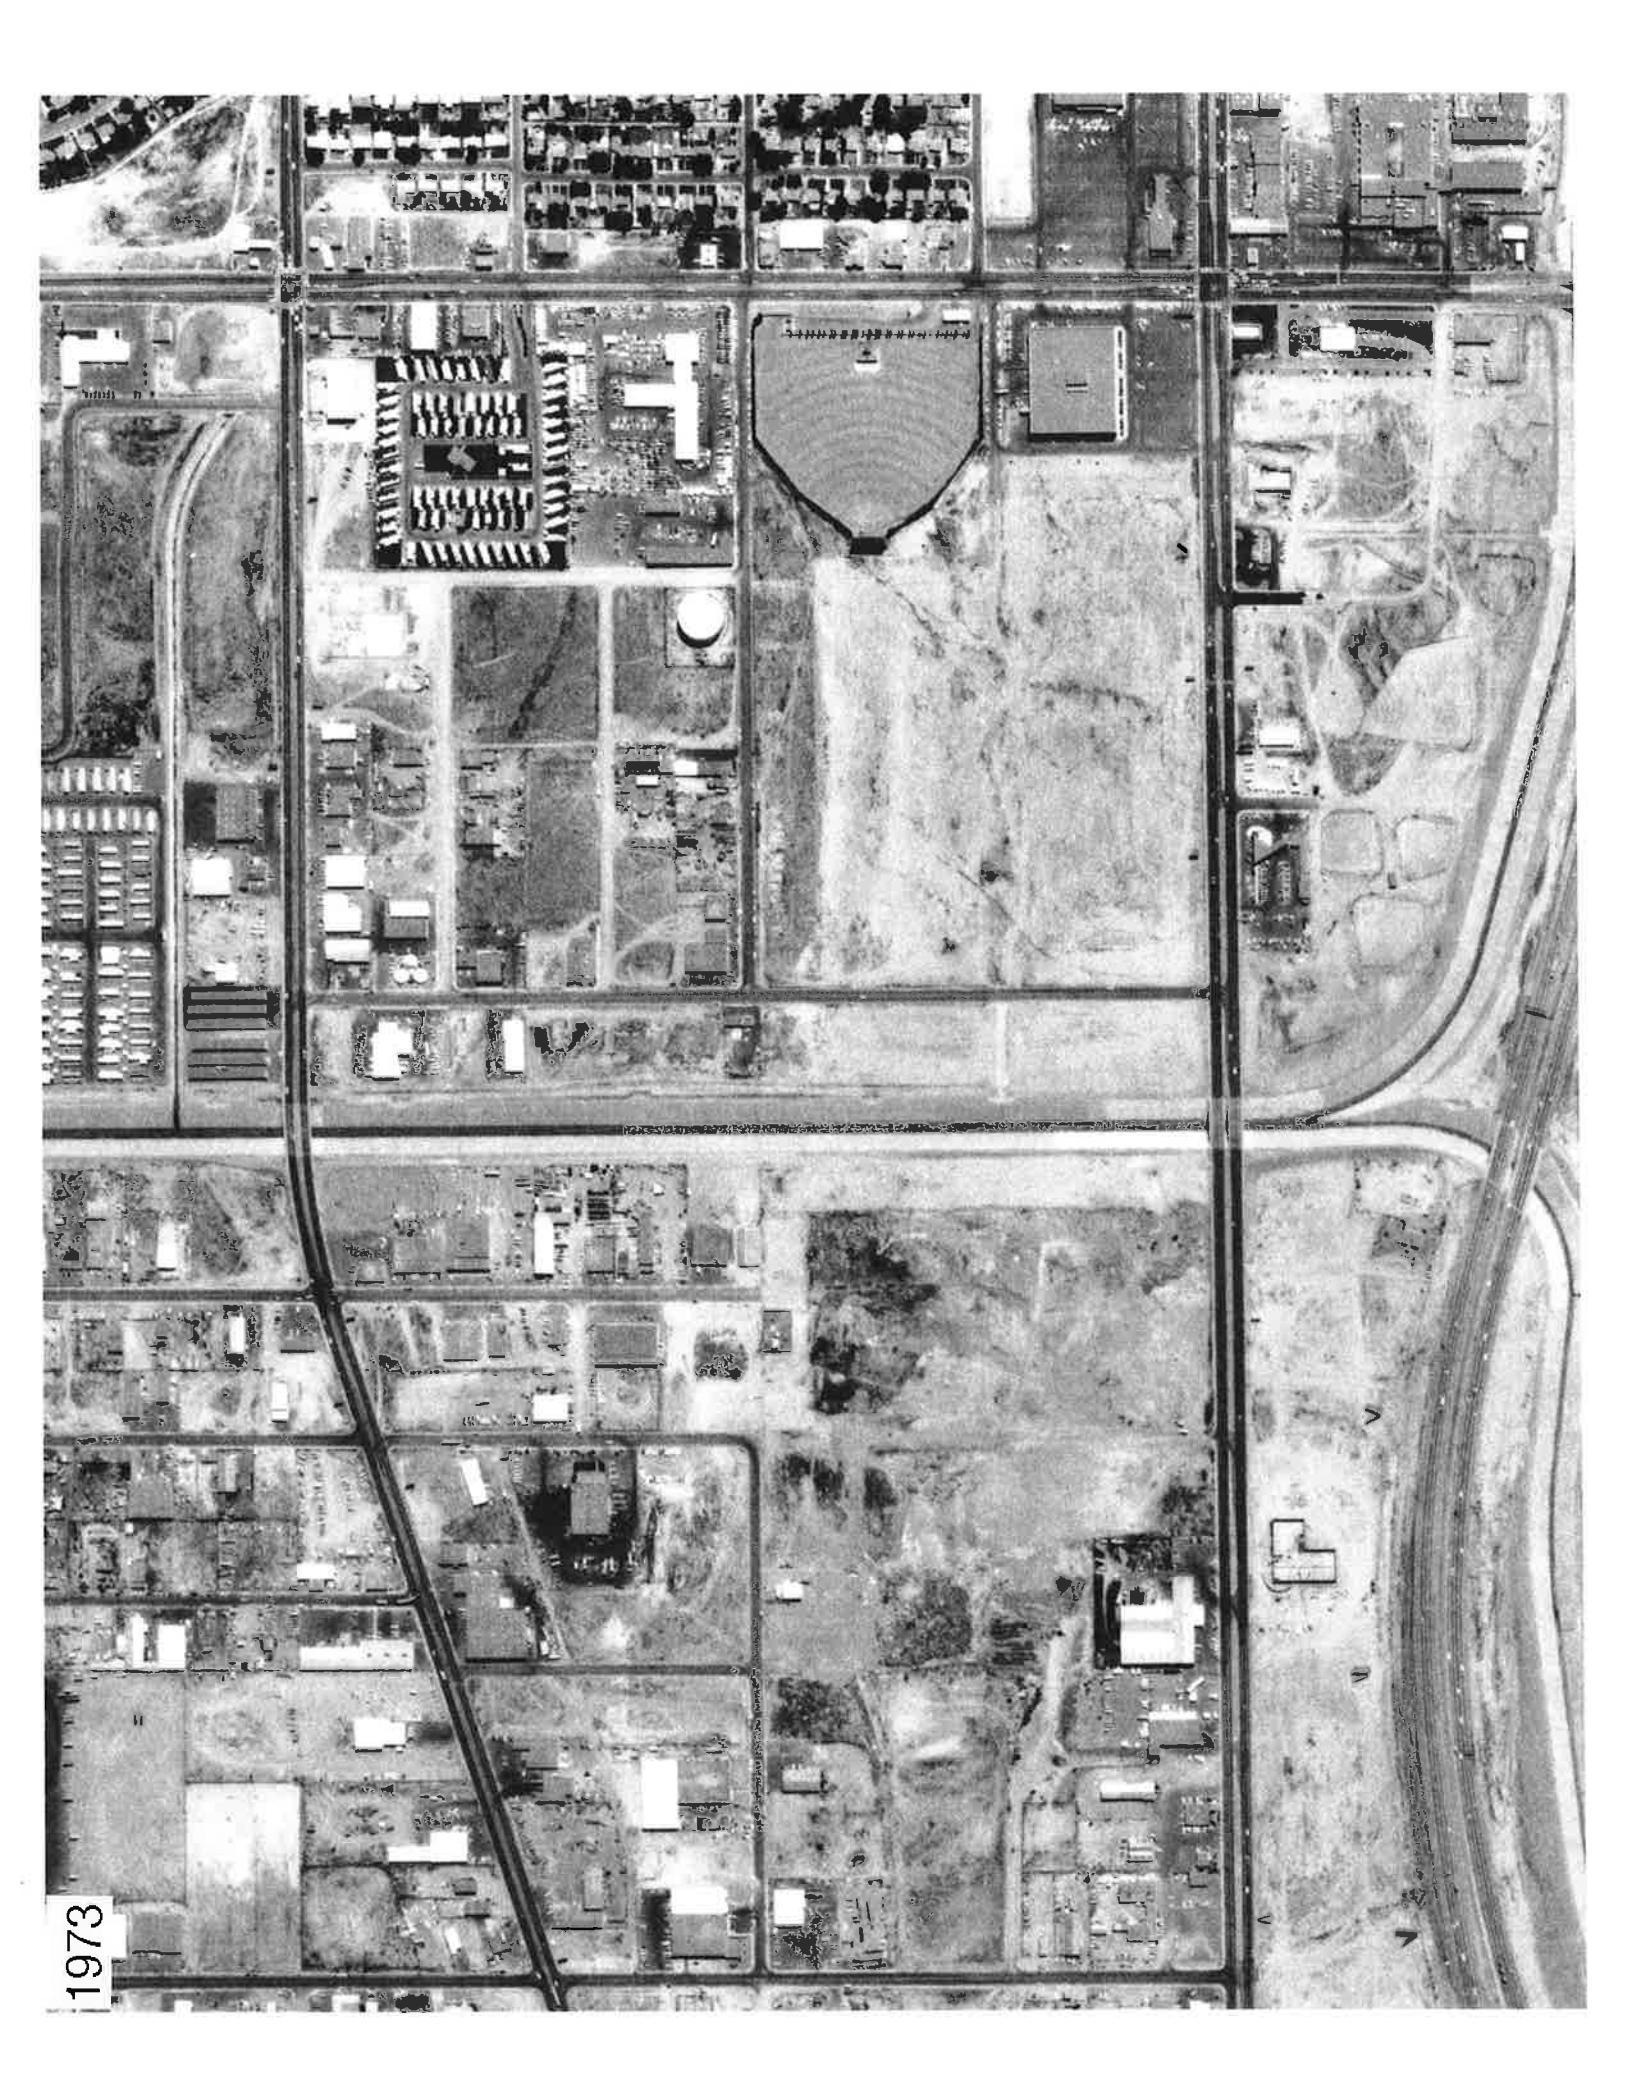
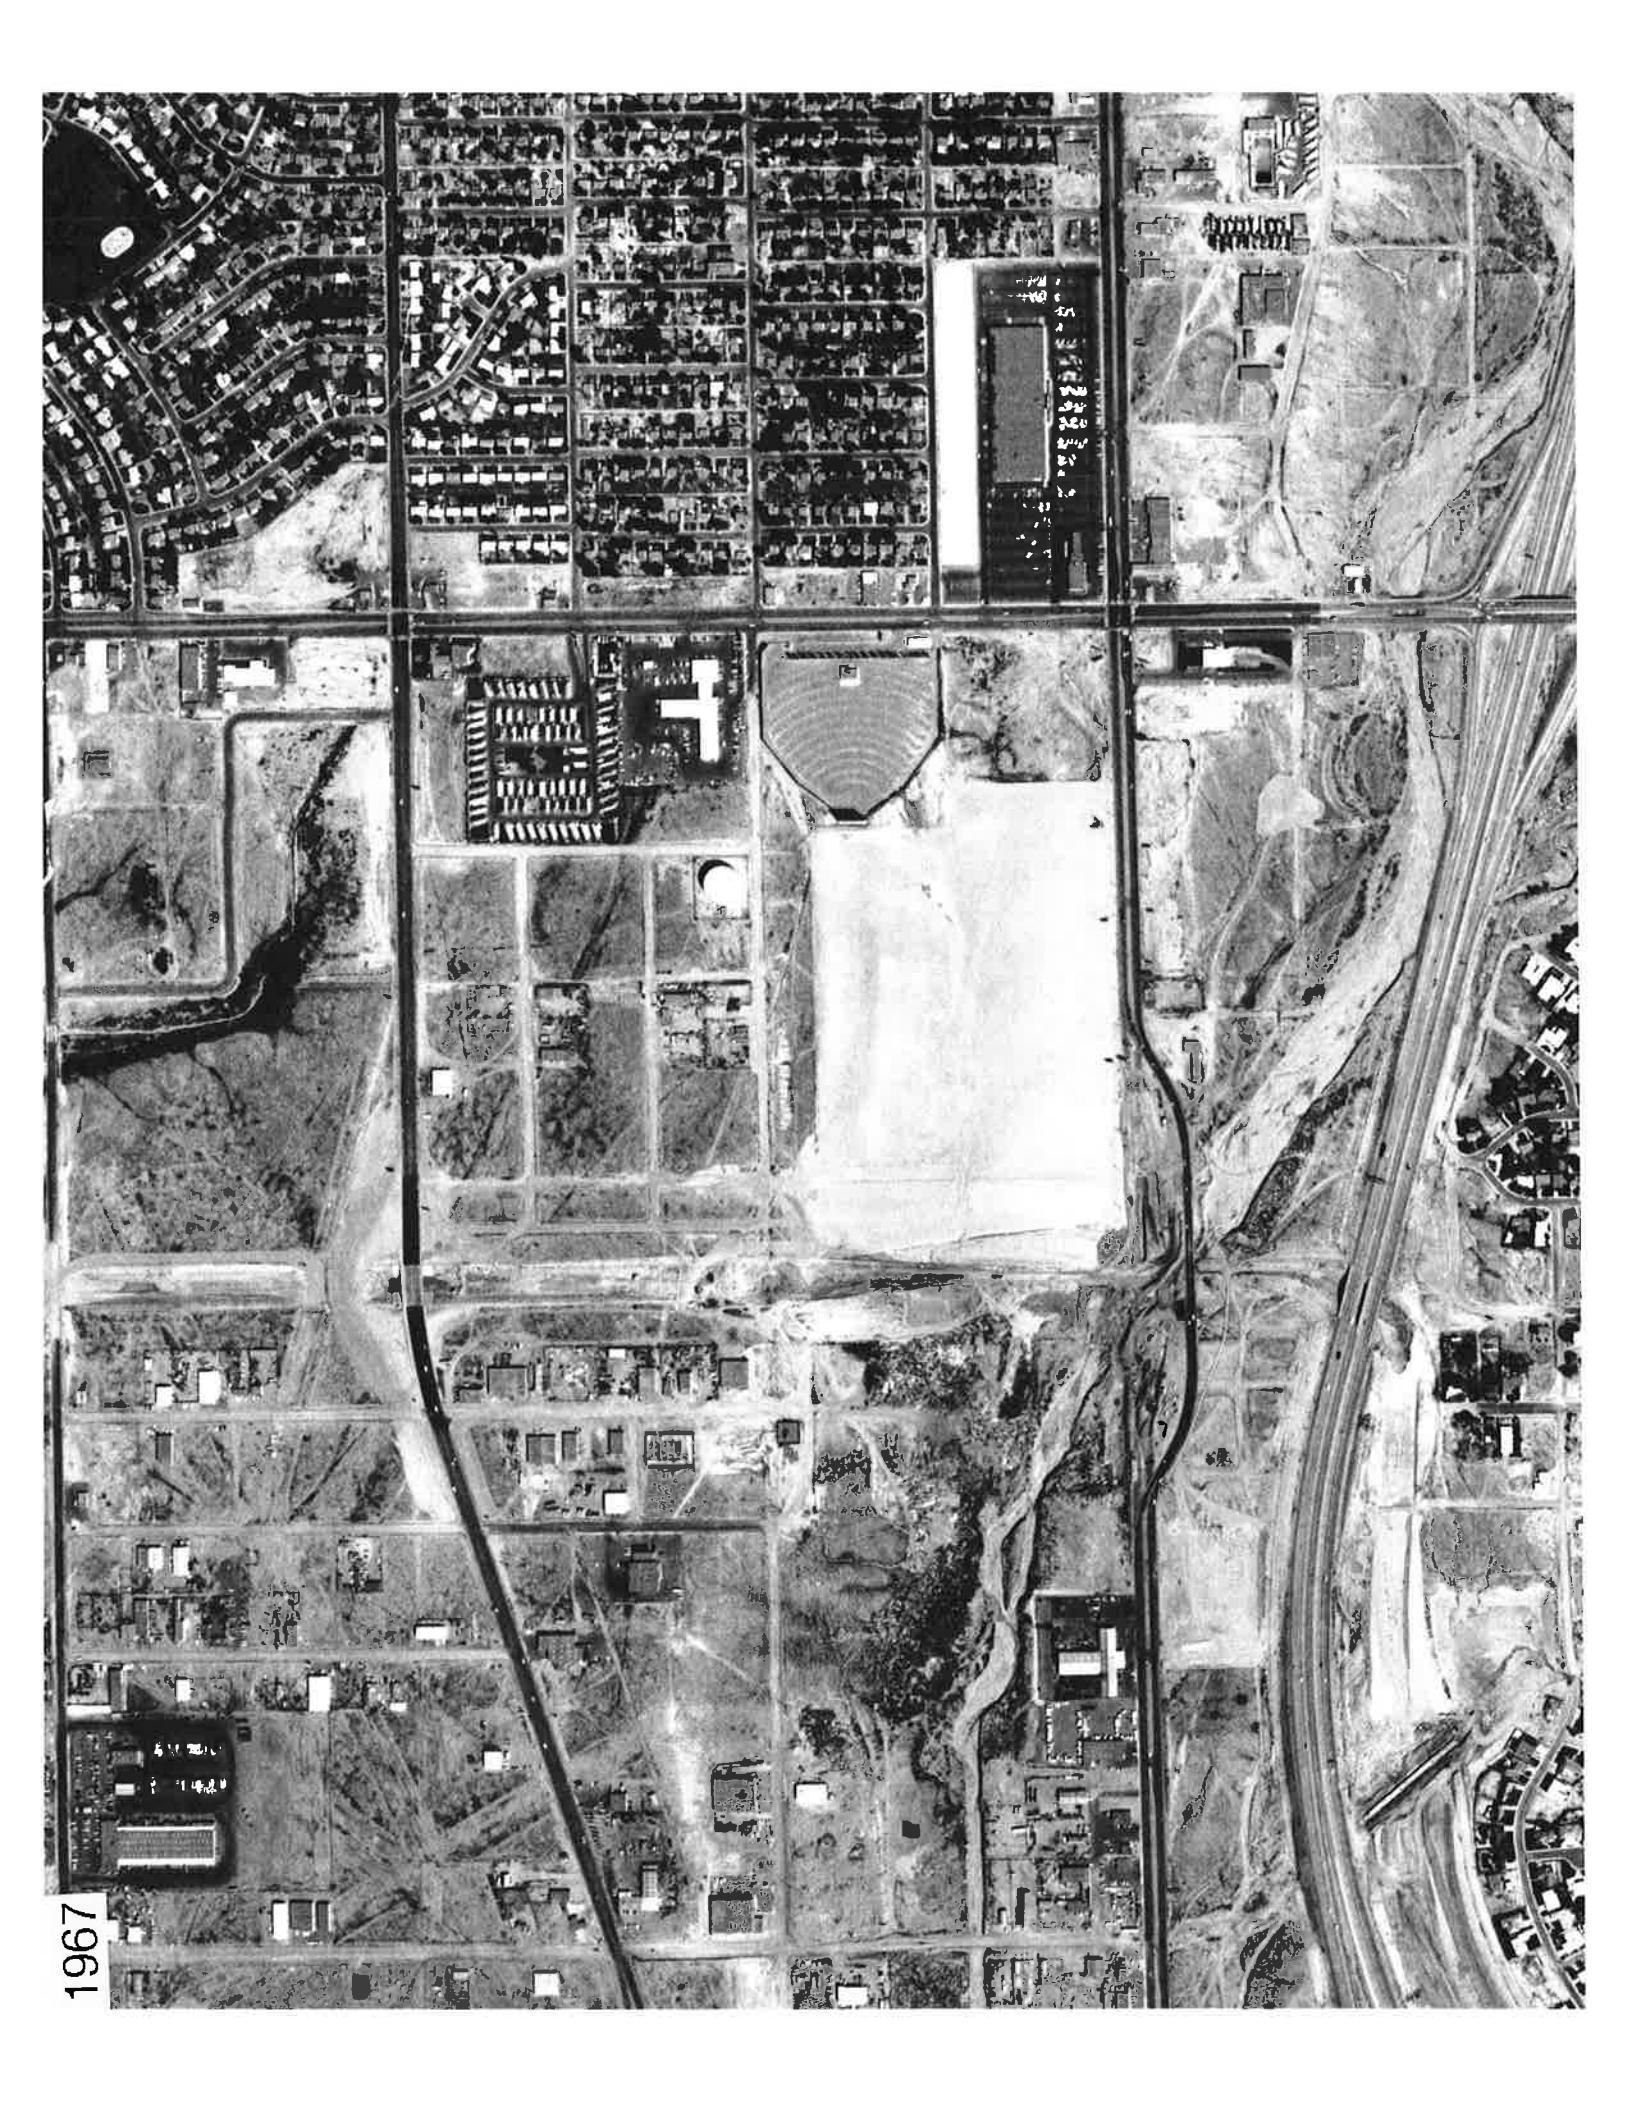
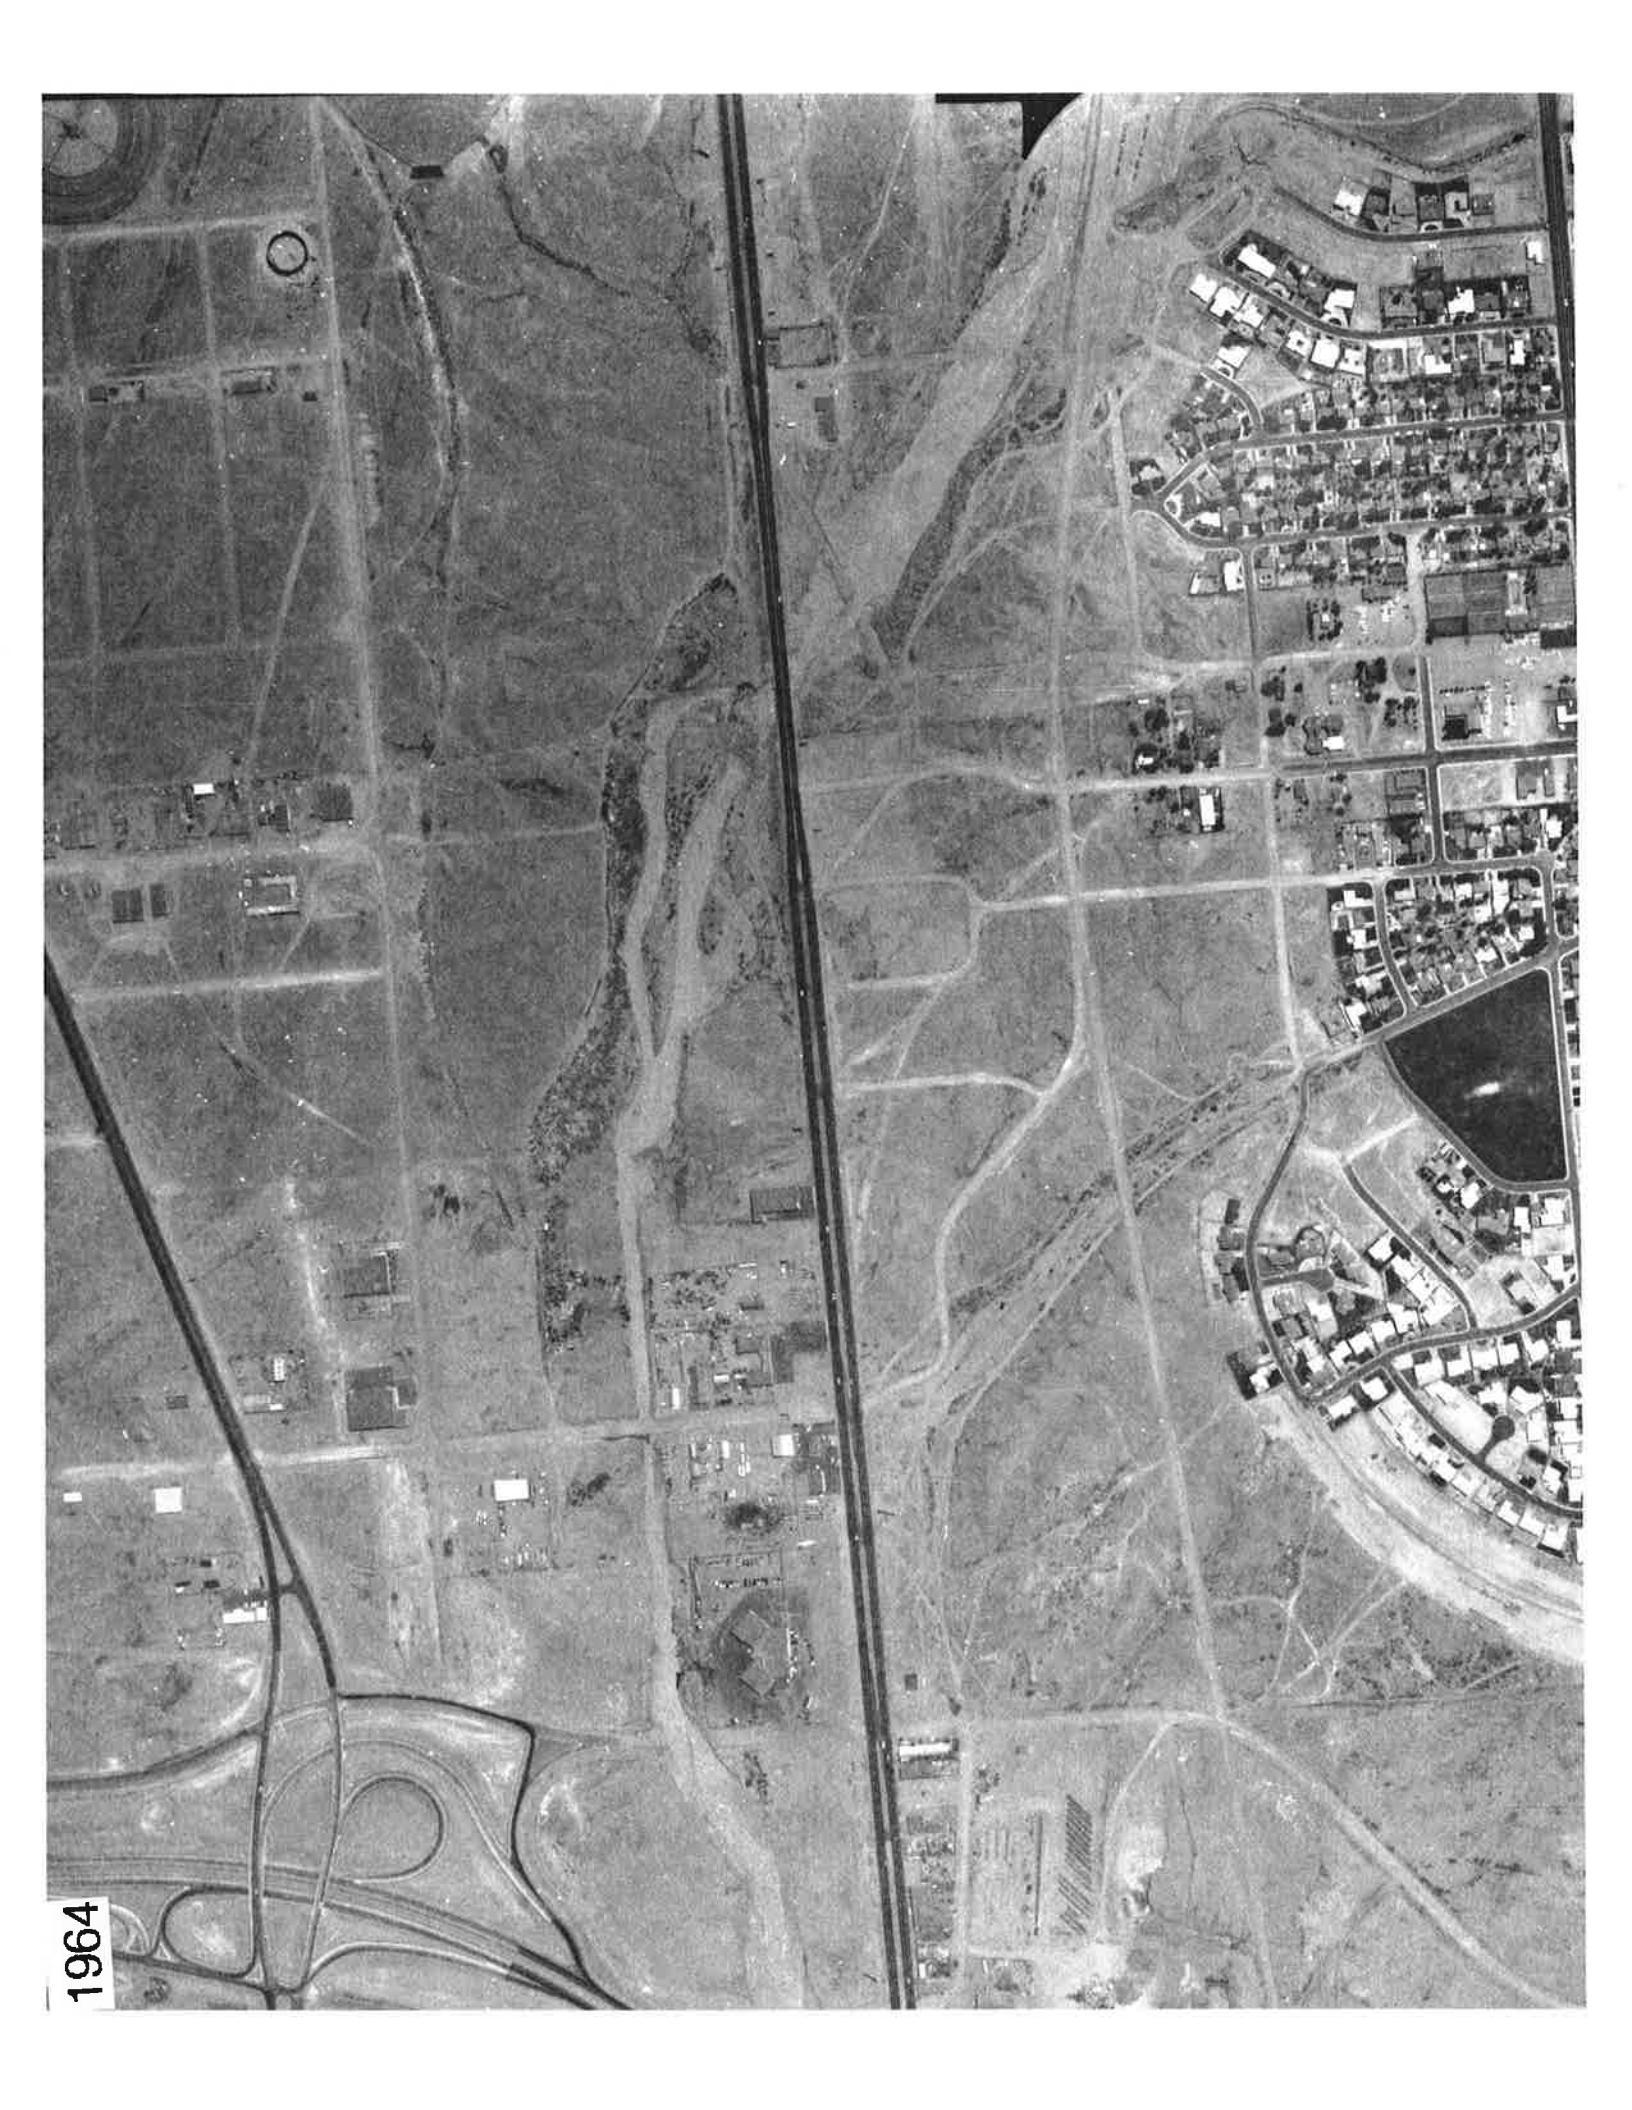
Aerial Photographs

SCS reviewed historical aerial photographs from EDAC for the years of 1996, 1991, 1989, 1982, 1973, 1967, 1964, 1959, 1954, 1951, and 1935. Copies of select aerials are included in Appendix A. From 1935 to 1967, the Arroyo del Embudo crossed the area from the southwest to the east and northeast. In the 1973 photograph, the arroyo had been mostly filled in. The present day North Diversion Channel is present in the 1973 aerial photograph. Menaul Boulevard was present on the 1951 aerial photograph and Carlisle Boulevard was present on the 1954 aerial photograph. The Menaul Boulevard area between Carlisle Boulevard and University Boulevard was mostly vacant in the 1954 photograph with an airport located to the north, a drive in theatre to the east (Carlisle), and subdivisions to the east and south (across present day I-40). Disturbed soil, from apparent construction activities, in the area was noted in most of the aerial photographs reviewed. SCS did not identify any areas of obvious land filling activities at the eight locations shown on Figure 1. Construction debris and /or household waste may have been used during the filling of the arroyo as indicated by Mr. Miller of Geotest, Inc.

Map ID 1 did not appear to be developed in the past and is vacant today. Map IDs 1, 2, 3 and 4 appear to have been located in the arroyo corridor prior to 1973. The 1959 aerial photograph shows soil disturbance in the area of Map IDs 5 and 6. The 1973 aerial photograph shows a structure at Map ID 5 and the 1964 aerial shows a structure at Map ID 6. Map ID 7 was vacant in 1982 and was developed in 1989 and Map ID 8 appears to be partially developed in 1982.
