**Voluntary Remediation Program  
Status Report  
City of Albuquerque Rail Yards  
VRP Site No. 53161007**

**Prepared for: NMED Ground Water Quality Bureau**

**Prepared by: Environmental Services Division  
Albuquerque Environmental Health Department**

**July 2019**

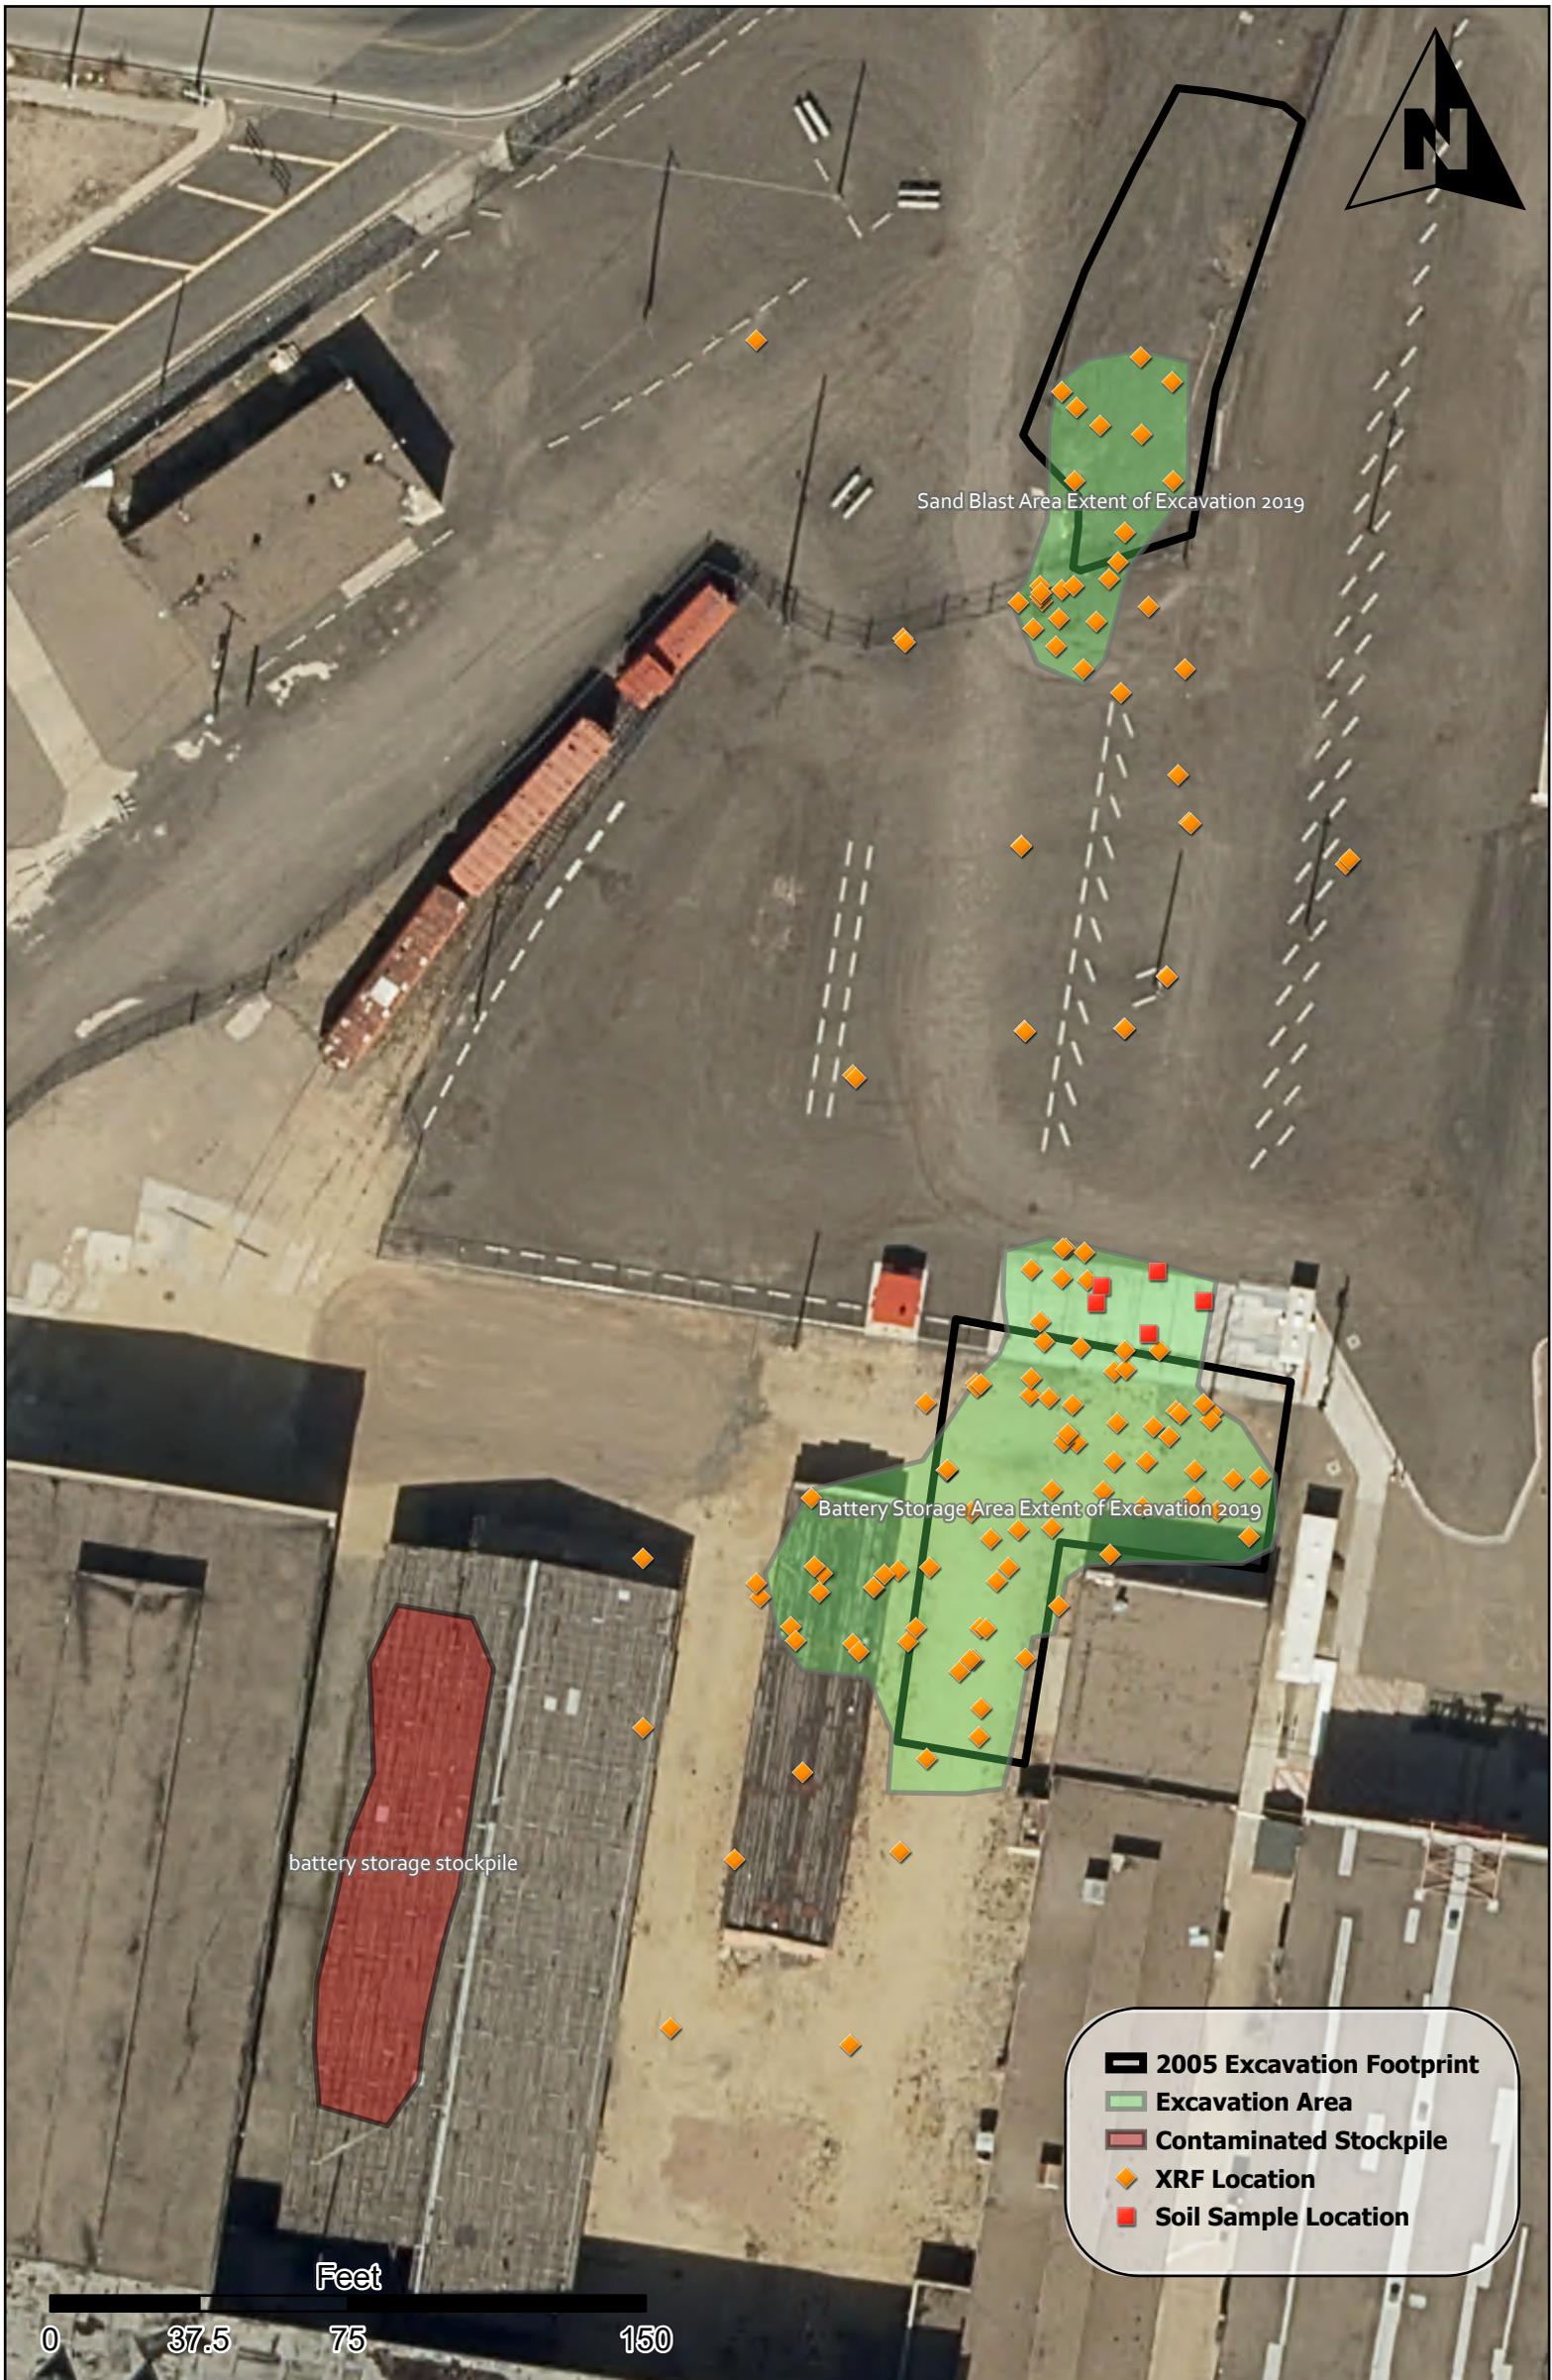
Figure 2

# Albuquerque Rail Yards Soil Excavation Battery Storage Area

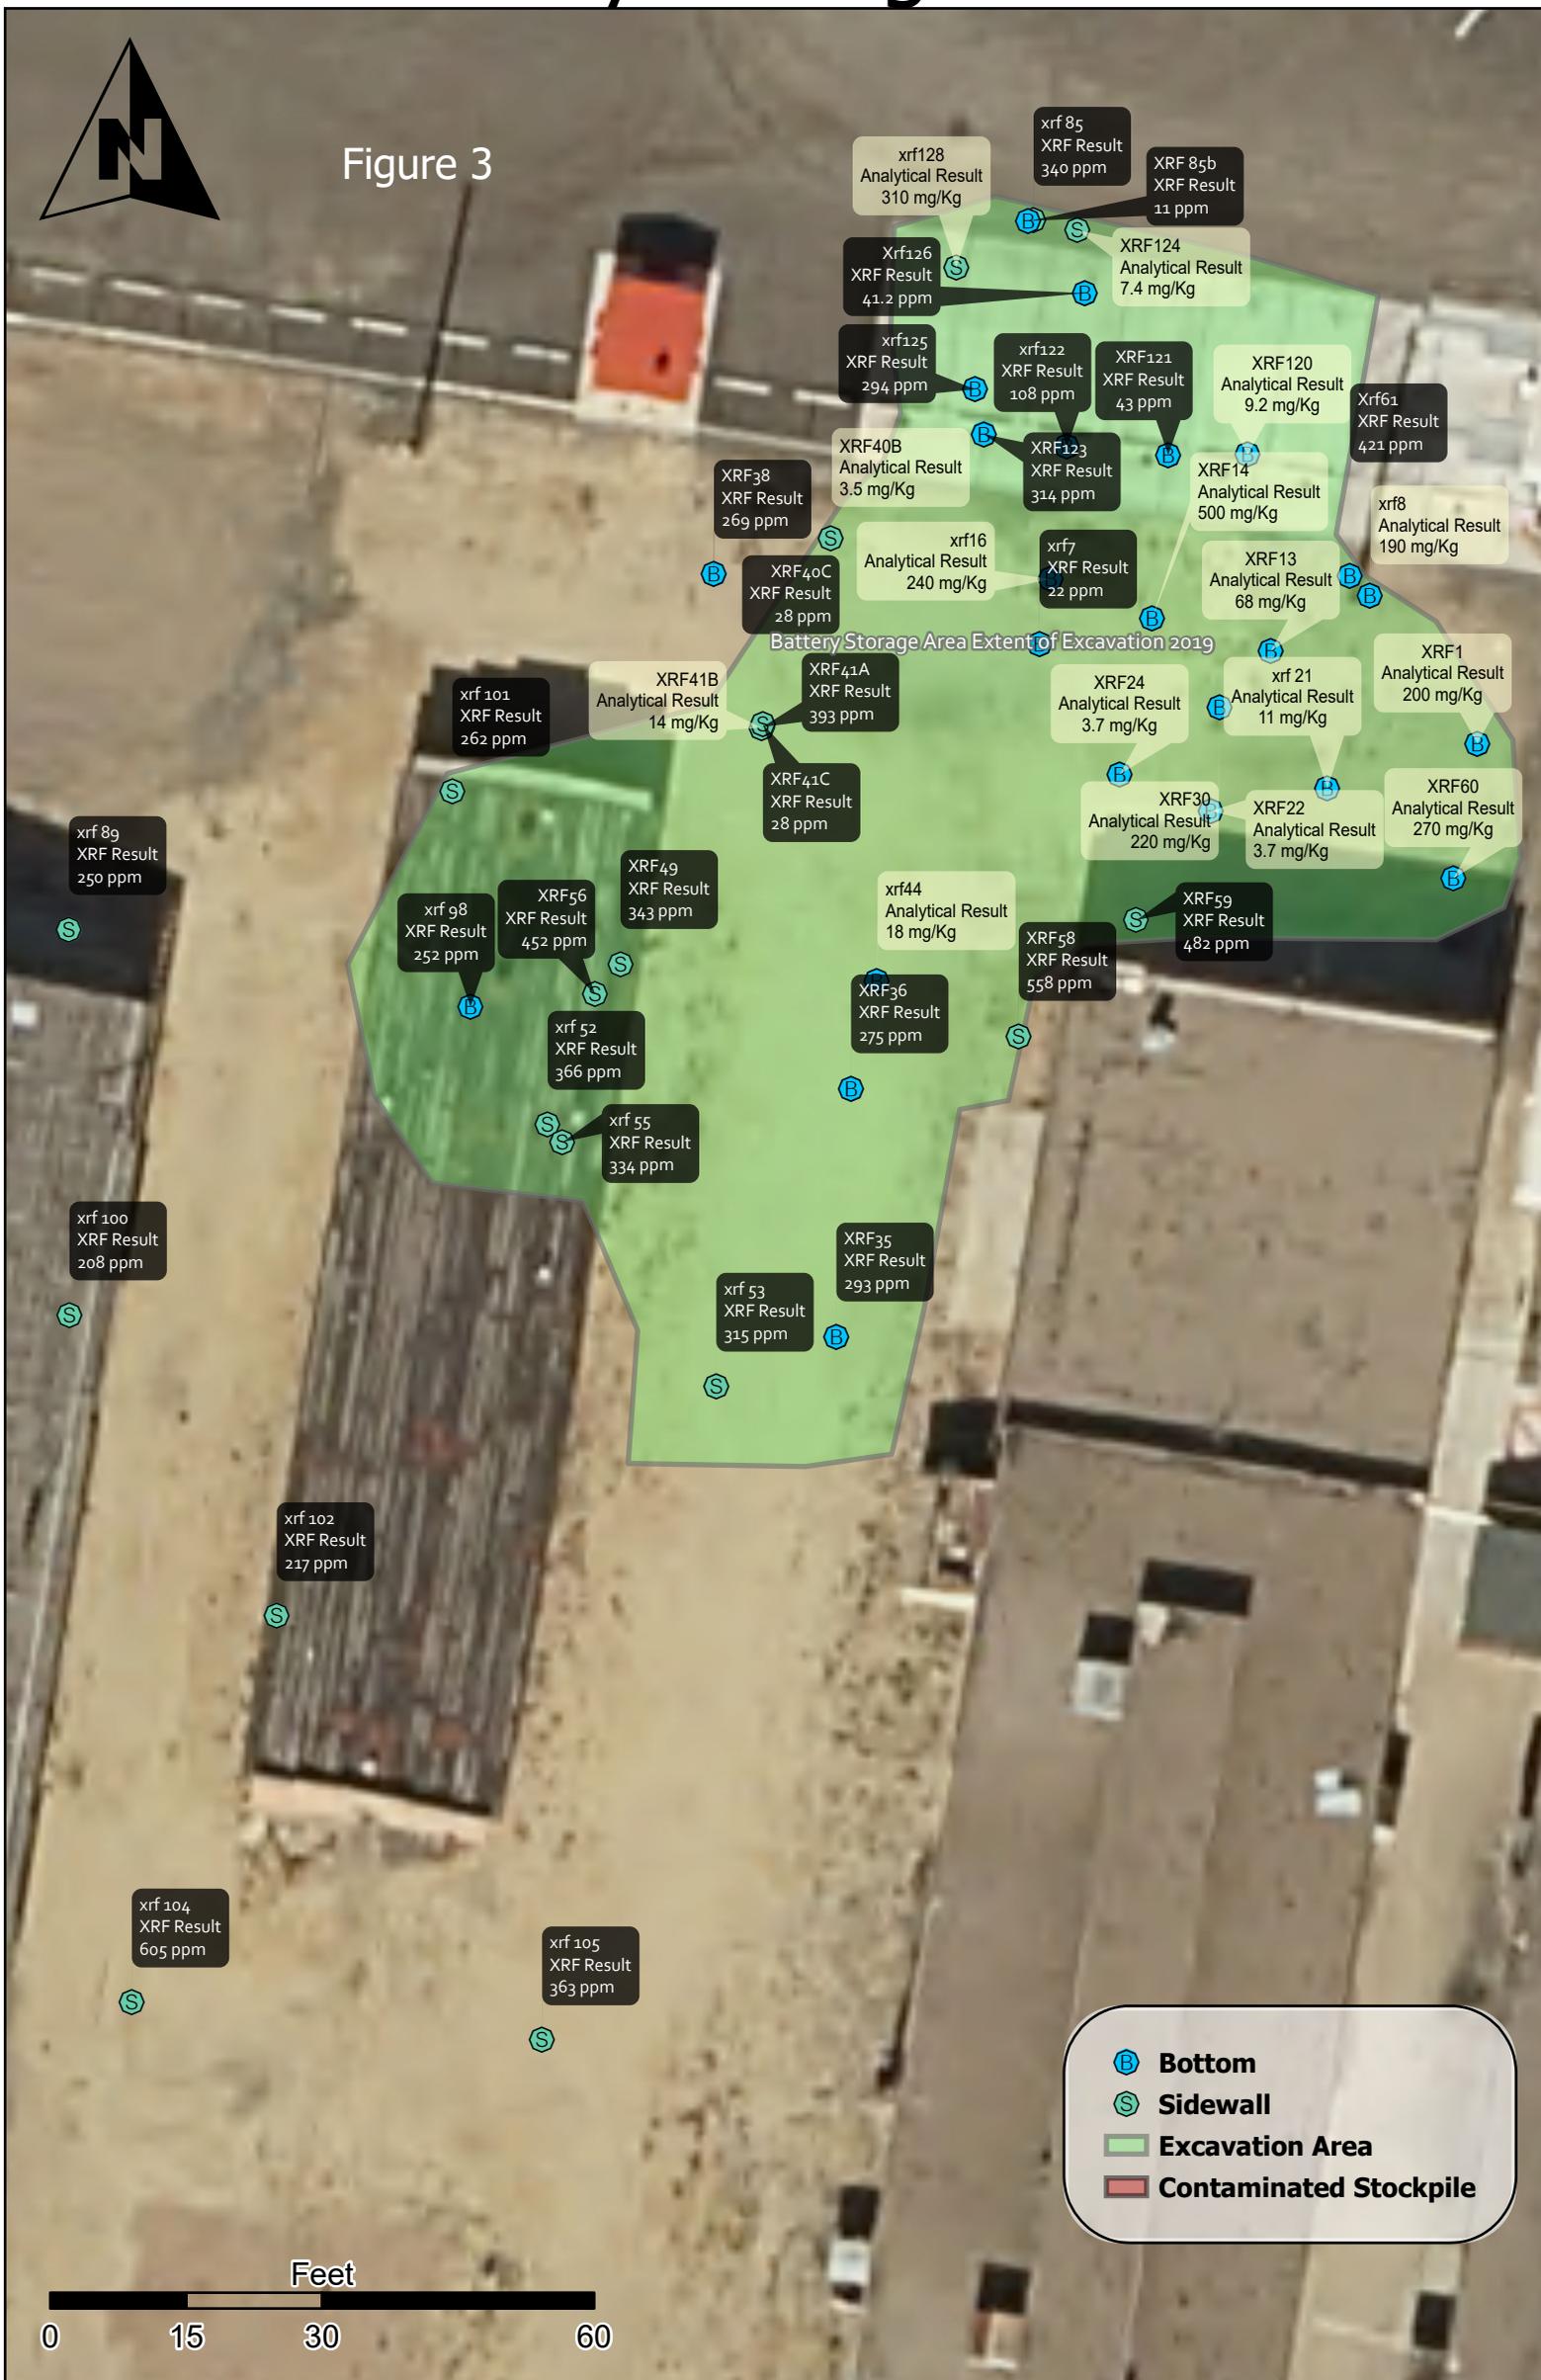
Figure 3

# Albuquerque Rail Yards Soil Excavation Sandblast Area

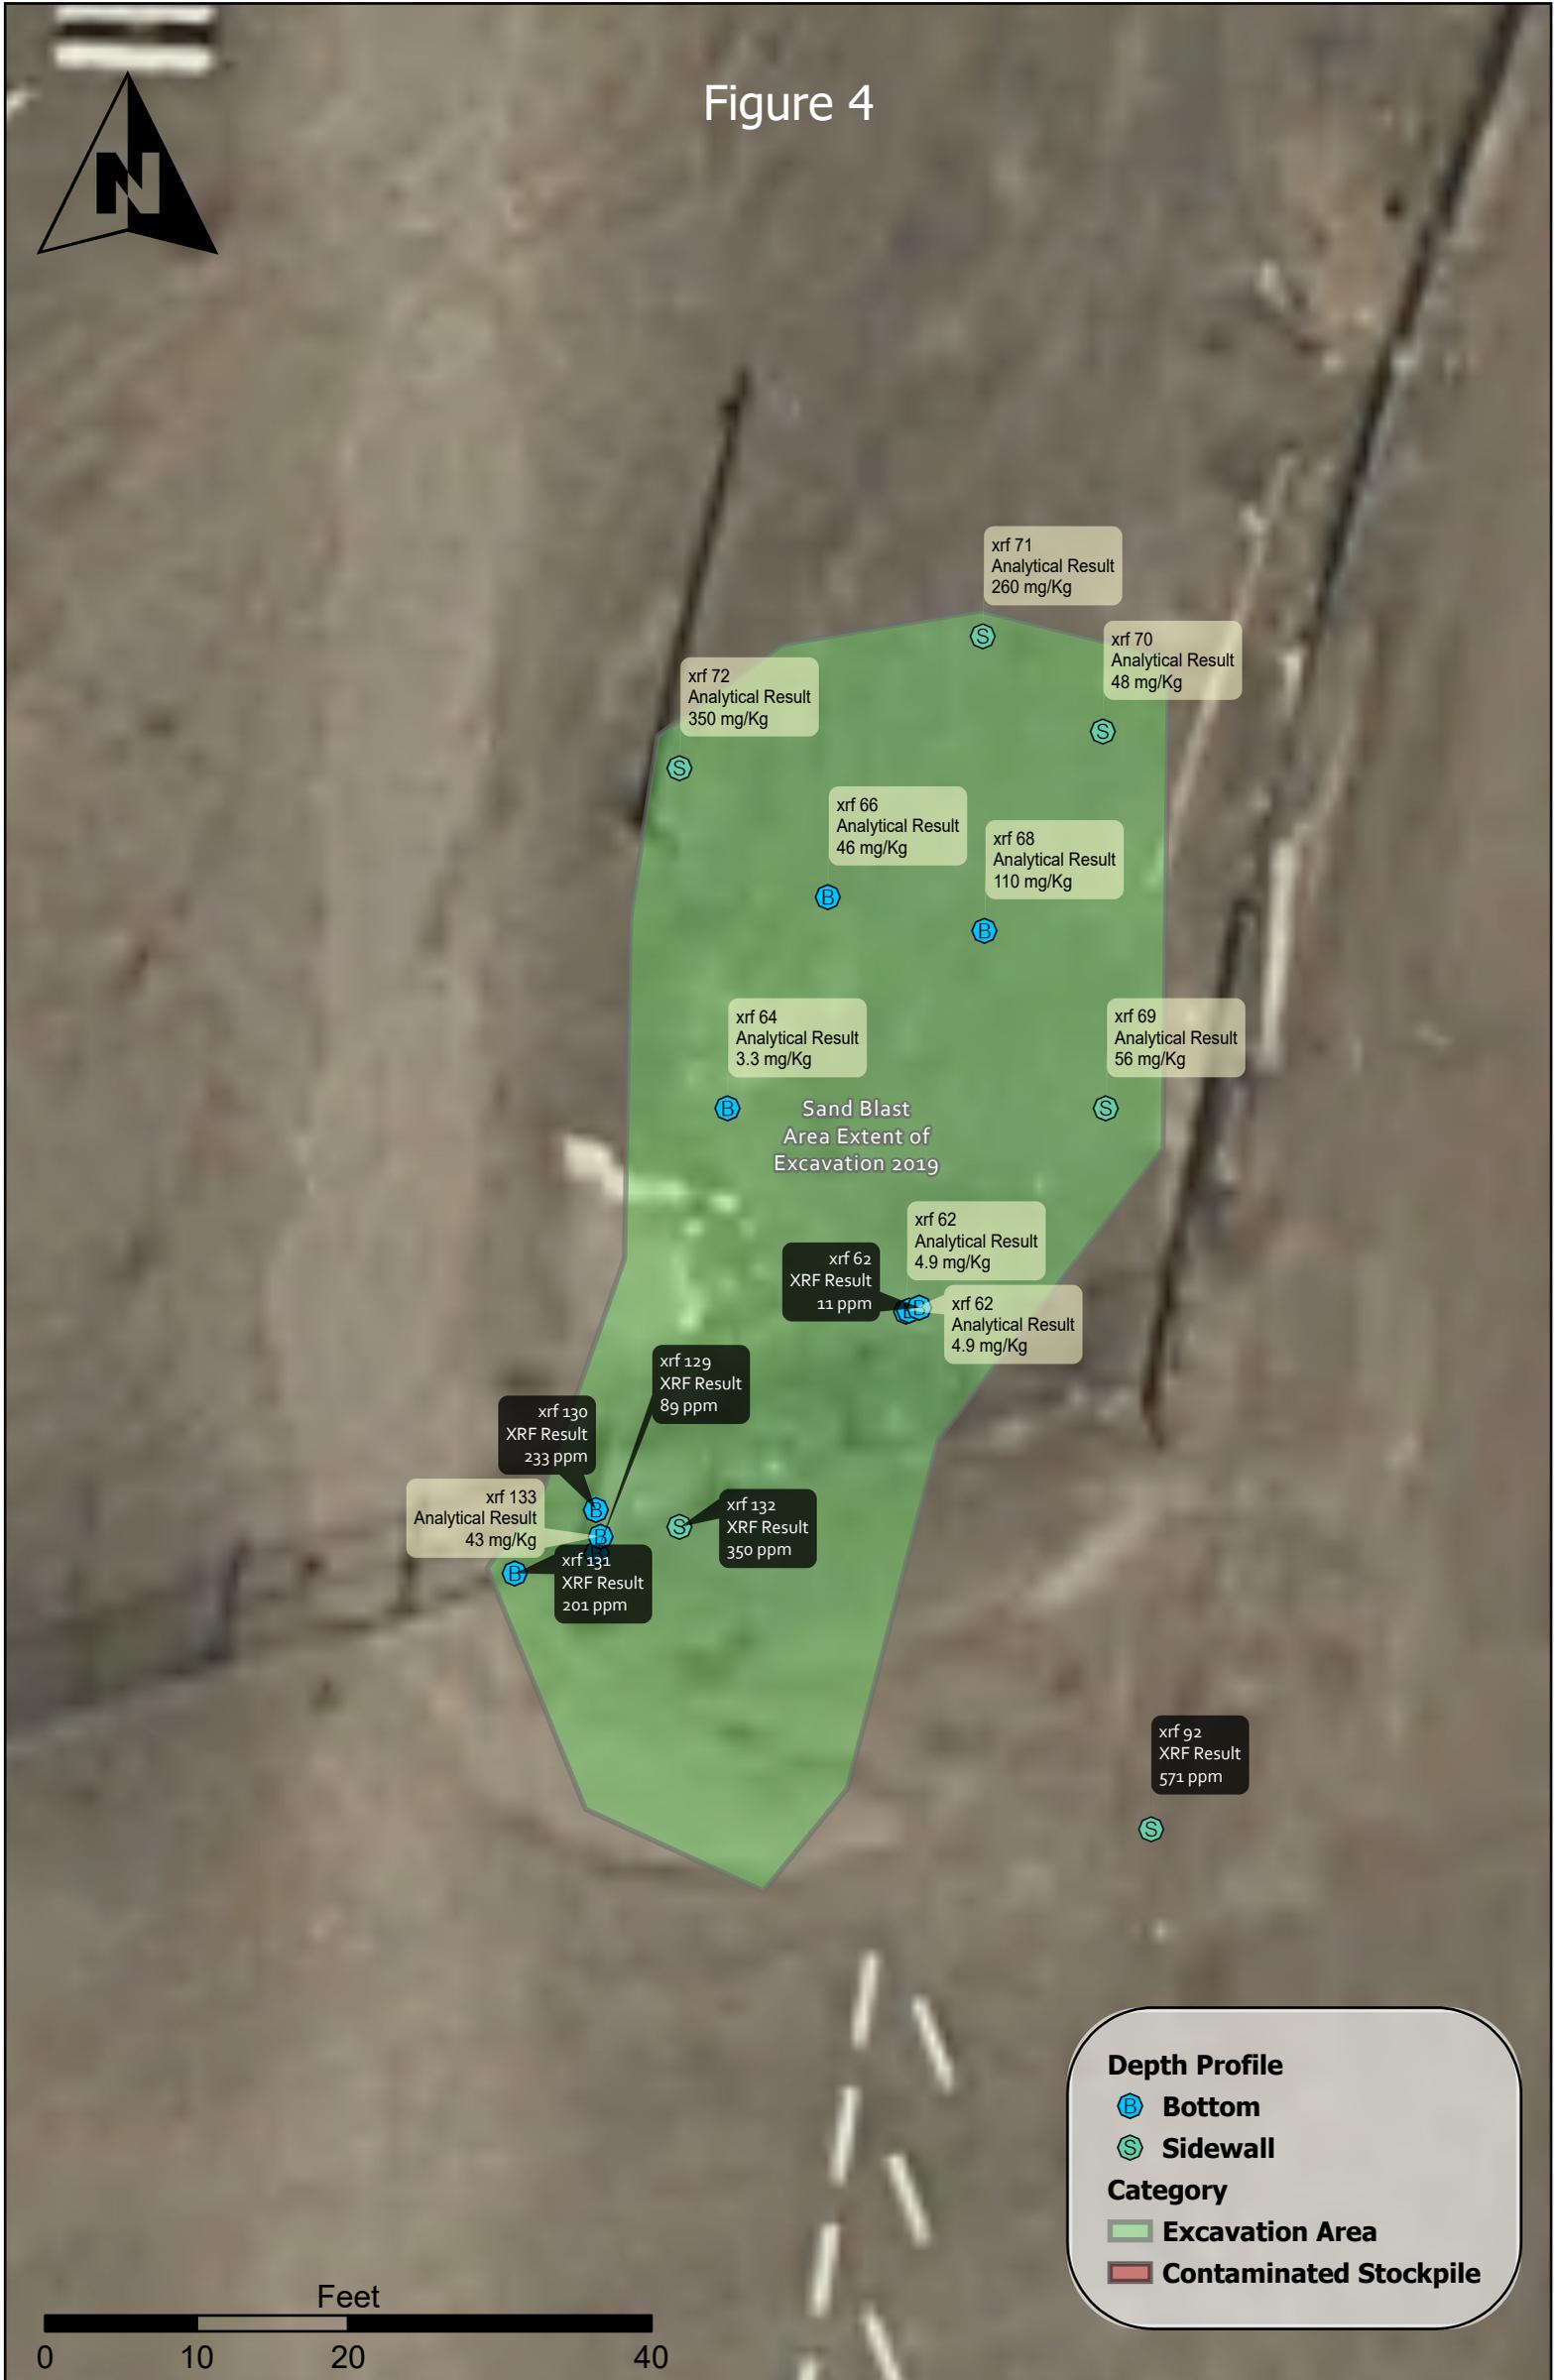
Figure 4

**Depth Profile**

- (B) Bottom
- (S) Sidewall

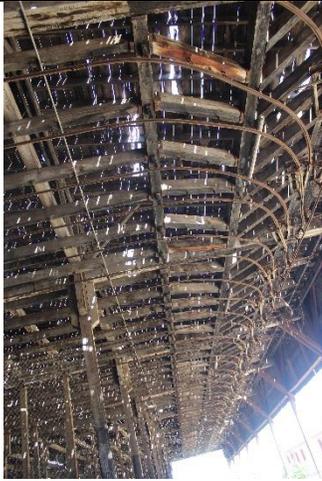
**Figure 1, Open Side of Sheet Metal House**

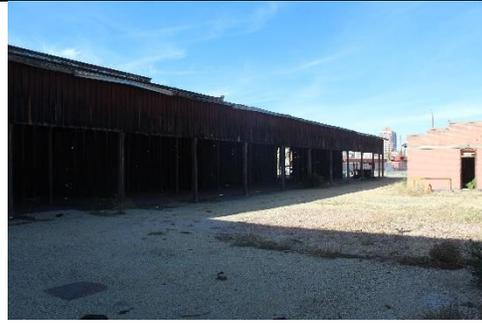
**Figure 2, Sheet Metal House, East Side**

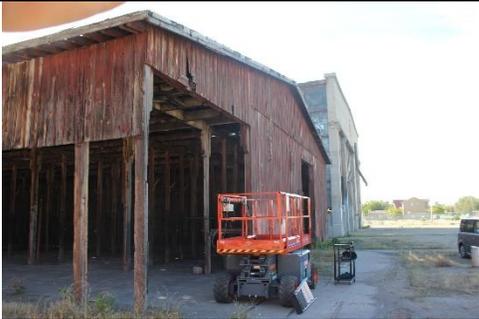
**Figure 3, Sheet Metal House, NE Corner**

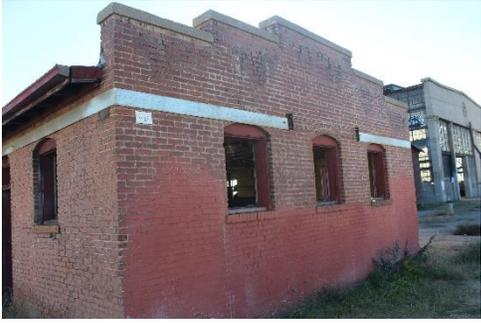
Figure 1 Front Exterior of North Wash Room

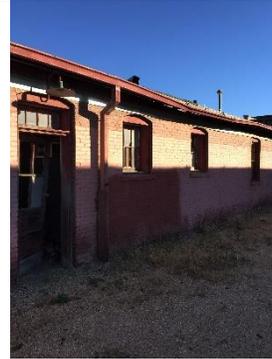
Figure 2 Exterior of North Wash Room

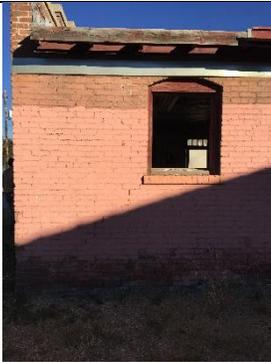
Figure 3 Window Exterior of North Wash Room

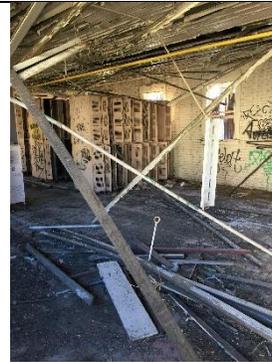
Figure 4 Interior of North Wash Room

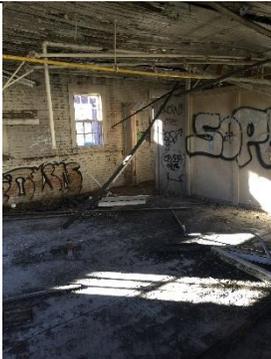
Figure 5 Interior of North Wash Room

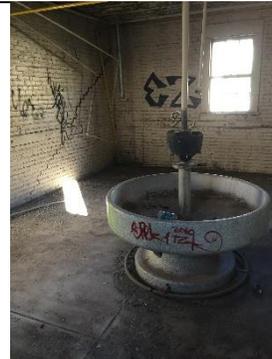
Figure 6 Interior of North Wash Room

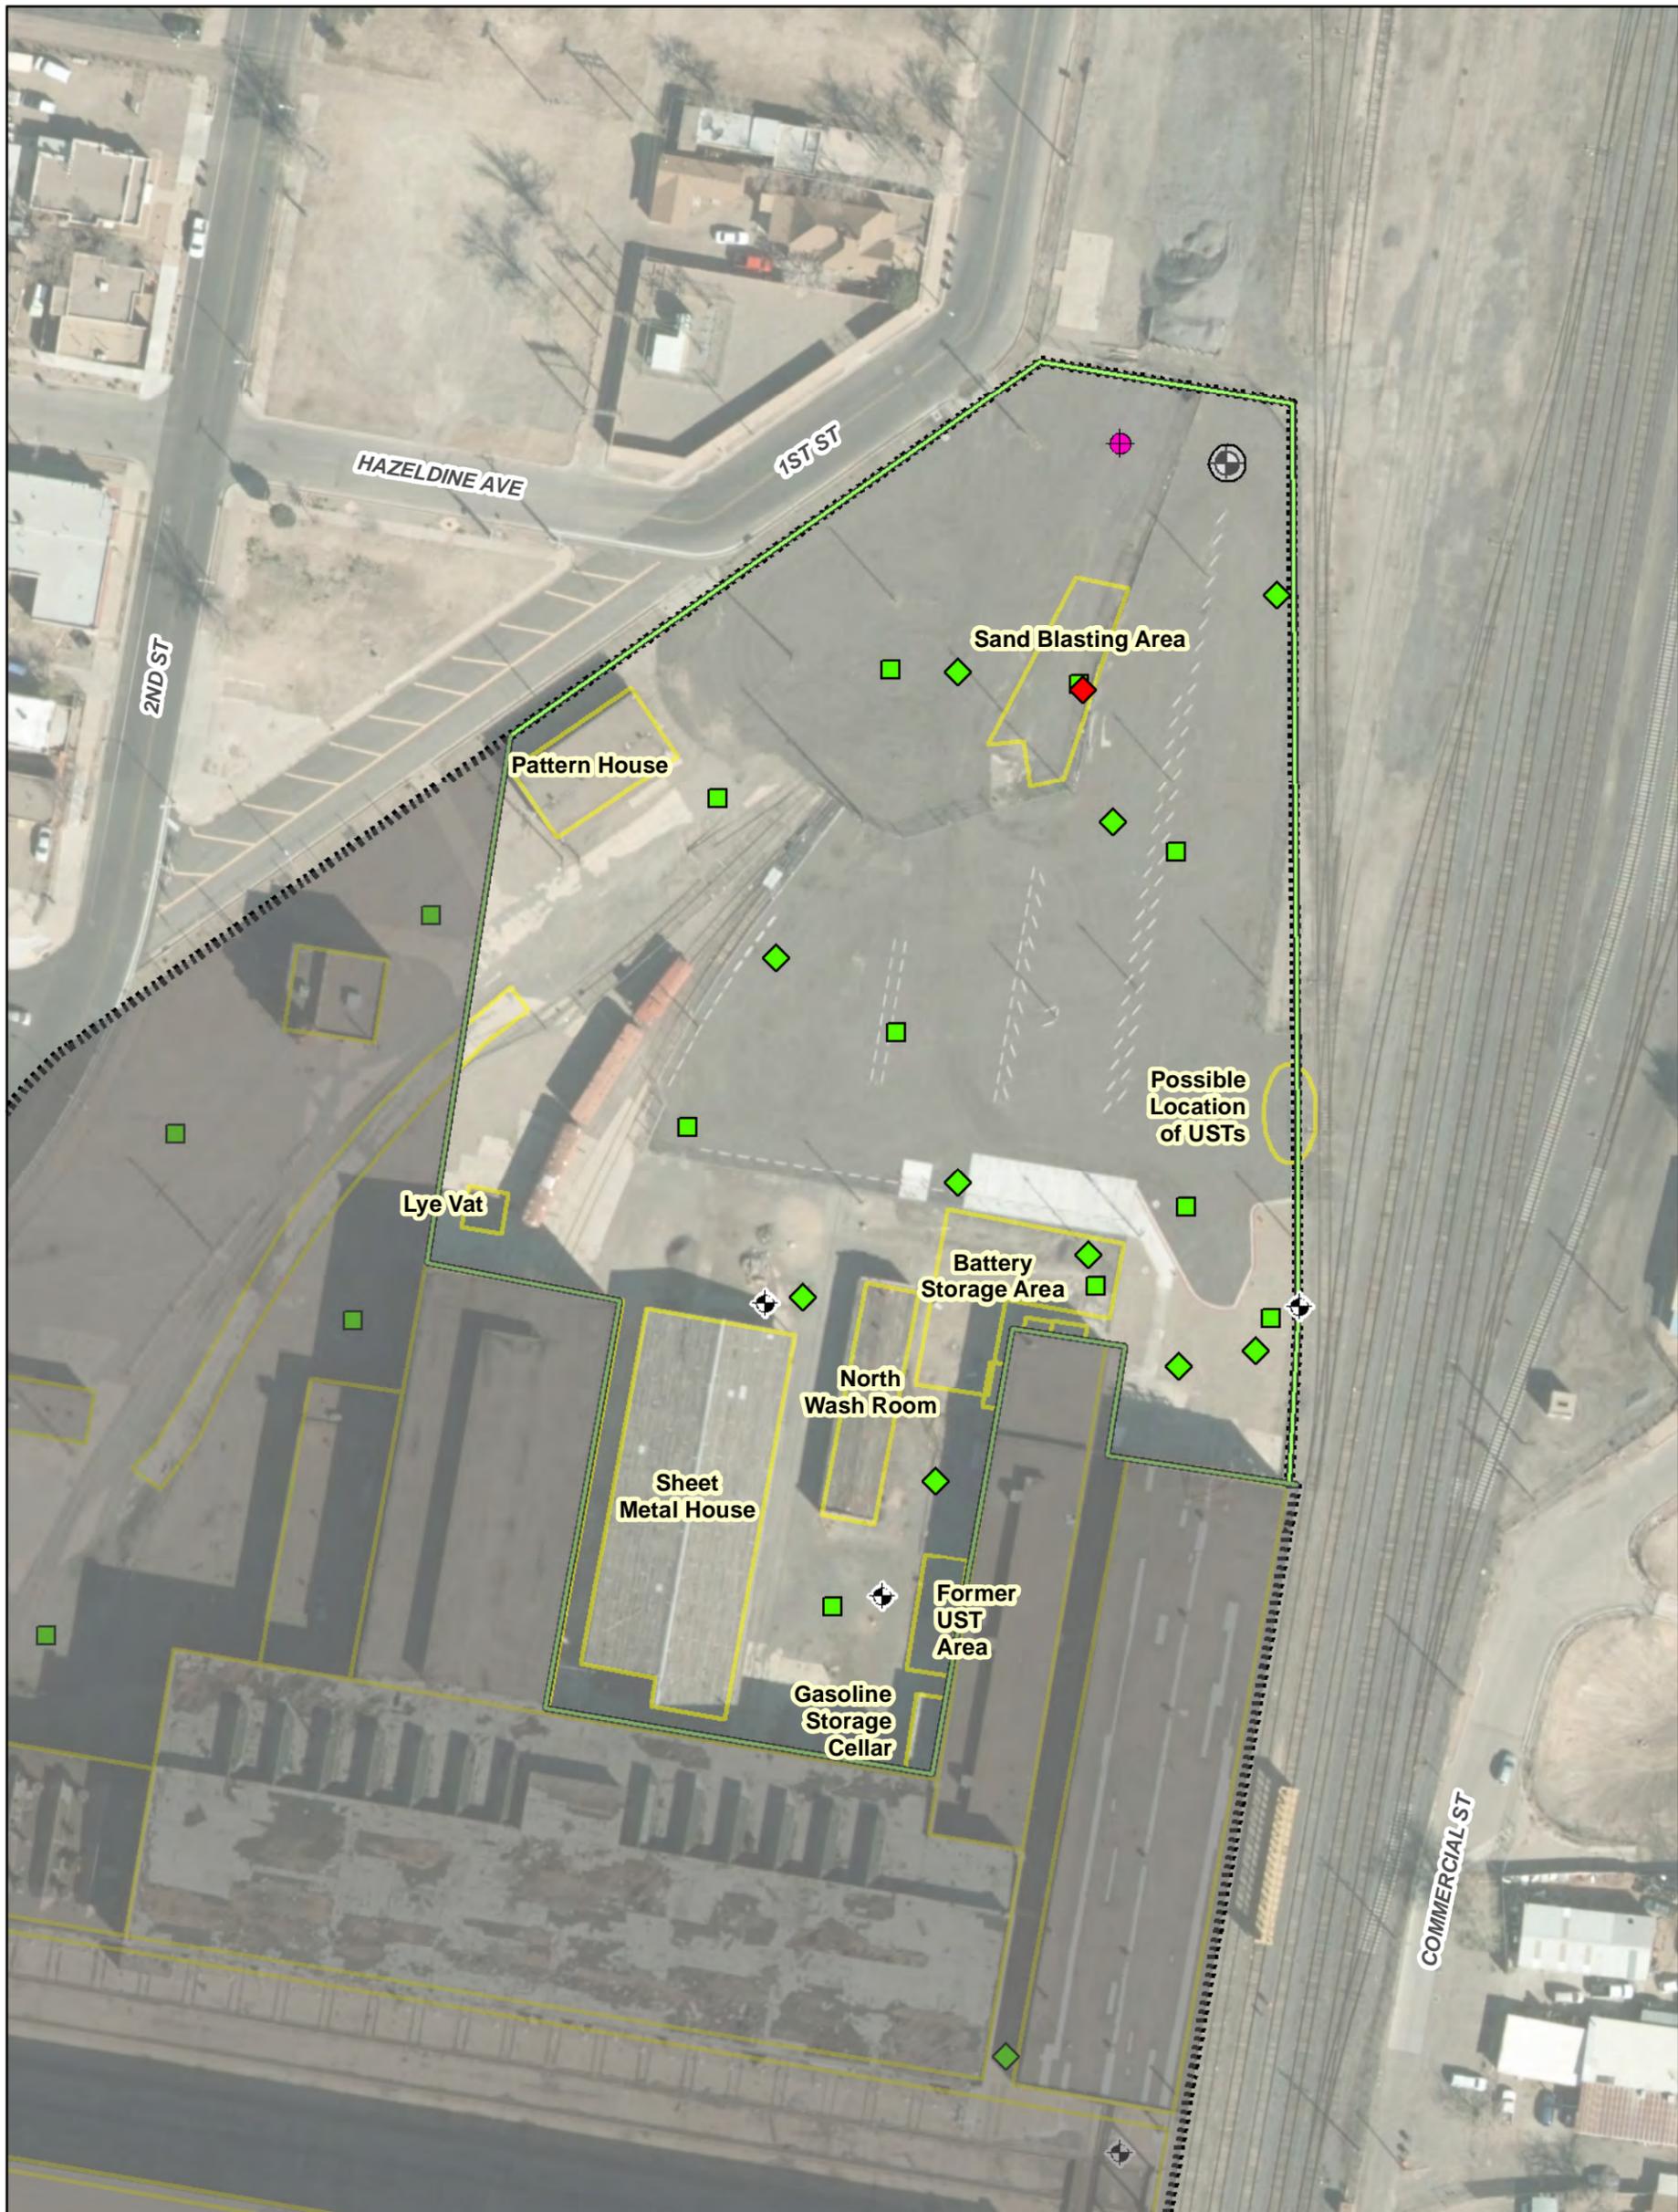
**Figure 3b**  
 Residential SSL Exceedances  
 (0-10 ft bgs), Arsenic  
 Additional Characterization,  
 Voluntary Remediation Program Activities,  
 Albuquerque Rail Yards, Albuquerque,  
 Bernalillo County, New Mexico

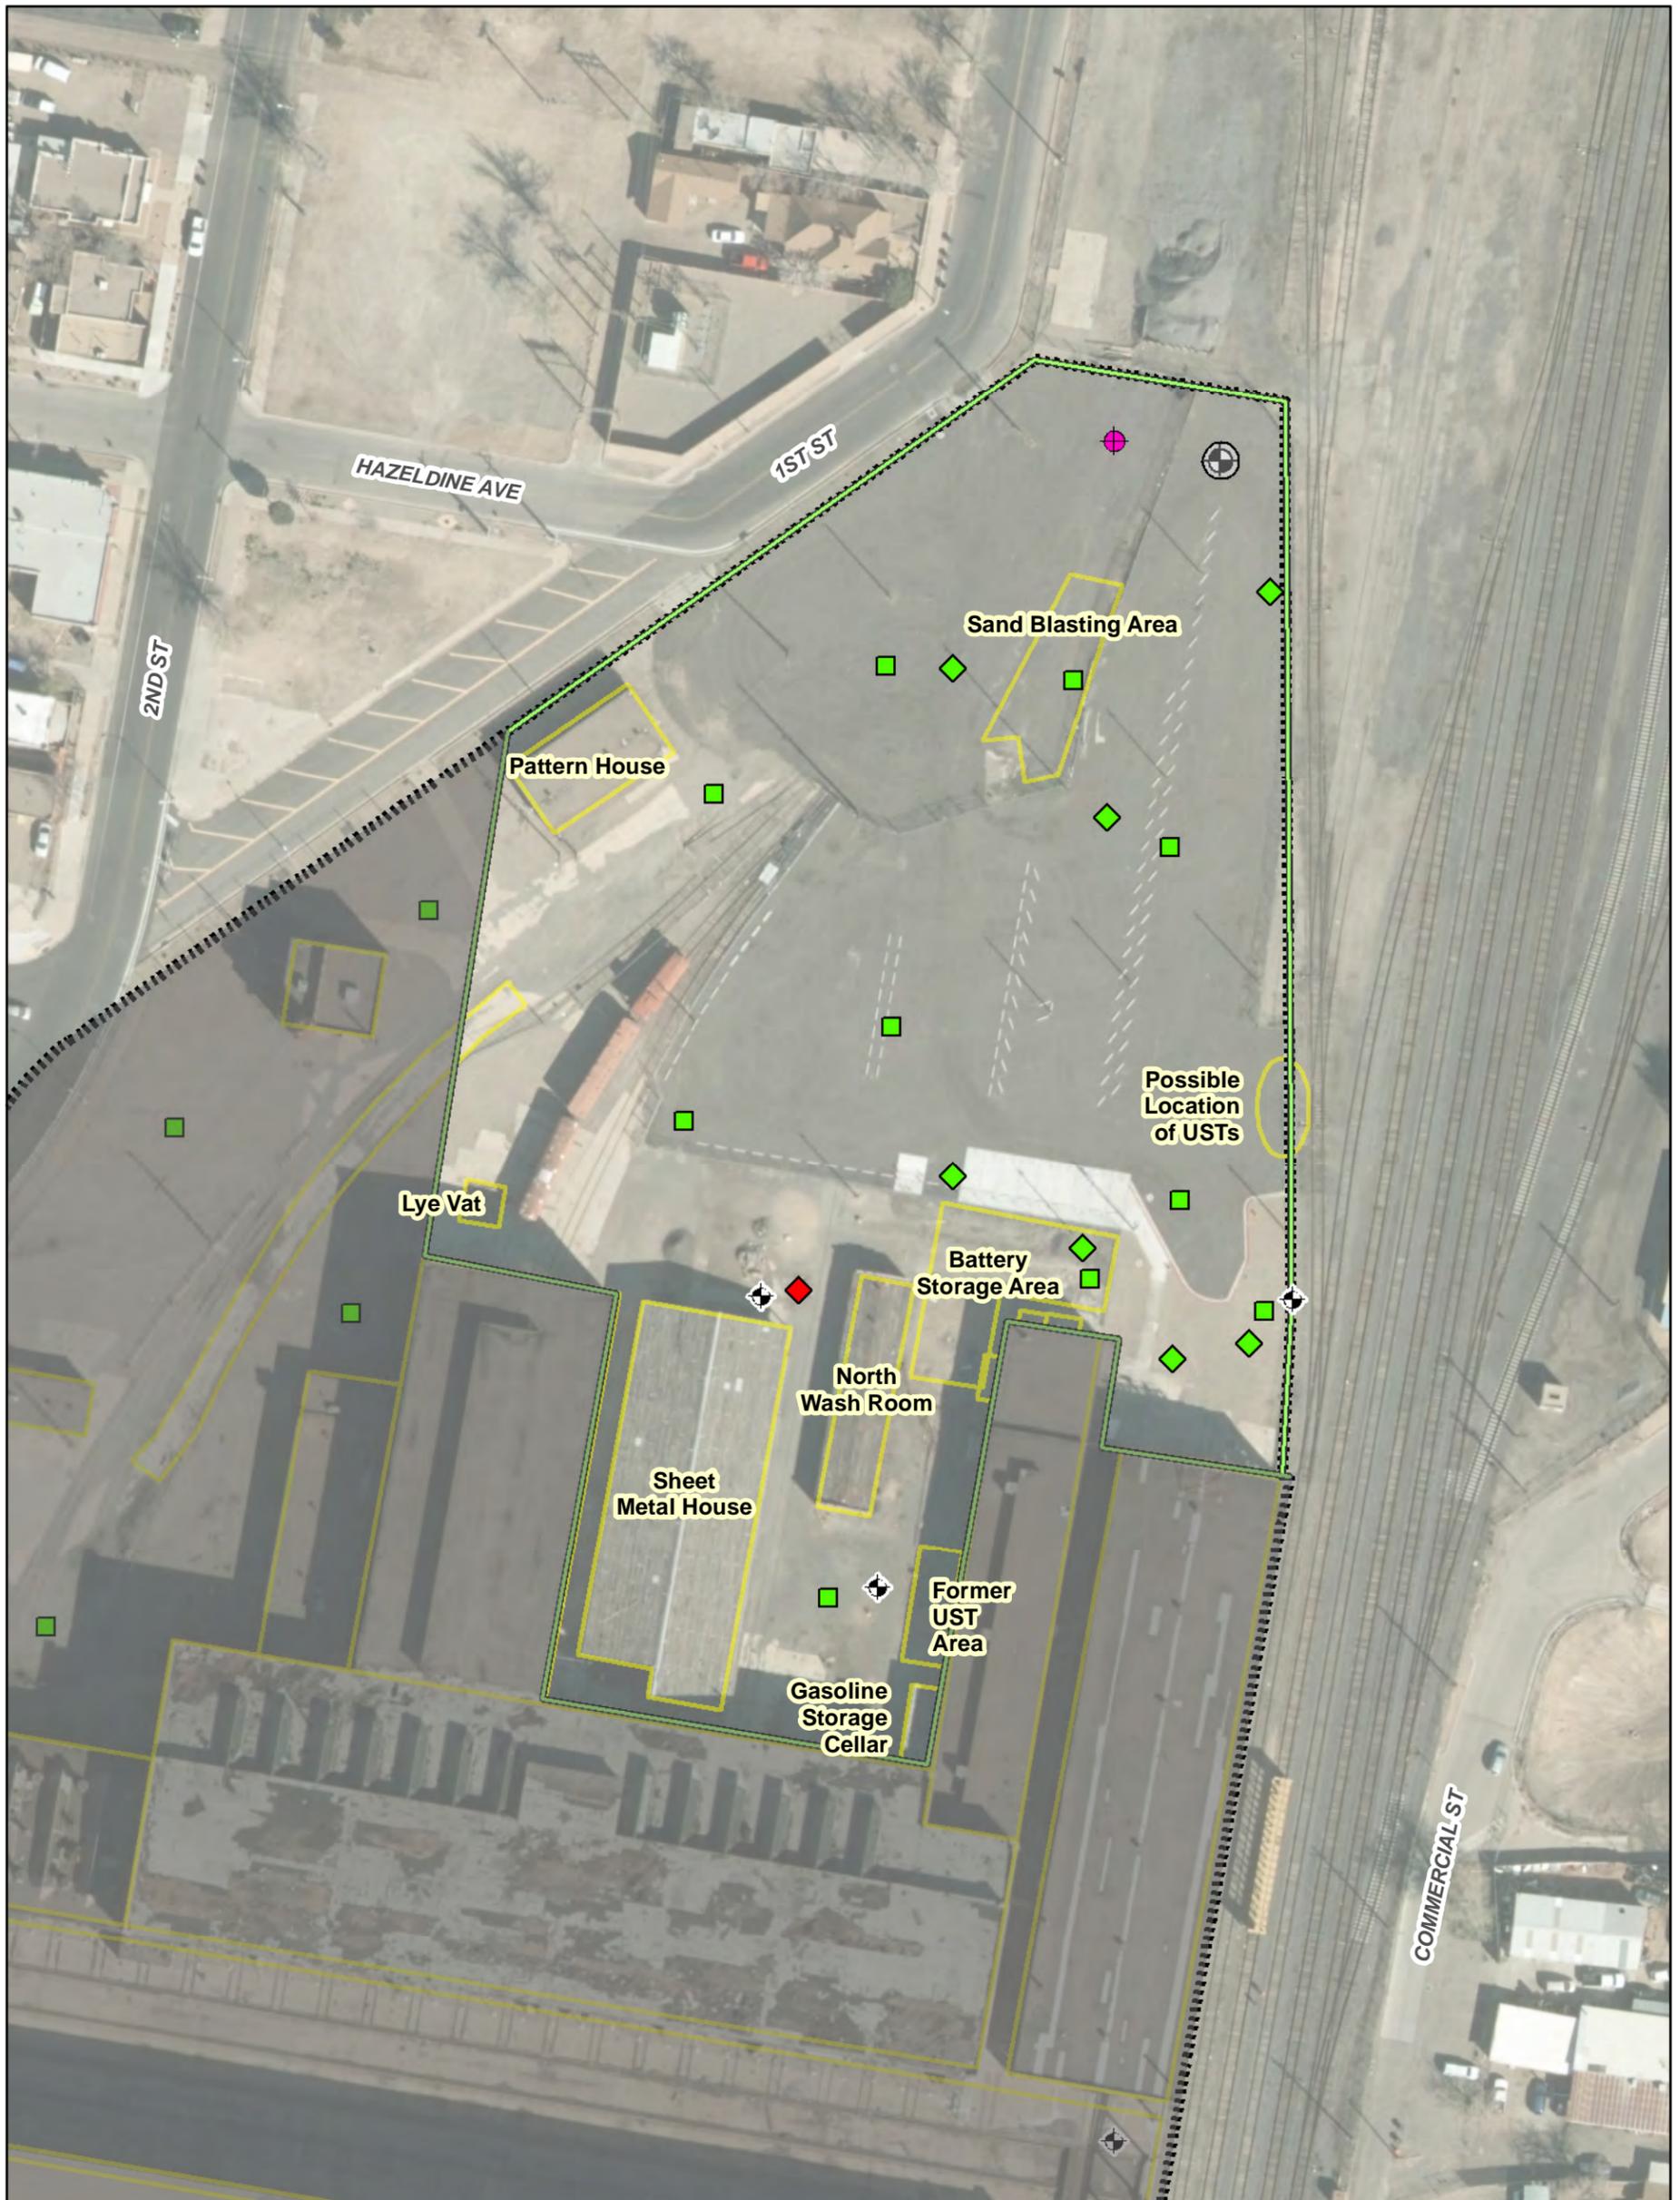
**Figure 3c**  
 Residential SSL Exceedances  
 (0-10 ft bgs), Chromium  
 Additional Characterization,  
 Voluntary Remediation Program Activities,  
 Albuquerque Rail Yards, Albuquerque,  
 Bernalillo County, New Mexico
