**Voluntary Remediation Program  
Status Report  
City of Albuquerque Rail Yards  
VRP Site No. 53161007**

**Prepared for: NMED Ground Water Quality Bureau**

**Prepared by: Environmental Services Division  
Albuquerque Environmental Health Department**

**July 2019**

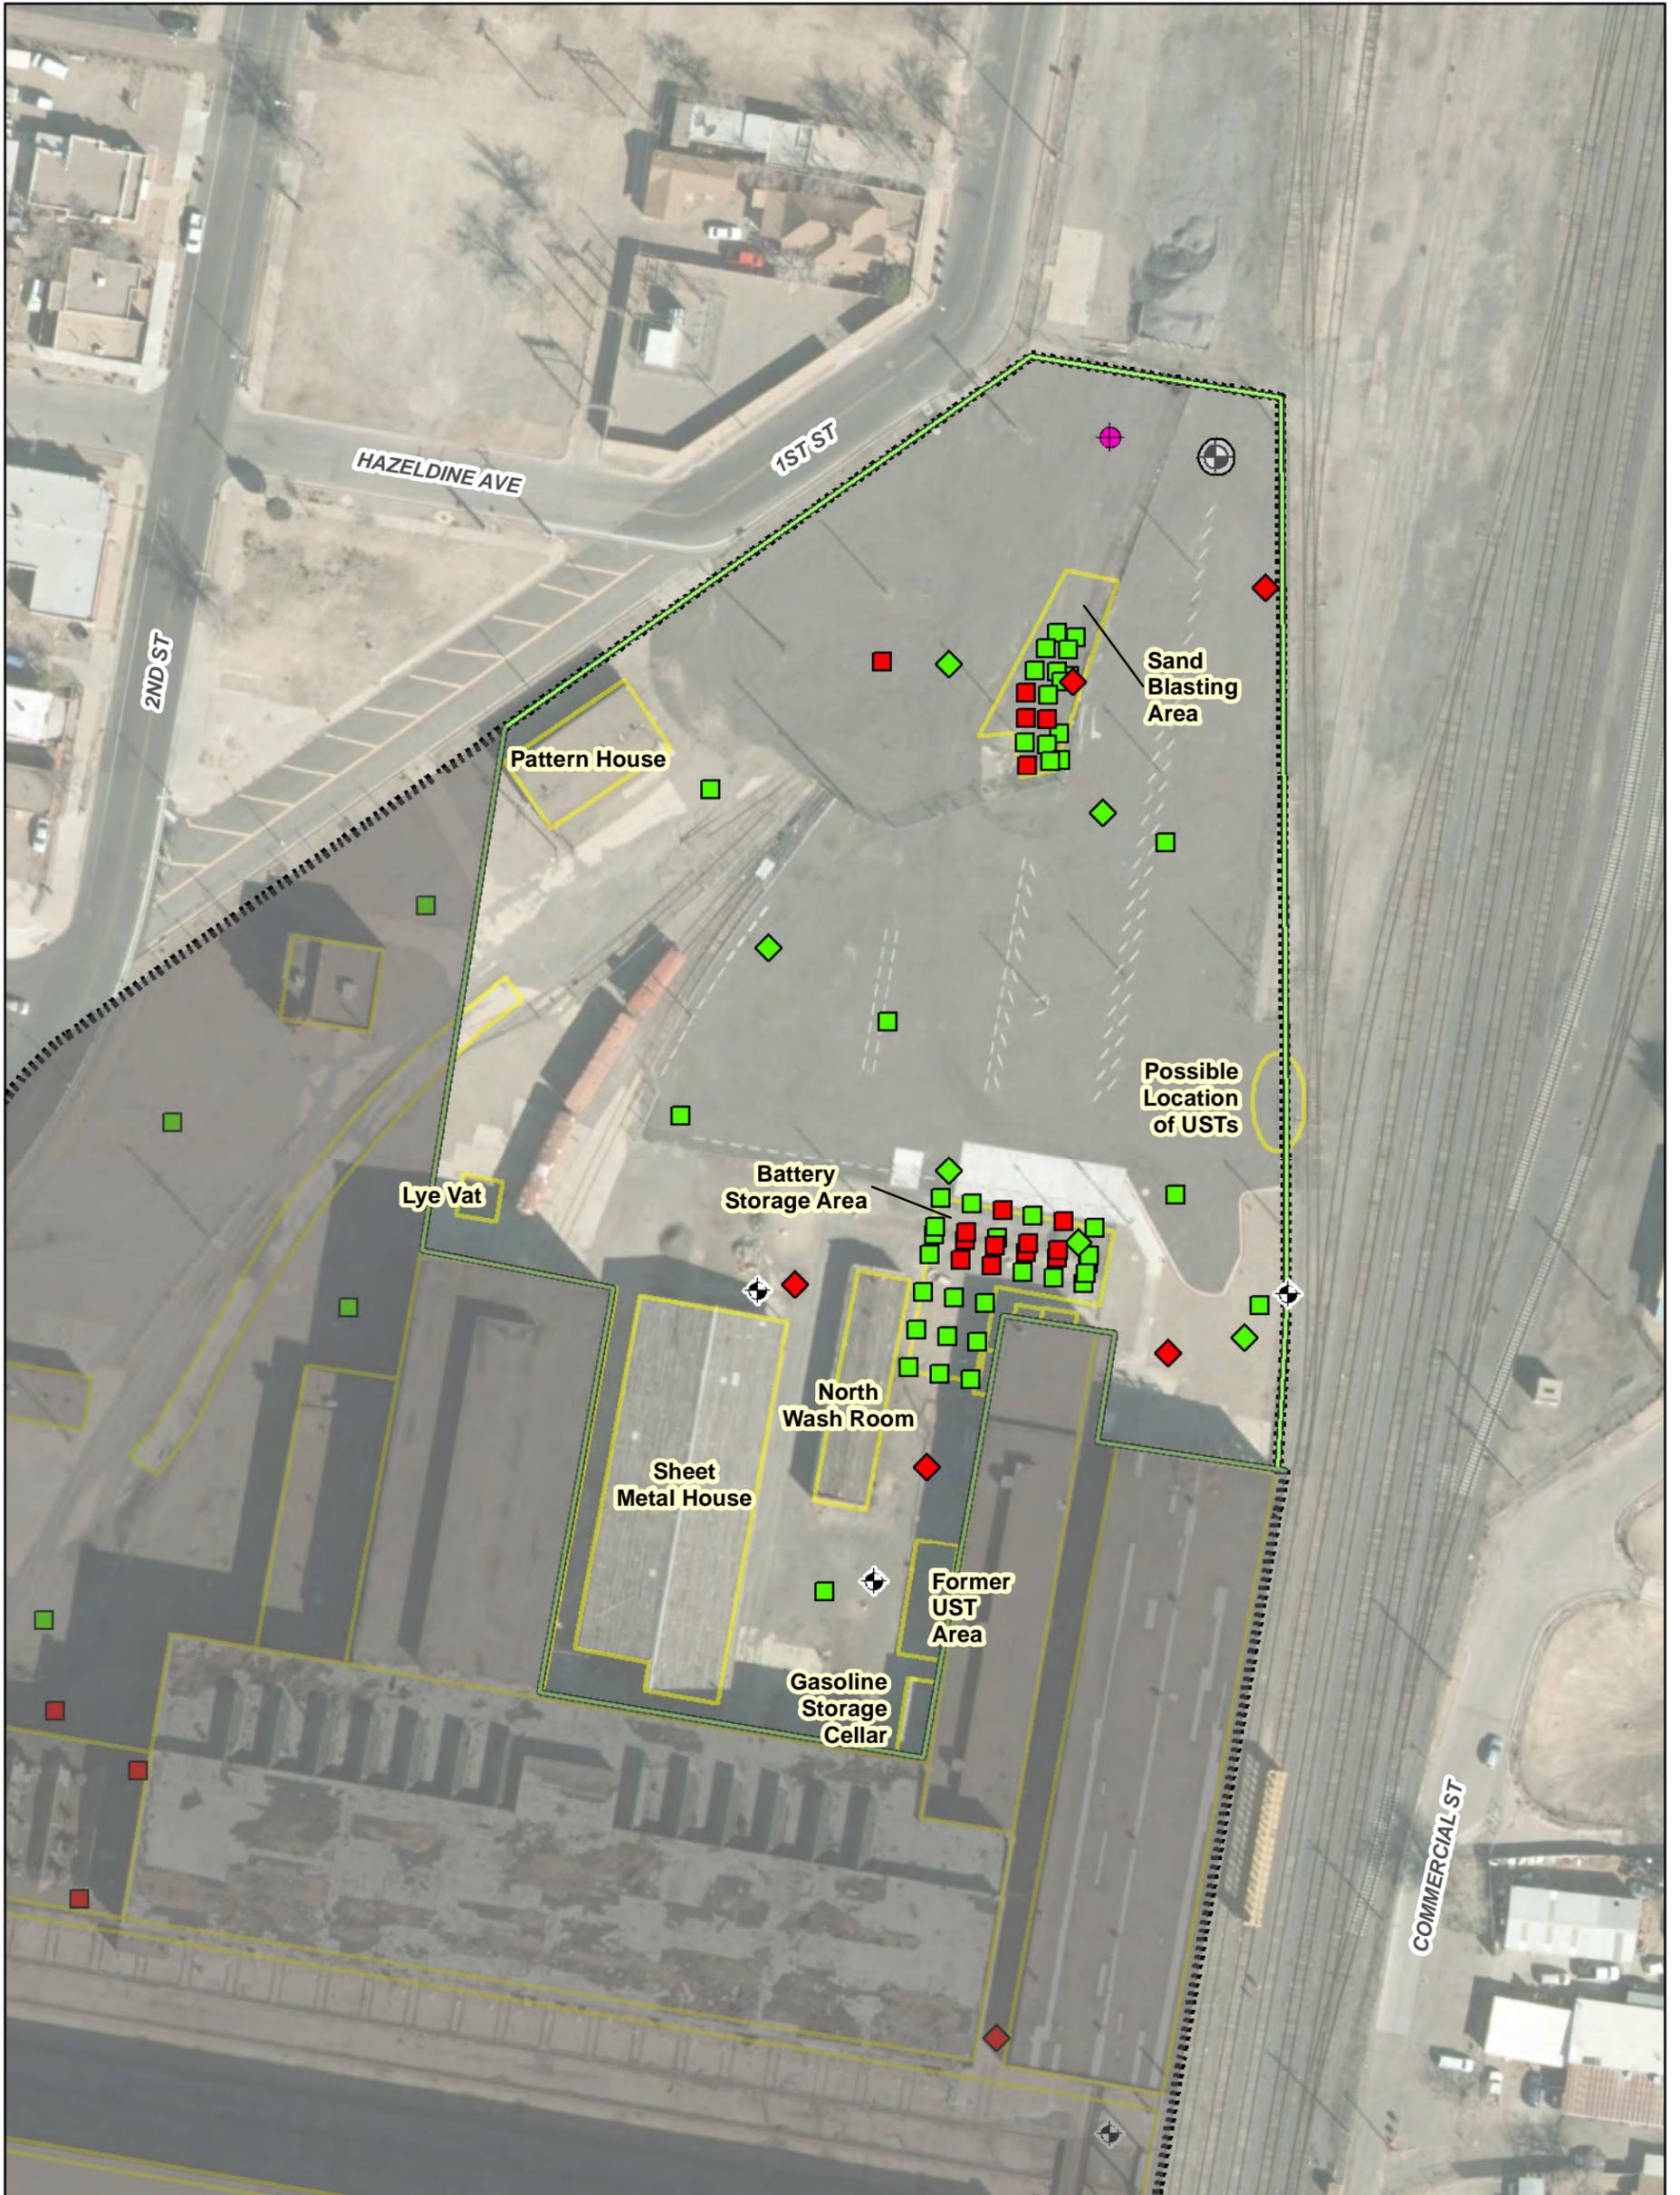
**Figure 3e**  
 Residential SSL Exceedances  
 (0-10 ft bgs), Lead  
 Additional Characterization,  
 Voluntary Remediation Program Activities,  
 Albuquerque Rail Yards, Albuquerque,  
 Bernalillo County, New Mexico

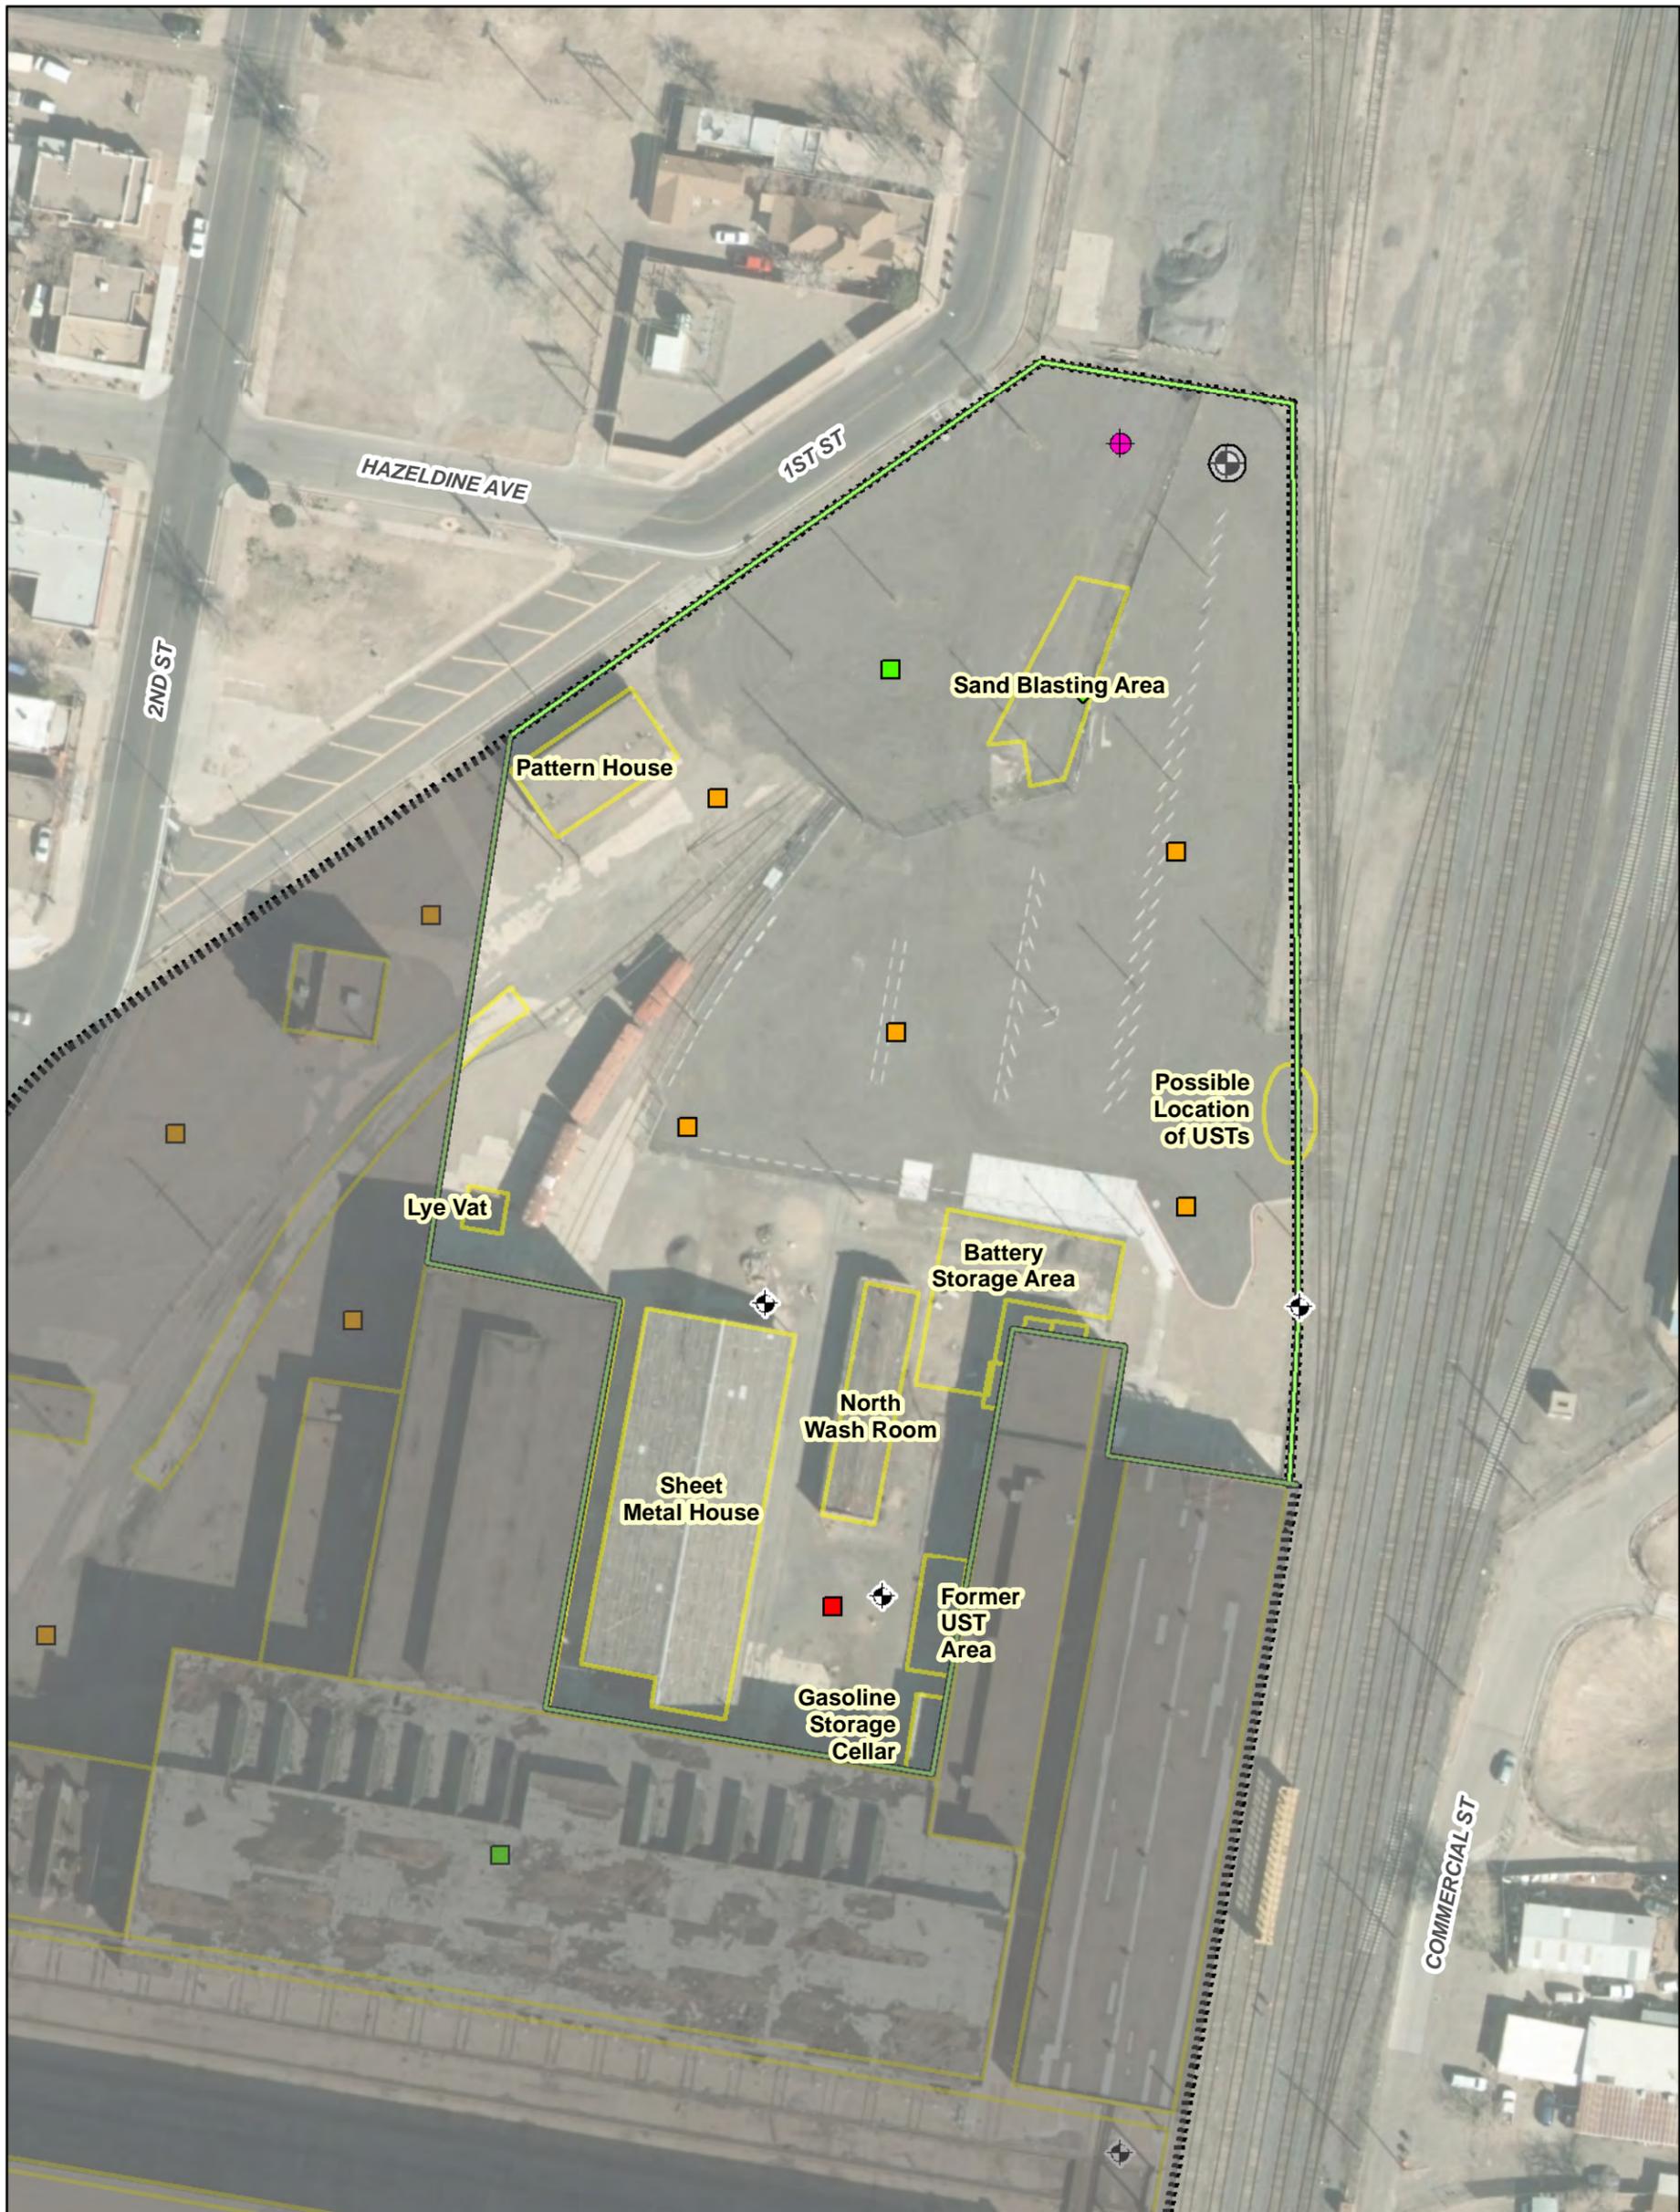
**Figure 3g**  
 Residential SSL Exceedances  
 (0-10 ft bgs), Thallium  
 Additional Characterization,  
 Voluntary Remediation Program Activities,  
 Albuquerque Rail Yards, Albuquerque,  
 Bernalillo County, New Mexico

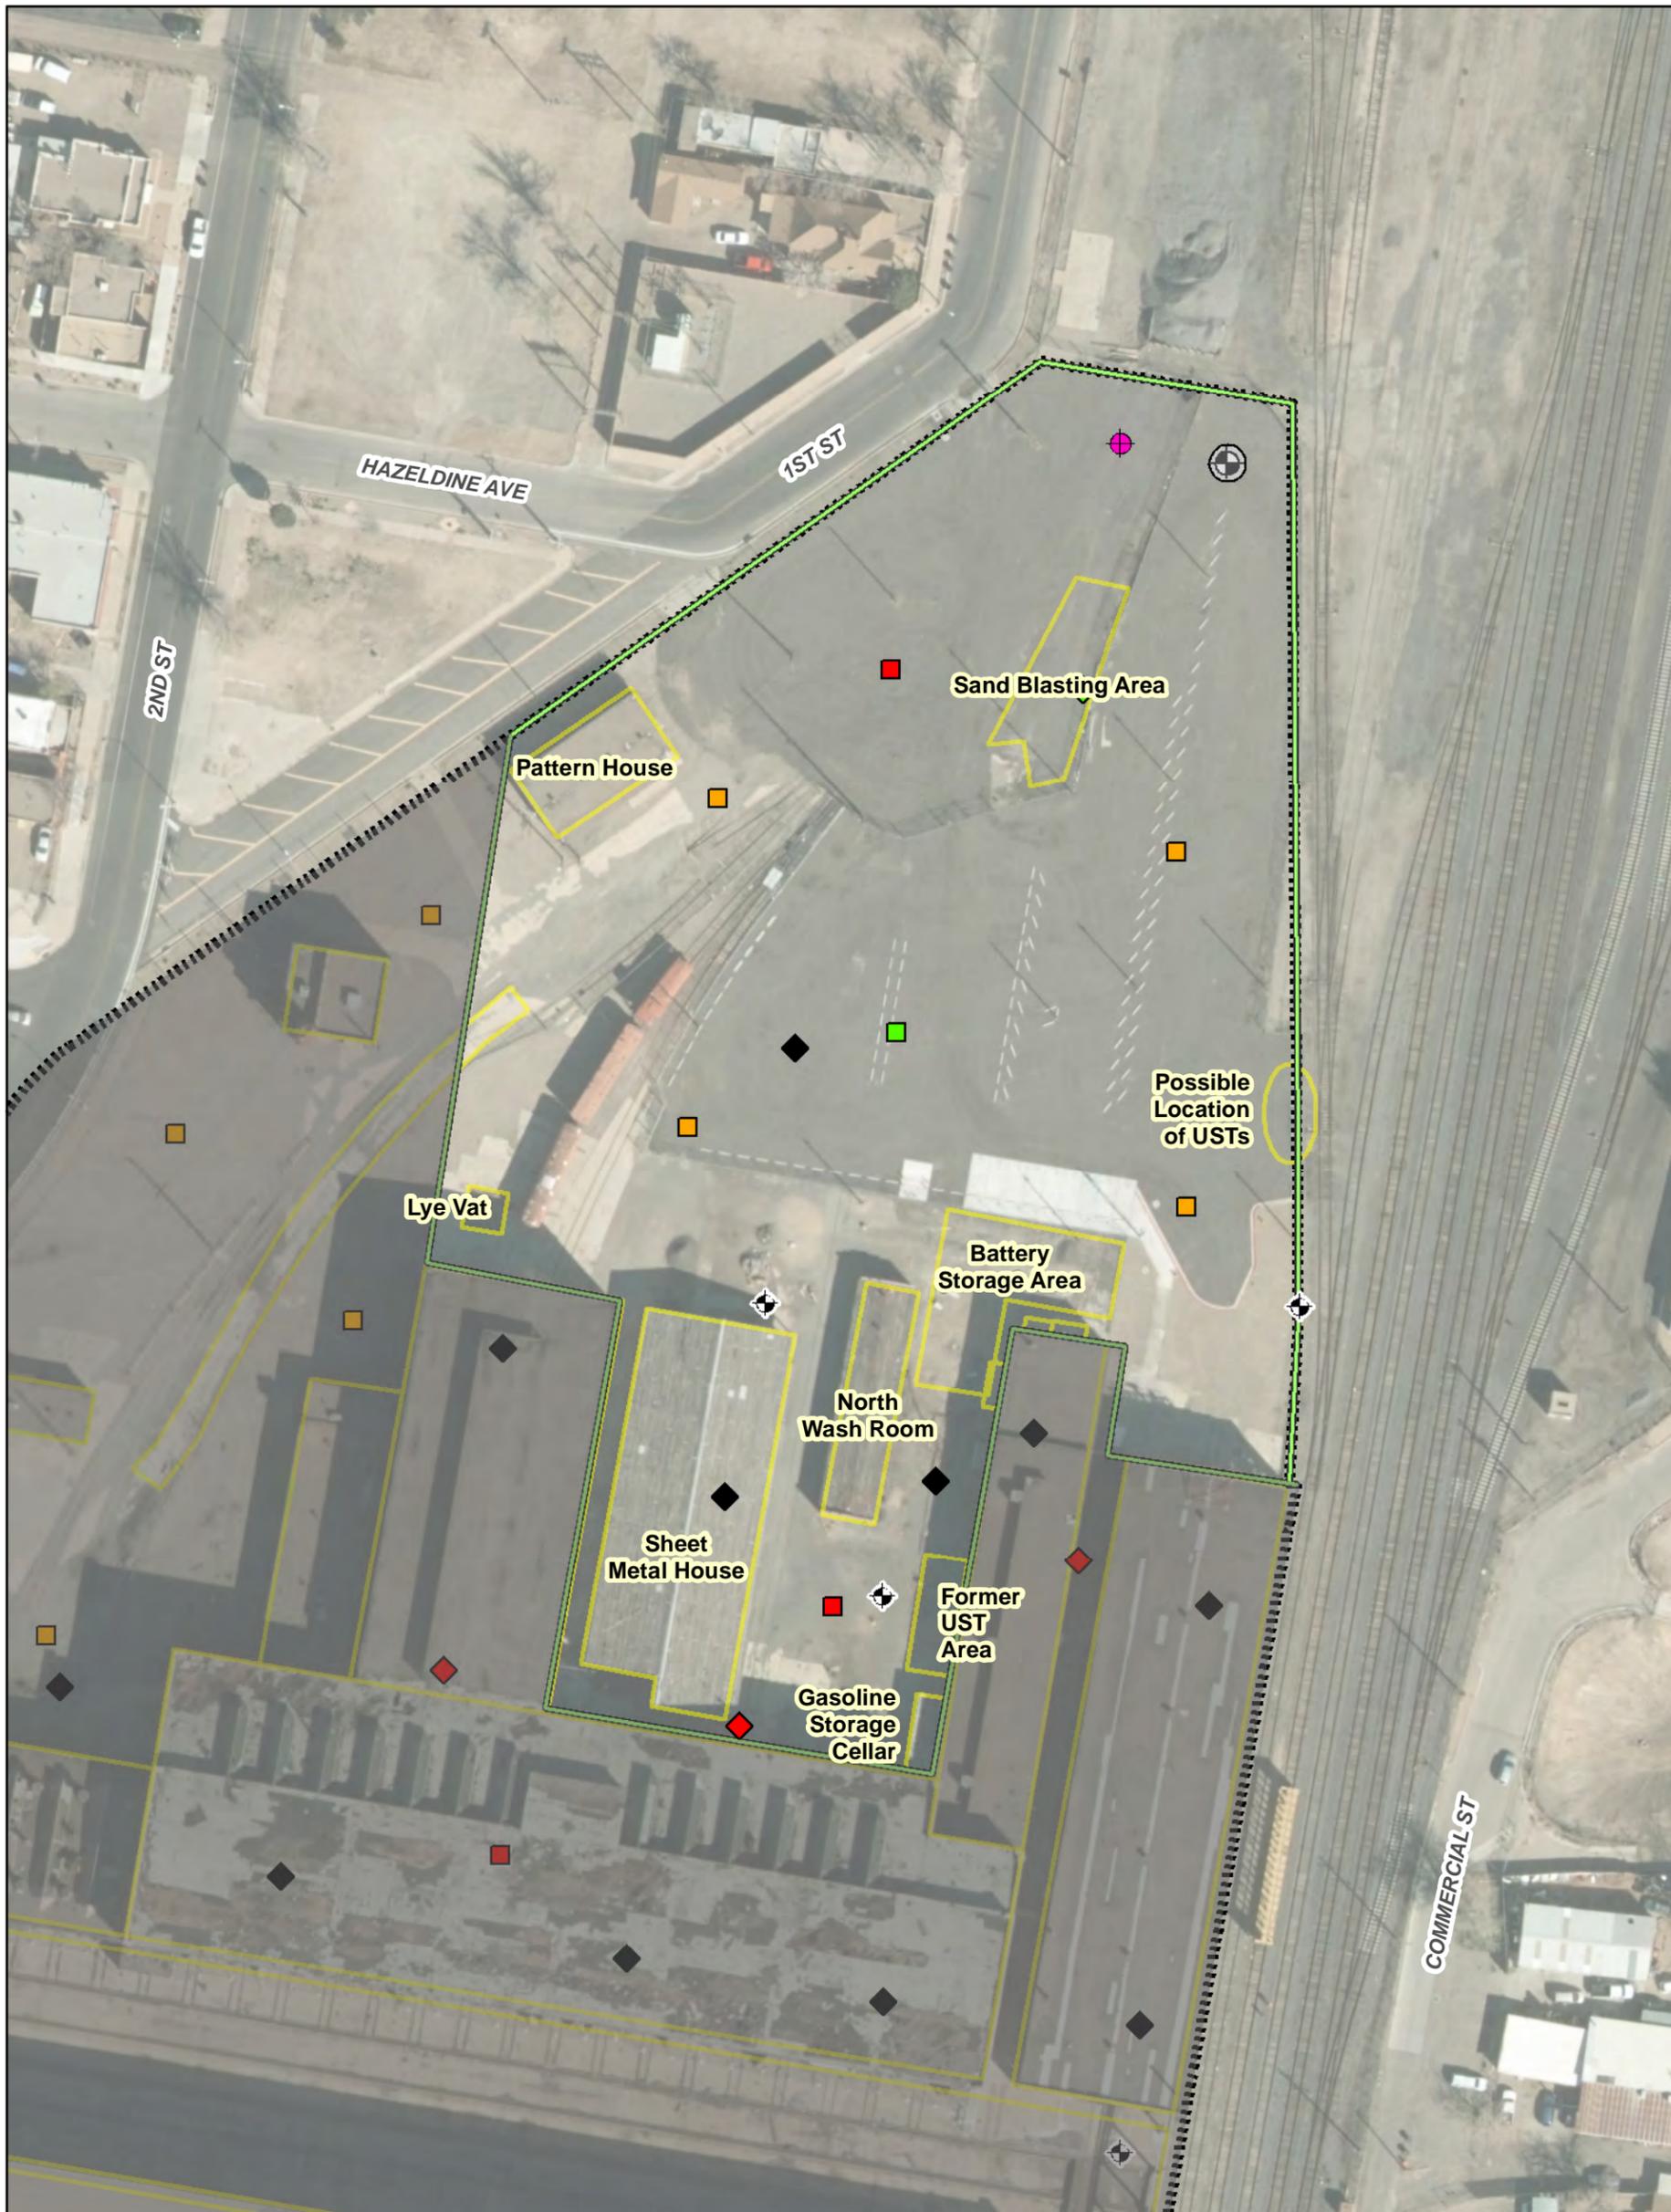
**Figure 4a**  
 Residential SSL Exceedances  
 (0-10 ft bgs), Benzo(a)anthracene  
 Additional Characterization,  
 Voluntary Remediation Program Activities,  
 Albuquerque Rail Yards, Albuquerque,  
 Bernalillo County, New Mexico

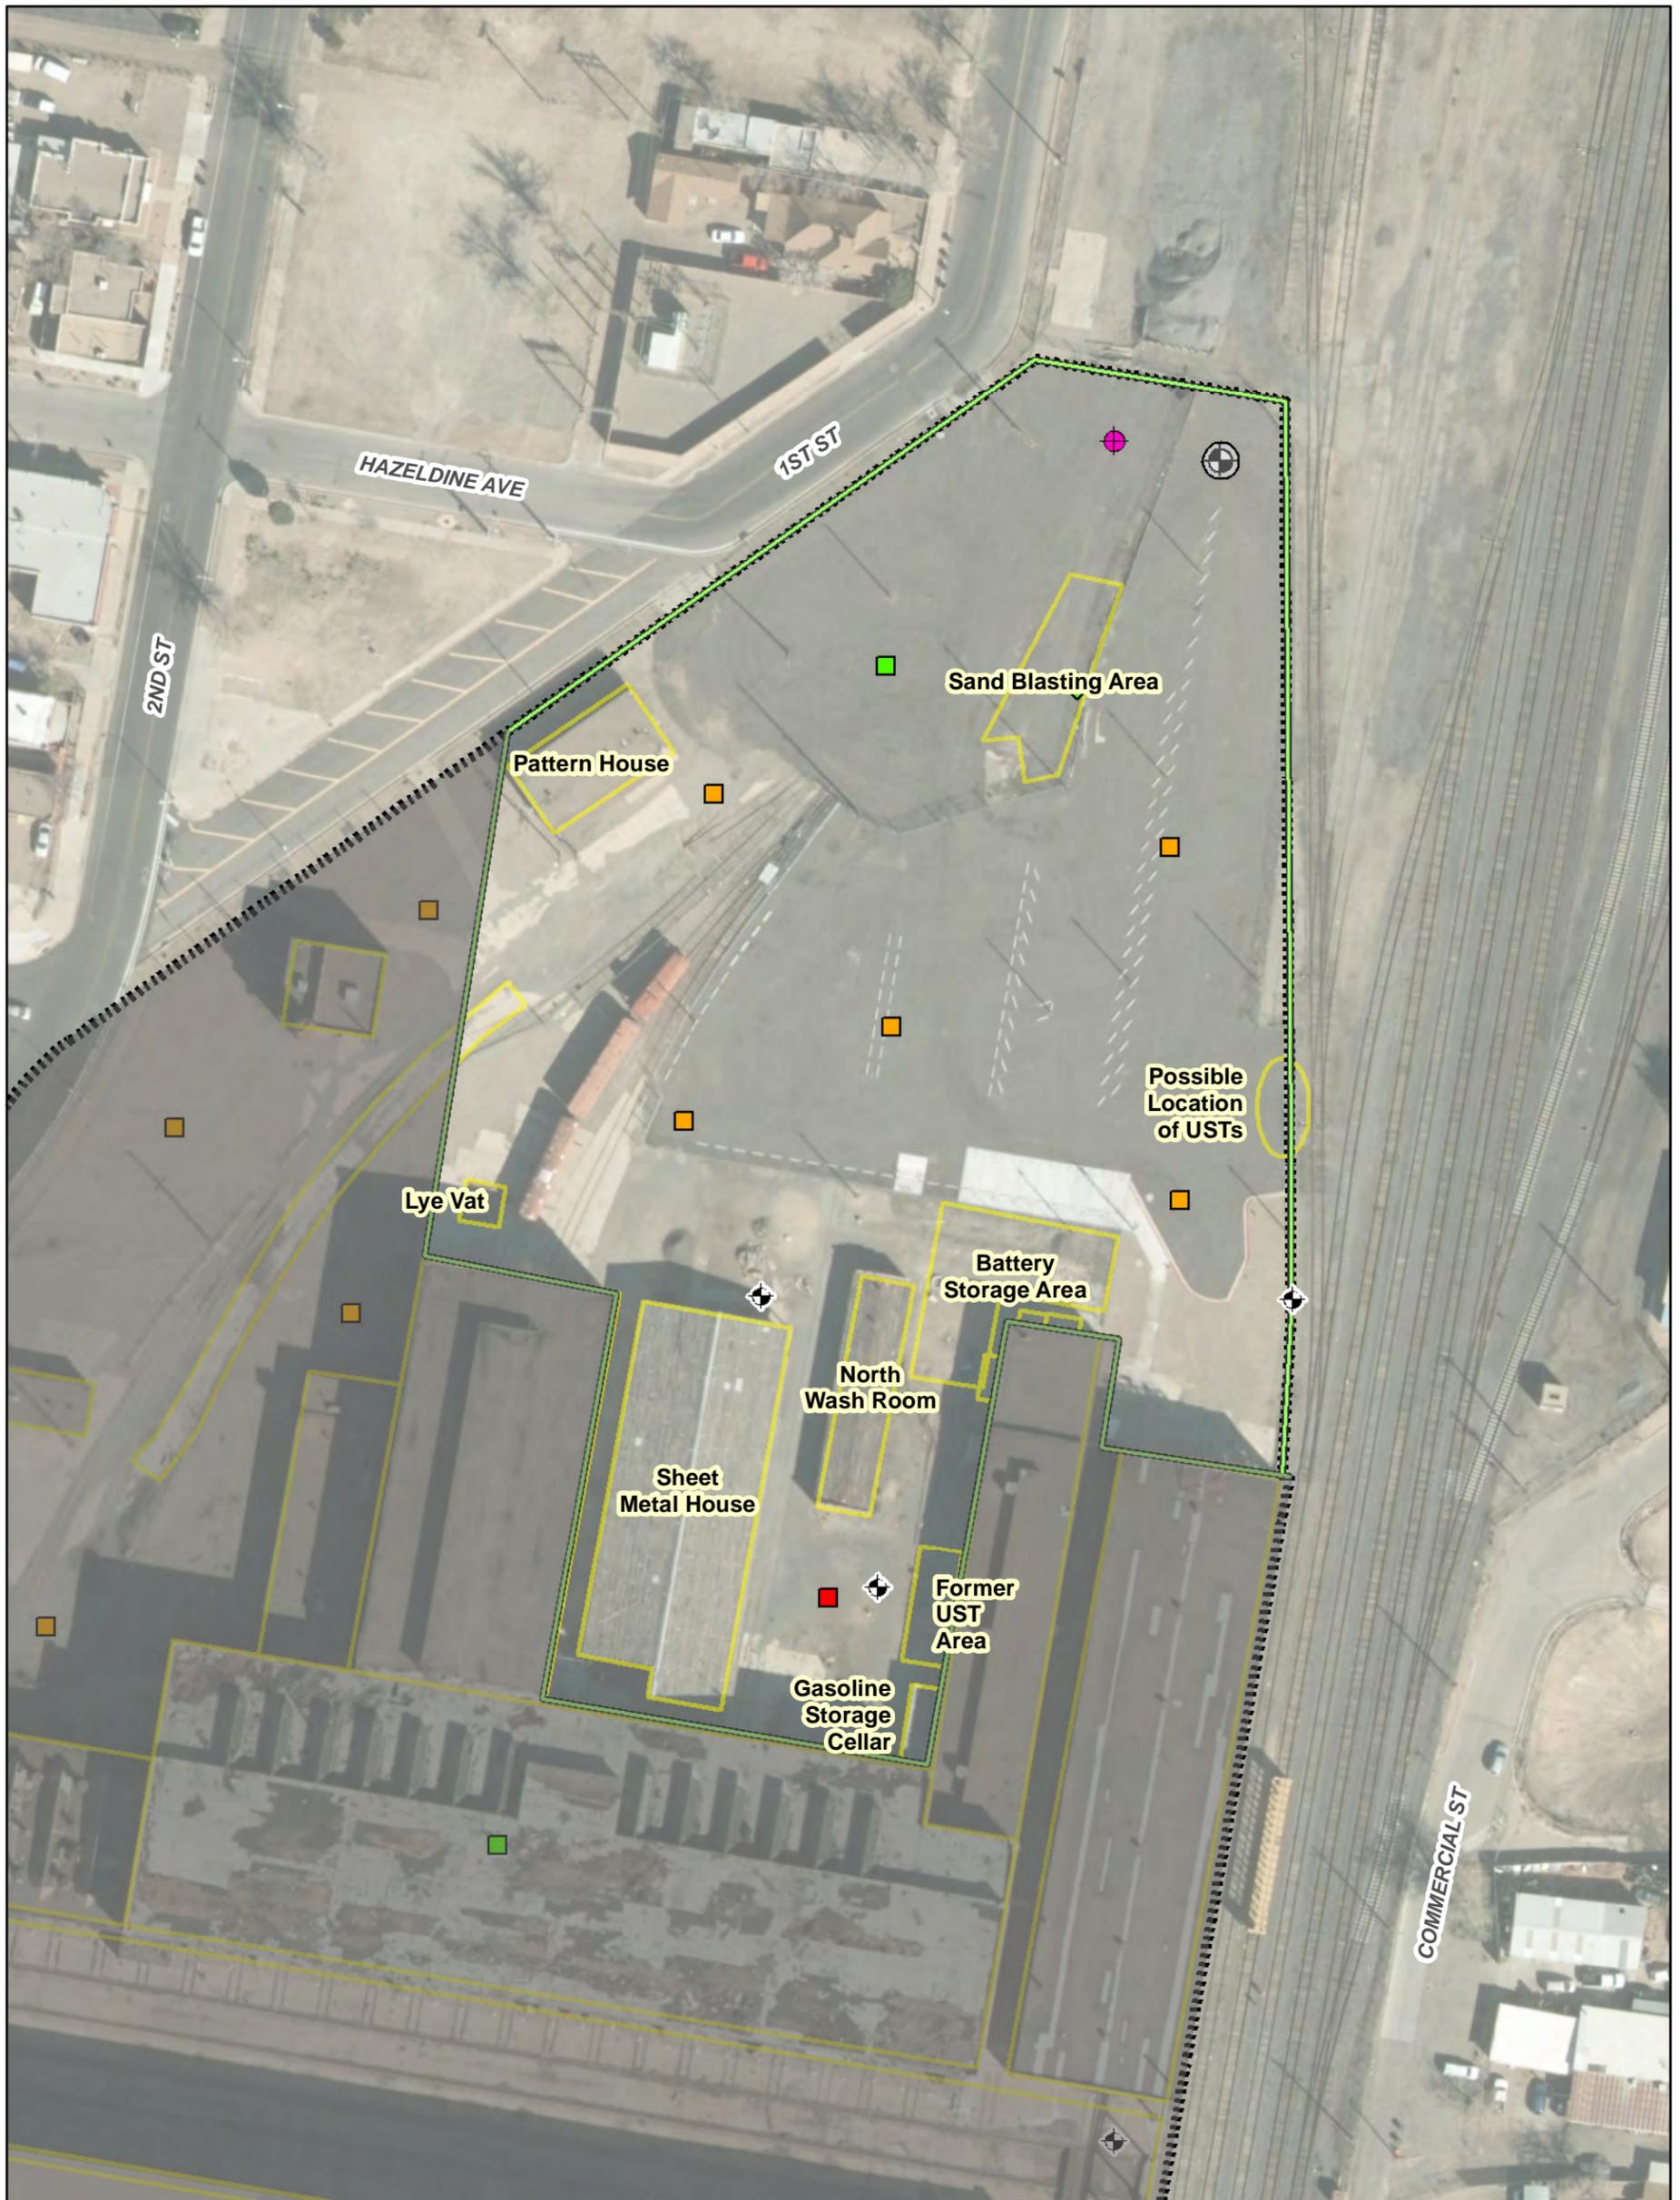
**Figure 4b**  
 Residential SSL Exceedances  
 (0-10 ft bgs), Benzo(a)pyrene  
 Additional Characterization,  
 Voluntary Remediation Program Activities,  
 Albuquerque Rail Yards, Albuquerque,  
 Bernalillo County, New Mexico

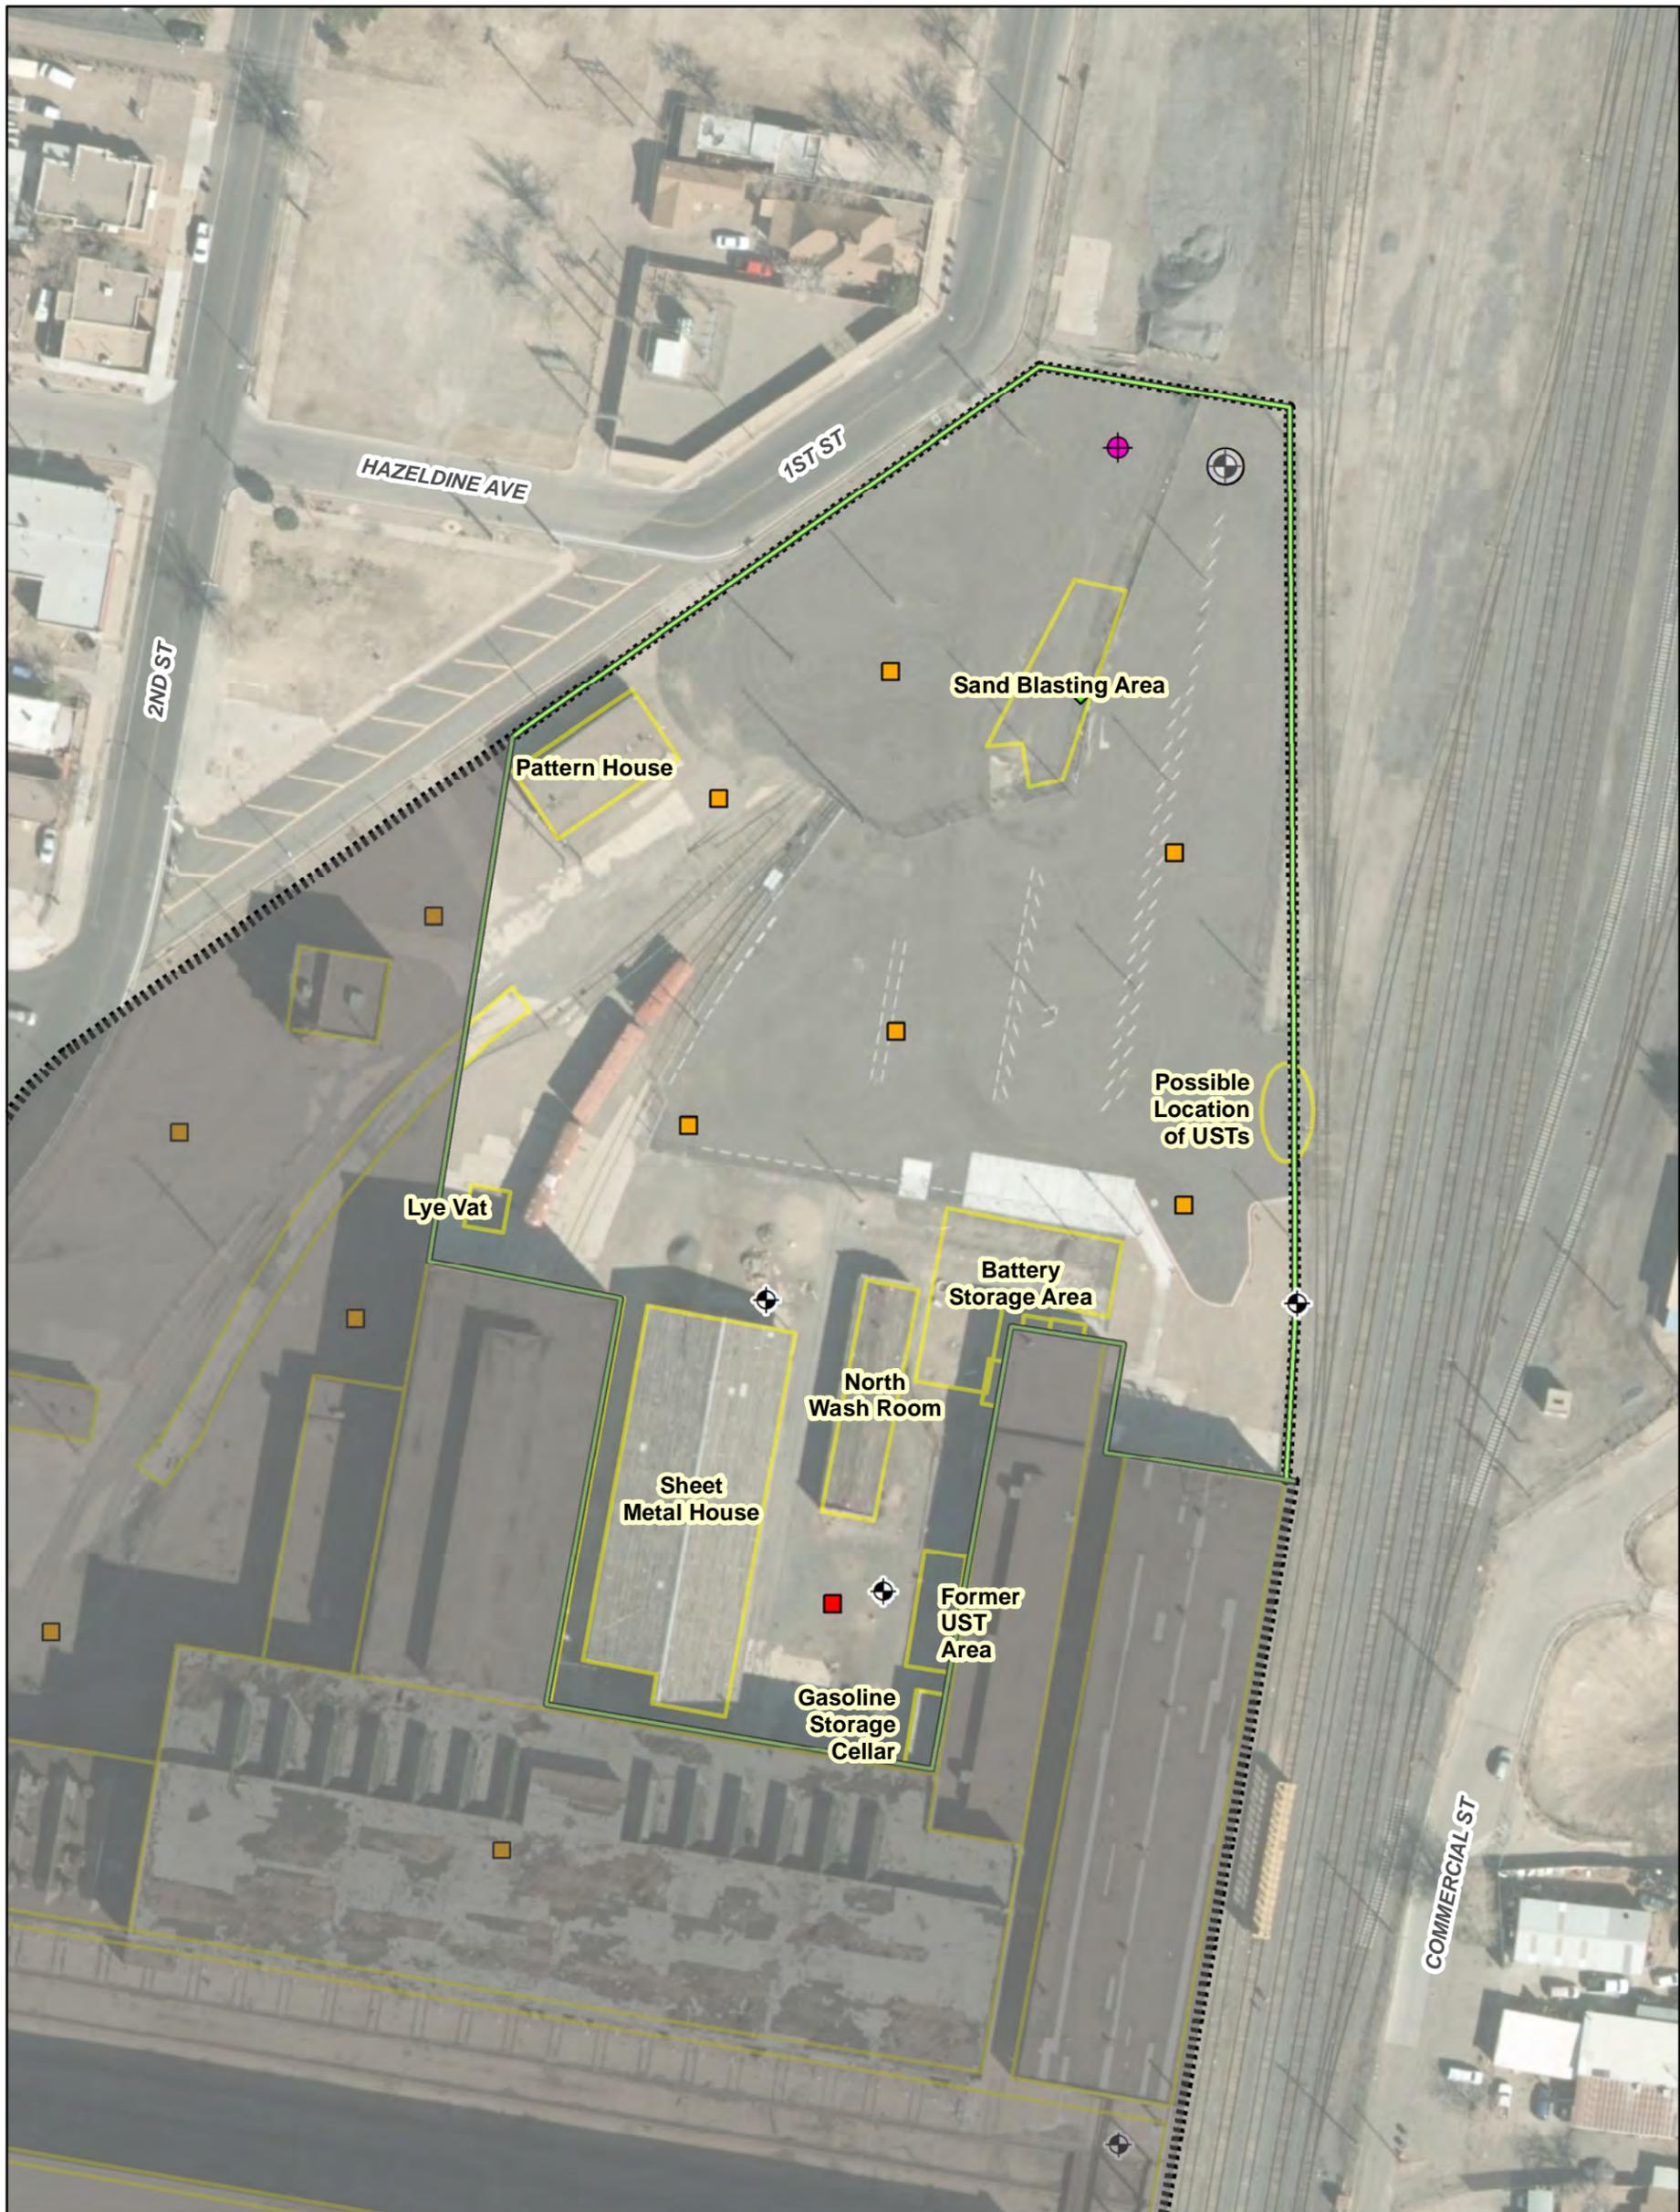
**Figure 4c**  
 Residential SSL Exceedances  
 (0-10 ft bgs), Benzo(b)fluoranthene  
 Additional Characterization,  
 Voluntary Remediation Program Activities,  
 Albuquerque Rail Yards, Albuquerque,  
 Bernalillo County, New Mexico

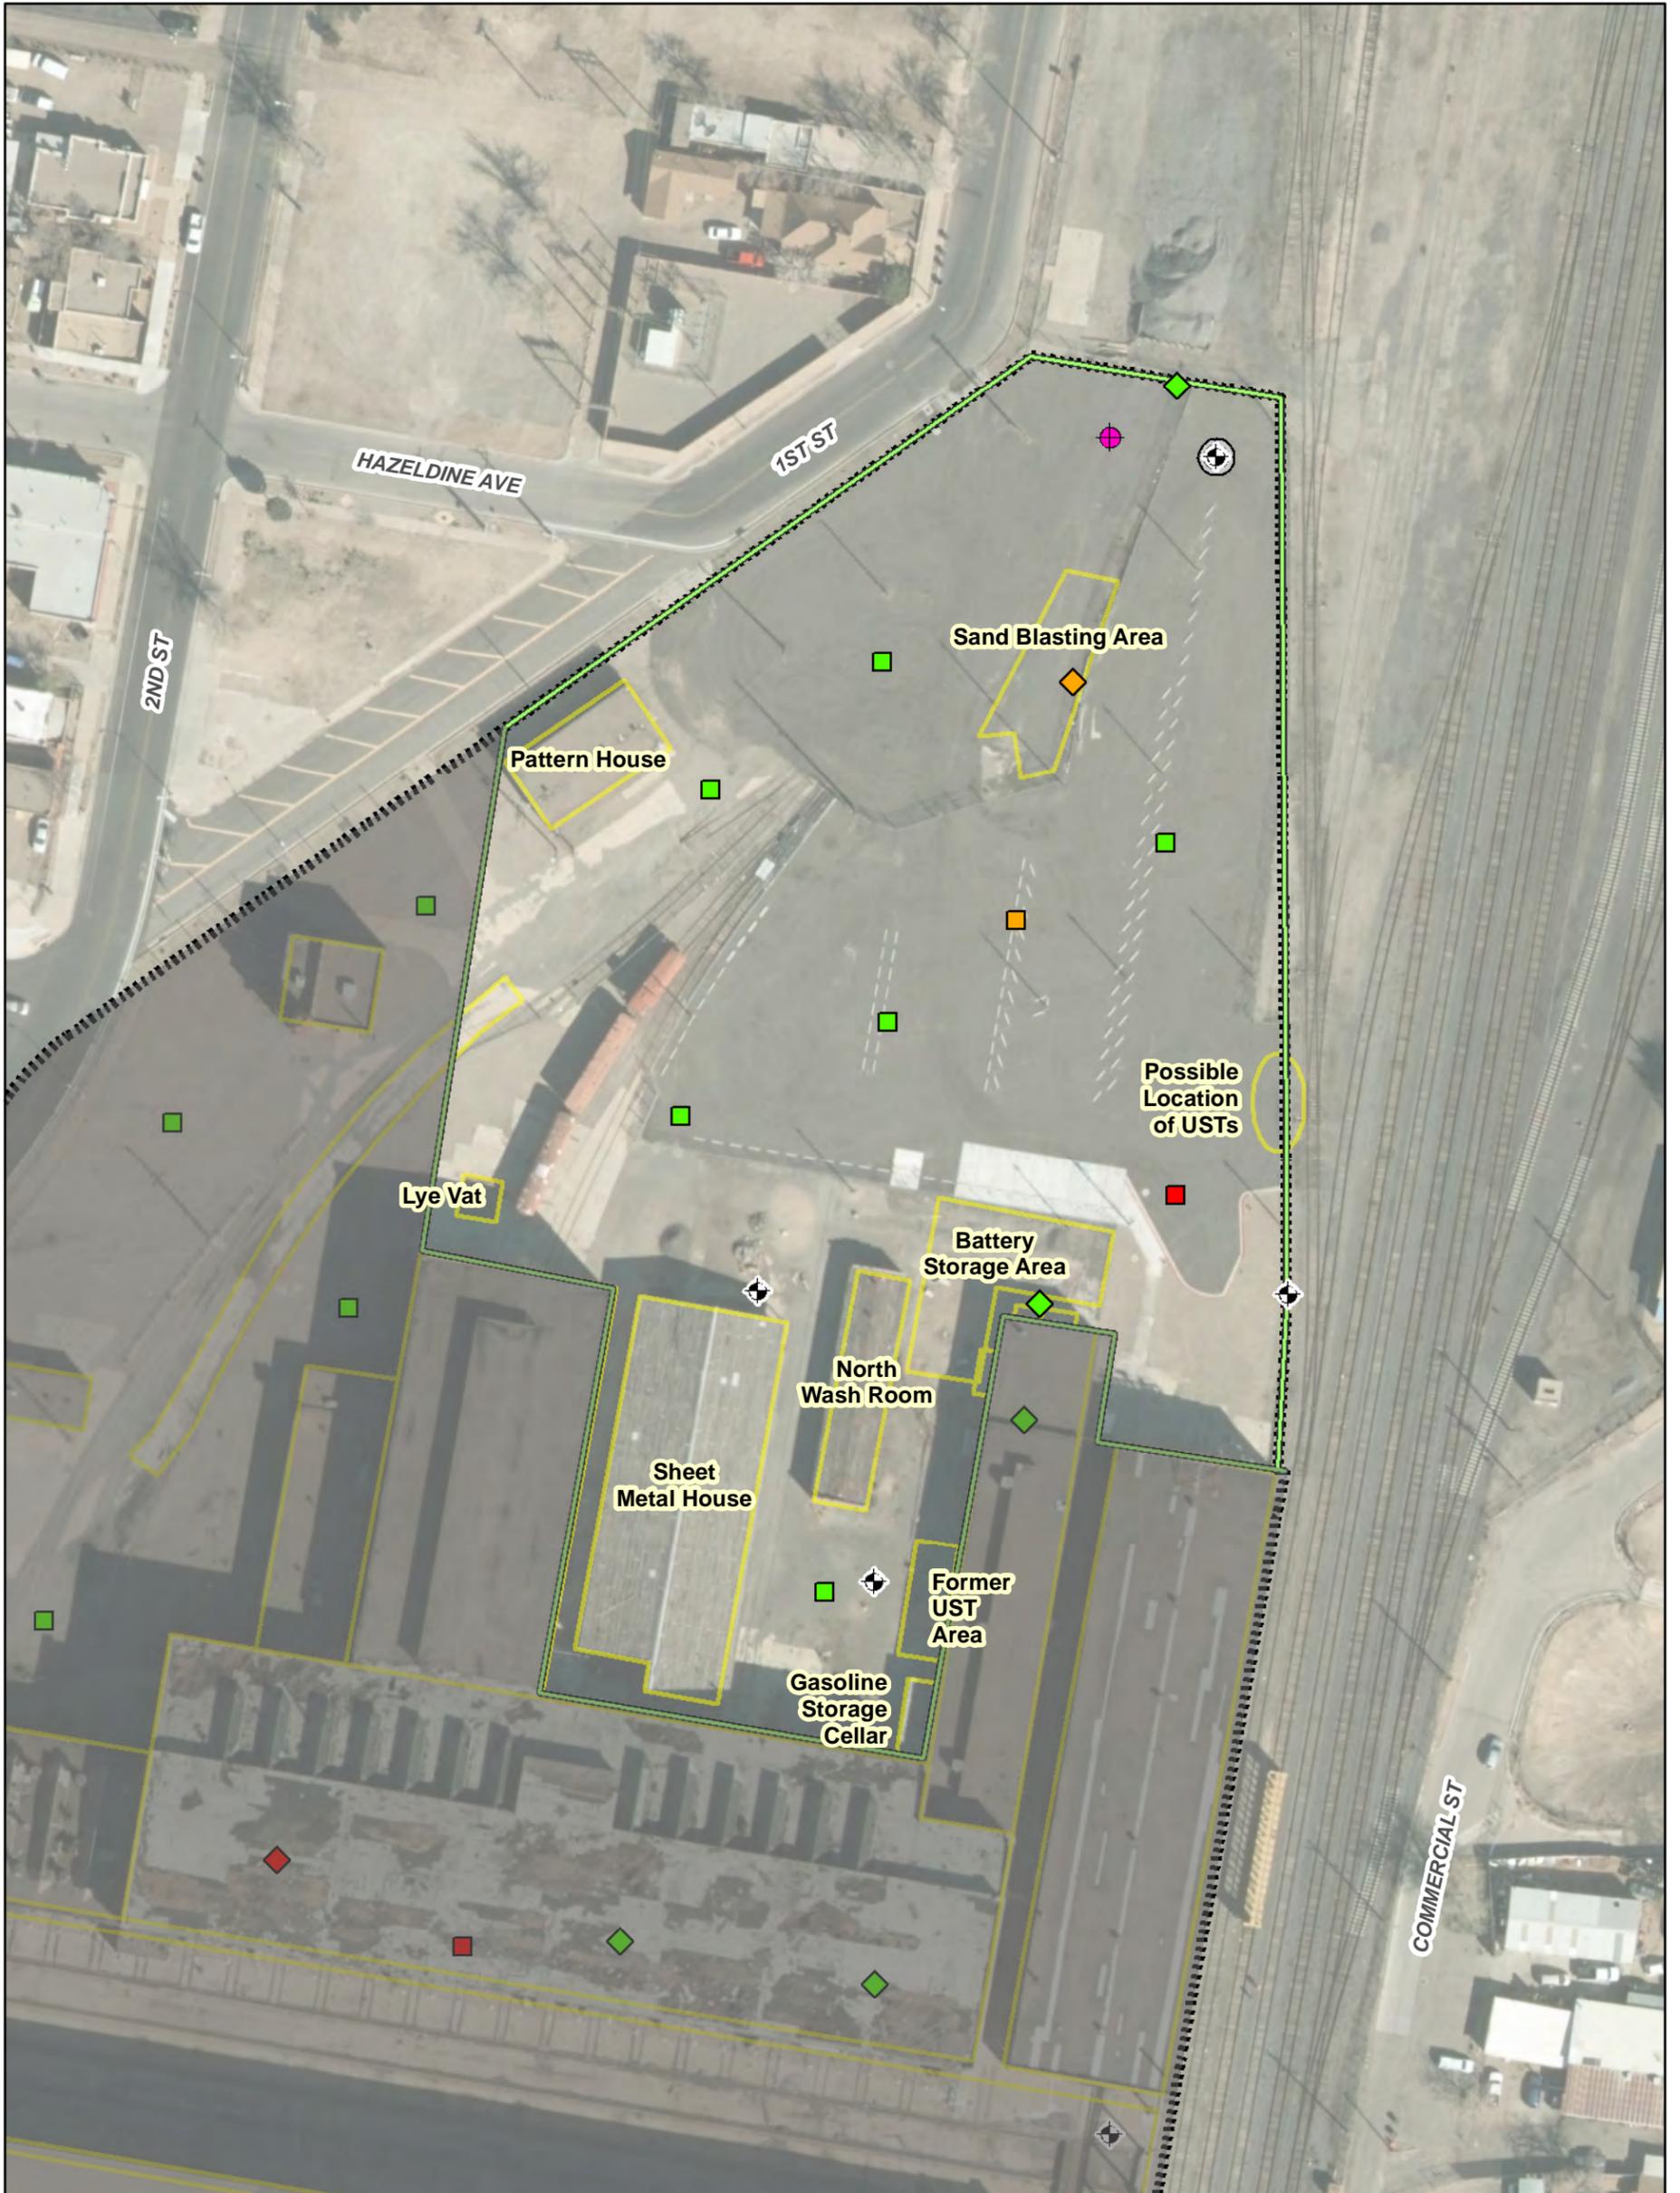
**Figure 4e**  
 Residential SSL Exceedances  
 (0-10 ft bgs), Indeno(1,2,3-cd)pyrene  
 Additional Characterization,  
 Voluntary Remediation Program Activities,  
 Albuquerque Rail Yards, Albuquerque,  
 Bernalillo County, New Mexico
