**Voluntary Remediation Program  
Status Report  
City of Albuquerque Rail Yards  
VRP Site No. 53161007**

**Prepared for: NMED Ground Water Quality Bureau**

**Prepared by: Environmental Services Division  
Albuquerque Environmental Health Department**

**July 2019**

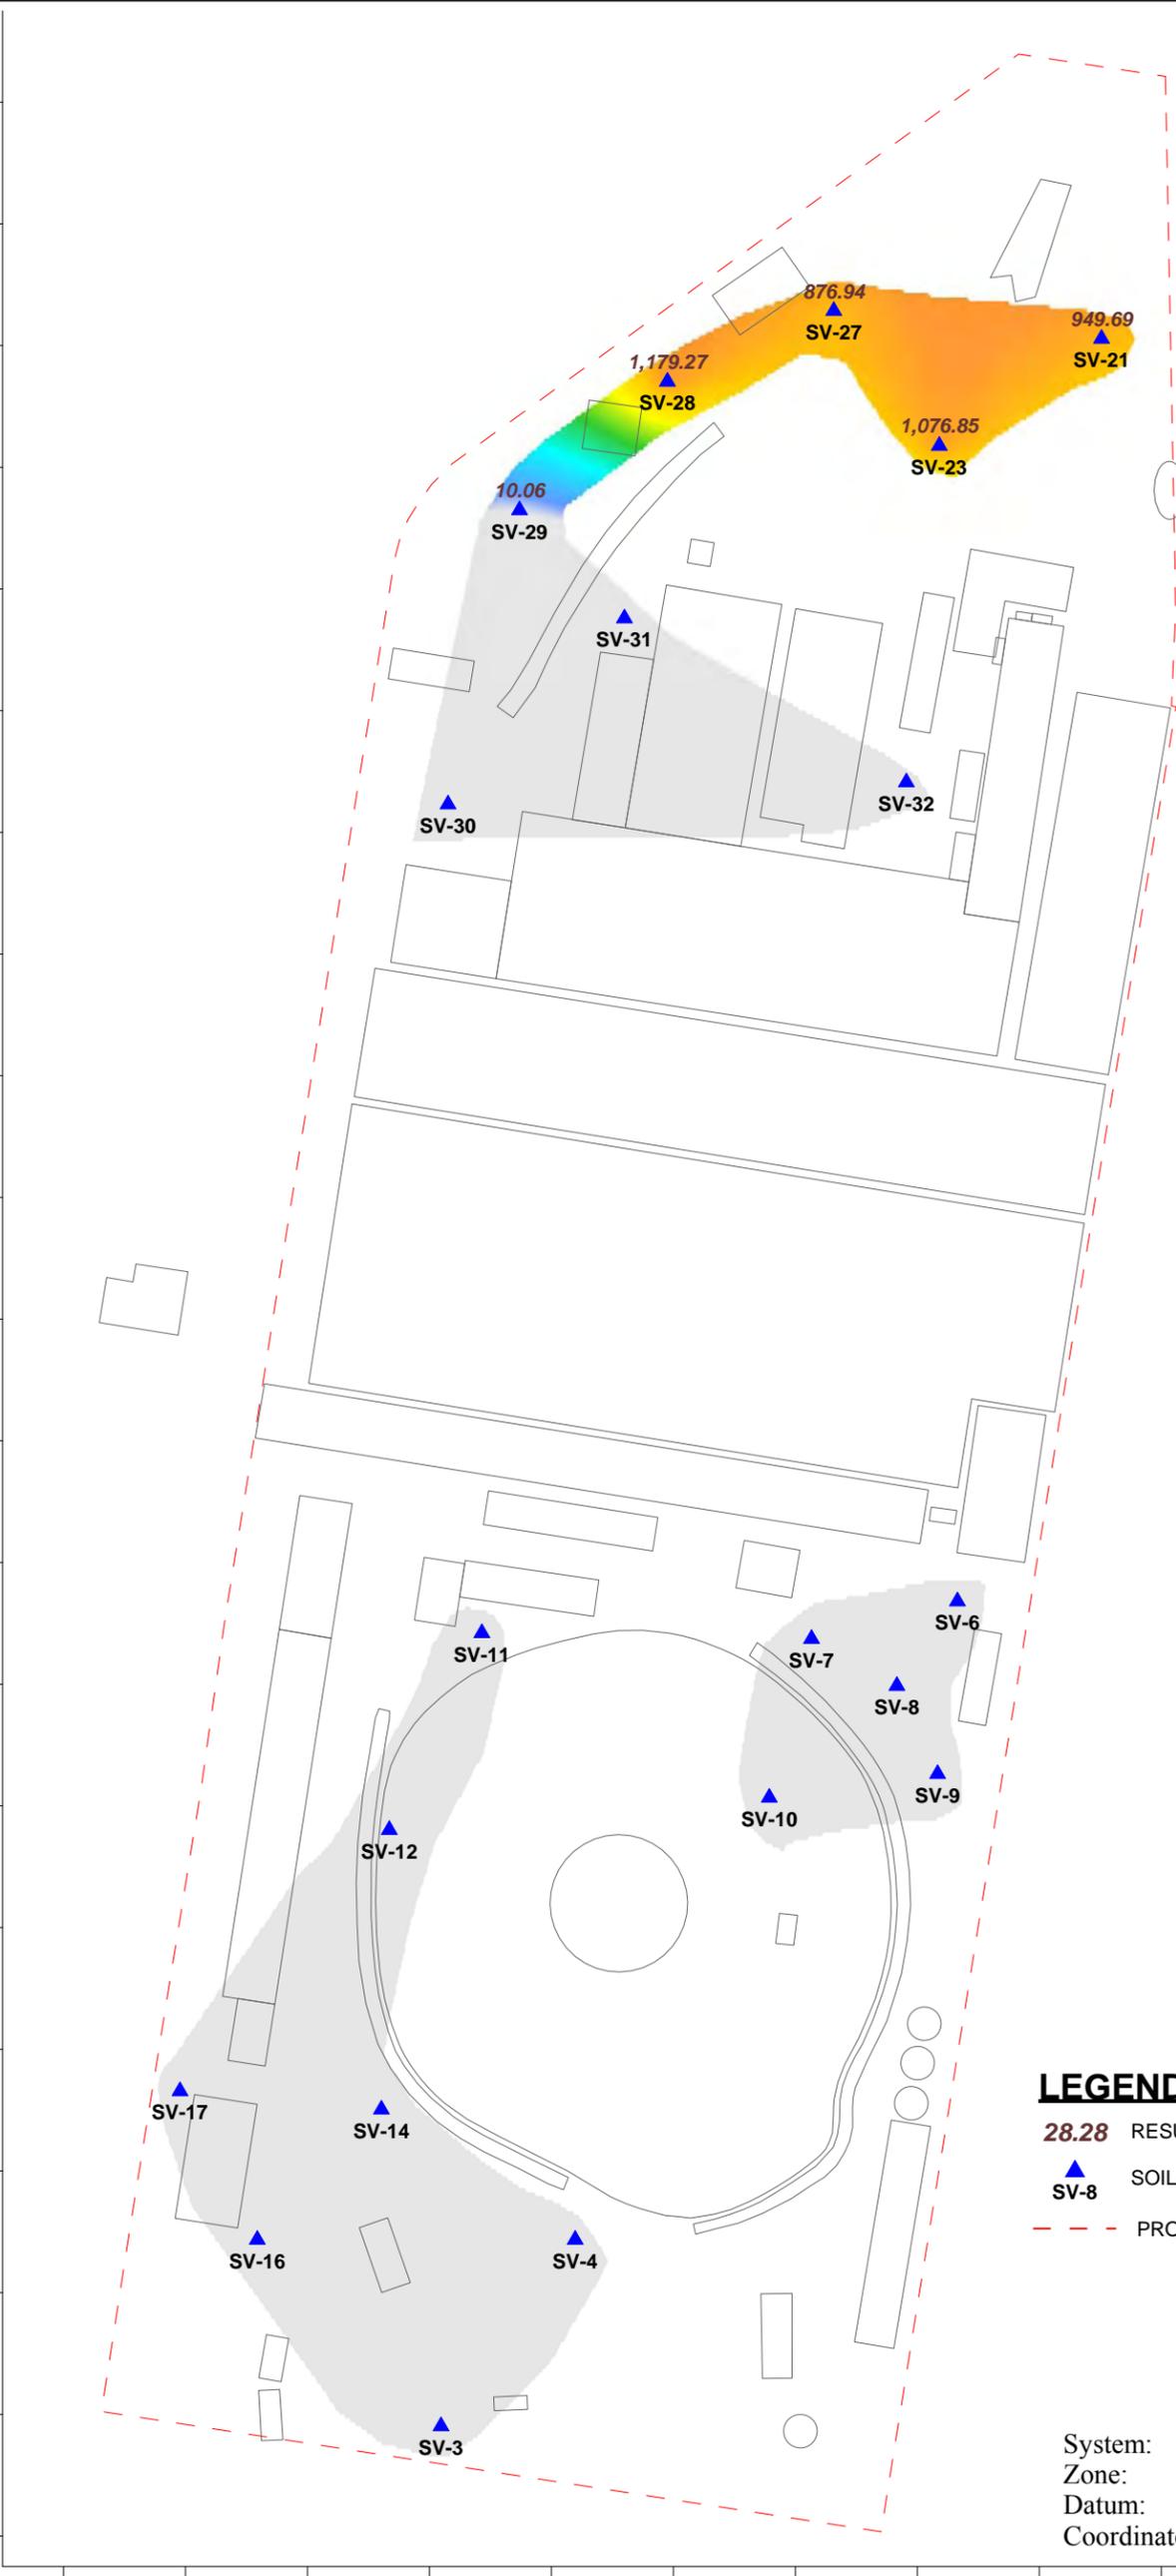
**Figure 3**  
**Soil-Gas Survey**  
**Naphthalene**  
**Albuquerque Railyards**  
**Albuquerque, NM**

- 28.28** RESULT IN  $\mu\text{g}/\text{m}^3$
- SV-8** SOIL-GAS SAMPLE LOCATION
- - - PROPERTY BOUNDARY

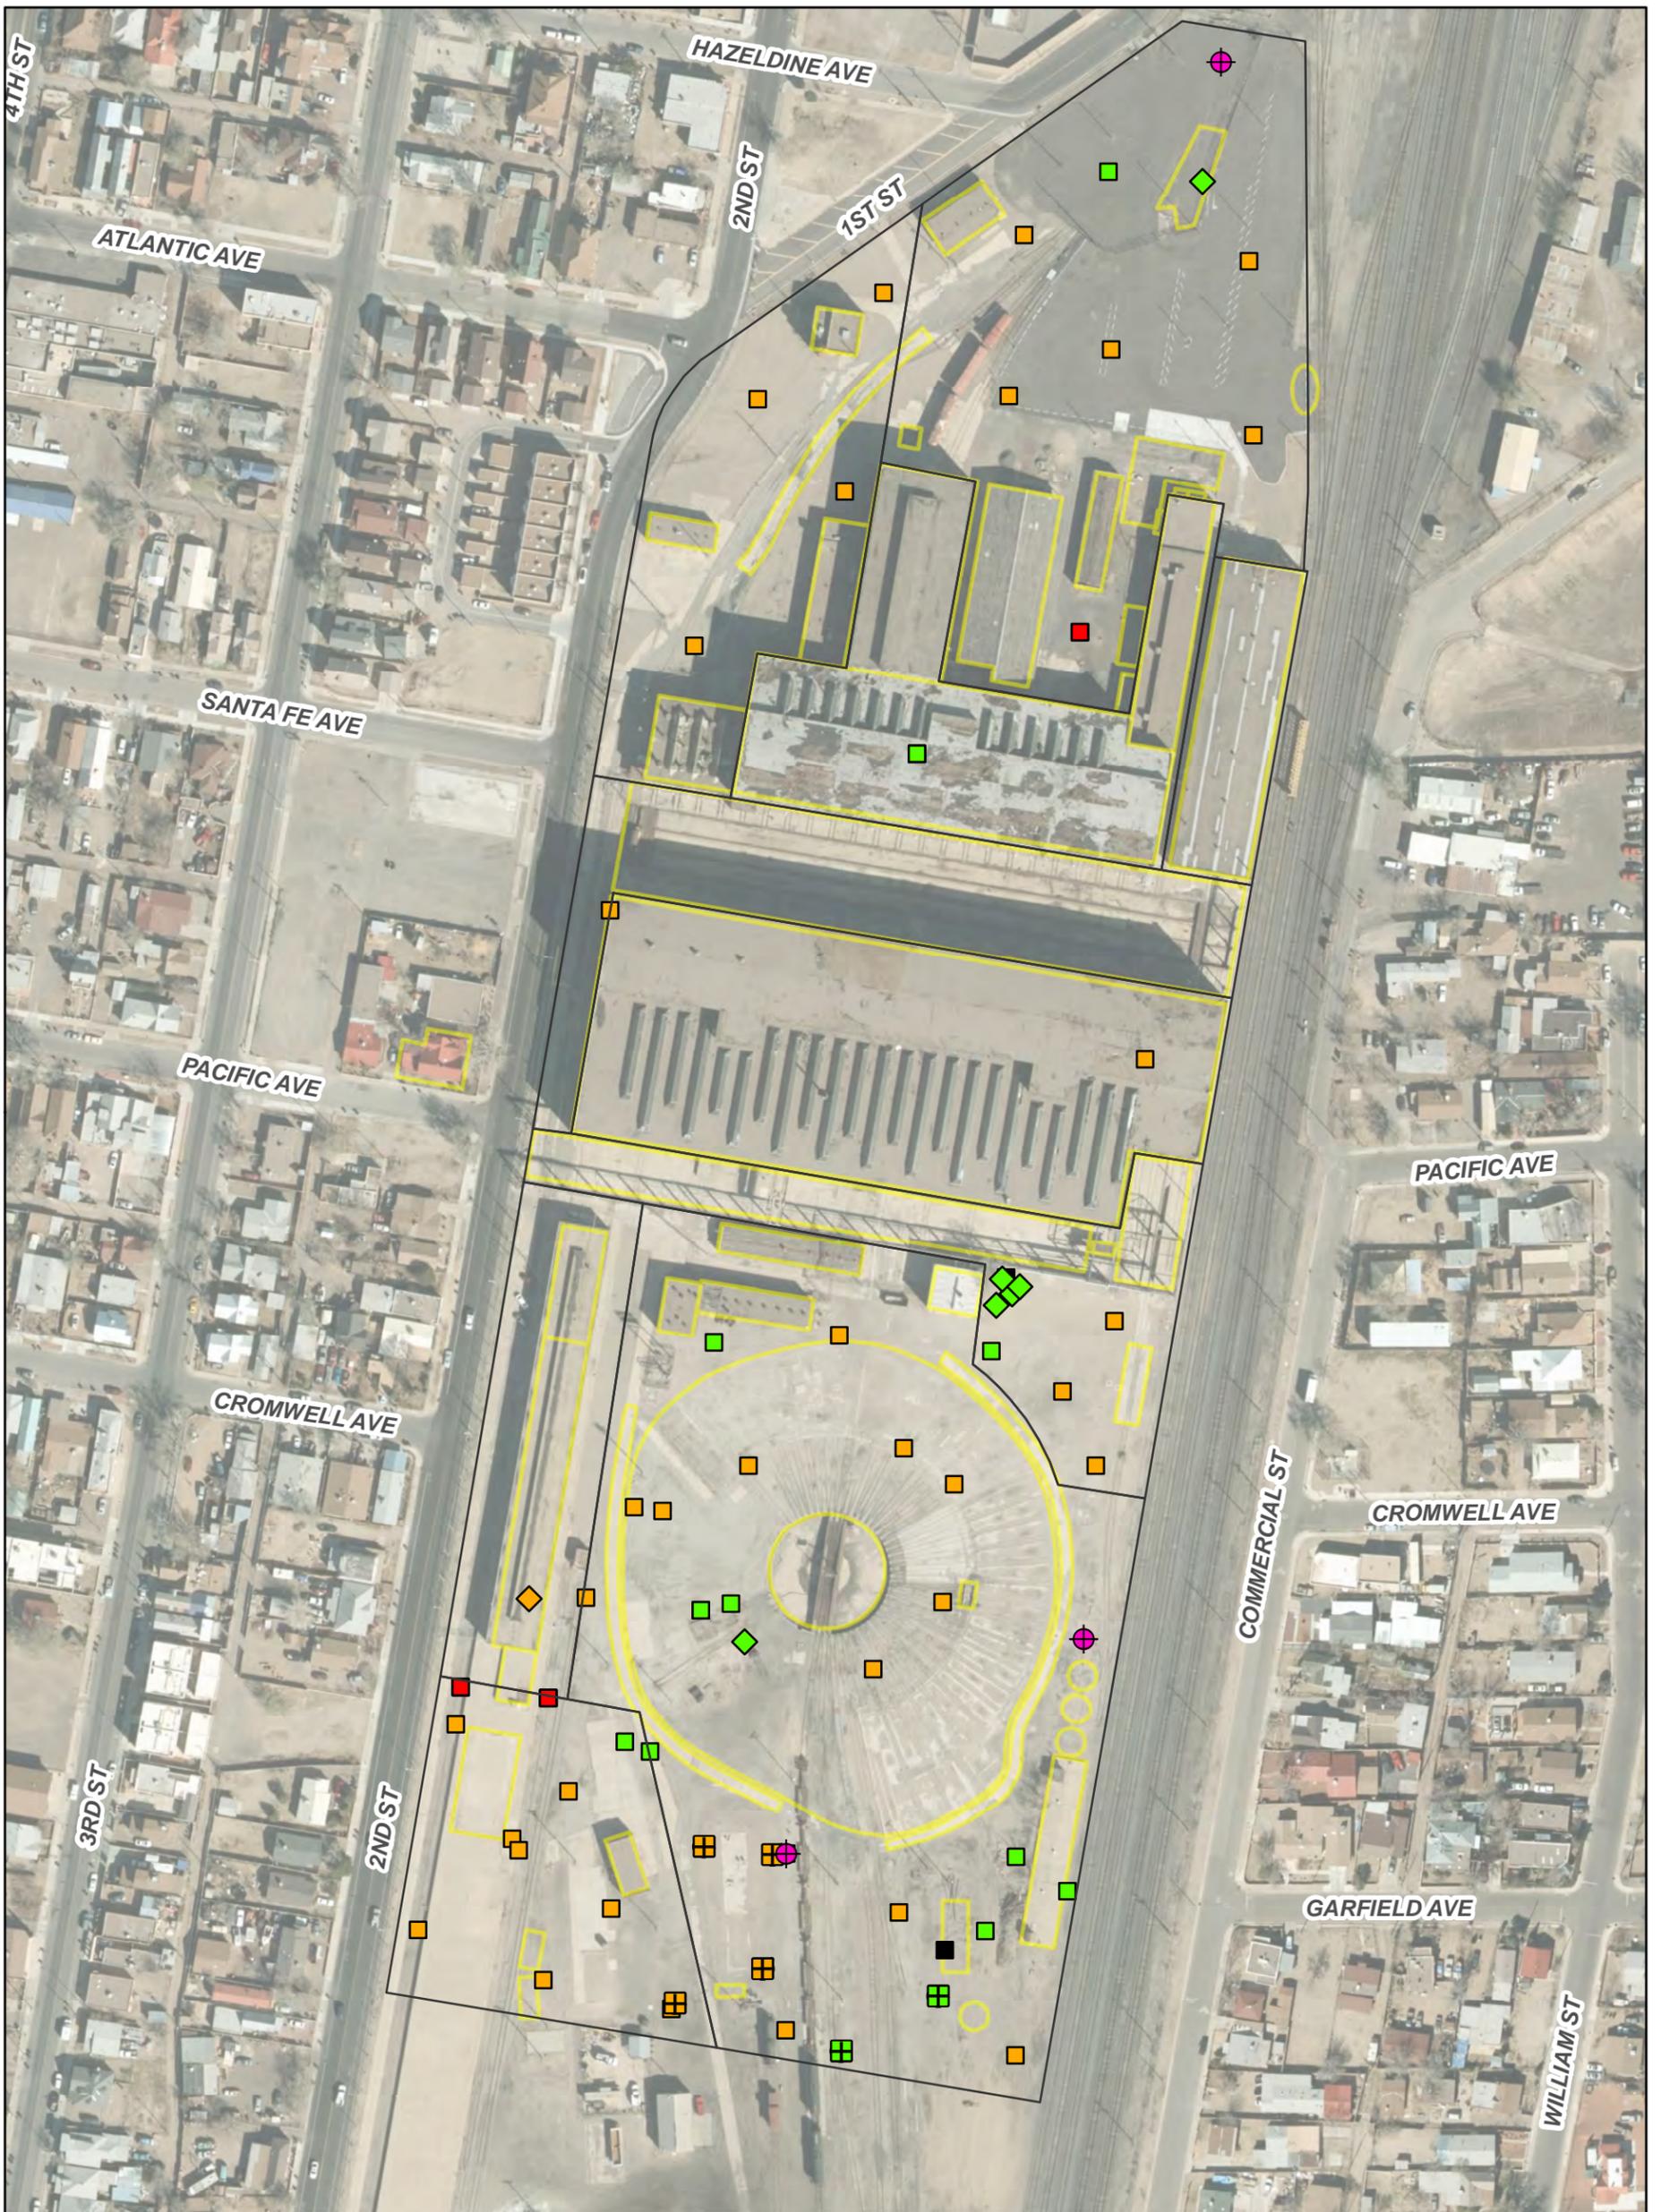
**Residential SSL Exceedances (0-10 ft bgs), Arsenic**  
 Additional Characterization, Voluntary Remediation Program Activities, Albuquerque Rail Yards, Albuquerque, Bernalillo County, New Mexico

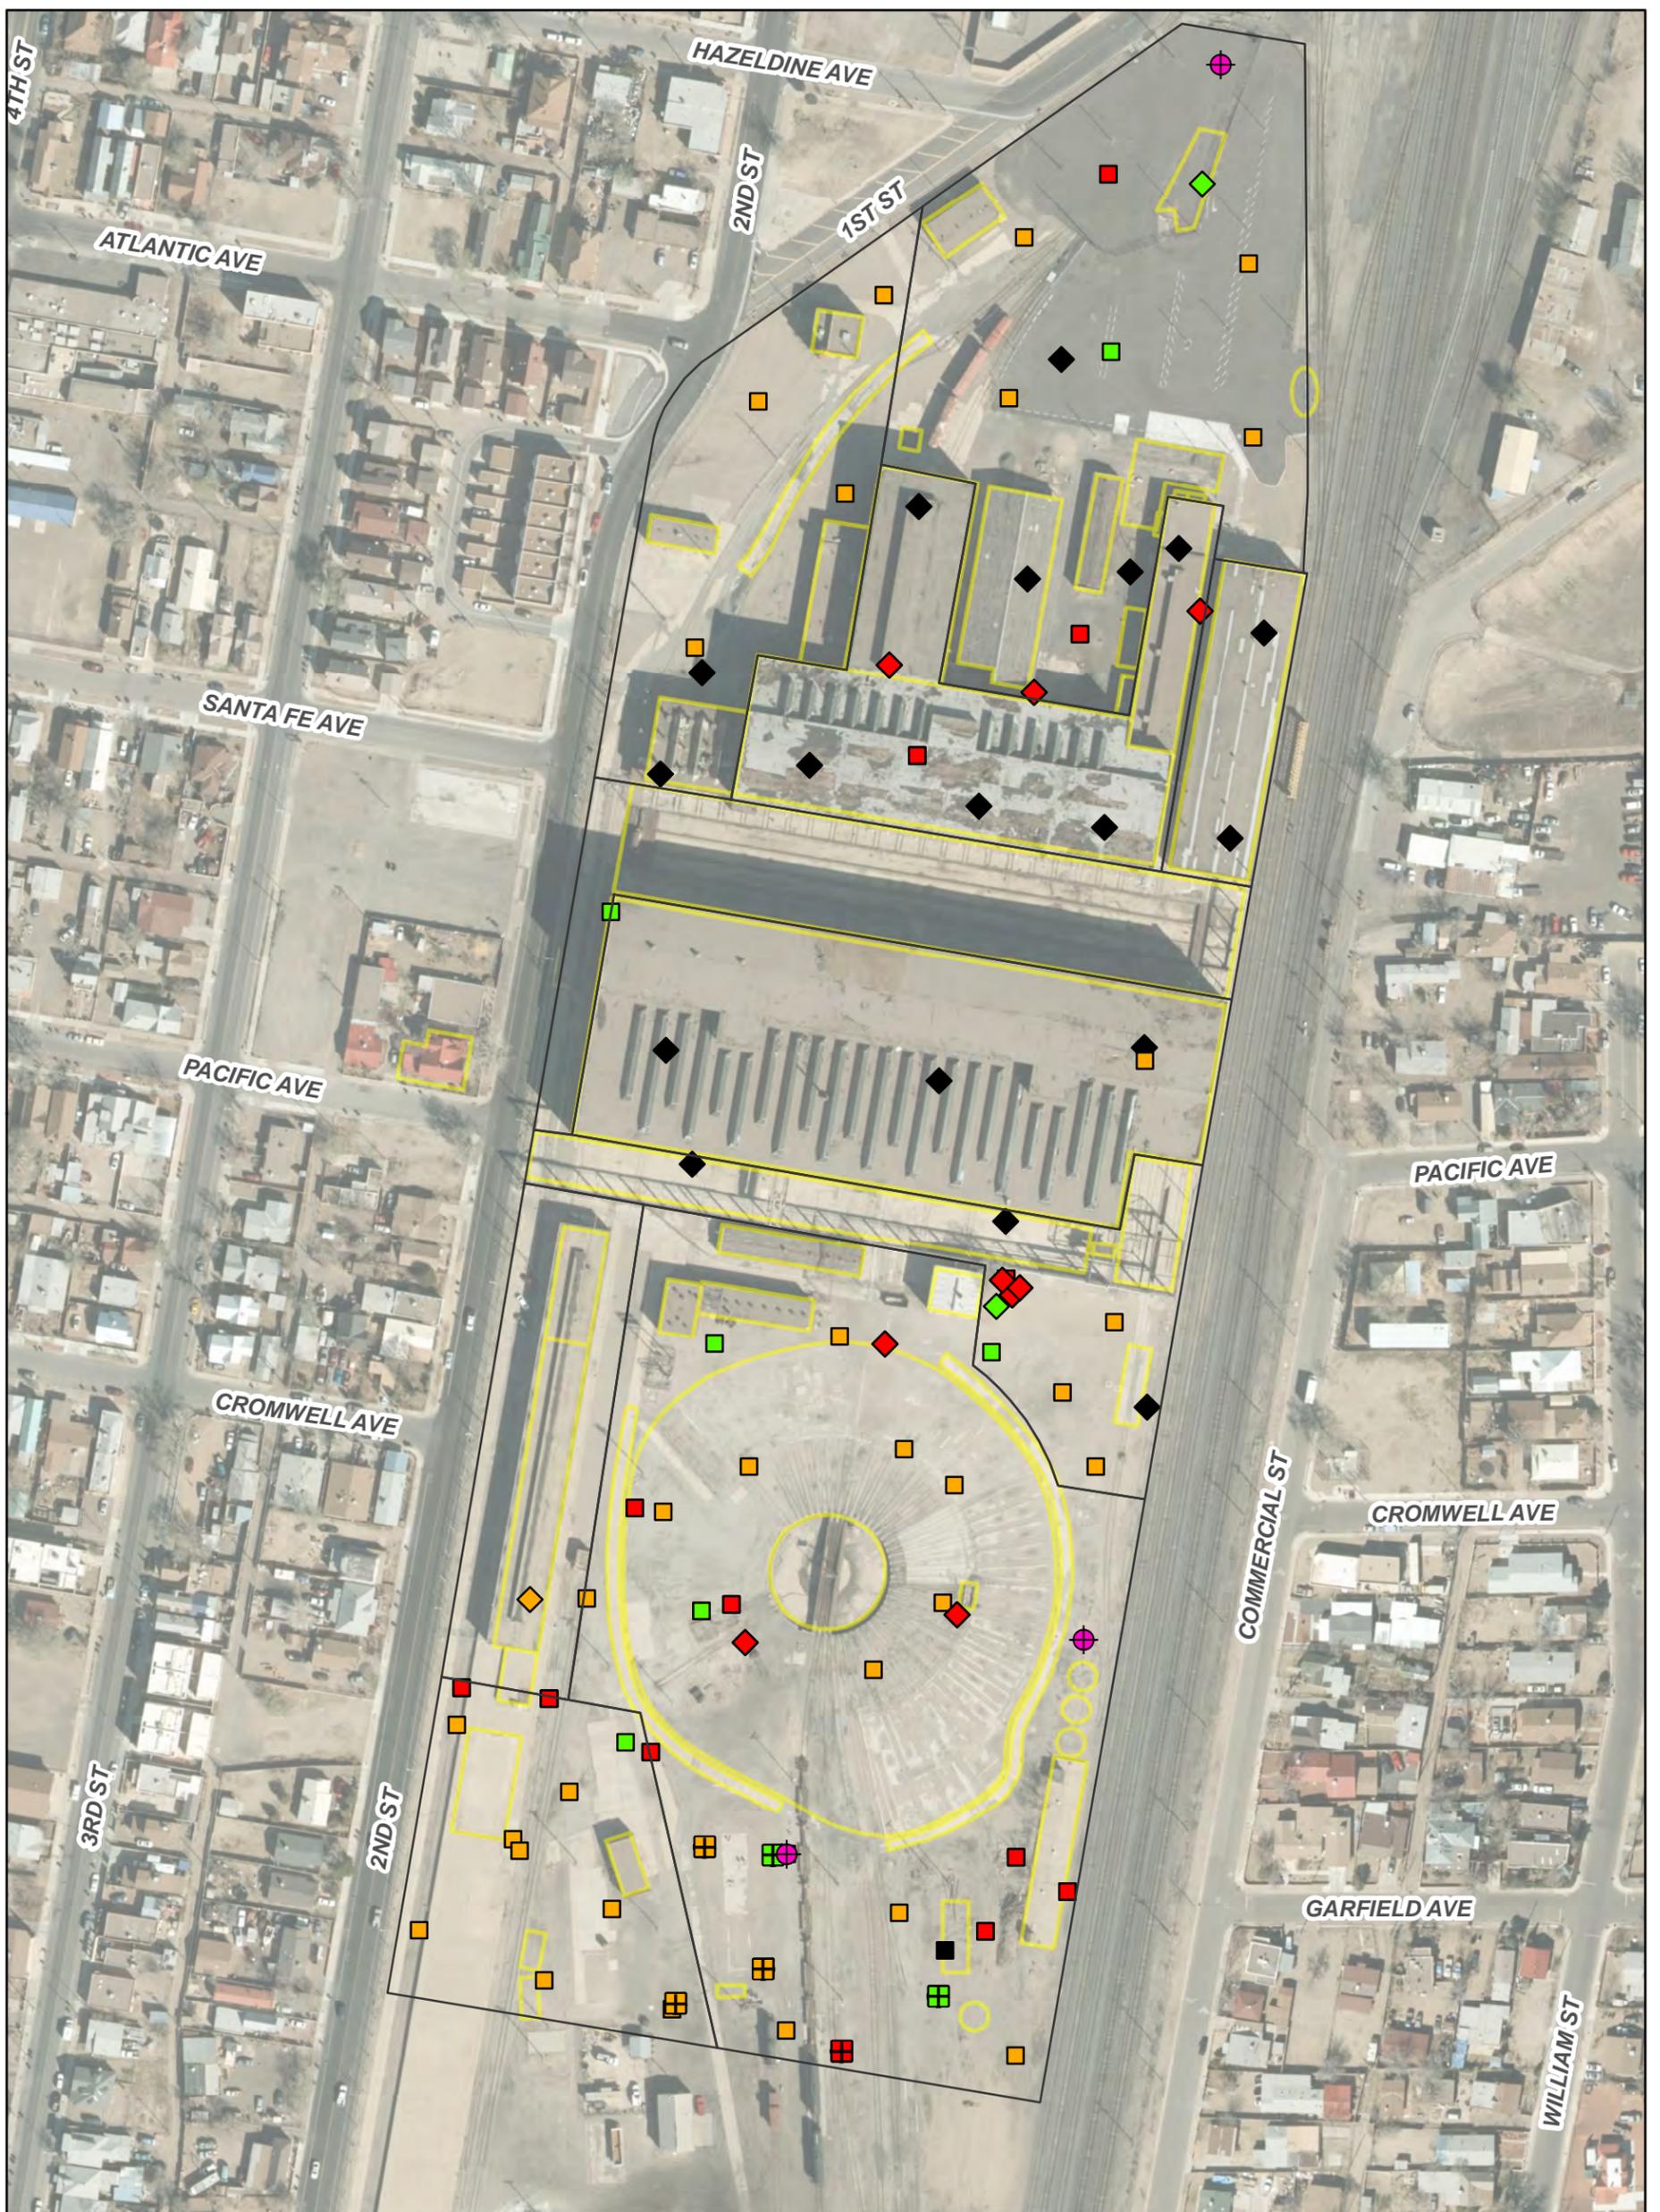
Residential SSL Exceedances  
 (0-10 ft bgs), Benzo(a)anthracene  
 Additional Characterization,  
 Voluntary Remediation Program Activities,  
 Albuquerque Rail Yards, Albuquerque,  
 Bernalillo County, New Mexico

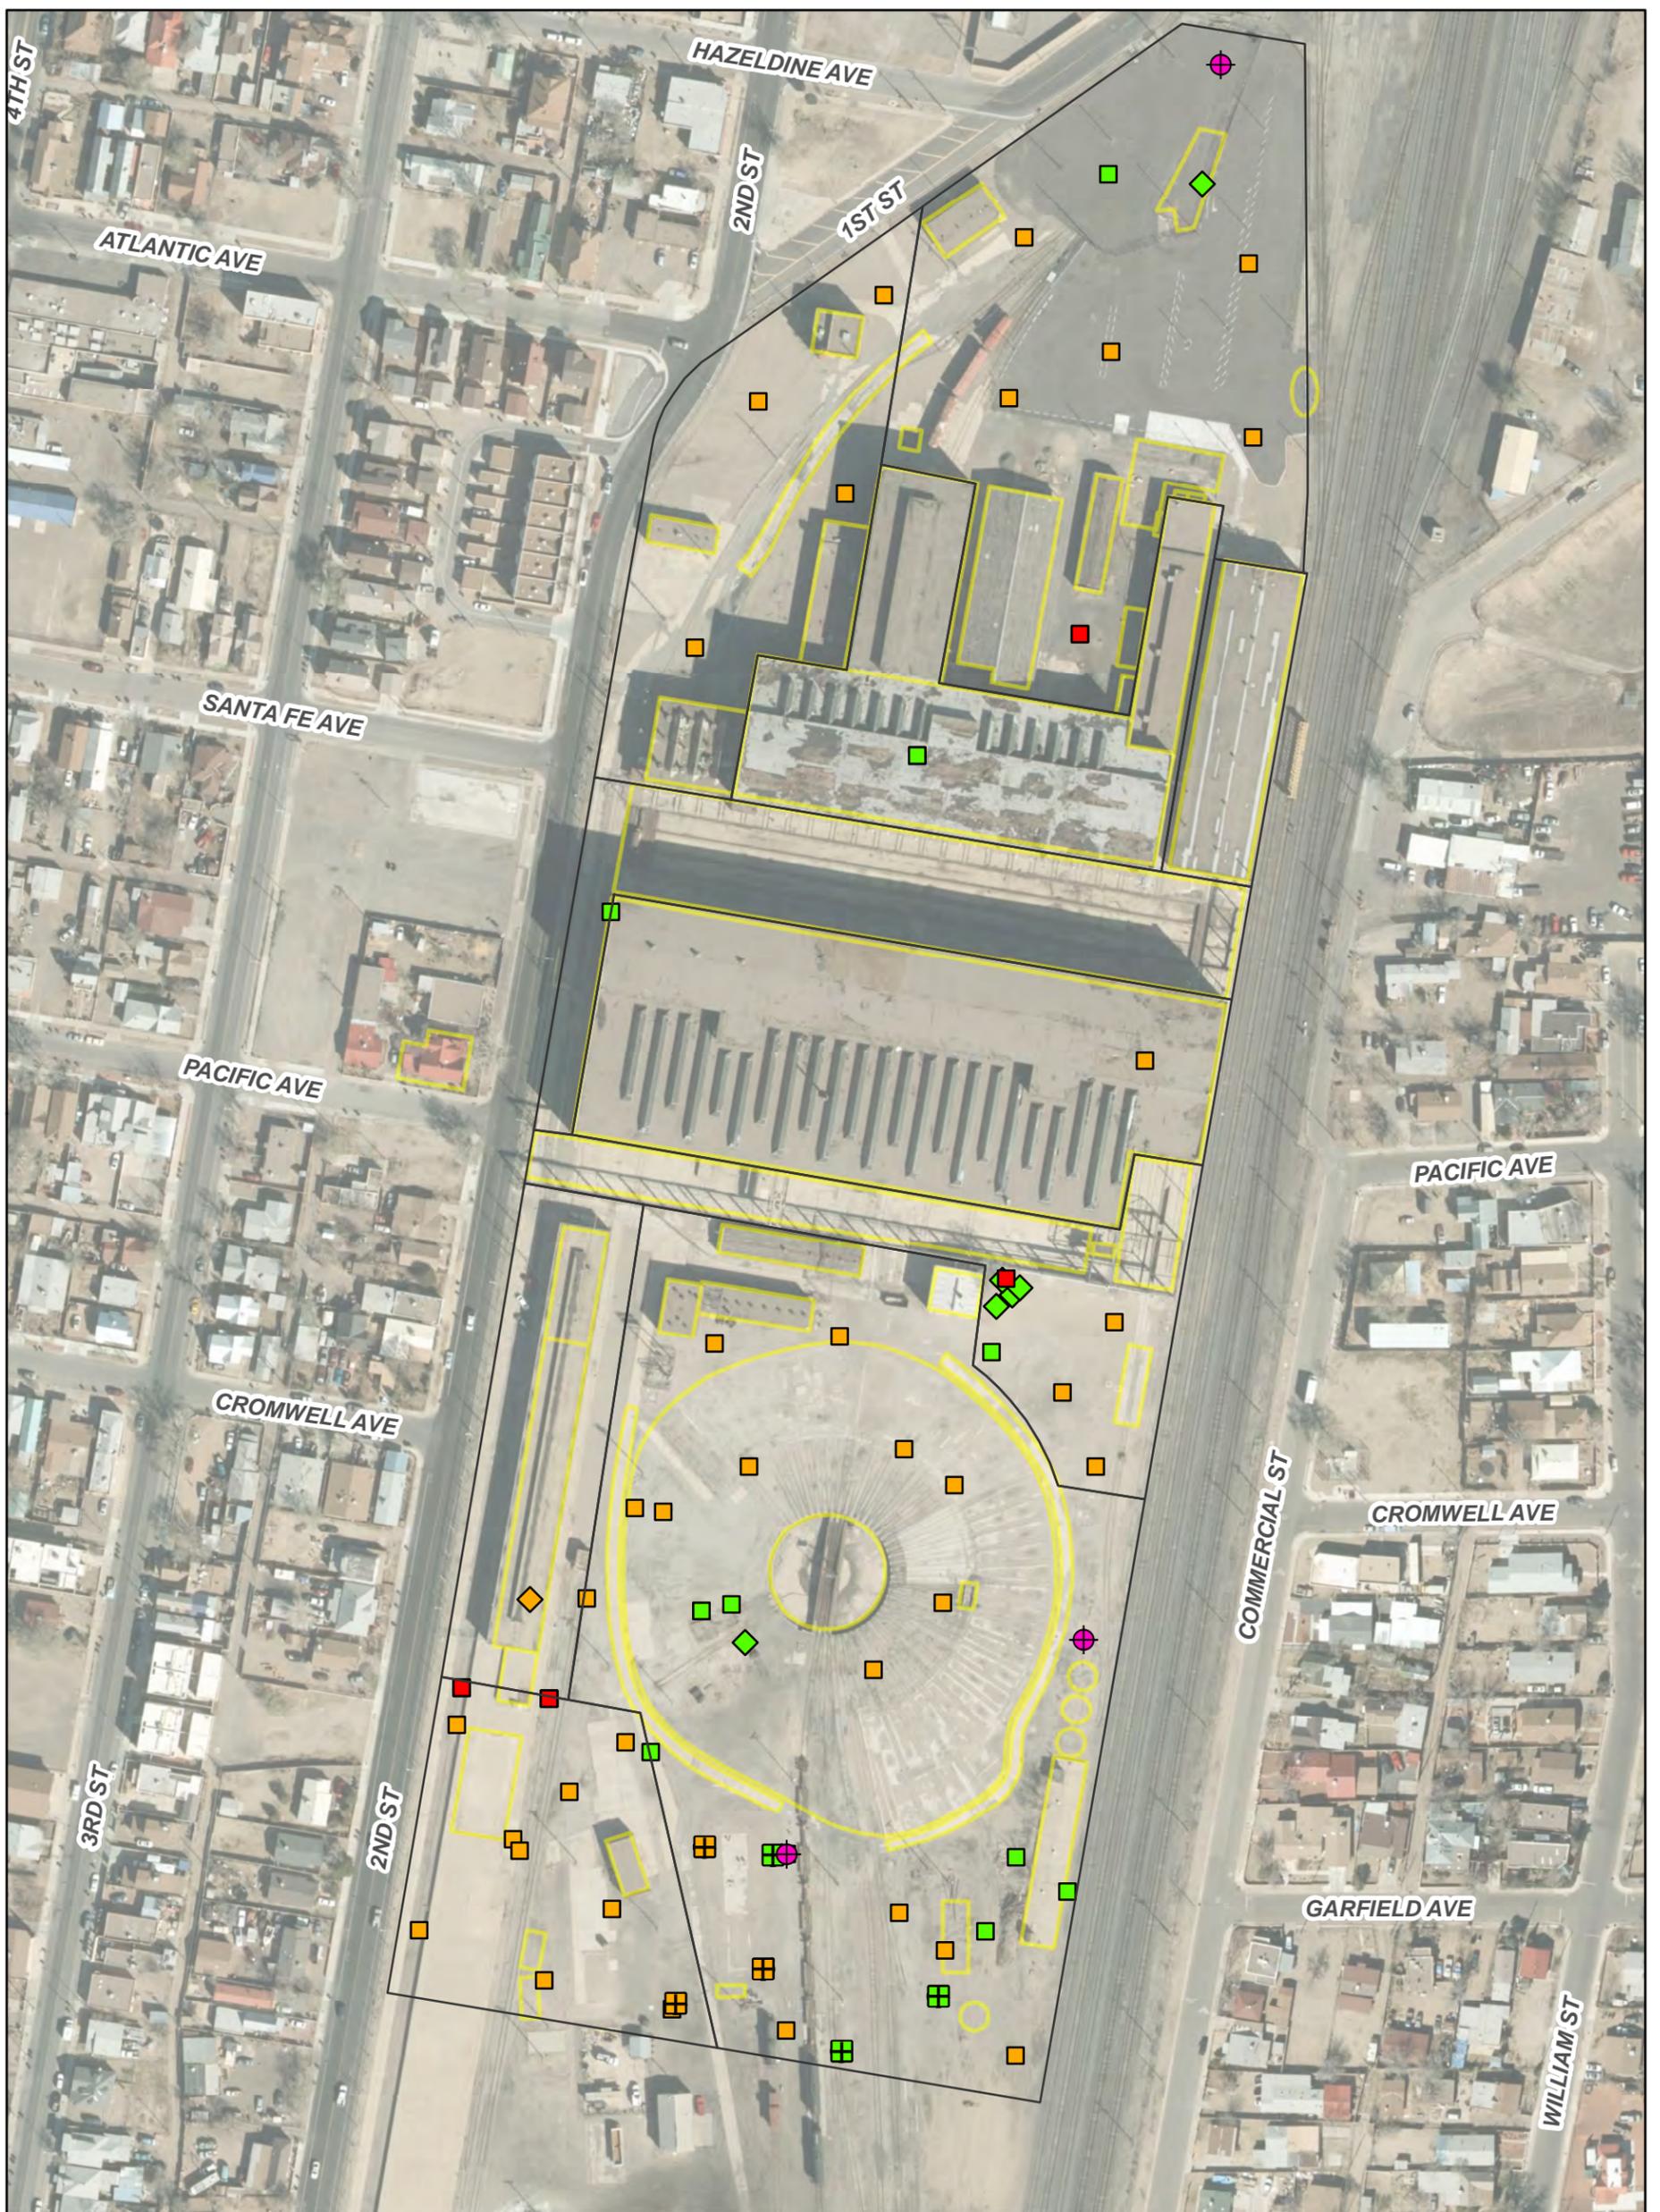
**Residential SSL Exceedances (0-10 ft bgs), Benzo(a)pyrene**  
 Additional Characterization,  
 Voluntary Remediation Program Activities,  
 Albuquerque Rail Yards, Albuquerque,  
 Bernalillo County, New Mexico

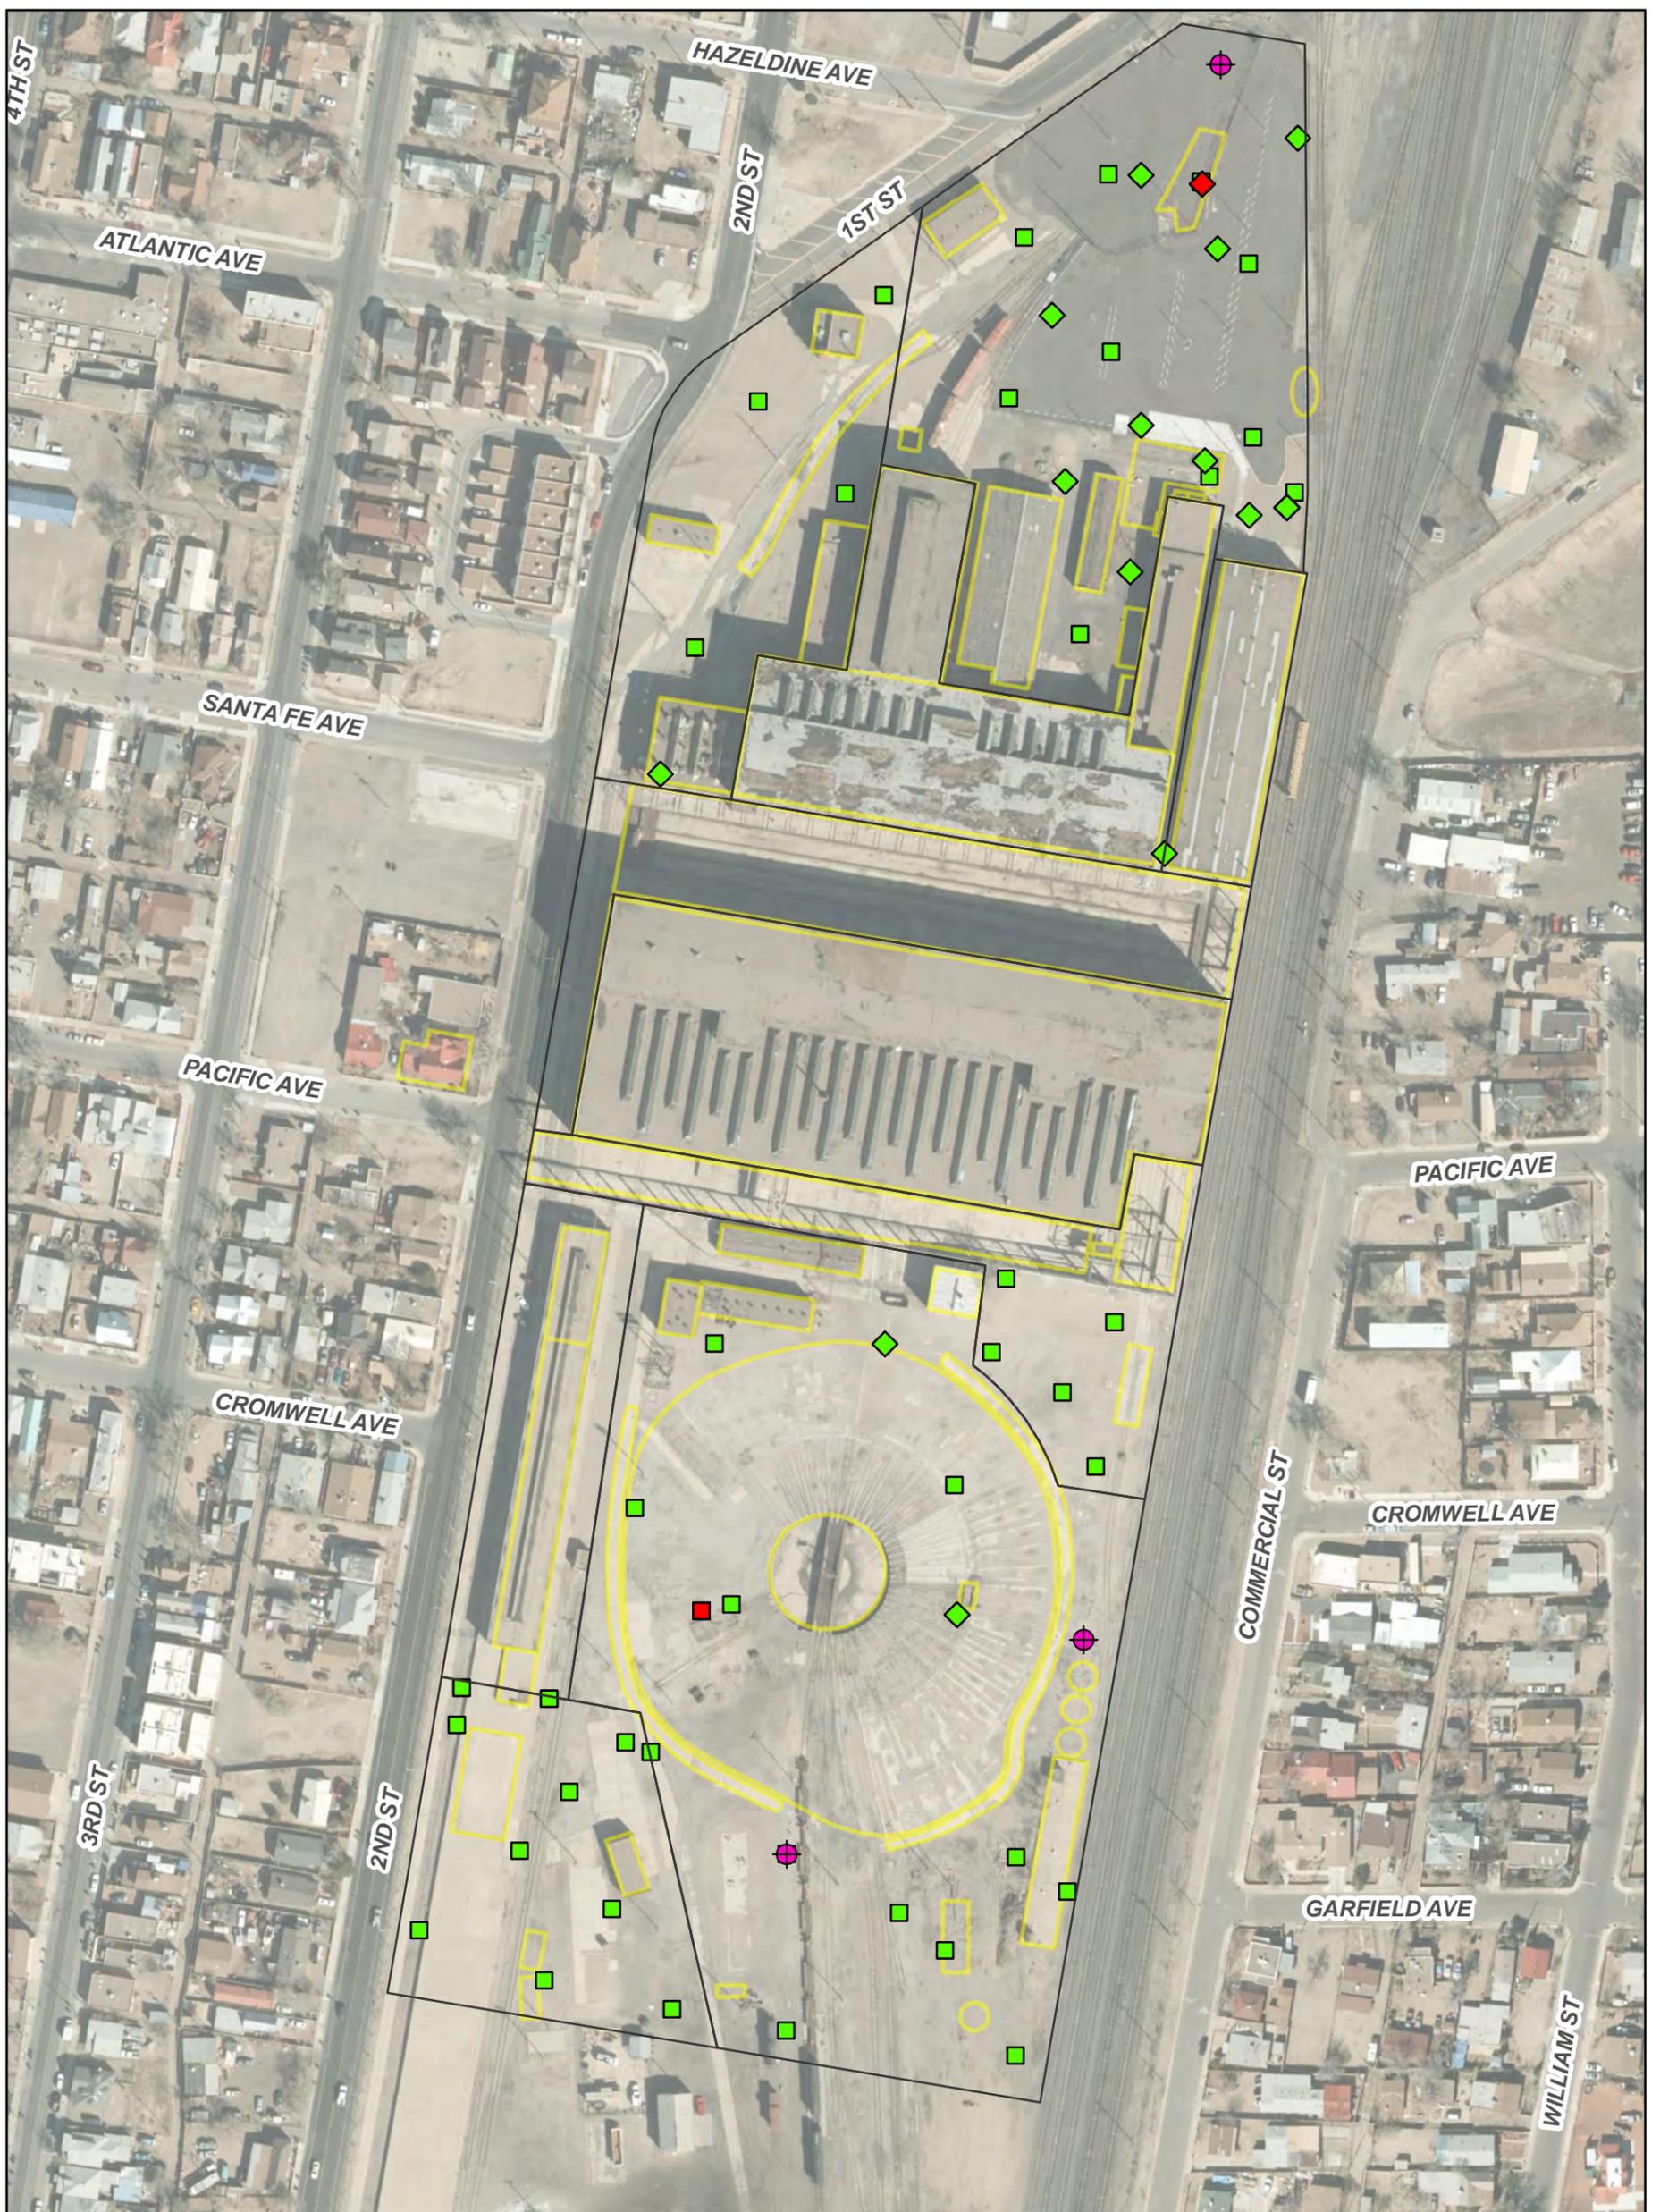
Residential SSL Exceedances  
 (0-10 ft bgs), Benzo(b)fluoranthene  
 Additional Characterization,  
 Voluntary Remediation Program Activities,  
 Albuquerque Rail Yards, Albuquerque,  
 Bernalillo County, New Mexico

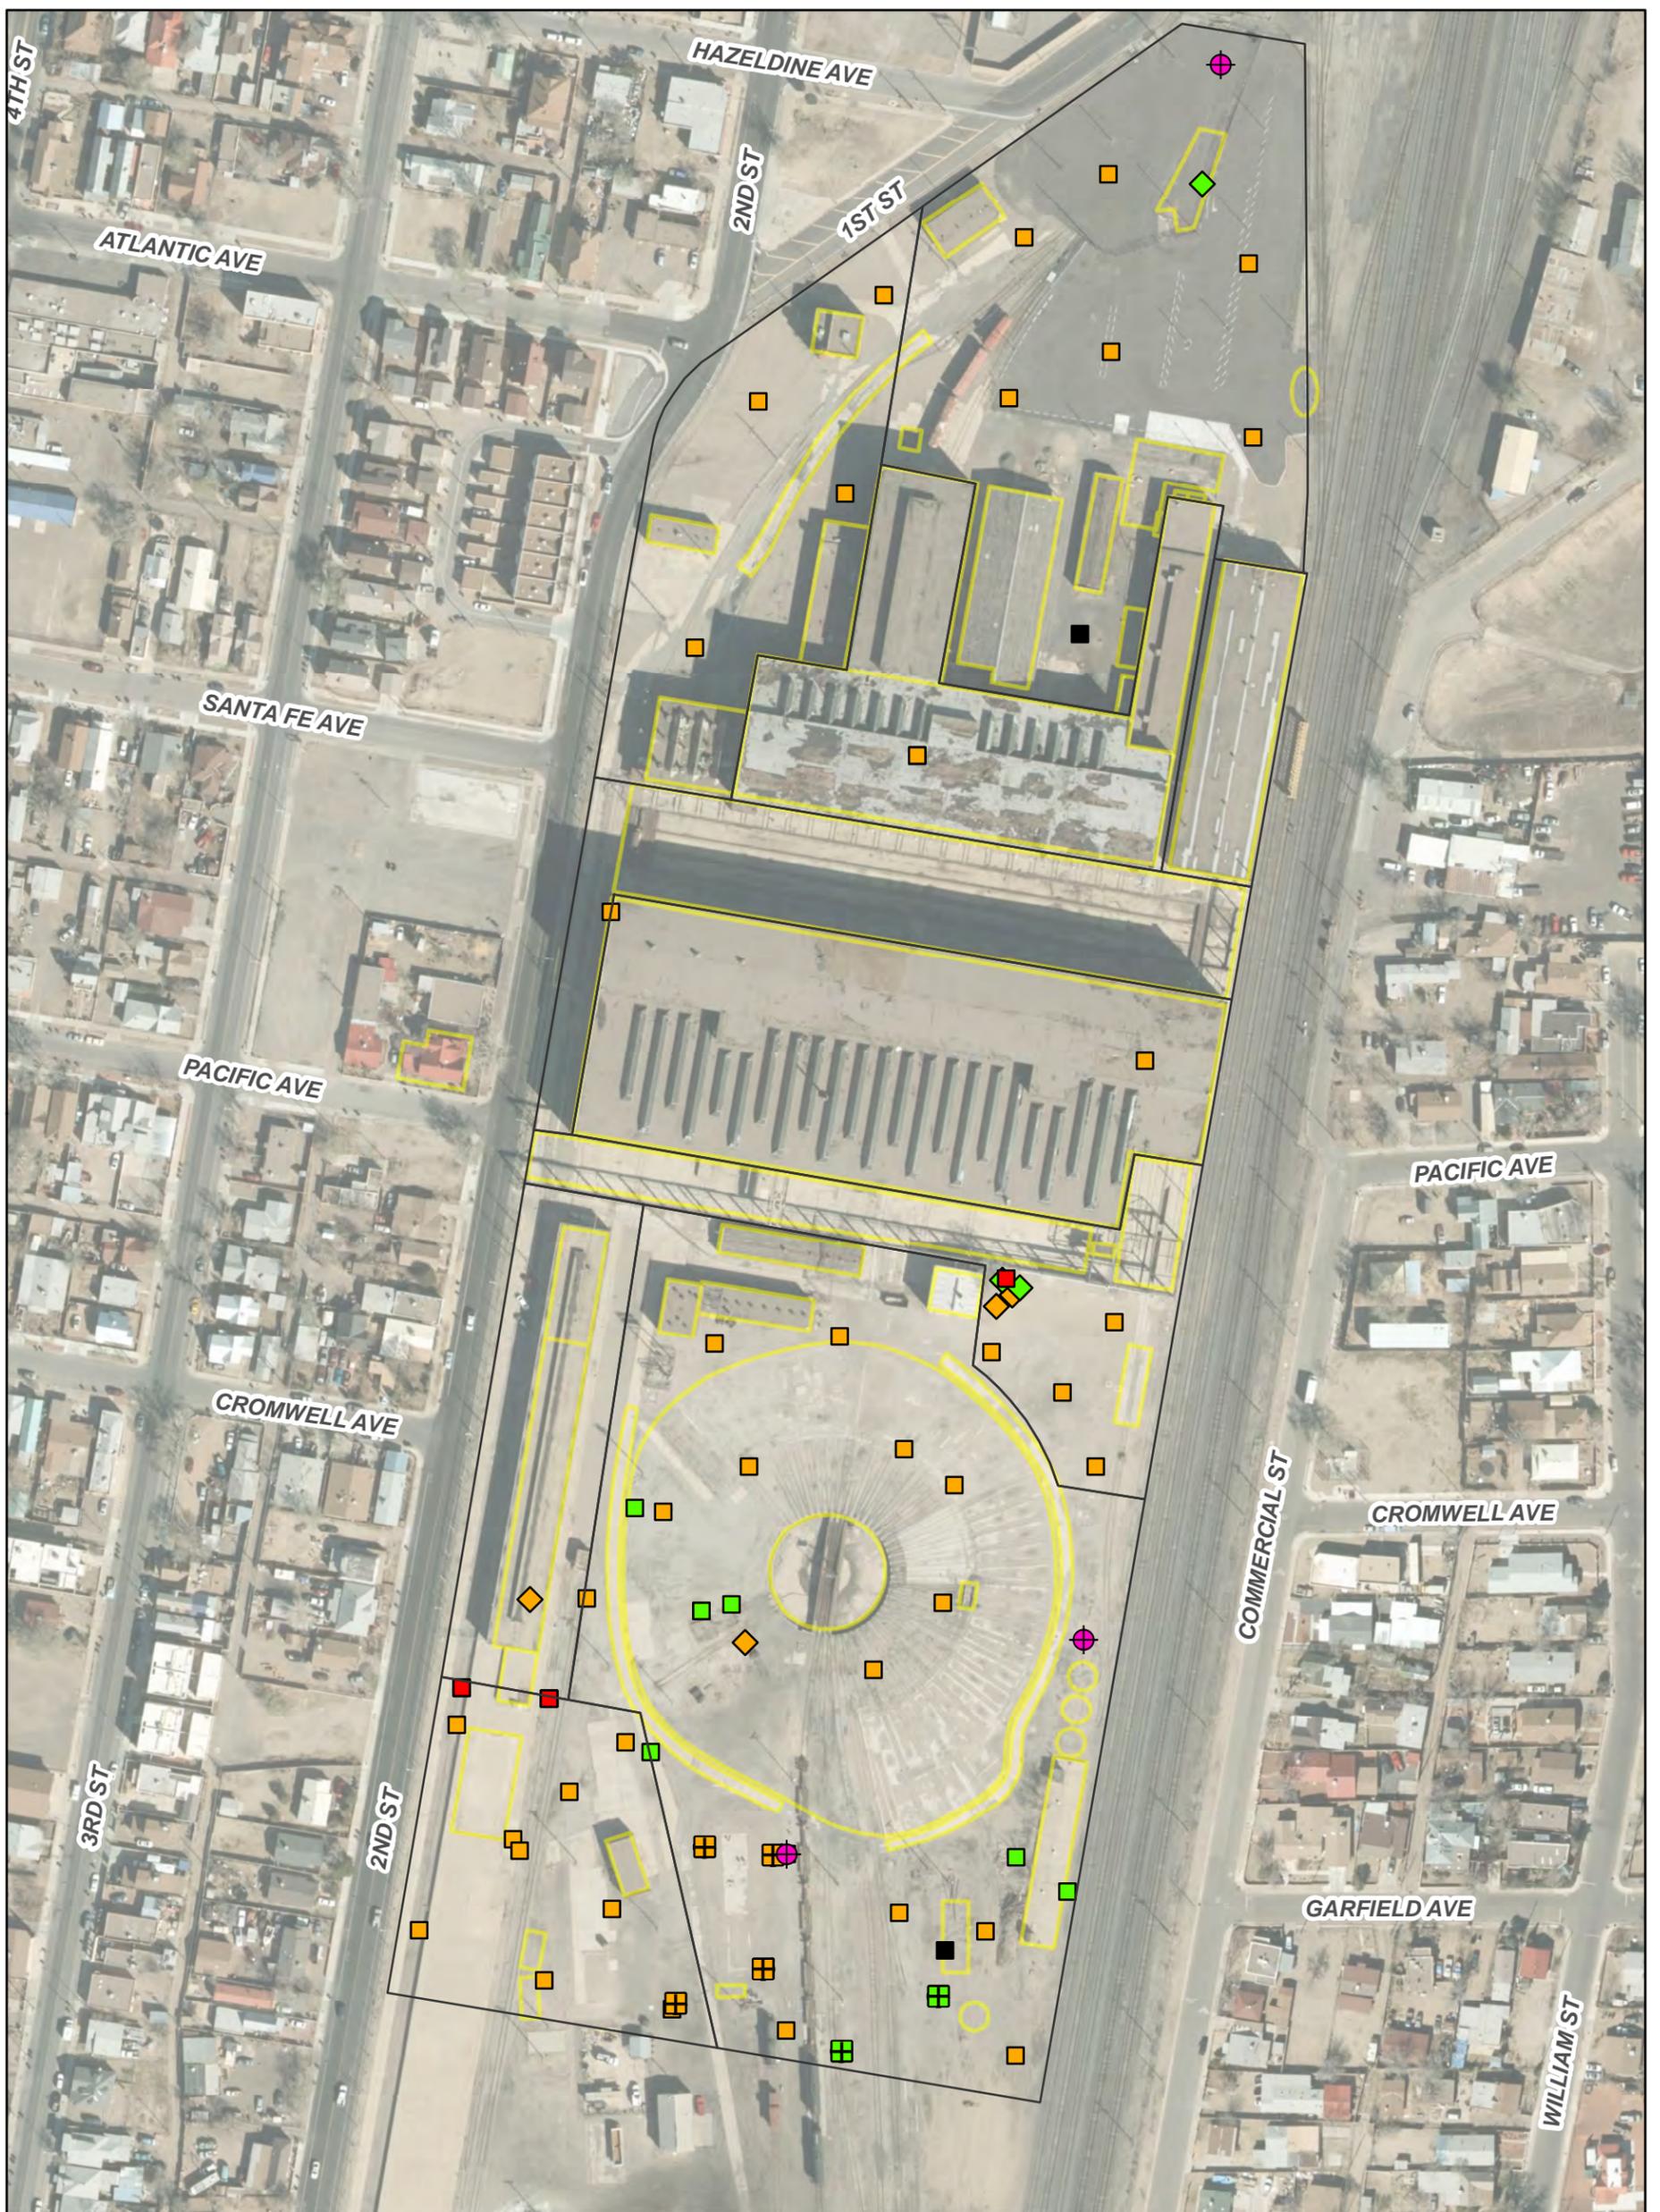
**Residential SSL Exceedances (0-10 ft bgs), Chromium**  
 Additional Characterization, Voluntary Remediation Program Activities, Albuquerque Rail Yards, Albuquerque, Bernalillo County, New Mexico
