**Voluntary Remediation Program  
Status Report  
City of Albuquerque Rail Yards  
VRP Site No. 53161007**

**Prepared for: NMED Ground Water Quality Bureau**

**Prepared by: Environmental Services Division  
Albuquerque Environmental Health Department**

**July 2019**

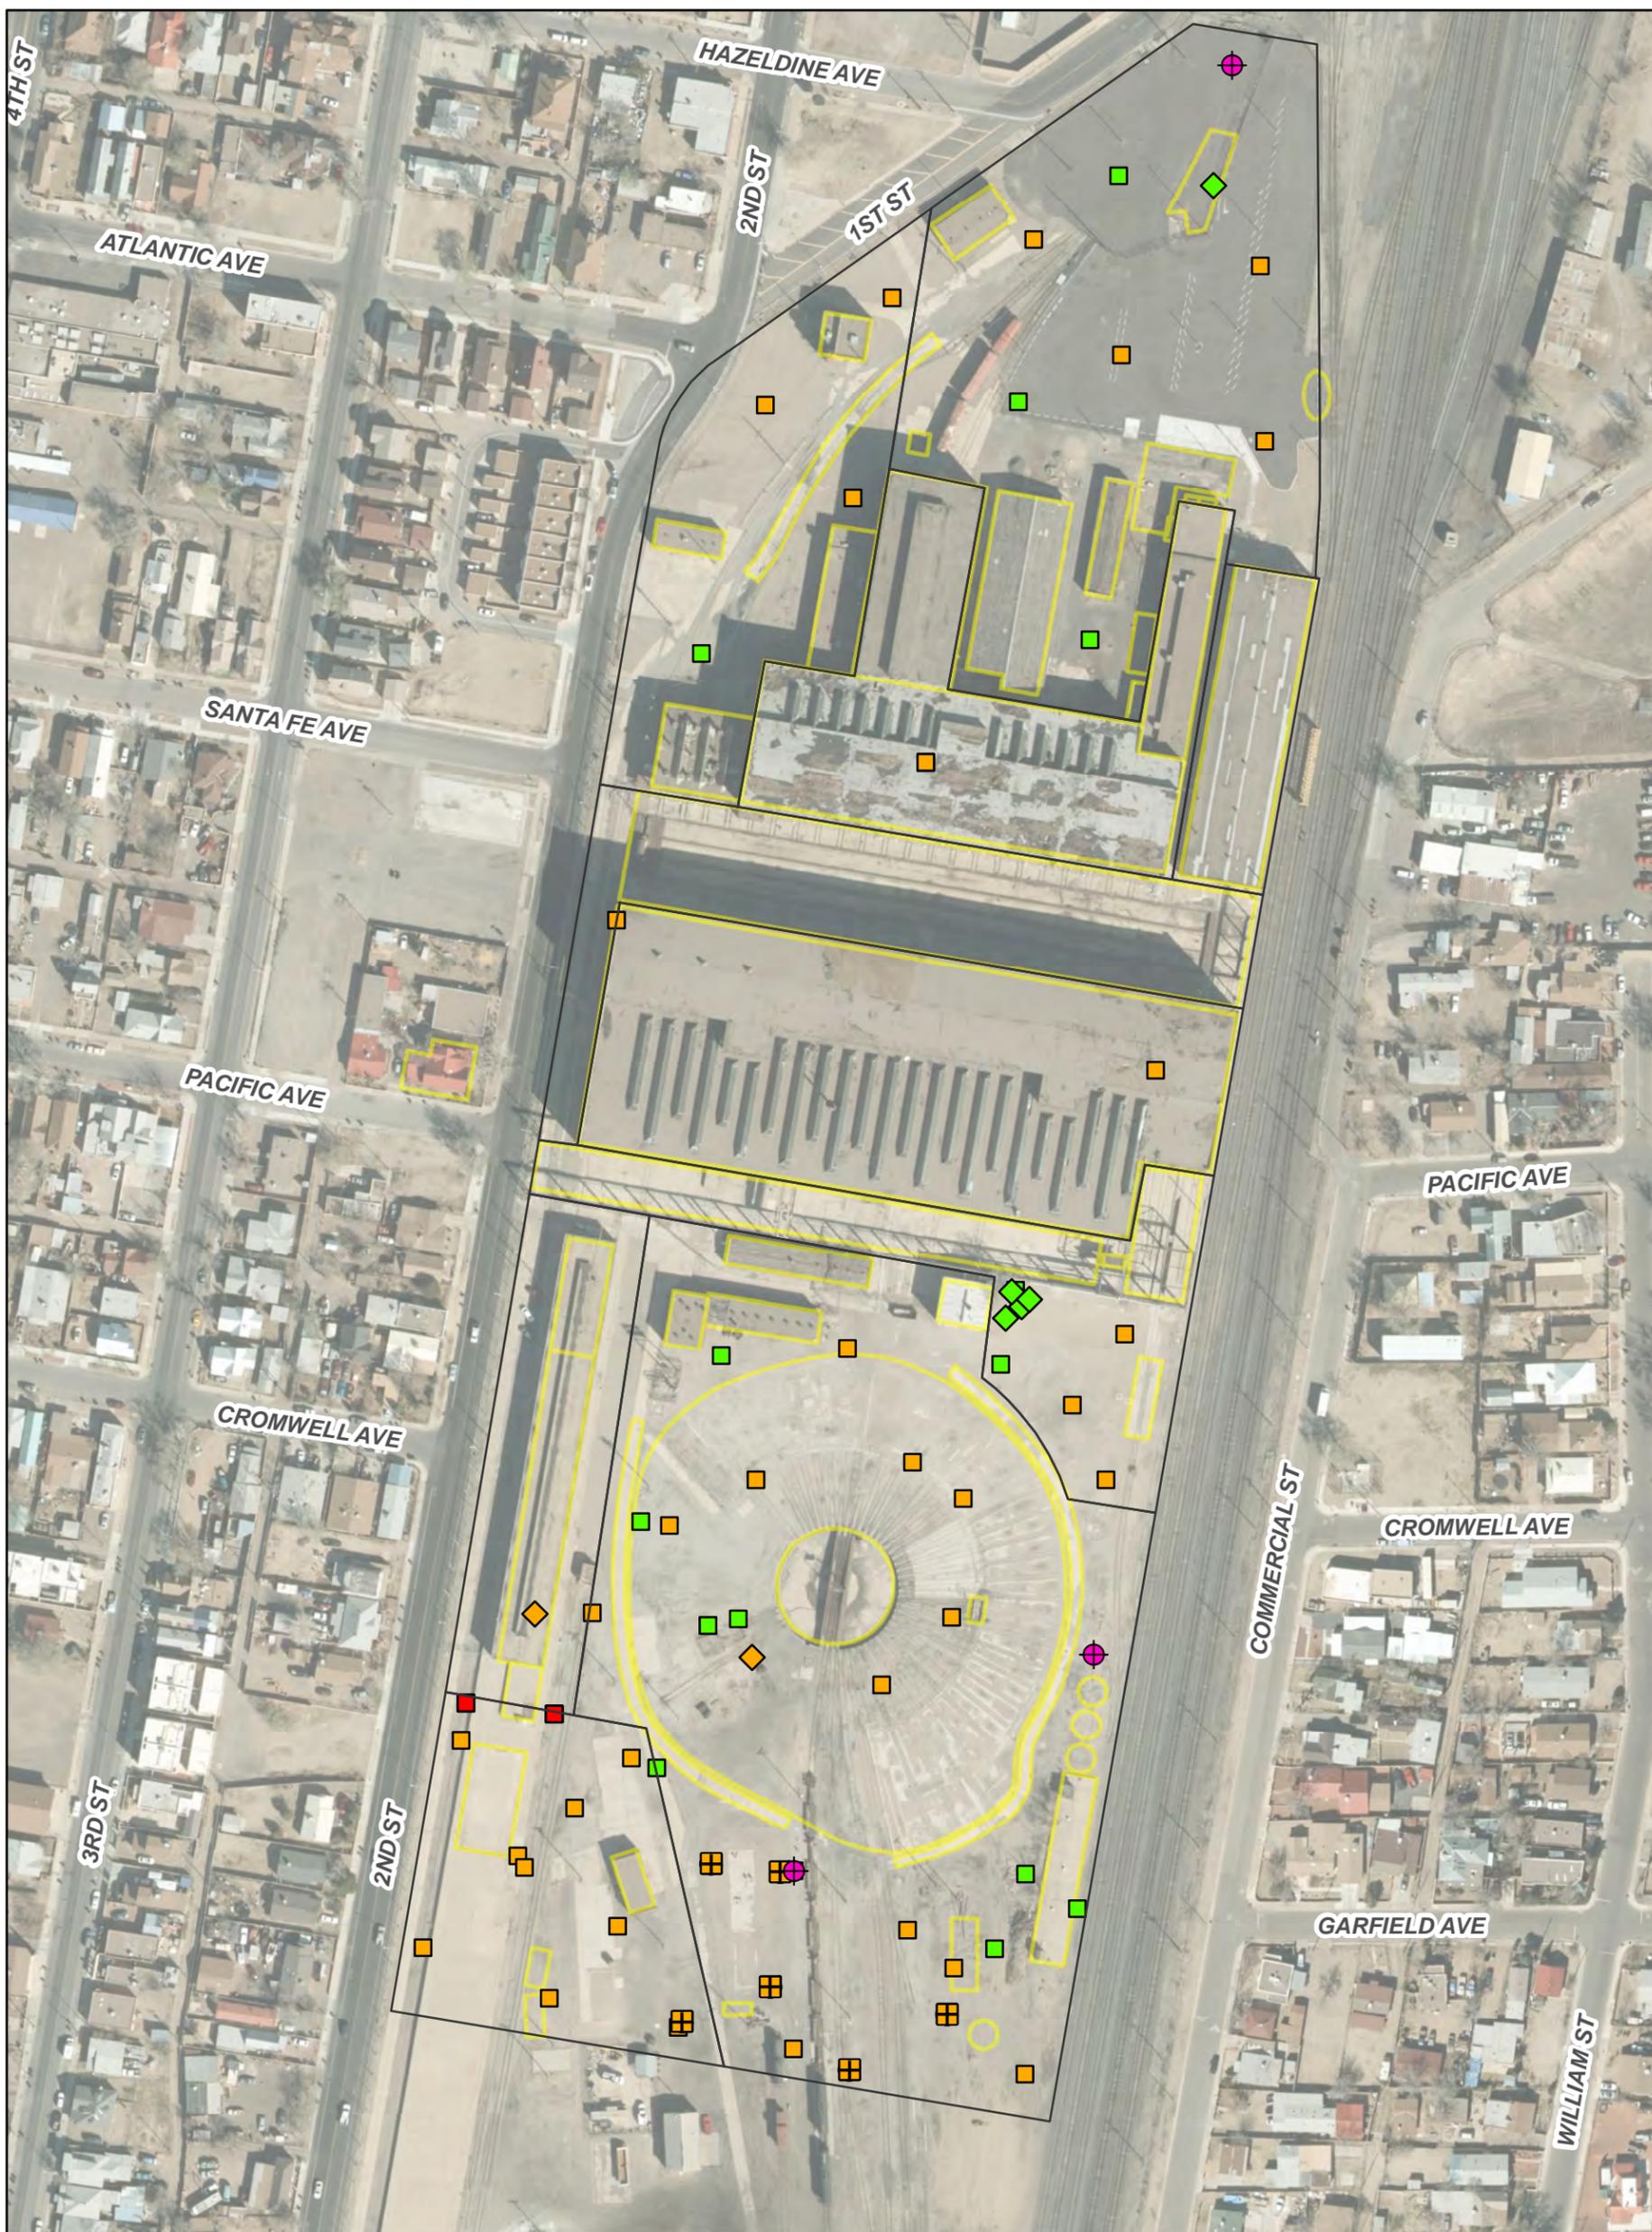
**Residential SSL Exceedances (0-10 ft bgs), Dibenzo(a,h)anthracene**  
 Additional Characterization, Voluntary Remediation Program Activities, Albuquerque Rail Yards, Albuquerque, Bernalillo County, New Mexico

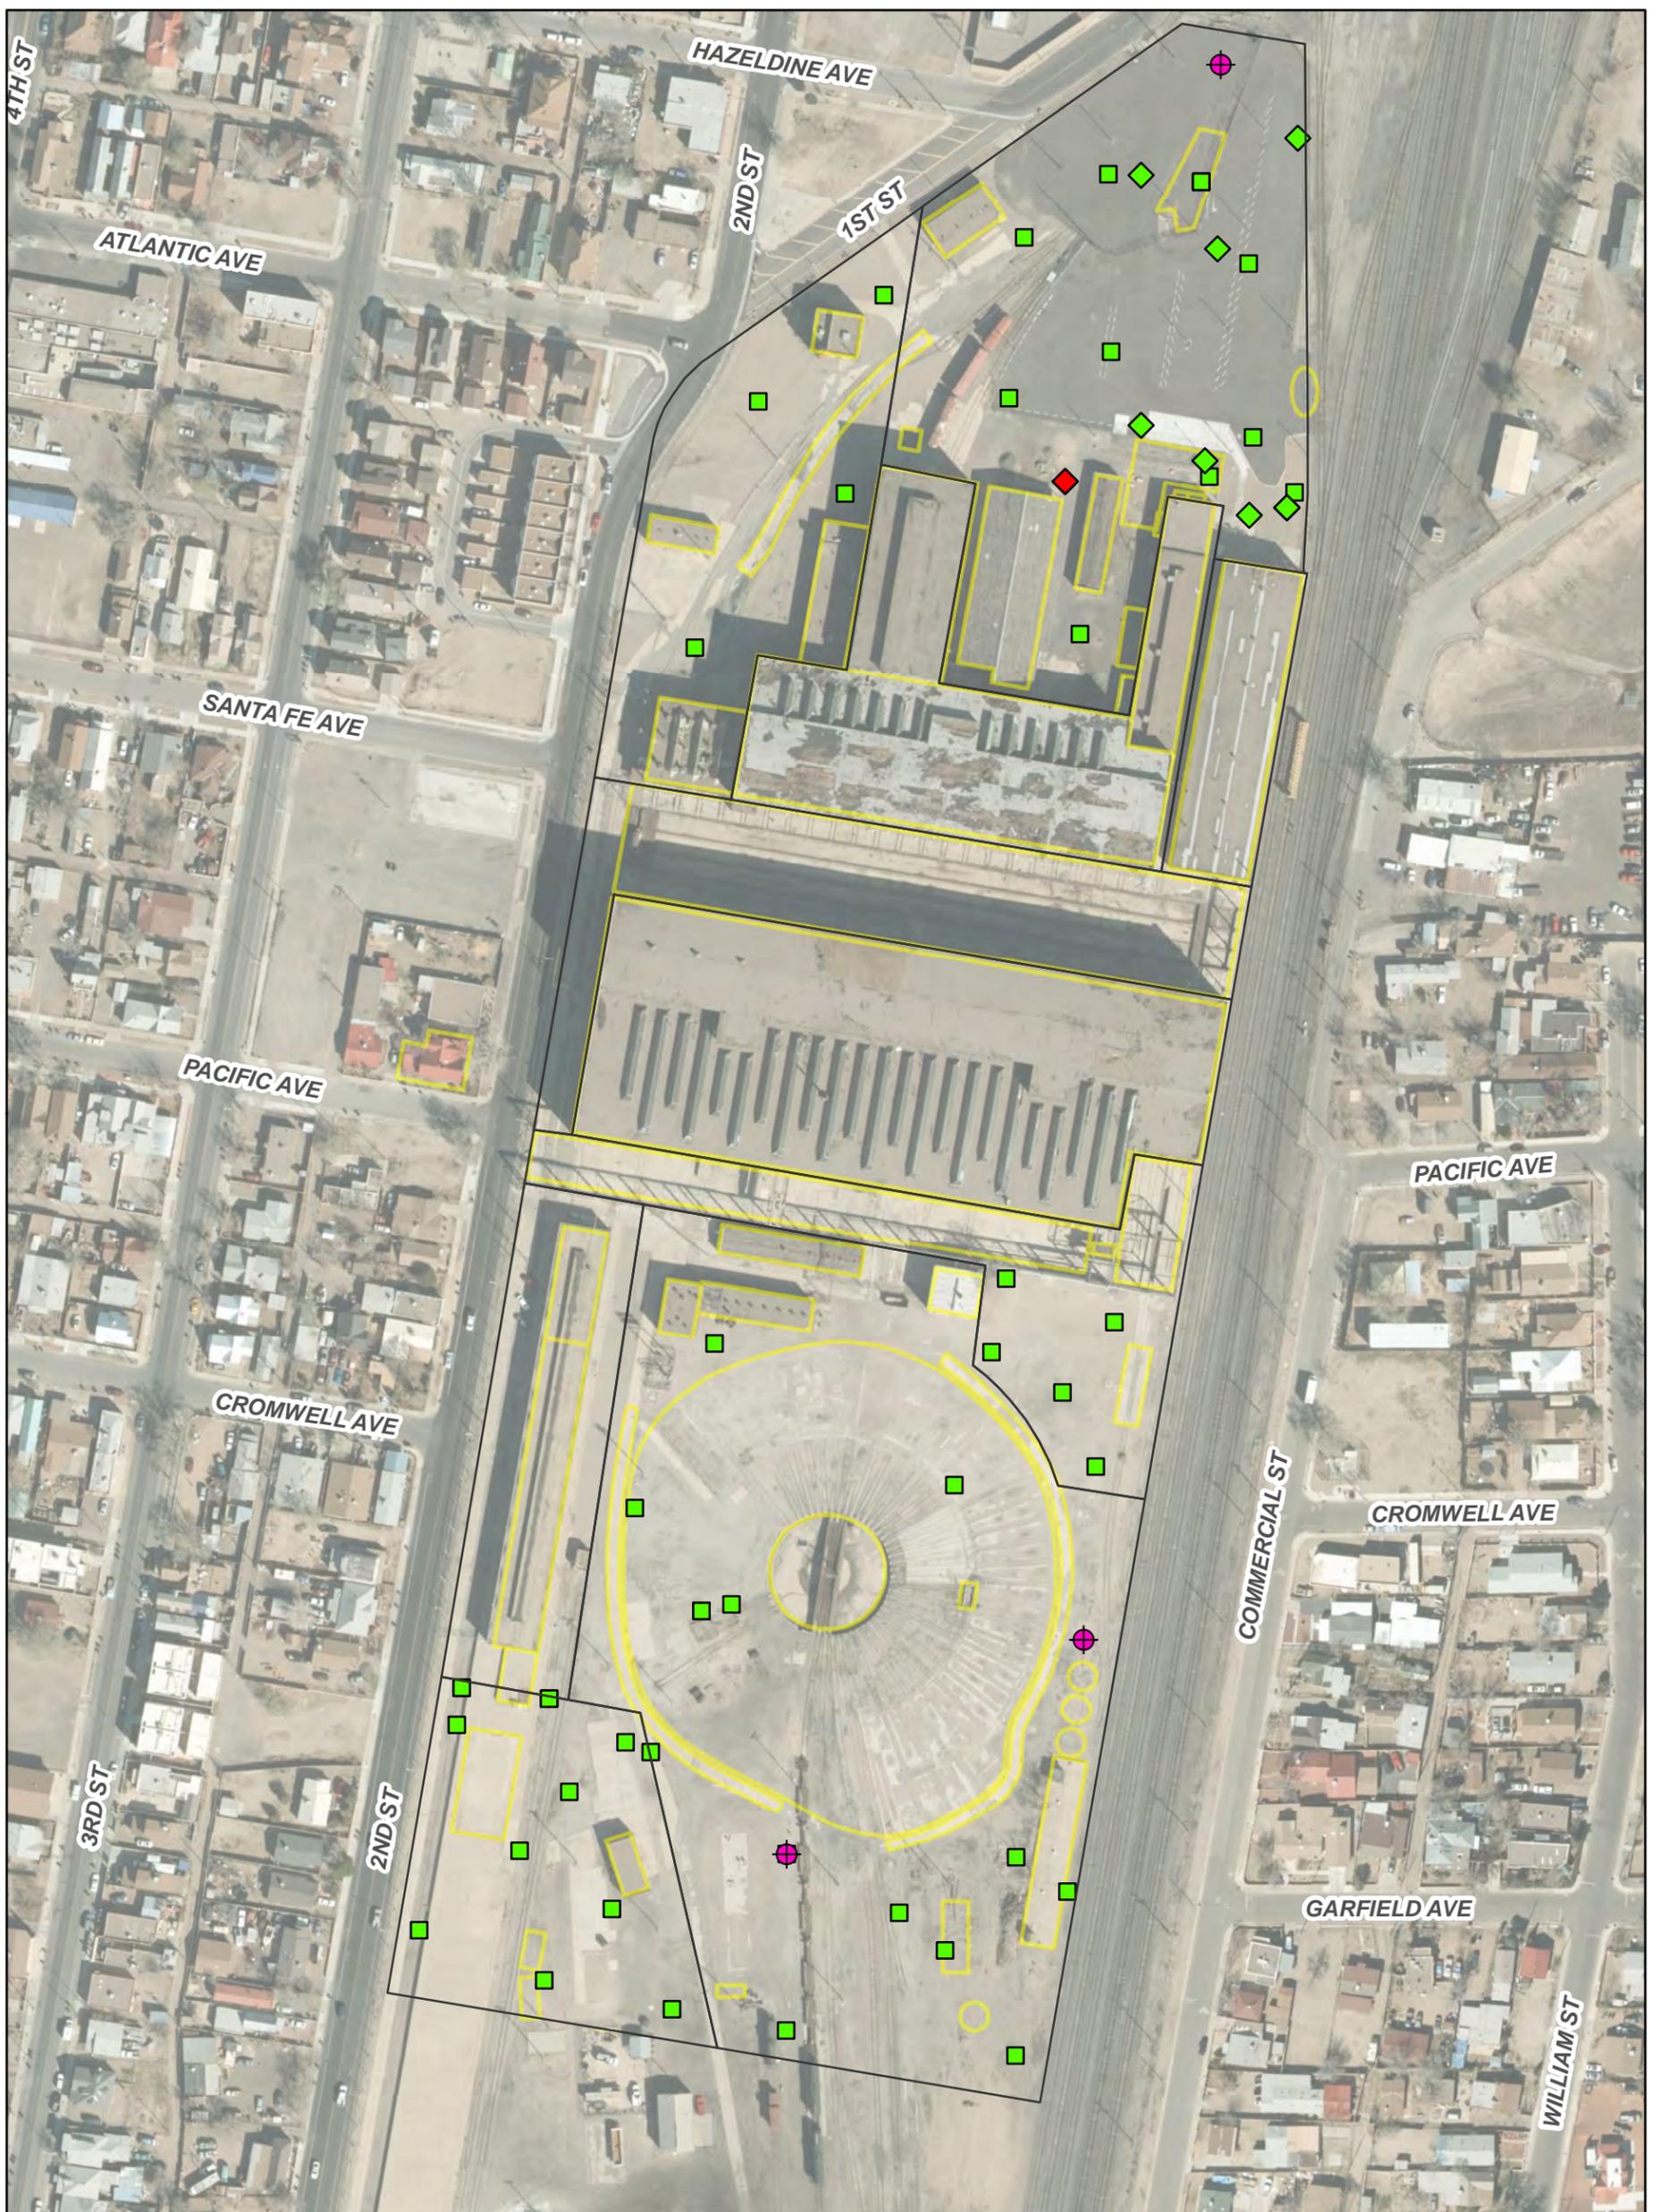
**Residential SSL Exceedances (0-10 ft bgs), Indeno(1,2,3-cd)pyrene**  
 Additional Characterization, Voluntary Remediation Program Activities, Albuquerque Rail Yards, Albuquerque, Bernalillo County, New Mexico

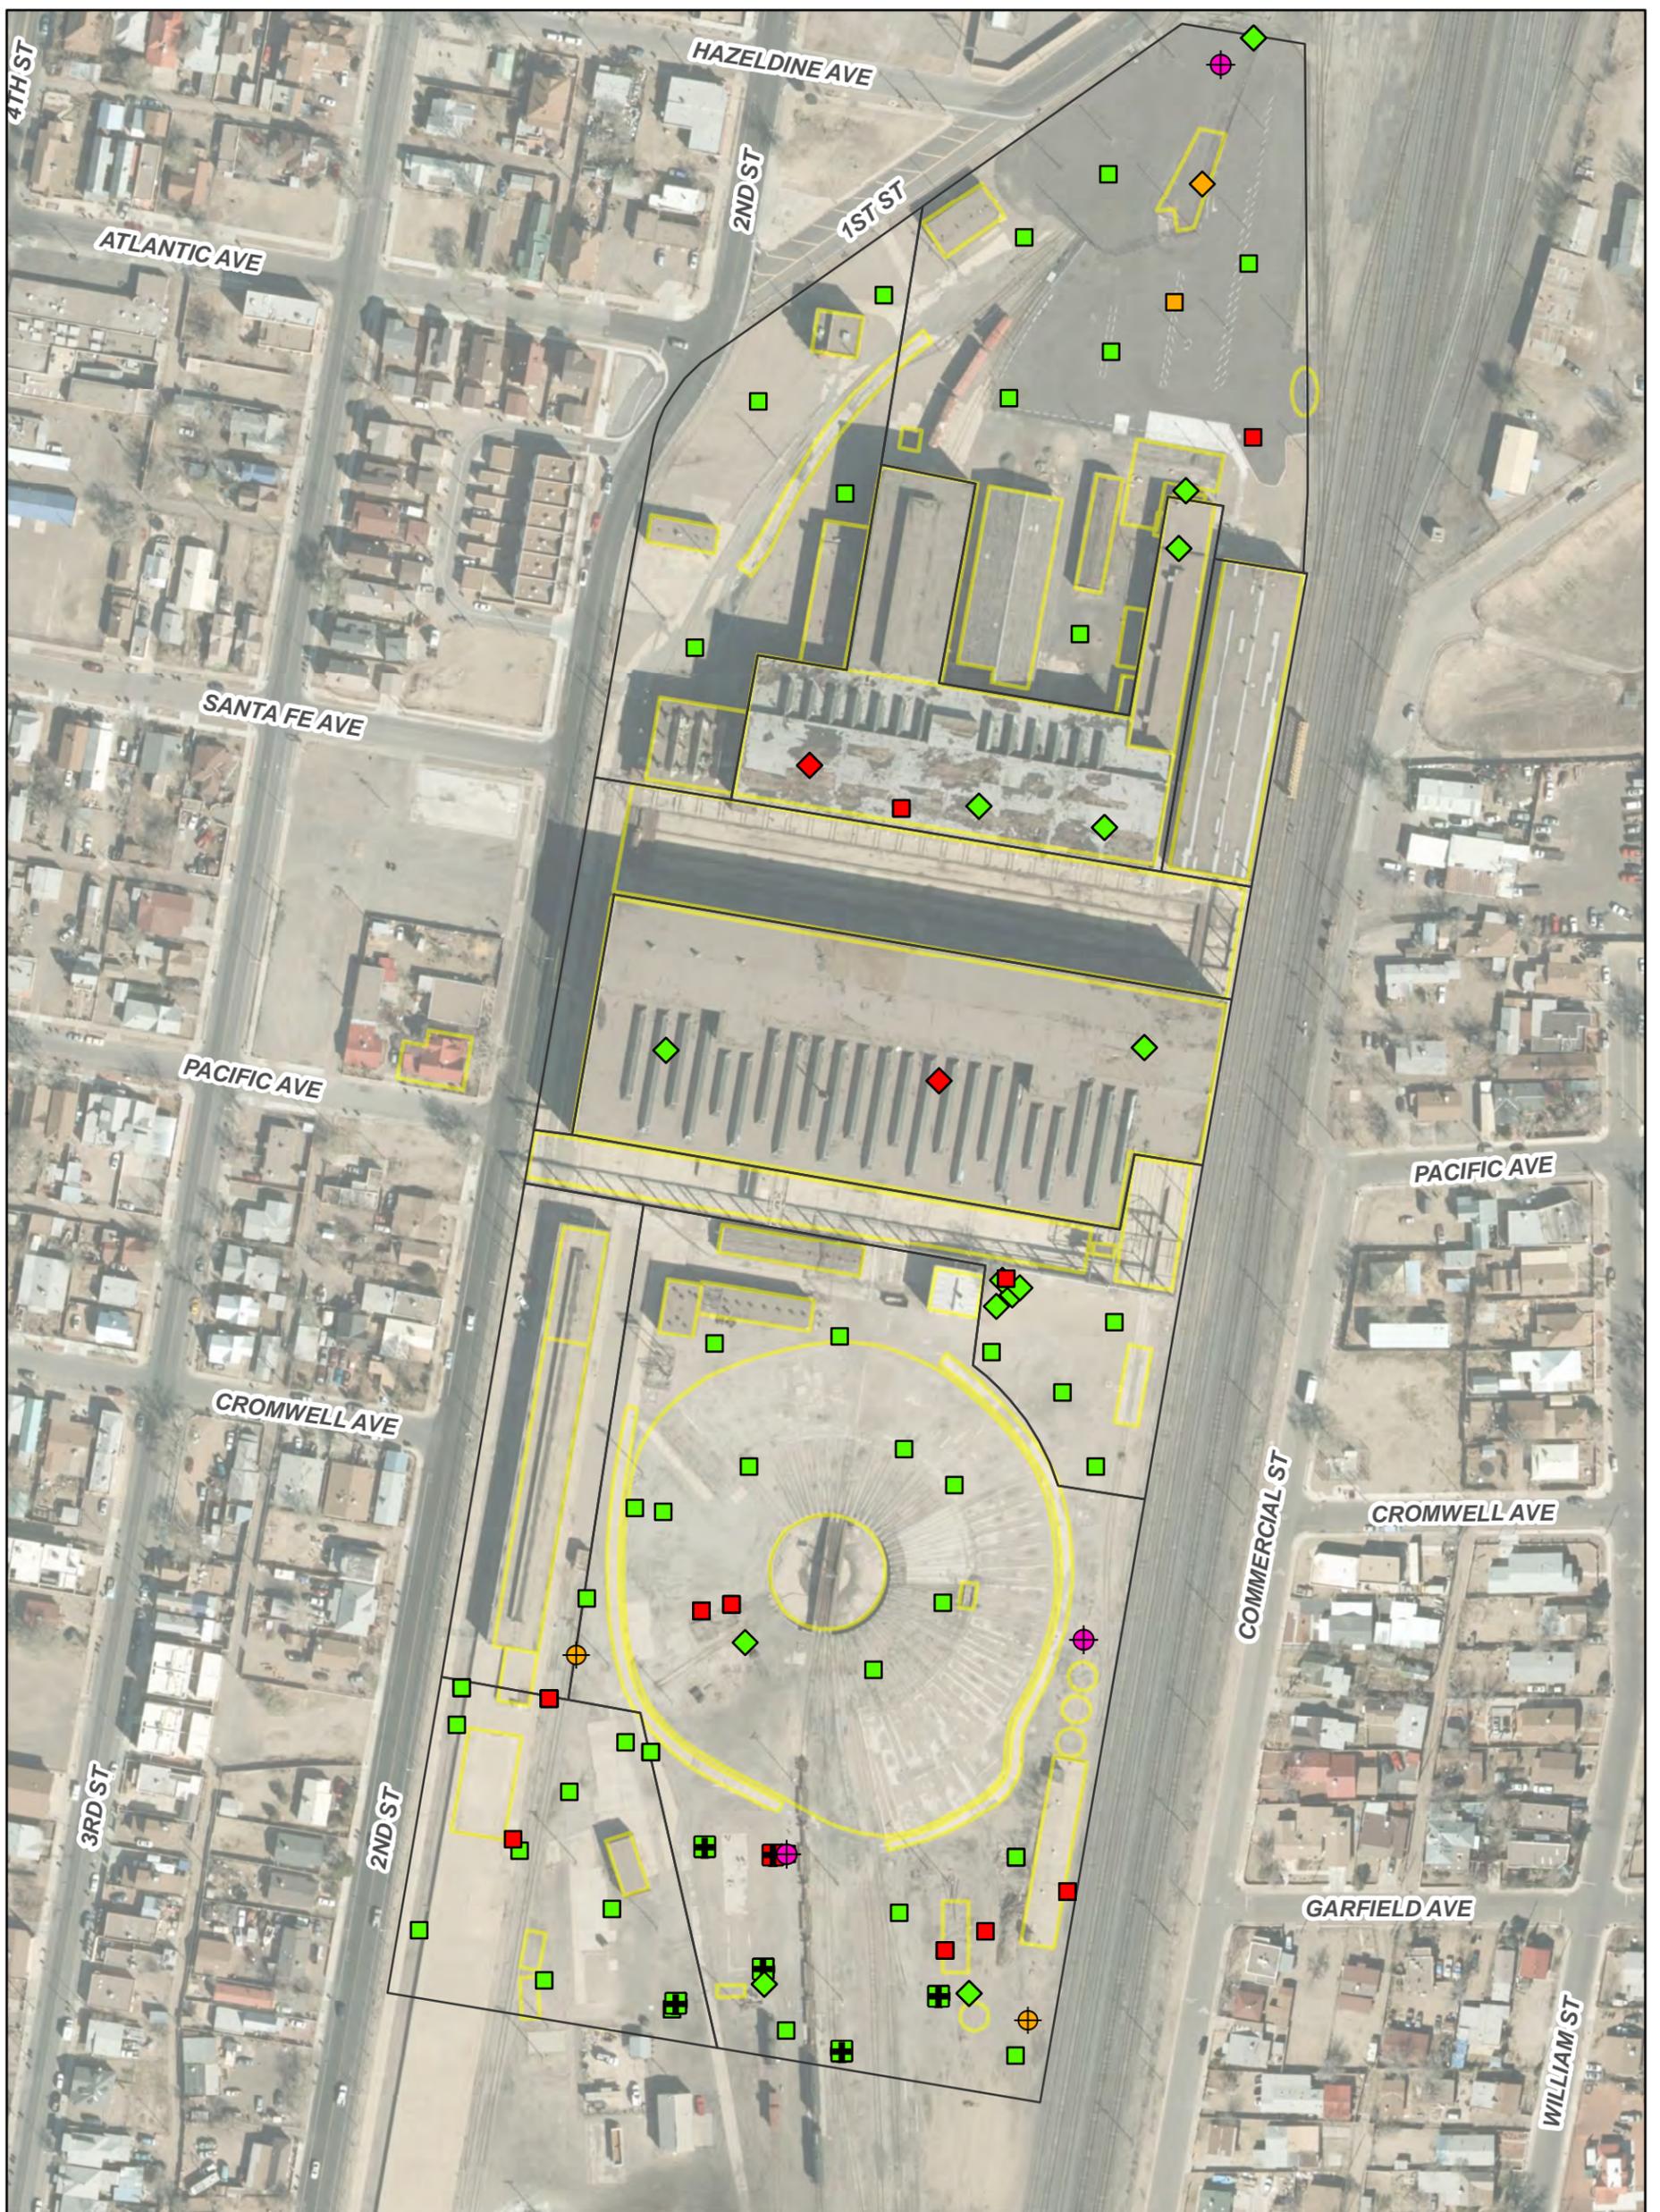
**Residential SSL Exceedances (0-10 ft bgs), Thallium**  
 Additional Characterization, Voluntary Remediation Program Activities, Albuquerque Rail Yards, Albuquerque, Bernalillo County, New Mexico

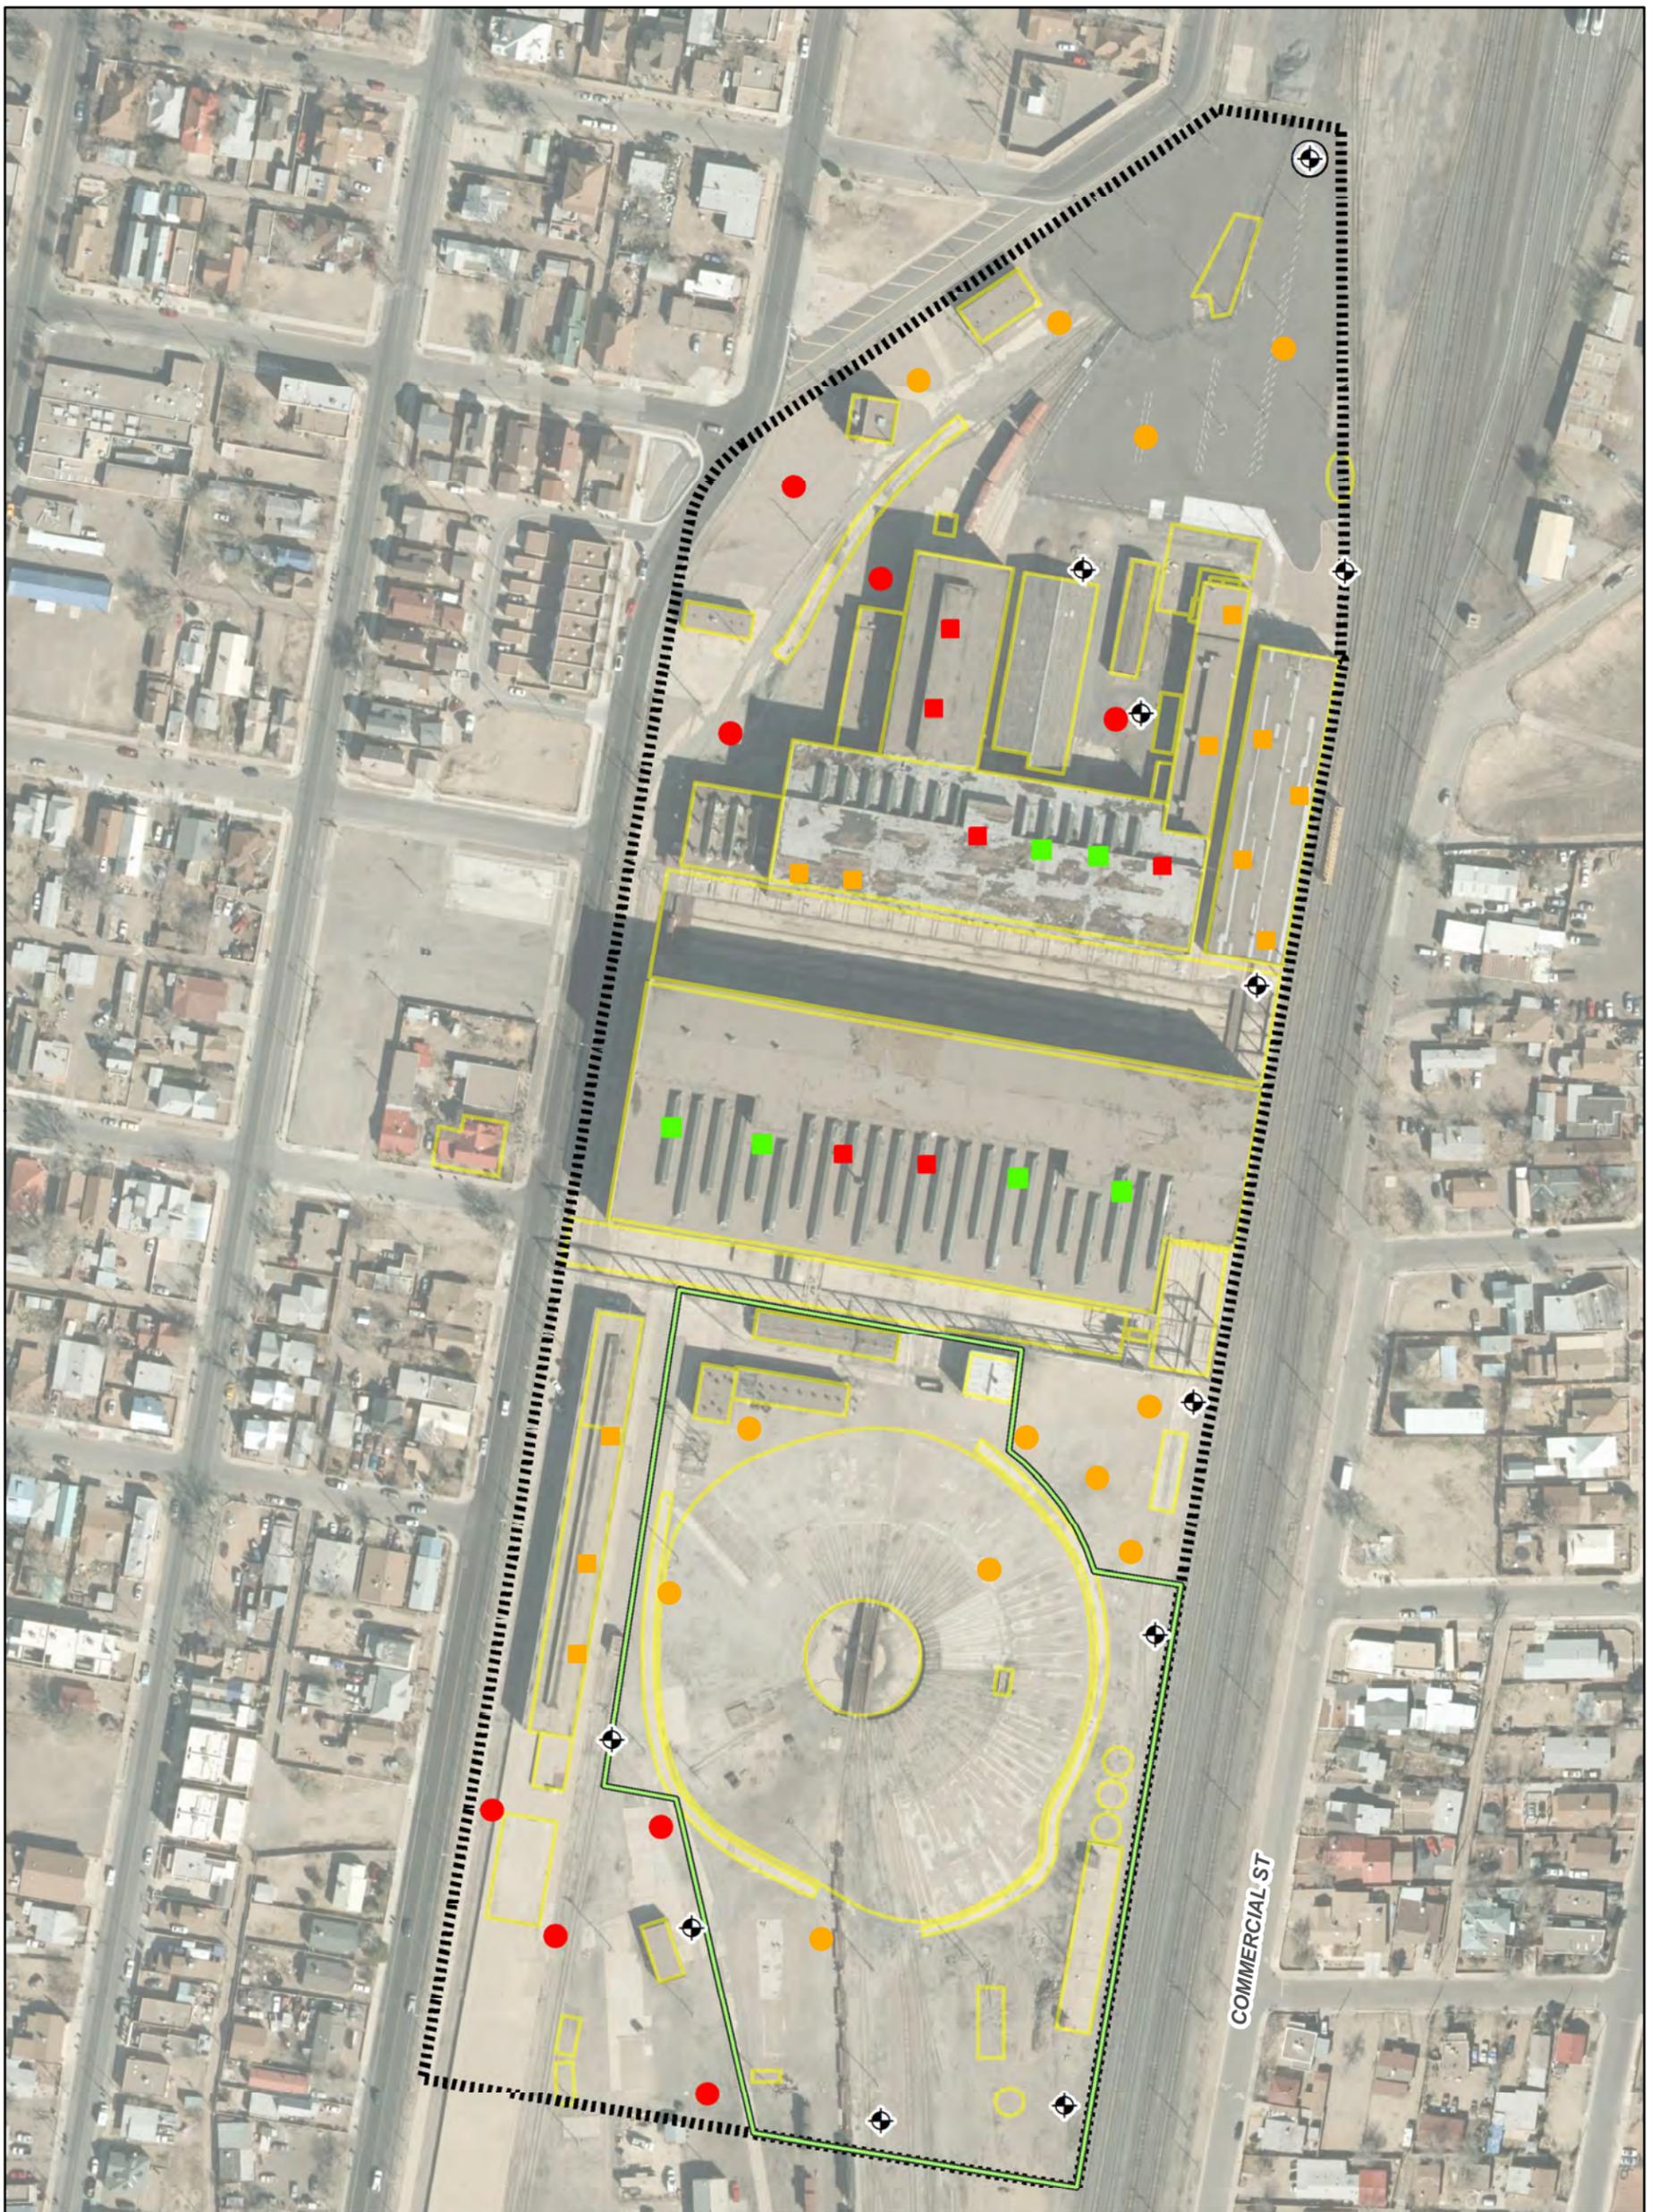
**Residential SSL Exceedances (0-10 ft bgs), TPH DRO + MRO, TPH Additional Characterization, Voluntary Remediation Program Activities, Albuquerque Rail Yards, Albuquerque, Bernalillo County, New Mexico**

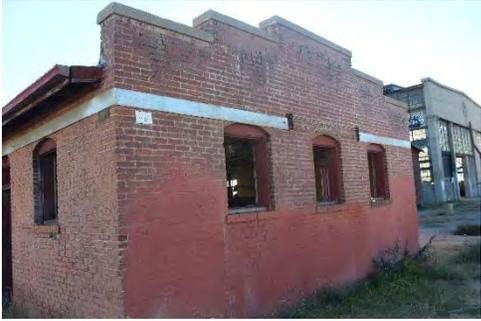
Figure 1 Front Exterior of North Wash Room

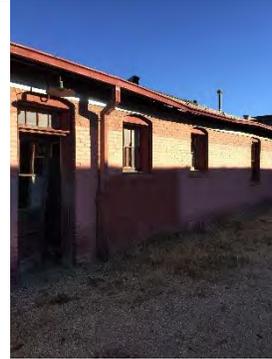
Figure 2 Exterior of North Wash Room

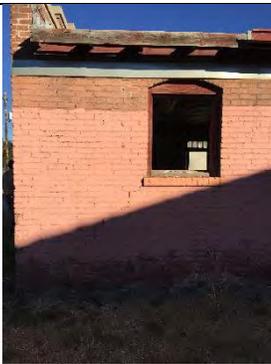
Figure 3 Window Exterior of North Wash Room

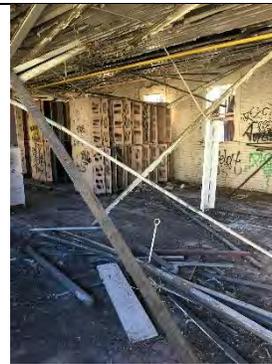
Figure 4 Interior of North Wash Room

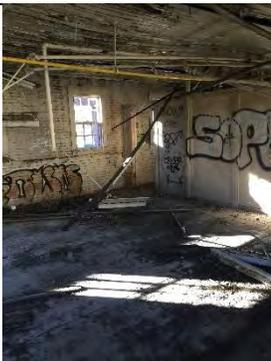
Figure 5 Interior of North Wash Room

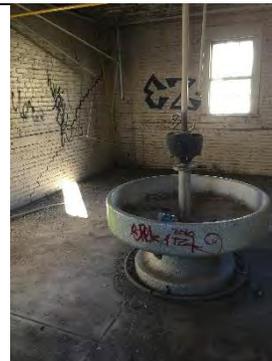
Figure 6 Interior of North Wash Room

- The Lead-based Paint inspection **did** identify “lead-based paint” at the North Wash Room. Those materials are listed in Appendix B, XRF Lead Measurements and Appendix D. Lead Based Paint Laboratory Results. These materials are regulated by OSHA in regards to those individuals which could be exposed during repair, renovation or demolition. It is recommended to have trained professionals in the OSHA Lead Construction standard handle the lead-based paint and lead-containing materials during disturbance of the material. At the conclusion of the construction activities we recommend a Lead Risk Assessment to include soil testing and settled dust be performed. A Lead Risk Assessment is recommended for this property based on the age and that children **may/are** expected to be present. A Risk Assessment should be conducted at the conclusions of operations to repair, renovate or abate the lead based coating.

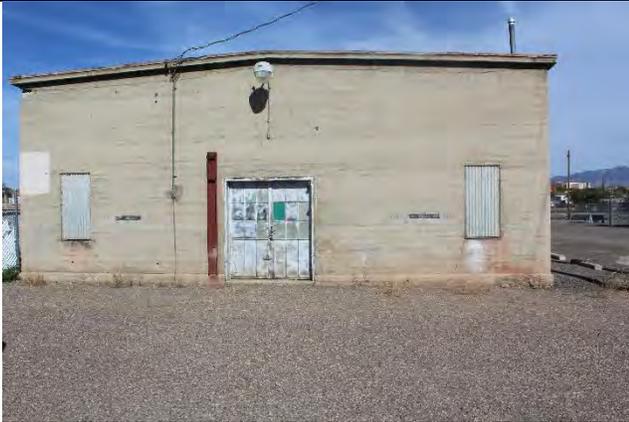
**Figure 1, Pattern House, South Side**

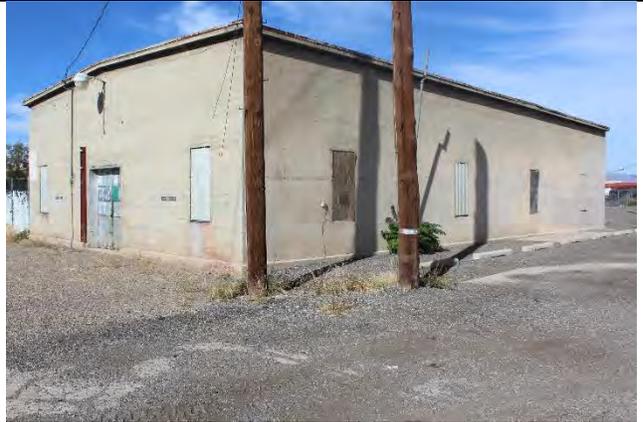
**Figure 2, Pattern House, Southwest Side**

- The Lead-based Paint inspection **did** identify “lead-based paint” at the Pattern House Building. Lead-containing items **were** identified at the Pattern House Building. Those materials are listed in Appendix B., XRF Lead Measurements and Appendix D., Lead Based Paint Chip Laboratory Analysis. These materials are regulated by OSHA in regards to those individuals which could be exposed during repair, renovation or demolition. It is recommended to have trained professionals in the OSHA Lead Construction standard handle the lead-based paint and lead-containing materials during disturbance of the material. At the conclusion of the construction activities we recommend a Lead Risk Assessment to include soil testing and settled dust be performed. A Lead Risk Assessment is recommended for this property based on the age and that children **may** be expected to be present. A Risk Assessment should be conducted at the conclusions of operations to repair, renovate or abate the lead based coating.

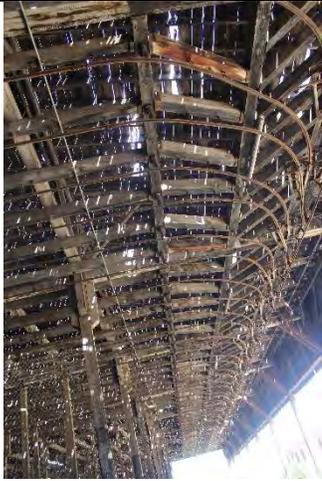
**Figure 1, Open Side of Sheet Metal House**

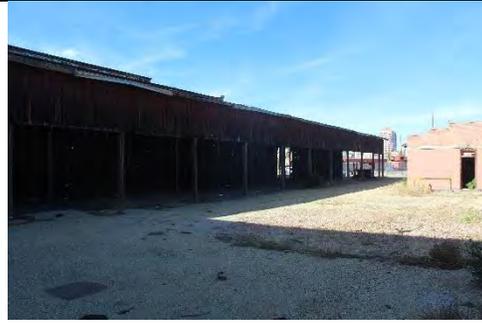
**Figure 2, Sheet Metal House, East Side**

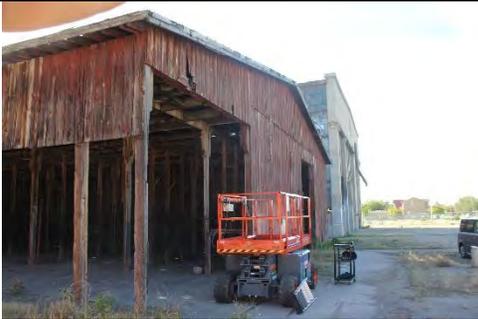
**Figure 3, Sheet Metal House, NE Corner**

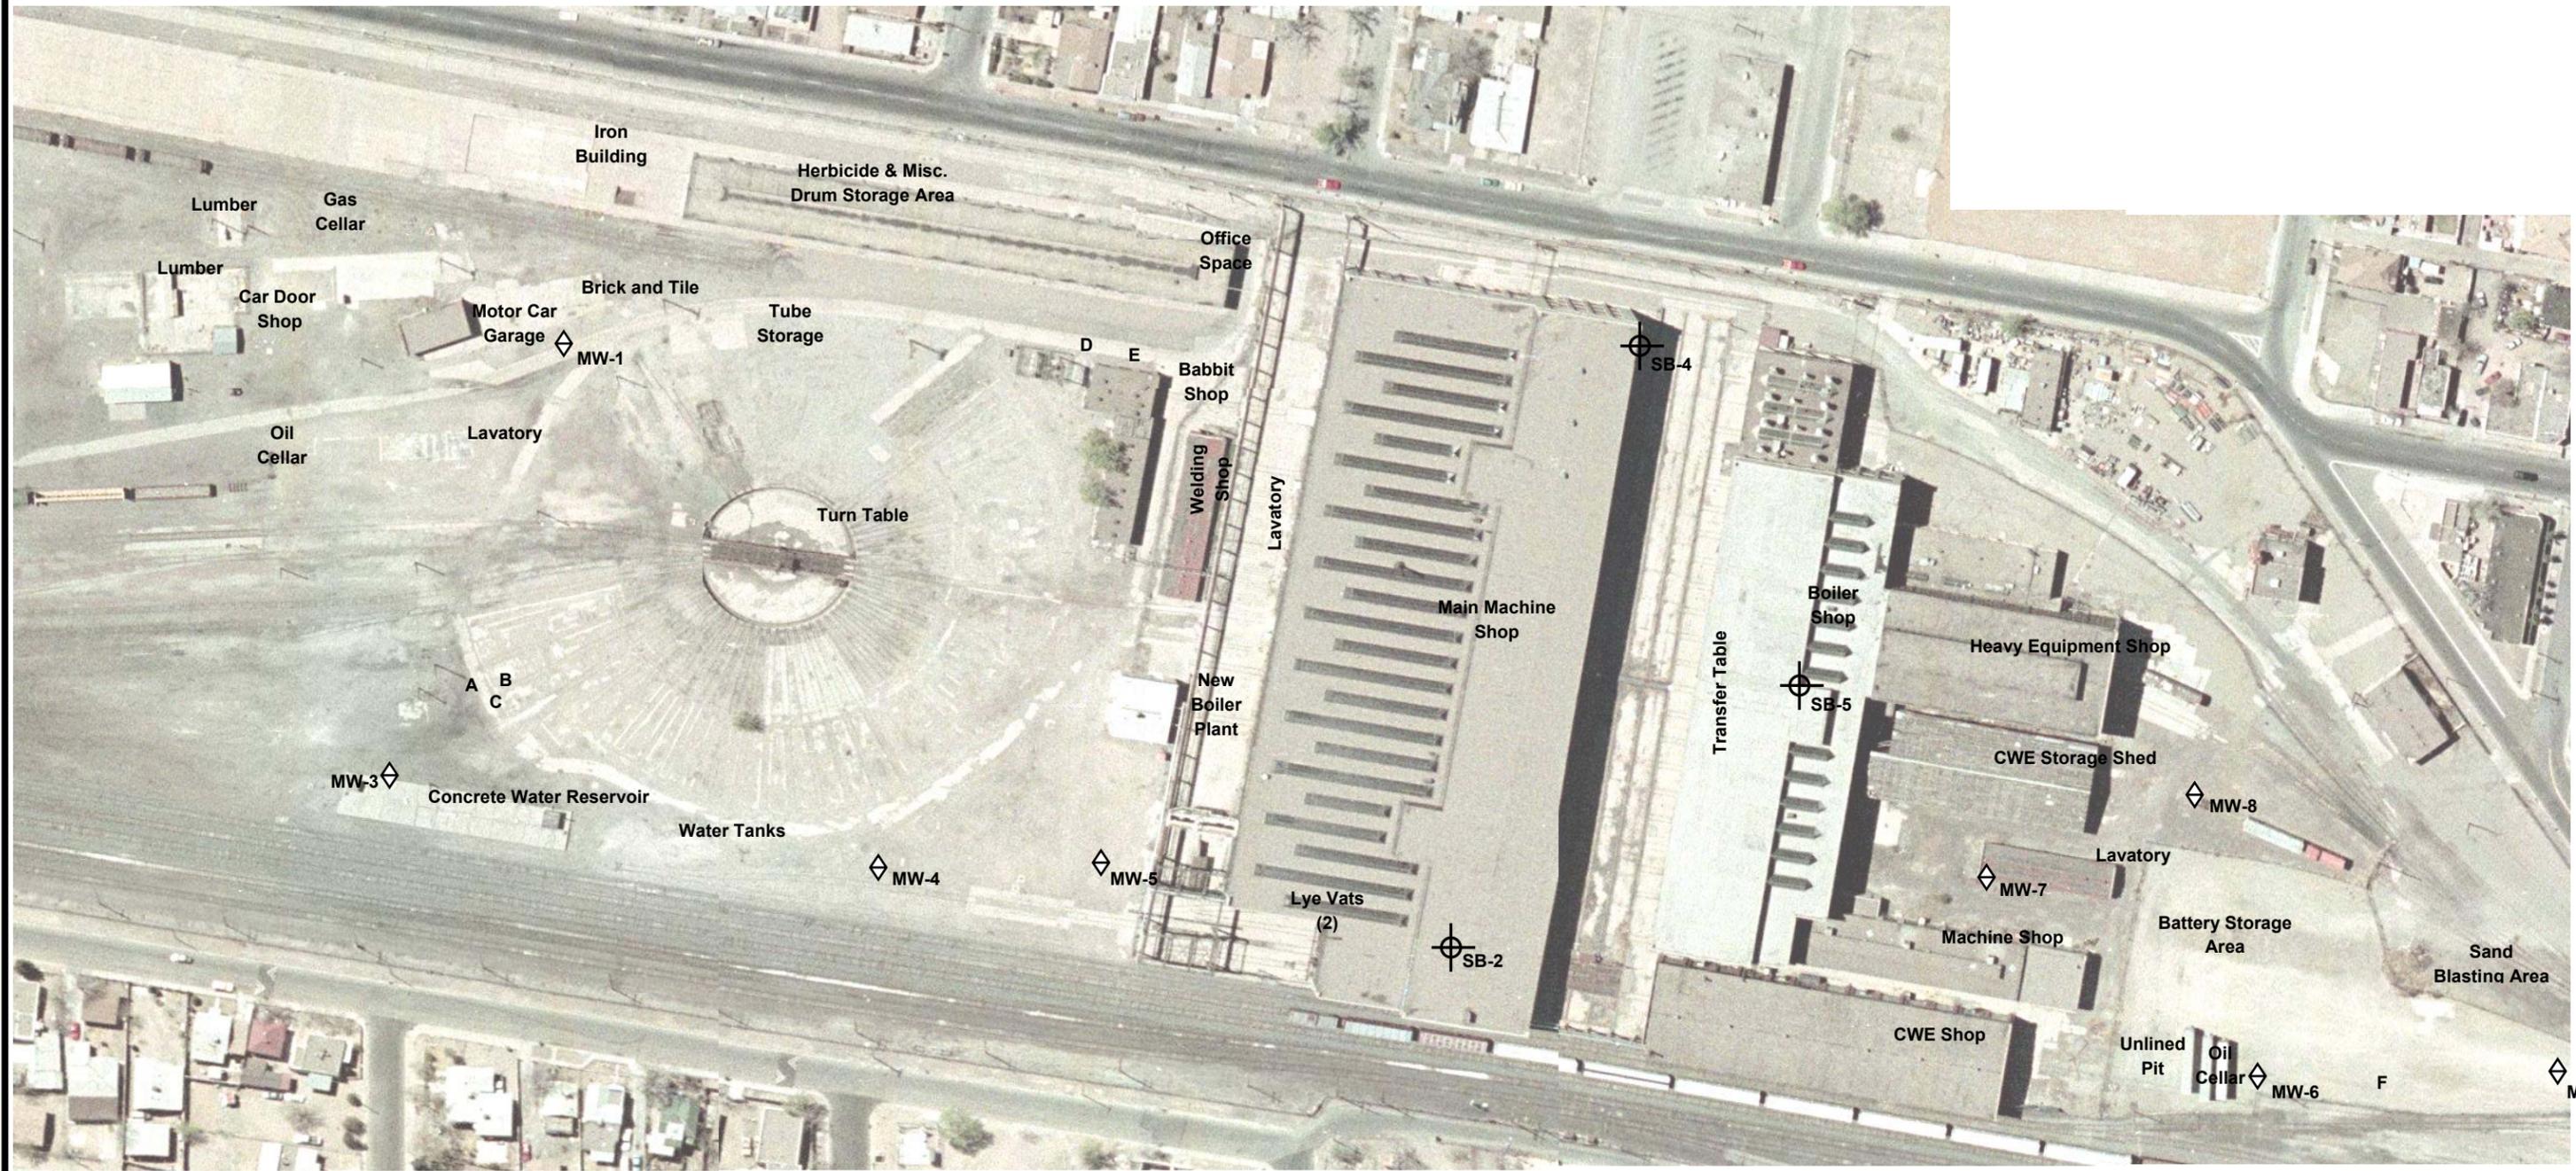
- A Sump
- B Former Oil Cellar
- C Former Oil Tank
- D New Transformer
- E Former Transformer Area
- F Northern Petroleum Area
- ⊕ Approximate Boring Location
- ◇ Approximate Monitoring Well Location
