**Voluntary Remediation Program  
Status Report  
City of Albuquerque Rail Yards  
VRP Site No. 53161007**

**Prepared for: NMED Ground Water Quality Bureau**

**Prepared by: Environmental Services Division  
Albuquerque Environmental Health Department**

**July 2019**

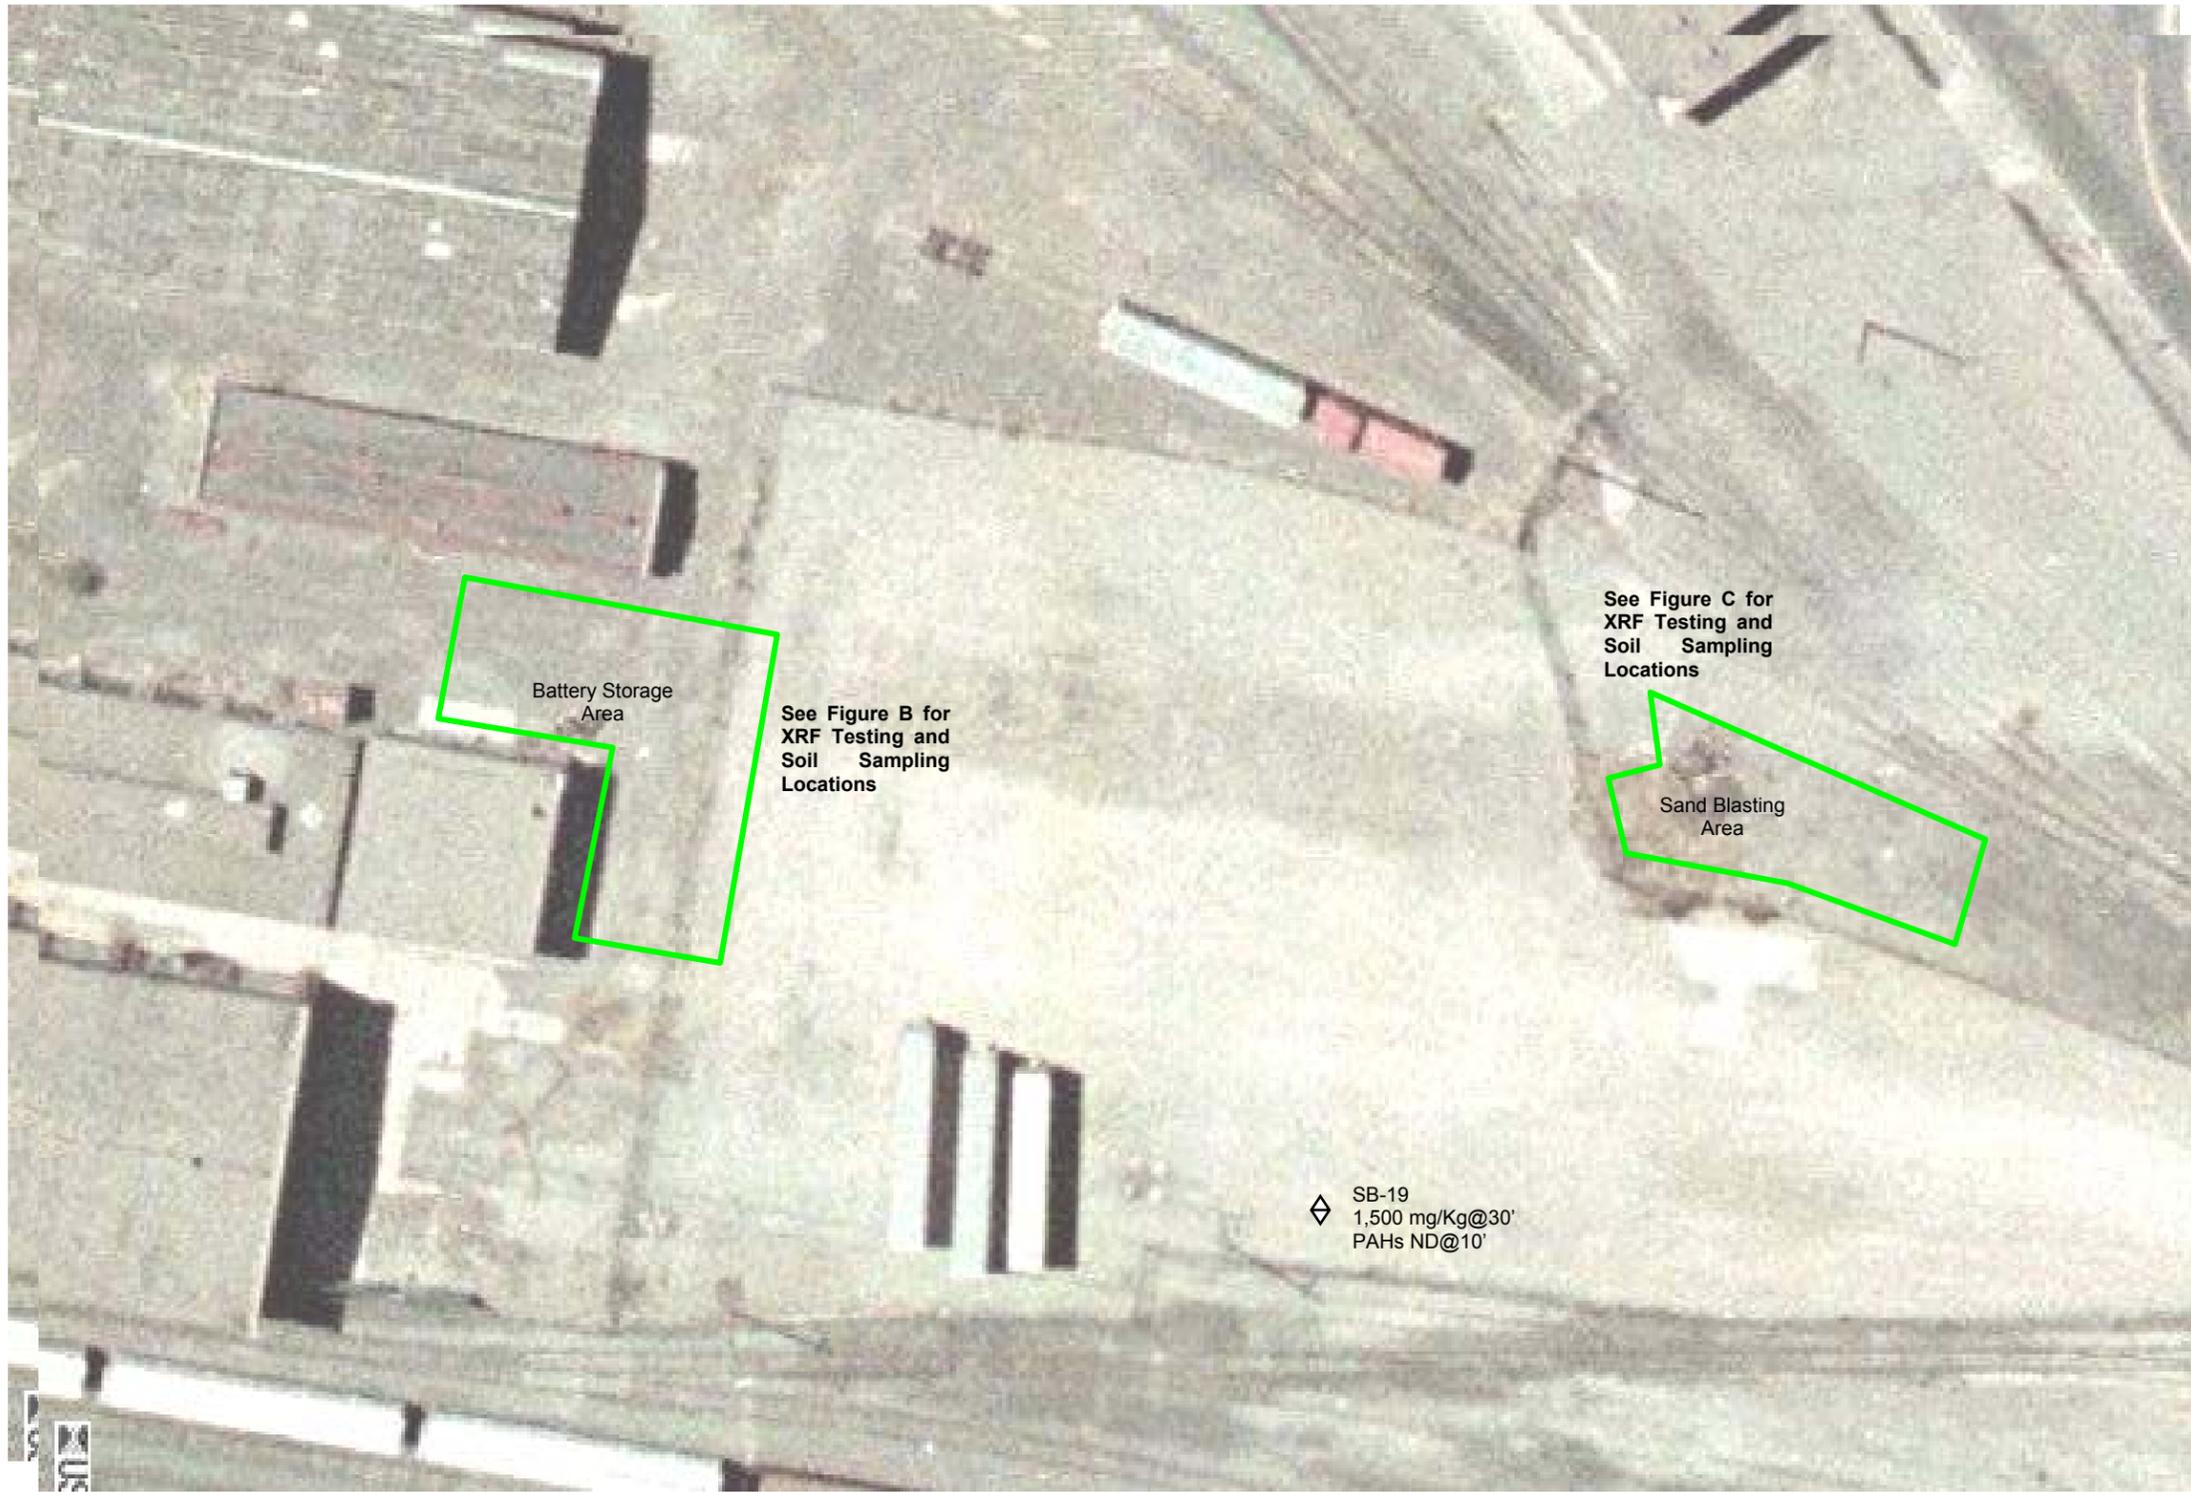
**EXCAVATION AREAS**  
Former AT&SF/ BNSF COMPANY CWE FACILITY  
ALBUQUERQUE, BERNALILLO COUNTY, NEW MEXICO

- ◇ Approximate Boring Location
  - Lead Impacted Soil Areas-Estimated Lead Impacts Greater than 750 mg/Kg\*
    - Battery Storage Excavated Area  
Estimated Total Volume = ~400 yds<sup>3</sup>
    - Sand Blasting Excavated Area  
Estimated Total Volume = ~140 yds<sup>3</sup>
- \*Commercial/Industrial SSLs

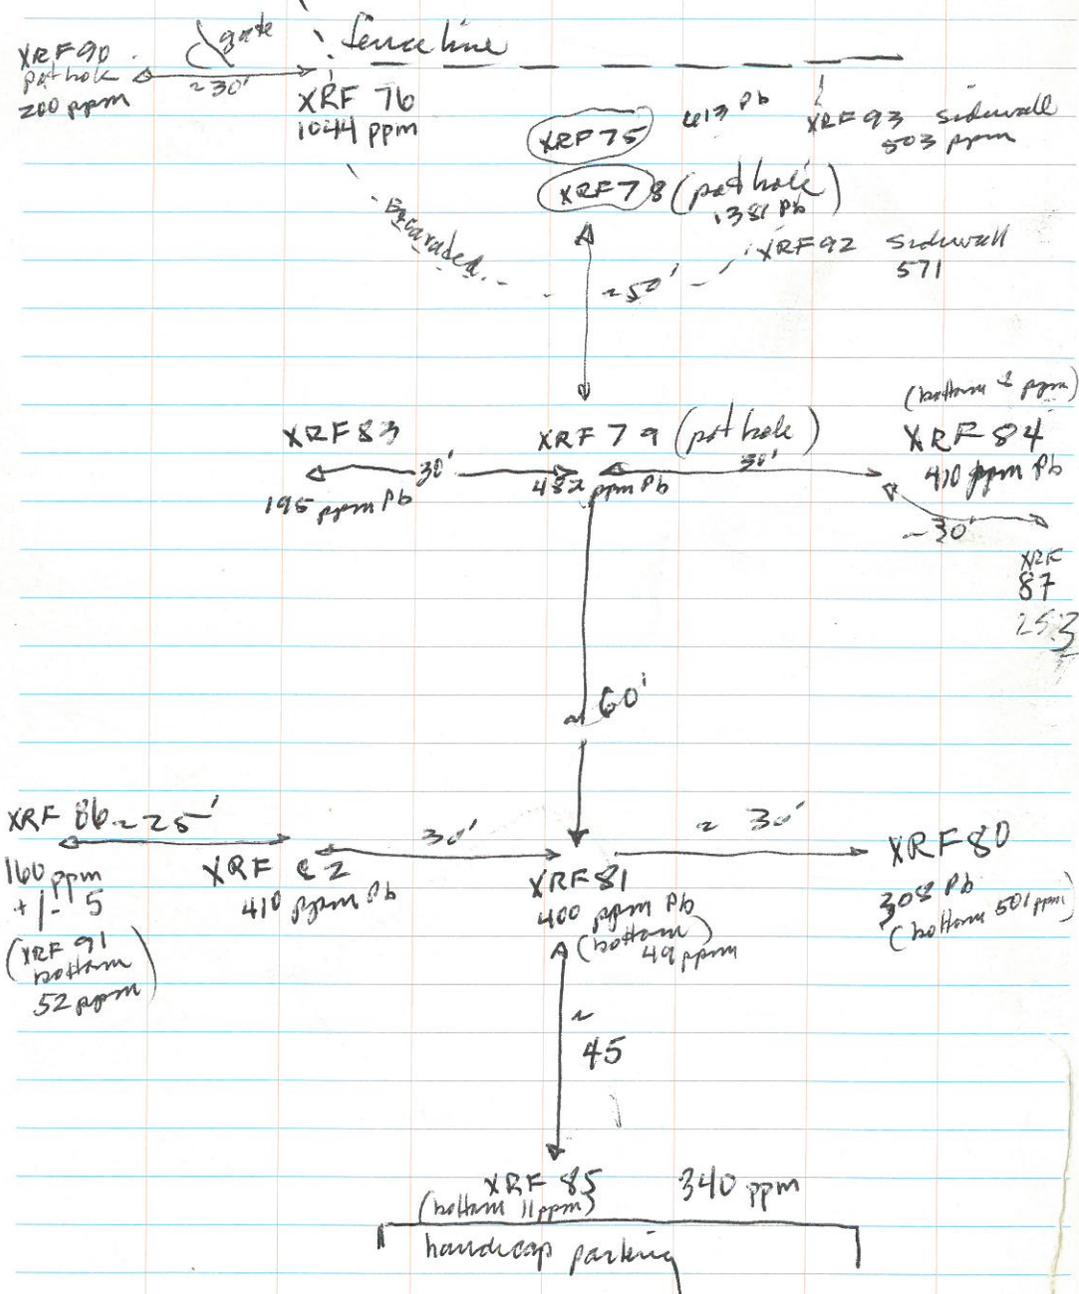
Sound blasting area N ↑

1125 XRF 80 308 ppm Pb ± 7  
 - SE path hole, collected on E. sidewalk, mixed industrial, ~ 2' bgs
