# PARCEL 10 ADDITIONAL CHARACTERIZATION REPORT

## CITY OF ALBUQUERQUE RAIL YARDS

Albuquerque, Bernalillo County, New Mexico

**April 27, 2016**

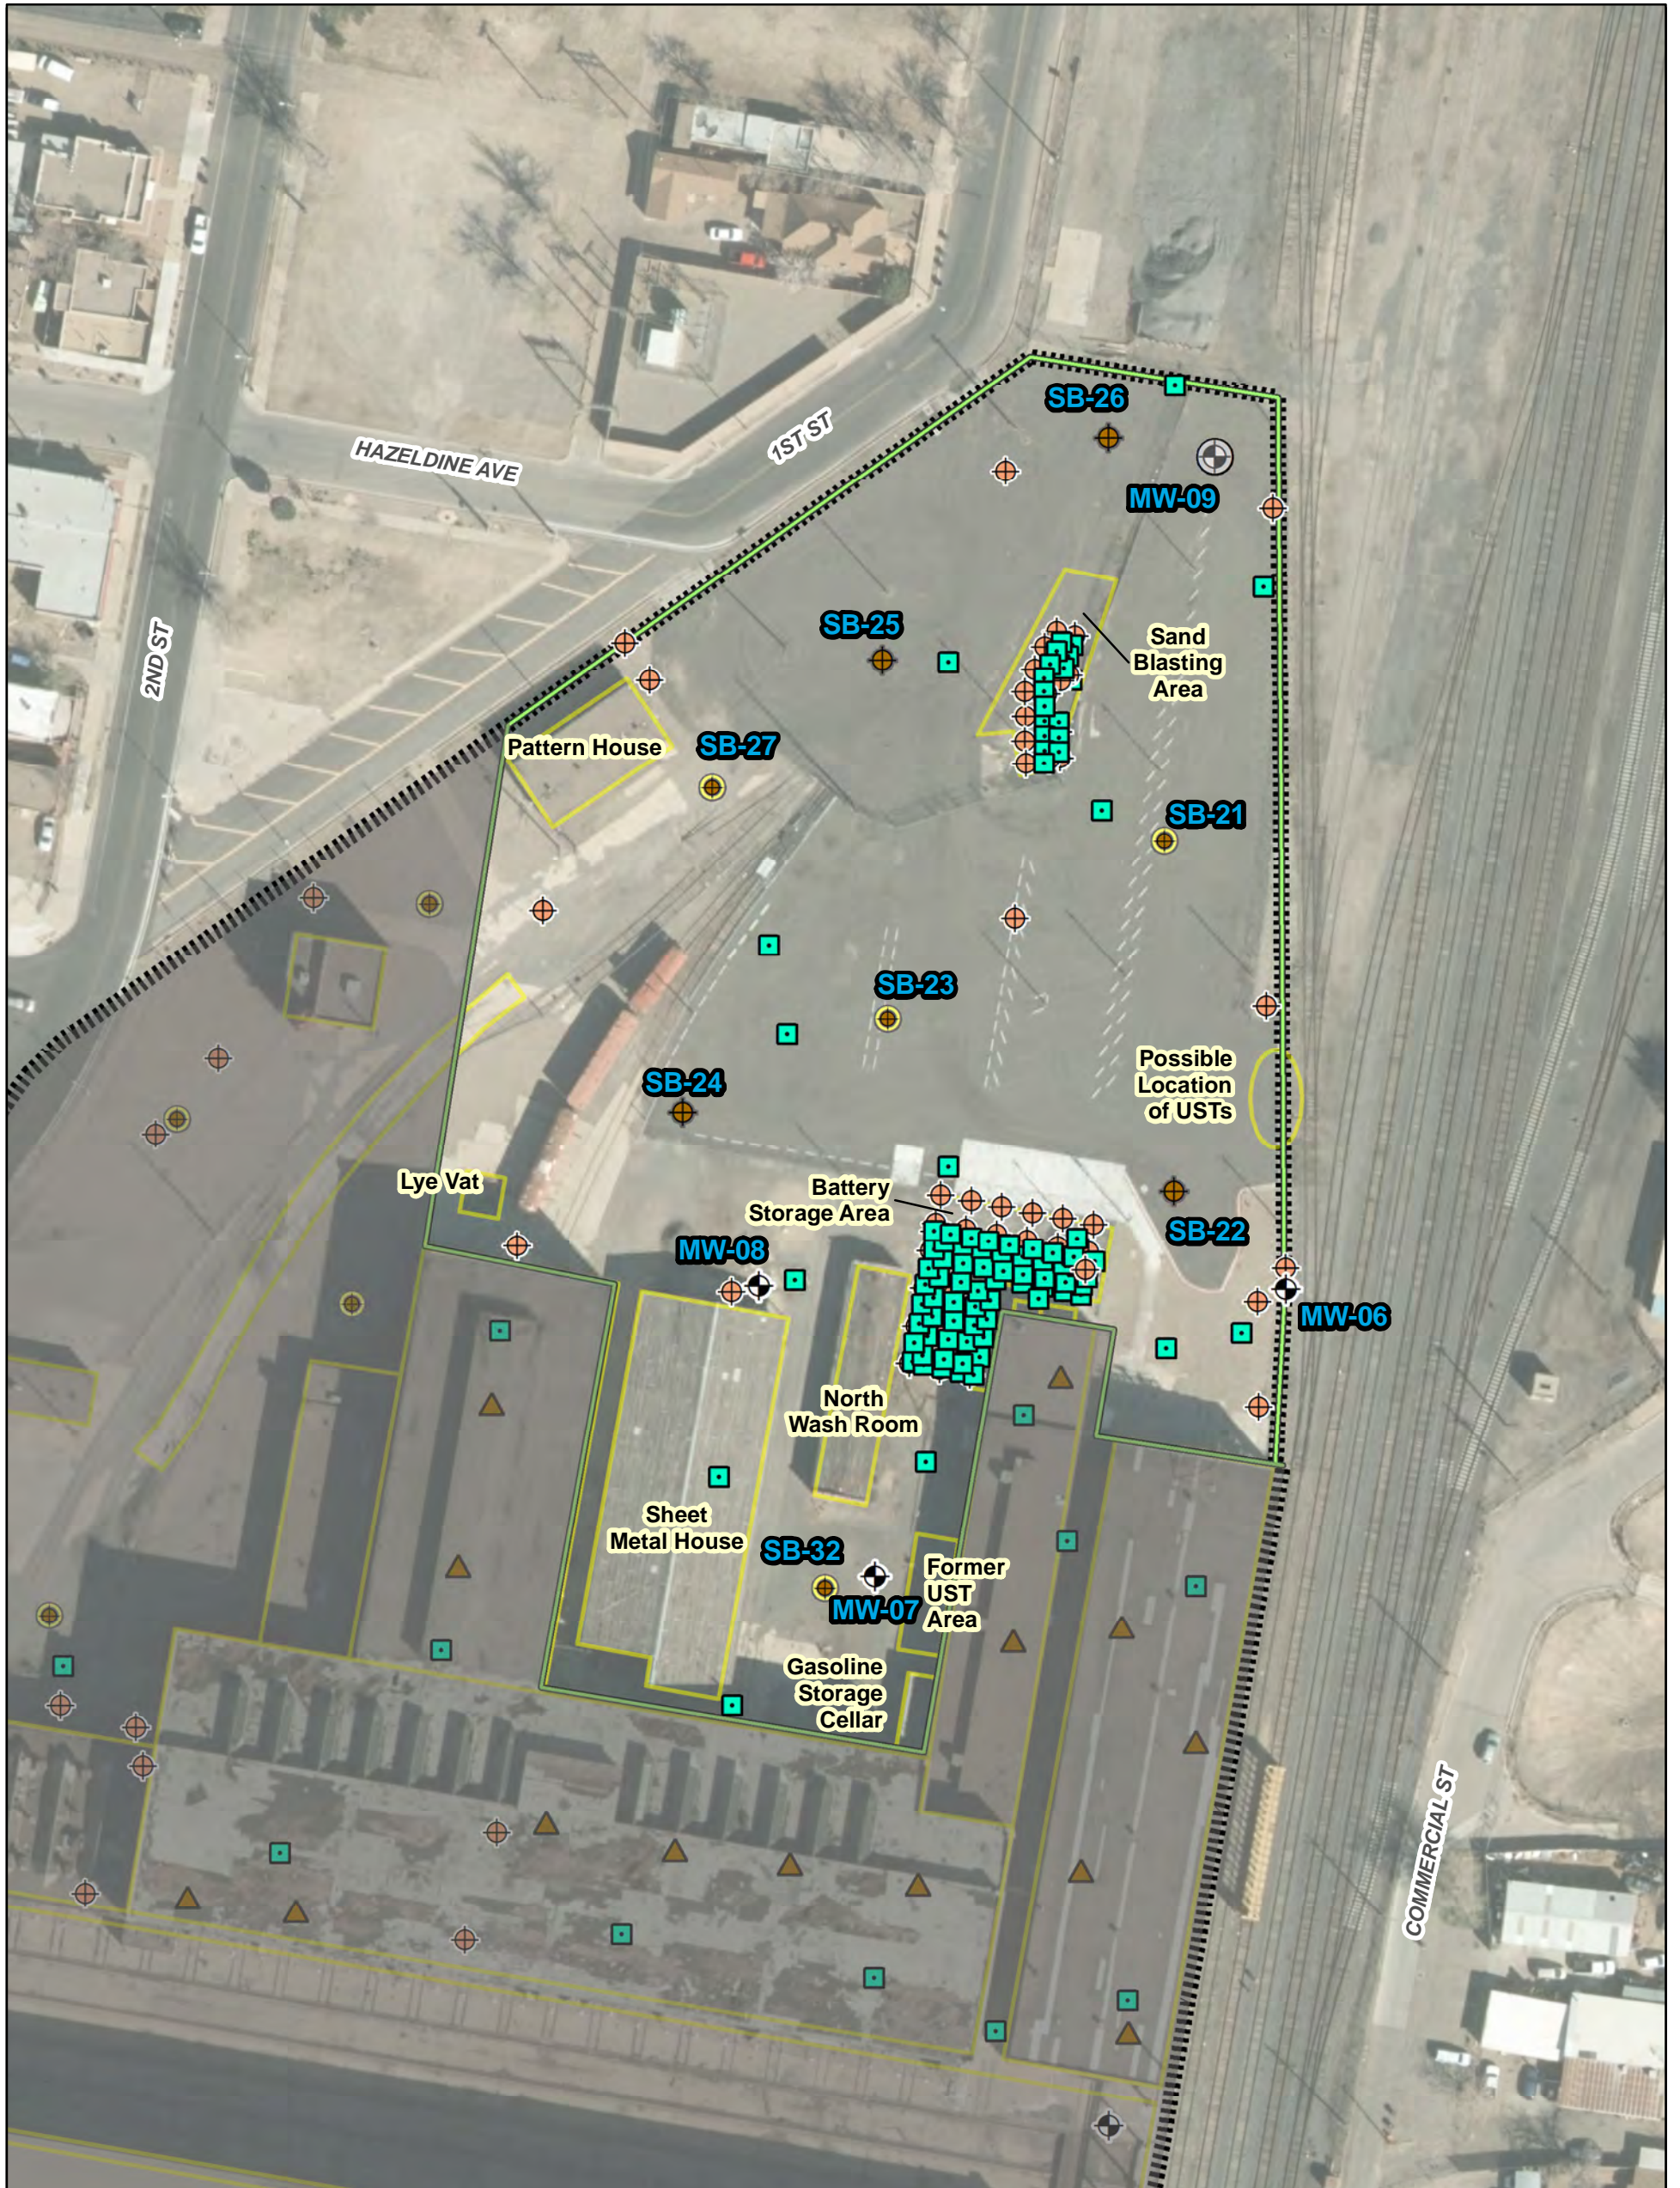
**Figure 2b**  
**Parcel 10 Soil and Soil Vapor Locations**  
 Additional Characterization,  
 Voluntary Remediation Program Activities,  
 Albuquerque Rail Yards, Albuquerque,  
 Bernalillo County, New Mexico

On October 27, 2016, eight soil borings (SB-21, SB-22, SB-23, SB-24, SB-25, SB-26, SB-27, and SB-32) were drilled using a truck-mounted Geoprobe<sup>®</sup> drilling rig operated by Vista GeoScience, LLC (Vista) of Golden, Colorado (**Figure 2b**). These eight soil boring locations were chosen based on the data gaps identified in the CSM and the proposed redevelopment plans provided by the COA. The Geoprobe<sup>®</sup> utilizes a rotary hammer mounted on a hydraulic ram that, in conjunction with the weight of the vehicle, advances a threaded, hollow-probed steel tube (Post Run Tubing or PRT) into the subsurface. Soil borings (SB-22, SB-24, SB-25, and SB-32) were advanced to a depth of 6 feet below ground surface (ft bgs) and soil borings (SB-21, SB-23, SB-26, and SB-27) were advanced to a depth of 15 ft bgs. The soil sampling locations were selected to collect data for the current proposed redevelopment scenario while also providing good spatial coverage across Parcel 10 in the event the proposed redevelopment scenario changes.

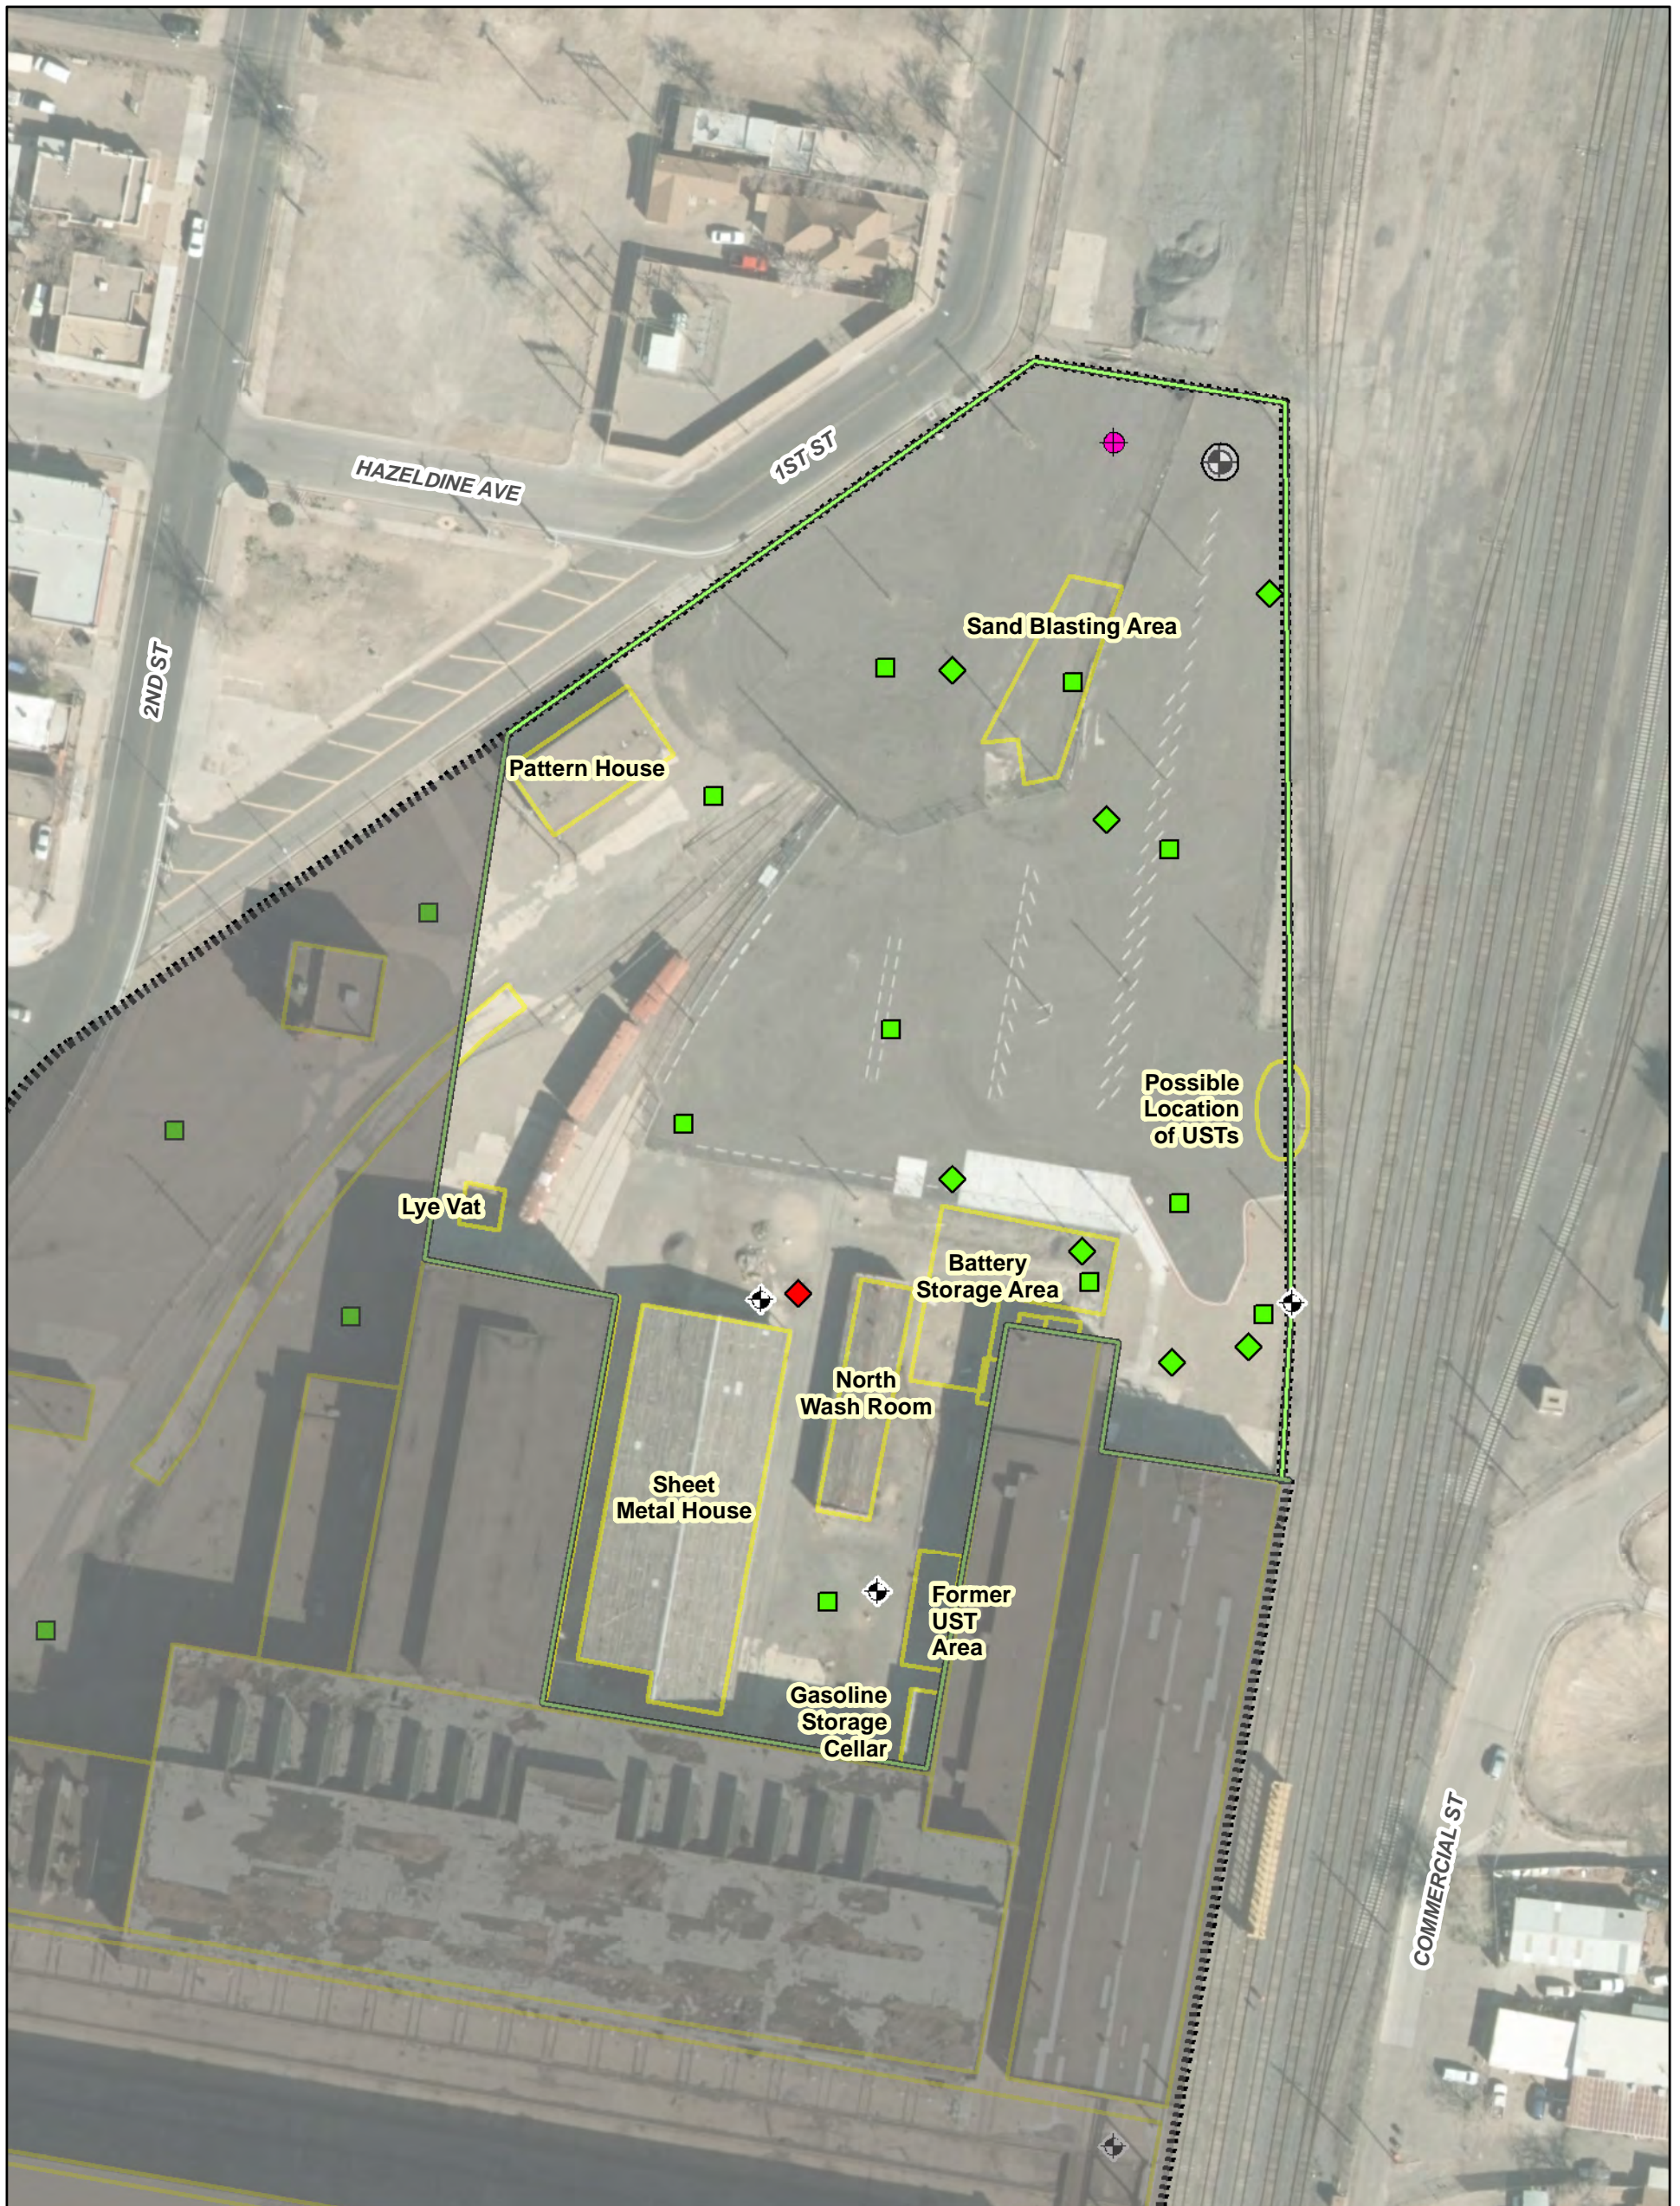
**Figure 3d**  
 Residential SSL Exceedances  
 (0-10 ft bgs), Iron  
 Additional Characterization,  
 Voluntary Remediation Program Activities,  
 Albuquerque Rail Yards, Albuquerque,  
 Bernalillo County, New Mexico

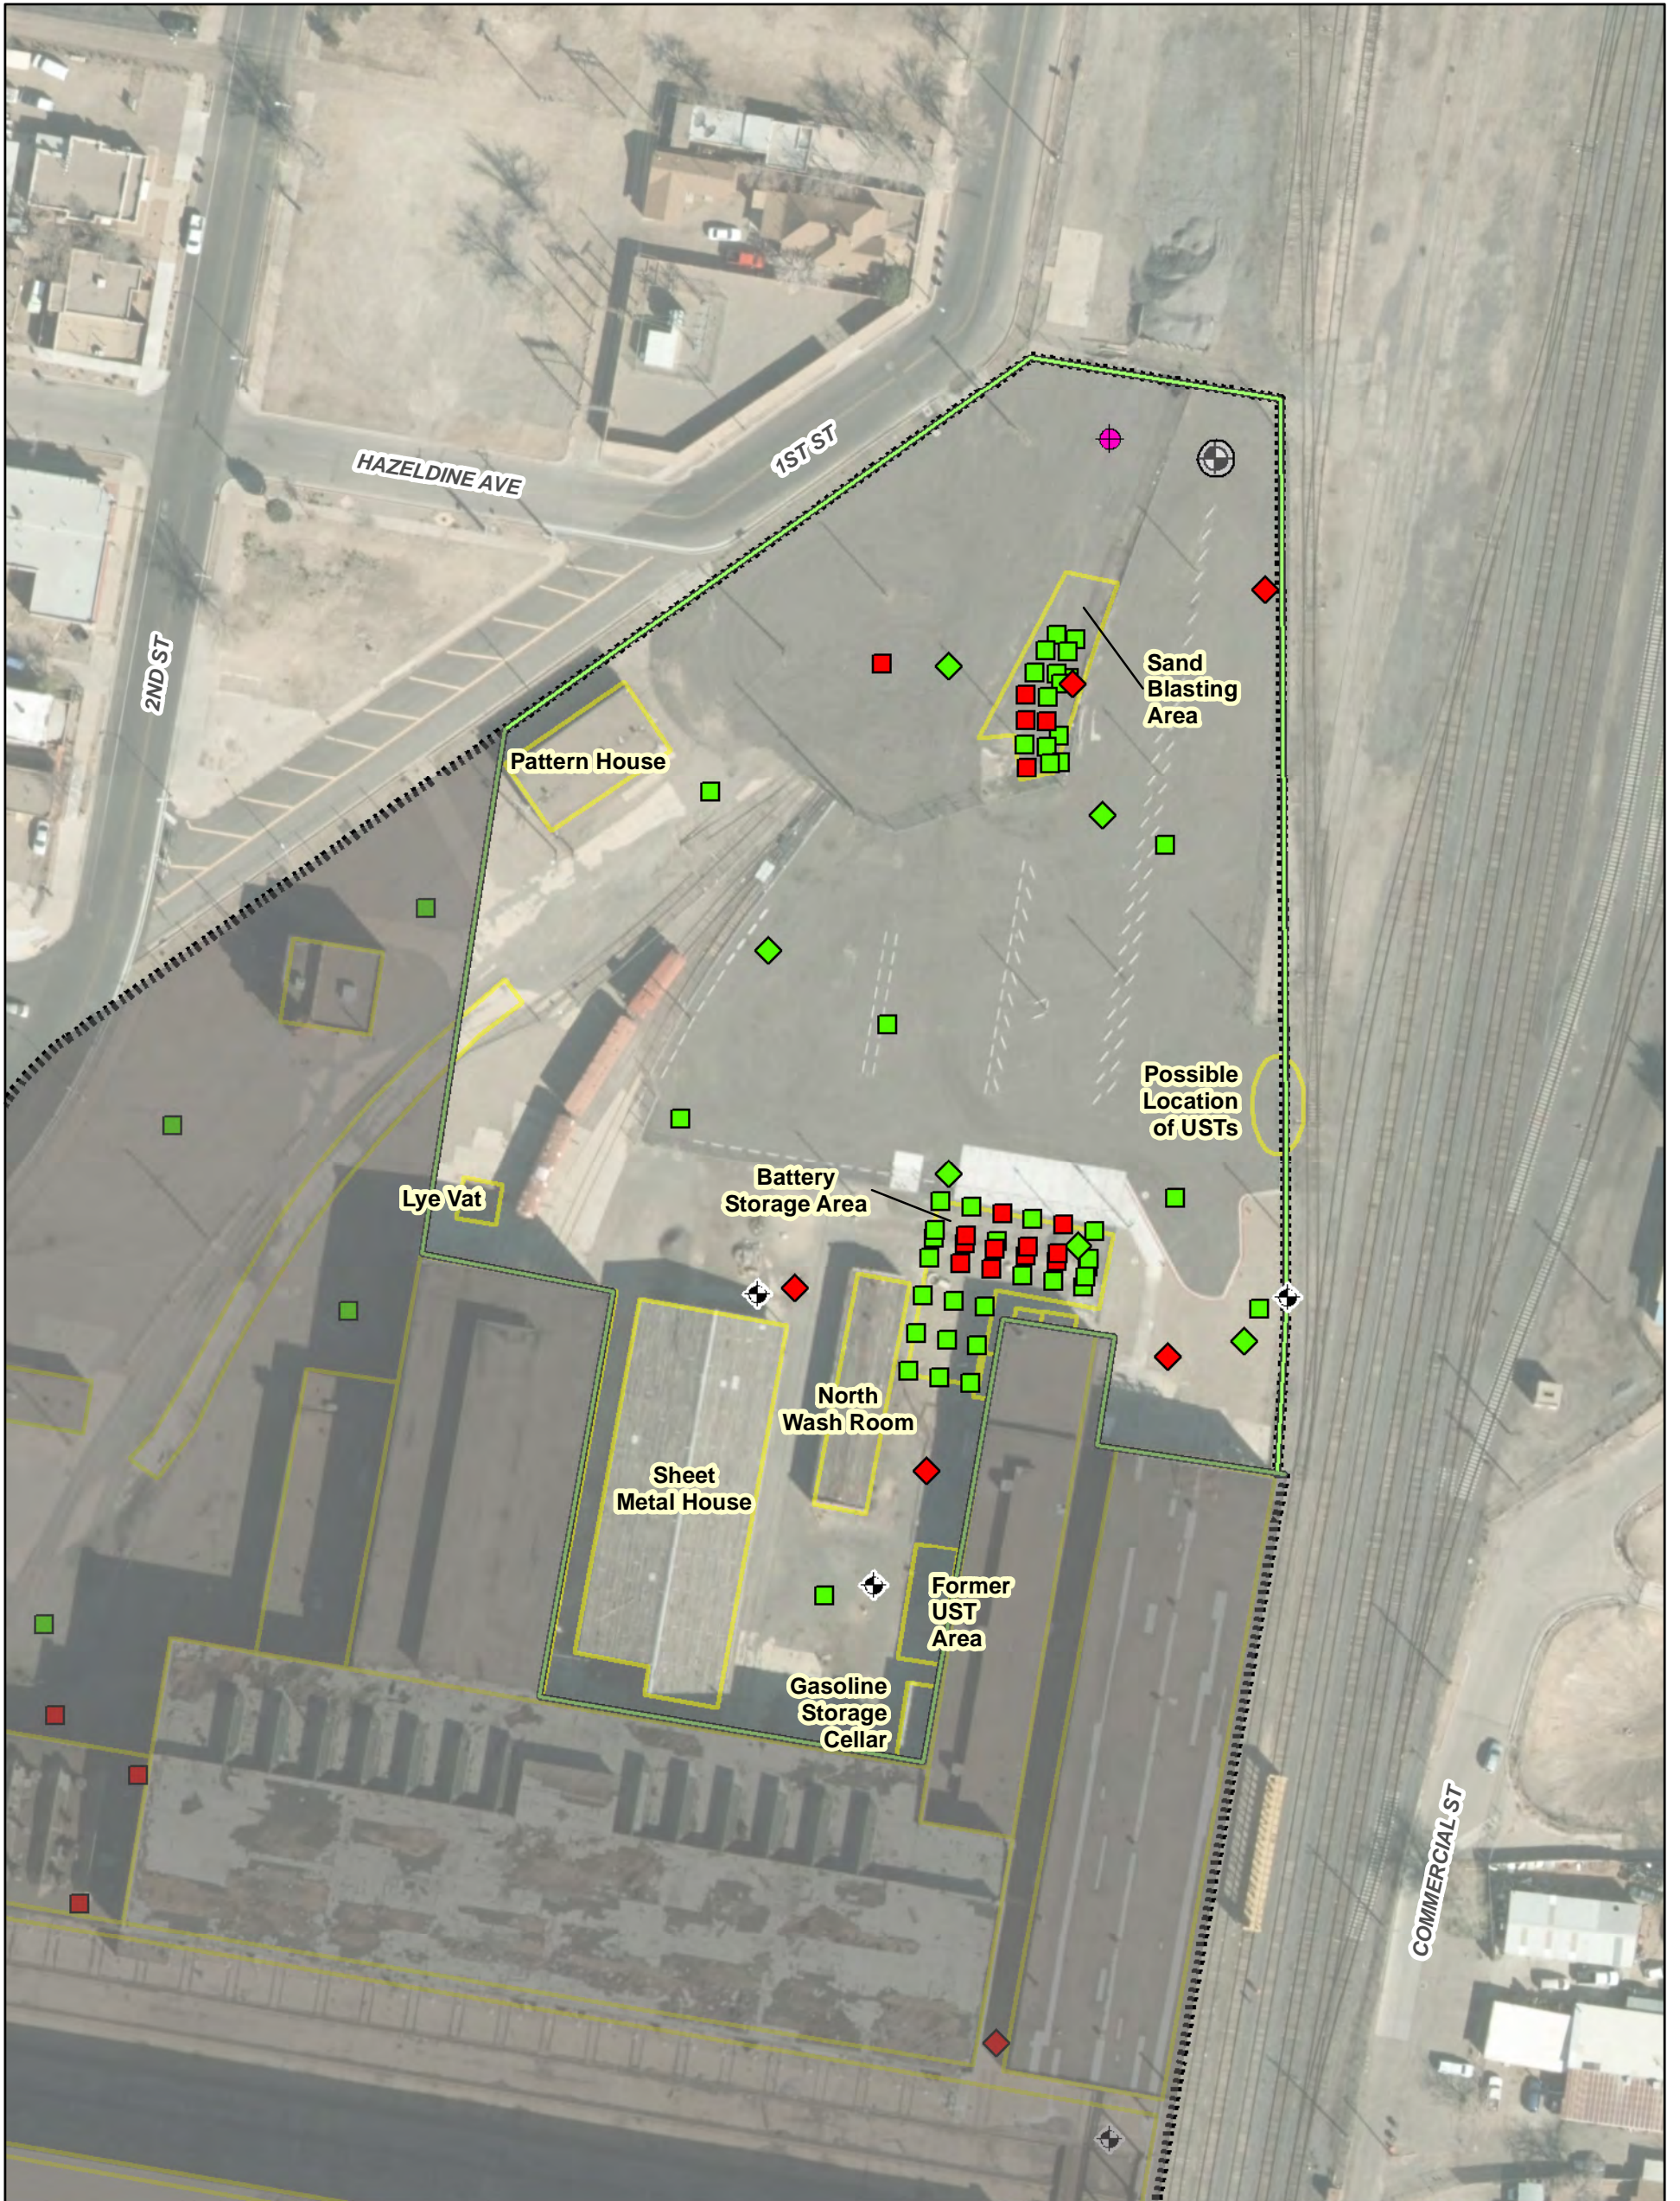
**Figure 3e**  
 Residential SSL Exceedances  
 (0-10 ft bgs), Lead  
 Additional Characterization,  
 Voluntary Remediation Program Activities,  
 Albuquerque Rail Yards, Albuquerque,  
 Bernalillo County, New Mexico

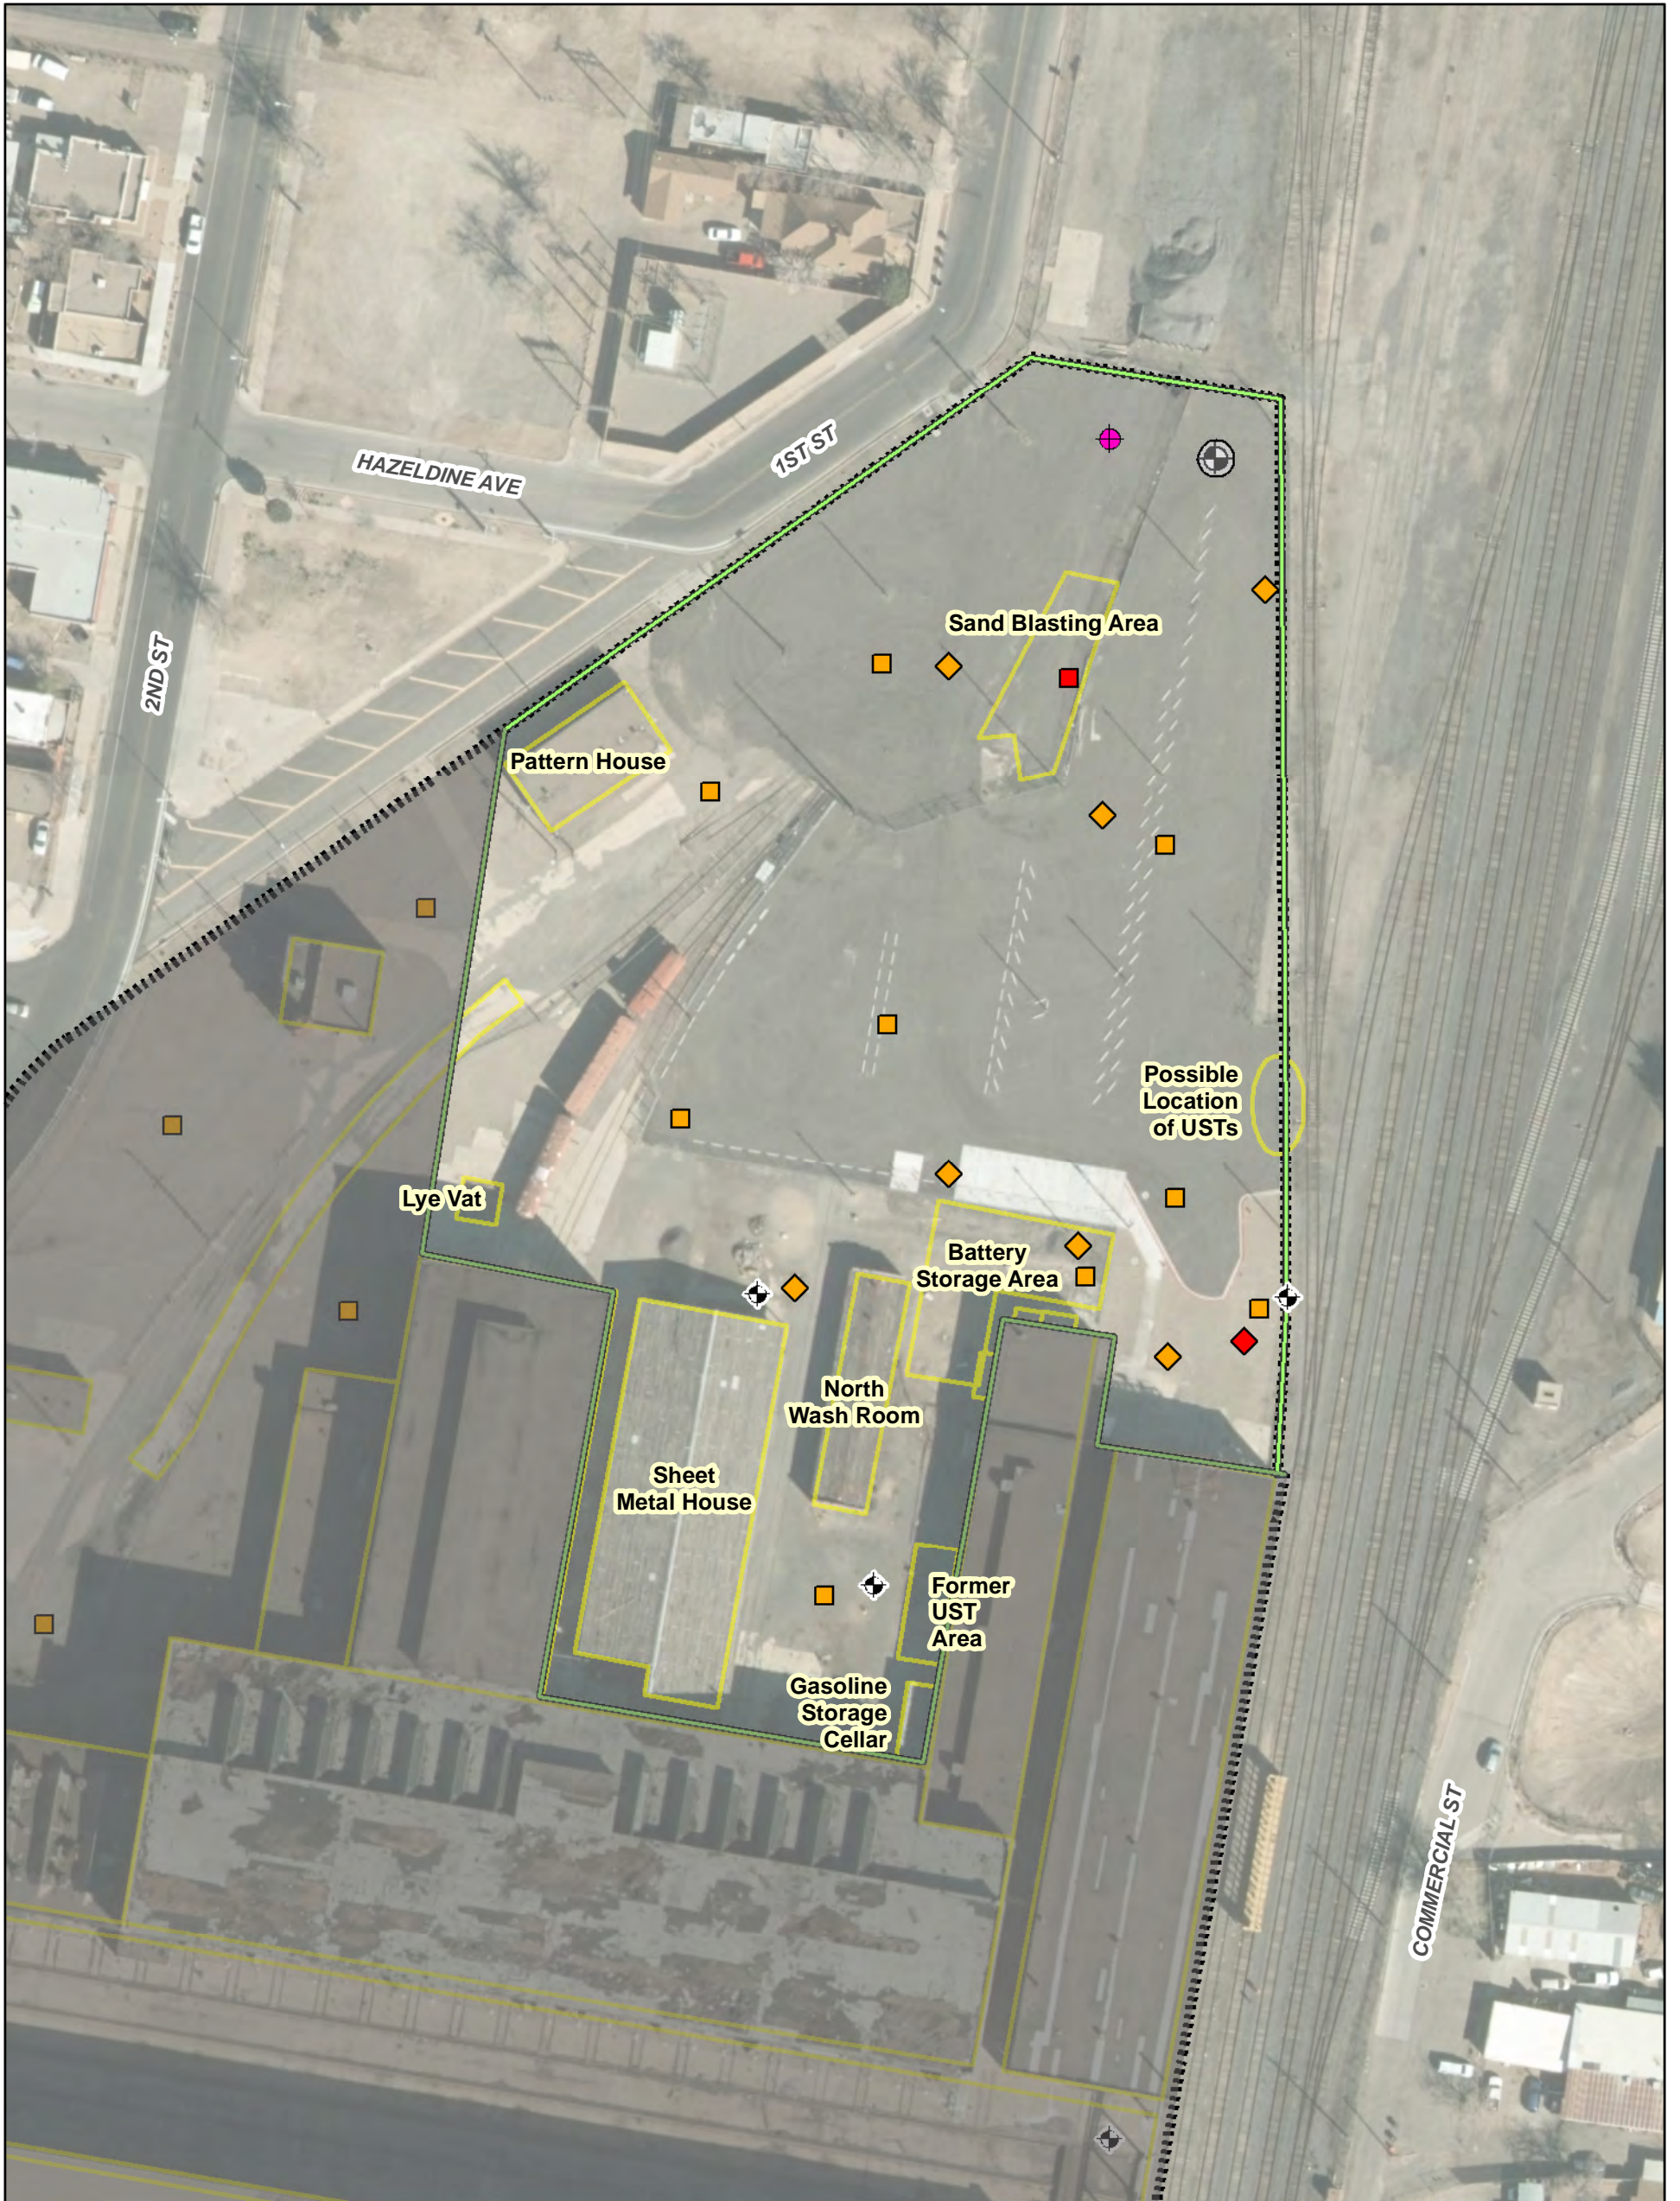
**Figure 3g**  
Residential SSL Exceedances  
(0-10 ft bgs), Thallium  
Additional Characterization,  
Voluntary Remediation Program Activities,  
Albuquerque Rail Yards, Albuquerque,  
Bernalillo County, New Mexico

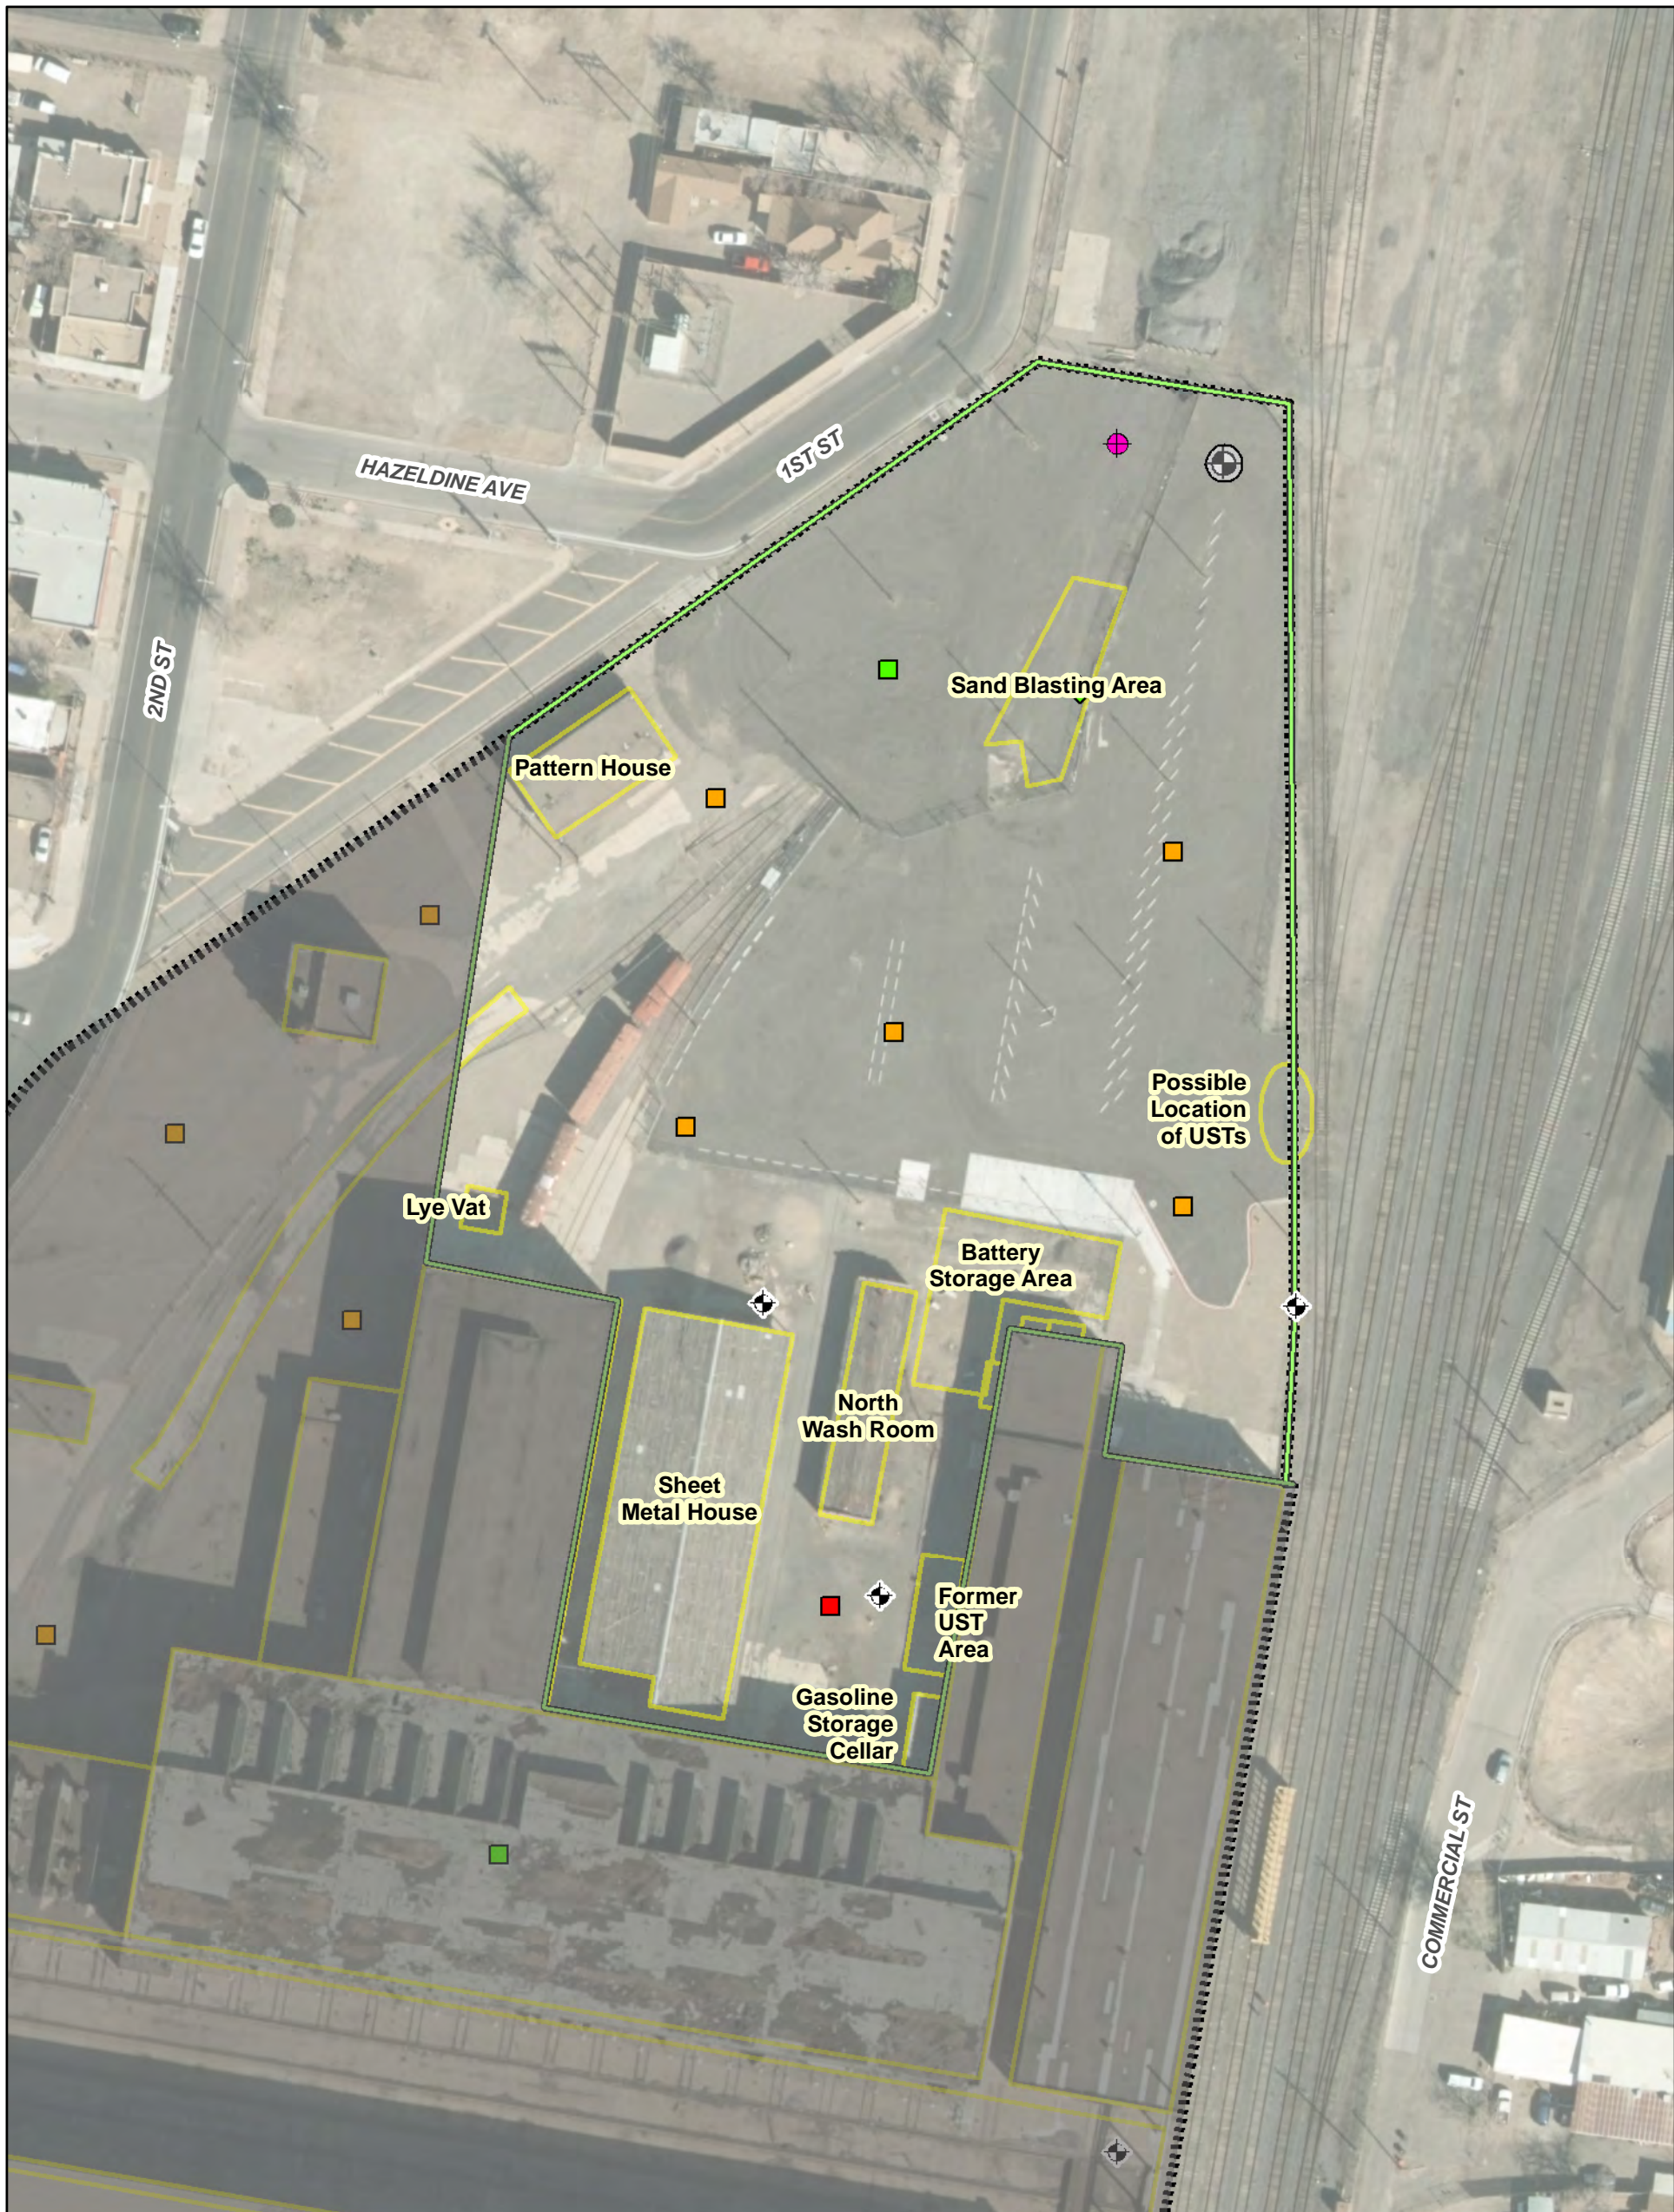
**Figure 4a**  
 Residential SSL Exceedances  
 (0-10 ft bgs), Benzo(a)anthracene  
 Additional Characterization,  
 Voluntary Remediation Program Activities,  
 Albuquerque Rail Yards, Albuquerque,  
 Bernalillo County, New Mexico

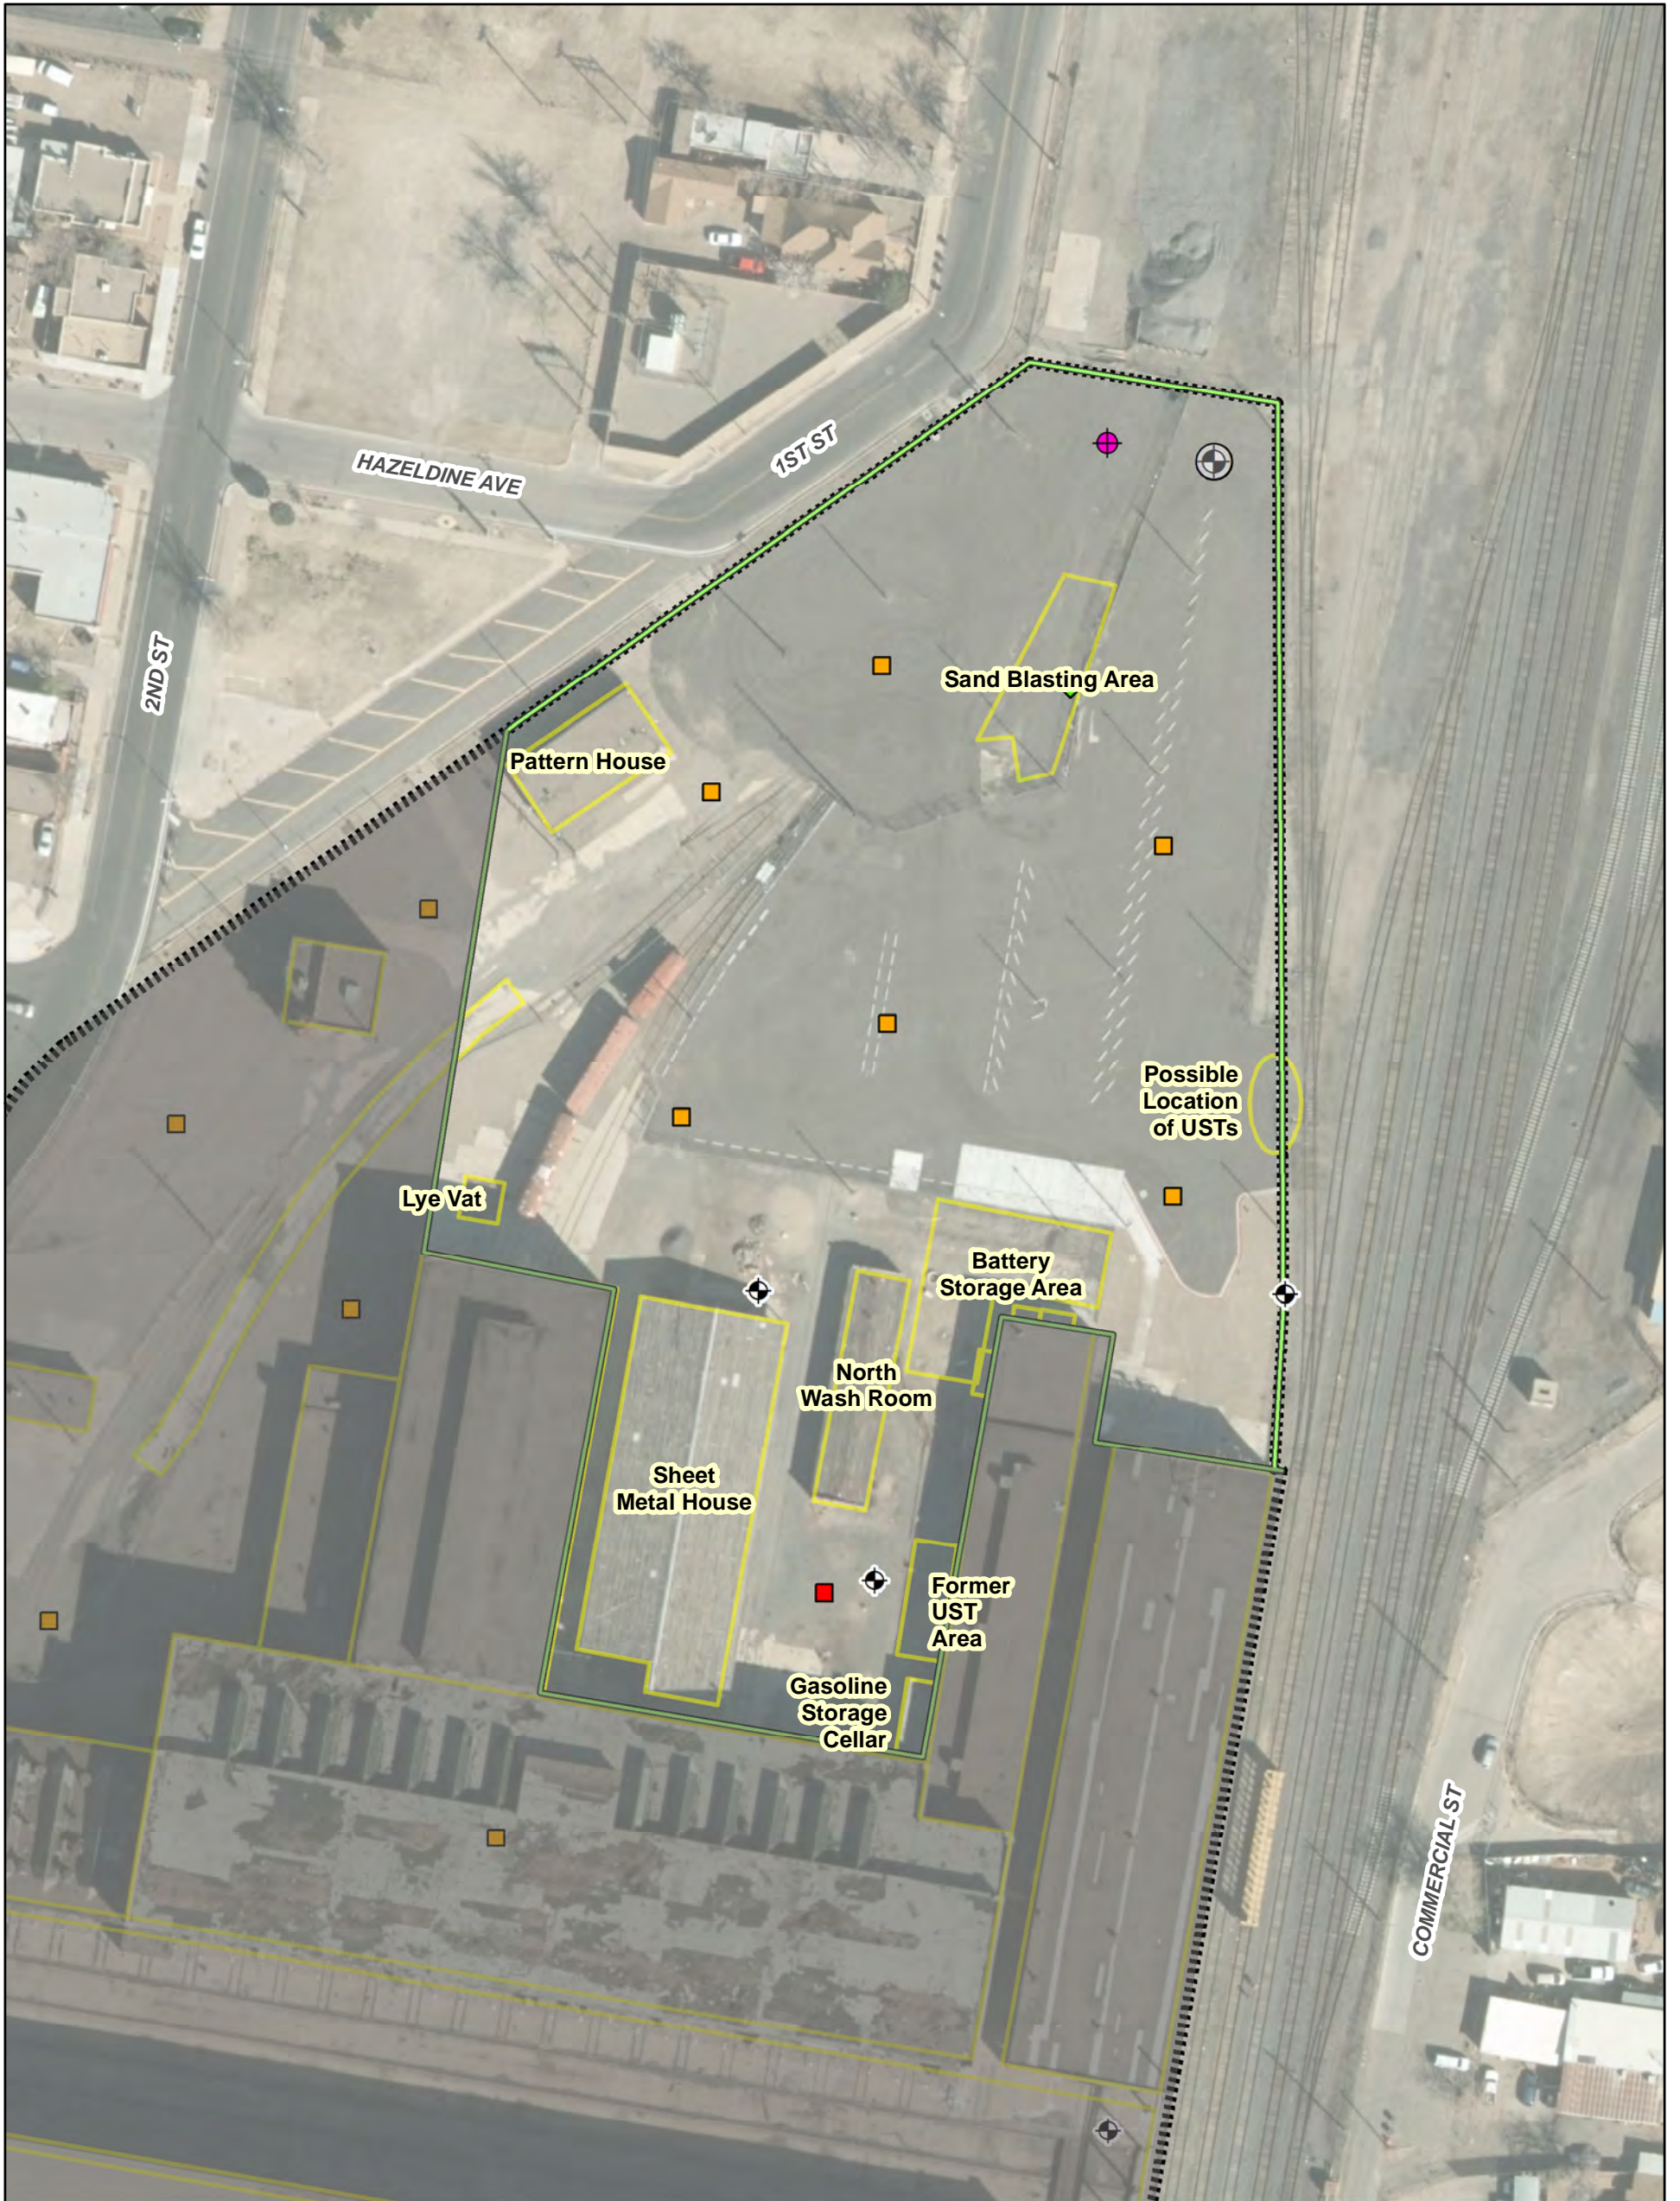
**Figure 4d**  
 Residential SSL Exceedances (0-10 ft bgs), Dibenzo(a,h)anthracene  
 Additional Characterization, Voluntary Remediation Program Activities, Albuquerque Rail Yards, Albuquerque, Bernalillo County, New Mexico
