# PARCEL 10 ADDITIONAL CHARACTERIZATION REPORT

## CITY OF ALBUQUERQUE RAIL YARDS

Albuquerque, Bernalillo County, New Mexico

**April 27, 2016**

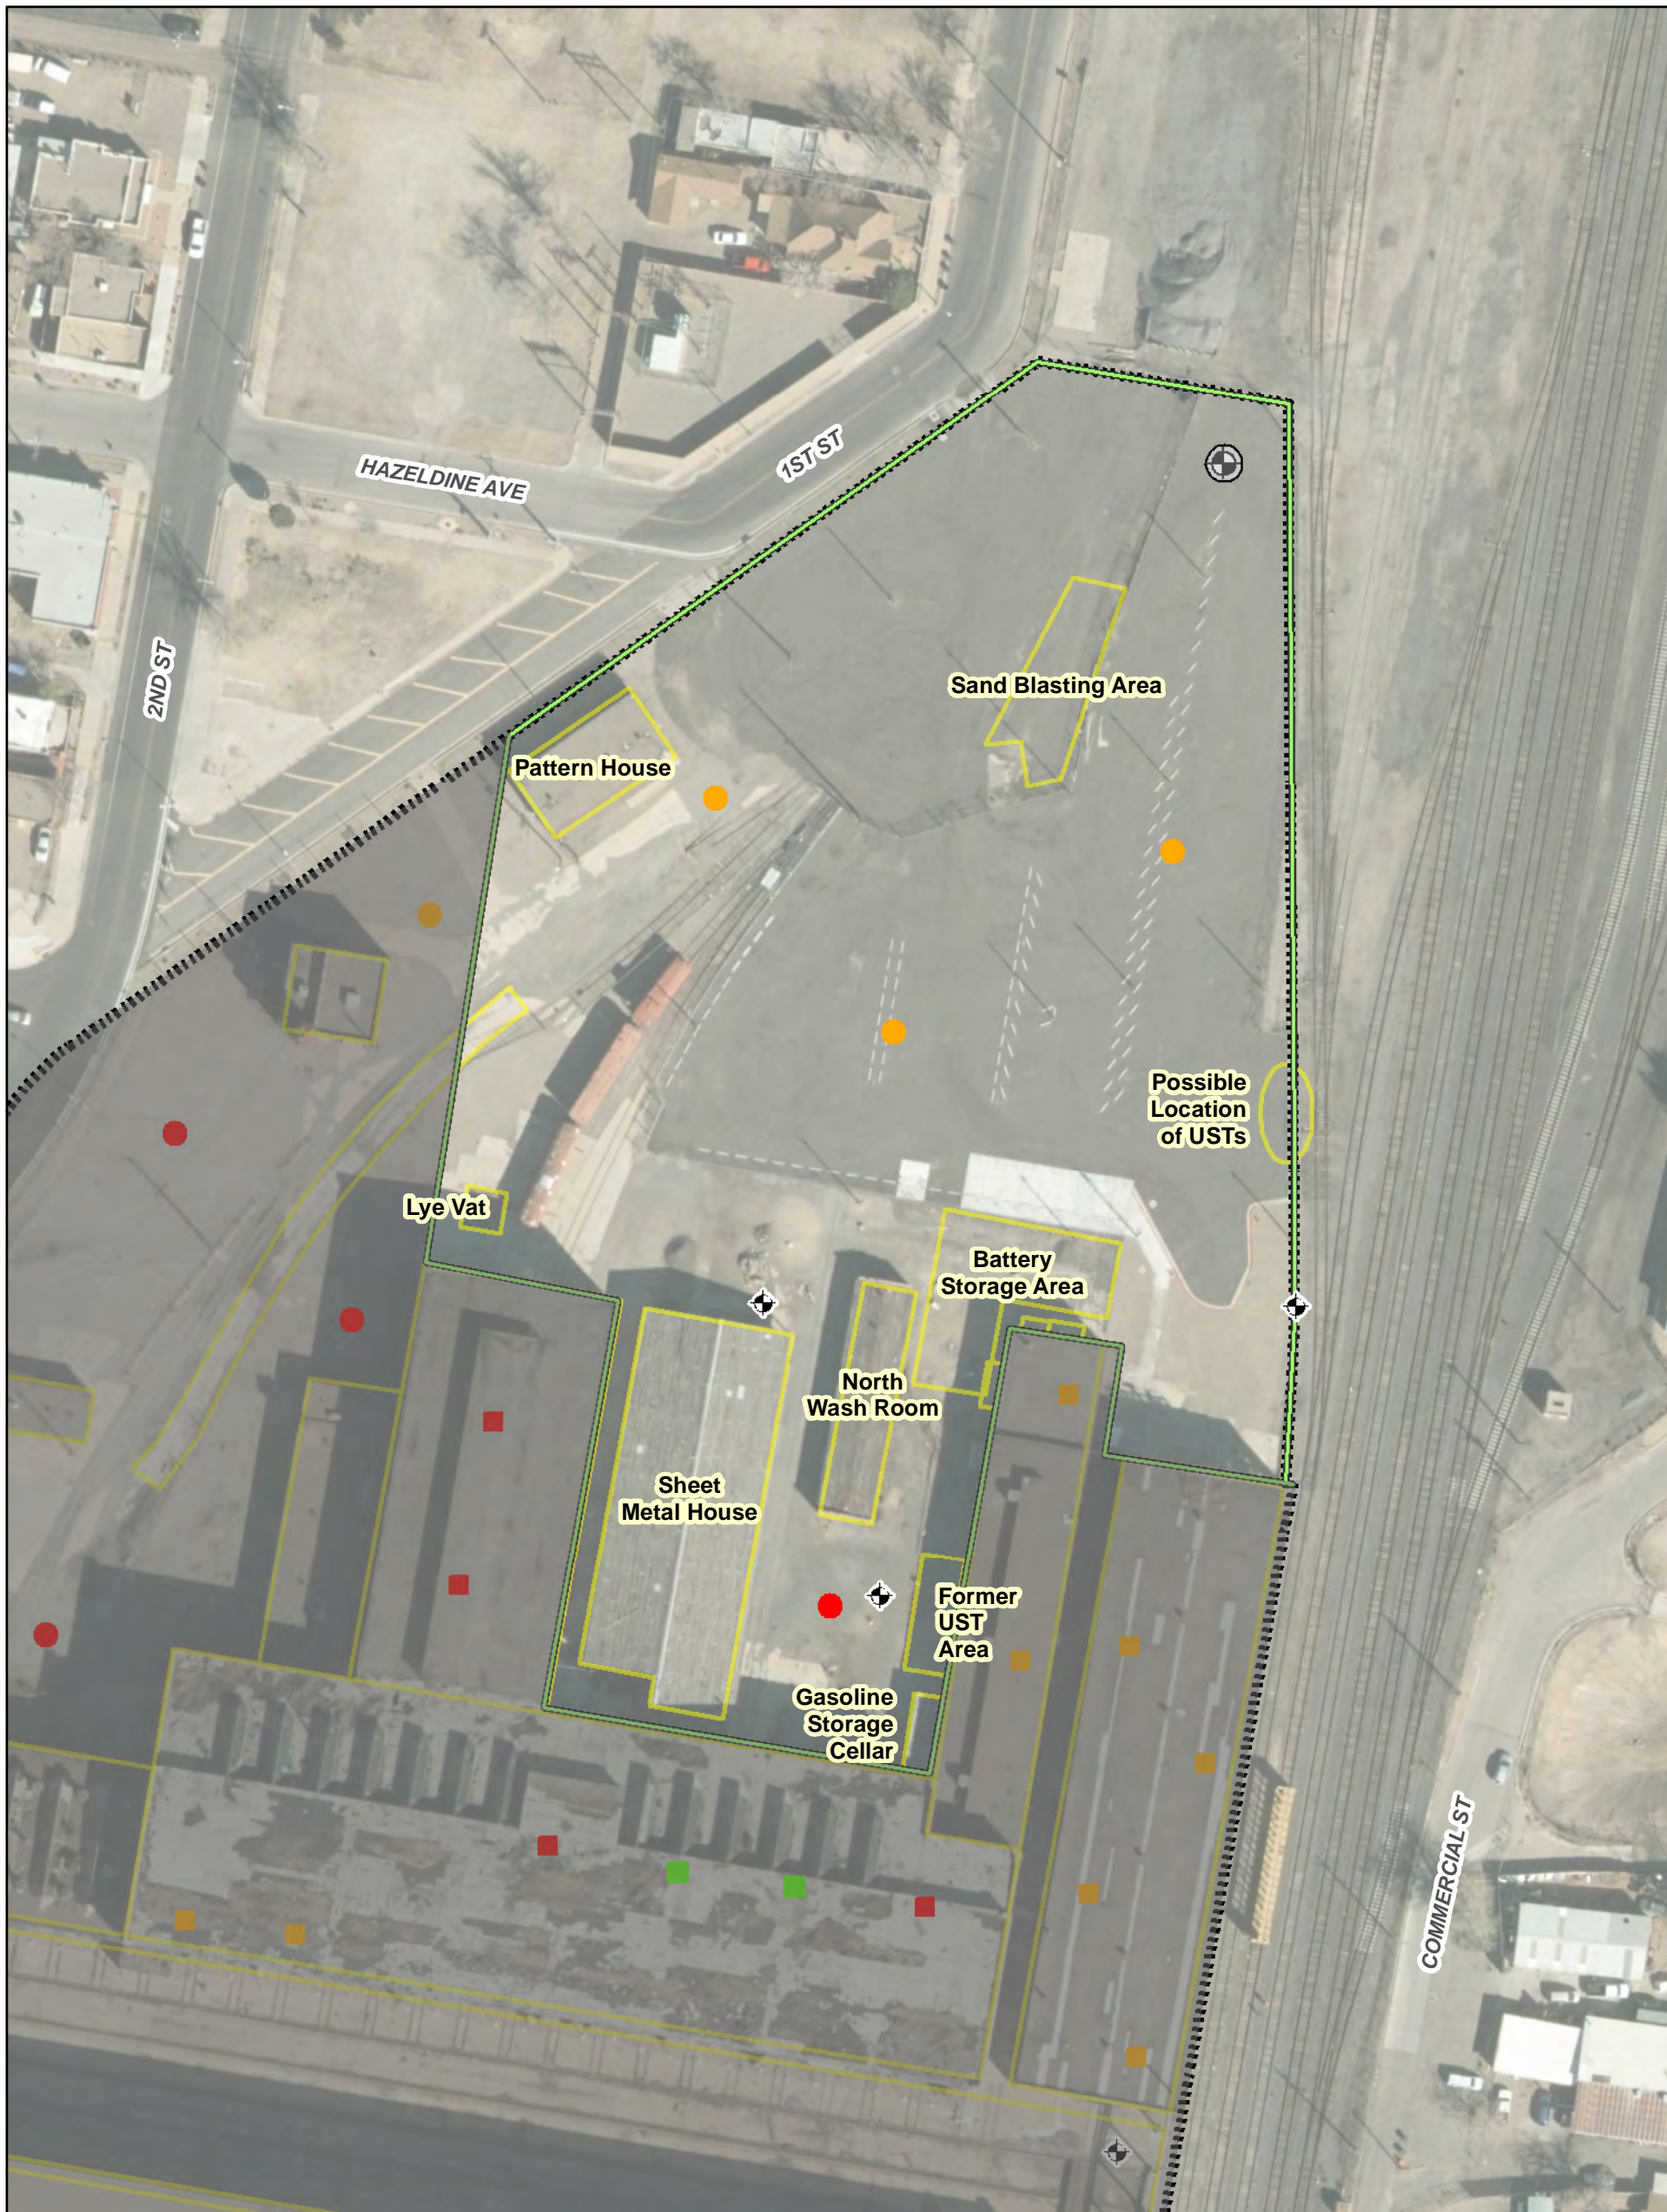
Note: VISL: Vapor Intrusion Screening Levels (NMED, 2015)

The CSM identified that there was inadequate coverage with regard to soil gas within Parcel 10. To fill this data gap, INTERA collected four soil gas samples within Parcel 10. The results from the soil gas sampling revealed the presence of 1,3-dichlorobenzene, 1,4-dioxane, p&m-xylenes, toluene, and naphthalene in soil gas. Additionally, the naphthalene soil gas detection was greater than the NMED VISL at one sampling location indicating a potential for soil vapor intrusion into any retrofitted building or building constructed within Parcel 10.

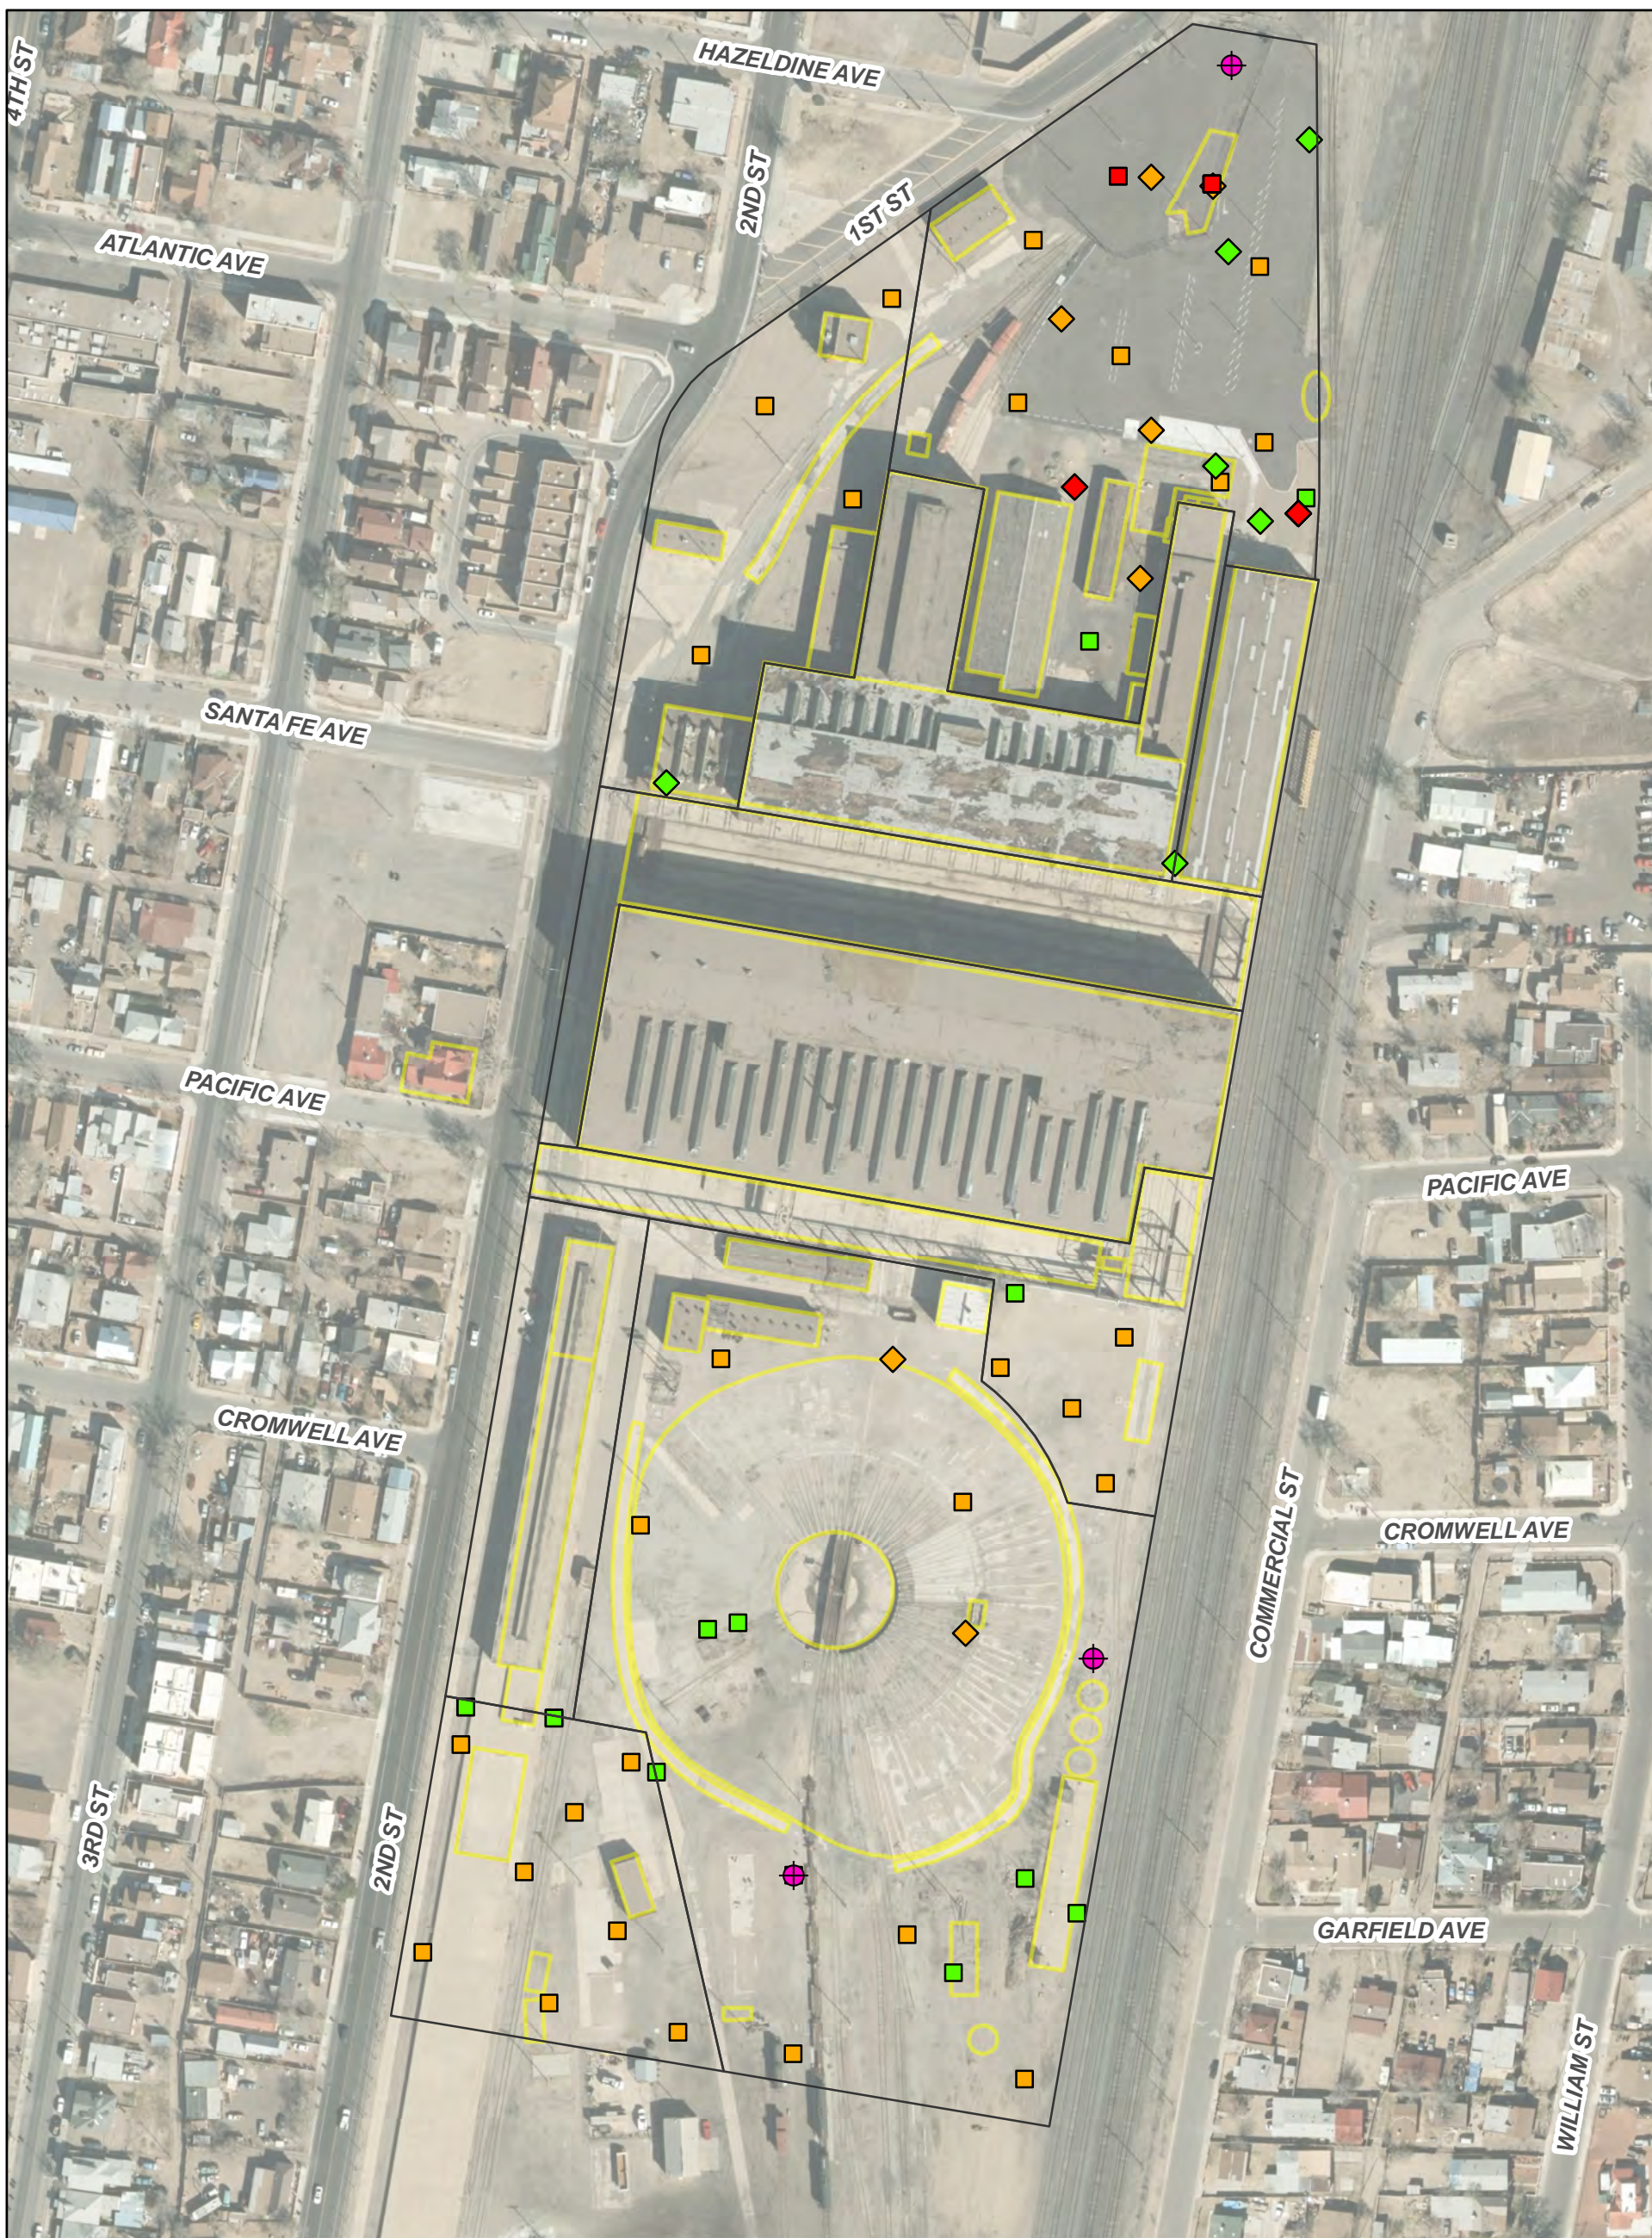
**Residential SSL Exceedances (0-10 ft bgs), Arsenic**  
 Additional Characterization, Voluntary Remediation Program Activities, Albuquerque Rail Yards, Albuquerque, Bernalillo County, New Mexico

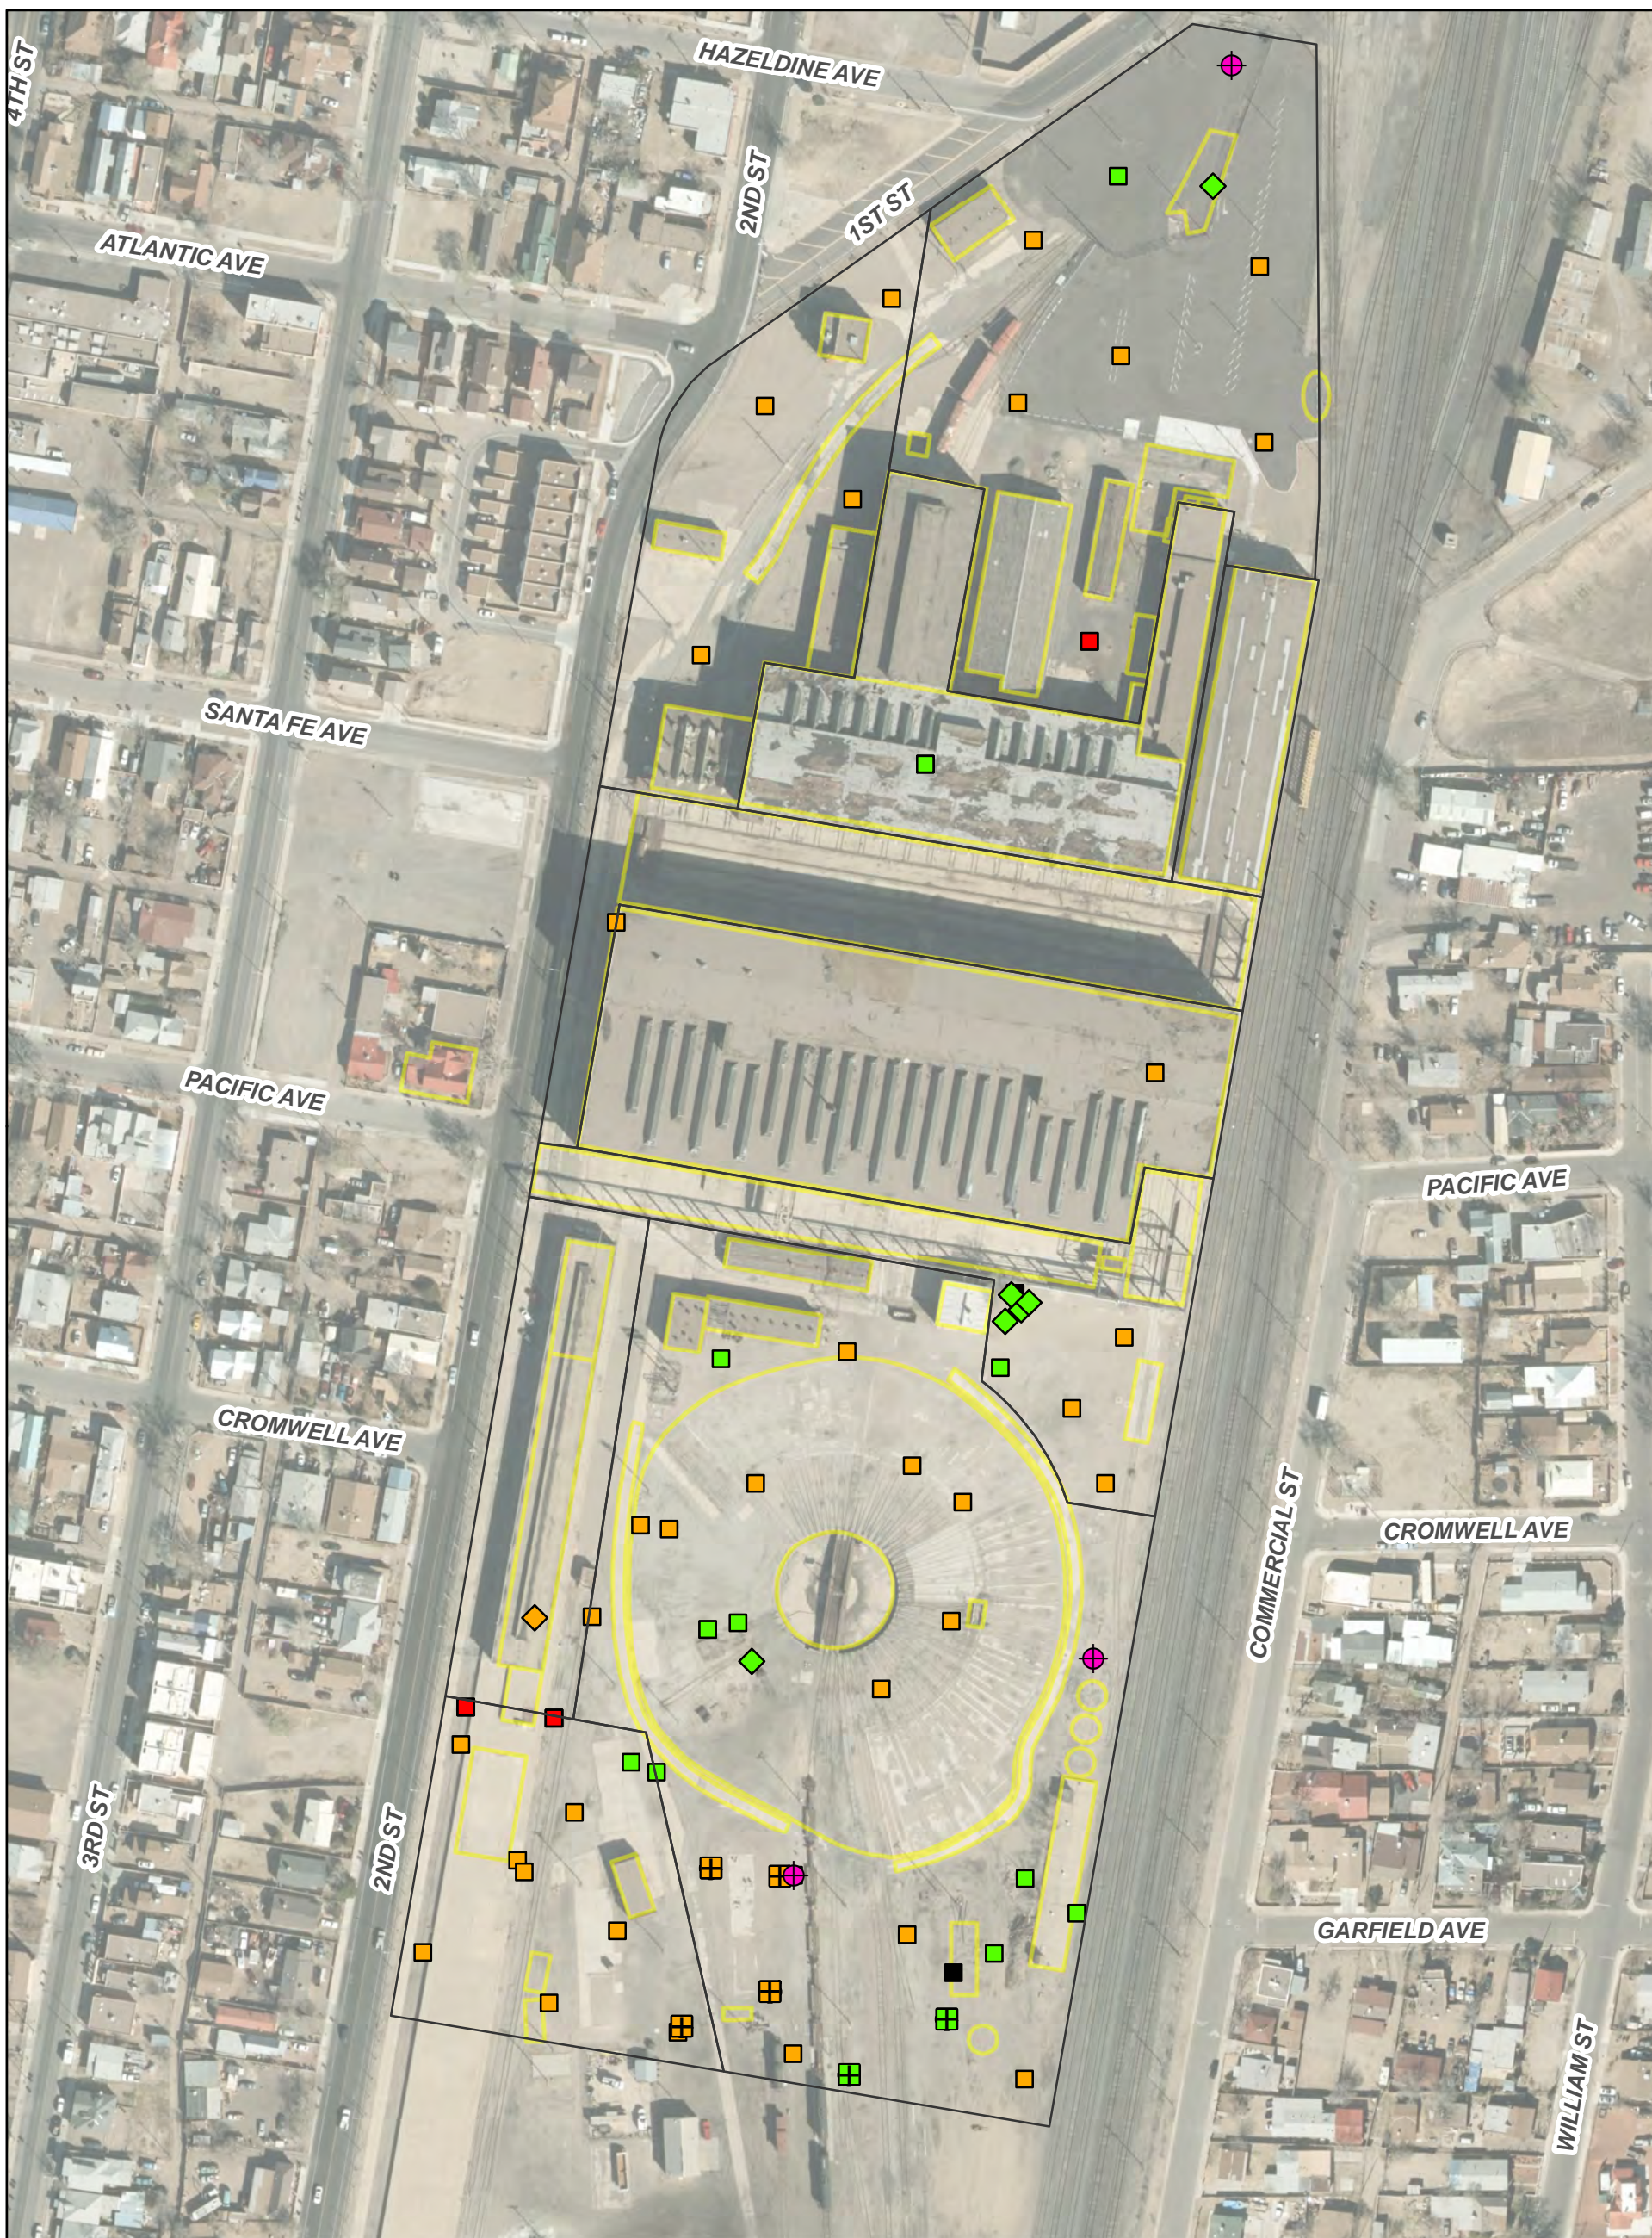
- Three soil samples were identified to contain benzo(a)pyrene concentrations that exceed the residential SSL. These soil samples were collected between the Sheet Metal House and the Flue Shop and west of the former sand blasting area (**Figure 4b**).

Residential SSL Exceedances  
 (0-10 ft bgs), Benzo(a)pyrene  
 Additional Characterization,  
 Voluntary Remediation Program Activities,  
 Albuquerque Rail Yards, Albuquerque,  
 Bernalillo County, New Mexico

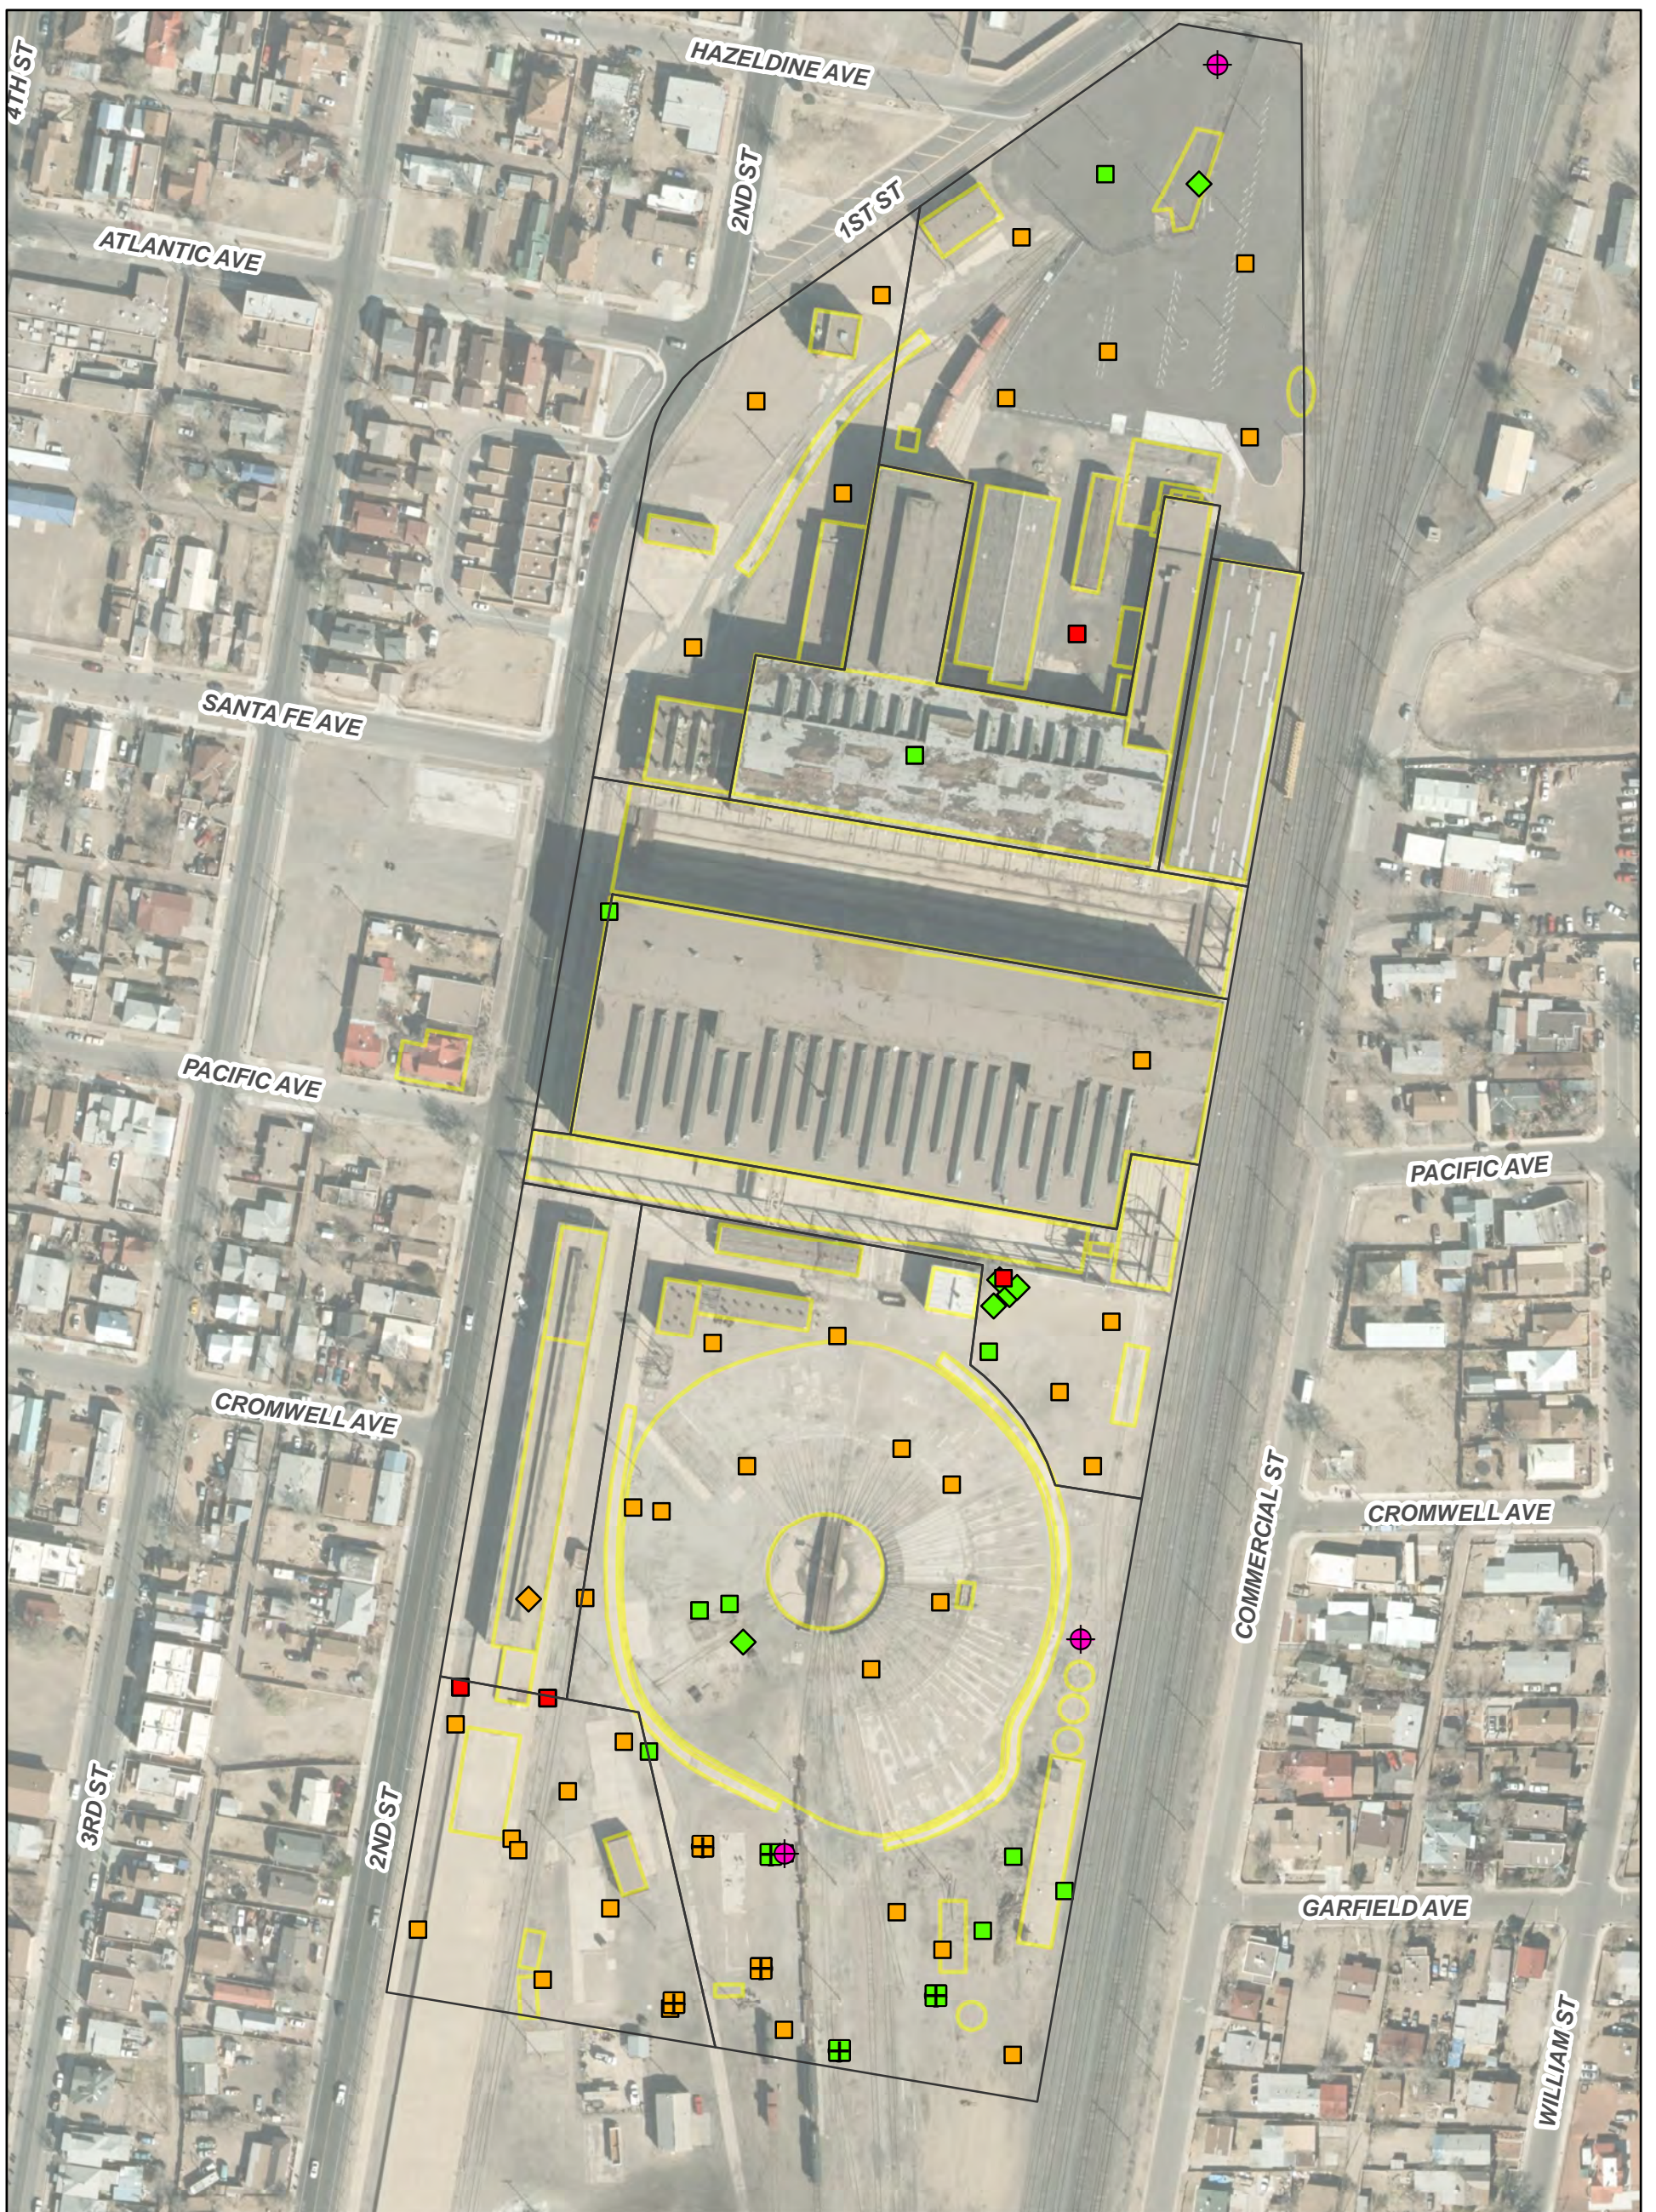
Residential SSL Exceedances  
 (0-10 ft bgs), Benzo(b)fluoranthene  
 Additional Characterization,  
 Voluntary Remediation Program Activities,  
 Albuquerque Rail Yards, Albuquerque,  
 Bernalillo County, New Mexico

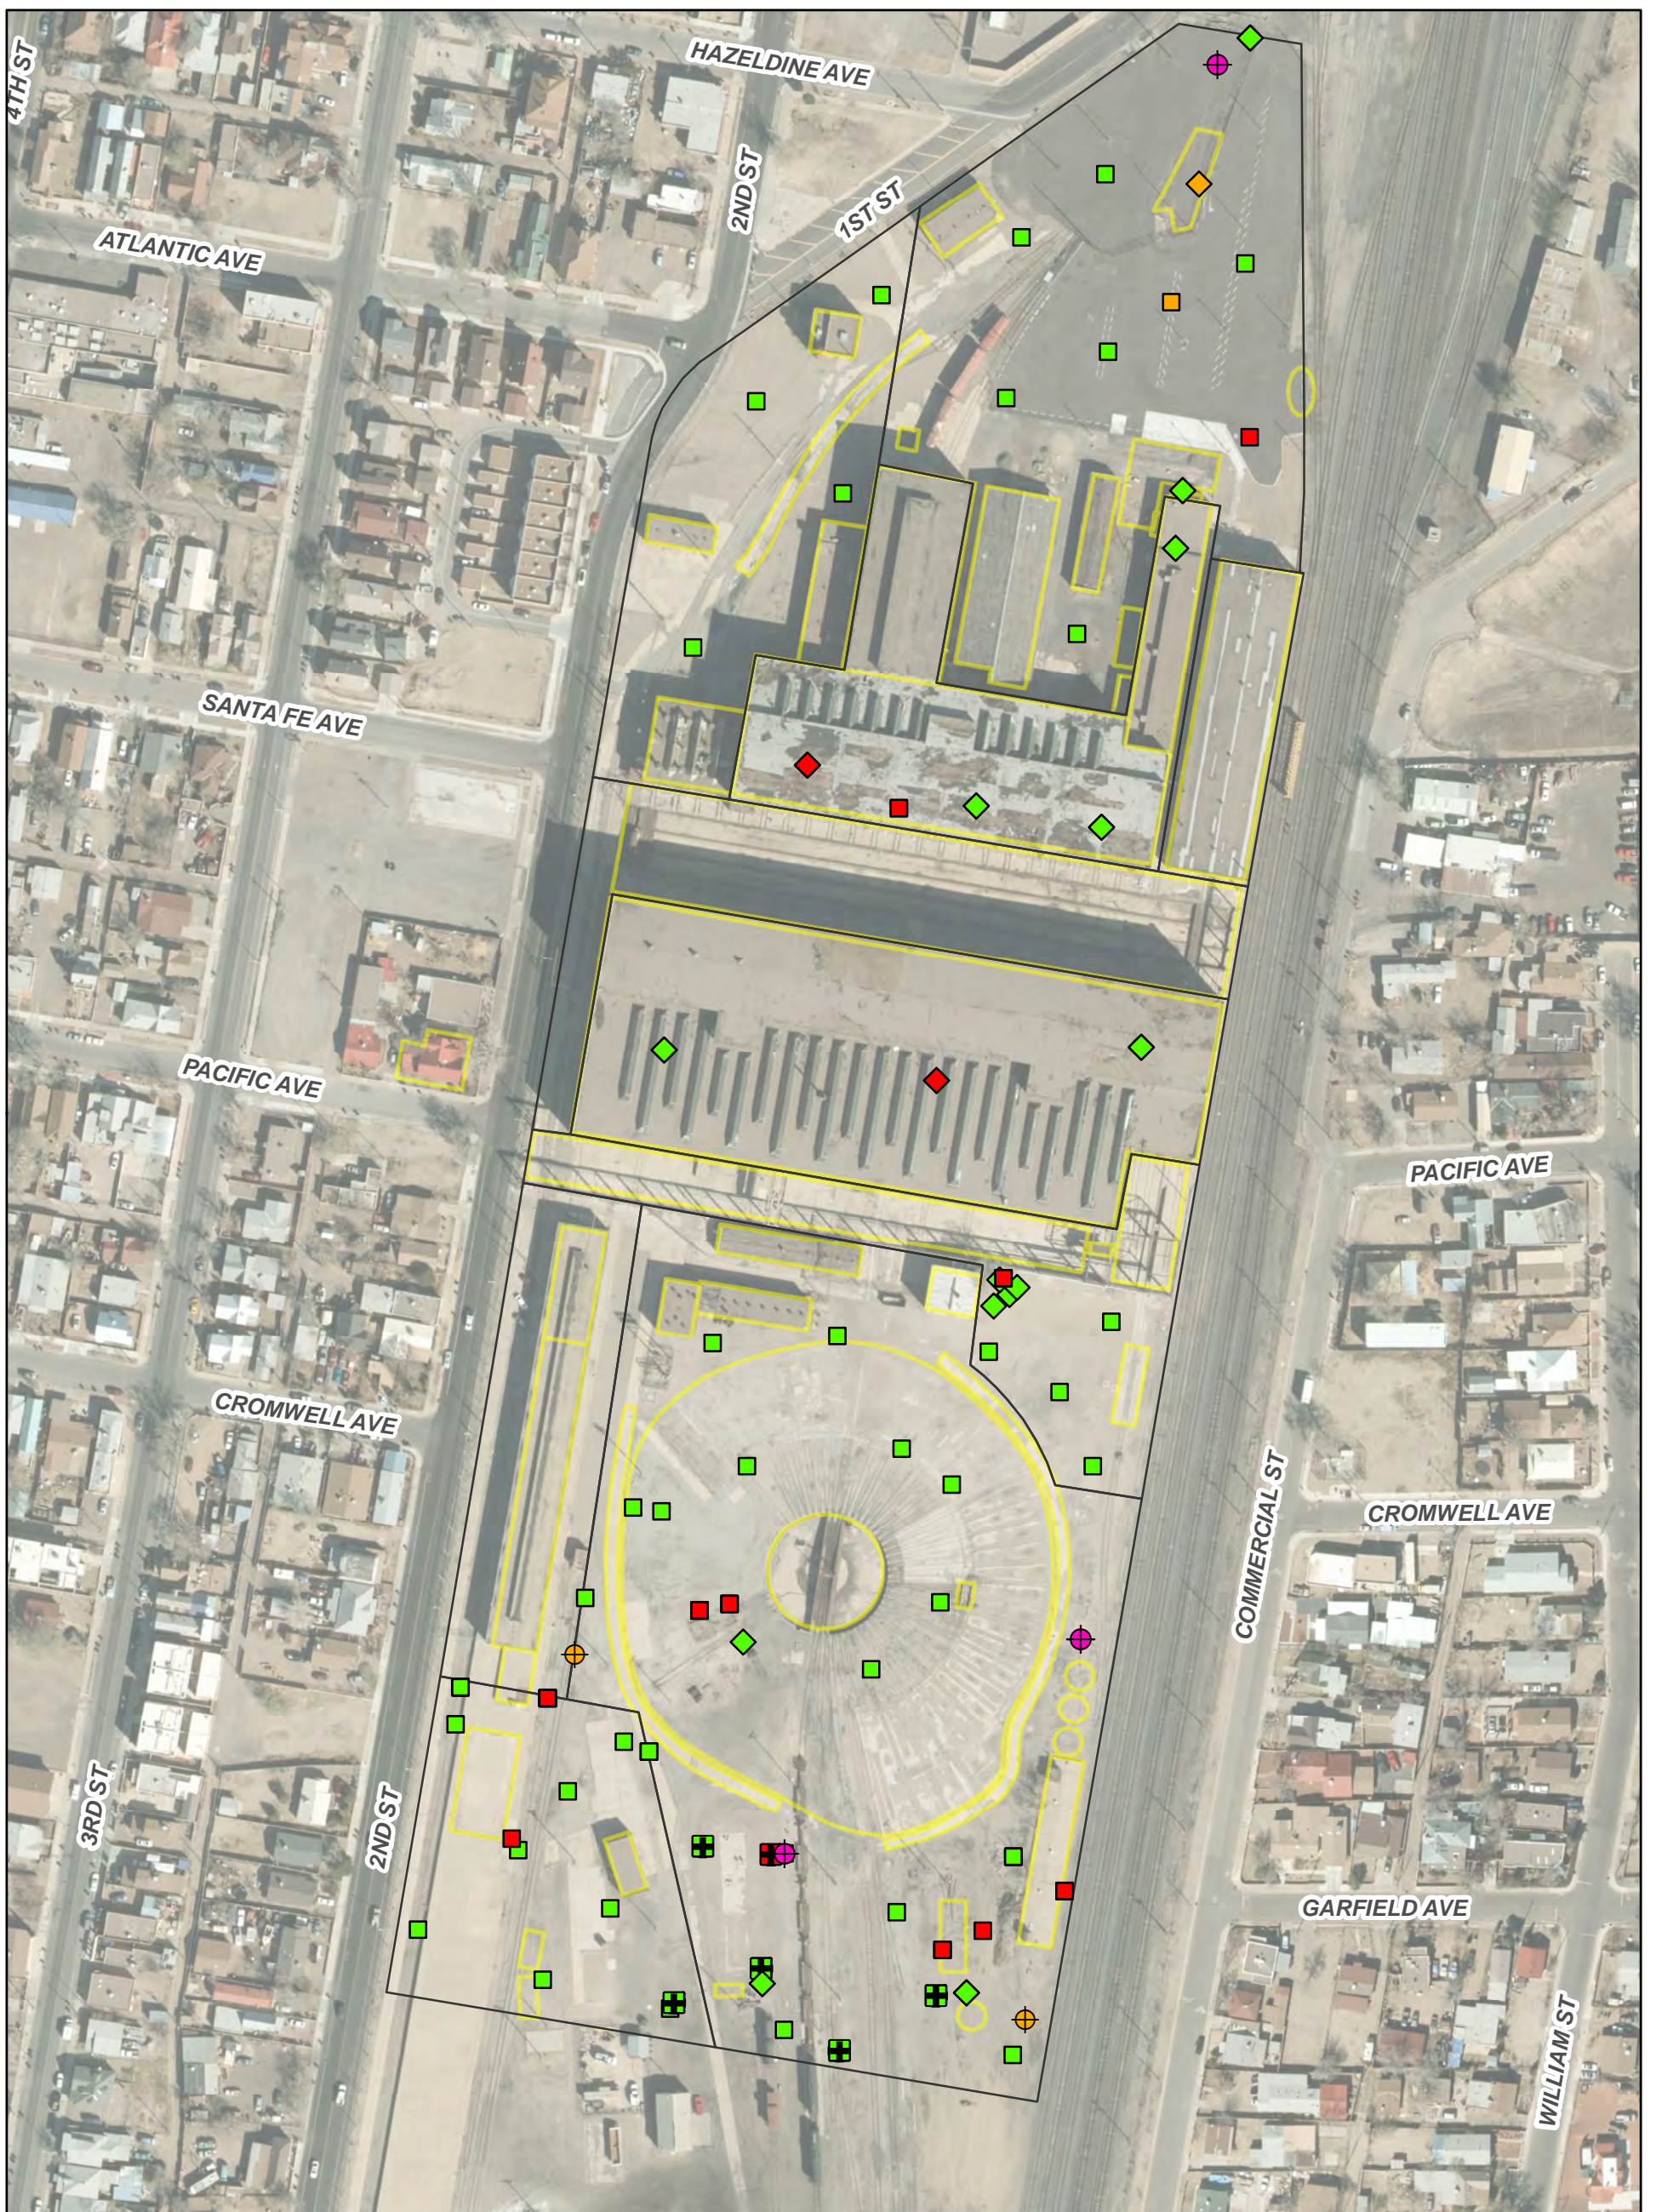
- One soil sample was identified to contain a TPH DRO+MRO concentration that exceeds the residential SSL. This soil sample was collected north of the Blacksmith Shop (**Figure 5**).

Note: TPH DRO + MRO is the summation of TPH DRO and TPH MRO, if non-detect than the laboratory reporting limit was used. Older TPH results from are reported as Total TPH. Some sample depths include a portion greater than 10 ft bgs (i.e., sample interval = 8 - 12 ft bgs).  
 SSL: Soil Screening Levels (NMED, 2015)

**Residential SSL Exceedances (0-10 ft bgs), TPH DRO + MRO, TPH Additional Characterization, Voluntary Remediation Program Activities, Albuquerque Rail Yards, Albuquerque, Bernalillo County, New Mexico**

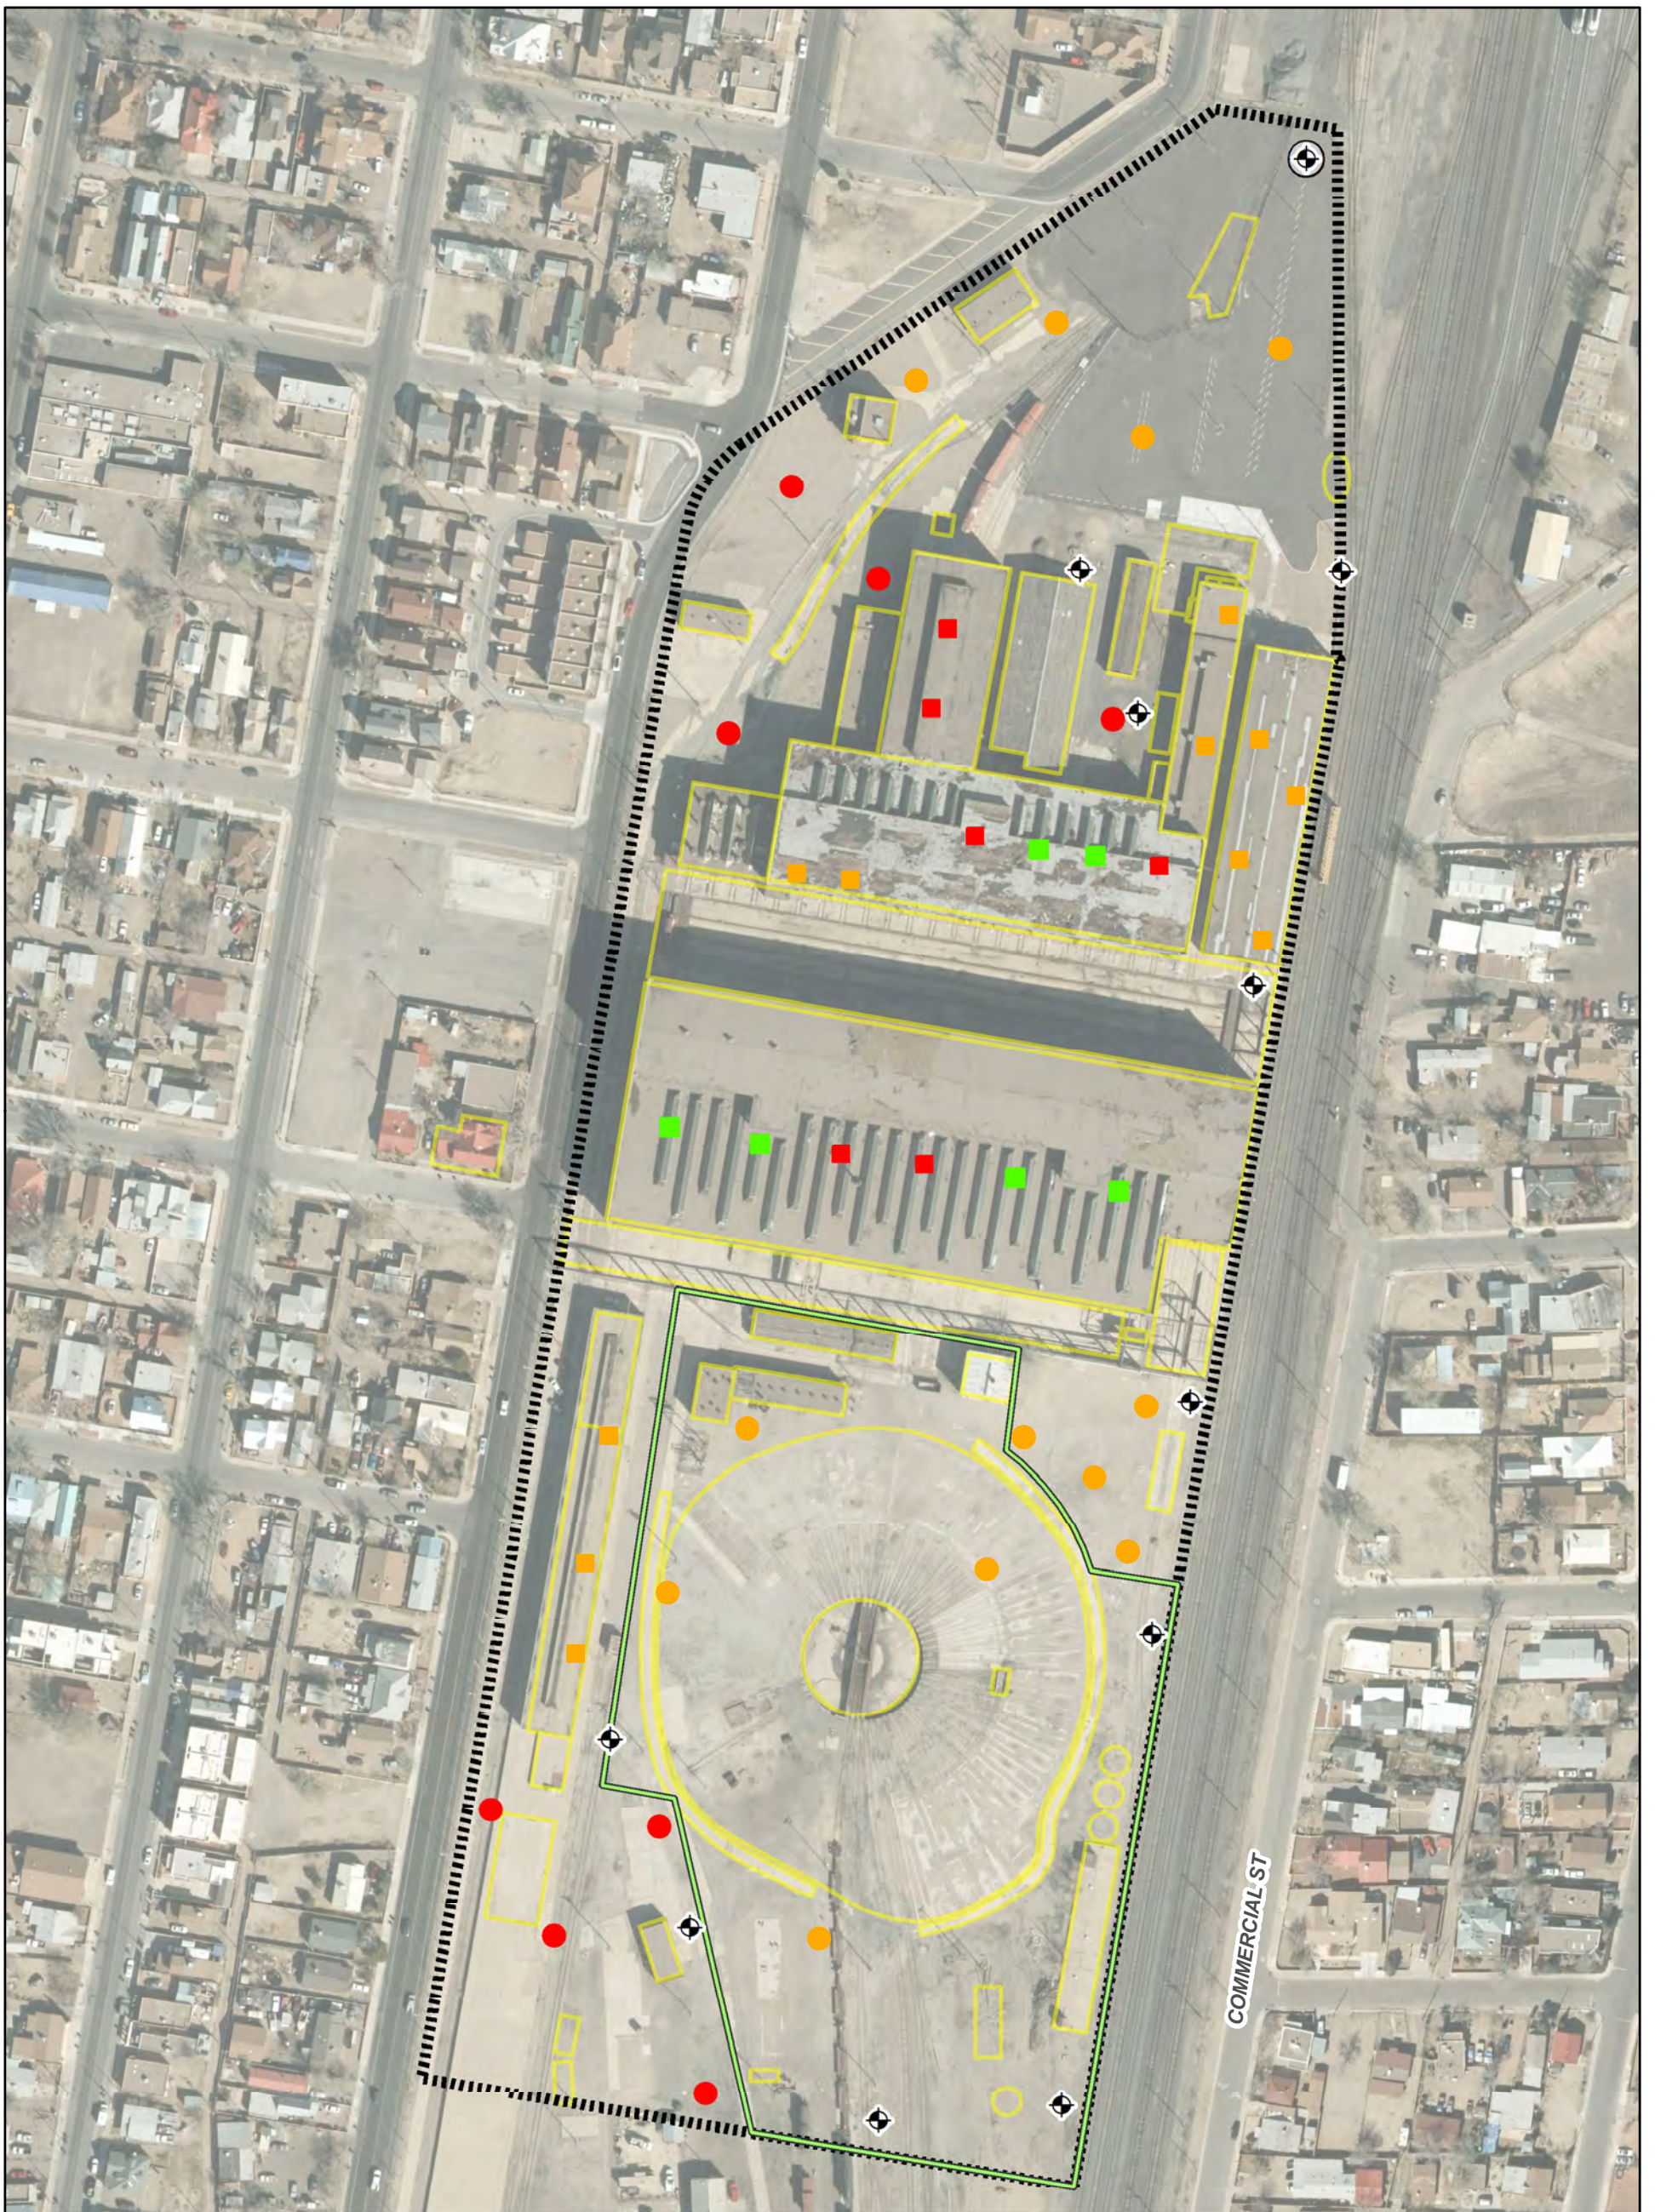
- Naphthalene concentrations in soil gas exceeded the NMED VISL of 8.26  $\mu\text{g}/\text{m}^3$  at one soil gas sampling location indicating a potential for vapor intrusion (**Table 3** and **Figure 6**).
- The laboratory RL for EDB in soil gas exceeded the corresponding NMED VISL (**Table 3**).
- Asbestos and LBP were detected in the Pattern House and North Wash Room.
- Asbestos was not detected in the Sheet Metal House.
- LBP was detected in the Sheet Metal House.

**VISL Exceedance**
