PARCEL 1 ADDITIONAL CHARACTERIZATION REPORT

CITY OF ALBUQUERQUE RAIL YARDS

Albuquerque, Bernalillo County, New Mexico

April 27, 2017

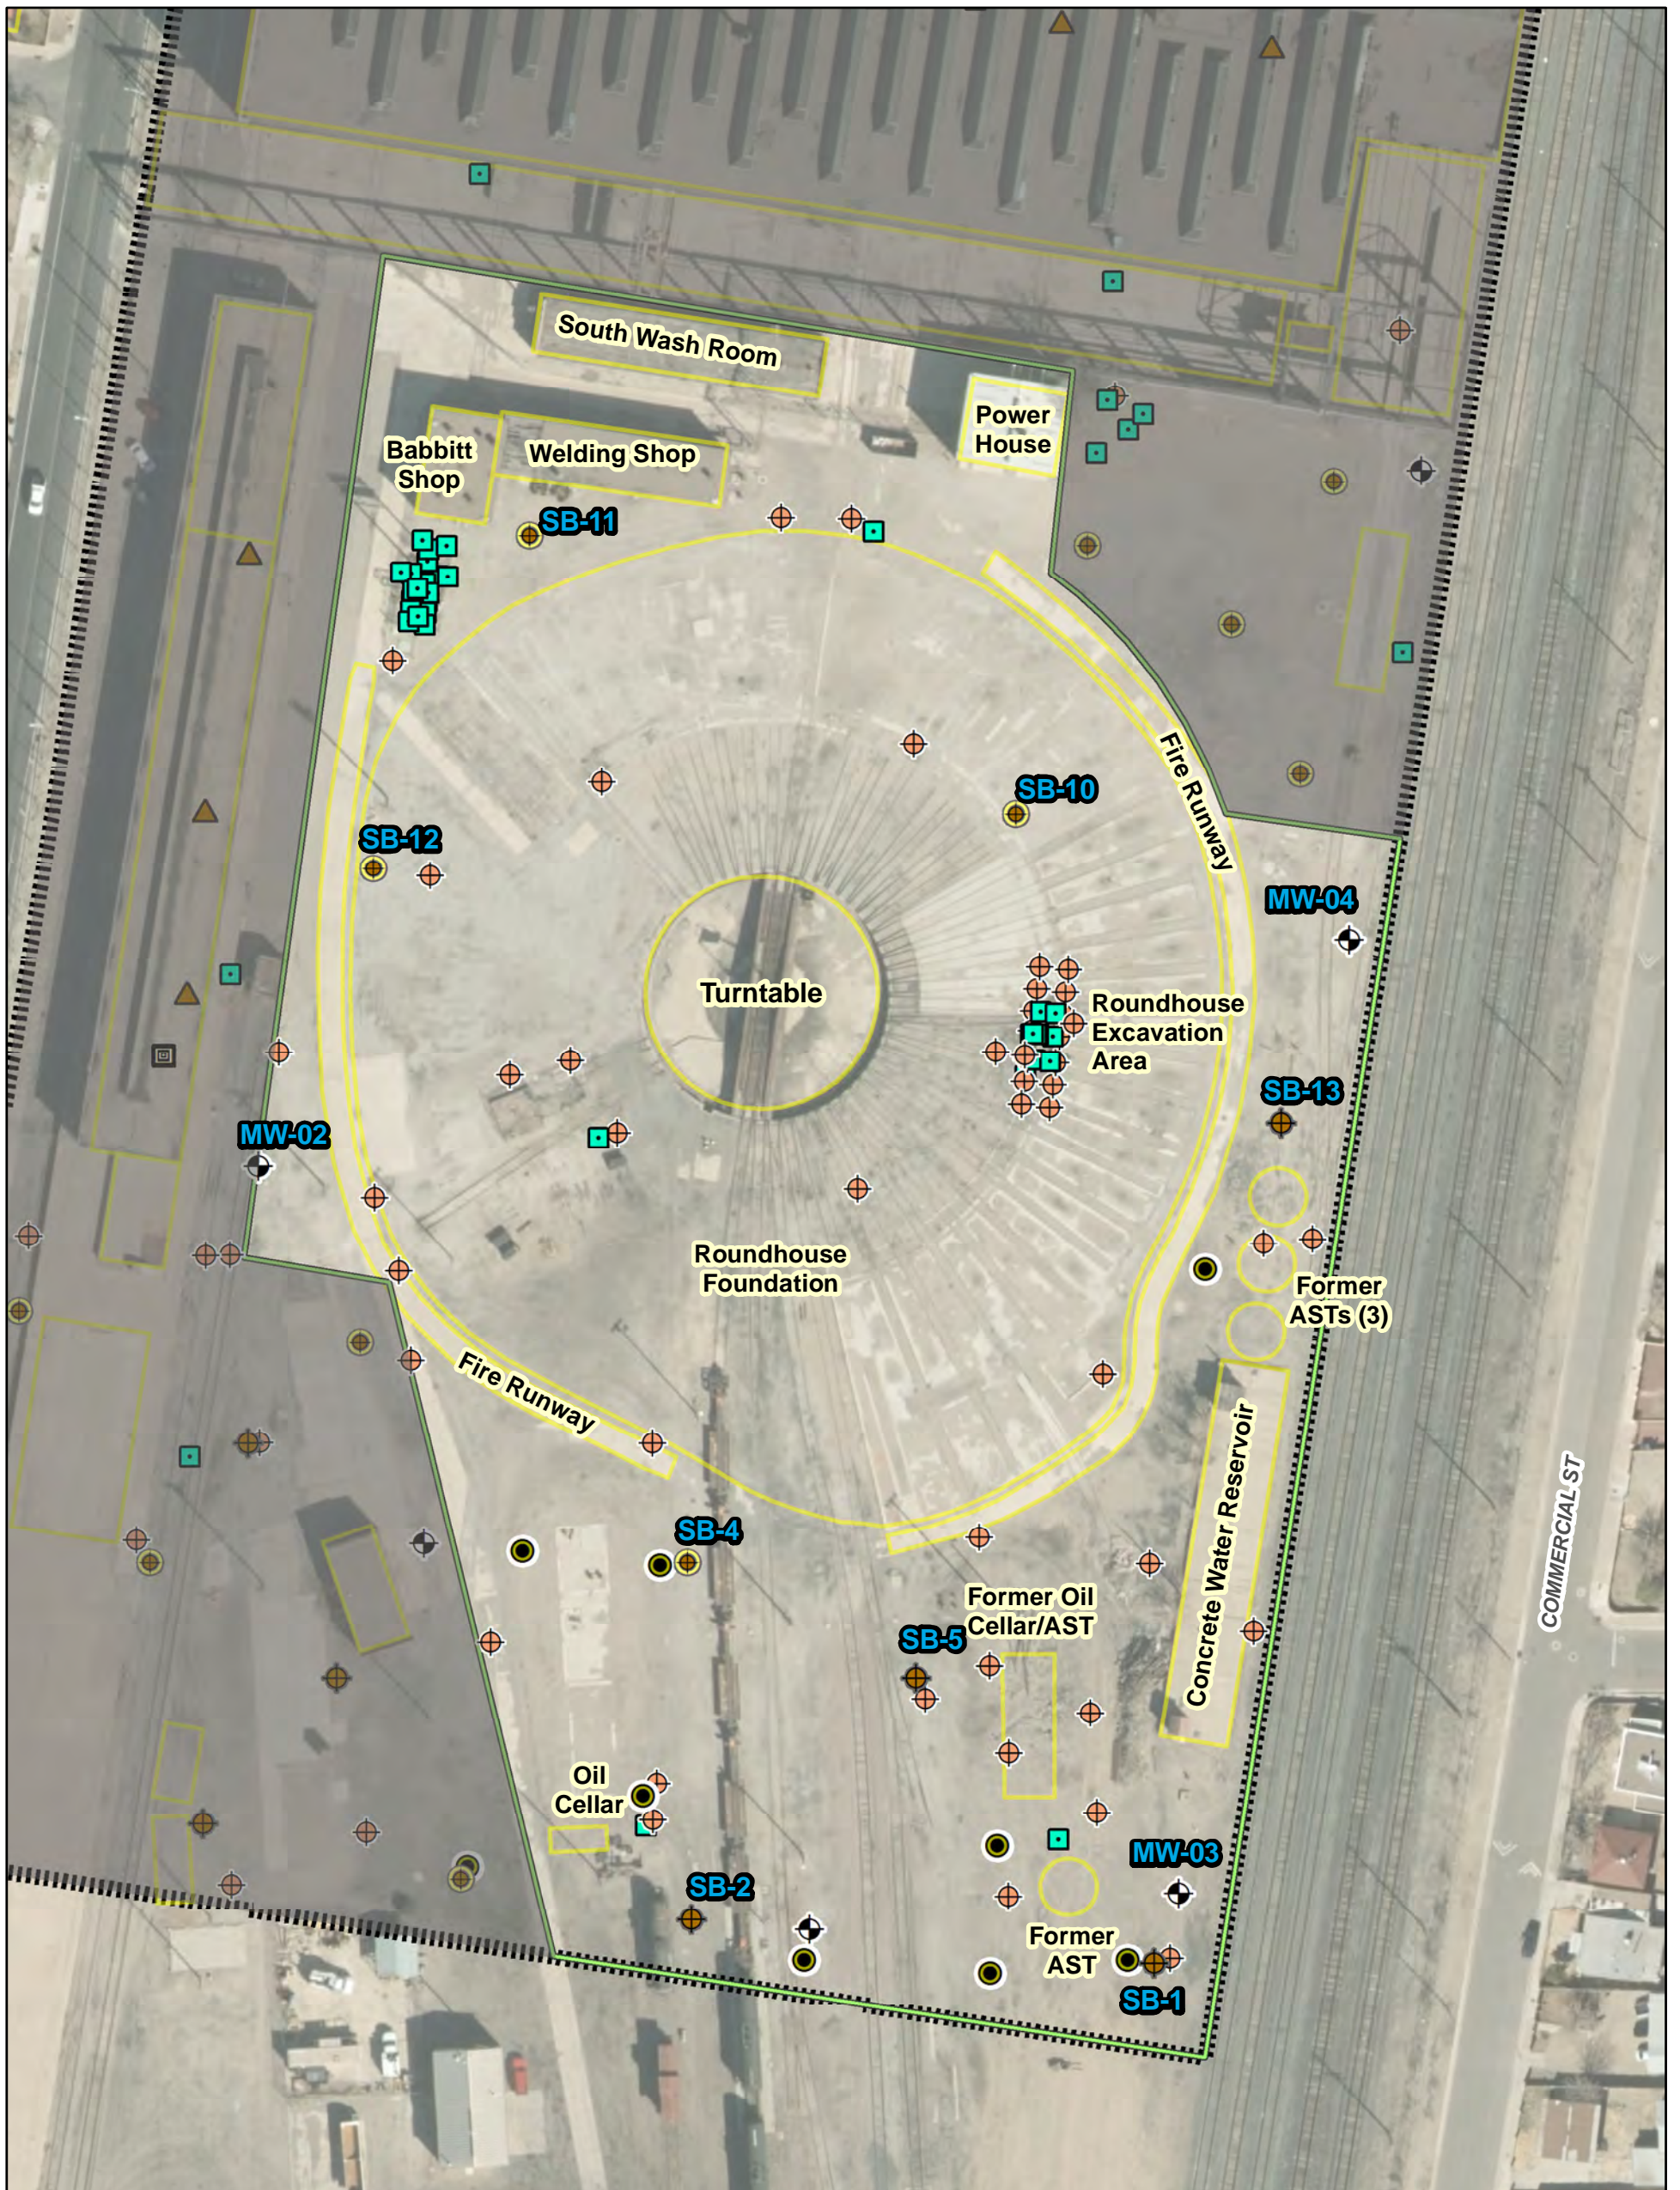
Figure 2b
 Parcel 1 2016 Soil and Soil Vapor
 Sample Locations
 Additional Characterization,
 Voluntary Remediation Program Activities,
 Albuquerque Rail Yards, Albuquerque,
 Bernalillo County, New Mexico

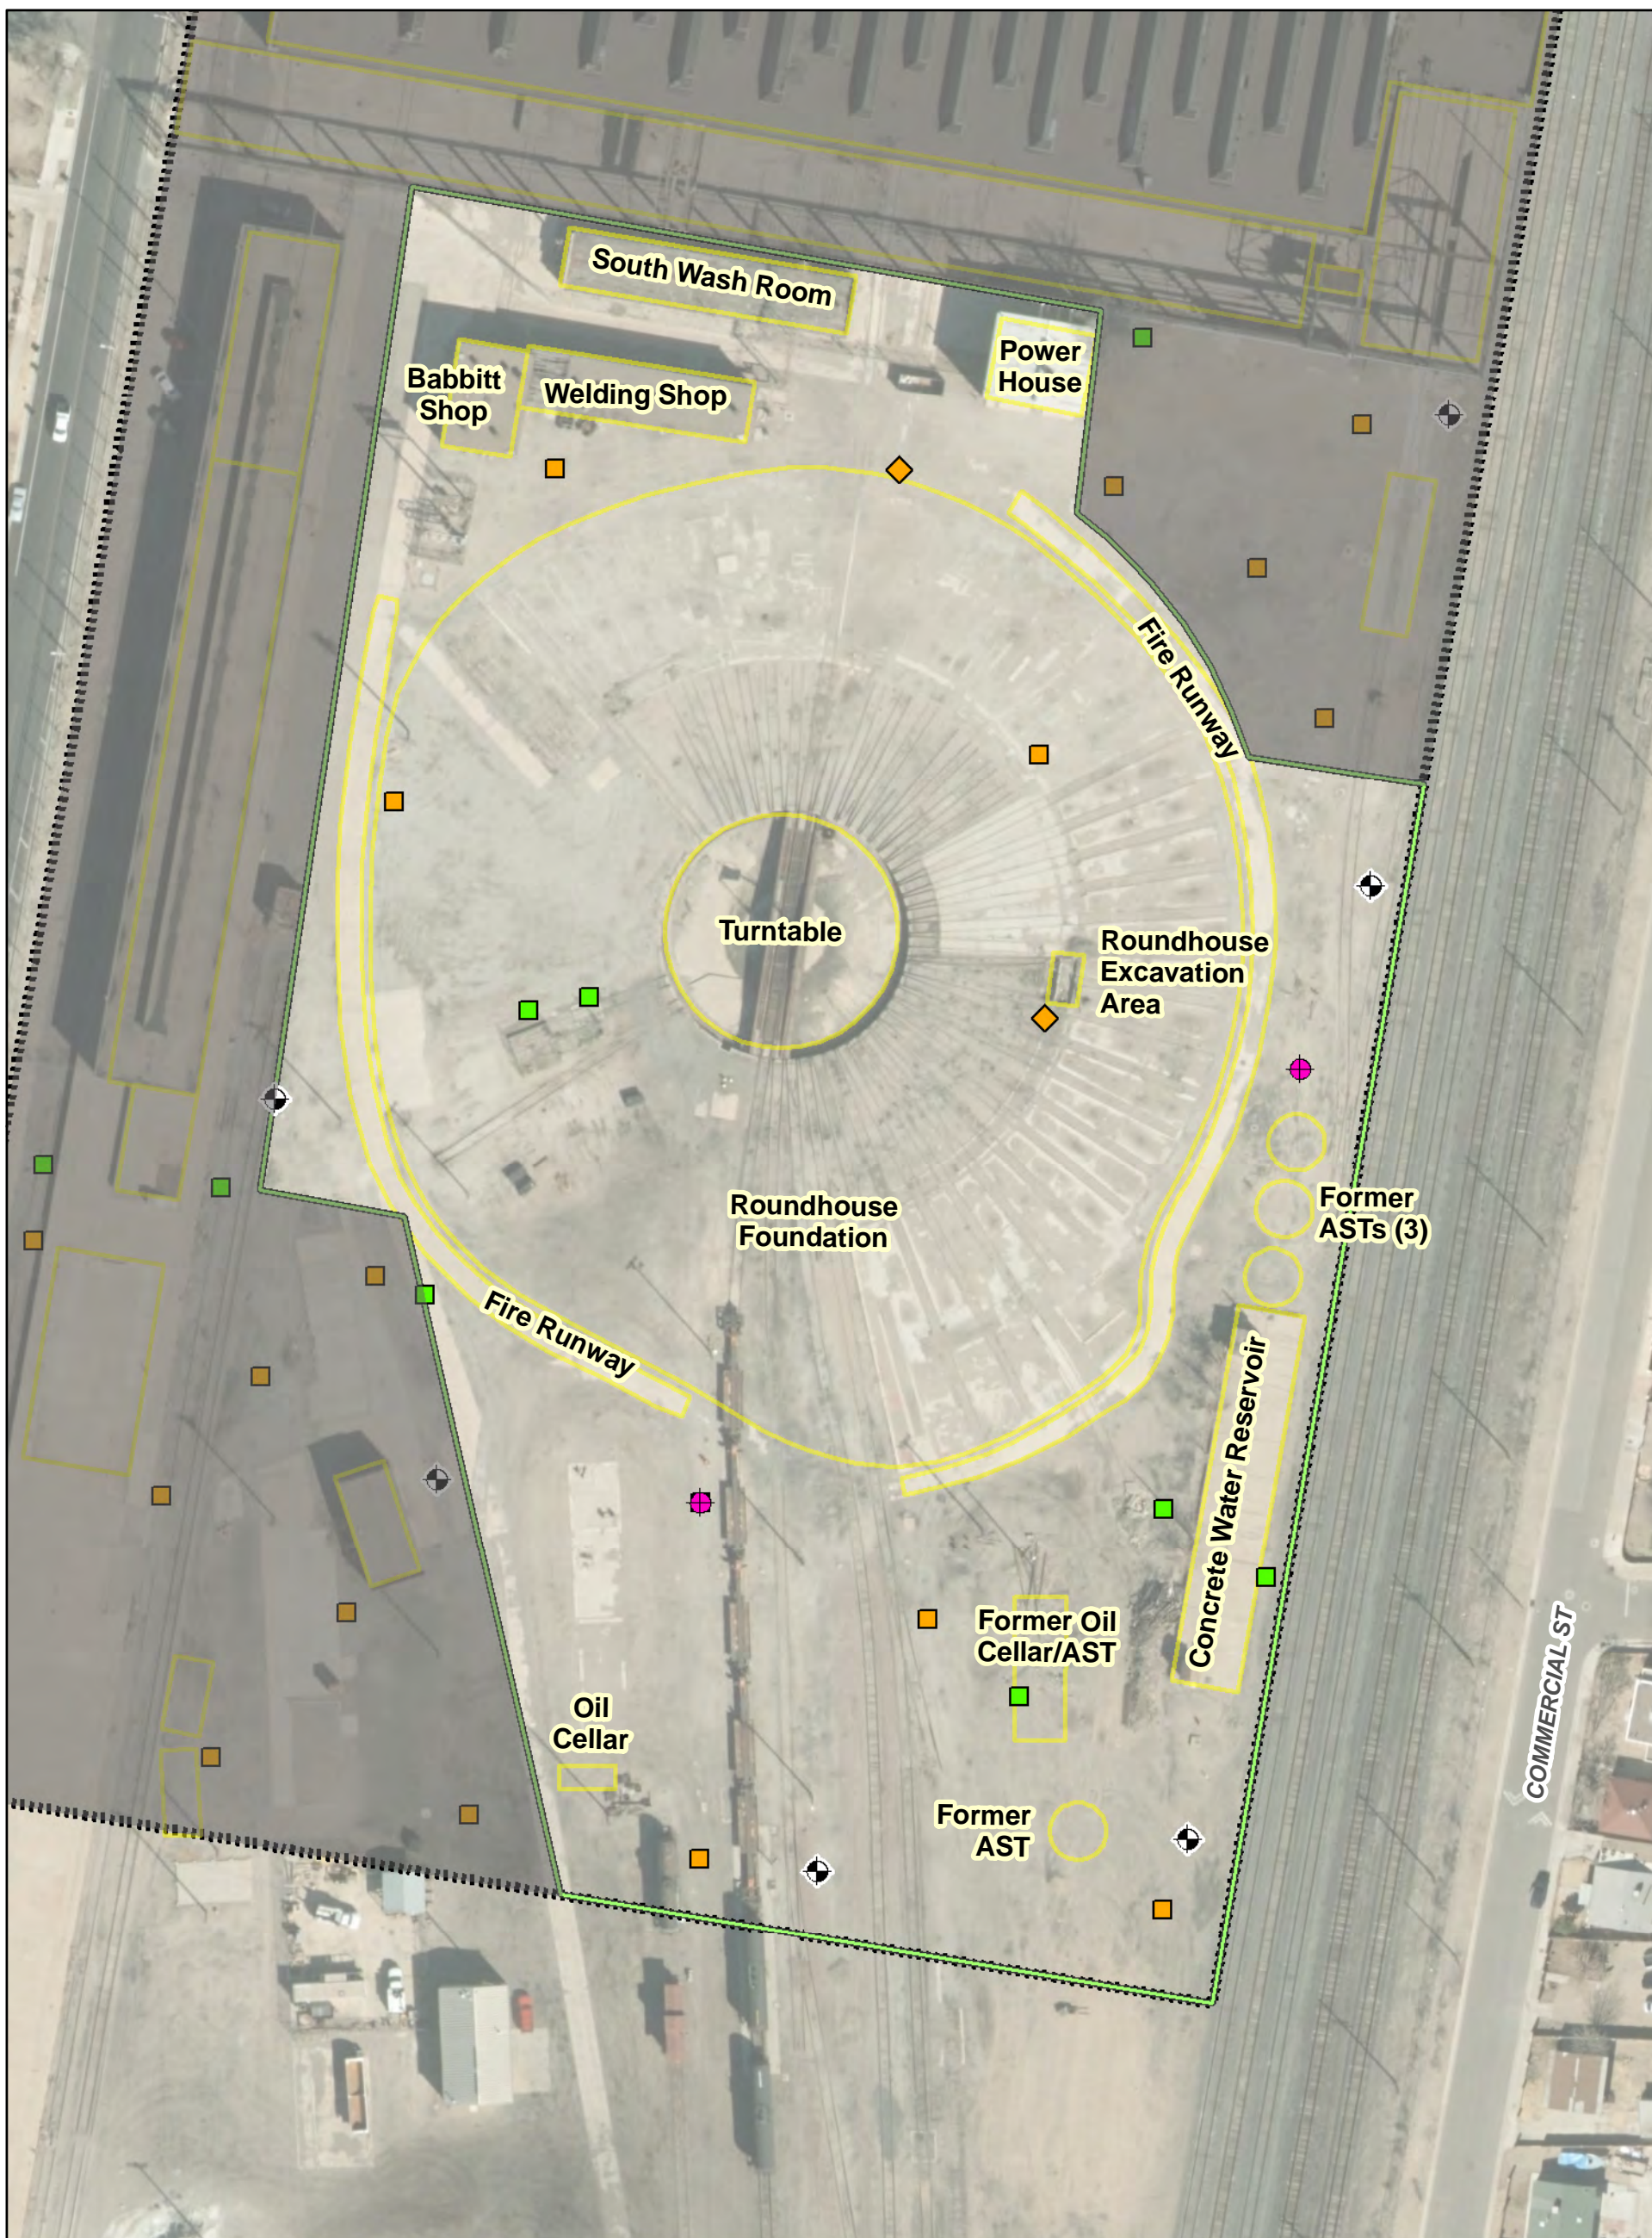
Figure 3a
 Residential SSL Exceedances
 (0-10 ft bgs), Antimony
 Additional Characterization,
 Voluntary Remediation Program Activities,
 Albuquerque Rail Yards, Albuquerque,
 Bernalillo County, New Mexico

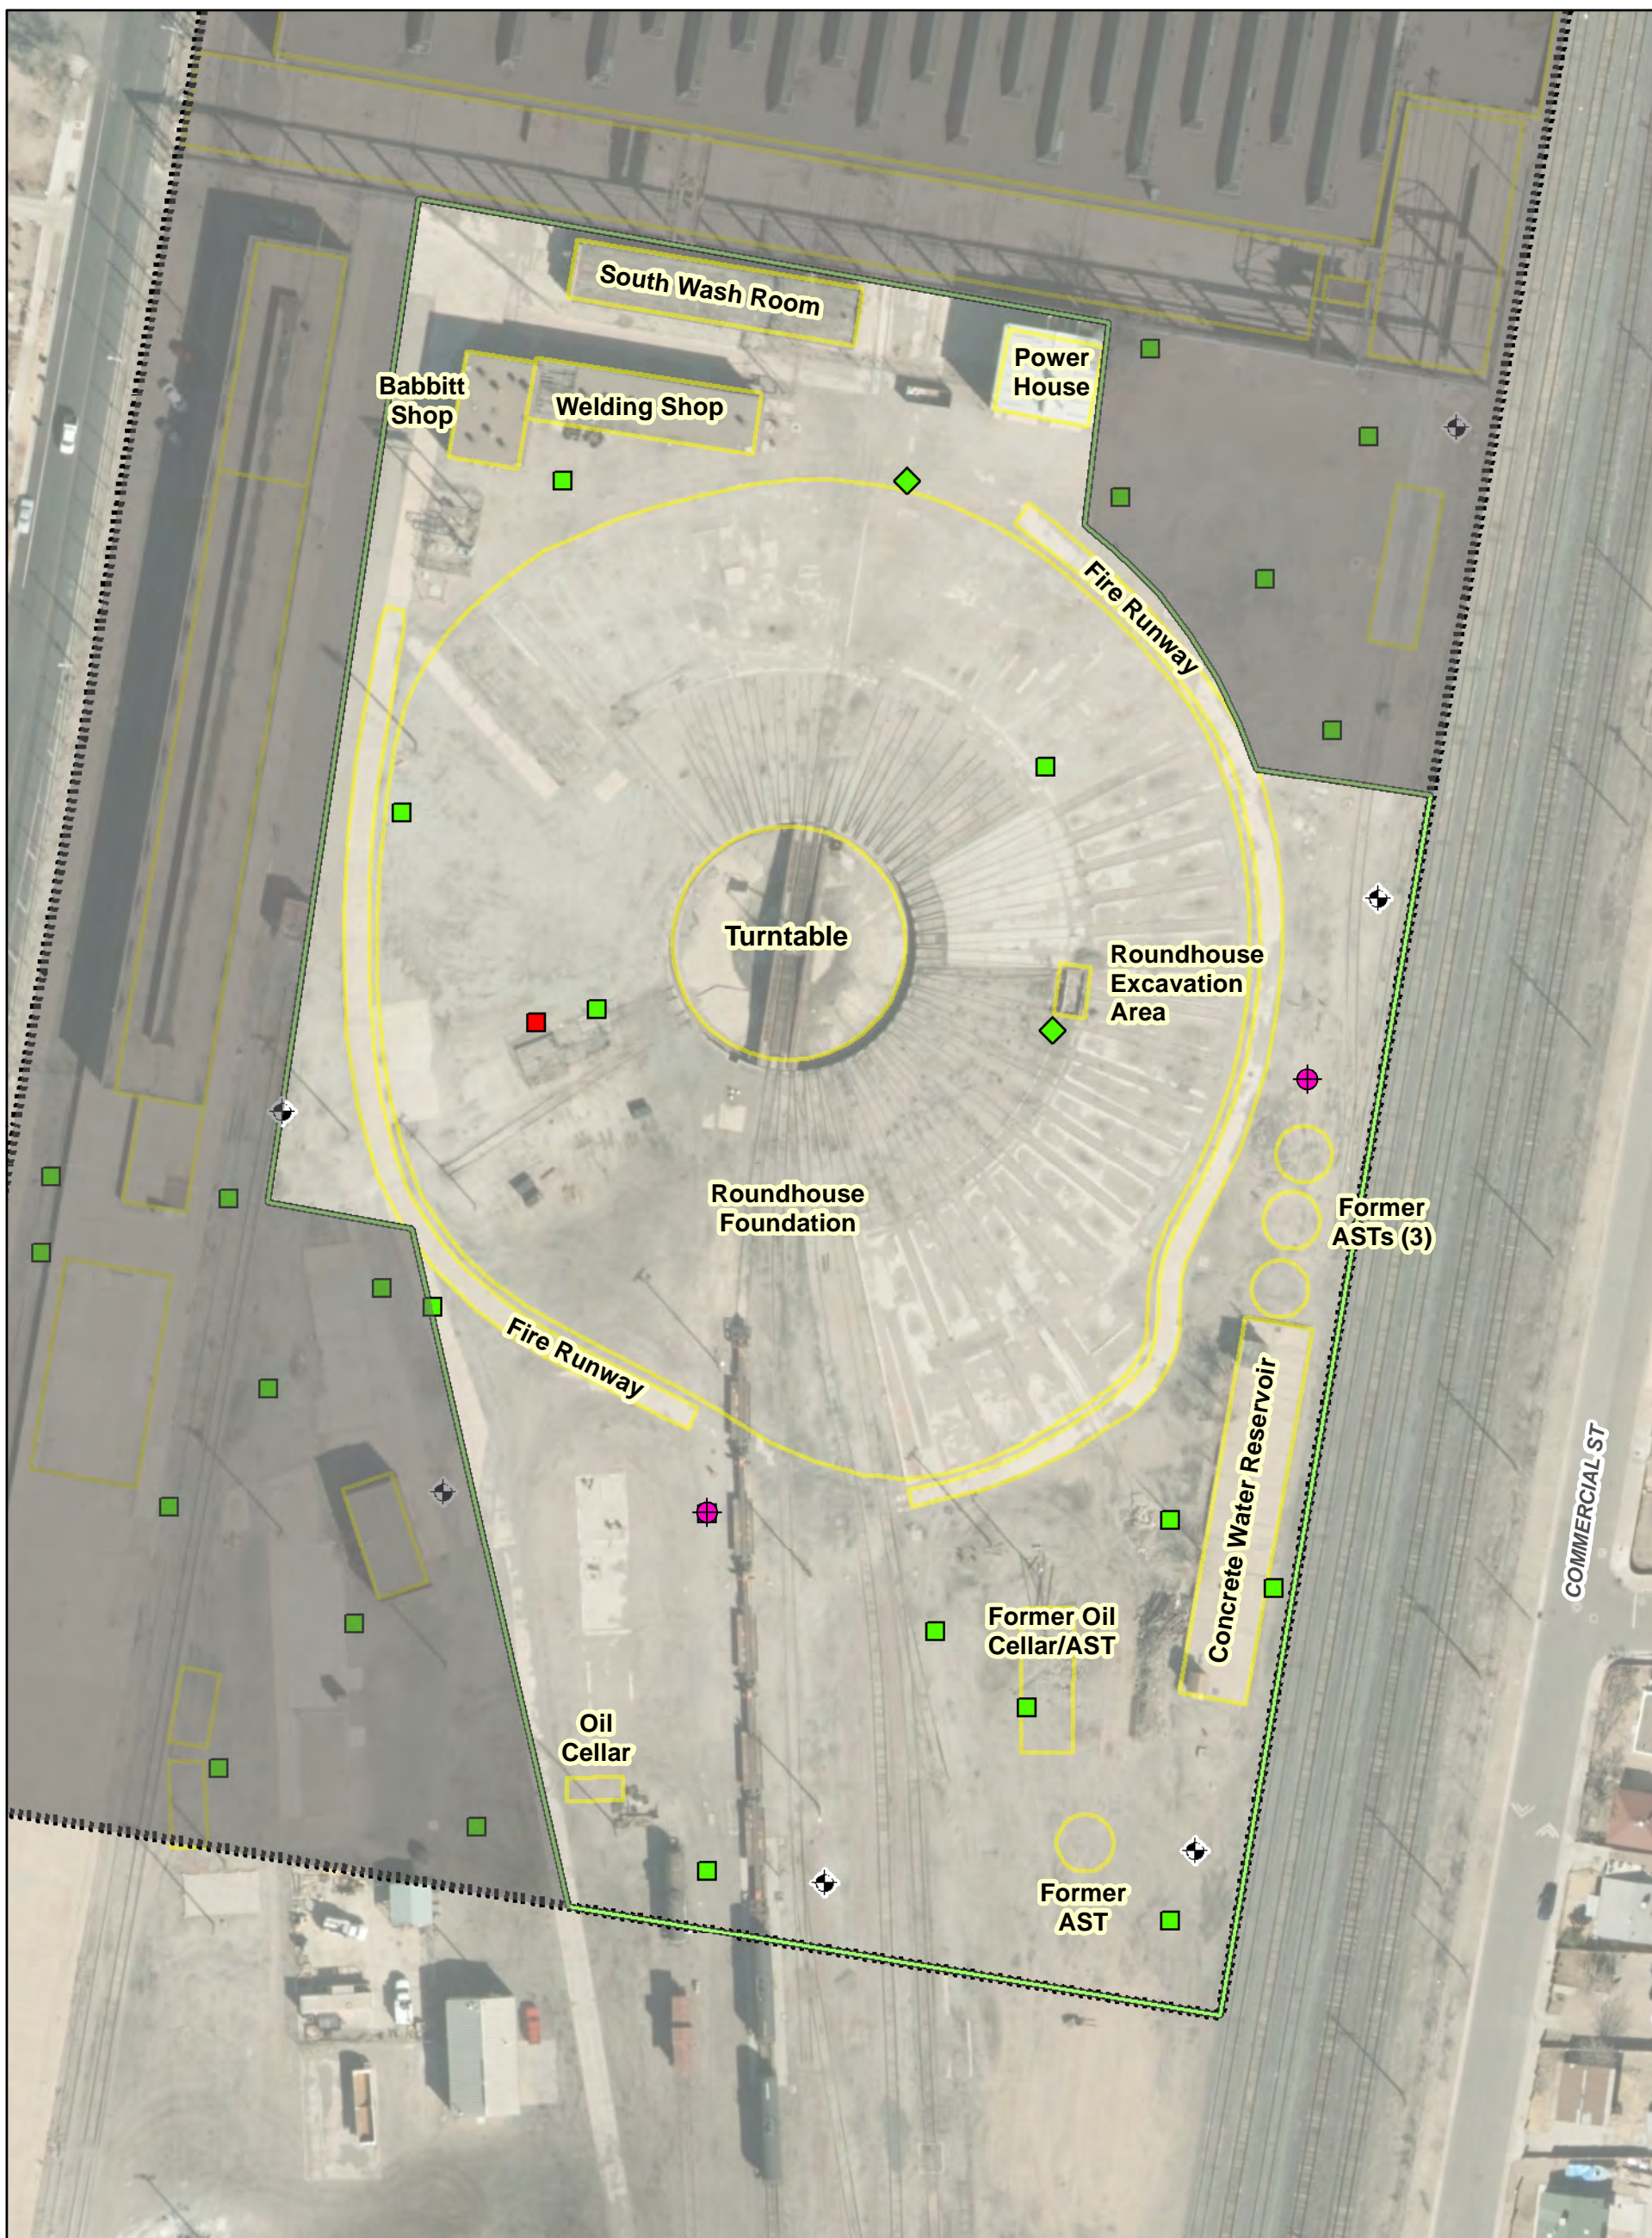
- One soil sample was identified to contain a chromium concentration that exceeds the chromium residential SSL, the location of this soil sample falls within the western portion of the Roundhouse Foundation footprint (**Figure 3c**).

Figure 3c
 Residential SSL Exceedances
 (0-10 ft bgs), Chromium
 Additional Characterization,
 Voluntary Remediation Program Activities,
 Albuquerque Rail Yards, Albuquerque,
 Bernalillo County, New Mexico

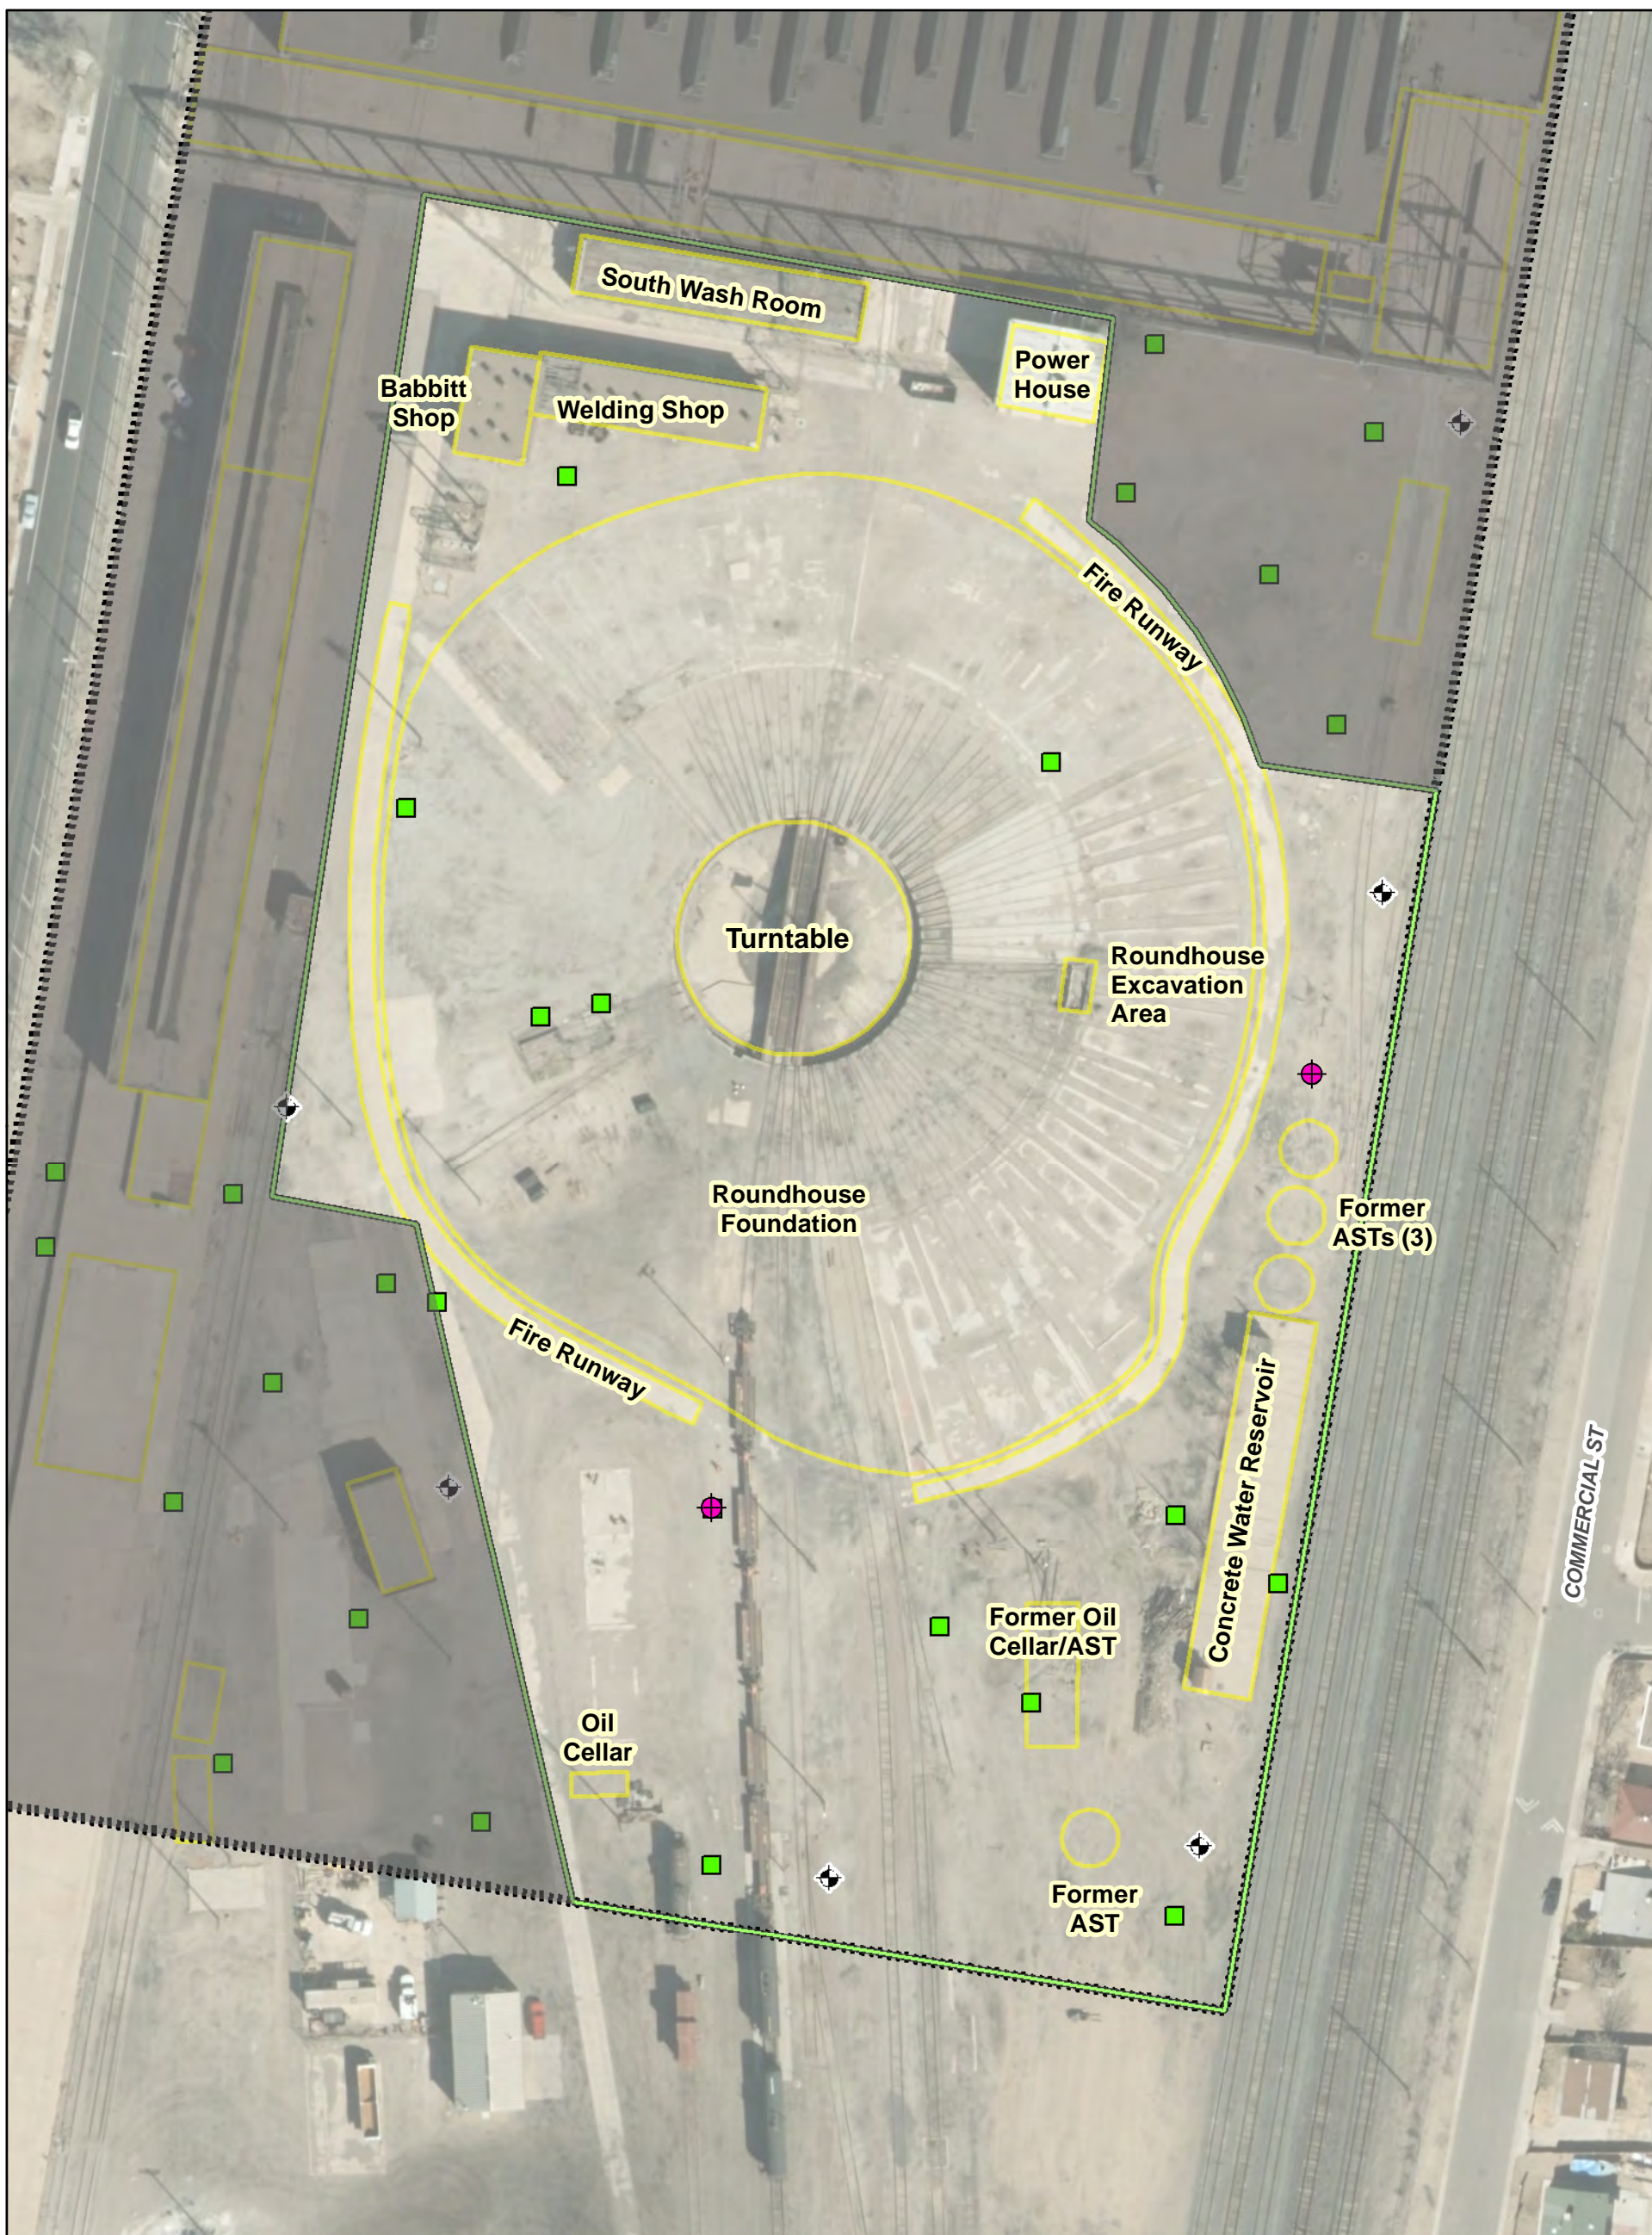
Figure 3d
 Residential SSL Exceedances
 (0-10 ft bgs), Iron
 Additional Characterization,
 Voluntary Remediation Program Activities,
 Albuquerque Rail Yards, Albuquerque,
 Bernalillo County, New Mexico

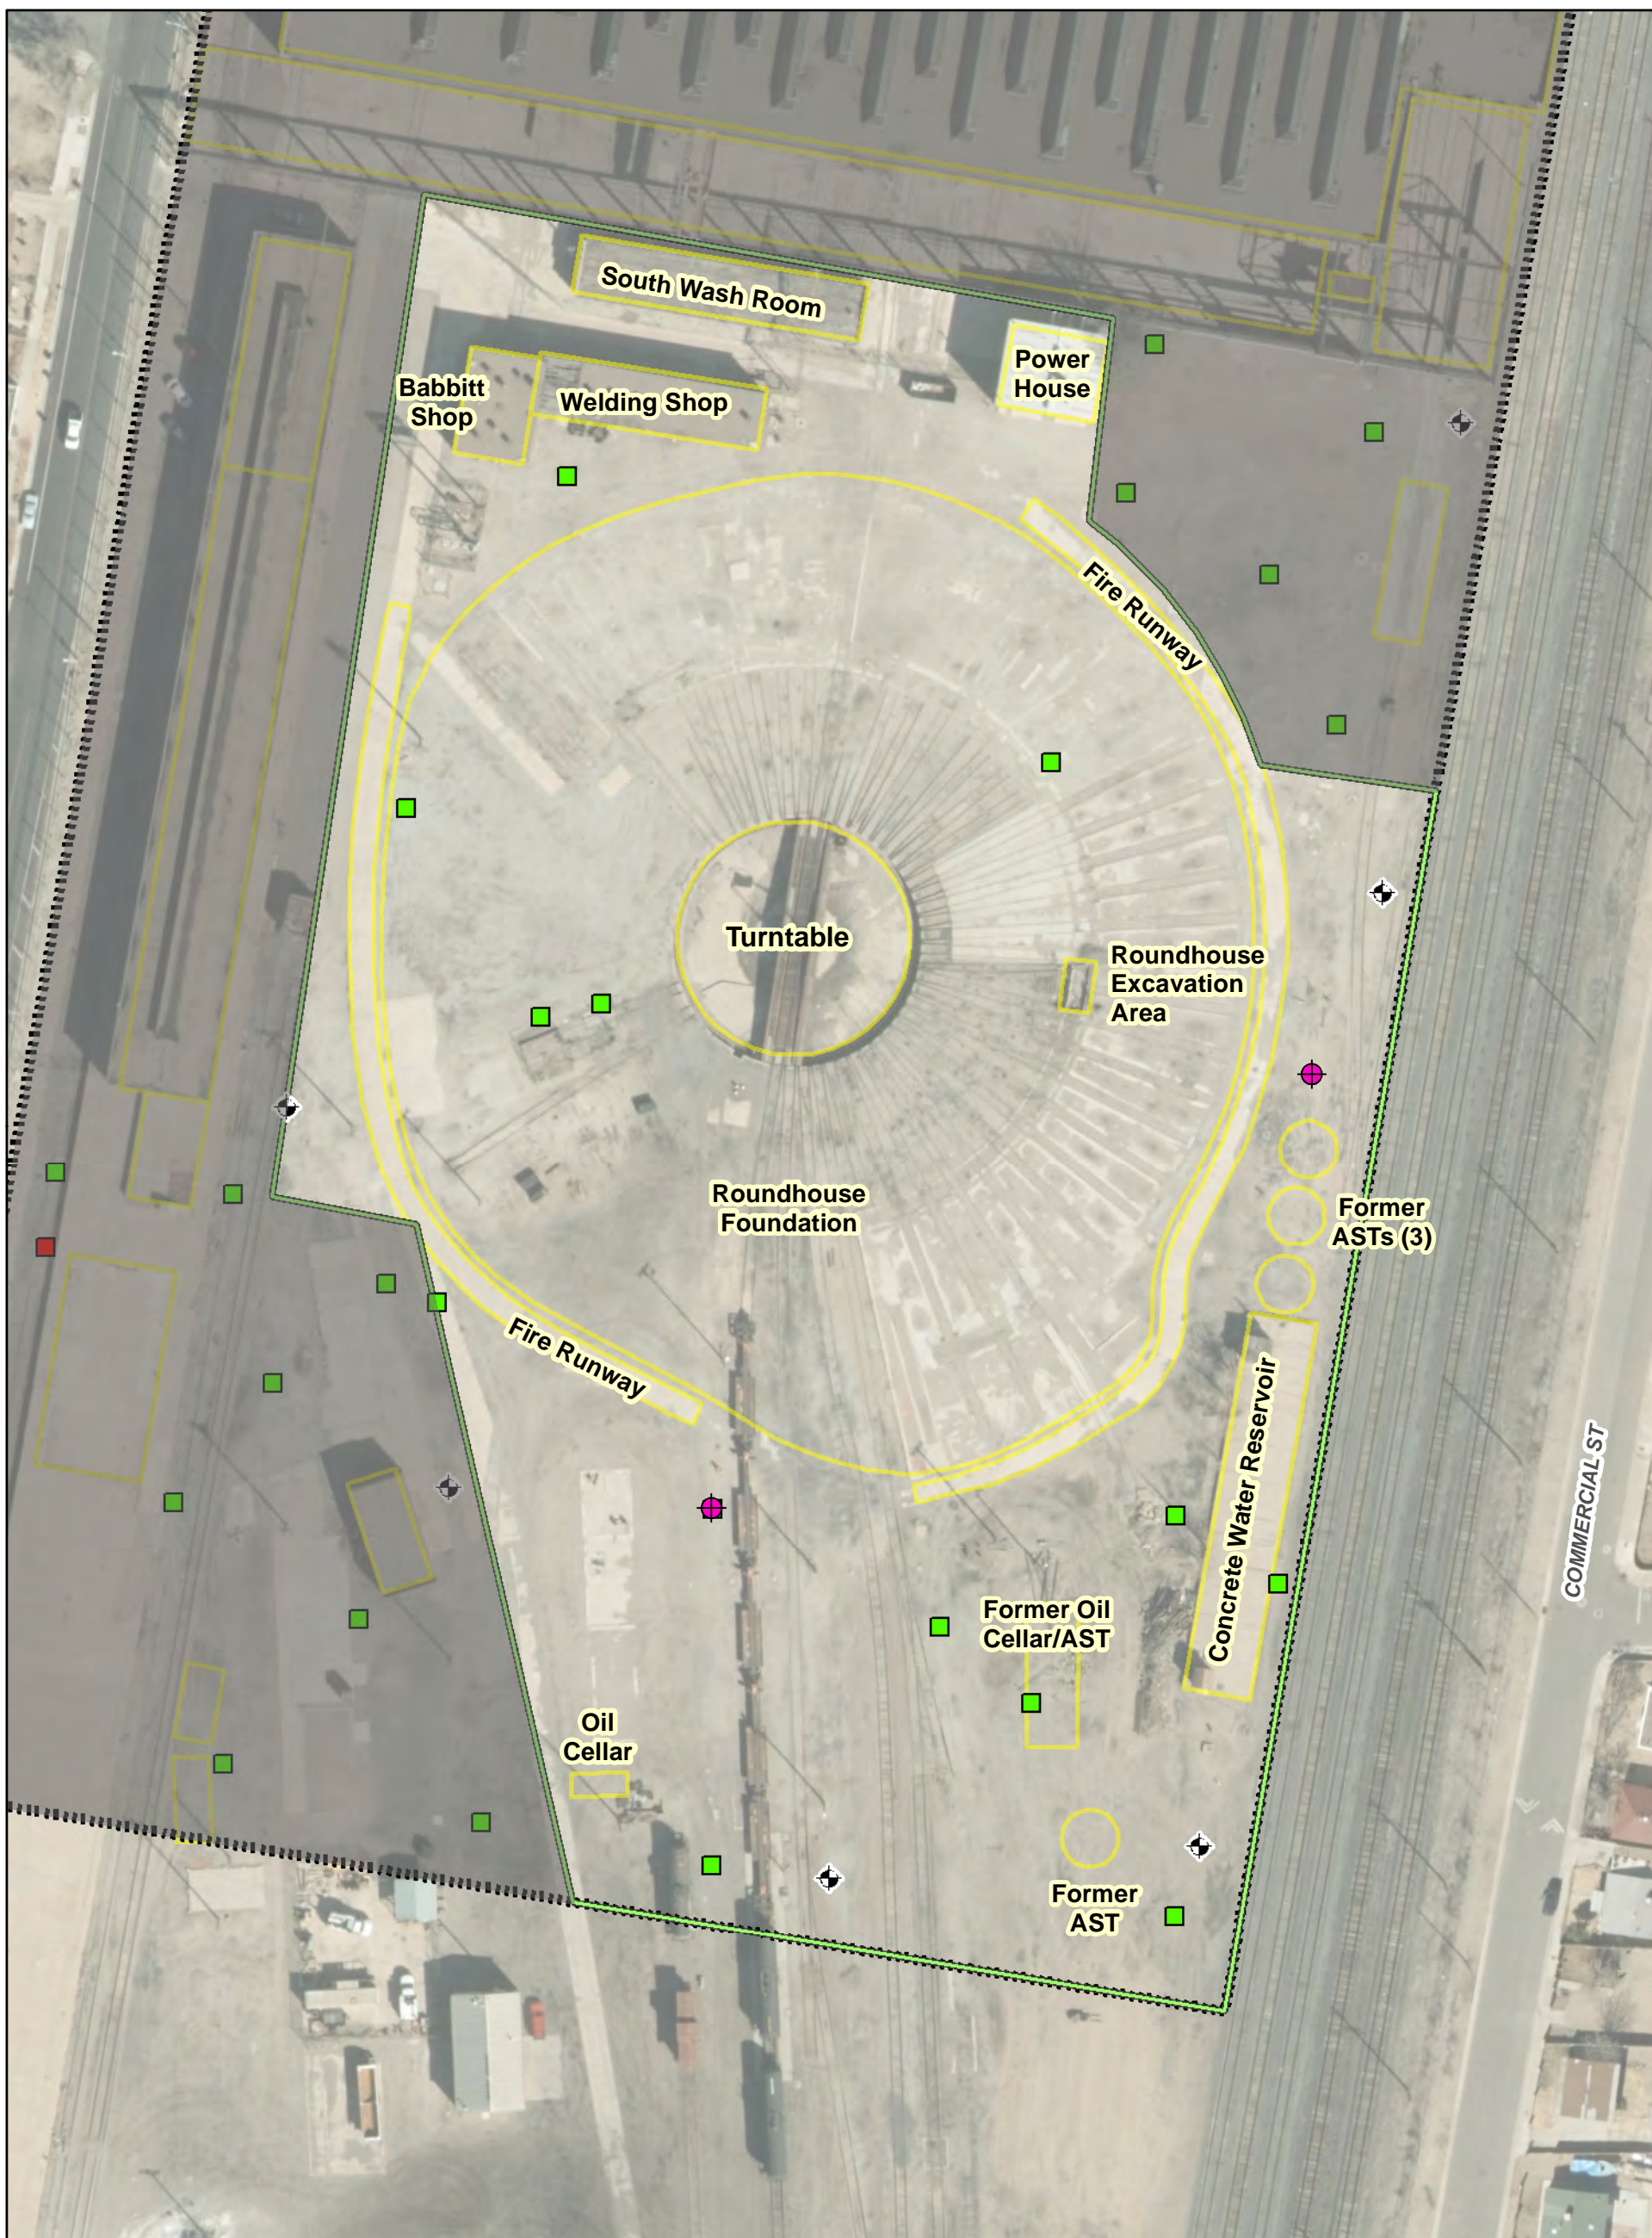
Figure 3f
Construction Worker SSL Exceedances (0-10 ft bgs), Manganese
Additional Characterization,
Voluntary Remediation Program Activities,
Albuquerque Rail Yards, Albuquerque,
Bernalillo County, New Mexico

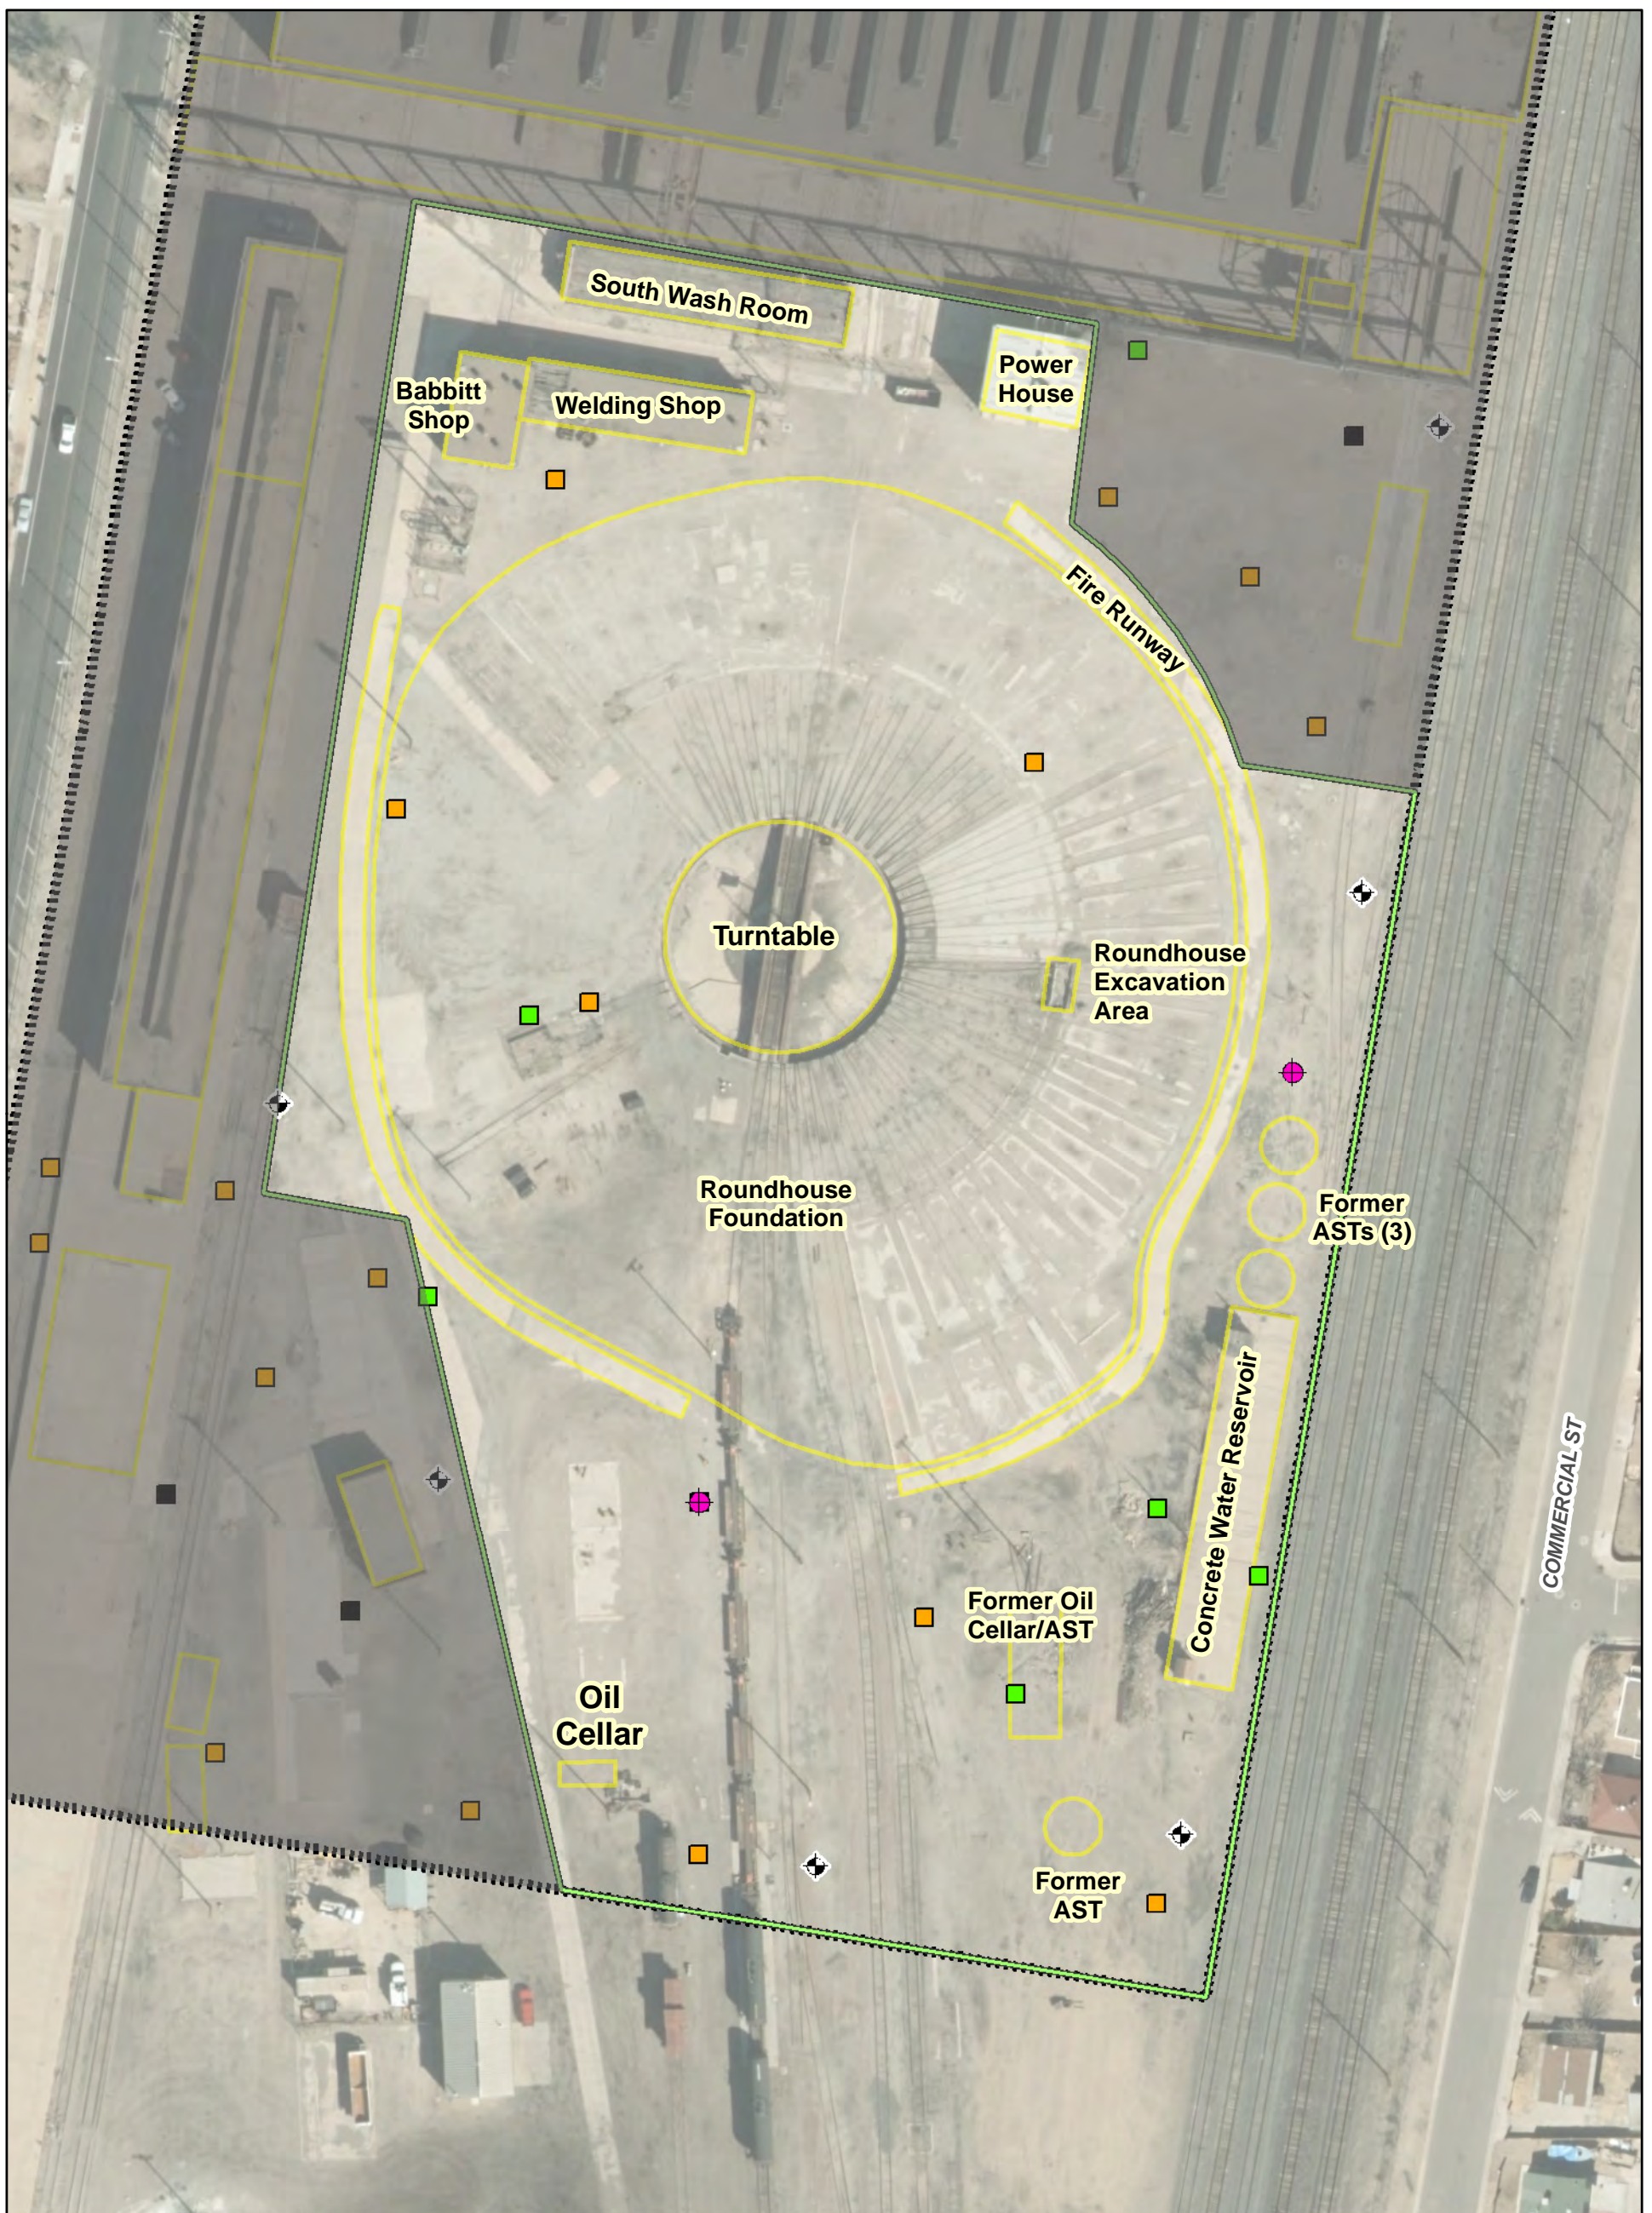
Figure 3g
 Residential SSL Exceedances
 (0-10 ft bgs), Thallium
 Additional Characterization,
 Voluntary Remediation Program Activities,
 Albuquerque Rail Yards, Albuquerque,
 Bernalillo County, New Mexico
