PARCEL 1 ADDITIONAL CHARACTERIZATION REPORT

CITY OF ALBUQUERQUE RAIL YARDS

Albuquerque, Bernalillo County, New Mexico

April 27, 2017

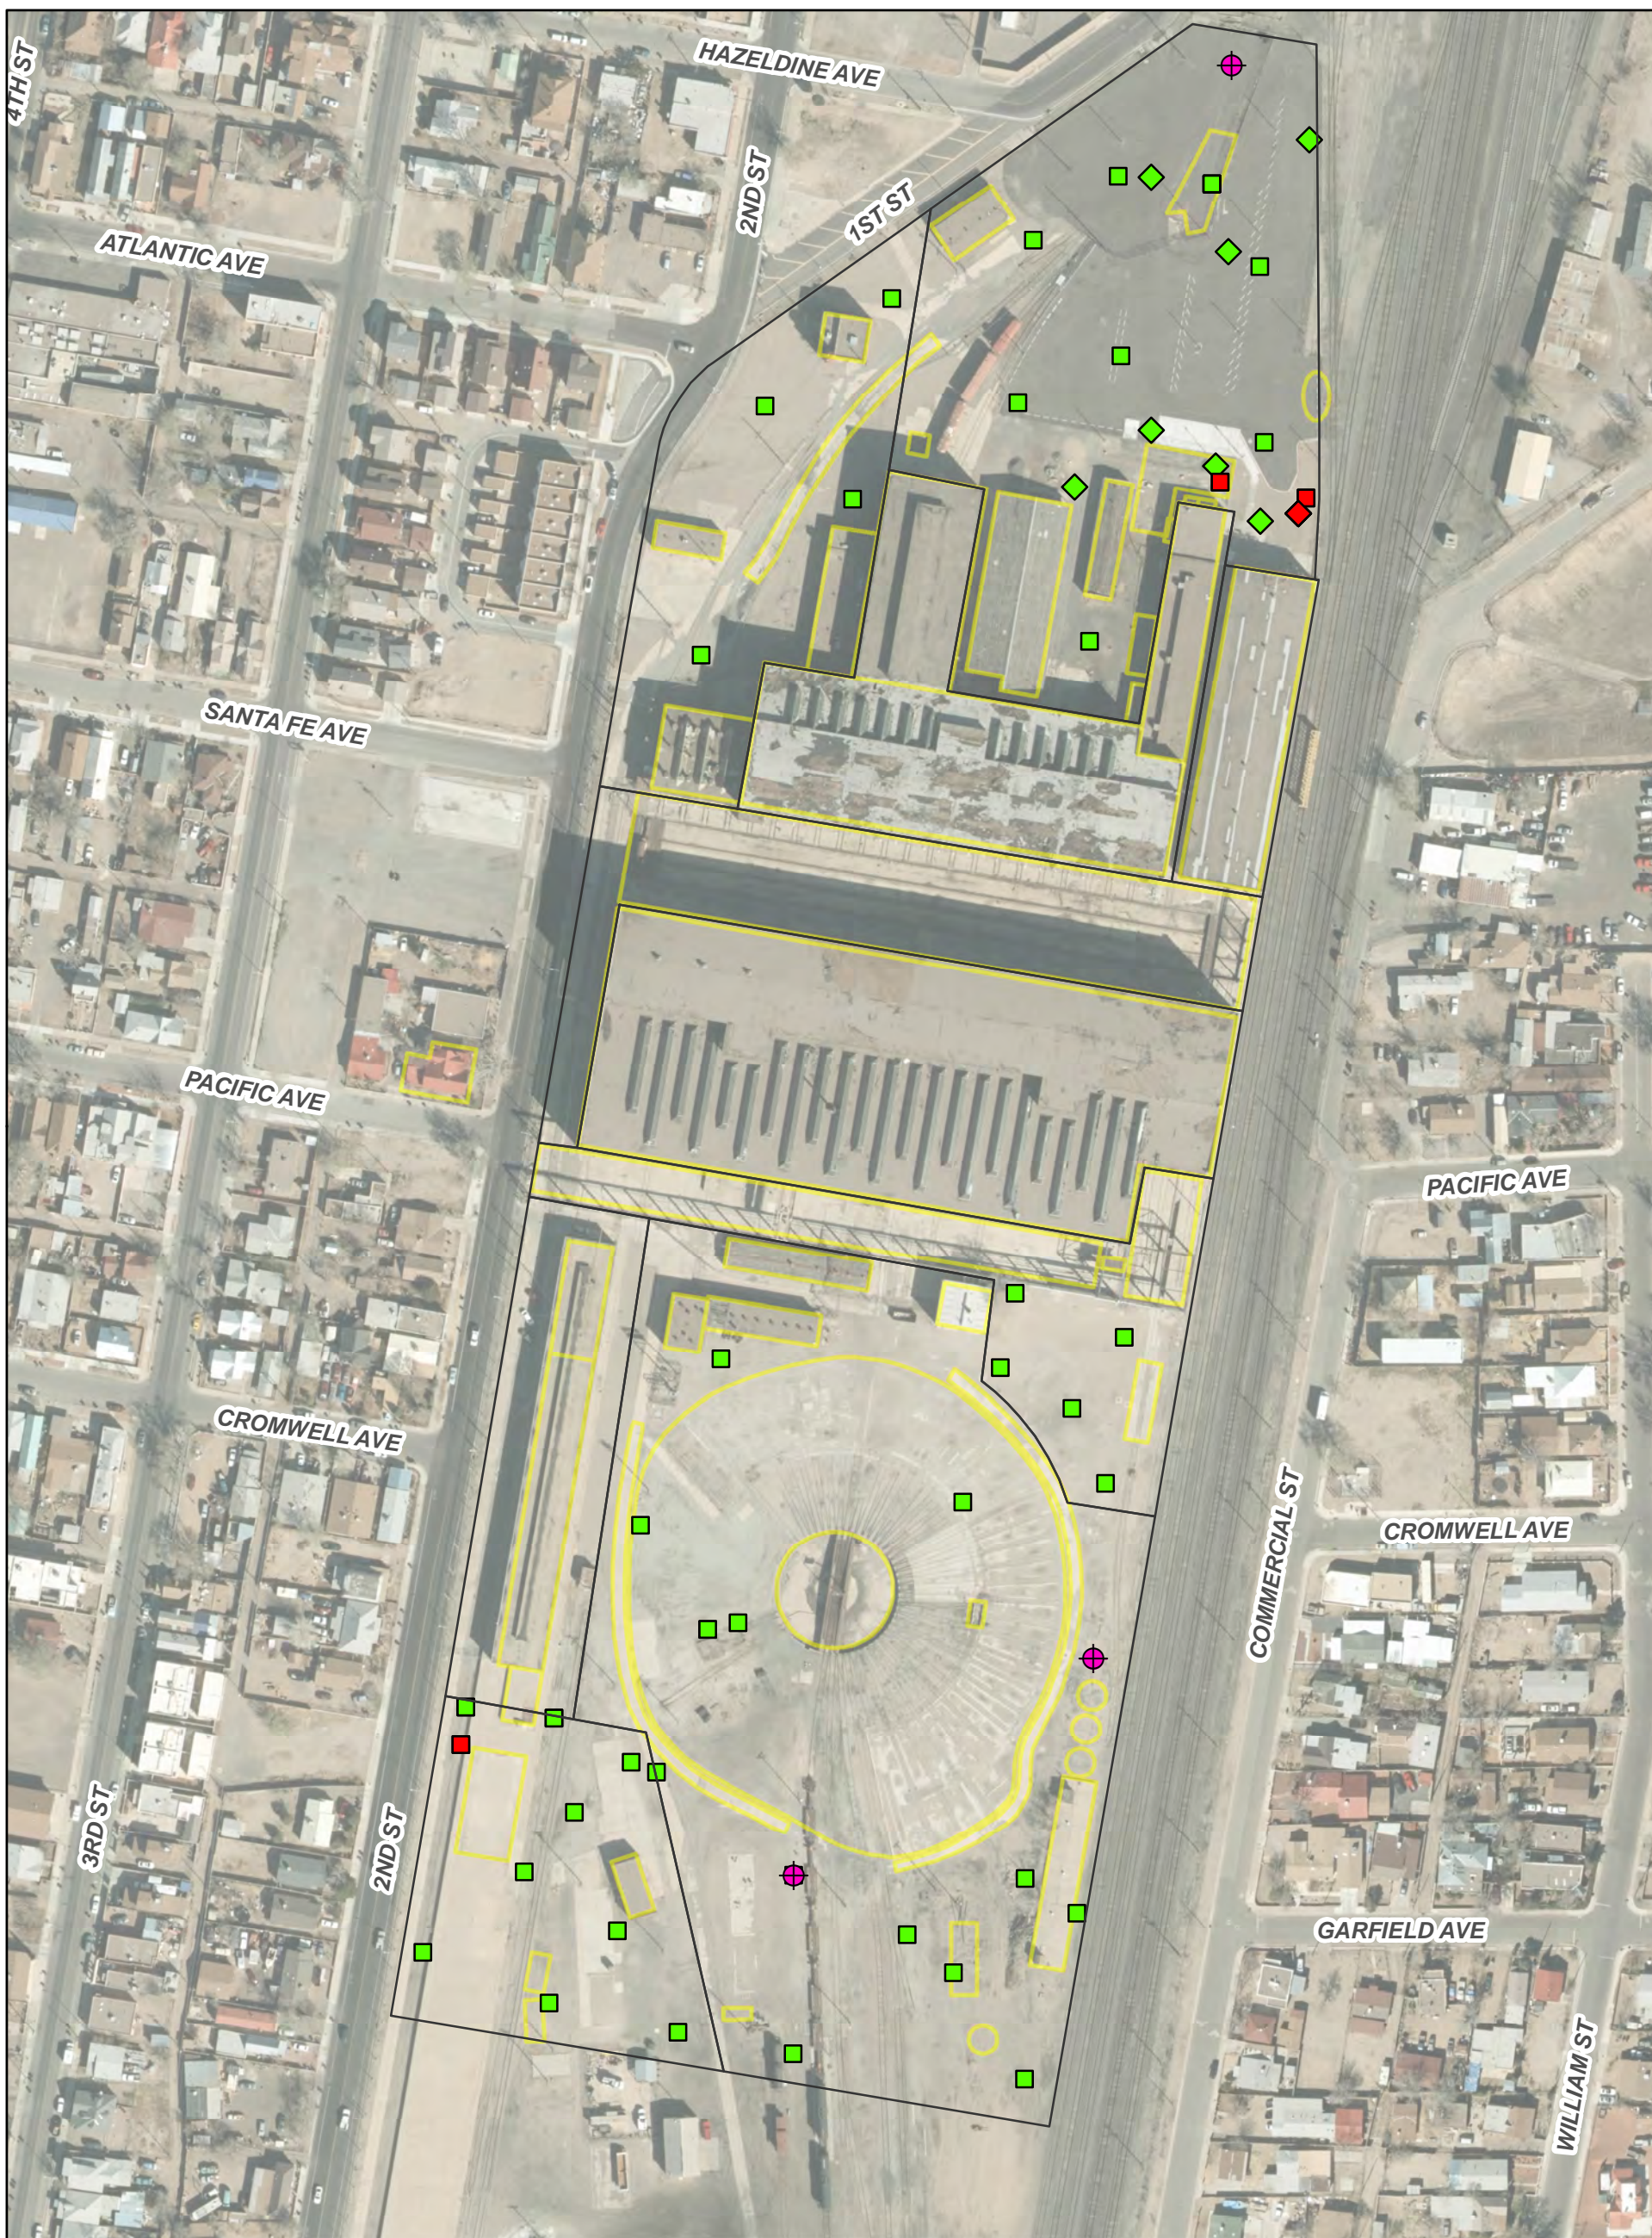
**Distribution of Dissolved-Phase Contaminants,
 November 4, 2016**
 Additional Characterization of
 Groundwater Report, City of Albuquerque Rail Yards,
 Albuquerque, Bernalillo County, New Mexico

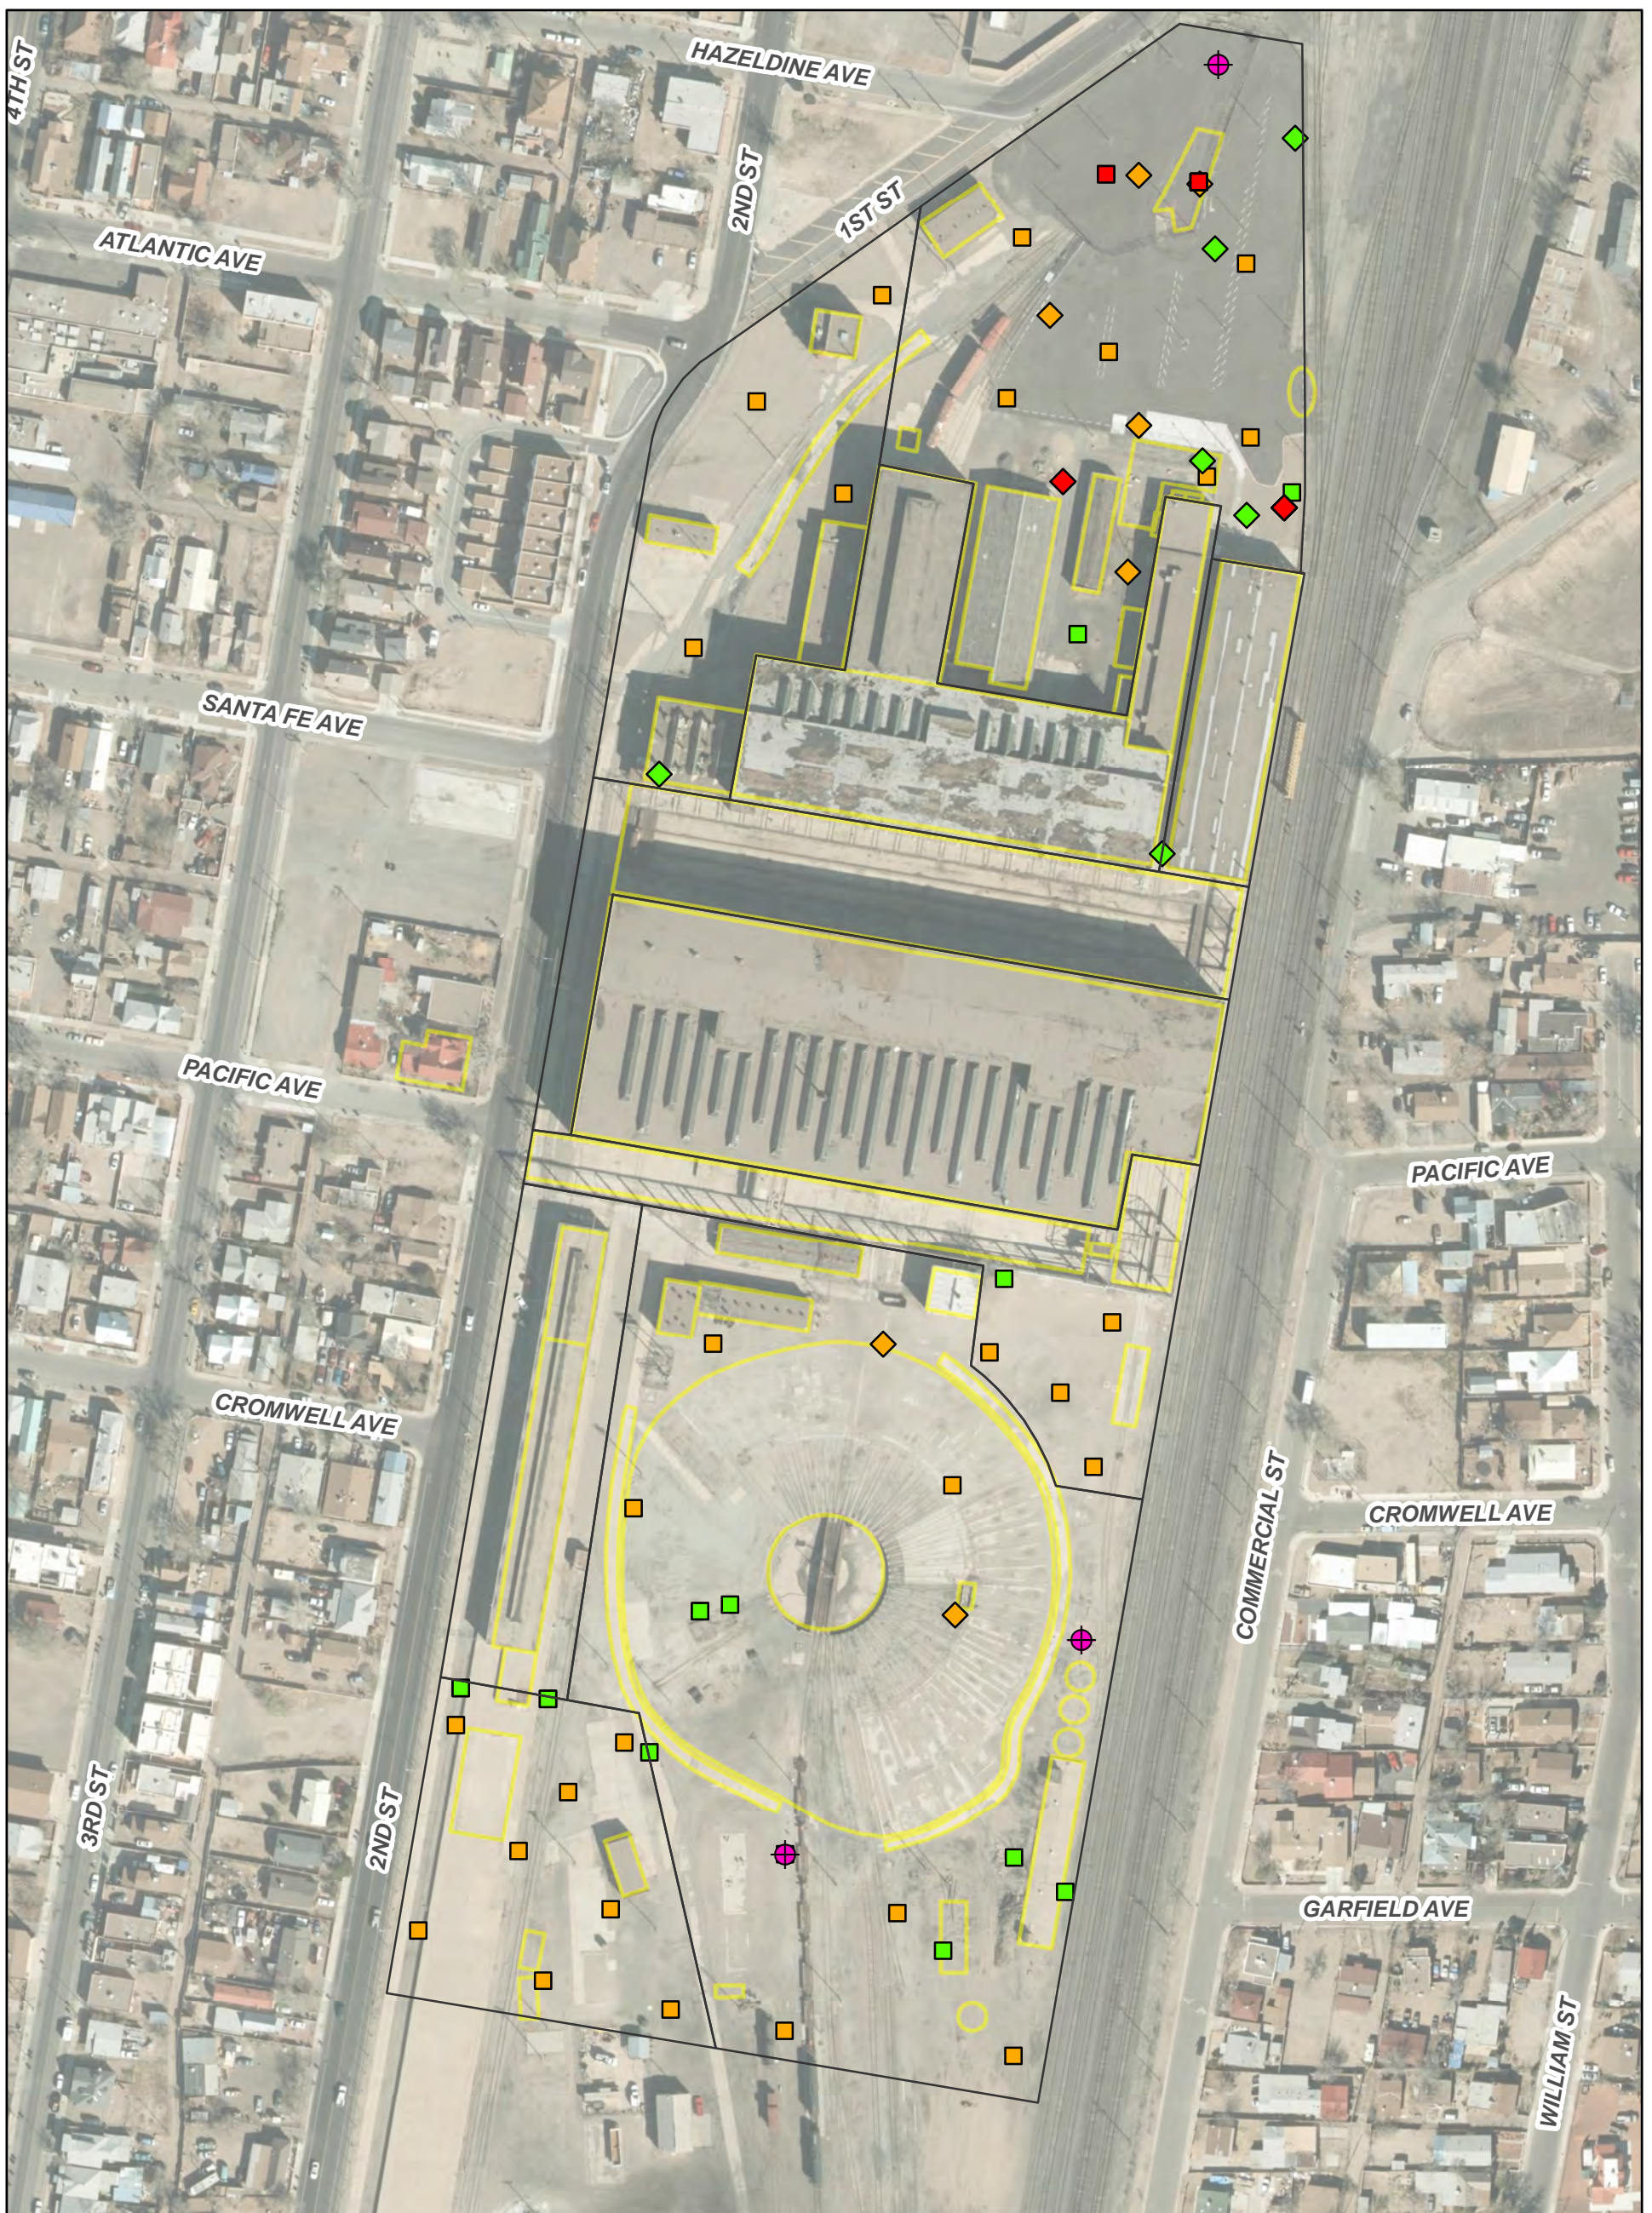
Residential SSL Exceedances (0-10 ft bgs), Arsenic
 Additional Characterization, Voluntary Remediation Program Activities, Albuquerque Rail Yards, Albuquerque, Bernalillo County, New Mexico

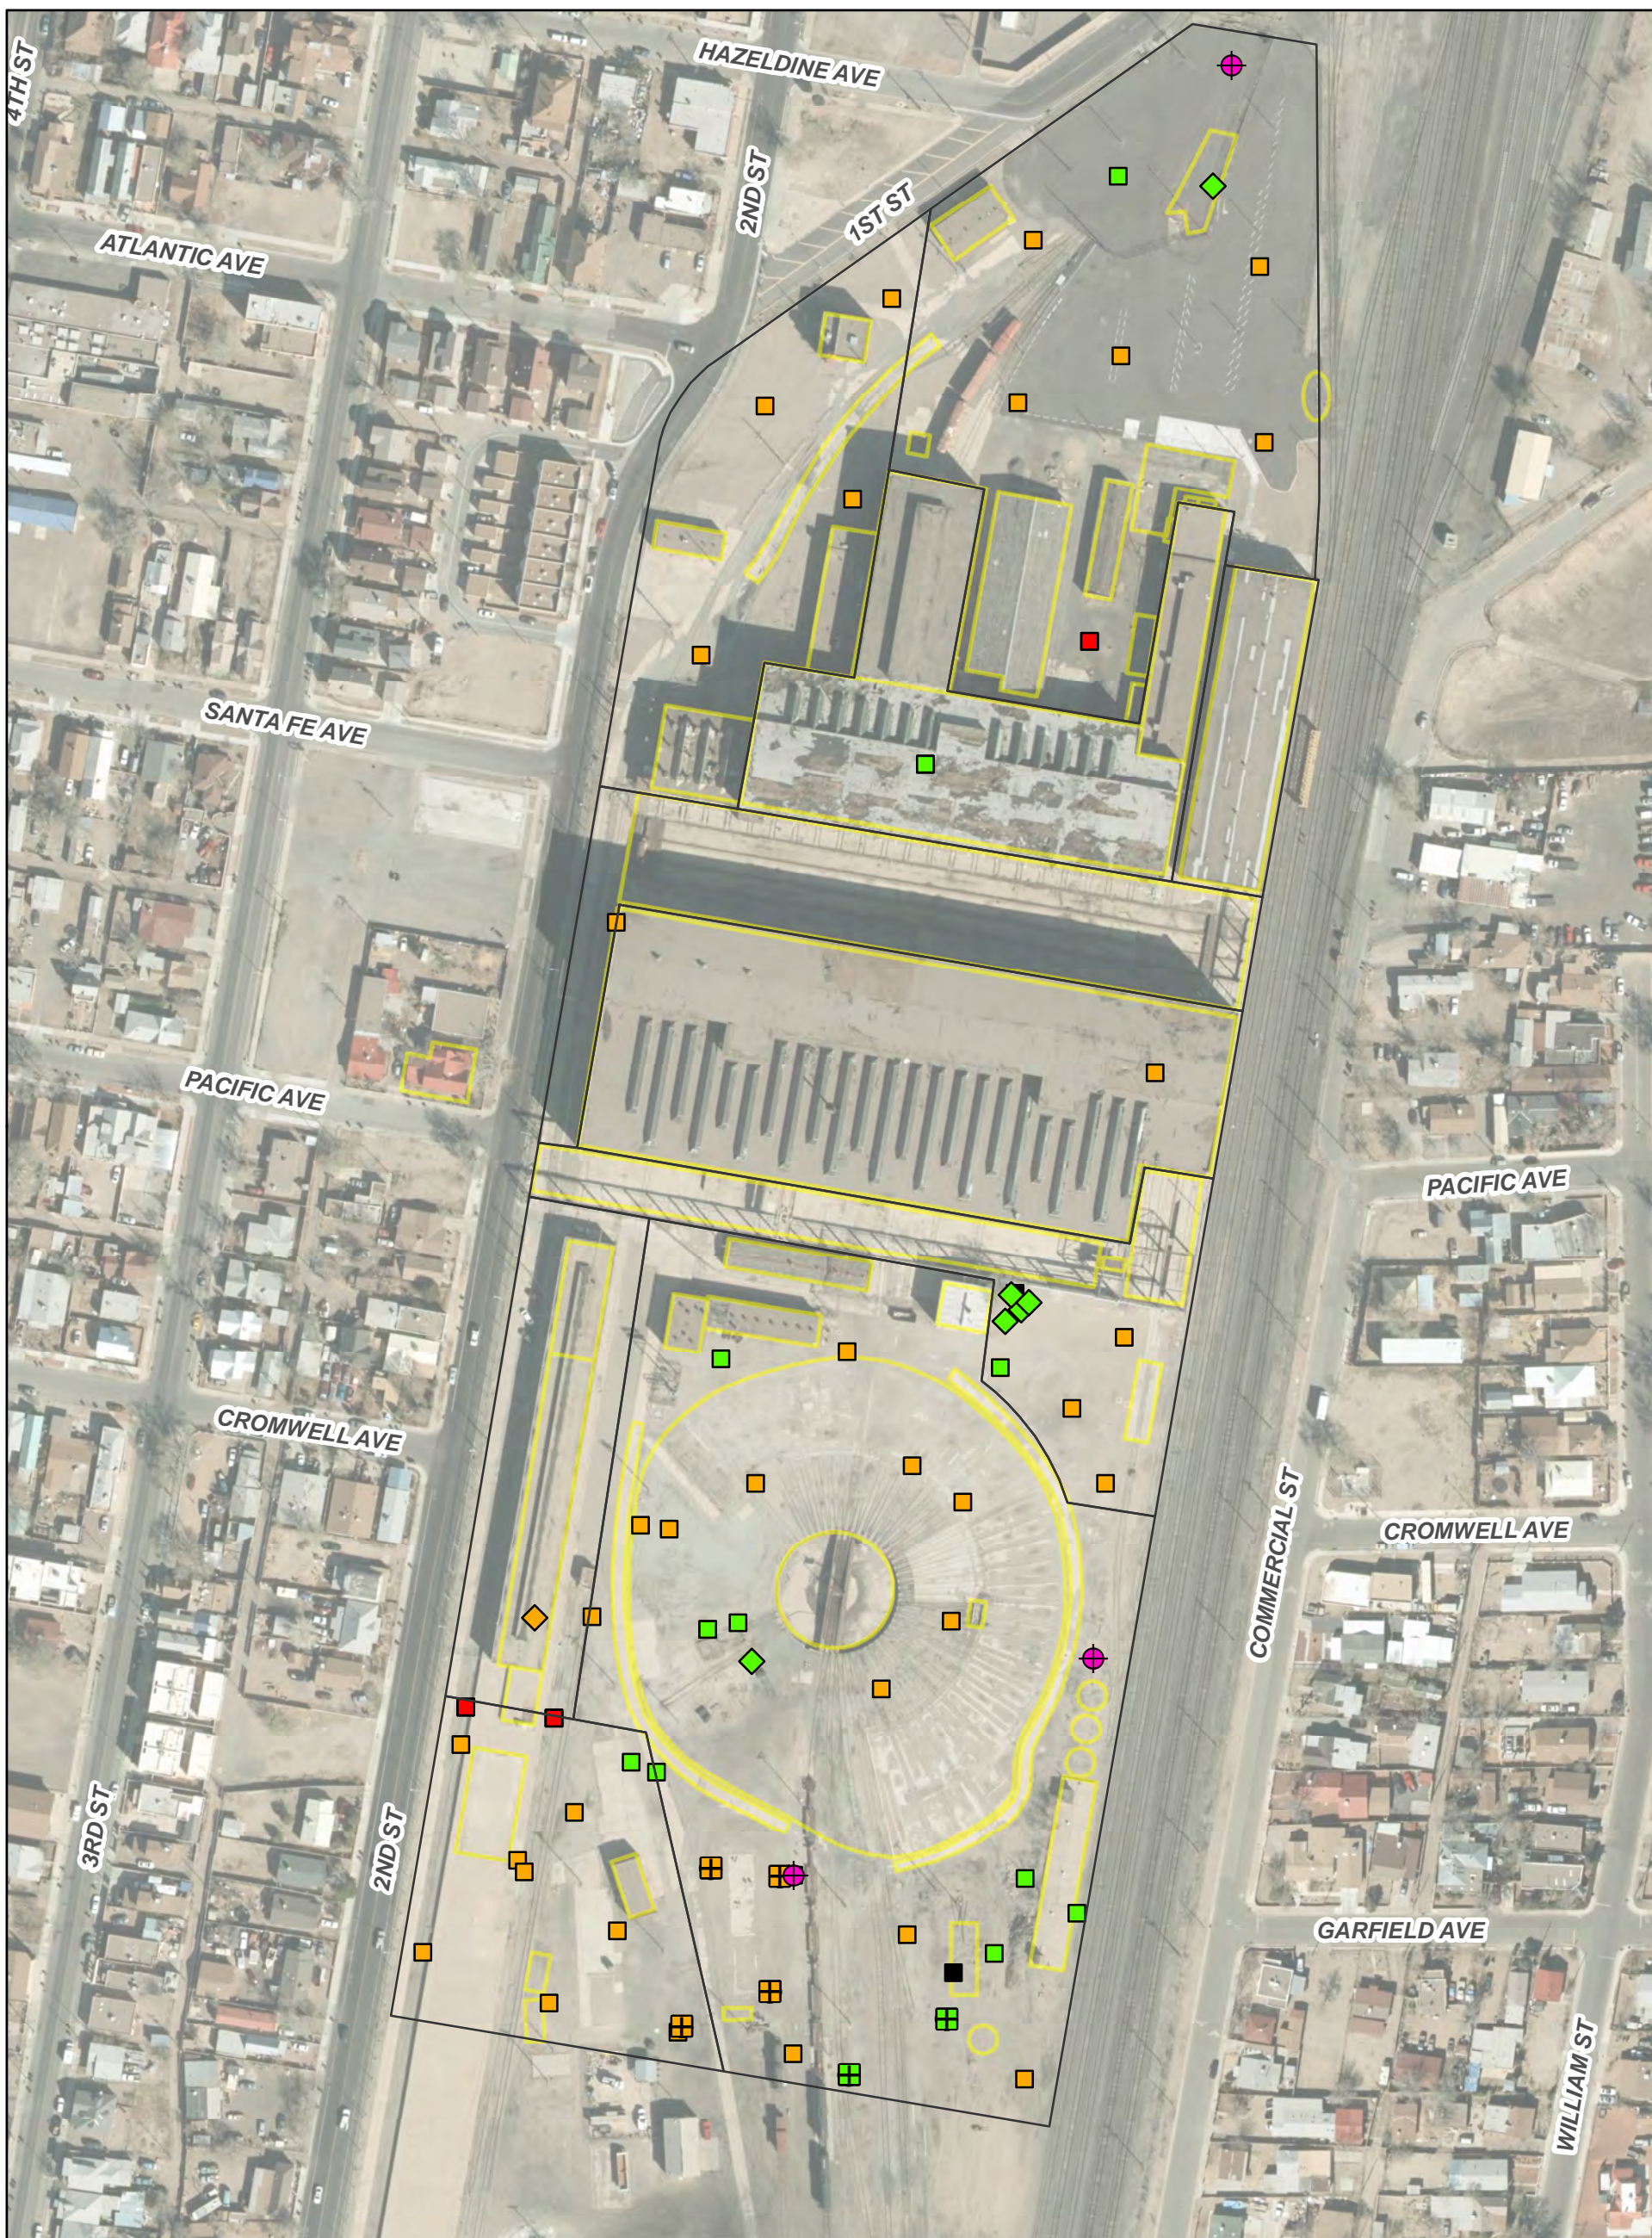
Residential SSL Exceedances
 (0-10 ft bgs), Benzo(a)pyrene
 Additional Characterization,
 Voluntary Remediation Program Activities,
 Albuquerque Rail Yards, Albuquerque,
 Bernalillo County, New Mexico

In summary, the locations of benzo(a)pyrene exceedances are generally collocated with all other exceedances (lead, arsenic, chromium, and TPH). As such, **Figure 4b** can be used to guide recommendations for remediation and/or engineering controls for redevelopment purposes.

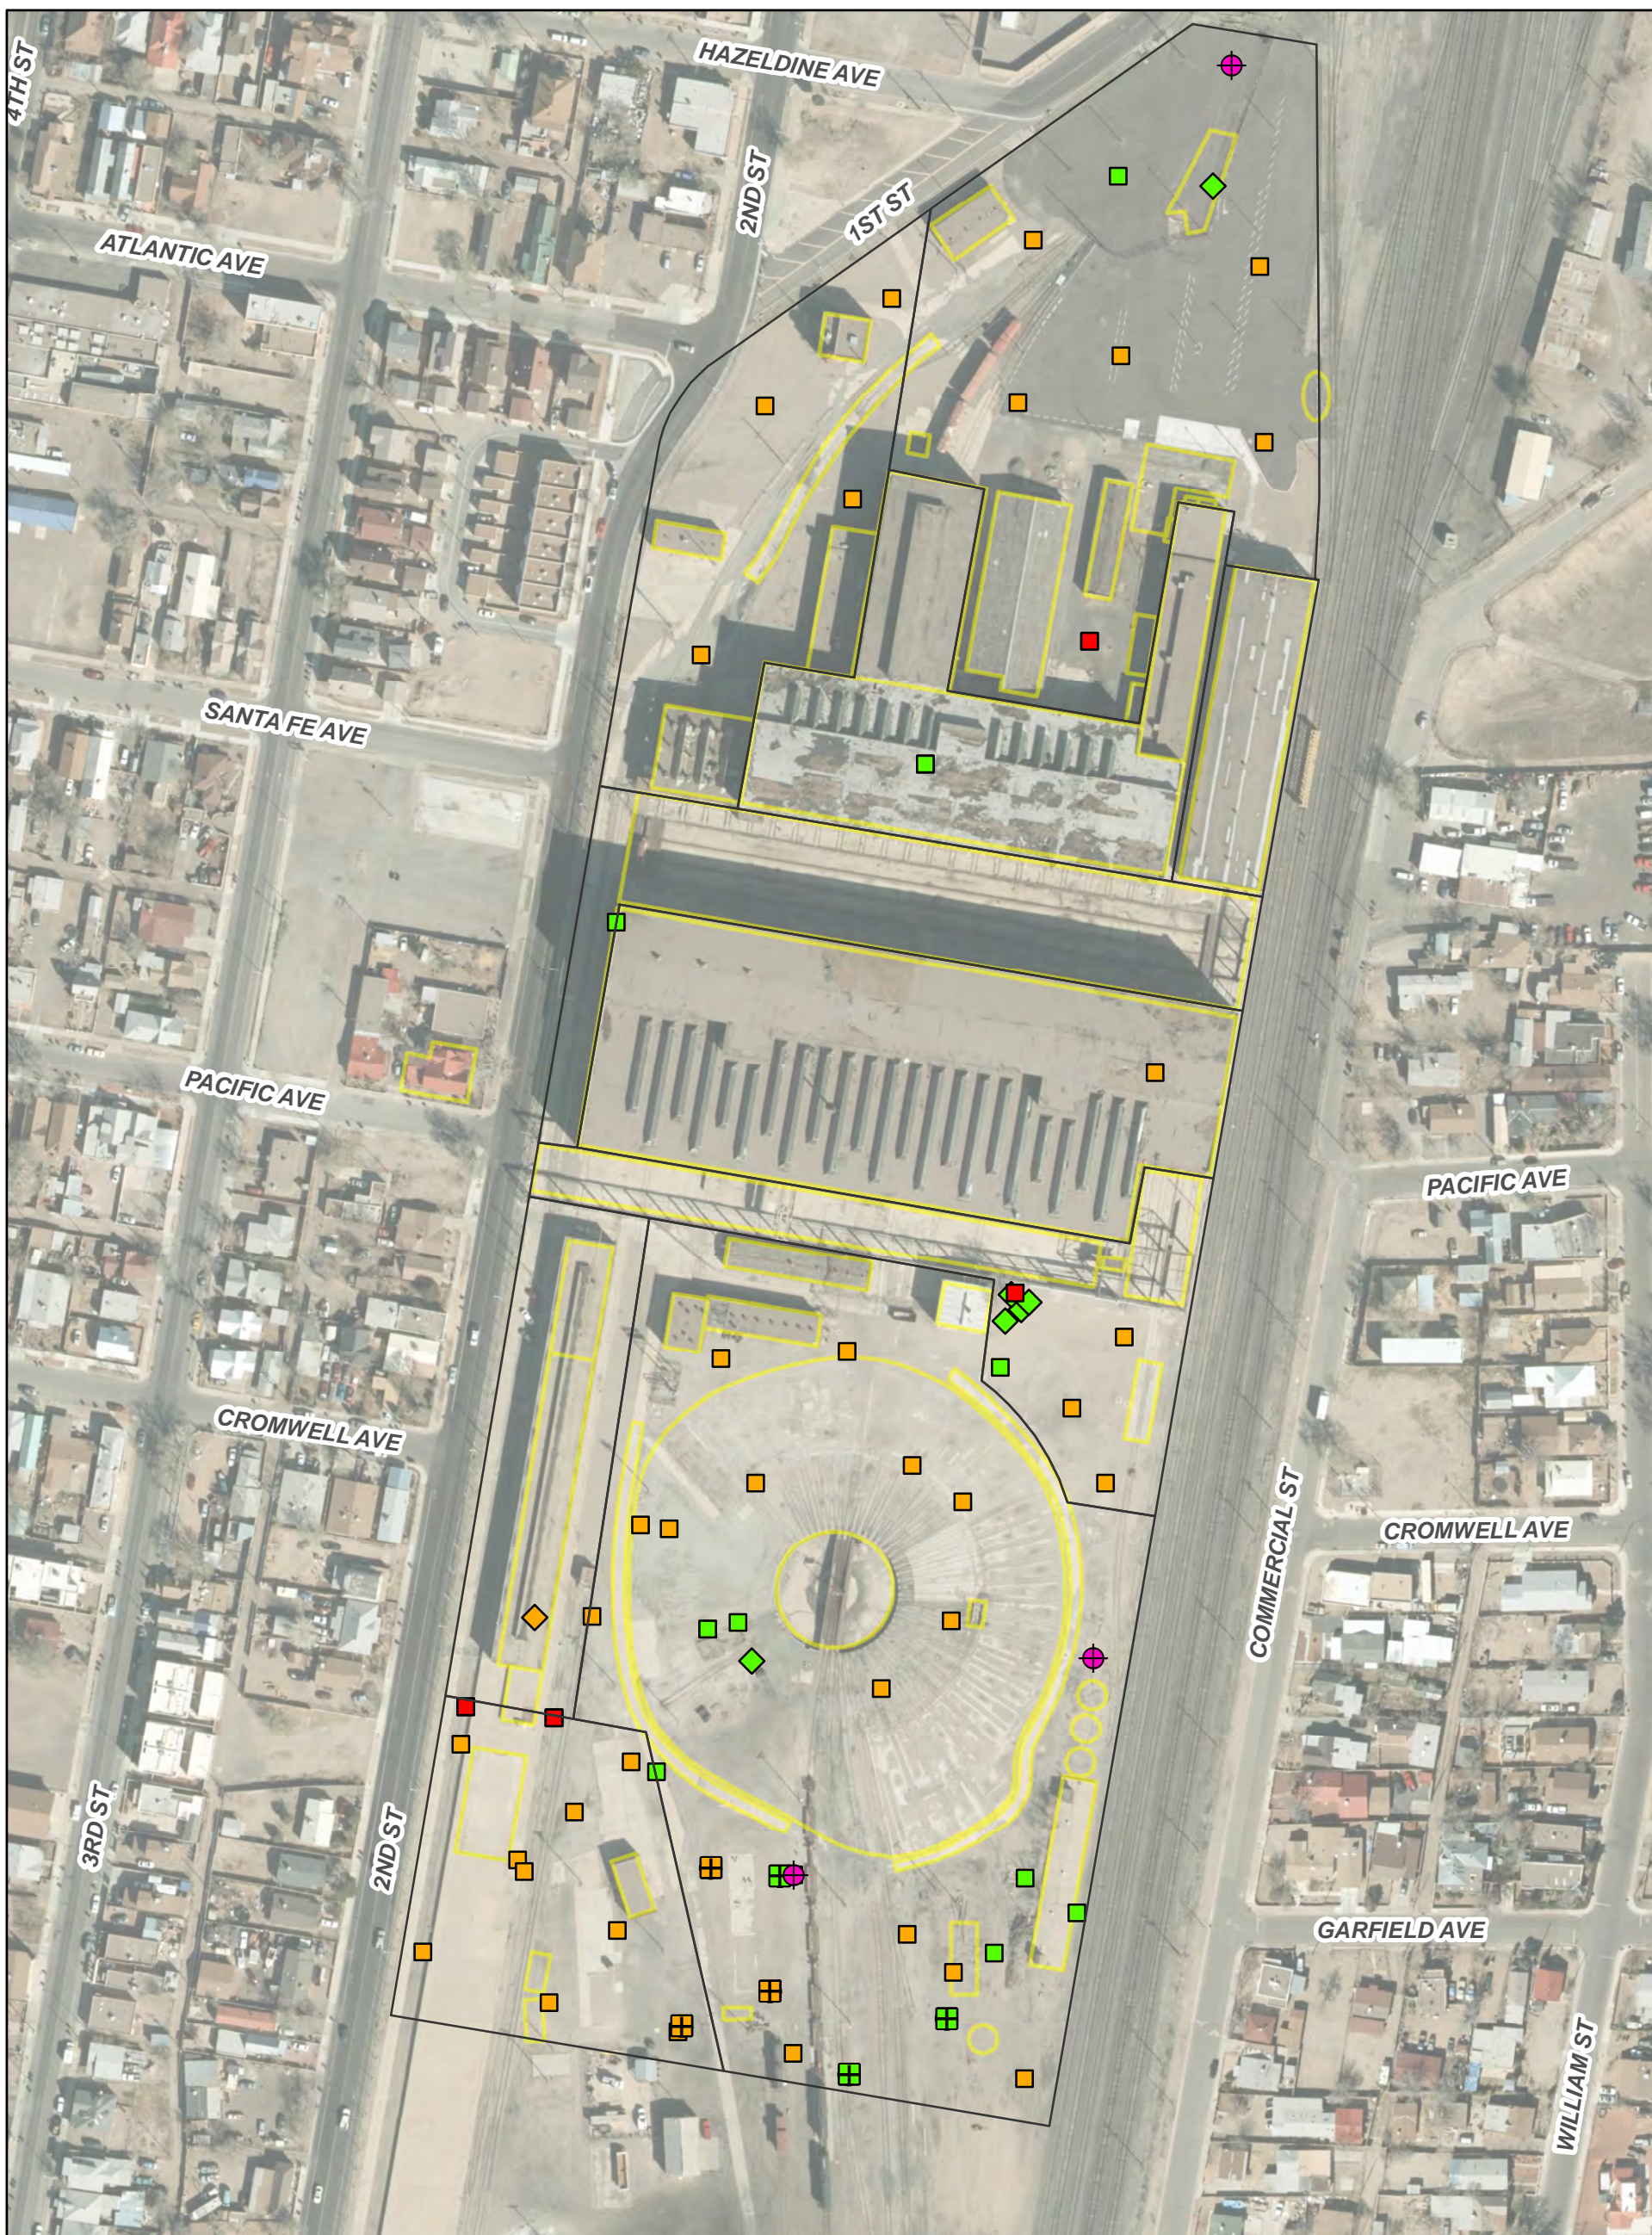
Residential SSL Exceedances
 (0-10 ft bgs), Benzo(b)fluoranthene
 Additional Characterization,
 Voluntary Remediation Program Activities,
 Albuquerque Rail Yards, Albuquerque,
 Bernalillo County, New Mexico

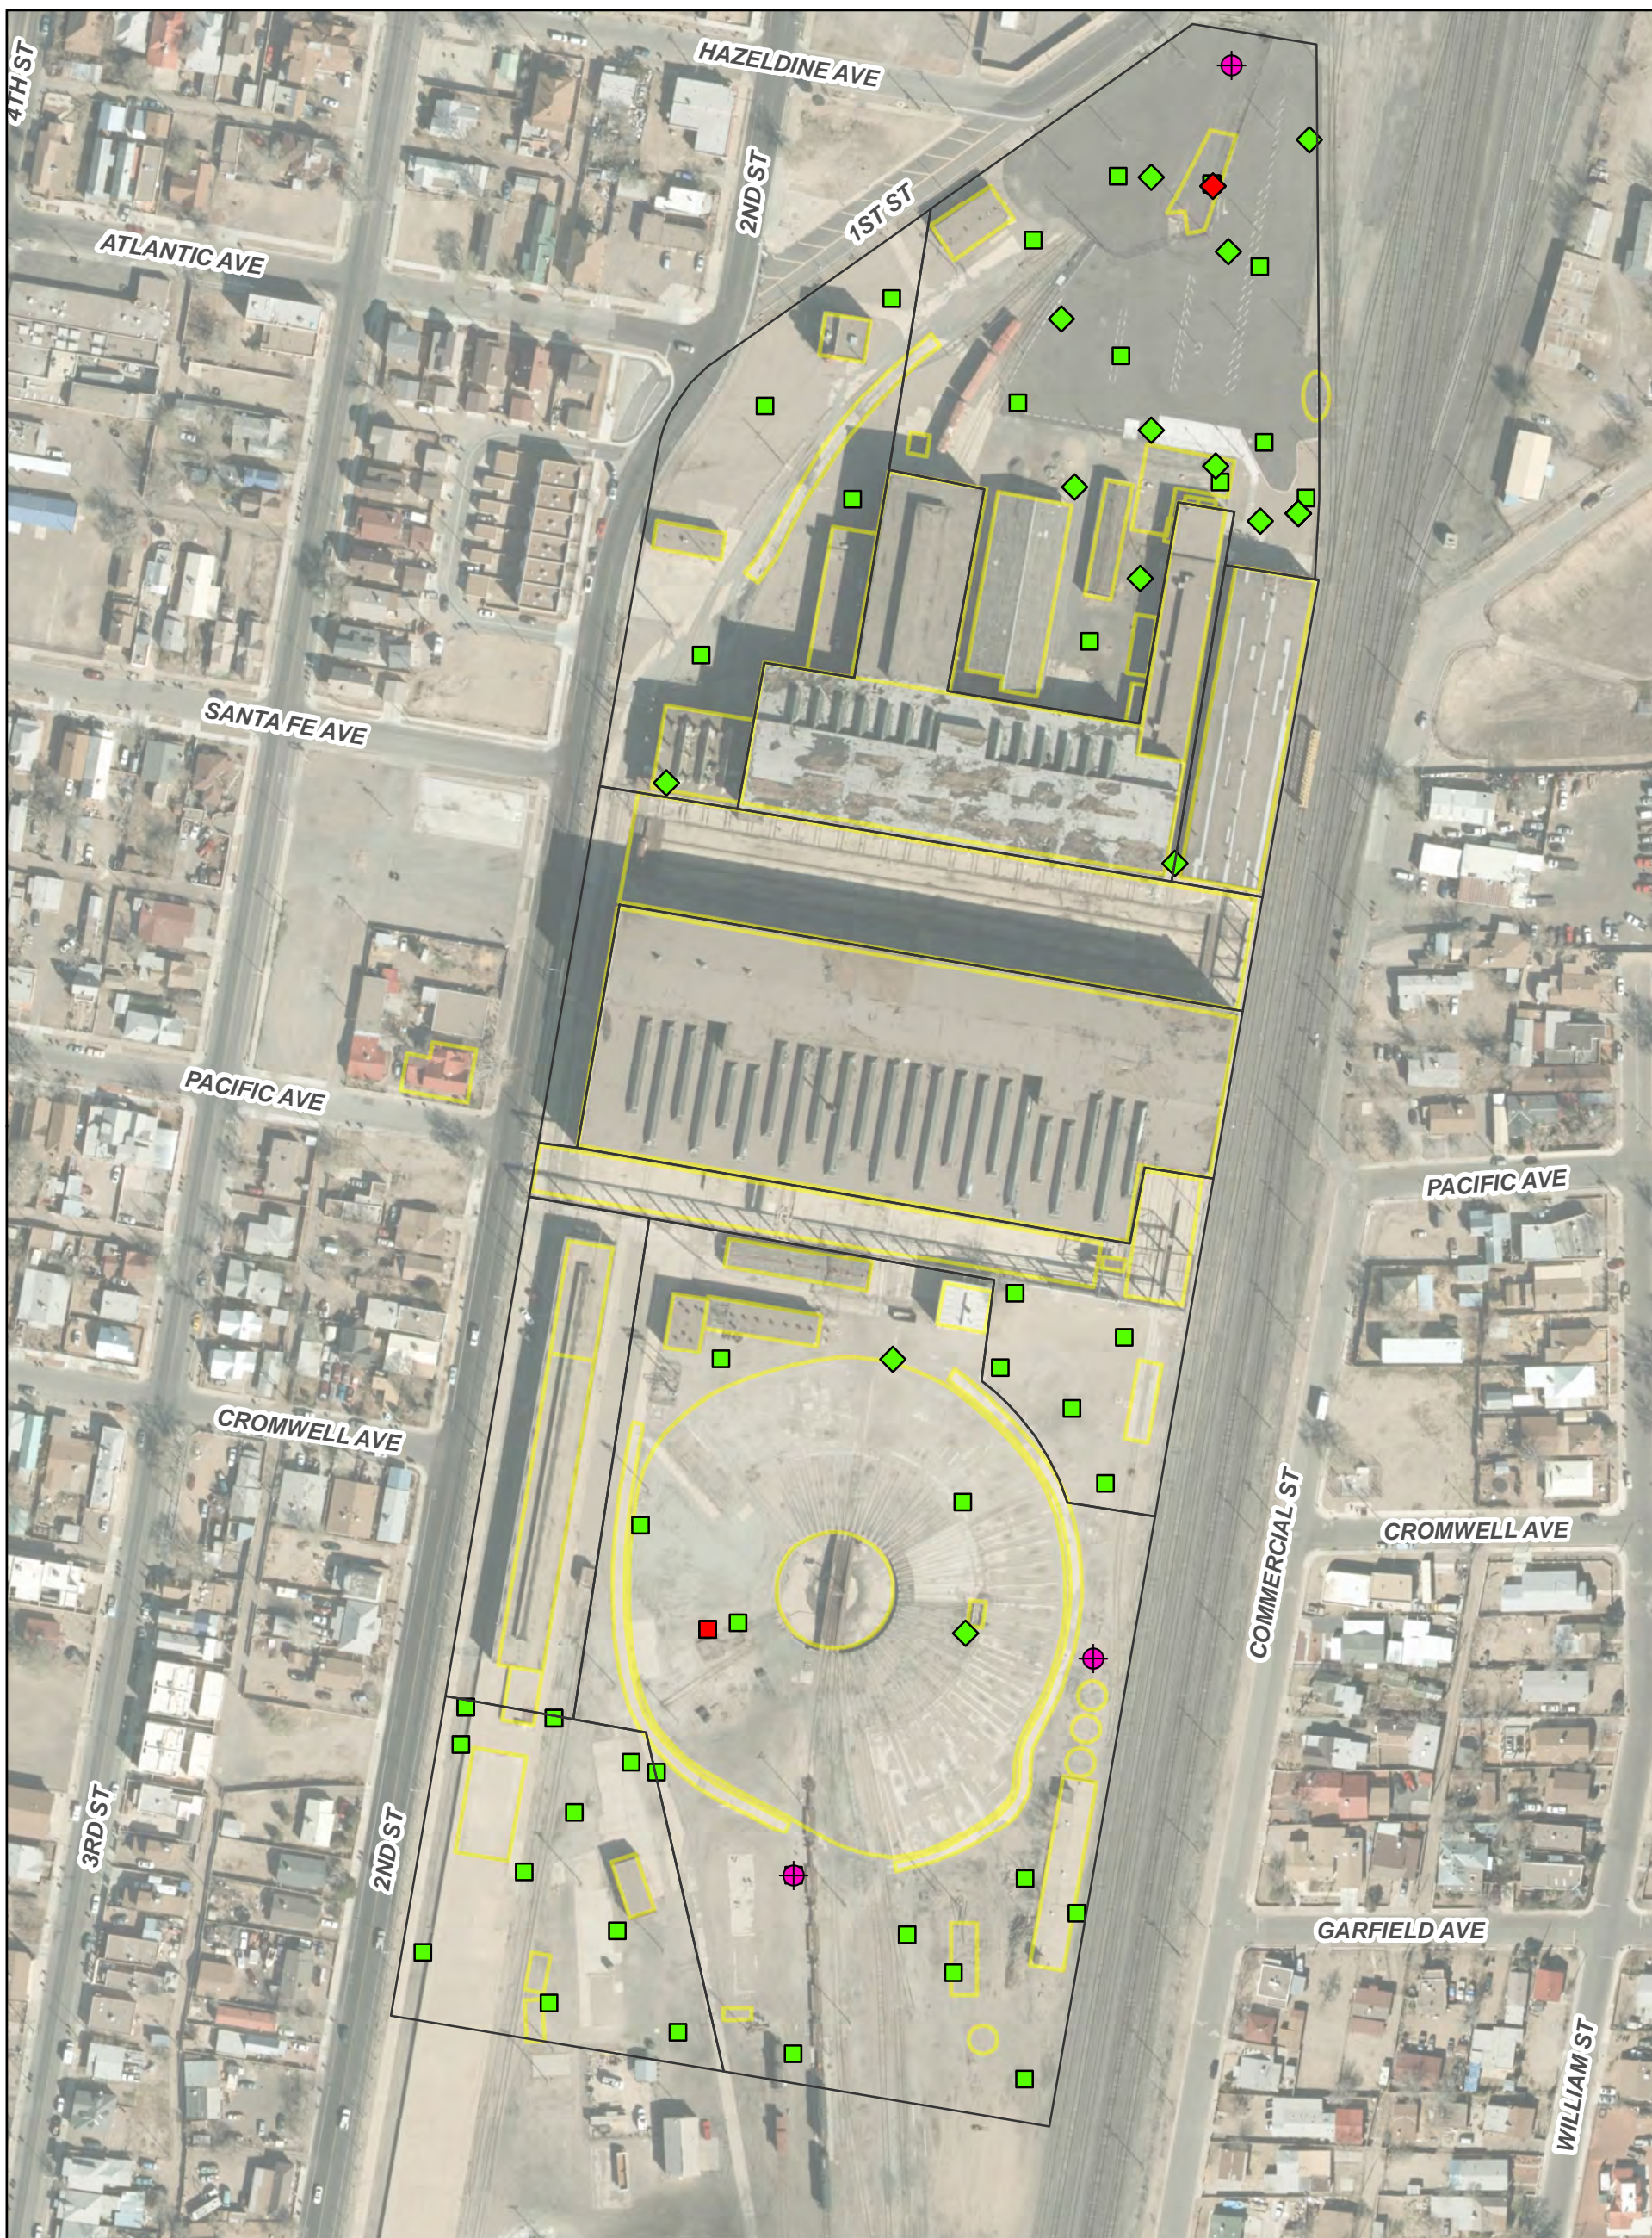
Residential SSL Exceedances (0-10 ft bgs), Chromium
 Additional Characterization, Voluntary Remediation Program Activities, Albuquerque Rail Yards, Albuquerque, Bernalillo County, New Mexico

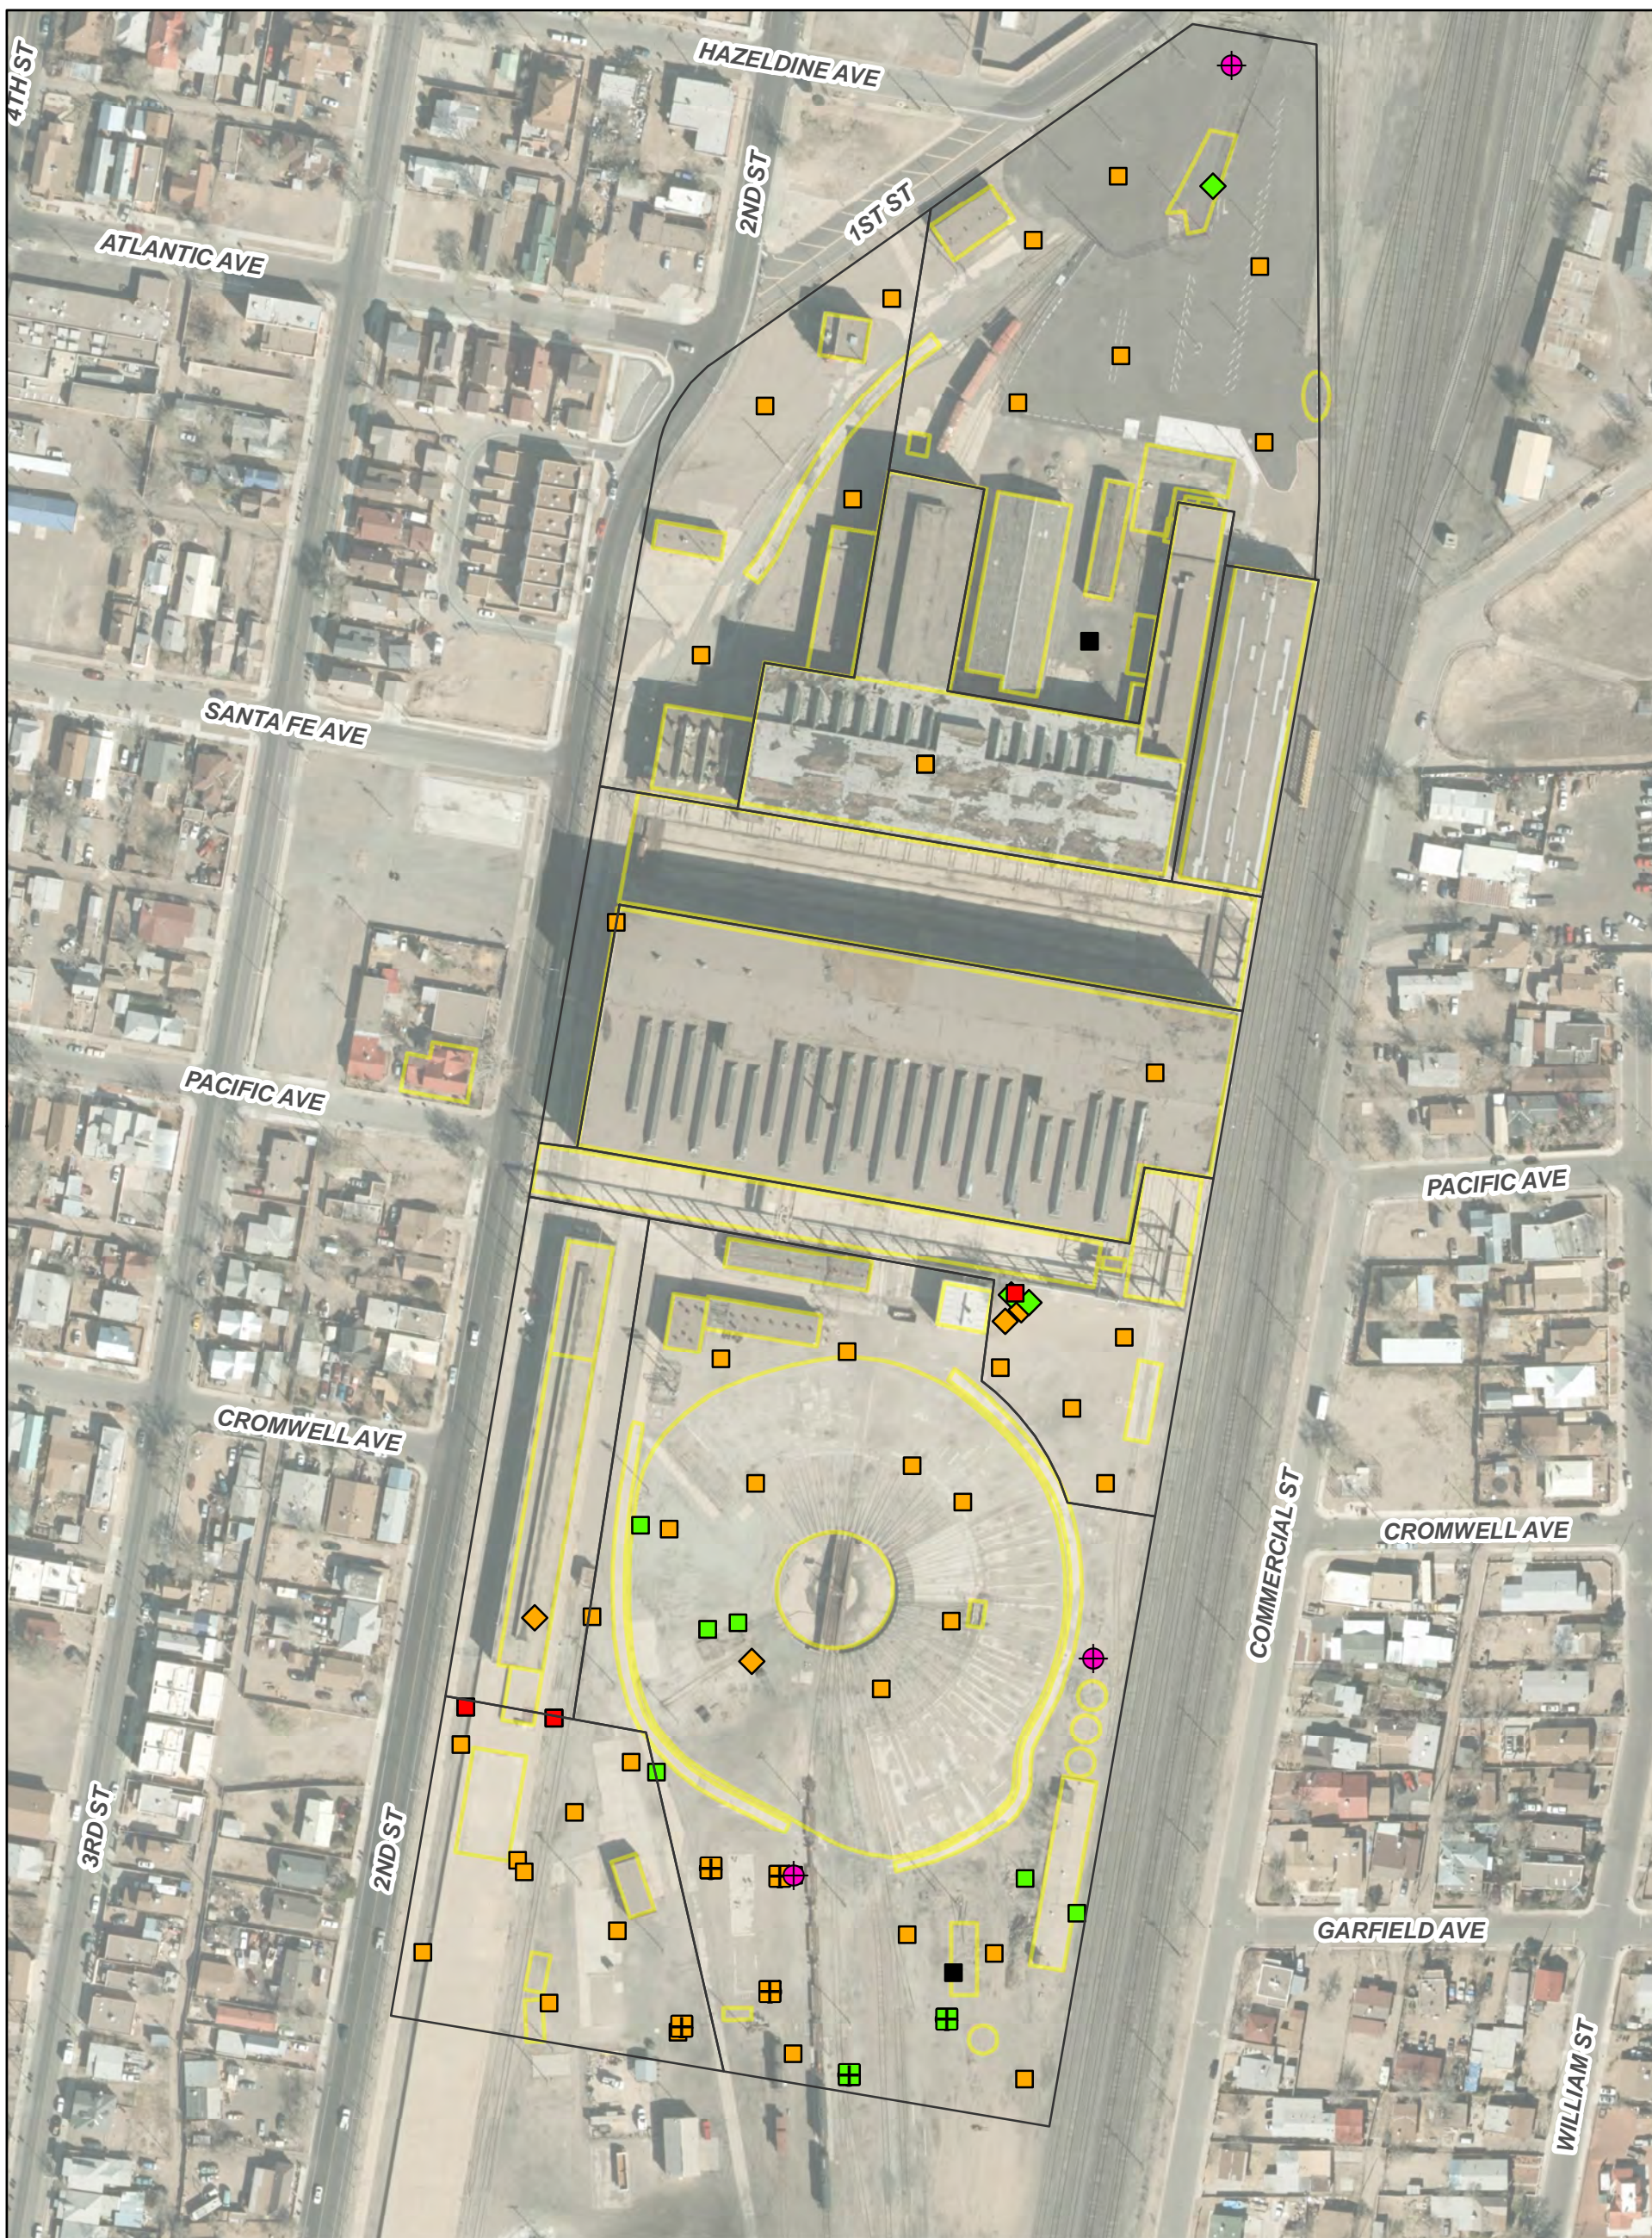
Residential SSL Exceedances (0-10 ft bgs), Dibenzo(a,h)anthracene
 Additional Characterization, Voluntary Remediation Program Activities, Albuquerque Rail Yards, Albuquerque, Bernalillo County, New Mexico
