PARCEL 1 ADDITIONAL CHARACTERIZATION REPORT

CITY OF ALBUQUERQUE RAIL YARDS

Albuquerque, Bernalillo County, New Mexico

April 27, 2017

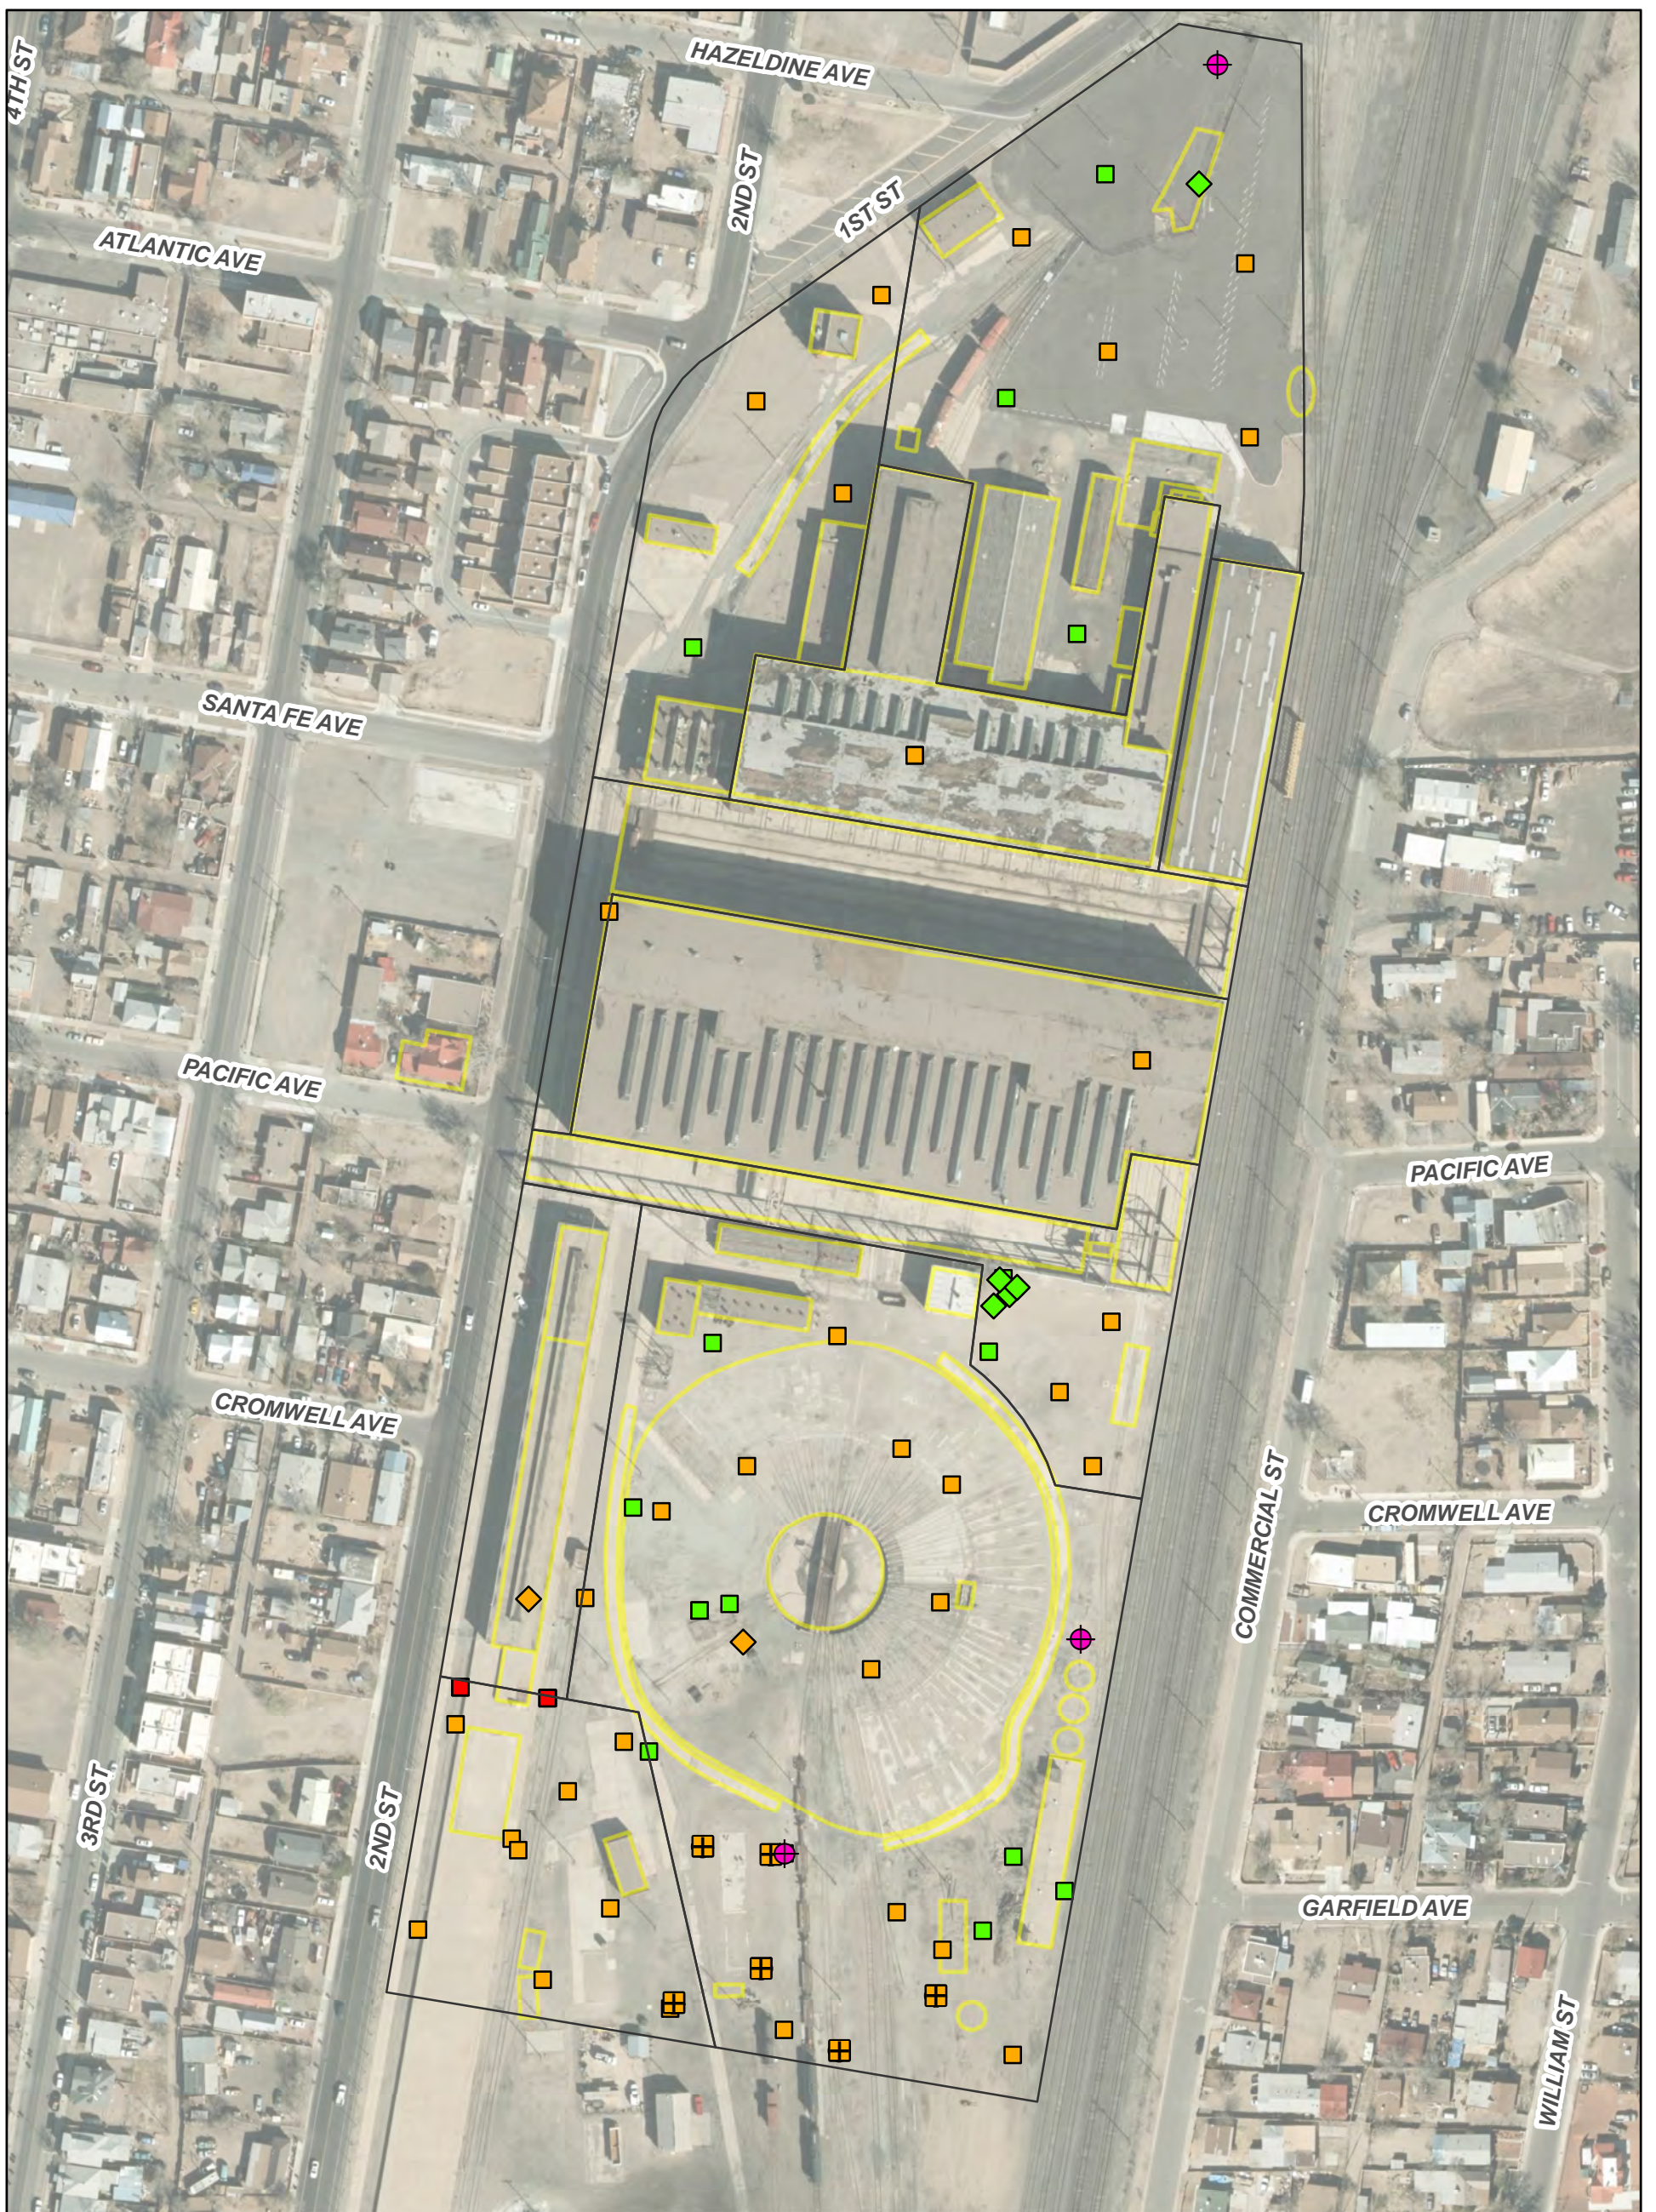
Residential SSL Exceedances
 (0-10 ft bgs), Indeno(1,2,3-cd)pyrene
 Additional Characterization,
 Voluntary Remediation Program Activities,
 Albuquerque Rail Yards, Albuquerque,
 Bernalillo County, New Mexico

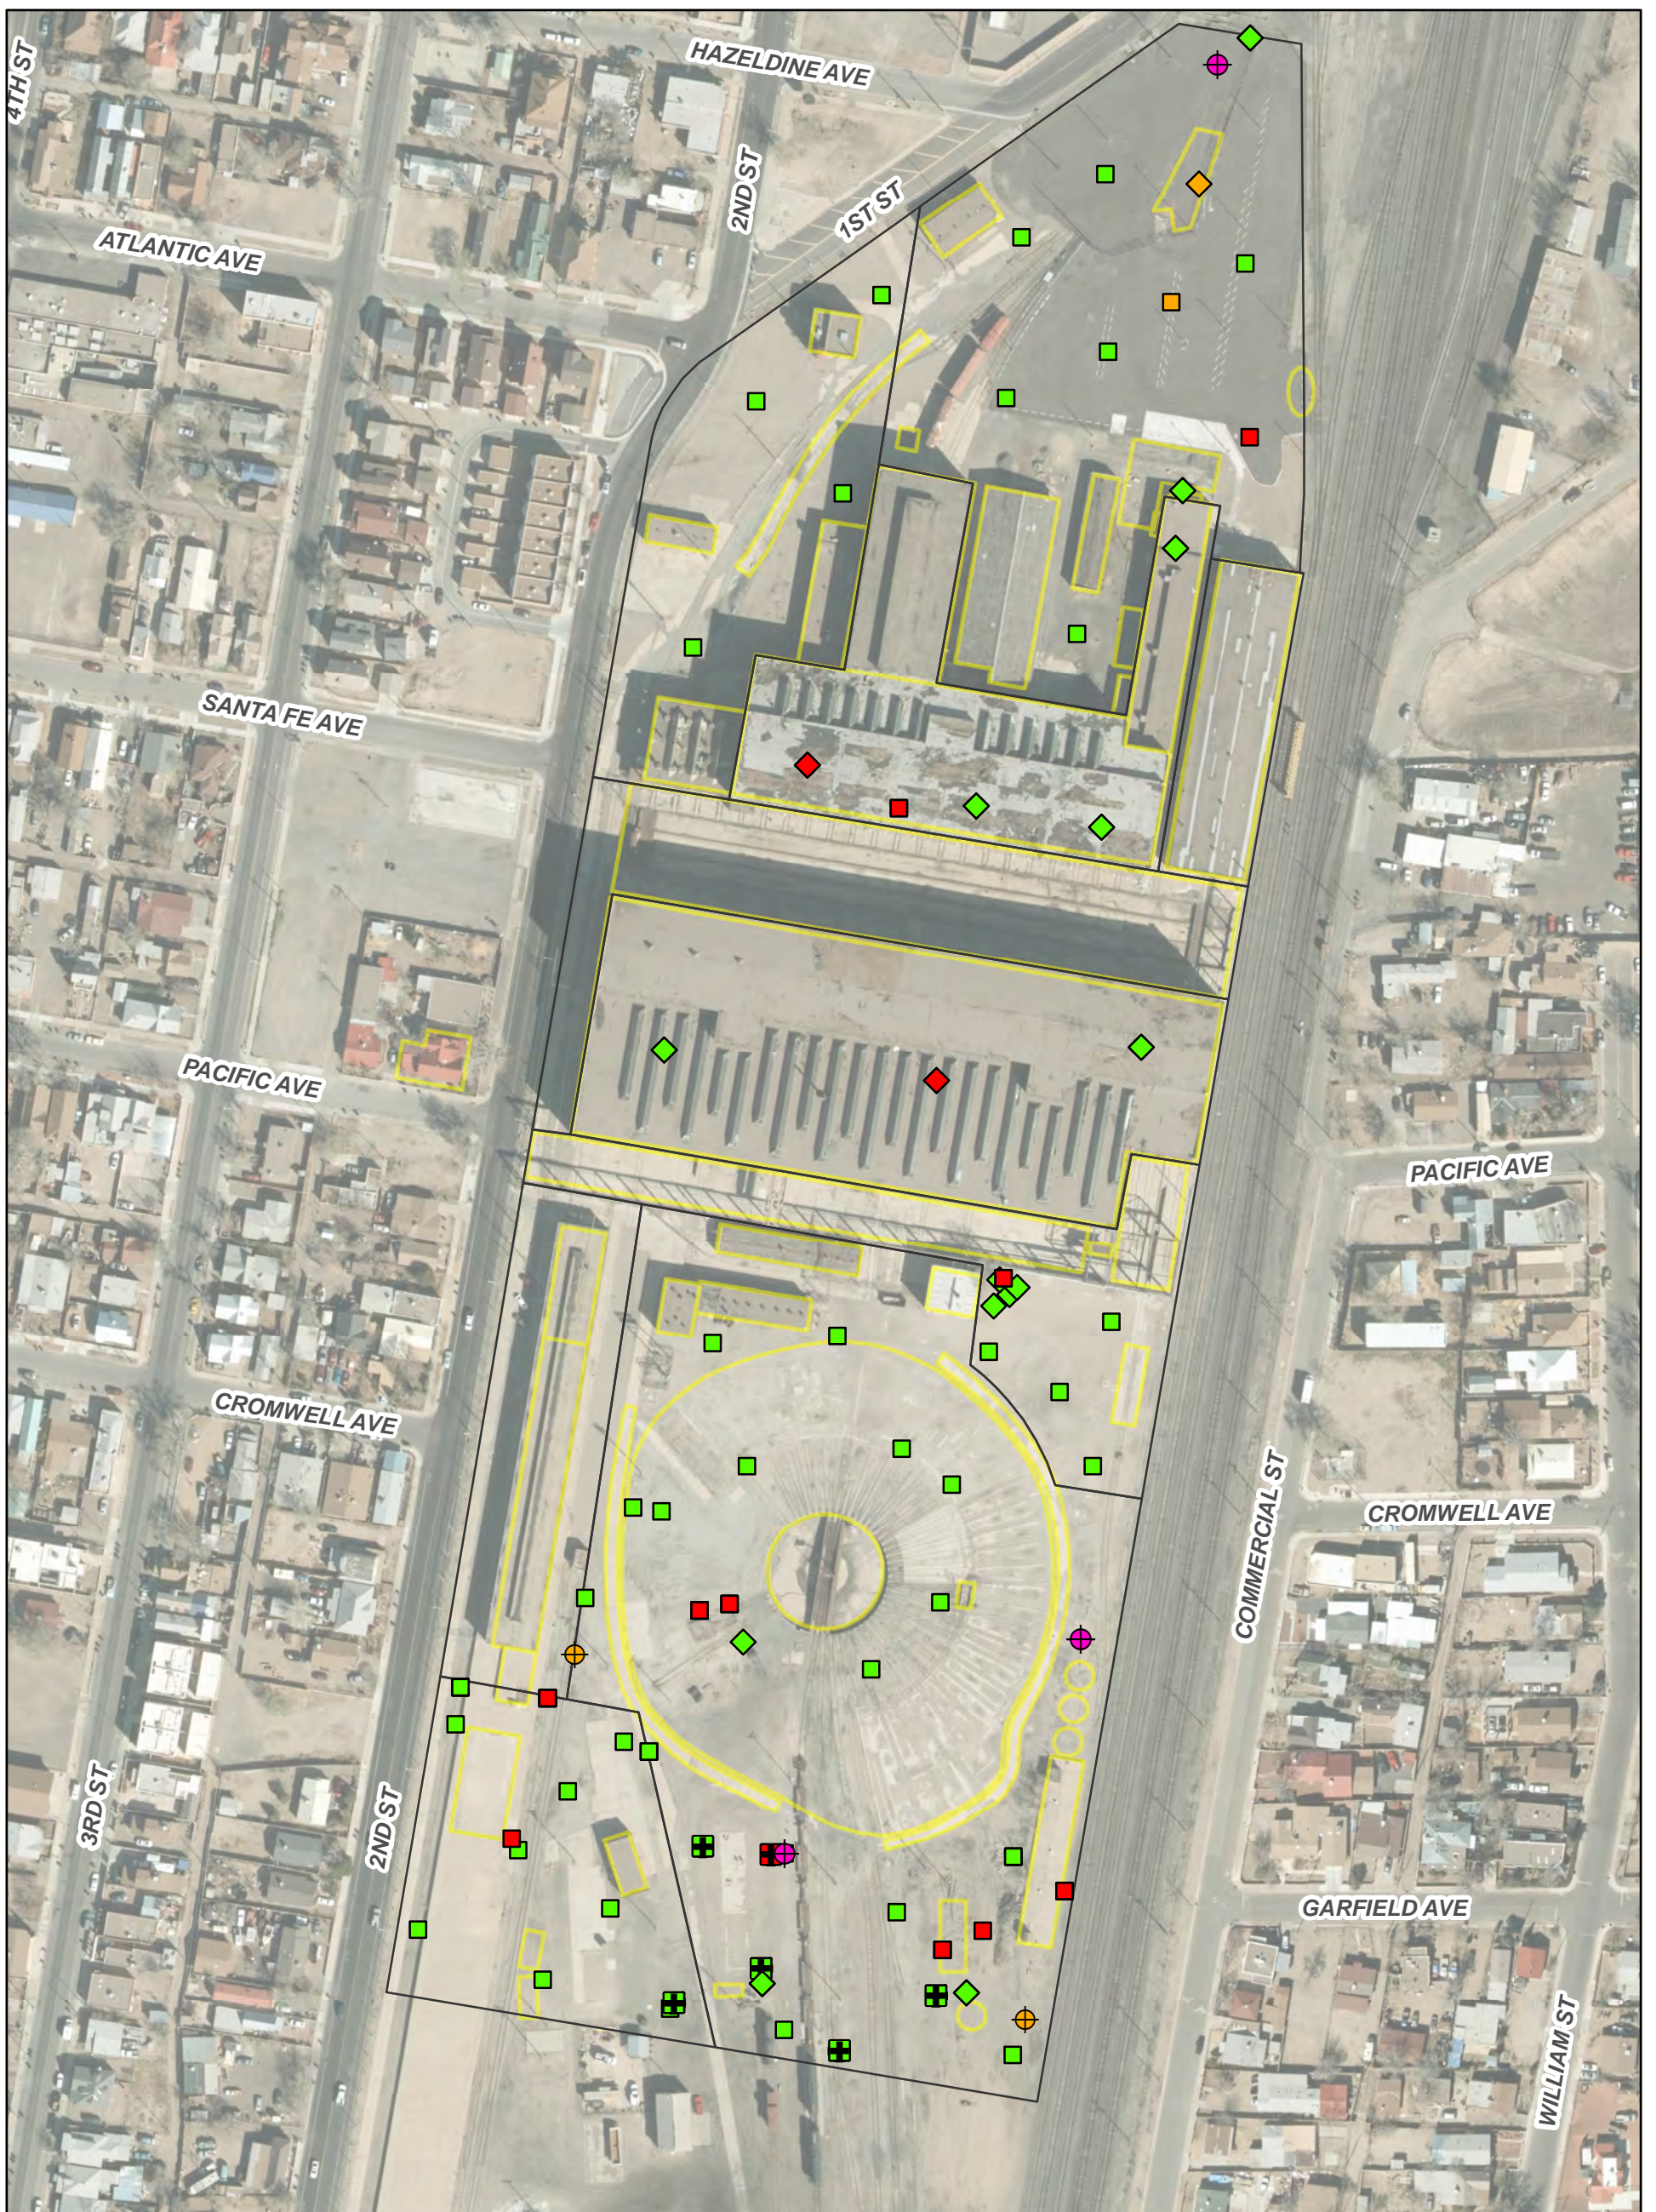
Residential SSL Exceedances (0-10 ft bgs), Thallium
 Additional Characterization, Voluntary Remediation Program Activities, Albuquerque Rail Yards, Albuquerque, Bernalillo County, New Mexico

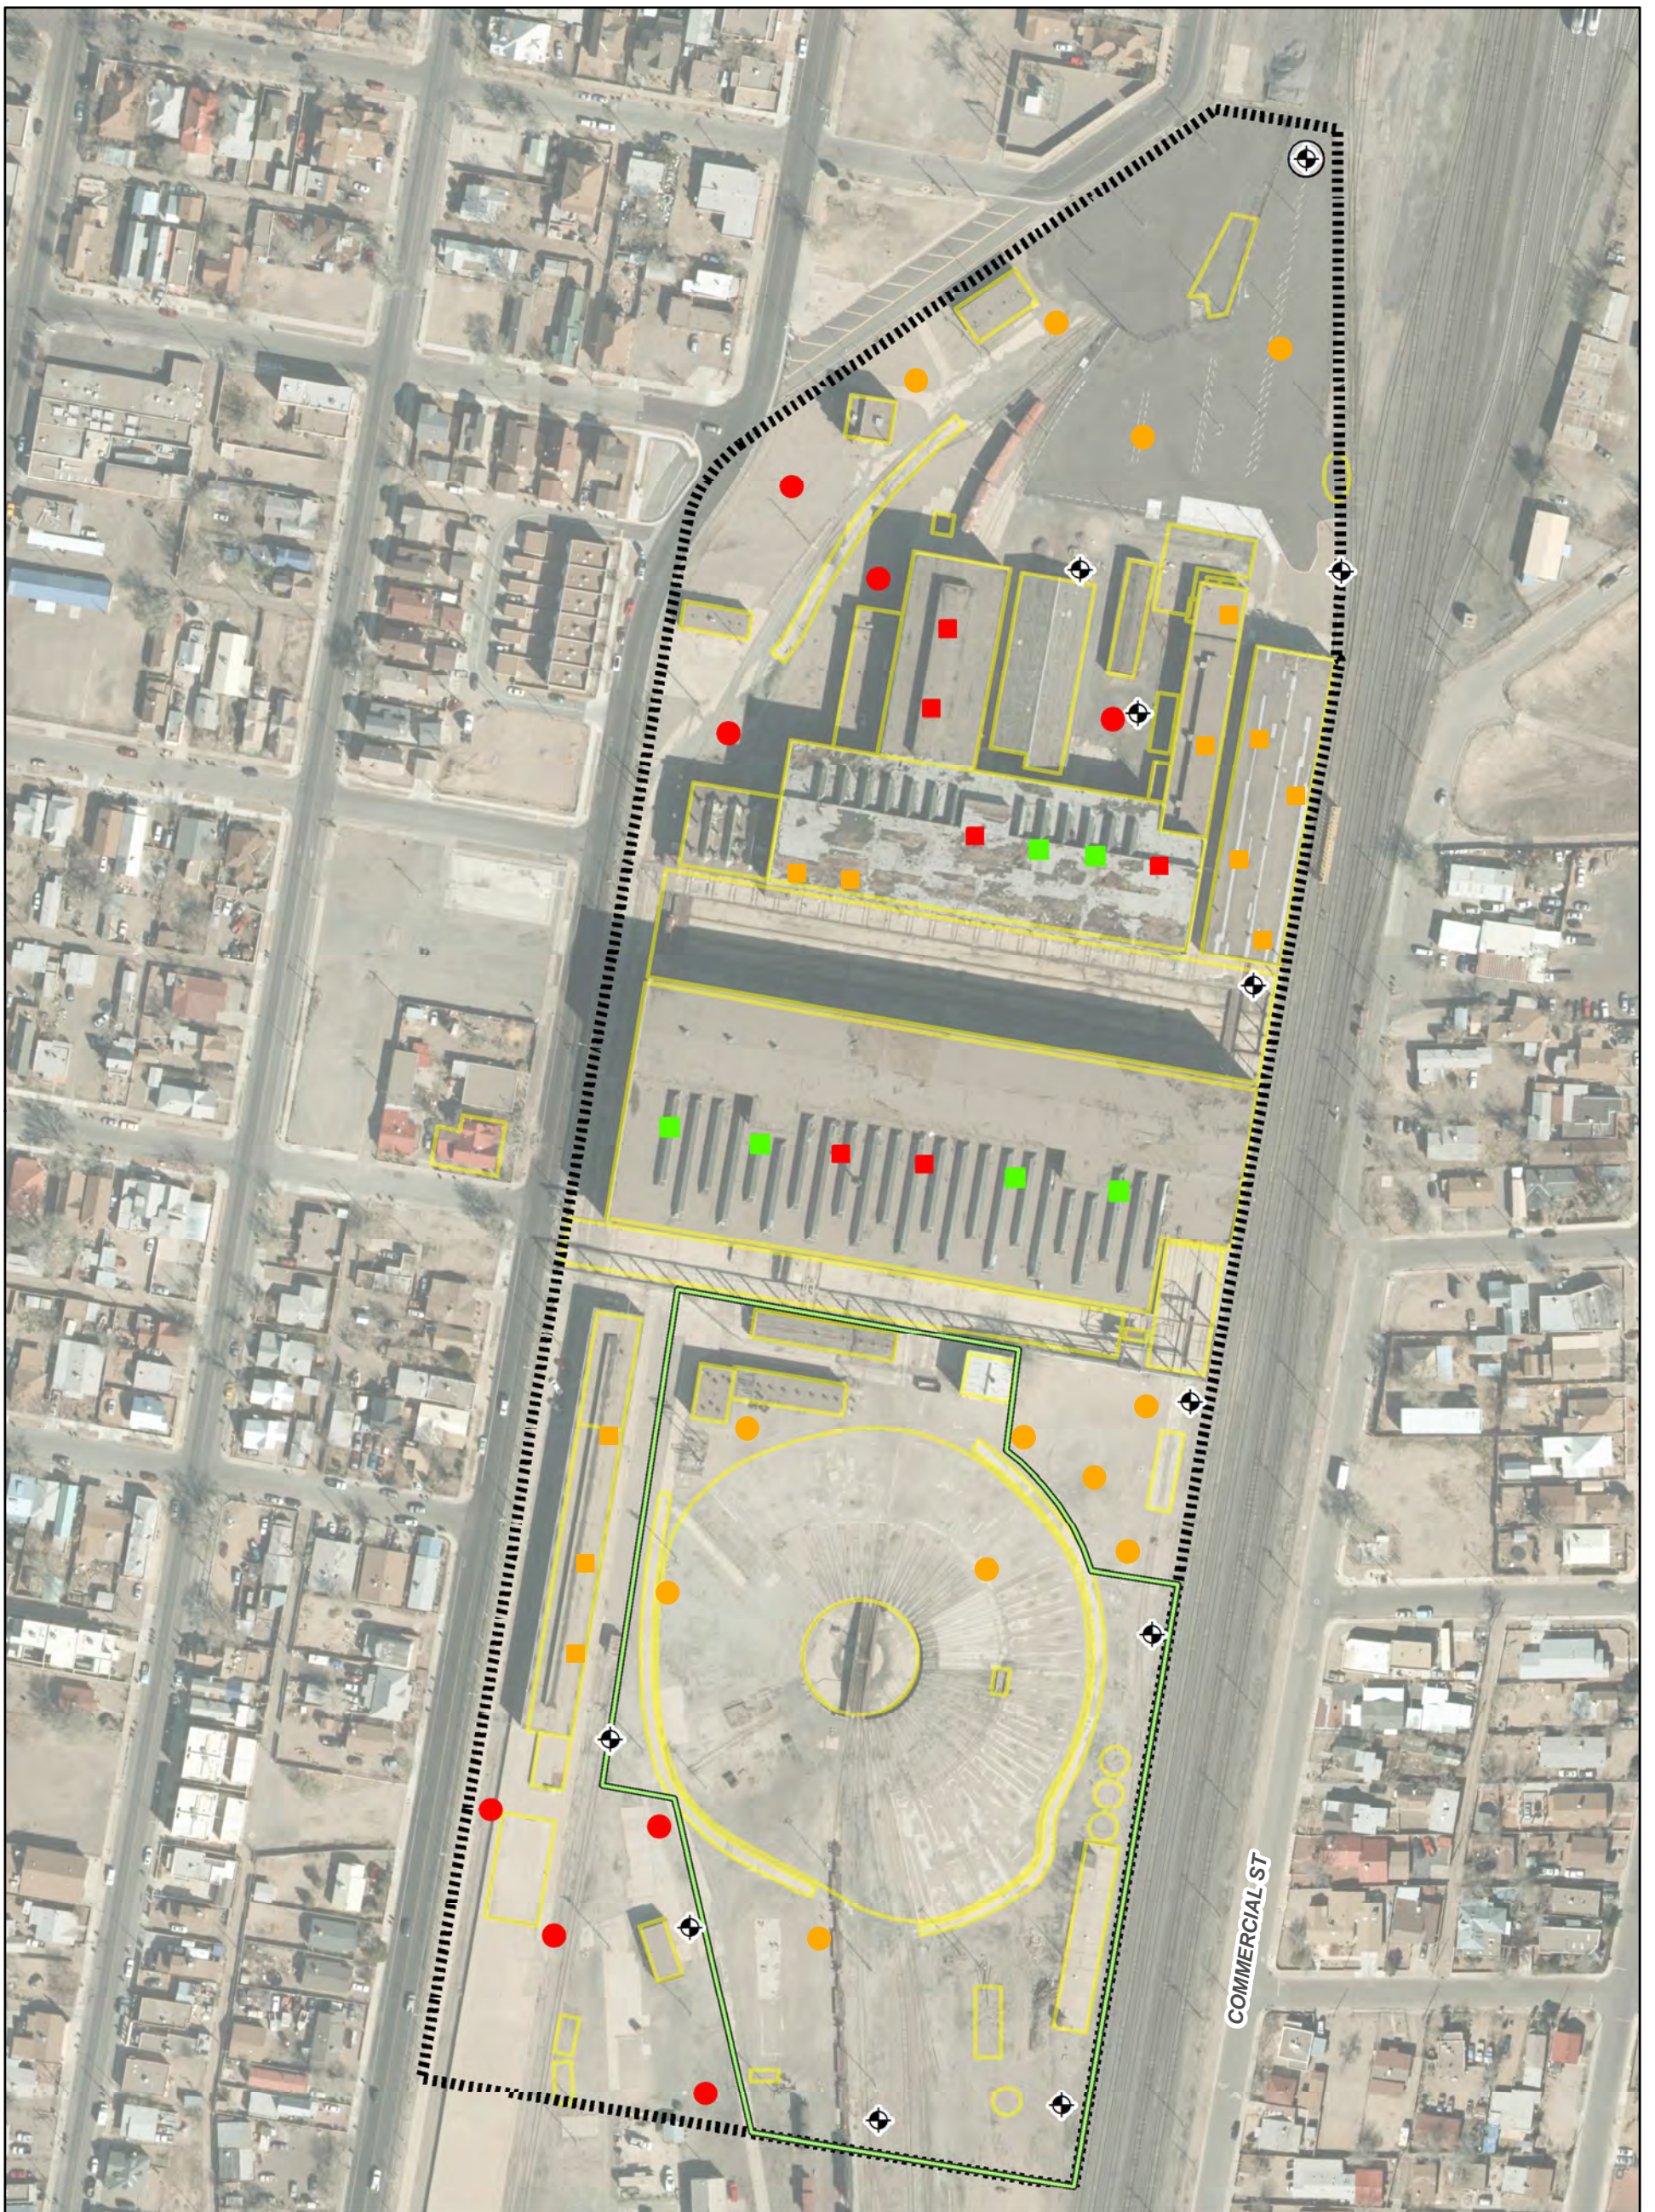
Note: TPH DRO + MRO is the summation of TPH DRO and TPH MRO, if non-detect than the laboratory reporting limit was used. Older TPH results from are reported as Total TPH. Some sample depths include a portion greater than 10 ft bgs (i.e., sample interval = 8 - 12 ft bgs).
 SSL: Soil Screening Levels (NMED, 2015)

Residential SSL Exceedances (0-10 ft bgs), TPH DRO + MRO, TPH Additional Characterization, Voluntary Remediation Program Activities, Albuquerque Rail Yards, Albuquerque, Bernalillo County, New Mexico
